# IndianOil

## JOURNEY RISK MANAGEMENT (JRM) STUDY

### Salem Terminal to Dhanalakshmi Agencies Adhoc

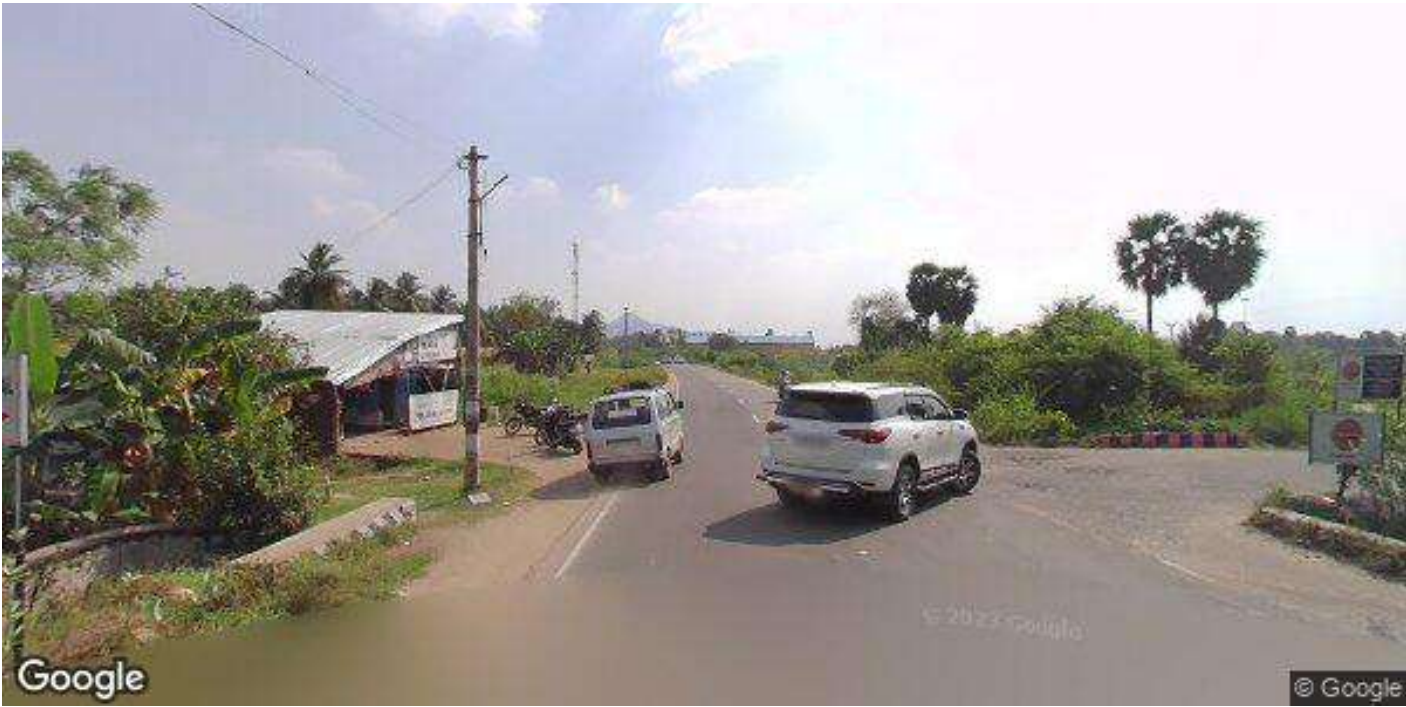
Risk Type: Turn  
Risk Level: High  
Speed Limit: 15 KM/Hr  
Coordinates: 11.44029, 77.87544

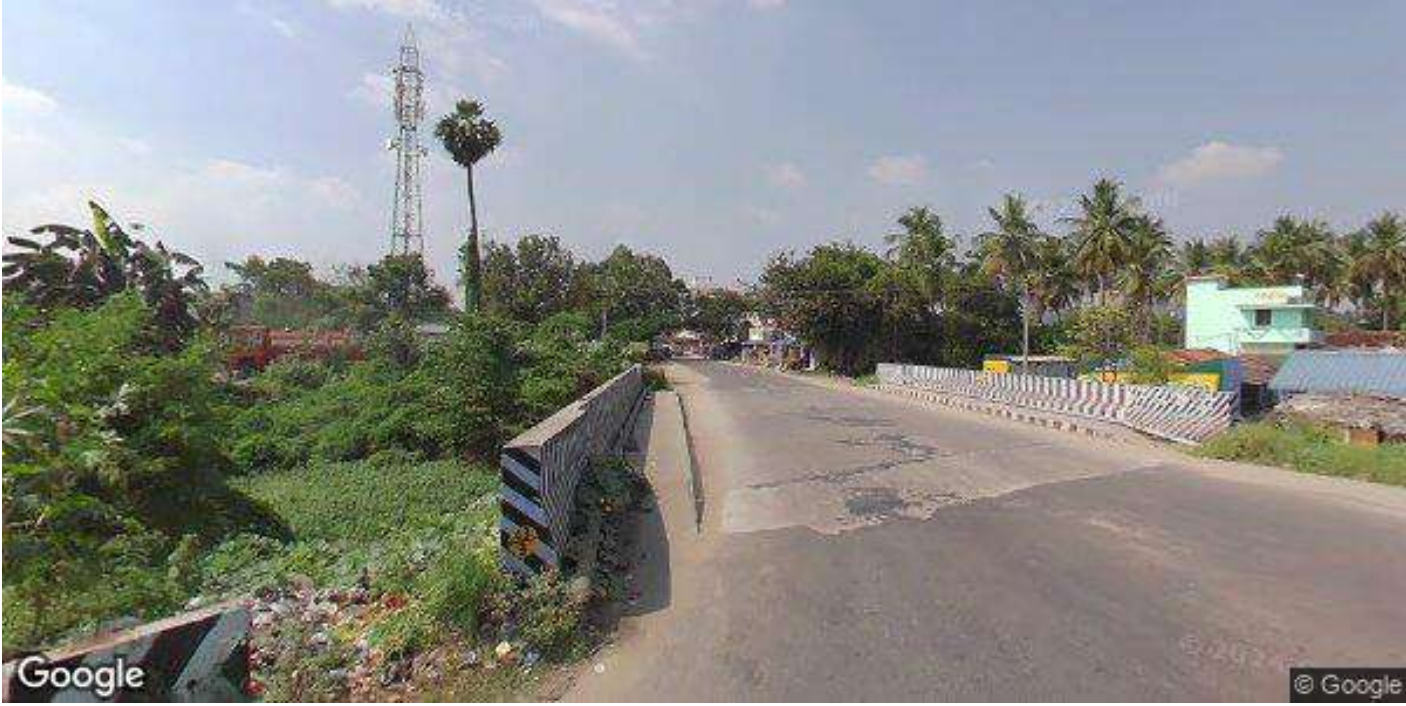
Risk Type: Turn  
Risk Level: Medium

**Speed Limit: 30 KM/Hr**  
**Coordinates: 11.44900, 77.87406**

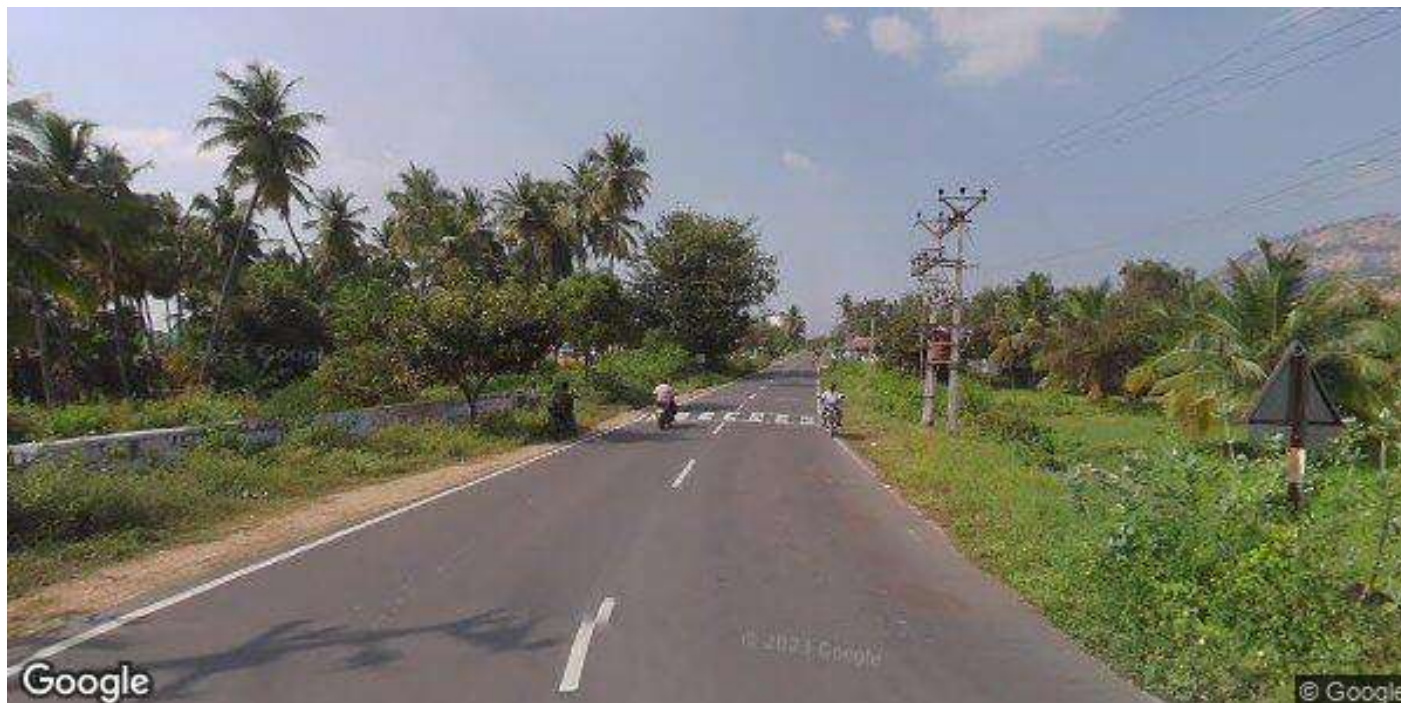
**Risk Type: Turn**  
**Risk Level: High**  
**Speed Limit: 15 KM/Hr**  
**Coordinates: 11.45353, 77.85697**

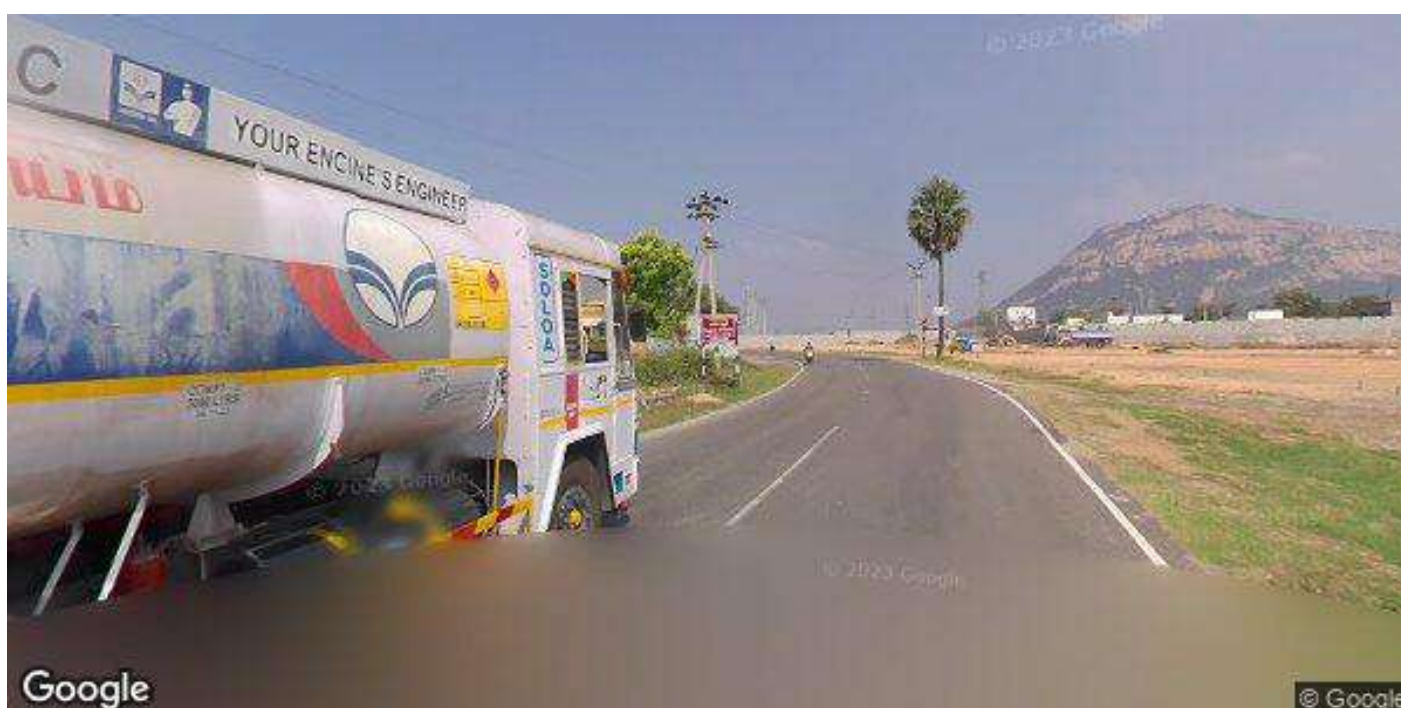
**Risk Type: Turn**  
**Risk Level: Medium**  
**Speed Limit: 30 KM/Hr**  
**Coordinates: 11.45853, 77.85139**

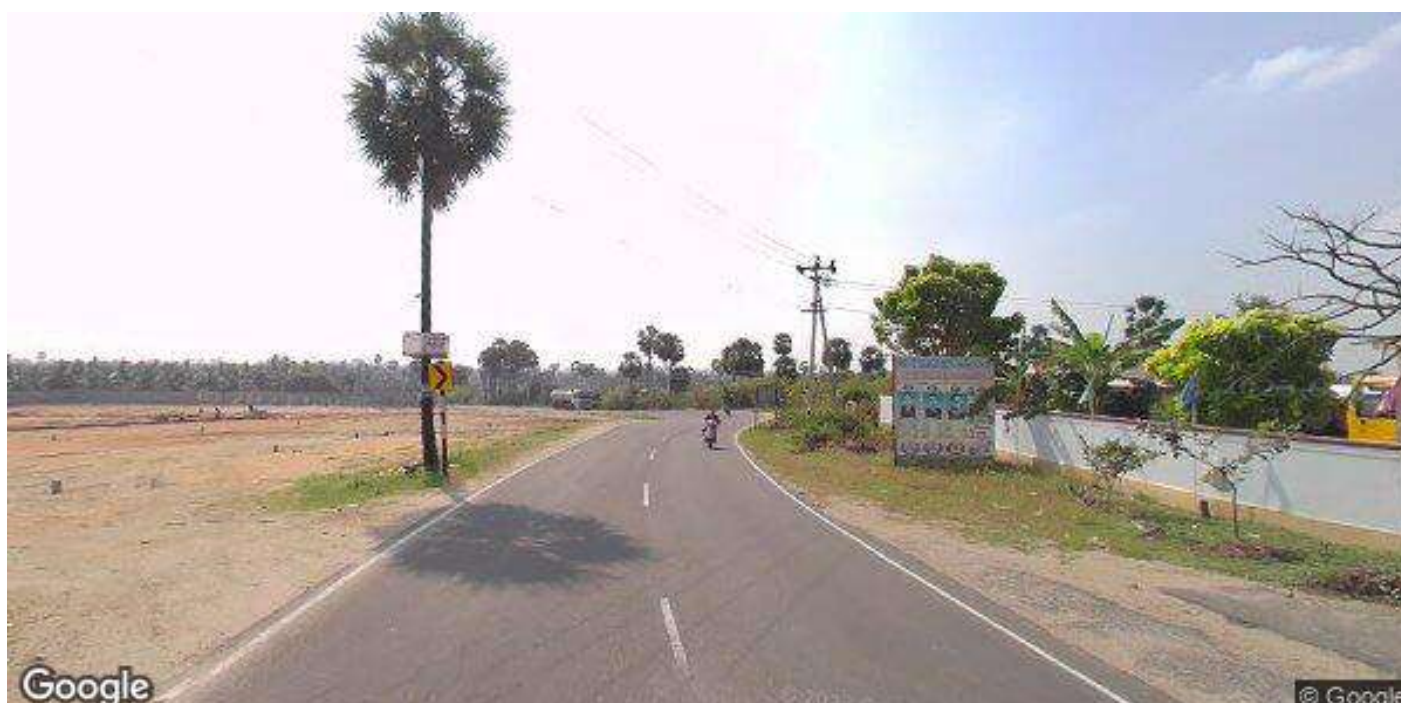
**Risk Type:** Turn  
**Risk Level:** Medium  
**Speed Limit:** 30 KM/Hr  
**Coordinates:** 11.45906, 77.85132

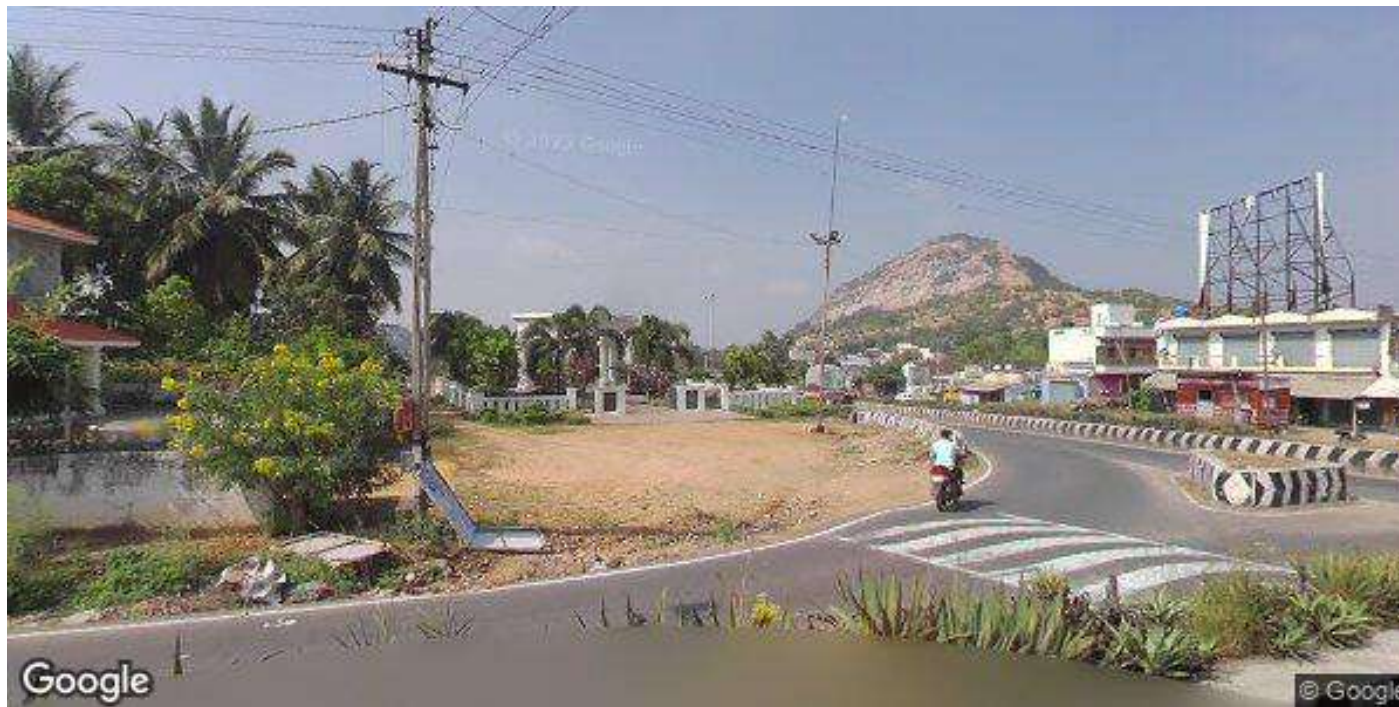
**Risk Type:** Turn  
**Risk Level:** High  
**Speed Limit:** 15 KM/Hr  
**Coordinates:** 11.46307, 77.84941

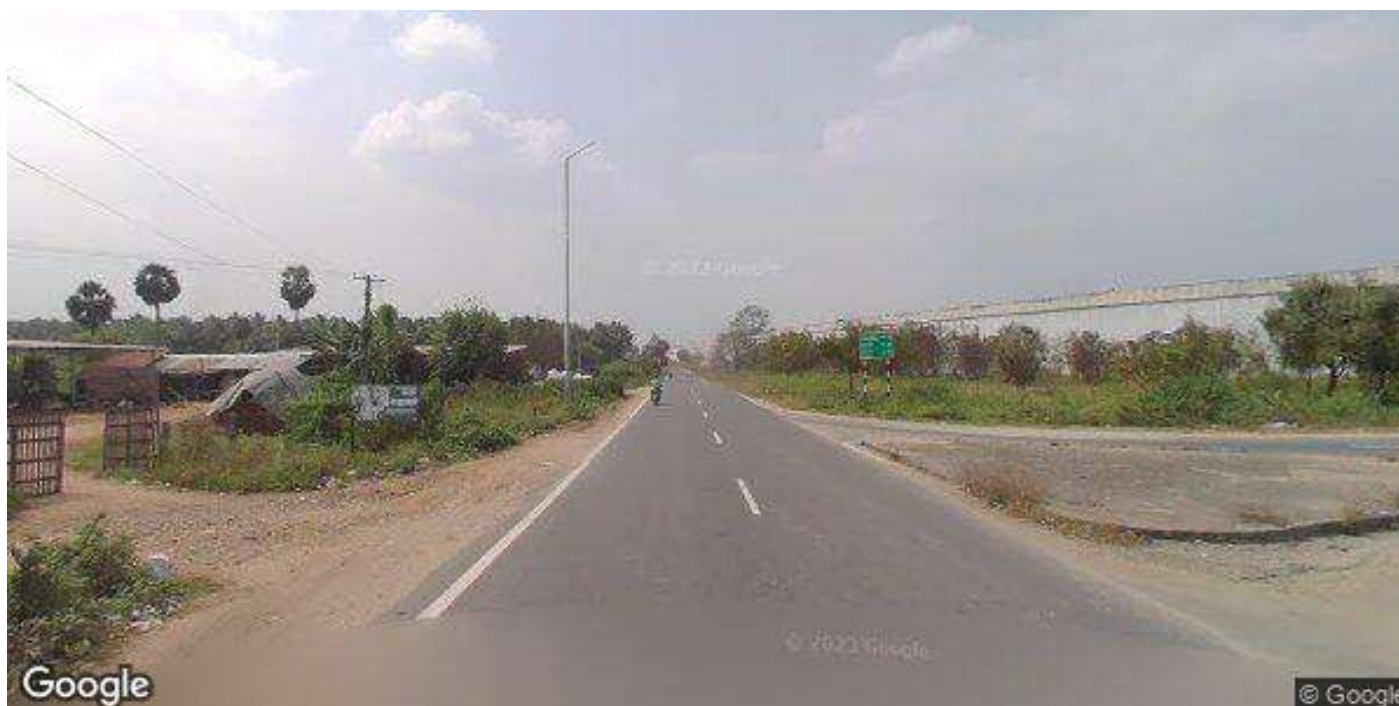
**Risk Type:** Turn  
**Risk Level:** High  
**Speed Limit:** 15 KM/Hr  
**Coordinates:** 11.45542, 77.81725

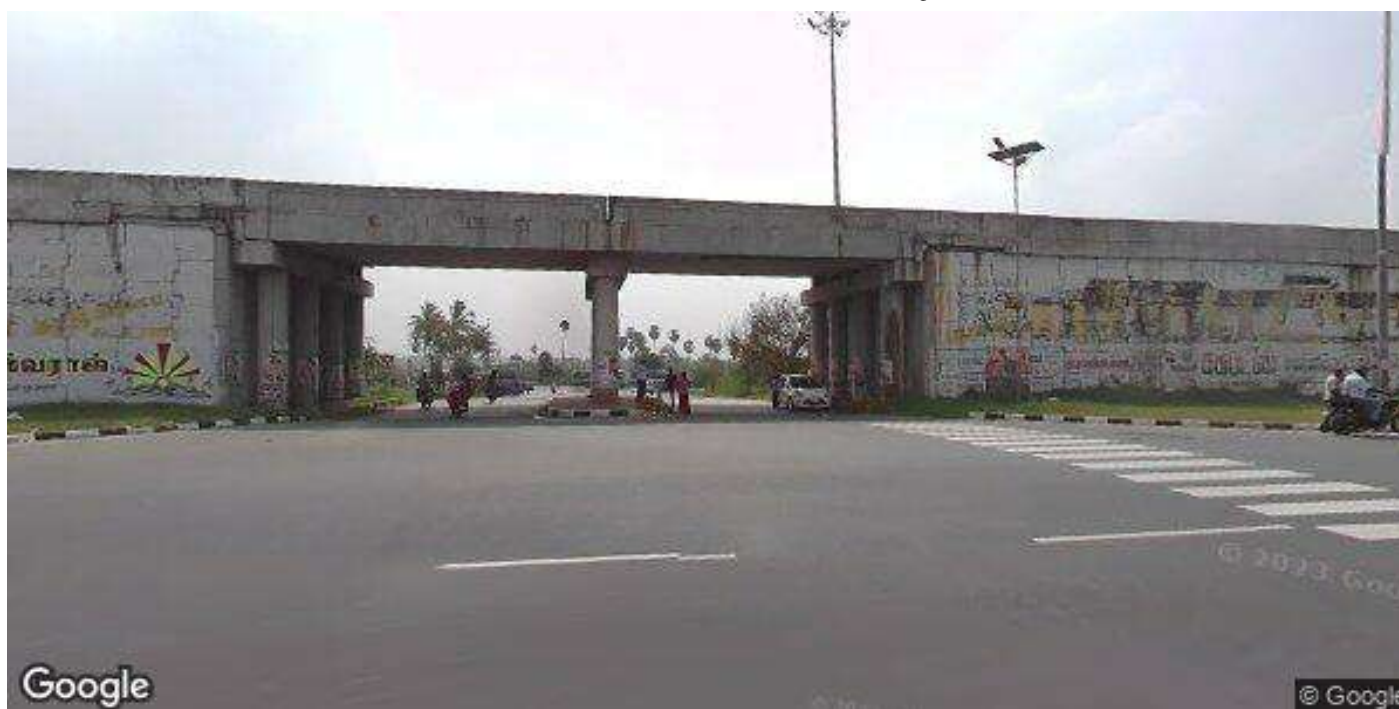
**Risk Type:** Turn  
**Risk Level:** High  
**Speed Limit:** 15 KM/Hr  
**Coordinates:** 11.45636, 77.81678

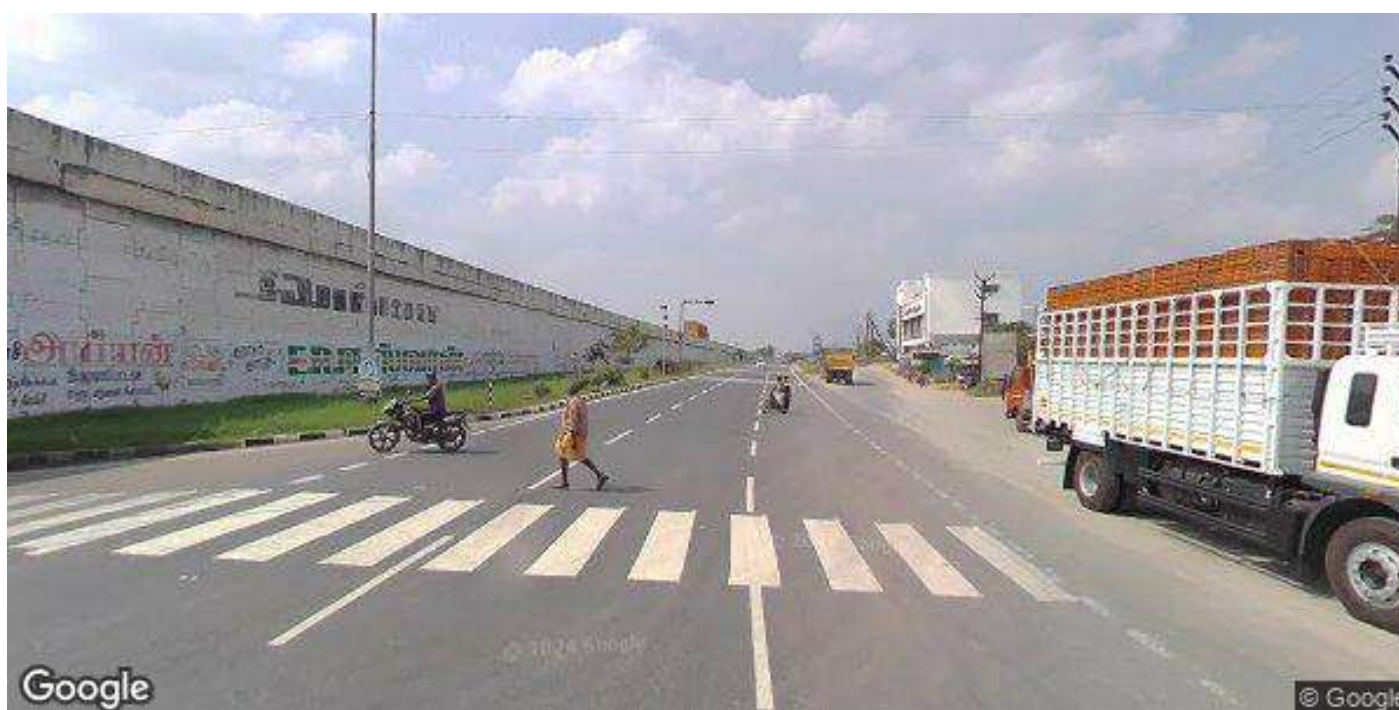
**Risk Type:** Turn  
**Risk Level:** High  
**Speed Limit:** 15 KM/Hr  
**Coordinates:** 11.49224, 77.89606

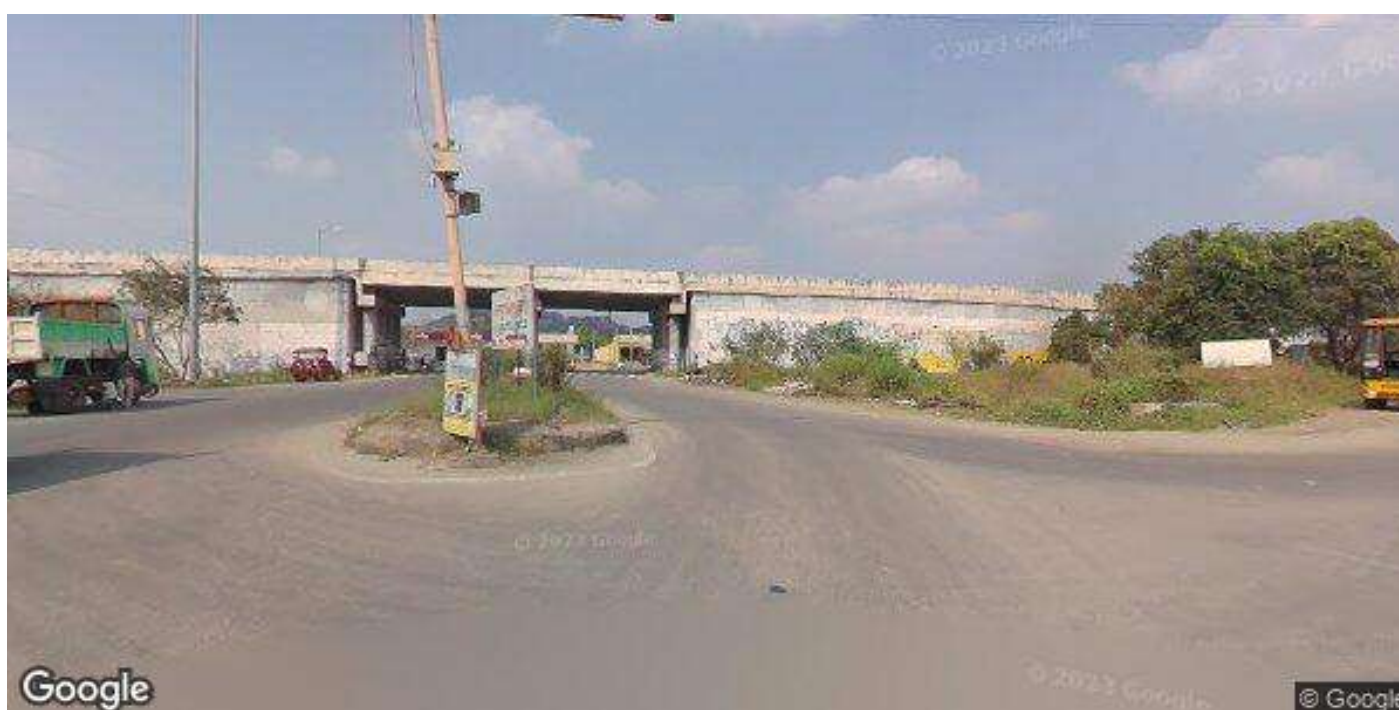
**Risk Type:** Turn  
**Risk Level:** High  
**Speed Limit:** 15 KM/Hr  
**Coordinates:** 11.49153, 77.89615

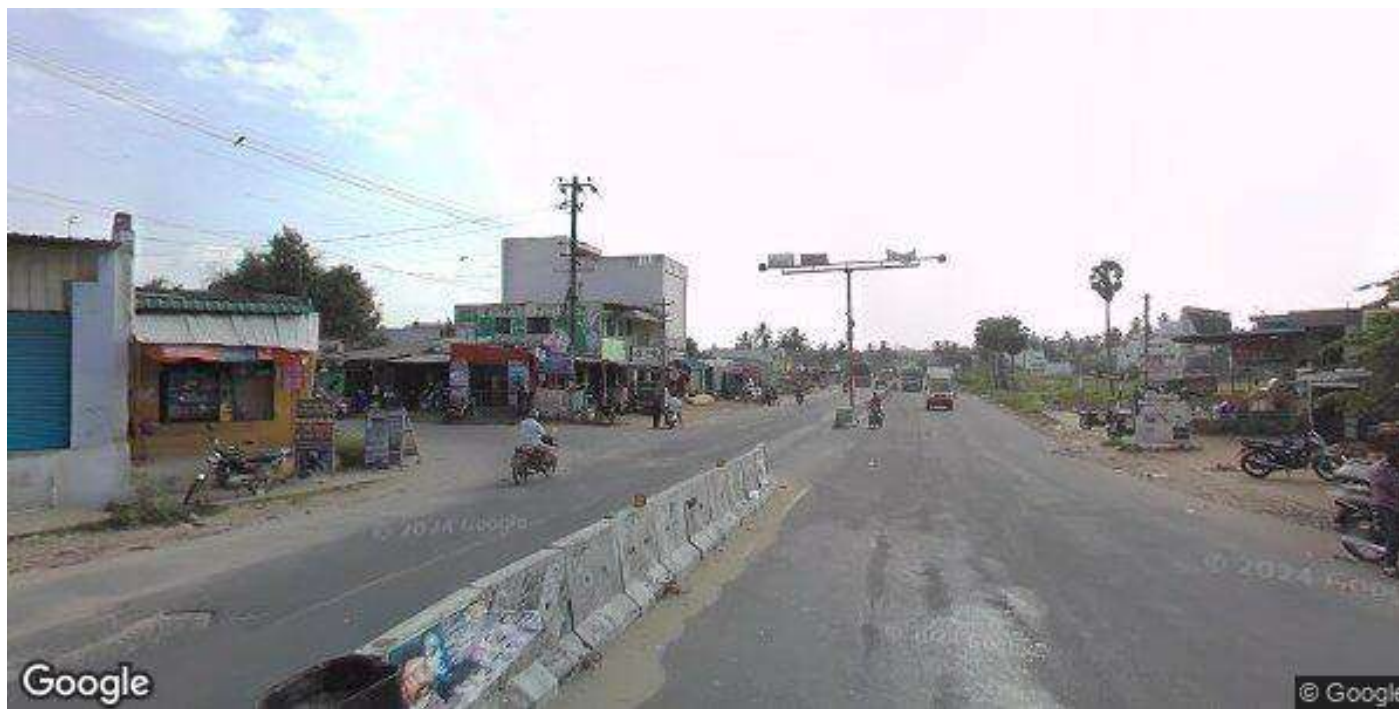
**Risk Type:** Blind Spot  
**Risk Level:** Blind Spot  
**Speed Limit:** 10 KM/Hr  
**Coordinates:** 11.48364, 77.88780

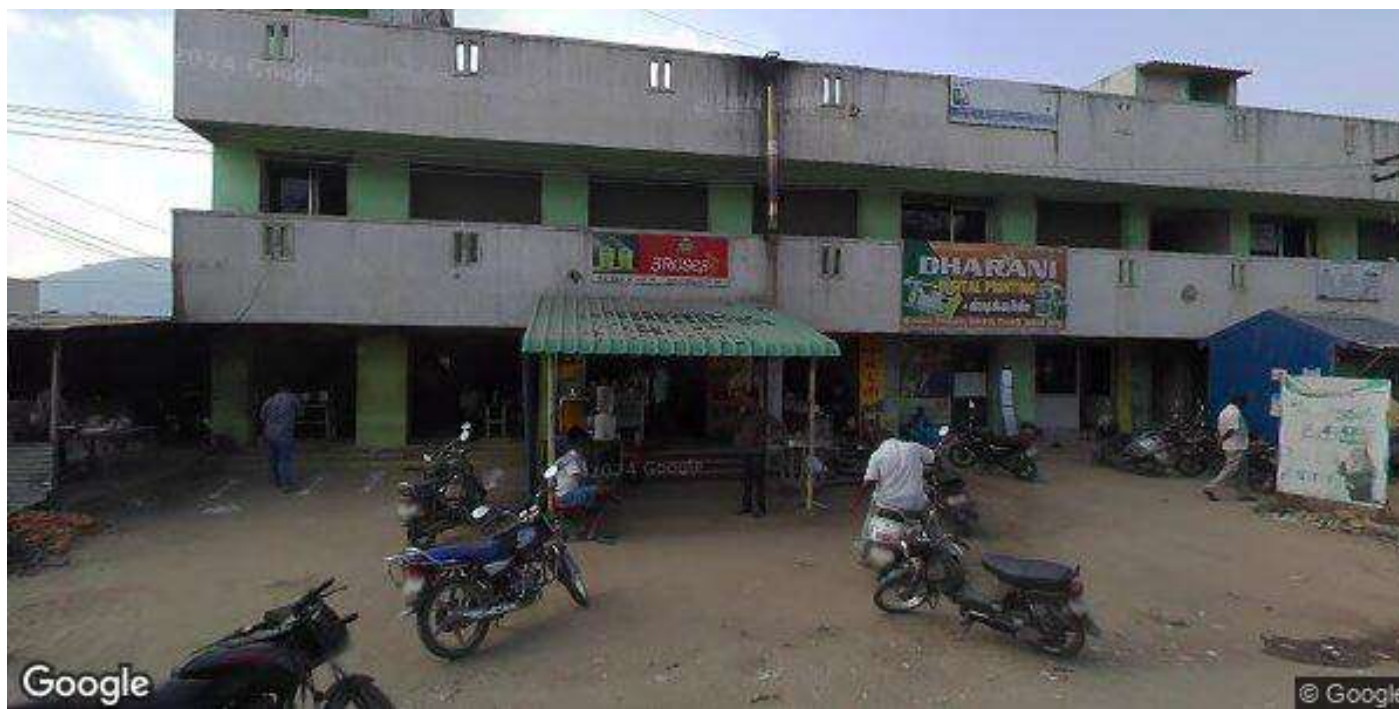
**Risk Type:** Turn  
**Risk Level:** Medium  
**Speed Limit:** 30 KM/Hr  
**Coordinates:** 11.49155, 77.88776

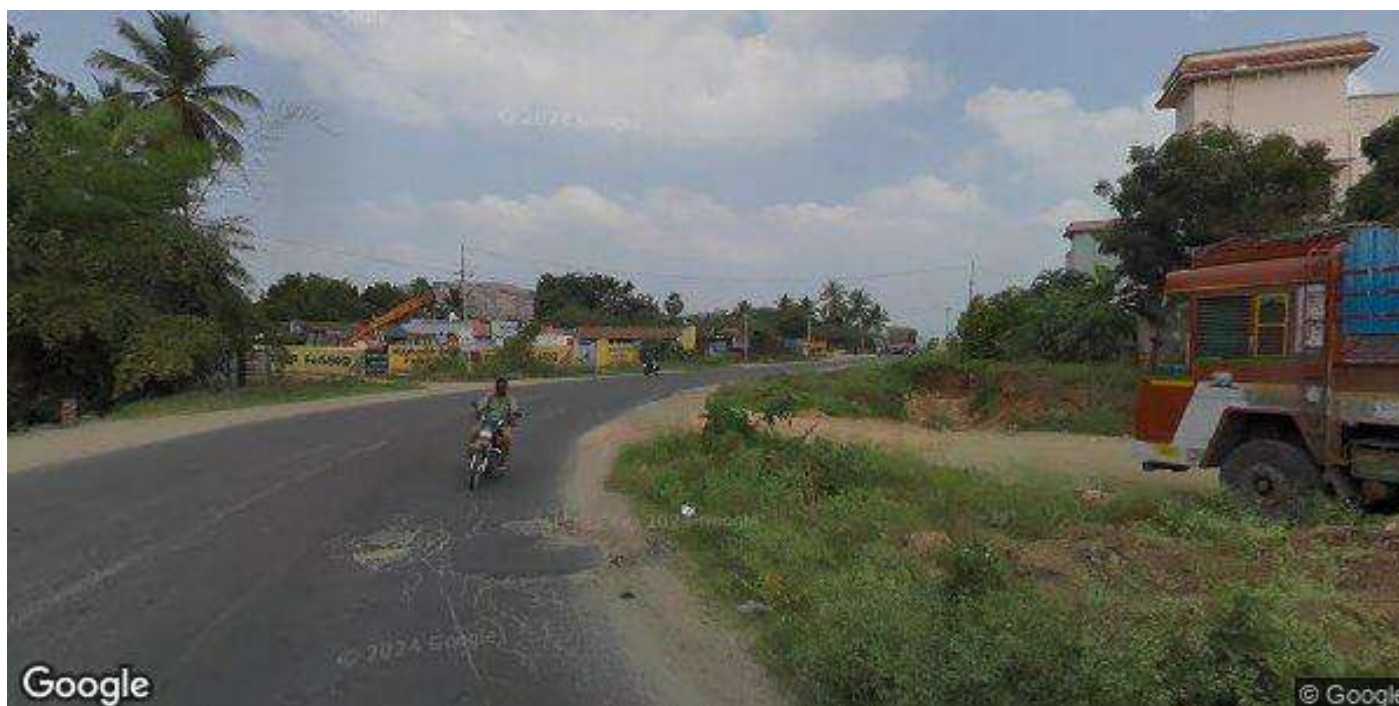
**Risk Type:** Turn  
**Risk Level:** Medium  
**Speed Limit:** 30 KM/Hr  
**Coordinates:** 11.49441, 77.88495

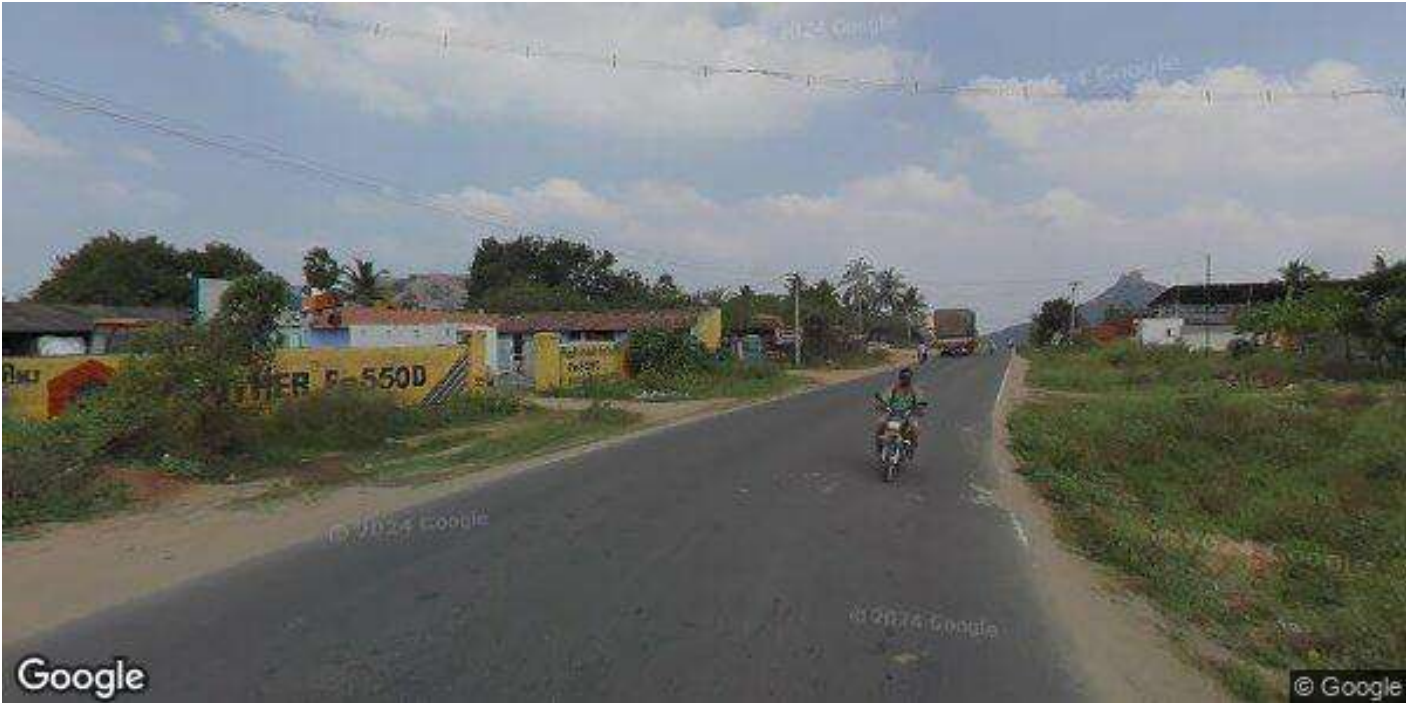
**Risk Type:** Turn  
**Risk Level:** Medium  
**Speed Limit:** 30 KM/Hr  
**Coordinates:** 11.49469, 77.88488

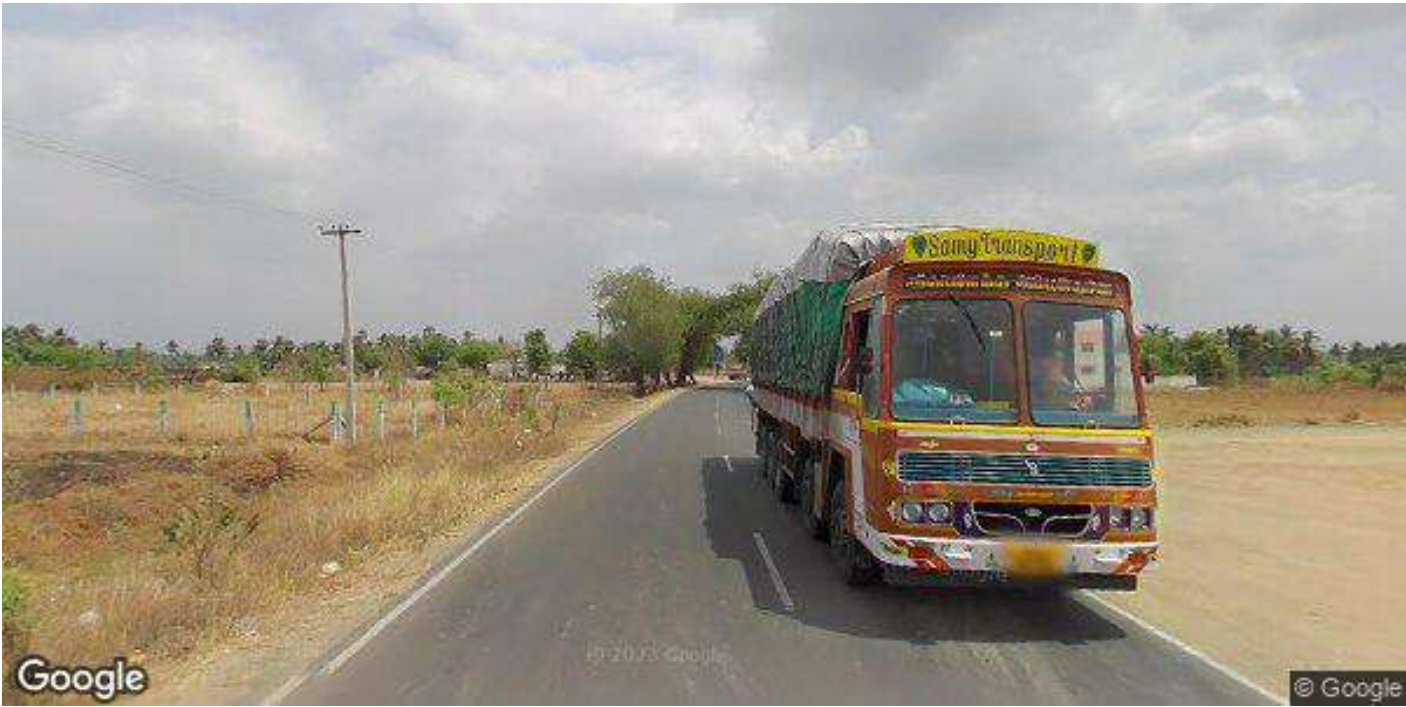
**Risk Type:** Turn  
**Risk Level:** High  
**Speed Limit:** 15 KM/Hr  
**Coordinates:** 11.55614, 77.89764

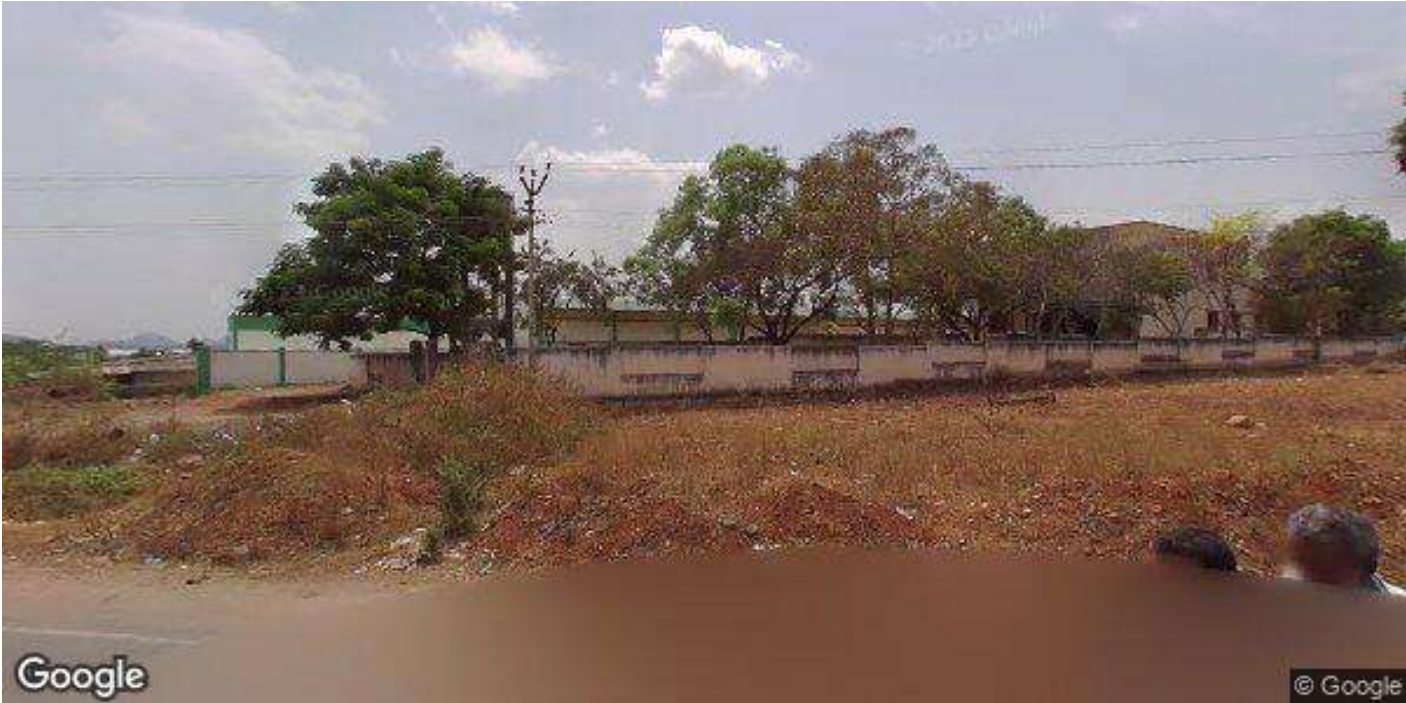
**Risk Type:** Turn  
**Risk Level:** High  
**Speed Limit:** 15 KM/Hr  
**Coordinates:** 11.58330, 77.90642

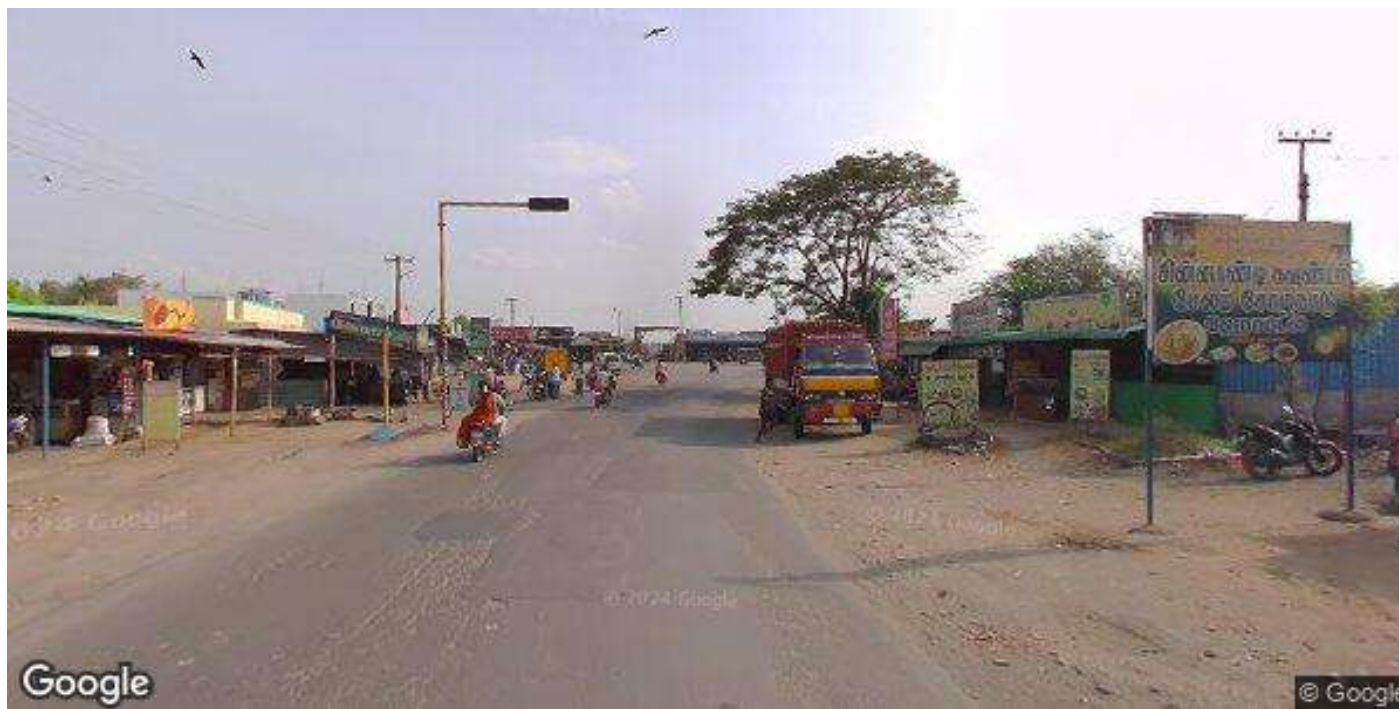
**Risk Type:** Turn  
**Risk Level:** Medium  
**Speed Limit:** 30 KM/Hr  
**Coordinates:** 11.64217, 77.95200

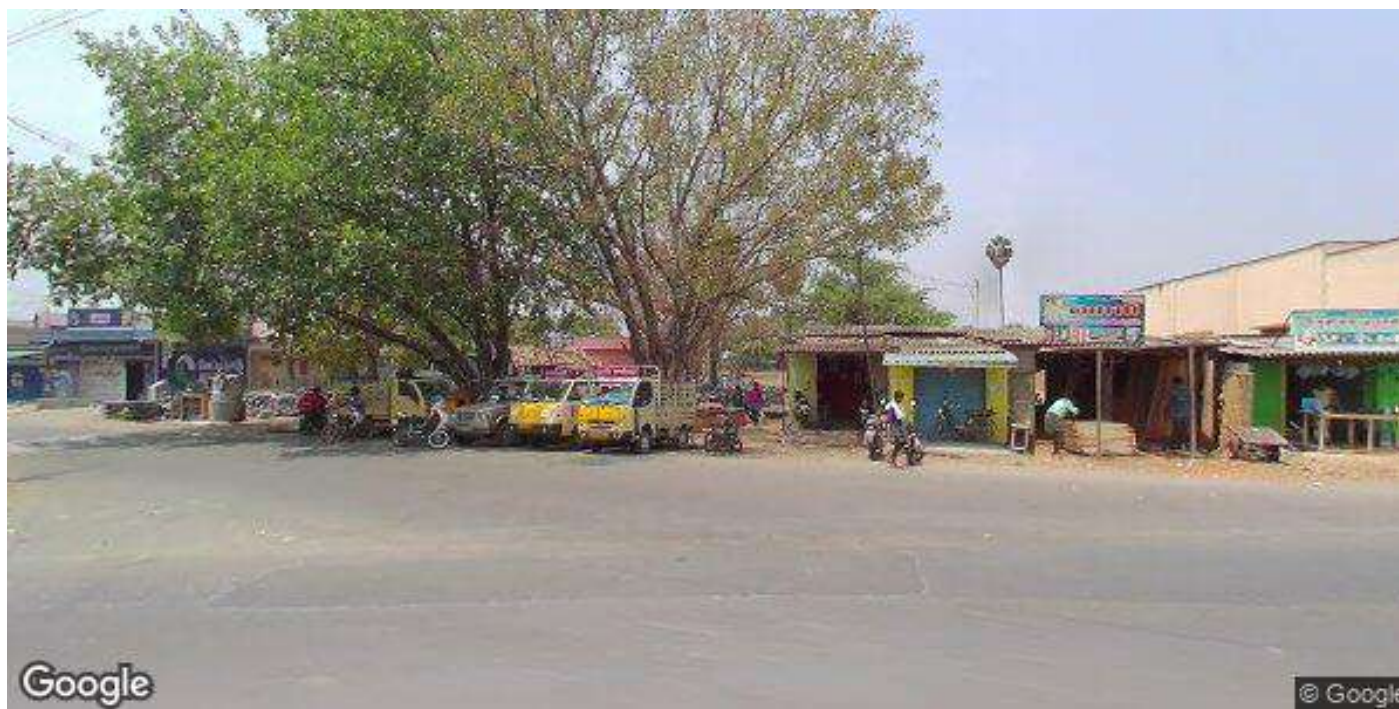
**Risk Type:** Turn  
**Risk Level:** Medium  
**Speed Limit:** 30 KM/Hr  
**Coordinates:** 11.64712, 77.95118

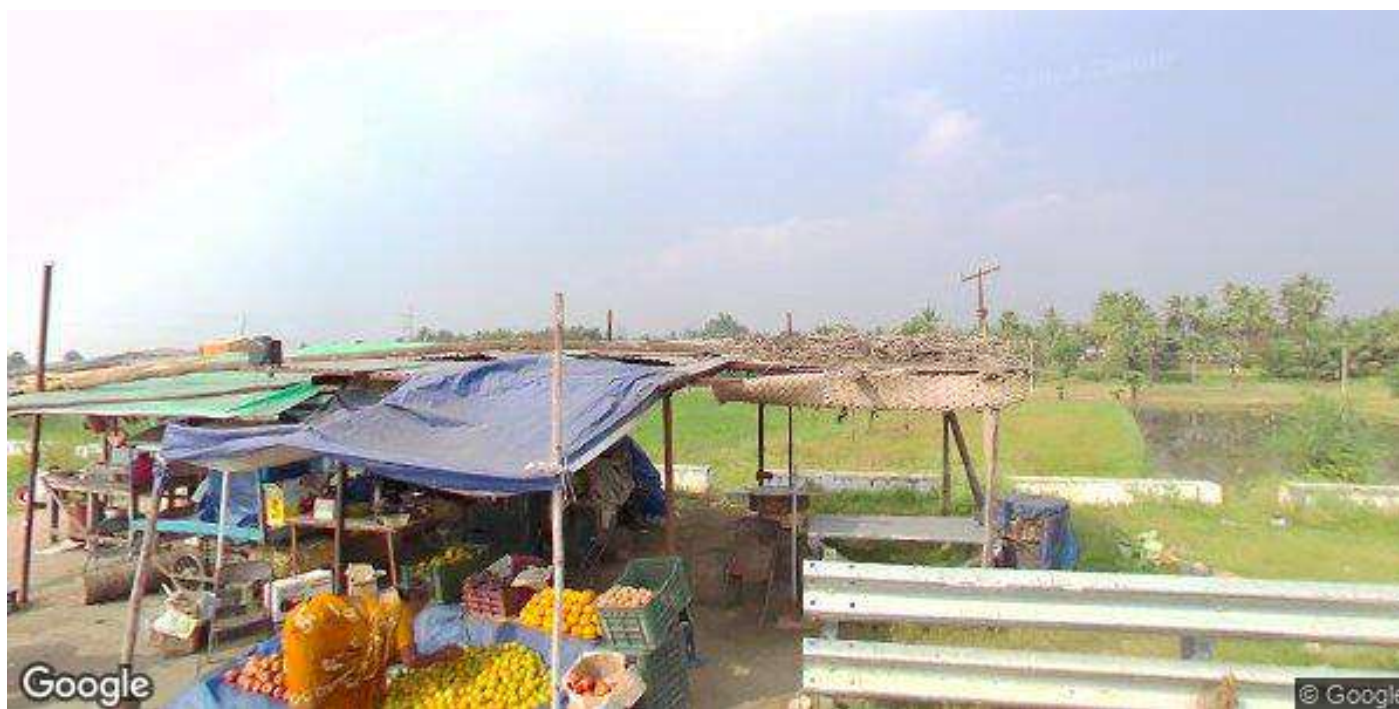
**Risk Type:** Turn  
**Risk Level:** Medium  
**Speed Limit:** 30 KM/Hr  
**Coordinates:** 11.67858, 77.96834

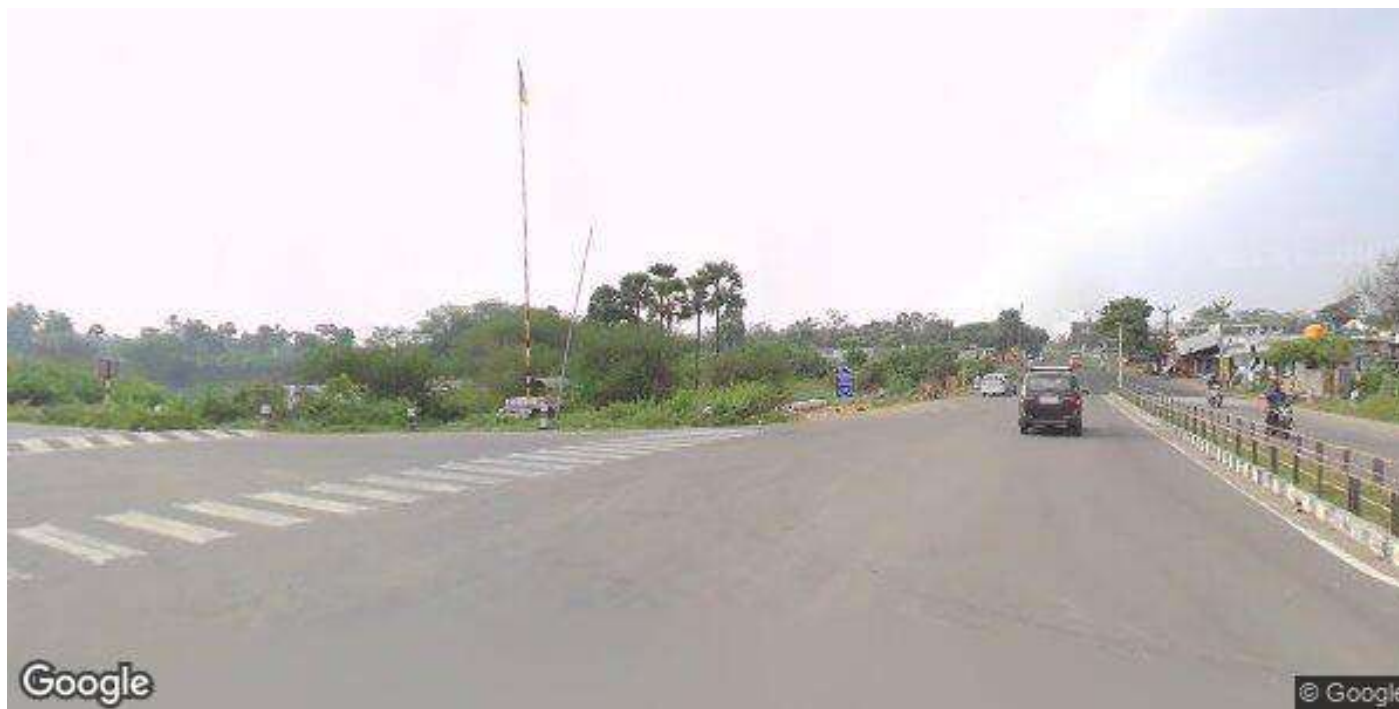
**Risk Type:** Turn  
**Risk Level:** High  
**Speed Limit:** 15 KM/Hr  
**Coordinates:** 11.70218, 77.97866

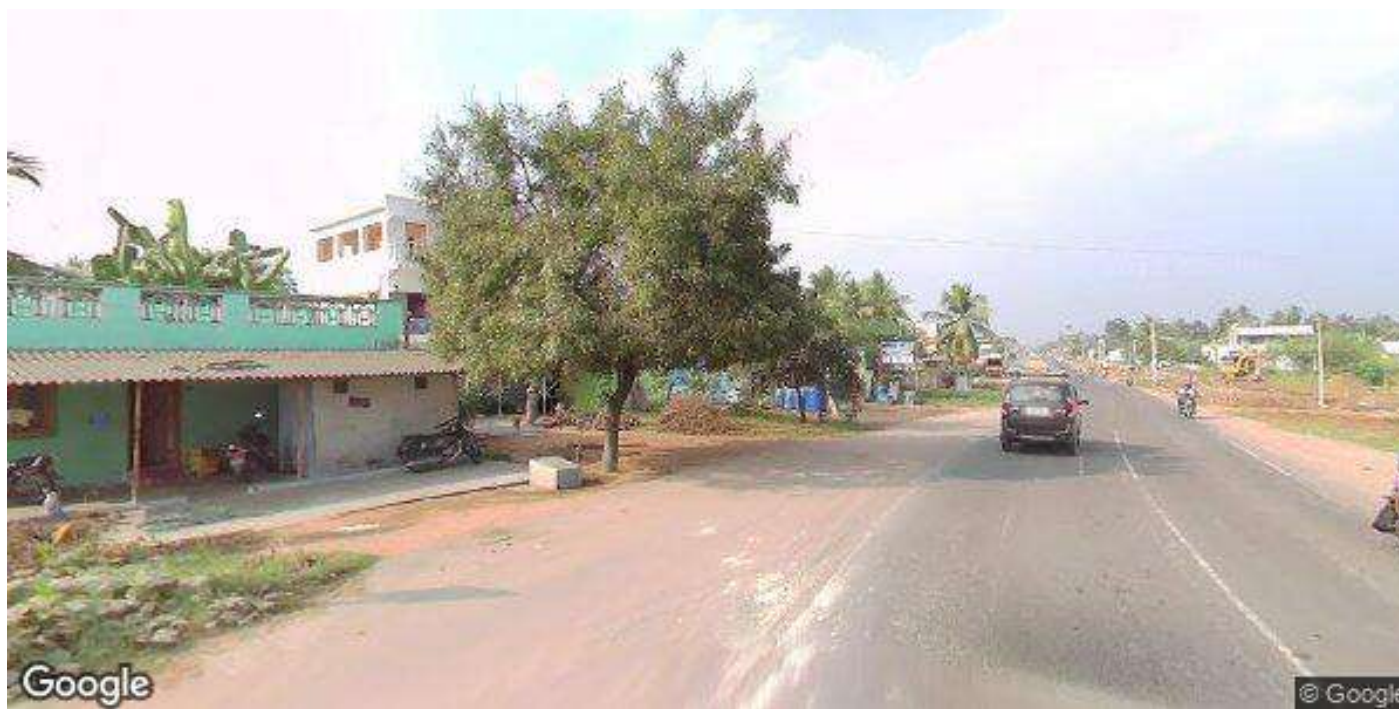
**Risk Type:** Turn  
**Risk Level:** Medium  
**Speed Limit:** 30 KM/Hr  
**Coordinates:** 11.71917, 78.01123

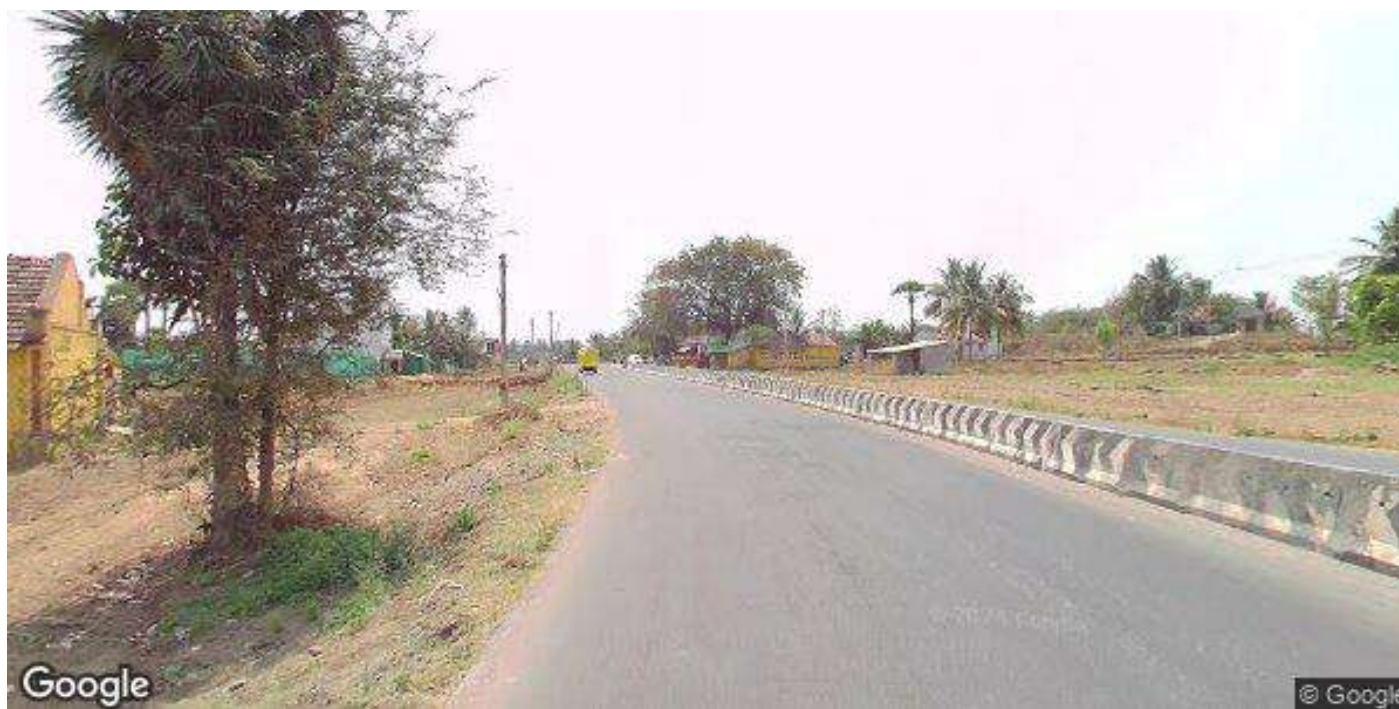
**Risk Type:** Turn  
**Risk Level:** Medium  
**Speed Limit:** 30 KM/Hr  
**Coordinates:** 11.72565, 78.01770
