# IndianOil

## JOURNEY RISK MANAGEMENT (JRM) STUDY

### Salem Terminal to Dhanalakshmi Agencies Adhoc

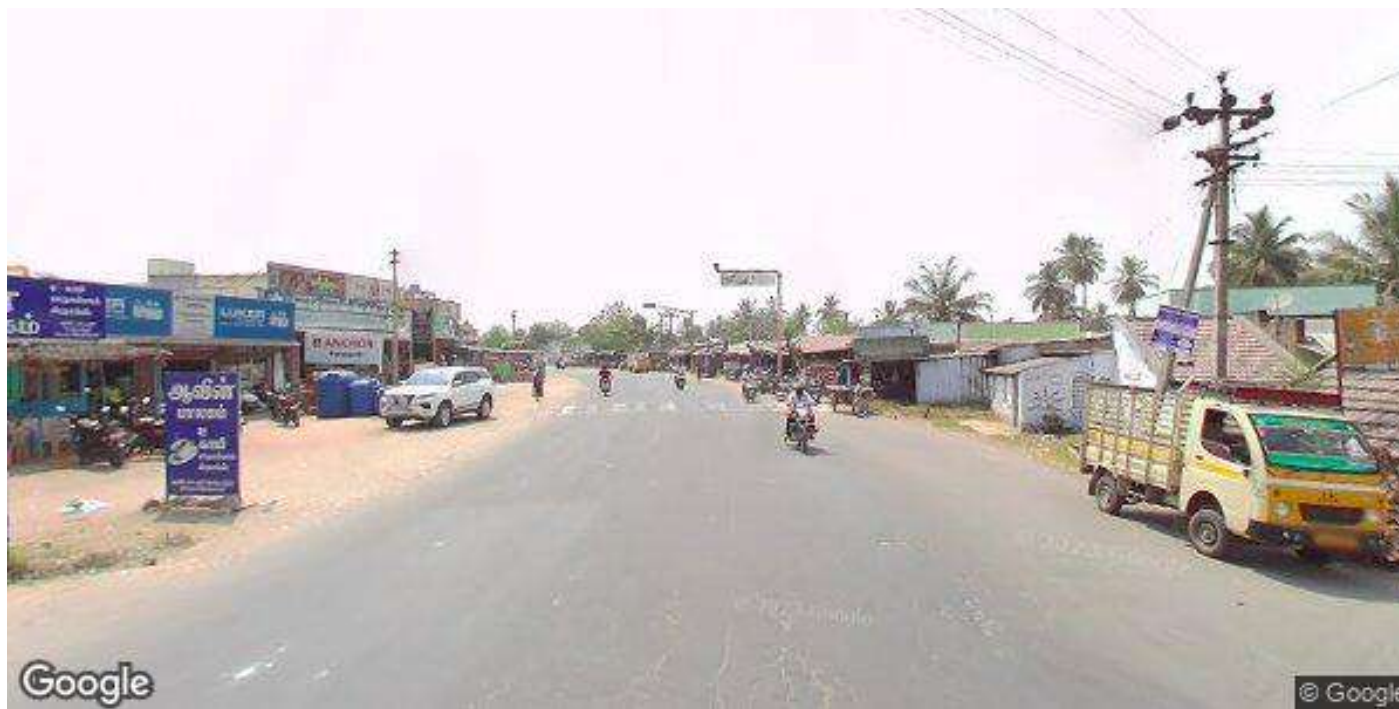
**Risk Type:** Turn  
**Risk Level:** Medium  
**Speed Limit:** 30 KM/Hr  
**Coordinates:** 11.73787, 78.03528

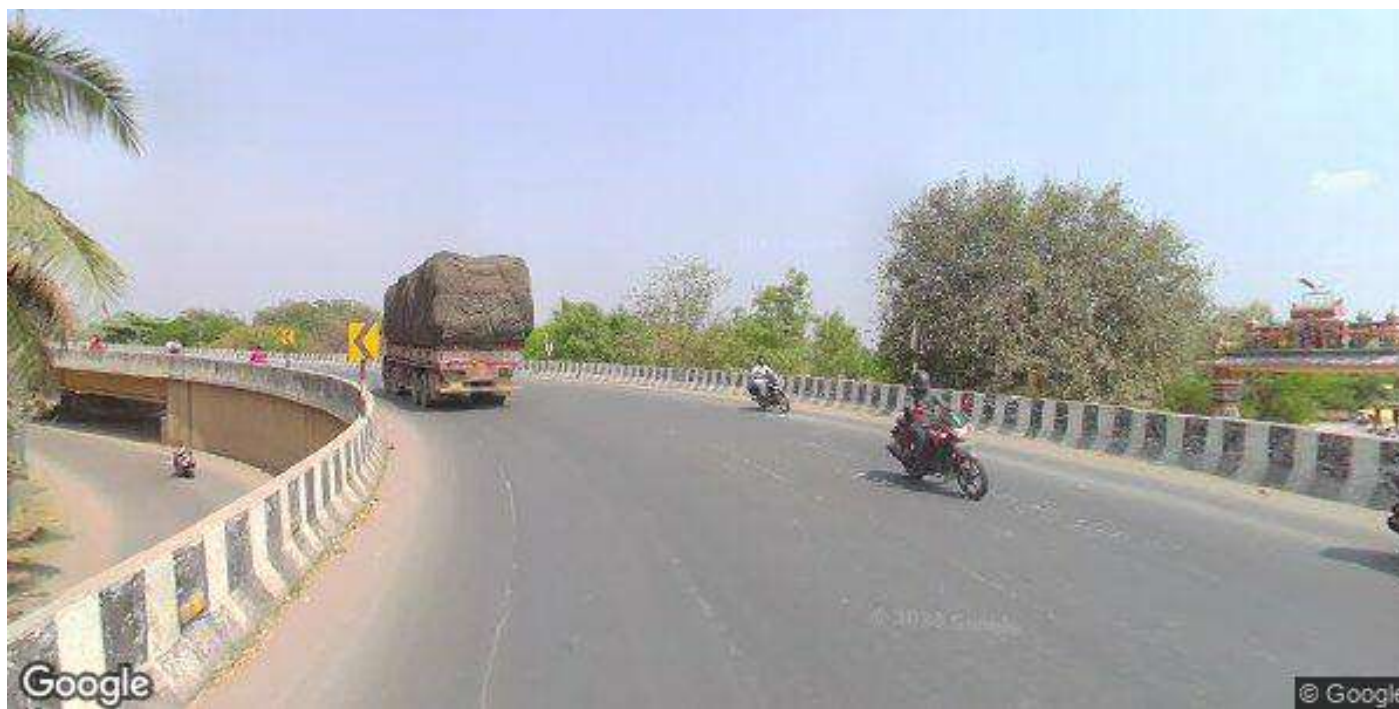
**Risk Type:** Turn  
**Risk Level:** High  
**Speed Limit:** 15 KM/Hr  
**Coordinates:** 11.73651, 78.03868

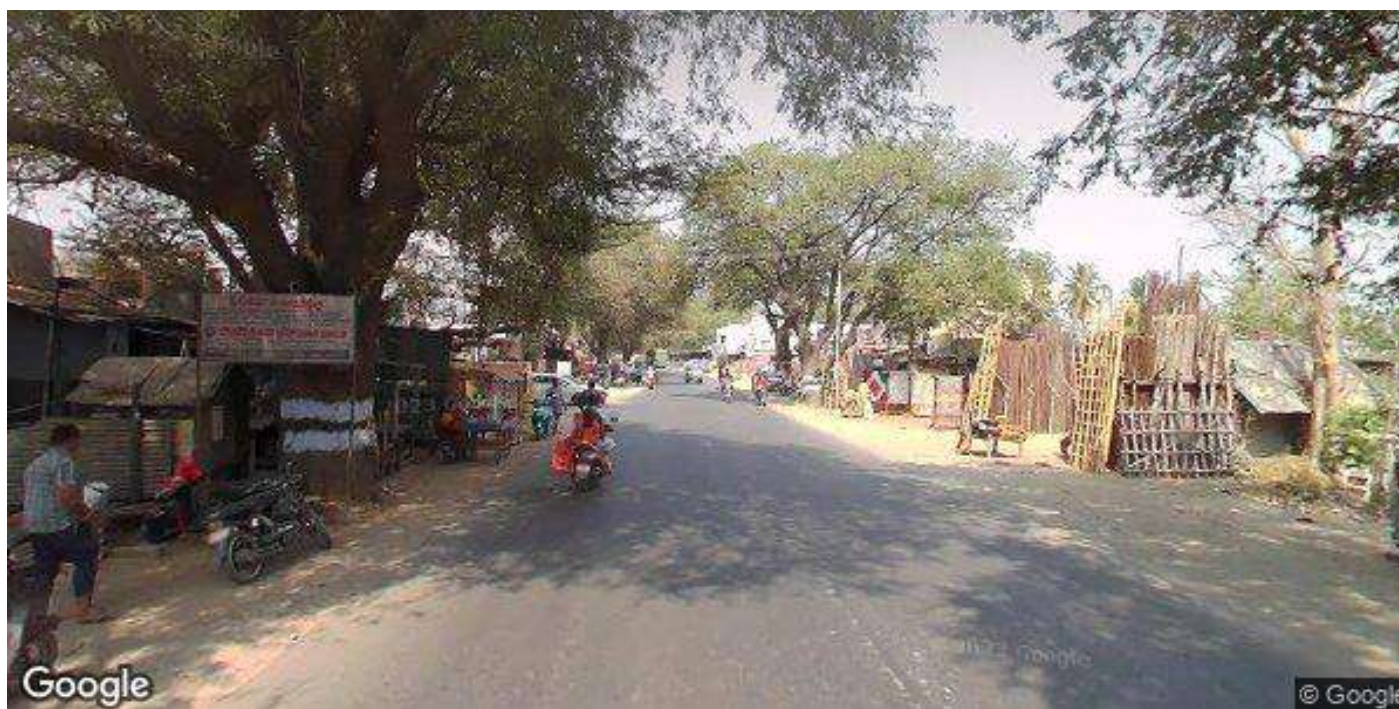
**Risk Type:** Turn  
**Risk Level:** Medium  
**Speed Limit:** 30 KM/Hr  
**Coordinates:** 11.74120, 78.04588

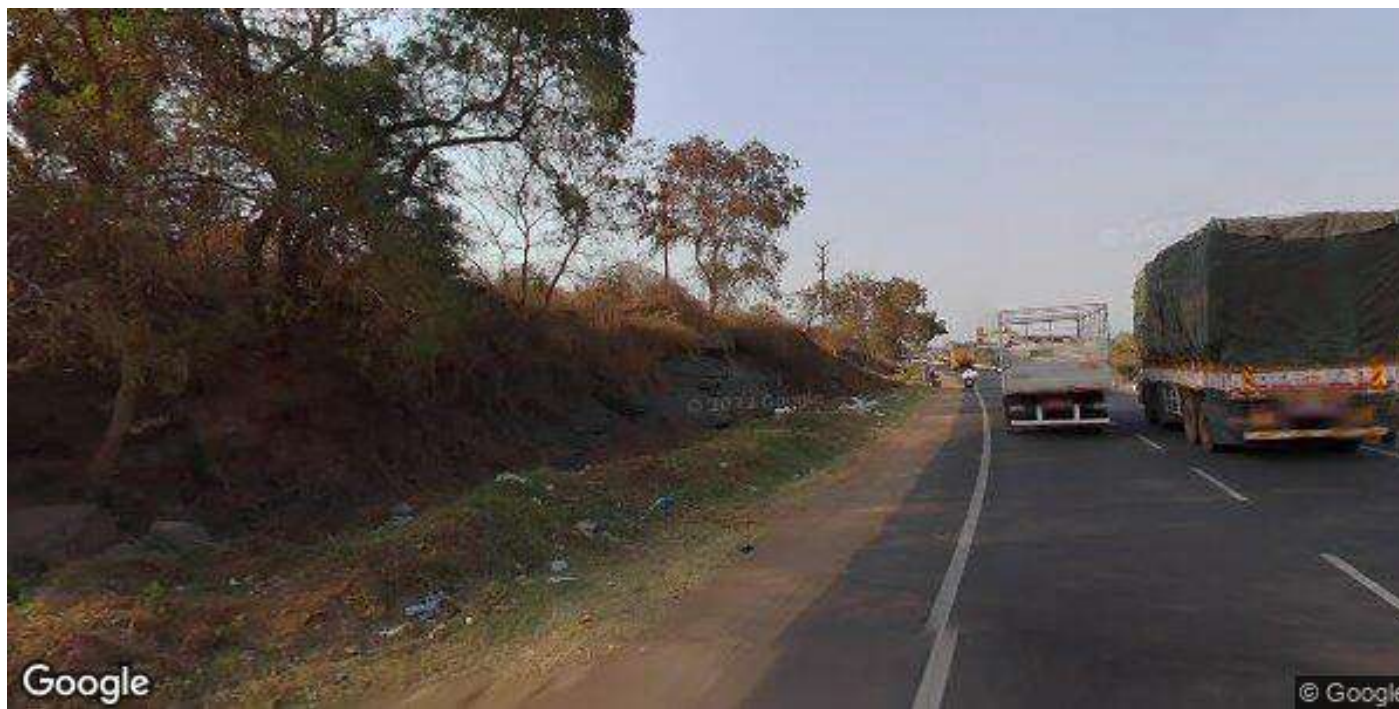
**Risk Type:** Turn  
**Risk Level:** Medium  
**Speed Limit:** 30 KM/Hr  
**Coordinates:** 11.78045, 78.05792

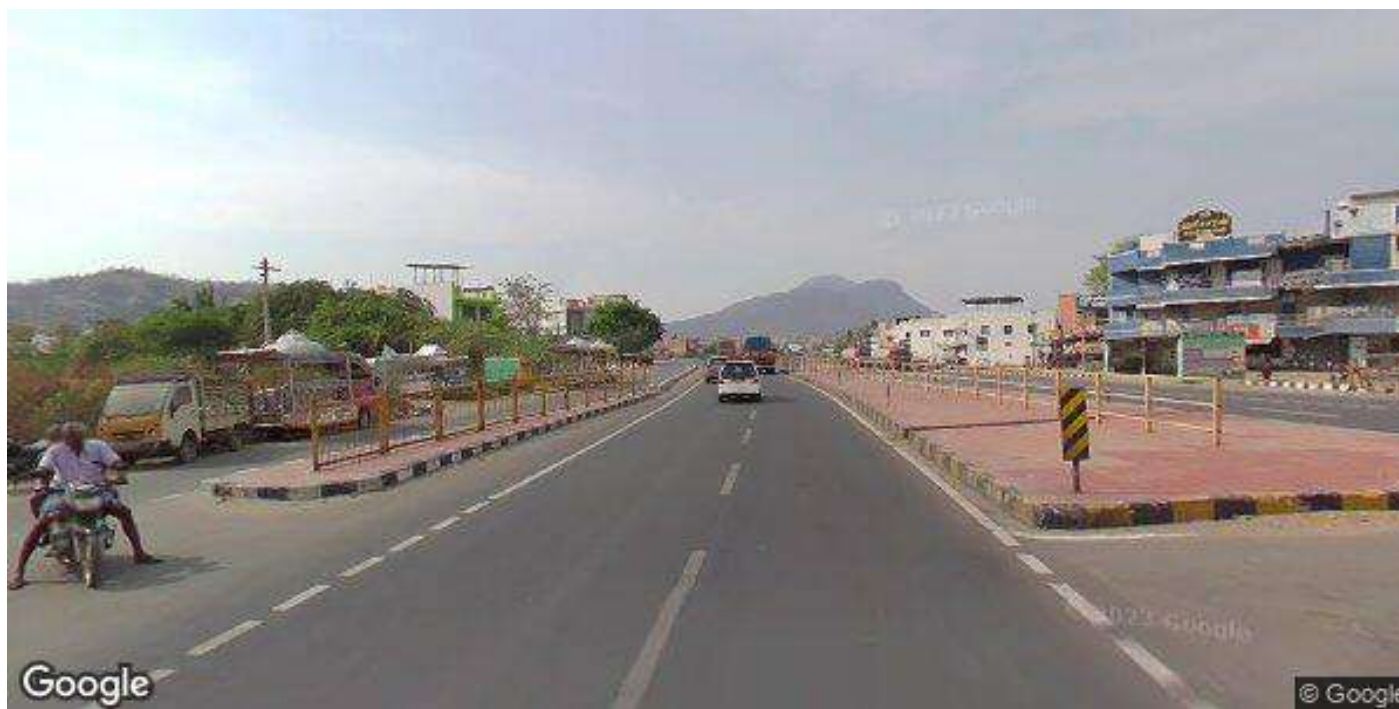
**Risk Type:** Blind Spot  
**Risk Level:** Blind Spot  
**Speed Limit:** 10 KM/Hr  
**Coordinates:** 11.87104, 78.08356

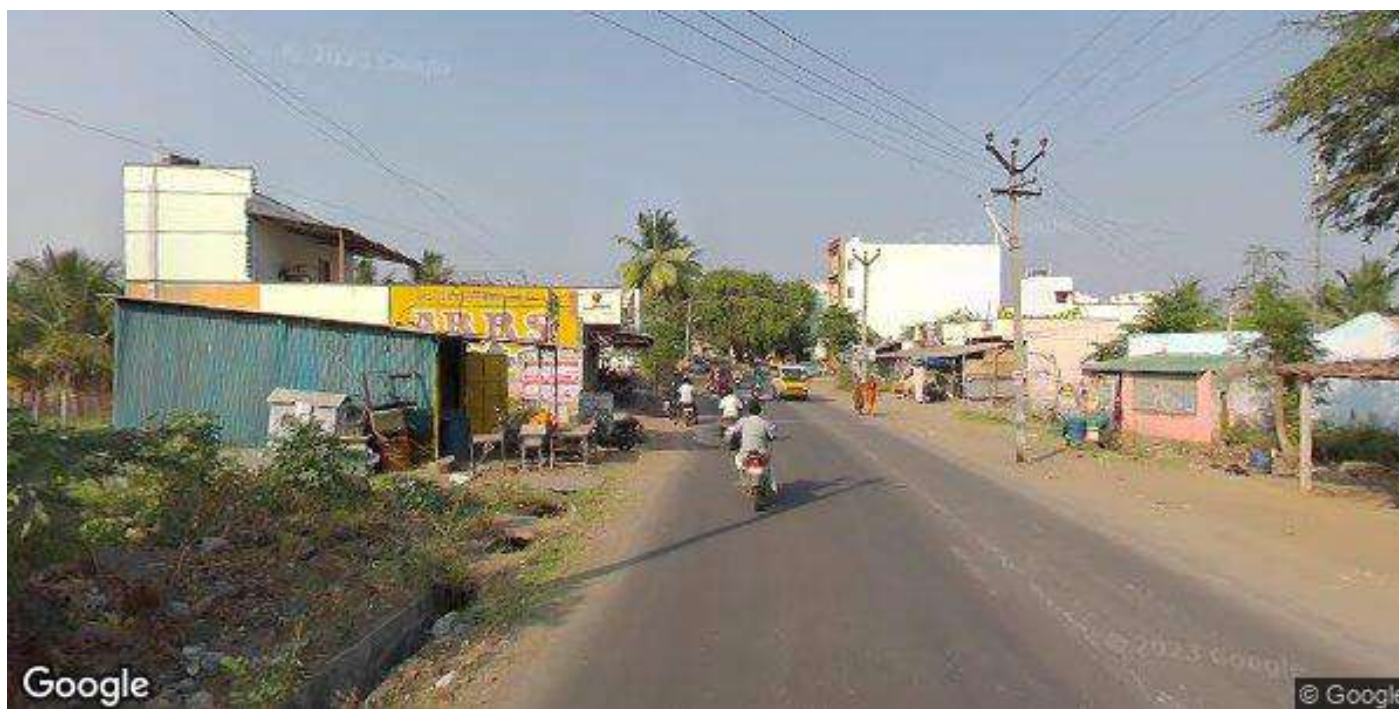
**Risk Type:** Turn  
**Risk Level:** Medium  
**Speed Limit:** 30 KM/Hr  
**Coordinates:** 11.87106, 78.08579

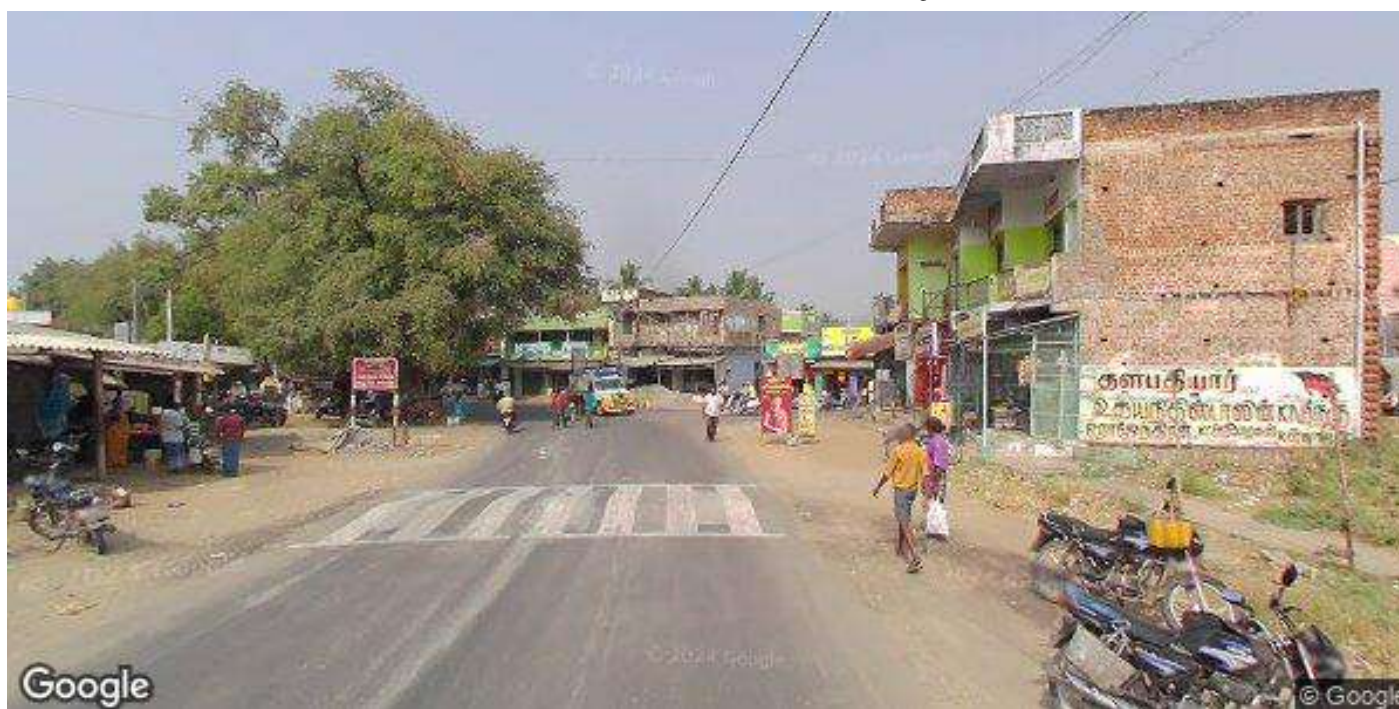
**Risk Type:** Turn  
**Risk Level:** Medium  
**Speed Limit:** 30 KM/Hr  
**Coordinates:** 11.87257, 78.08738

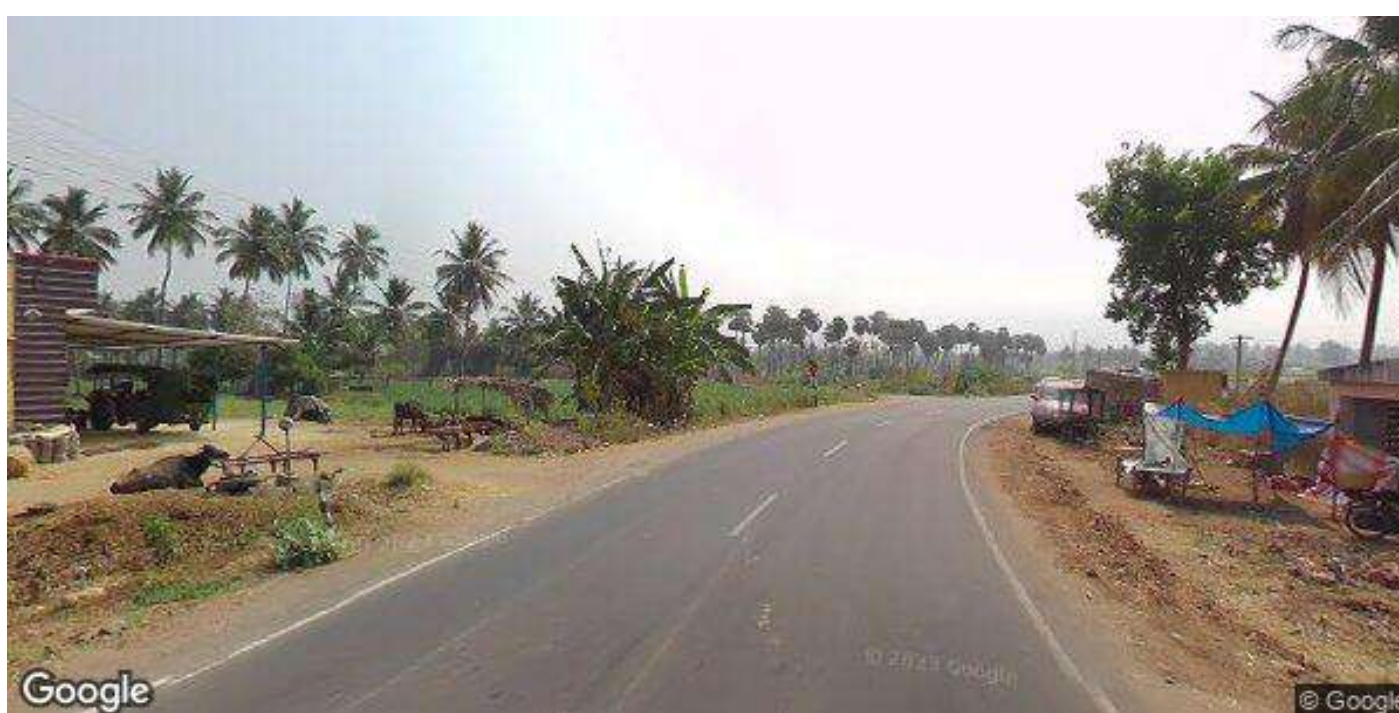
**Risk Type:** Turn  
**Risk Level:** Medium  
**Speed Limit:** 30 KM/Hr  
**Coordinates:** 11.86902, 78.12044
