# IndianOil

## JOURNEY RISK MANAGEMENT (JRM) STUDY

### Salem Terminal TO EDCCWS ERODE RING ROAD

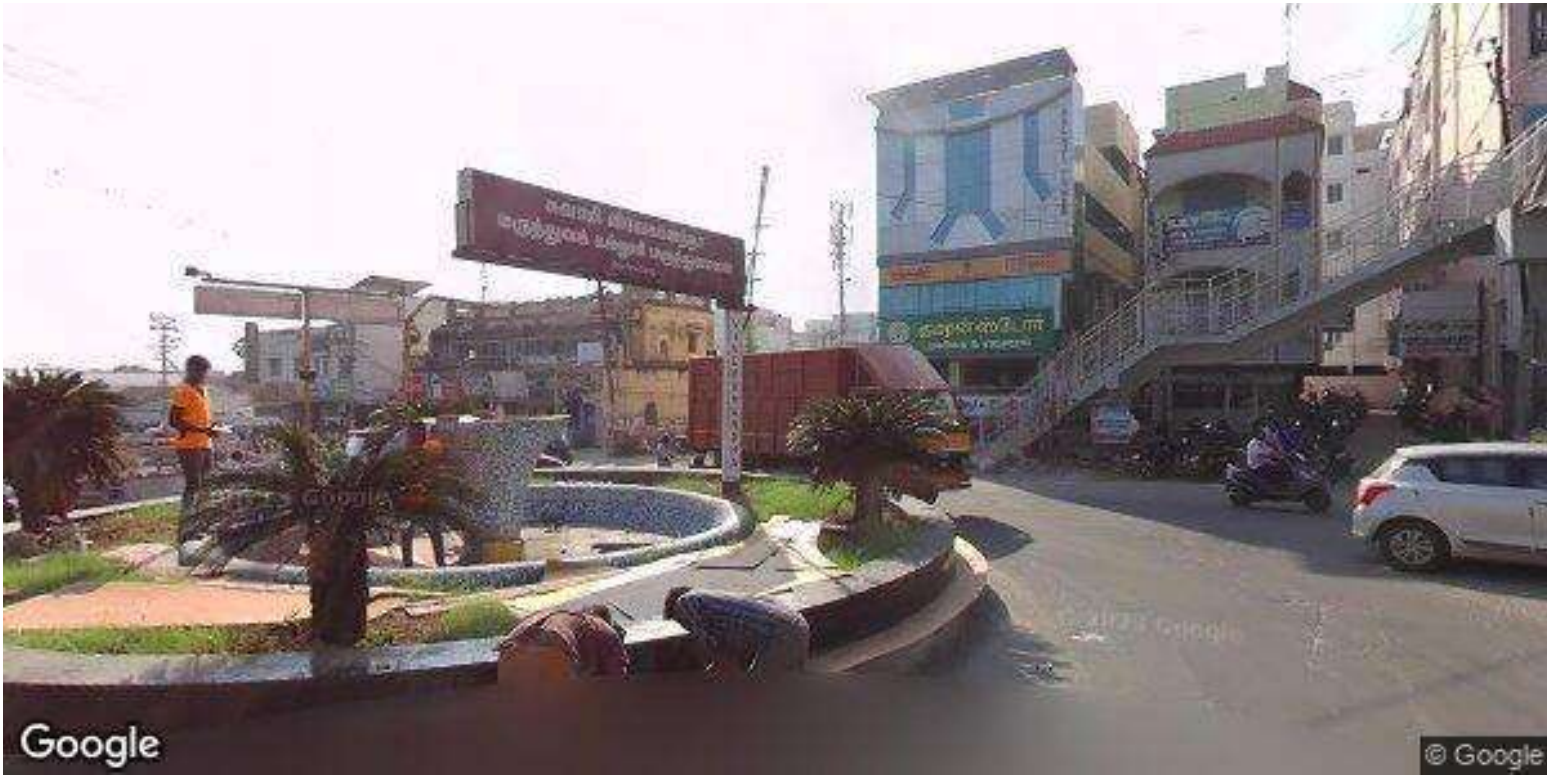
Coordinates: 11.38395, 77.89480

Risk Type: Roundabout

Risk Level: High

Speed Limit: 15 KM/Hr
