# IndianOil

## JOURNEY RISK MANAGEMENT (JRM) STUDY

### Salem Terminal to AEGAN PETRO FILLS

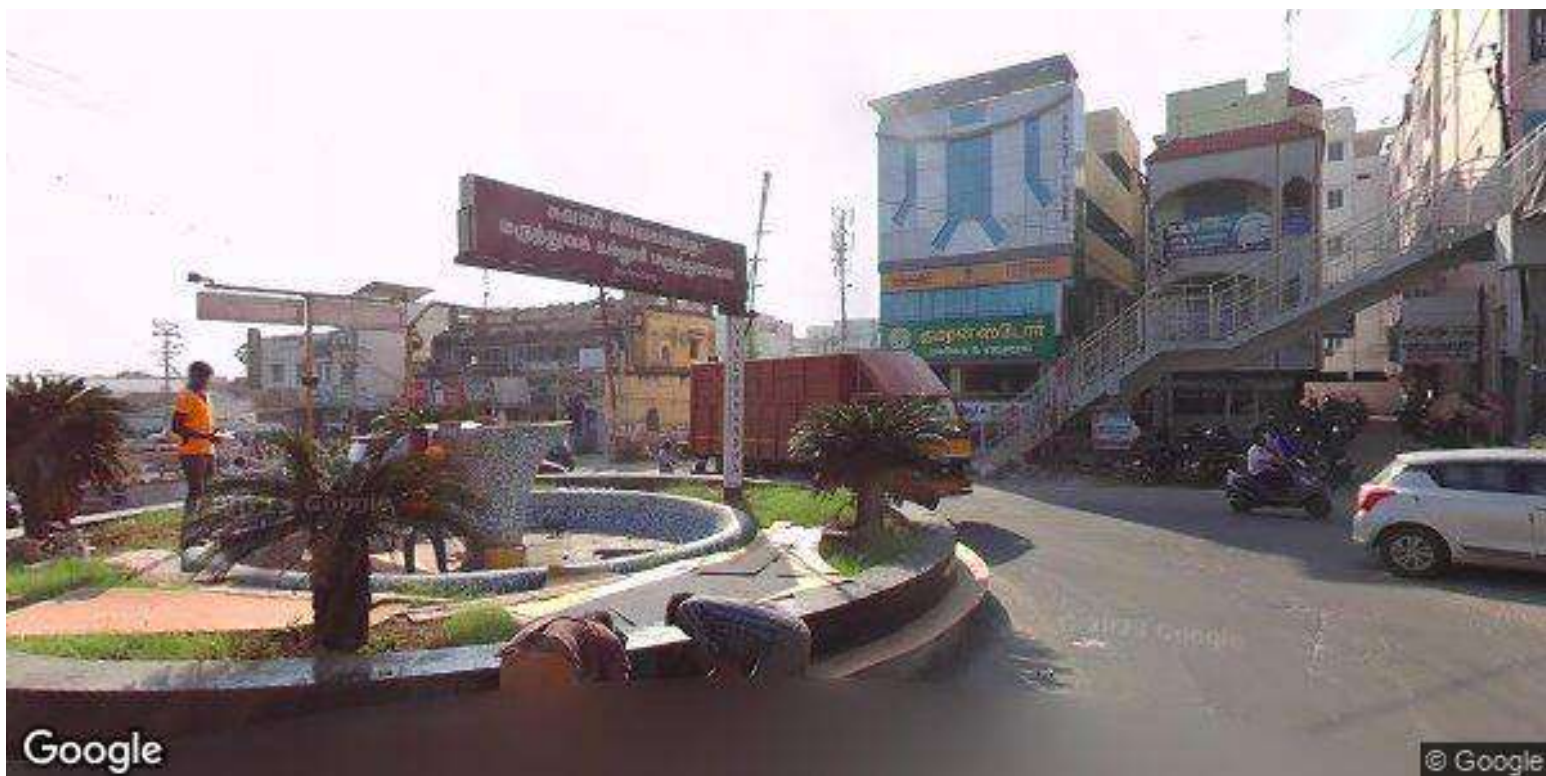
**Risk Type:** Roundabout

**Risk Level:** High

**Speed Limit: 15 KM/Hr**  
**Coordinates: 11.38395, 77.89480**

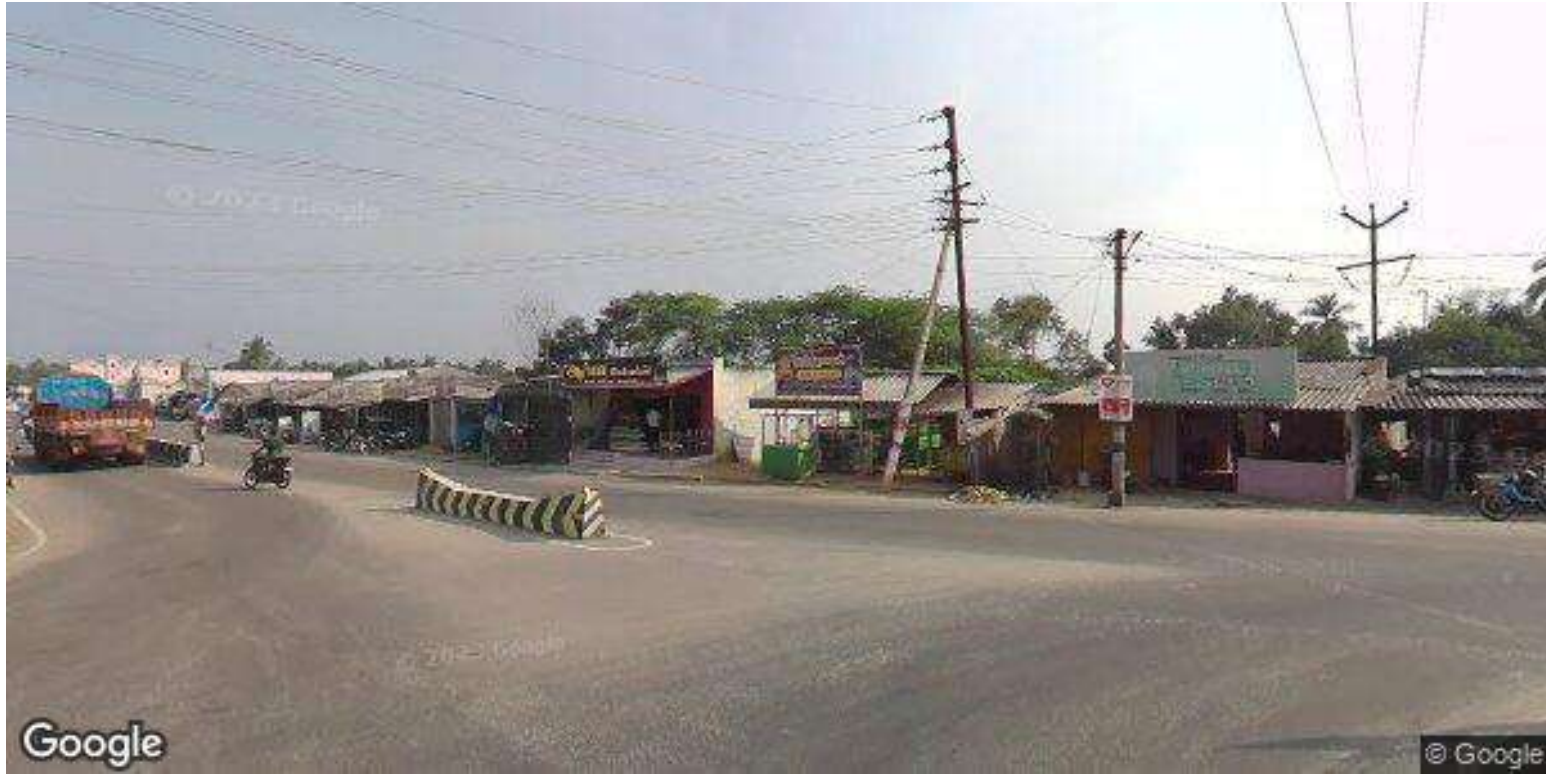
**Risk Type: Roundabout**  
**Risk Level: High**  
**Speed Limit: 15 KM/Hr**  
**Coordinates: 11.04637, 77.73761**

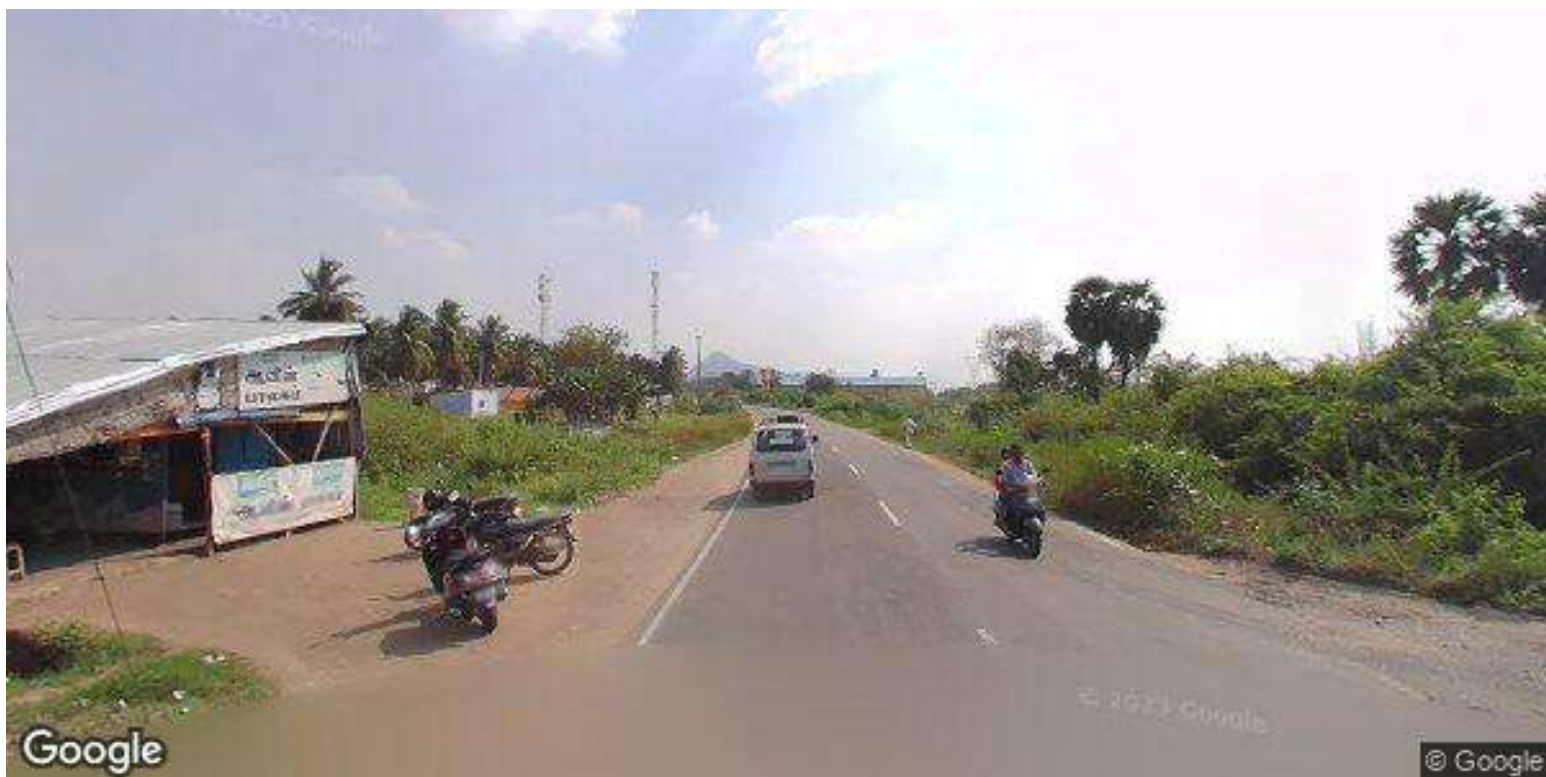
**Risk Type: Turn**  
**Risk Level: High**  
**Speed Limit: 15 KM/Hr**  
**Coordinates: 11.44022, 77.87546**

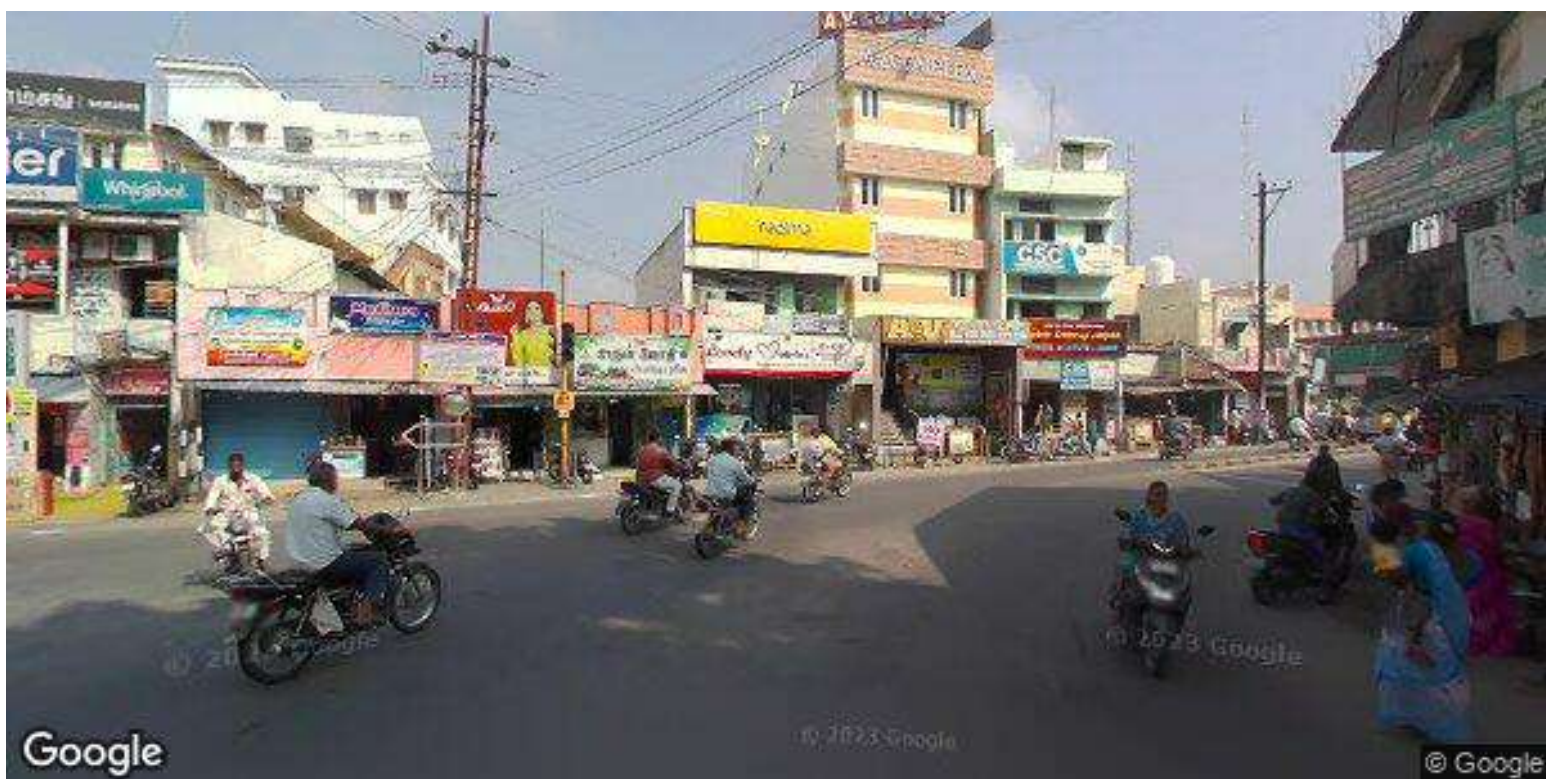
**Risk Type: Turn**

**Risk Level: Medium**

**Speed Limit: 30 KM/Hr**

**Coordinates: 11.37842, 77.89452**

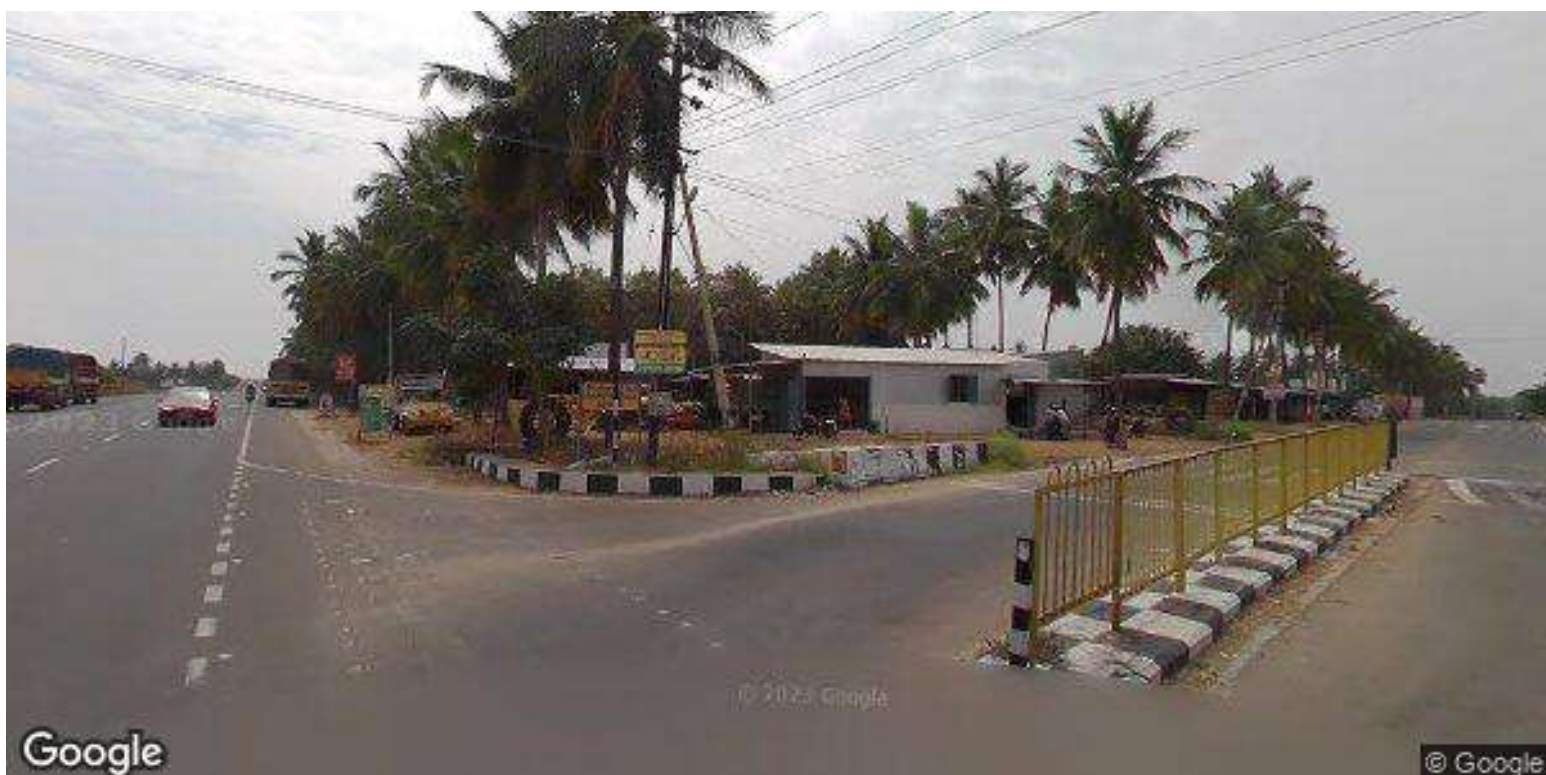
**Risk Type:** Turn  
**Risk Level:** High  
**Speed Limit:** 15 KM/Hr  
**Coordinates:** 11.30859, 77.92918

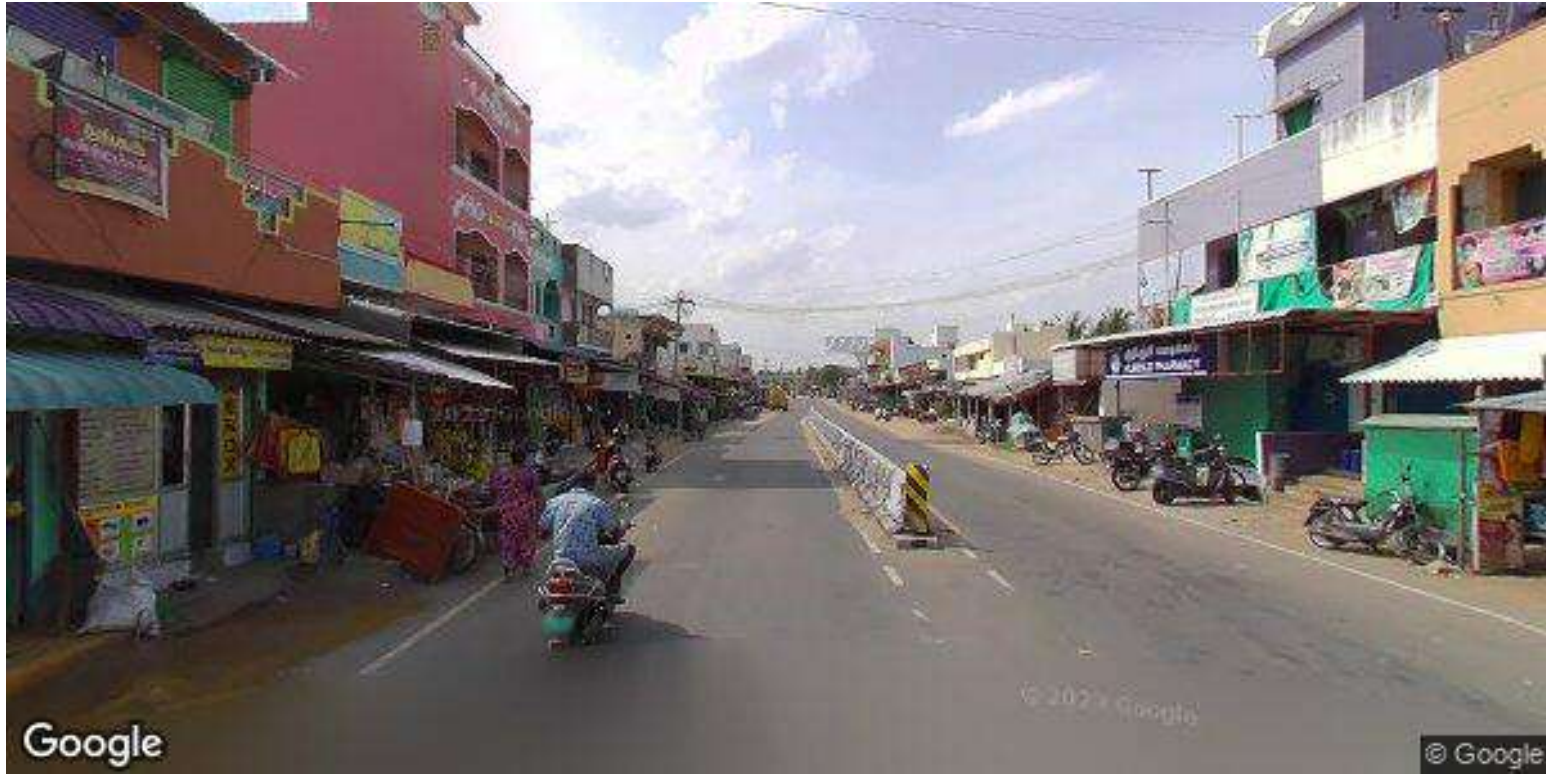
**Risk Type:** Turn  
**Risk Level:** High  
**Speed Limit:** 15 KM/Hr  
**Coordinates:** 11.24000, 77.87363

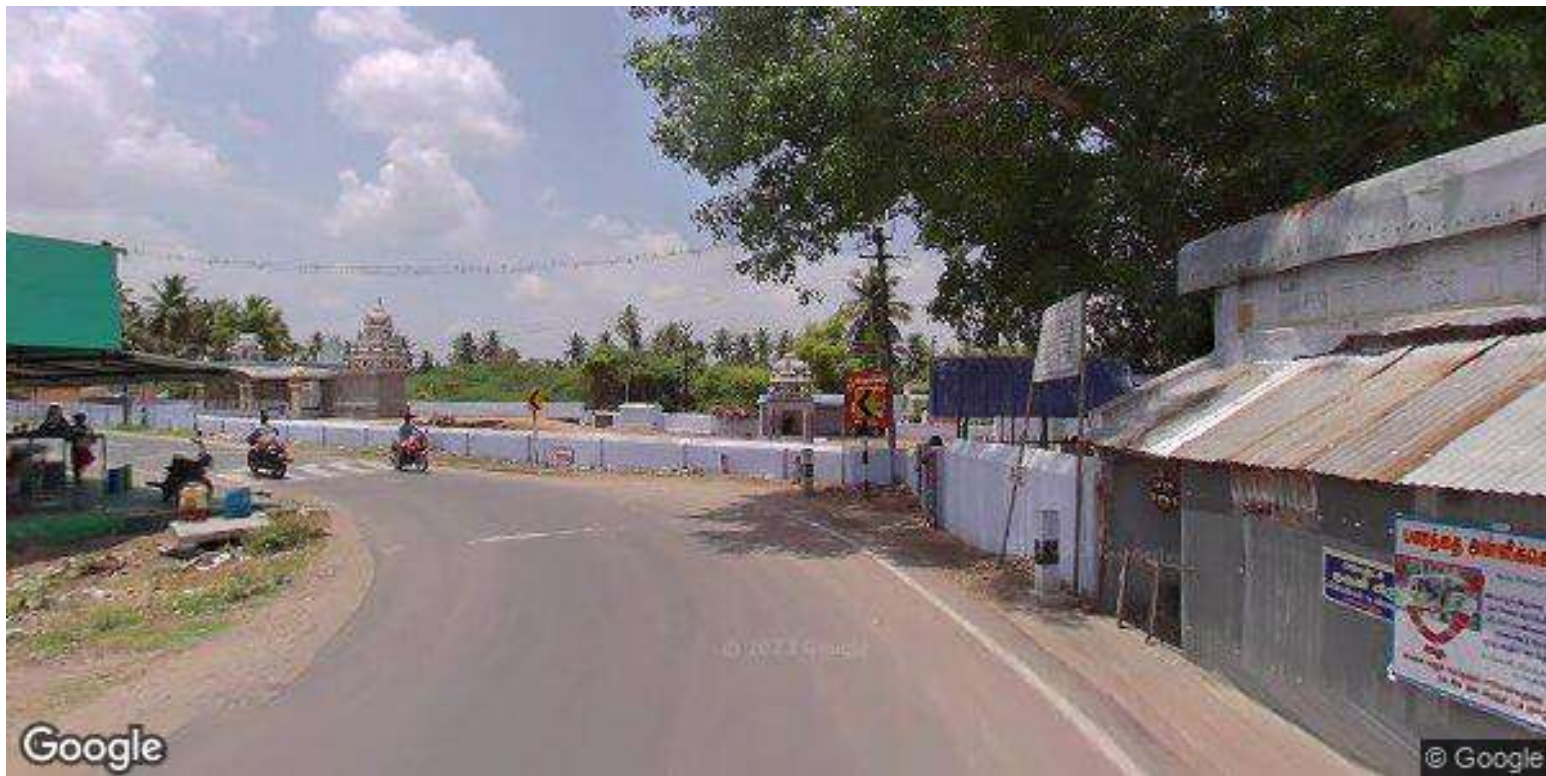
**Risk Type:** Turn  
**Risk Level:** Medium  
**Speed Limit:** 30 KM/Hr  
**Coordinates:** 11.24053, 77.86902

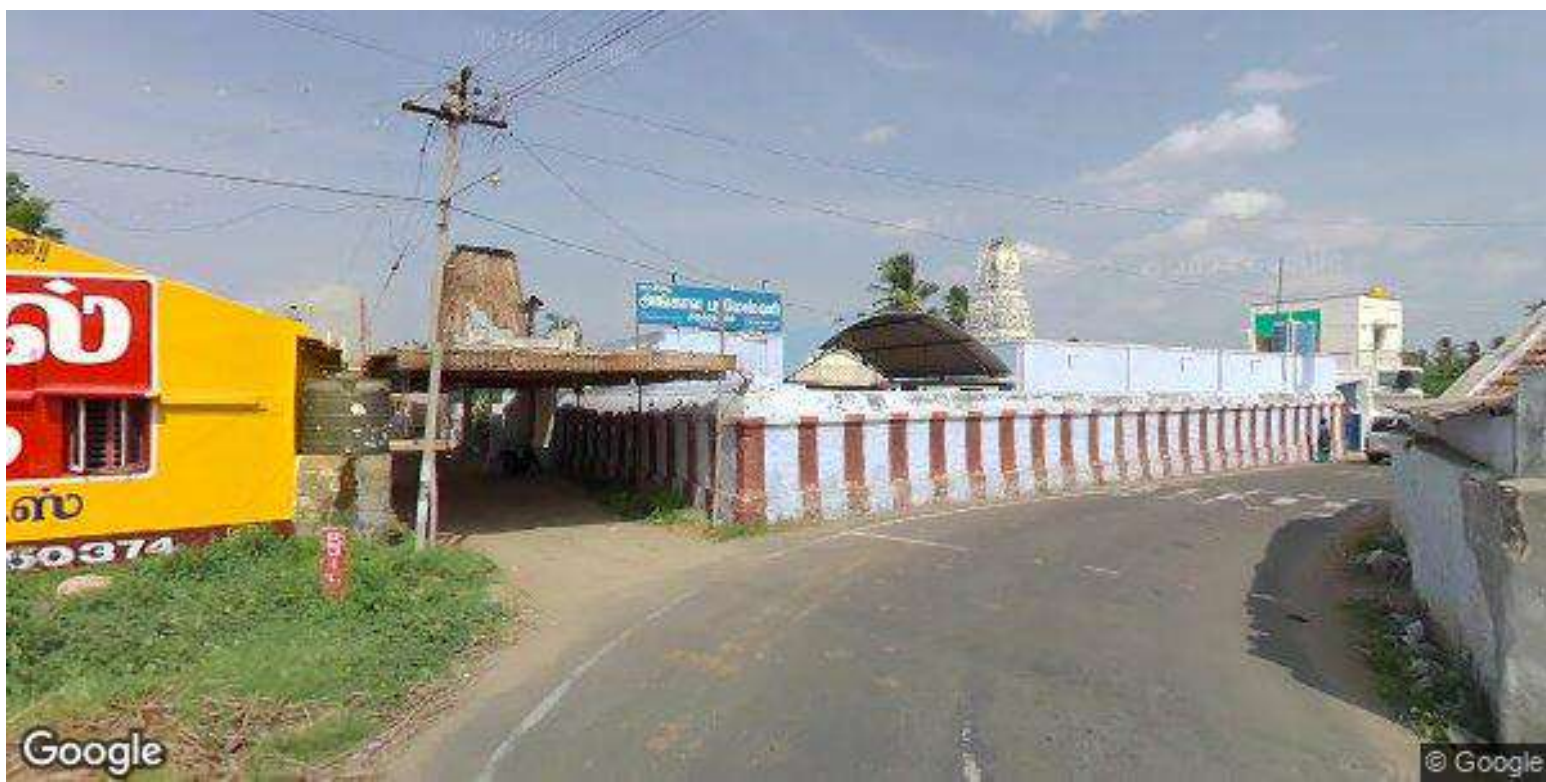
**Risk Type:** Turn

**Risk Level:** Medium

**Speed Limit:** 30 KM/Hr

**Coordinates:** 11.24115, 77.86891

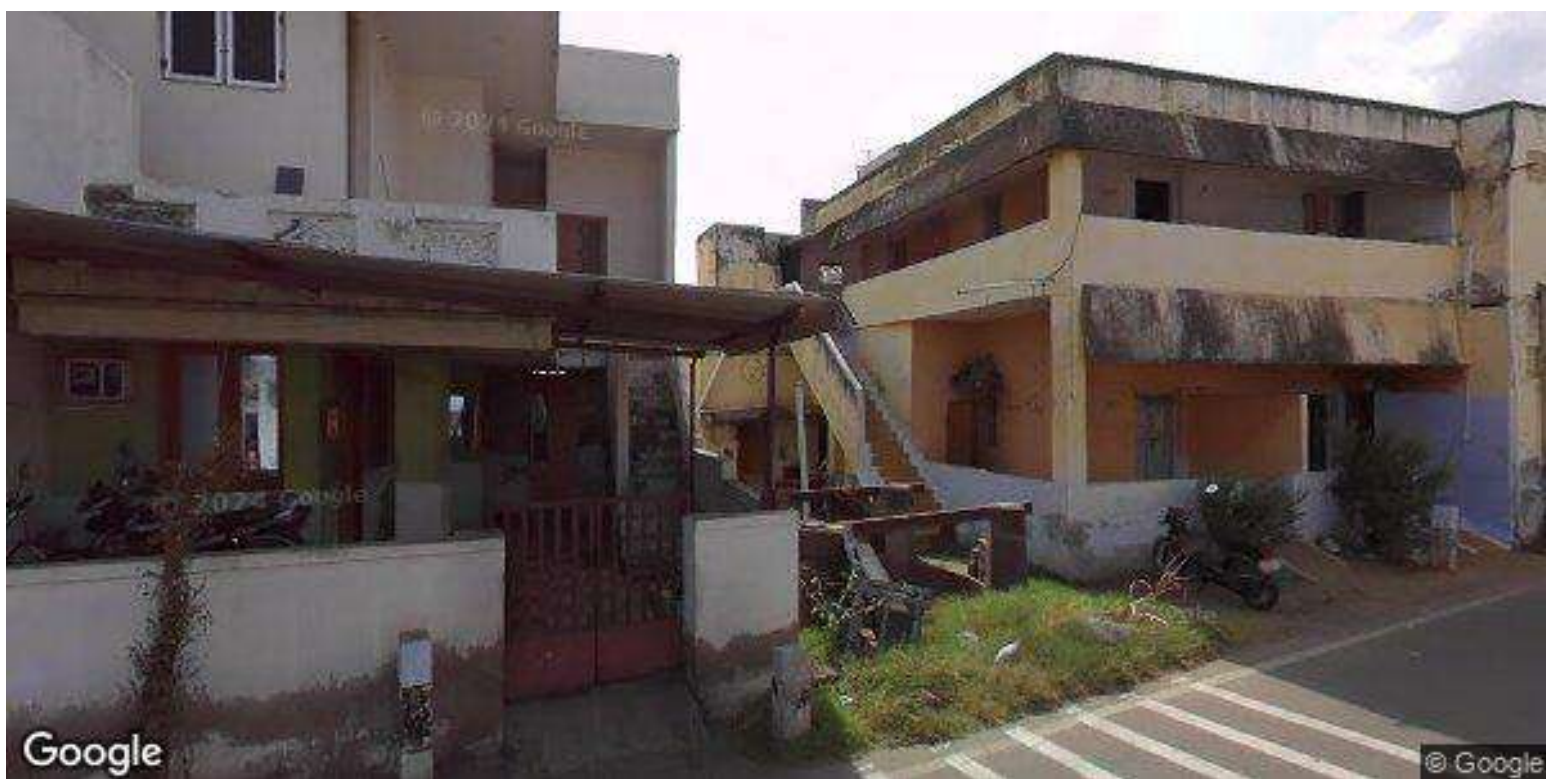
**Risk Type:** Turn

**Risk Level:** Medium

**Speed Limit:** 30 KM/Hr

**Coordinates:** 11.24122, 77.86883

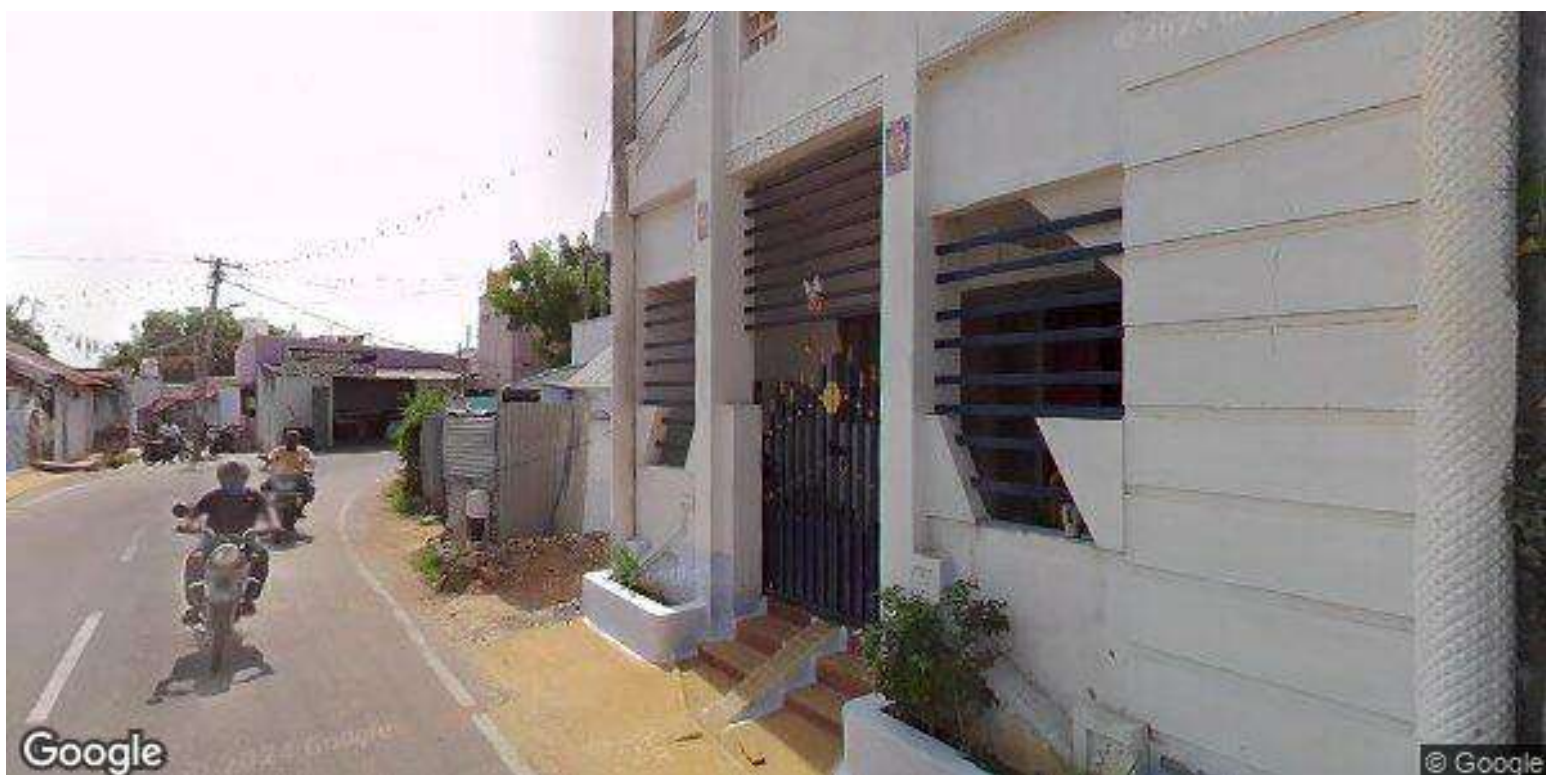
**Risk Type: Turn**

**Risk Level: High**

**Speed Limit: 15 KM/Hr**

**Coordinates: 11.24159, 77.86874**

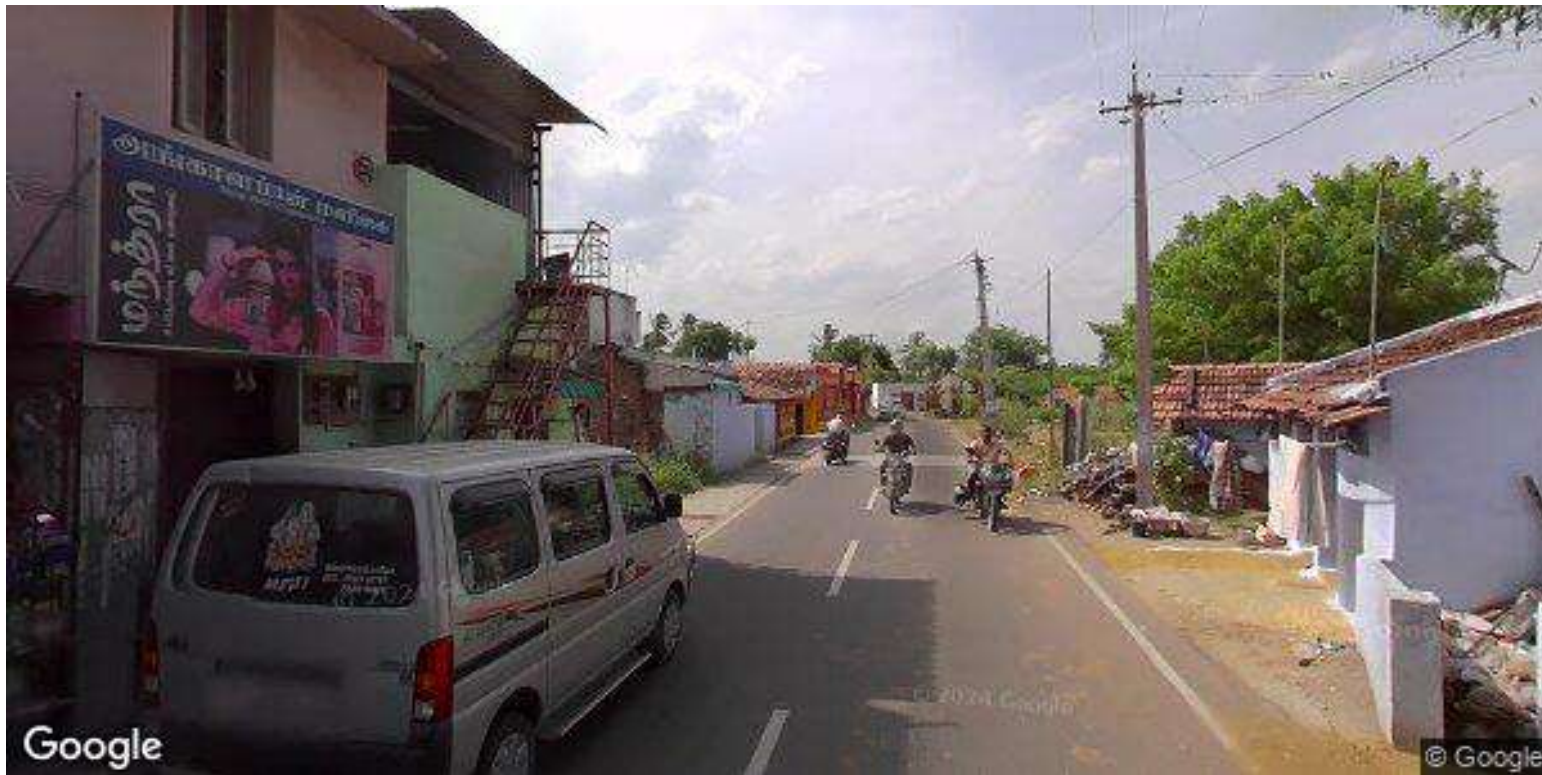
**Risk Type: Turn**

**Risk Level: High**

**Speed Limit: 15 KM/Hr**

**Coordinates: 11.24170, 77.86842**

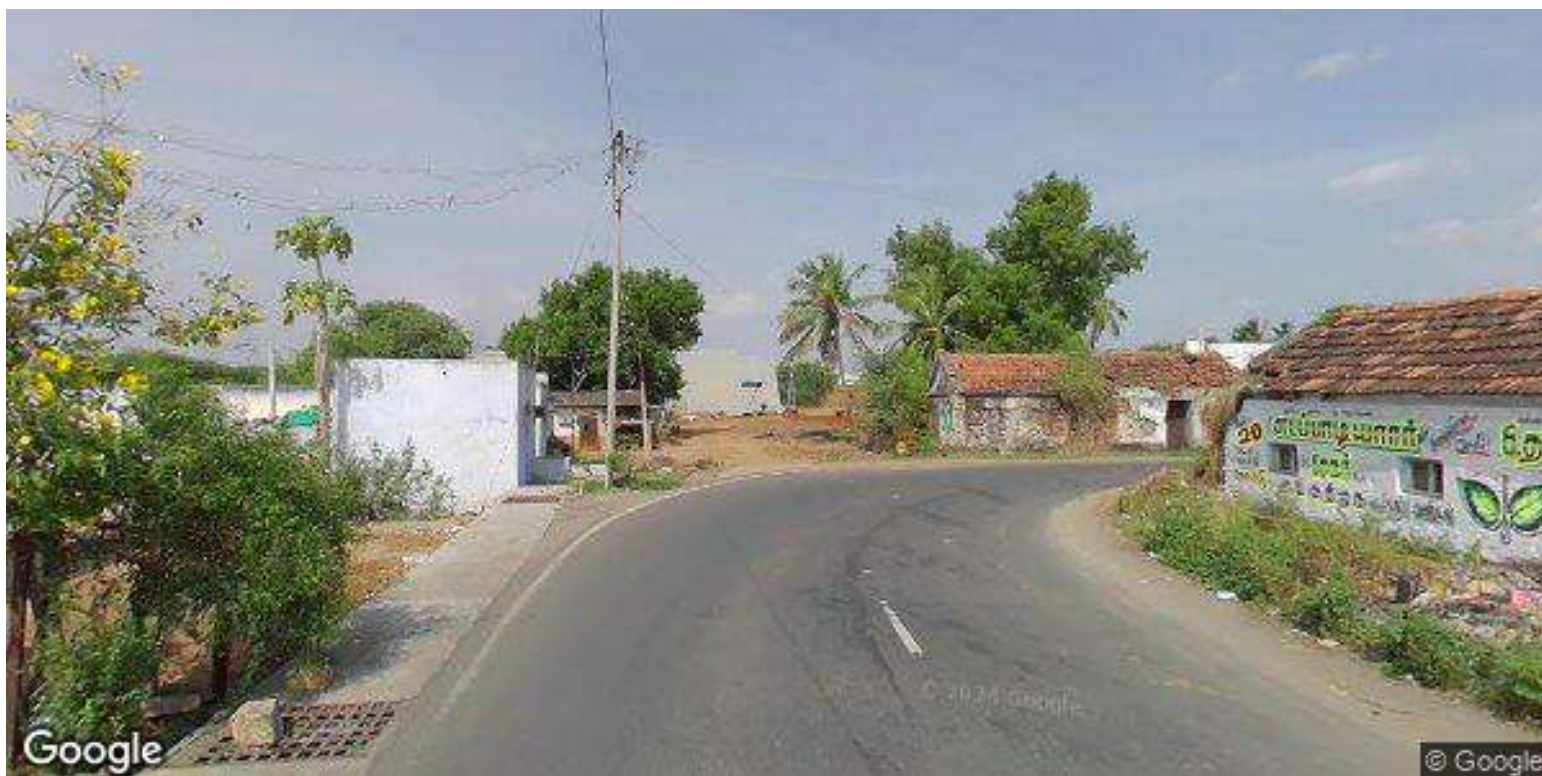
**Risk Type: Turn**

**Risk Level: High**

**Speed Limit: 15 KM/Hr**

**Coordinates: 11.24248, 77.86829**

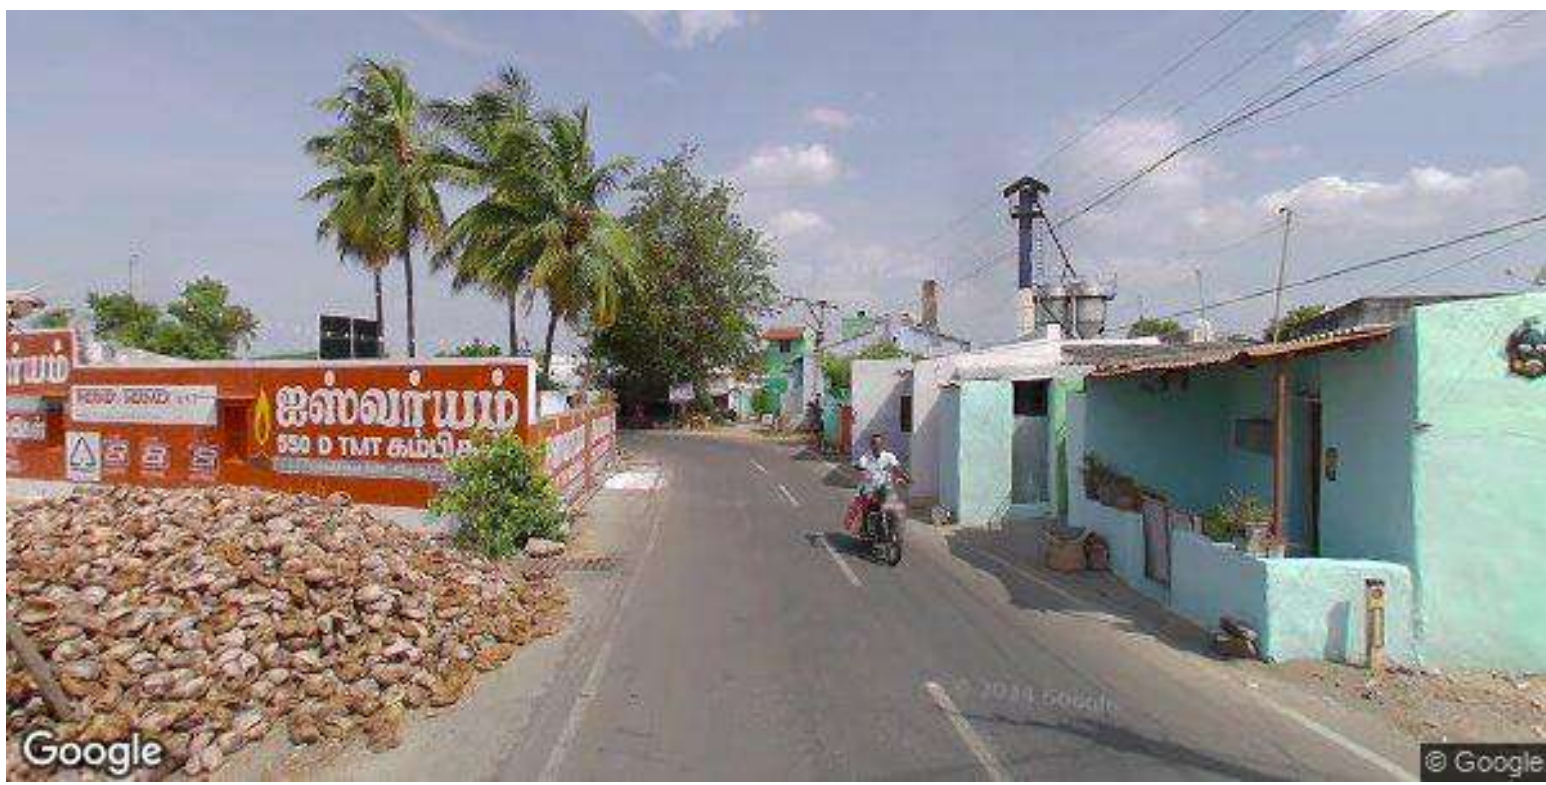
**Risk Type:** Turn

**Risk Level:** Medium

**Speed Limit:** 30 KM/Hr

**Coordinates:** 11.24257, 77.86776

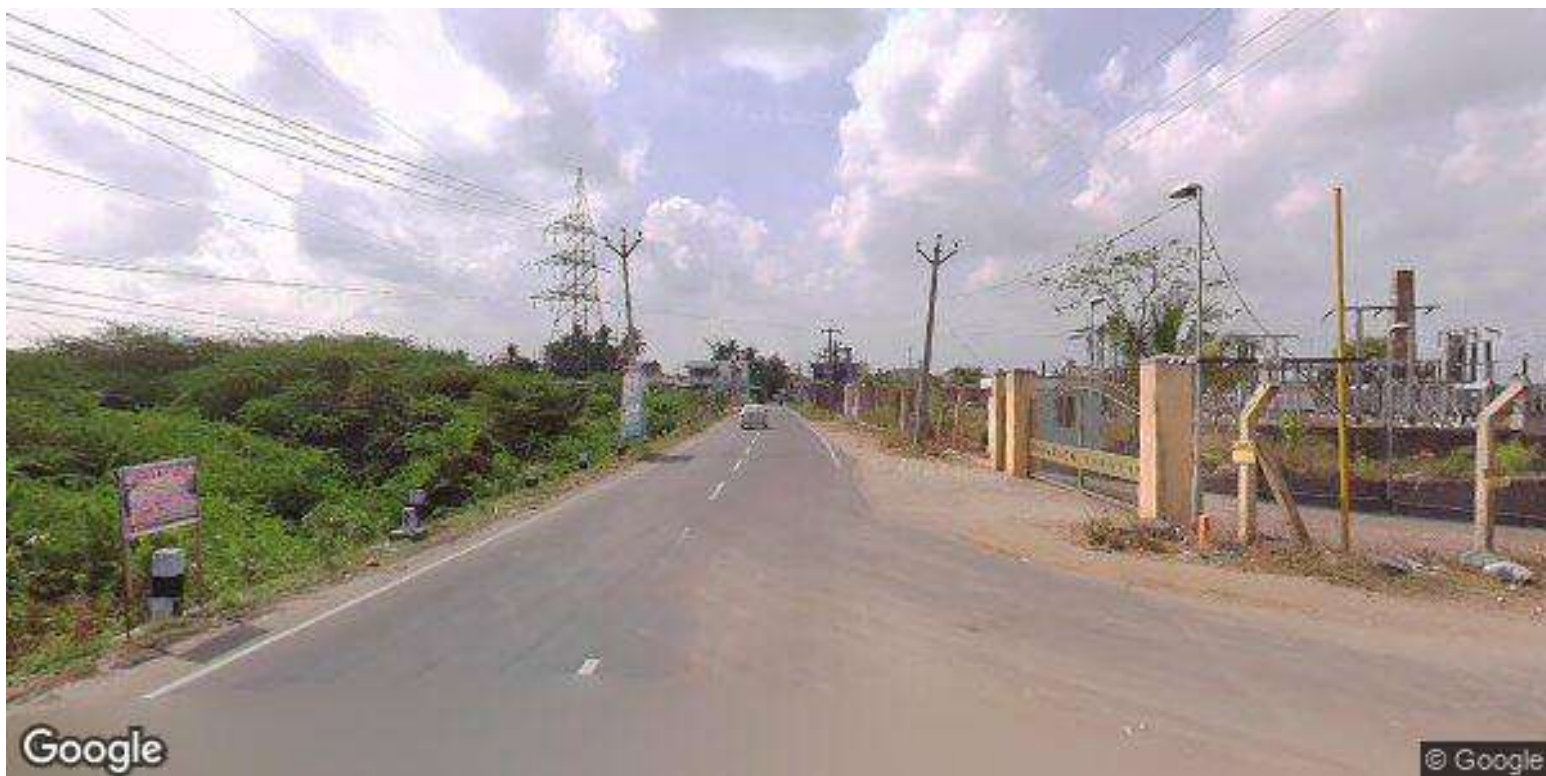
**Risk Type:** Blind Spot

**Risk Level:** Blind Spot

**Speed Limit:** 10 KM/Hr

**Coordinates:** 11.24384, 77.86689

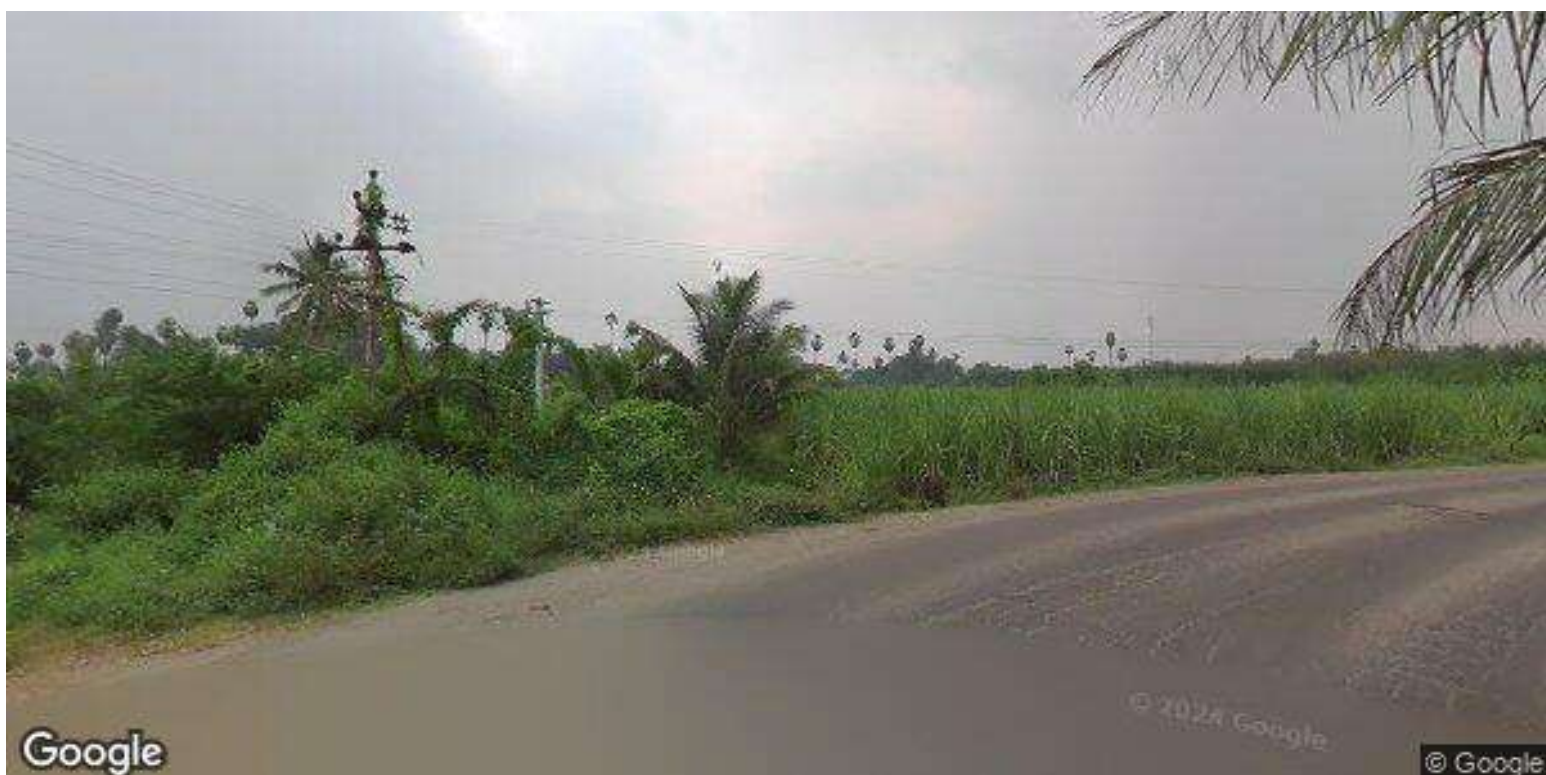
**Risk Type:** Turn

**Risk Level:** Medium

**Speed Limit:** 30 KM/Hr

**Coordinates:** 11.24101, 77.86034

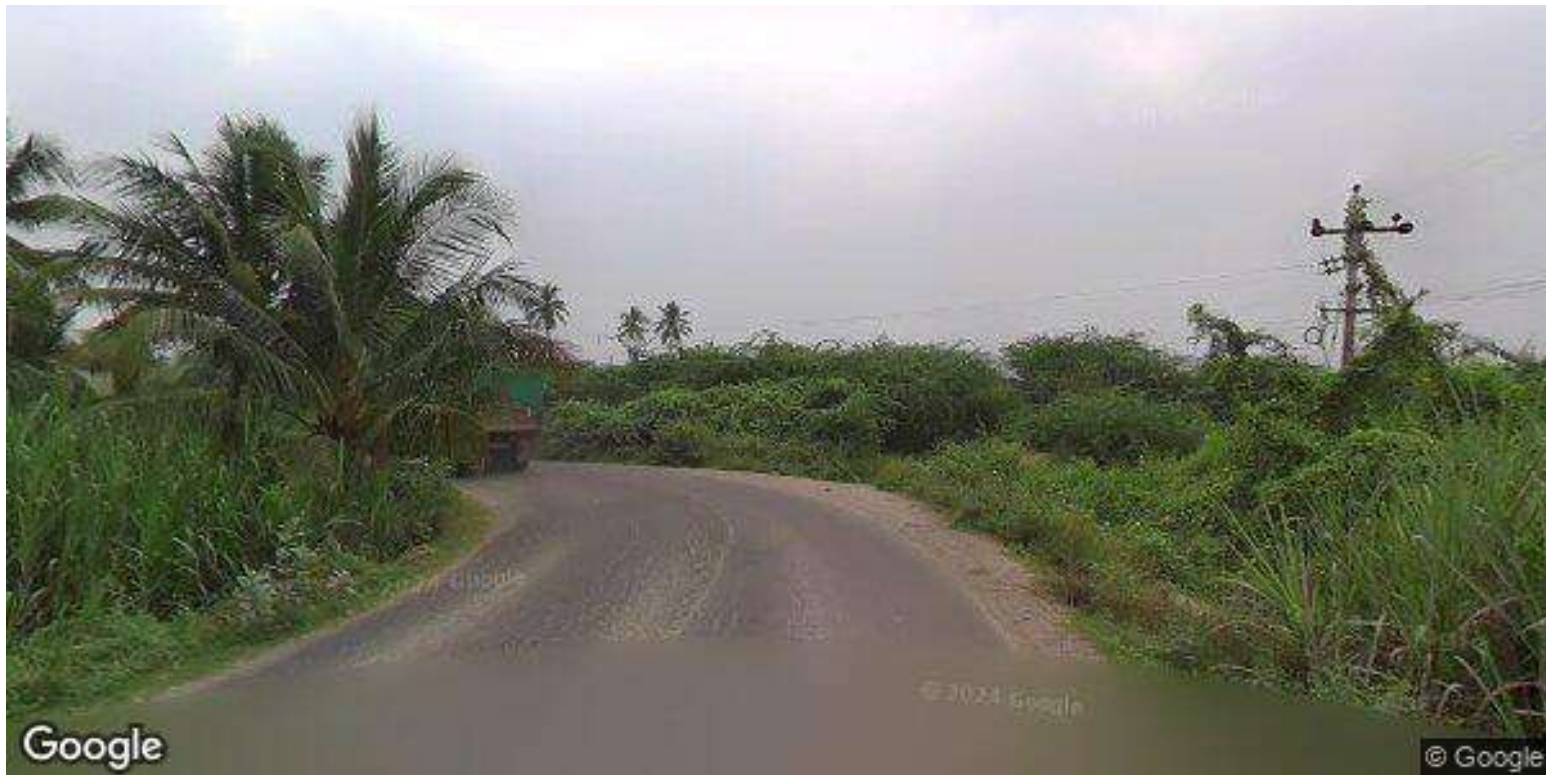
**Risk Type:** Turn

**Risk Level:** Medium

**Speed Limit:** 30 KM/Hr

**Coordinates:** 11.24103, 77.86020

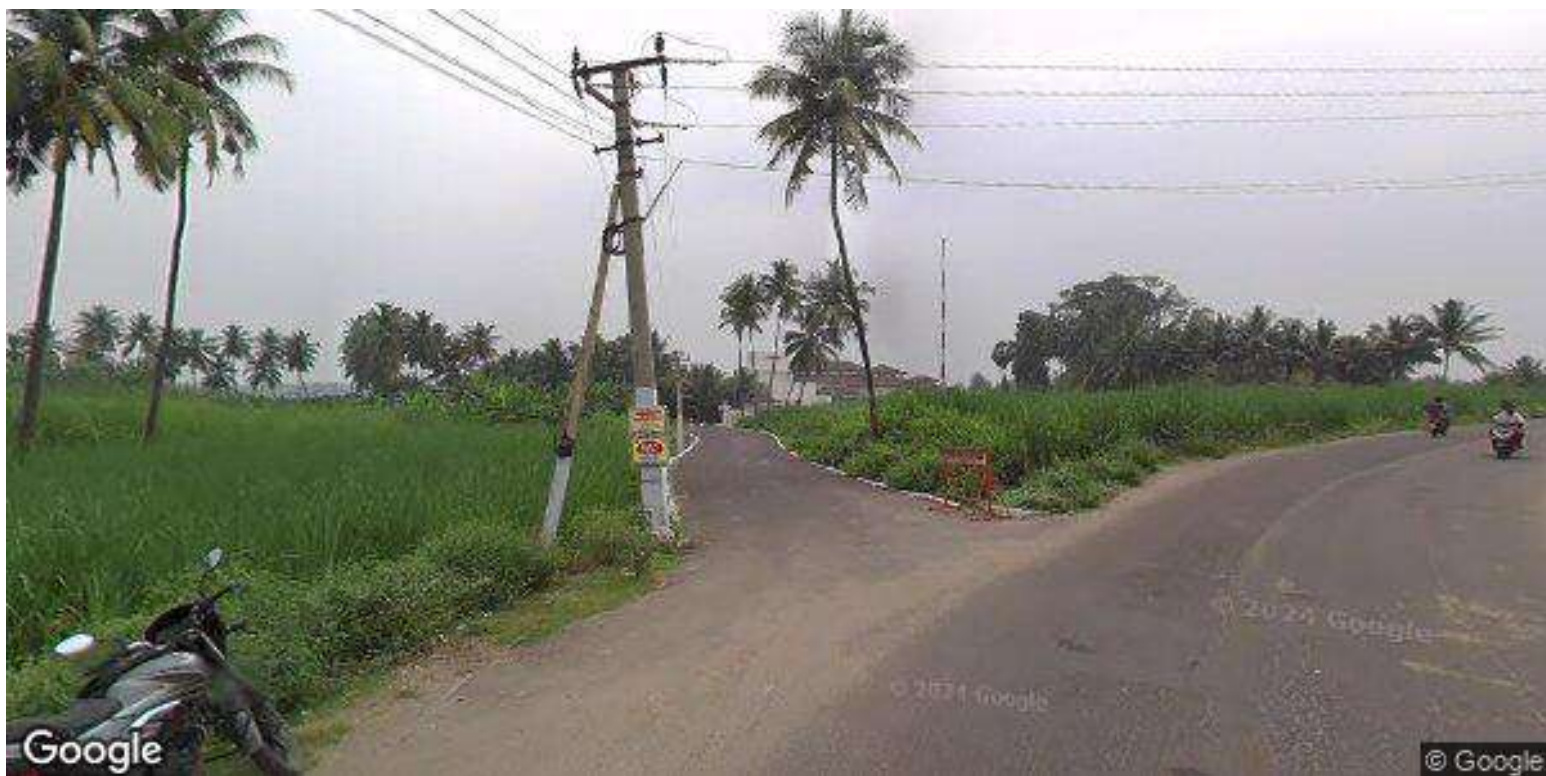
**Risk Type:** Turn

**Risk Level:** Medium

**Speed Limit:** 30 KM/Hr

**Coordinates:** 11.24197, 77.85905

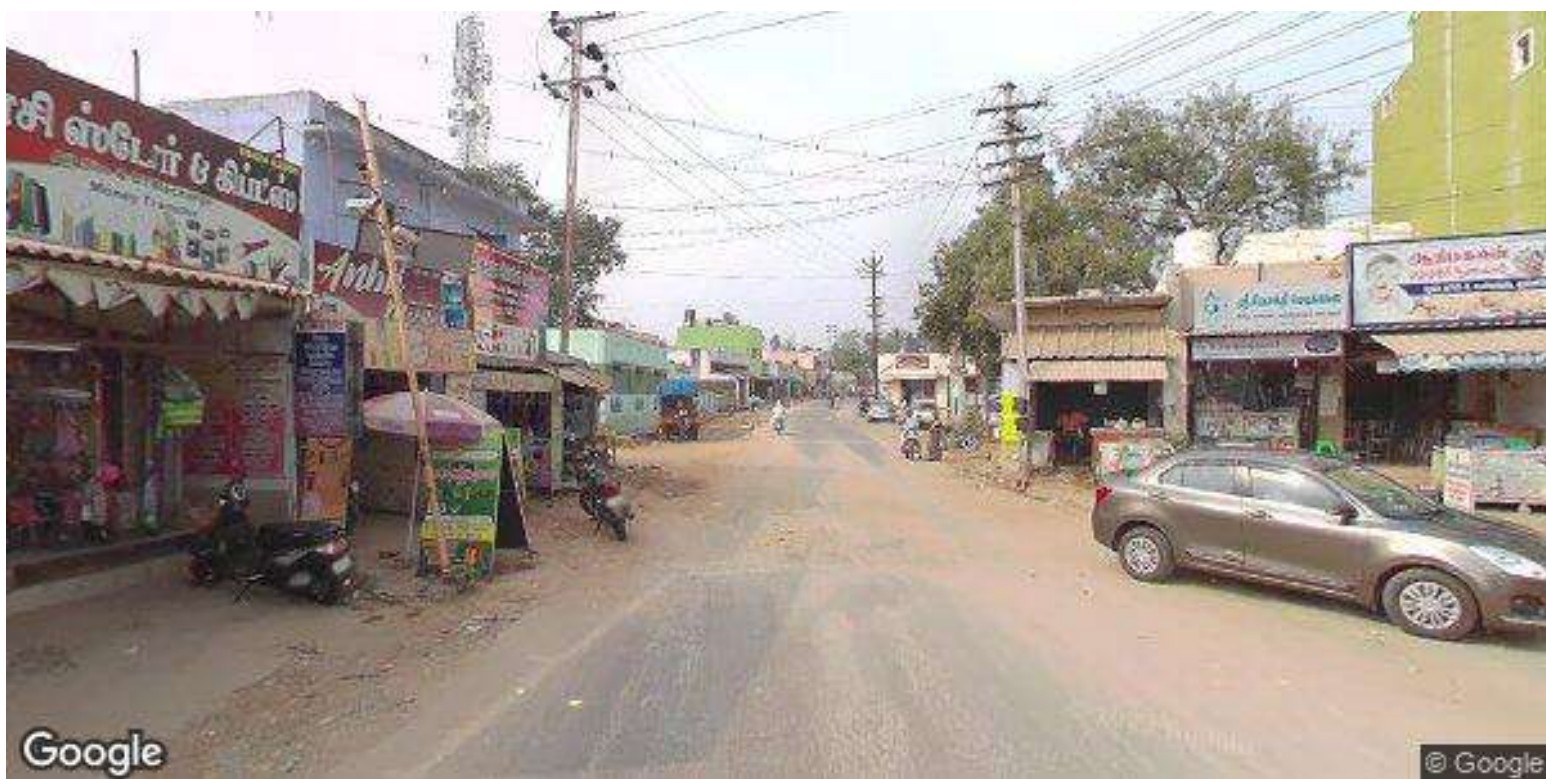
**Risk Type:** Turn

**Risk Level:** High

**Speed Limit:** 15 KM/Hr

**Coordinates:** 11.18856, 77.77110

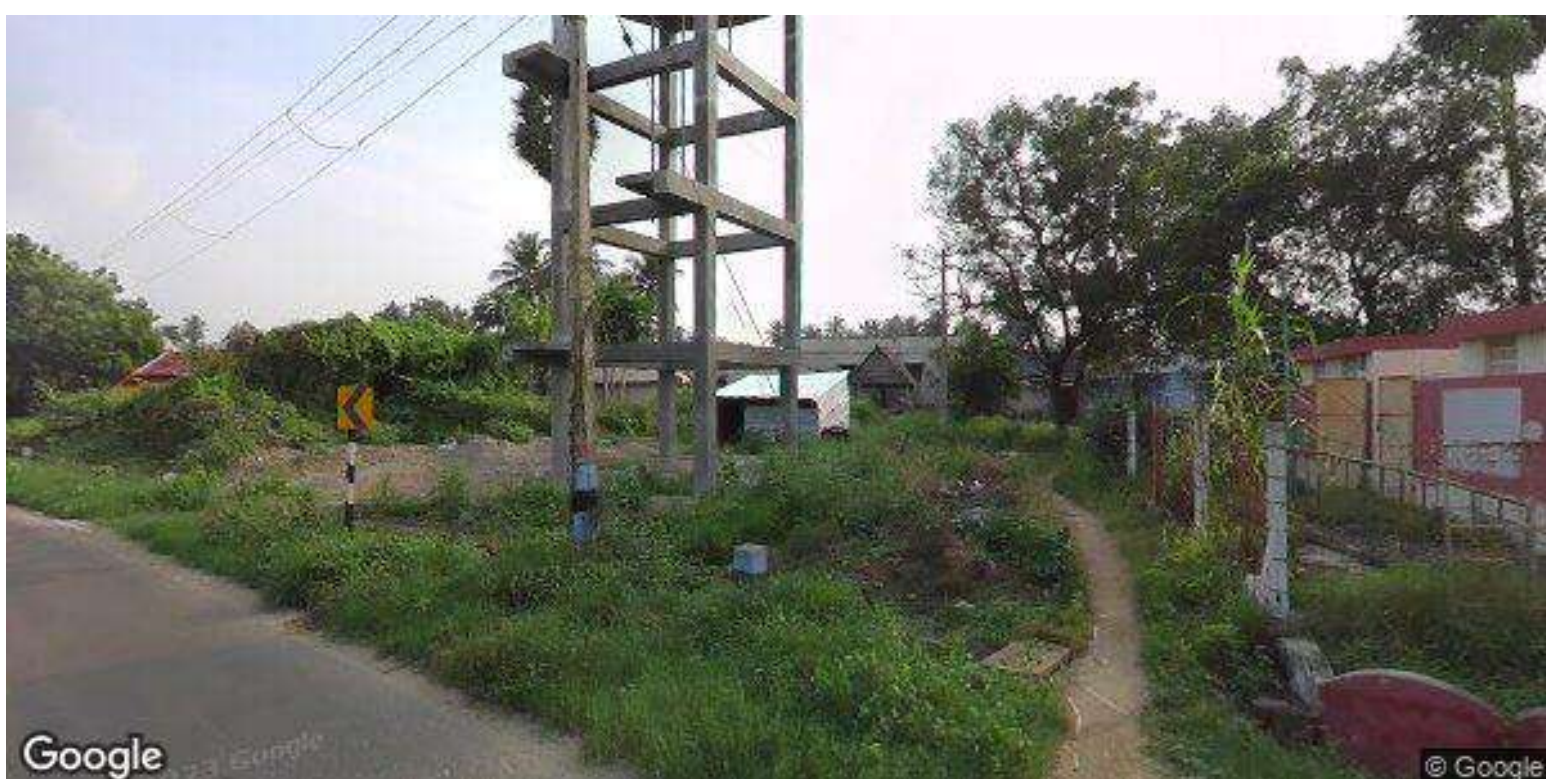
**Risk Type:** Turn  
**Risk Level:** Medium  
**Speed Limit:** 30 KM/Hr  
**Coordinates:** 11.16404, 77.77379
