# IndianOil

## JOURNEY RISK MANAGEMENT (JRM) STUDY

### Salem Terminal to AEGAN PETRO FILLS

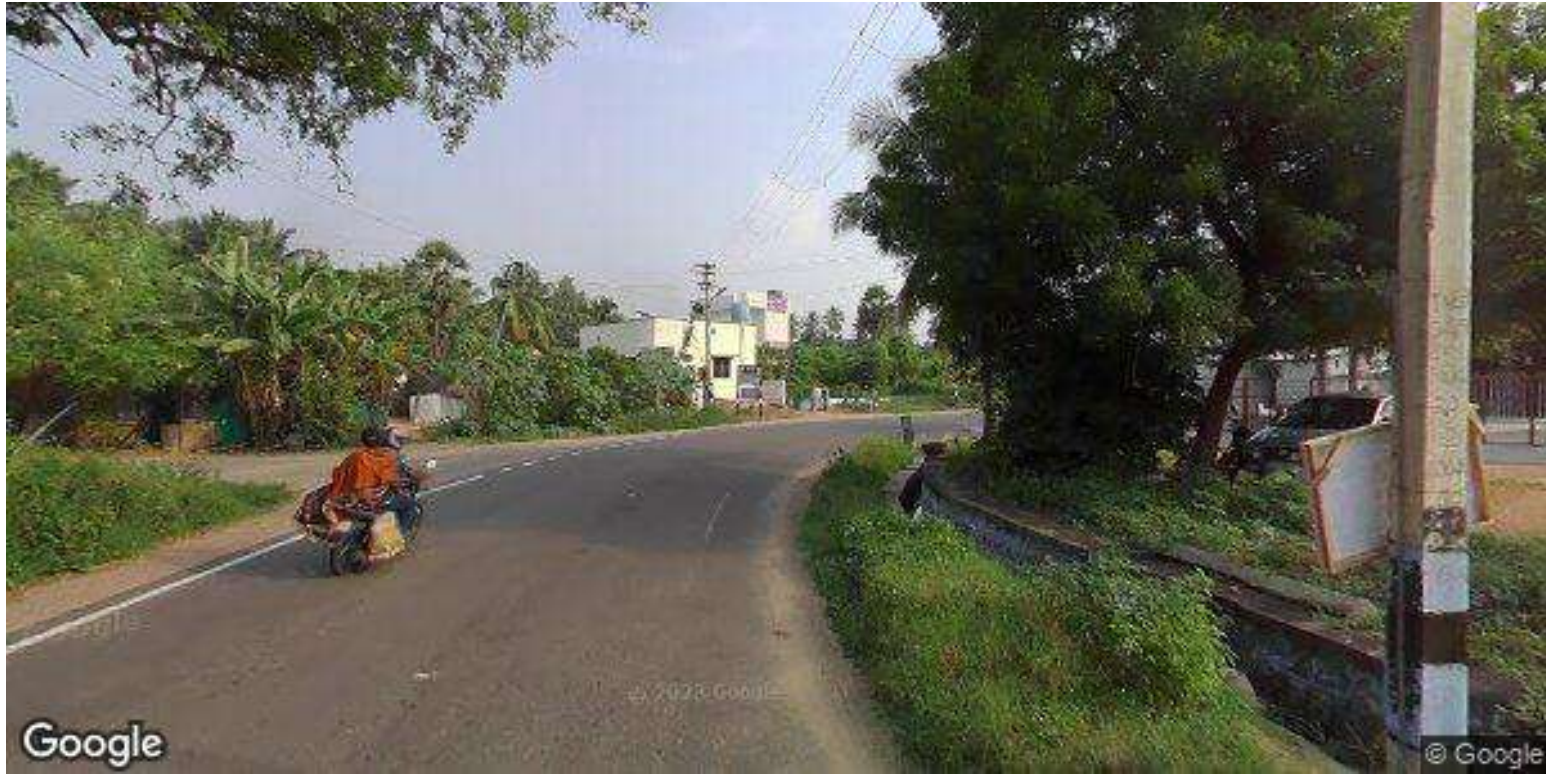
**Risk Type:** Turn  
**Risk Level:** Medium  
**Speed Limit:** 30 KM/Hr  
**Coordinates:** 11.16377, 77.77421

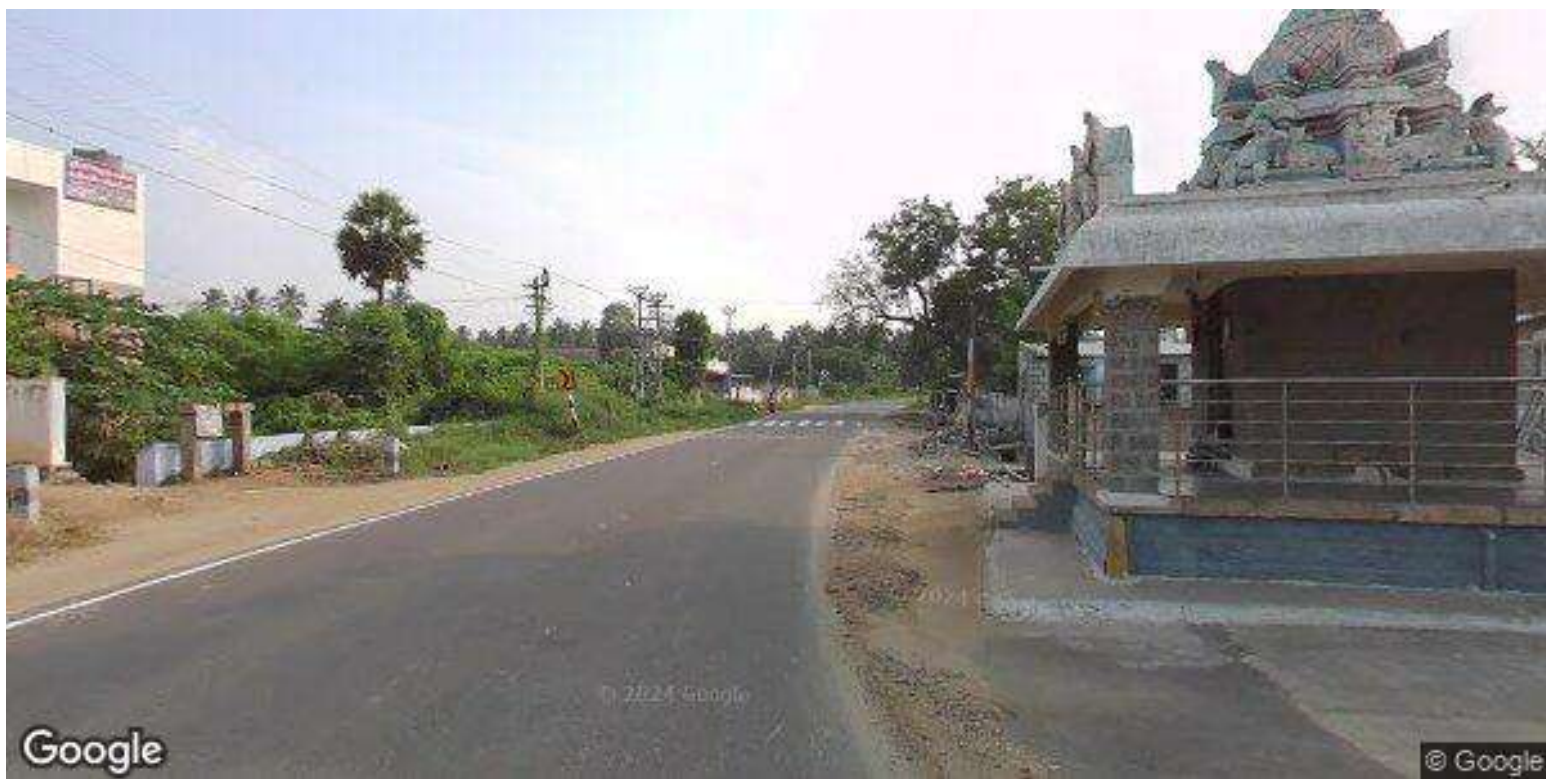
**Risk Type:** Turn  
**Risk Level:** Medium  
**Speed Limit:** 30 KM/Hr  
**Coordinates:** 11.16354, 77.77435

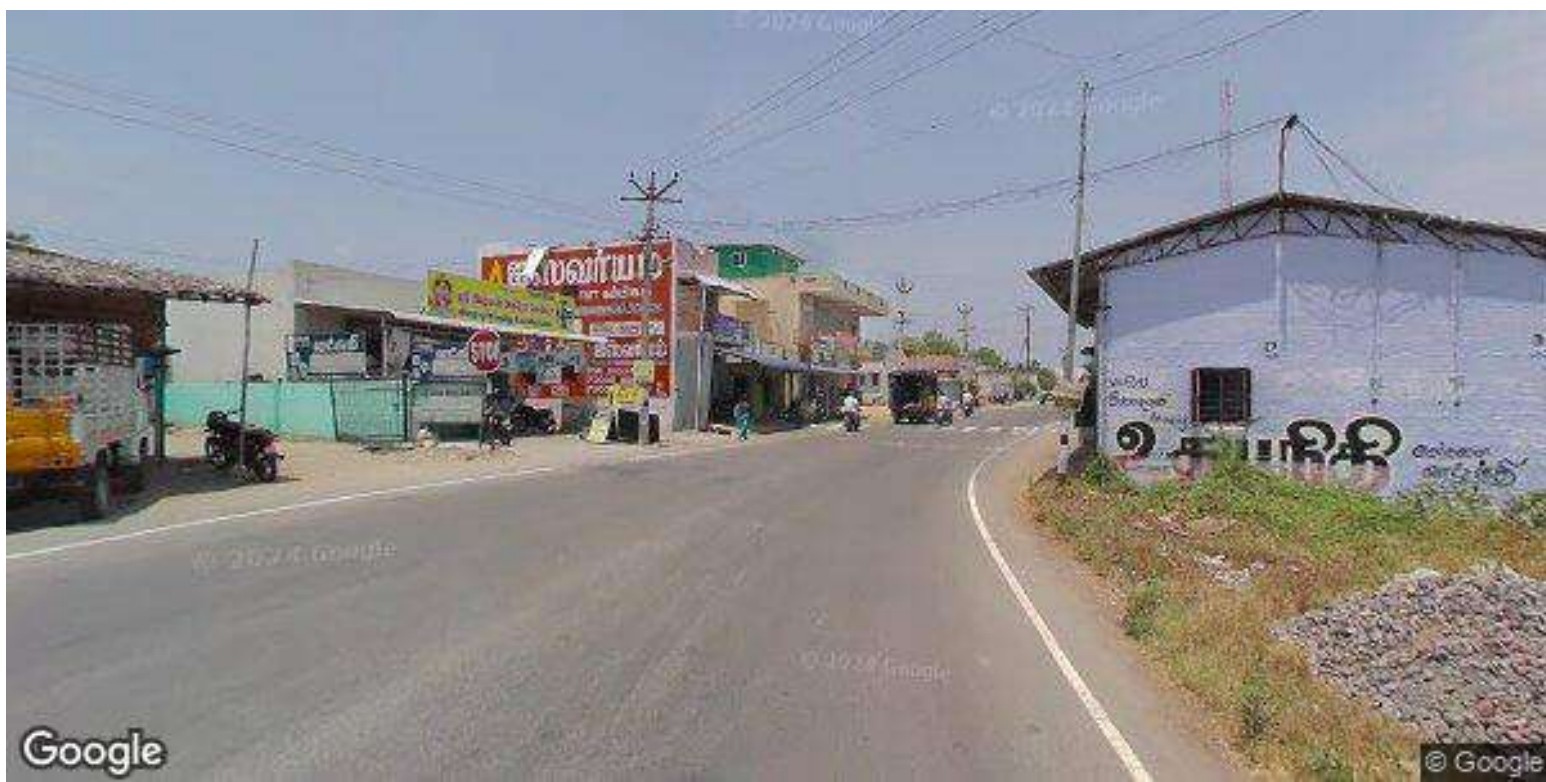
**Risk Type:** Turn

**Risk Level:** Medium

**Speed Limit:** 30 KM/Hr

**Coordinates:** 11.04718, 77.73742

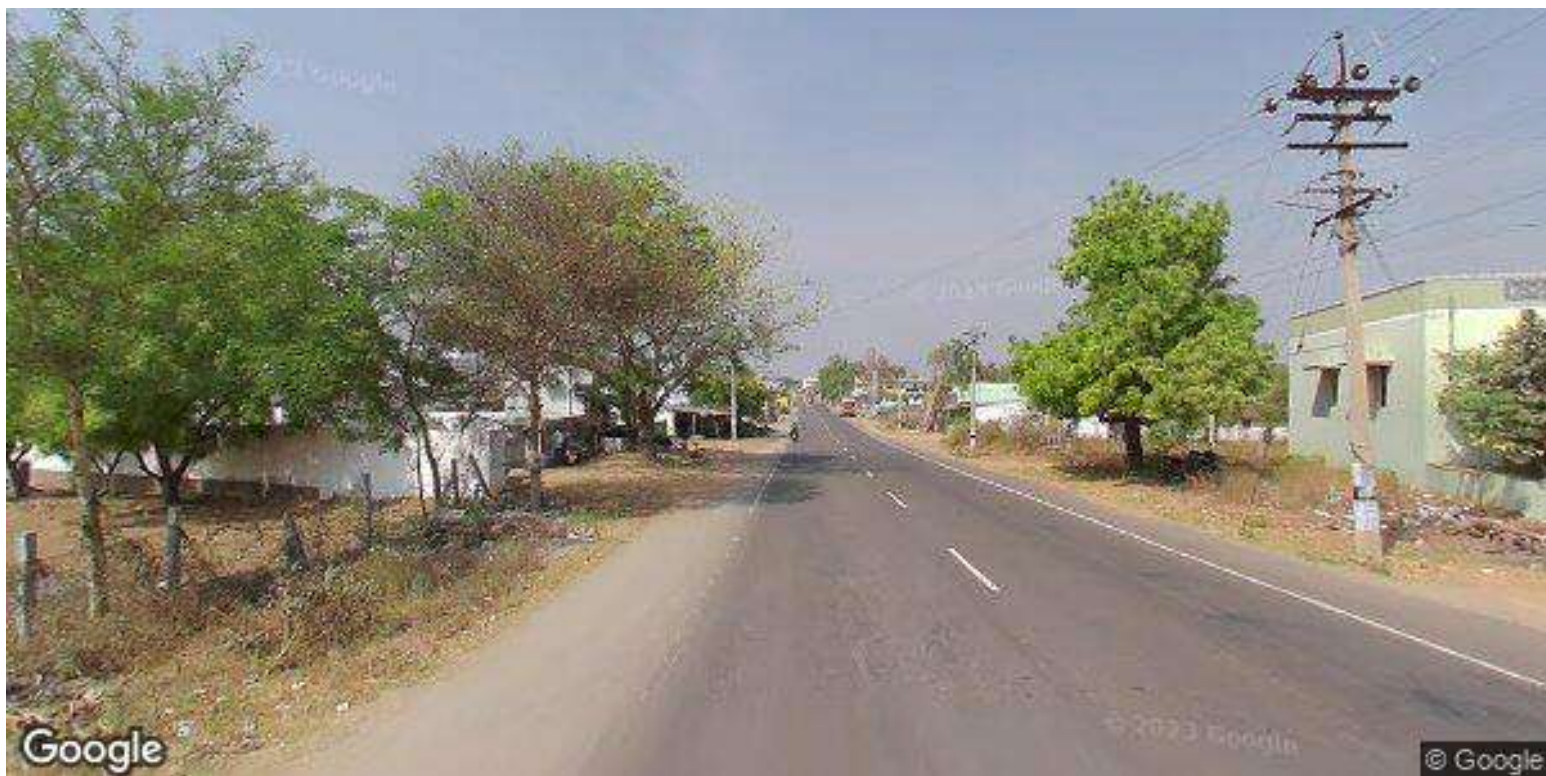
**Risk Type:** Turn

**Risk Level:** High

**Speed Limit:** 15 KM/Hr

**Coordinates:** 11.04826, 77.74469

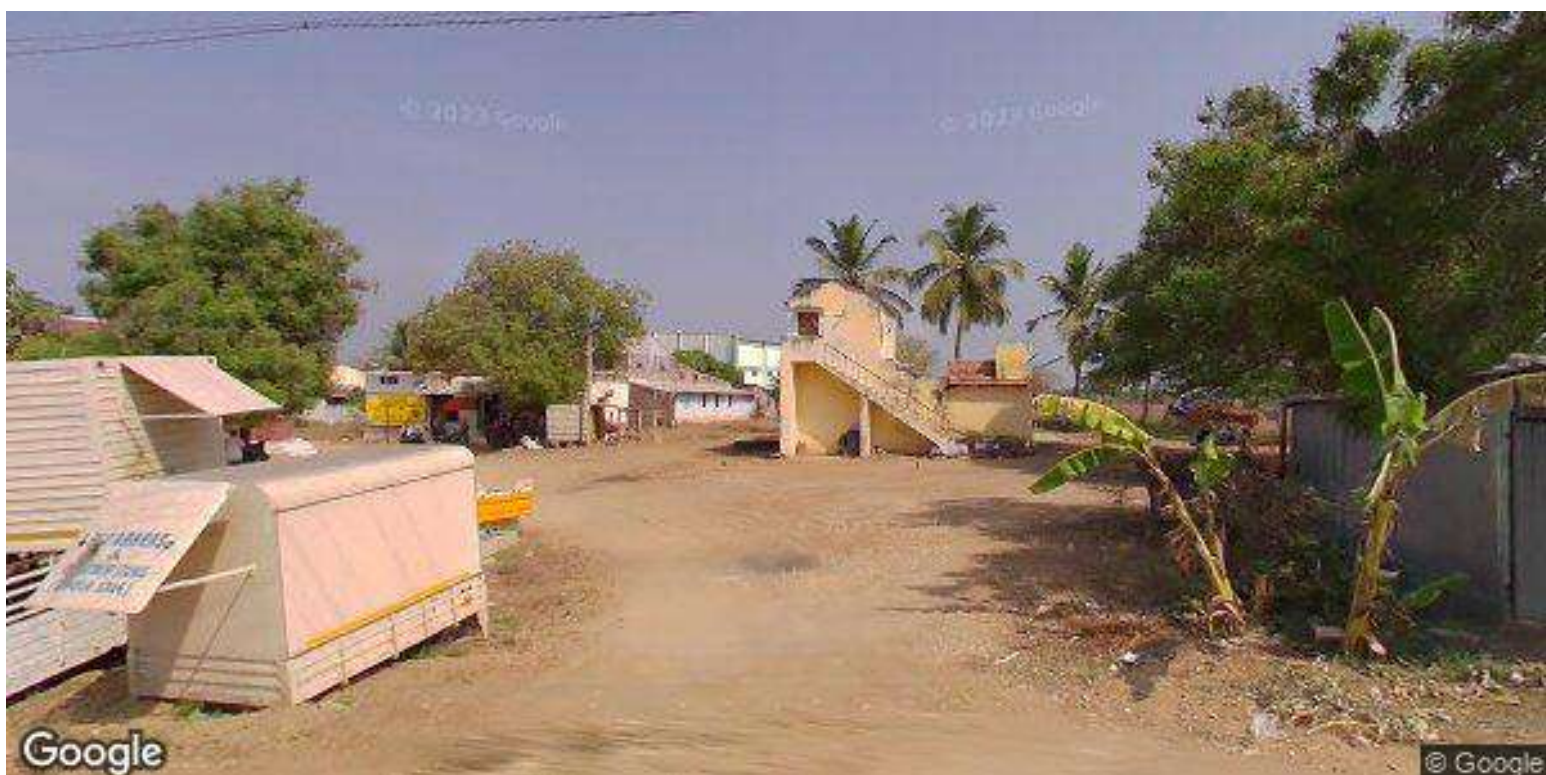
**Risk Type:** Blind Spot  
**Risk Level:** Blind Spot  
**Speed Limit:** 10 KM/Hr  
**Coordinates:** 11.04848, 77.74469

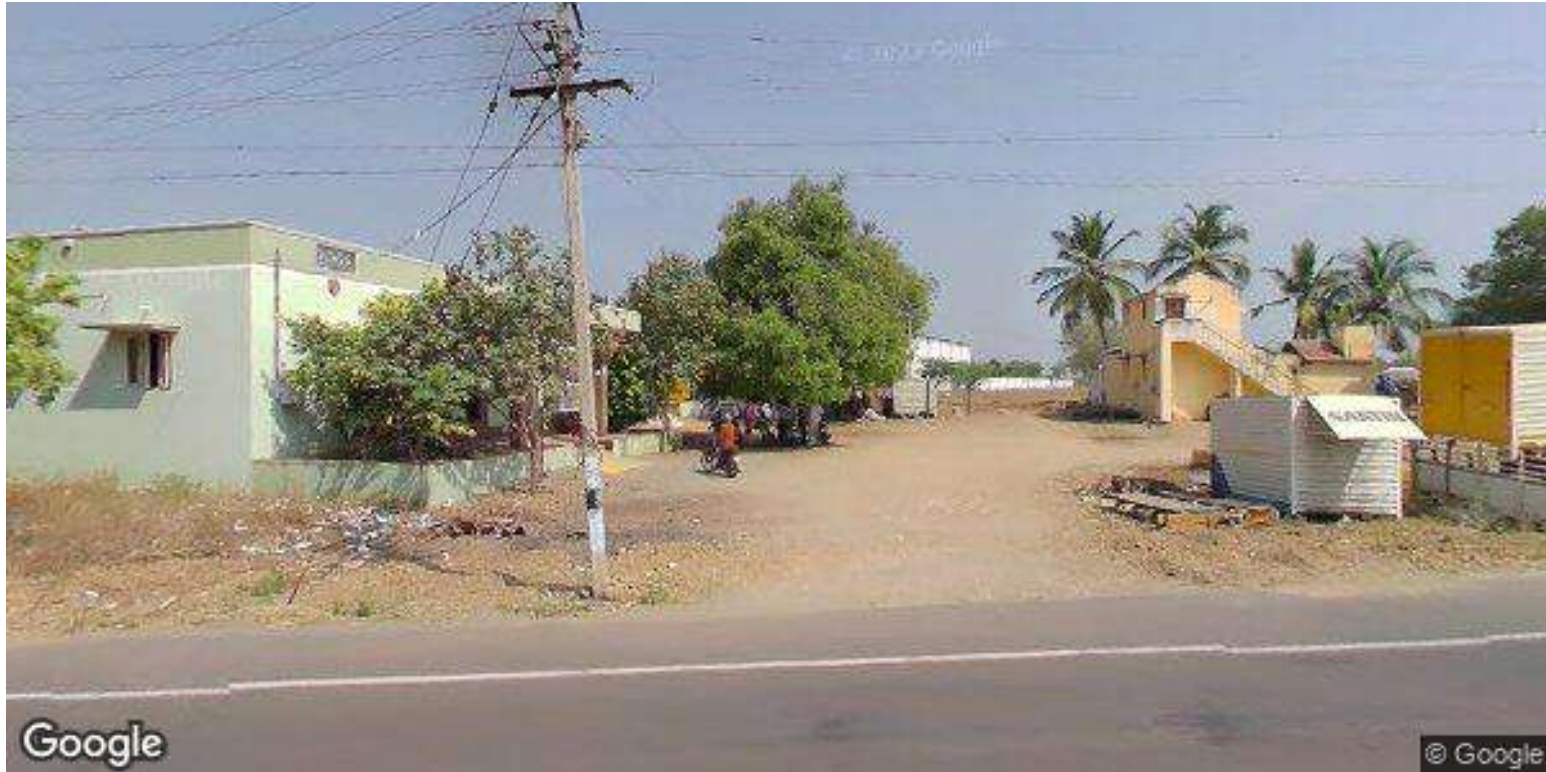
**Risk Type:** Turn  
**Risk Level:** High  
**Speed Limit:** 15 KM/Hr  
**Coordinates:** 11.04838, 77.74455

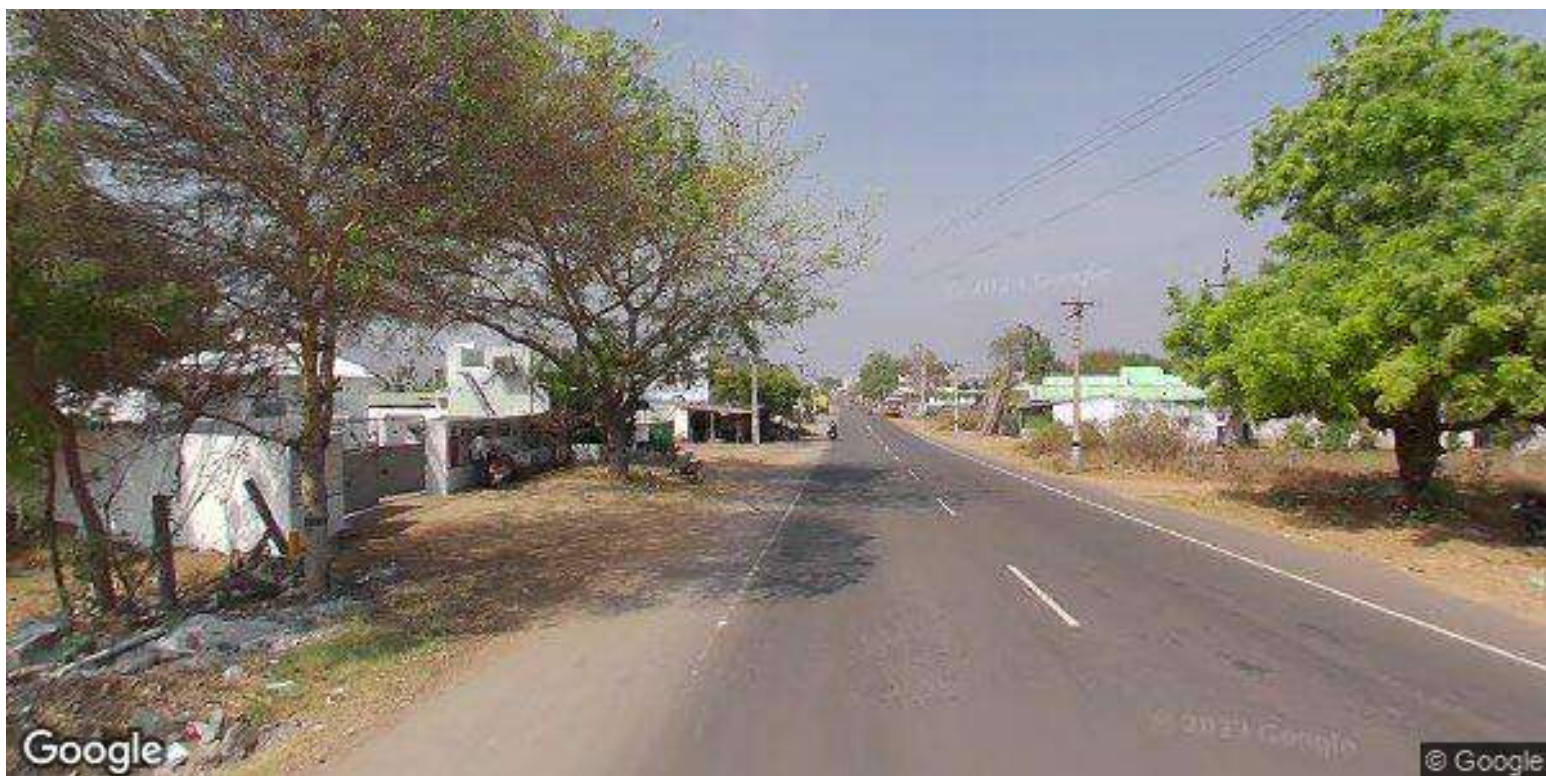
**Risk Type:** Turn  
**Risk Level:** High  
**Speed Limit:** 15 KM/Hr  
**Coordinates:** 11.04821, 77.74461
