## **JOURNEY RISK MANAGEMENT (JRM) STUDY**

### **Salem Terminal To SRI GANESH LATCHUMI TRADERS**

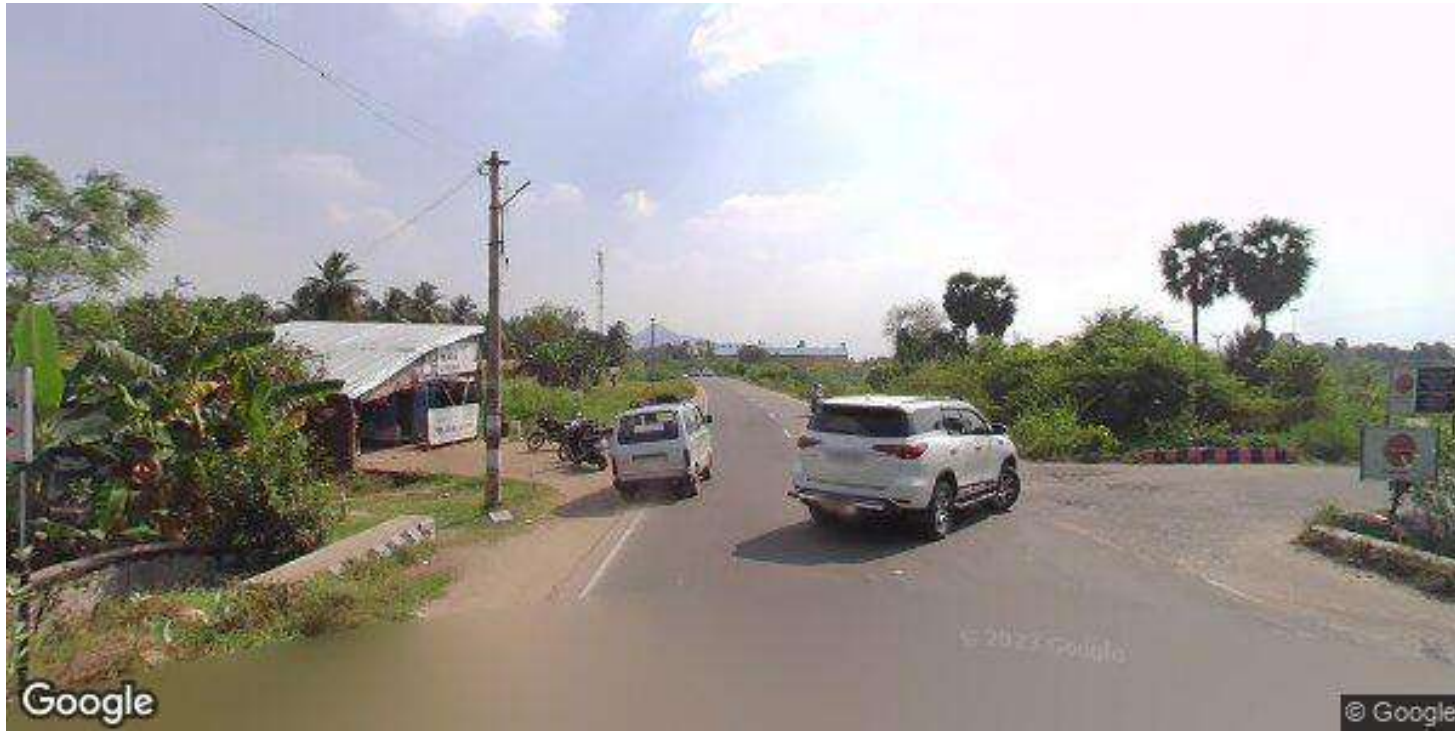
**Coordinates:** 11.44029, 77.87544

**Risk Type:** Turn

**Risk Level:** High

**Speed Limit:** 15 KM/Hr

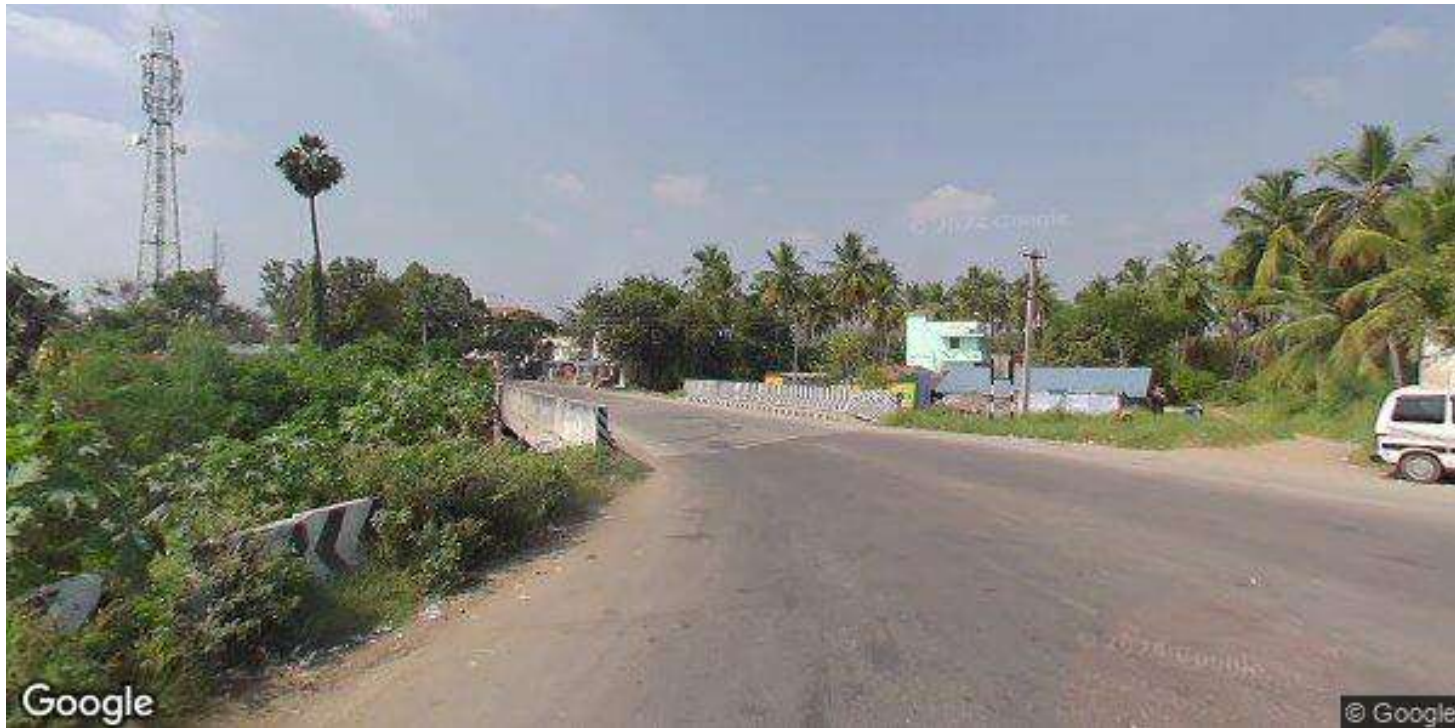
**Coordinates:** 11.44893, 77.87413

**Risk Type:** Turn

**Risk Level:** High

**Speed Limit:** 15 KM/Hr

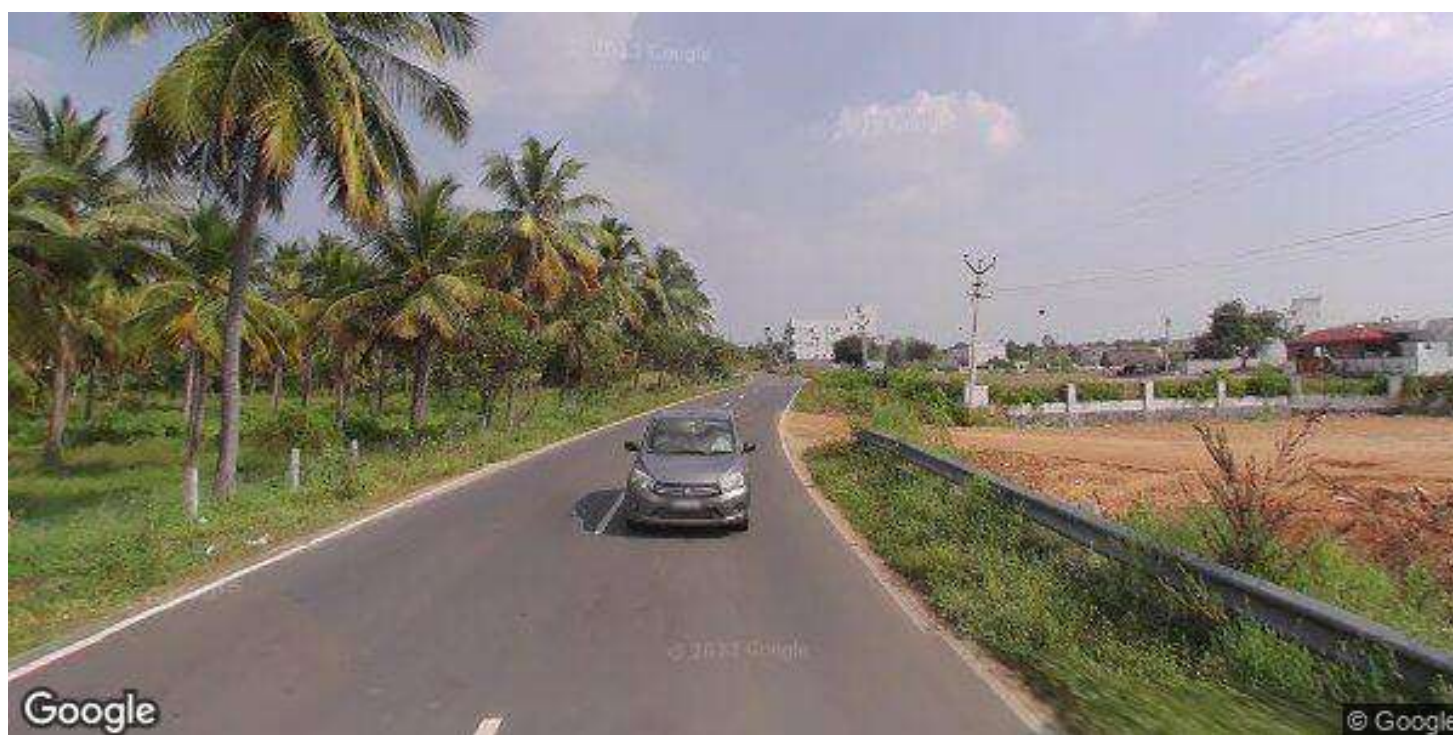
**Coordinates:** 11.45354, 77.85798

**Risk Type:** Turn

**Risk Level:** Medium

**Speed Limit:** 30 KM/Hr

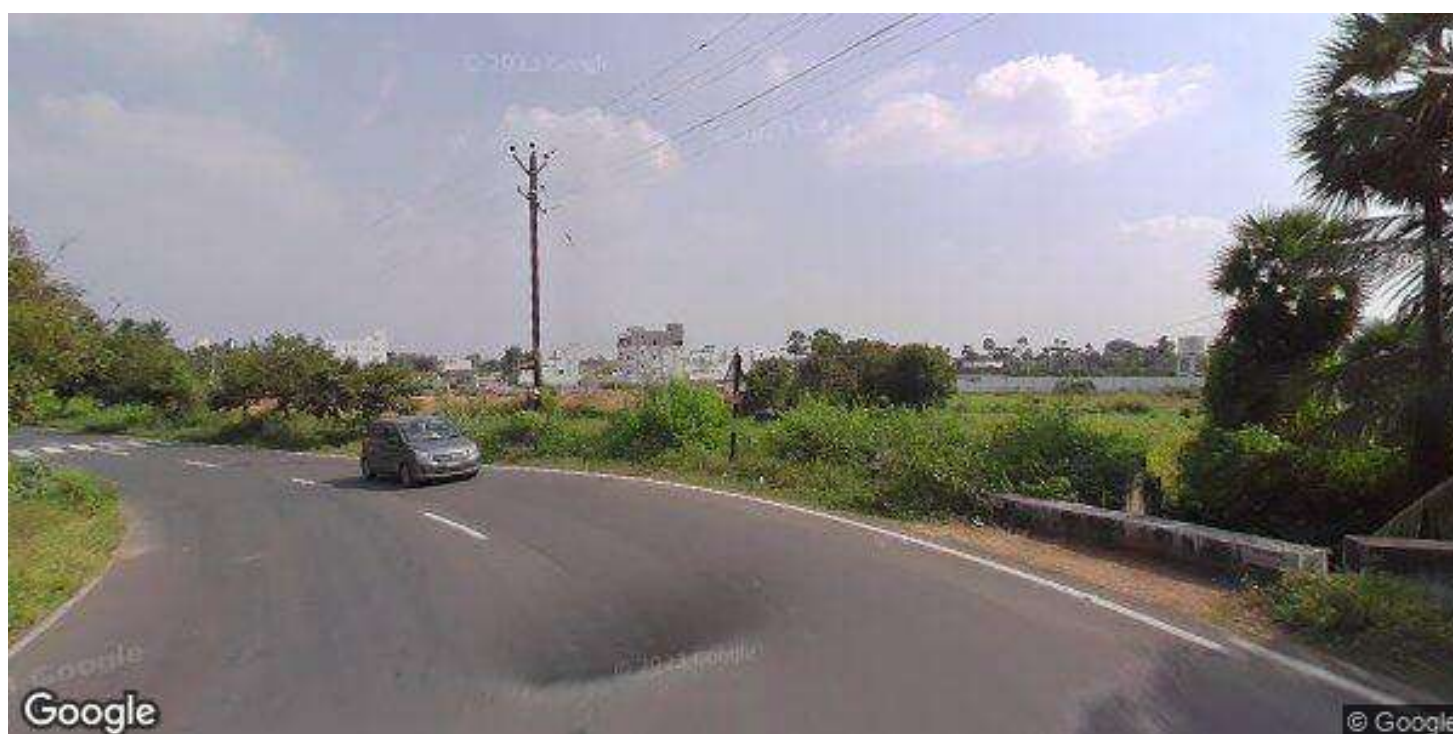
**Coordinates: 11.45350, 77.85700**

**Risk Type:** Turn

**Risk Level:** High

**Speed Limit: 15 KM/Hr**

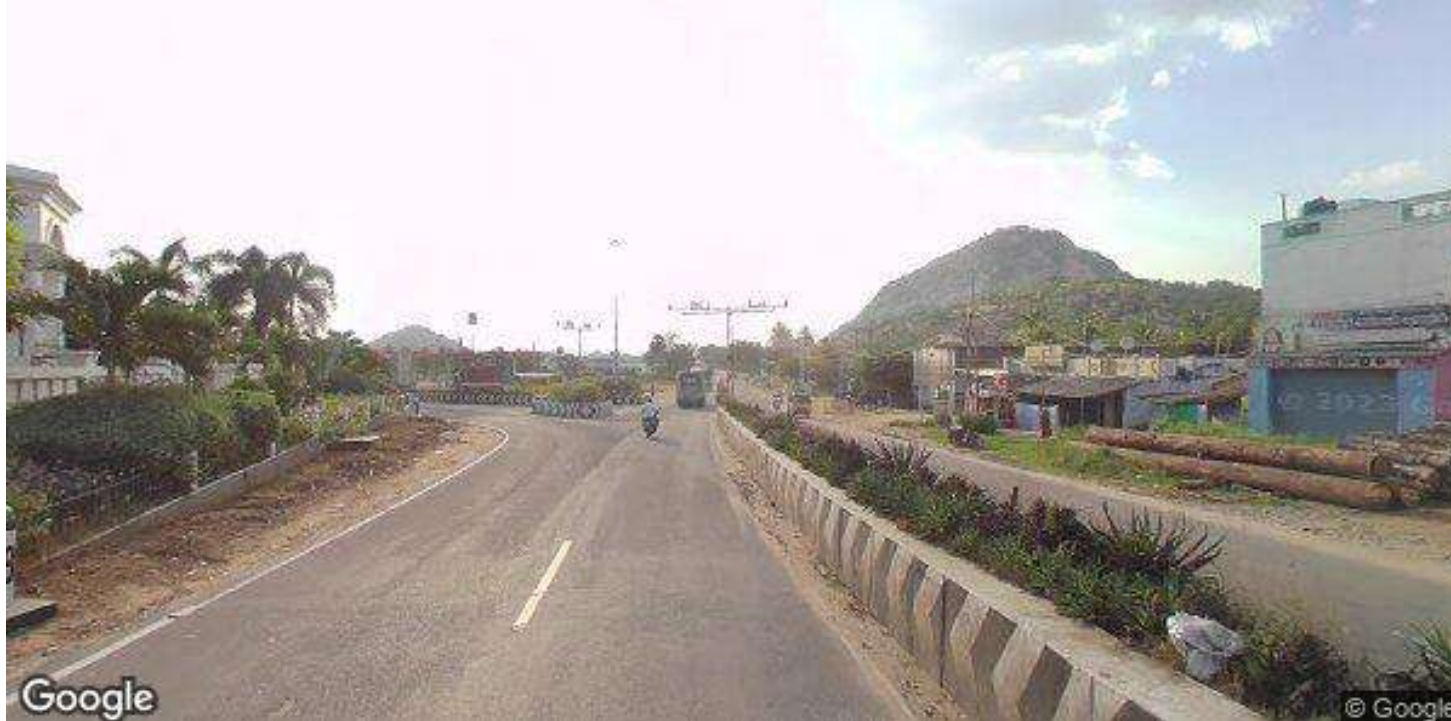
**Coordinates:** 11.46317, 77.84906

**Risk Type:** Turn

**Risk Level:** Medium

**Speed Limit:** 30 KM/Hr

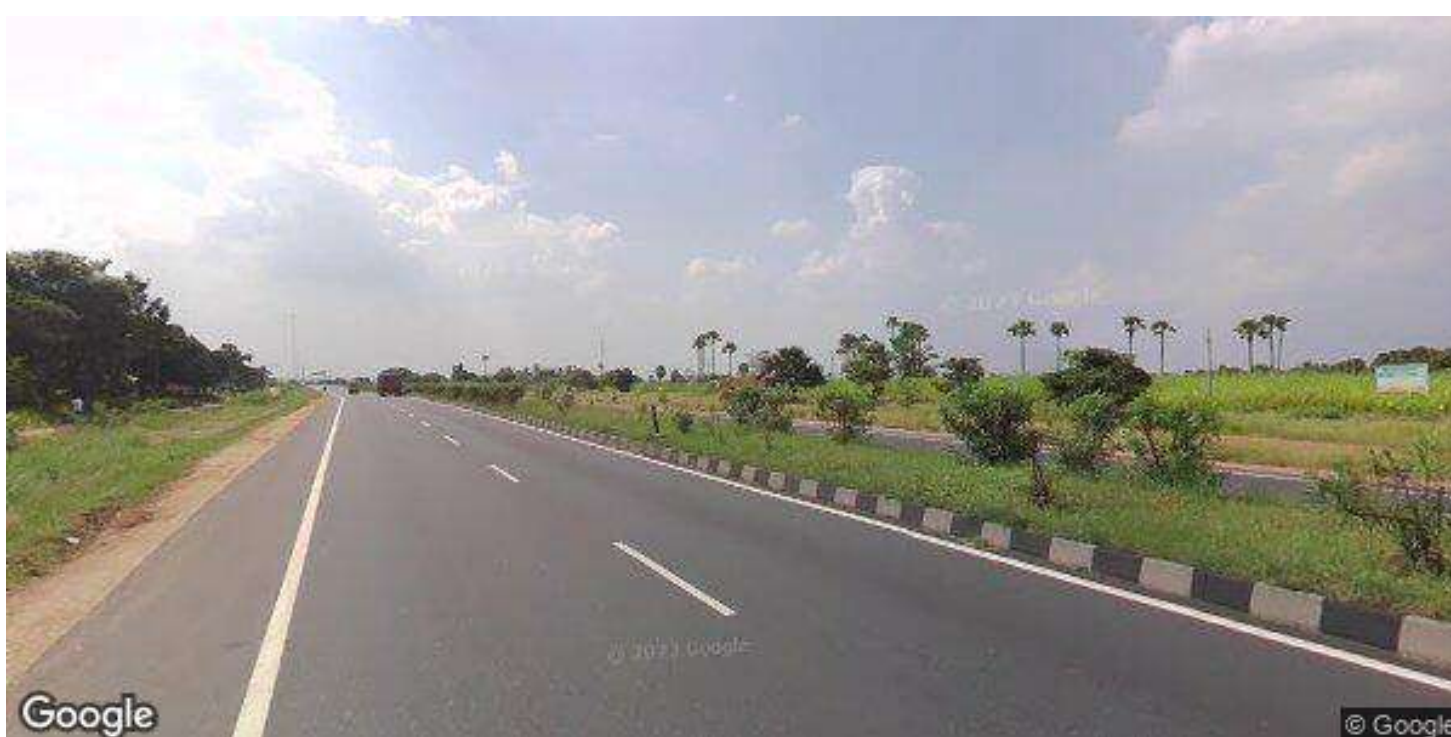
**Coordinates: 11.29012, 77.56873**

**Risk Type:** Turn

**Risk Level:** Medium

**Speed Limit: 30 KM/Hr**

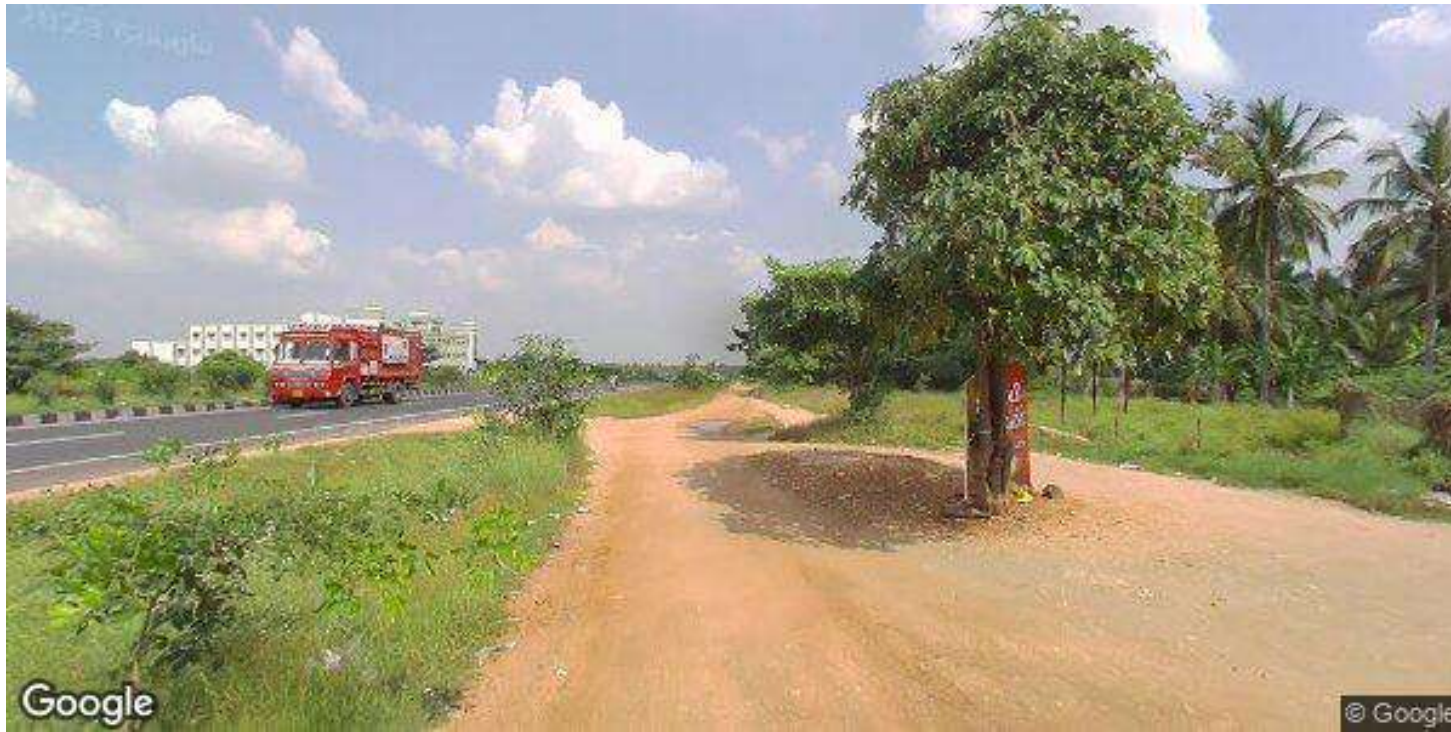
**Coordinates: 11.28994, 77.56861**

**Risk Type: Turn**

**Risk Level: Medium**

**Speed Limit: 30 KM/Hr**

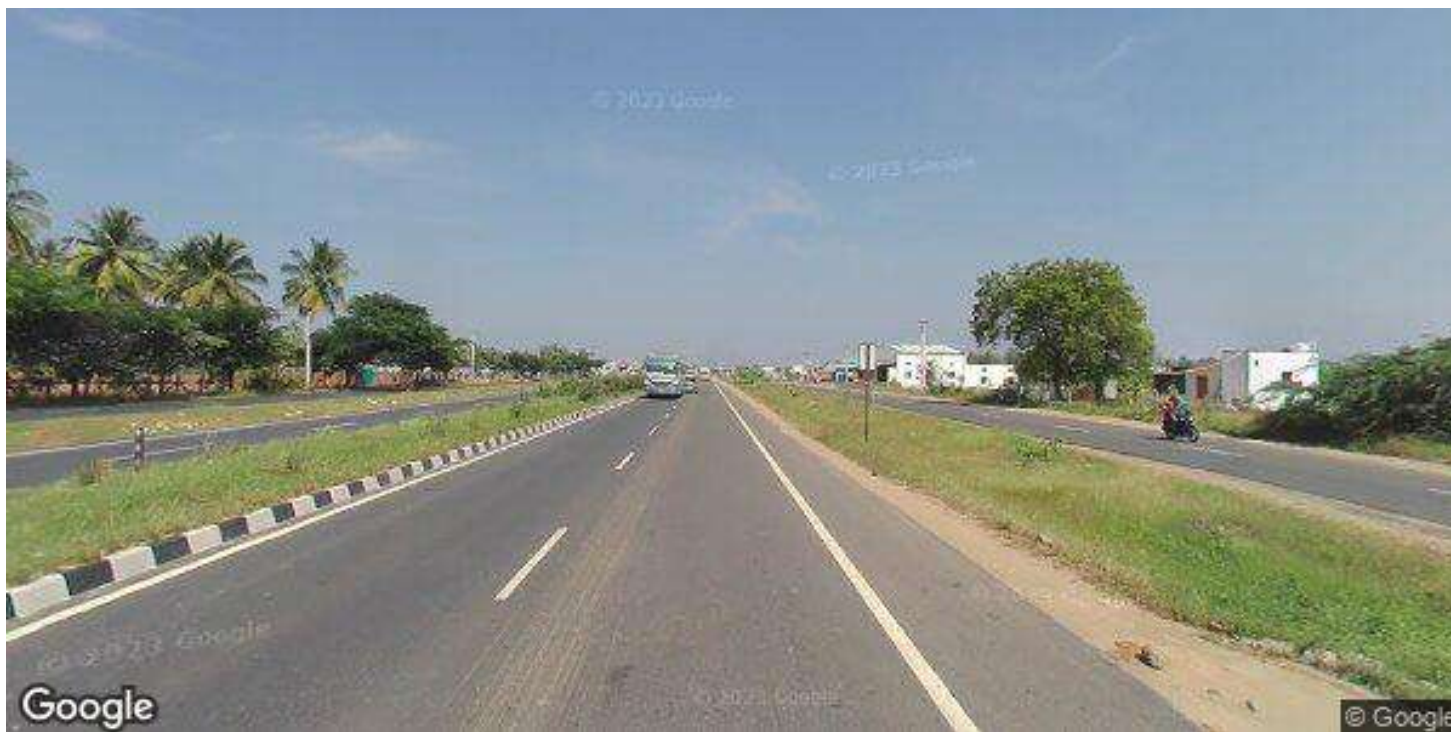
**Coordinates: 11.20358, 77.42732**

**Risk Type: Turn**

**Risk Level: High**

**Speed Limit: 15 KM/Hr**

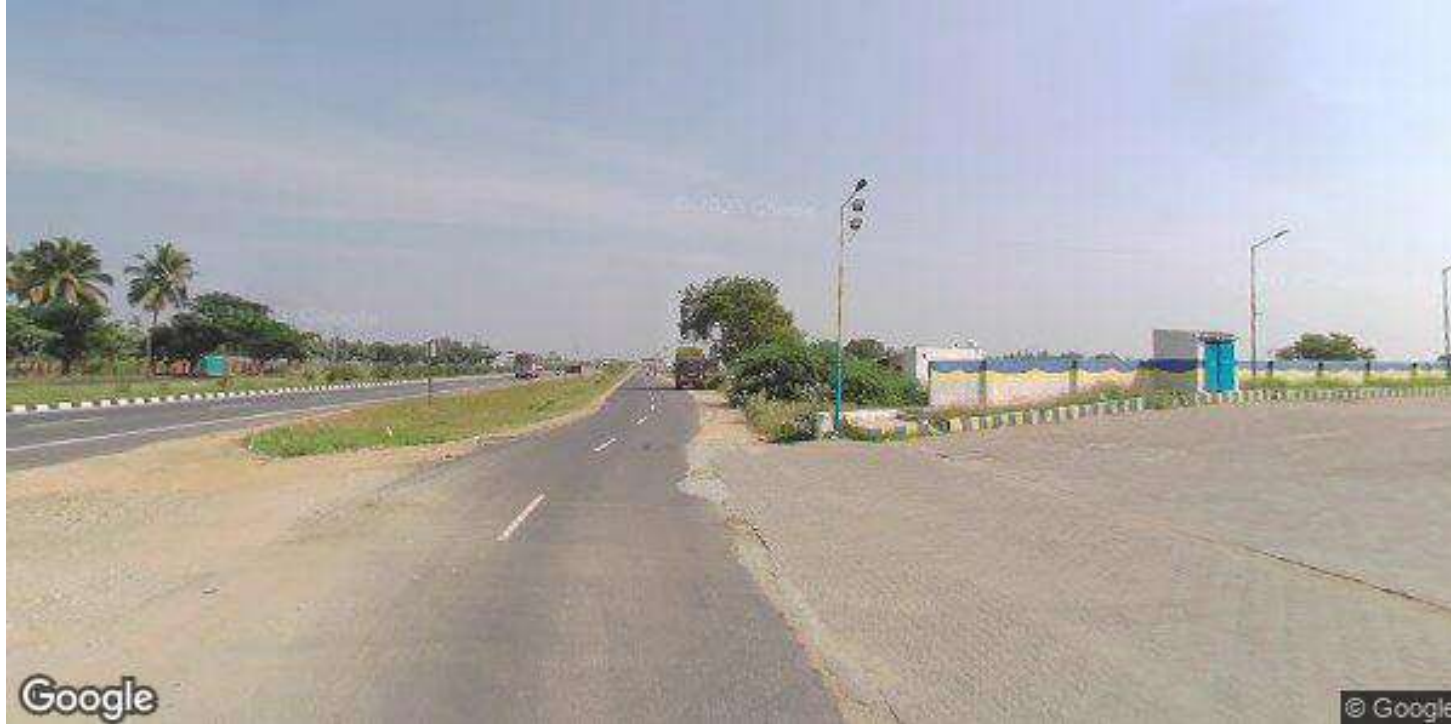
**Coordinates:** 11.20335, 77.42730

**Risk Type:** Turn

**Risk Level:** High

**Speed Limit:** 15 KM/Hr

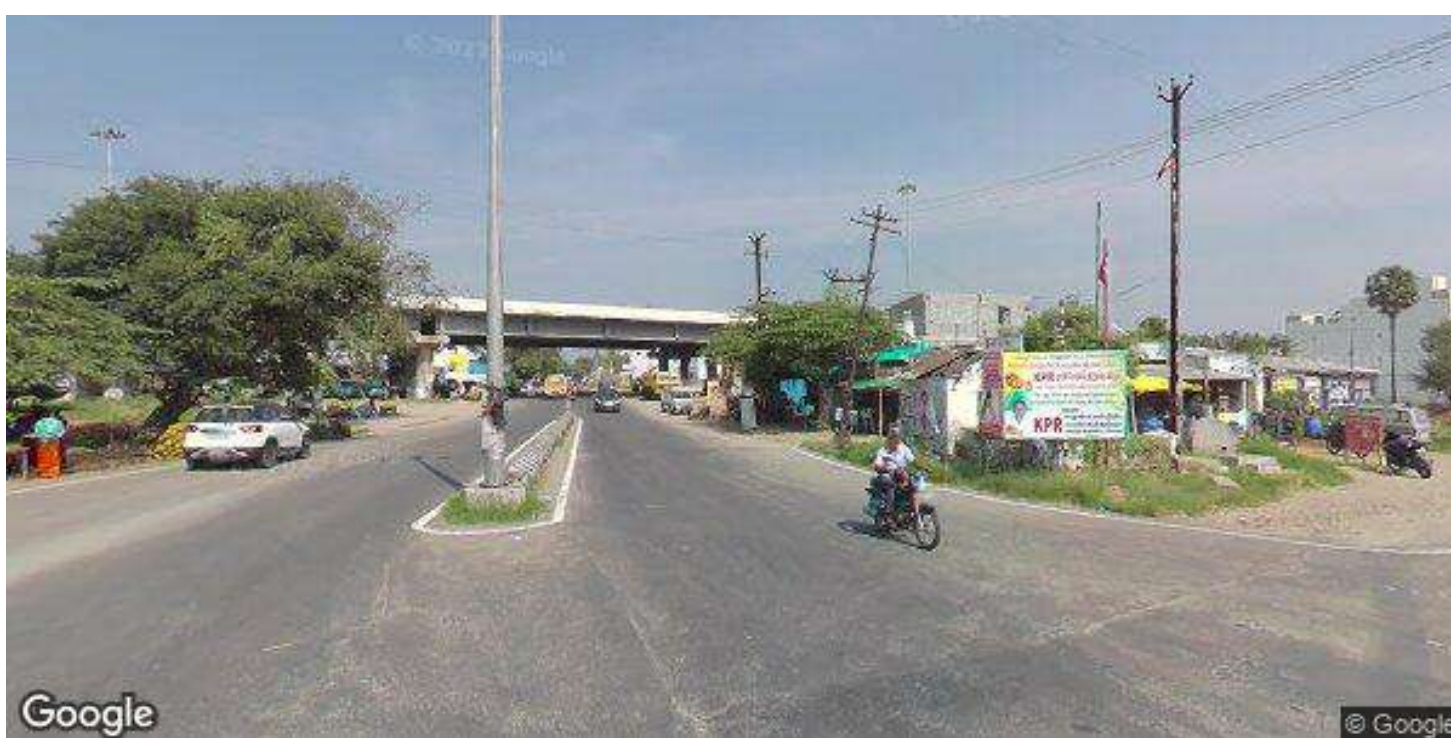
**Coordinates:** 11.19962, 77.42240

**Risk Type:** Turn

**Risk Level:** High

**Speed Limit:** 15 KM/Hr
