## JOURNEY RISK MANAGEMENT (JRM) STUDY

### Salem Terminal TO SINTHIYA NATESAN FUELS

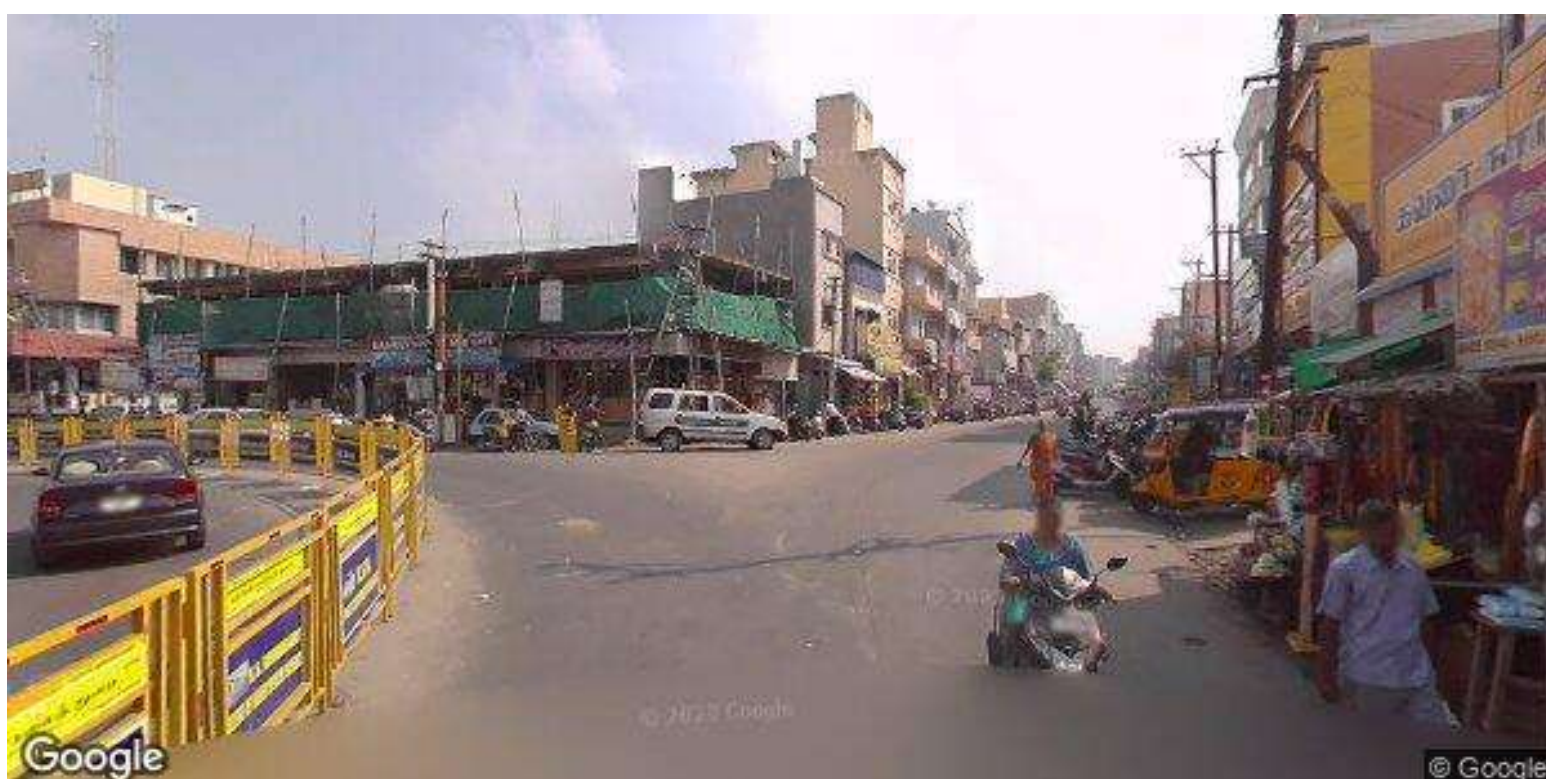
Coordinates: 11.37862, 77.89488

Risk Type: Turn

Risk Level: High

Speed Limit: 15 KM/Hr

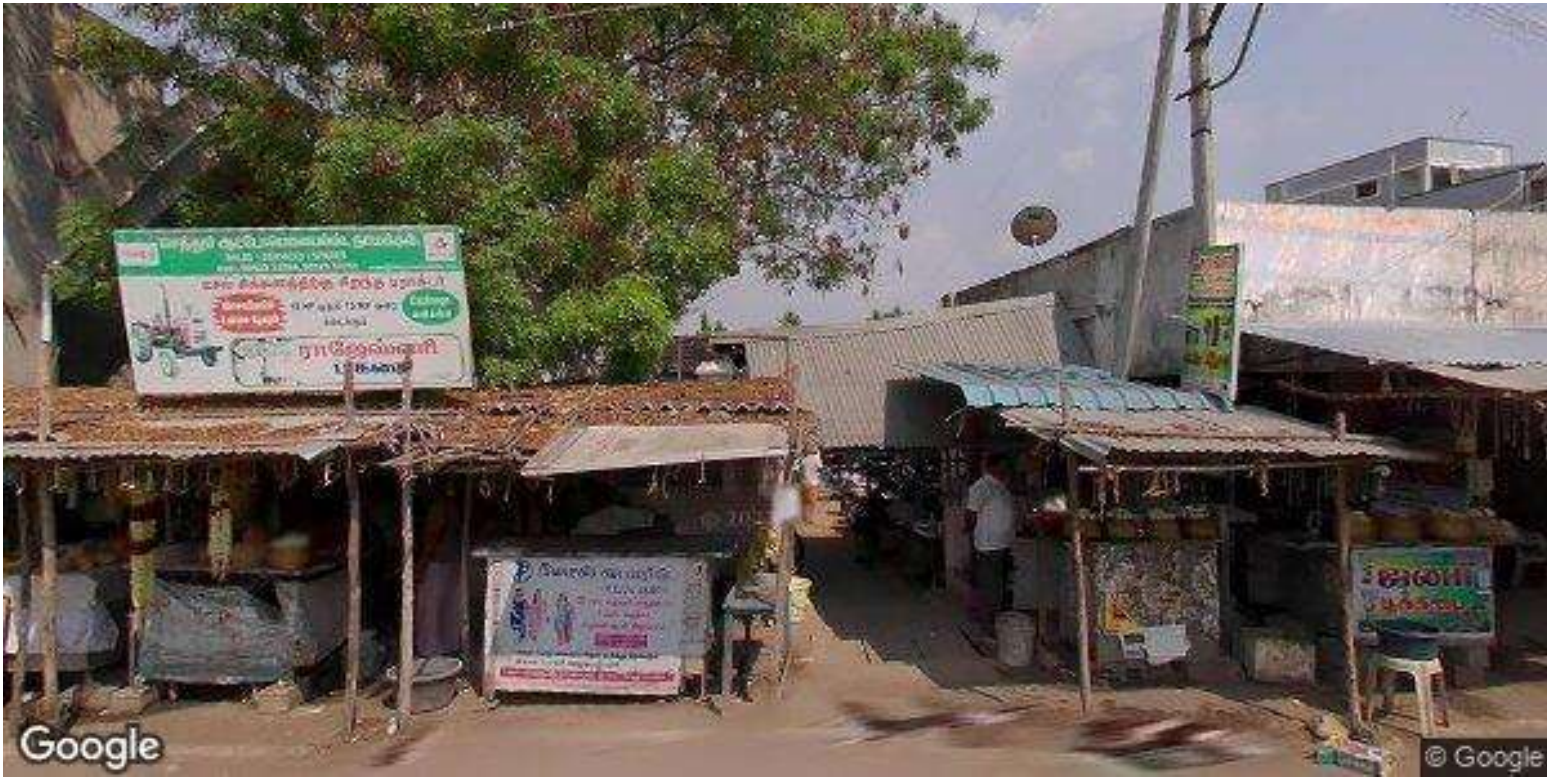
Risk Type: Turn  
Risk Level: High  
Speed Limit: 15 KM/Hr  
Coordinates: 11.15573, 78.02176

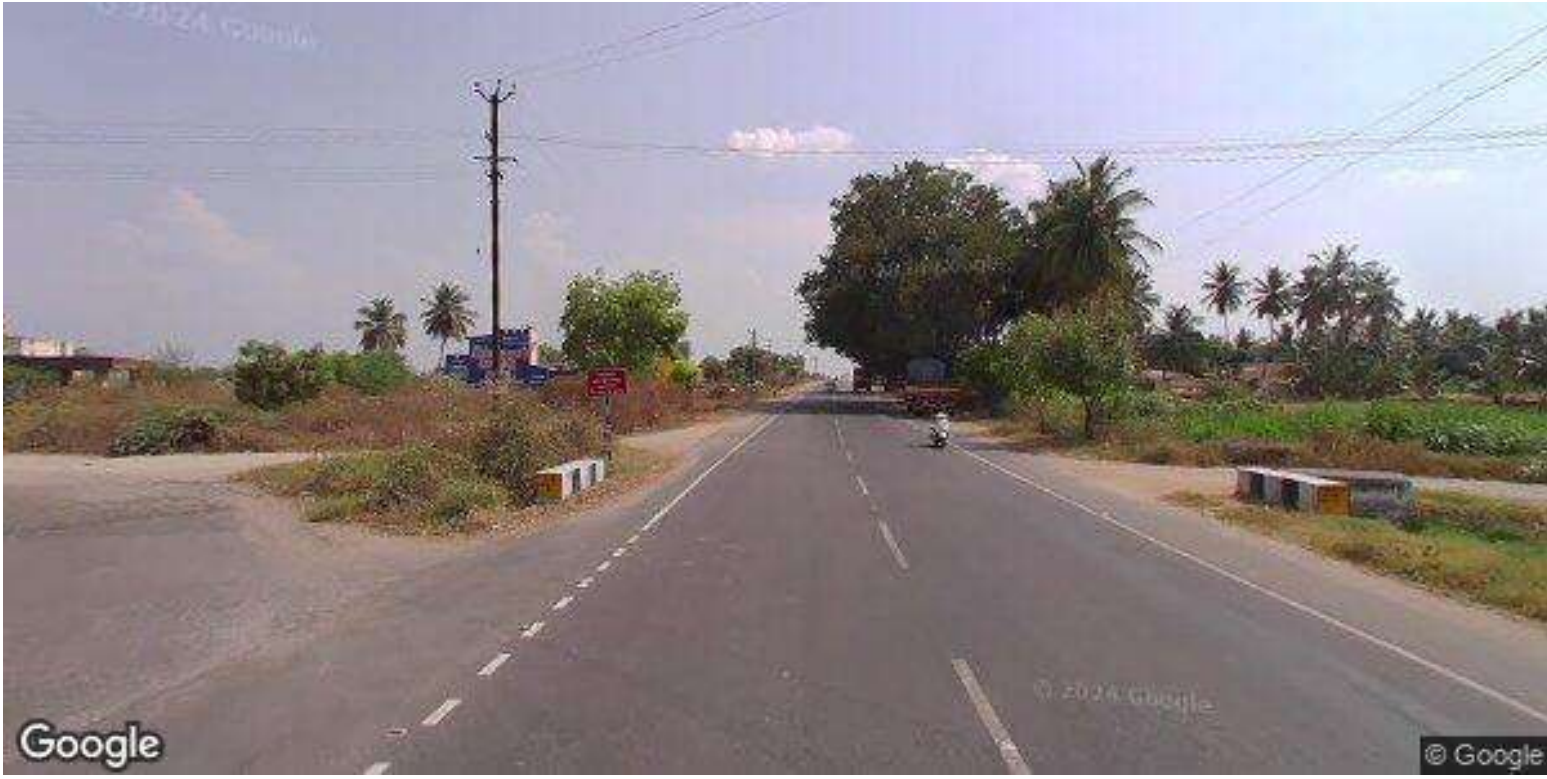
Risk Type: Turn  
Risk Level: High  
Speed Limit: 15 KM/Hr  
Coordinates: 11.14545, 78.02208

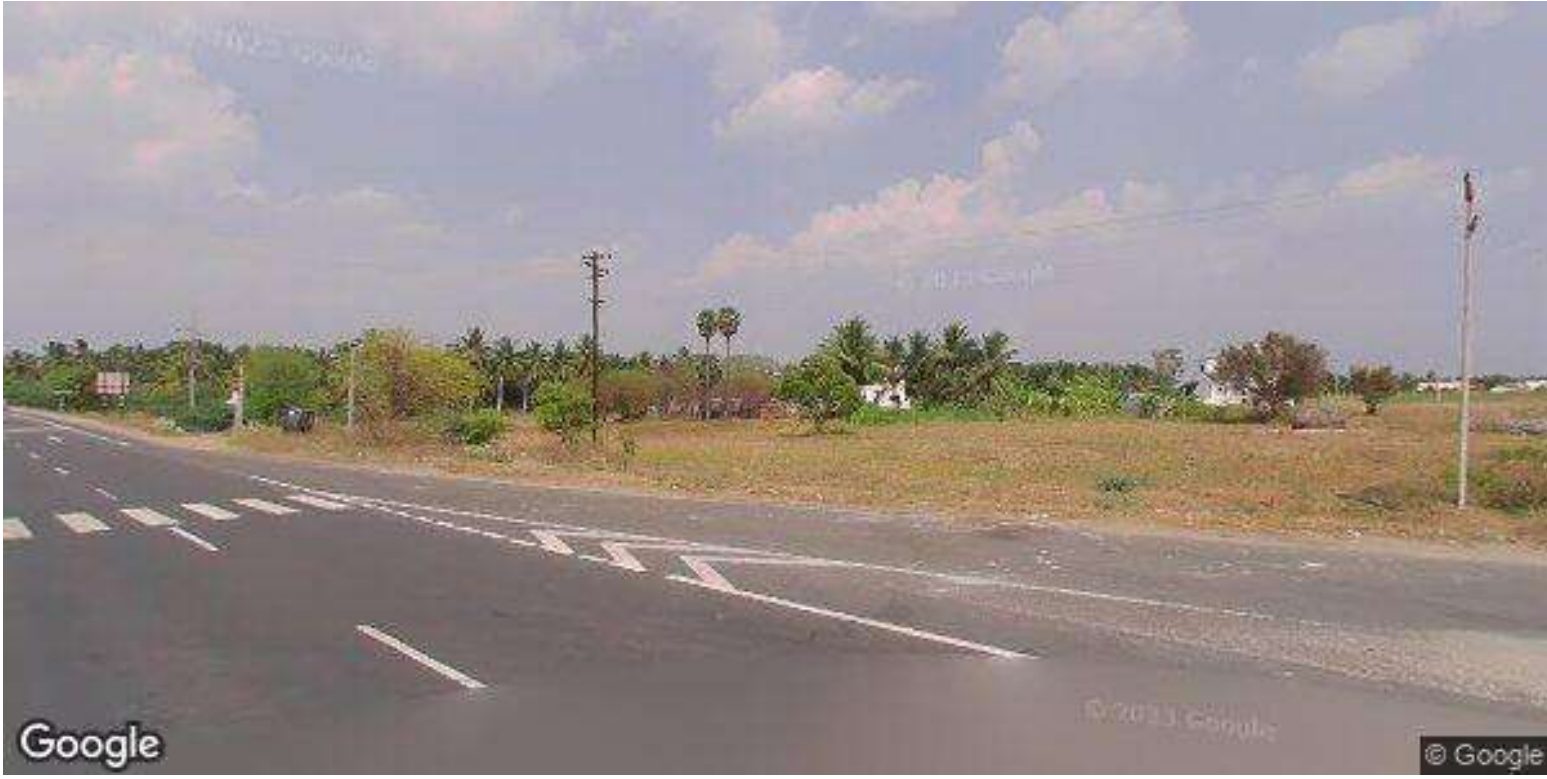
**Risk Type:** Turn  
**Risk Level:** High  
**Speed Limit:** 15 KM/Hr  
**Coordinates:** 11.14480, 78.02291

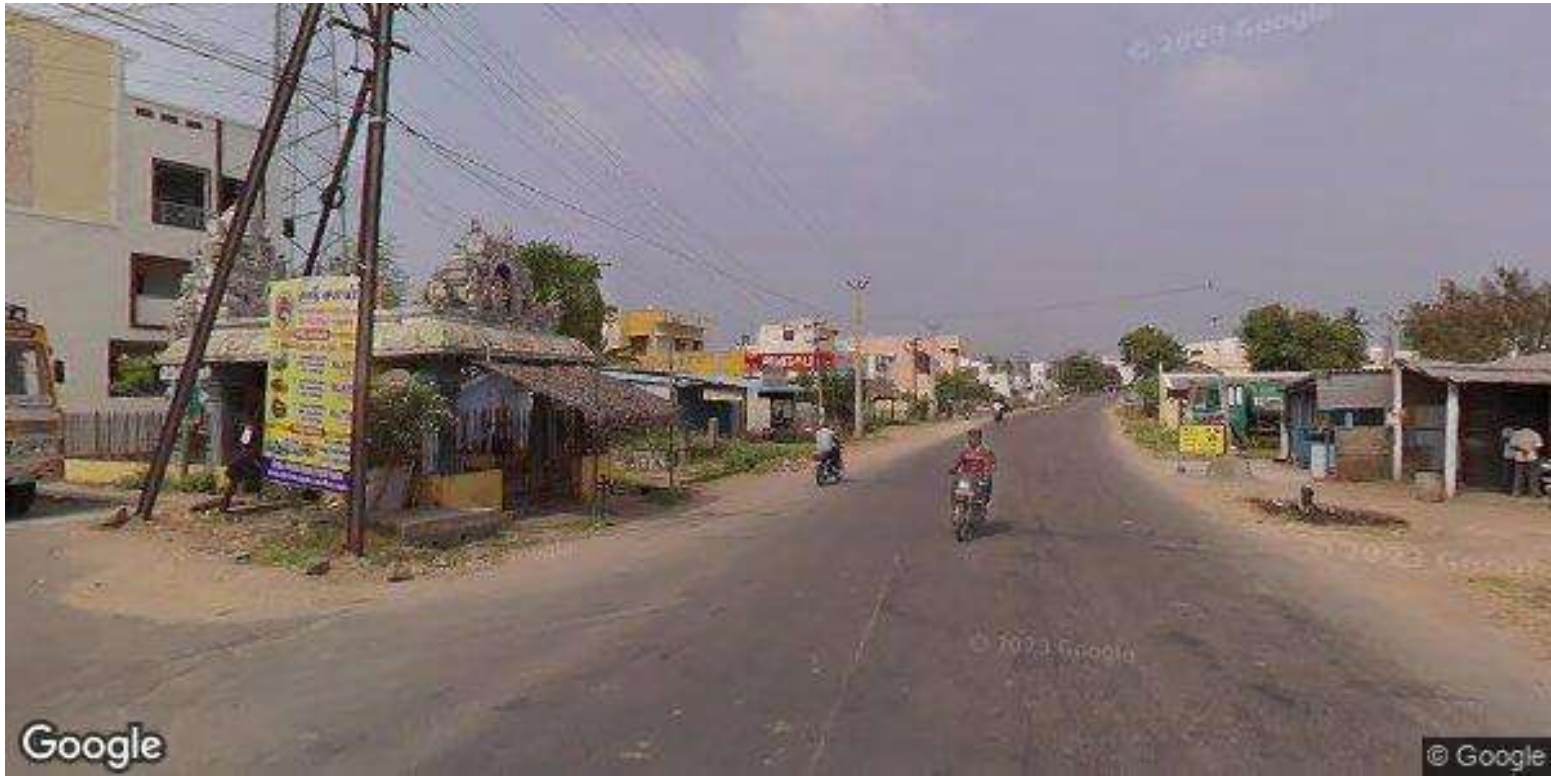
**Risk Type:** Turn  
**Risk Level:** Medium  
**Speed Limit:** 30 KM/Hr  
**Coordinates:** 10.98525, 78.07657

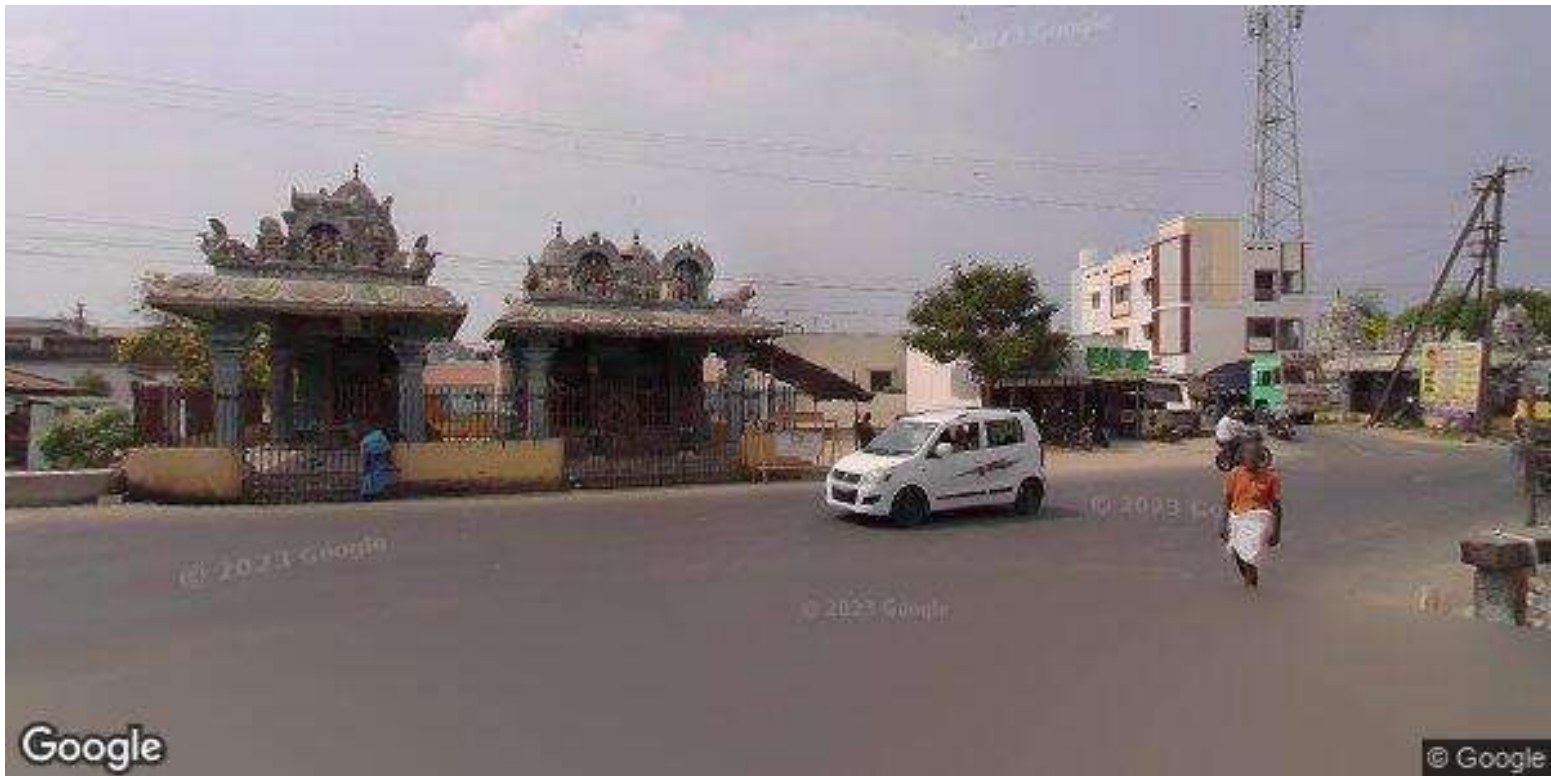
**Risk Type:** Turn  
**Risk Level:** High  
**Speed Limit:** 15 KM/Hr  
**Coordinates:** 10.98502, 78.07675

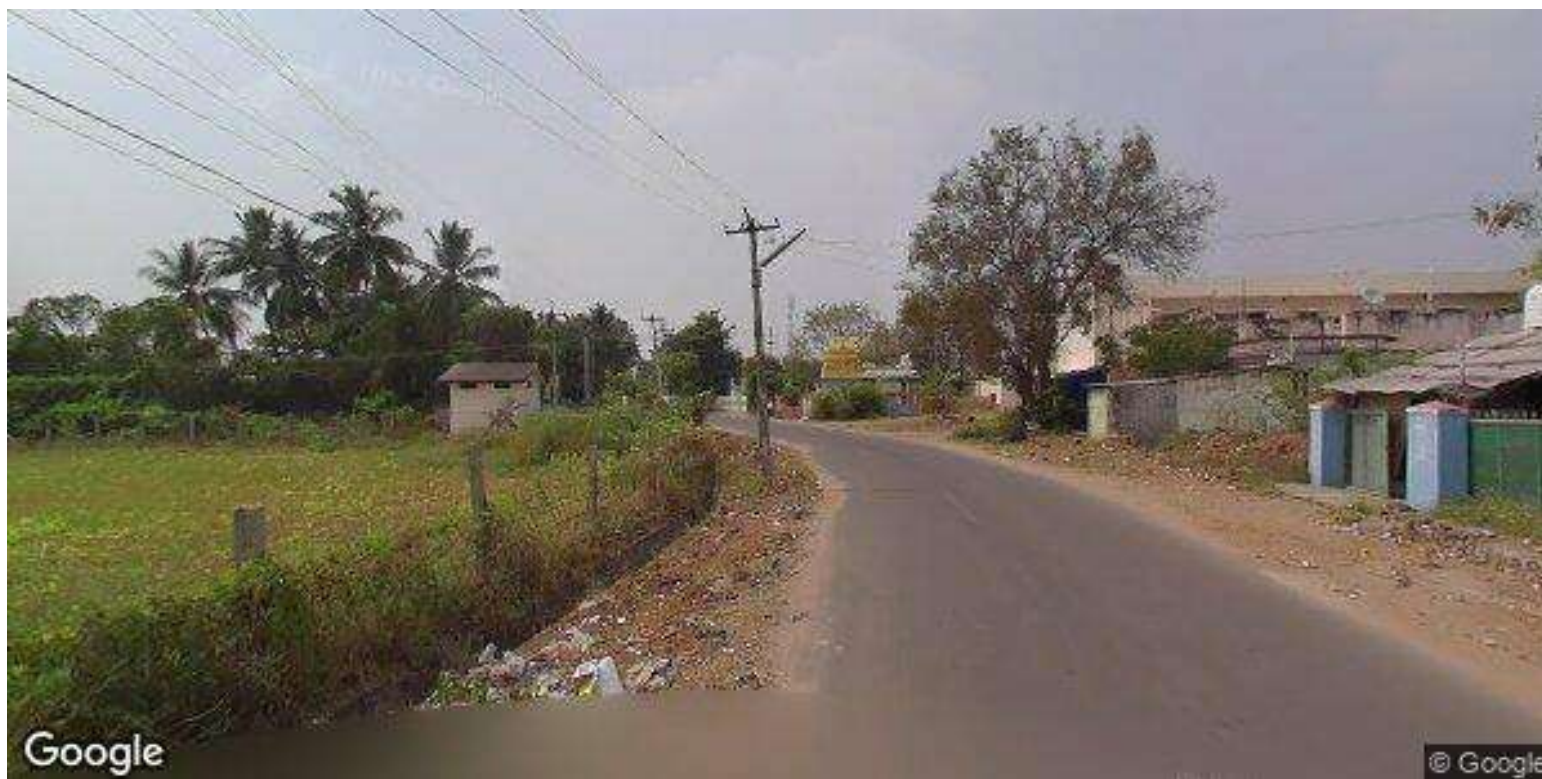
**Coordinates:** 10.98538, 78.07910

**Risk Type:** Turn

**Risk Level:** Medium

**Speed Limit:** 30 KM/Hr

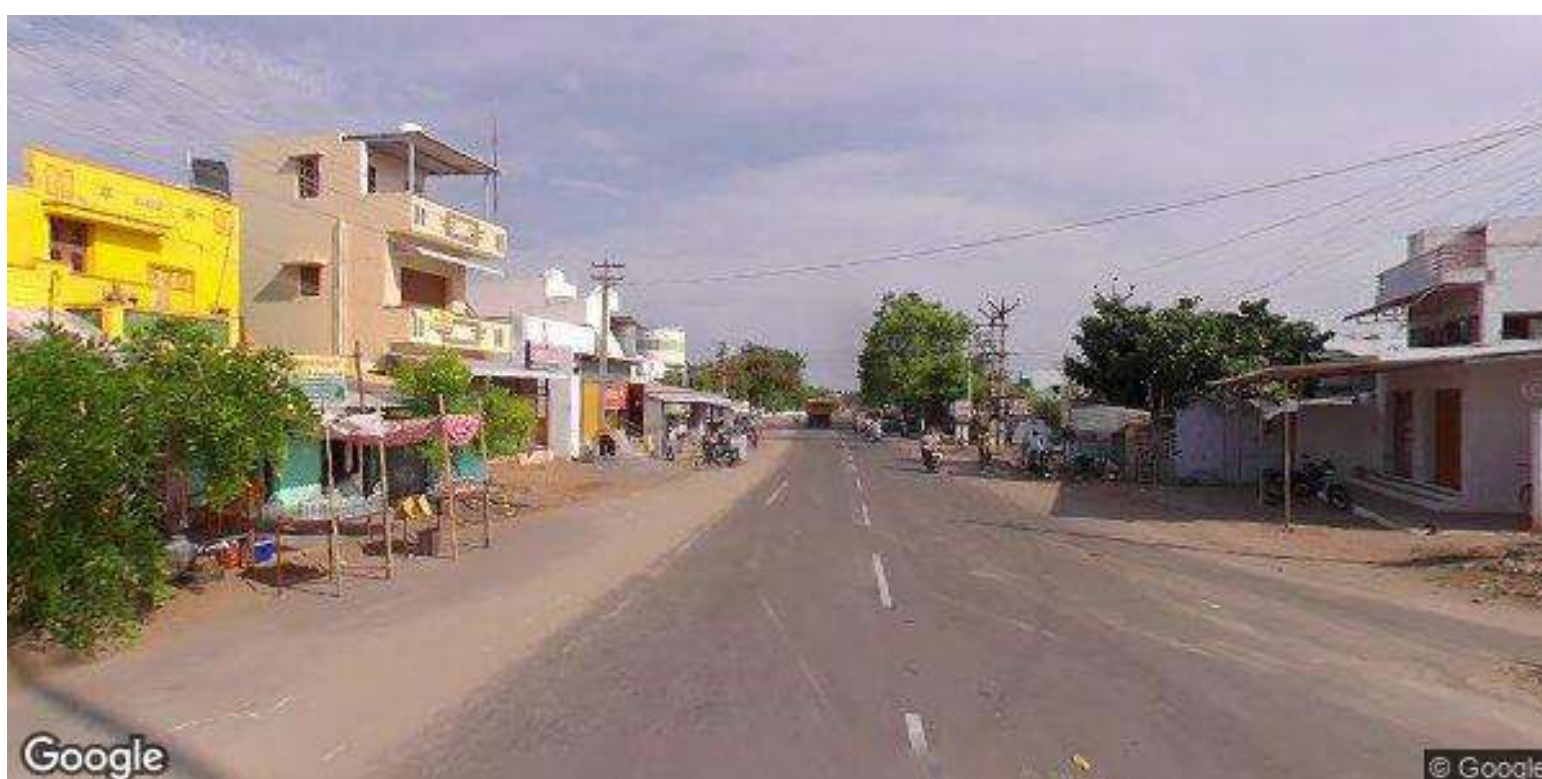
**Coordinates:** 10.98105, 78.09484

**Risk Type:** Turn

**Risk Level:** High

**Speed Limit:** 15 KM/Hr

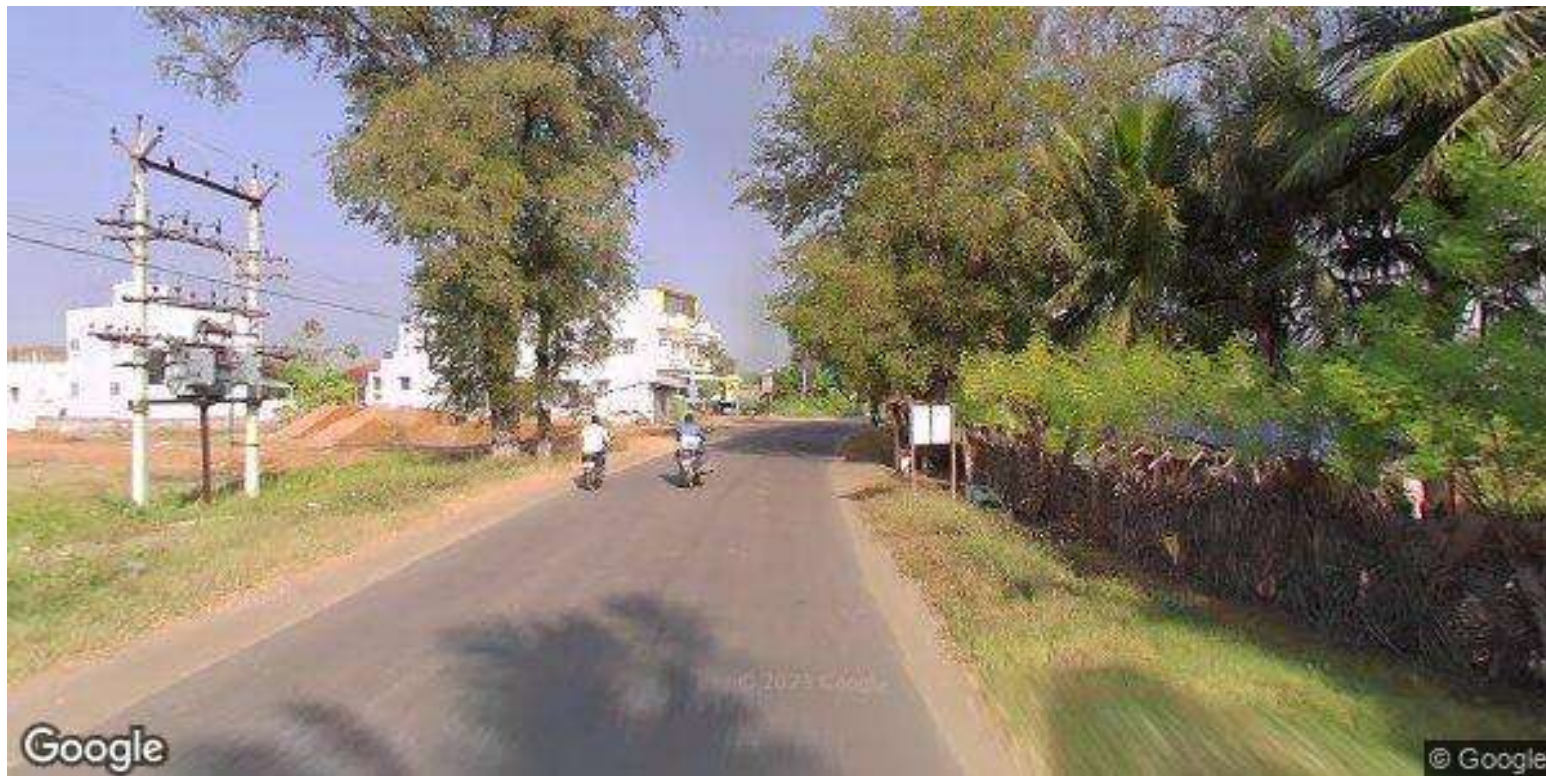
**Coordinates:** 10.97971, 78.09917

**Risk Type:** Turn

**Risk Level:** Medium

**Speed Limit:** 30 KM/Hr

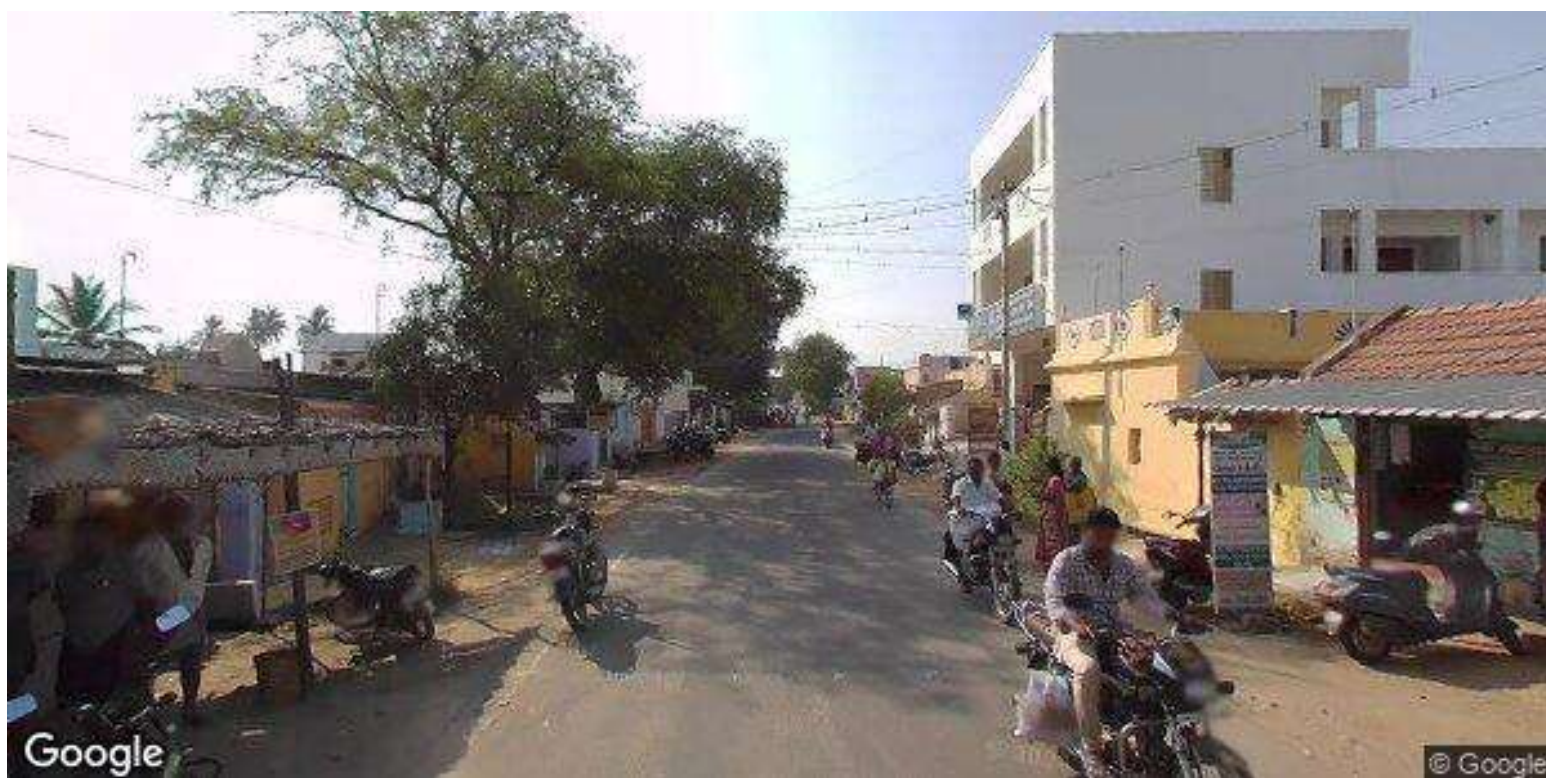
**Coordinates:** 10.97878, 78.10821

**Risk Type:** Turn

**Risk Level:** Medium

**Speed Limit:** 30 KM/Hr

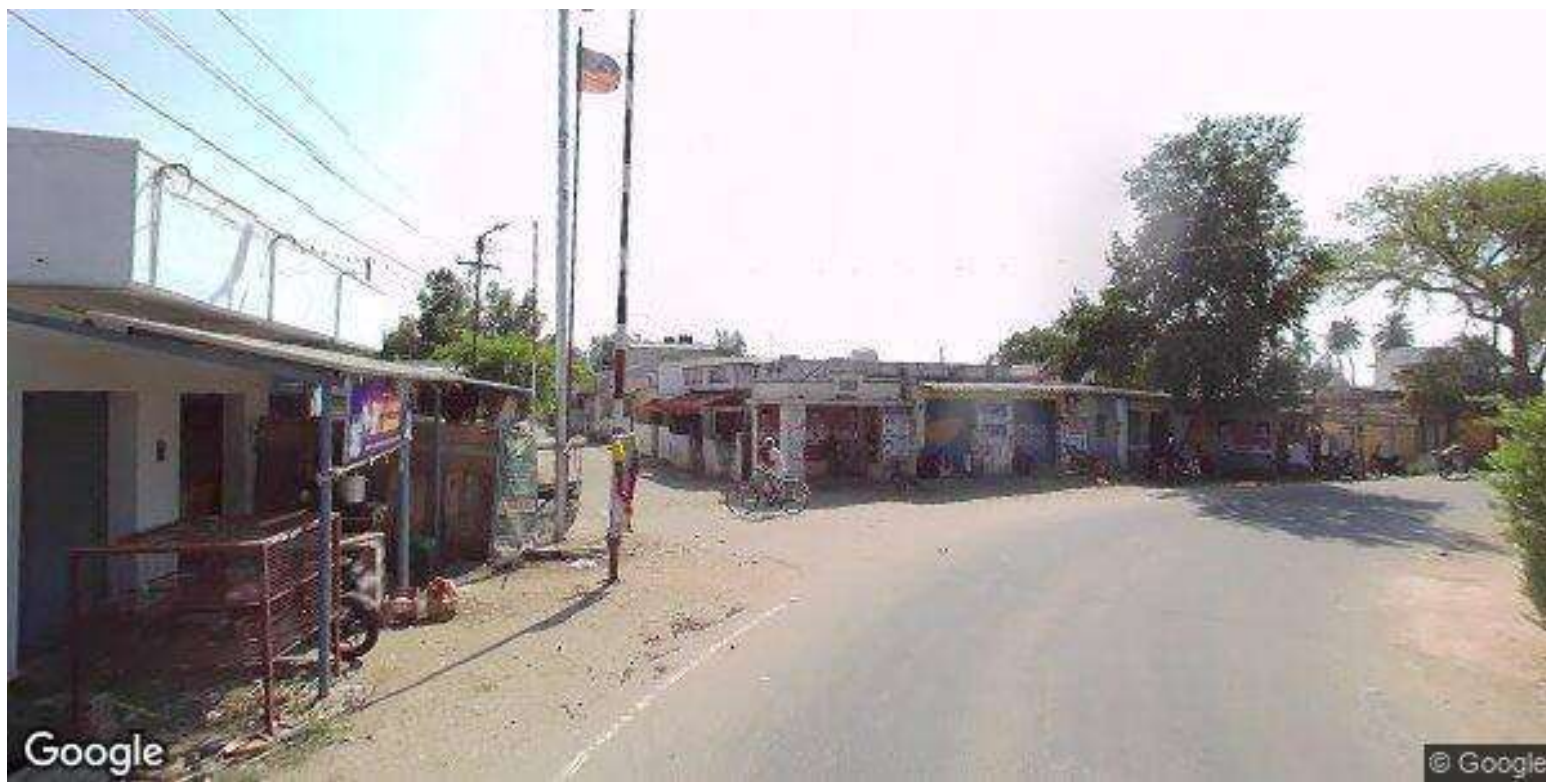
**Coordinates:** 10.97884, 78.10836

**Risk Type:** Turn

**Risk Level:** Medium

**Speed Limit:** 30 KM/Hr

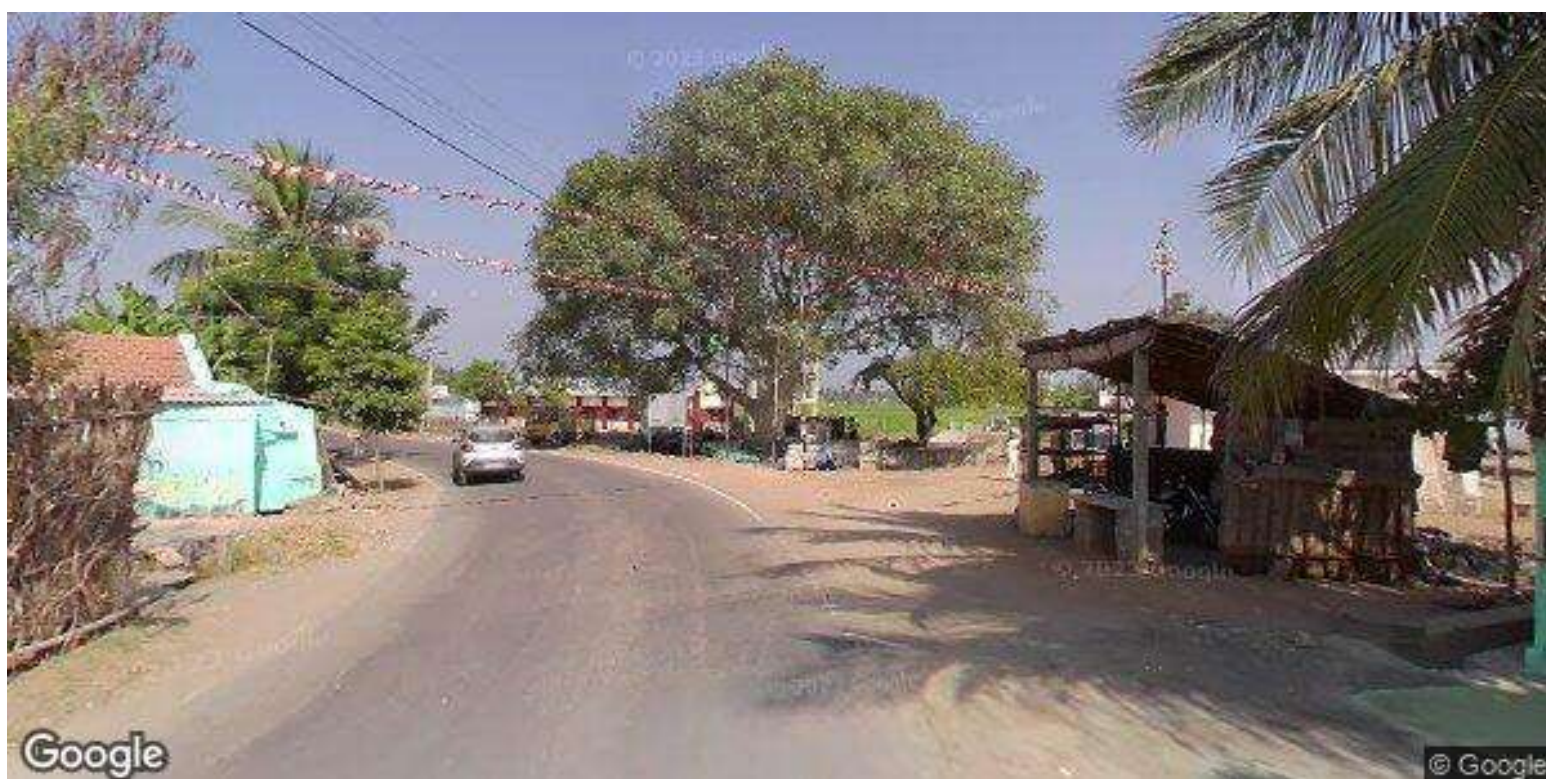
**Coordinates:** 10.97974, 78.11011

**Risk Type:** Turn

**Risk Level:** Medium

**Speed Limit:** 30 KM/Hr

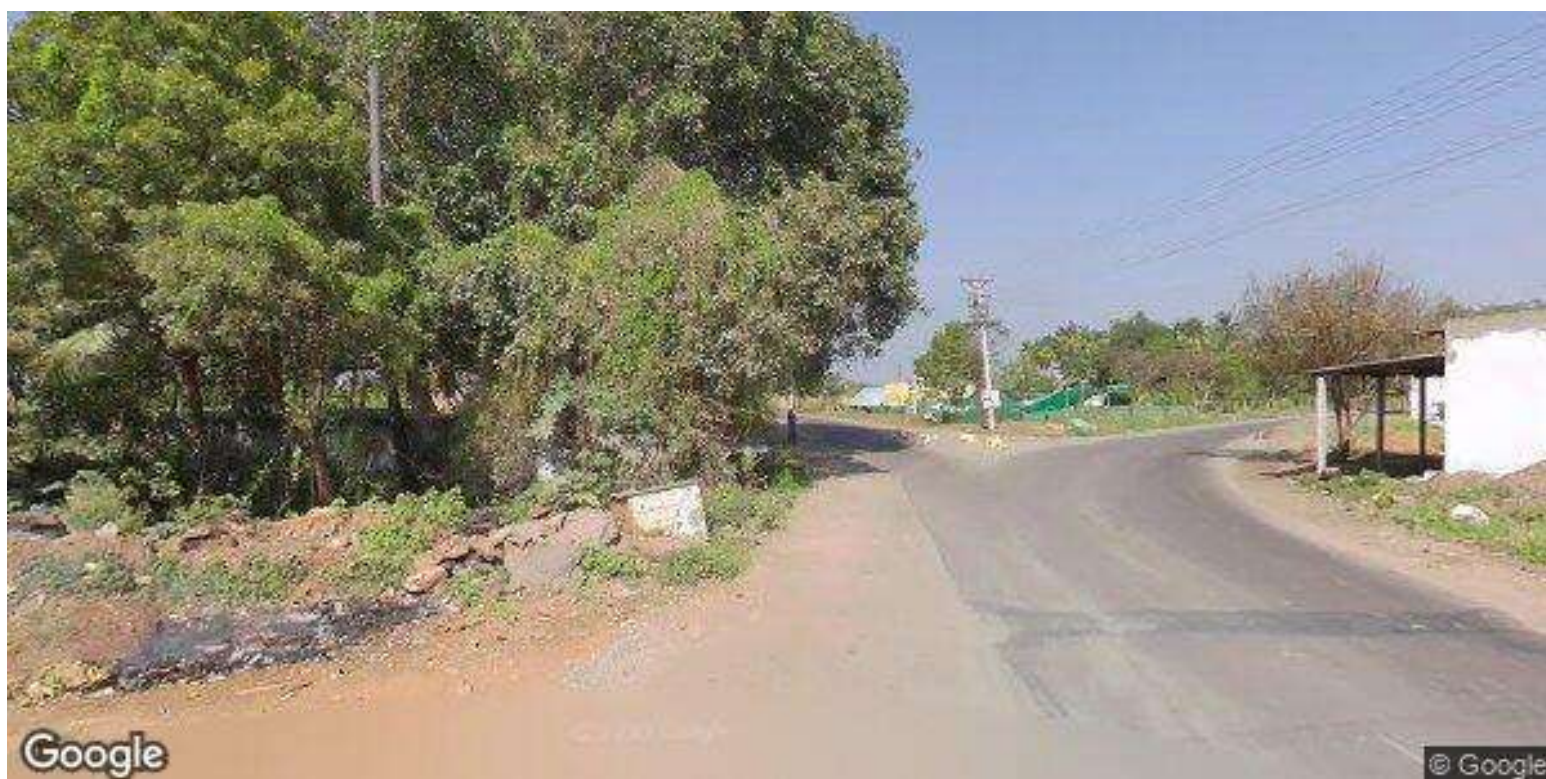
**Risk Type:** Turn  
**Risk Level:** Medium  
**Speed Limit:** 30 KM/Hr  
**Coordinates:** 10.98122, 78.11110

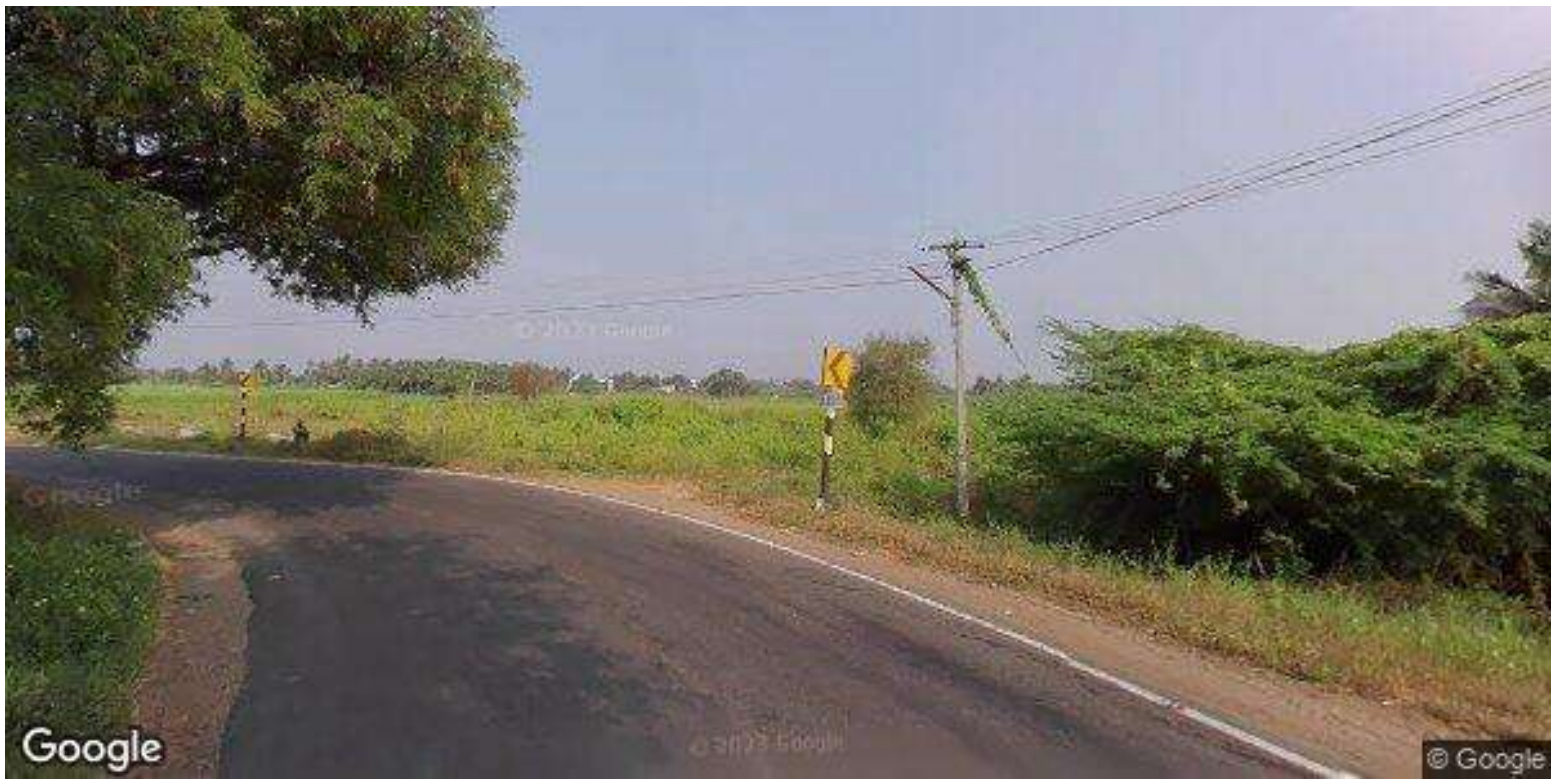
**Risk Type:** Turn  
**Risk Level:** High  
**Speed Limit:** 15 KM/Hr  
**Coordinates:** 10.98164, 78.11315

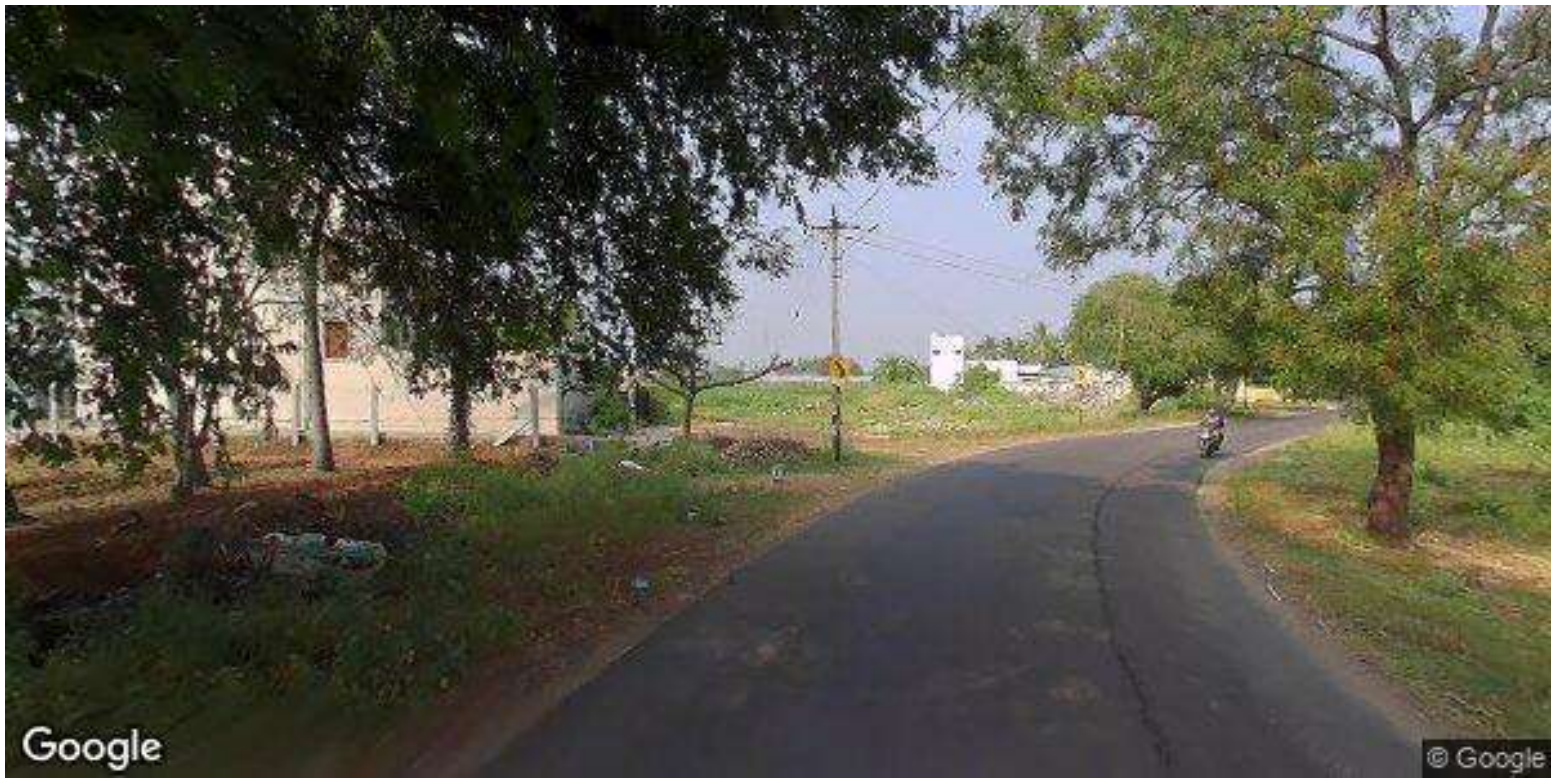
**Risk Type:** Turn  
**Risk Level:** Medium  
**Speed Limit:** 30 KM/Hr  
**Coordinates:** 10.98250, 78.11346

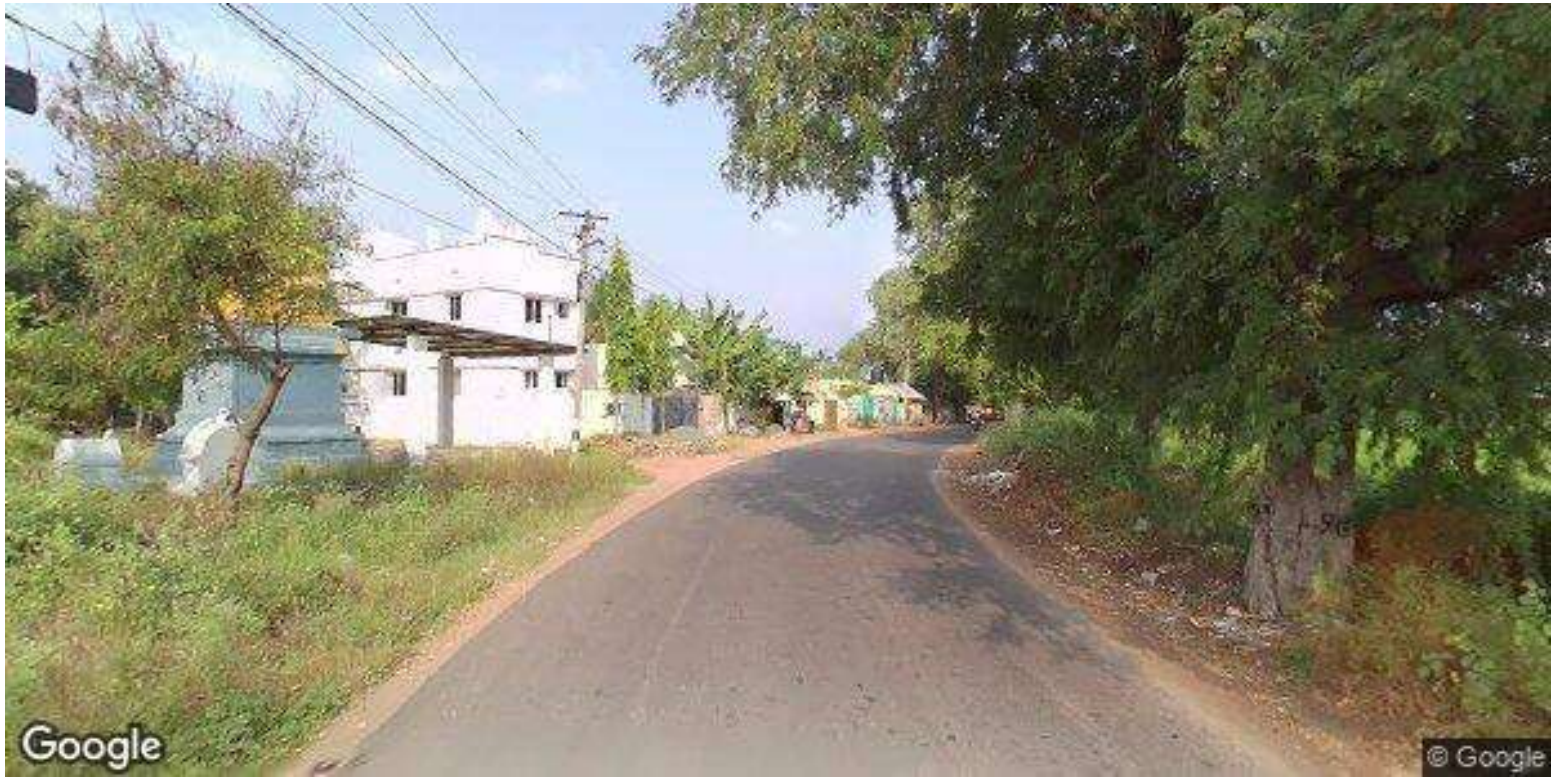
**Risk Type:** Turn  
**Risk Level:** Medium  
**Speed Limit:** 30 KM/Hr  
**Coordinates:** 10.98457, 78.11549

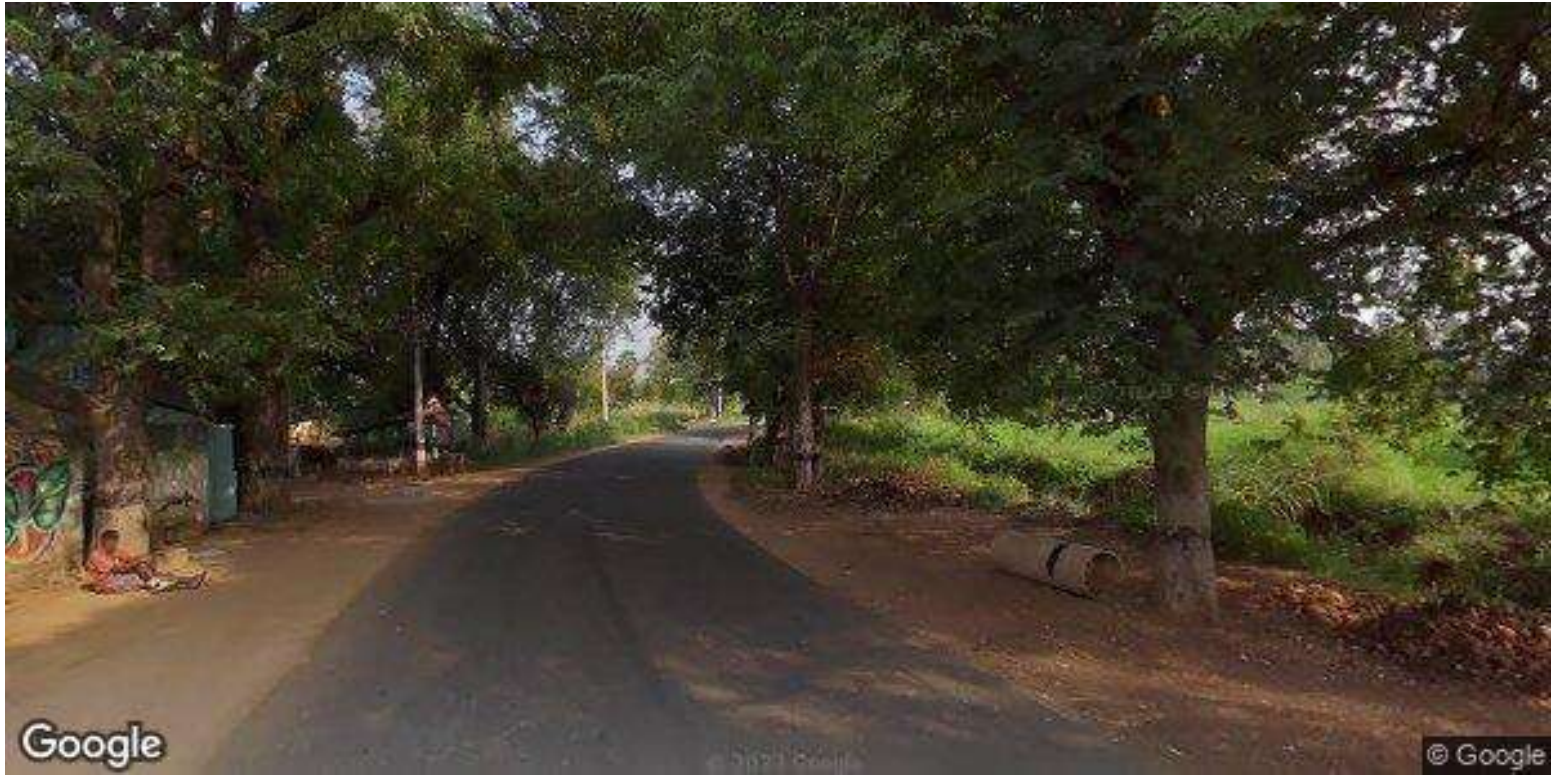
**Risk Type:** Turn  
**Risk Level:** Medium  
**Speed Limit:** 30 KM/Hr  
**Coordinates:** 10.98465, 78.11595

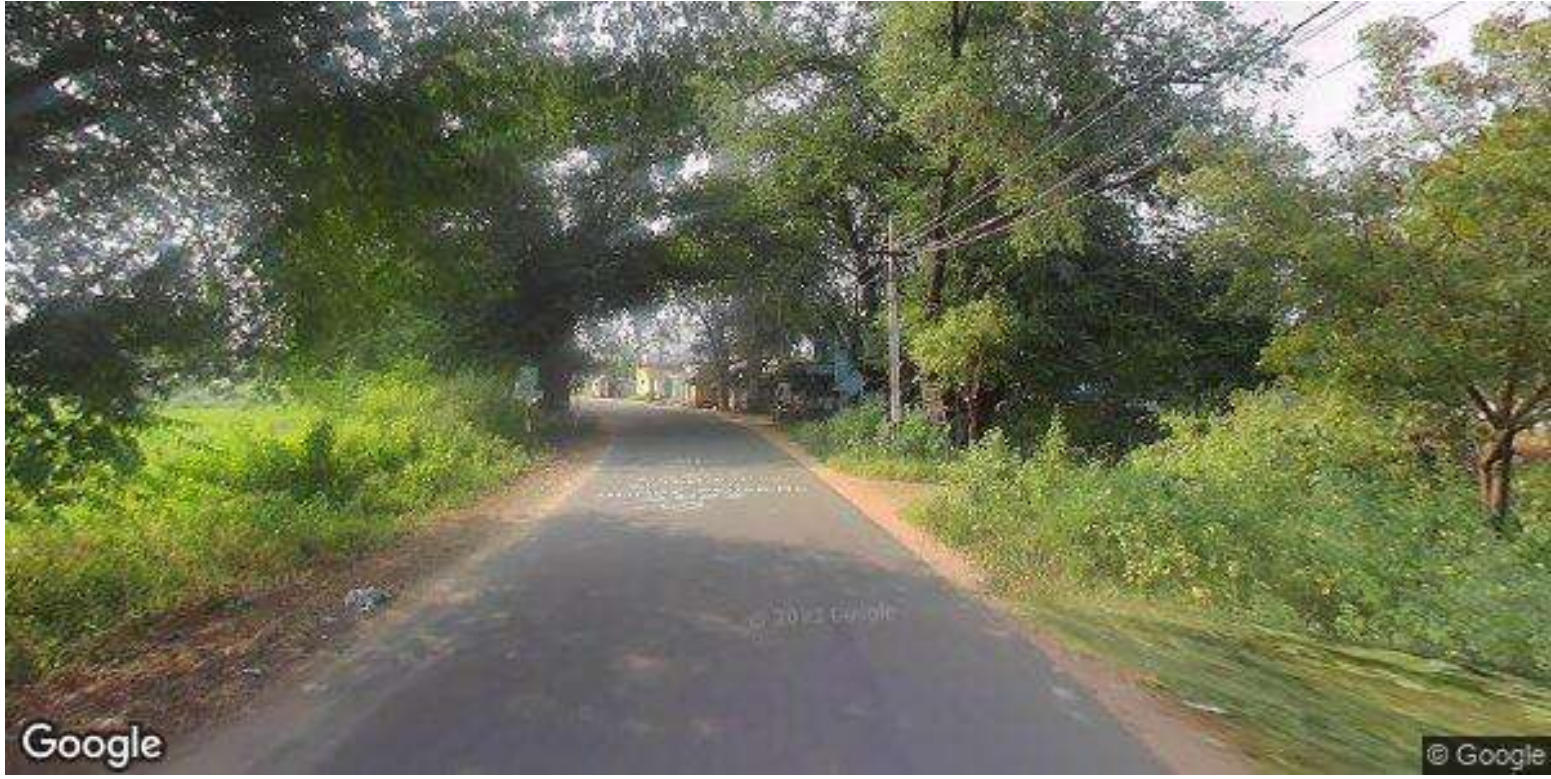
**Risk Type:** Turn  
**Risk Level:** Medium  
**Speed Limit:** 30 KM/Hr  
**Coordinates:** 10.98449, 78.11650
