## JOURNEY RISK MANAGEMENT (JRM) STUDY

### Salem Terminal TO SINTHIYA NATESAN FUELS

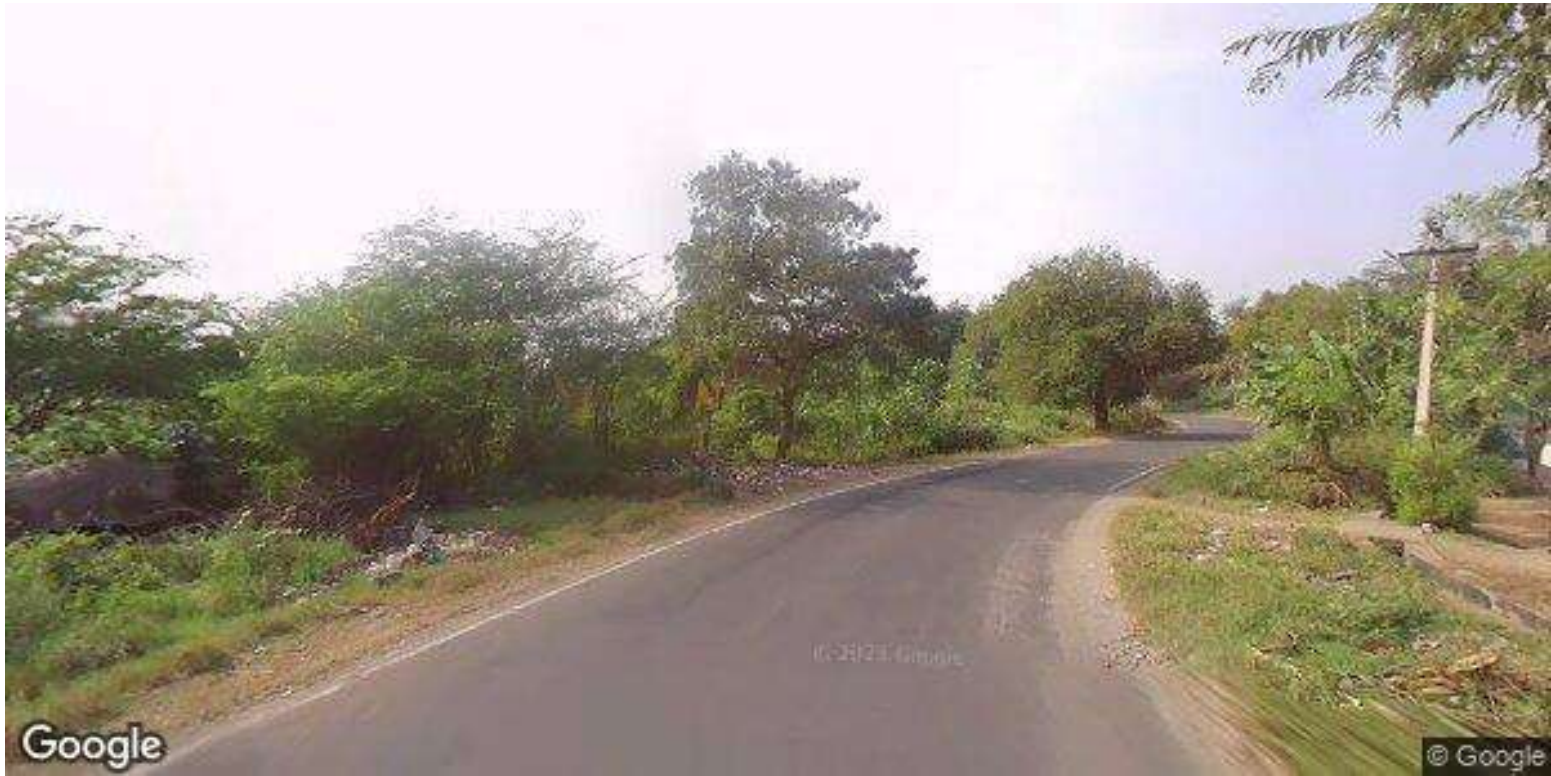
**Risk Type:** Turn  
**Risk Level:** Medium  
**Speed Limit:** 30 KM/Hr  
**Coordinates:** 10.98369, 78.11700

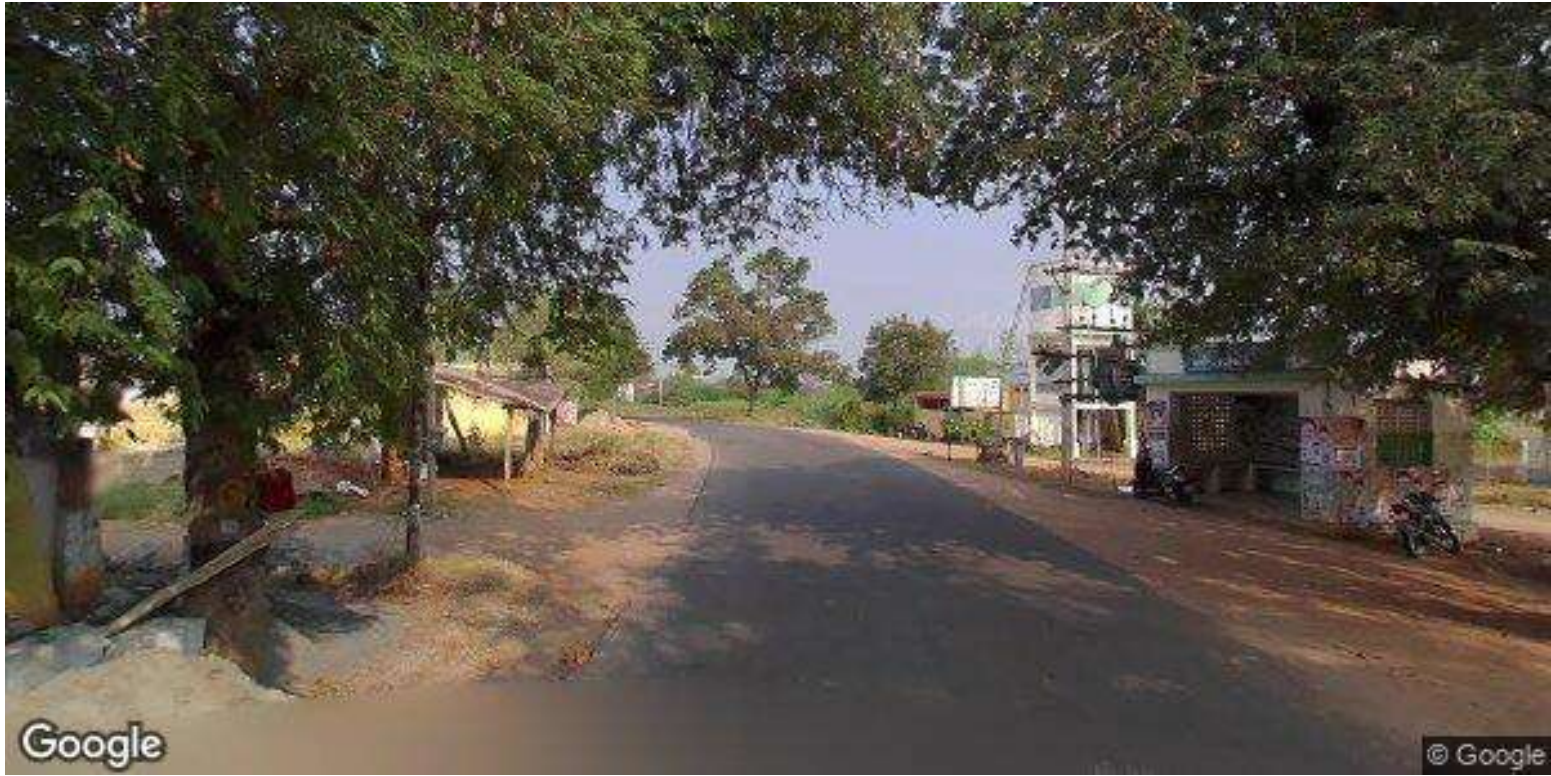
**Risk Type:** Turn  
**Risk Level:** Medium  
**Speed Limit:** 30 KM/Hr  
**Coordinates:** 10.98332, 78.11883
