# IndianOil

## JOURNEY RISK MANAGEMENT (JRM) STUDY

**Salem Terminal to CHENTHUR KUMARAA AND CO**

**Route Safety Analysis: CVQF+23W, Sangagiri to FH39+PMQ, P.Mettupalayam, Tamil Nadu**

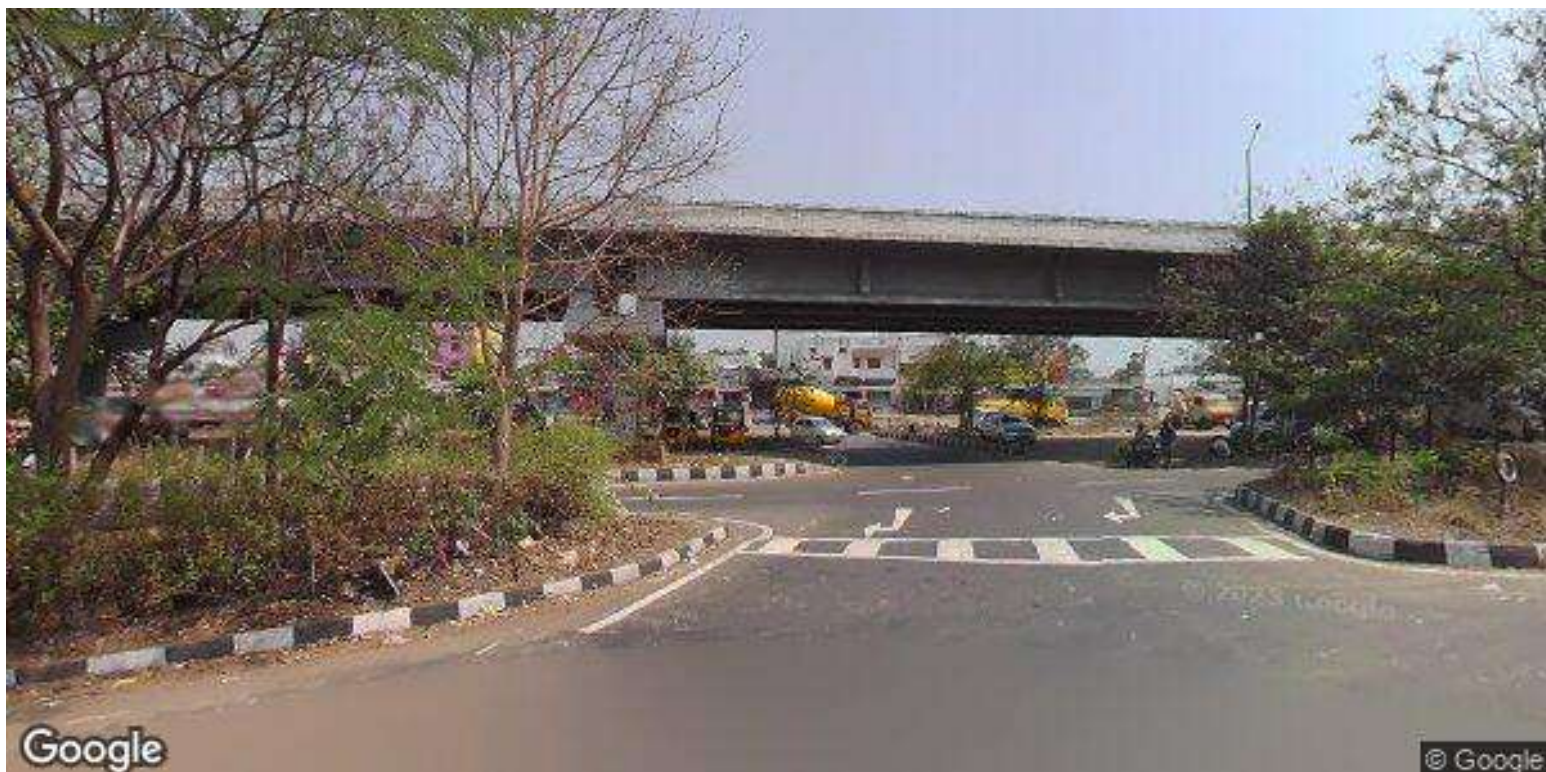
| | Risk Type | Risk Level | Coordinates | Speed Limit |
|---|---|---|---|---|
| 11 | Turn | High | 11.43026, 77.67525 | 15 KM/Hr |

**Risk Type:** Turn  
**Risk Level:** High  
**Speed Limit:** 15 KM/Hr  
**Coordinates:** 11.43026, 77.67525

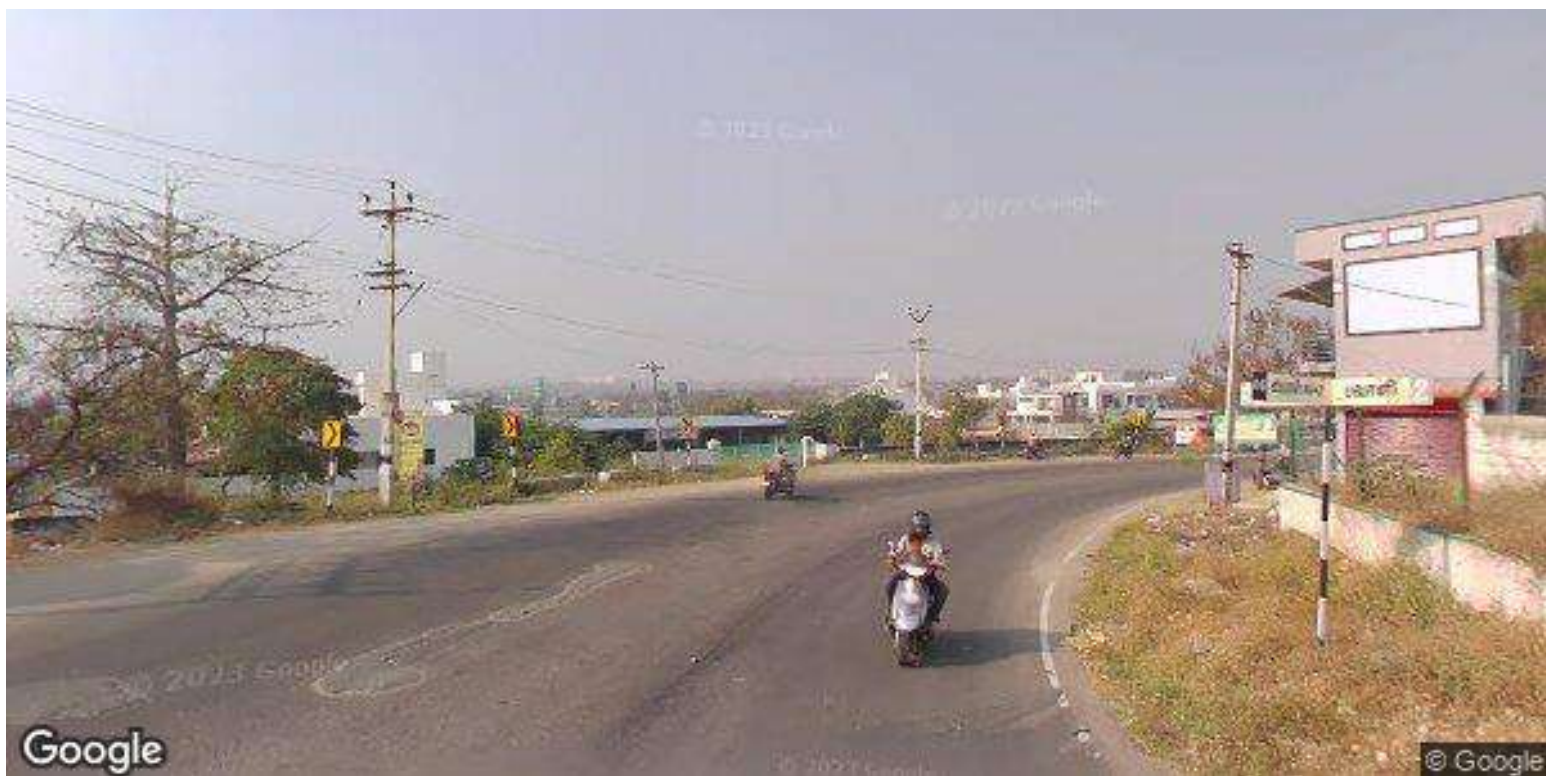
| | Risk Type | Risk Level | Coordinates | Speed Limit |
|---|---|---|---|---|
| 13 | Turn | High | 11.43278, 77.67024 | 15 KM/Hr |

**Risk Type:** Turn  
**Risk Level:** High  
**Speed Limit:** 15 KM/Hr  
**Coordinates:** 11.43278, 77.67024

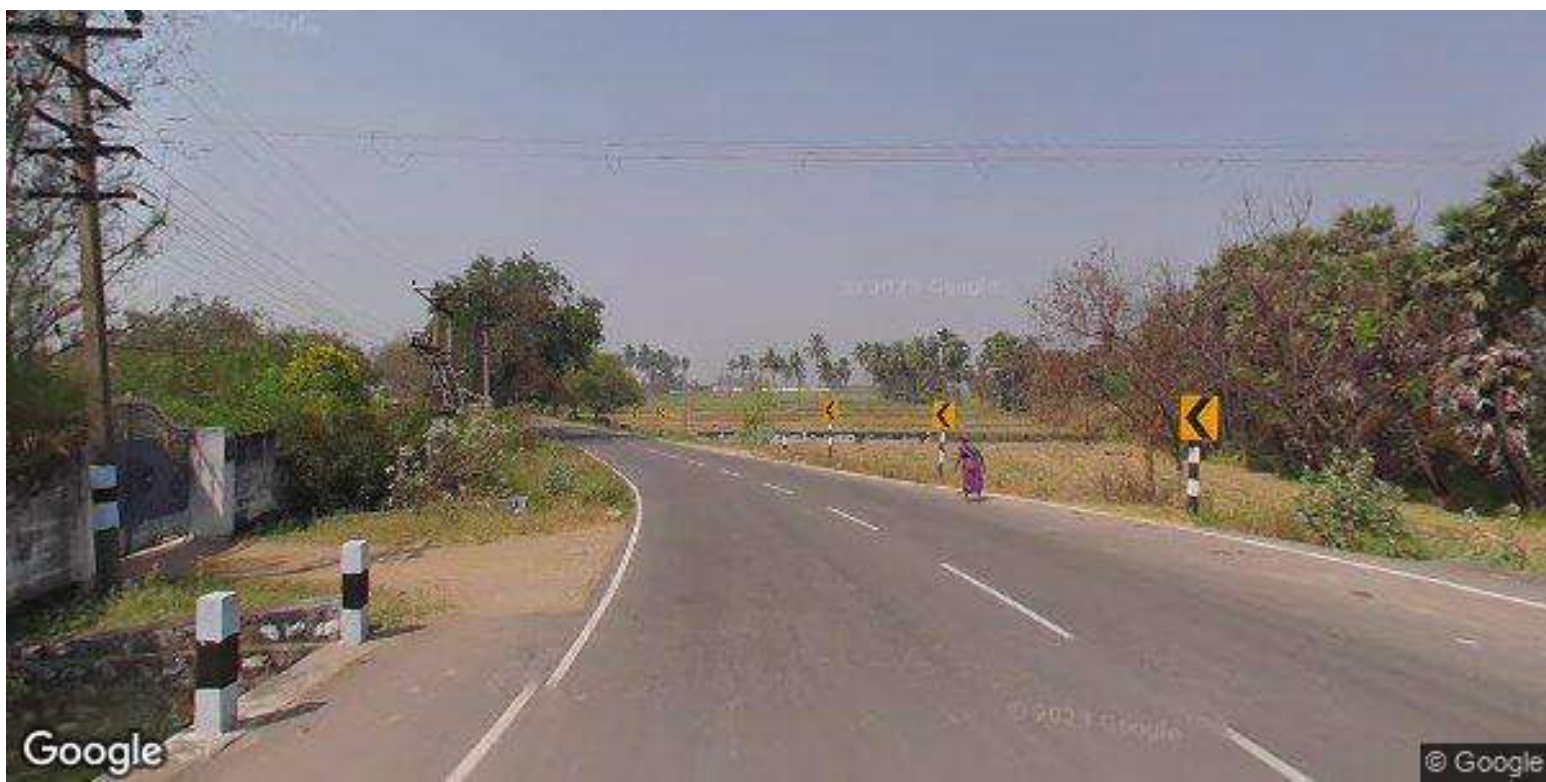
| | Risk Type | Risk Level | Coordinates | Speed Limit |
|---|---|---|---|---|
| 14 | Turn | Medium | 11.43223, 77.65338 | 30 KM/Hr |

**Risk Type:** Turn

**Risk Level:** Medium

**Speed Limit:** 30 KM/Hr

**Coordinates:** 11.43223, 77.65338

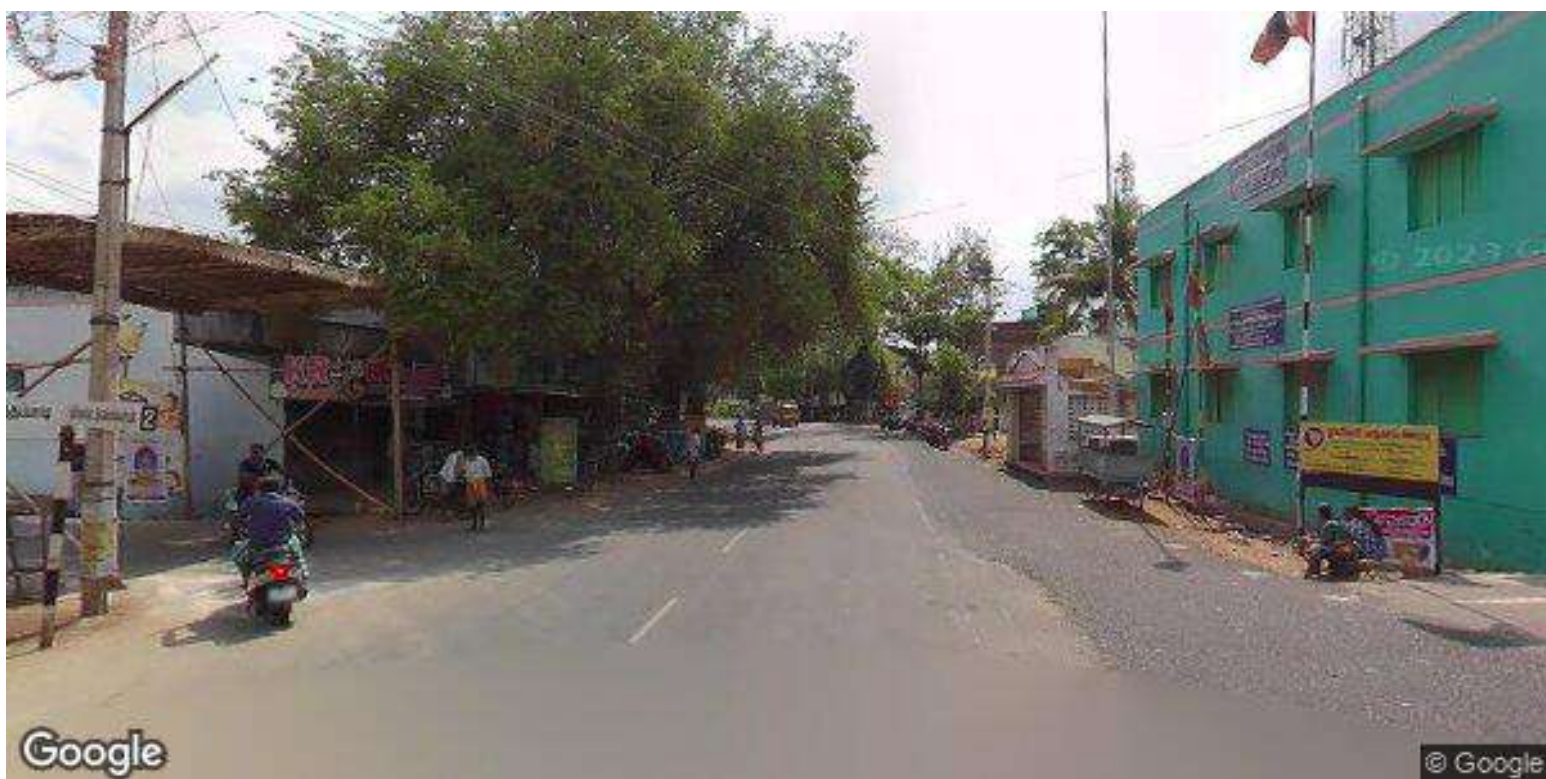
| | Risk Type | Risk Level | Coordinates | Speed Limit |
|---|---|---|---|---|
| 15 | Blind Spot | Blind Spot | 11.42842, 77.56890 | 10 KM/Hr |

**Risk Type:** Blind Spot

**Risk Level:** Blind Spot

**Speed Limit:** 10 KM/Hr

**Coordinates:** 11.42842, 77.56890

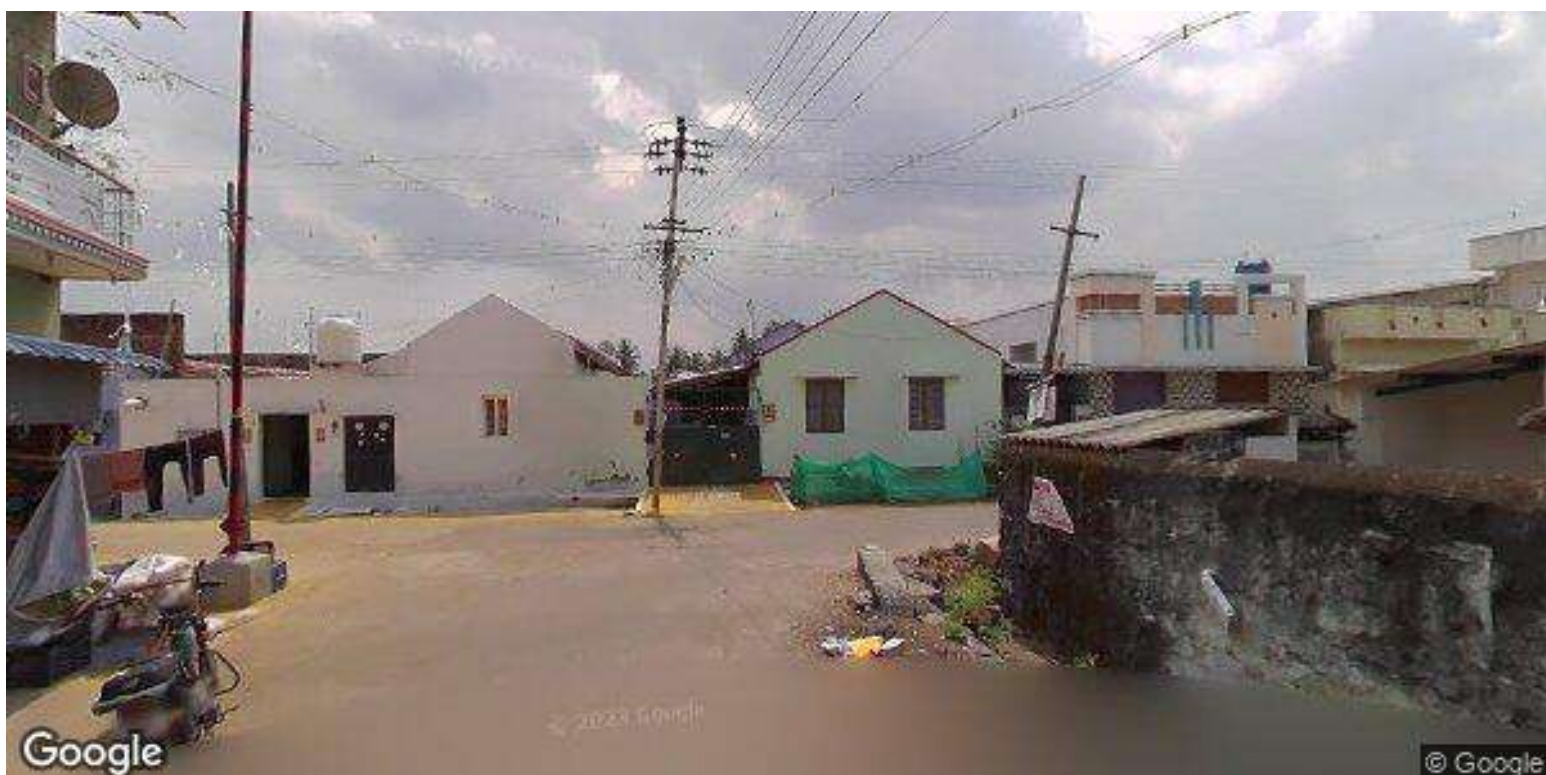
| | Risk Type | Risk Level | Coordinates | Speed Limit |
|---|---|---|---|---|
| 16 | Turn | High | 11.43611, 77.57066 | 15 KM/Hr |

**Risk Type:** Turn  
**Risk Level:** High  
**Speed Limit:** 15 KM/Hr  
**Coordinates:** 11.43611, 77.57066

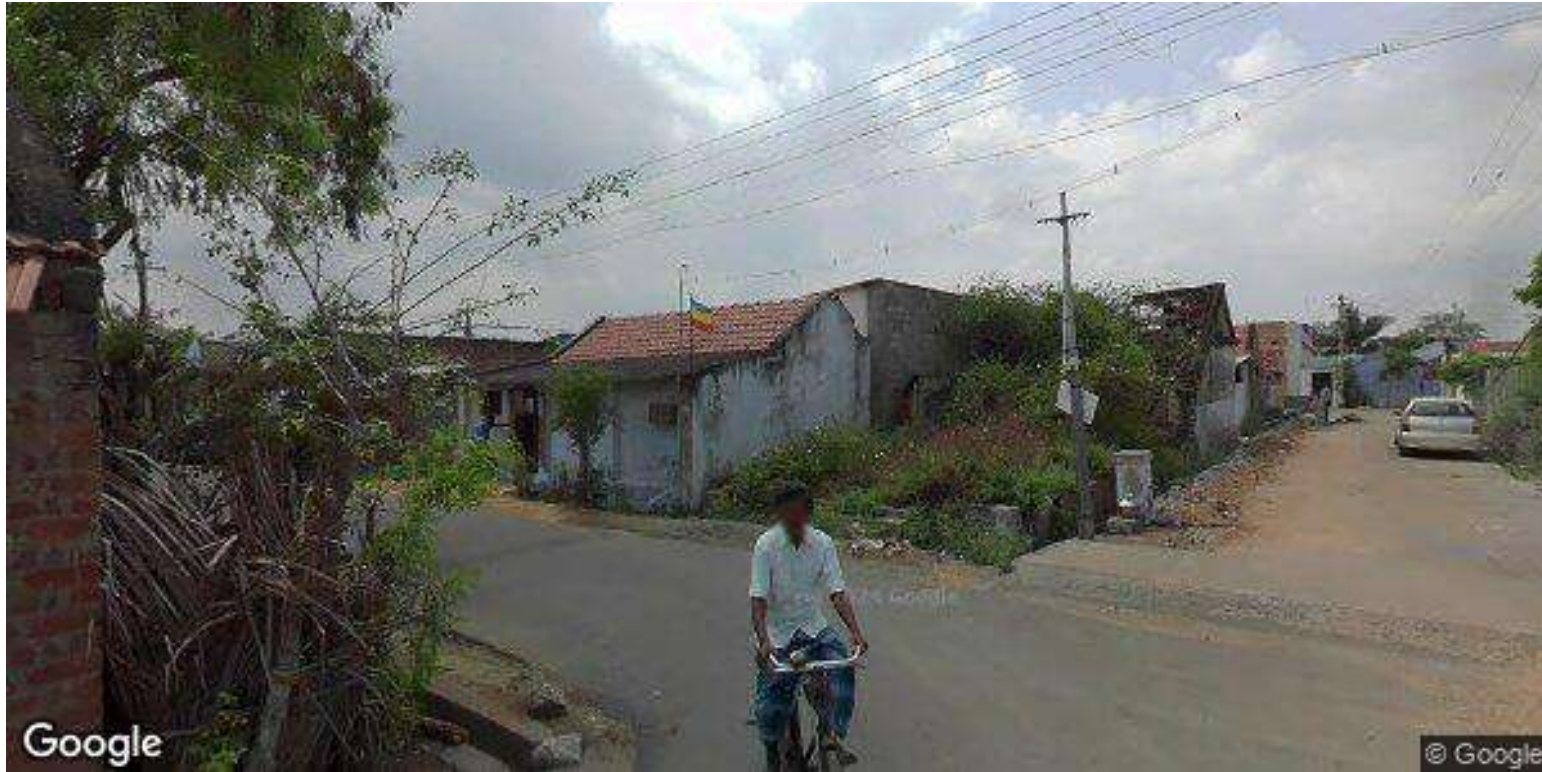
| | Risk Type | Risk Level | Coordinates | Speed Limit |
|---|---|---|---|---|
| 17 | Turn | High | 11.43638, 77.56965 | 15 KM/Hr |

**Risk Type:** Turn  
**Risk Level:** High  
**Speed Limit:** 15 KM/Hr  
**Coordinates:** 11.43638, 77.56965

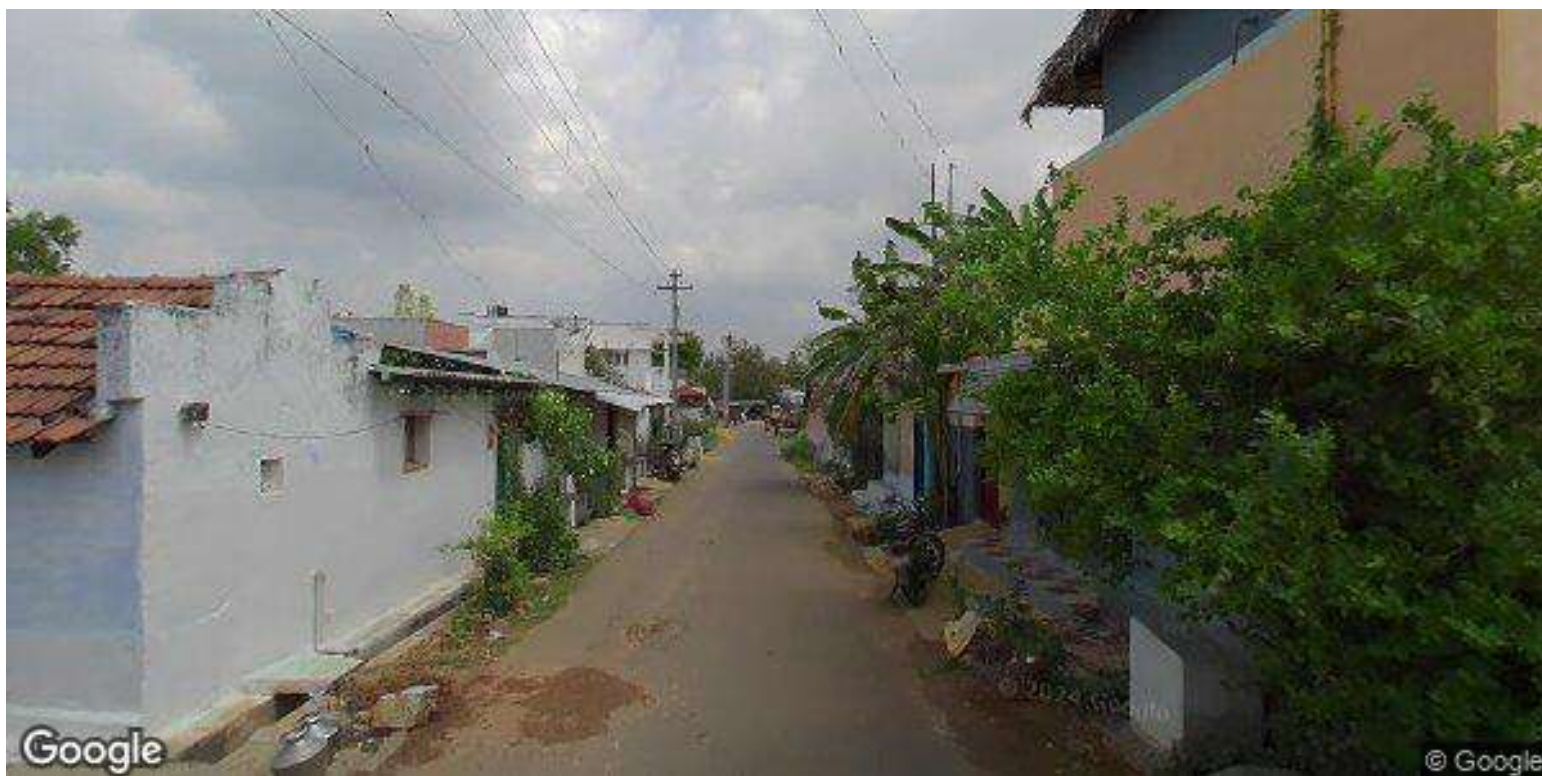
| | Risk Type | Risk Level | Coordinates | Speed Limit |
|---|---|---|---|---|
| 18 | Turn | Medium | 11.43684, 77.56970 | 30 KM/Hr |

**Risk Type:** Turn  
**Risk Level:** Medium  
**Speed Limit:** 30 KM/Hr  
**Coordinates:** 11.43684, 77.56970

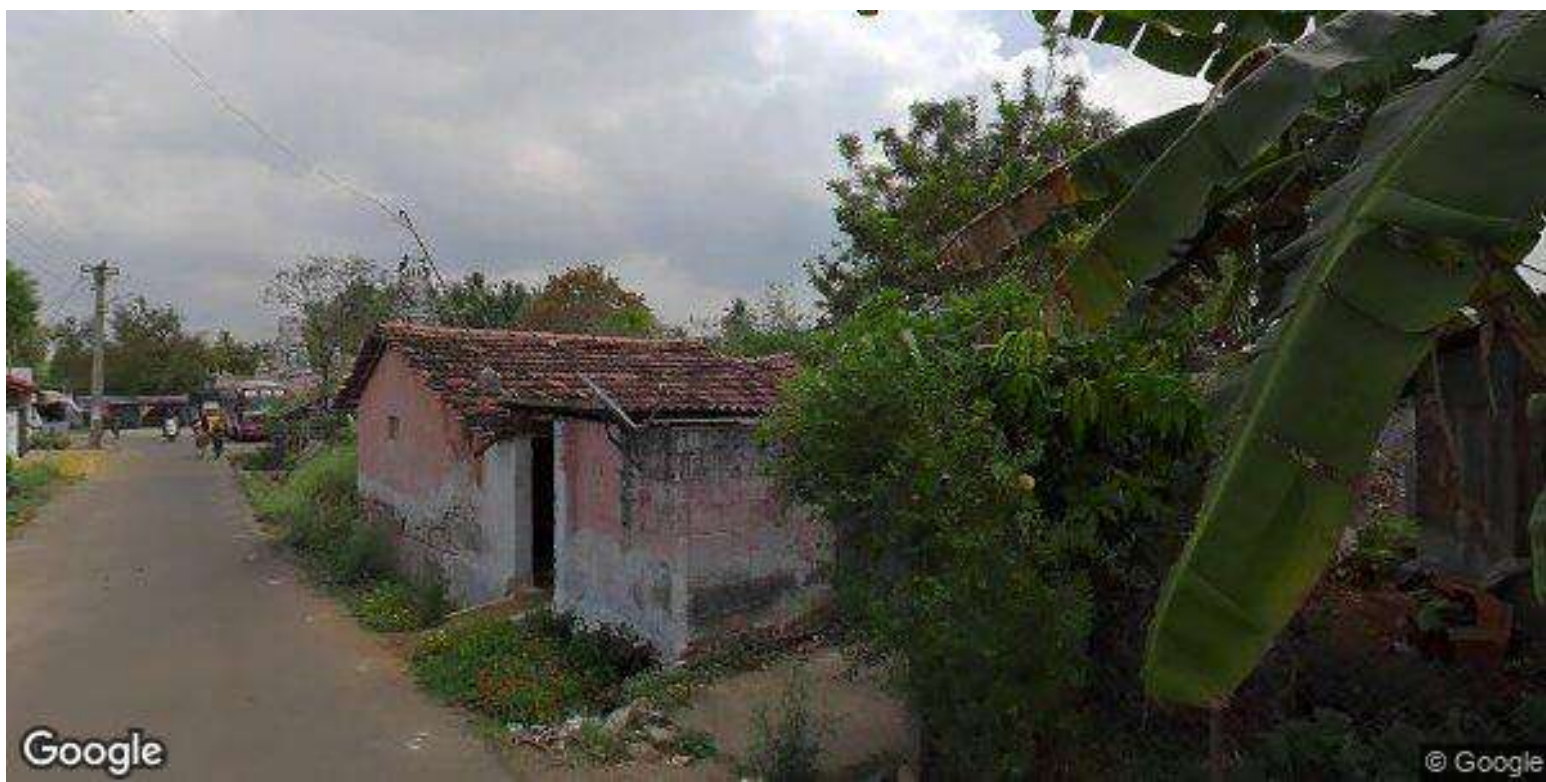
| | Risk Type | Risk Level | Coordinates | Speed Limit |
|---|---|---|---|---|
| 19 | Turn | Medium | 11.43701, 77.56983 | 30 KM/Hr |

**Risk Type:** Turn

**Risk Level:** Medium

**Speed Limit:** 30 KM/Hr

**Coordinates:** 11.43701, 77.56983

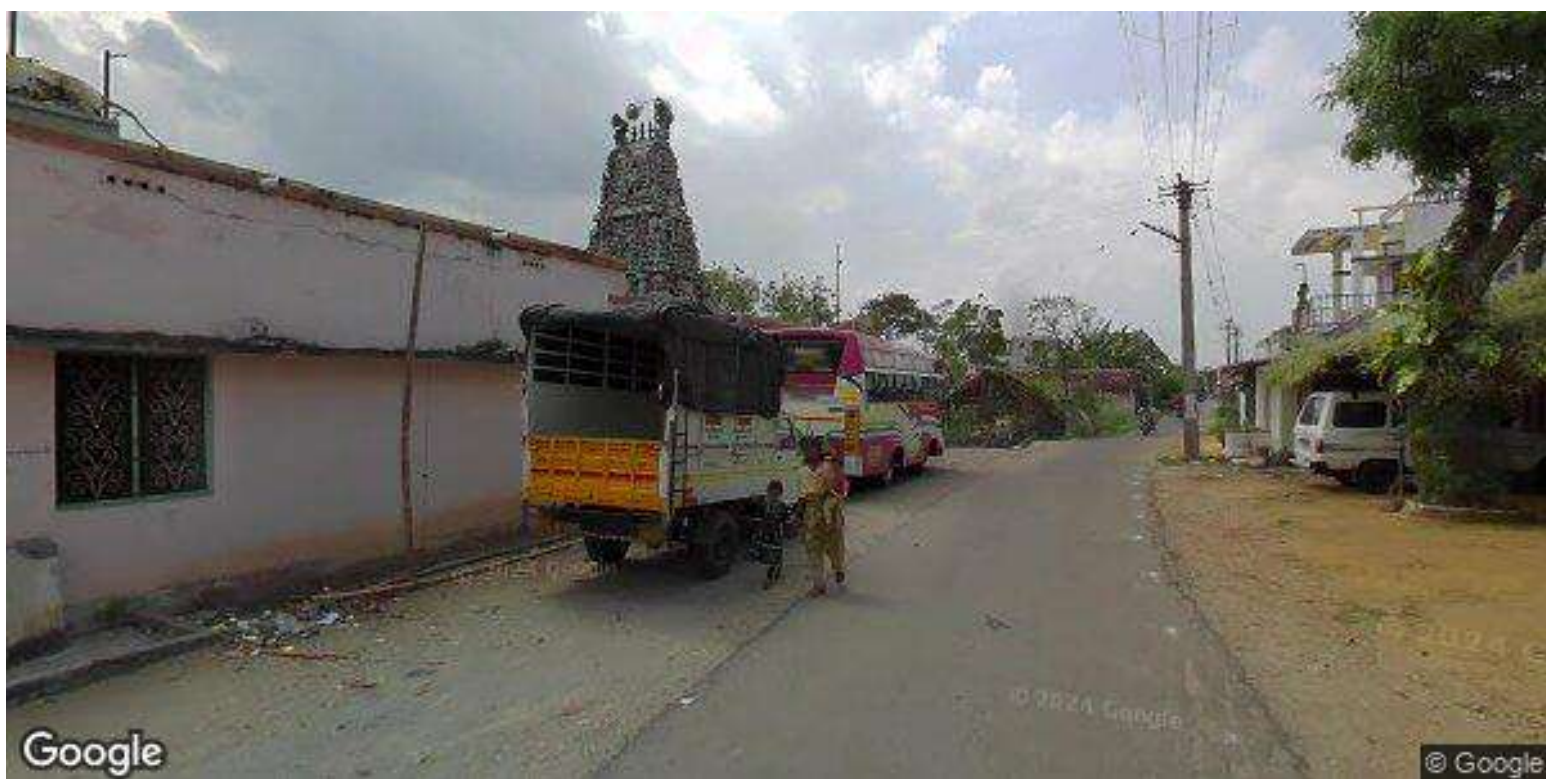
| | Risk Type | Risk Level | Coordinates | Speed Limit |
|---|---|---|---|---|
| 20 | Turn | Medium | 11.43757, 77.56992 | 30 KM/Hr |

**Risk Type:** Turn

**Risk Level:** Medium

**Speed Limit:** 30 KM/Hr

**Coordinates:** 11.43757, 77.56992

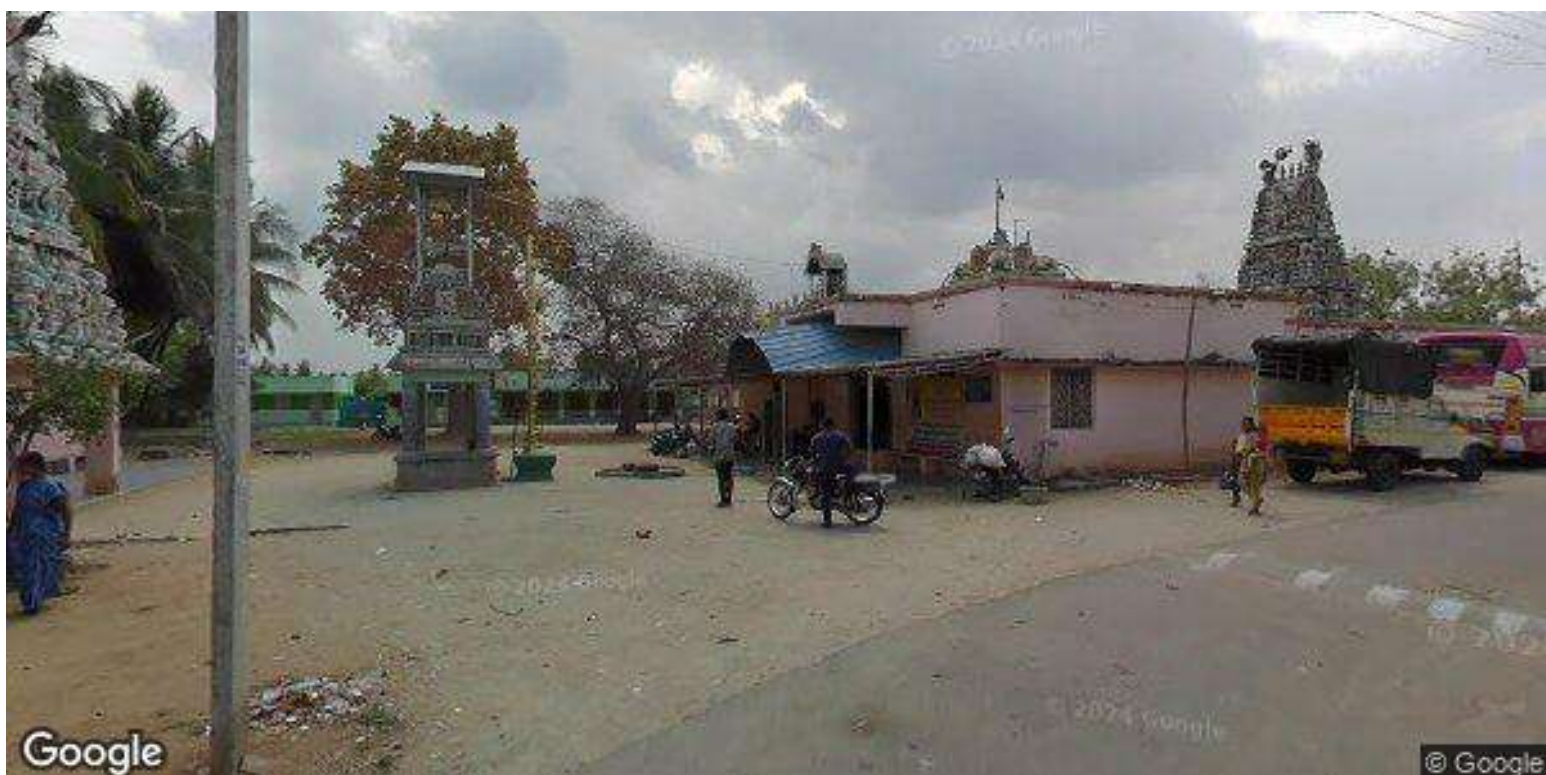
| | Risk Type | Risk Level | Coordinates | Speed Limit |
|---|---|---|---|---|
| 21 | Turn | High | 11.43768, 77.56985 | 15 KM/Hr |

**Risk Type:** Turn  
**Risk Level:** High  
**Speed Limit:** 15 KM/Hr  
**Coordinates:** 11.43768, 77.56985

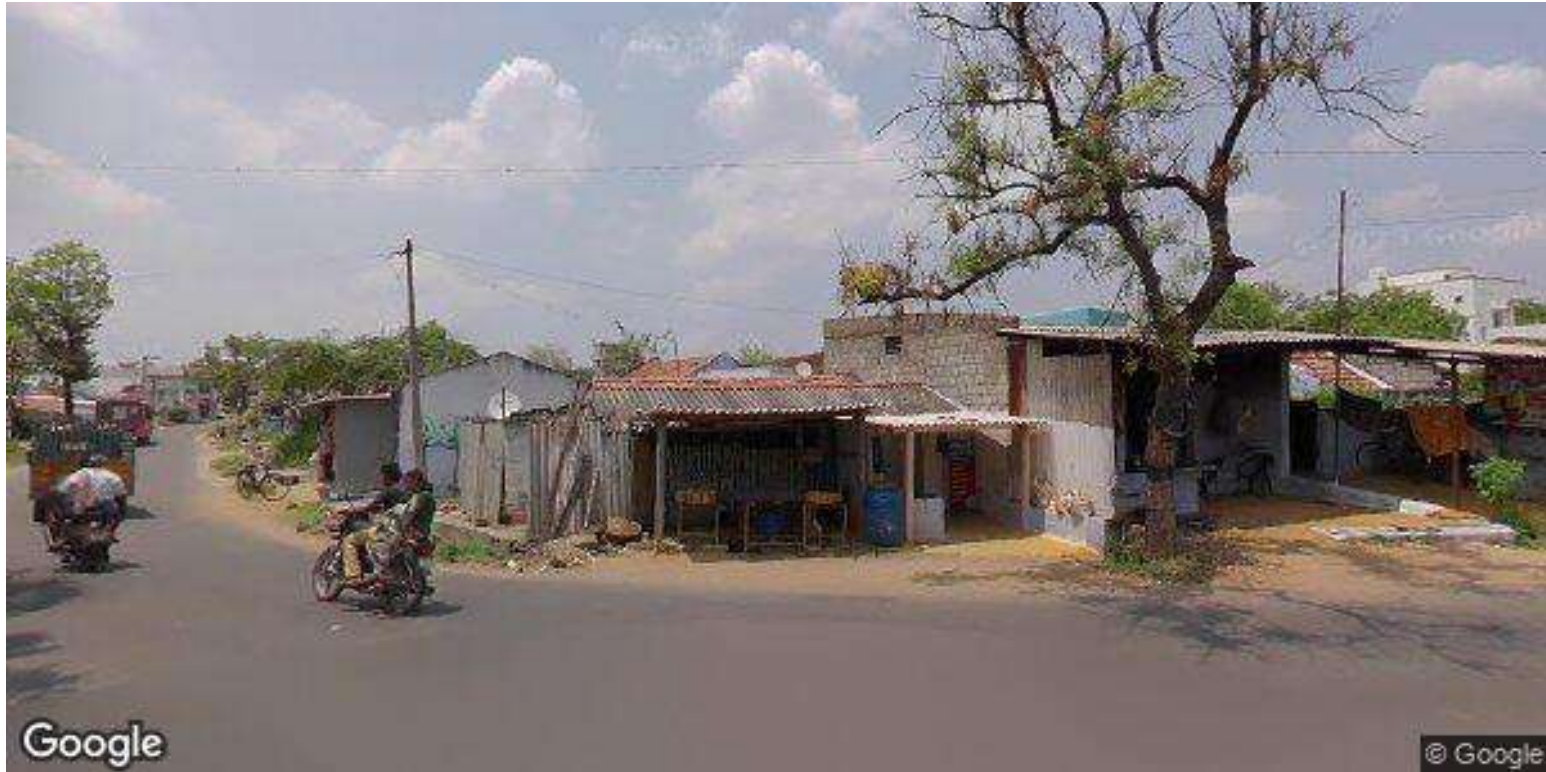
| | Risk Type | Risk Level | Coordinates | Speed Limit |
|---|---|---|---|---|
| 22 | Blind Spot | Blind Spot | 11.43830, 77.56581 | 10 KM/Hr |

**Risk Type:** Blind Spot  
**Risk Level:** Blind Spot  
**Speed Limit:** 10 KM/Hr  
**Coordinates:** 11.43830, 77.56581

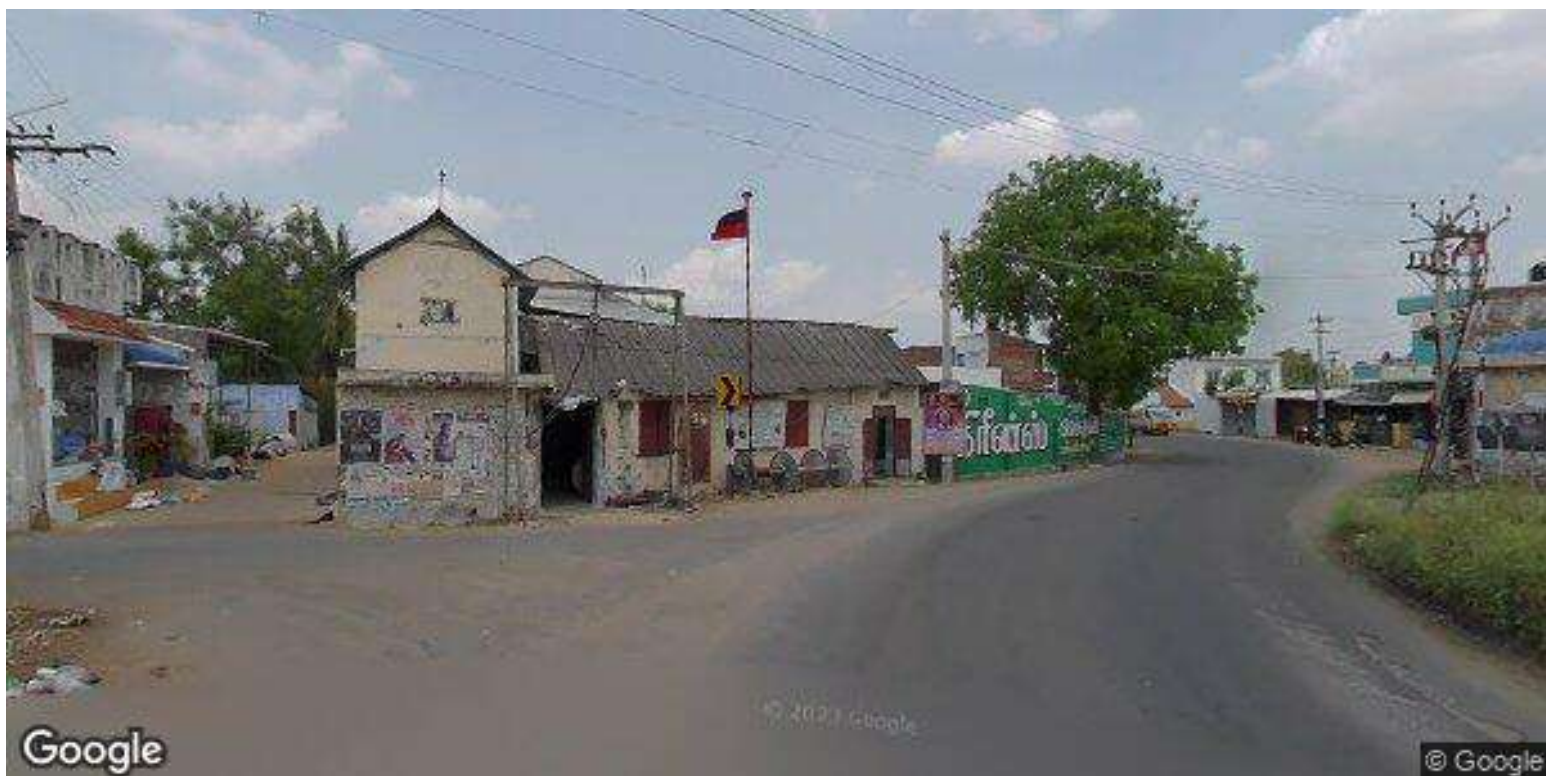
| | Risk Type | Risk Level | Coordinates | Speed Limit |
|---|---|---|---|---|
| 23 | Turn | High | 11.44358, 77.56608 | 15 KM/Hr |

**Risk Type:** Turn  
**Risk Level:** High  
**Speed Limit:** 15 KM/Hr  
**Coordinates:** 11.44358, 77.56608
