# IndianOil

## JOURNEY RISK MANAGEMENT (JRM) STUDY

### Salem Terminal to SRINIVASHA AGENCIES

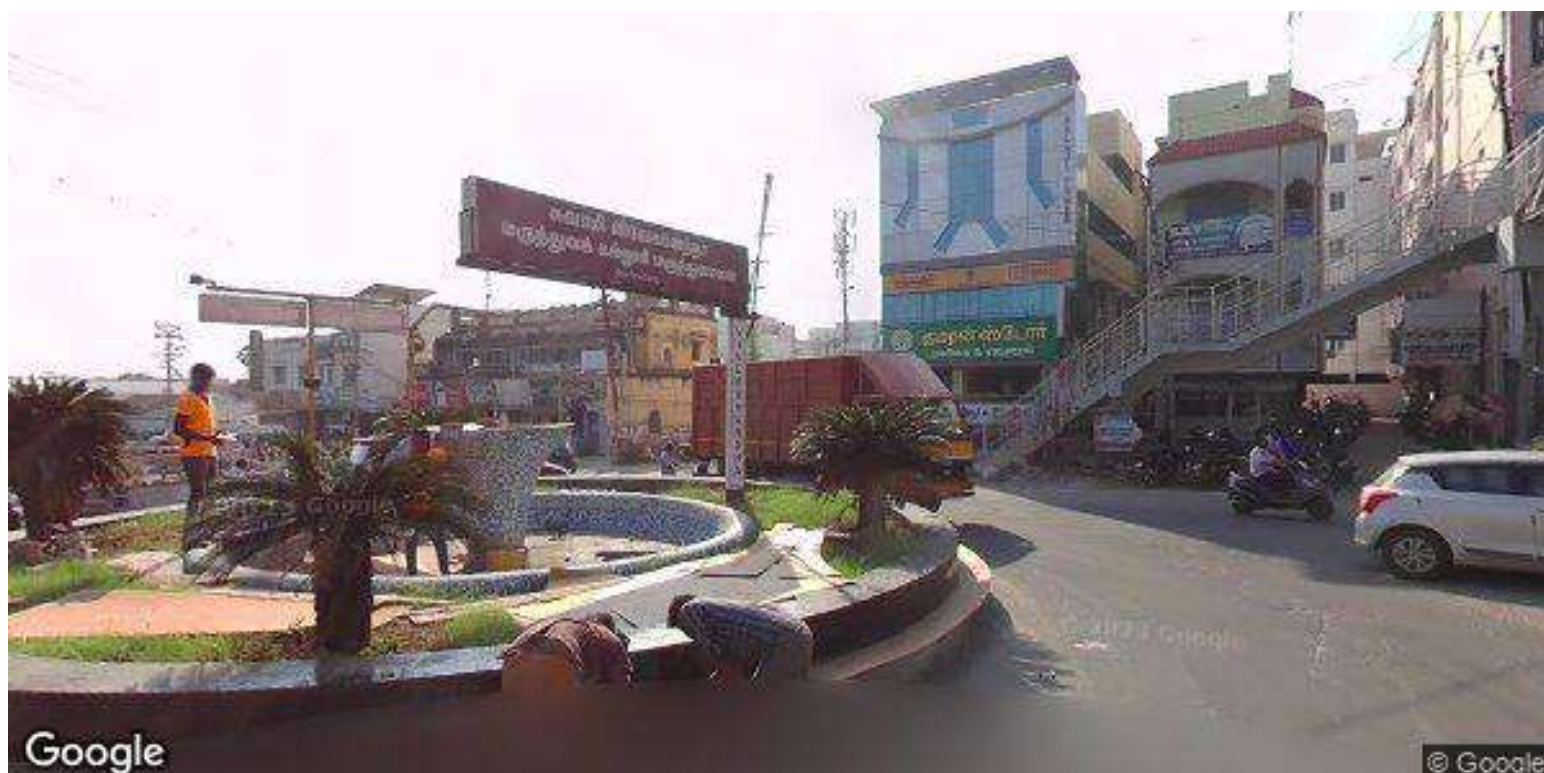
**Risk Type:** Roundabout

**Risk Level:** High

**Speed Limit: 15 KM/Hr**  
**Coordinates: 11.38395, 77.89480**

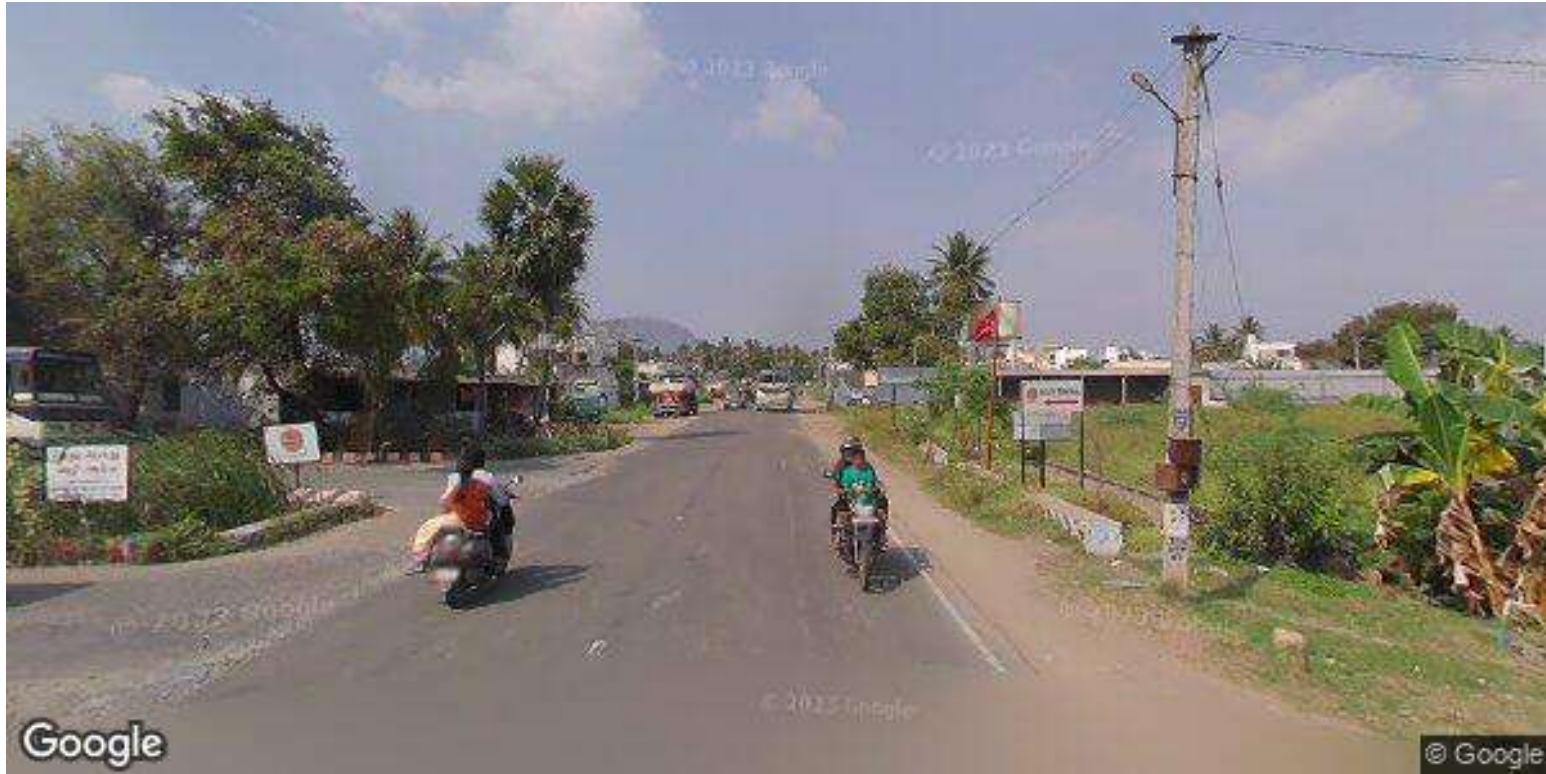
**Risk Type: Turn**  
**Risk Level: High**  
**Speed Limit: 15 KM/Hr**  
**Coordinates: 11.44019, 77.87547**

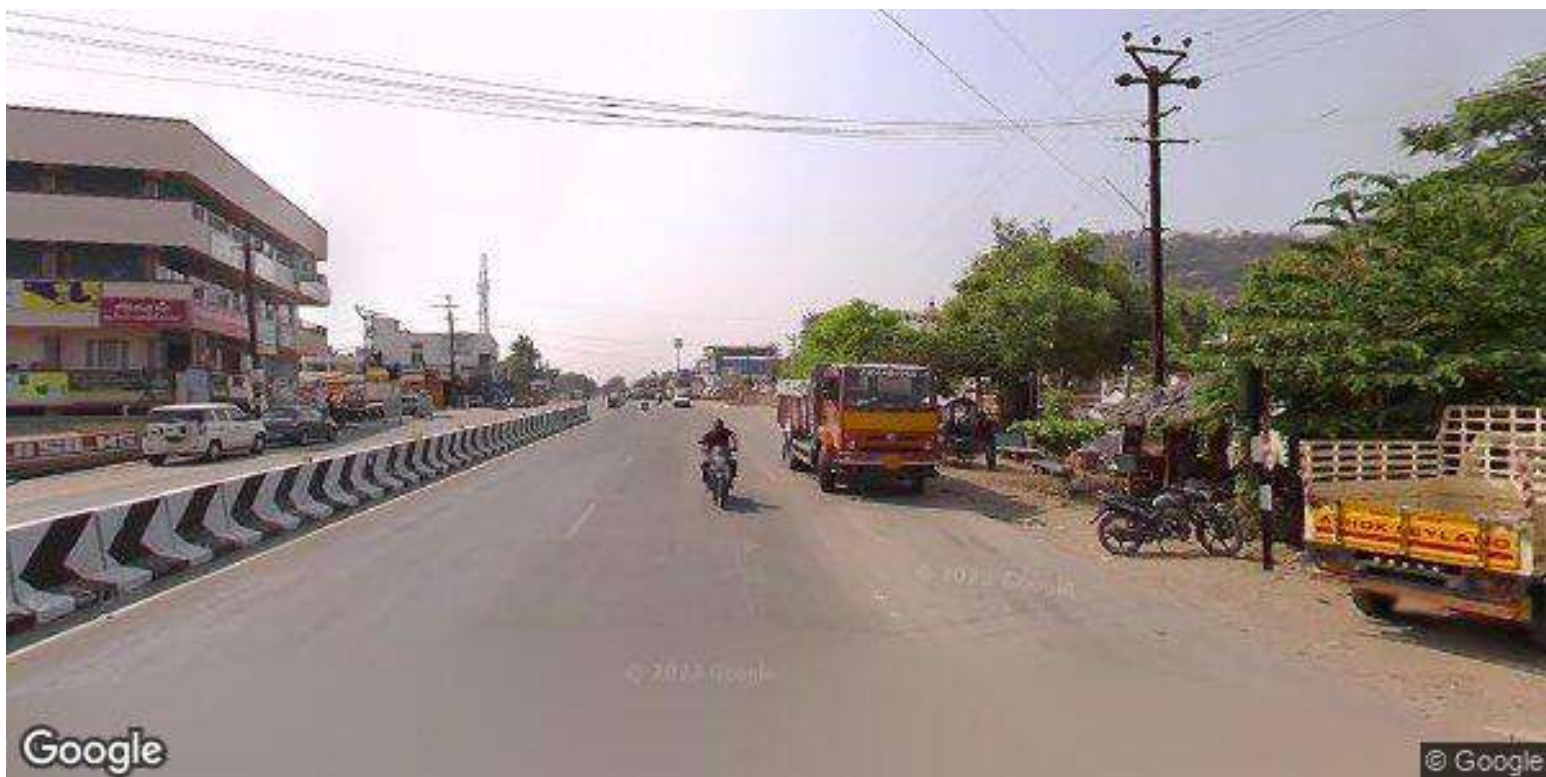
**Risk Type: Turn**  
**Risk Level: Medium**  
**Speed Limit: 30 KM/Hr**  
**Coordinates: 11.39685, 77.88861**

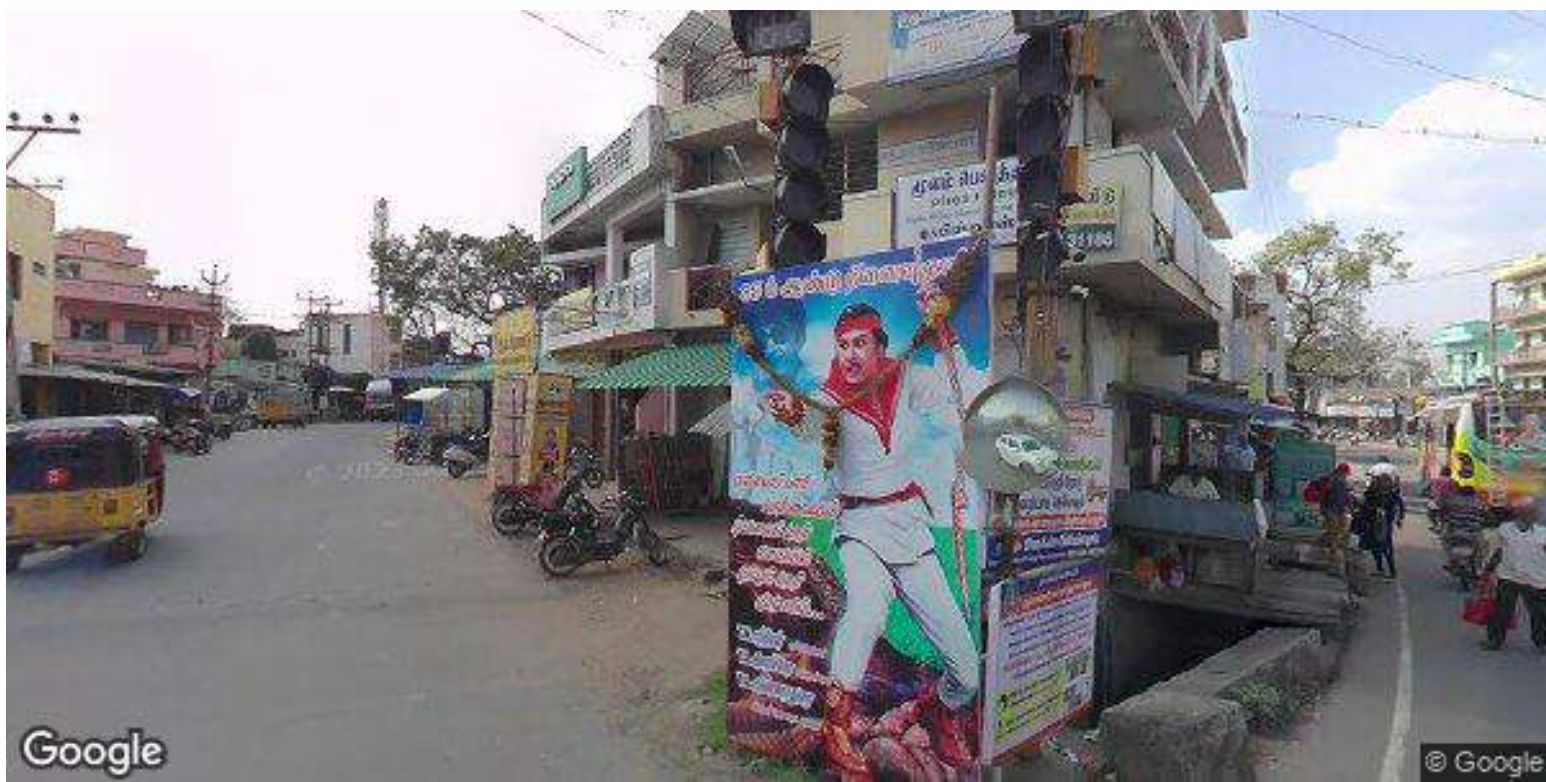
**Risk Type:** Turn

**Risk Level:** Medium

**Speed Limit:** 30 KM/Hr

**Coordinates:** 11.38342, 77.89975

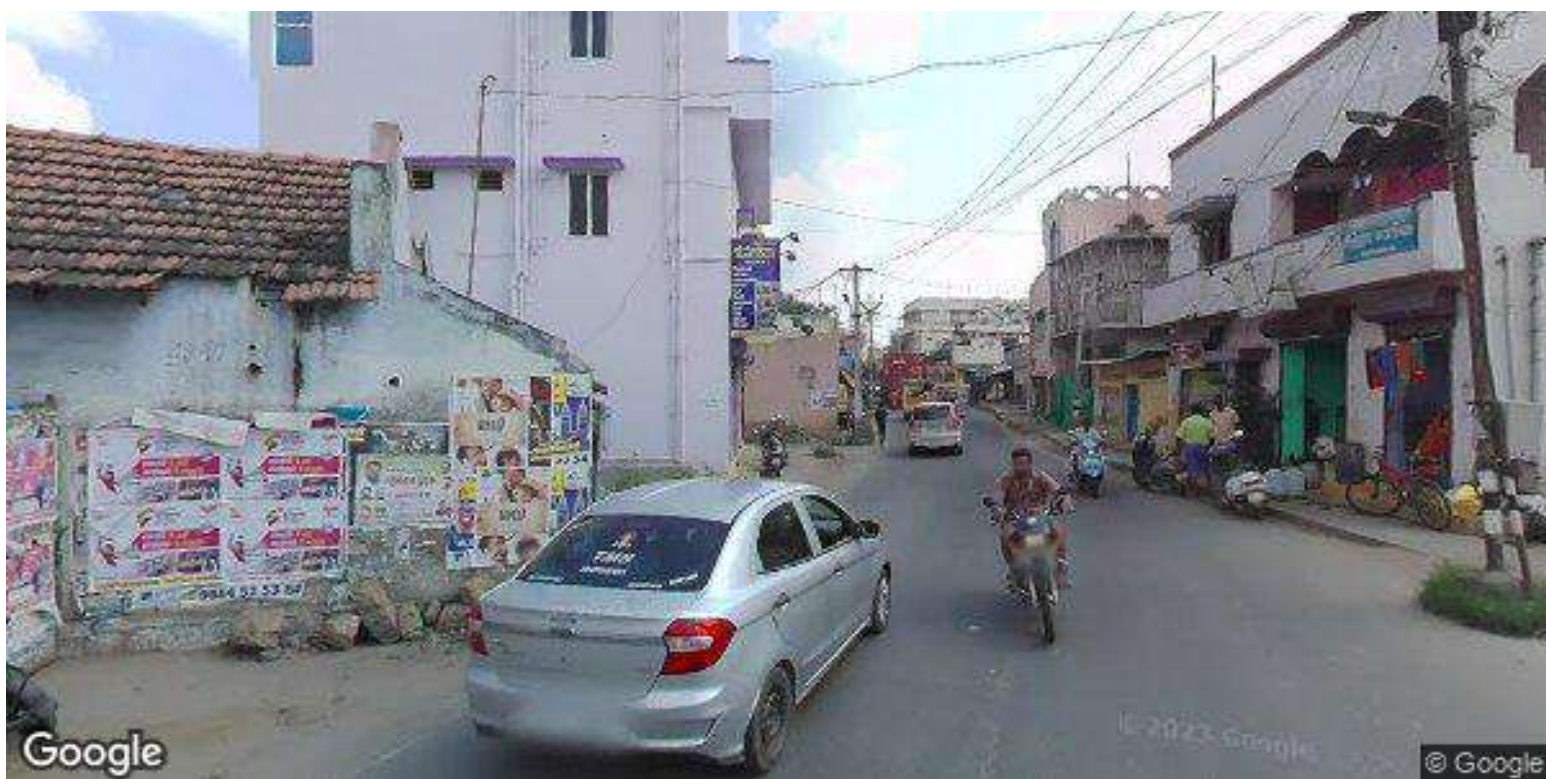
**Risk Type:** Turn

**Risk Level:** Medium

**Speed Limit:** 30 KM/Hr

**Coordinates:** 11.38295, 77.90001

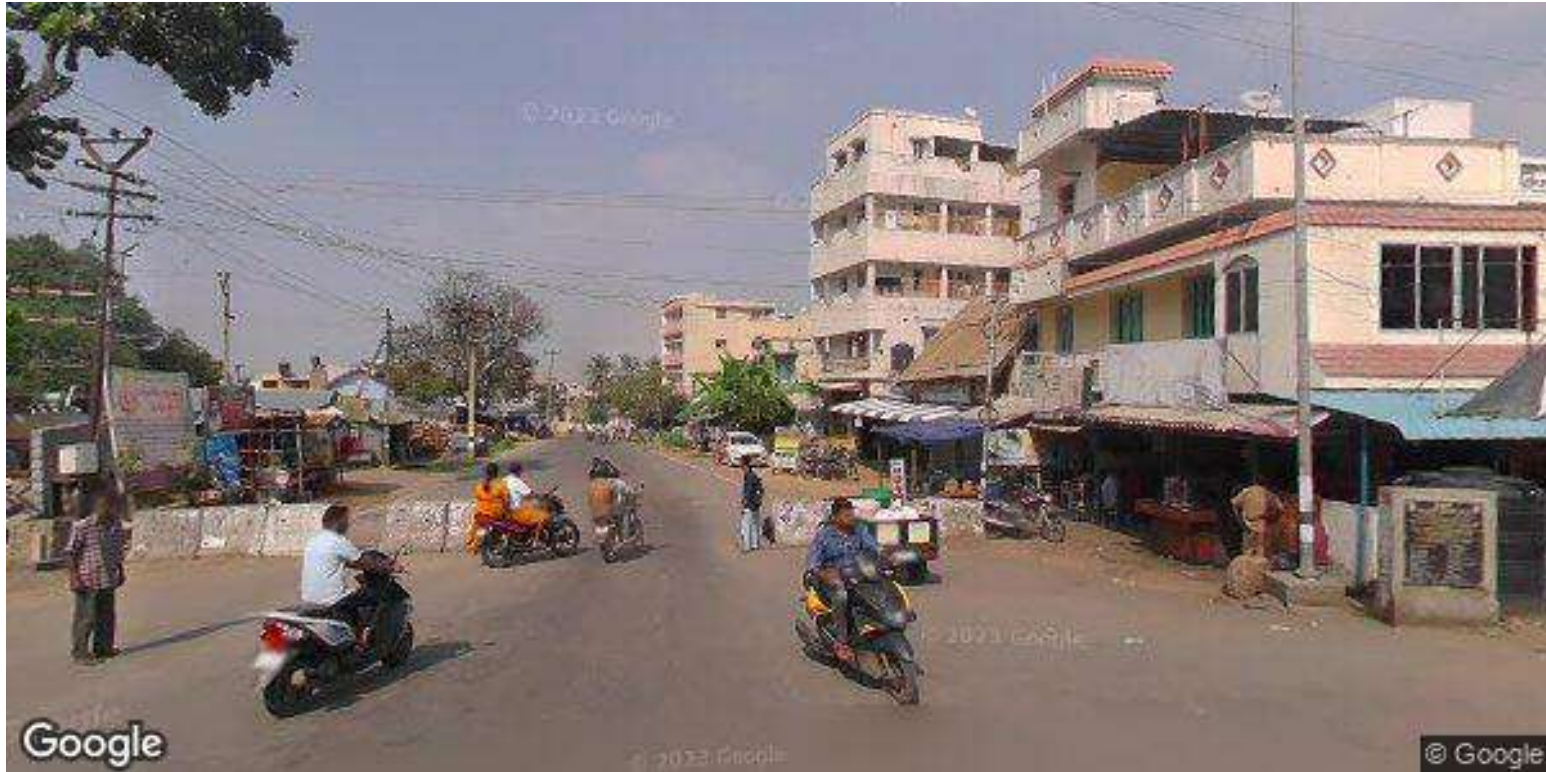
**Risk Type:** Blind Spot  
**Risk Level:** Blind Spot  
**Speed Limit:** 10 KM/Hr  
**Coordinates:** 11.37841, 77.90140

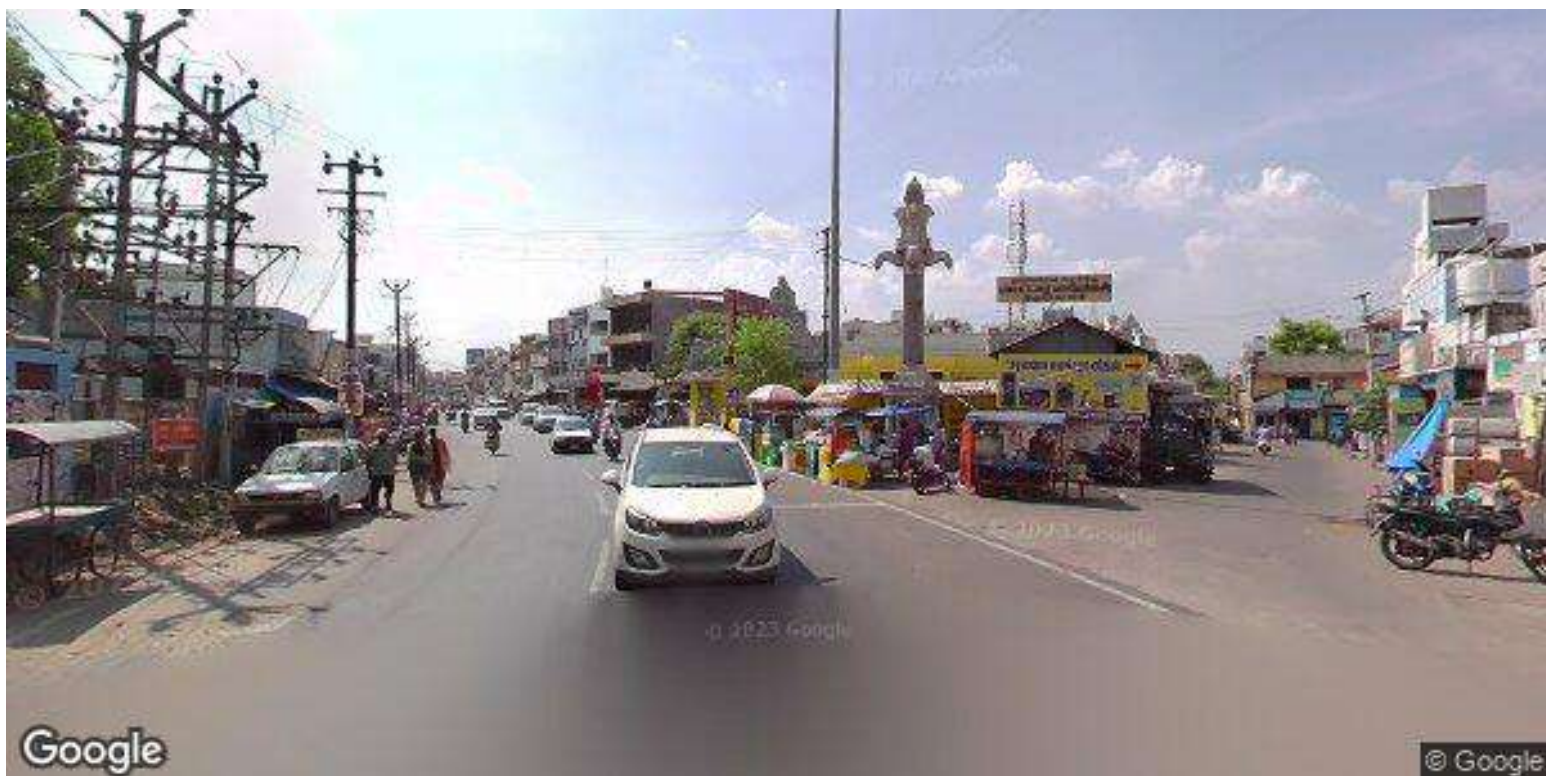
**Risk Type:** Turn  
**Risk Level:** Medium  
**Speed Limit:** 30 KM/Hr  
**Coordinates:** 11.22411, 78.16637

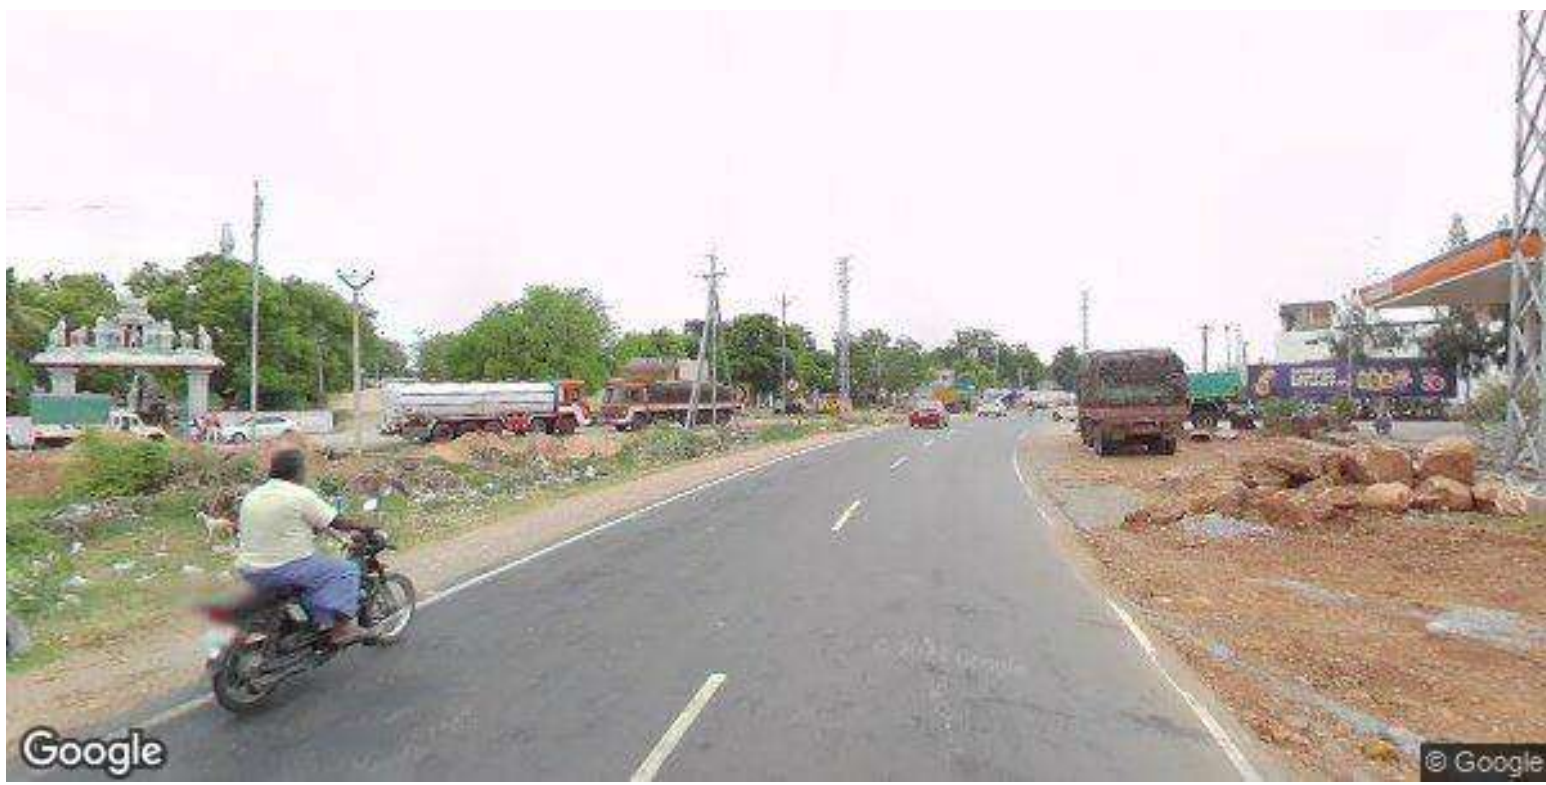
**Risk Type:** Turn

**Risk Level:** Medium

**Speed Limit:** 30 KM/Hr

**Coordinates:** 11.12316, 78.23249

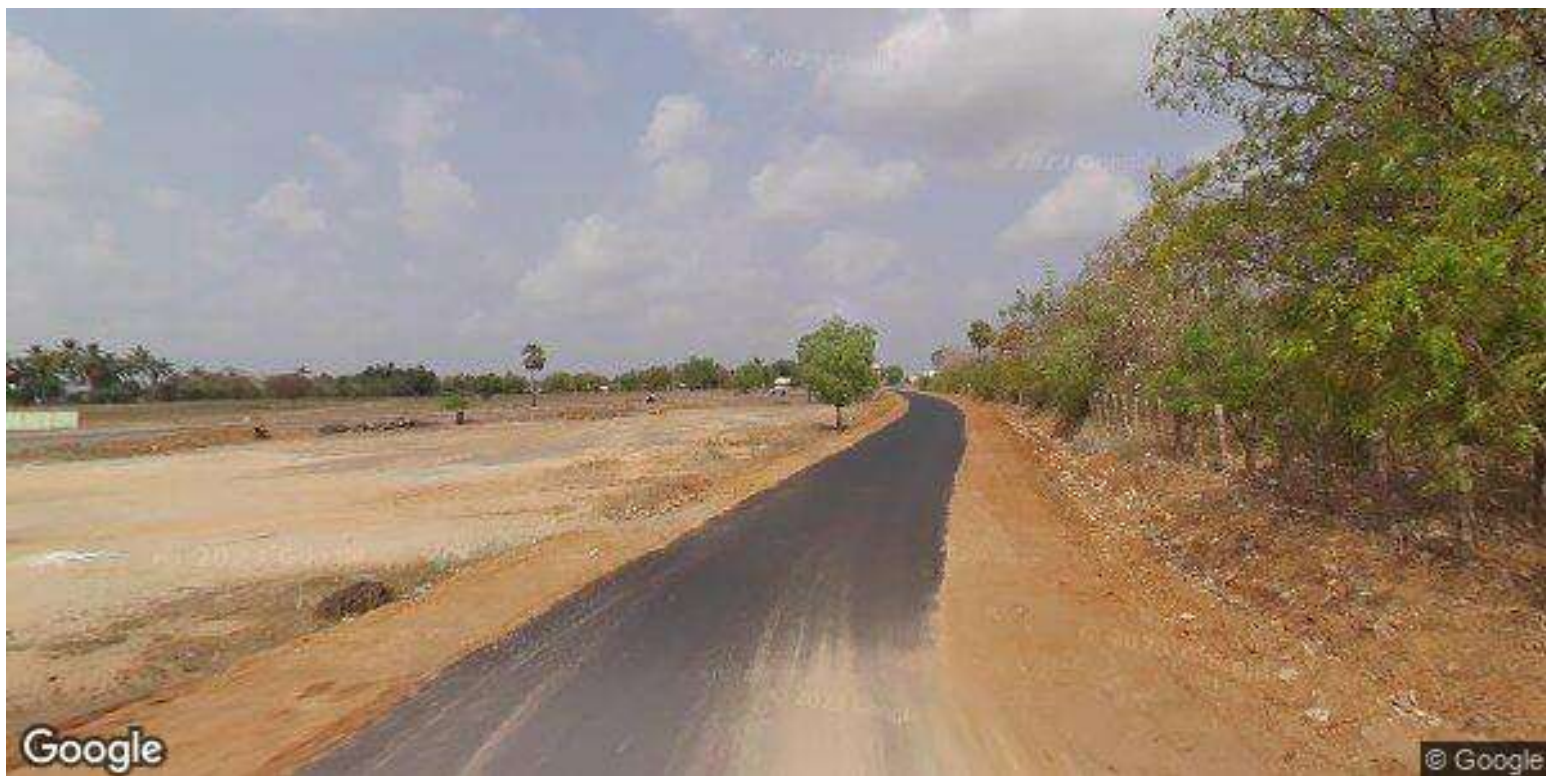
**Risk Type:** Turn

**Risk Level:** Medium

**Speed Limit:** 30 KM/Hr

**Coordinates:** 11.01955, 78.29606

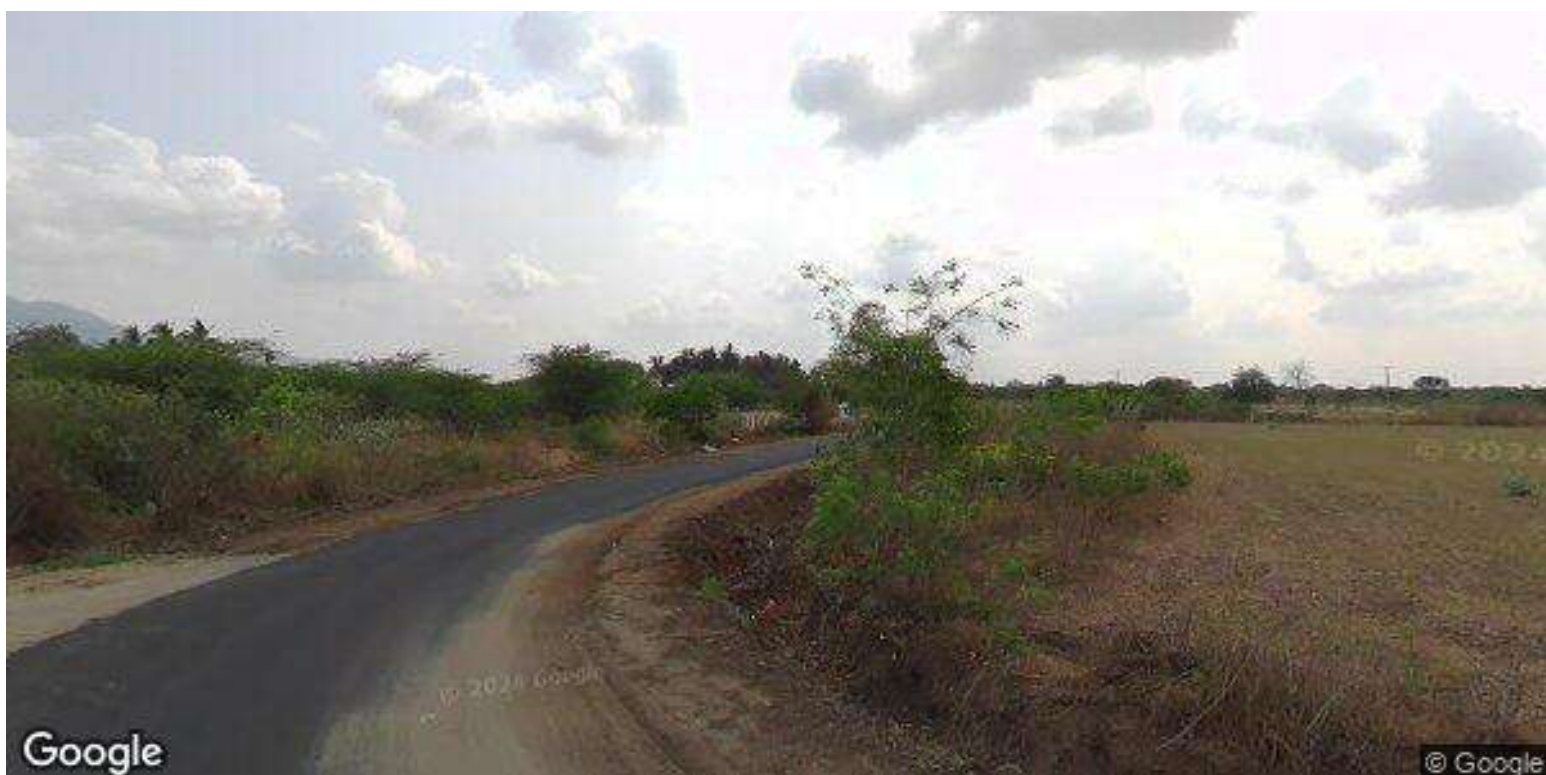
**Risk Type:** Turn  
**Risk Level:** High  
**Speed Limit:** 15 KM/Hr  
**Coordinates:** 11.02380, 78.30469

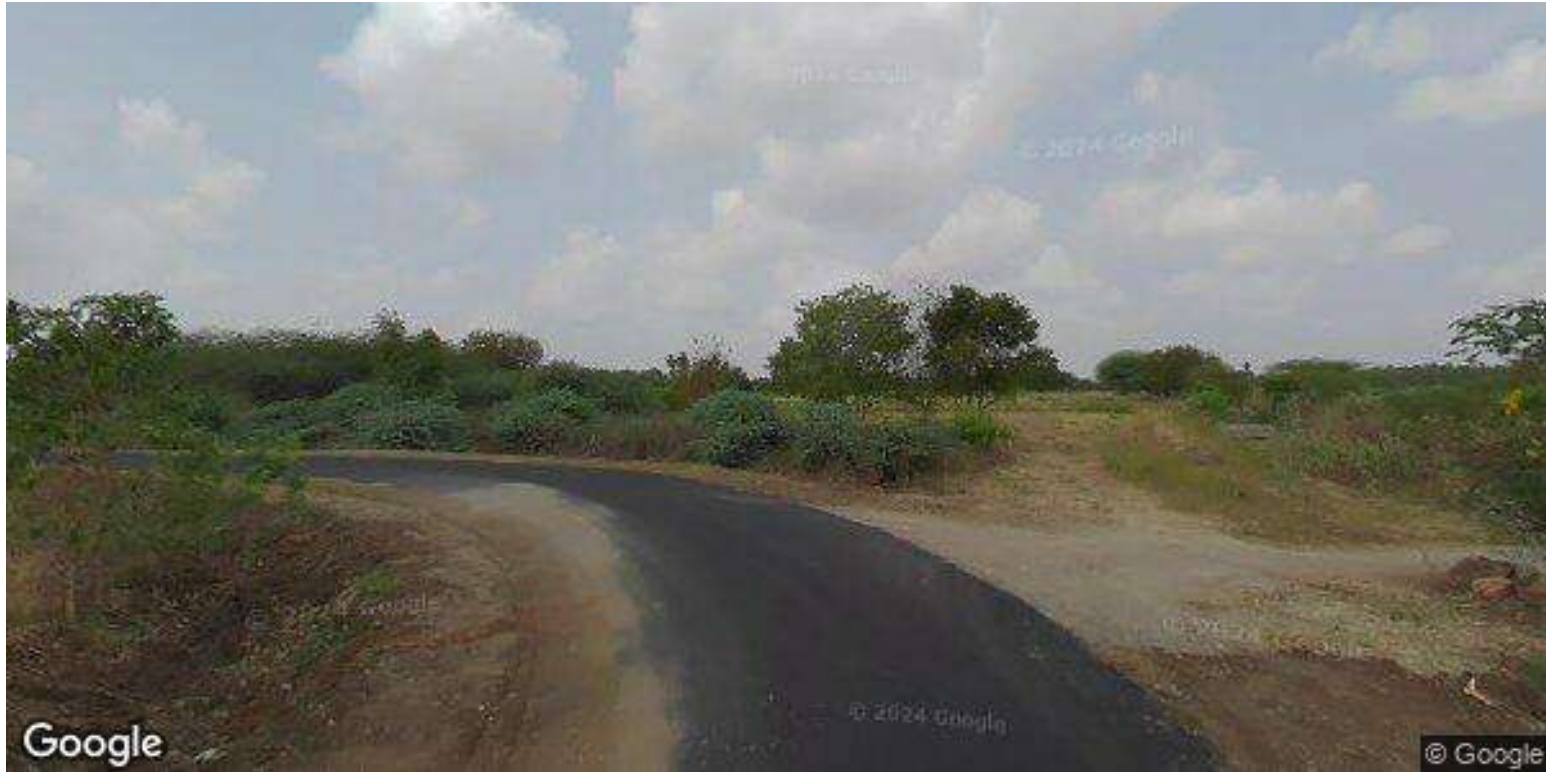
**Risk Type:** Turn  
**Risk Level:** Medium  
**Speed Limit:** 30 KM/Hr  
**Coordinates:** 11.02388, 78.30485

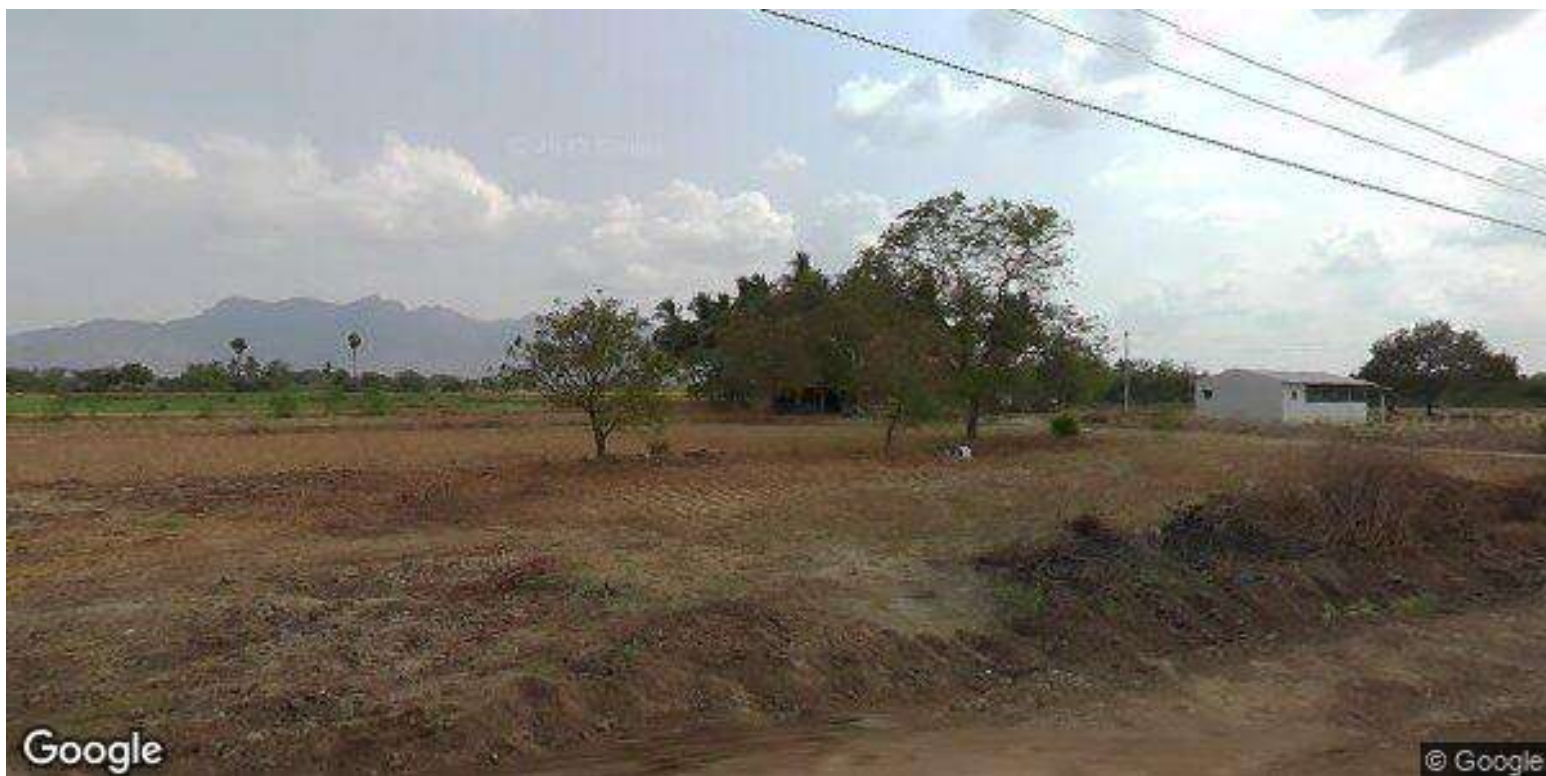
**Risk Type:** Turn  
**Risk Level:** Medium  
**Speed Limit:** 30 KM/Hr  
**Coordinates:** 11.02379, 78.30624

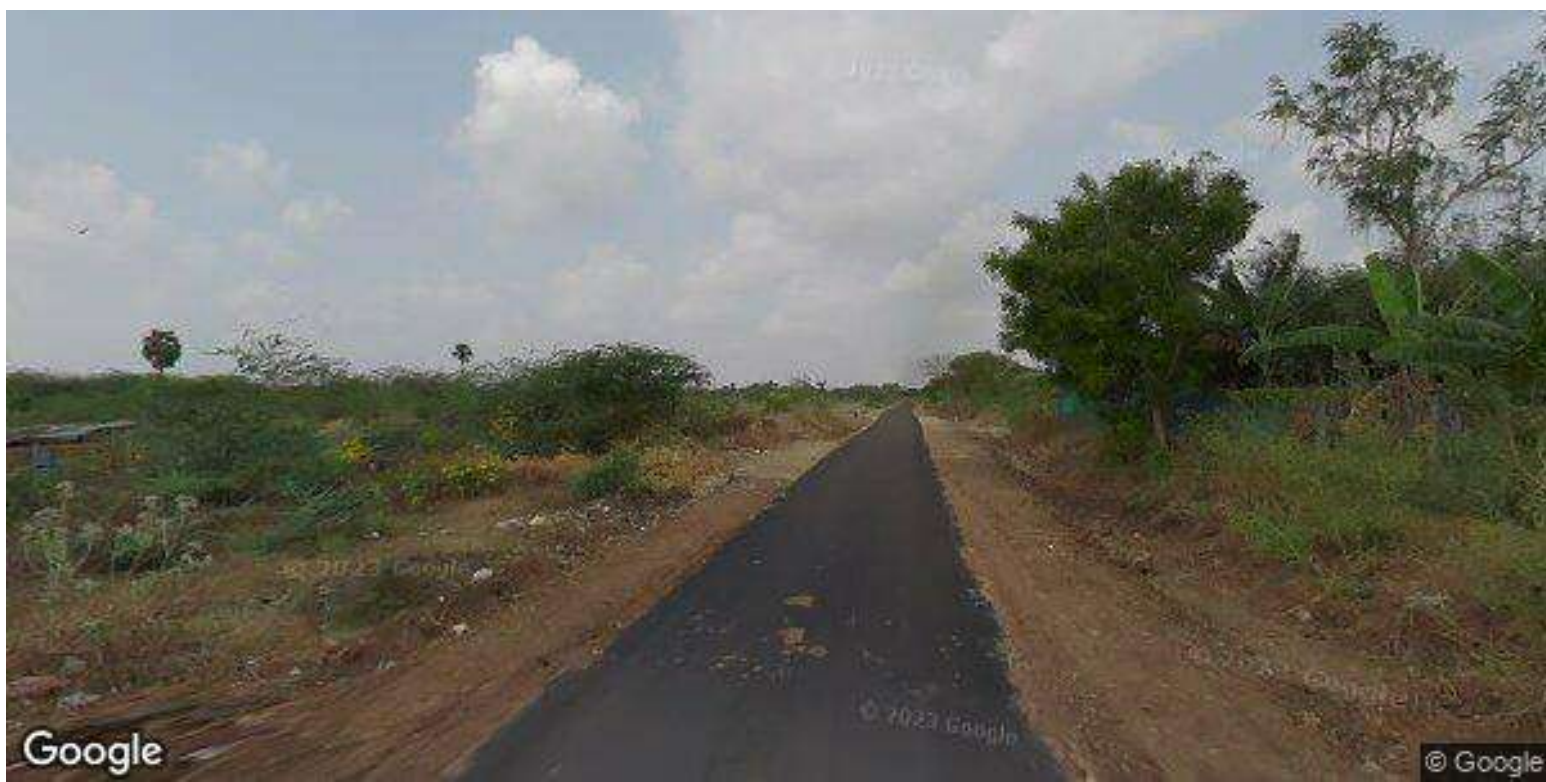
**Risk Type:** Turn

**Risk Level:** Medium

**Speed Limit:** 30 KM/Hr

**Coordinates:** 11.02309, 78.30986

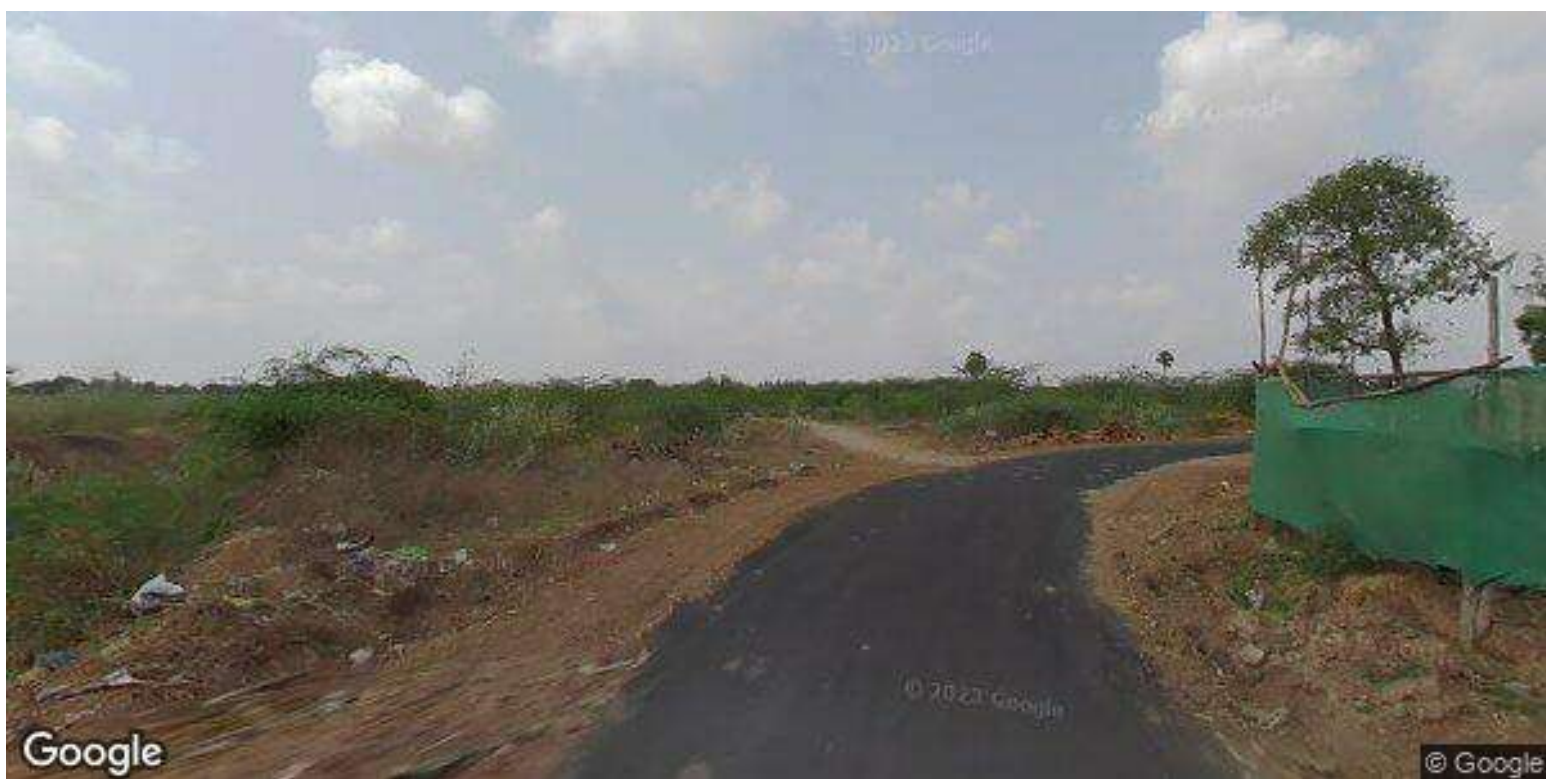
**Risk Type:** Turn

**Risk Level:** Medium

**Speed Limit:** 30 KM/Hr

**Coordinates:** 11.02318, 78.31014

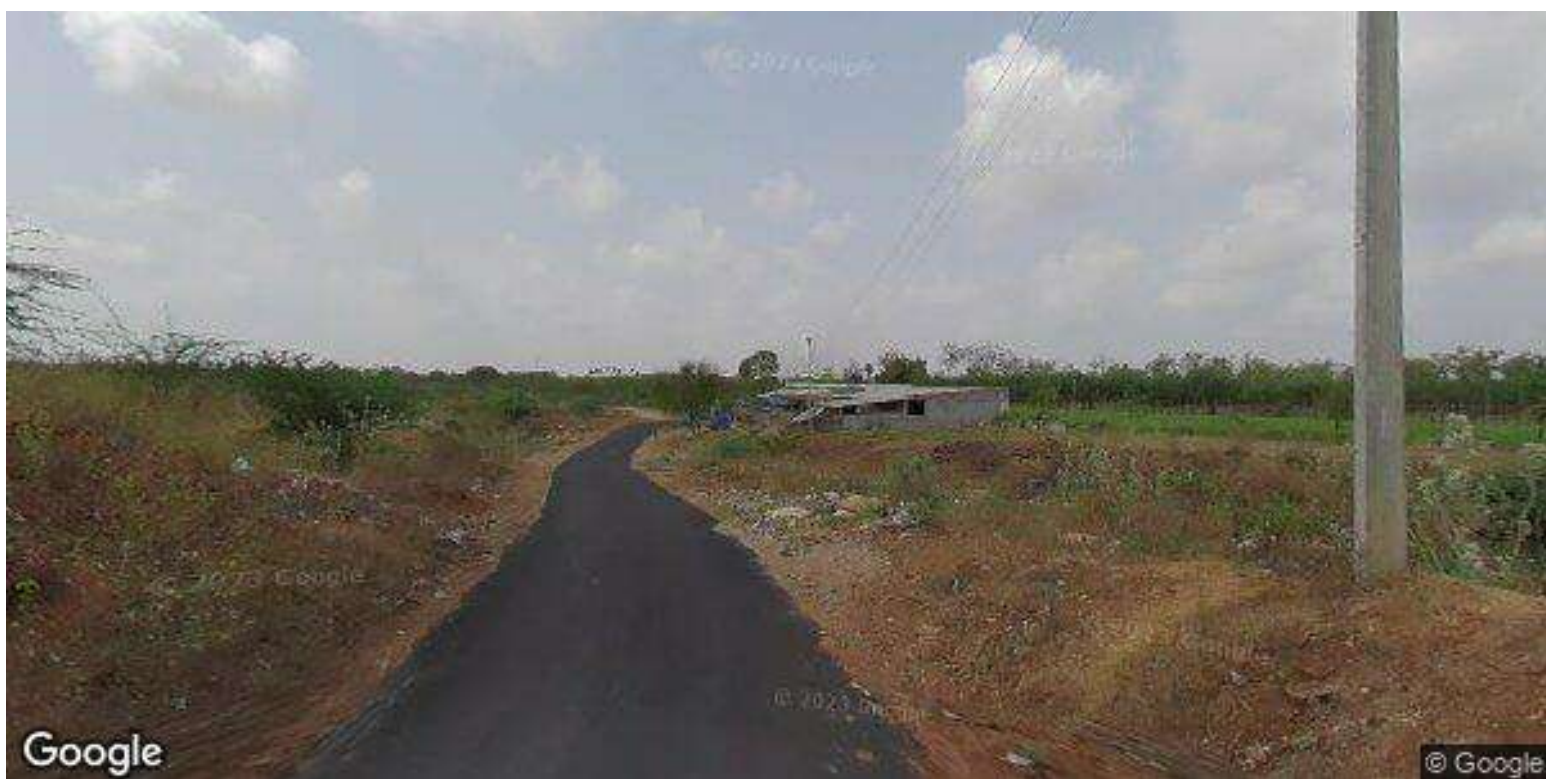
**Risk Type:** Turn  
**Risk Level:** Medium  
**Speed Limit:** 30 KM/Hr  
**Coordinates:** 11.02361, 78.31051

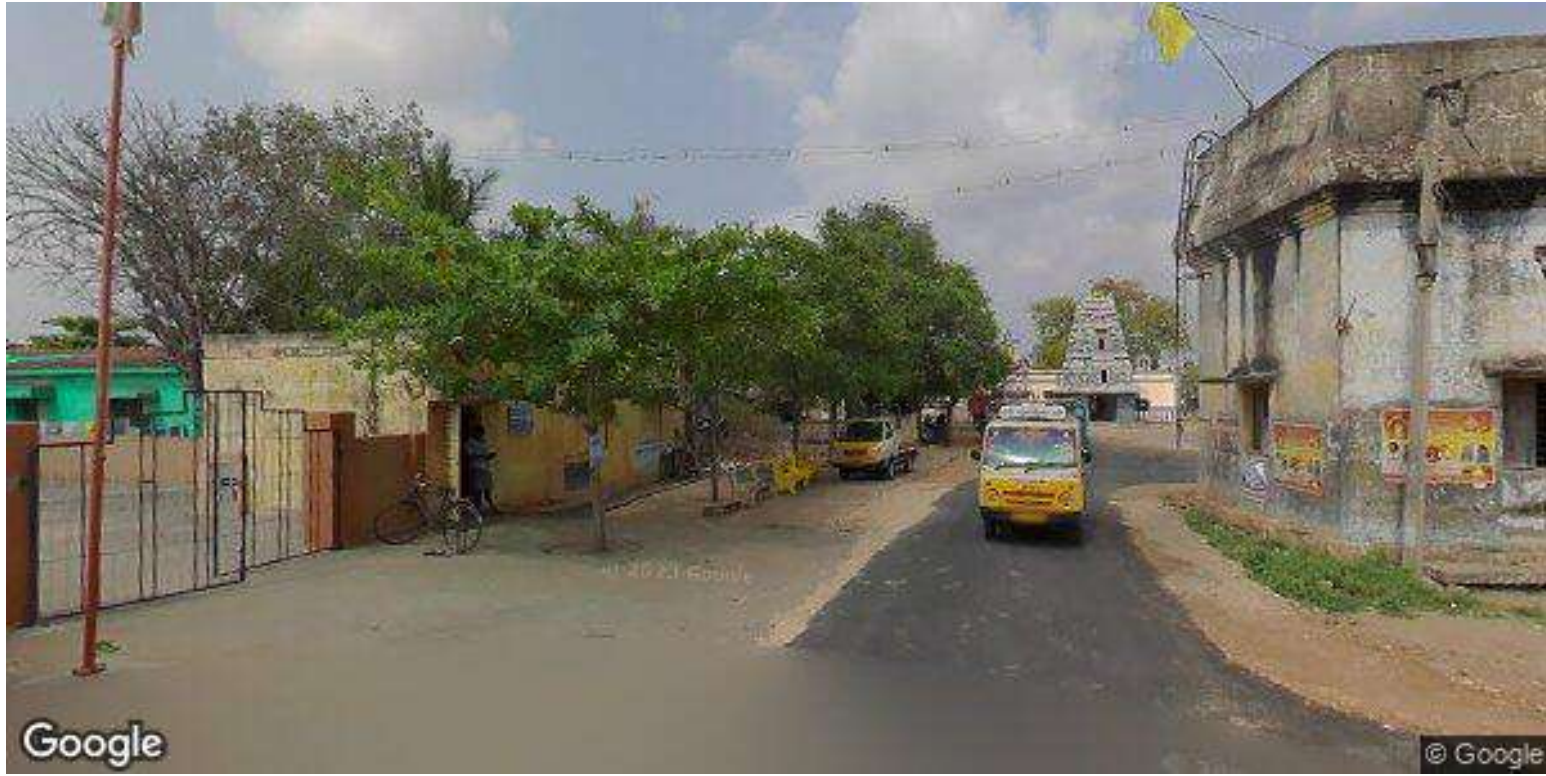
**Risk Type:** Turn  
**Risk Level:** High  
**Speed Limit:** 15 KM/Hr  
**Coordinates:** 11.02379, 78.31257

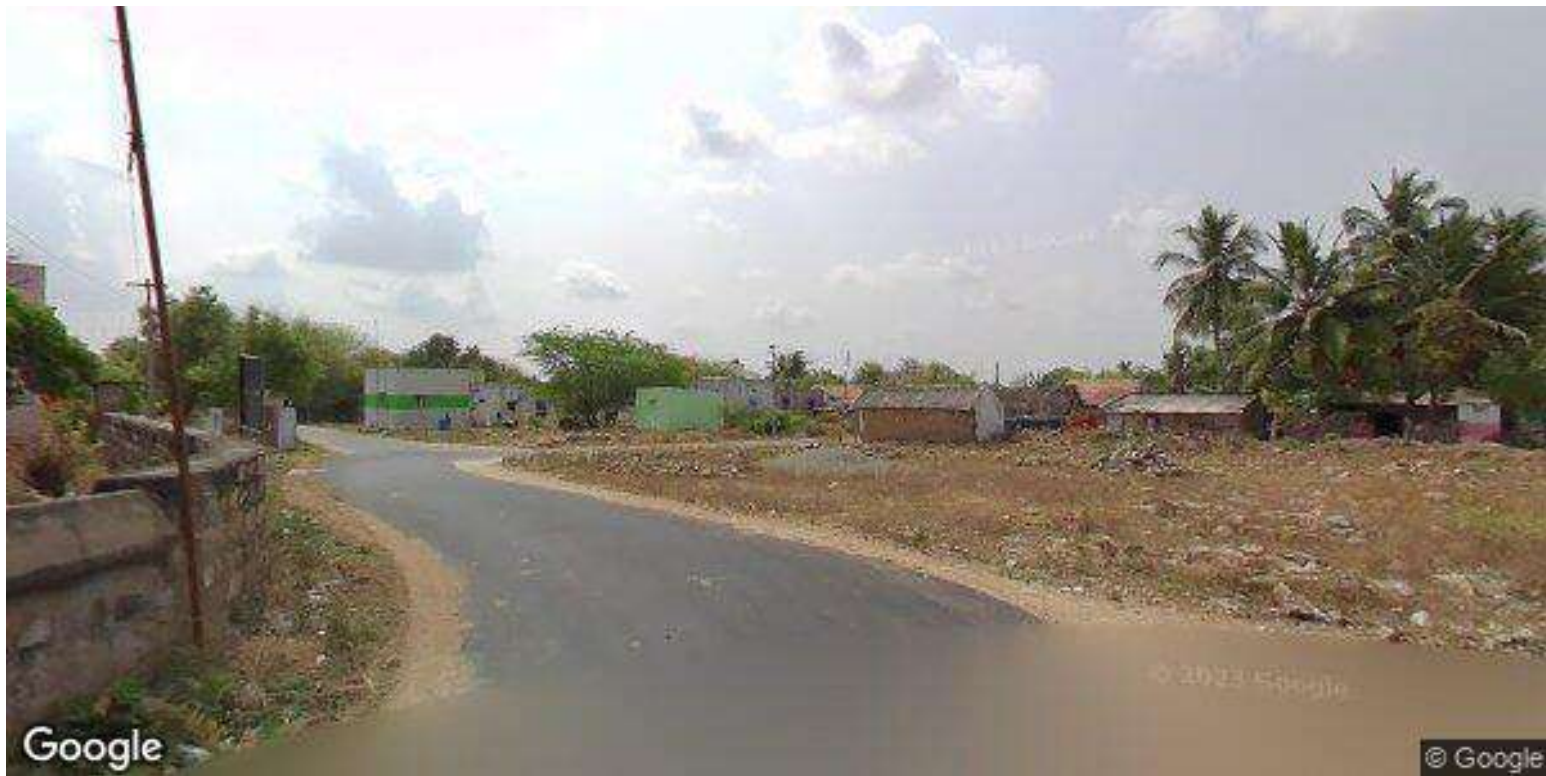
**Risk Type:** Turn  
**Risk Level:** High  
**Speed Limit:** 15 KM/Hr  
**Coordinates:** 11.02331, 78.31290

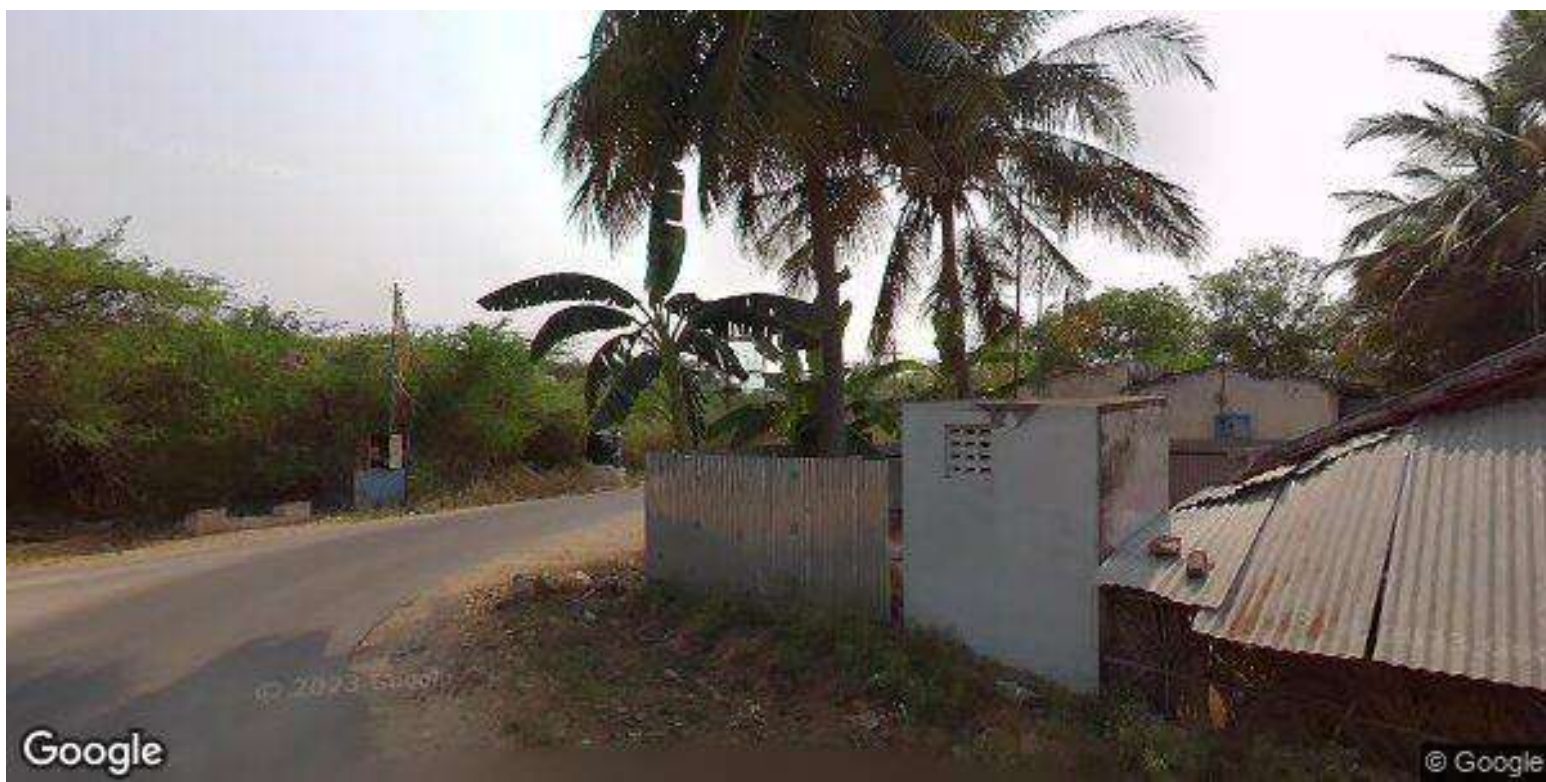
**Risk Type:** Turn

**Risk Level:** Medium

**Speed Limit:** 30 KM/Hr

**Coordinates:** 11.02315, 78.31531
