# IndianOil

## JOURNEY RISK MANAGEMENT (JRM) STUDY

### Salem Terminal to SRINIVASHA AGENCIES

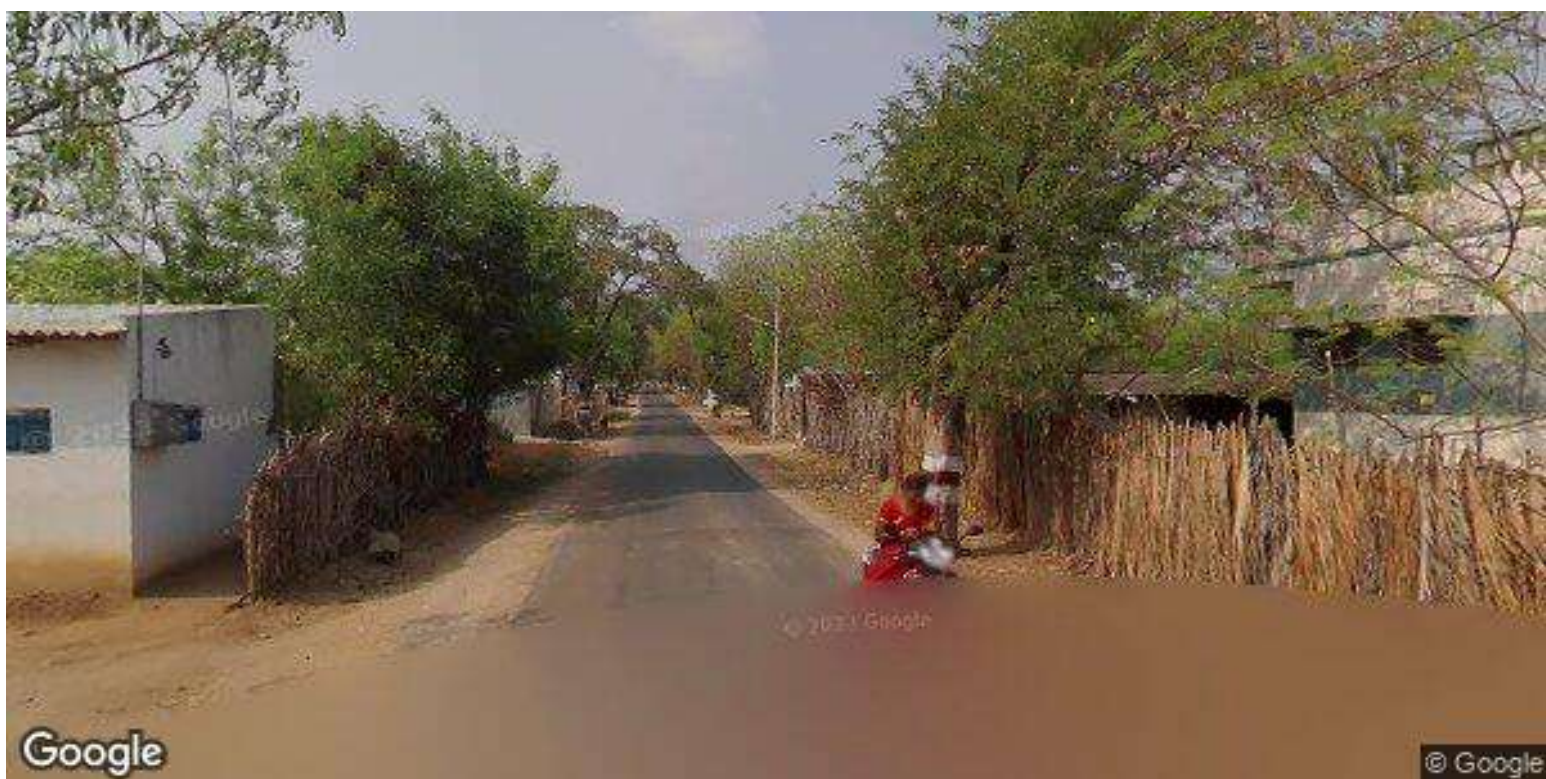
**Risk Type:** Turn

**Risk Level:** Medium

**Speed Limit:** 30 KM/Hr

**Coordinates:** 11.02337, 78.31554

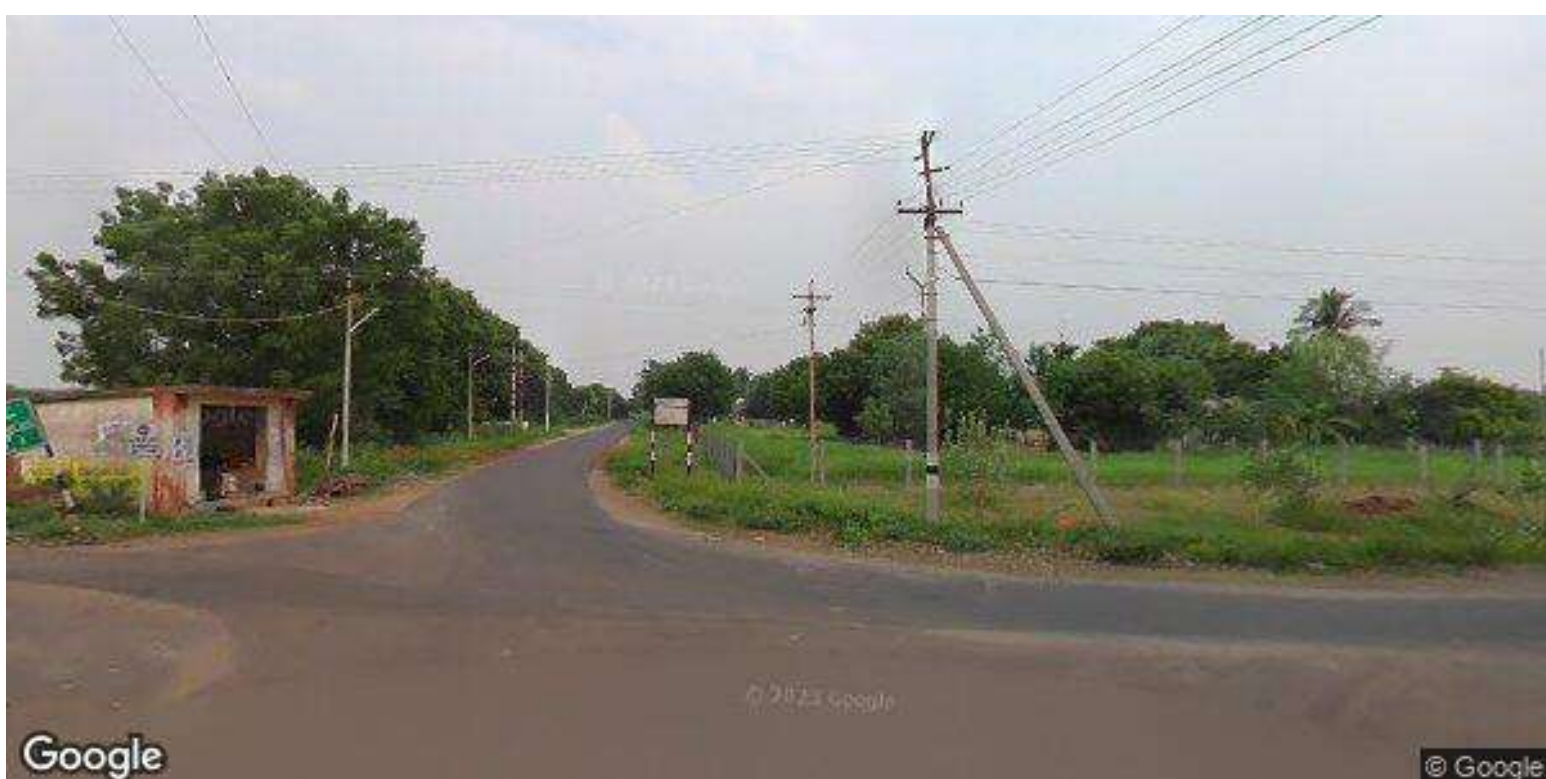
**Risk Type:** Turn  
**Risk Level:** High  
**Speed Limit:** 15 KM/Hr  
**Coordinates:** 11.02636, 78.31603

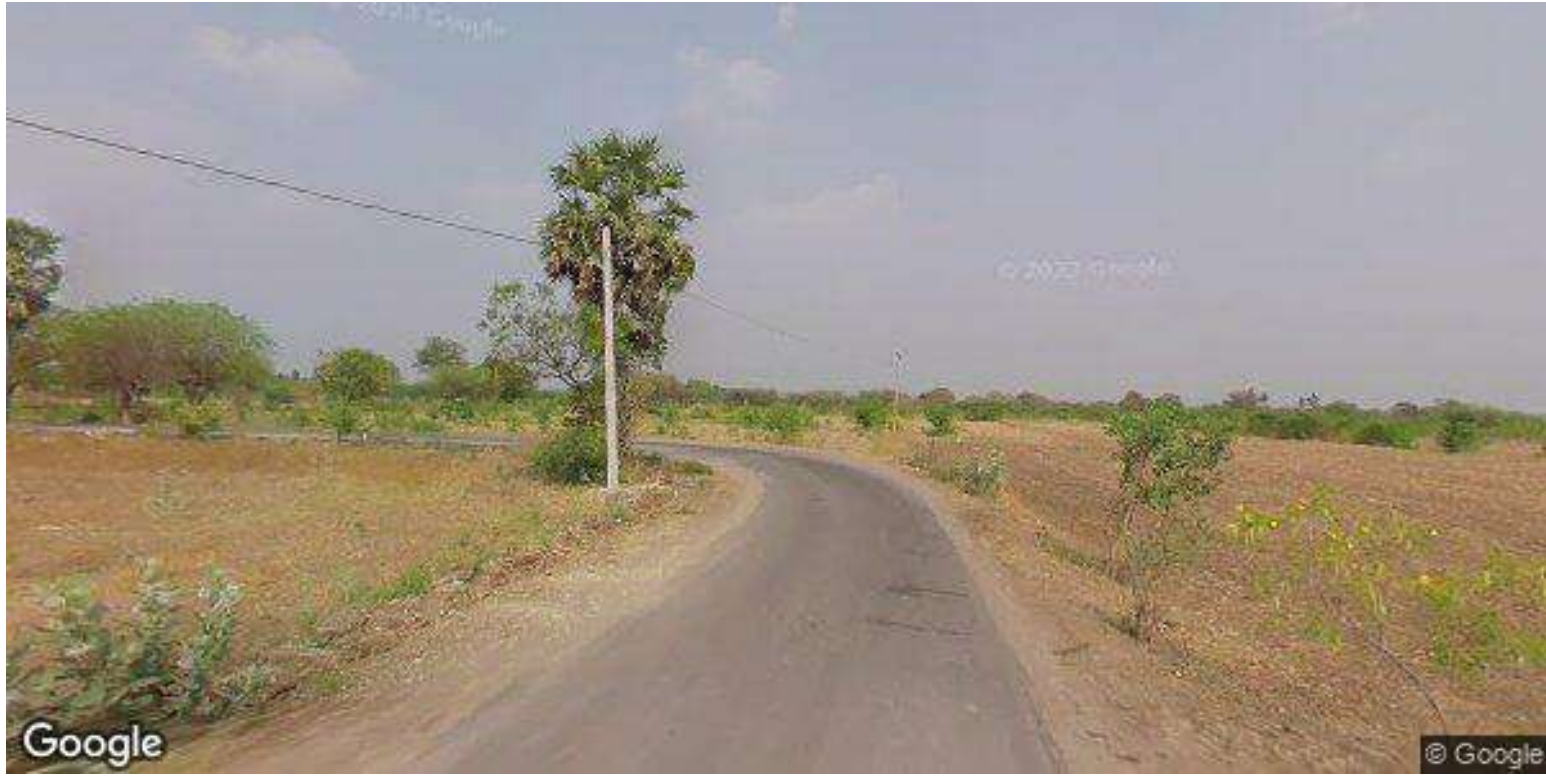
**Risk Type:** Turn  
**Risk Level:** High  
**Speed Limit:** 15 KM/Hr  
**Coordinates:** 11.02623, 78.31782

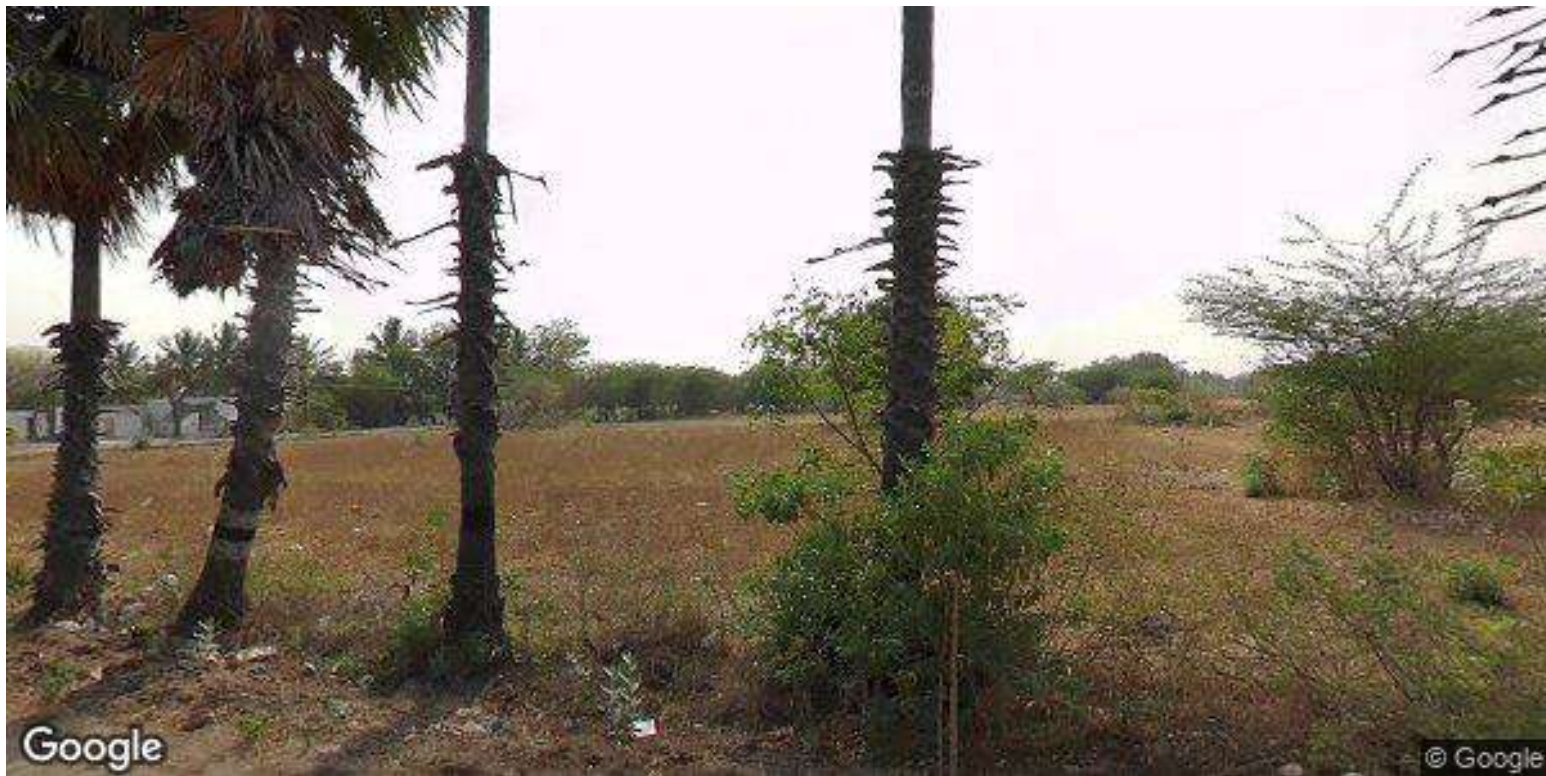
**Risk Type:** Turn  
**Risk Level:** High  
**Speed Limit:** 15 KM/Hr  
**Coordinates:** 11.02669, 78.31793

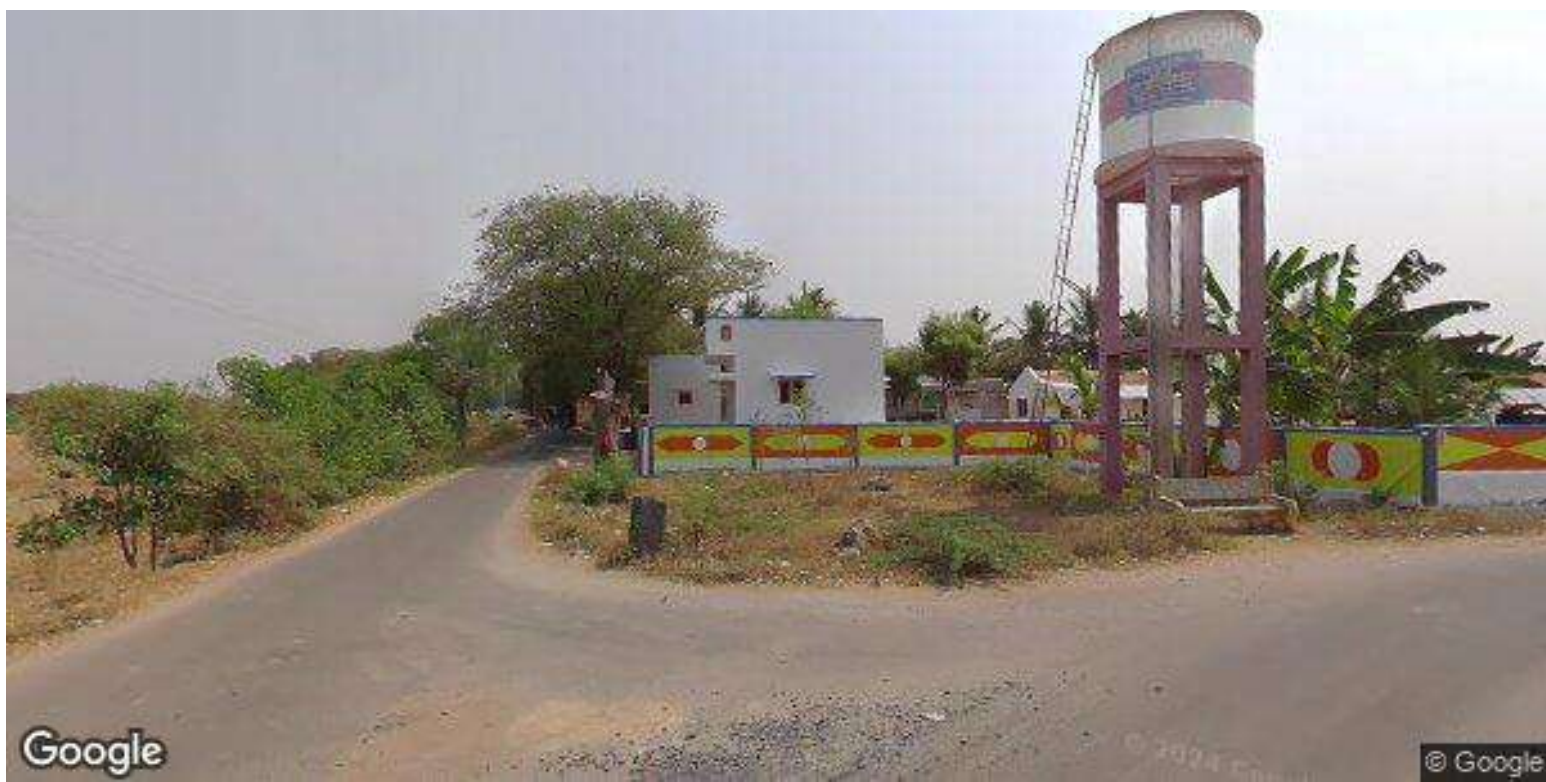
**Risk Type:** Blind Spot  
**Risk Level:** Blind Spot  
**Speed Limit:** 10 KM/Hr  
**Coordinates:** 11.02672, 78.32798

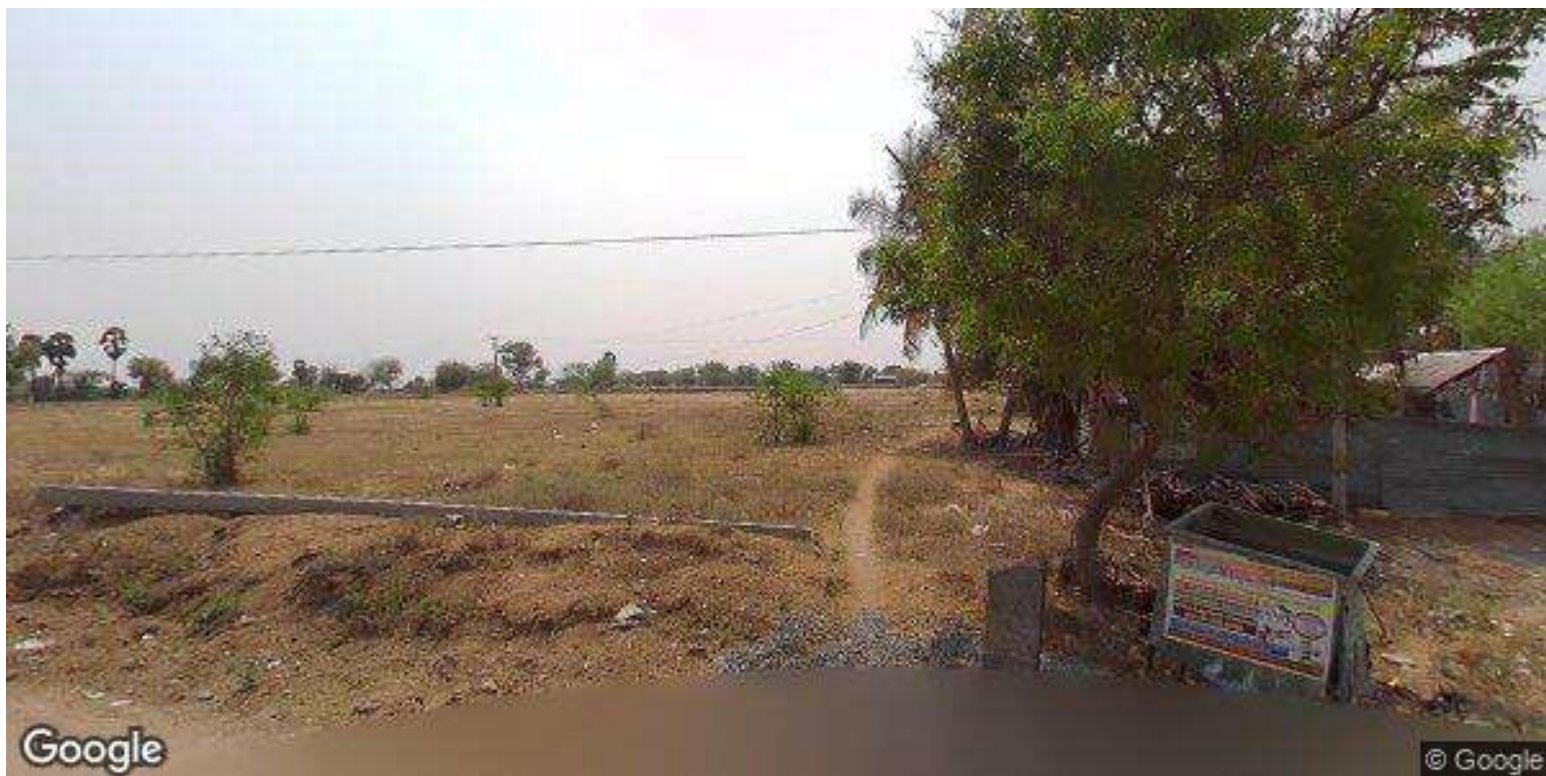
**Risk Type:** Turn  
**Risk Level:** High  
**Speed Limit:** 15 KM/Hr  
**Coordinates:** 11.02792, 78.32782

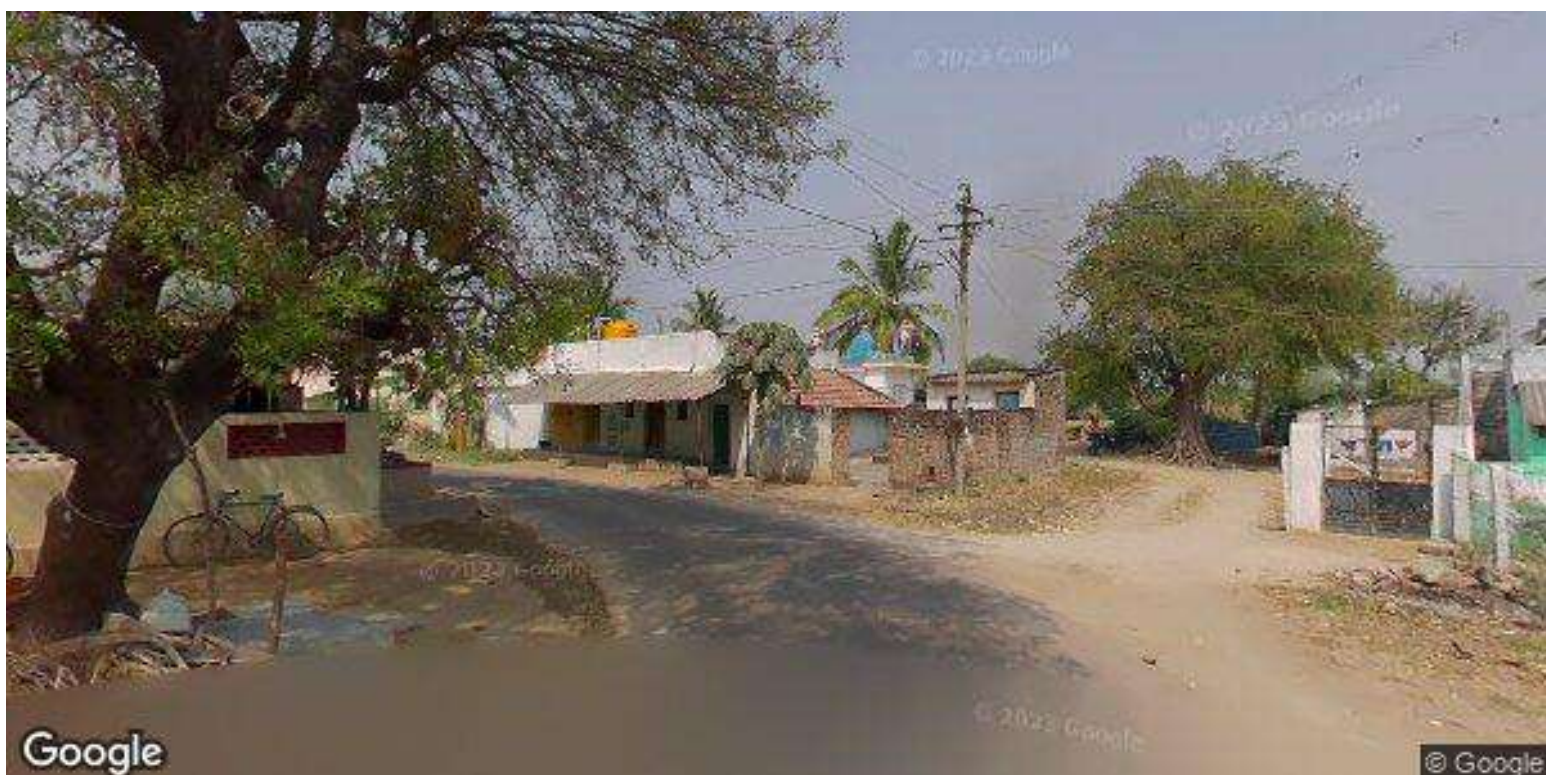
**Risk Type:** Turn

**Risk Level:** High

**Speed Limit:** 15 KM/Hr

**Coordinates:** 11.02840, 78.32974

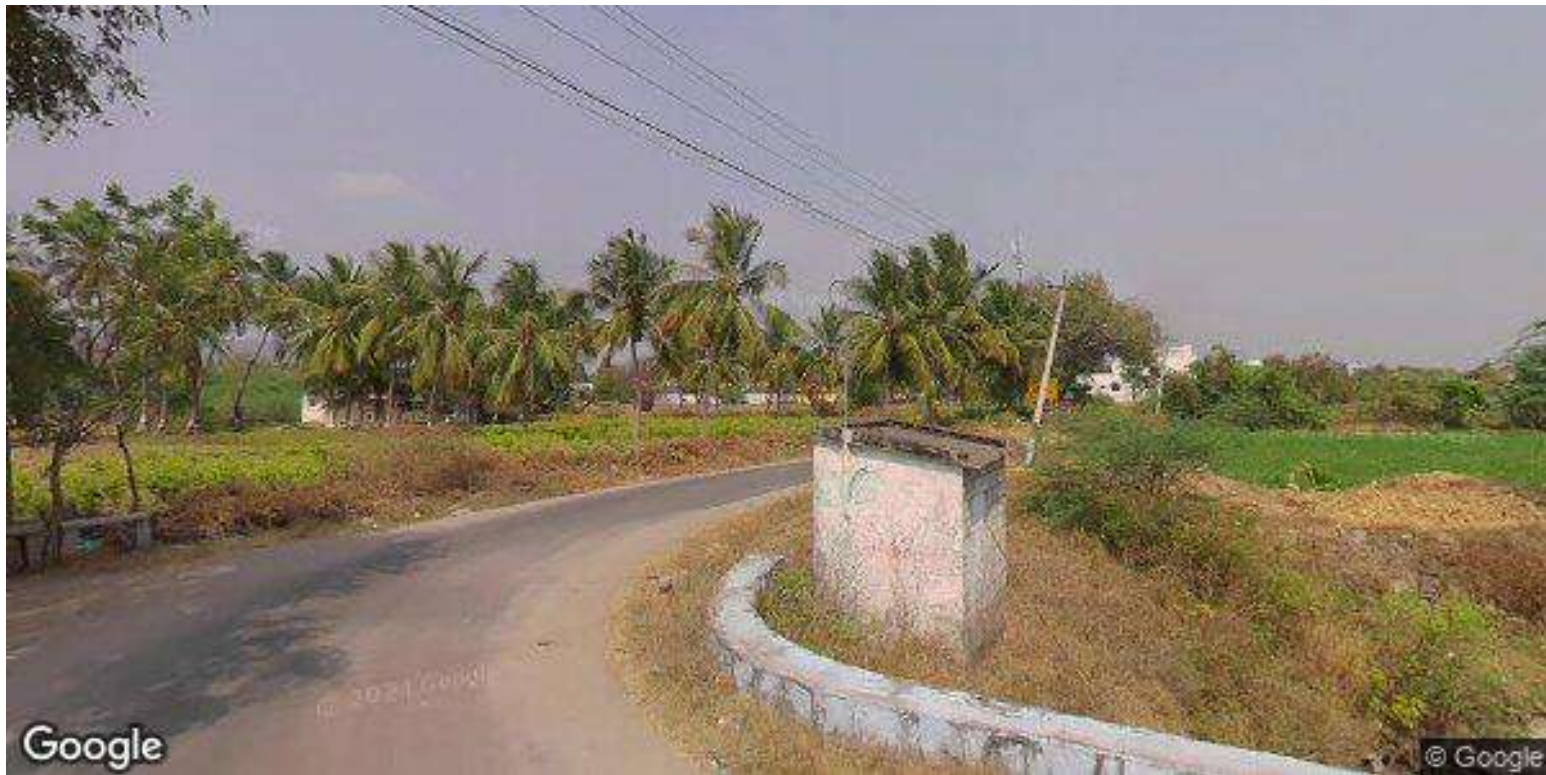
**Risk Type:** Turn

**Risk Level:** High

**Speed Limit:** 15 KM/Hr

**Coordinates:** 11.02989, 78.33033

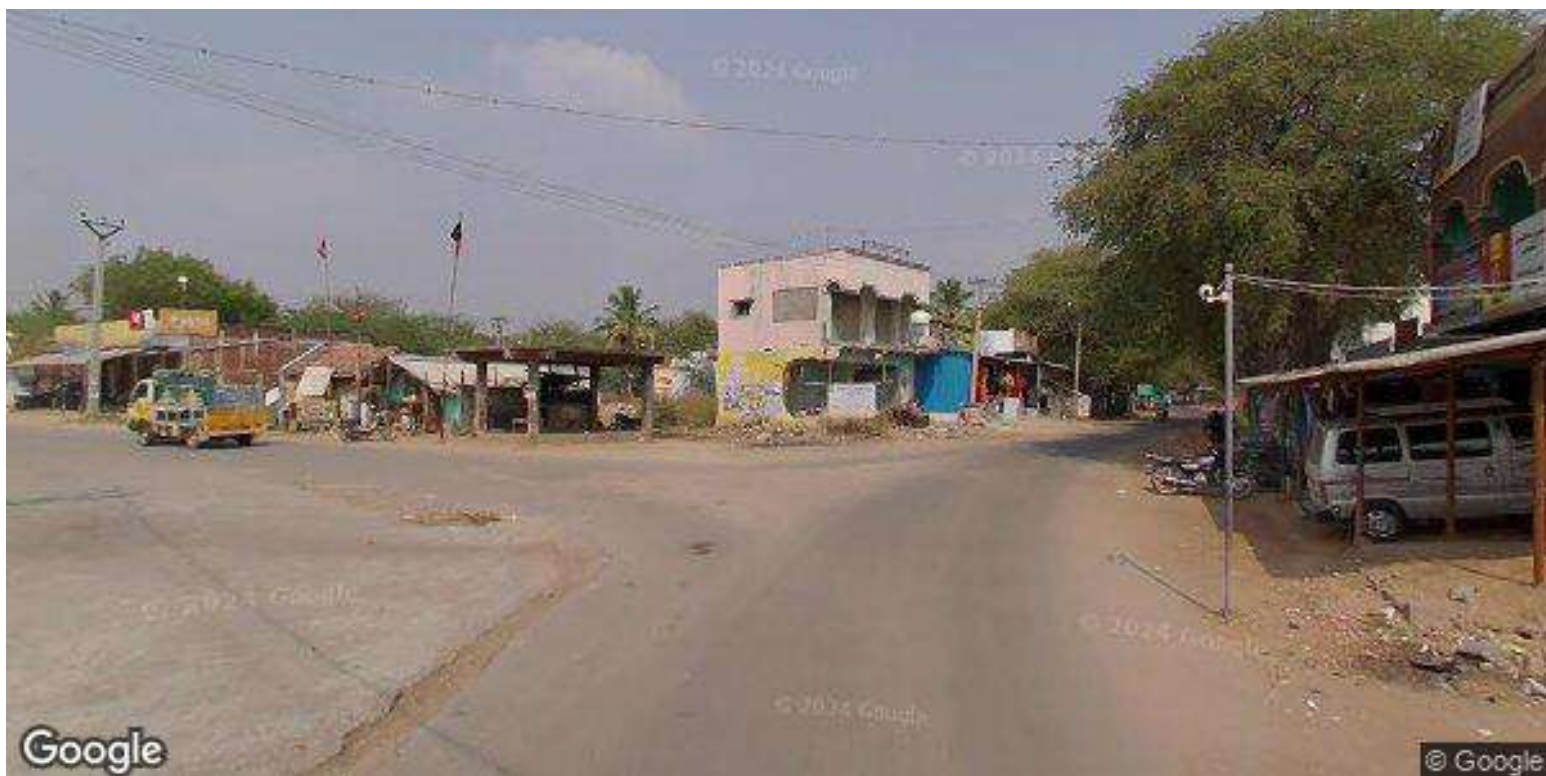
**Risk Type:** Turn

**Risk Level:** Medium

**Speed Limit:** 30 KM/Hr

**Coordinates:** 11.03026, 78.33423

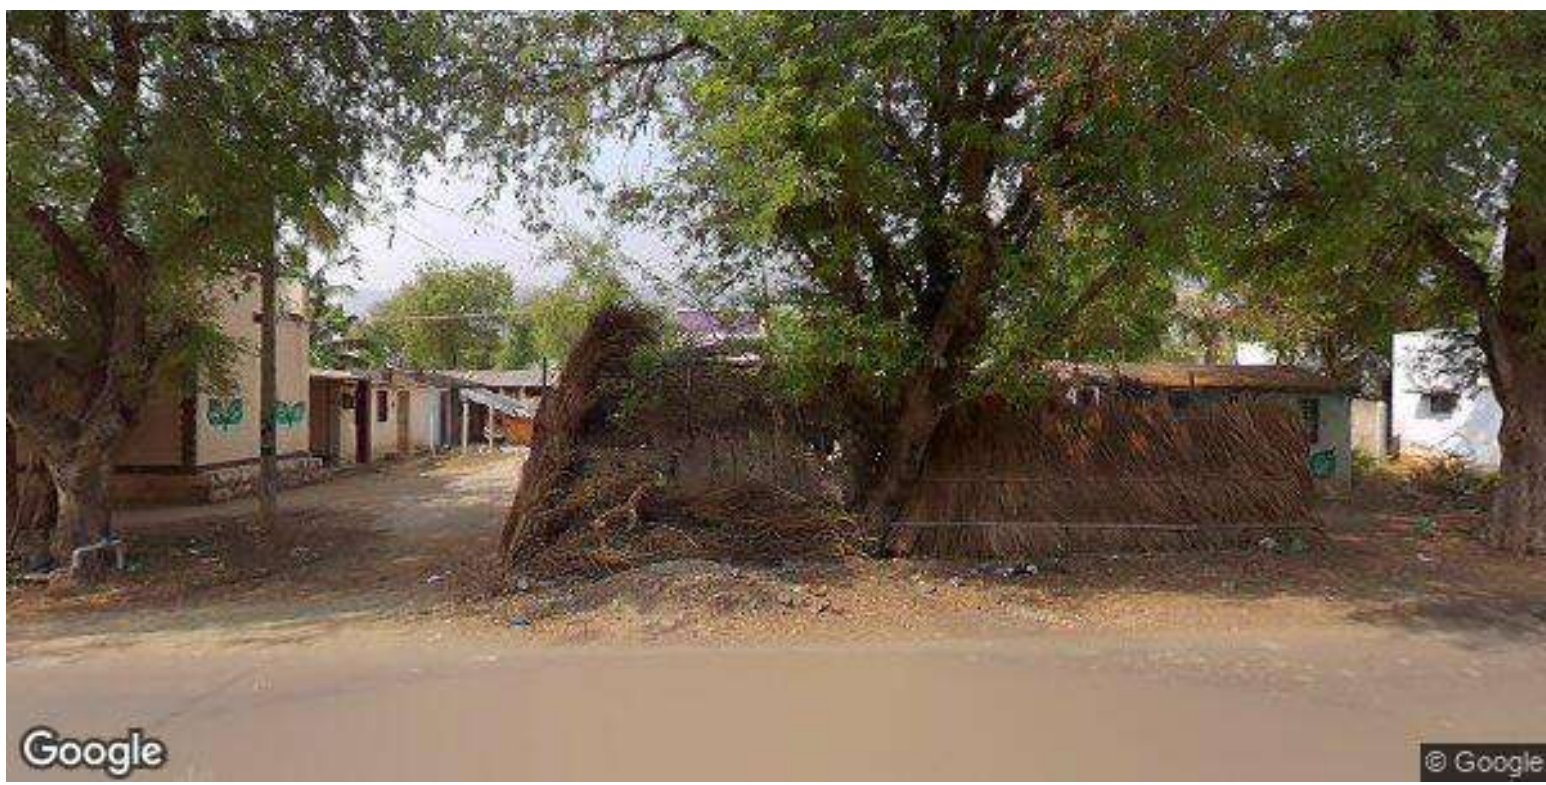
**Risk Type:** Blind Spot

**Risk Level:** Blind Spot

**Speed Limit:** 10 KM/Hr

**Coordinates:** 11.03014, 78.33509
