# IndianOil

## JOURNEY RISK MANAGEMENT (JRM) STUDY

### Salem Terminal to NPS PETROLEUMS

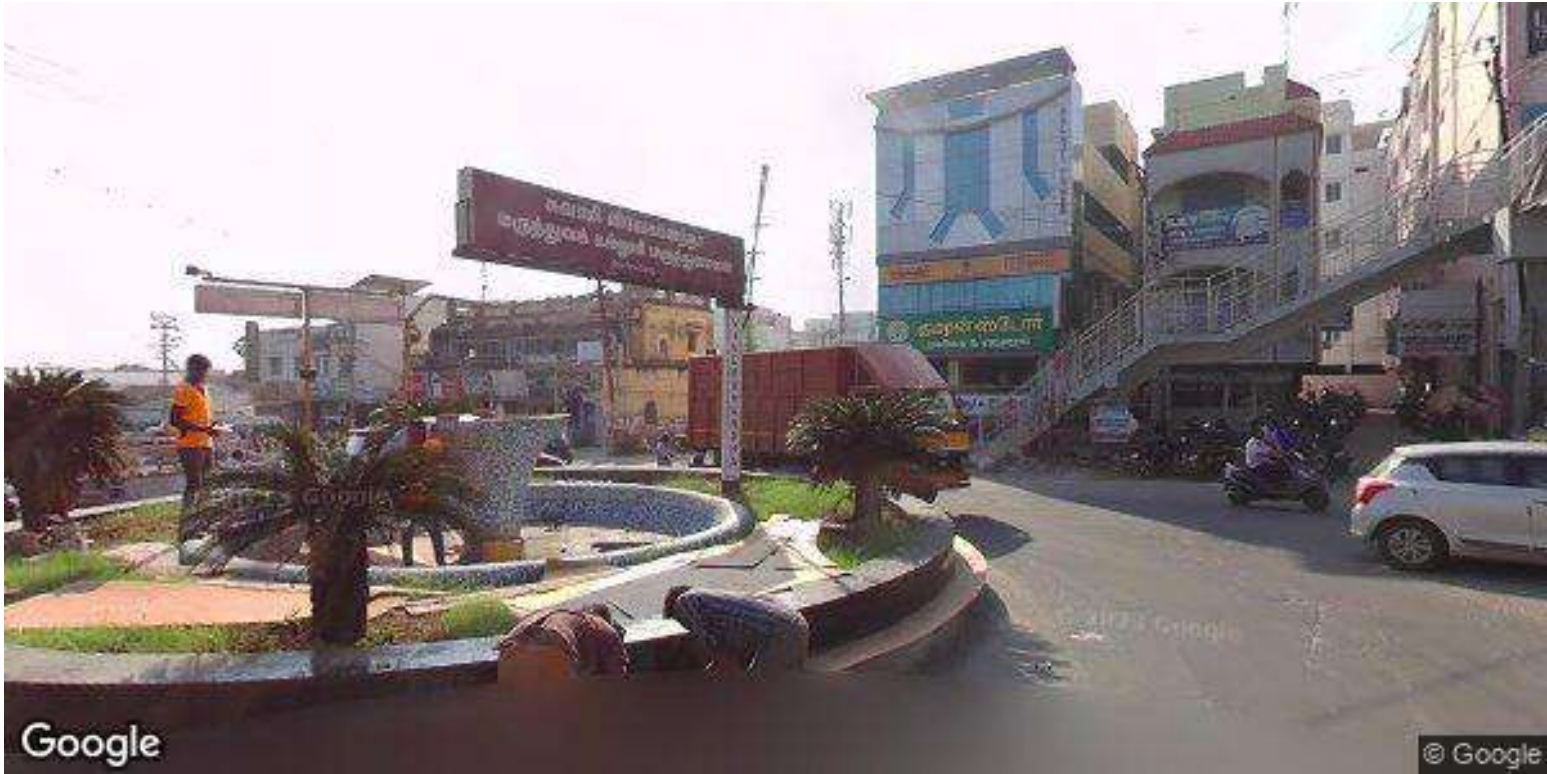
**Coordinates: 11.38395, 77.89480**

**Risk Type: Roundabout**

**Risk Level: High**

**Speed Limit: 15 KM/Hr**

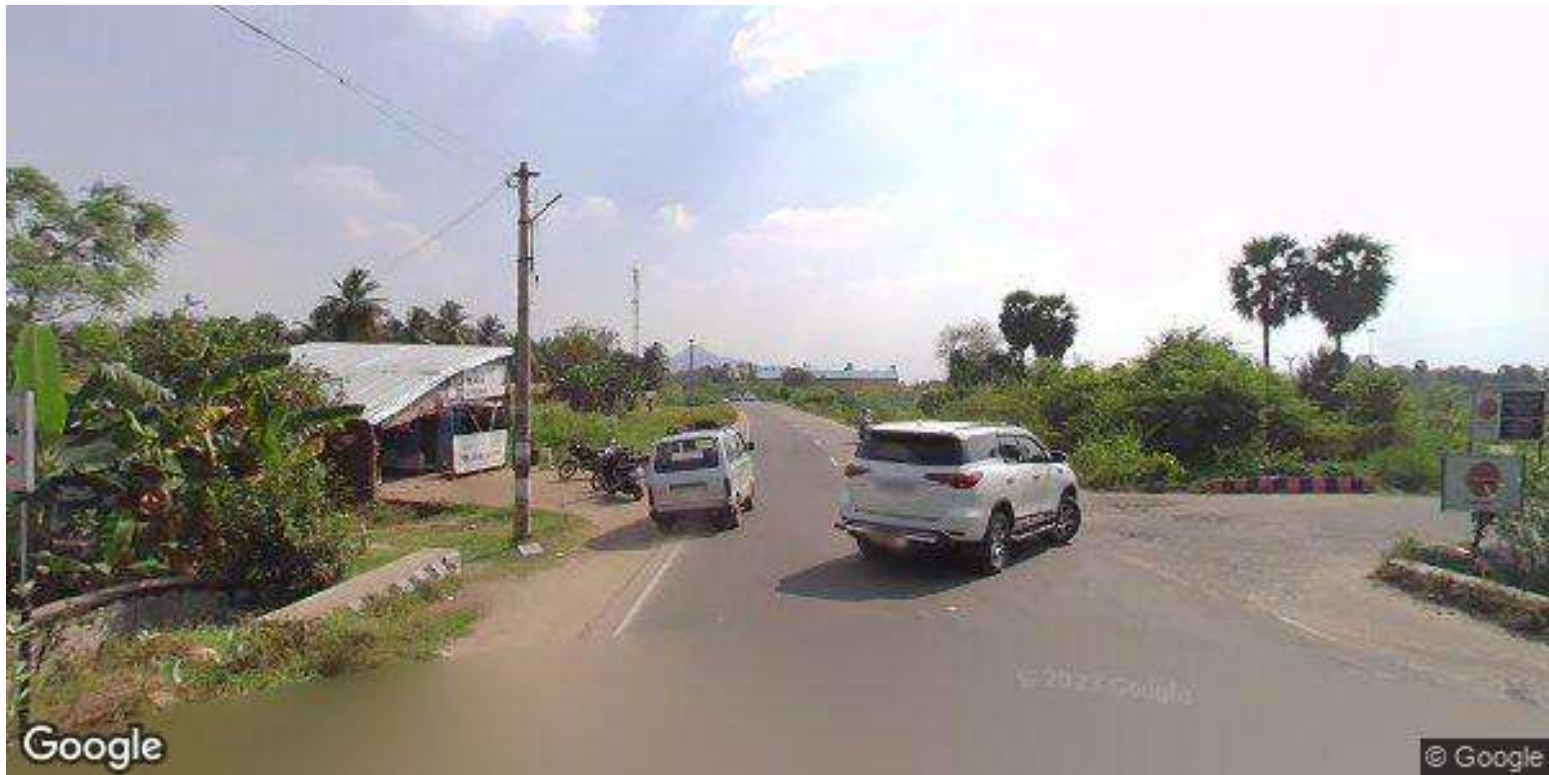
**Coordinates: 11.44029, 77.87544**

**Risk Type: Blind Spot**

**Risk Level: Blind Spot**

**Speed Limit: 10 KM/Hr**

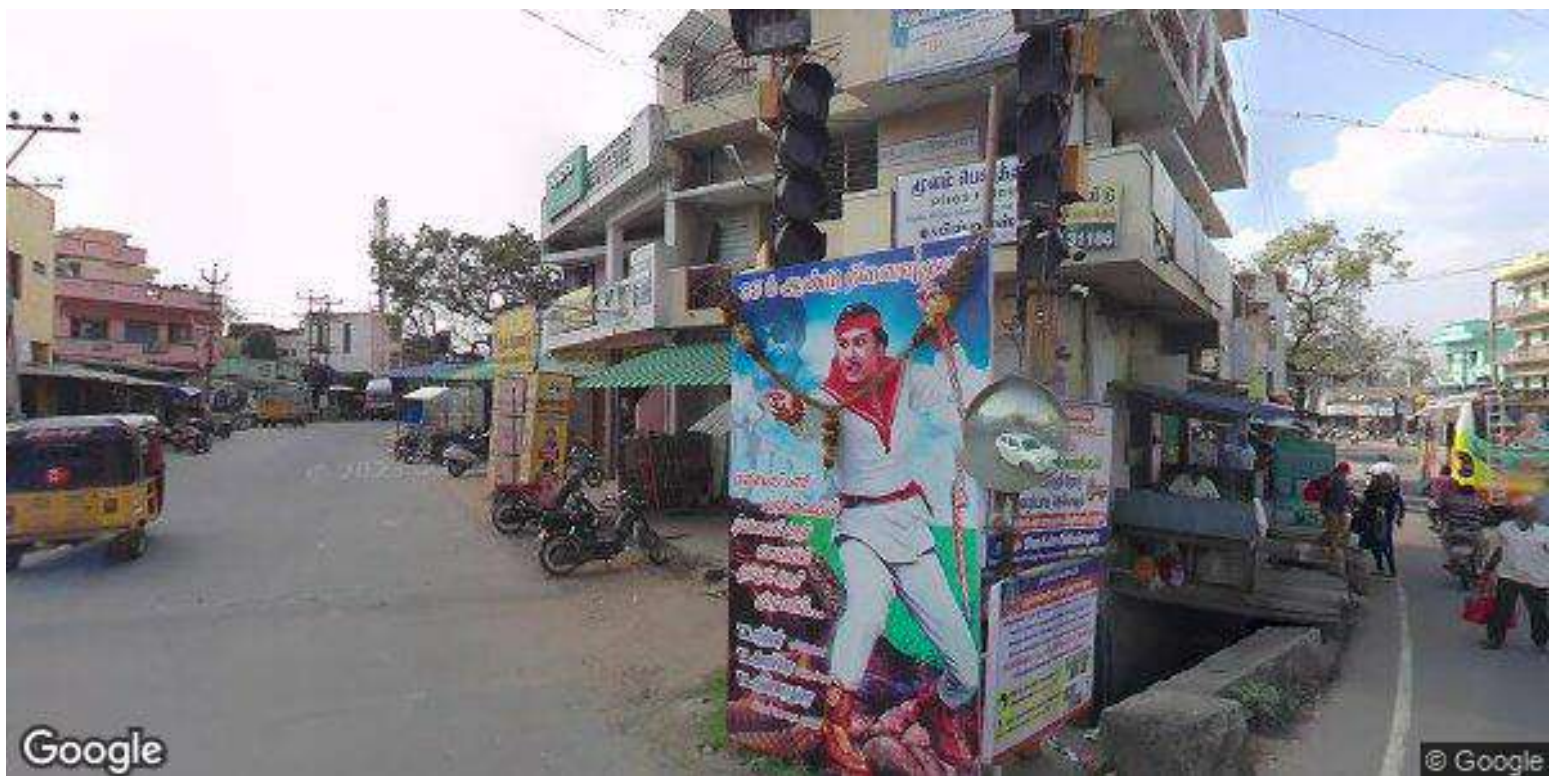
**Coordinates: 11.38342, 77.89975**

**Risk Type: Turn**

**Risk Level: Medium**

**Speed Limit: 30 KM/Hr**

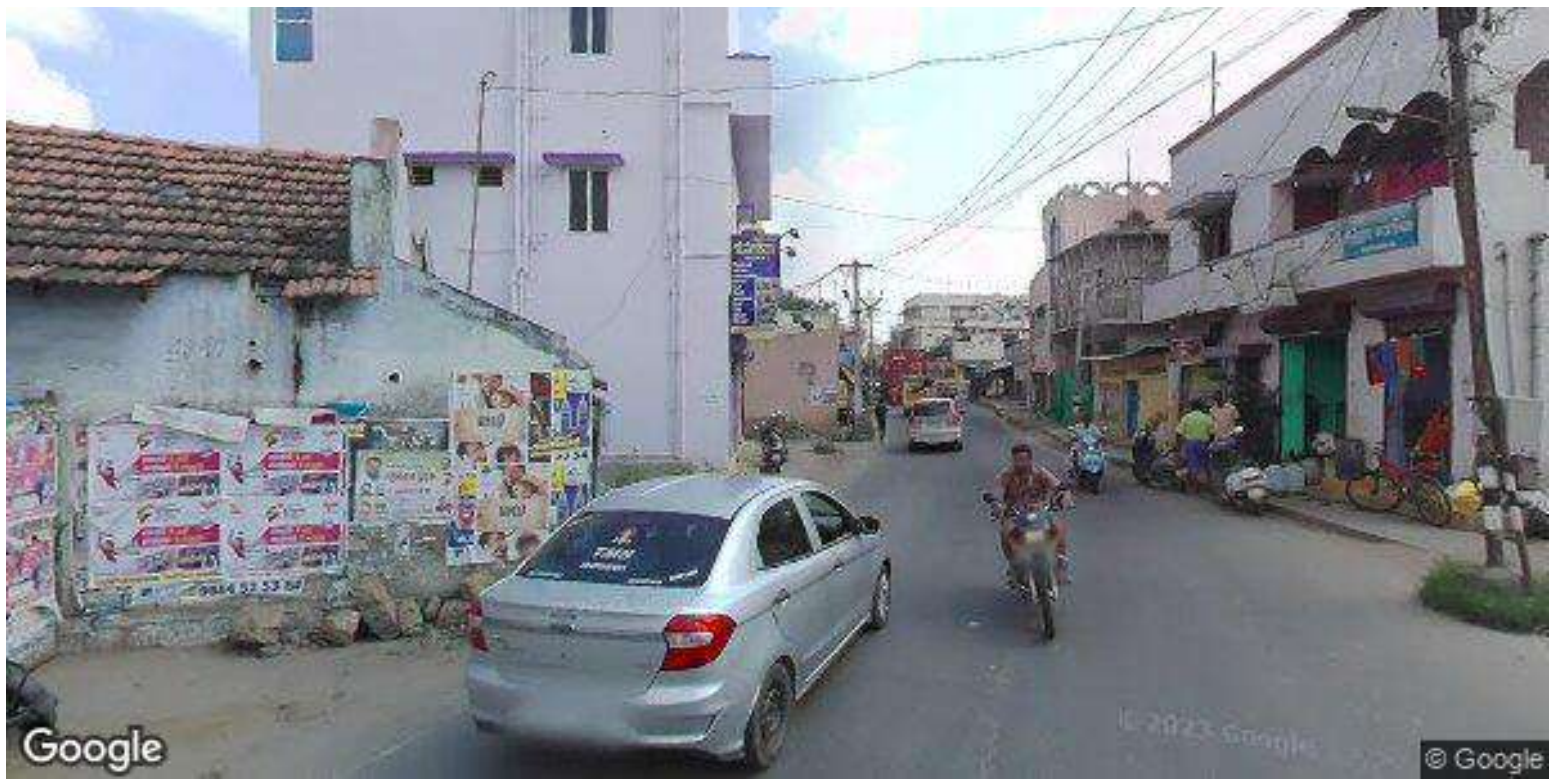
**Coordinates:** 11.38295, 77.90001

**Risk Type:** Turn

**Risk Level:** Medium

**Speed Limit:** 30 KM/Hr

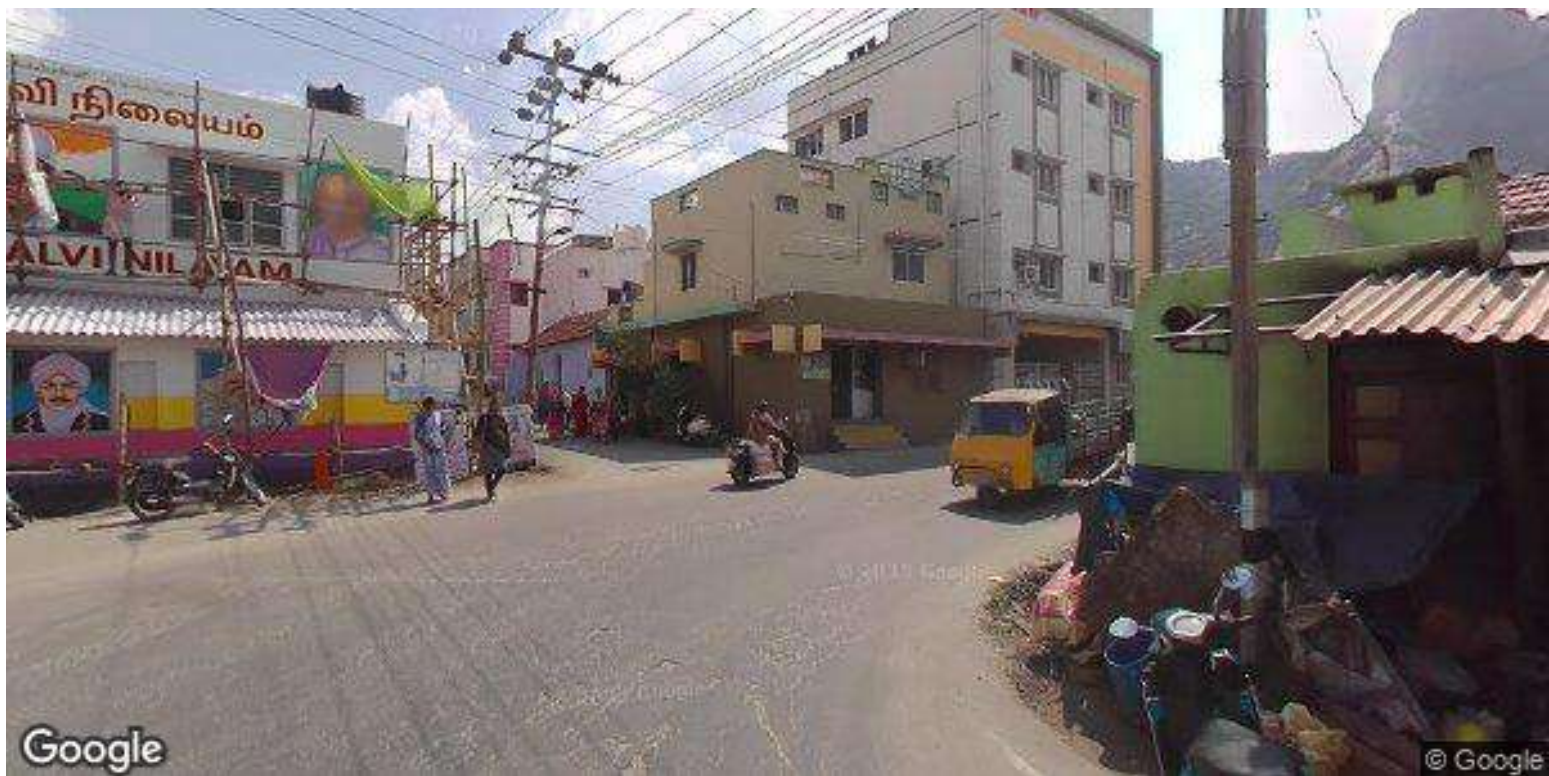
**Coordinates:** 11.38186, 77.90258

**Risk Type:** Turn

**Risk Level:** High

**Speed Limit:** 15 KM/Hr

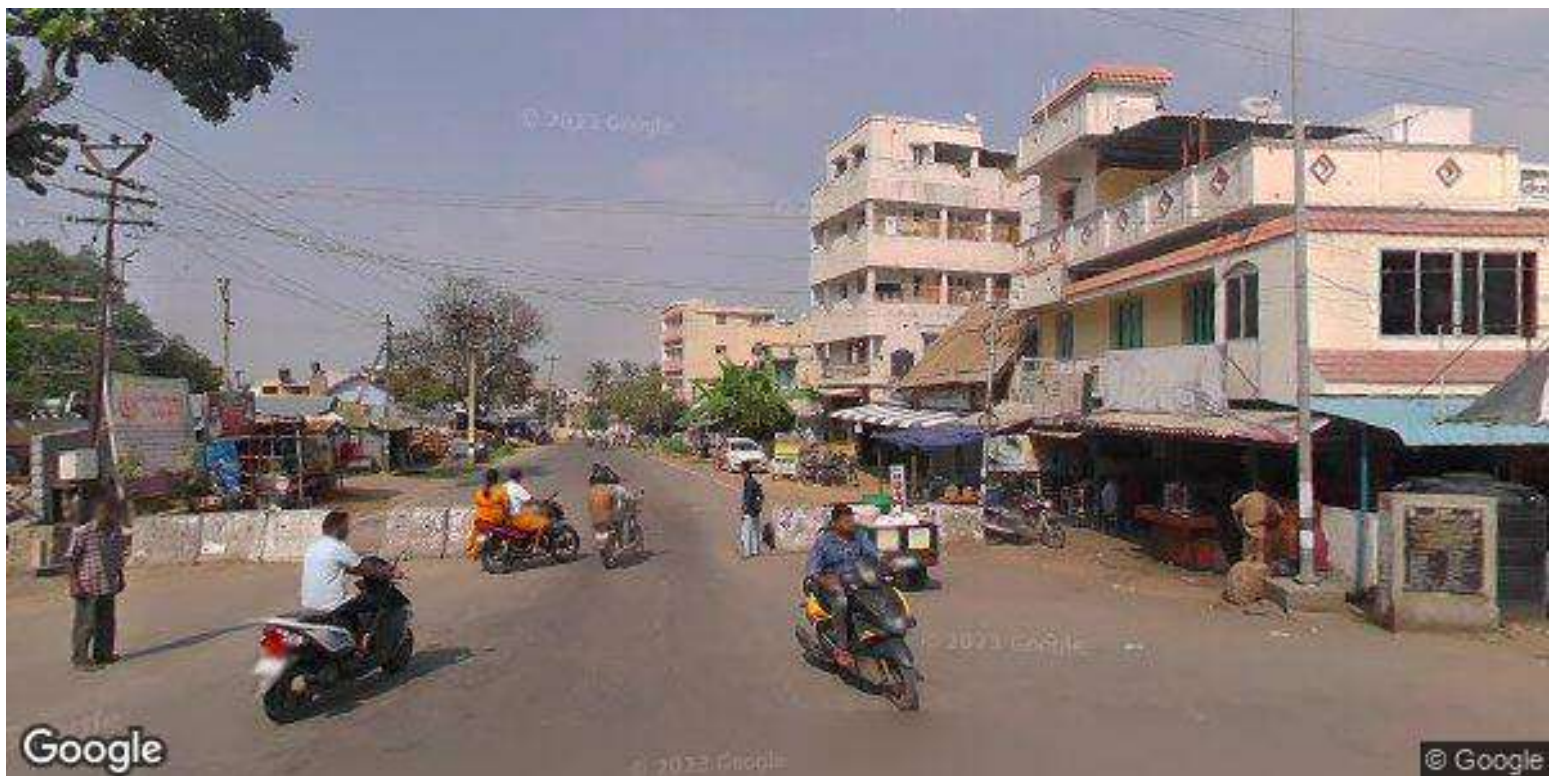
**Risk Type:** Blind Spot  
**Risk Level:** Blind Spot  
**Speed Limit:** 10 KM/Hr  
**Coordinates:** 11.37841, 77.90140

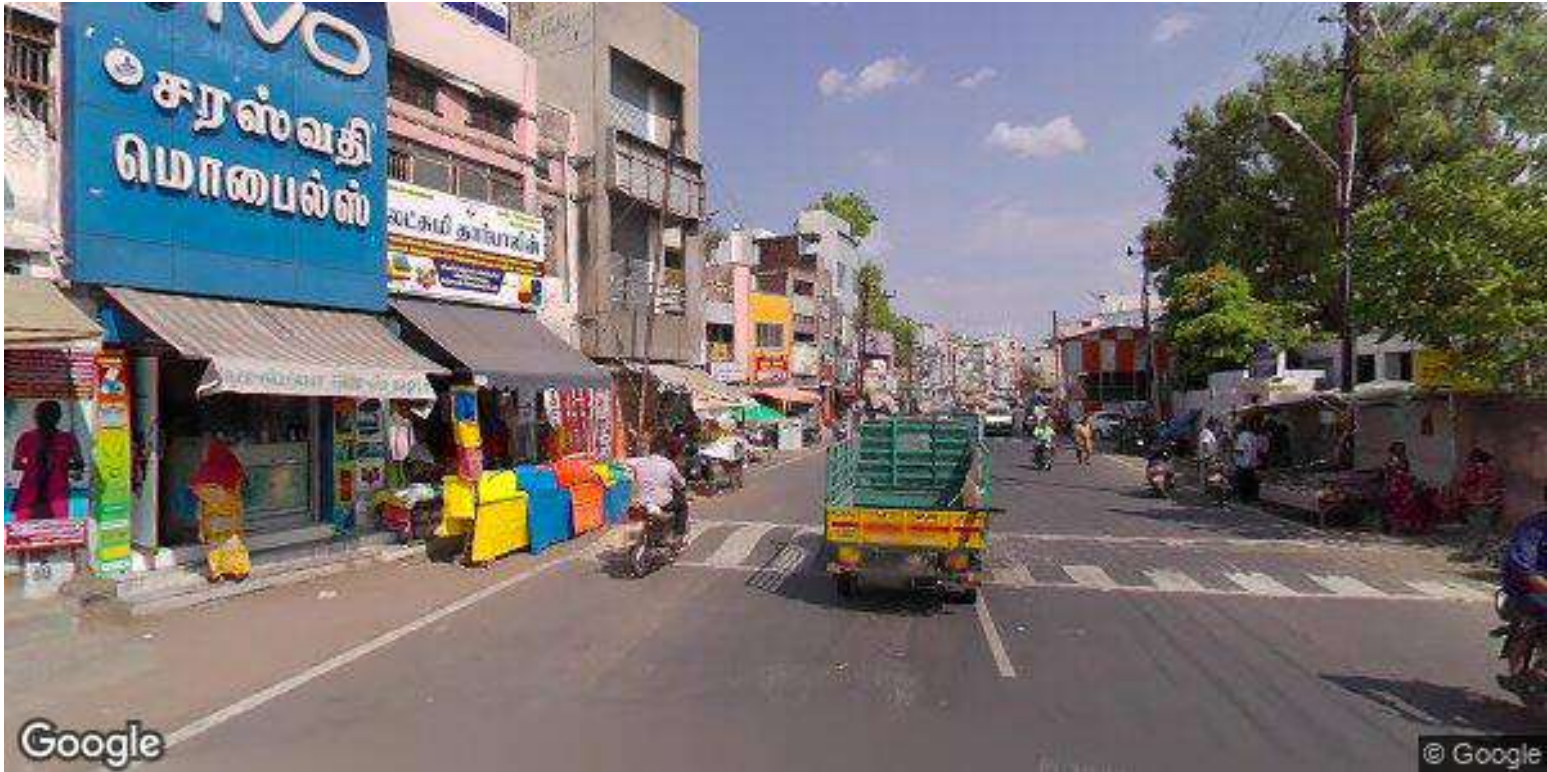
**Risk Type:** Turn  
**Risk Level:** Medium  
**Speed Limit:** 30 KM/Hr  
**Coordinates:** 11.22407, 78.16640

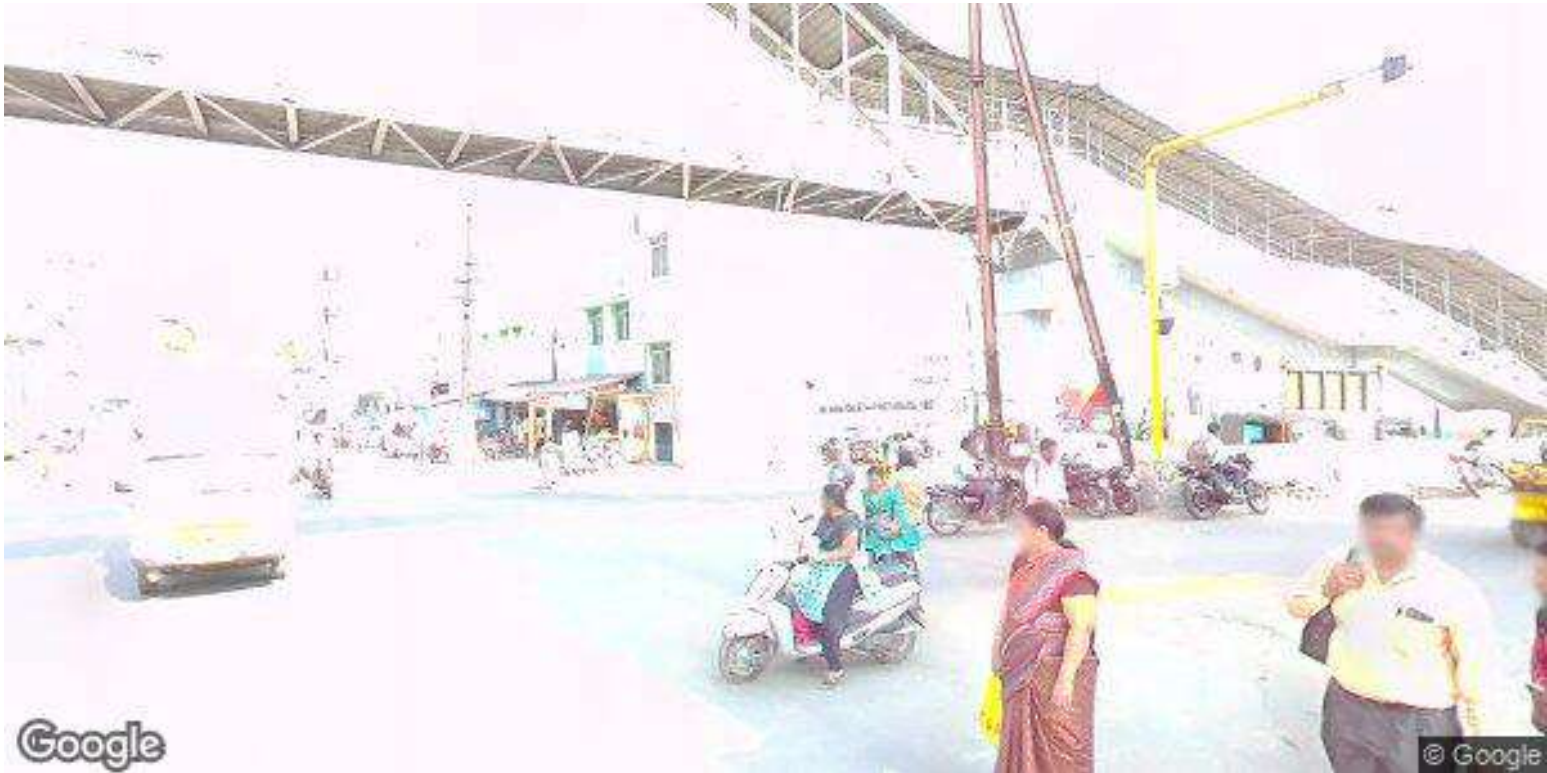
**Risk Type:** Blind Spot  
**Risk Level:** Blind Spot  
**Speed Limit:** 10 KM/Hr  
**Coordinates:** 11.21912, 78.16824

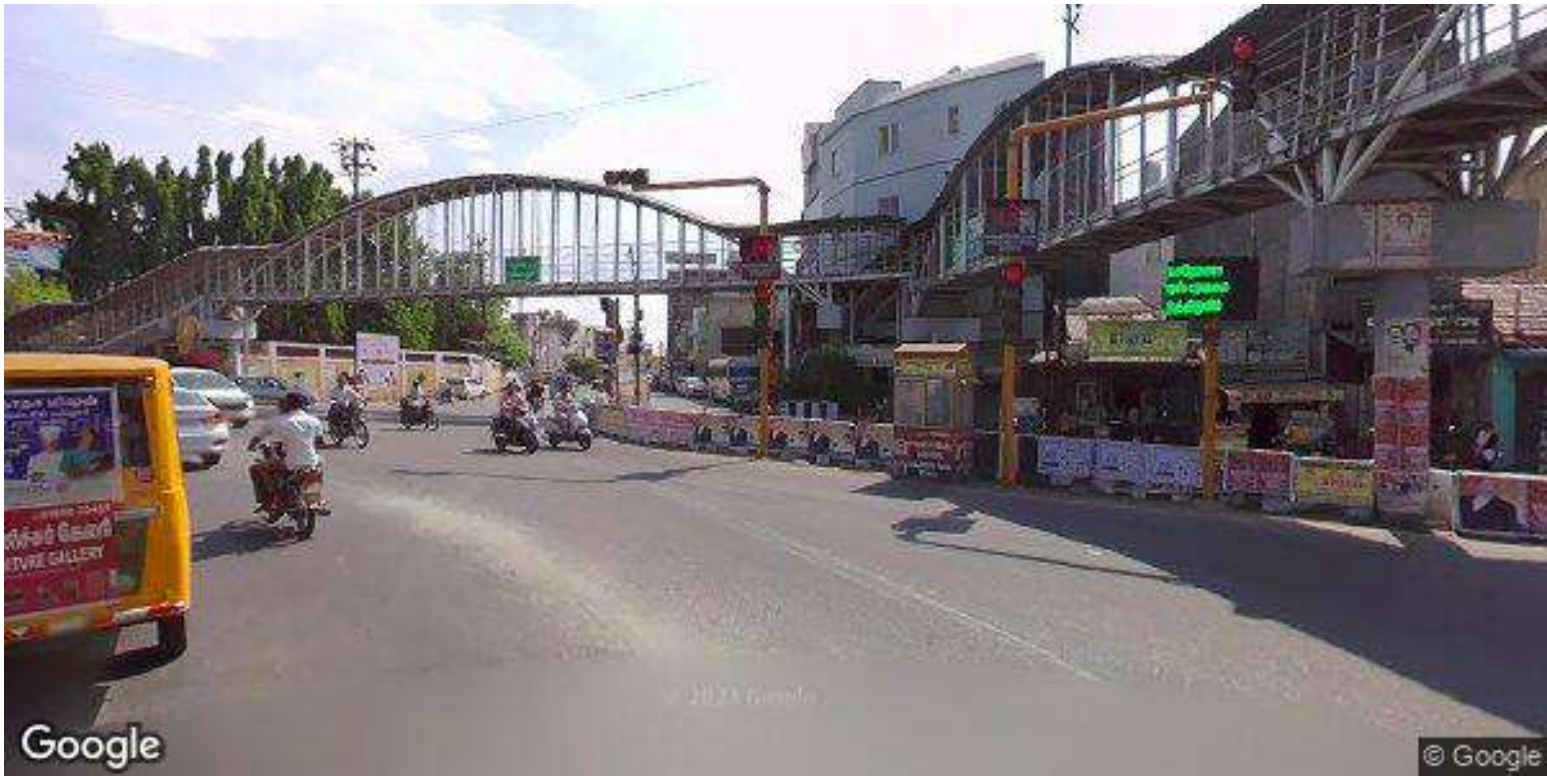
**Risk Type:** Turn  
**Risk Level:** Medium  
**Speed Limit:** 30 KM/Hr  
**Coordinates:** 11.21889, 78.16777

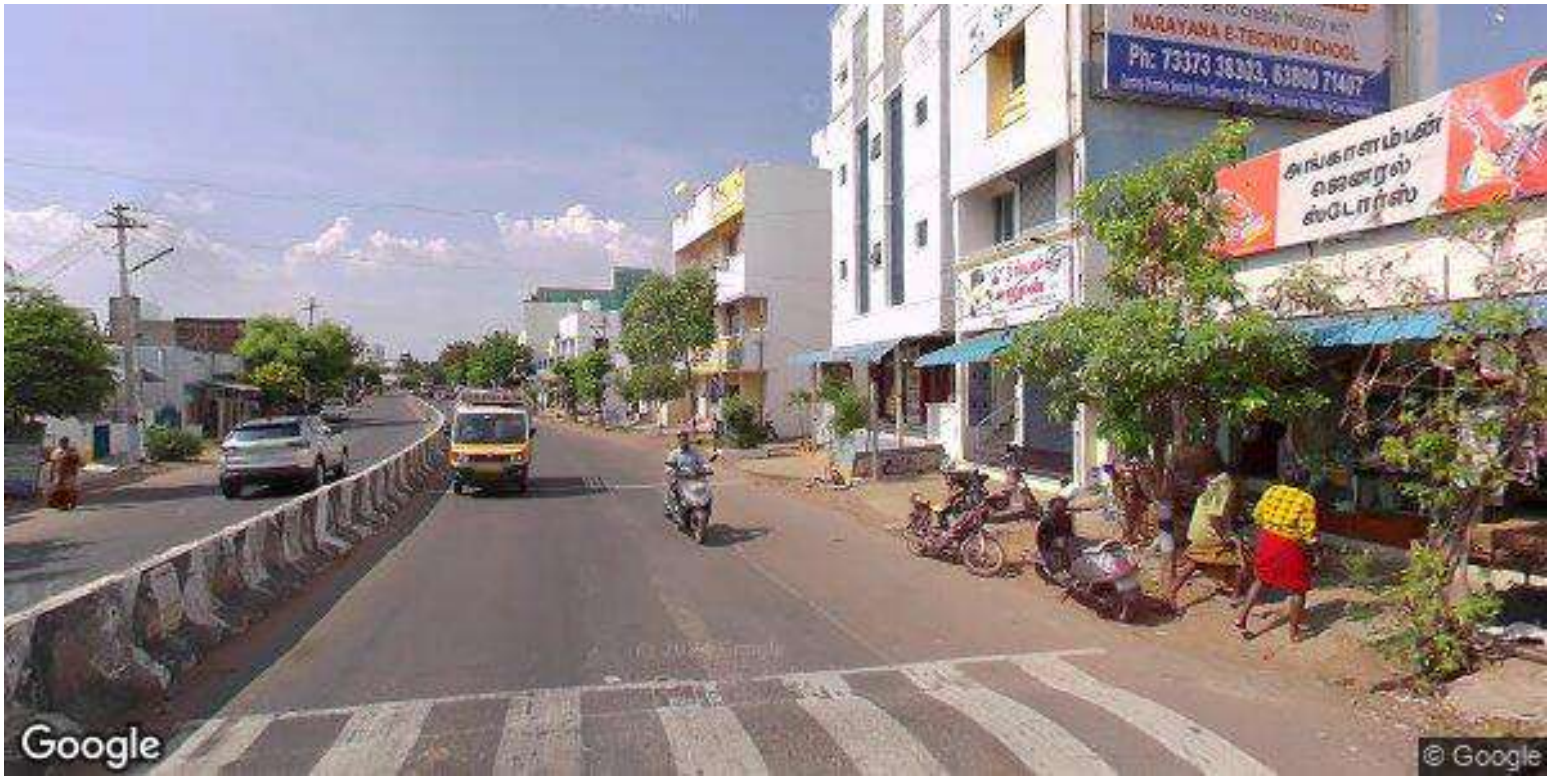
**Risk Type:** Turn  
**Risk Level:** Medium  
**Speed Limit:** 30 KM/Hr  
**Coordinates:** 11.20117, 78.16779

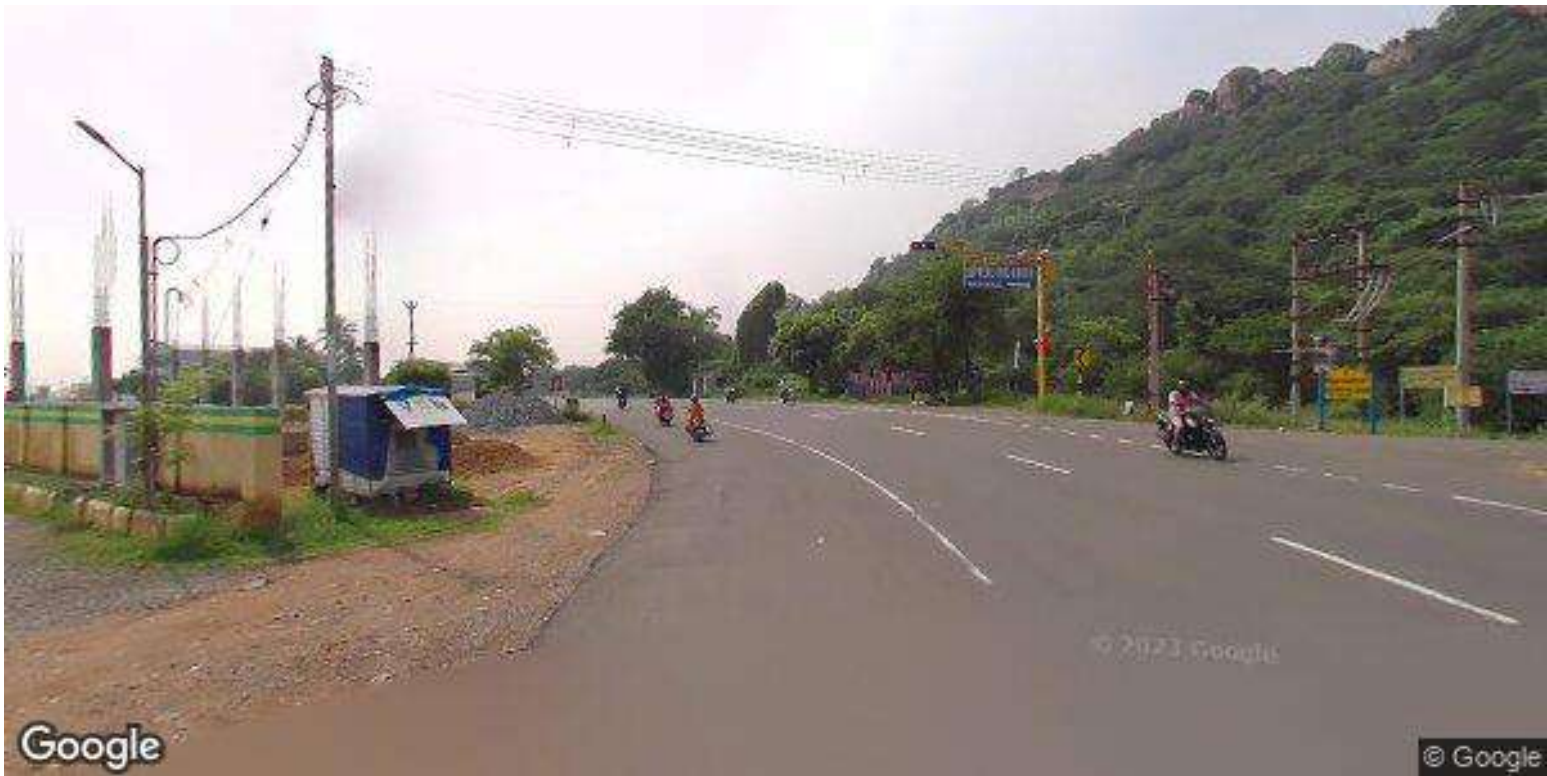
**Coordinates:** 11.19145, 78.16640

**Risk Type:** Turn

**Risk Level:** Medium

**Speed Limit:** 30 KM/Hr
