# IndianOil

## JOURNEY RISK MANAGEMENT (JRM) STUDY

### Salem Terminal TO KPS AGENCY

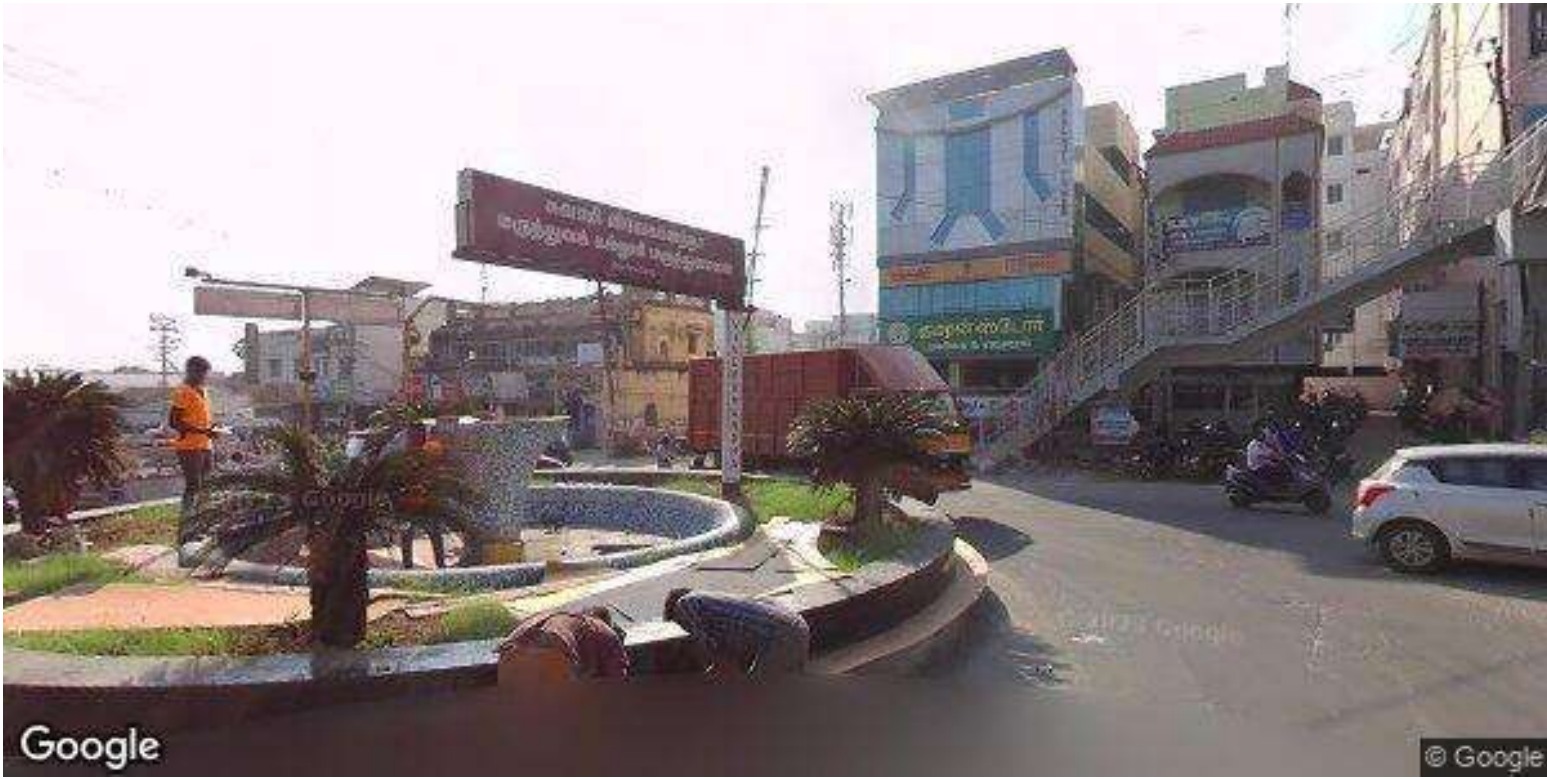
**Risk Type:** Roundabout  
**Risk Level:** High  
**Speed Limit:** 15 KM/Hr  
**Coordinates:** 11.38395, 77.89480

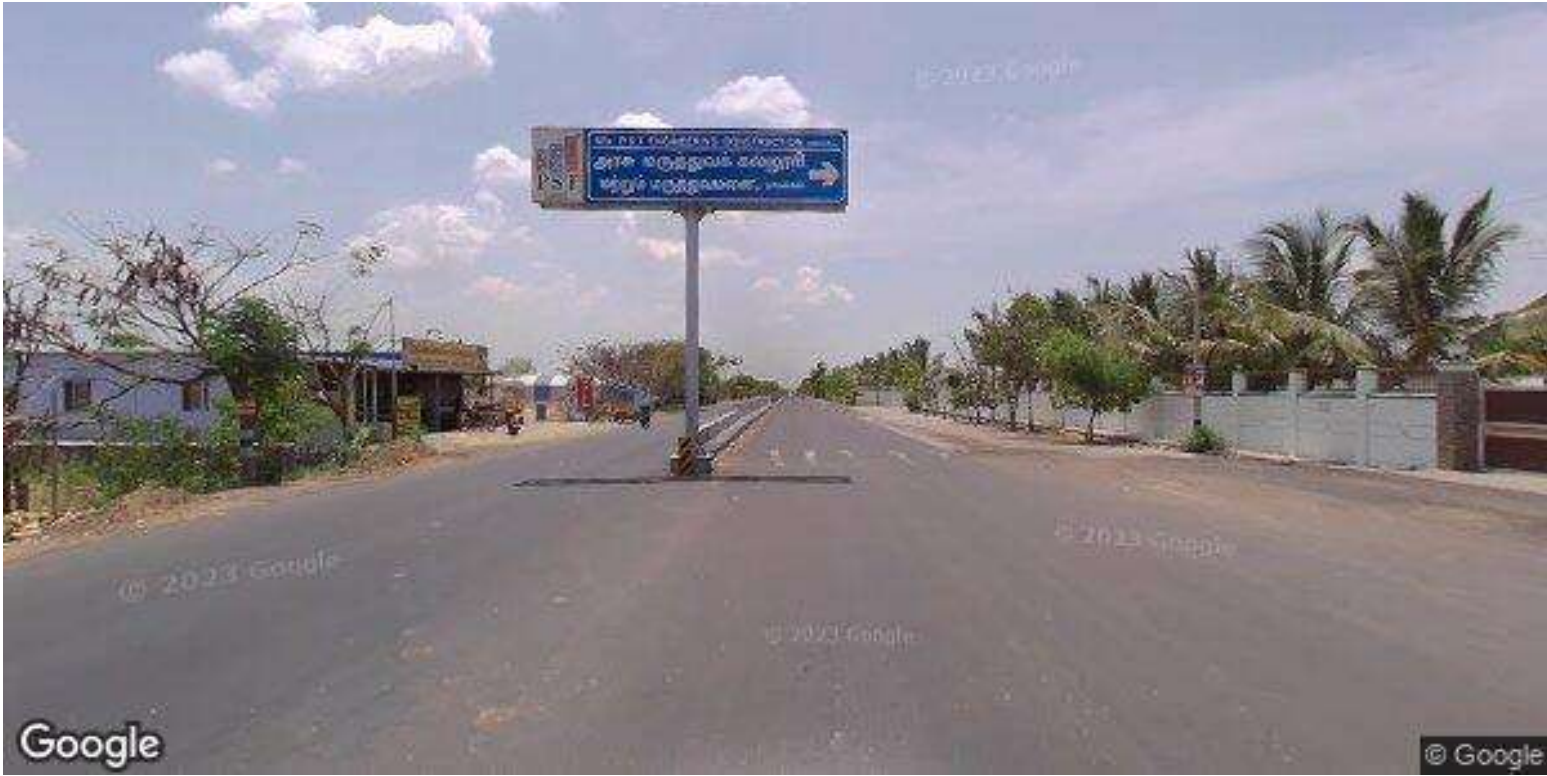
**Risk Type:** U-Turn  
**Risk Level:** High  
**Speed Limit:** 10 KM/Hr  
**Coordinates:** 11.2490908, 78.12459989999999

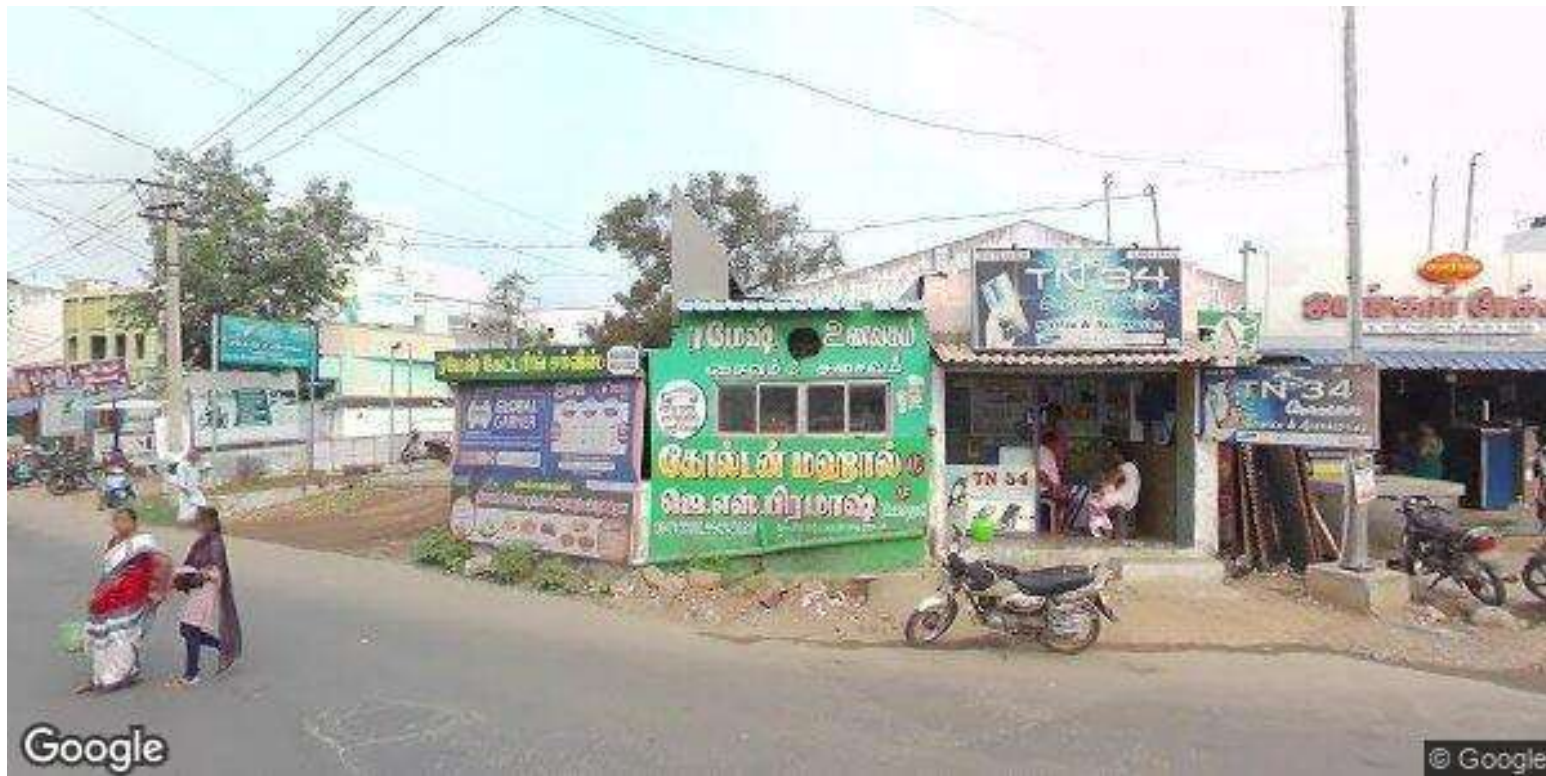
**Risk Type:** Turn

**Risk Level:** High

**Speed Limit:** 15 KM/Hr

**Coordinates:** 11.38346, 77.89975

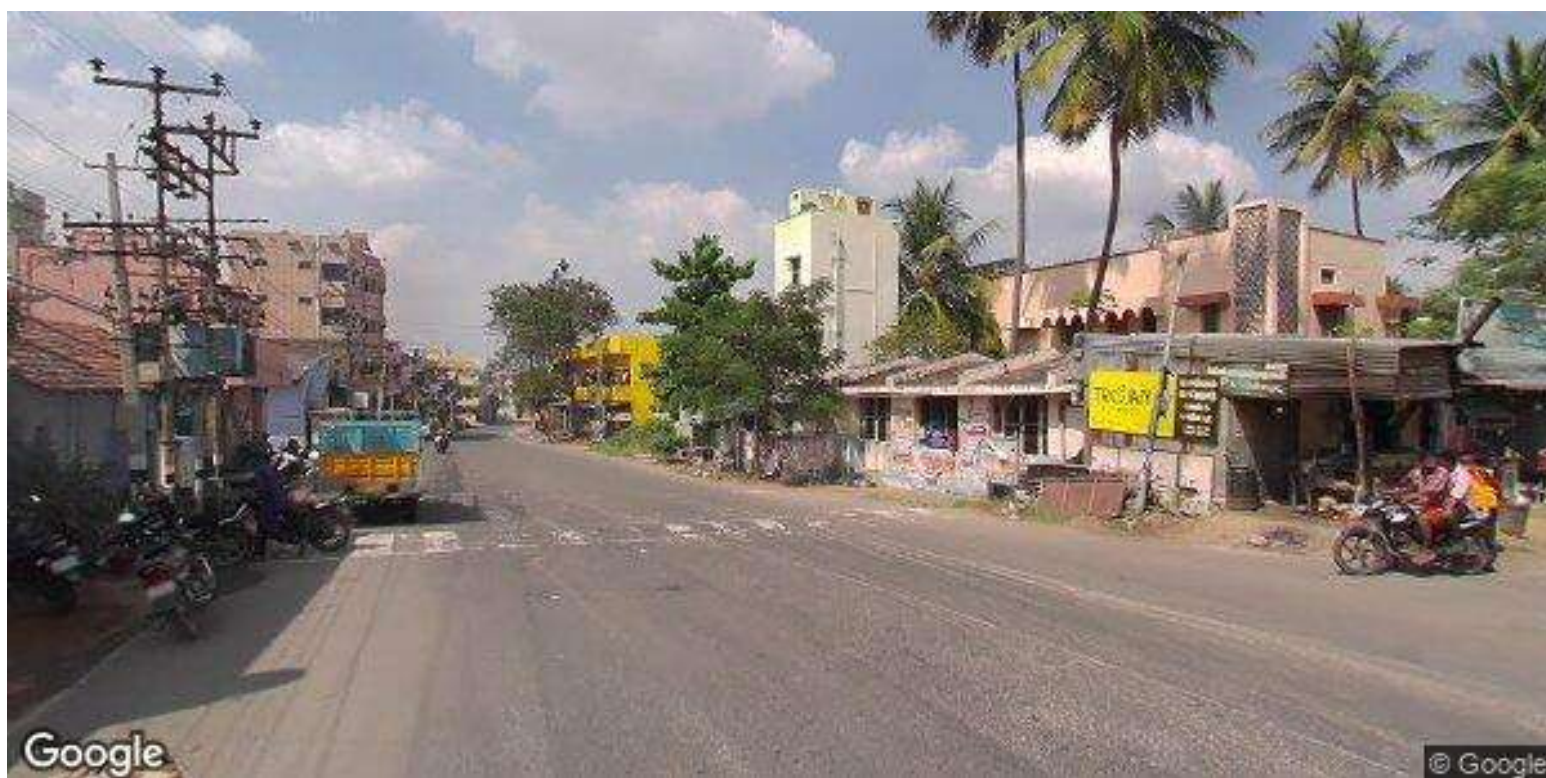
**Risk Type:** Turn

**Risk Level:** Medium

**Speed Limit:** 30 KM/Hr

**Coordinates:** 11.38190, 77.90254

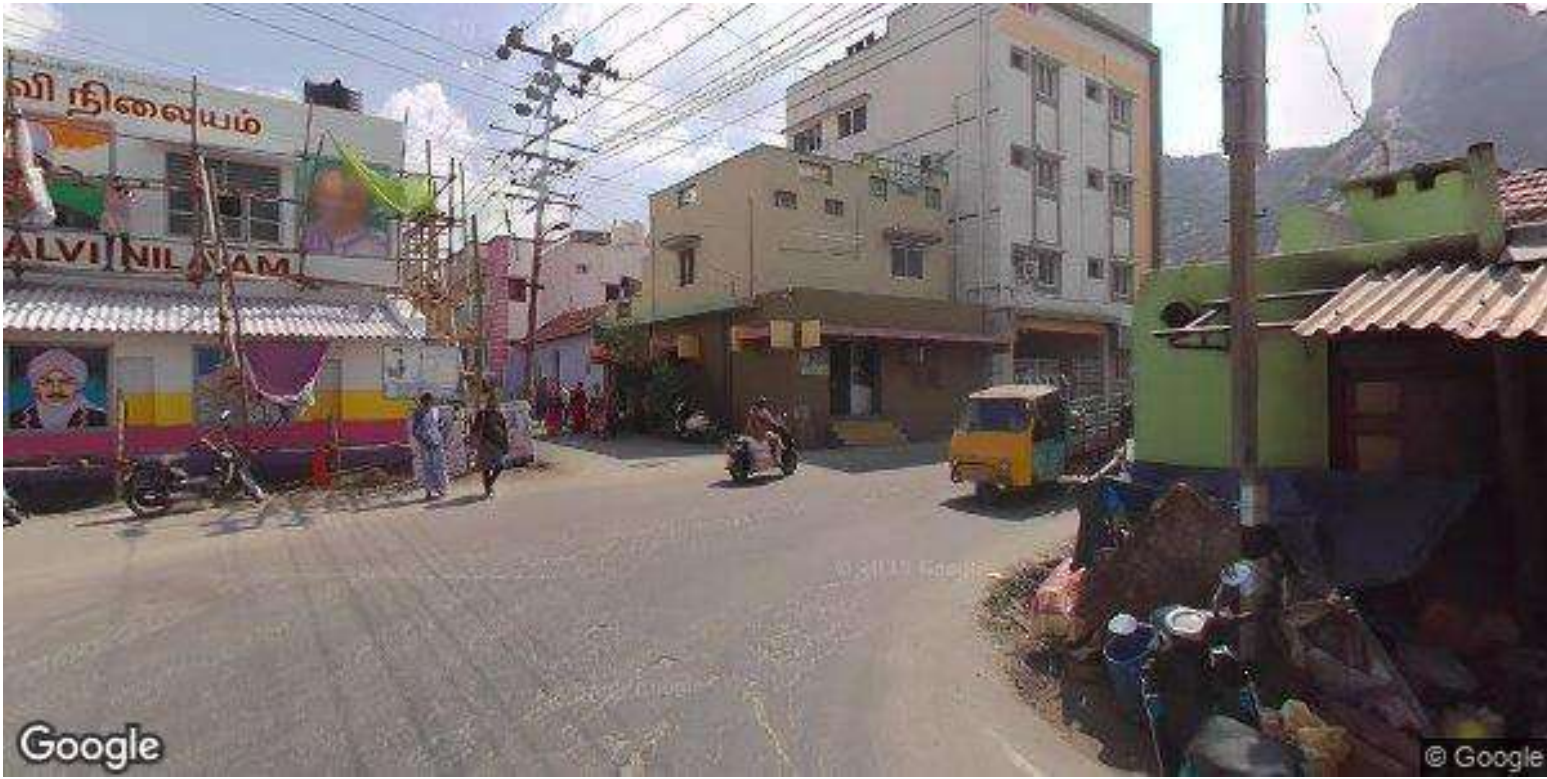
Risk Type: Turn  
Risk Level: High  
Speed Limit: 15 KM/Hr  
Coordinates: 11.38186, 77.90258

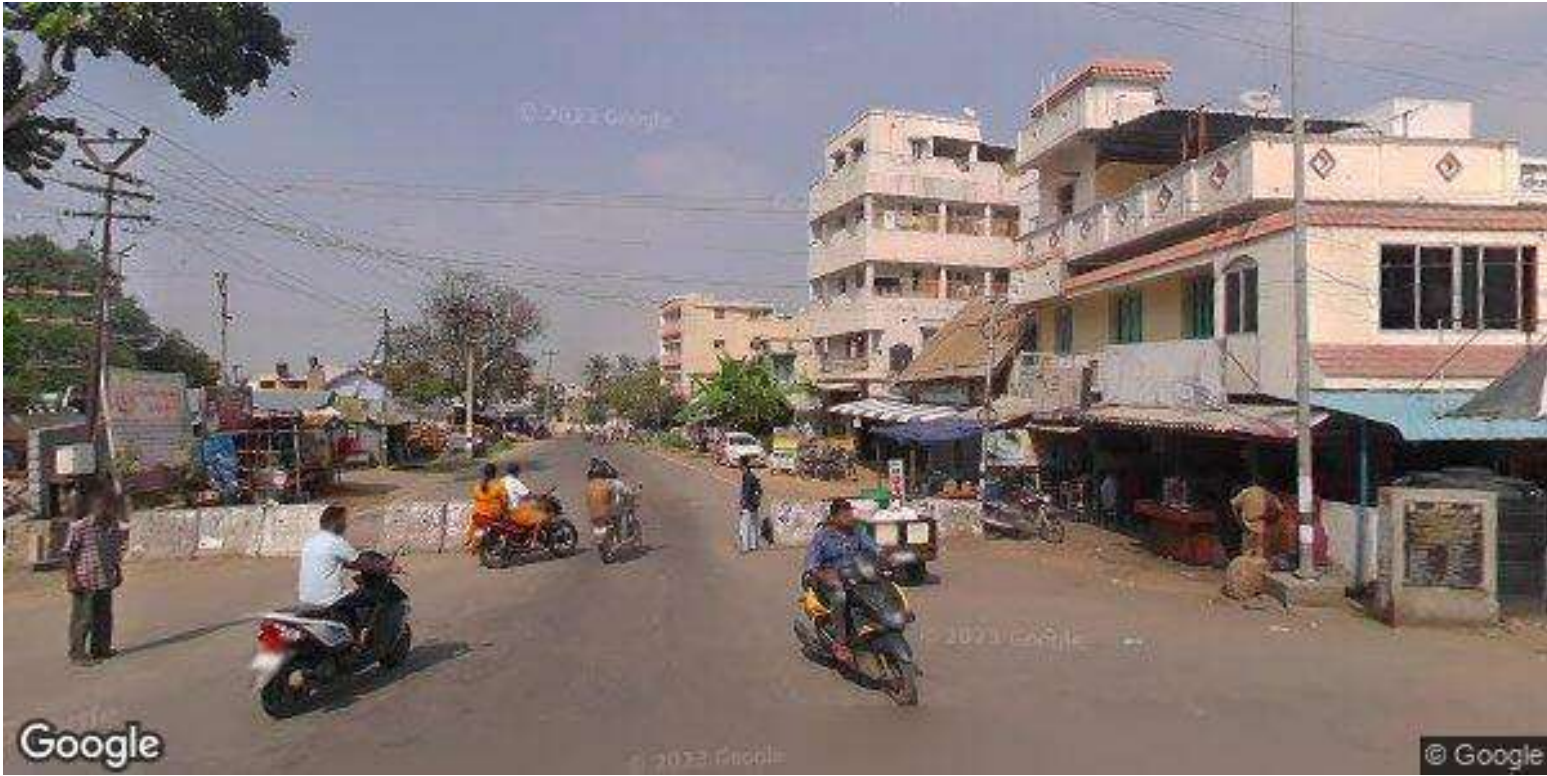
Risk Type: Blind Spot  
Risk Level: Blind Spot  
Speed Limit: 10 KM/Hr  
Coordinates: 11.37841, 77.90140

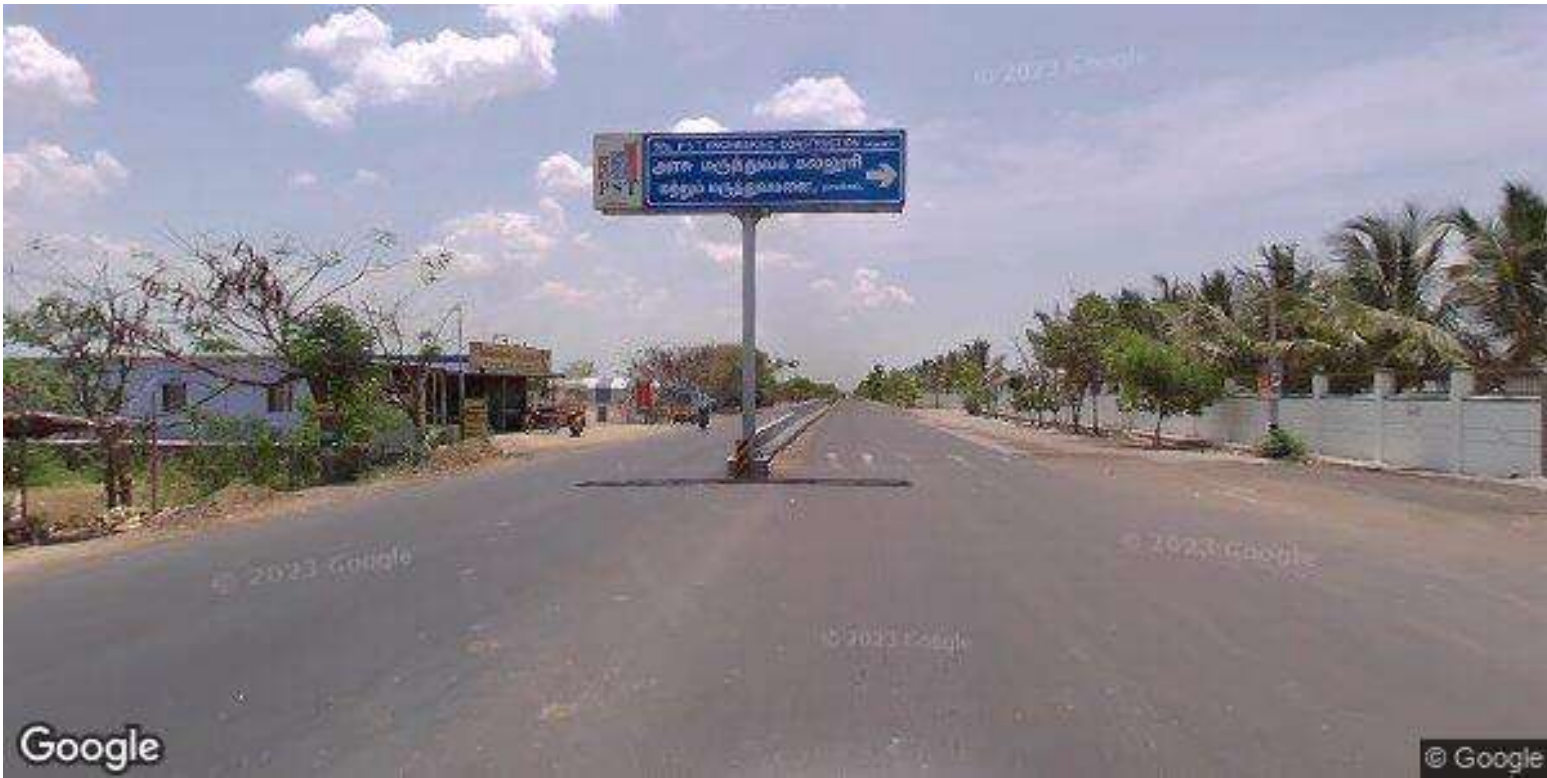
**Risk Type:** Blind Spot  
**Risk Level:** Blind Spot  
**Speed Limit:** 10 KM/Hr  
**Coordinates:** 11.24909, 78.12460

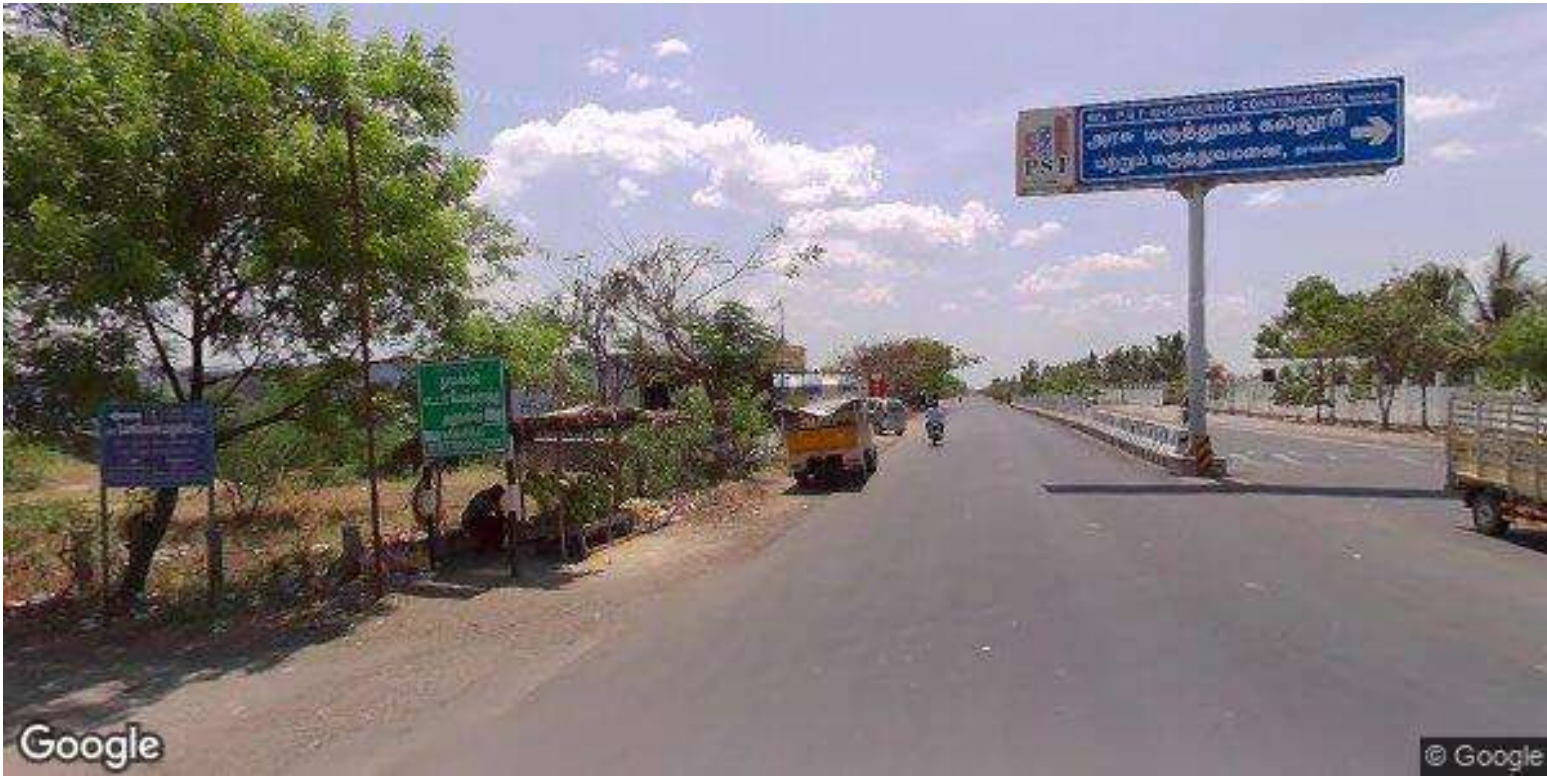
**Risk Type:** Turn  
**Risk Level:** High  
**Speed Limit:** 15 KM/Hr  
**Coordinates:** 11.24902, 78.12457
