## JOURNEY RISK MANAGEMENT (JRM) STUDY

### Salem Terminal TO TPT Fuel Services

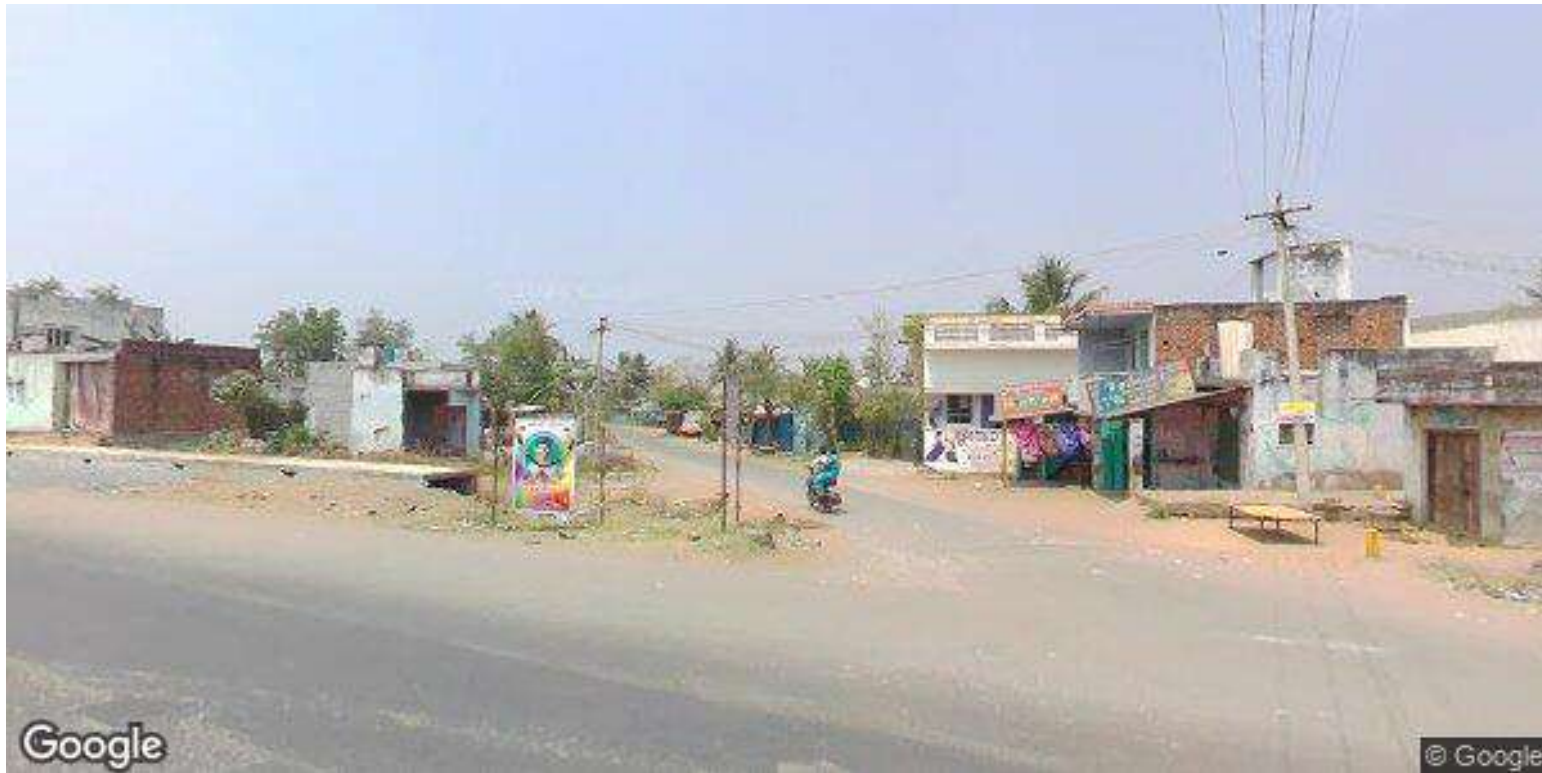
**Coordinates:** 11.6624013, 77.9603388

**Risk Type:** U-Turn

**Risk Level:** High

**Speed Limit:** 10 KM/Hr

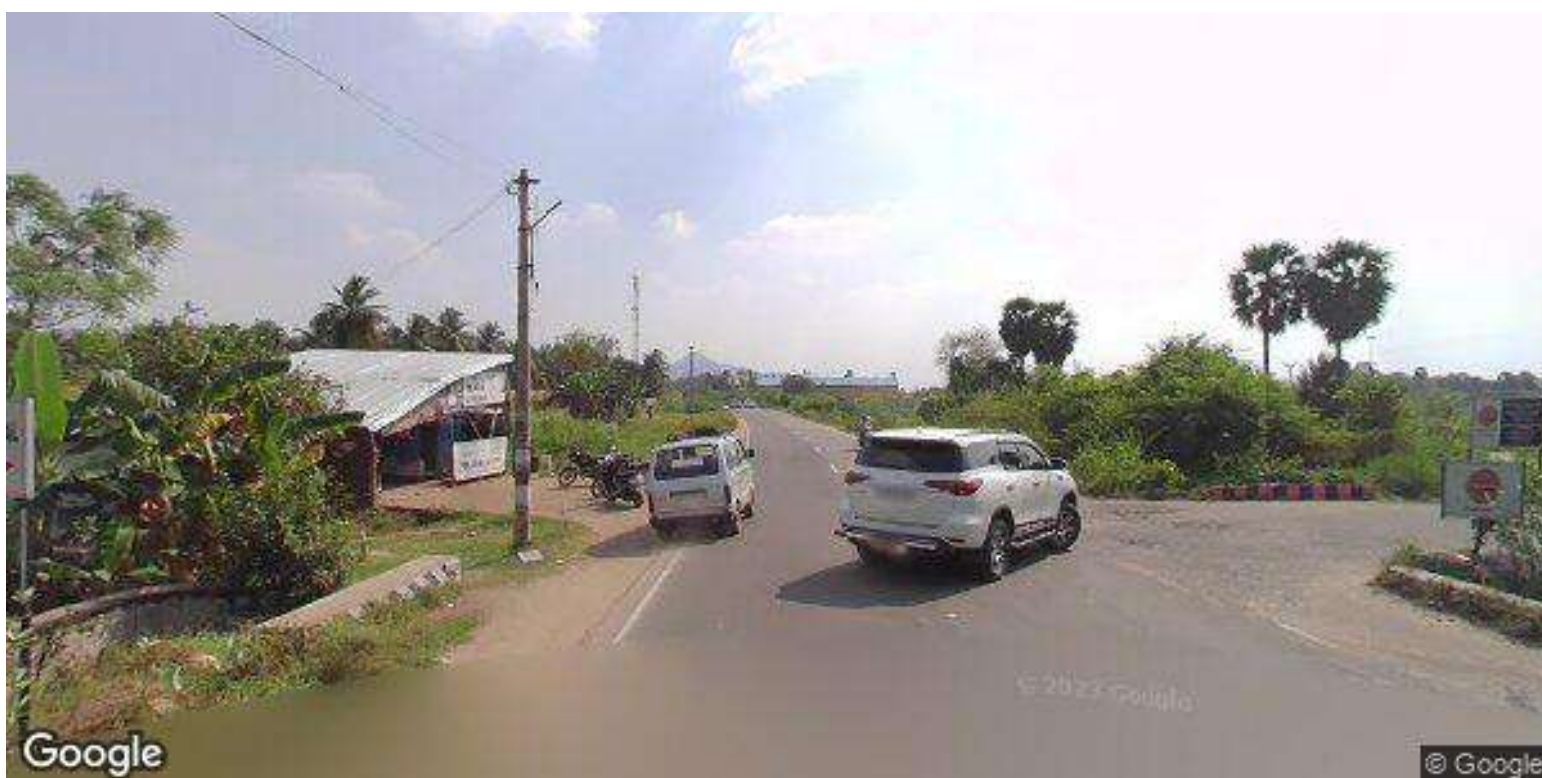
**Coordinates:** 11.44029, 77.87544

**Risk Type:** Turn

**Risk Level:** High

**Speed Limit:** 15 KM/Hr

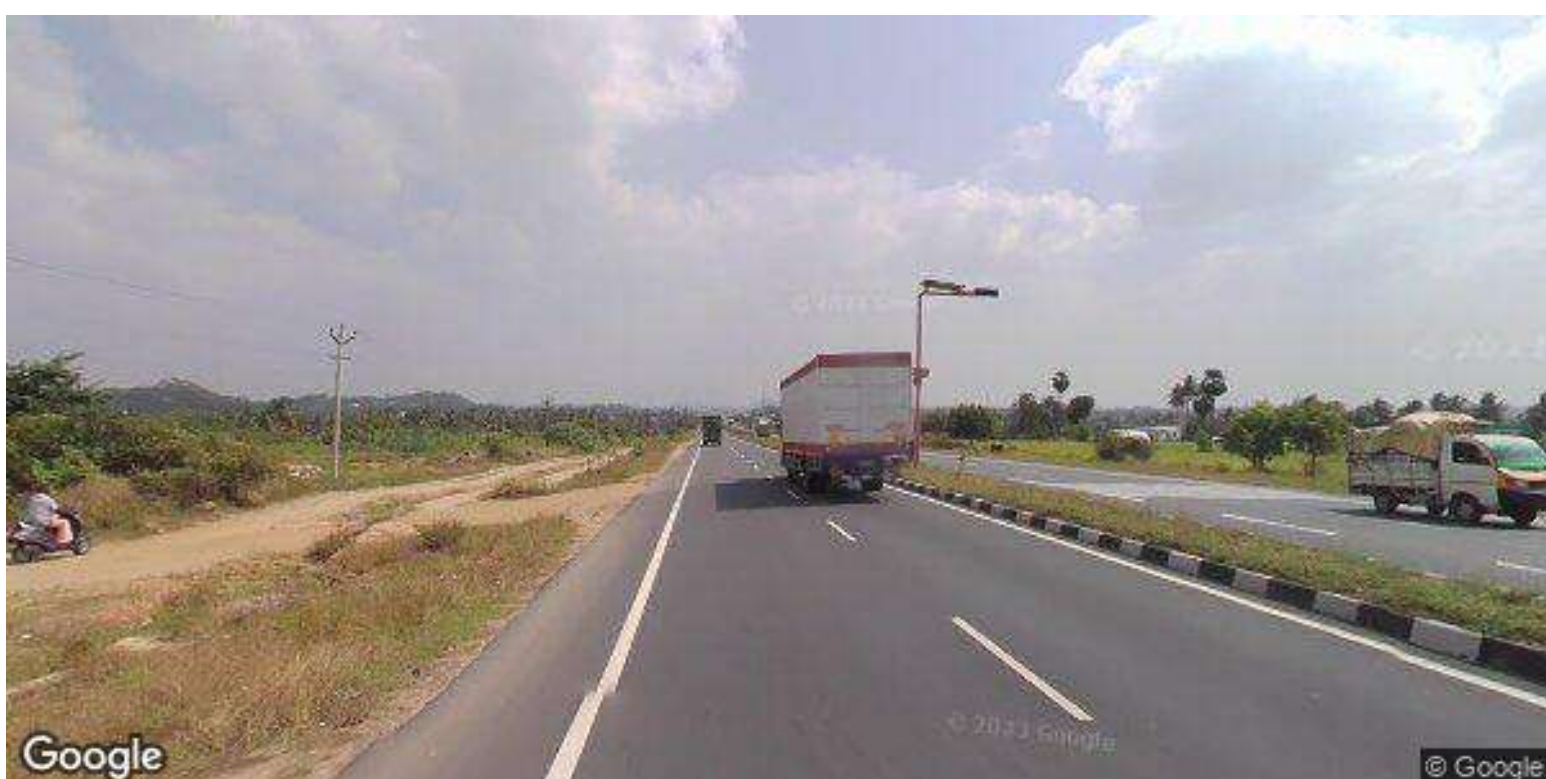
**Risk Type:** Turn  
**Risk Level:** High  
**Speed Limit:** 15 KM/Hr  
**Coordinates:** 11.49409, 77.88004

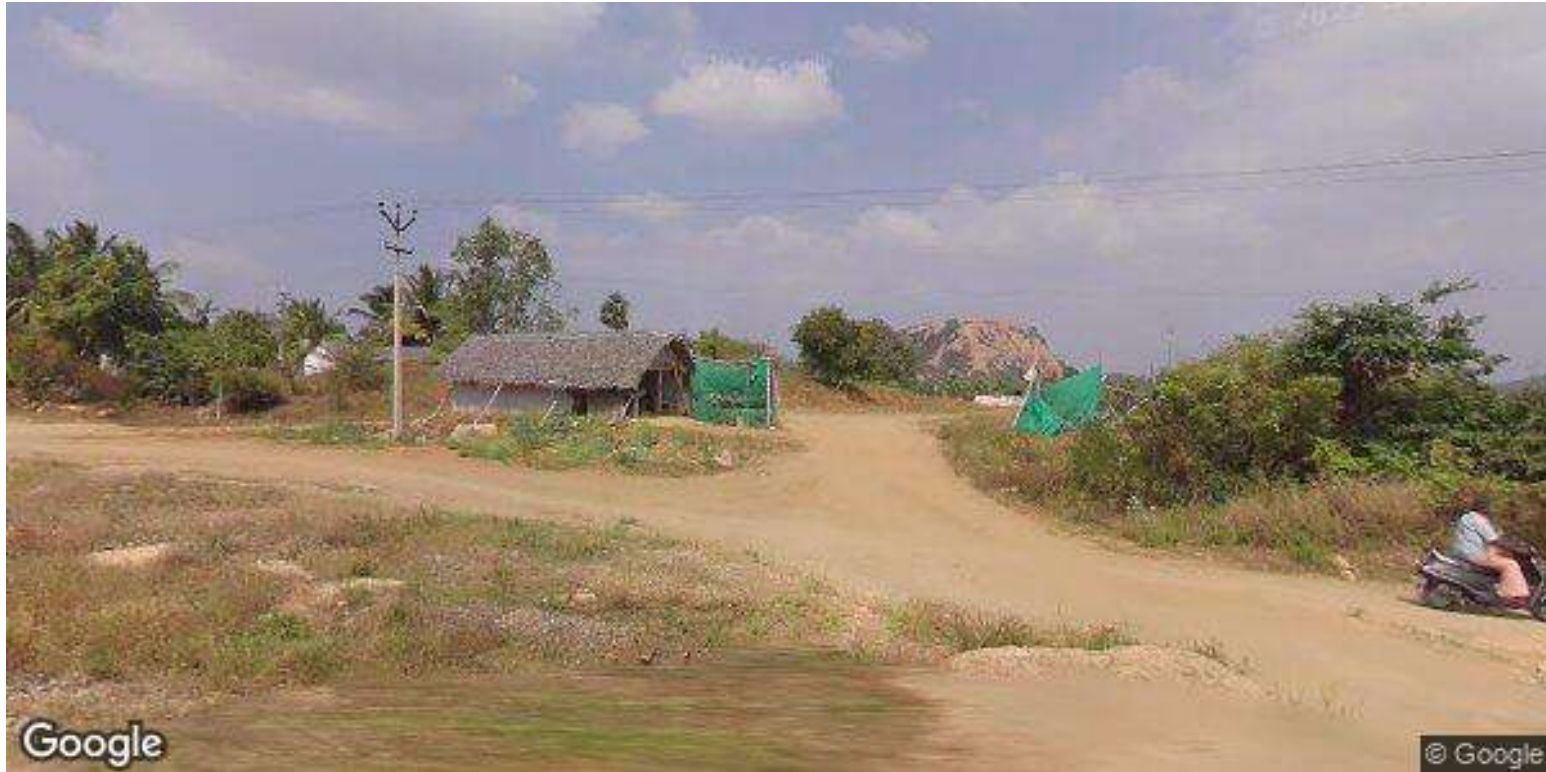
**Risk Type:** Turn  
**Risk Level:** Medium  
**Speed Limit:** 30 KM/Hr  
**Coordinates:** 11.49419, 77.88015

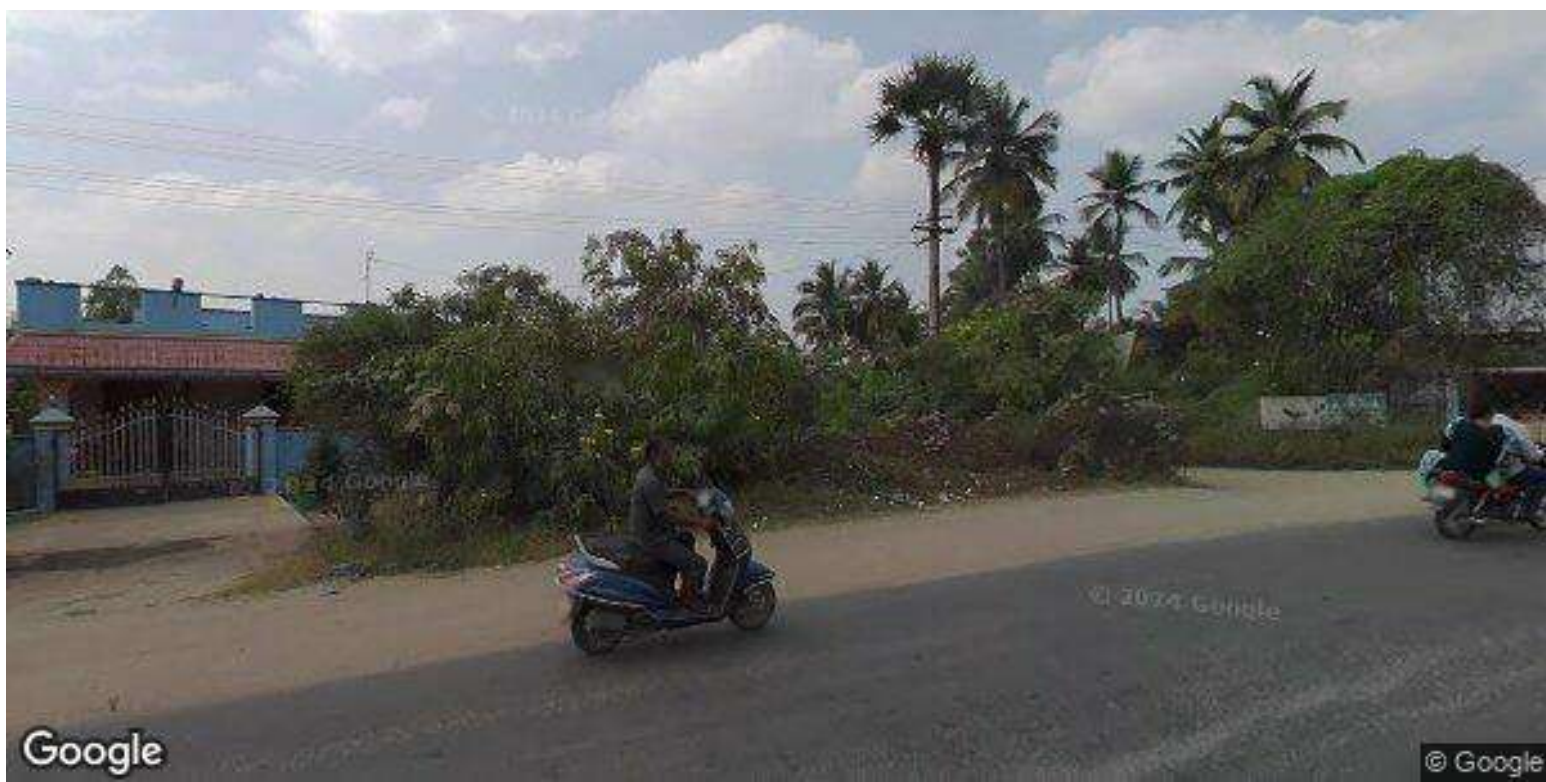
**Coordinates:** 11.49419, 77.88454

**Risk Type:** Turn

**Risk Level:** Medium

**Speed Limit:** 30 KM/Hr

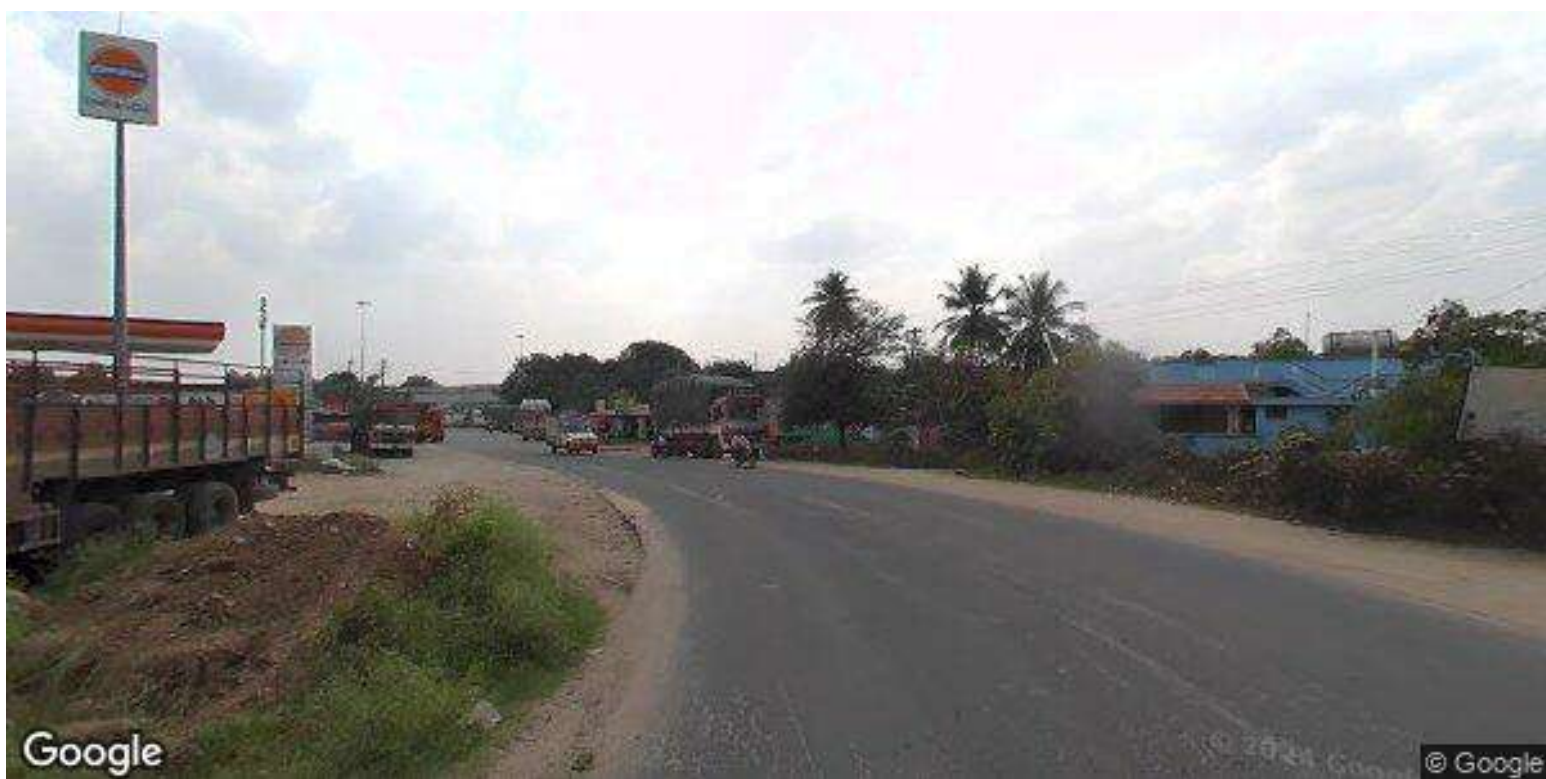
**Coordinates:** 11.49448, 77.88490

**Risk Type:** Turn

**Risk Level:** High

**Speed Limit:** 15 KM/Hr

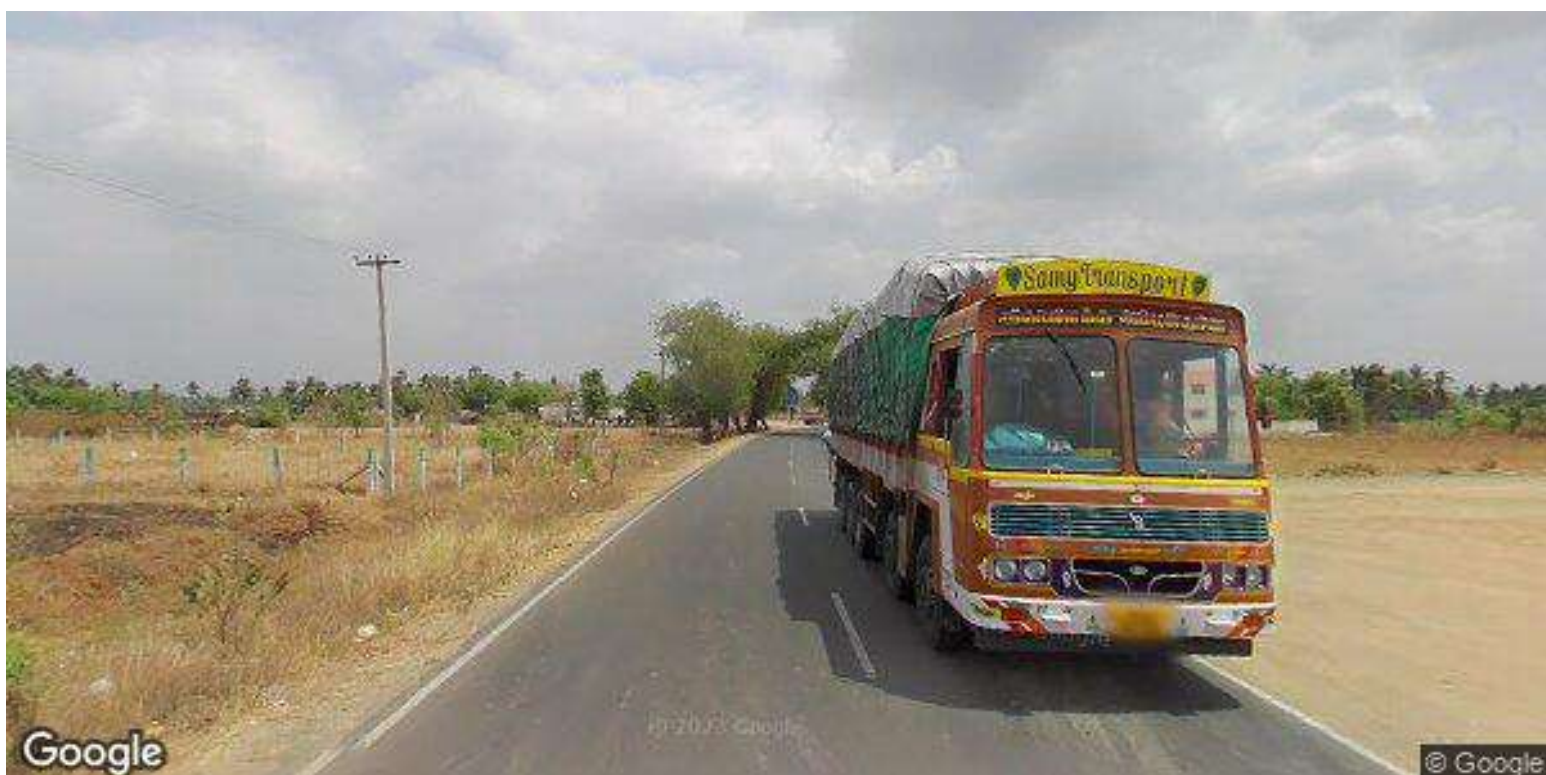
**Risk Type:** Turn  
**Risk Level:** High  
**Speed Limit:** 15 KM/Hr  
**Coordinates:** 11.55614, 77.89764

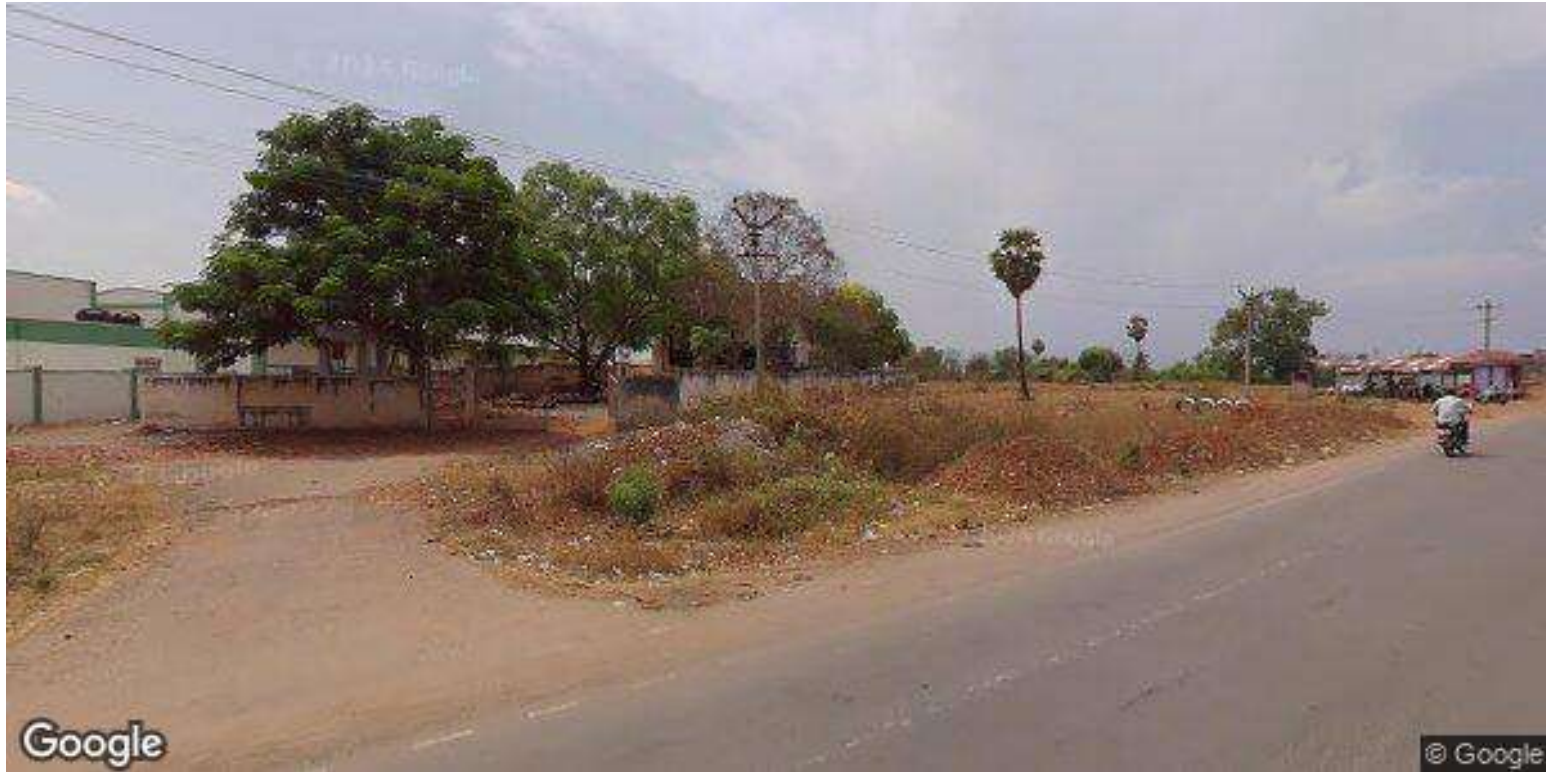
**Risk Type:** Turn  
**Risk Level:** High  
**Speed Limit:** 15 KM/Hr  
**Coordinates:** 11.58320, 77.90646

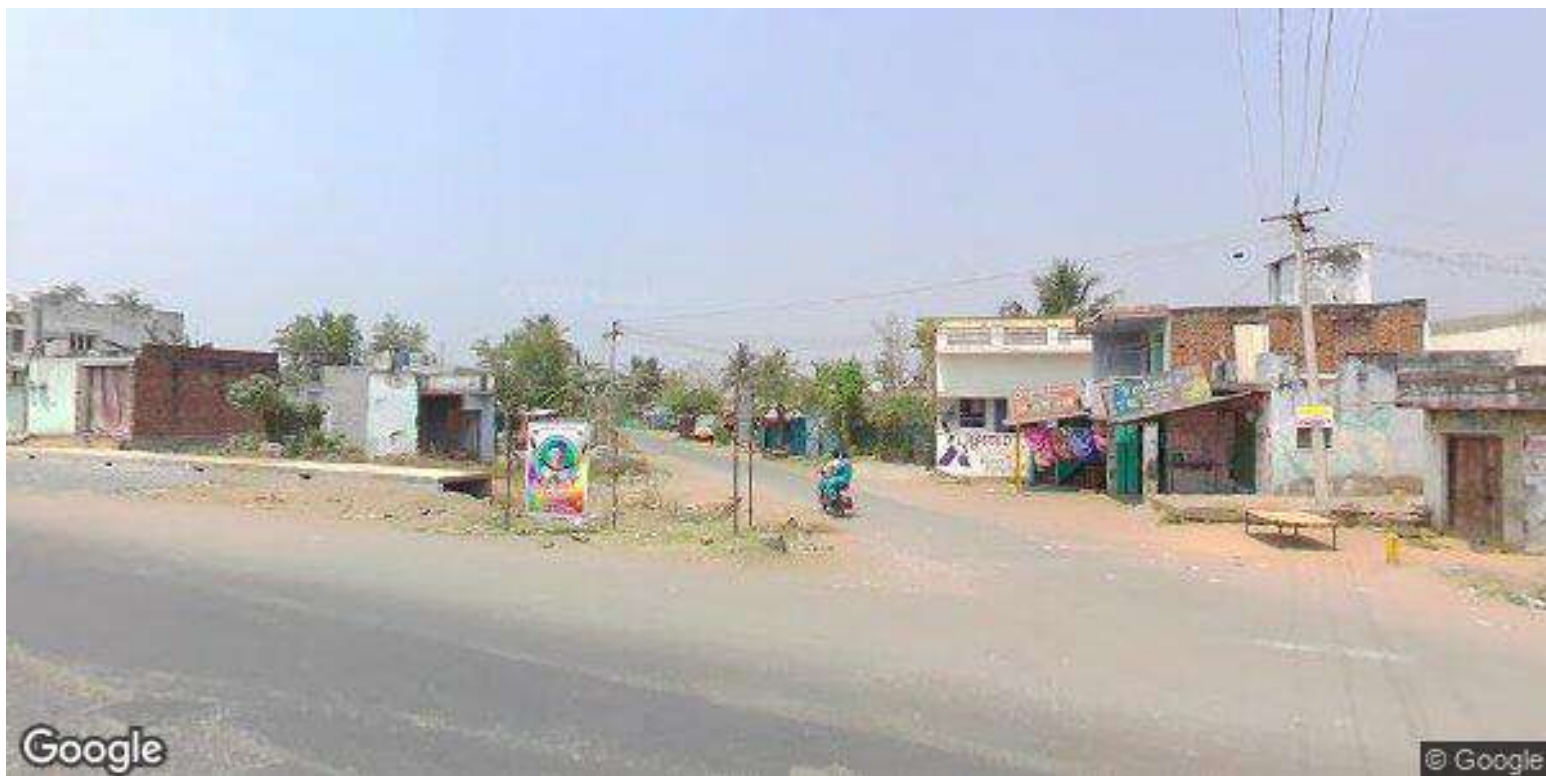
**Coordinates:** 11.66240, 77.96034

**Risk Type:** Blind Spot

**Risk Level:** Blind Spot

**Speed Limit:** 10 KM/Hr

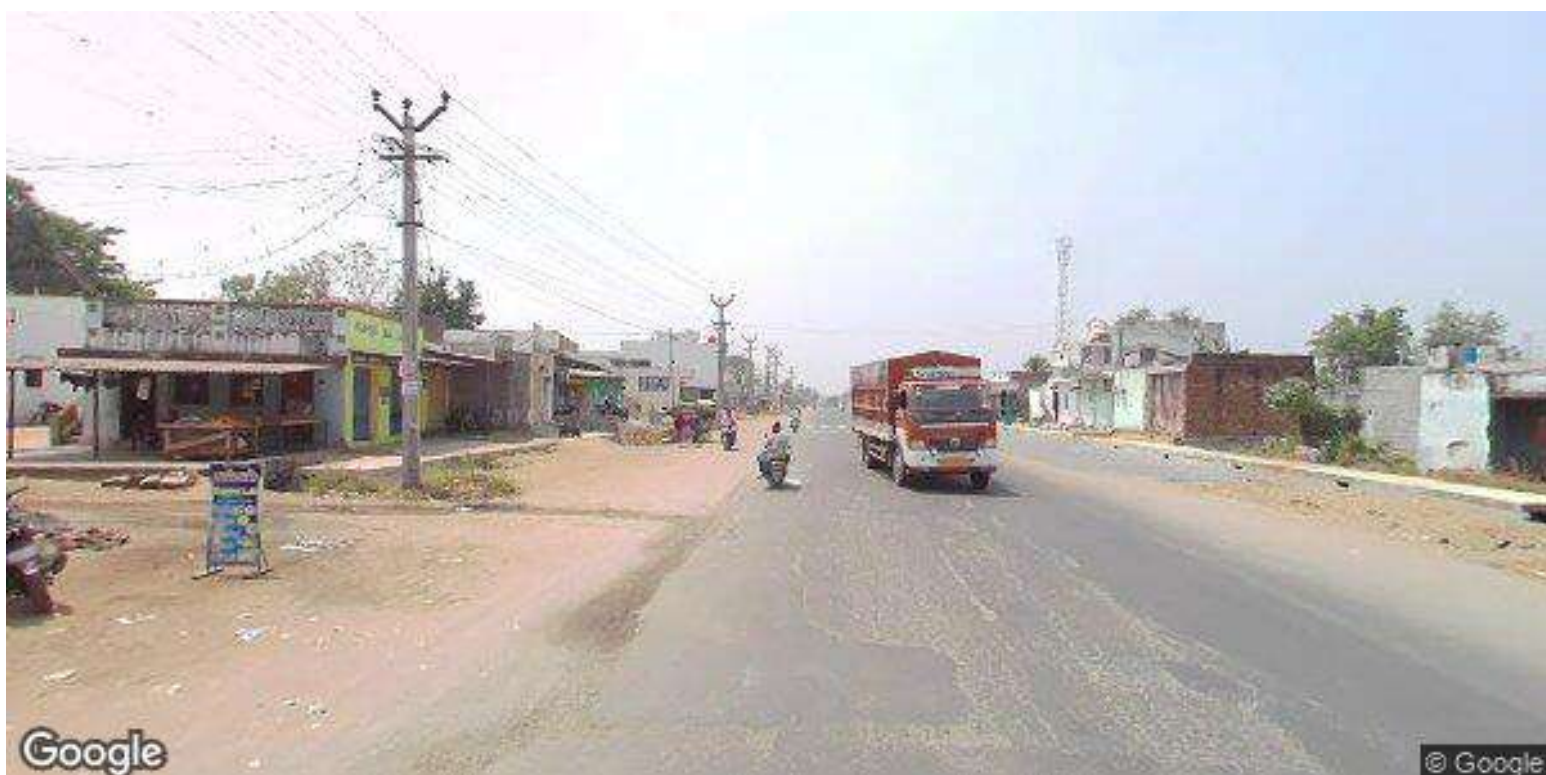
**Coordinates:** 11.66236, 77.96040

**Risk Type:** Turn

**Risk Level:** High

**Speed Limit:** 15 KM/Hr
