# IndianOil

## JOURNEY RISK MANAGEMENT (JRM) STUDY

### Salem Terminal TO PALANISAMY AGENCIES

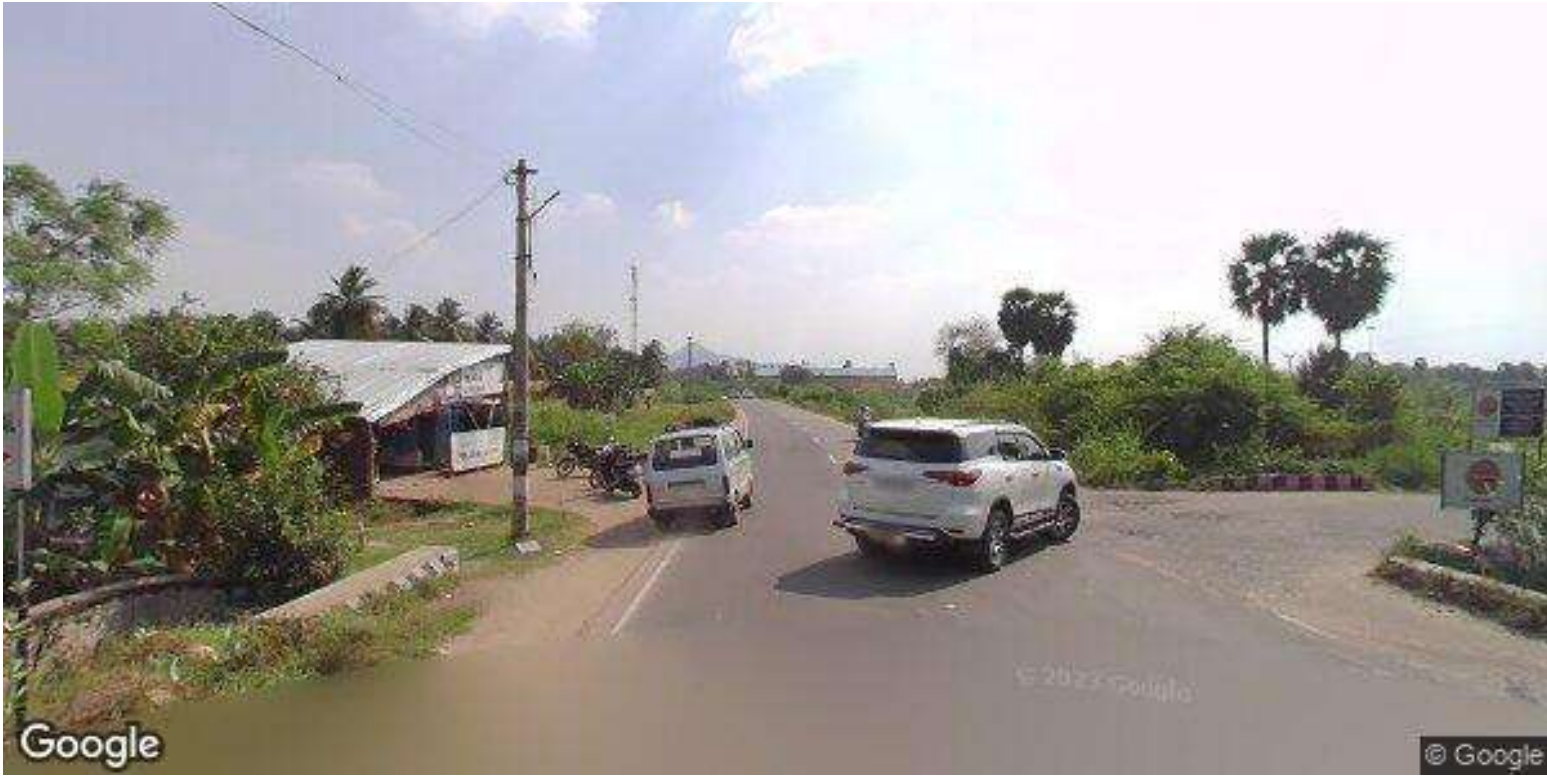
Risk Type: Blind Spot  
Risk Level: Blind Spot  
Speed Limit: 10 KM/Hr  
Coordinates: 11.44029, 77.87544

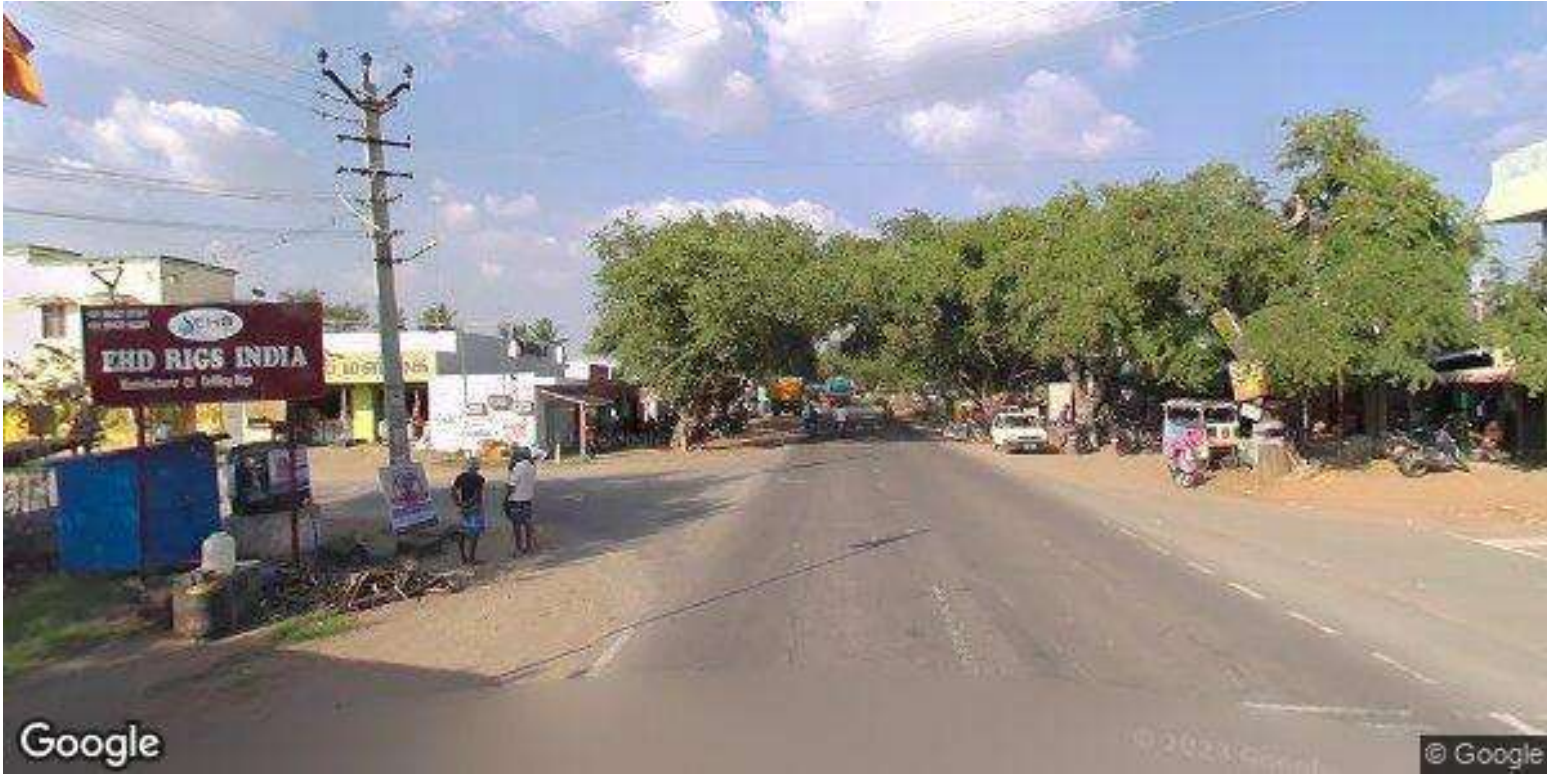
**Coordinates: 11.41975, 77.88075**

Risk Type: Blind Spot  
Risk Level: Blind Spot

**Speed Limit: 10 KM/Hr**

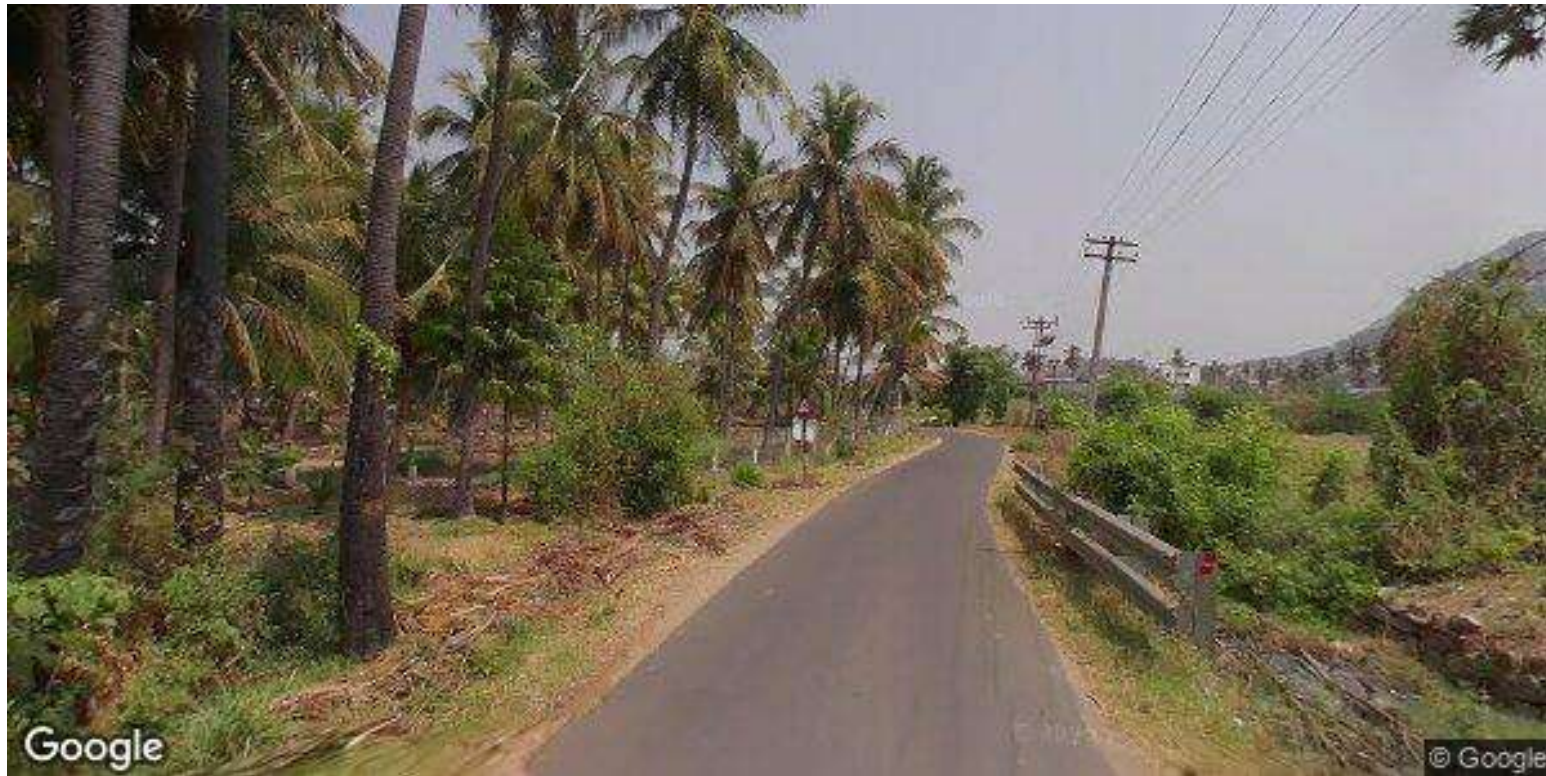
**Coordinates: 11.41876, 77.88487**

**Risk Type: Turn**

**Risk Level: Medium**

**Speed Limit: 30 KM/Hr**

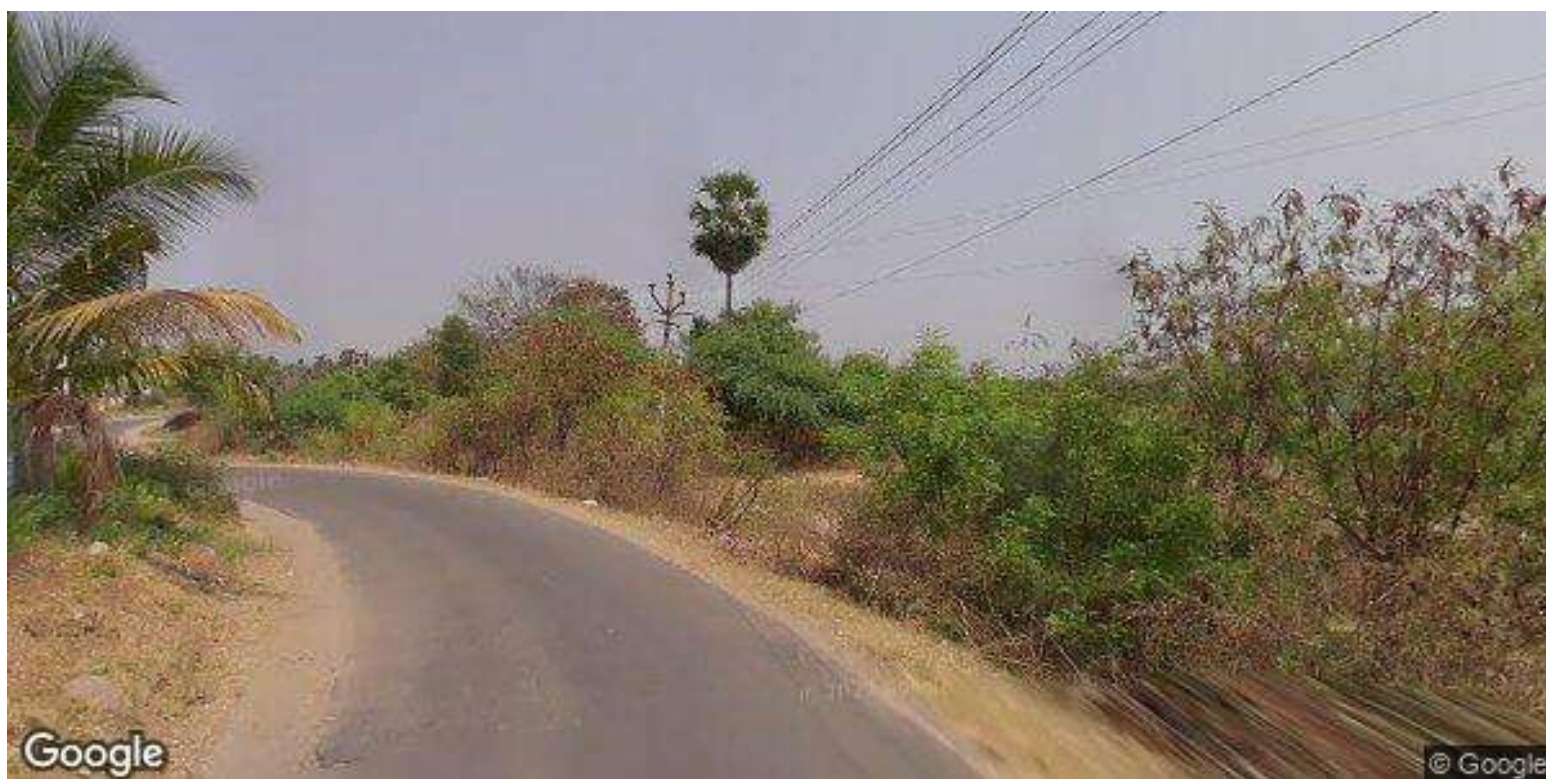
**Coordinates: 11.41829, 77.88568**

**Risk Type: Turn**

**Risk Level: Medium**

**Speed Limit: 30 KM/Hr**

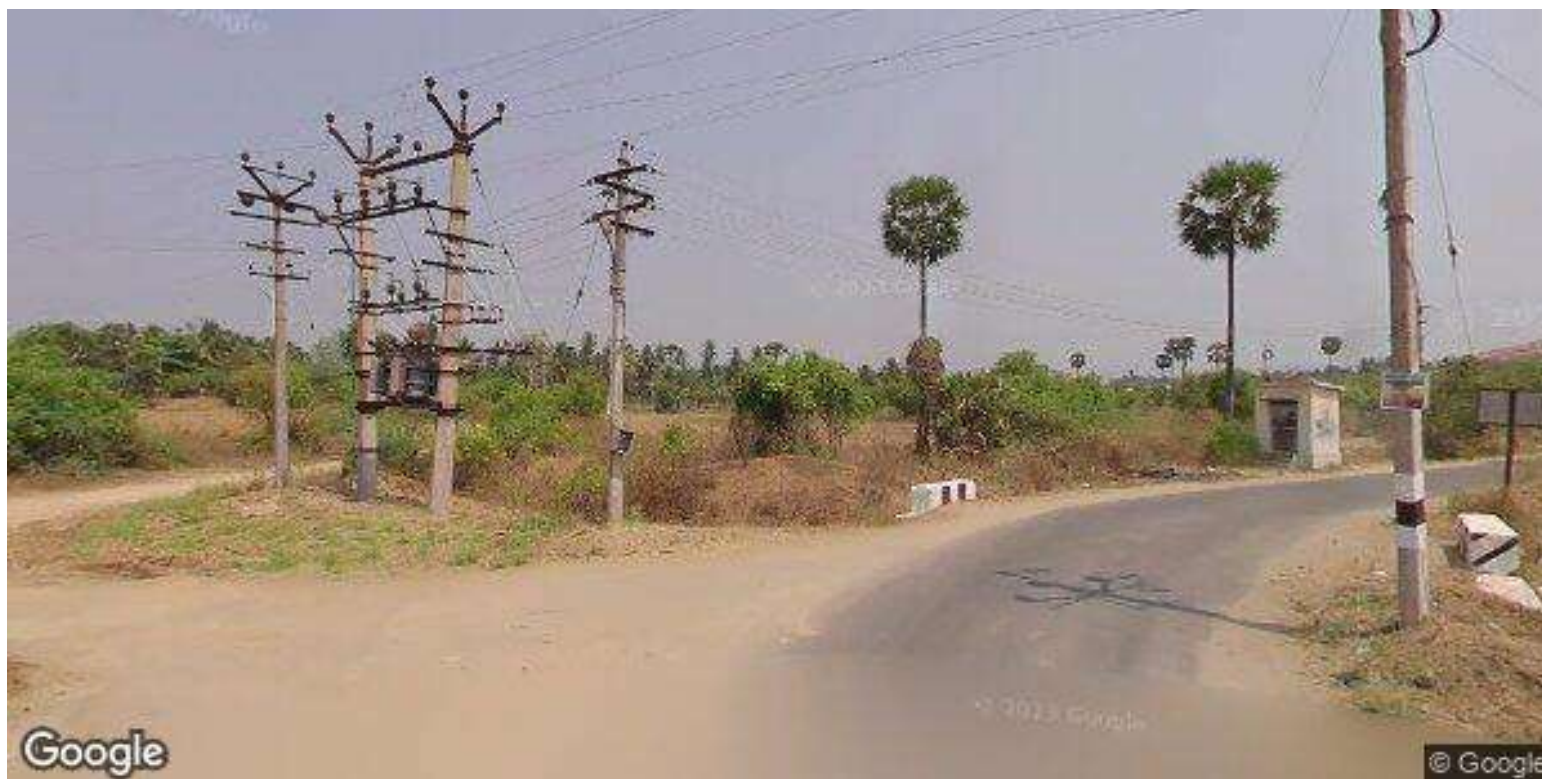
**Coordinates:** 11.41859, 77.88692

**Risk Type:** Turn

**Risk Level:** High

**Speed Limit:** 15 KM/Hr

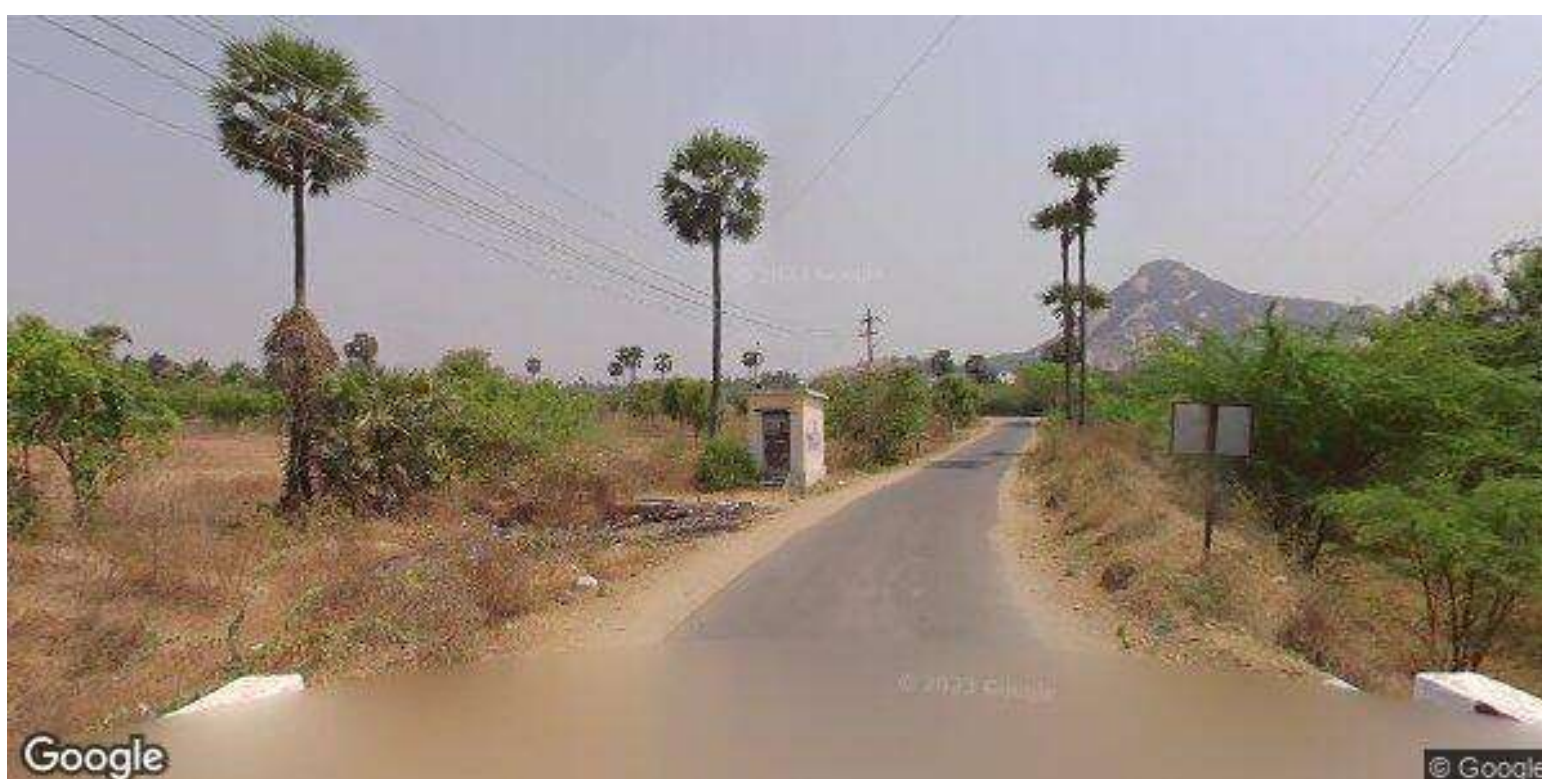
**Coordinates:** 11.41852, 77.88700

**Risk Type:** Turn

**Risk Level:** Medium

**Speed Limit:** 30 KM/Hr

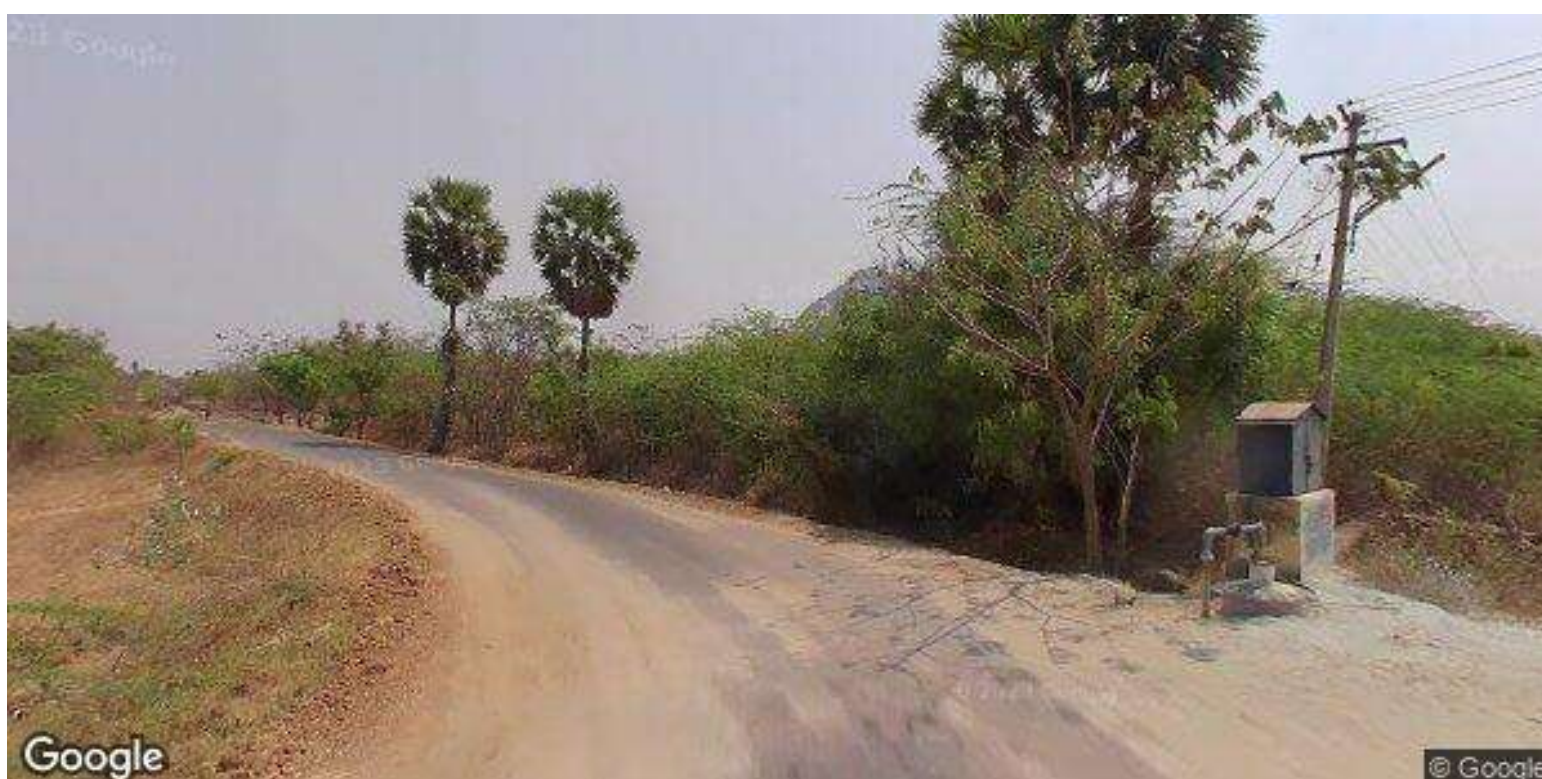
**Risk Type:** Turn  
**Risk Level:** Medium  
**Speed Limit:** 30 KM/Hr  
**Coordinates:** 11.41769, 77.88730

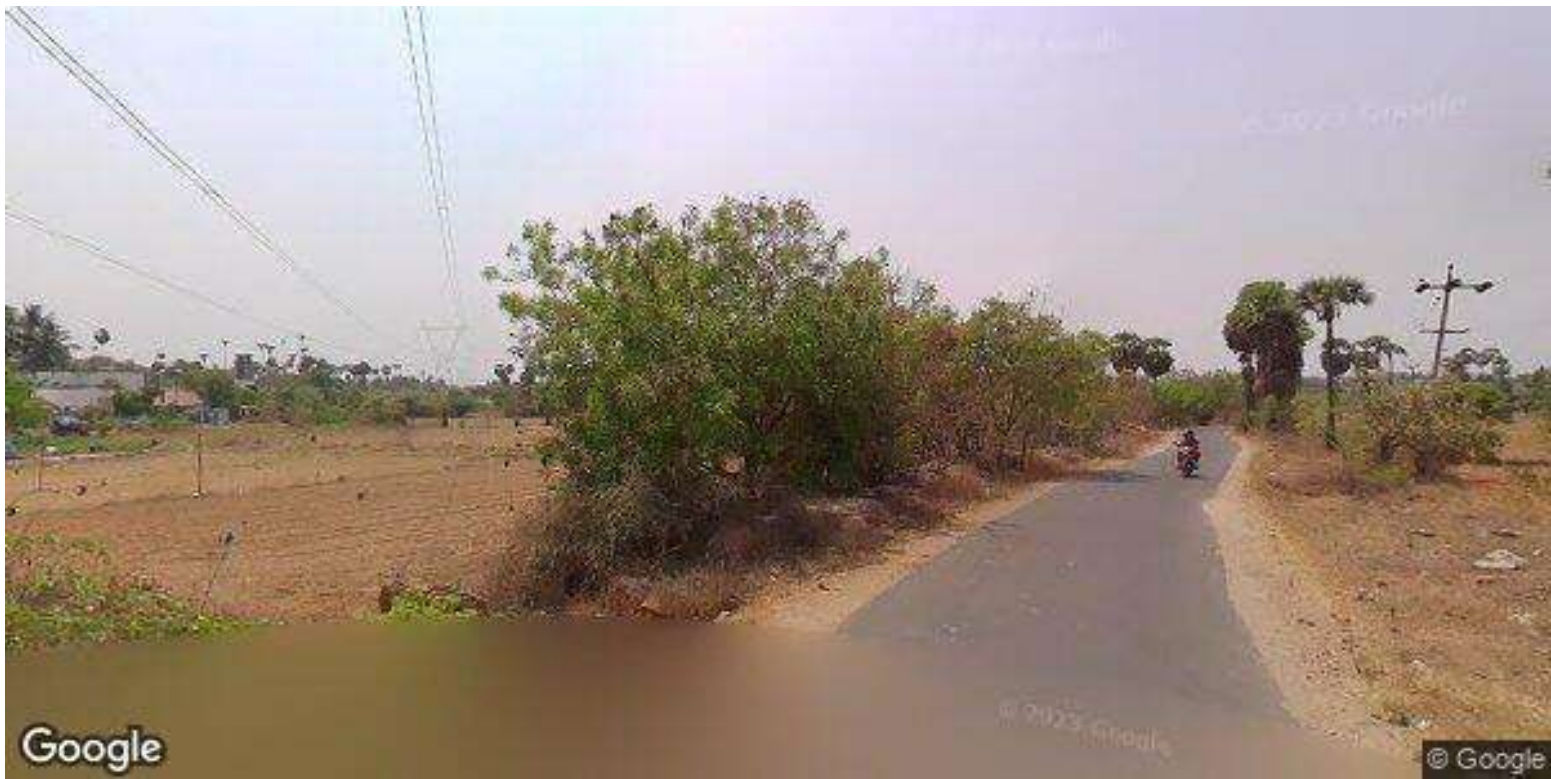
**Risk Type:** Turn  
**Risk Level:** Medium  
**Speed Limit:** 30 KM/Hr  
**Coordinates:** 11.41630, 77.89077

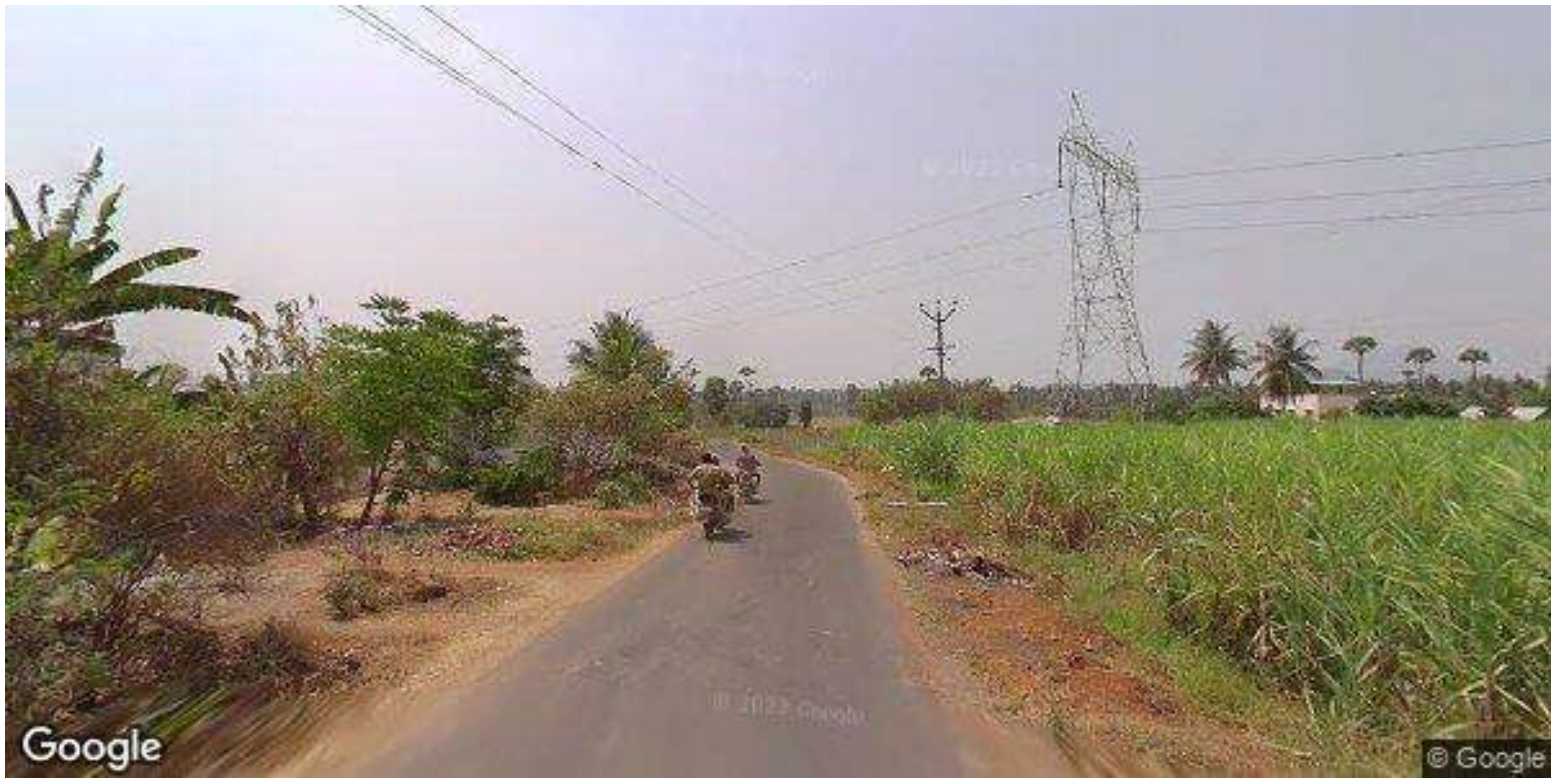
**Risk Type:** Turn  
**Risk Level:** Medium  
**Speed Limit:** 30 KM/Hr  
**Coordinates:** 11.41601, 77.89198

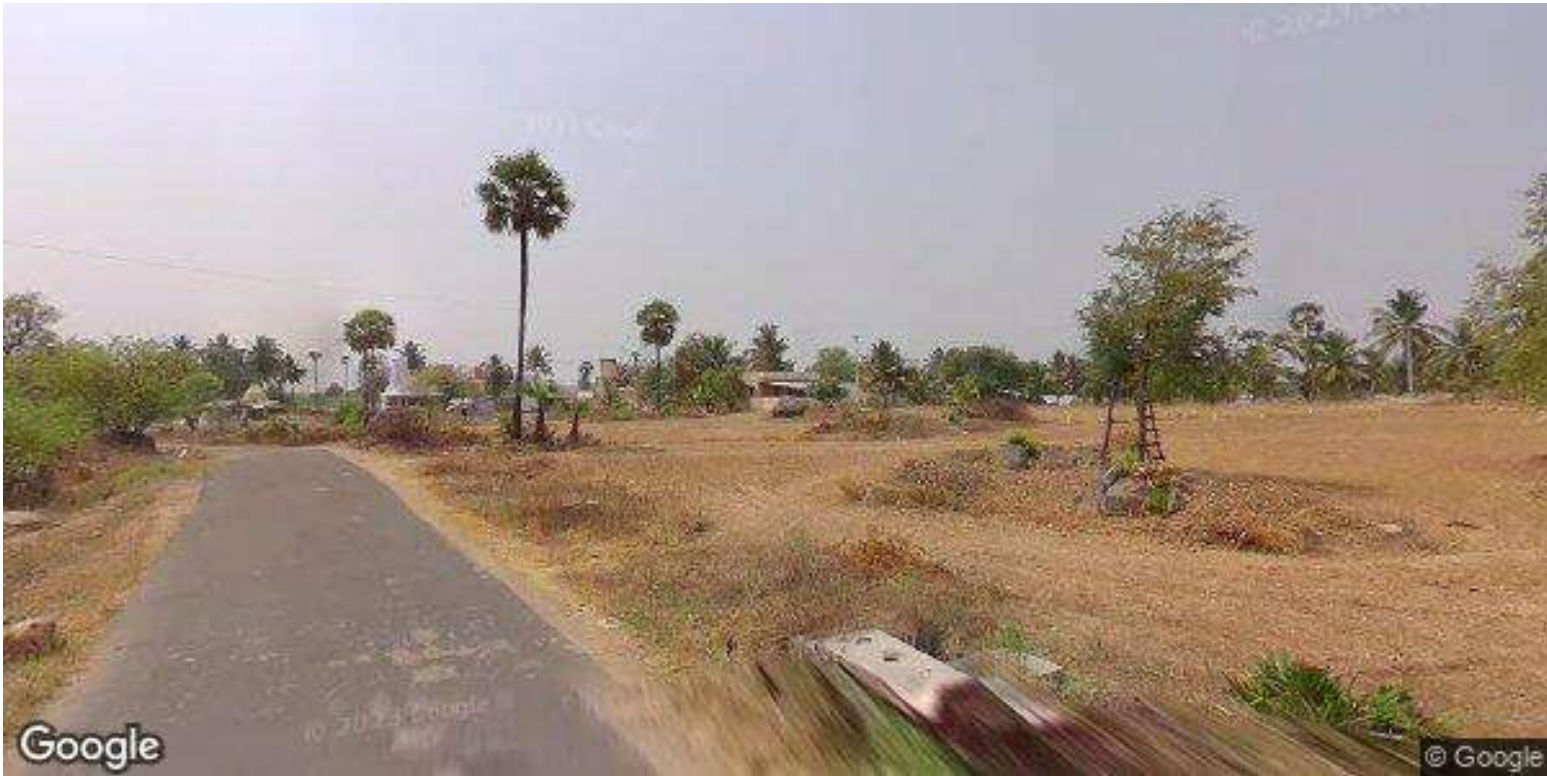
**Risk Type:** Turn  
**Risk Level:** Medium  
**Speed Limit:** 30 KM/Hr  
**Coordinates:** 11.41603, 77.89479

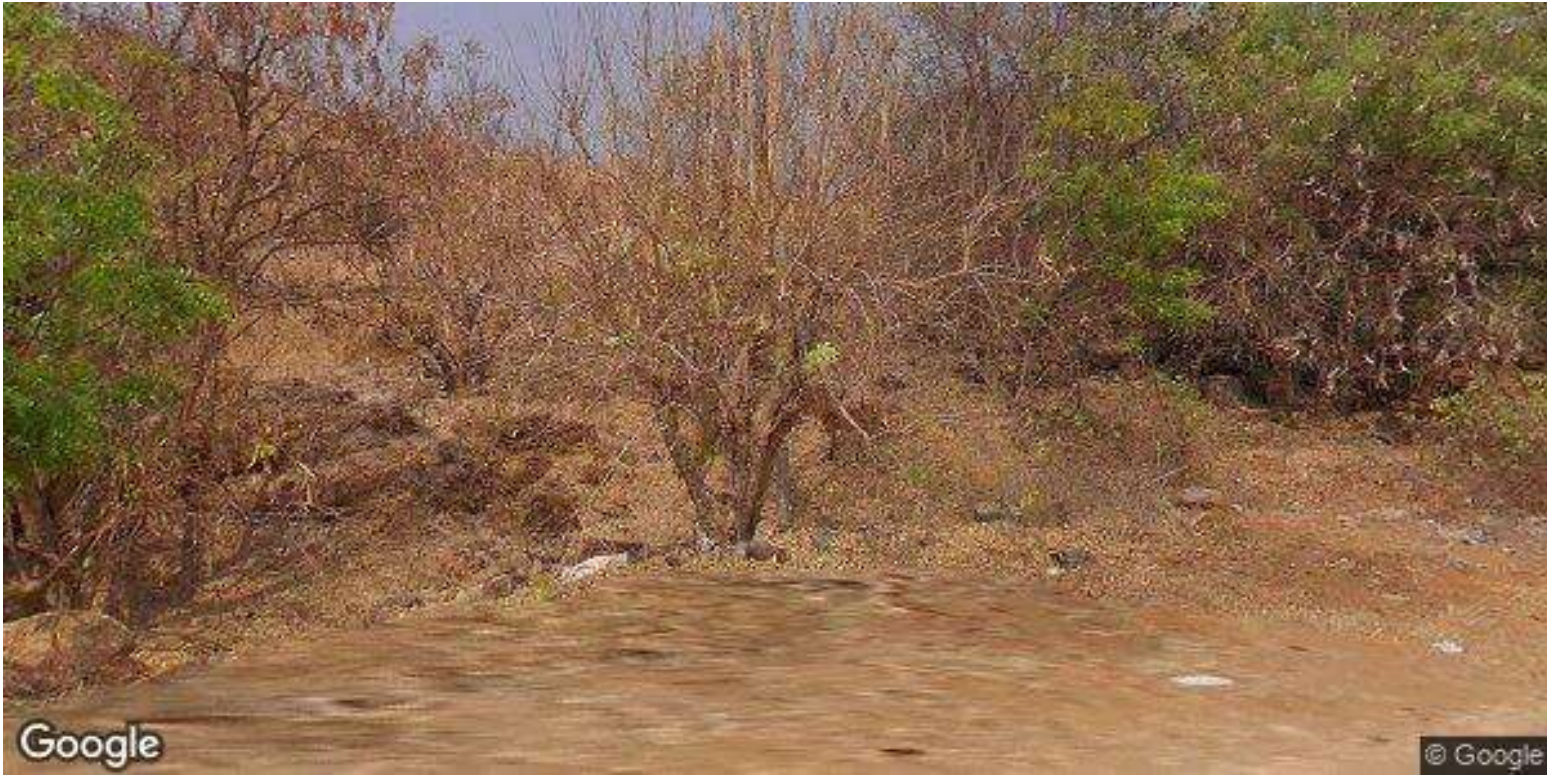
**Risk Type:** Turn  
**Risk Level:** Medium  
**Speed Limit:** 30 KM/Hr  
**Coordinates:** 11.41439, 77.90025

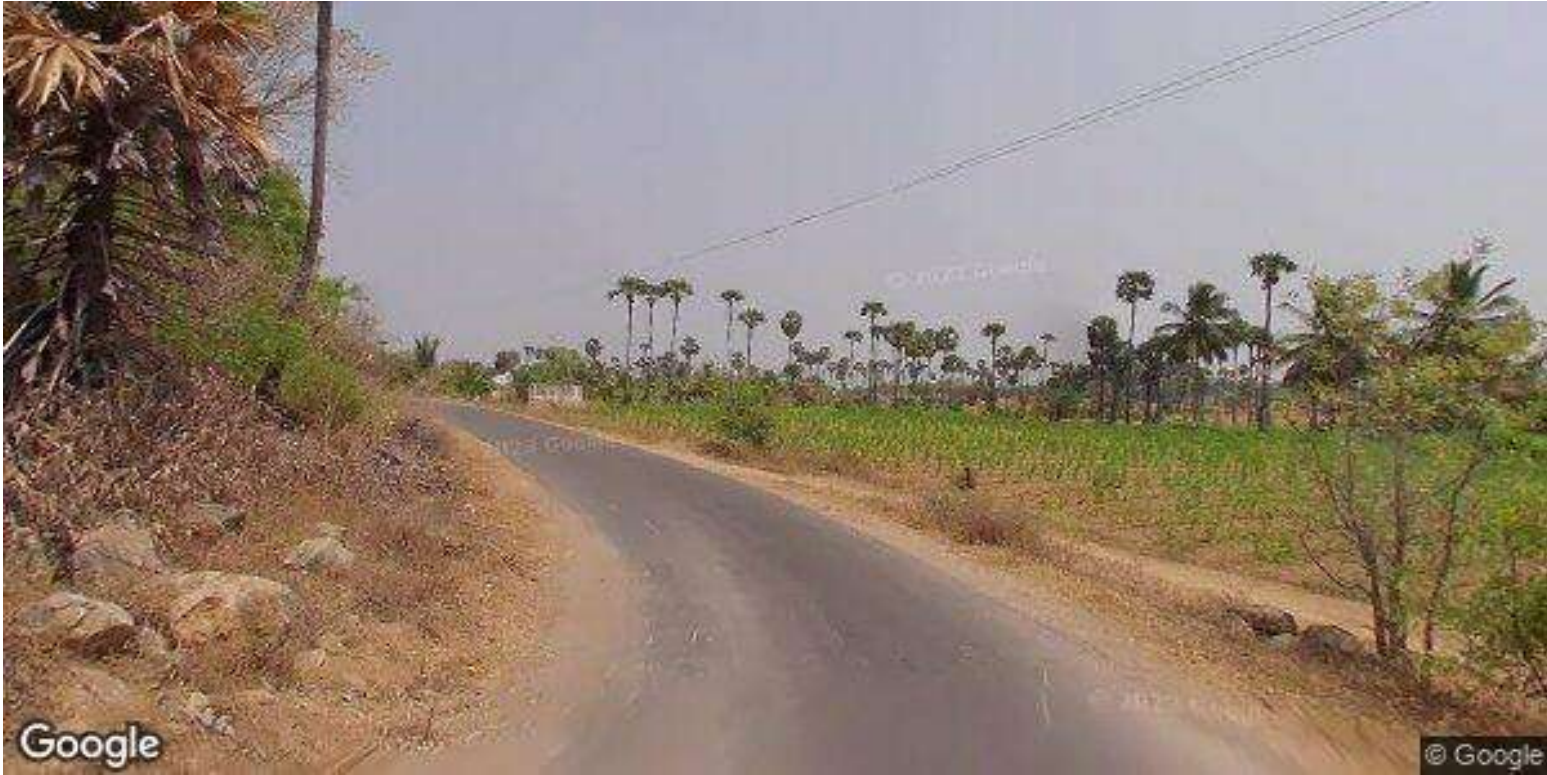
**Coordinates:** 11.41377, 77.90073

**Risk Type:** Turn

**Risk Level:** Medium

**Speed Limit:** 30 KM/Hr

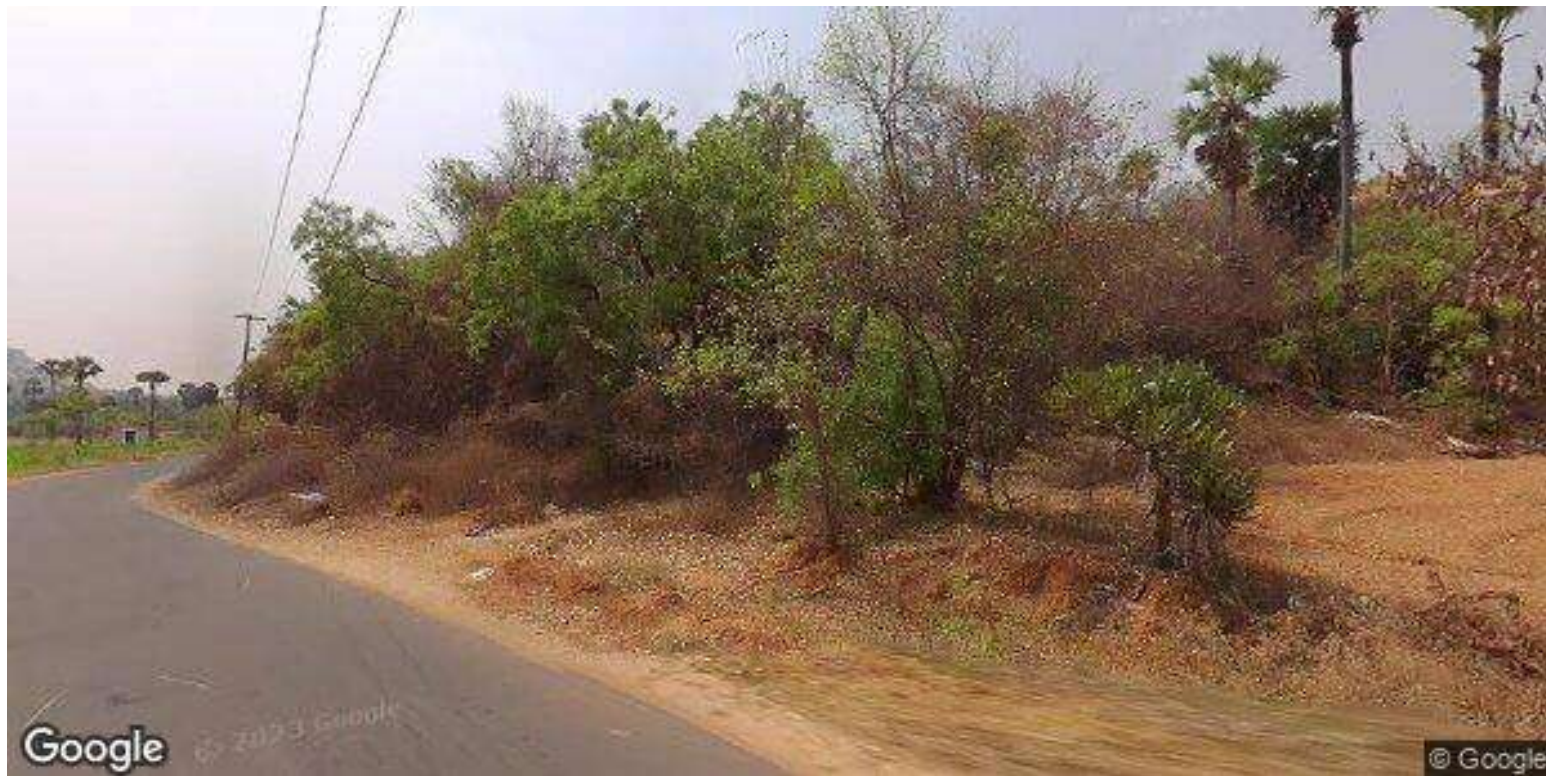
**Coordinates:** 11.41389, 77.90161

**Risk Type:** Turn

**Risk Level:** Medium

**Speed Limit:** 30 KM/Hr

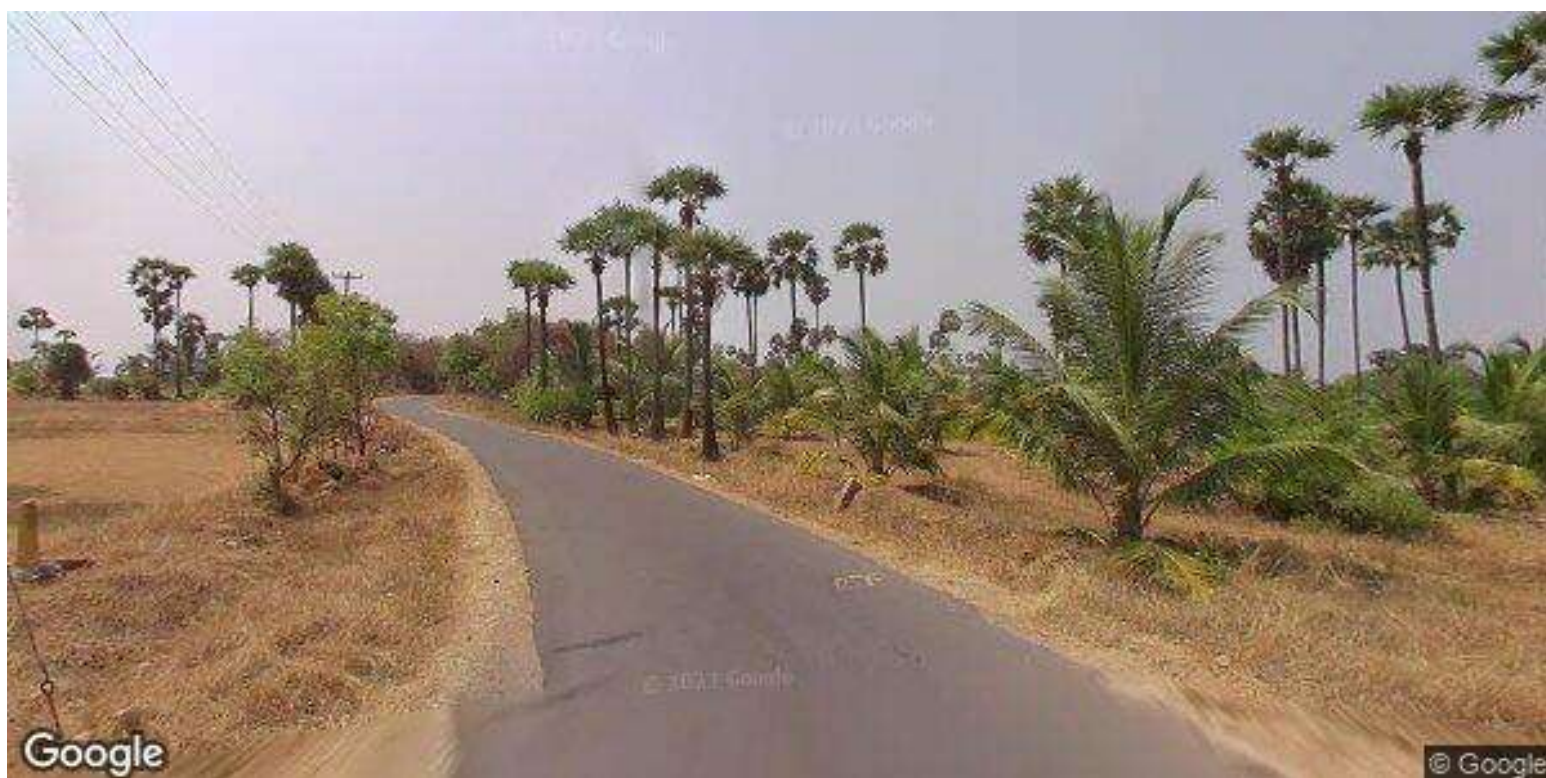
**Coordinates:** 11.41325, 77.90313

**Risk Type:** Turn

**Risk Level:** Medium

**Speed Limit:** 30 KM/Hr

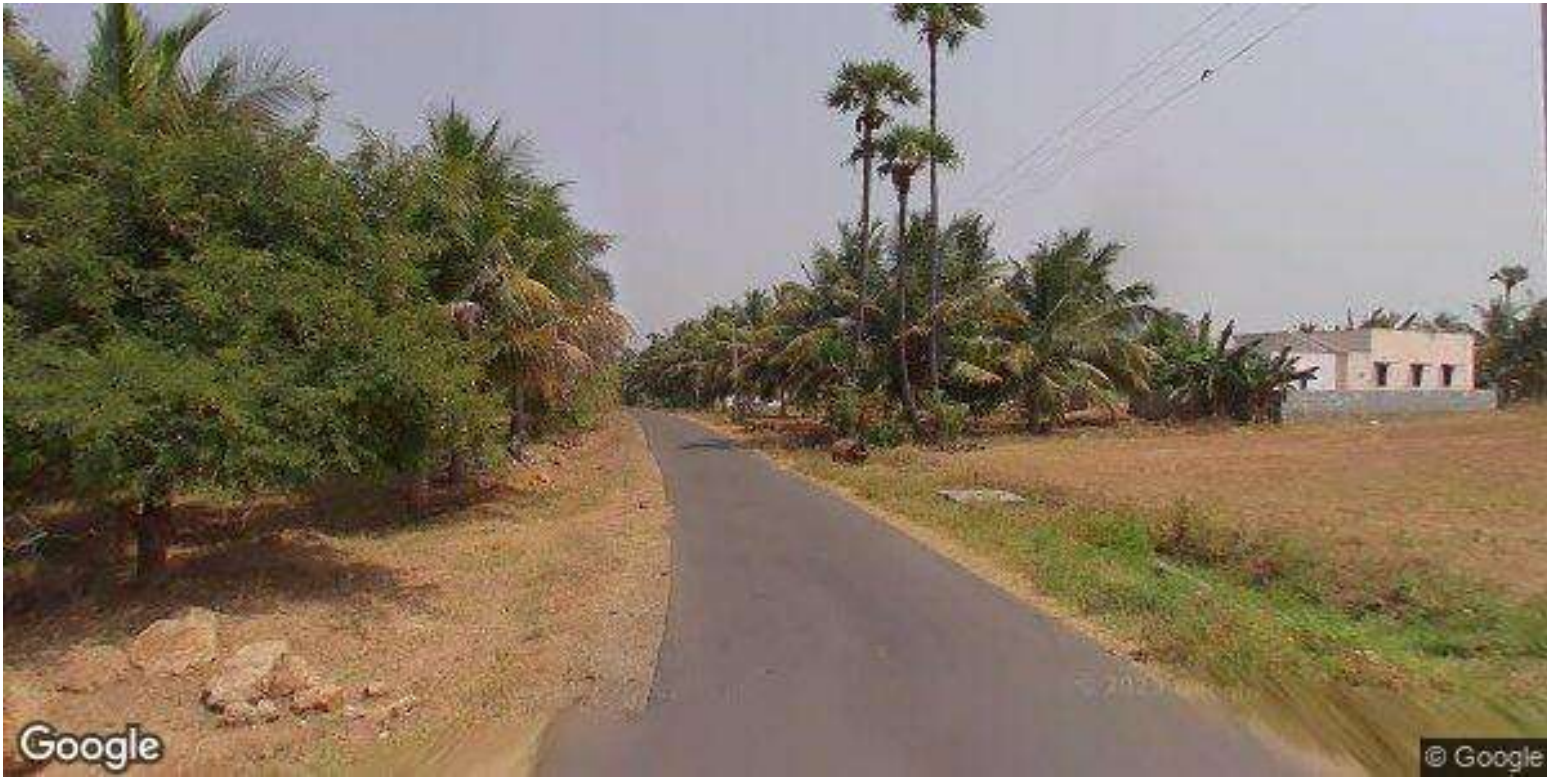
**Risk Type:** Turn  
**Risk Level:** Medium  
**Speed Limit:** 30 KM/Hr  
**Coordinates:** 11.41276, 77.90349

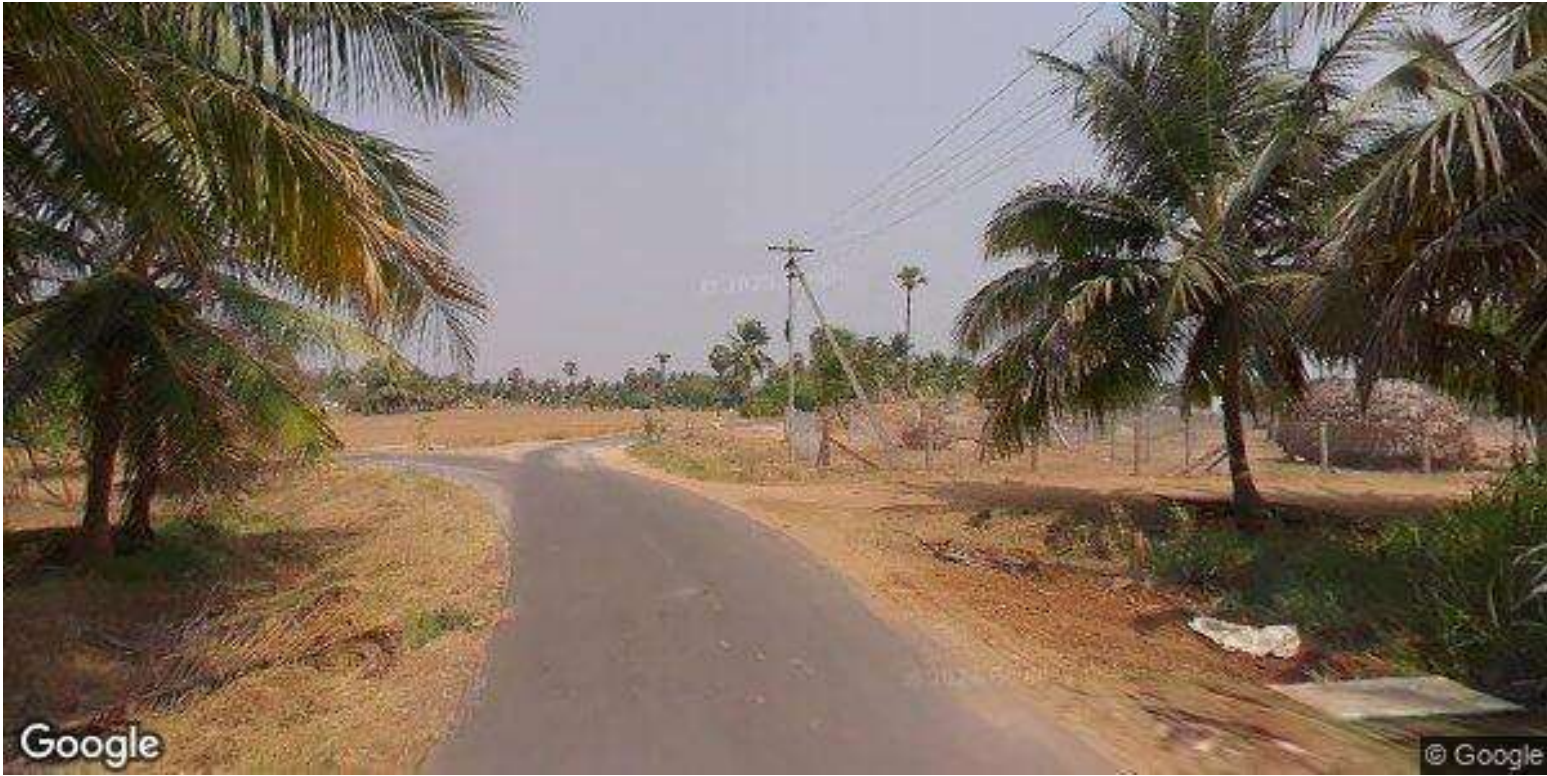
**Risk Type:** Turn  
**Risk Level:** Medium  
**Speed Limit:** 30 KM/Hr  
**Coordinates:** 11.41227, 77.90470

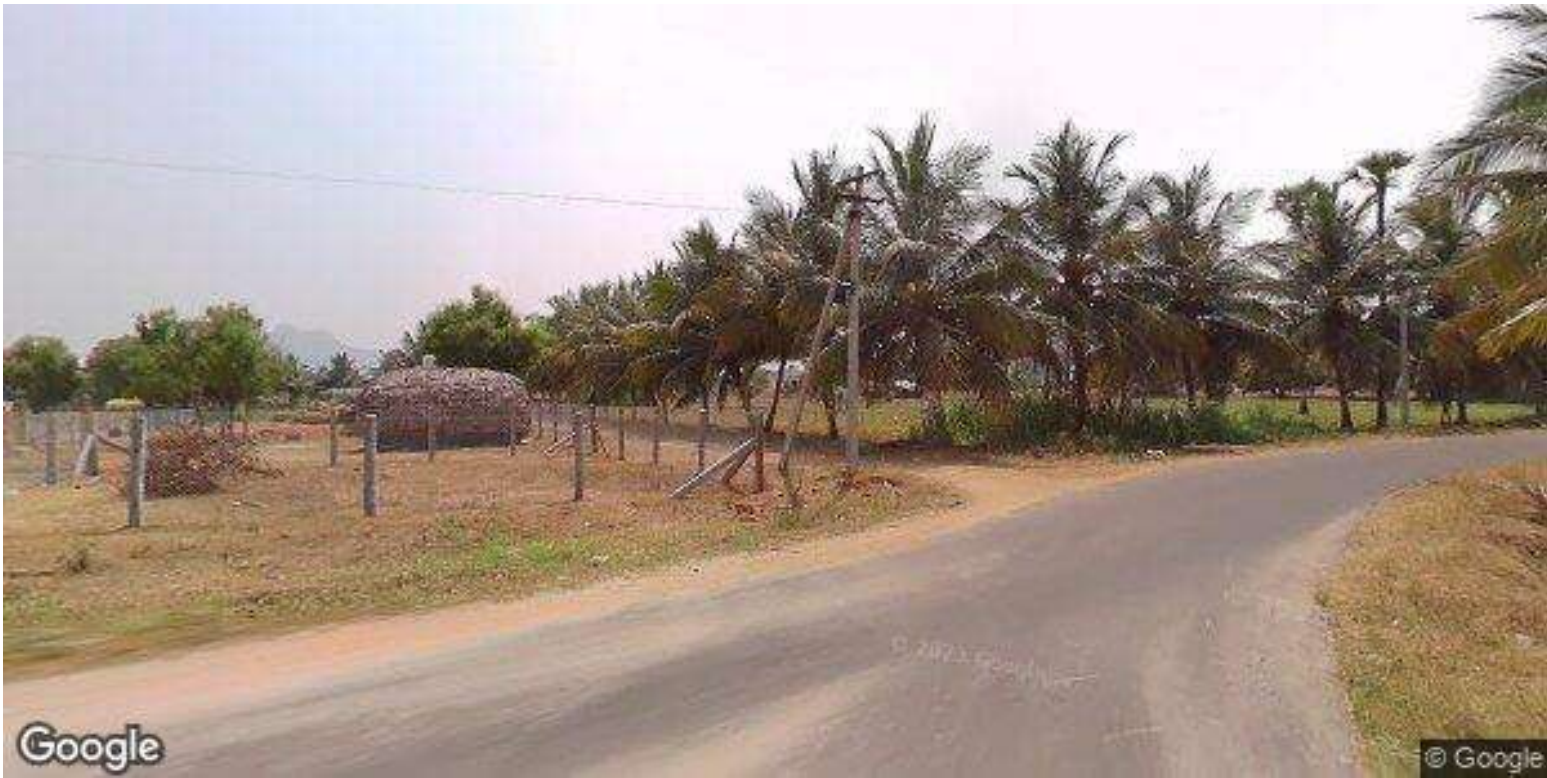
**Risk Type:** Turn  
**Risk Level:** Medium  
**Speed Limit:** 30 KM/Hr  
**Coordinates:** 11.41235, 77.90492

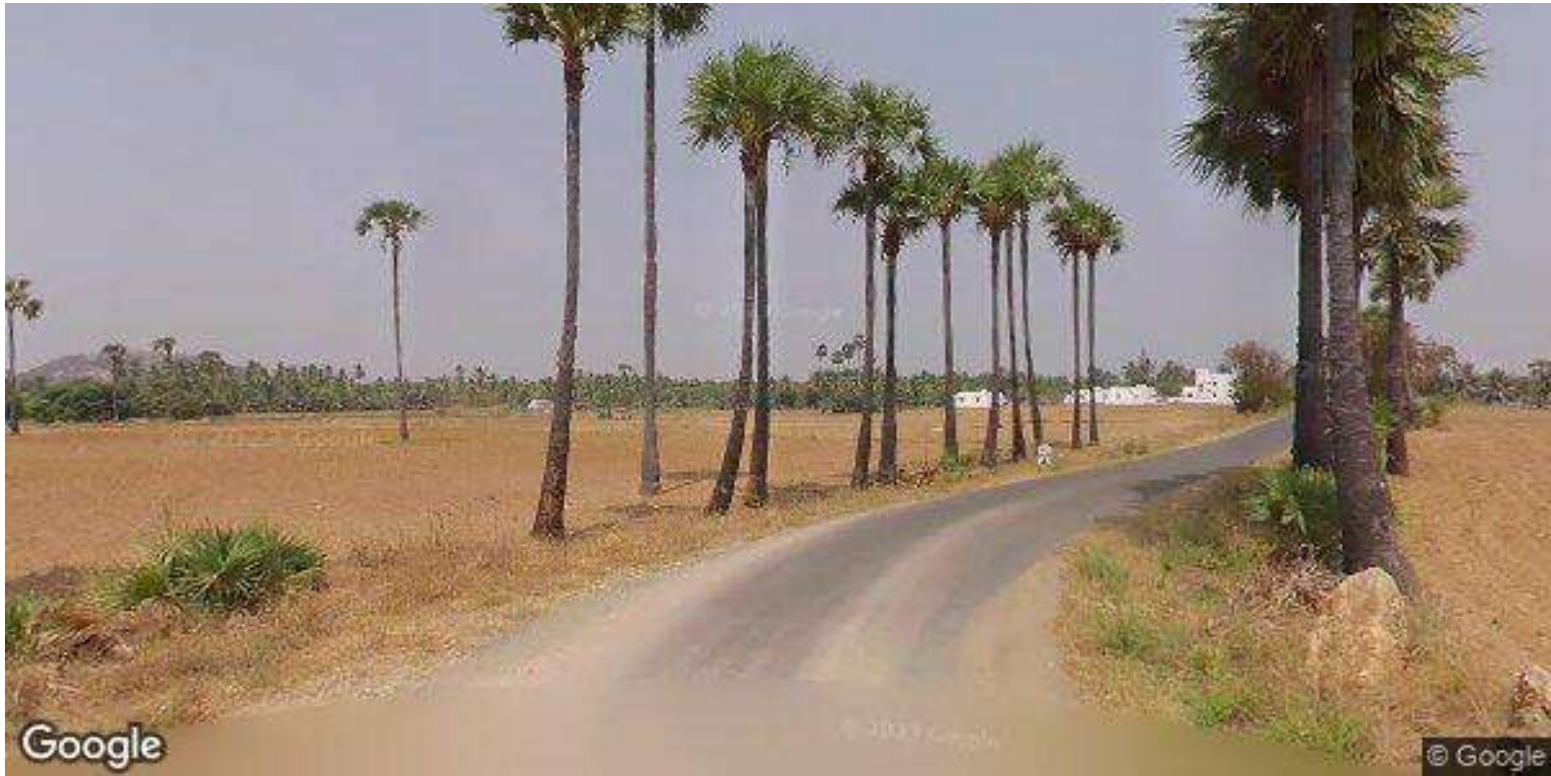
**Risk Type:** Turn  
**Risk Level:** Medium  
**Speed Limit:** 30 KM/Hr  
**Coordinates:** 11.41271, 77.90516
