# IndianOil

## JOURNEY RISK MANAGEMENT (JRM) STUDY

### Salem Terminal TO PALANISAMY AGENCIES

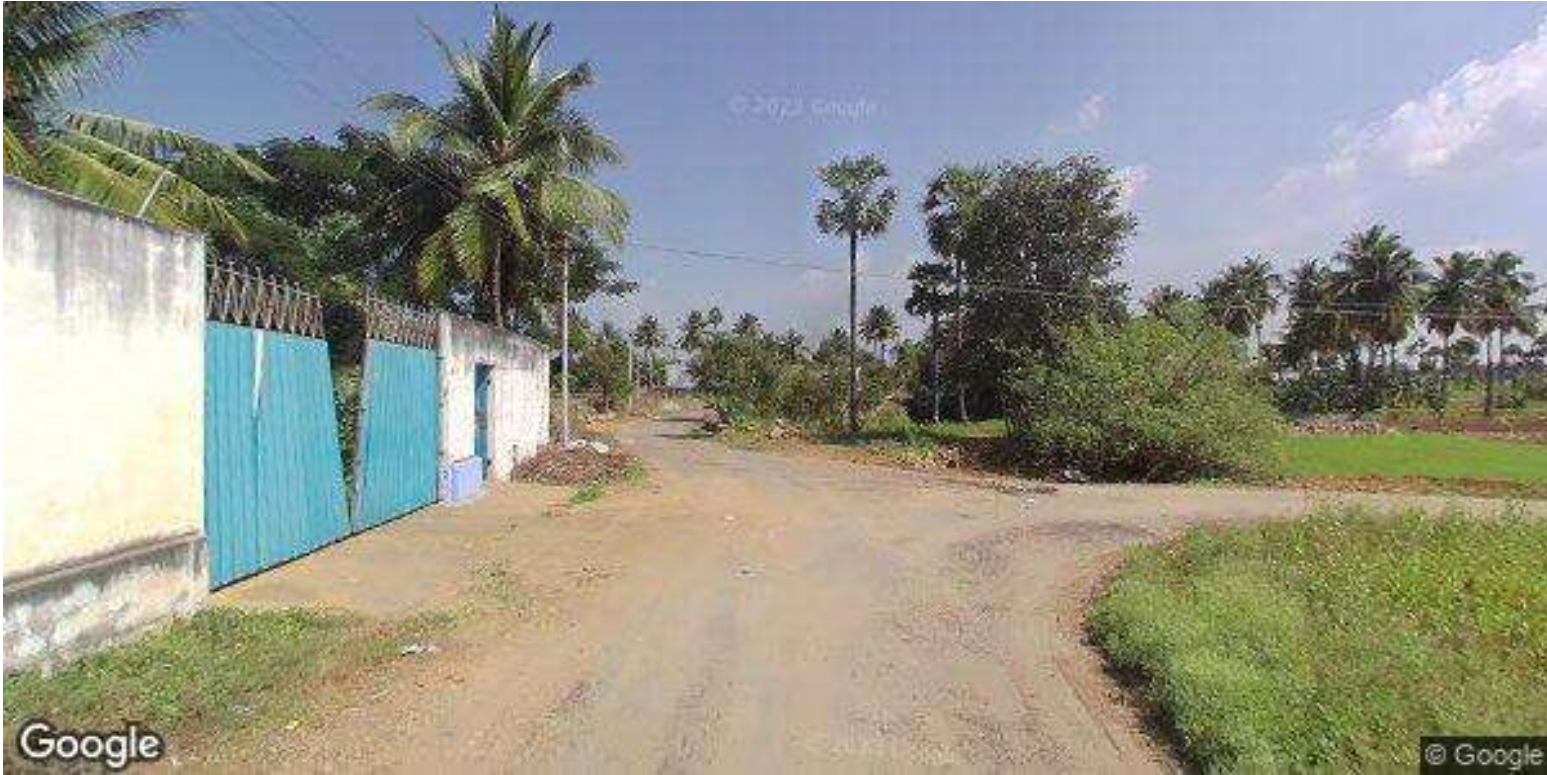
**Risk Type:** Turn  
**Risk Level:** Medium  
**Speed Limit:** 30 KM/Hr  
**Coordinates:** 11.41207, 77.91604

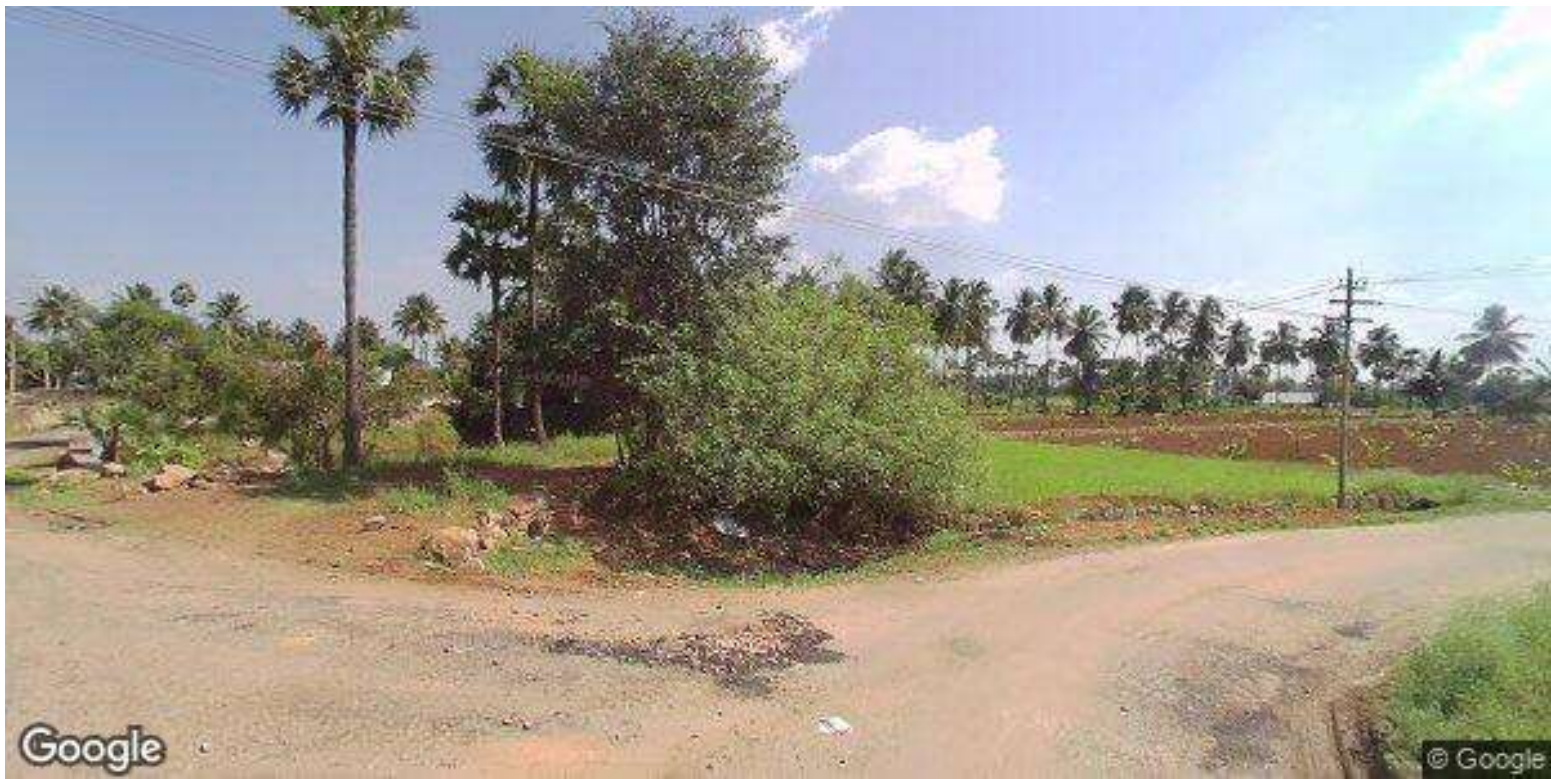
**Risk Type:** Turn  
**Risk Level:** High  
**Speed Limit:** 15 KM/Hr  
**Coordinates:** 11.41204, 77.91610

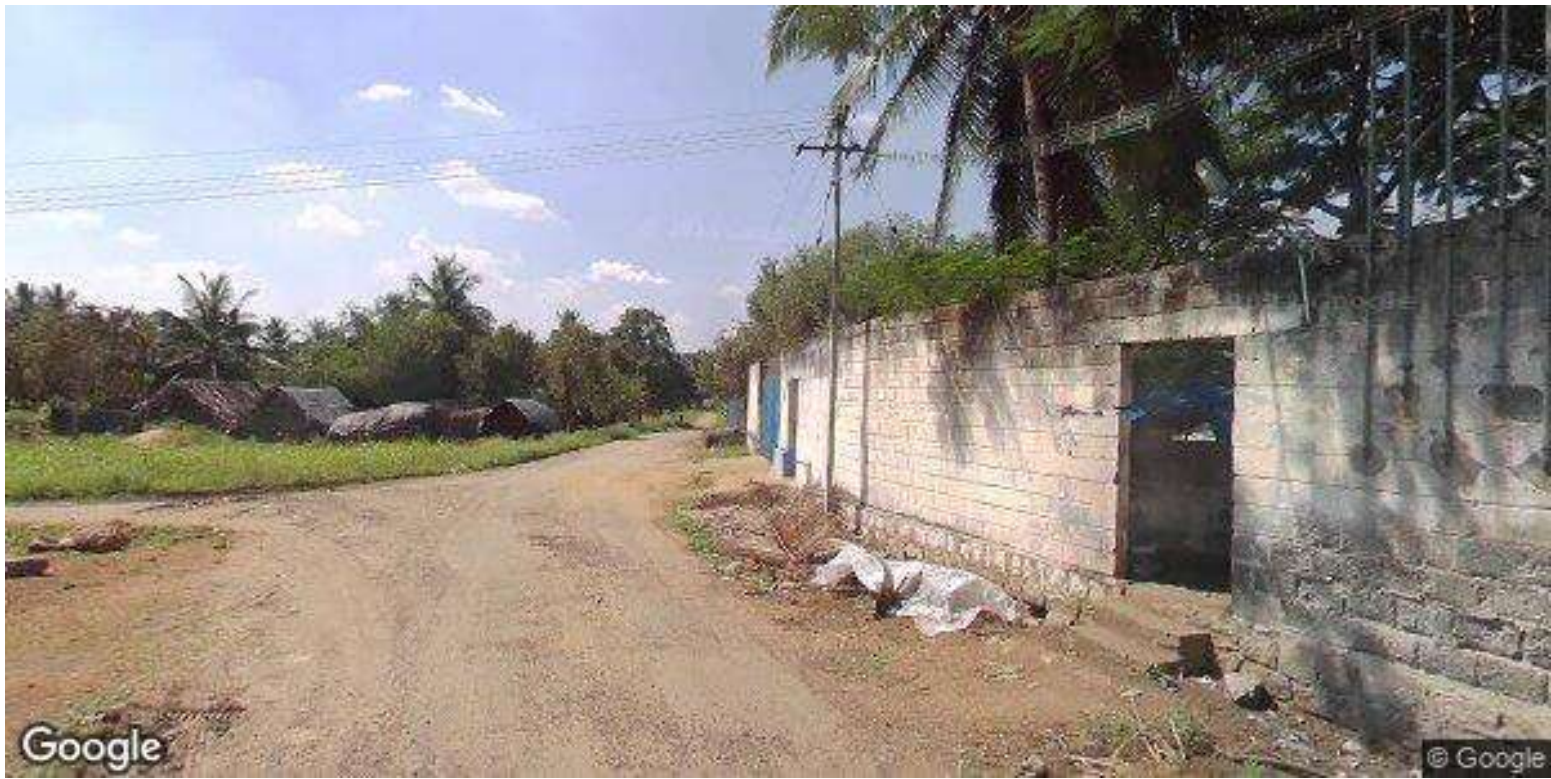
**Risk Type:** Turn  
**Risk Level:** Medium  
**Speed Limit:** 30 KM/Hr  
**Coordinates:** 11.41216, 77.91626

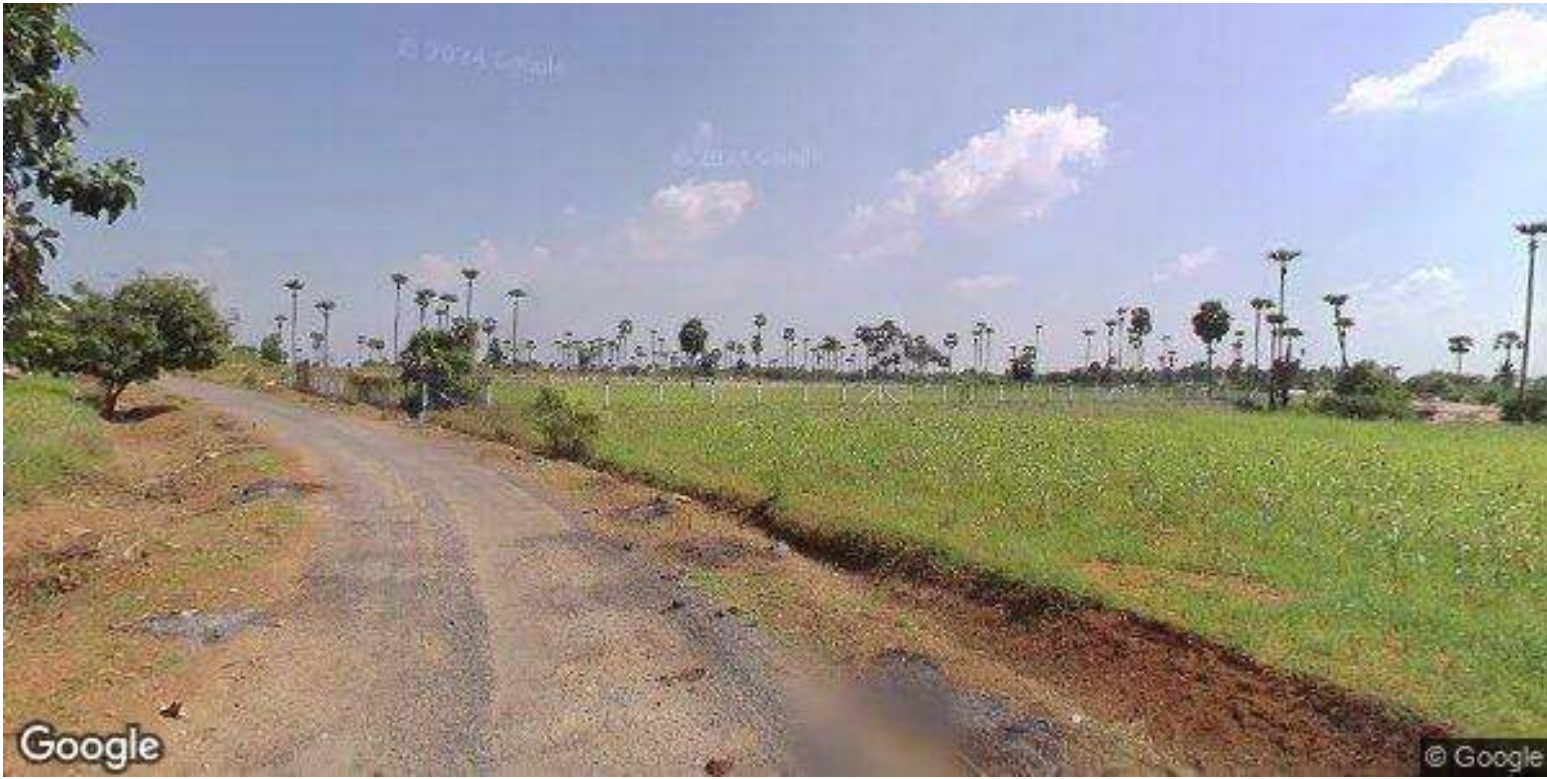
**Risk Type:** Turn  
**Risk Level:** Medium  
**Speed Limit:** 30 KM/Hr  
**Coordinates:** 11.41183, 77.91755

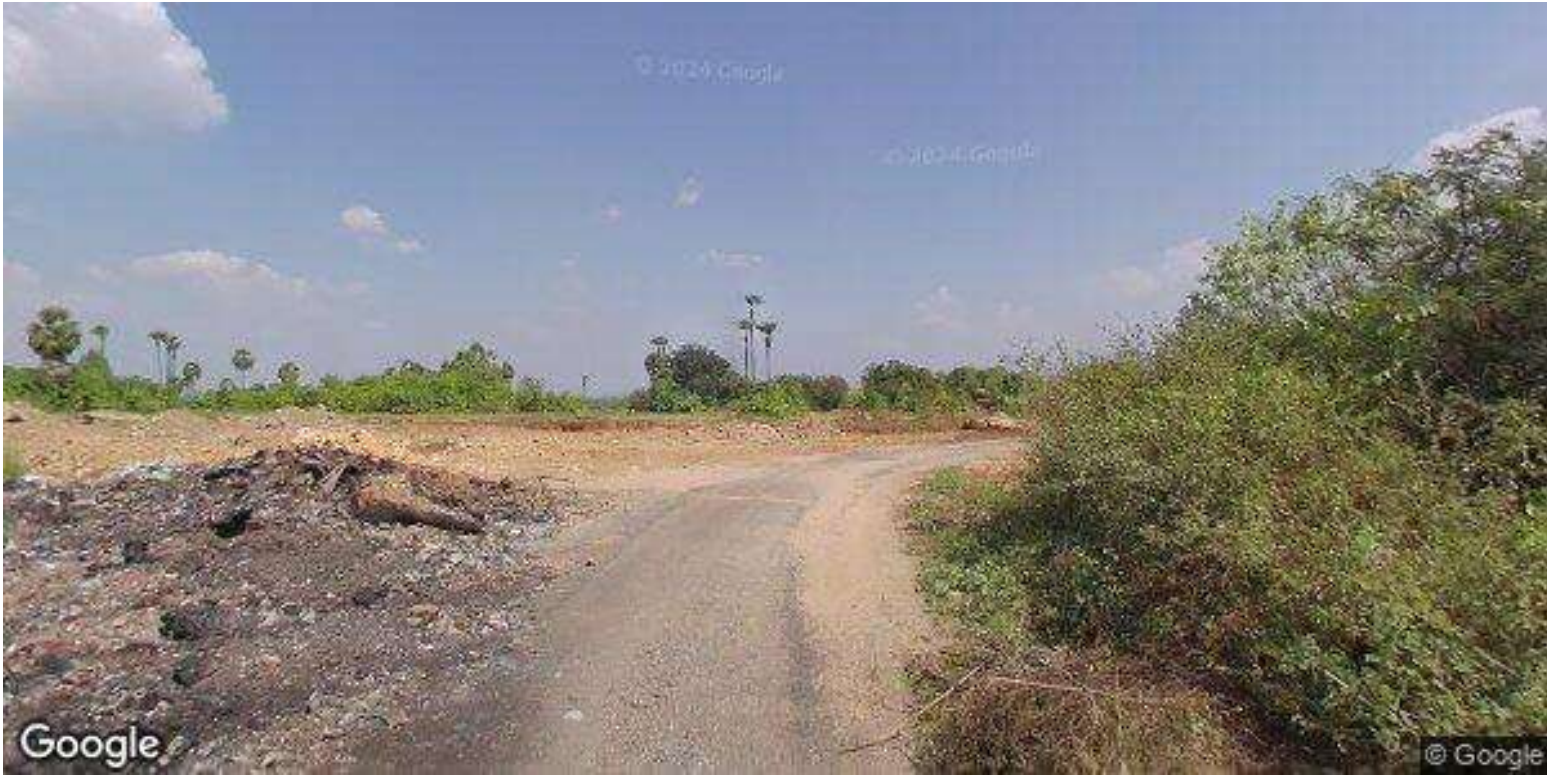
**Risk Type:** Turn  
**Risk Level:** Medium  
**Speed Limit:** 30 KM/Hr  
**Coordinates:** 11.41342, 77.92087

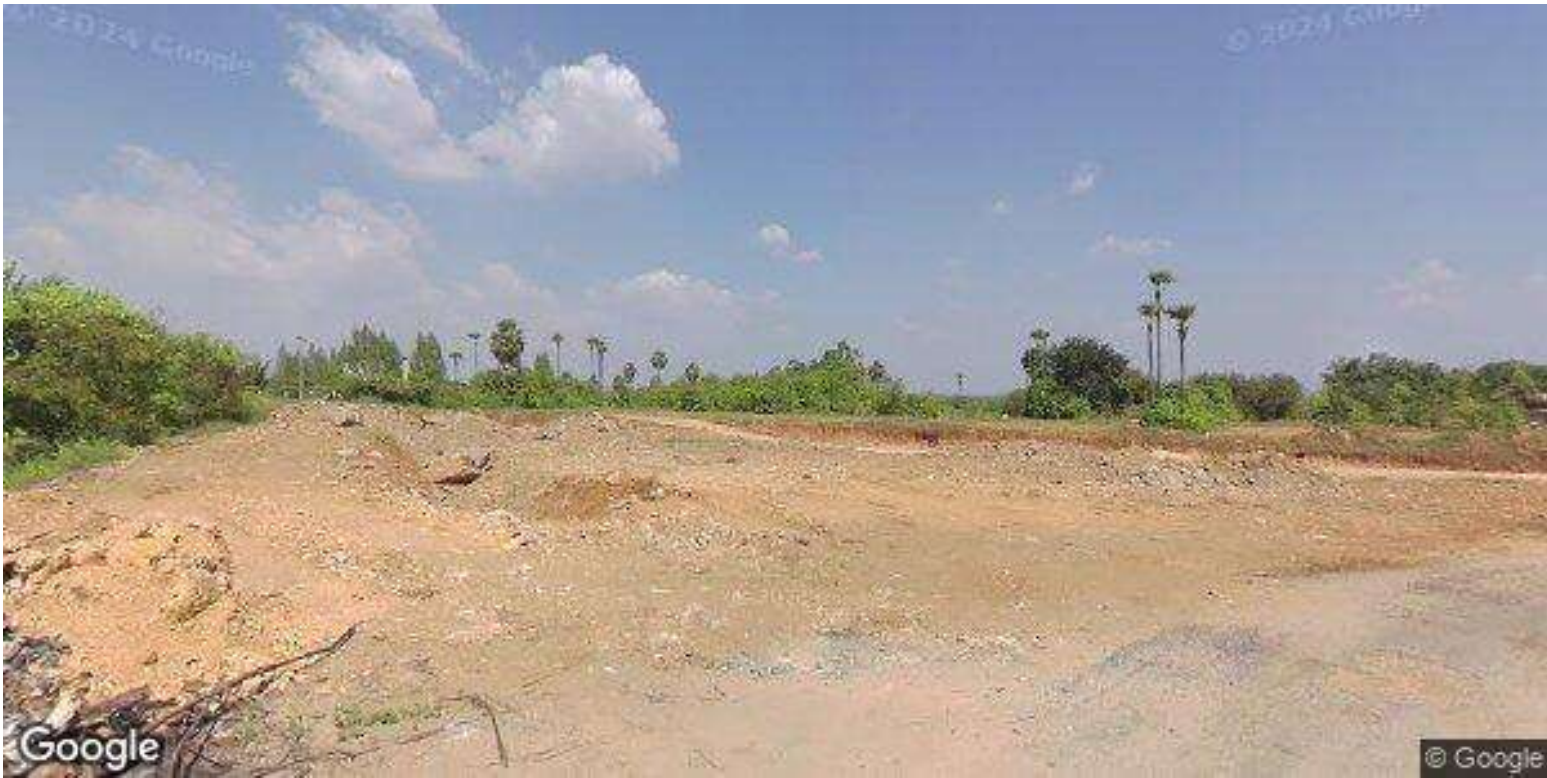
**Risk Type:** Blind Spot  
**Risk Level:** Blind Spot  
**Speed Limit:** 10 KM/Hr  
**Coordinates:** 11.41350, 77.92093

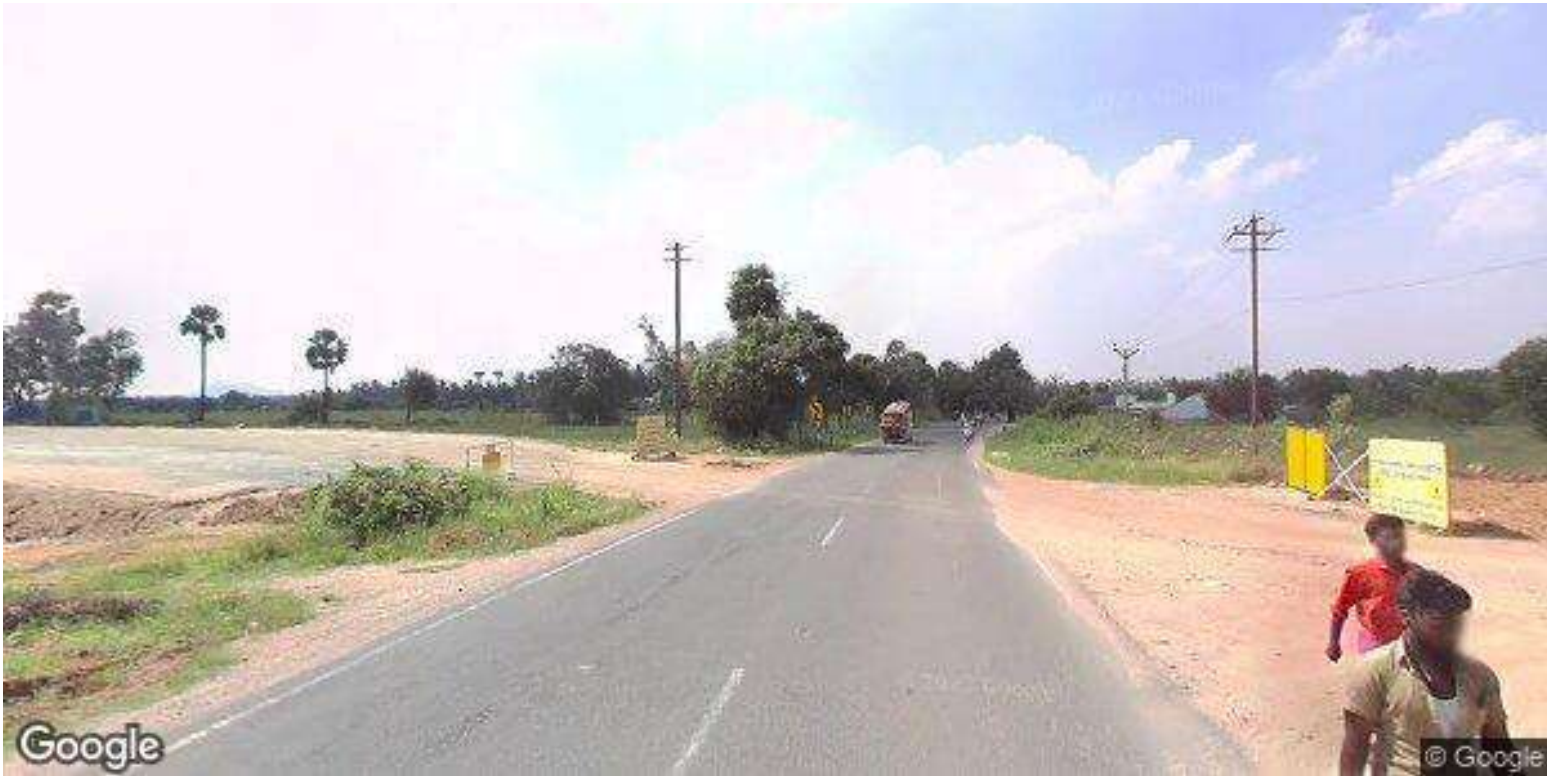
**Risk Type:** Turn  
**Risk Level:** High  
**Speed Limit:** 15 KM/Hr  
**Coordinates:** 11.40566, 77.92355

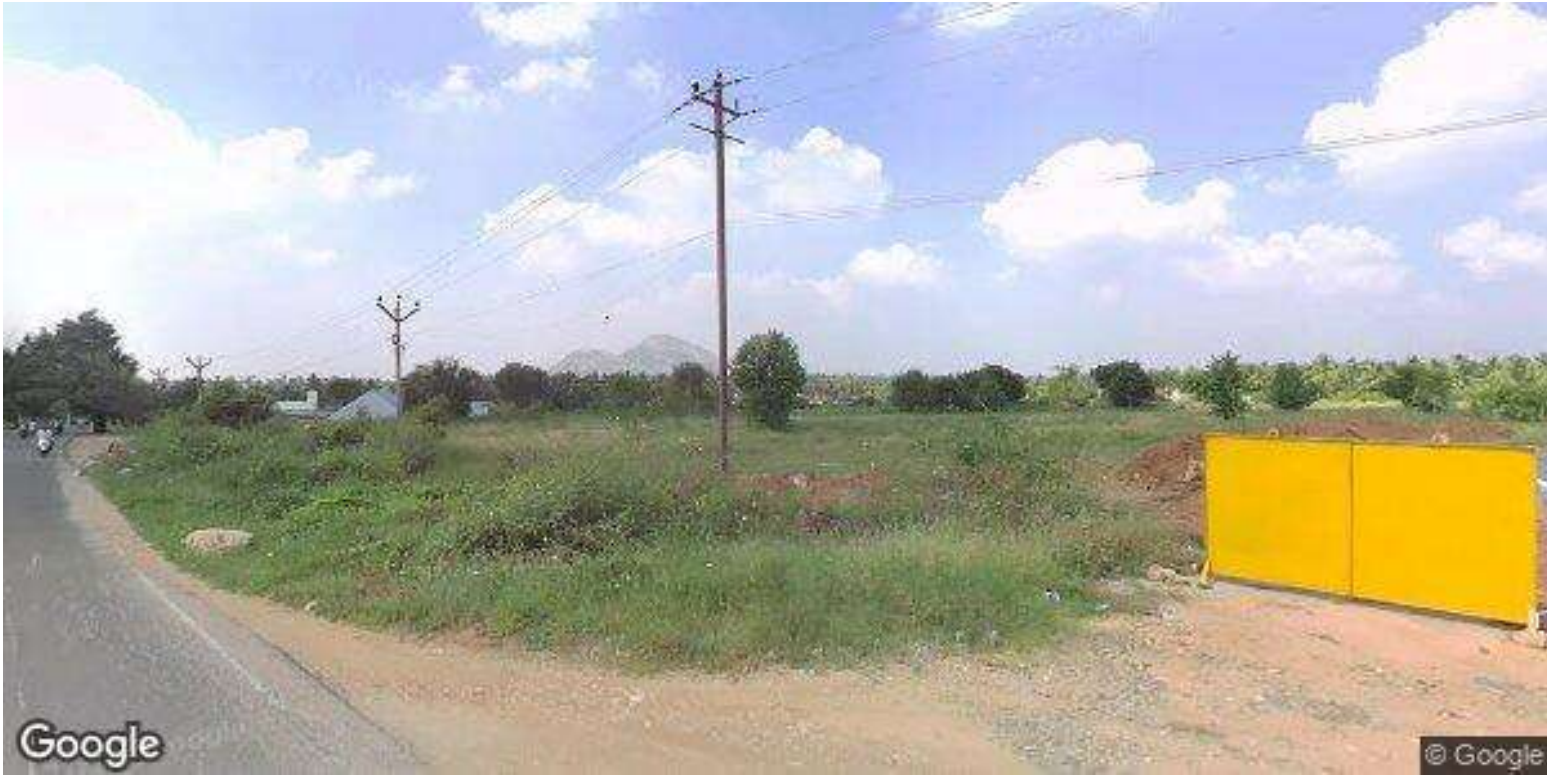
**Risk Type:** Turn  
**Risk Level:** High  
**Speed Limit:** 15 KM/Hr  
**Coordinates:** 11.40557, 77.92343

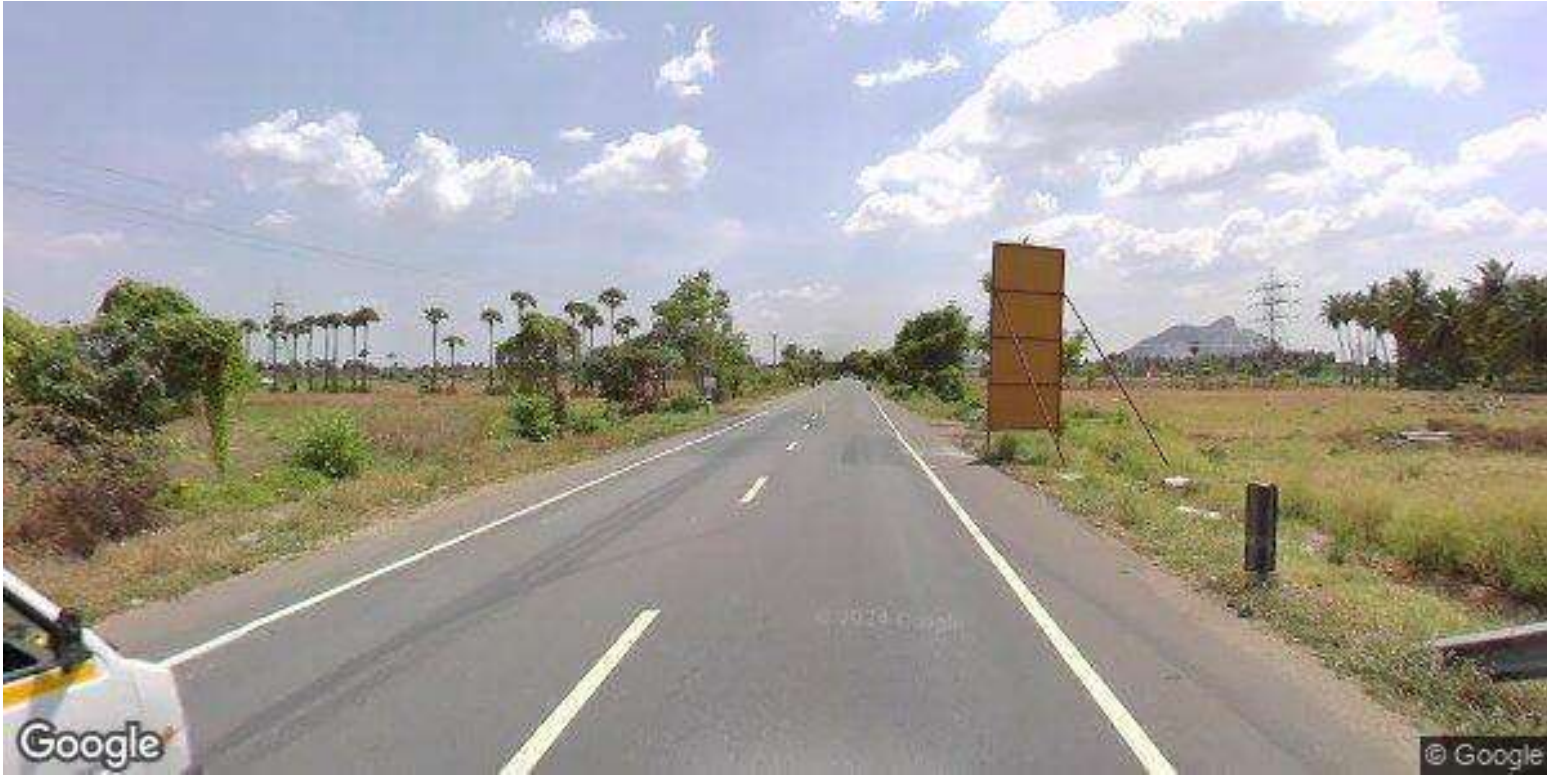
**Risk Type:** Blind Spot  
**Risk Level:** Blind Spot  
**Speed Limit:** 10 KM/Hr  
**Coordinates:** 11.36920, 77.94568
