## **JOURNEY RISK MANAGEMENT (JRM) STUDY**

### **Salem Terminal to SRI VANGALAMMAN FUEL AGENCIES**

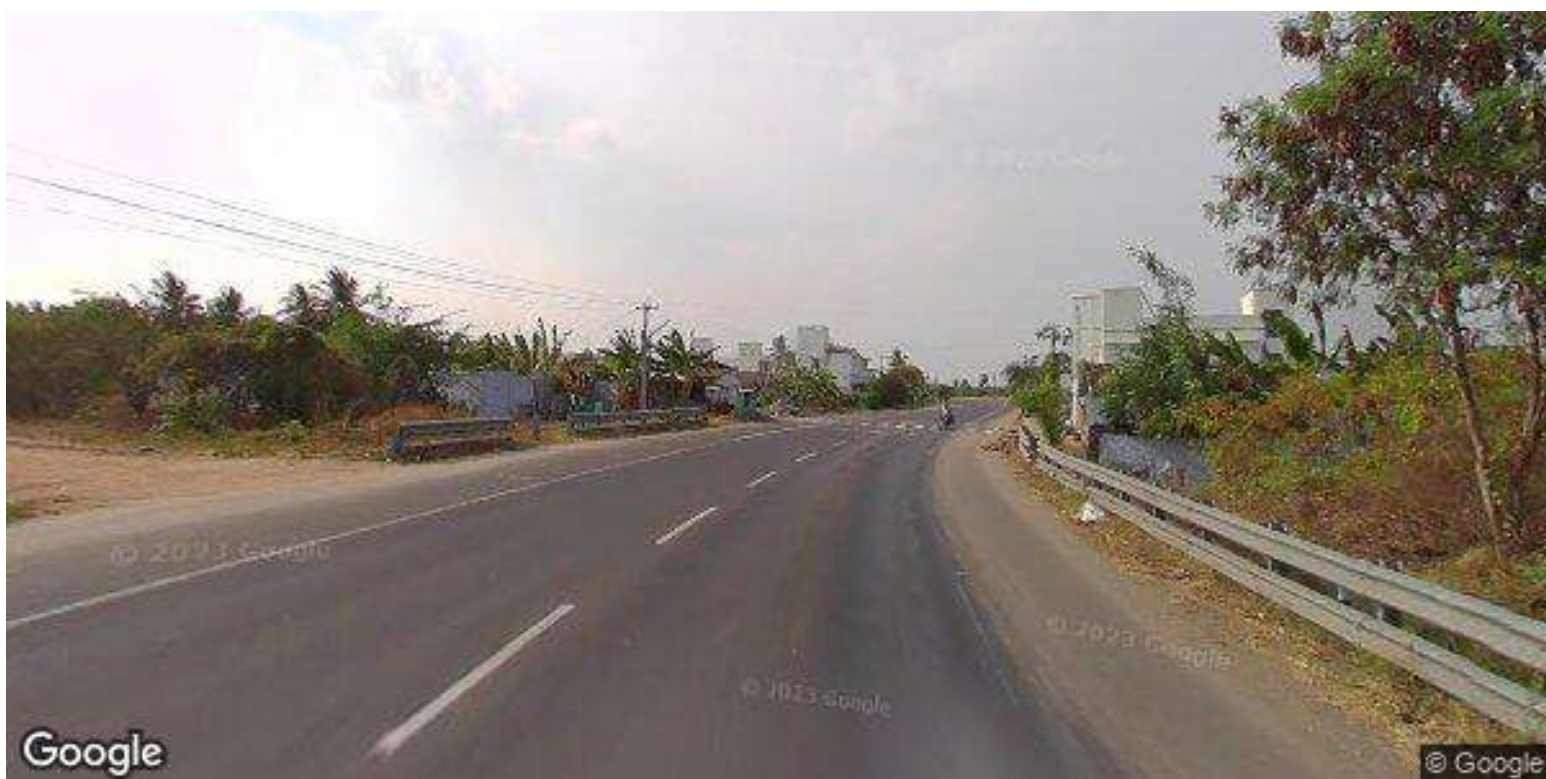
**Coordinates:** 11.16764, 78.01565

**Risk Type:** Turn

**Risk Level:** Medium

**Speed Limit:** 30 KM/Hr

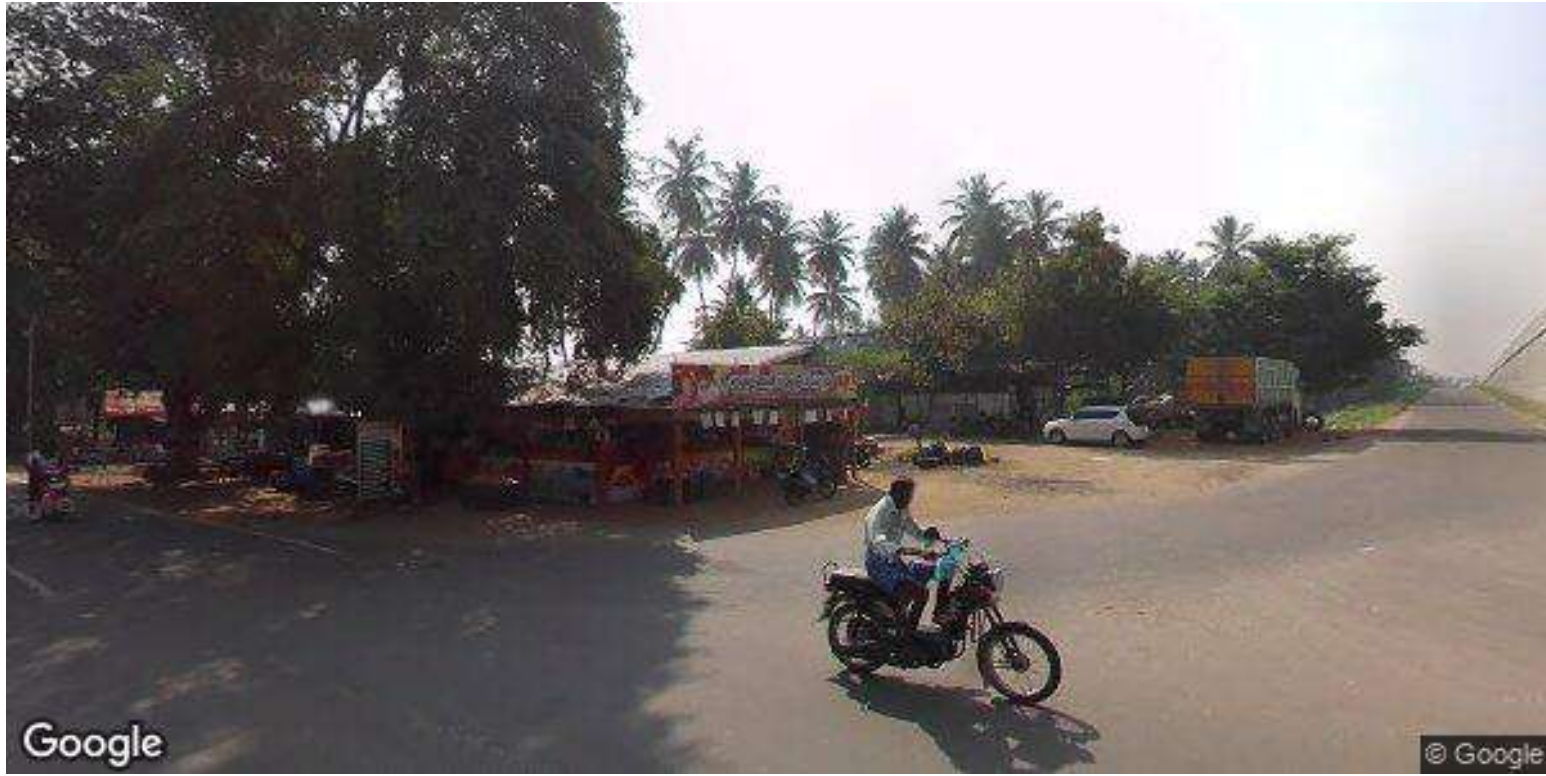
**Risk Type:** Blind Spot  
**Risk Level:** Blind Spot  
**Speed Limit:** 10 KM/Hr  
**Coordinates:** 11.11397, 78.01722

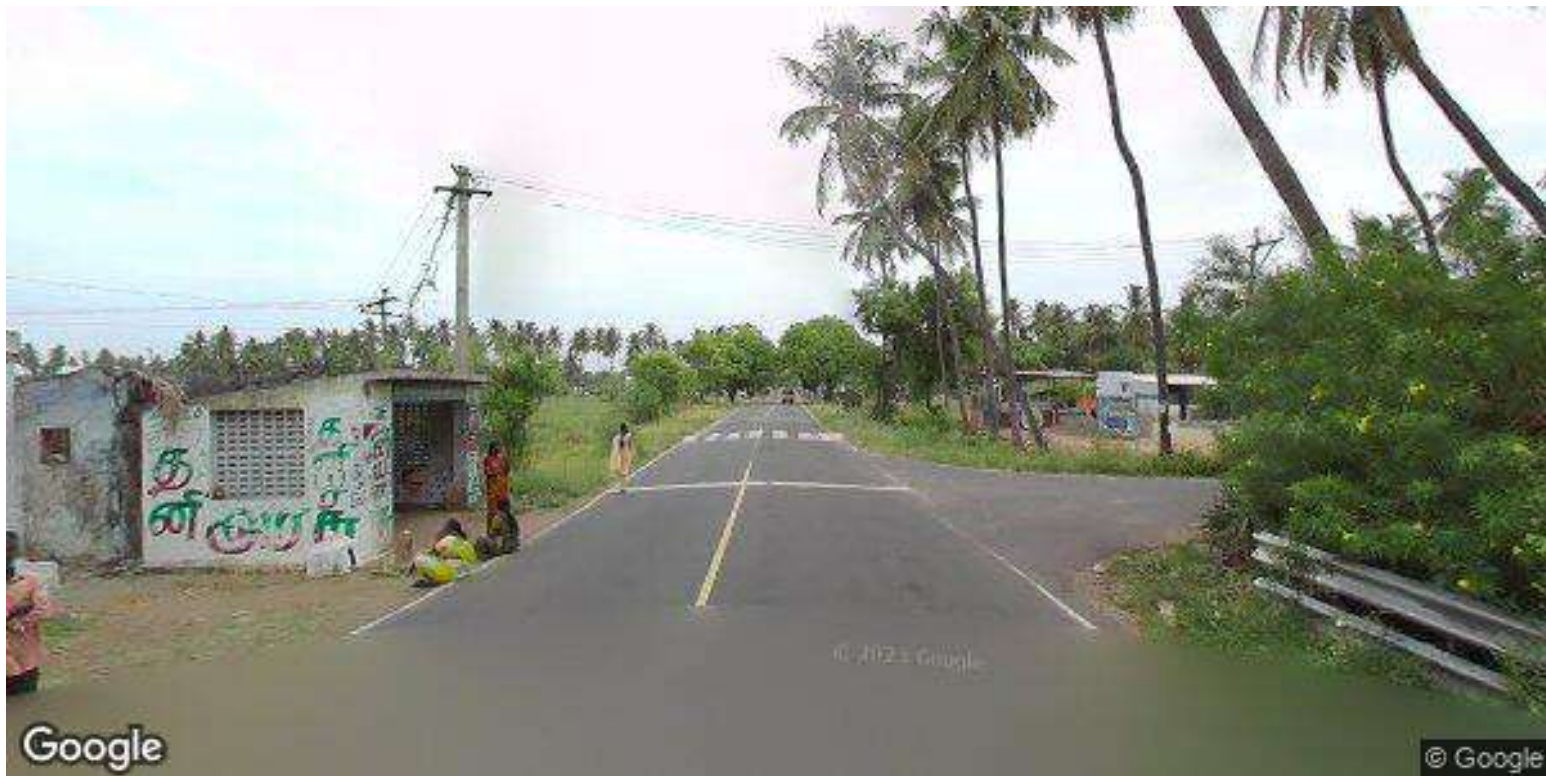
**Risk Type:** Turn  
**Risk Level:** Medium  
**Speed Limit:** 30 KM/Hr  
**Coordinates:** 11.10418, 78.04796
