# IndianOil

## **JOURNEY RISK MANAGEMENT (JRM) STUDY**

### **Salem Terminal to SRI RAGAVENDRA FUELS**

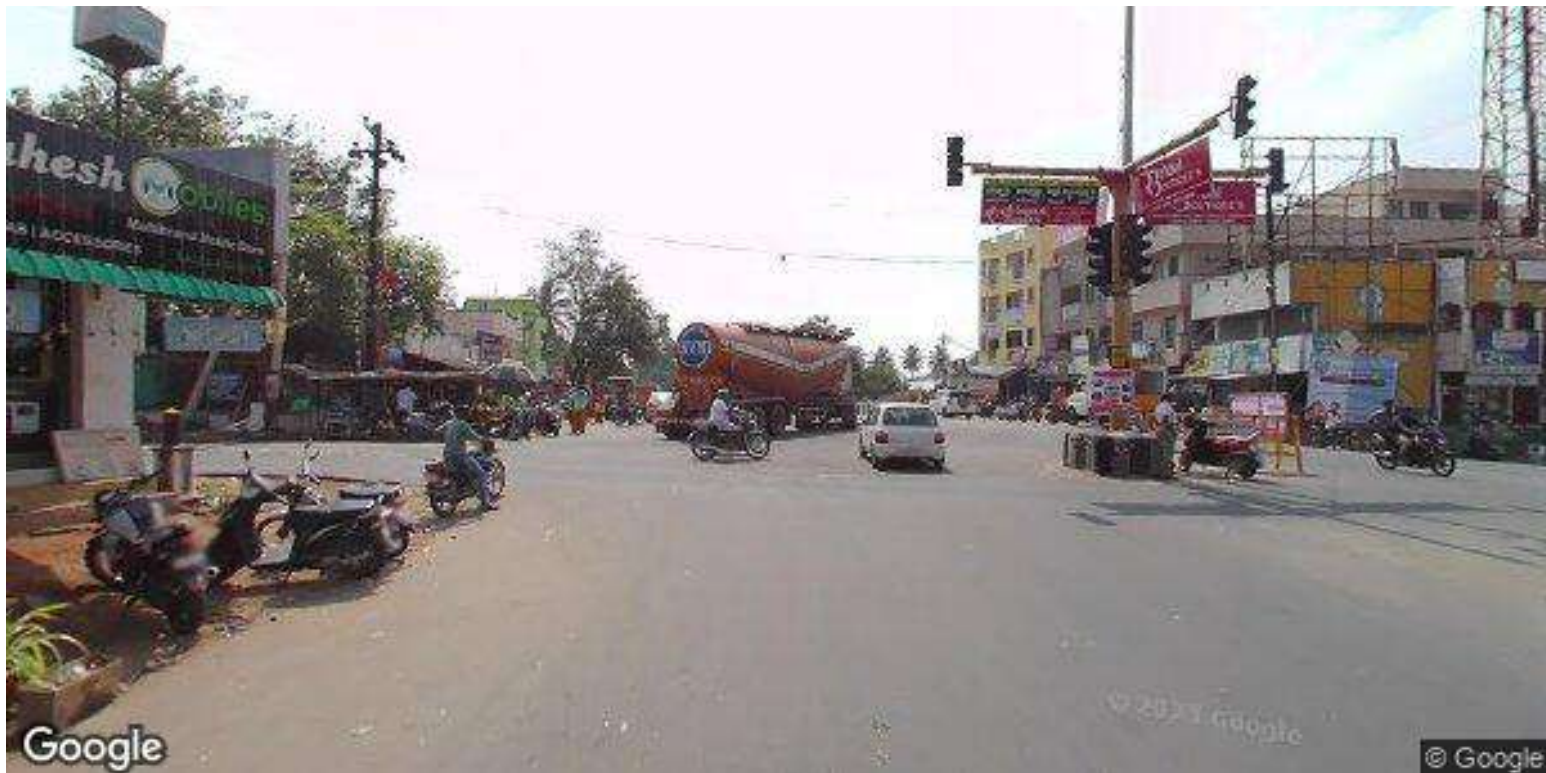
**Coordinates:** 11.36616, 77.88885

**Risk Type:** Turn

**Risk Level:** Medium

**Speed Limit:** 30 KM/Hr

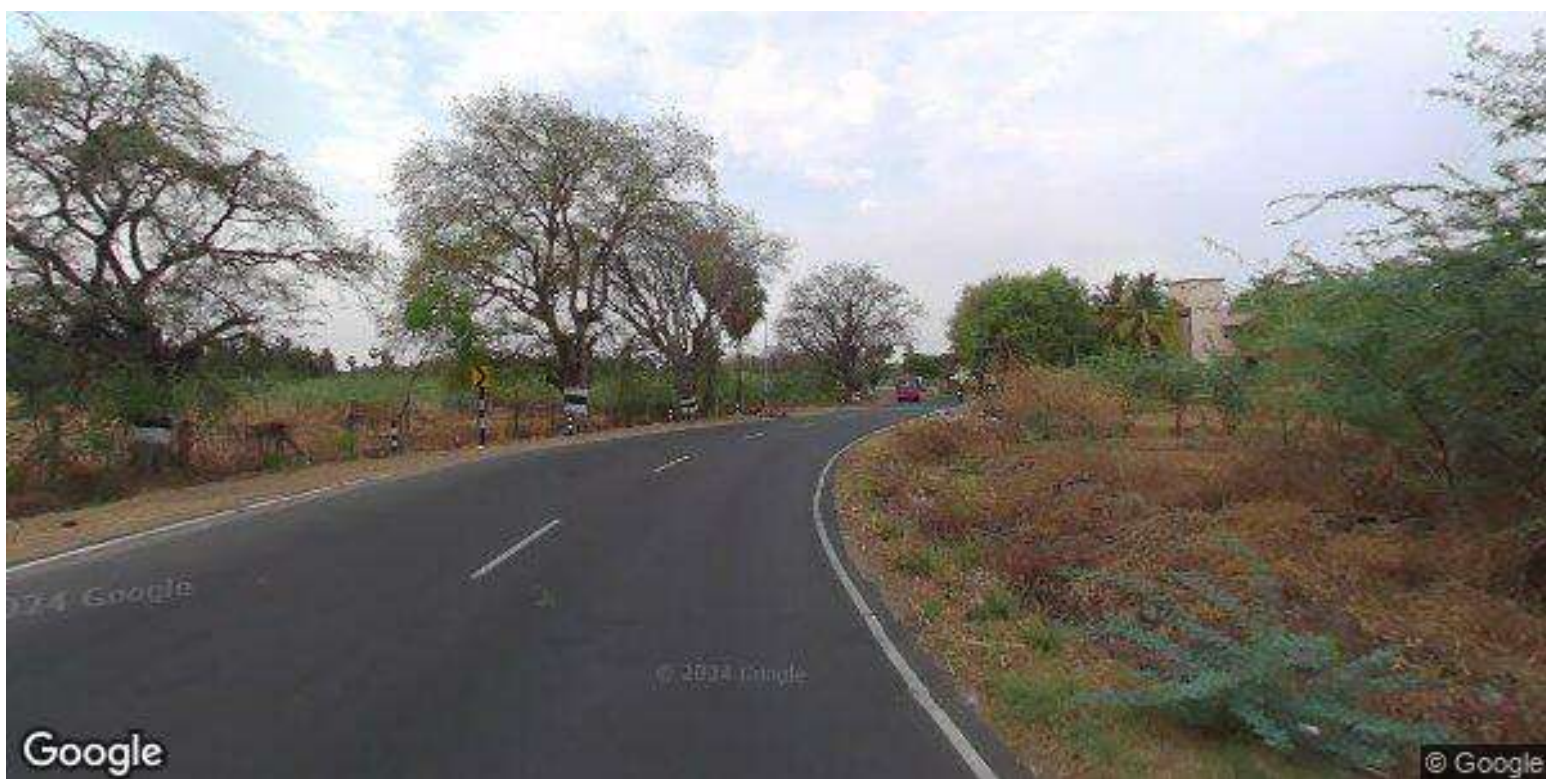
**Coordinates:** 11.34067, 77.86347

**Risk Type:** Turn

**Risk Level:** Medium

**Speed Limit:** 30 KM/Hr

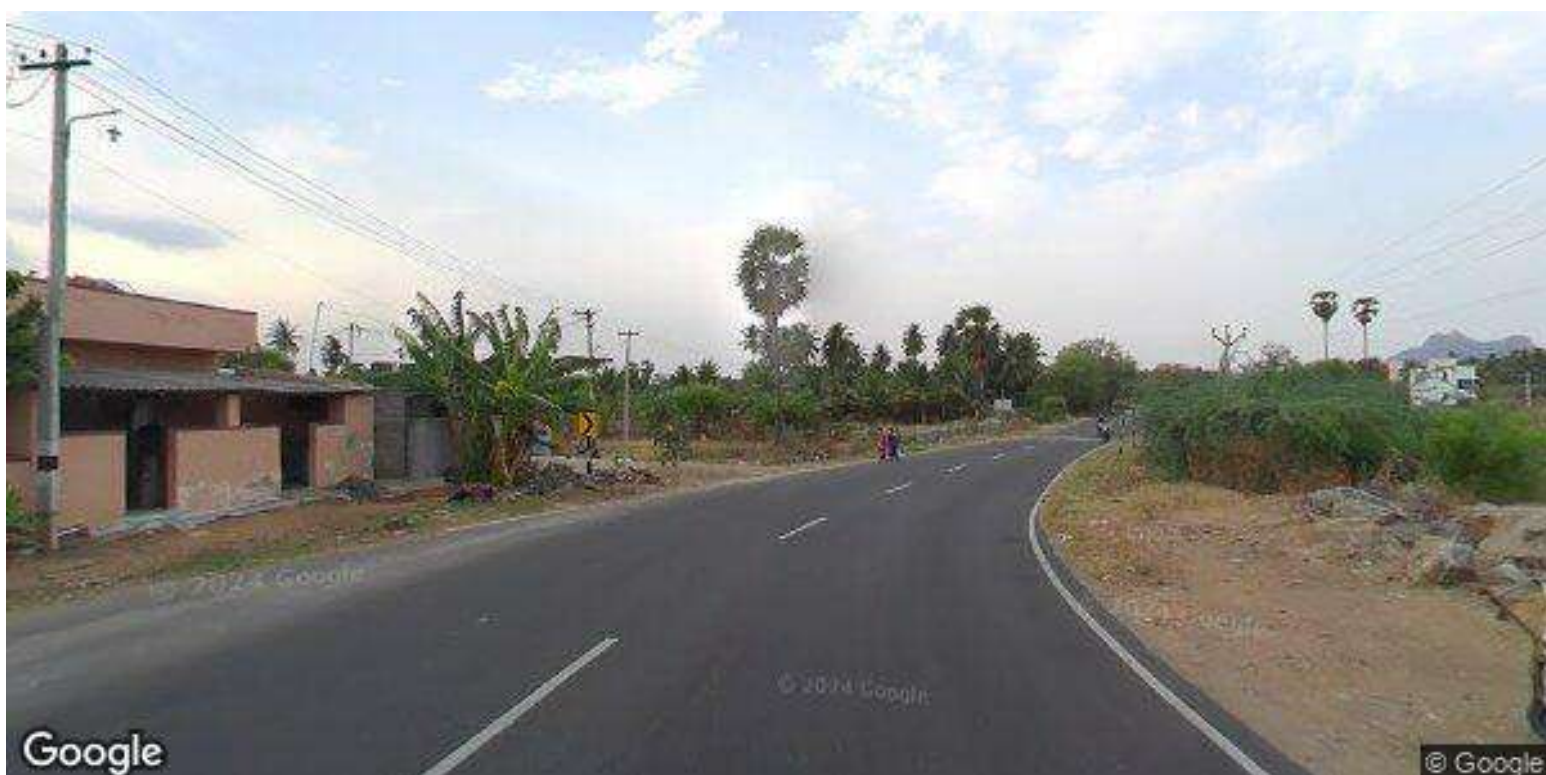
**Coordinates:** 11.33882, 77.86218

**Risk Type:** Turn

**Risk Level:** Medium

**Speed Limit:** 30 KM/Hr

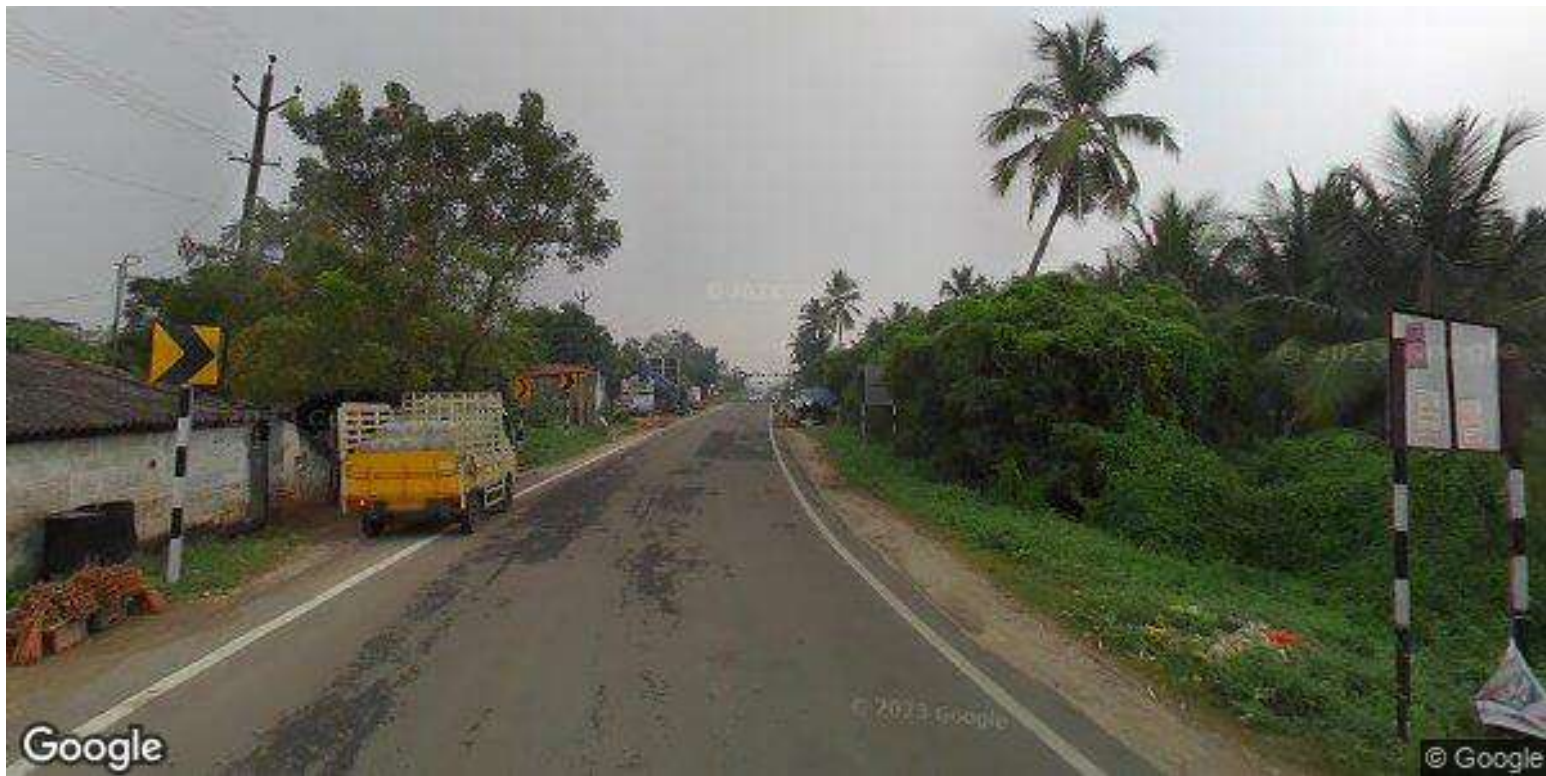
**Coordinates:** 11.30973, 77.76712

**Risk Type:** Turn

**Risk Level:** Medium

**Speed Limit:** 30 KM/Hr

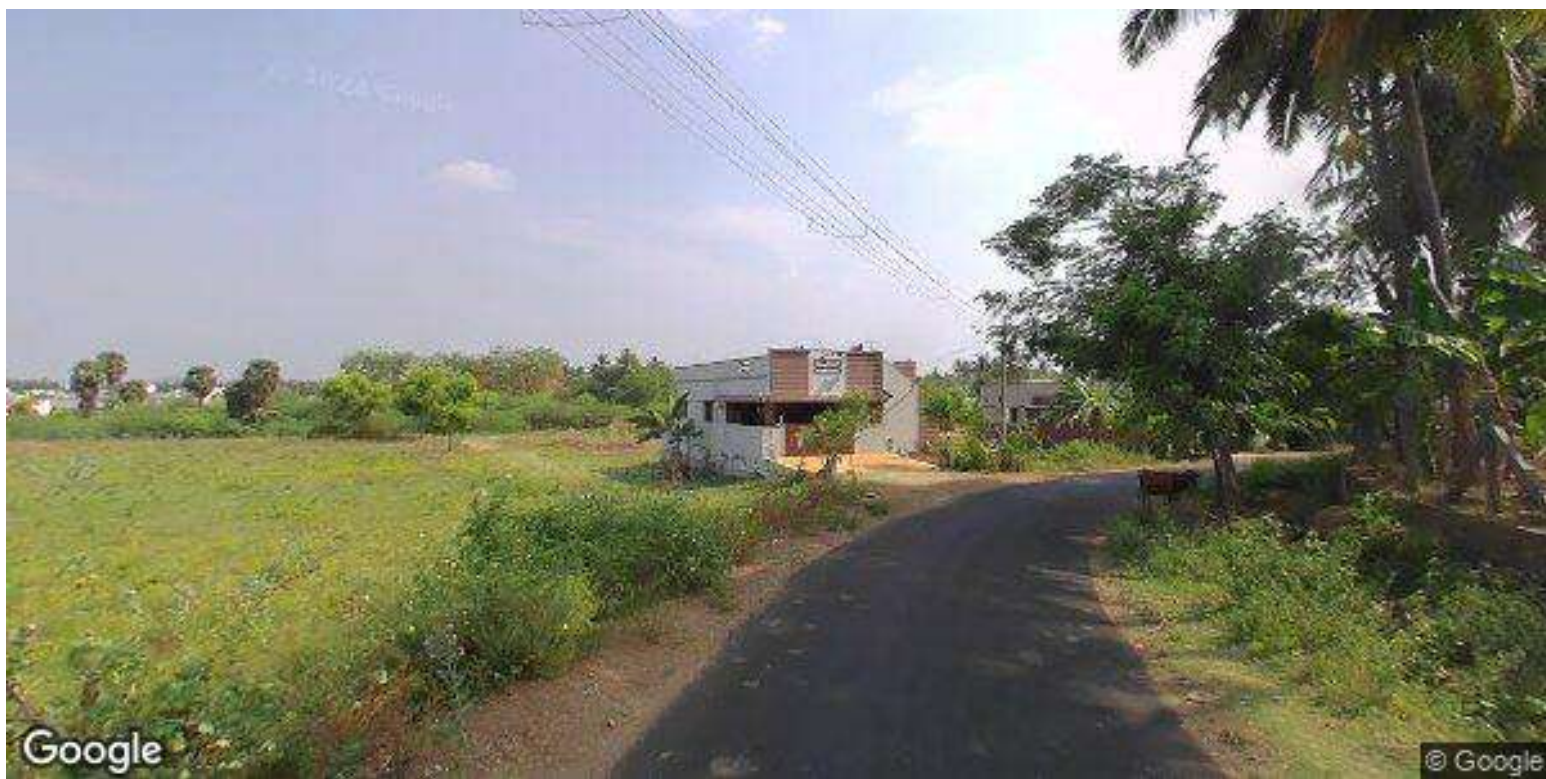
**Risk Type:** Turn  
**Risk Level:** Medium  
**Speed Limit:** 30 KM/Hr  
**Coordinates:** 11.27336, 77.72999

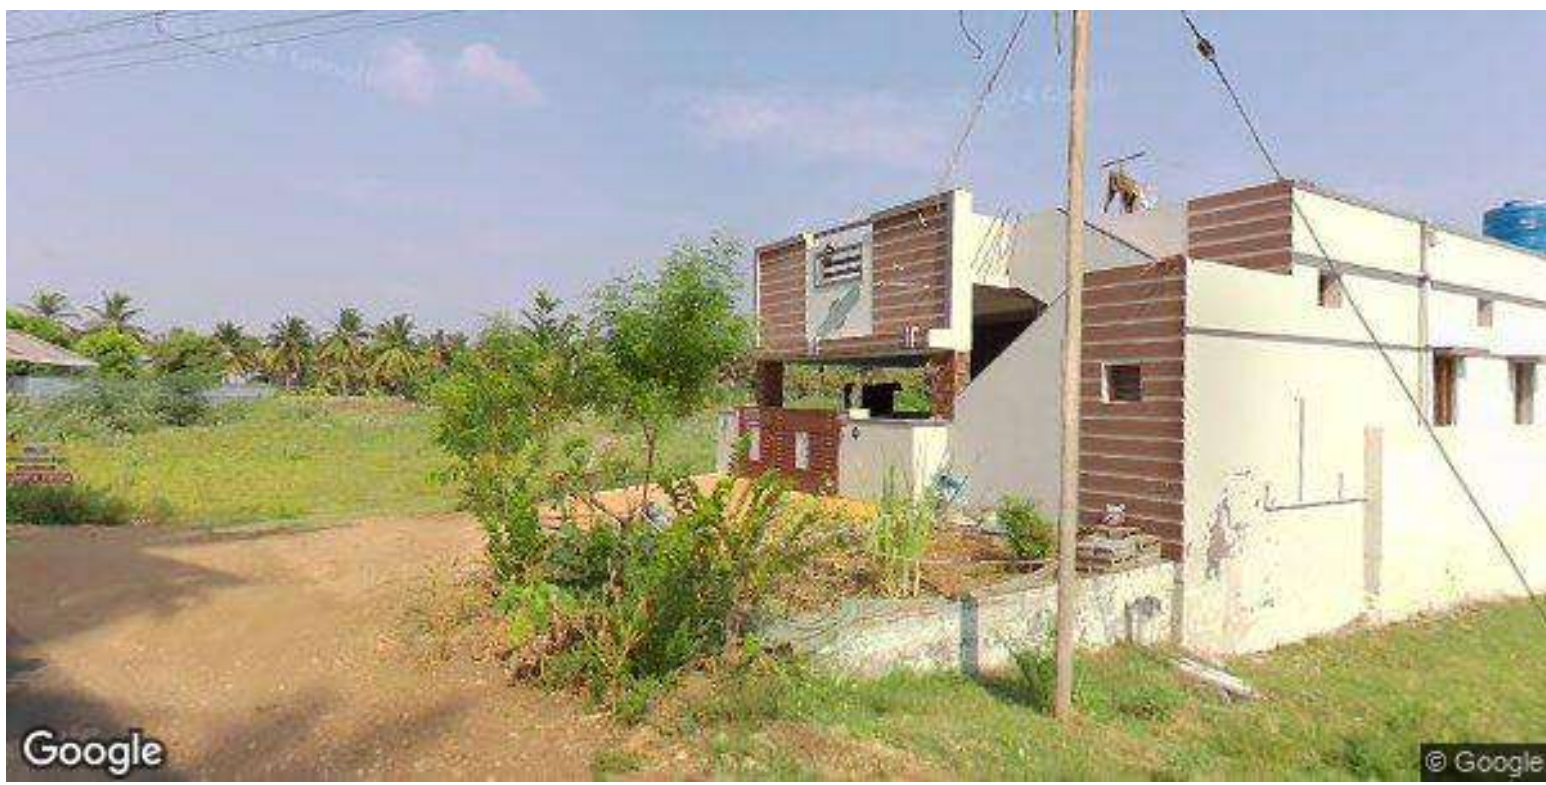
**Coordinates:** 11.27319, 77.72981

**Risk Type:** Turn

**Risk Level:** Medium

**Speed Limit:** 30 KM/Hr

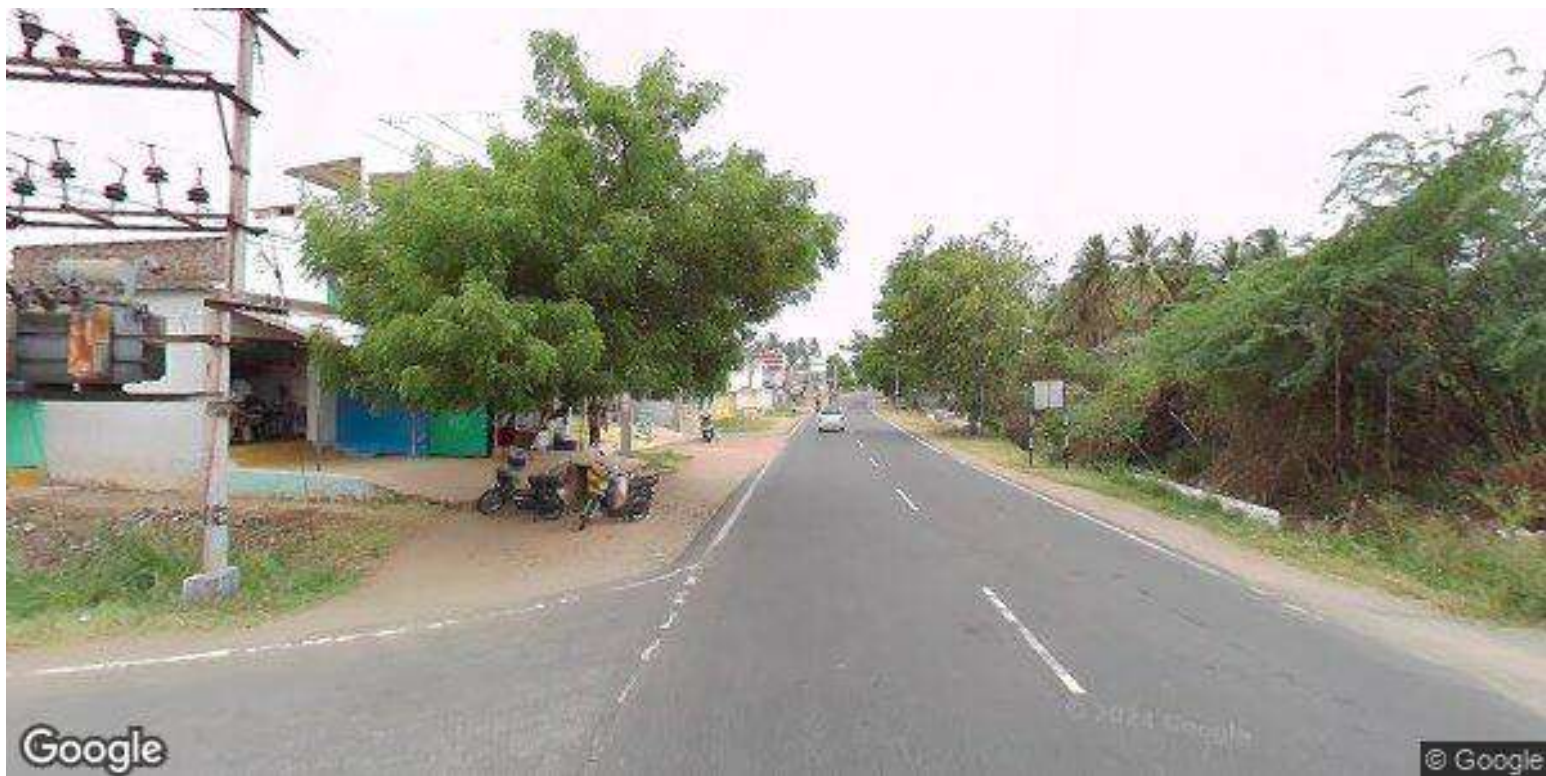
**Coordinates:** 11.27328, 77.72705

**Risk Type:** Turn

**Risk Level:** High

**Speed Limit:** 15 KM/Hr

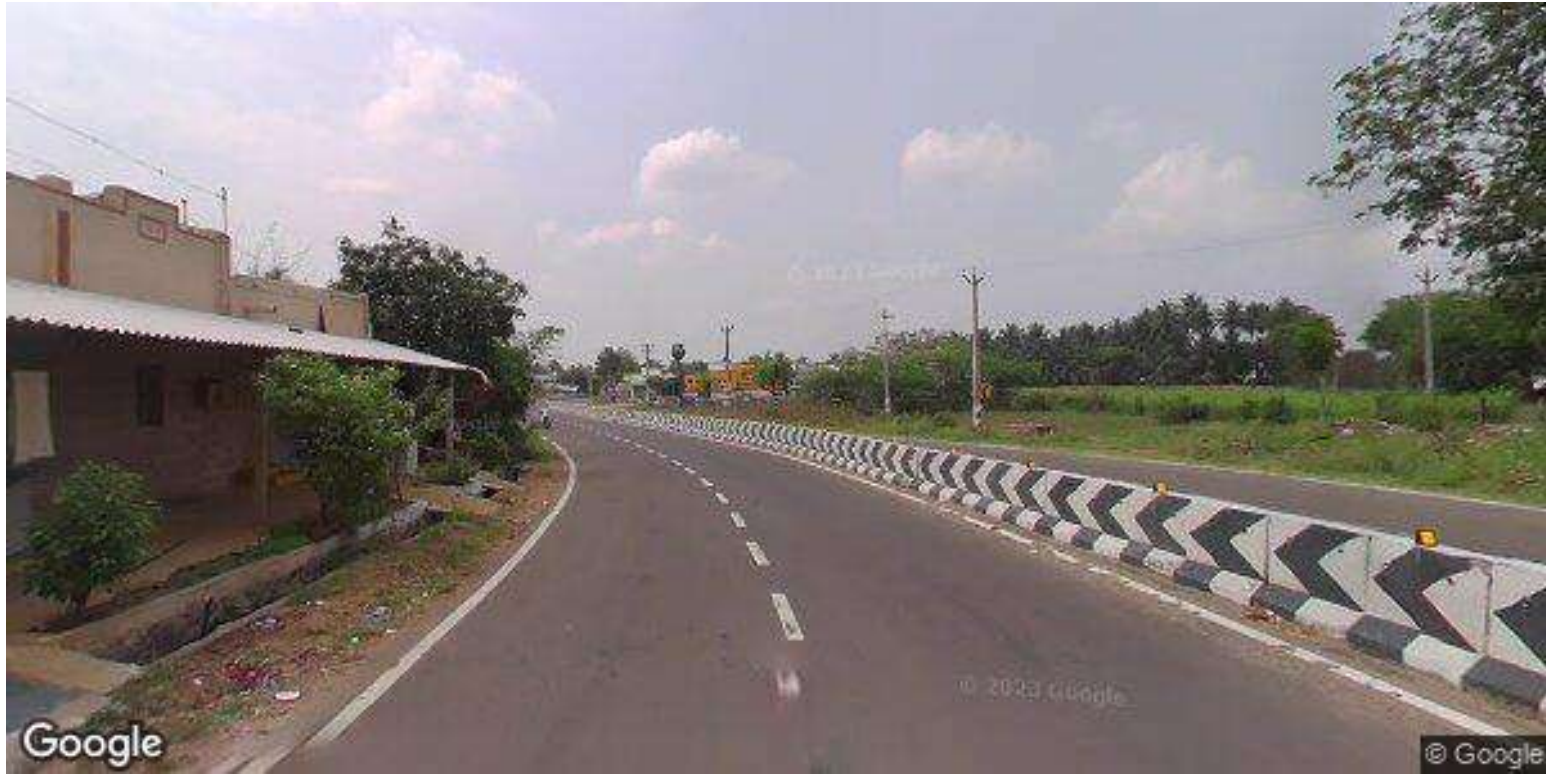
**Coordinates:** 11.22387, 77.71385

**Risk Type:** Turn

**Risk Level:** Medium

**Speed Limit:** 30 KM/Hr

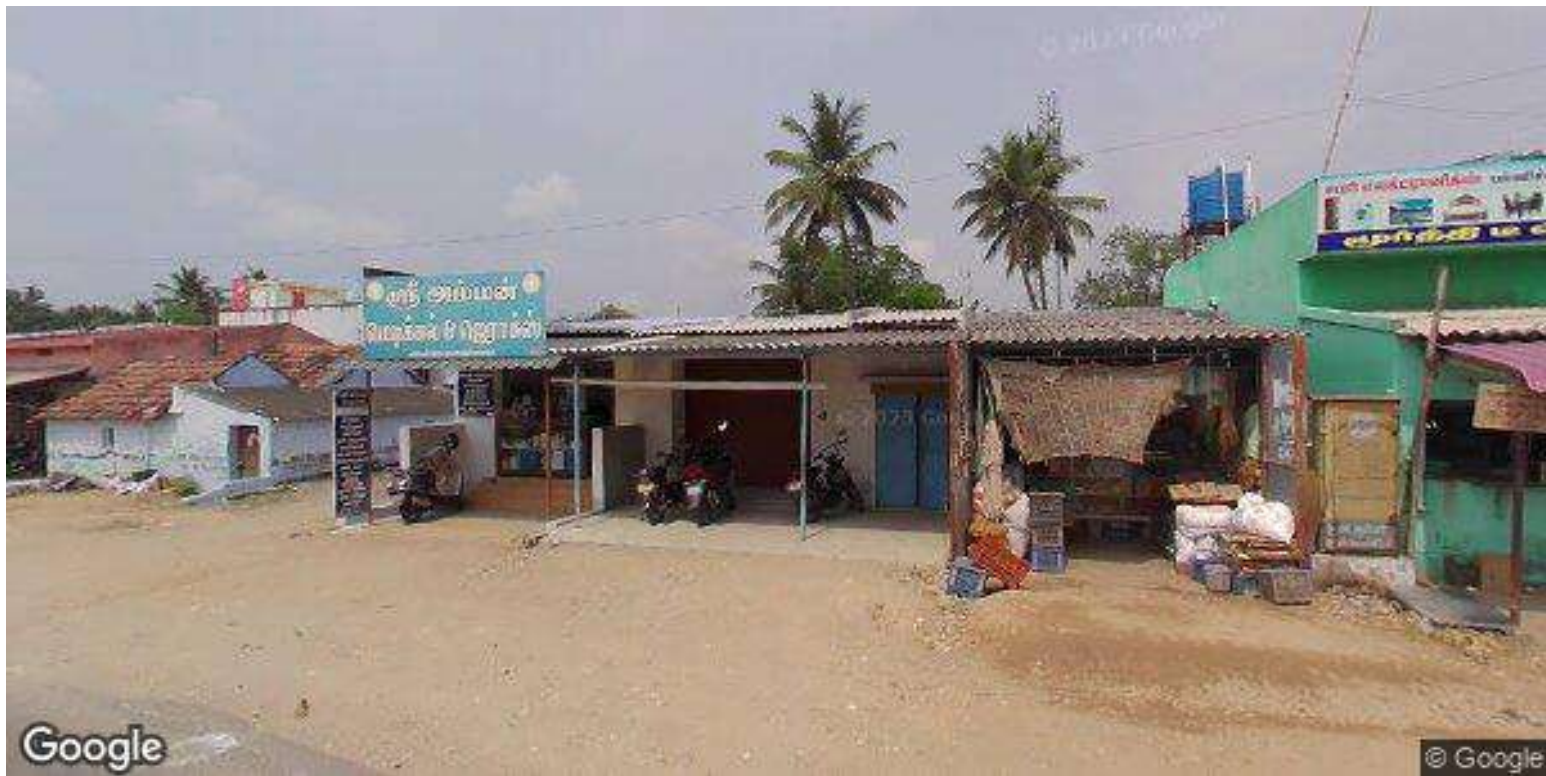
**Coordinates:** 11.20776, 77.70916

**Risk Type:** Turn

**Risk Level:** Medium

**Speed Limit:** 30 KM/Hr

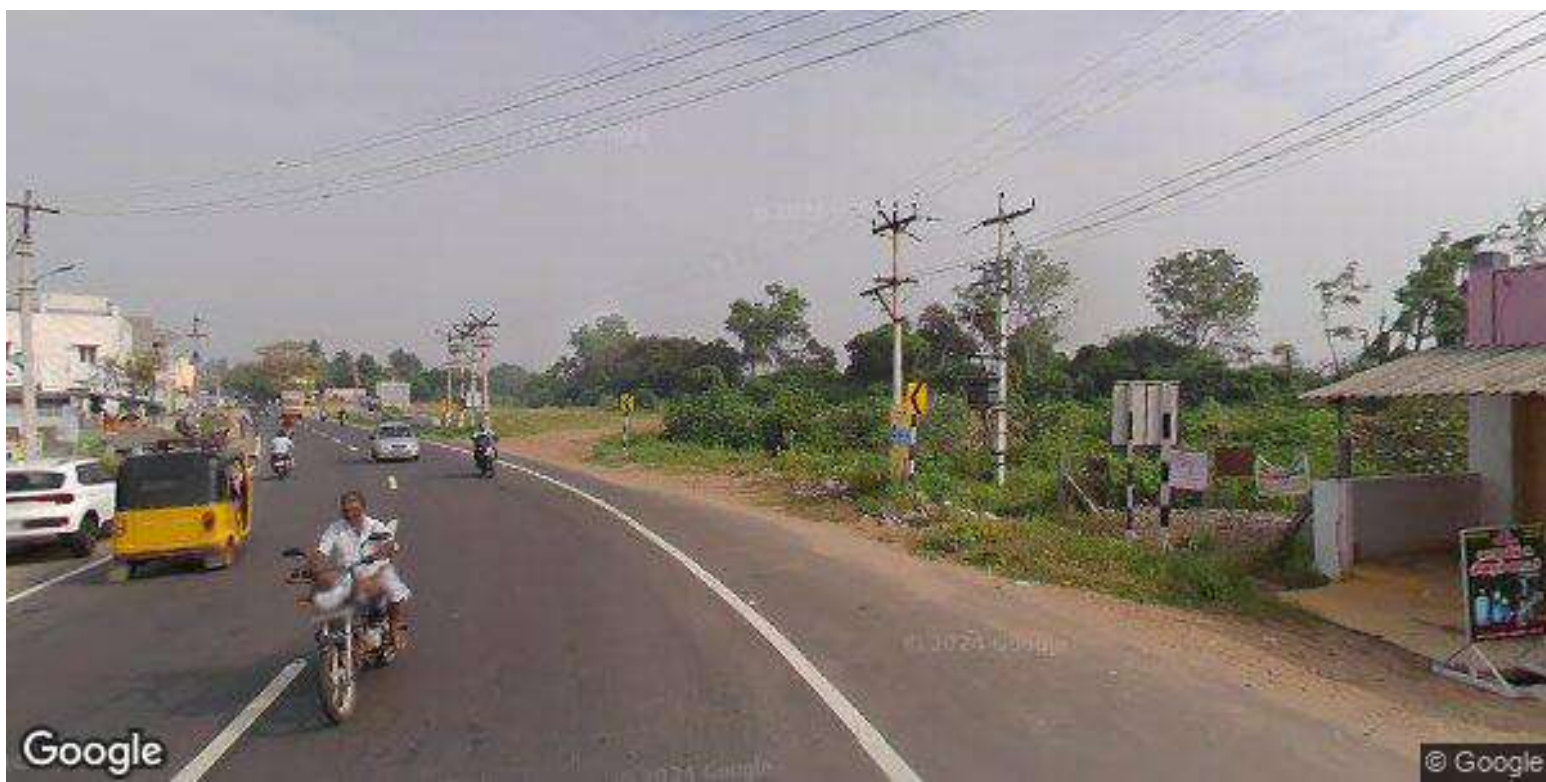
**Coordinates:** 11.16078, 77.70122

**Risk Type:** Turn

**Risk Level:** Medium

**Speed Limit:** 30 KM/Hr

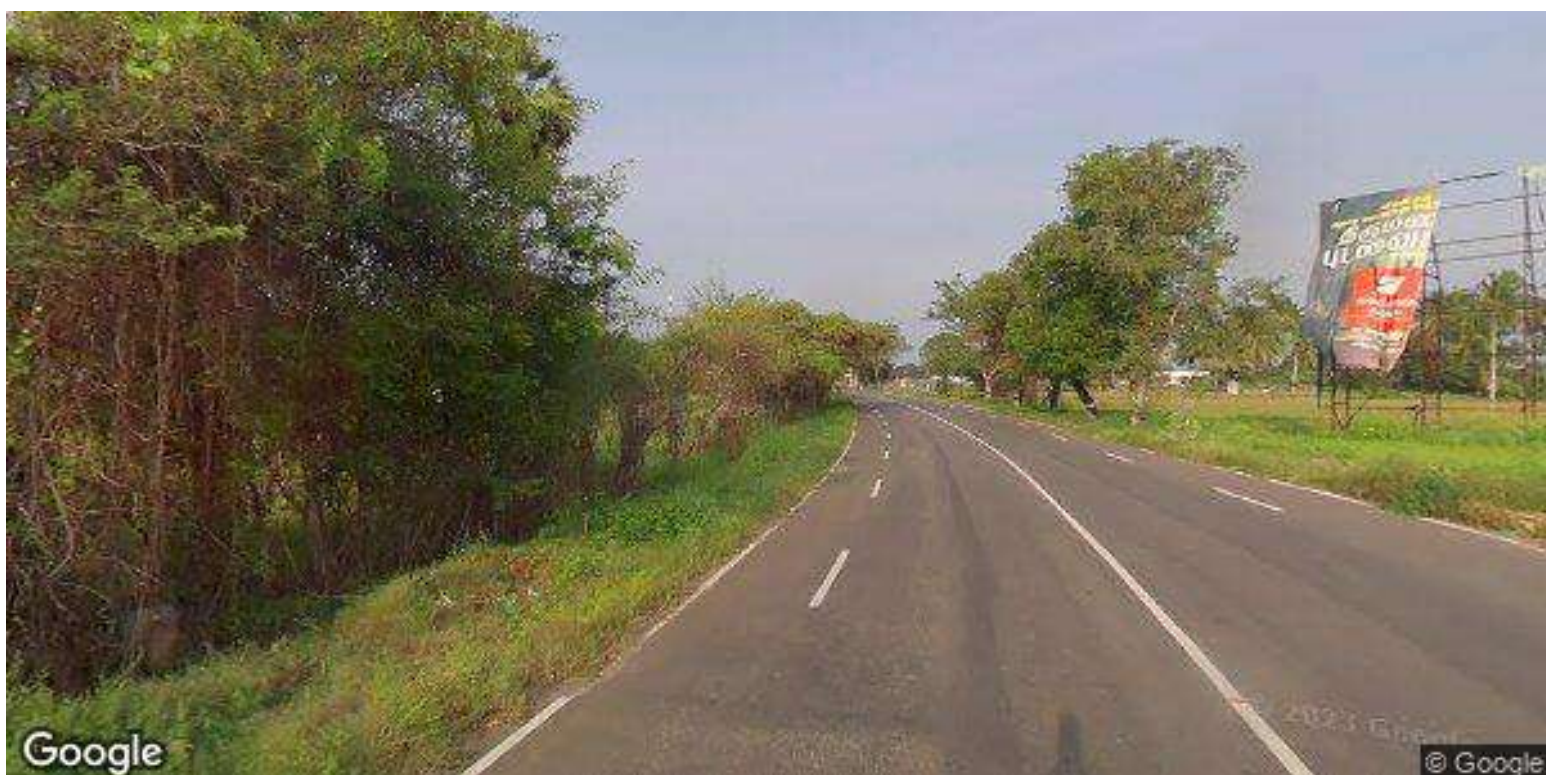
**Risk Type:** Turn  
**Risk Level:** Medium  
**Speed Limit:** 30 KM/Hr  
**Coordinates:** 11.11932, 77.67786

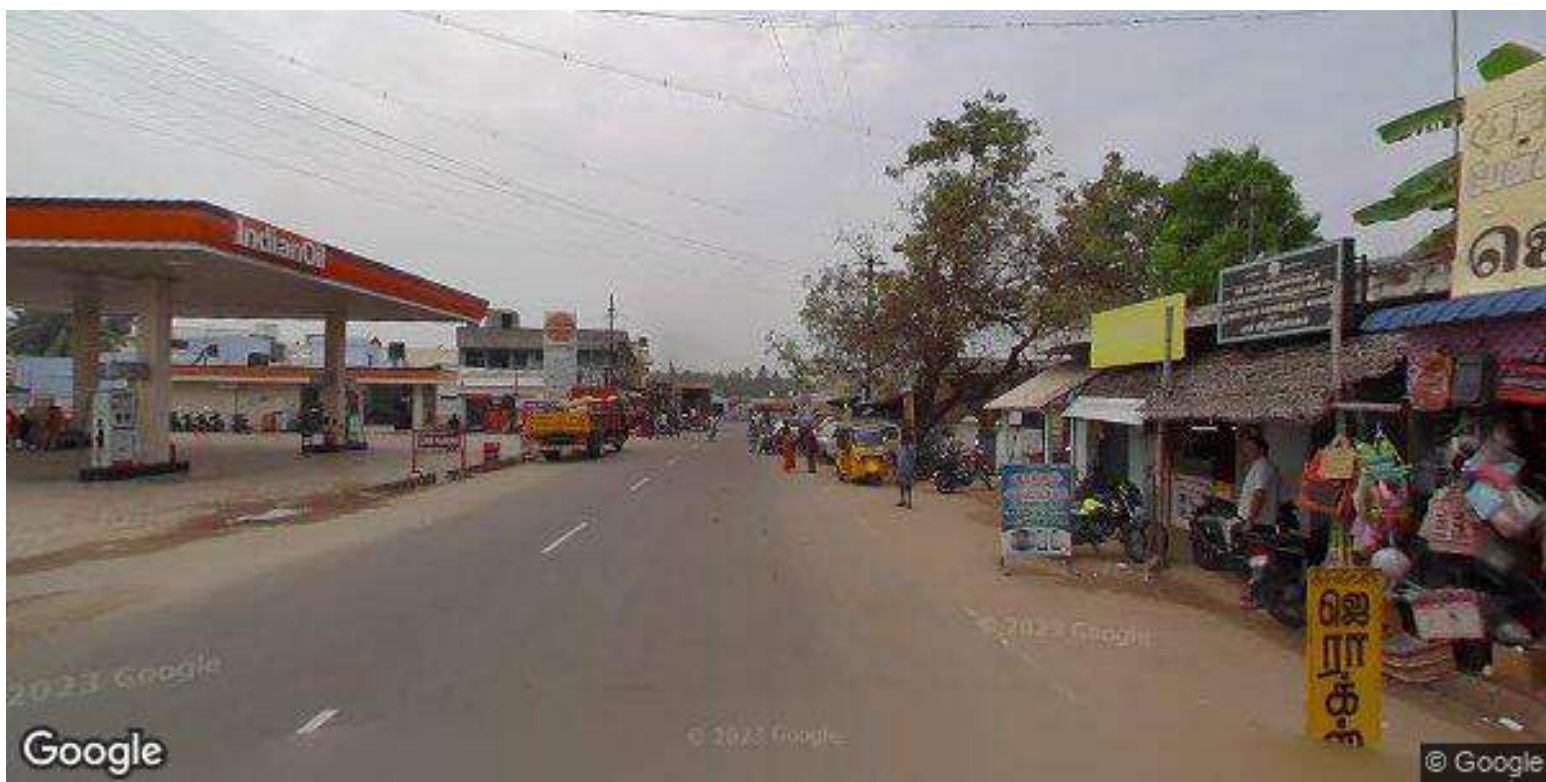
**Risk Type:** Blind Spot  
**Risk Level:** Blind Spot  
**Speed Limit:** 10 KM/Hr  
**Coordinates:** 11.08565, 77.66268

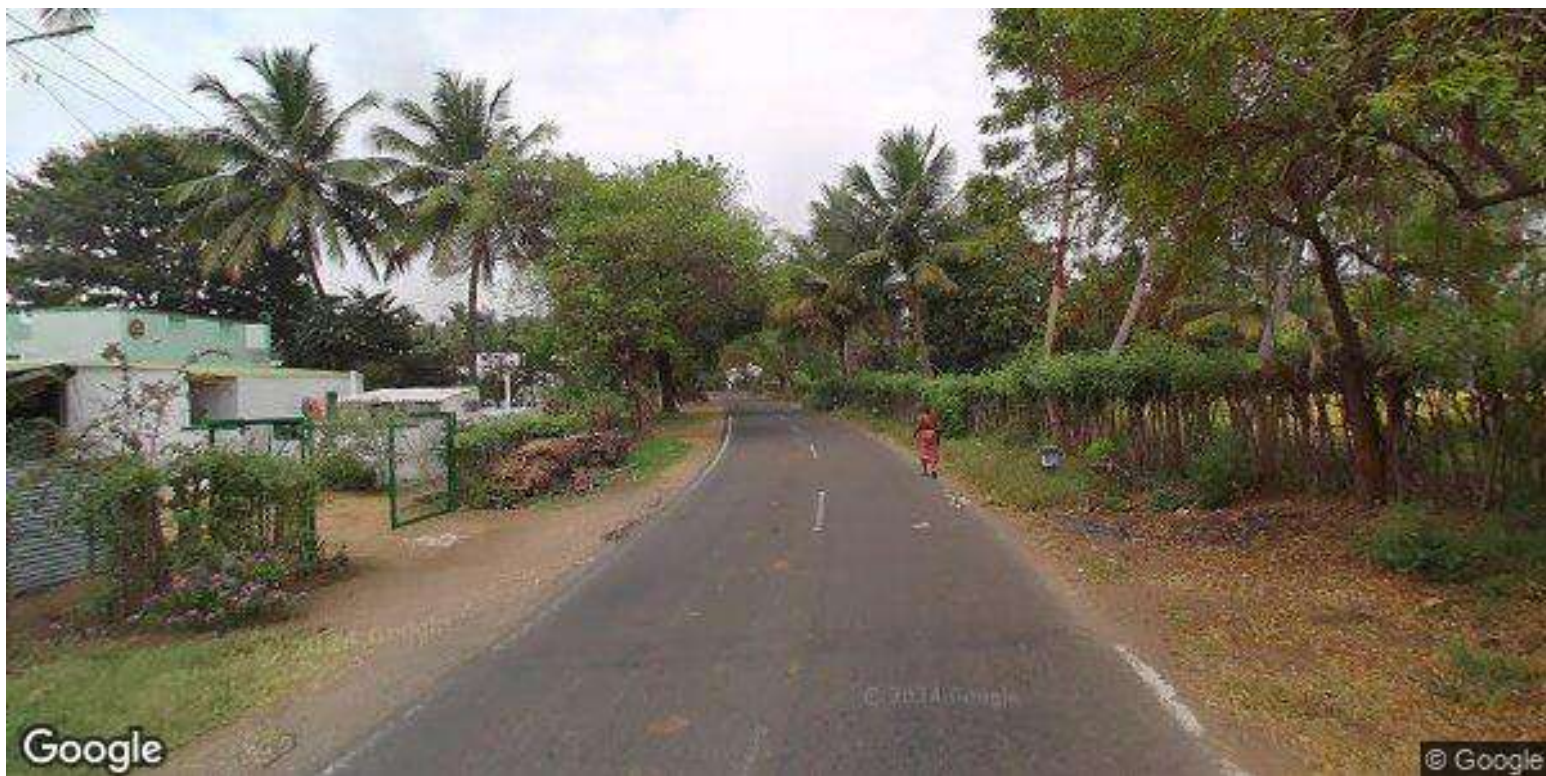
**Risk Type:** Turn  
**Risk Level:** Medium  
**Speed Limit:** 30 KM/Hr  
**Coordinates:** 11.08380, 77.68463

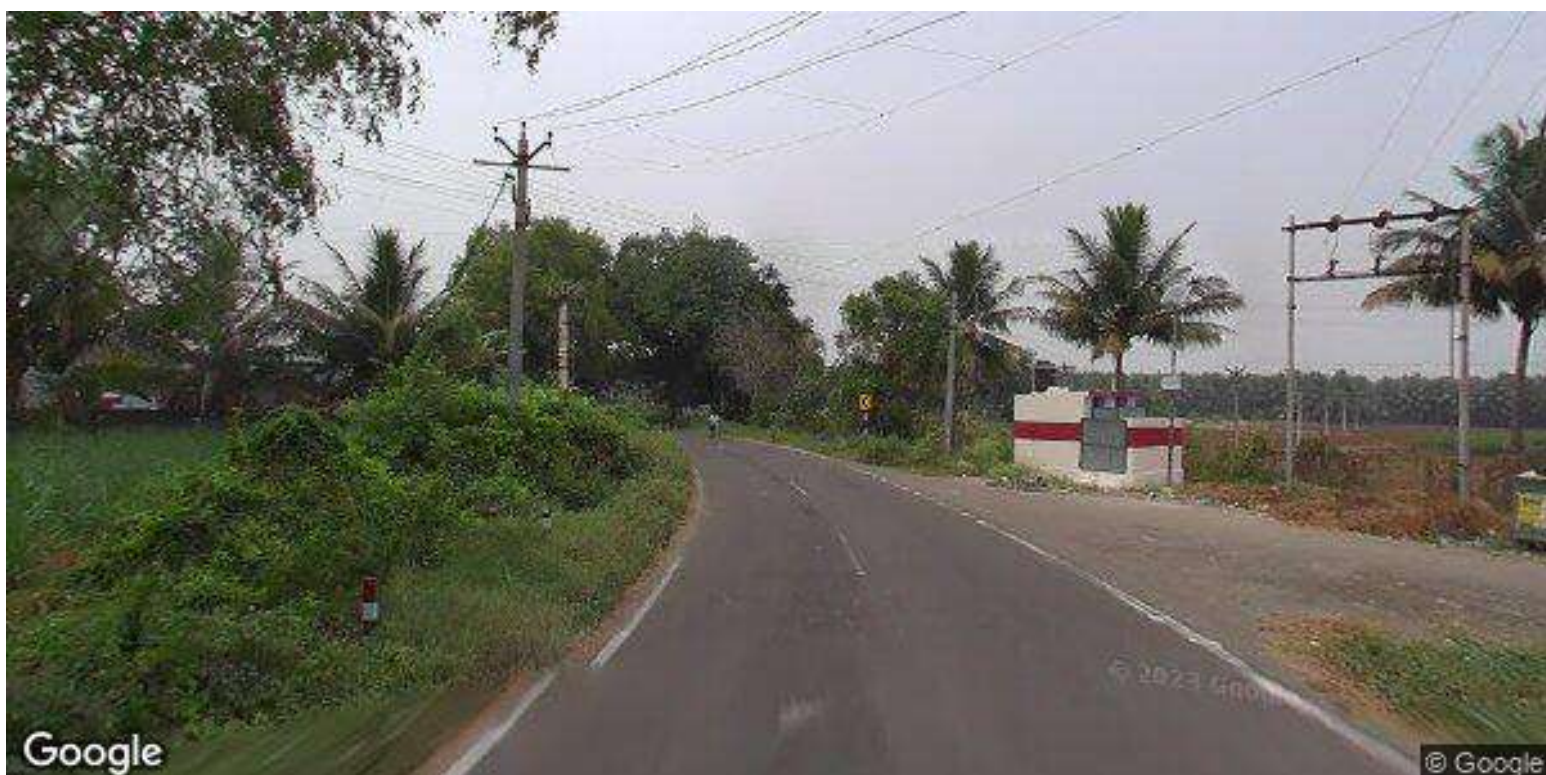
**Coordinates:** 11.08165, 77.68830

**Risk Type:** Turn

**Risk Level:** Medium

**Speed Limit:** 30 KM/Hr

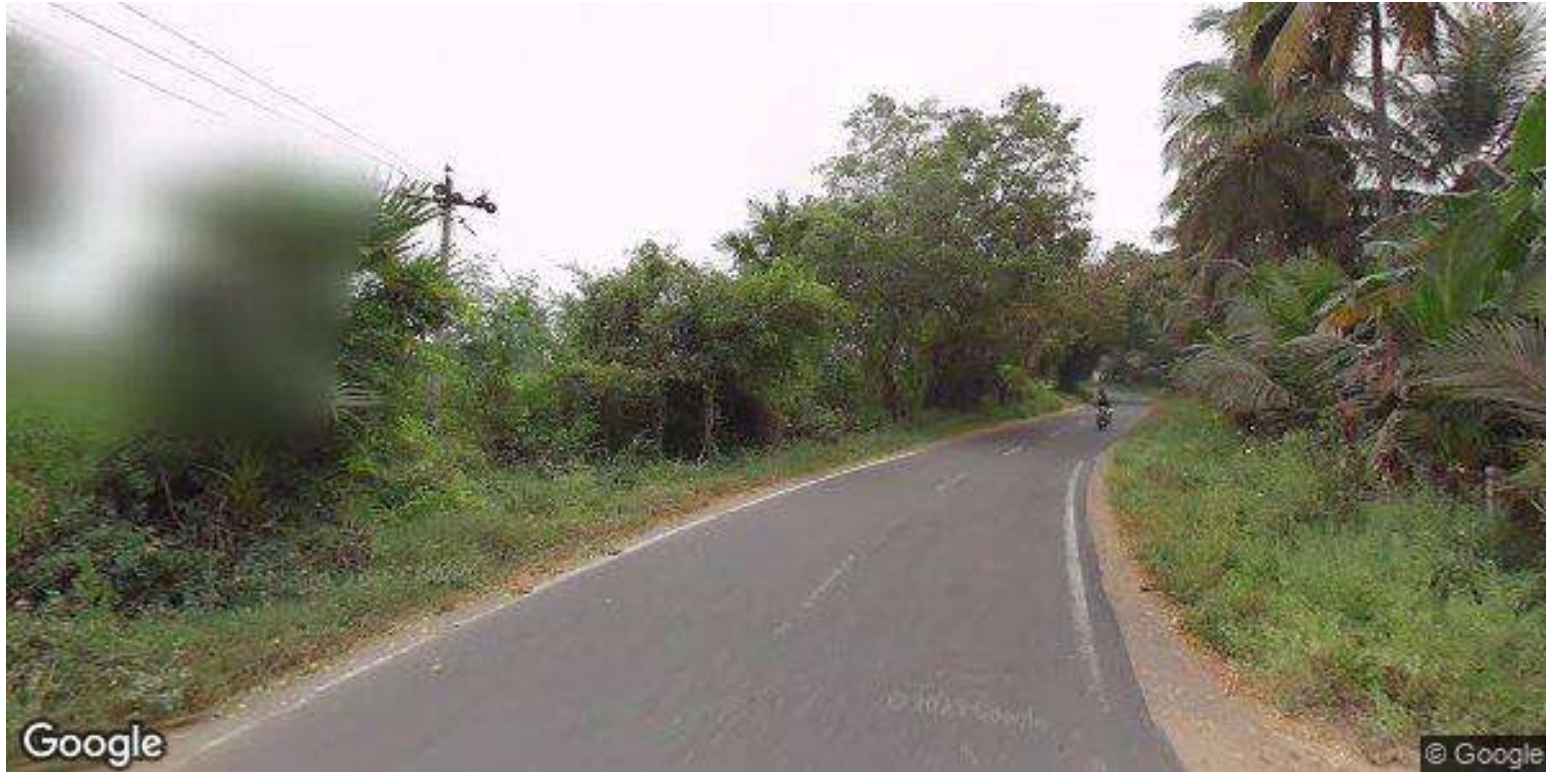
**Coordinates:** 11.07800, 77.68953

**Risk Type:** Turn

**Risk Level:** Medium

**Speed Limit:** 30 KM/Hr

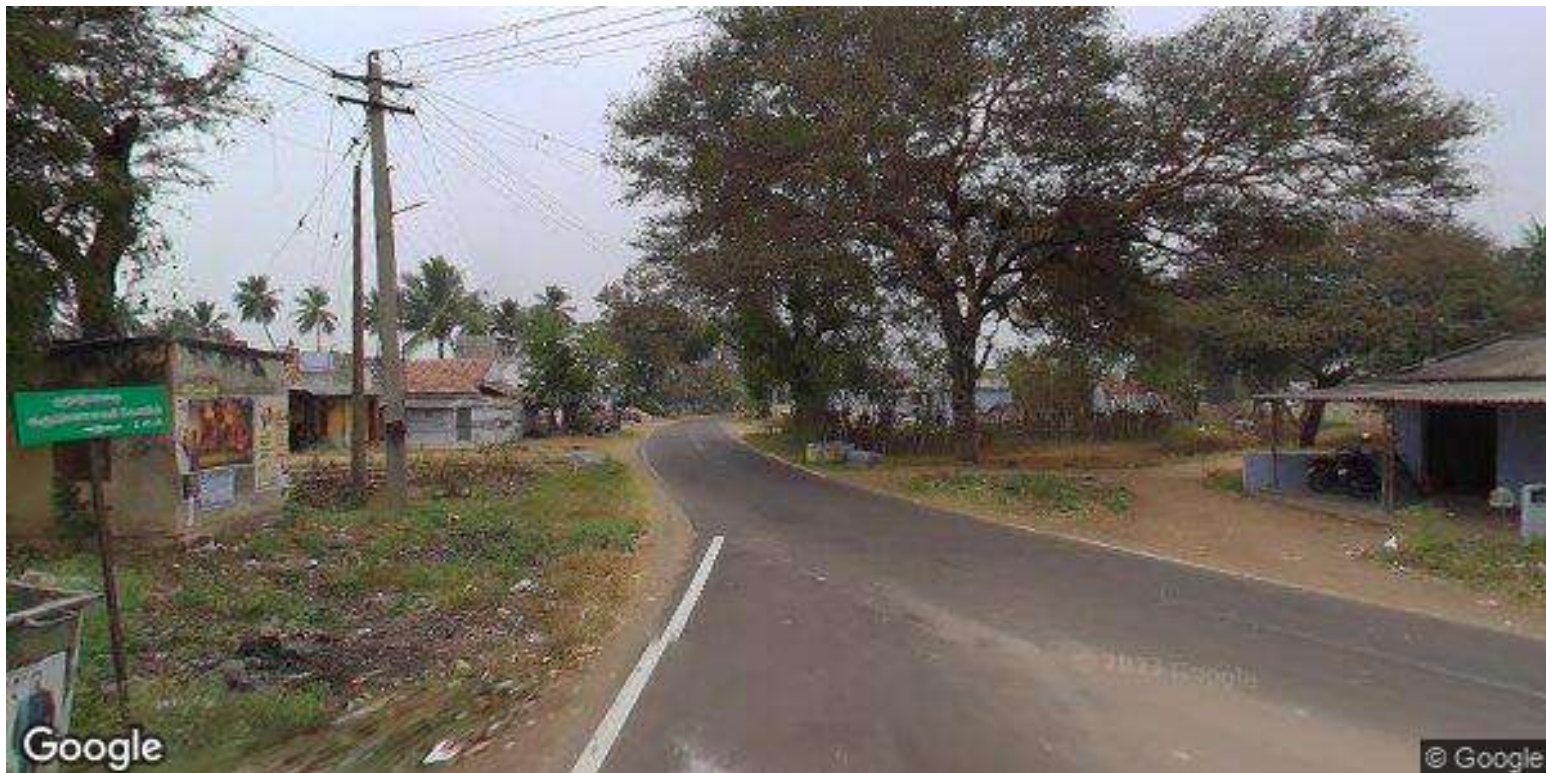
**Coordinates:** 11.07327, 77.68855

**Risk Type:** Turn

**Risk Level:** High

**Speed Limit:** 15 KM/Hr

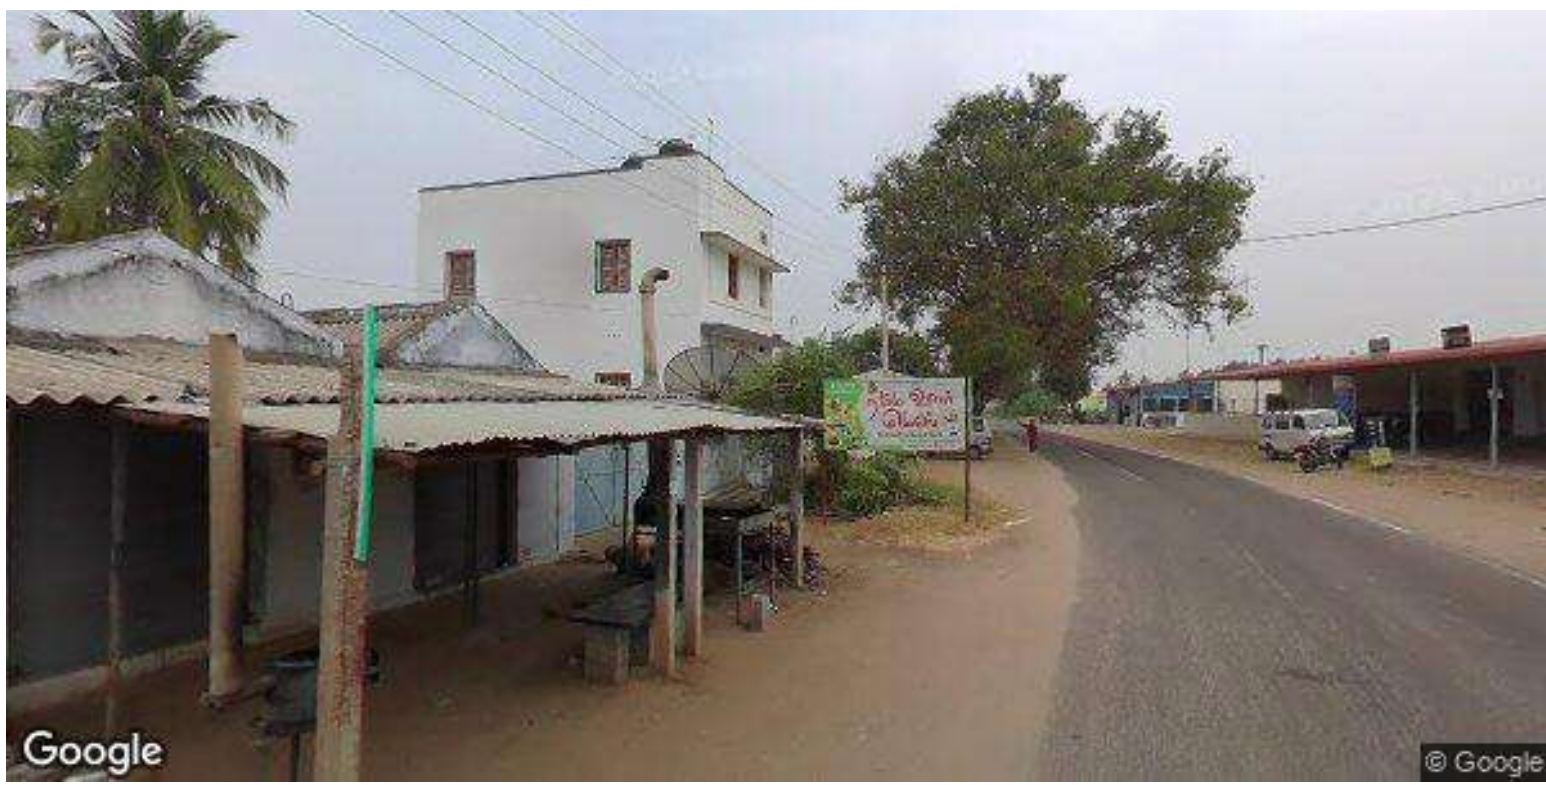
**Coordinates:** 11.07301, 77.68877

**Risk Type:** Turn

**Risk Level:** Medium

**Speed Limit:** 30 KM/Hr
