## **JOURNEY RISK MANAGEMENT (JRM) STUDY**

### **Salem Terminal To SREE BALAJI AGENCIES**

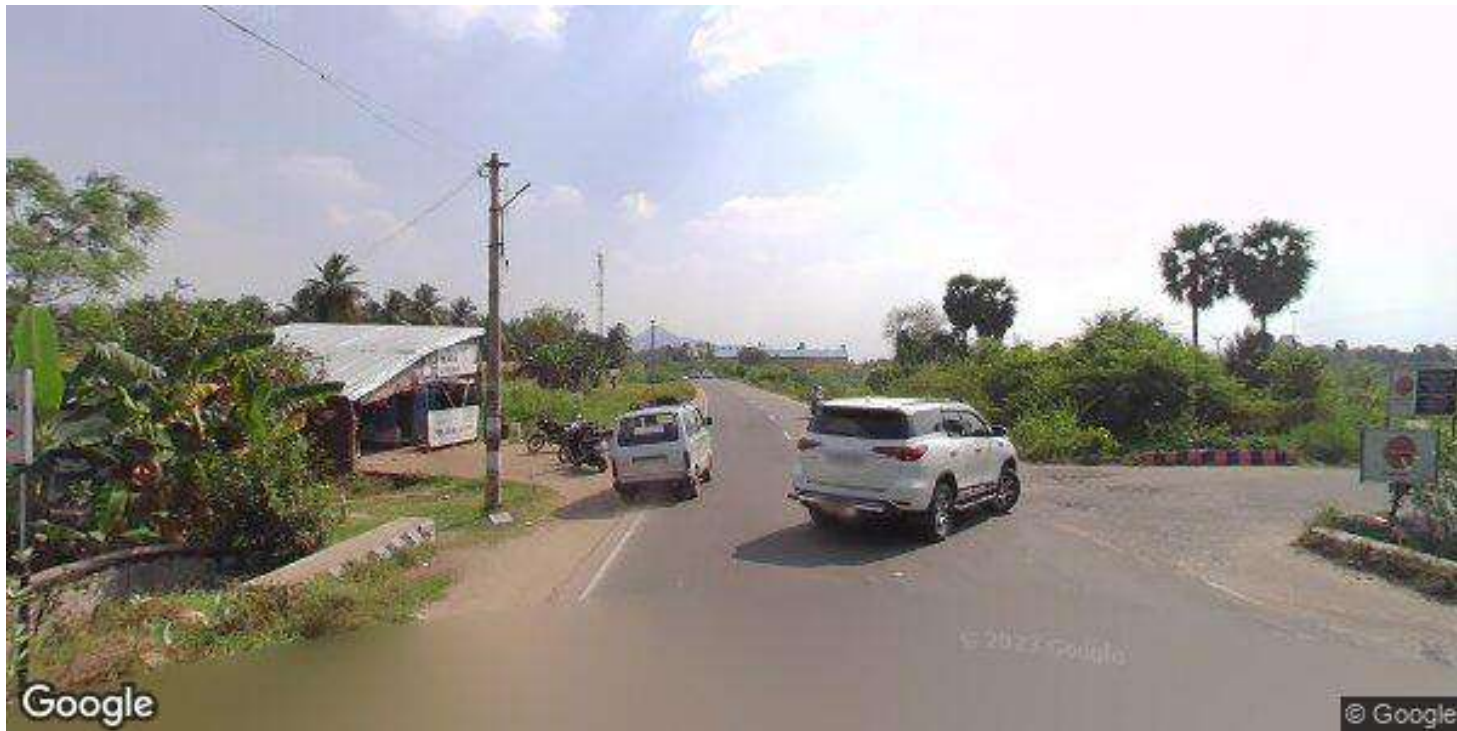
**Coordinates:** 11.44029, 77.87544

**Risk Type:** Turn

**Risk Level:** High

**Speed Limit:** 15 KM/Hr

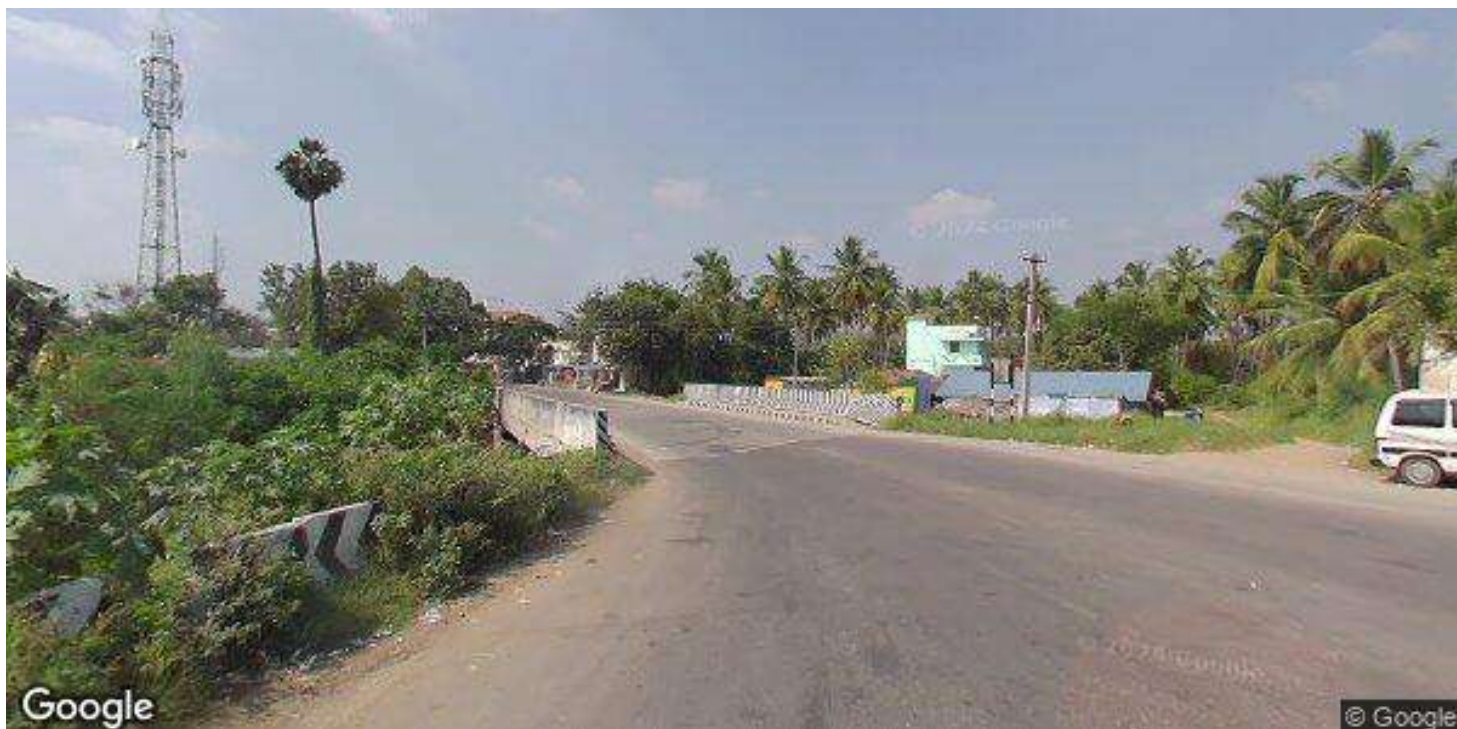
**Coordinates: 11.44893, 77.87413**

**Risk Type:** Turn

**Risk Level:** Medium

**Speed Limit: 30 KM/Hr**

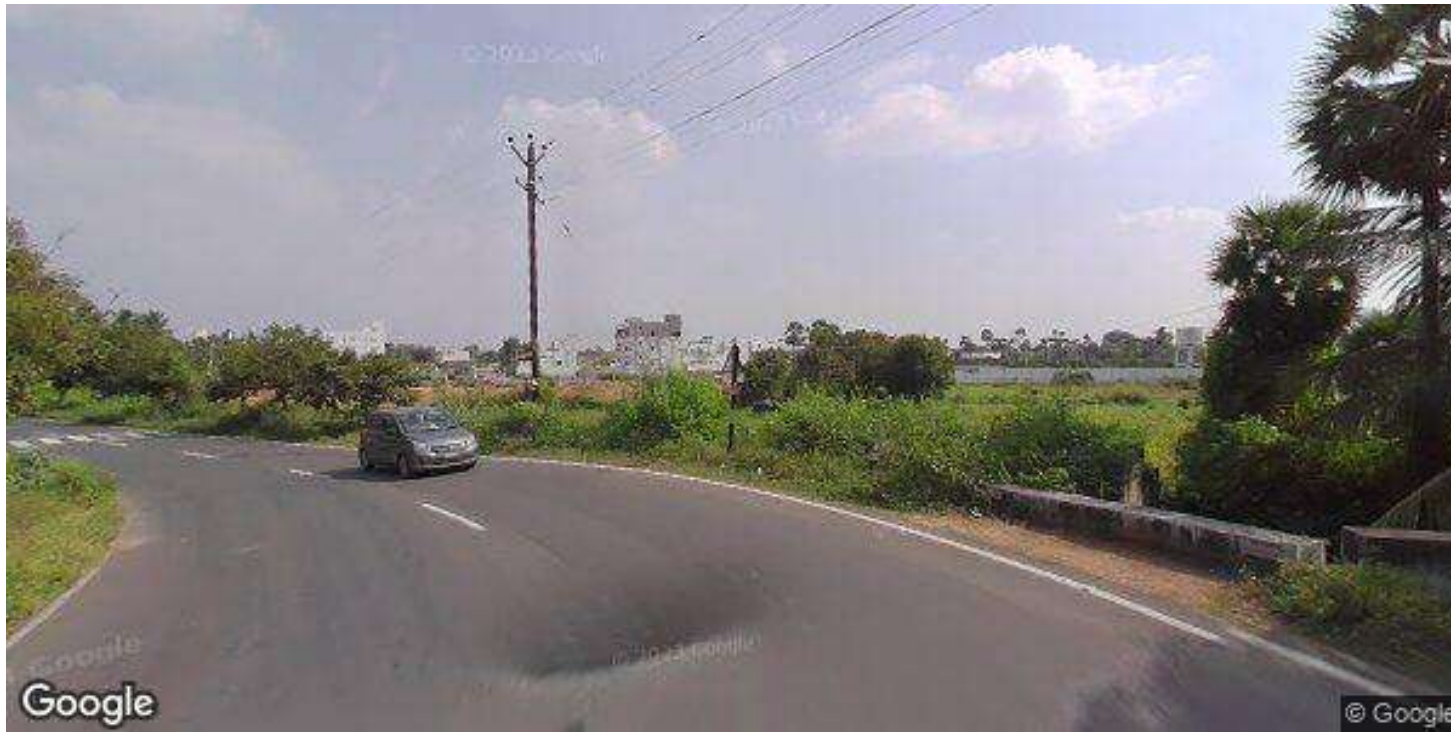
**Coordinates: 11.45350, 77.85700**

**Risk Type: Turn**

**Risk Level: High**

**Speed Limit: 15 KM/Hr**

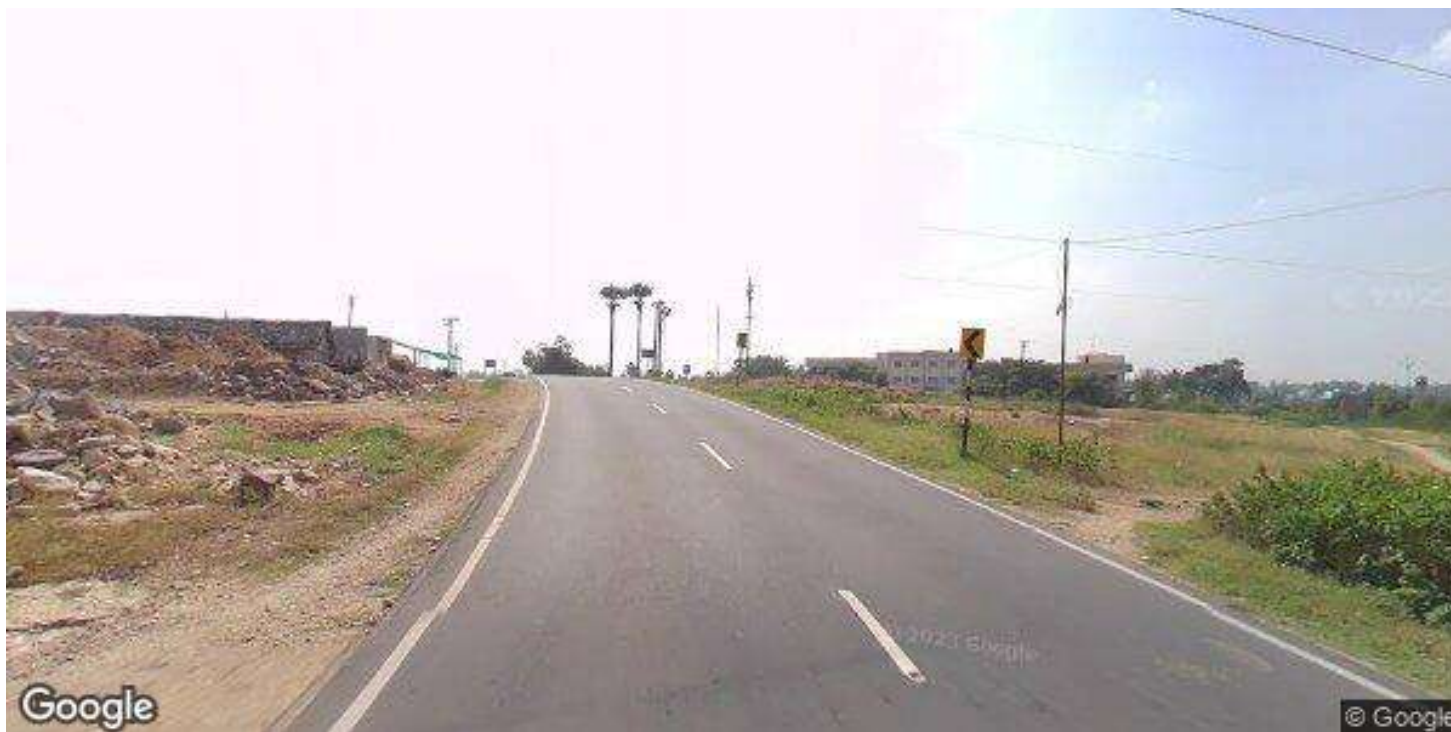
**Coordinates: 11.46046, 77.85037**

**Risk Type: Turn**

**Risk Level: Medium**

**Speed Limit: 30 KM/Hr**

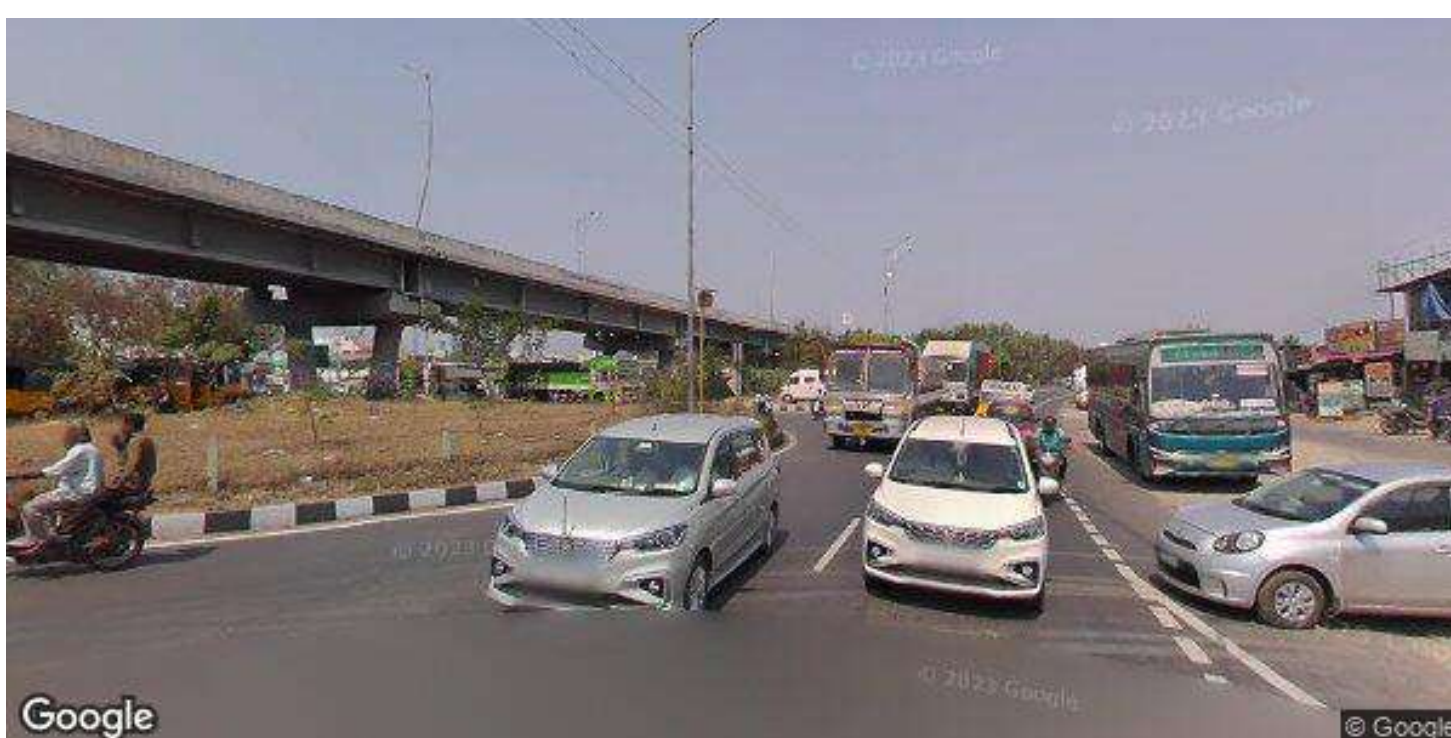
**Risk Type:** Turn  
**Risk Level:** High  
**Speed Limit:** 15 KM/Hr  
**Coordinates:** 11.43001, 77.67575

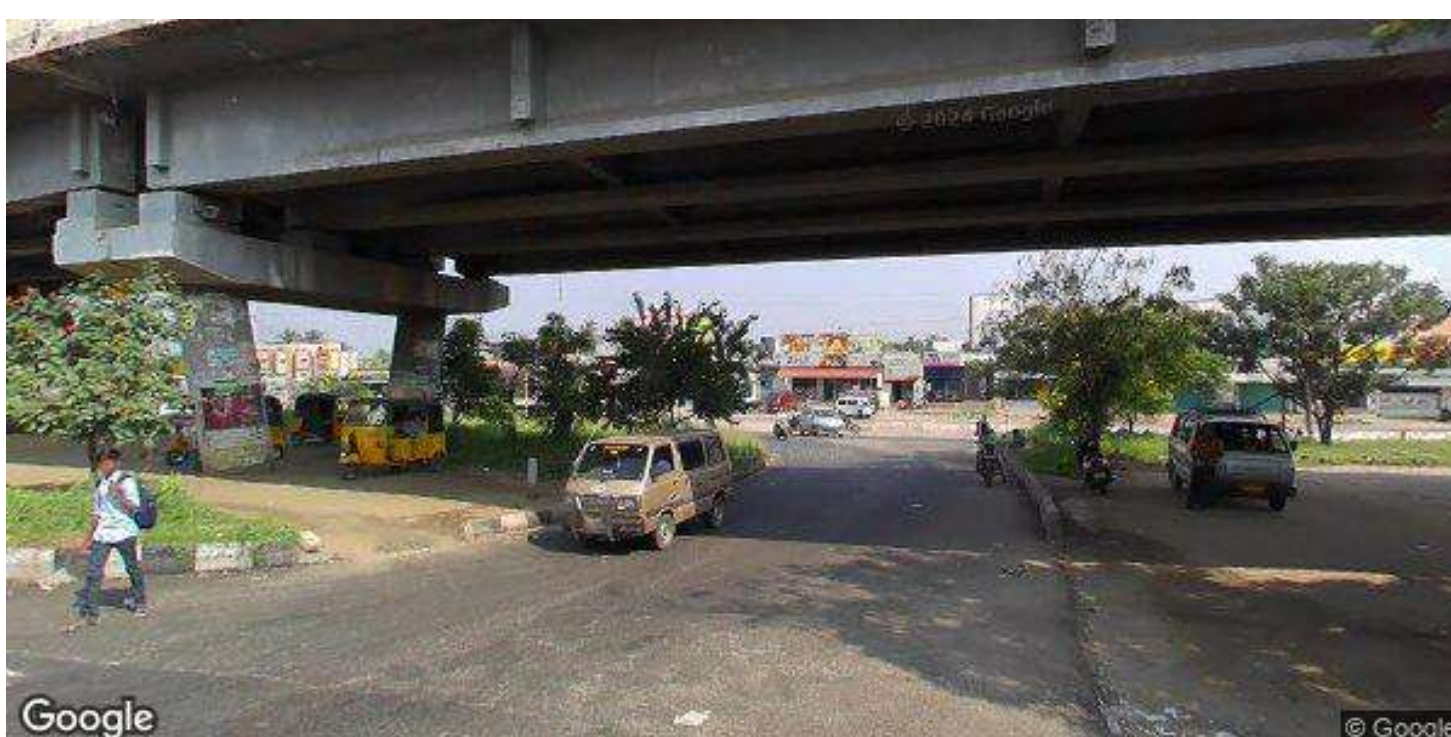
**Coordinates: 11.43007, 77.67543**

**Risk Type:** Turn  
**Risk Level:** Medium

**Speed Limit: 30 KM/Hr**

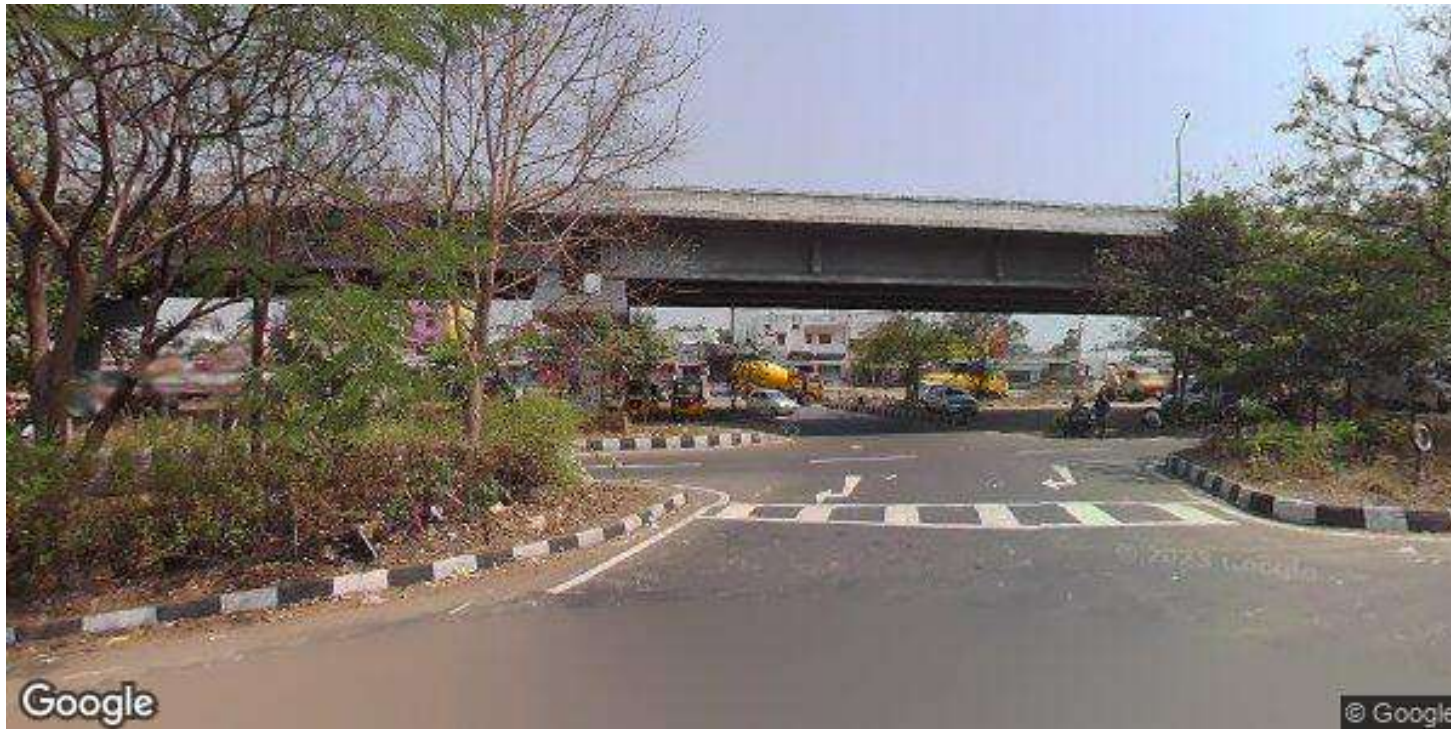
**Coordinates: 11.43026, 77.67525**

**Risk Type: Turn**

**Risk Level: High**

**Speed Limit: 15 KM/Hr**

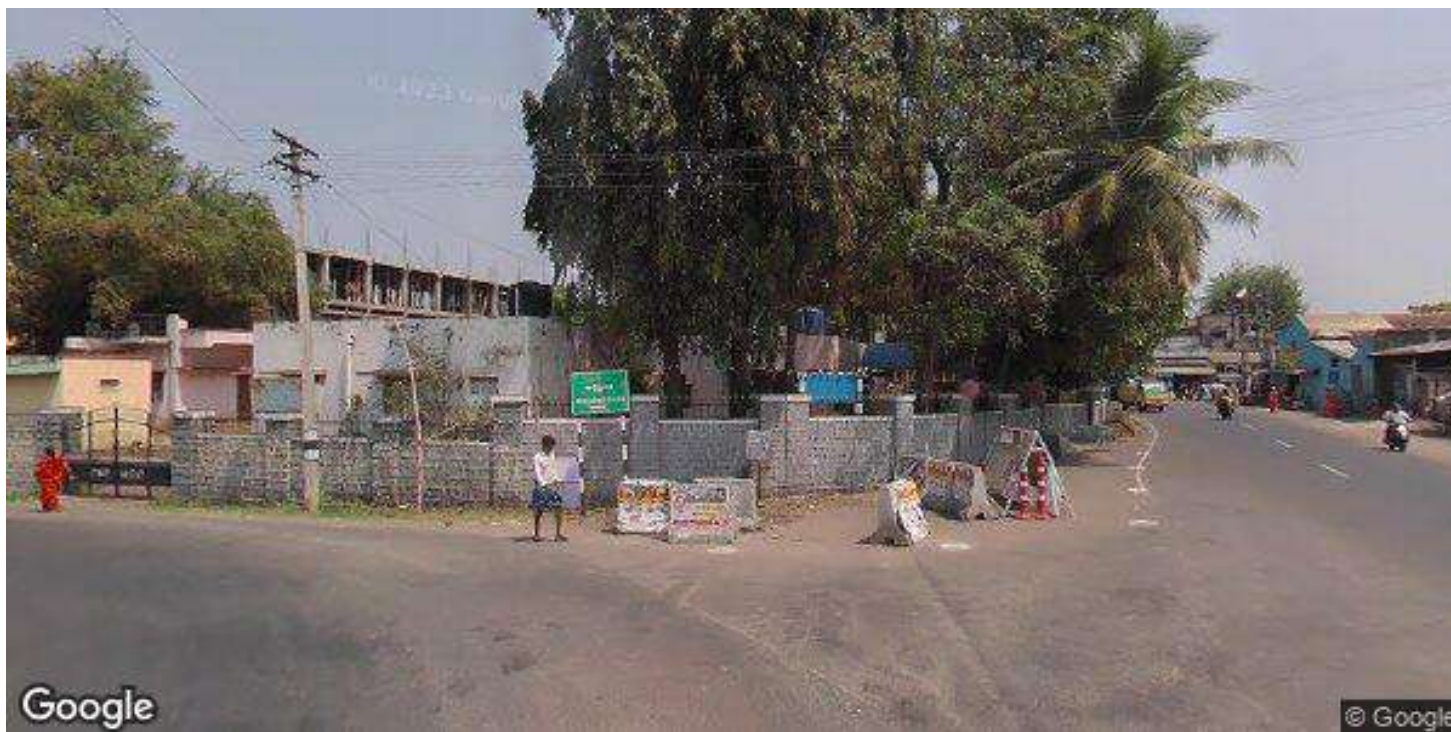
**Coordinates: 11.43864, 77.68225**

**Risk Type: Turn**

**Risk Level: High**

**Speed Limit: 15 KM/Hr**

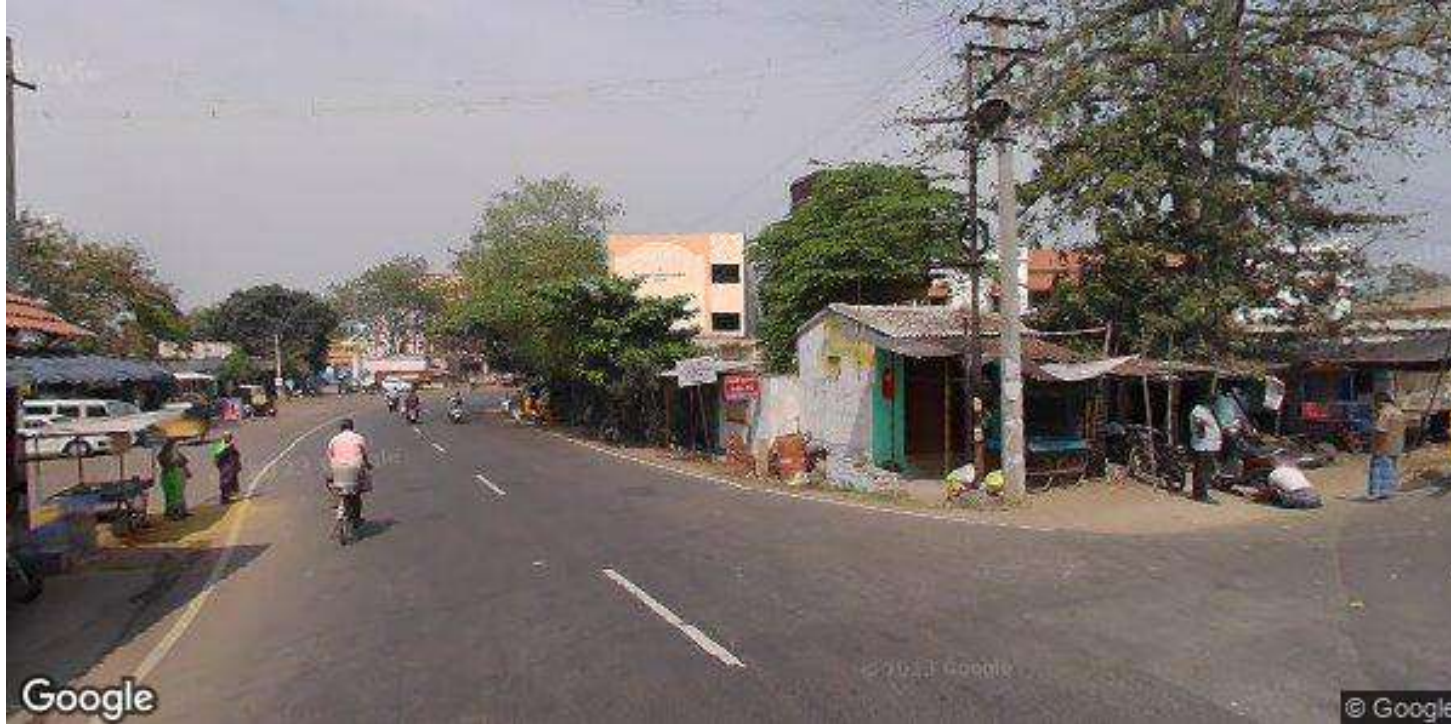
**Coordinates:** 11.43965, 77.68224

**Risk Type:** Turn

**Risk Level:** Medium

**Speed Limit:** 30 KM/Hr

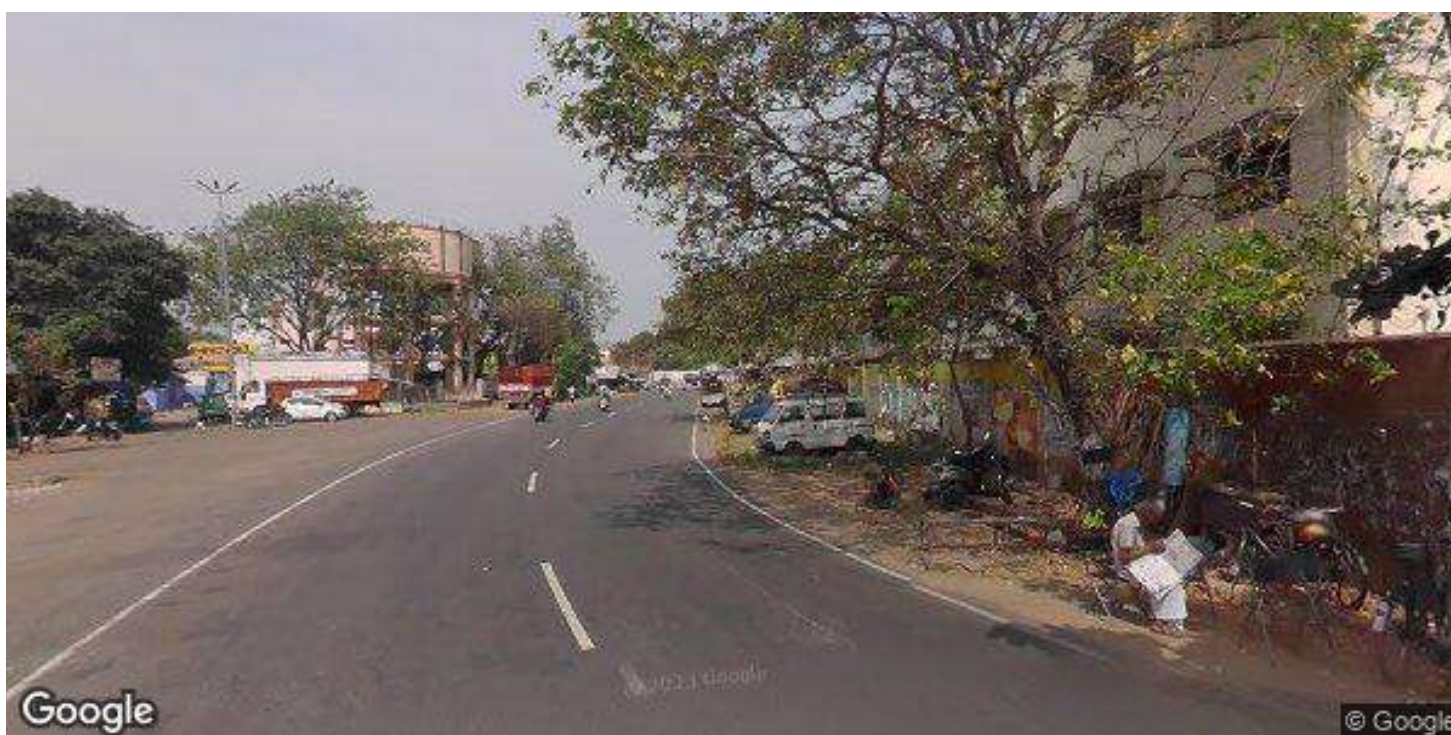
**Coordinates:** 11.43997, 77.68198

**Risk Type:** Turn

**Risk Level:** Medium

**Speed Limit:** 30 KM/Hr

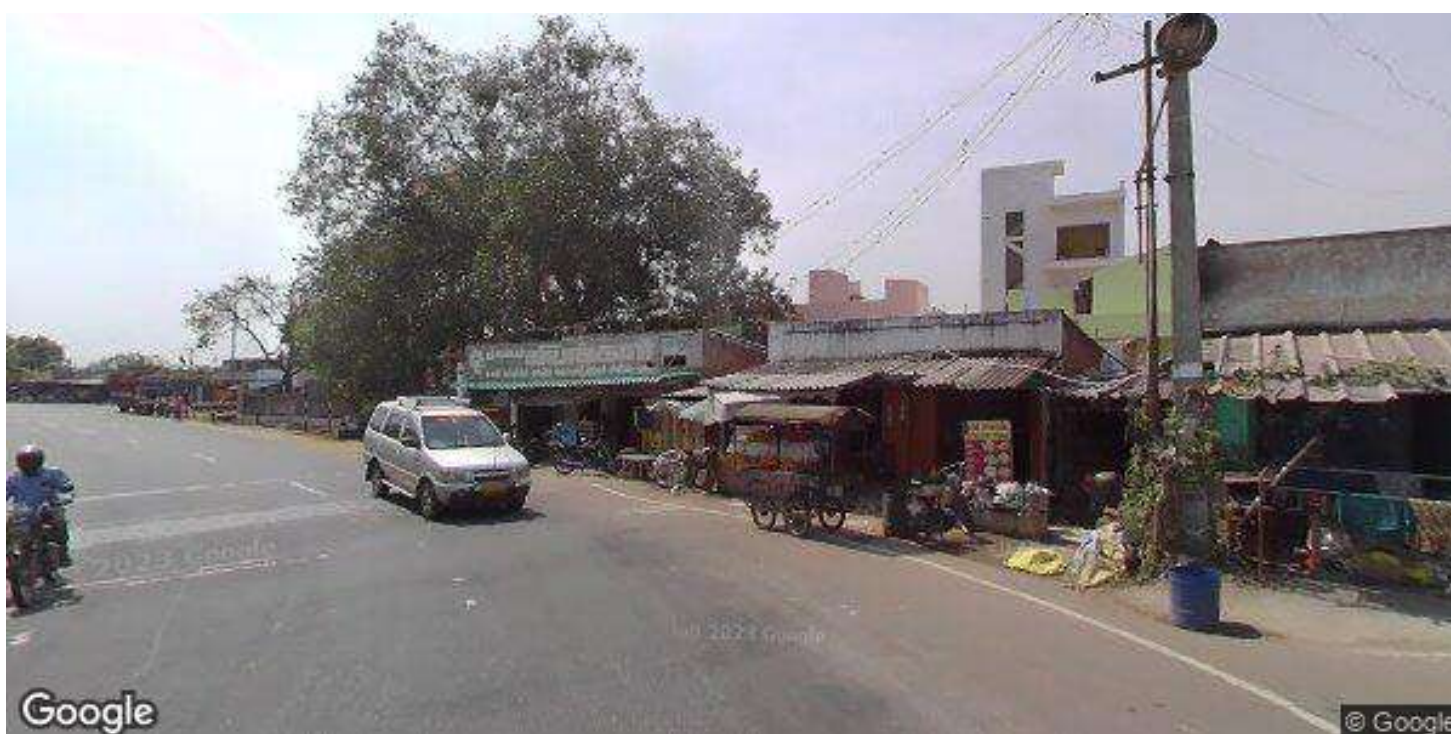
Coordinates: 11.44105, 77.68187

**Risk Type:** Turn

**Risk Level:** High

Speed Limit: 15 KM/Hr

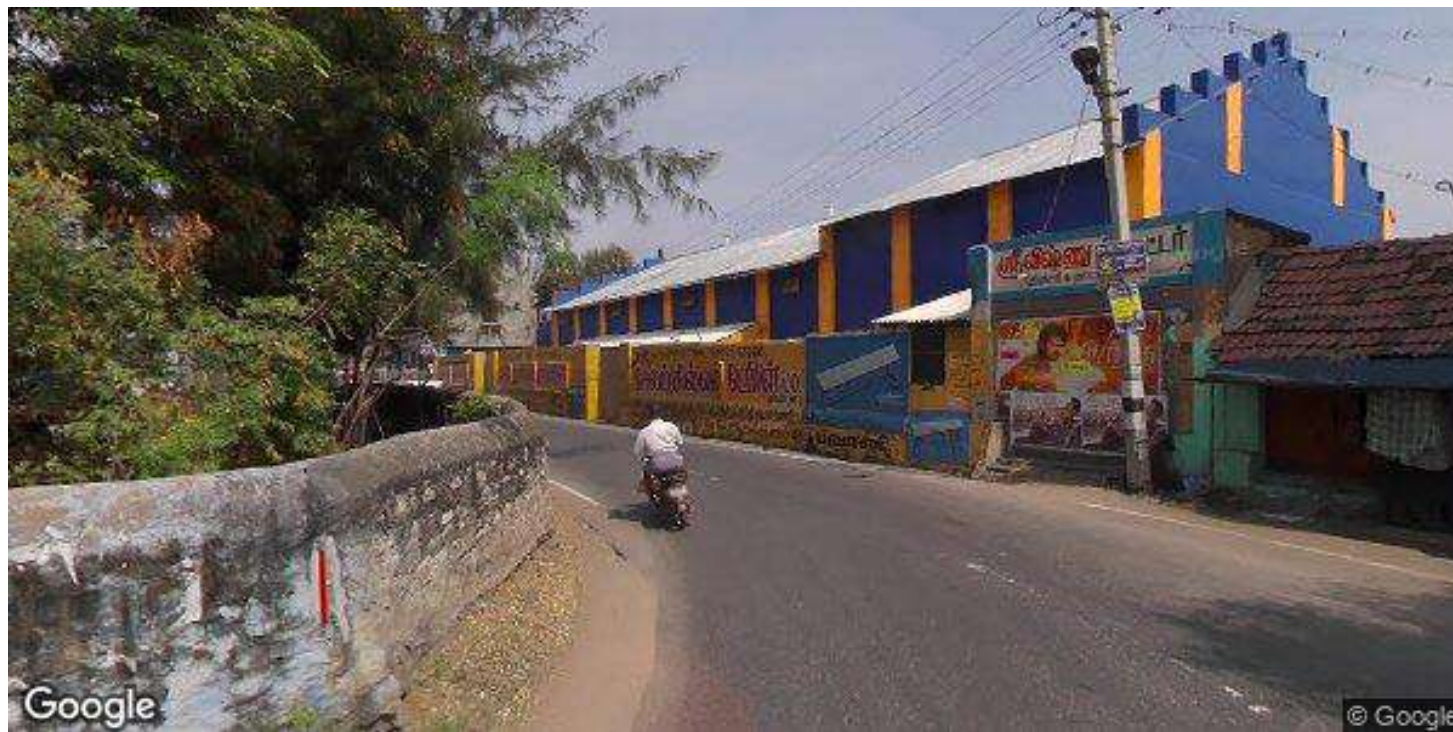
Coordinates: 11.44119, 77.68217

Risk Type: Turn

Risk Level: High

Speed Limit: 15 KM/Hr

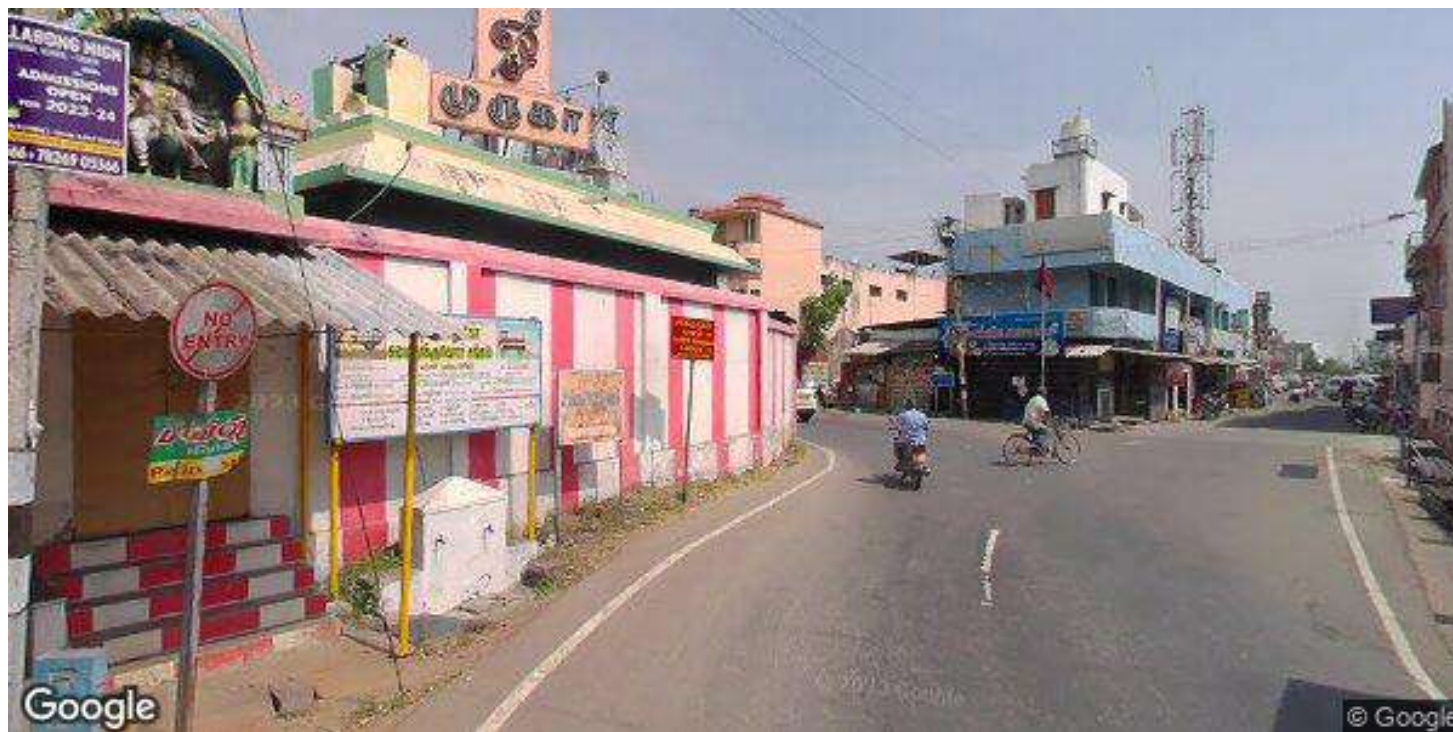
Coordinates: 11.44295, 77.68261

Risk Type: Turn

Risk Level: Medium

Speed Limit: 30 KM/Hr

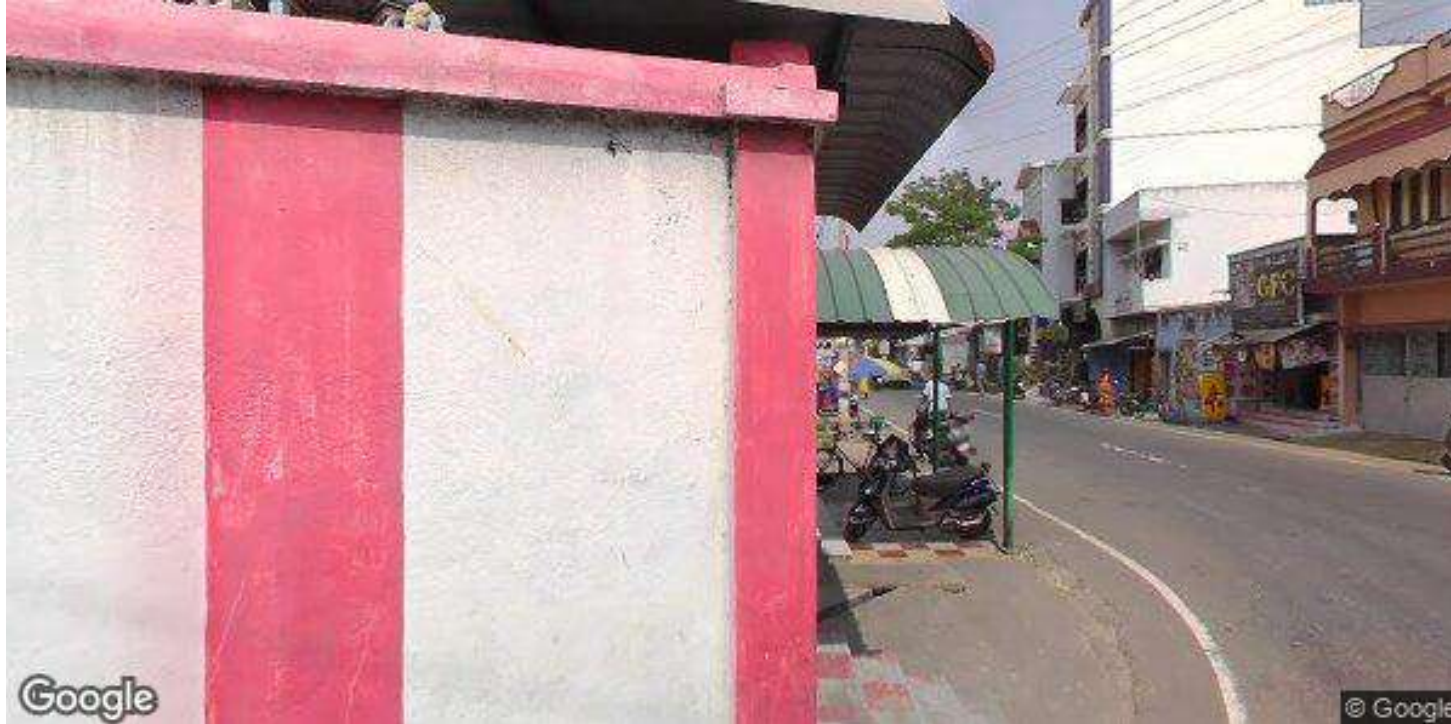
**Coordinates:** 11.44298, 77.68272

**Risk Type:** Turn

**Risk Level:** Medium

**Speed Limit:** 30 KM/Hr

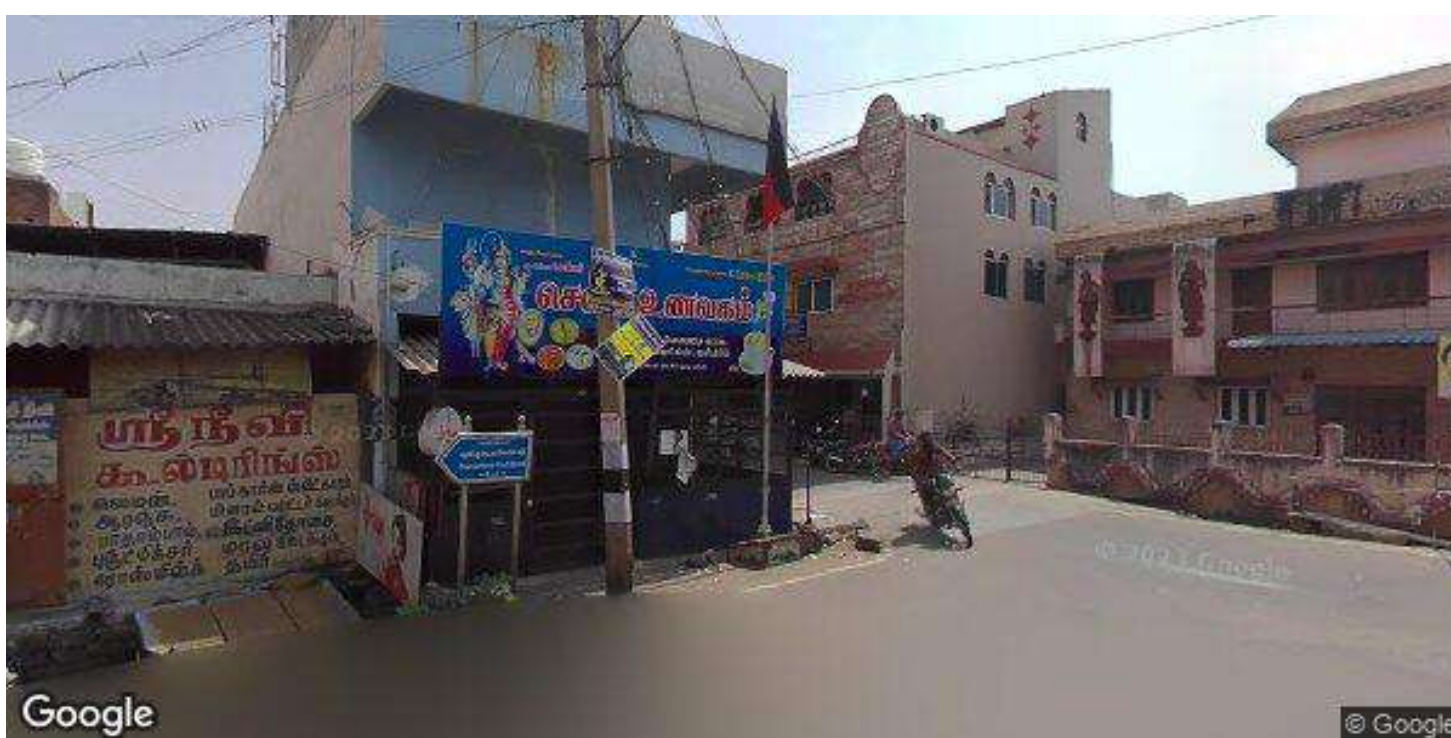
**Coordinates:** 11.44305, 77.68277

**Risk Type:** Turn

**Risk Level:** Medium

**Speed Limit:** 30 KM/Hr

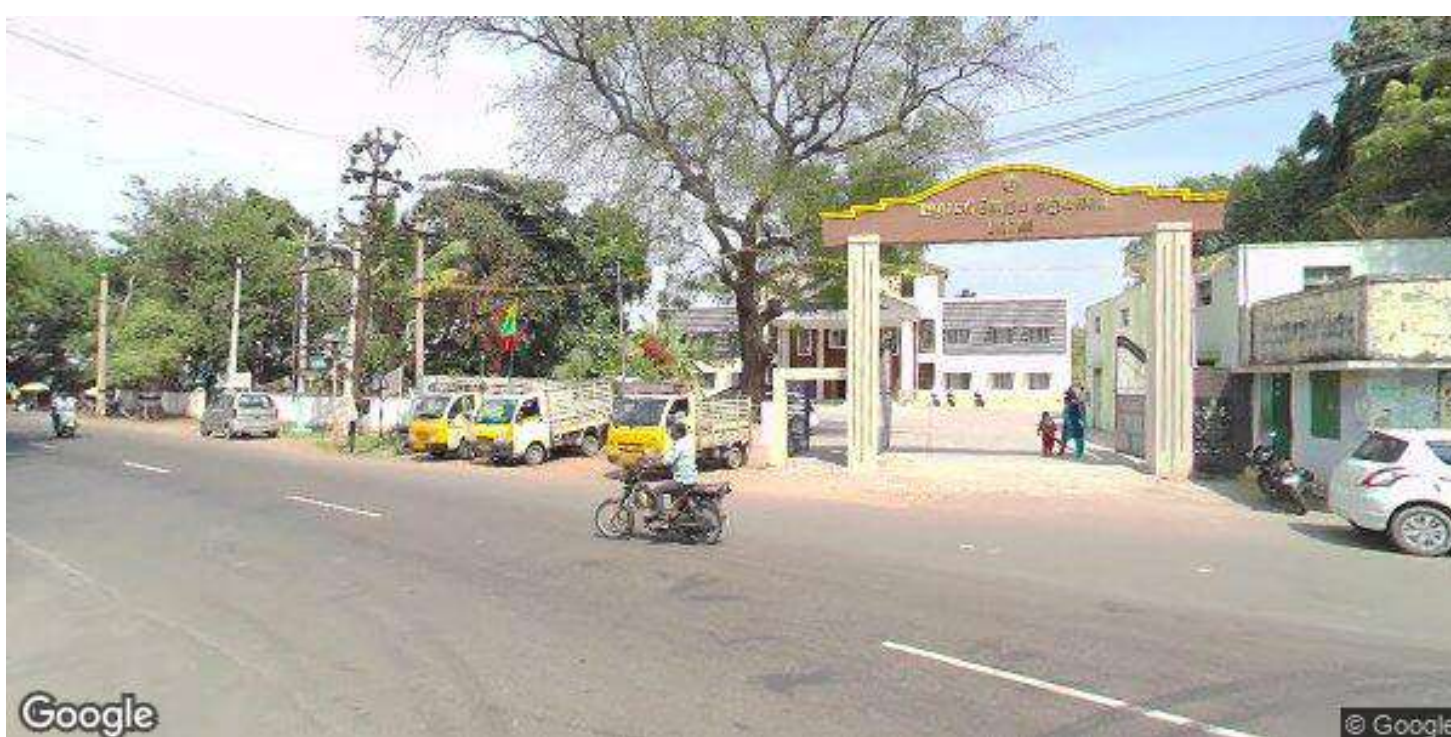
**Coordinates: 11.44853, 77.68331**

**Risk Type:** Turn

**Risk Level:** High

**Speed Limit: 15 KM/Hr**

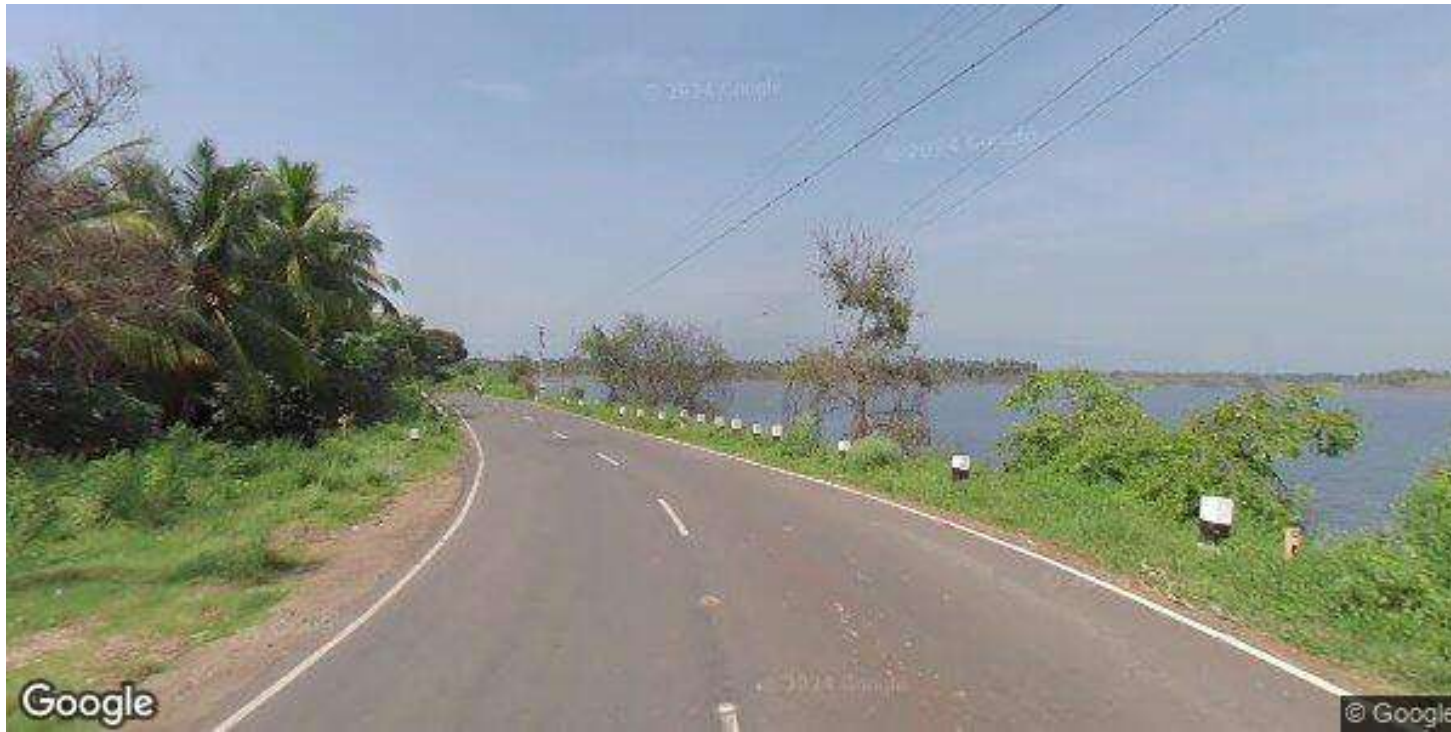
**Coordinates: 11.48124, 77.57031**

**Risk Type: Turn**

**Risk Level: Medium**

**Speed Limit: 30 KM/Hr**

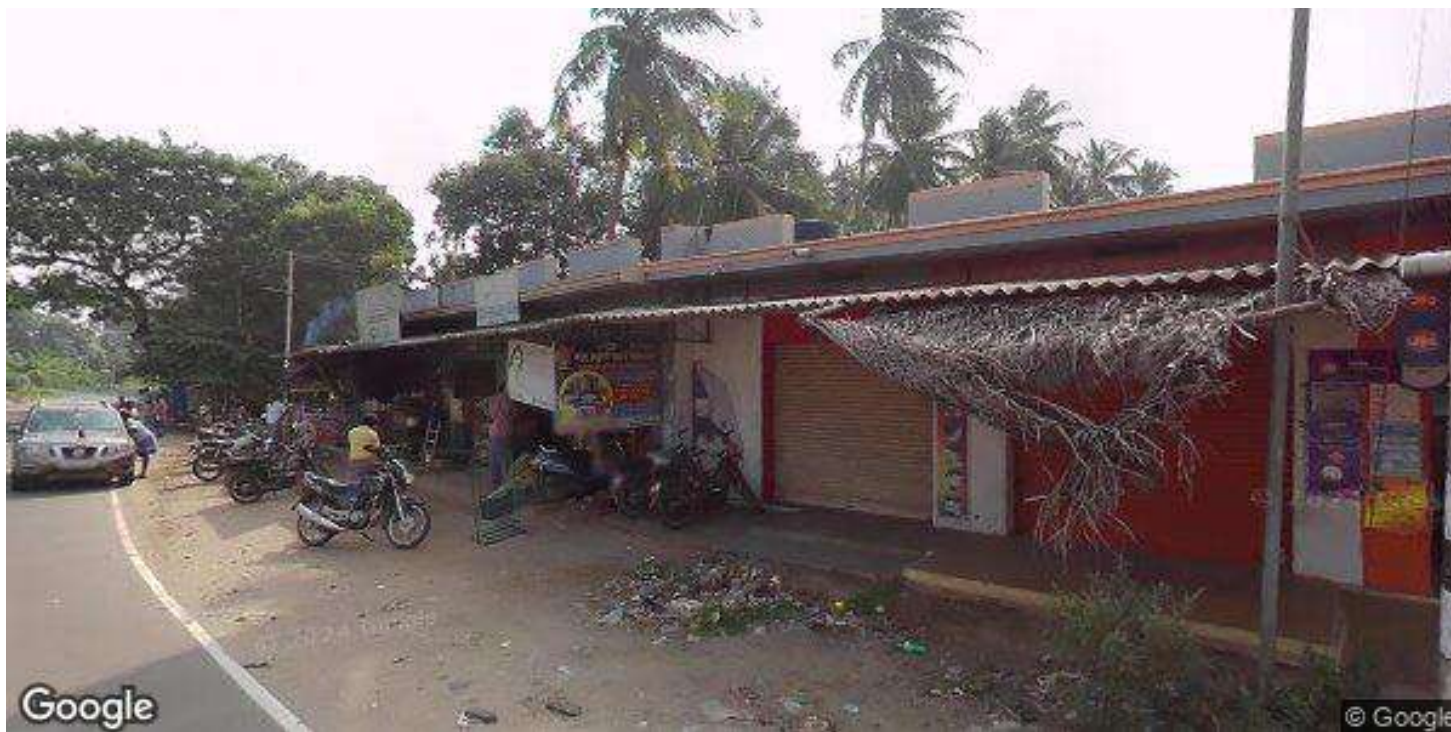
**Coordinates: 11.52420, 77.52412**

**Risk Type: Blind Spot**

**Risk Level: Blind Spot**

**Speed Limit: 10 KM/Hr**
