## JOURNEY RISK MANAGEMENT (JRM) STUDY

### Salem Terminal to VELLAVAN SAKKTHI FILLING

### Route Safety Analysis for Sangagiri to Komarapalayam, Tamil Nadu

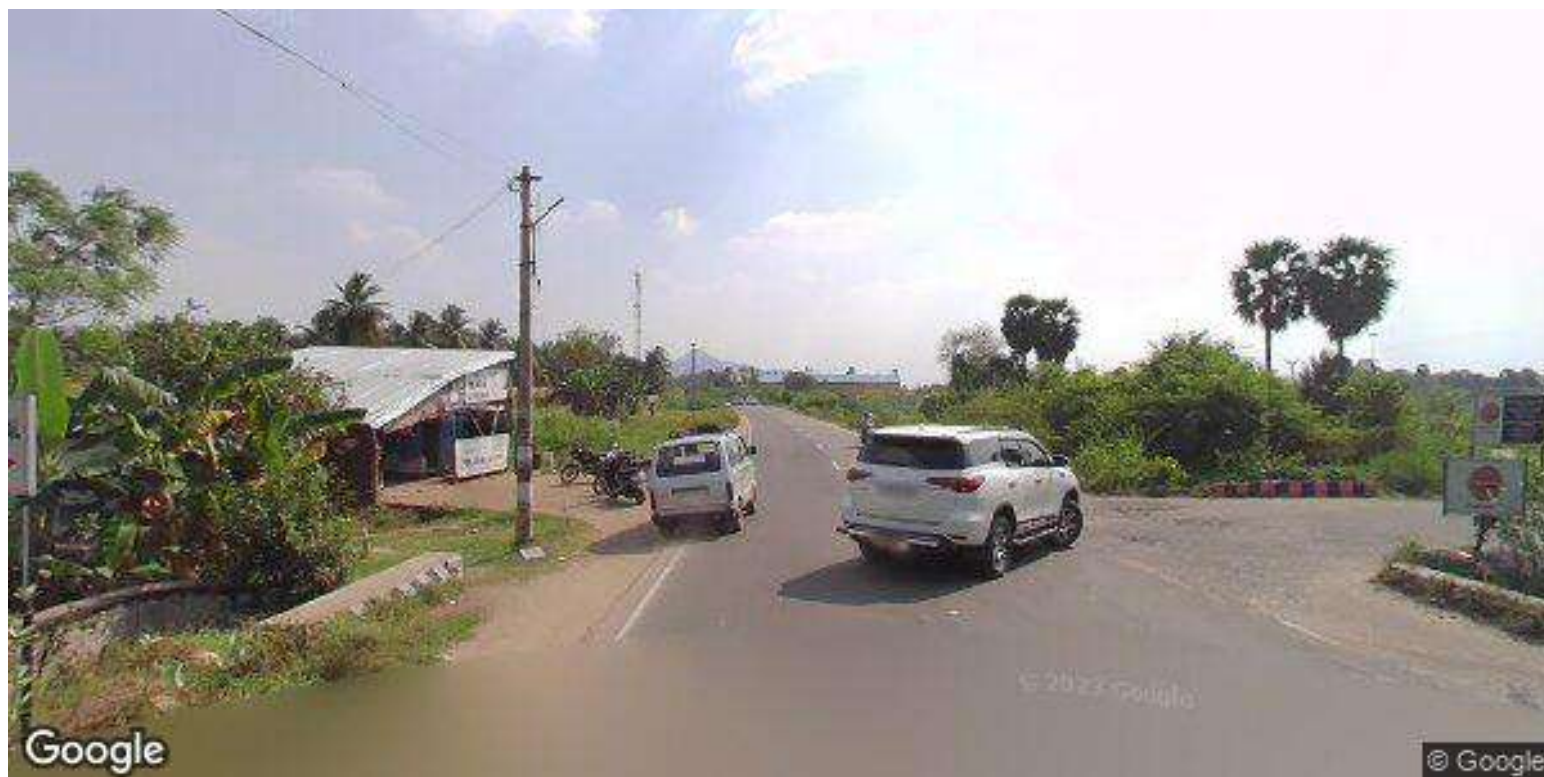
**Coordinates:** 11.44029, 77.87544

**Risk Type:** Turn

**Risk Level:** High

**Speed Limit:** 15 KM/Hr

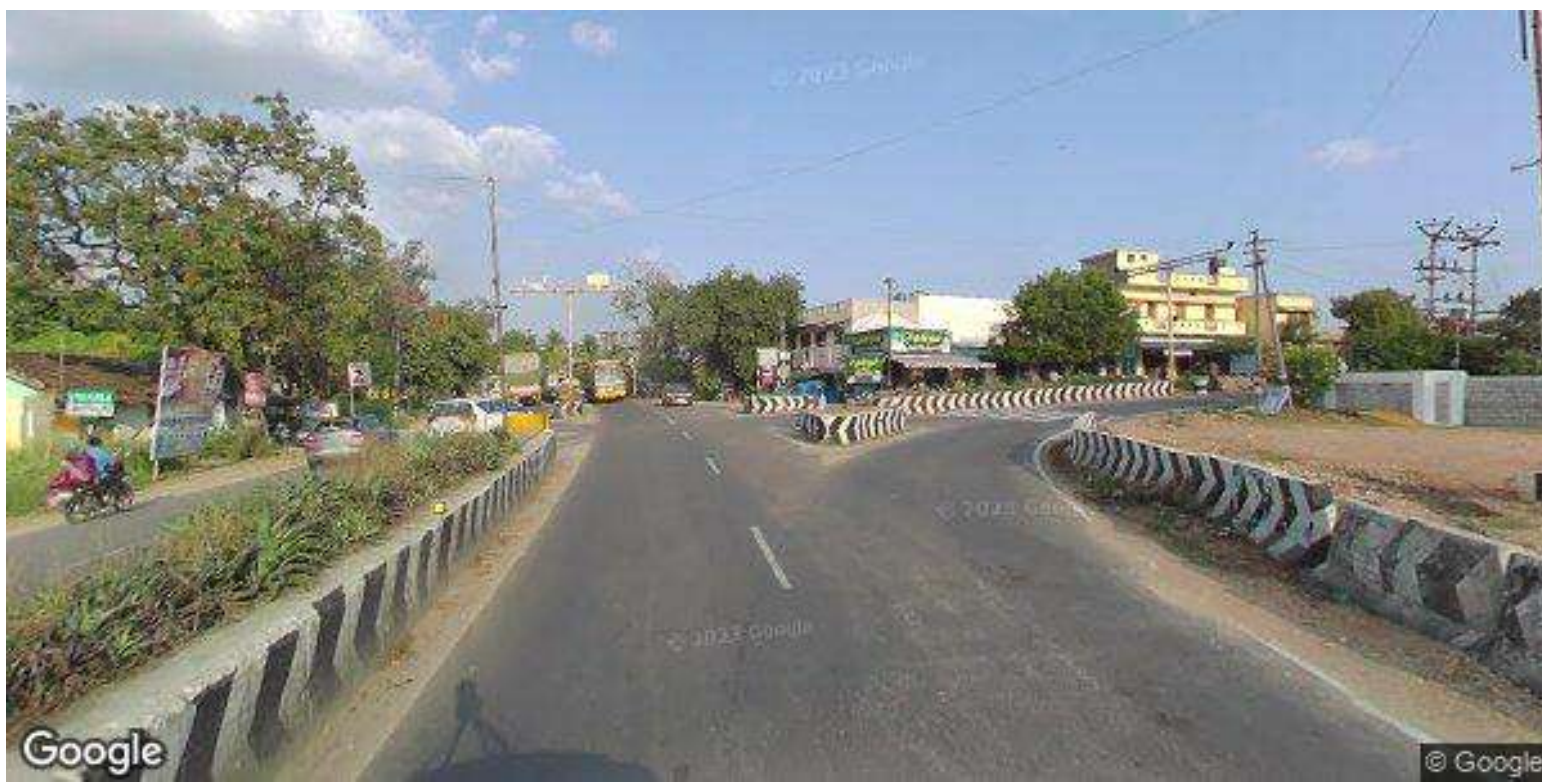
**Coordinates:** 11.46318, 77.84913

**Risk Type:** Turn

**Risk Level:** Medium

**Speed Limit:** 30 KM/Hr

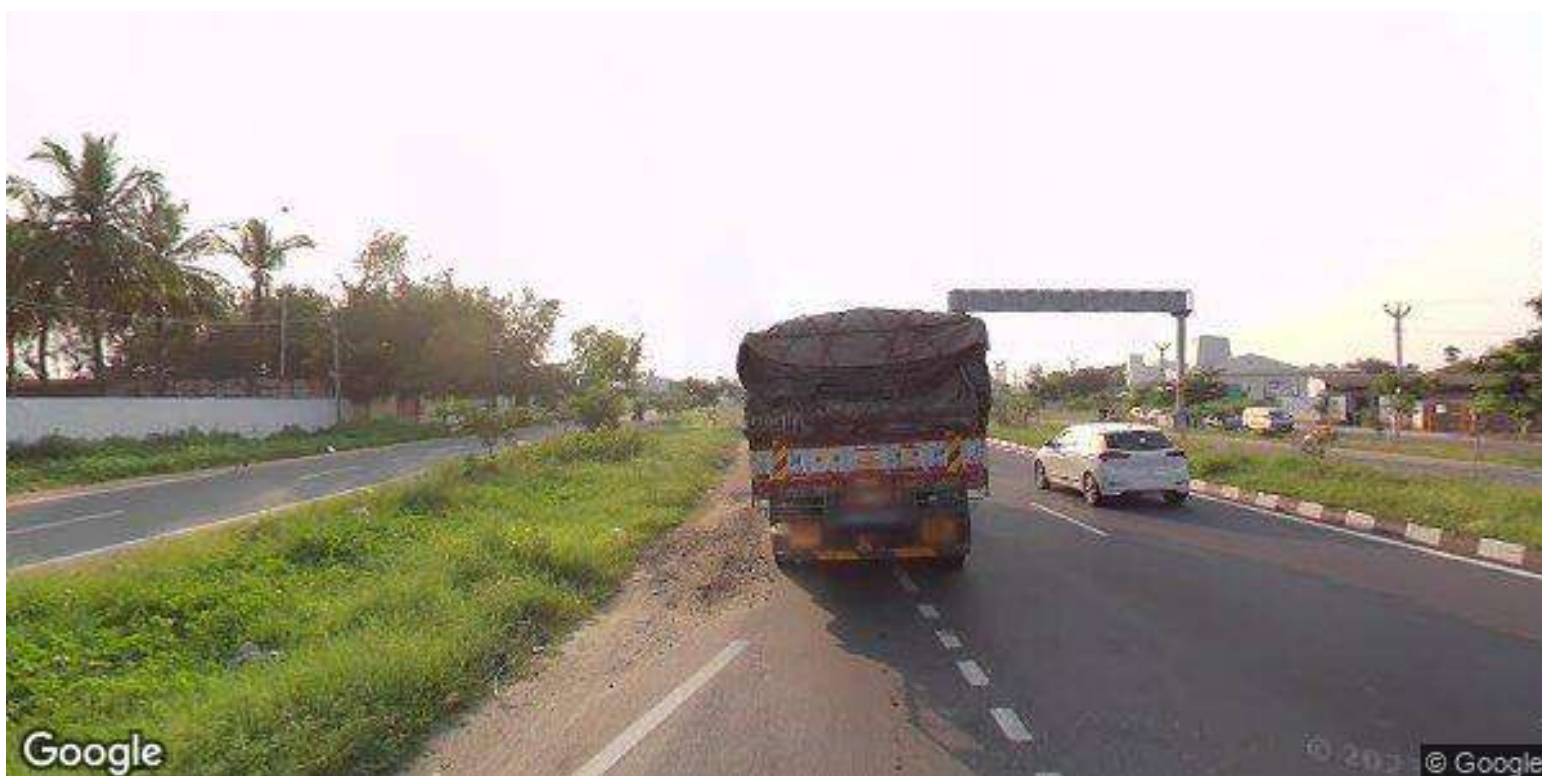
**Coordinates:** 11.45517, 77.81345

**Risk Type:** Turn

**Risk Level:** High

**Speed Limit:** 15 KM/Hr

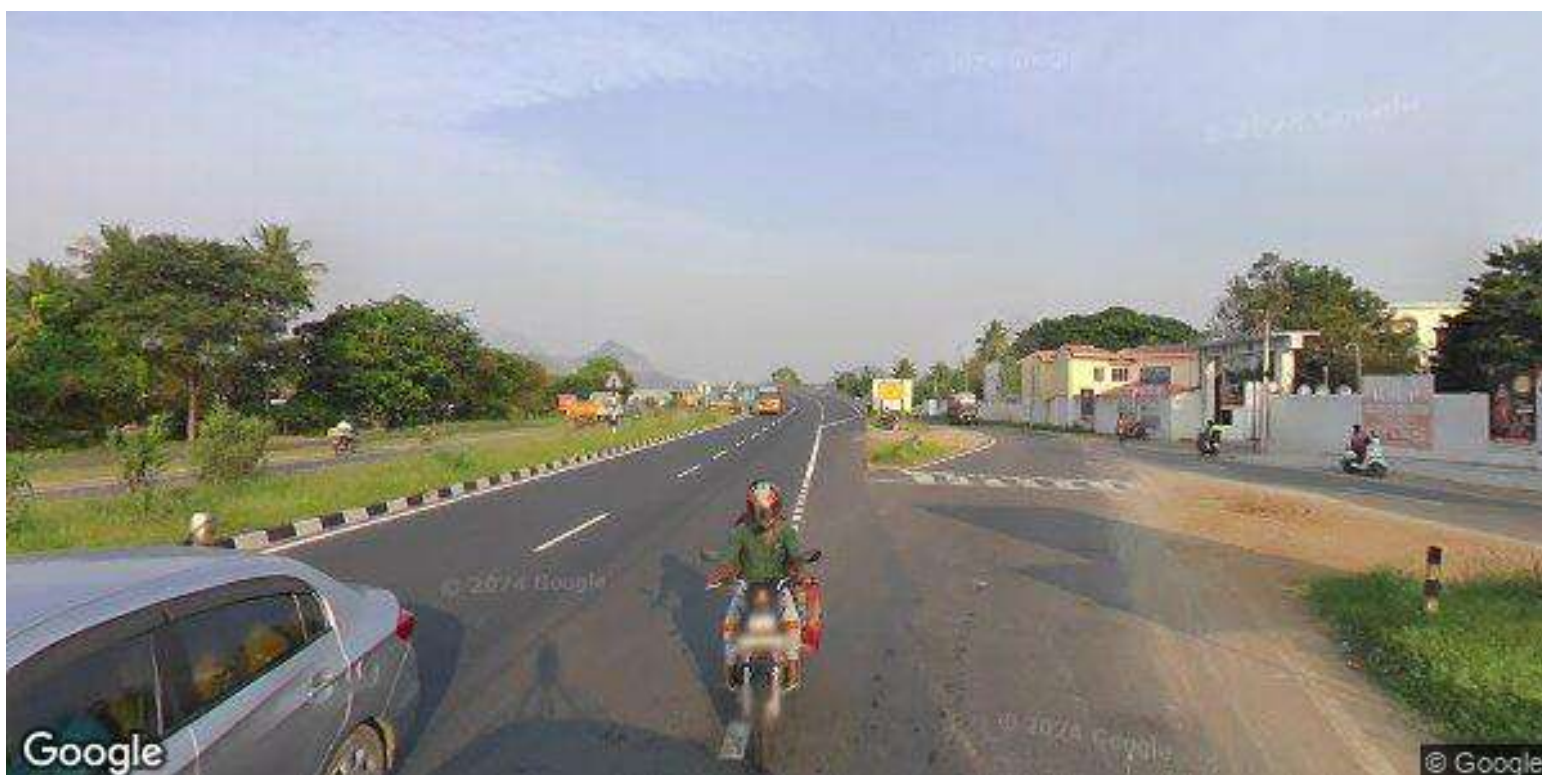
**Coordinates: 11.45521, 77.81343**

**Risk Type: Turn**

**Risk Level: High**

**Speed Limit: 15 KM/Hr**

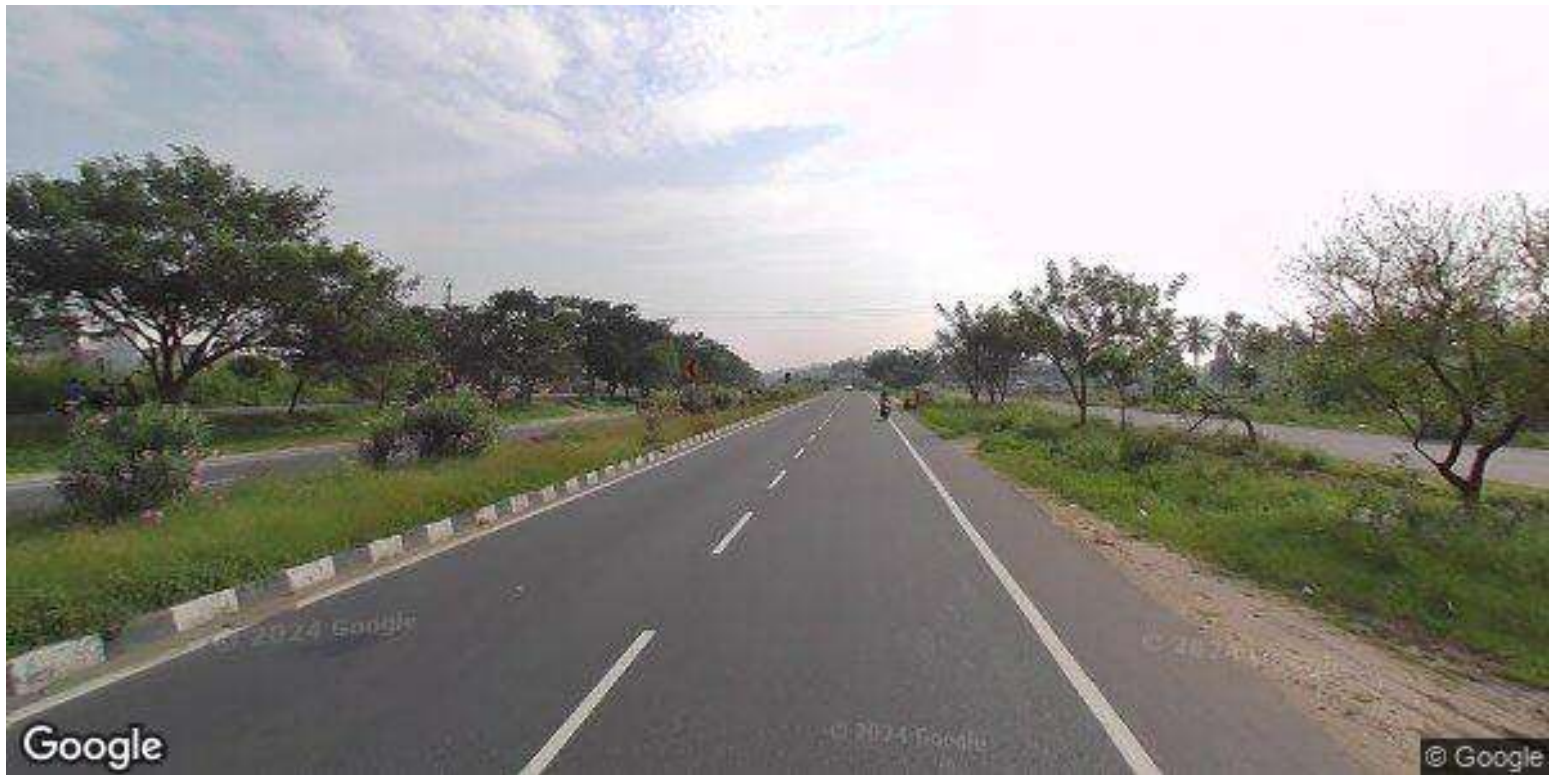
**Coordinates: 11.44467, 77.72092**

**Risk Type: Turn**

**Risk Level: Medium**

**Speed Limit: 30 KM/Hr**

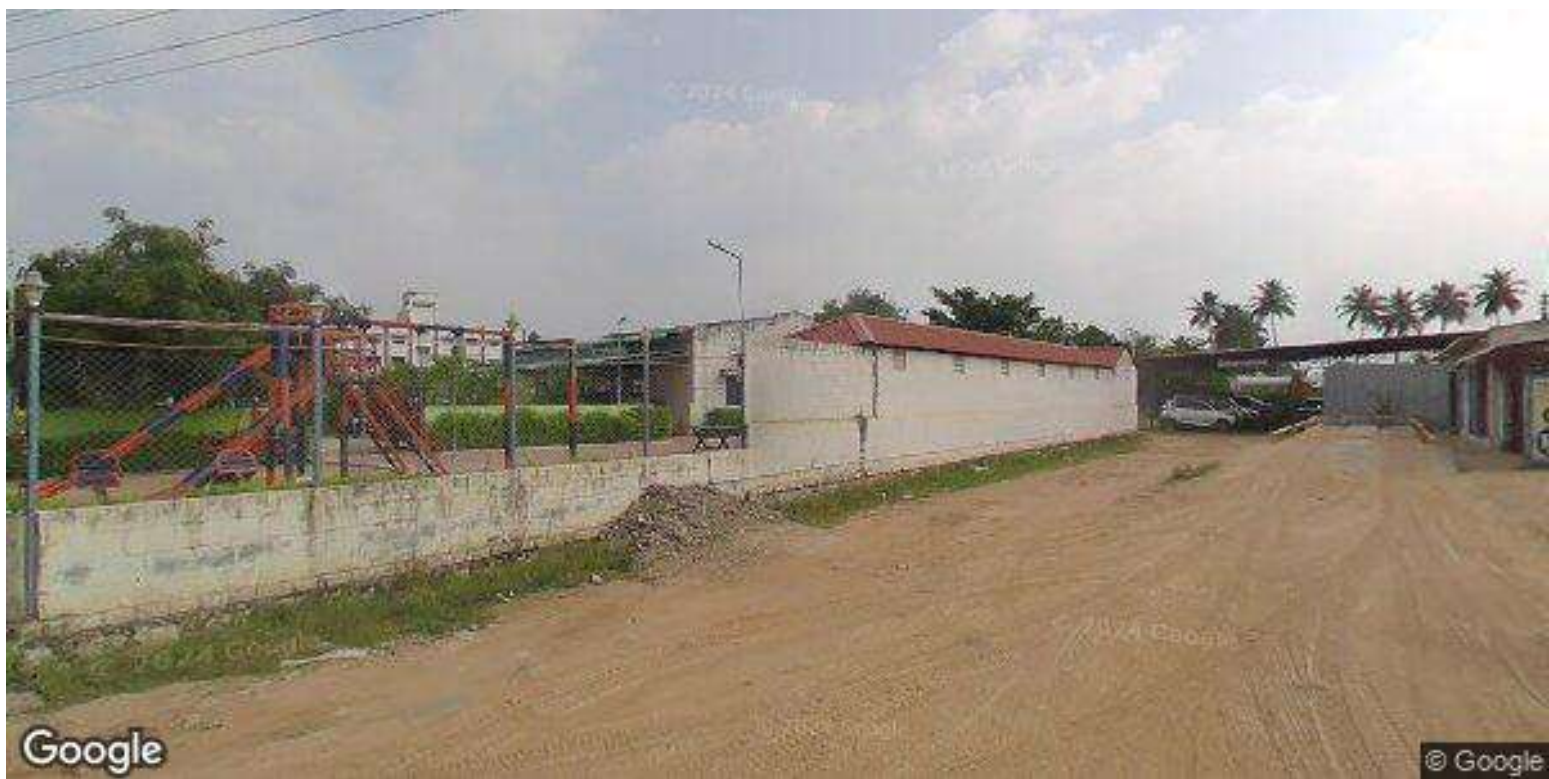
**Coordinates: 11.44377, 77.71562**

**Risk Type: Turn**

**Risk Level: High**

**Speed Limit: 15 KM/Hr**

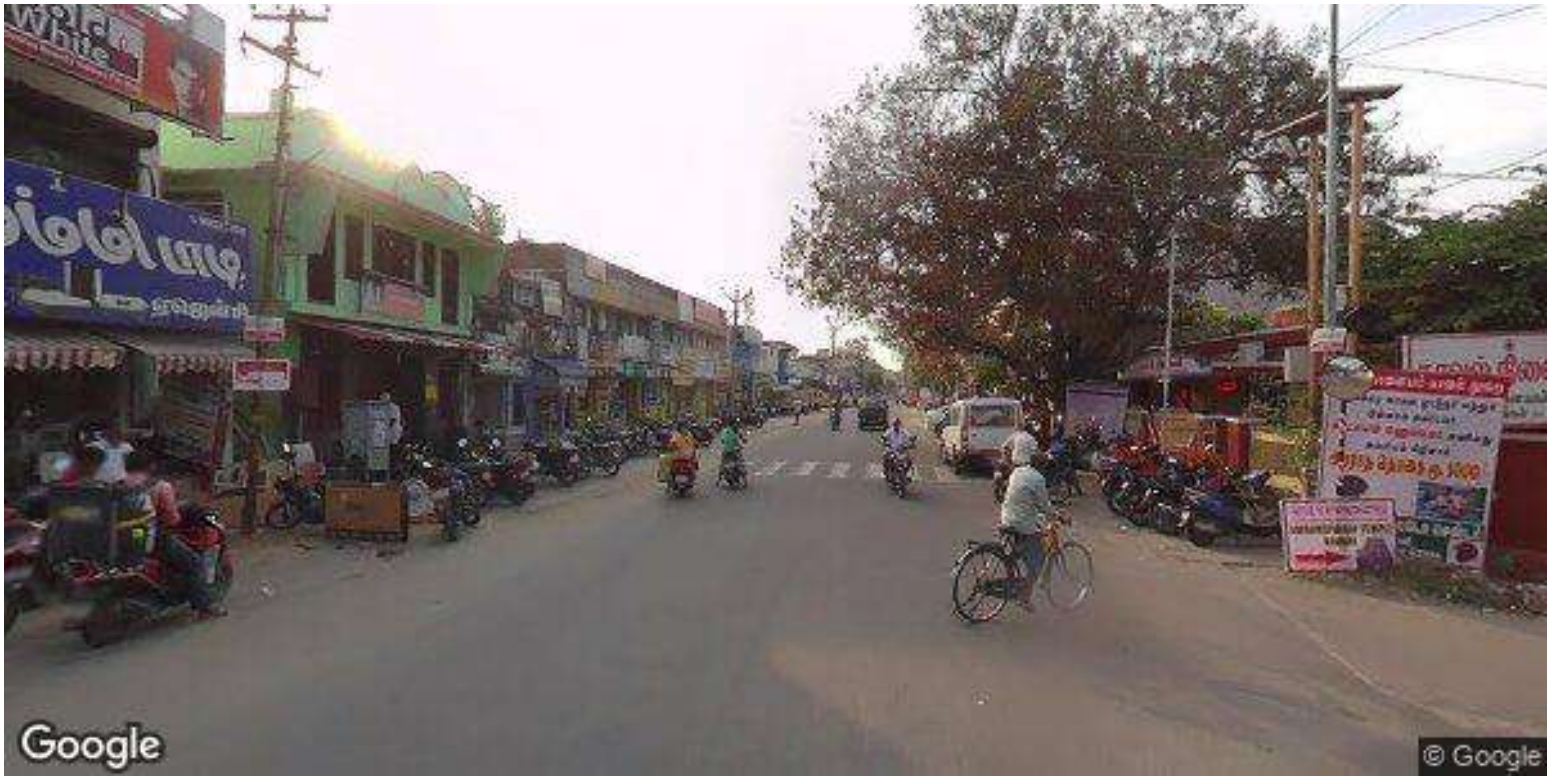
**Risk Type:** Blind Spot  
**Risk Level:** Blind Spot  
**Speed Limit:** 10 KM/Hr  
**Coordinates:** 11.44105, 77.69331

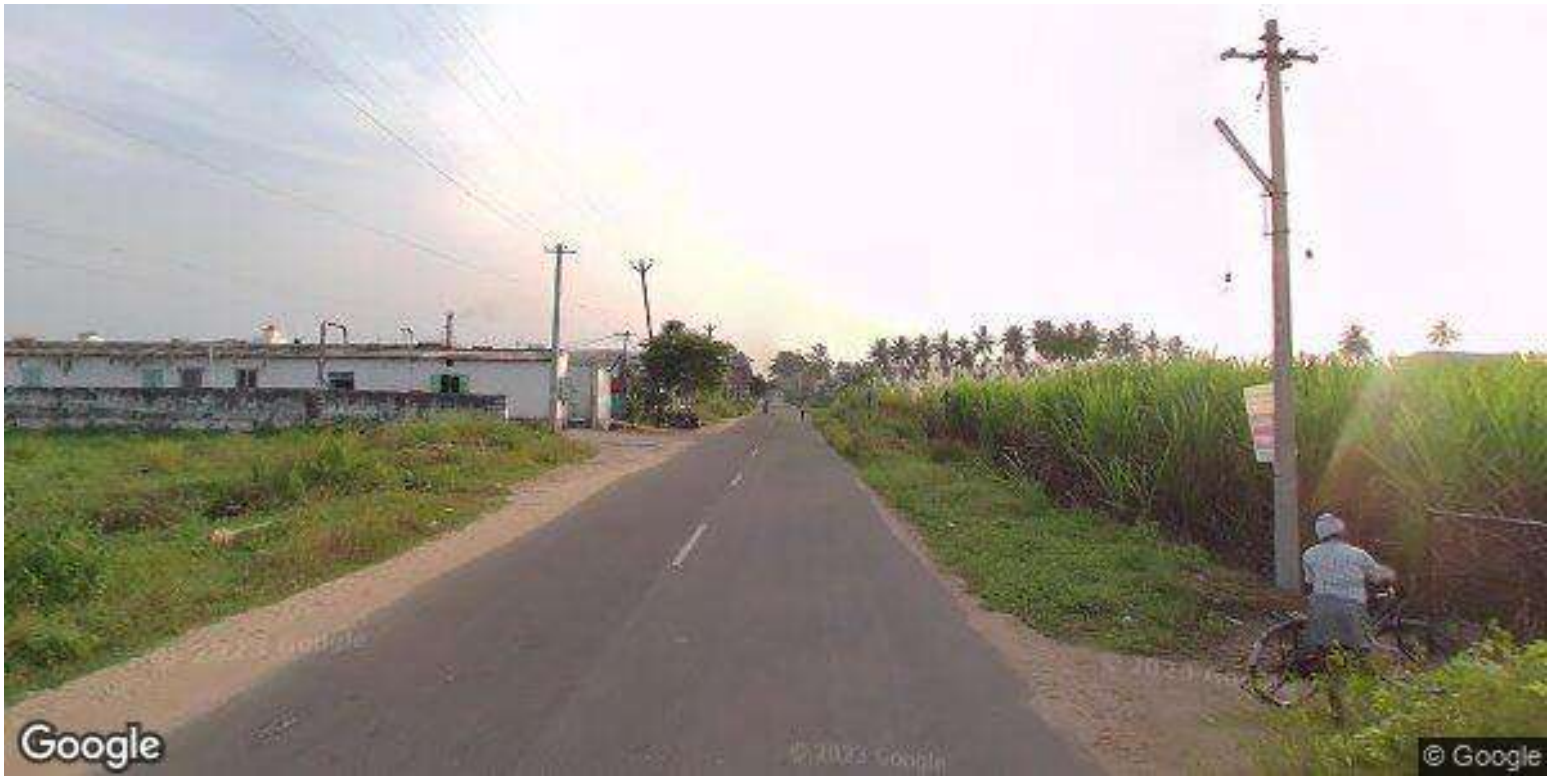
**Risk Type:** Turn  
**Risk Level:** High  
**Speed Limit:** 15 KM/Hr  
**Coordinates:** 11.45711, 77.69765
