## JOURNEY RISK MANAGEMENT (JRM) STUDY

### Salem Terminal TO SAI VENKATESWARA FUELS

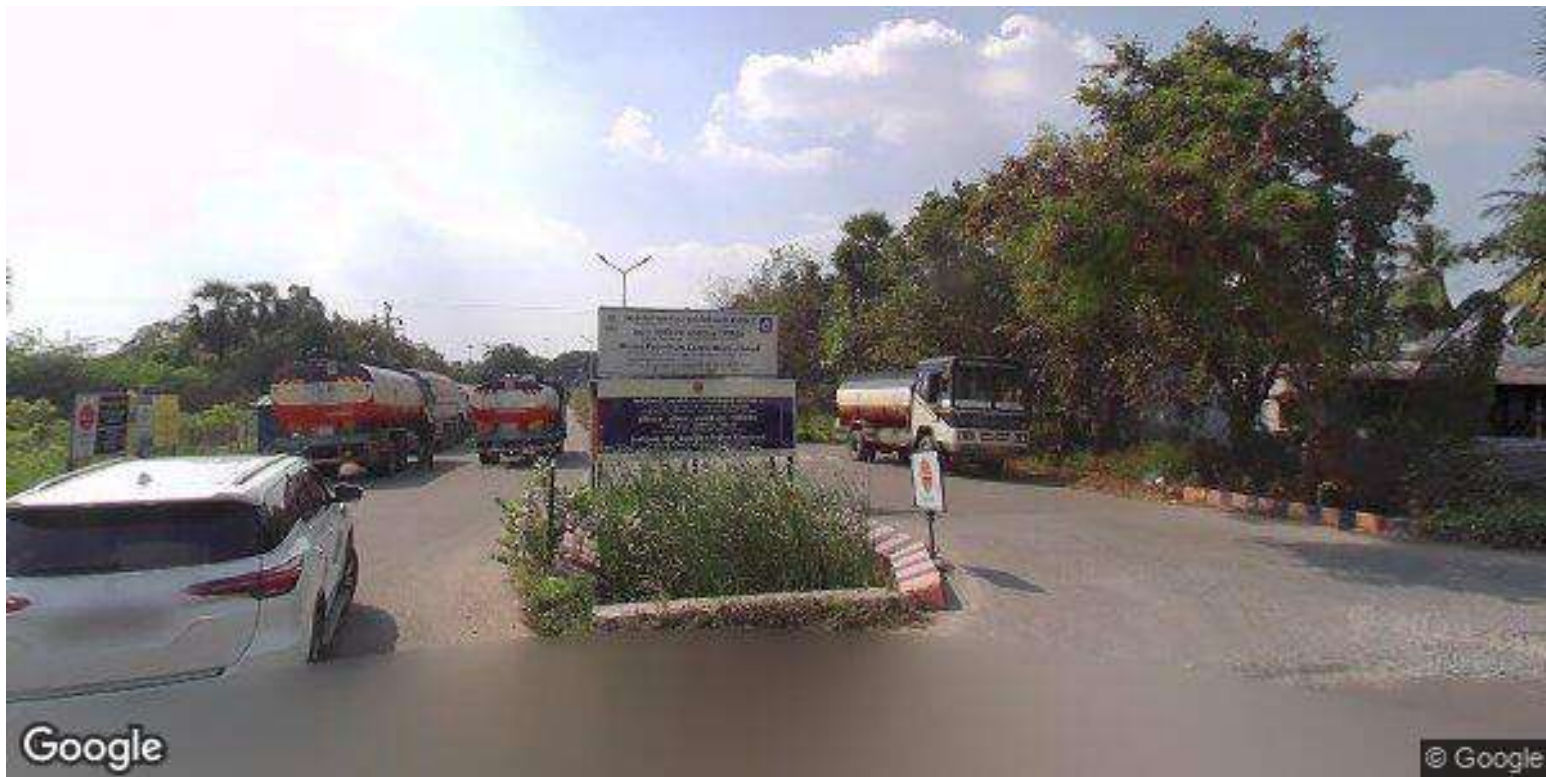
**Coordinates:** 11.44024, 77.87528

**Risk Type:** Turn

**Risk Level:** High

**Speed Limit:** 15 KM/Hr

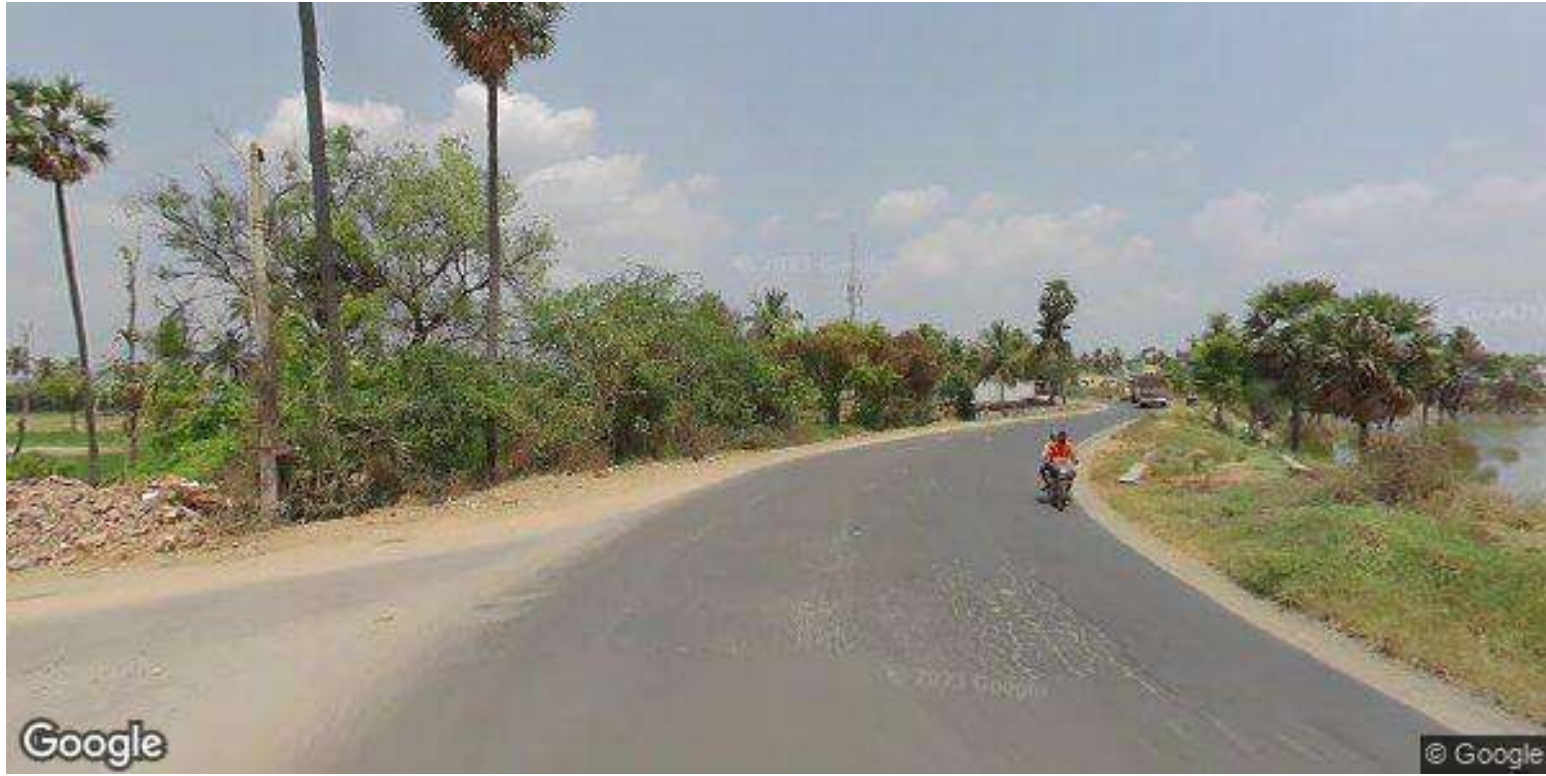
**Risk Type:** Turn  
**Risk Level:** Medium  
**Speed Limit:** 30 KM/Hr  
**Coordinates:** 11.56083, 77.89921

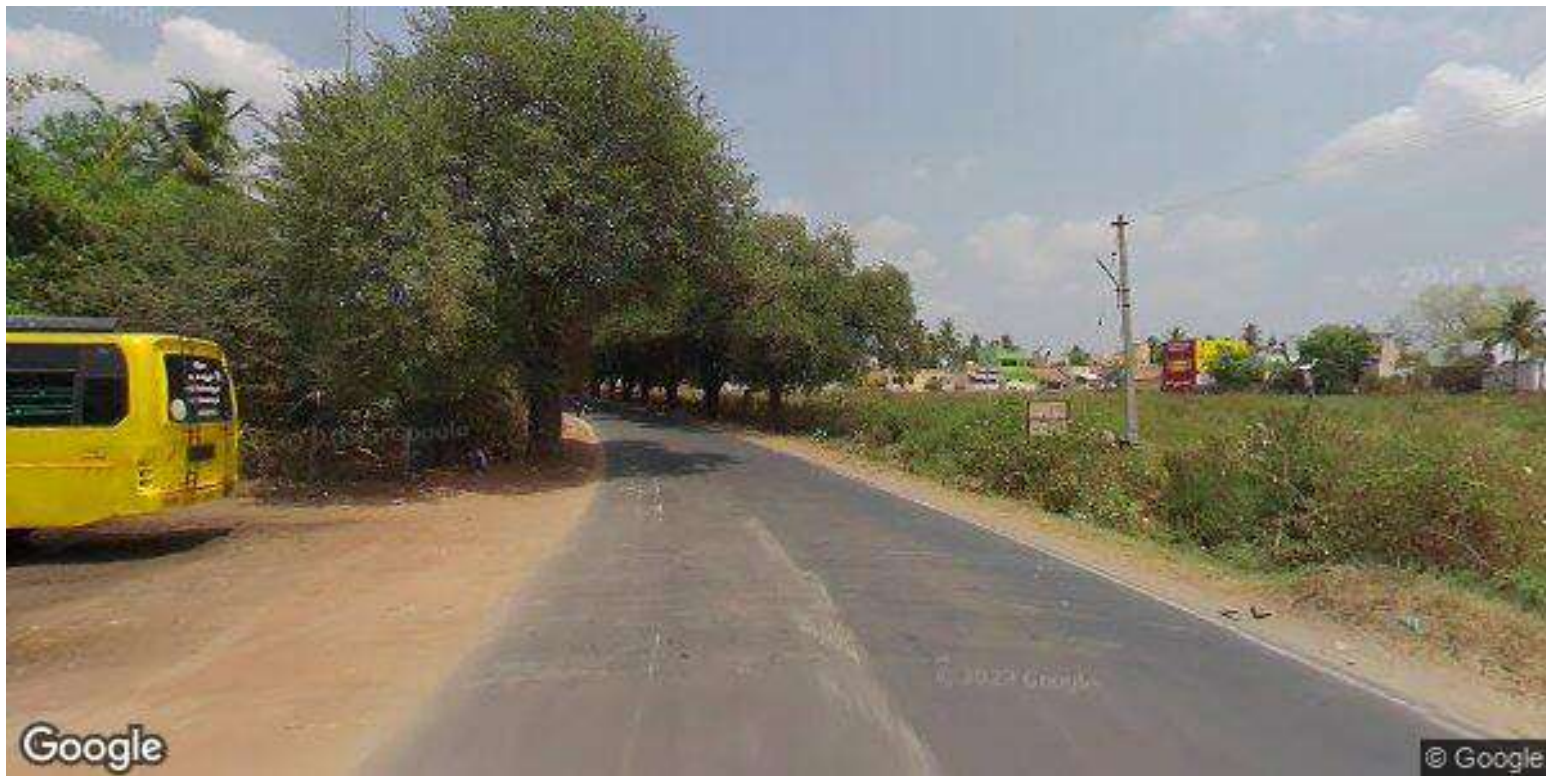
**Risk Type:** Turn  
**Risk Level:** Medium  
**Speed Limit:** 30 KM/Hr  
**Coordinates:** 11.56180, 77.90019

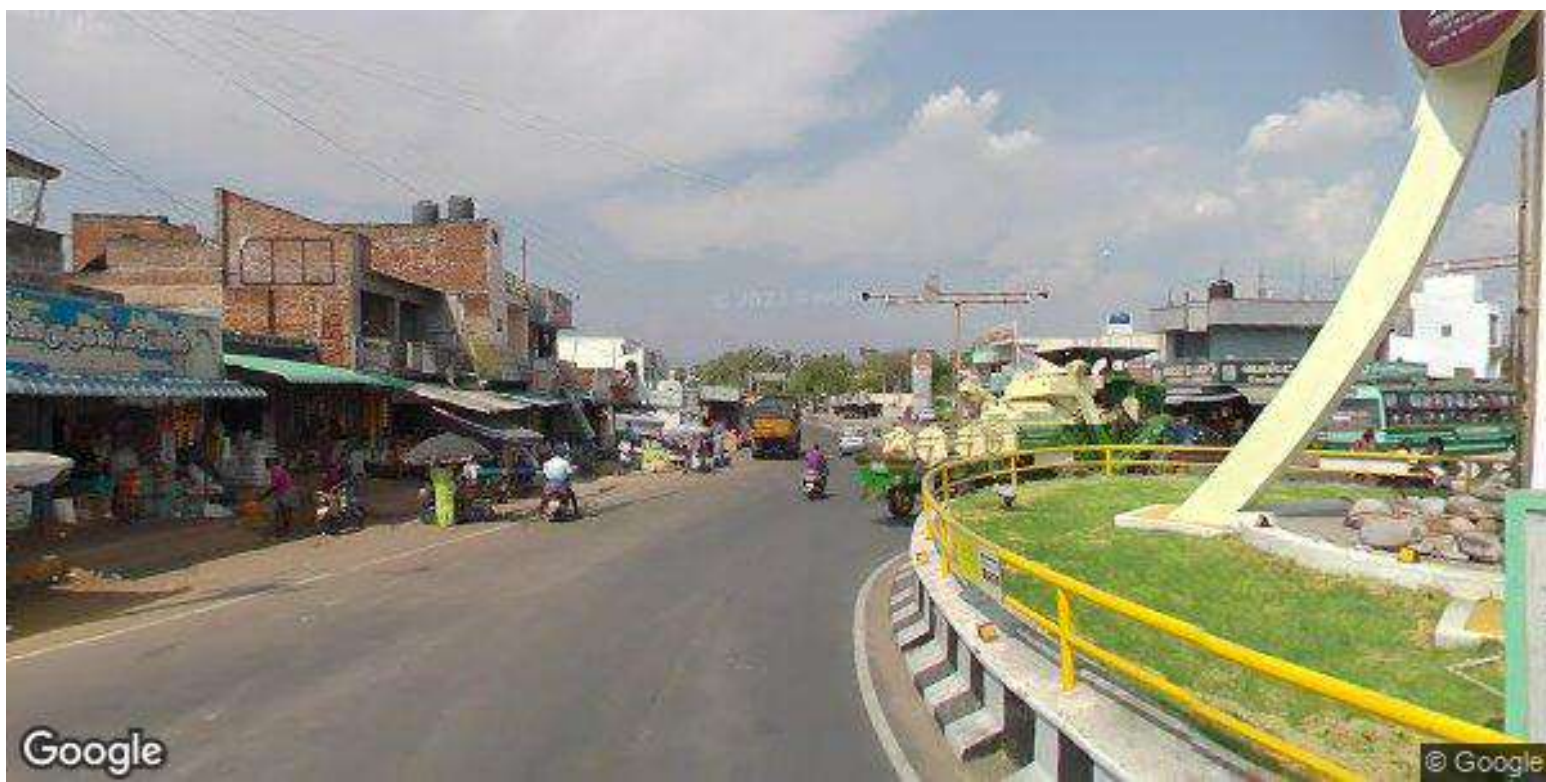
**Coordinates:** 11.57048, 77.90224

**Risk Type:** Turn

**Risk Level:** Medium

**Speed Limit:** 30 KM/Hr

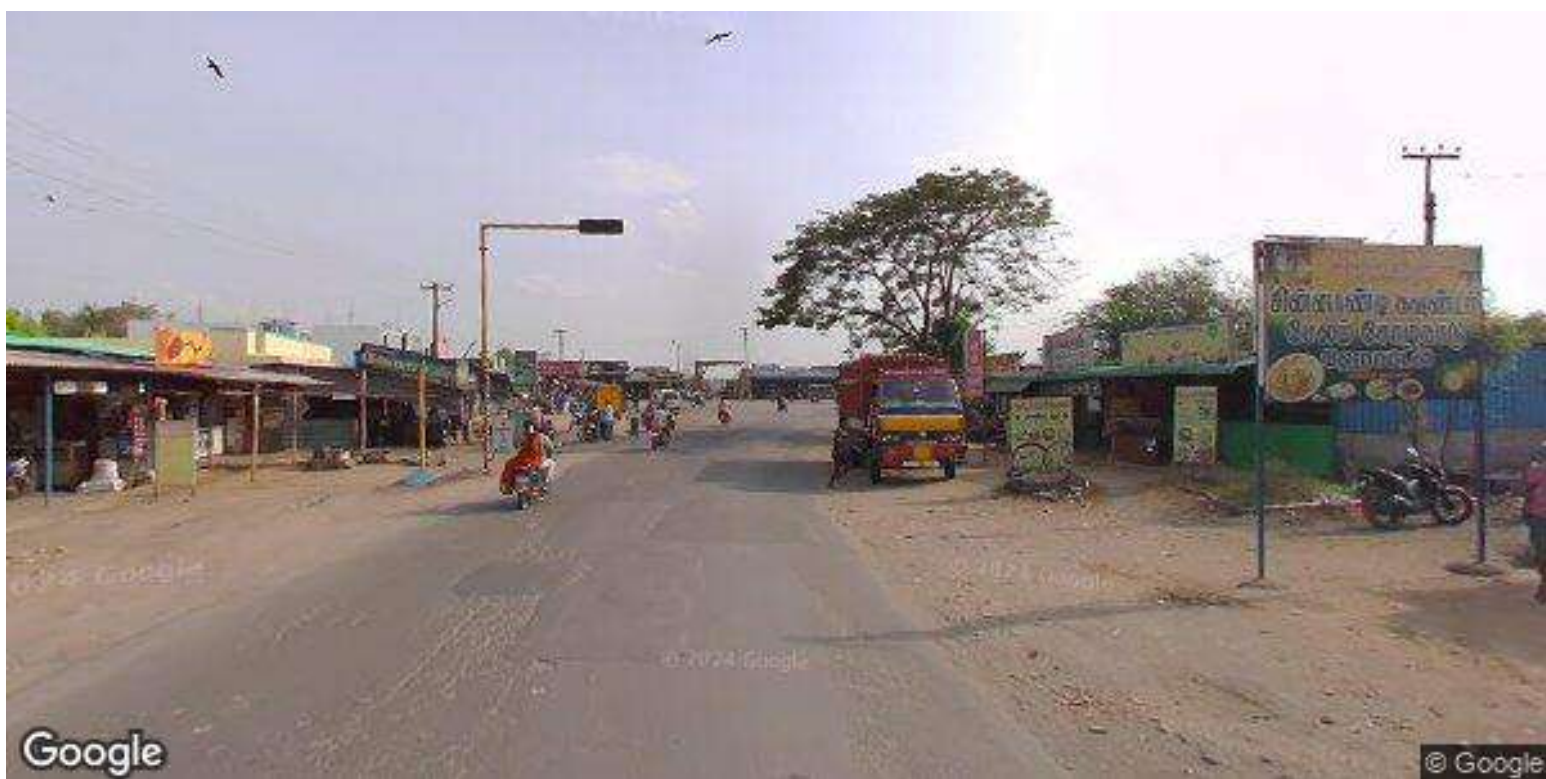
**Coordinates:** 11.64217, 77.95200

**Risk Type:** Turn

**Risk Level:** Medium

**Speed Limit:** 30 KM/Hr

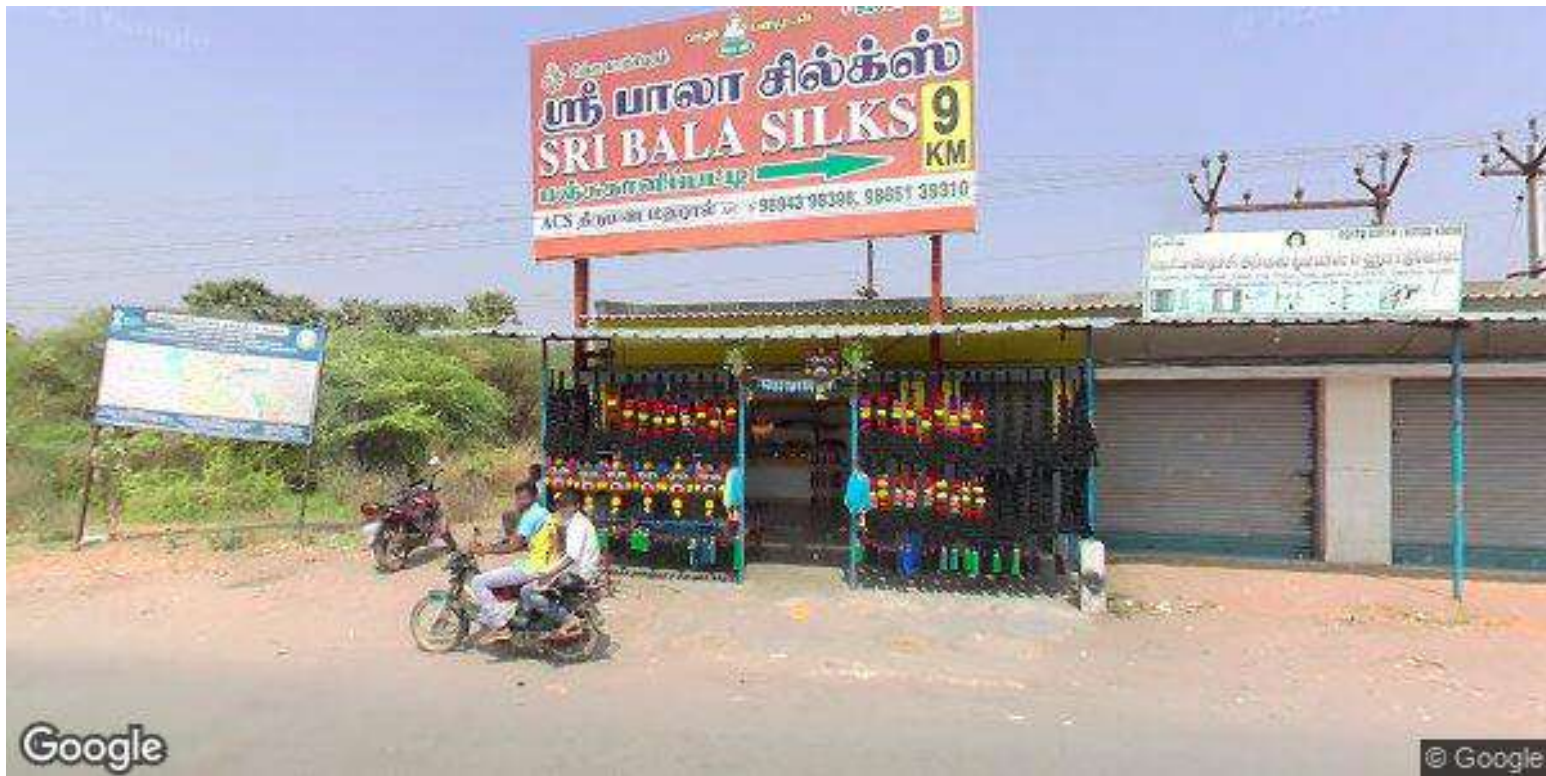
**Coordinates: 11.70233, 77.97869**

**Risk Type: Turn**

**Risk Level: High**

**Speed Limit: 15 KM/Hr**

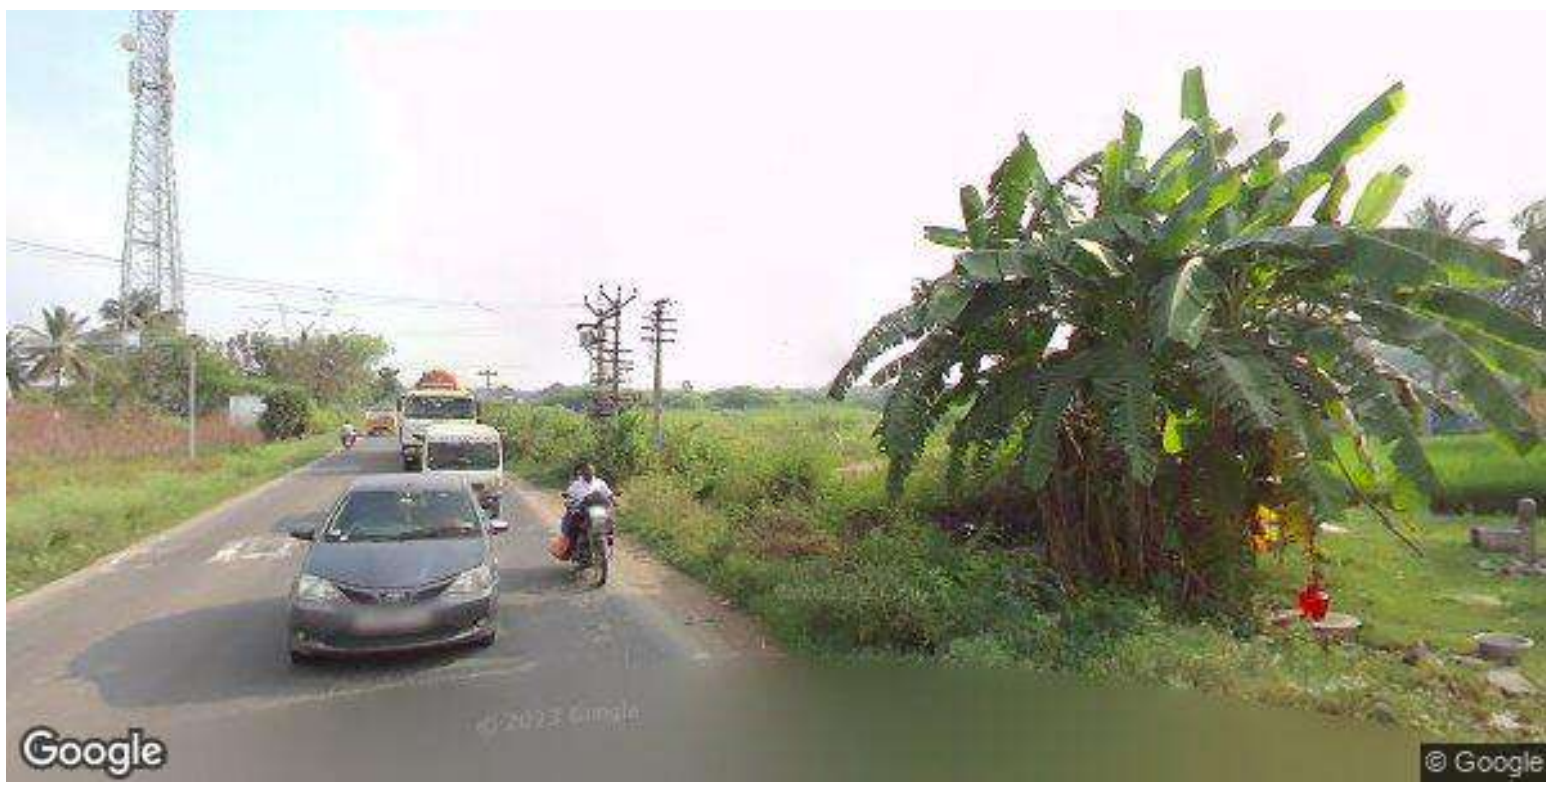
**Coordinates:** 11.71394, 77.99572

**Risk Type:** Turn

**Risk Level:** Medium

**Speed Limit:** 30 KM/Hr

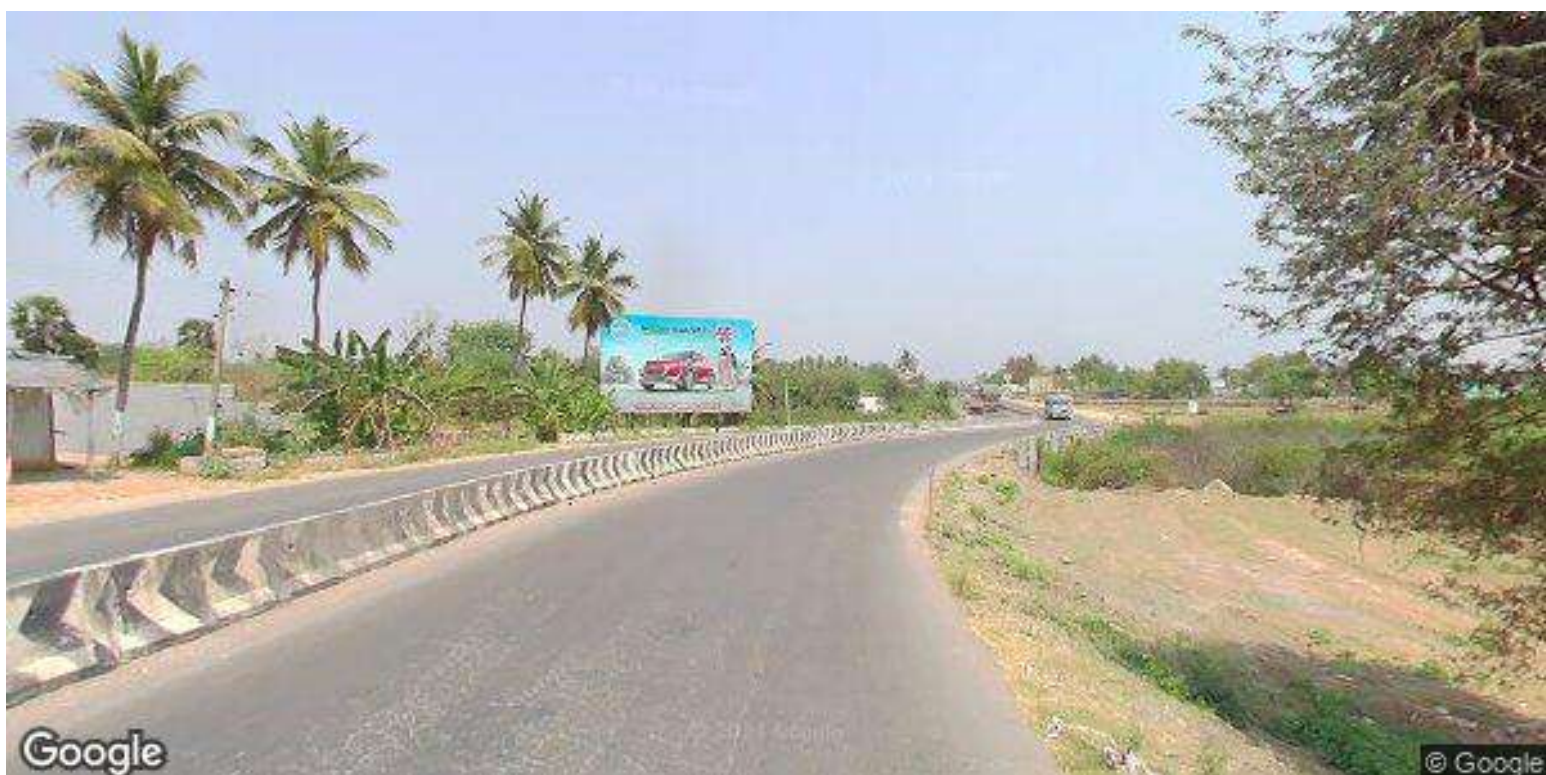
**Coordinates: 11.72559, 78.01758**

**Risk Type: Turn**

**Risk Level: Medium**

**Speed Limit: 30 KM/Hr**

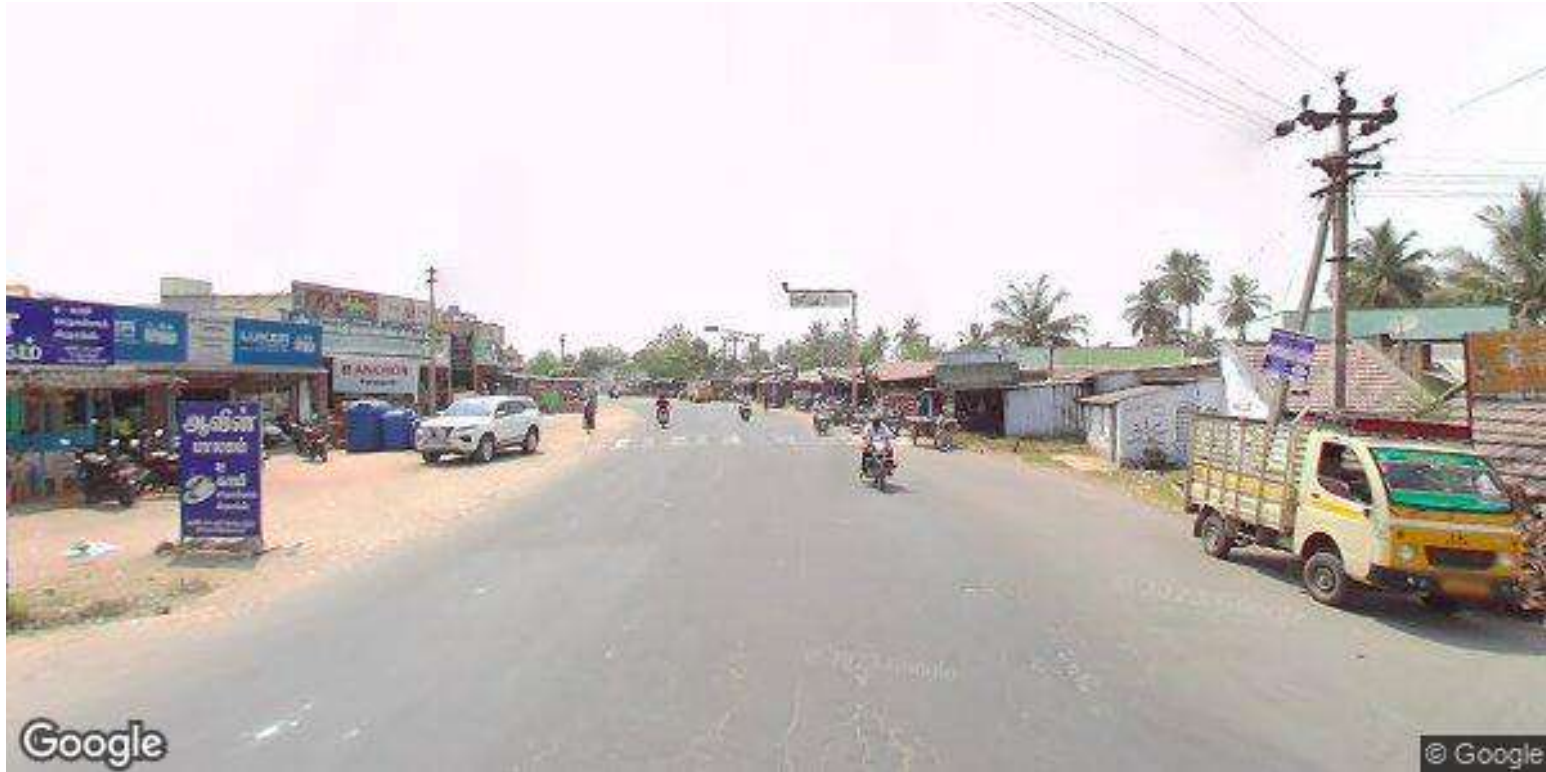
**Coordinates: 11.73787, 78.03528**

**Risk Type: Turn**

**Risk Level: Medium**

**Speed Limit: 30 KM/Hr**

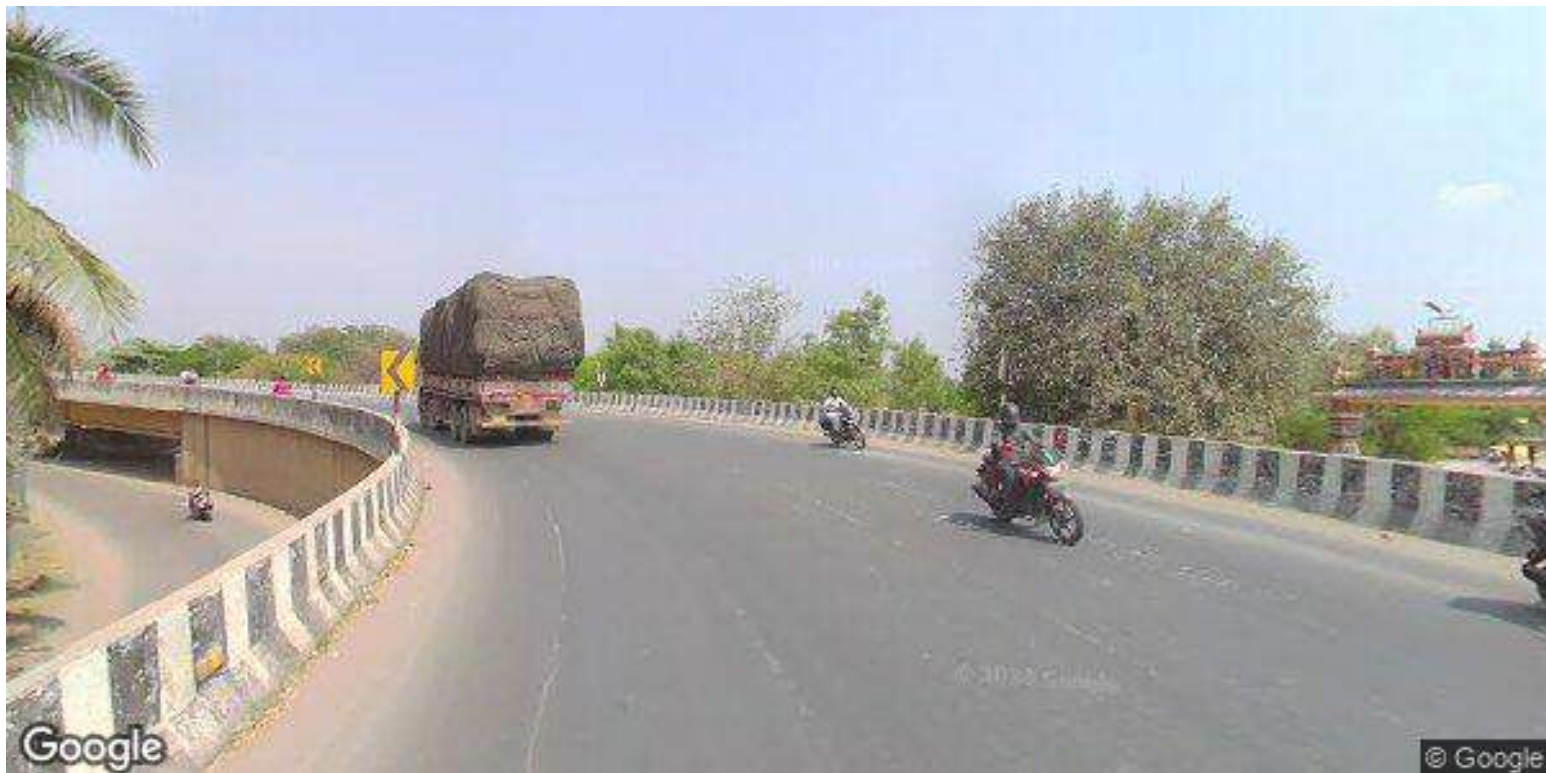
**Coordinates: 11.73651, 78.03868**

**Risk Type: Turn**

**Risk Level: High**

**Speed Limit: 15 KM/Hr**

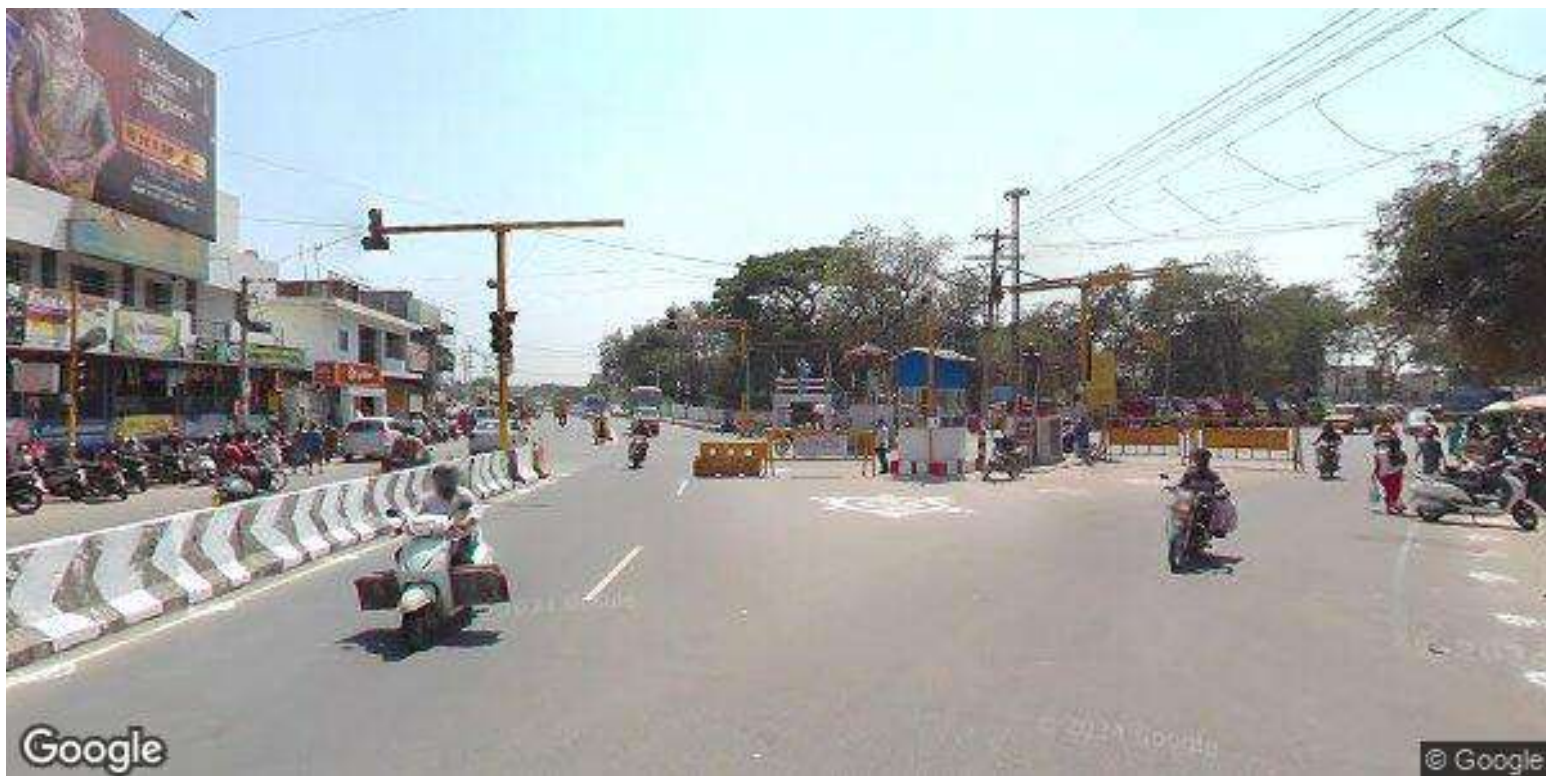
**Coordinates:** 11.74309, 78.04725

**Risk Type:** Turn

**Risk Level:** Medium

**Speed Limit:** 30 KM/Hr

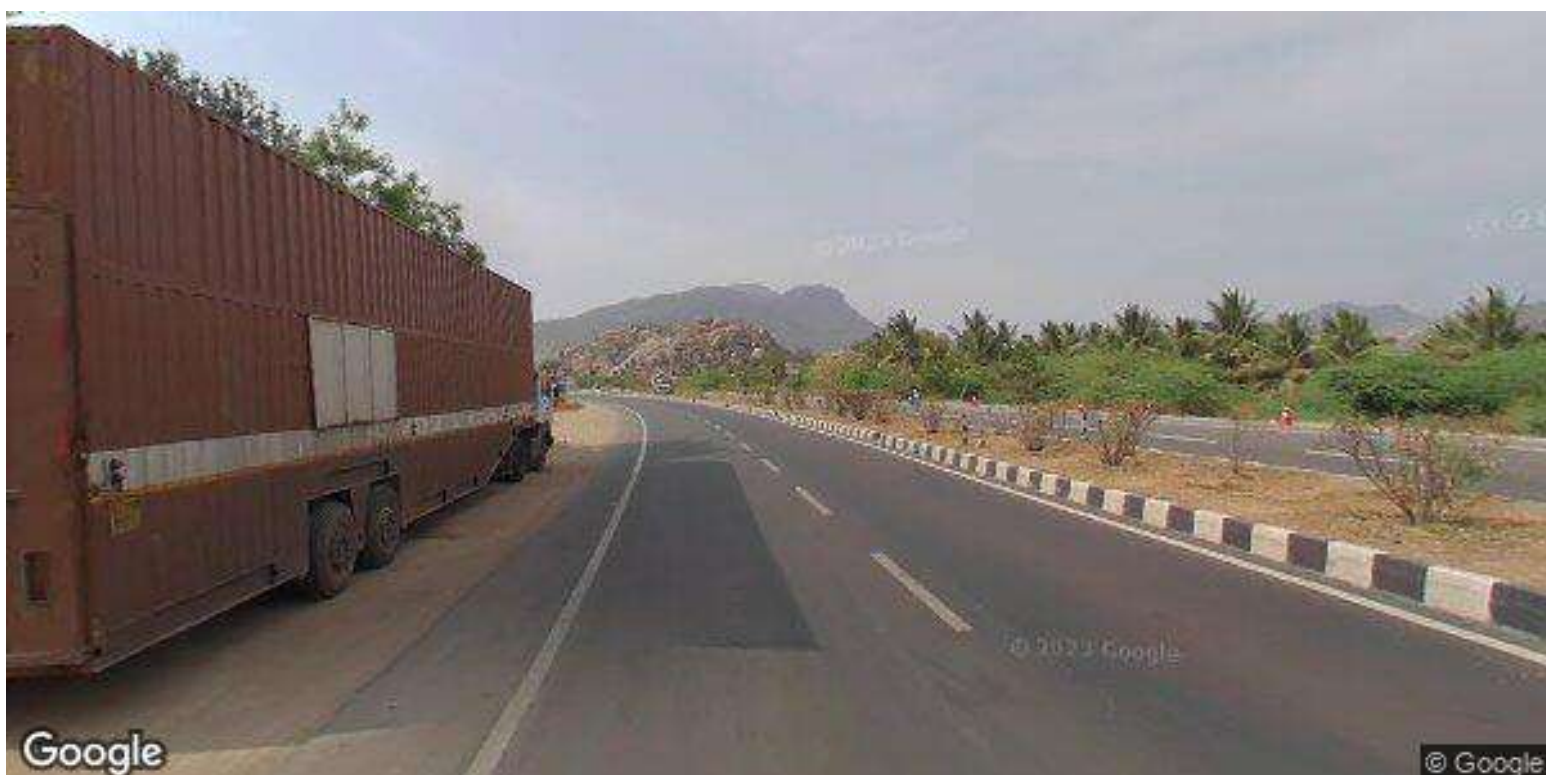
**Risk Type:** Turn  
**Risk Level:** Medium  
**Speed Limit:** 30 KM/Hr  
**Coordinates:** 11.87913, 78.08206

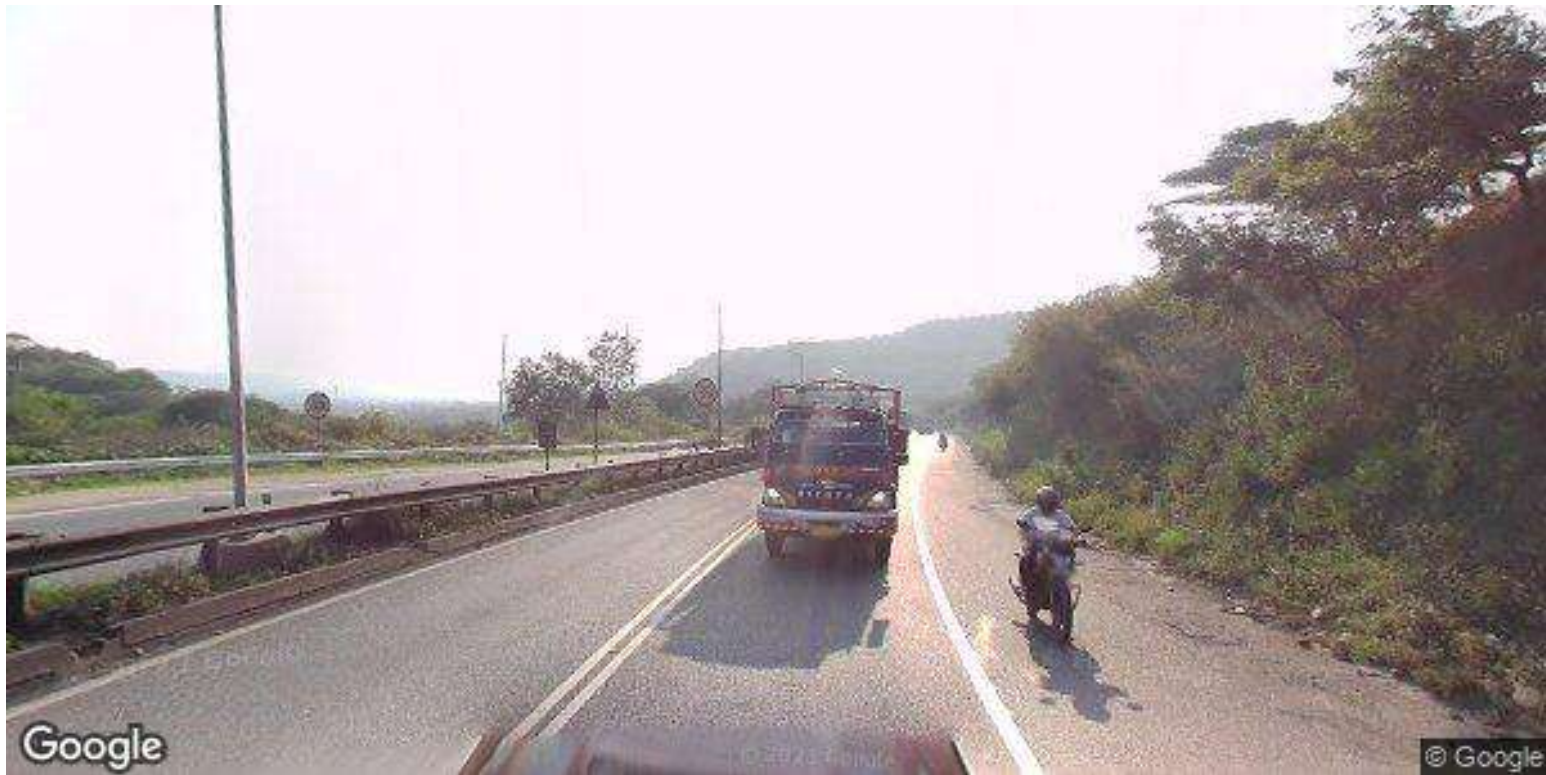
**Risk Type:** Turn  
**Risk Level:** Medium  
**Speed Limit:** 30 KM/Hr  
**Coordinates:** 11.95803, 78.04964

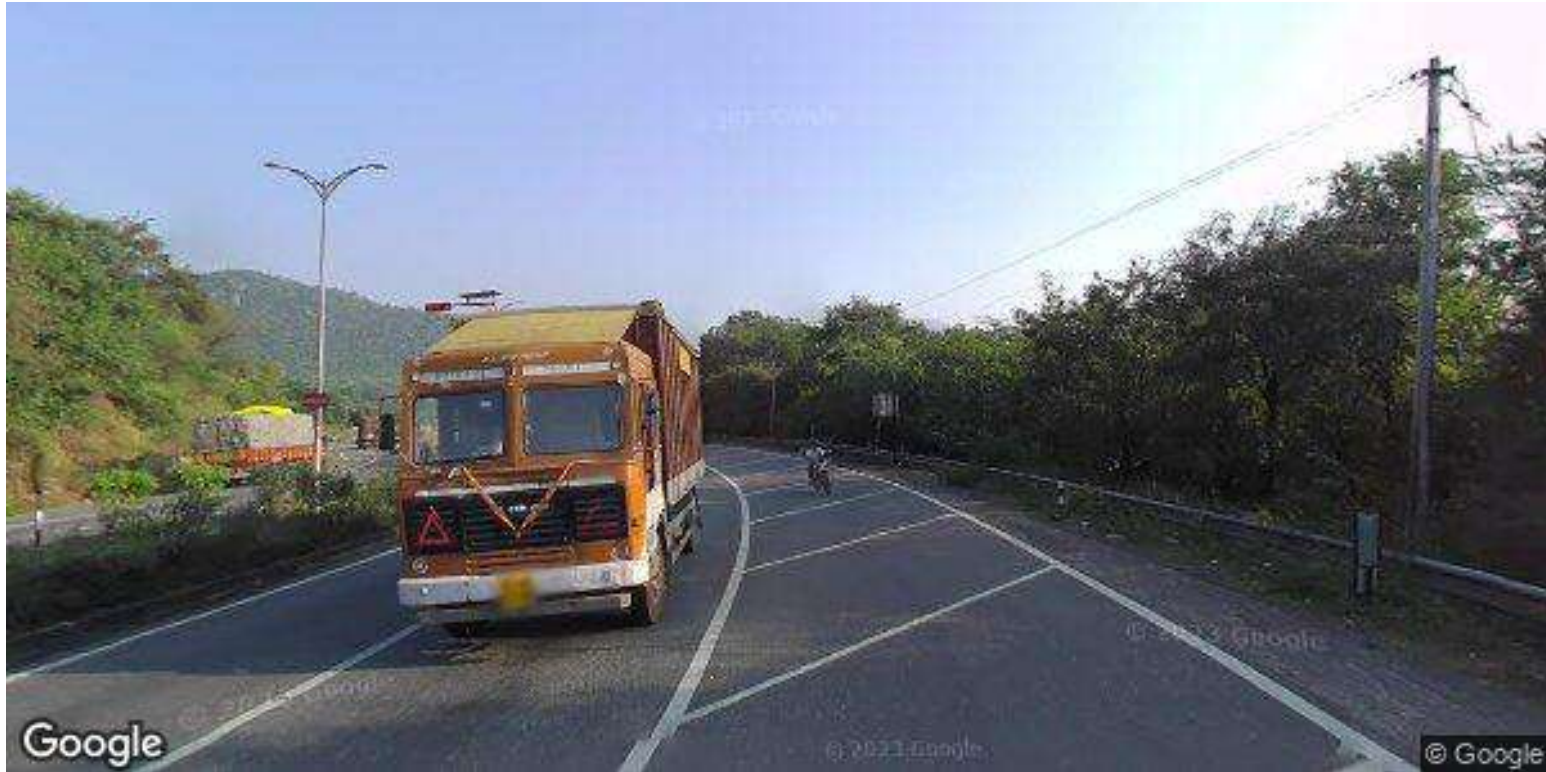
**Risk Type:** Turn  
**Risk Level:** High  
**Speed Limit:** 15 KM/Hr  
**Coordinates:** 11.96542, 78.04938

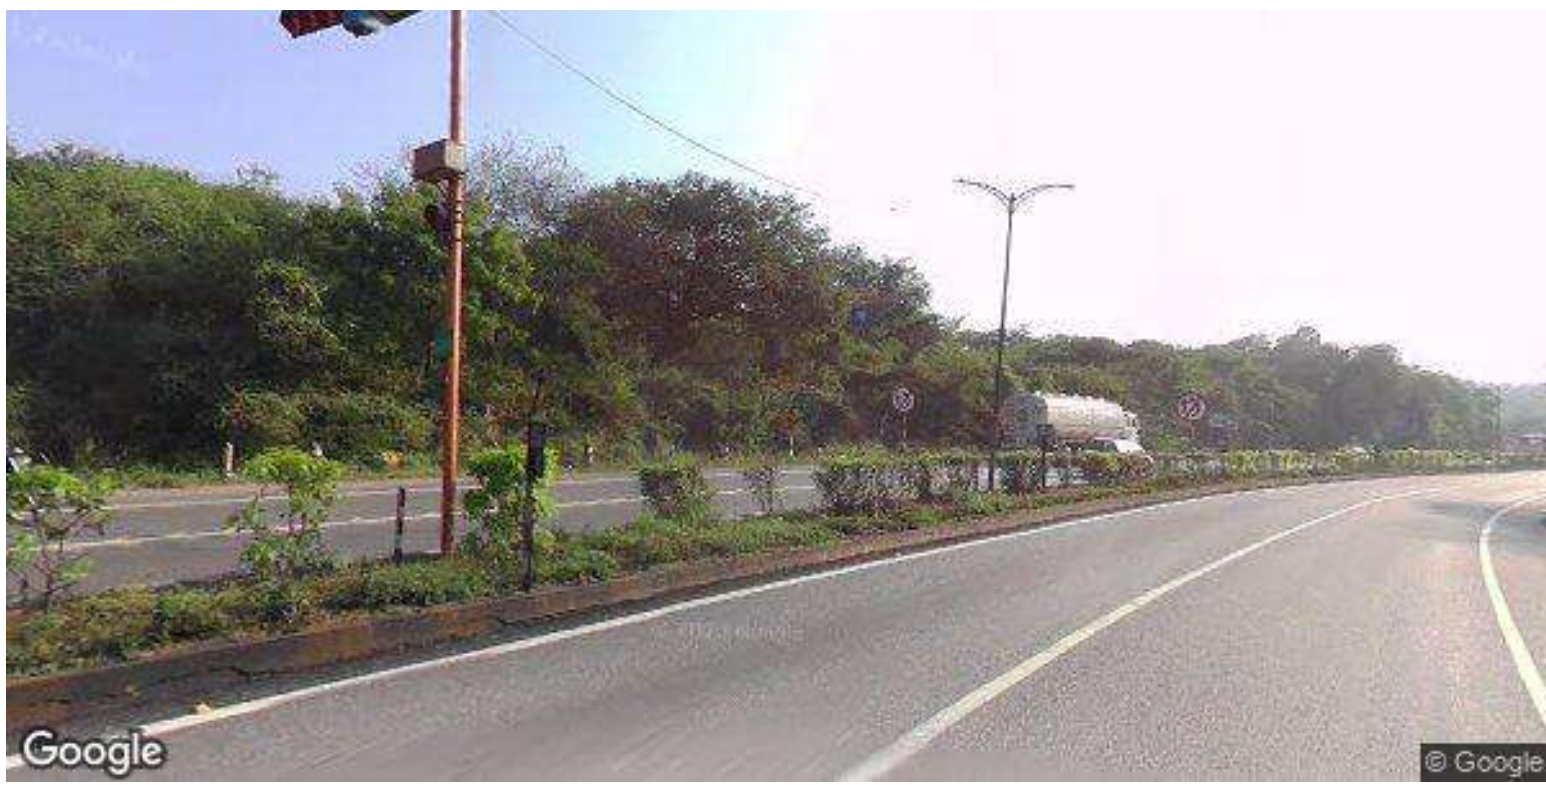
**Coordinates:** 11.96804, 78.05080

**Risk Type:** Turn

**Risk Level:** Medium

**Speed Limit:** 30 KM/Hr

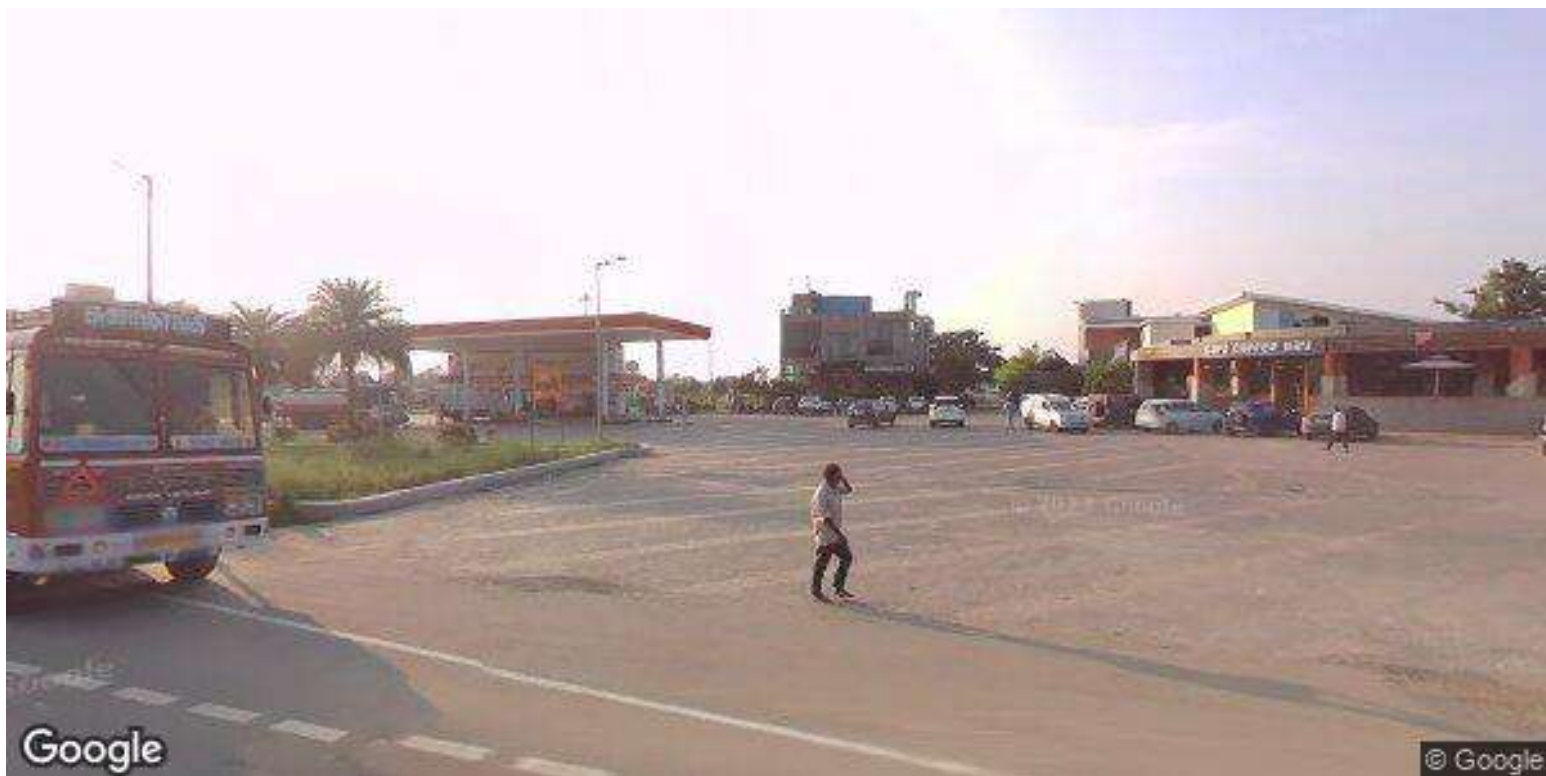
**Coordinates:** 12.02456, 78.09864

**Risk Type:** Blind Spot

**Risk Level:** Blind Spot

**Speed Limit:** 10 KM/Hr
