# IndianOil

## JOURNEY RISK MANAGEMENT (JRM) STUDY

### Salem Terminal TO SELVA VINAYAGA FUELS

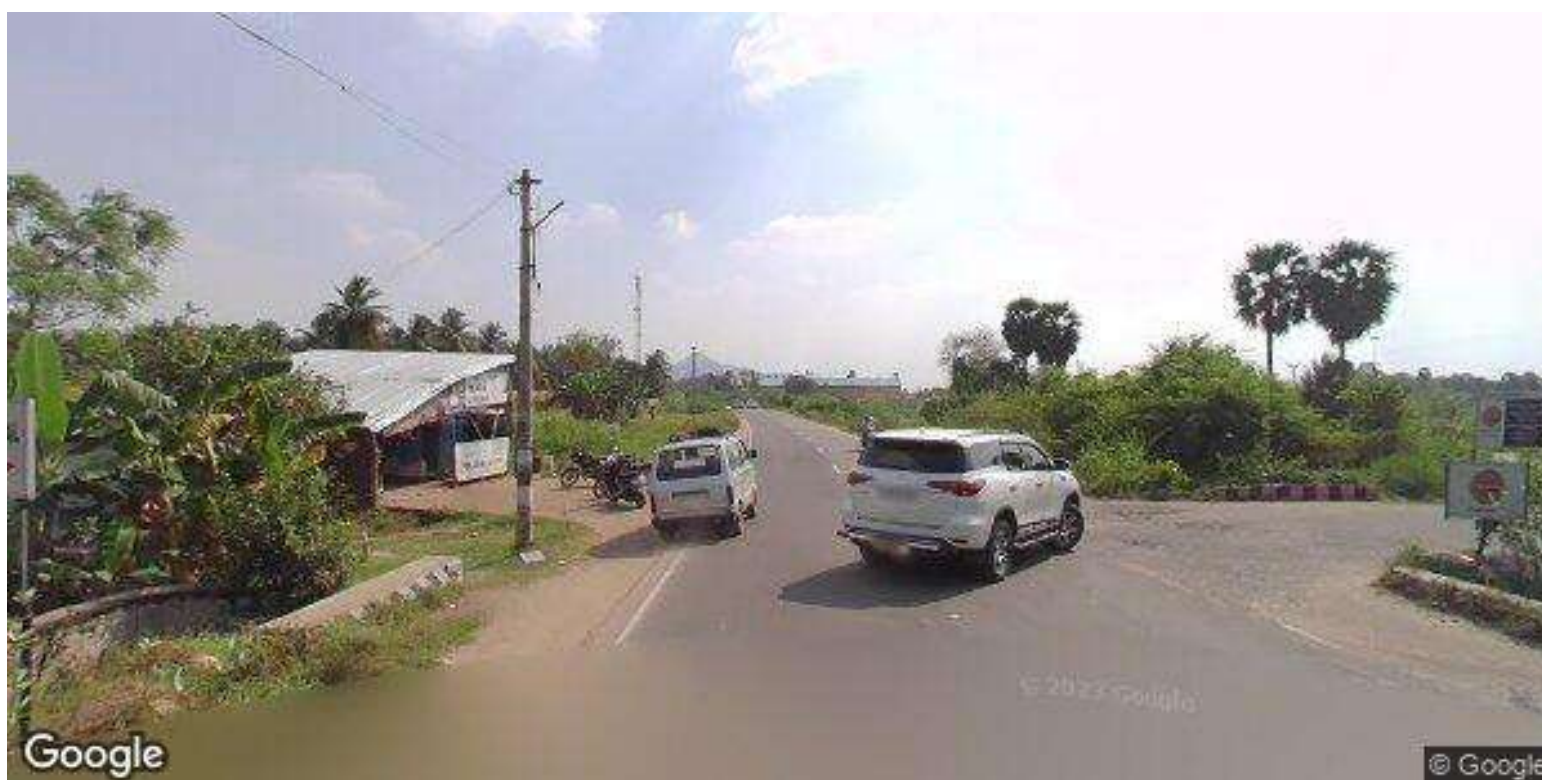
**Coordinates:** 11.44029, 77.87544

**Risk Type:** Turn

**Risk Level:** High

**Speed Limit:** 15 KM/Hr

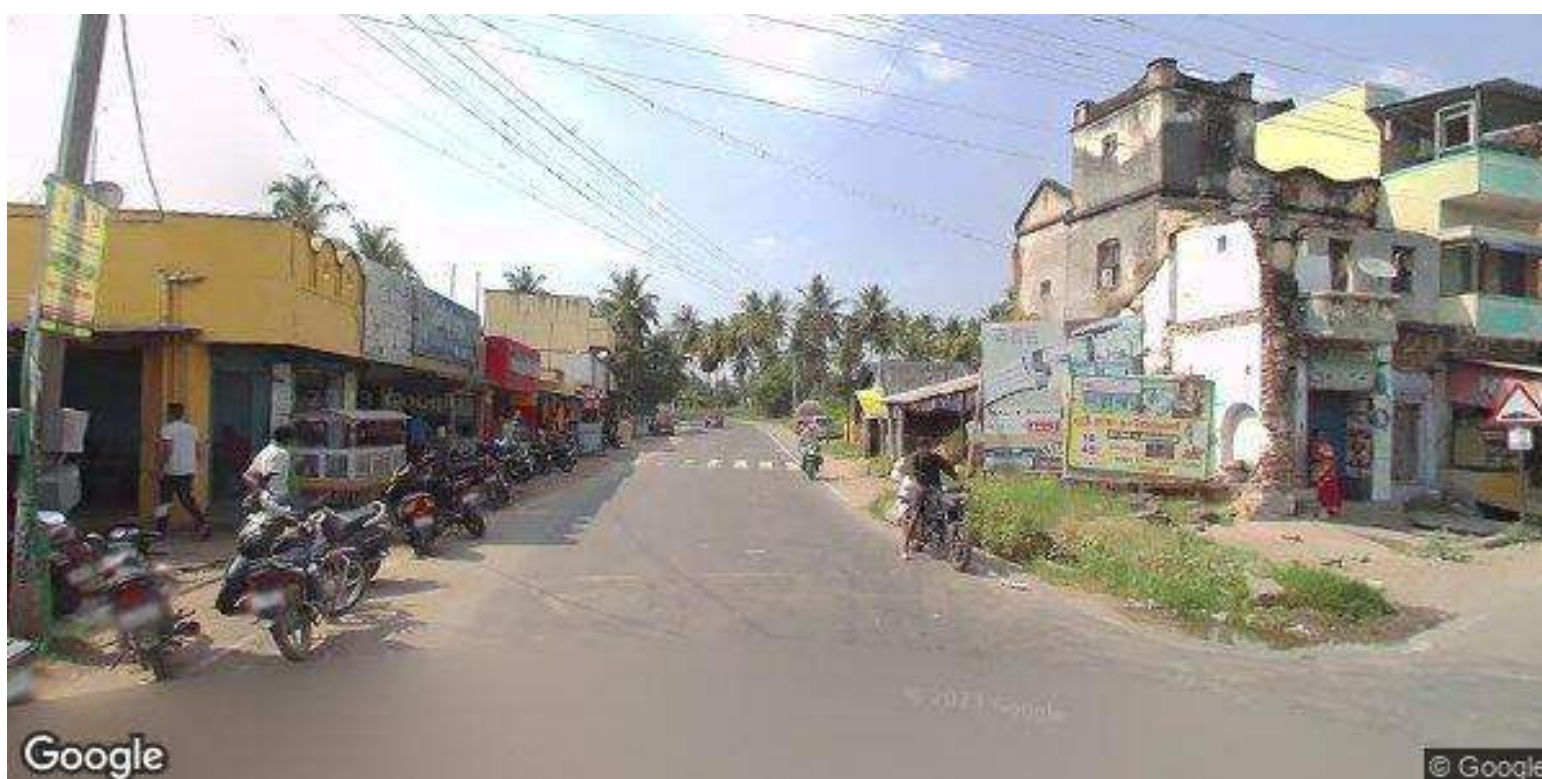
**Coordinates:** 11.45007, 77.87201

**Risk Type:** Turn

**Risk Level:** High

**Speed Limit:** 15 KM/Hr

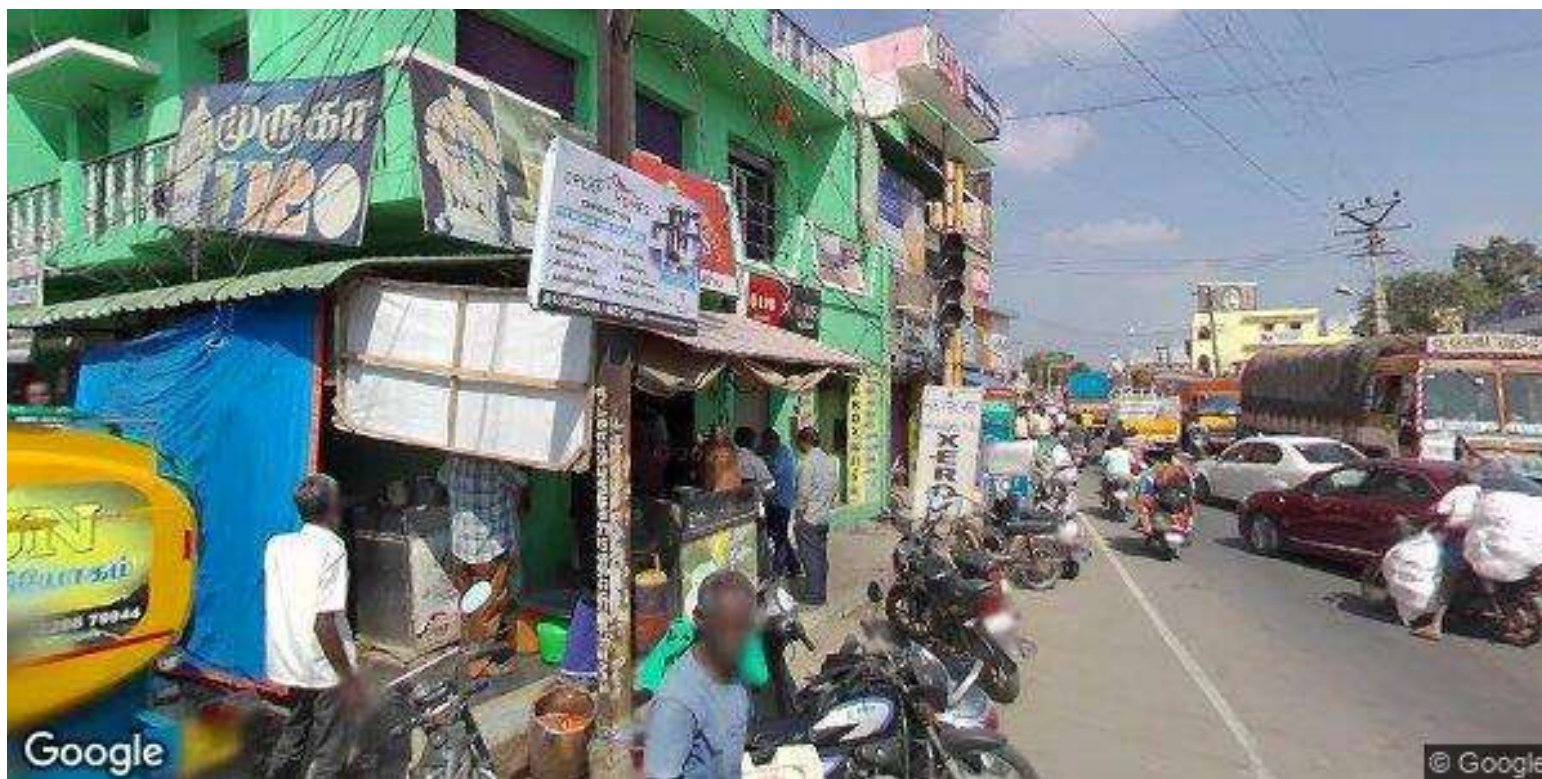
**Coordinates:** 11.47407, 77.86839

**Risk Type:** Turn

**Risk Level:** High

**Speed Limit:** 15 KM/Hr

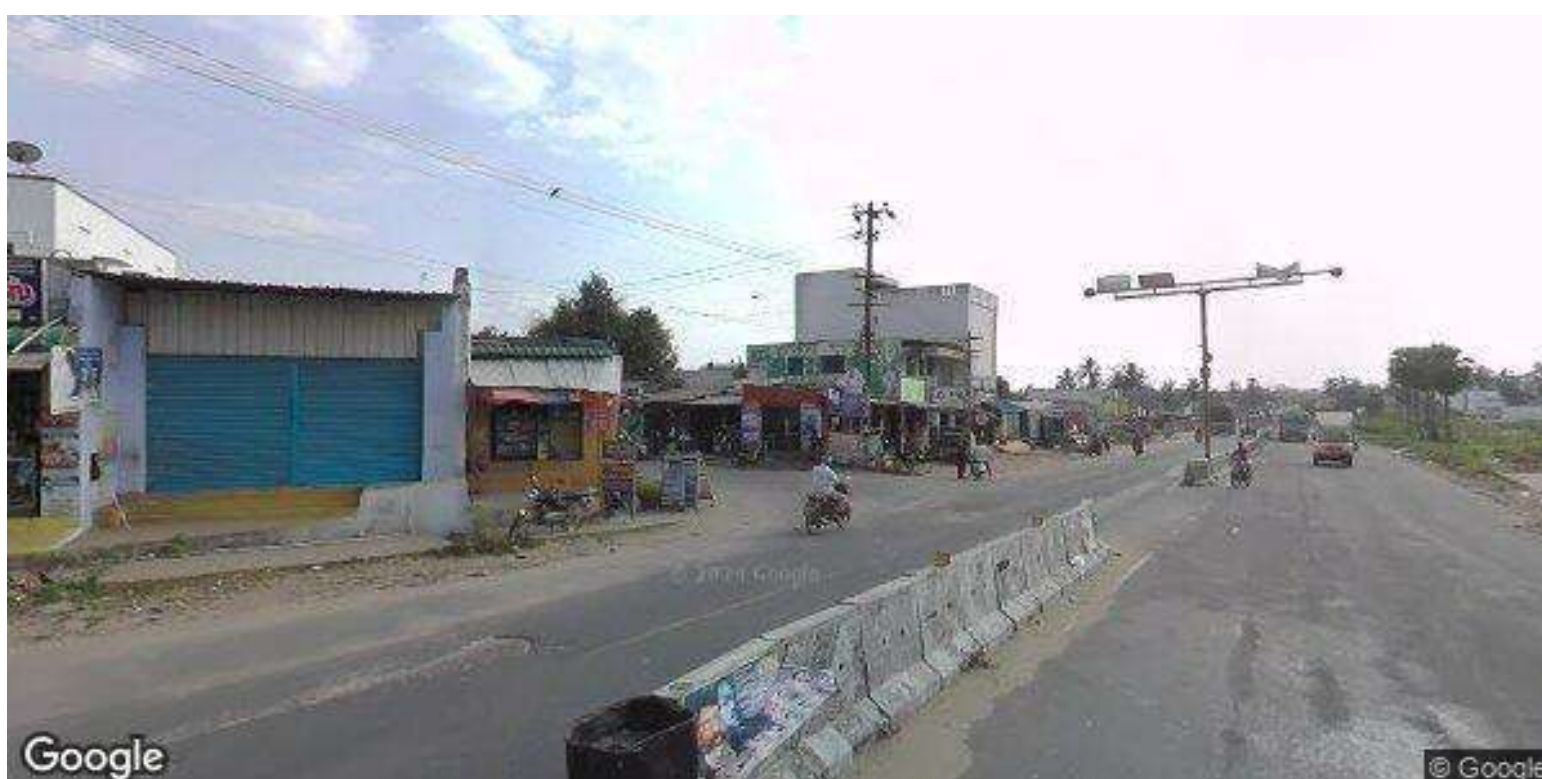
**Coordinates:** 11.48363, 77.88780

**Risk Type:** Turn

**Risk Level:** Medium

**Speed Limit:** 30 KM/Hr

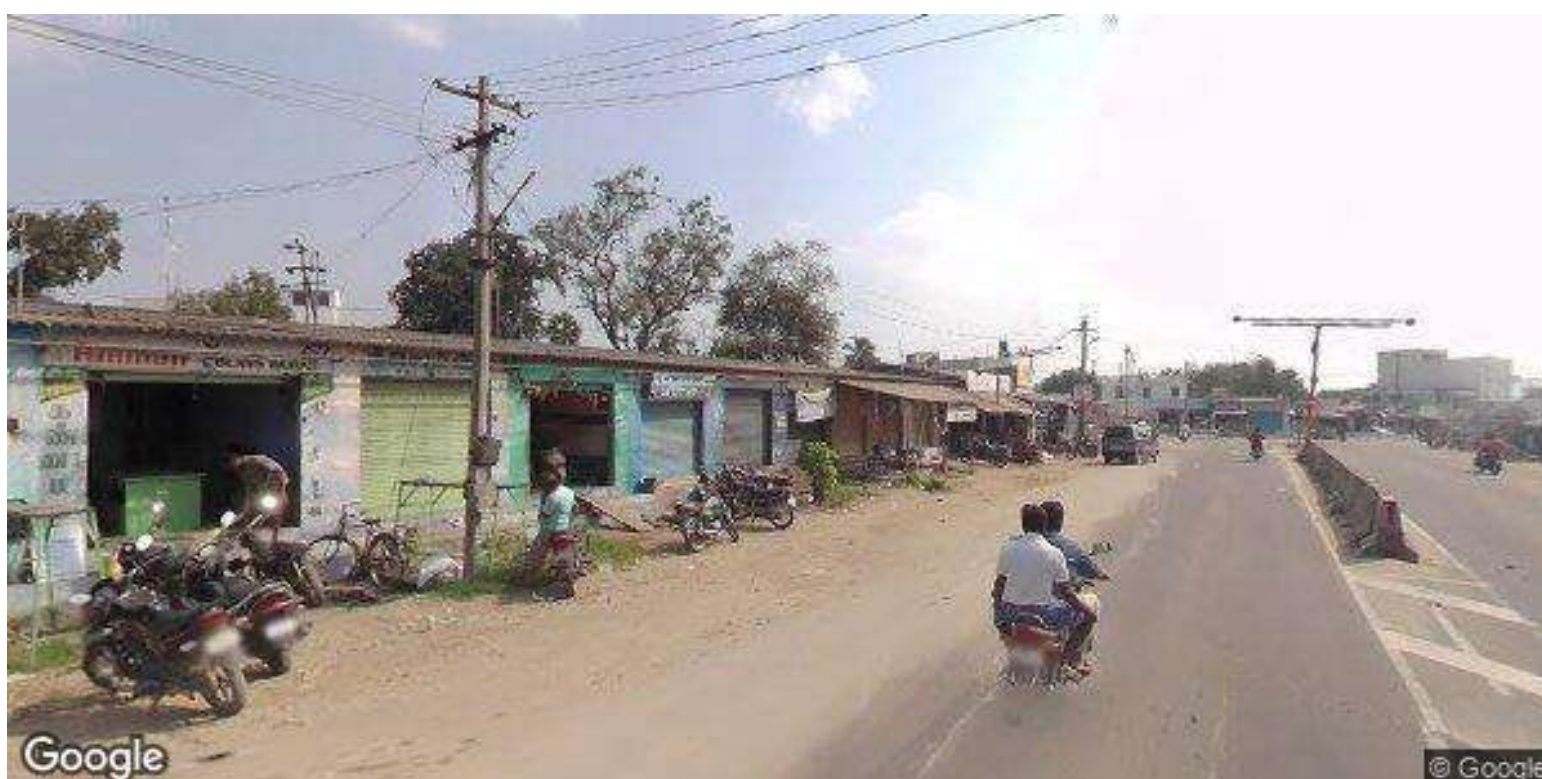
**Risk Type:** Turn  
**Risk Level:** Medium  
**Speed Limit:** 30 KM/Hr  
**Coordinates:** 11.48446, 77.88787

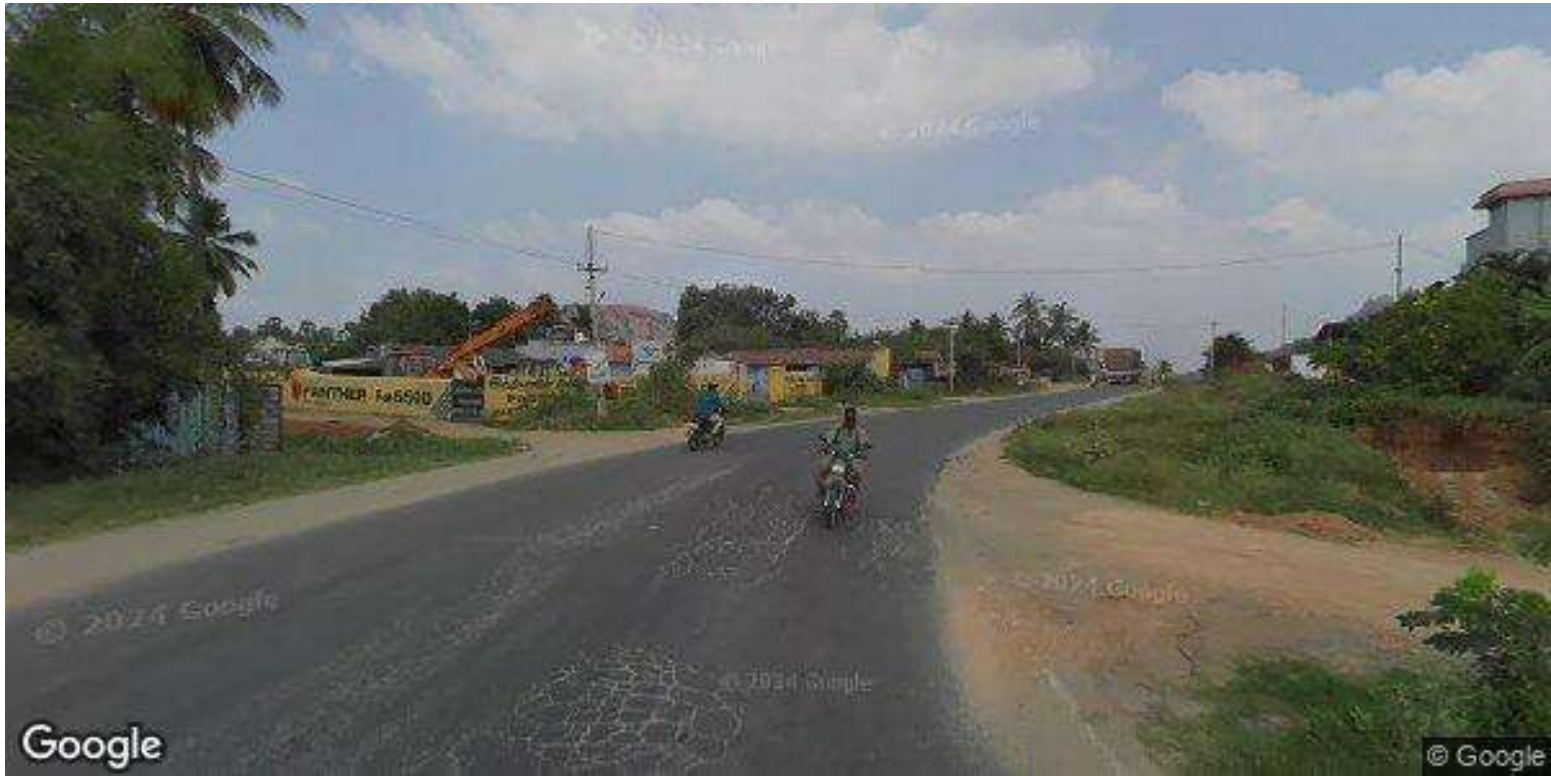
**Risk Type:** Turn  
**Risk Level:** Medium  
**Speed Limit:** 30 KM/Hr  
**Coordinates:** 11.49451, 77.88489

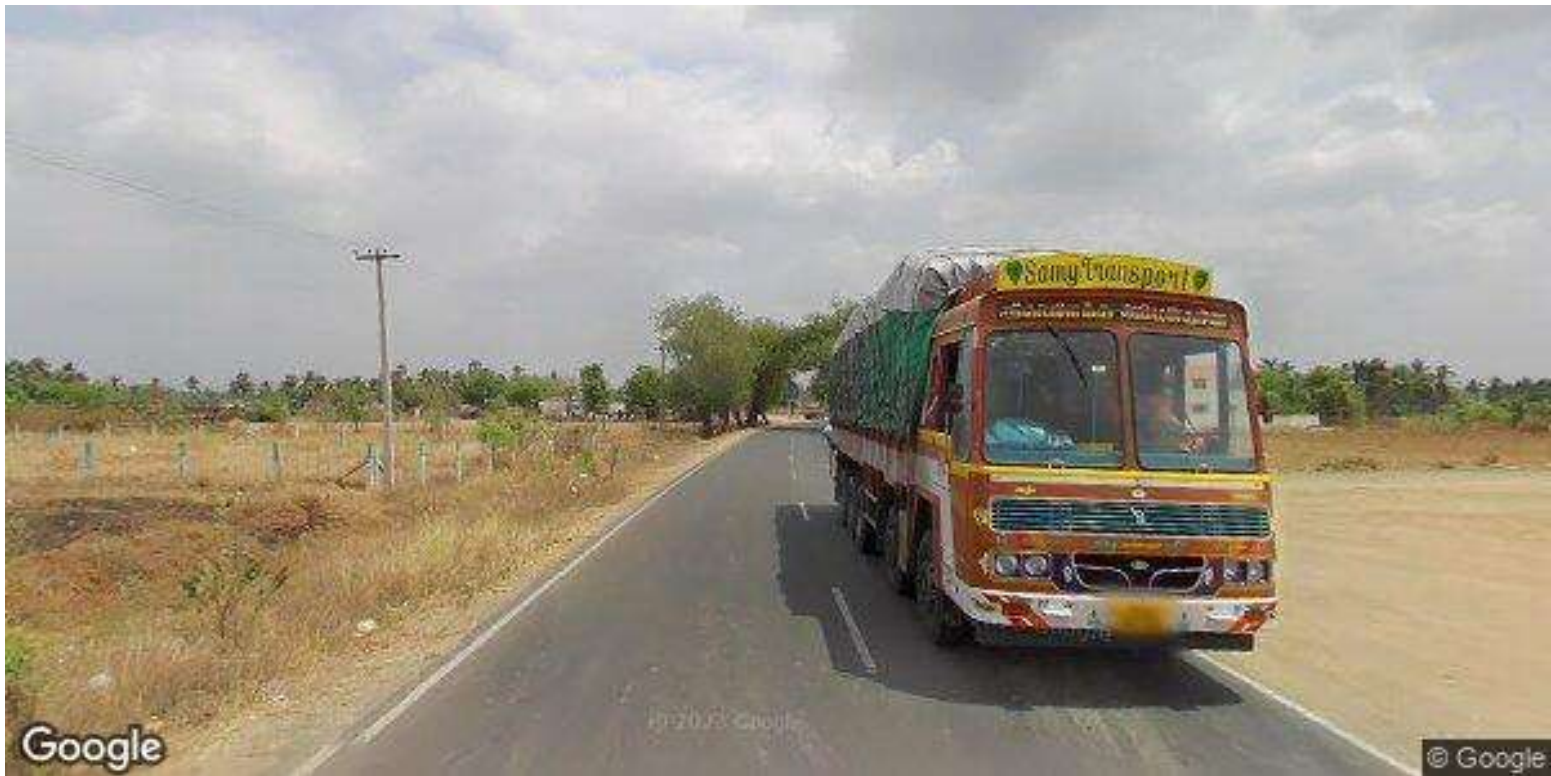
**Risk Type:** Turn  
**Risk Level:** High  
**Speed Limit:** 15 KM/Hr  
**Coordinates:** 11.55614, 77.89764

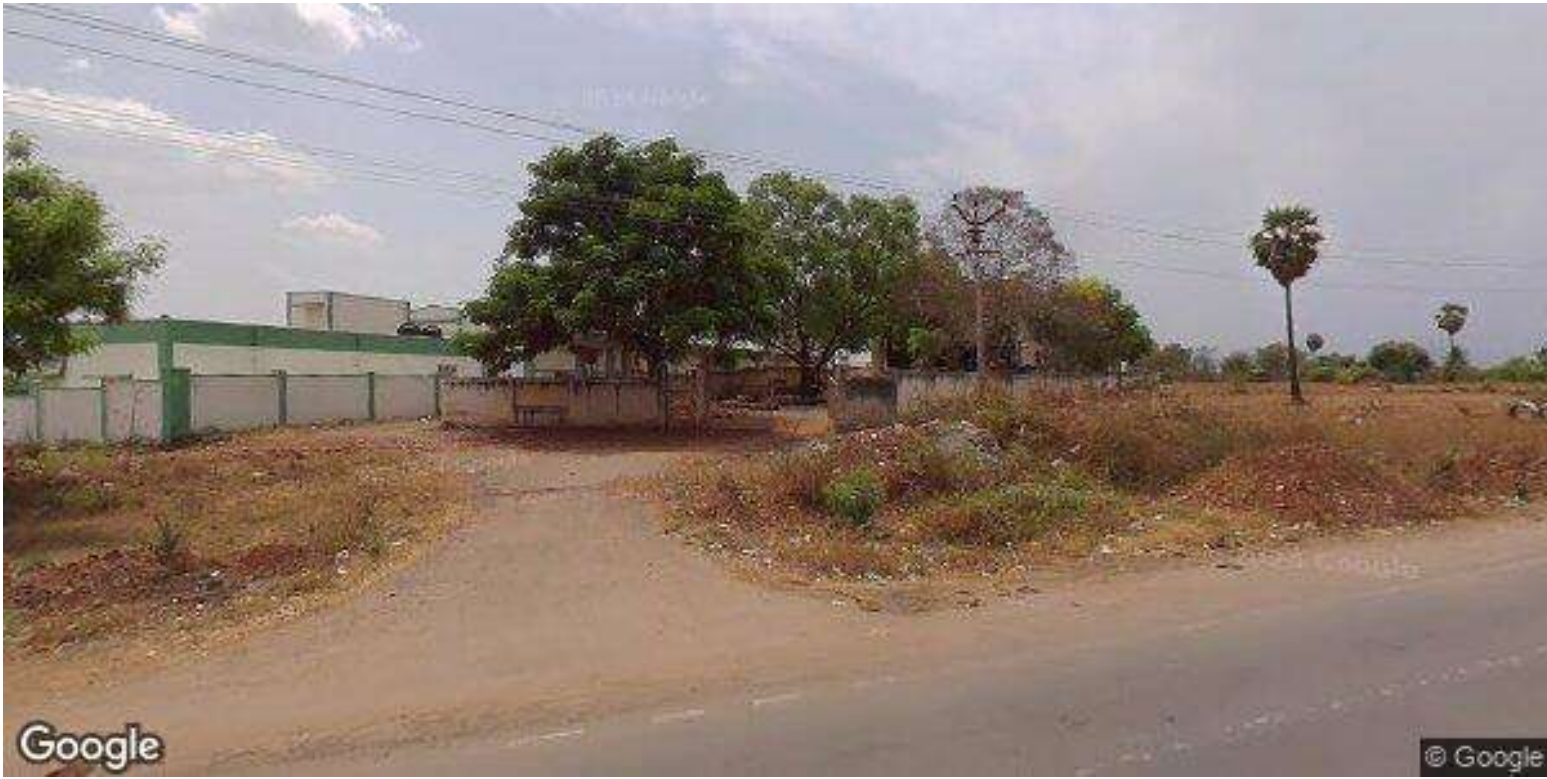
**Risk Type:** Turn  
**Risk Level:** High  
**Speed Limit:** 15 KM/Hr  
**Coordinates:** 11.58317, 77.90647

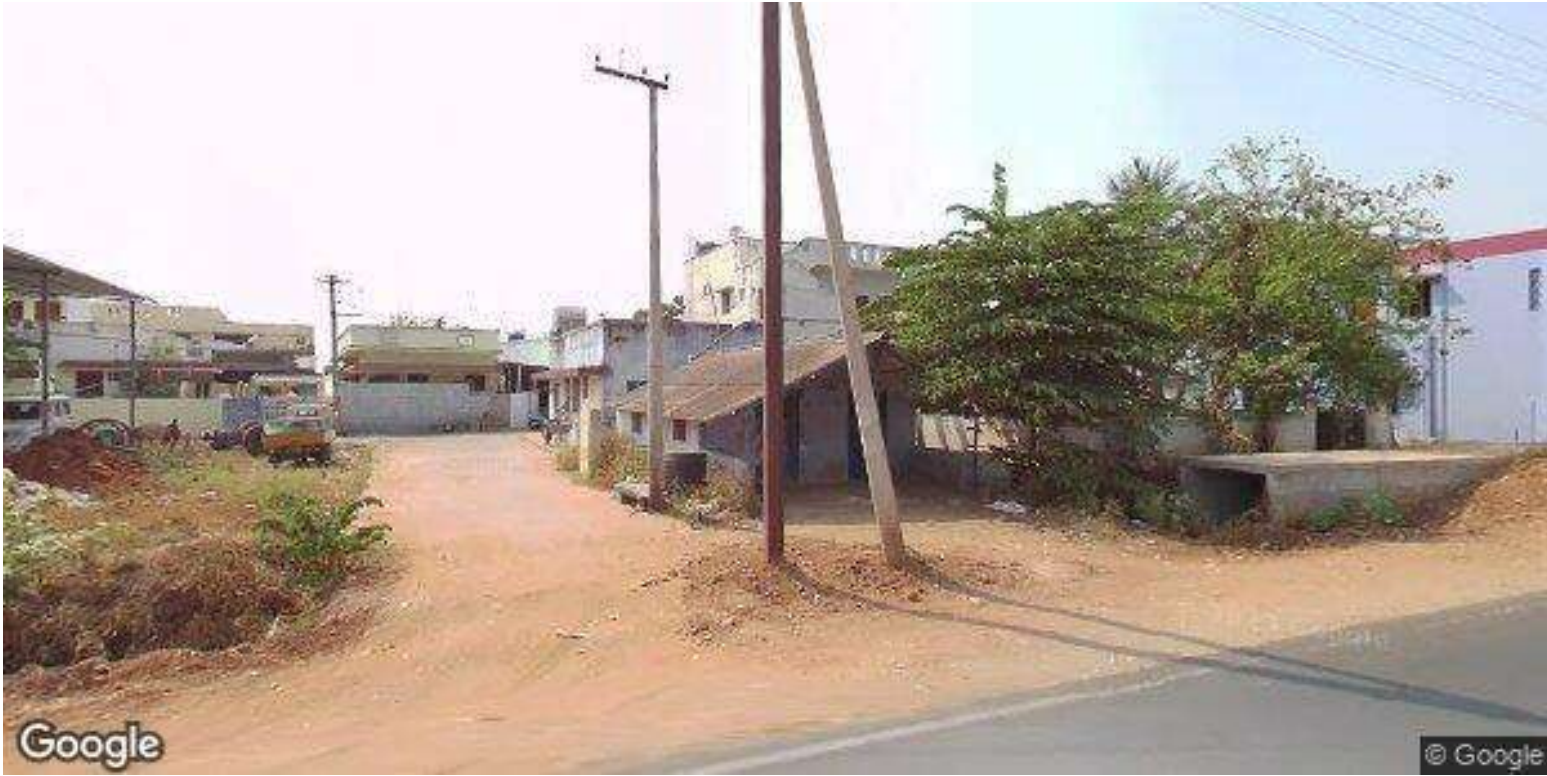
**Risk Type:** Turn  
**Risk Level:** Medium  
**Speed Limit:** 30 KM/Hr  
**Coordinates:** 11.59061, 77.90583
