# IndianOil

## JOURNEY RISK MANAGEMENT (JRM) STUDY

### Salem Terminal to N.P.AGENCY

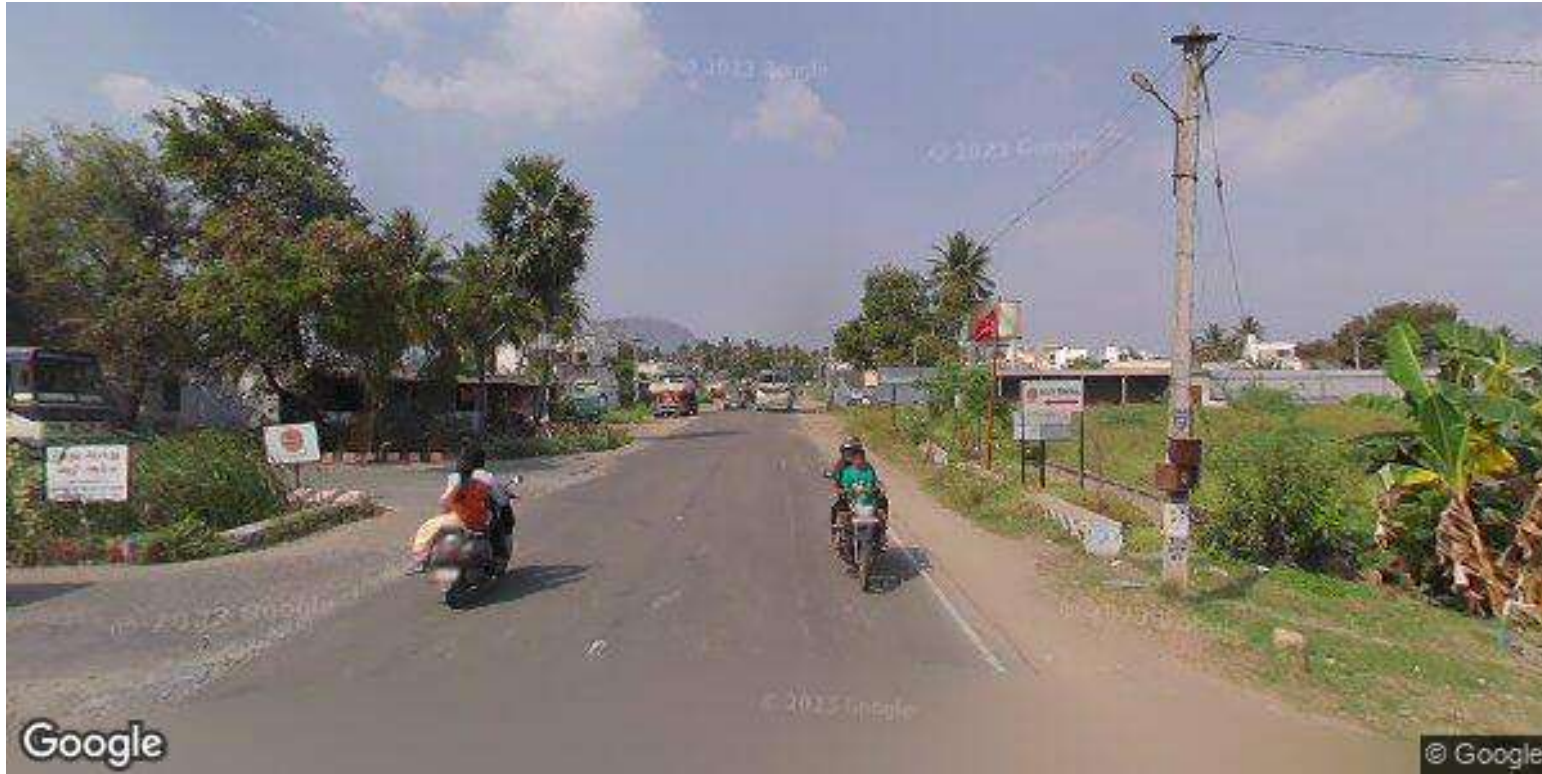
**Risk Type: Turn**  
**Risk Level: High**  
**Speed Limit: 15 KM/Hr**  
**Coordinates: 11.44019, 77.87547**

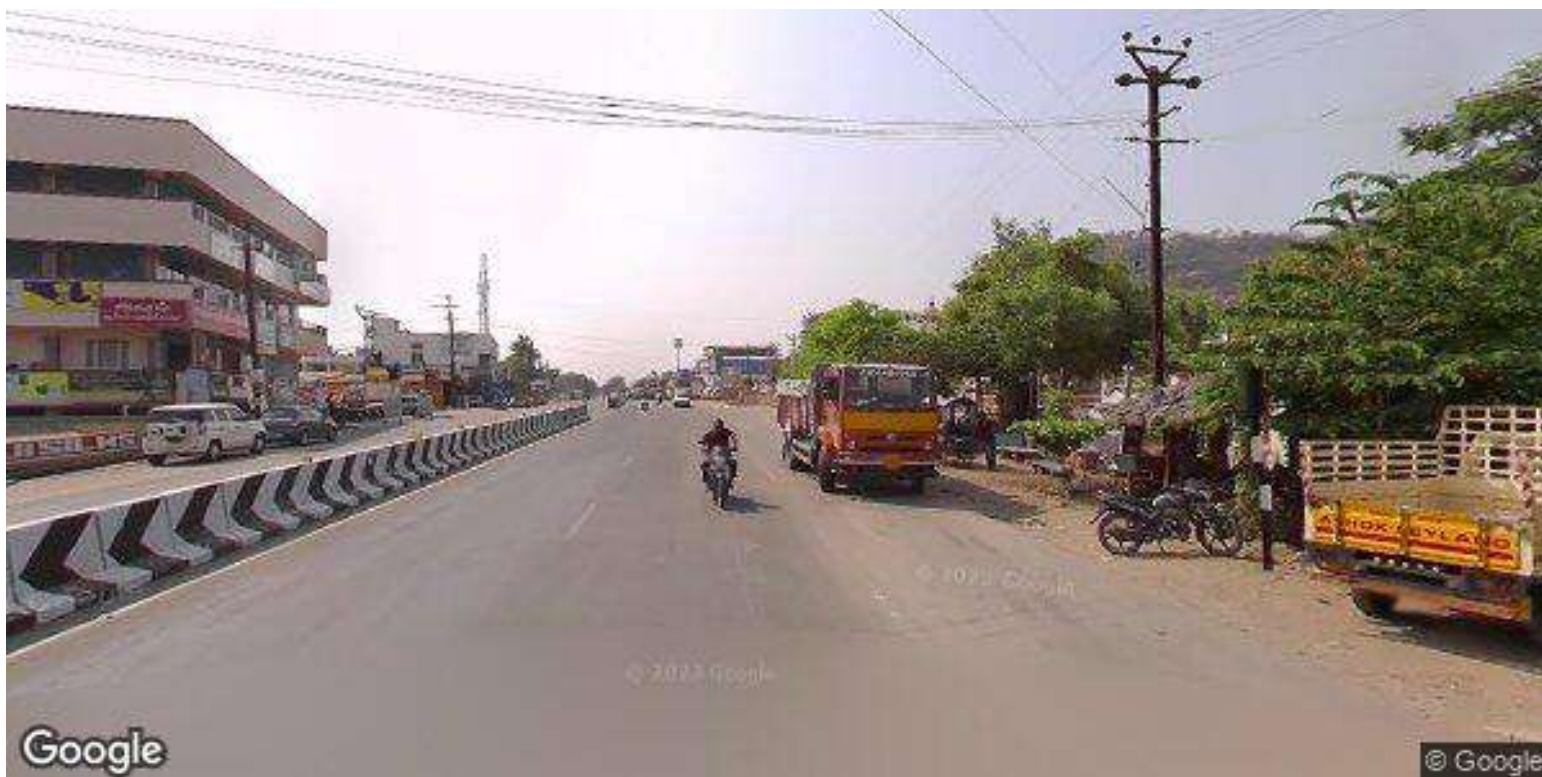
**Risk Type: Turn**  
**Risk Level: Medium**  
**Speed Limit: 30 KM/Hr**  
**Coordinates: 11.39685, 77.88861**

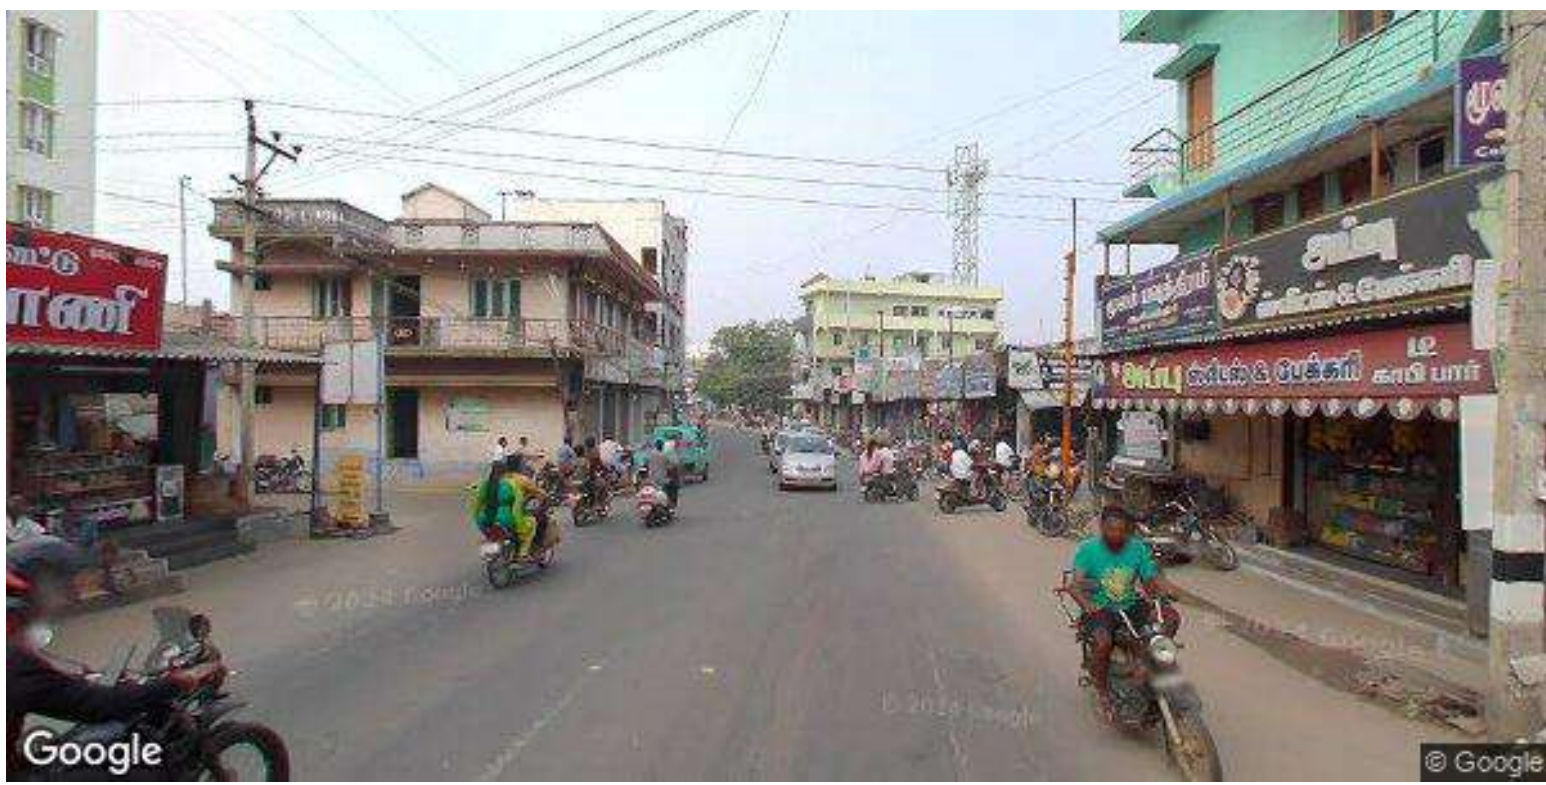
**Risk Type:** Turn

**Risk Level:** Medium

**Speed Limit:** 30 KM/Hr

**Coordinates:** 11.38376, 77.89914

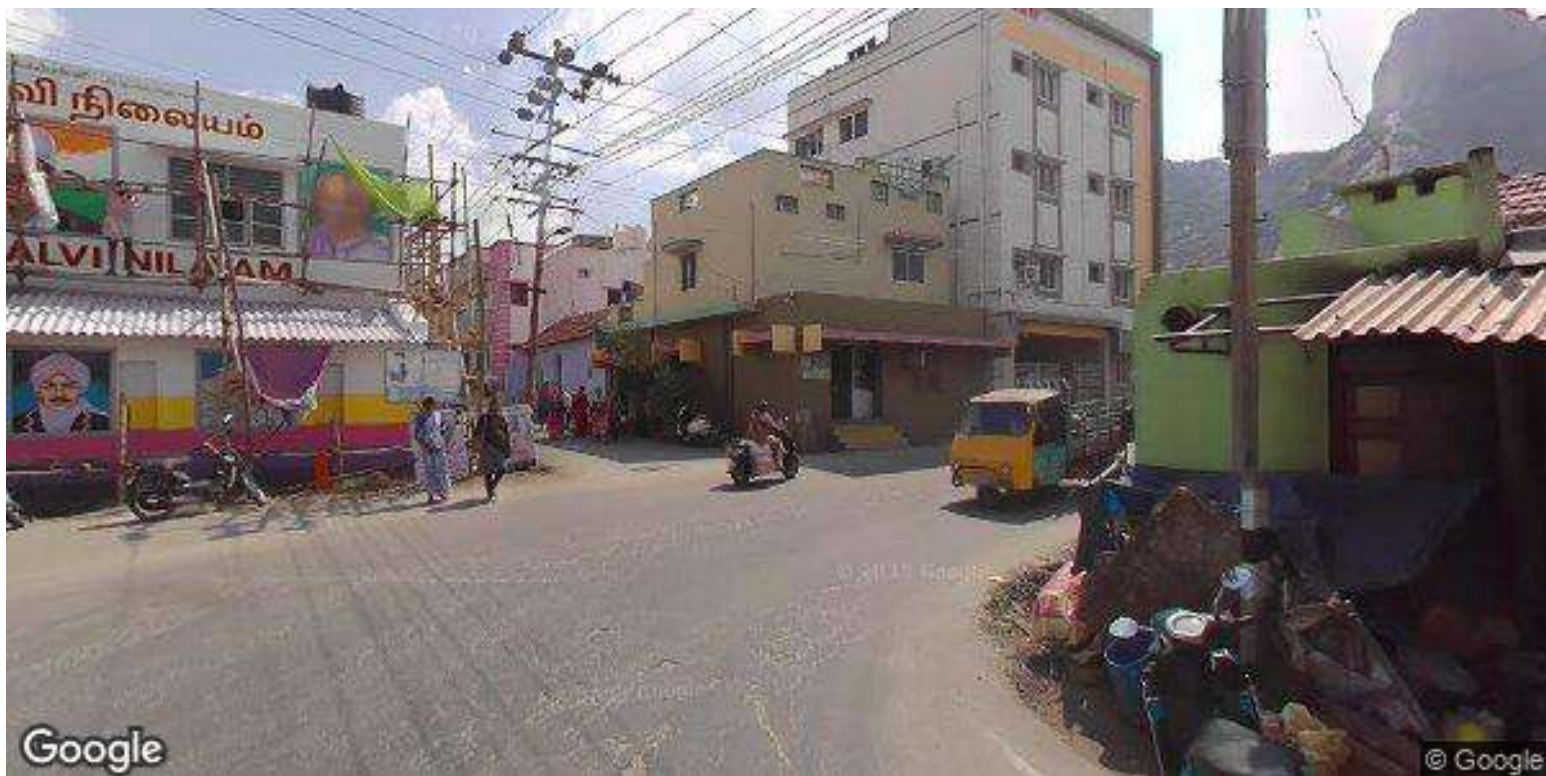
**Risk Type:** Turn

**Risk Level:** High

**Speed Limit:** 15 KM/Hr

**Coordinates:** 11.38186, 77.90258

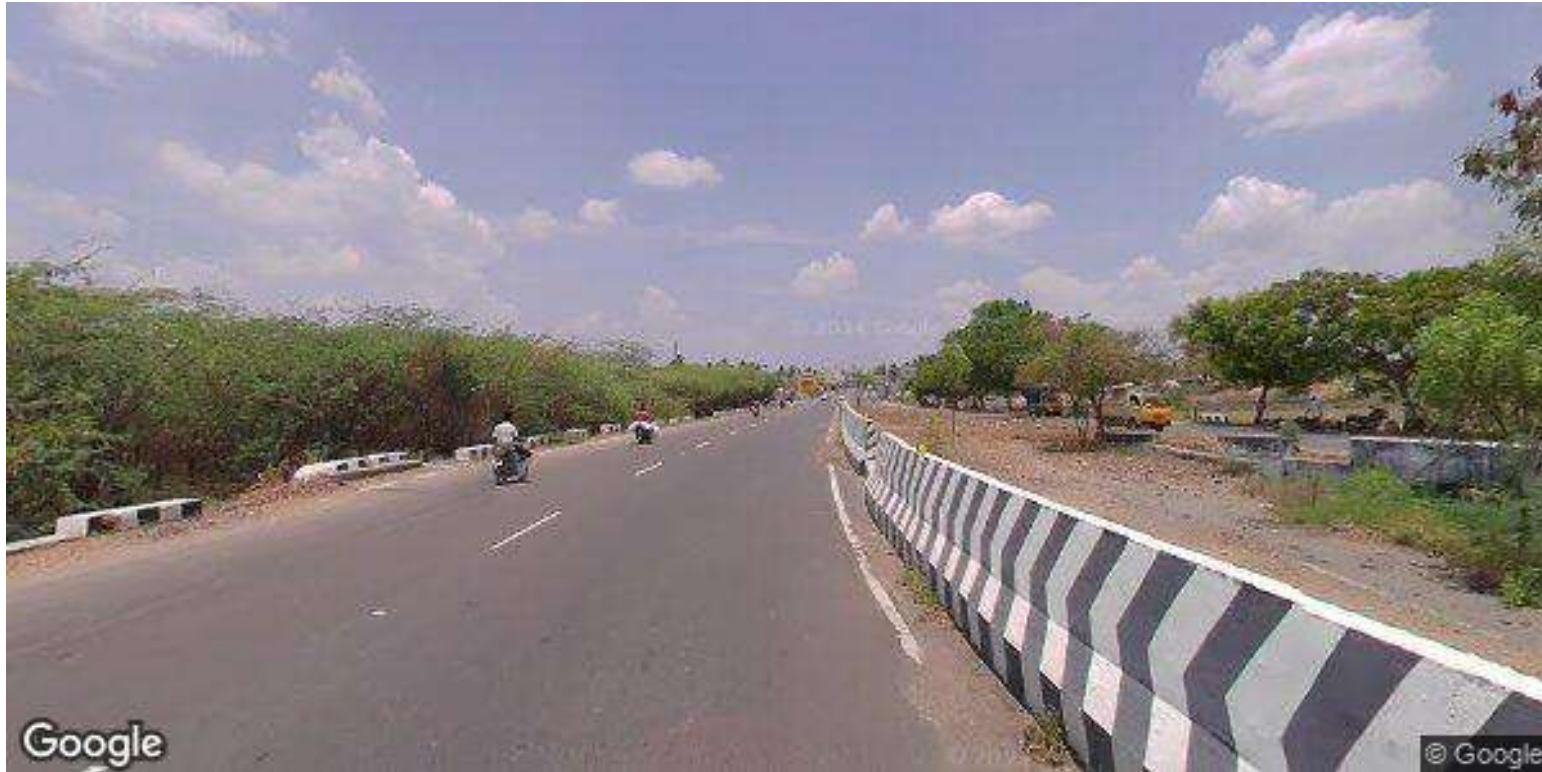
**Risk Type:** Turn  
**Risk Level:** Medium  
**Speed Limit:** 30 KM/Hr  
**Coordinates:** 11.33425, 78.00843

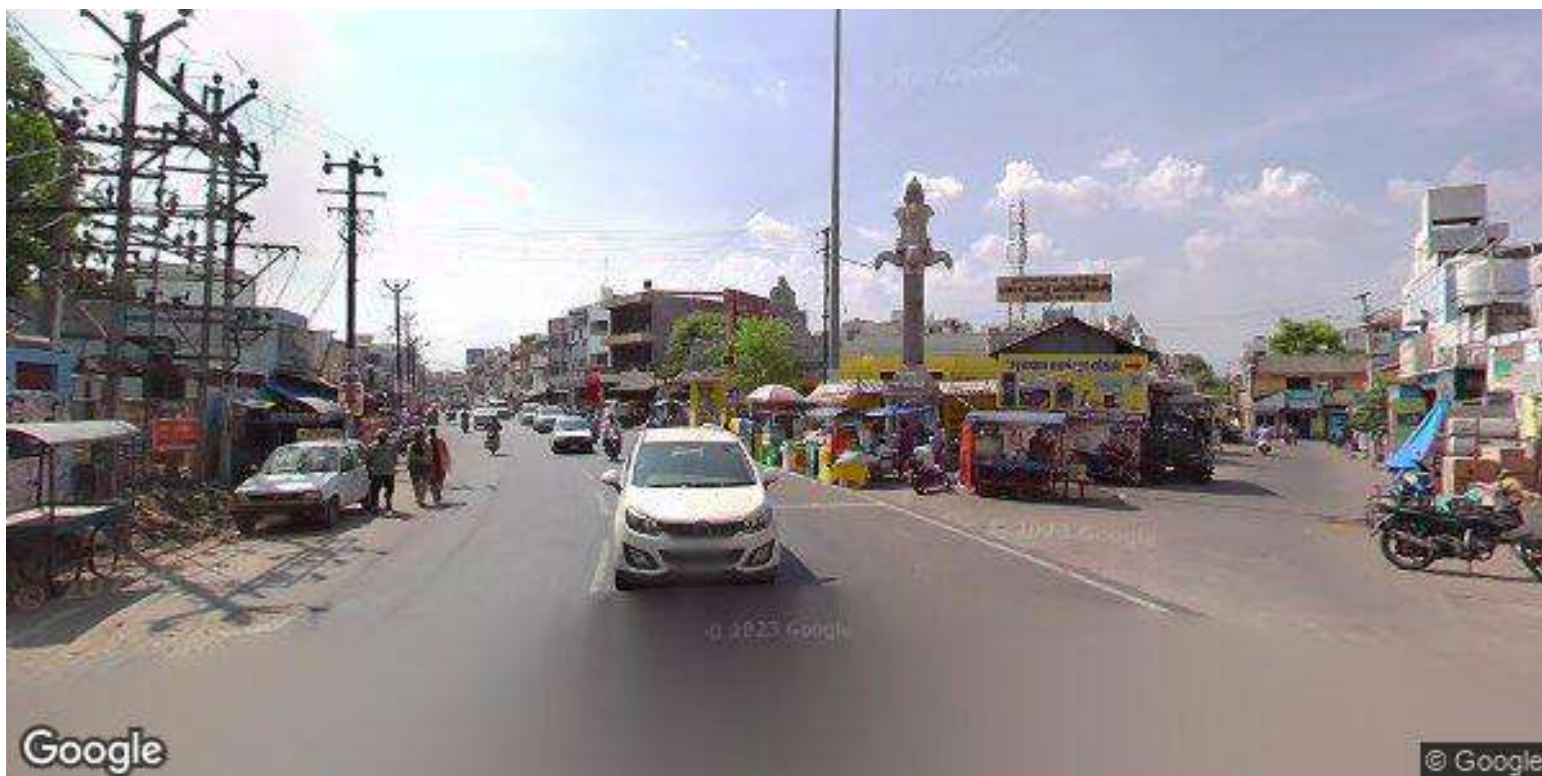
**Risk Type:** Turn  
**Risk Level:** Medium  
**Speed Limit:** 30 KM/Hr  
**Coordinates:** 11.22411, 78.16637

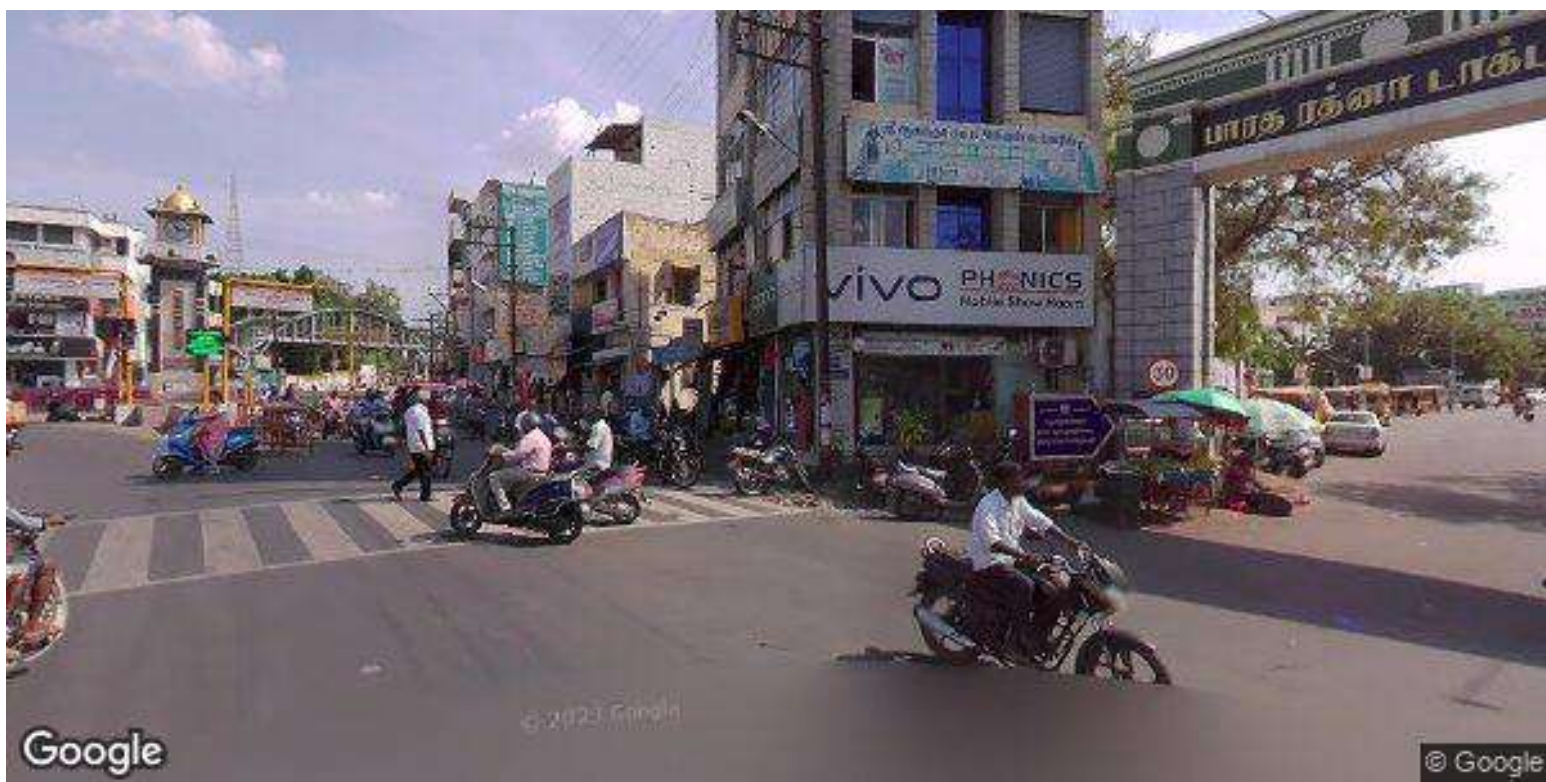
**Risk Type:** Turn

**Risk Level:** Medium

**Speed Limit:** 30 KM/Hr

**Coordinates:** 11.21992, 78.16759

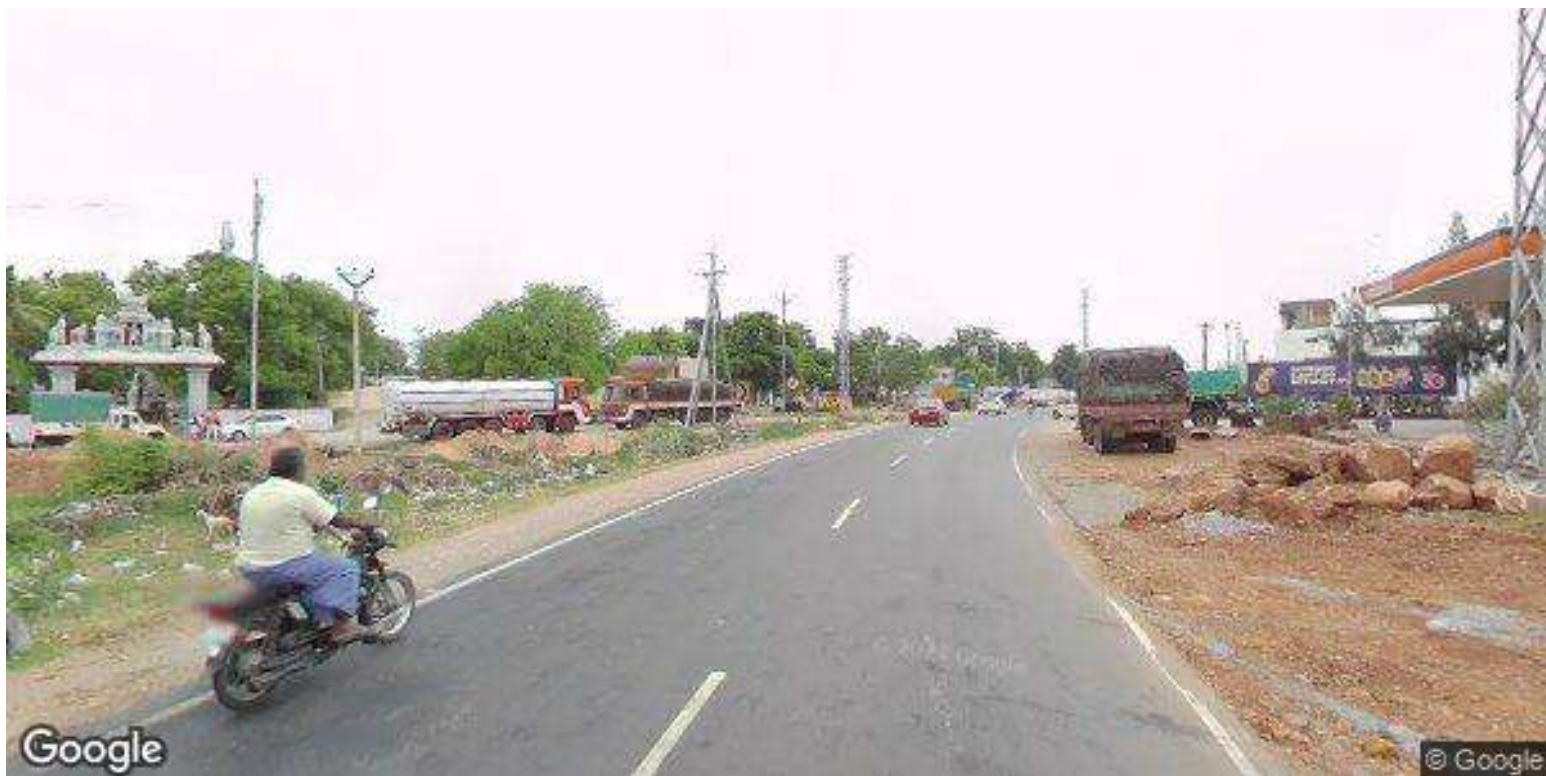
**Risk Type:** Turn

**Risk Level:** Medium

**Speed Limit:** 30 KM/Hr

**Coordinates:** 11.12316, 78.23249

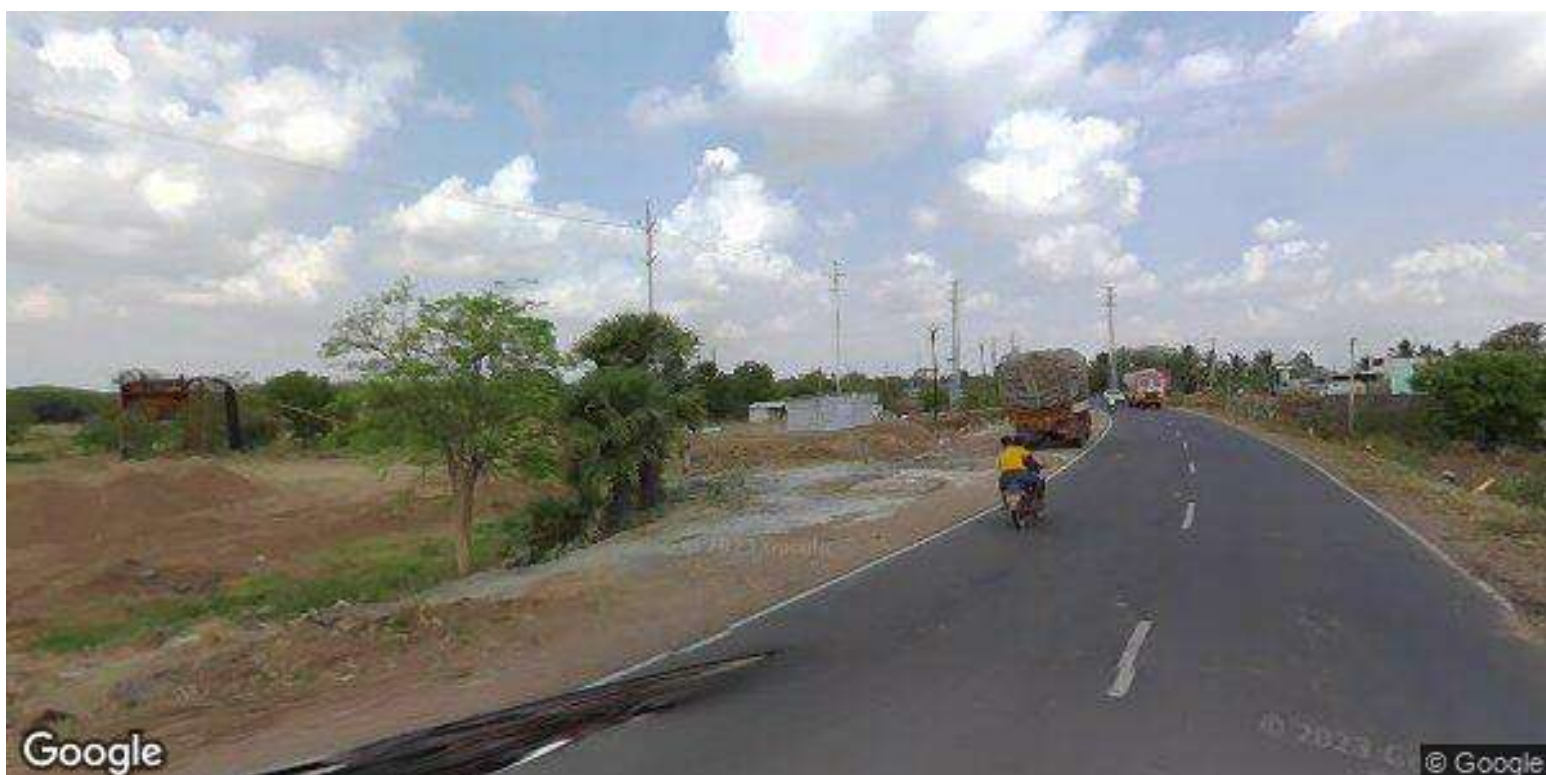
**Risk Type:** Turn

**Risk Level:** Medium

**Speed Limit:** 30 KM/Hr

**Coordinates:** 11.12001, 78.23557

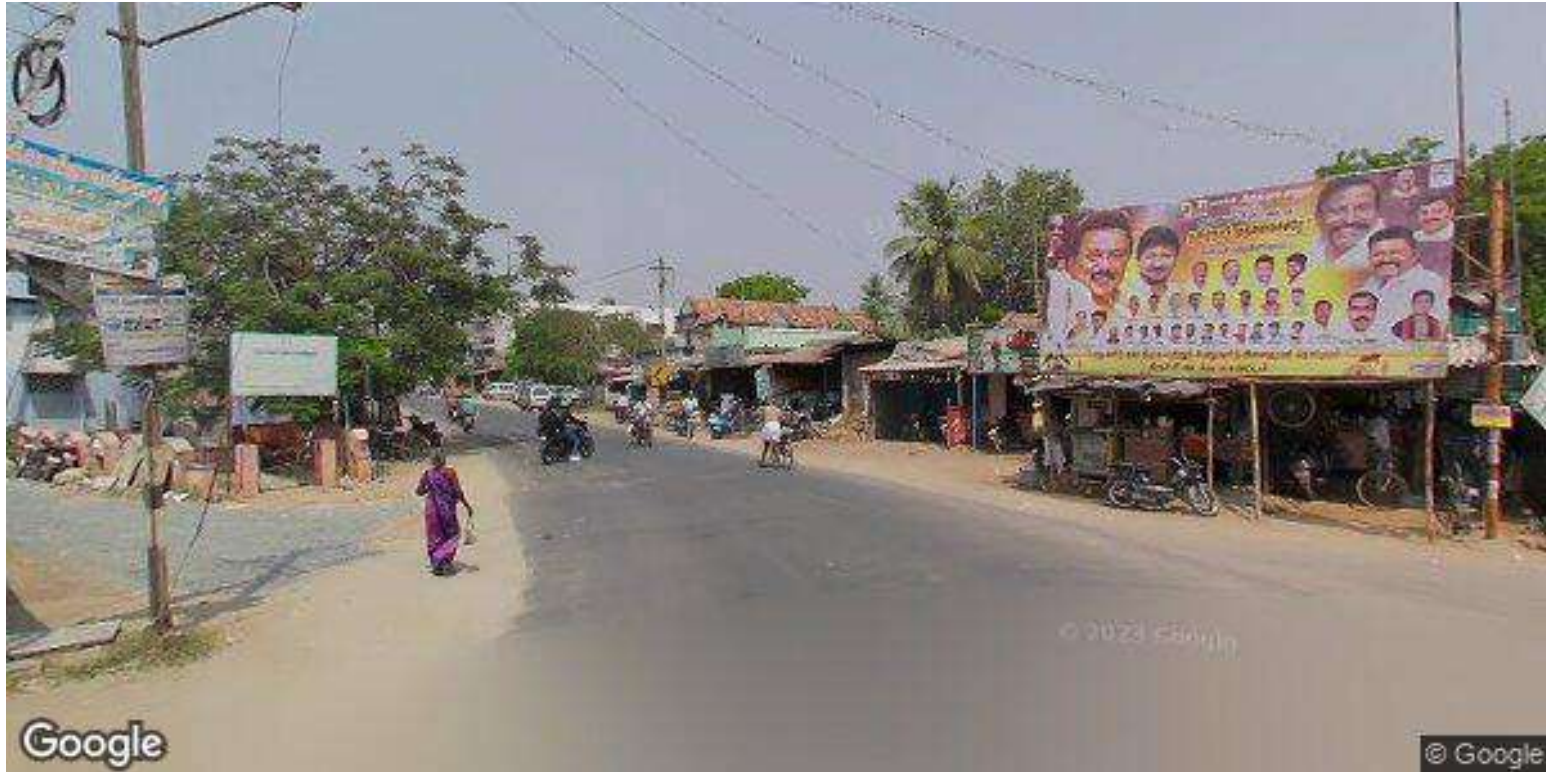
**Risk Type:** Turn

**Risk Level:** Medium

**Speed Limit:** 30 KM/Hr

**Coordinates:** 10.98686, 78.33767

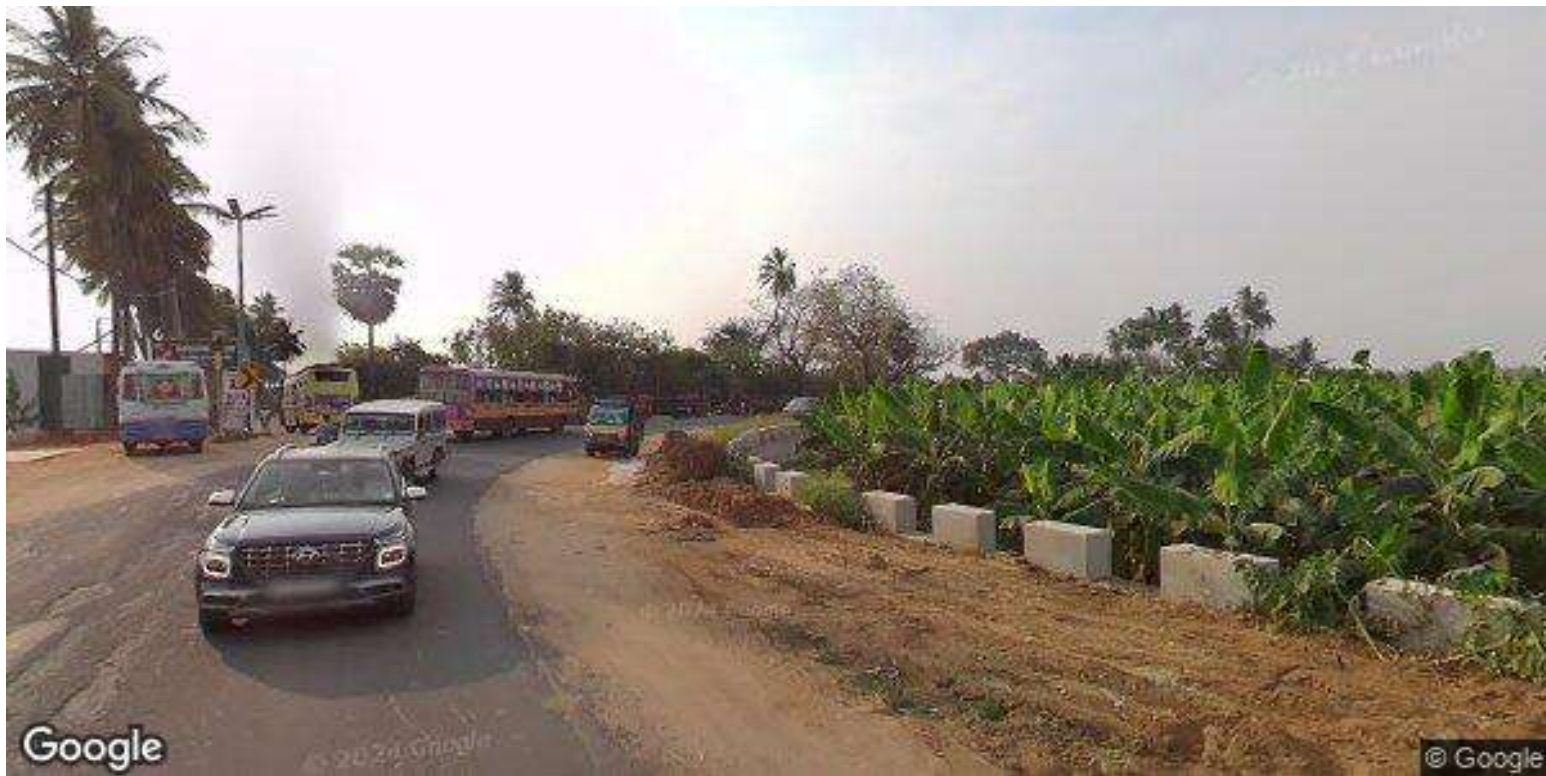
**Risk Type:** Turn

**Risk Level:** Medium

**Speed Limit:** 30 KM/Hr

**Coordinates:** 10.97256, 78.34408

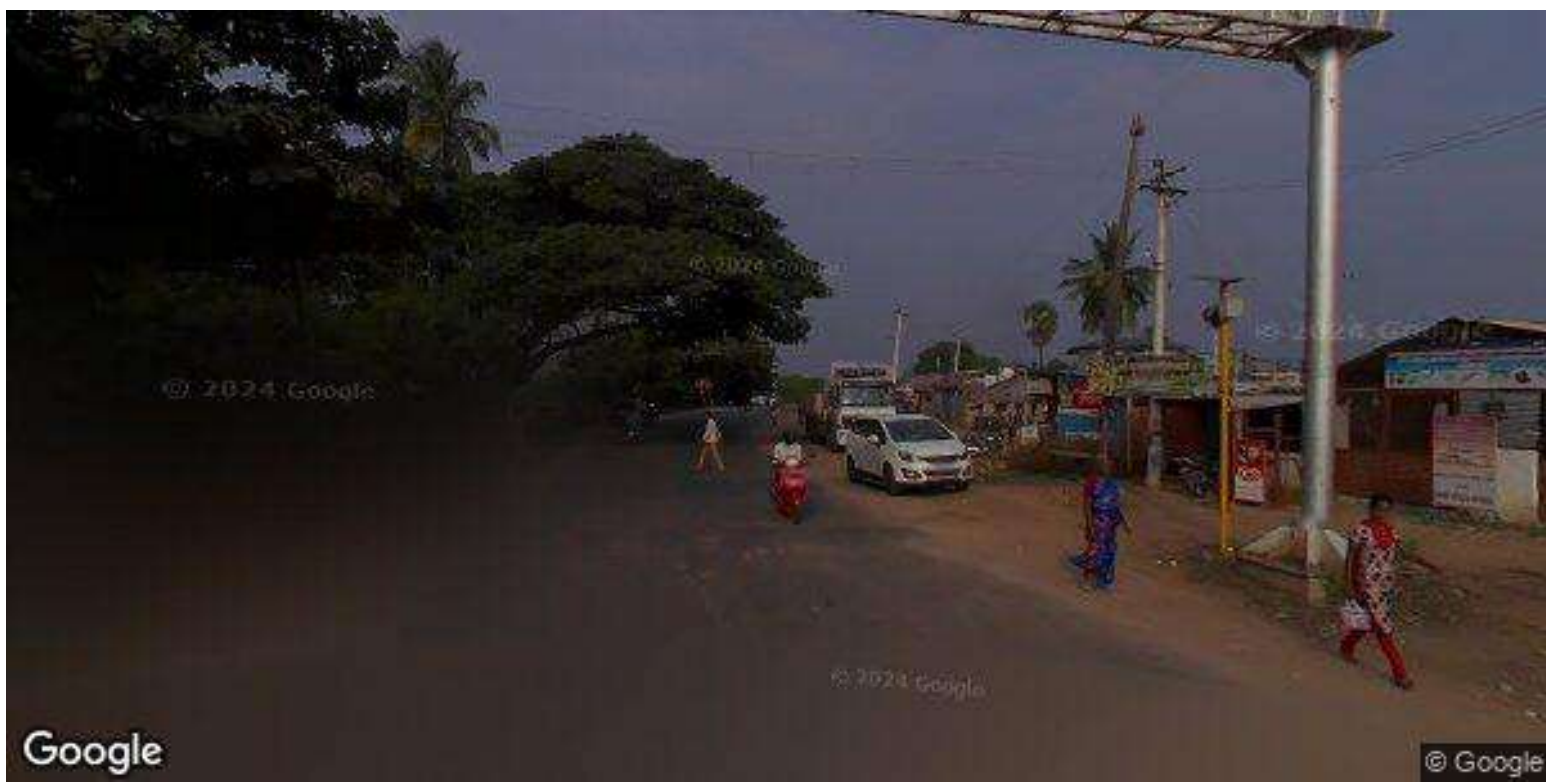
**Risk Type:** Turn

**Risk Level:** High

**Speed Limit:** 15 KM/Hr

**Coordinates:** 10.96031, 78.42222

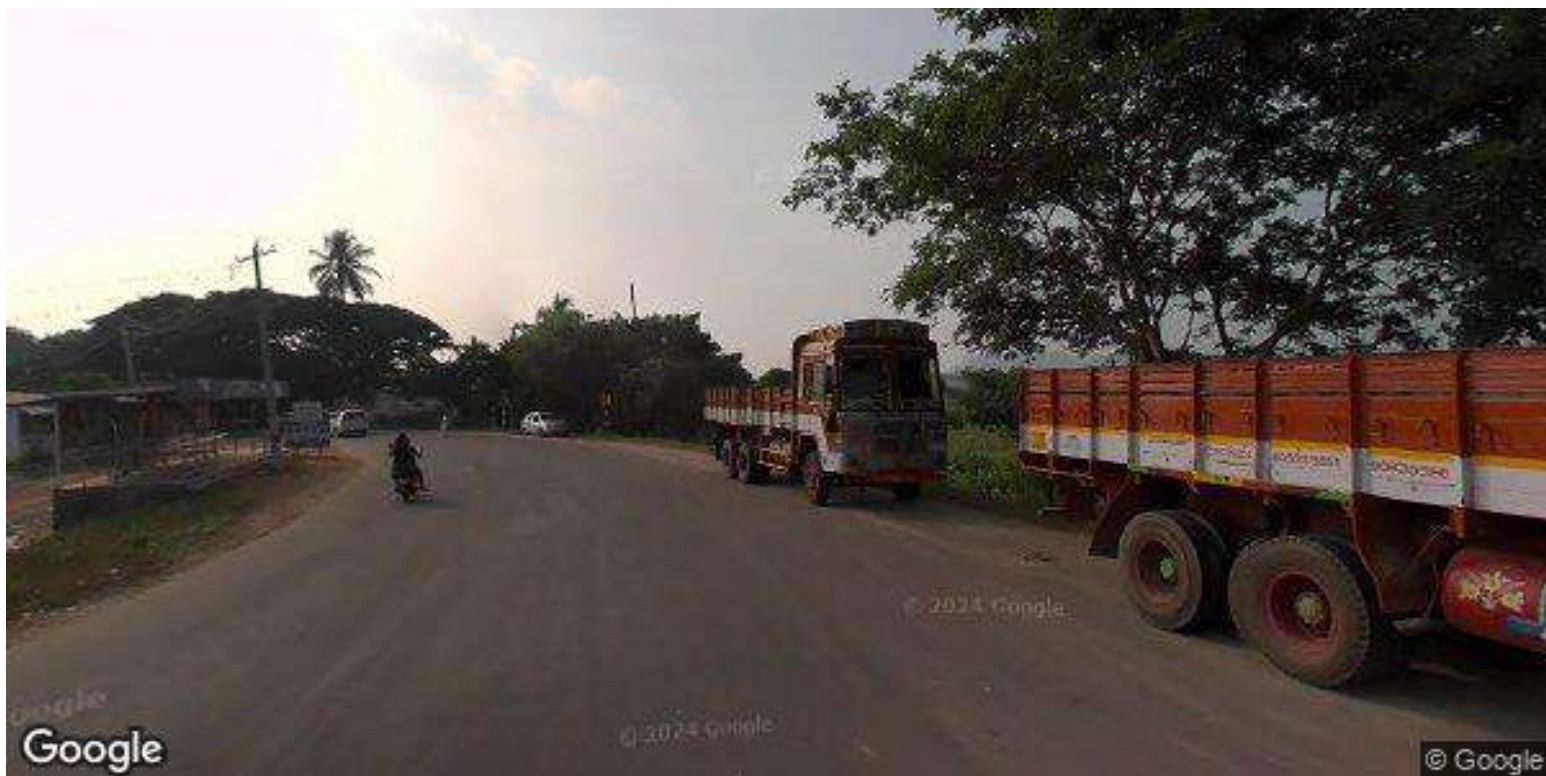
**Risk Type:** Turn

**Risk Level:** High

**Speed Limit:** 15 KM/Hr

**Coordinates:** 10.96084, 78.42307

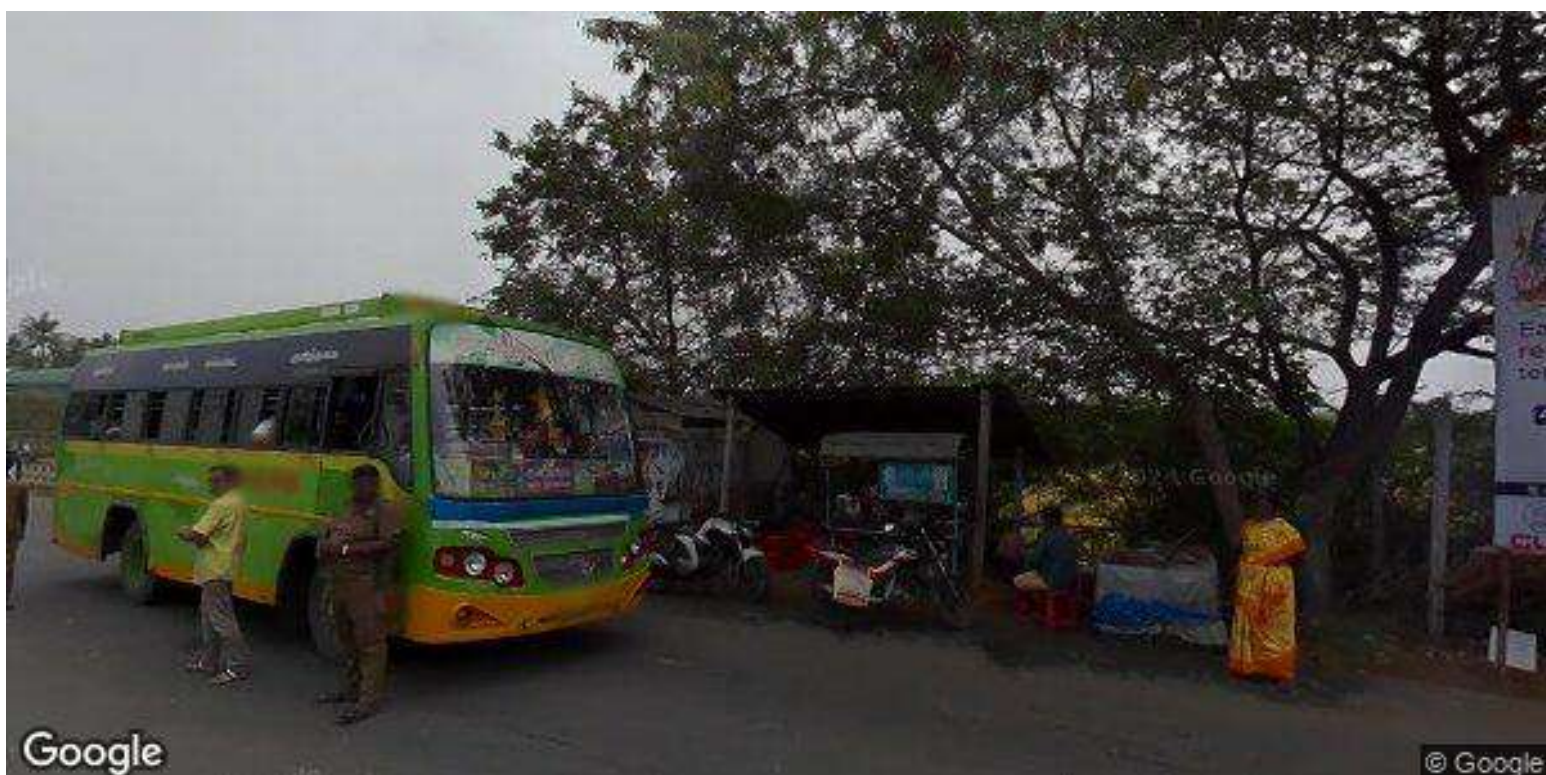
**Risk Type:** Blind Spot  
**Risk Level:** Blind Spot  
**Speed Limit:** 10 KM/Hr  
**Coordinates:** 10.96050, 78.42371

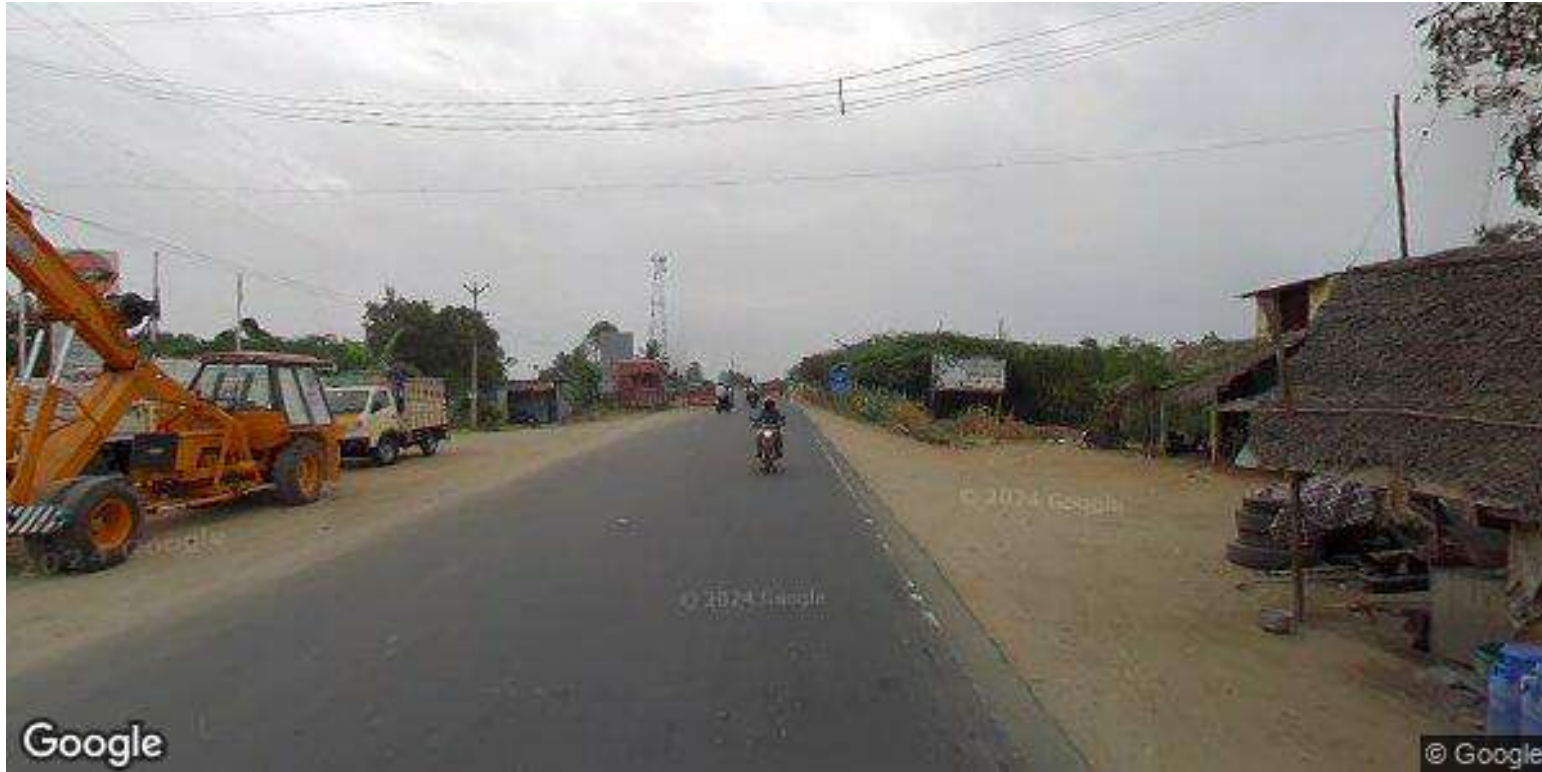
**Risk Type:** Blind Spot  
**Risk Level:** Blind Spot  
**Speed Limit:** 10 KM/Hr  
**Coordinates:** 10.94455, 78.41419

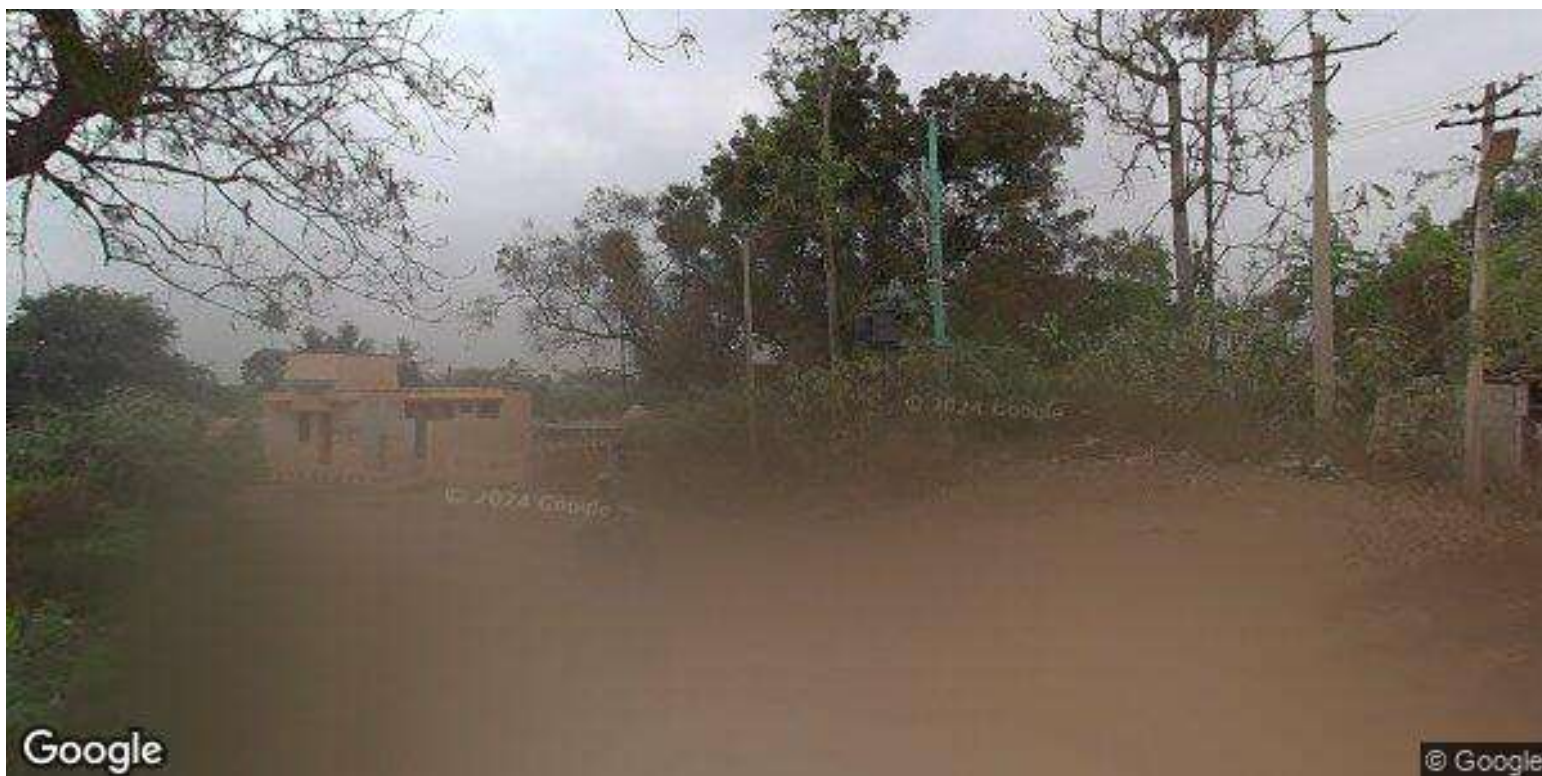
**Risk Type:** Turn  
**Risk Level:** High  
**Speed Limit:** 15 KM/Hr  
**Coordinates:** 10.94435, 78.41548

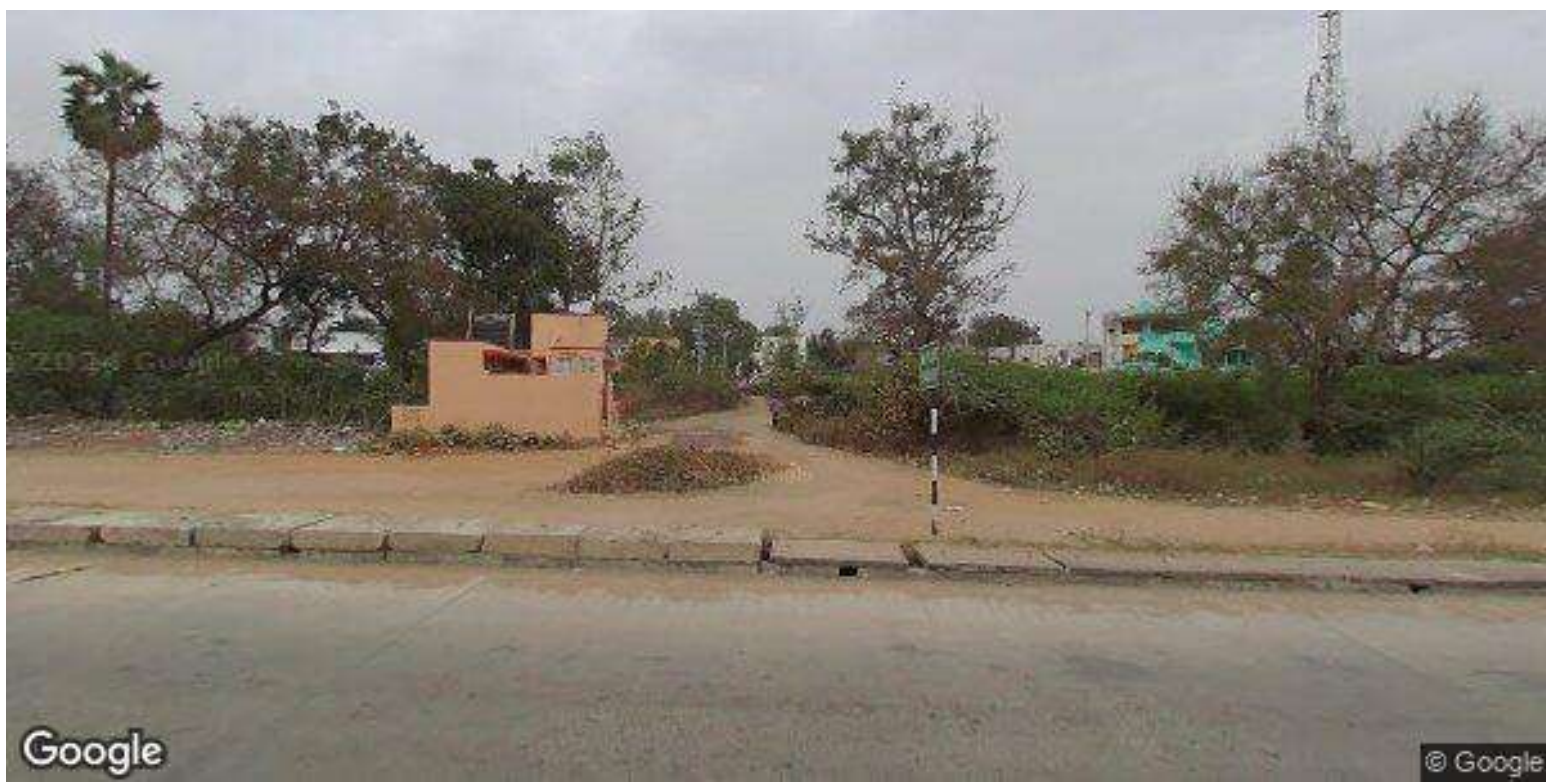
**Risk Type:** Turn

**Risk Level:** Medium

**Speed Limit:** 30 KM/Hr

**Coordinates:** 10.94465, 78.41565

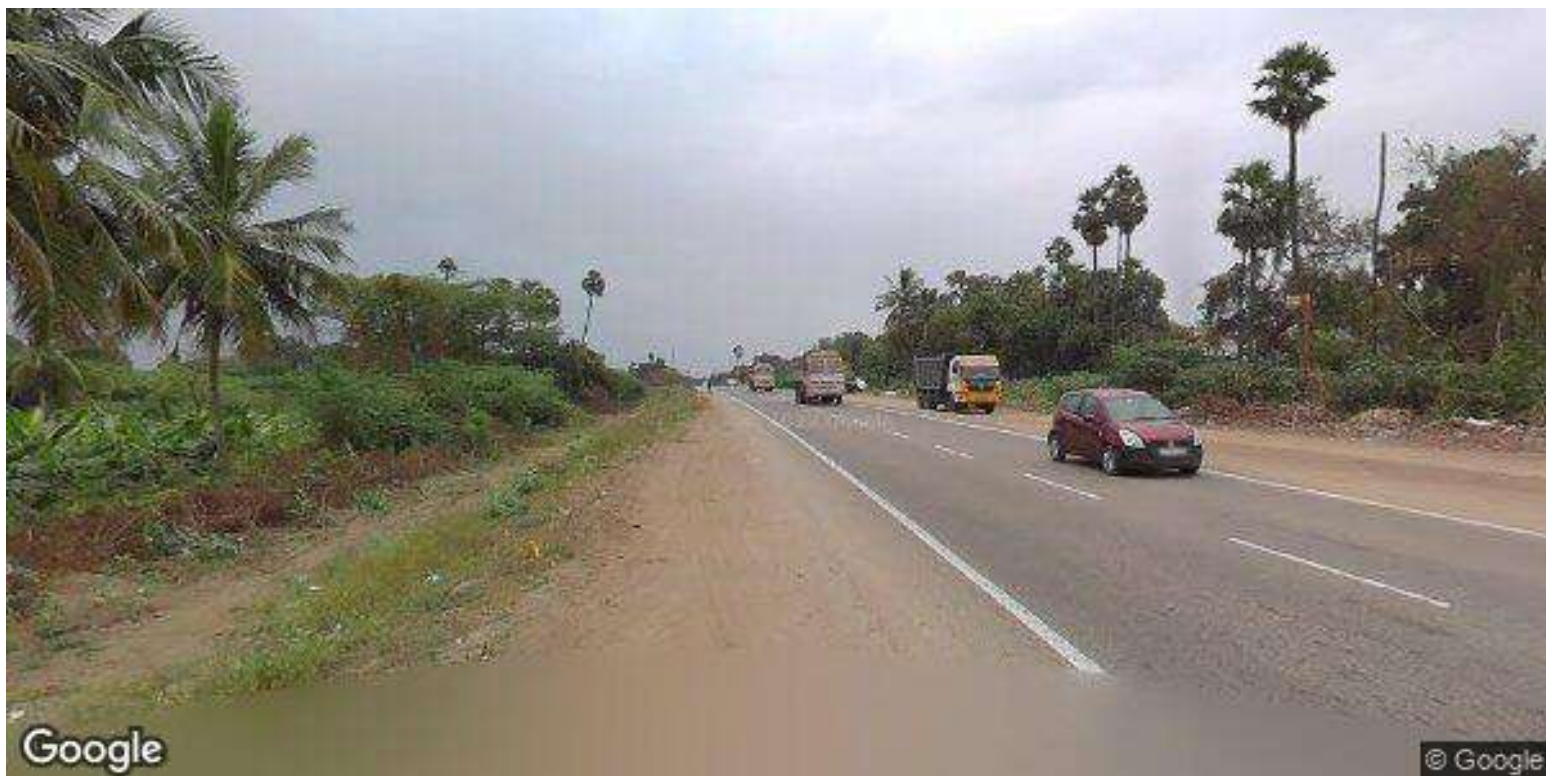
**Risk Type:** Turn

**Risk Level:** Medium

**Speed Limit:** 30 KM/Hr

**Coordinates:** 10.94478, 78.41595

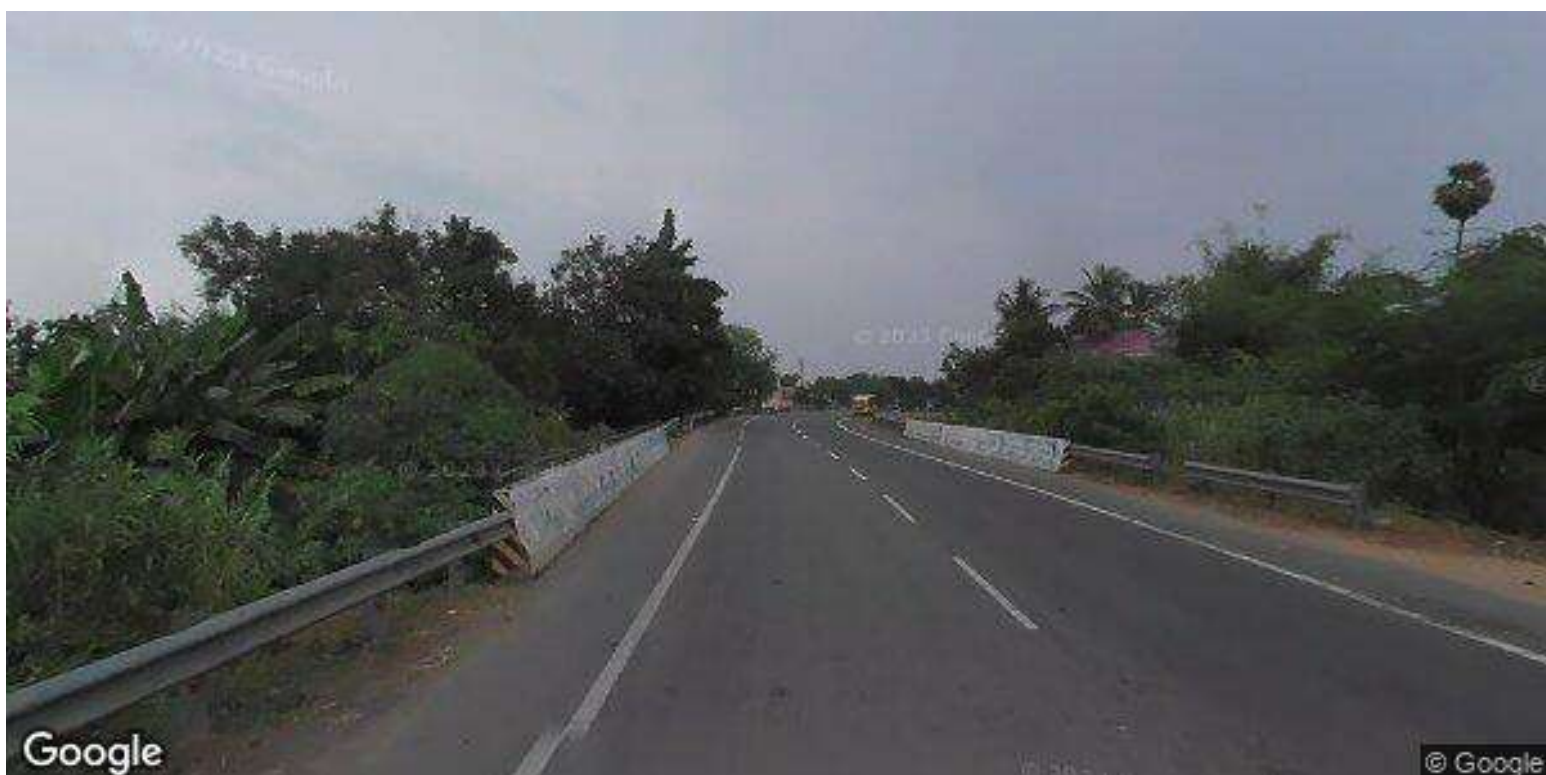
**Risk Type:** Turn  
**Risk Level:** Medium  
**Speed Limit:** 30 KM/Hr  
**Coordinates:** 10.89656, 78.52077
