# IndianOil

## JOURNEY RISK MANAGEMENT (JRM) STUDY

### Salem Terminal to N.P.AGENCY

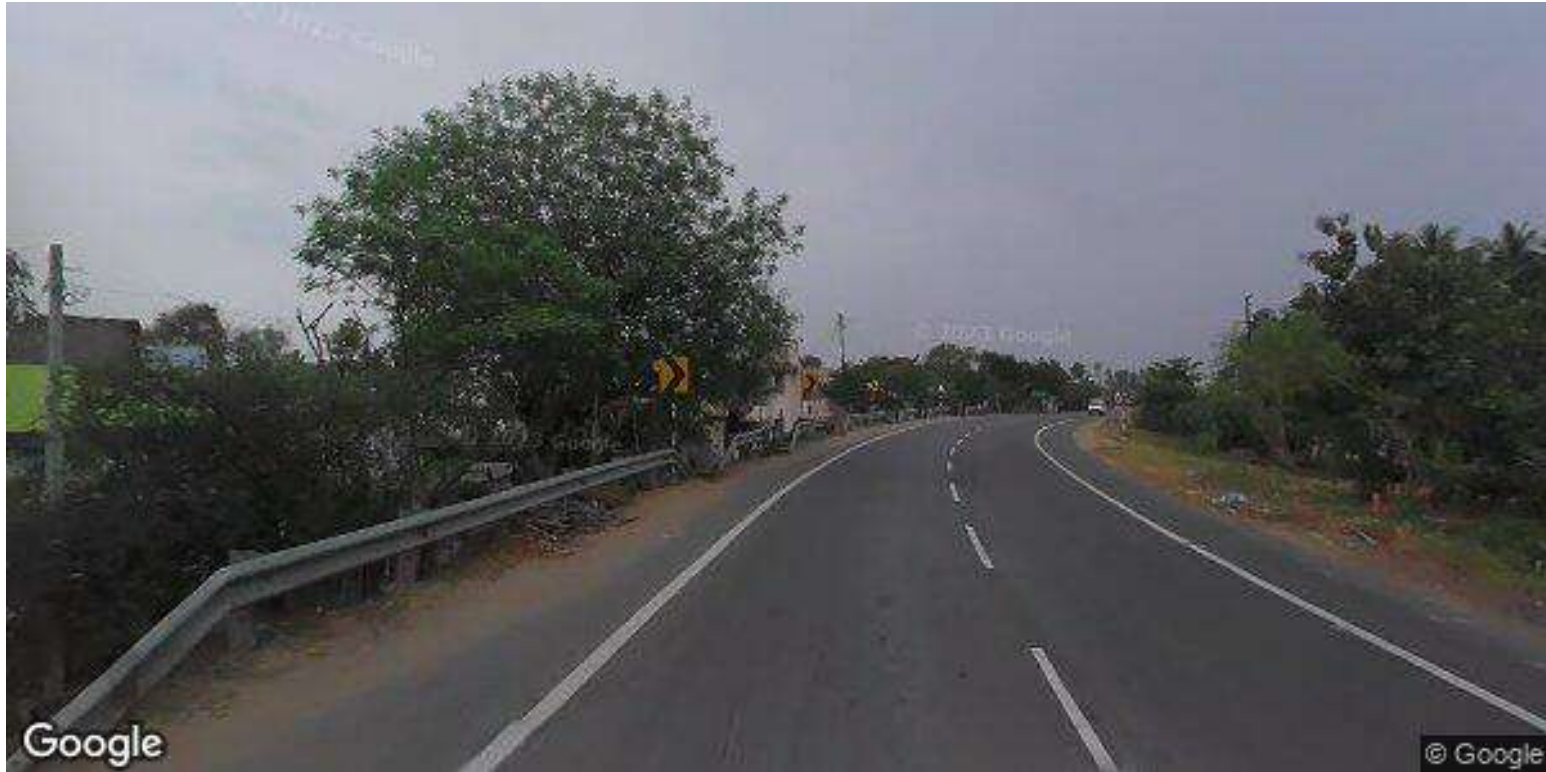
**Risk Type:** Turn  
**Risk Level:** Medium  
**Speed Limit:** 30 KM/Hr  
**Coordinates:** 10.89694, 78.52119

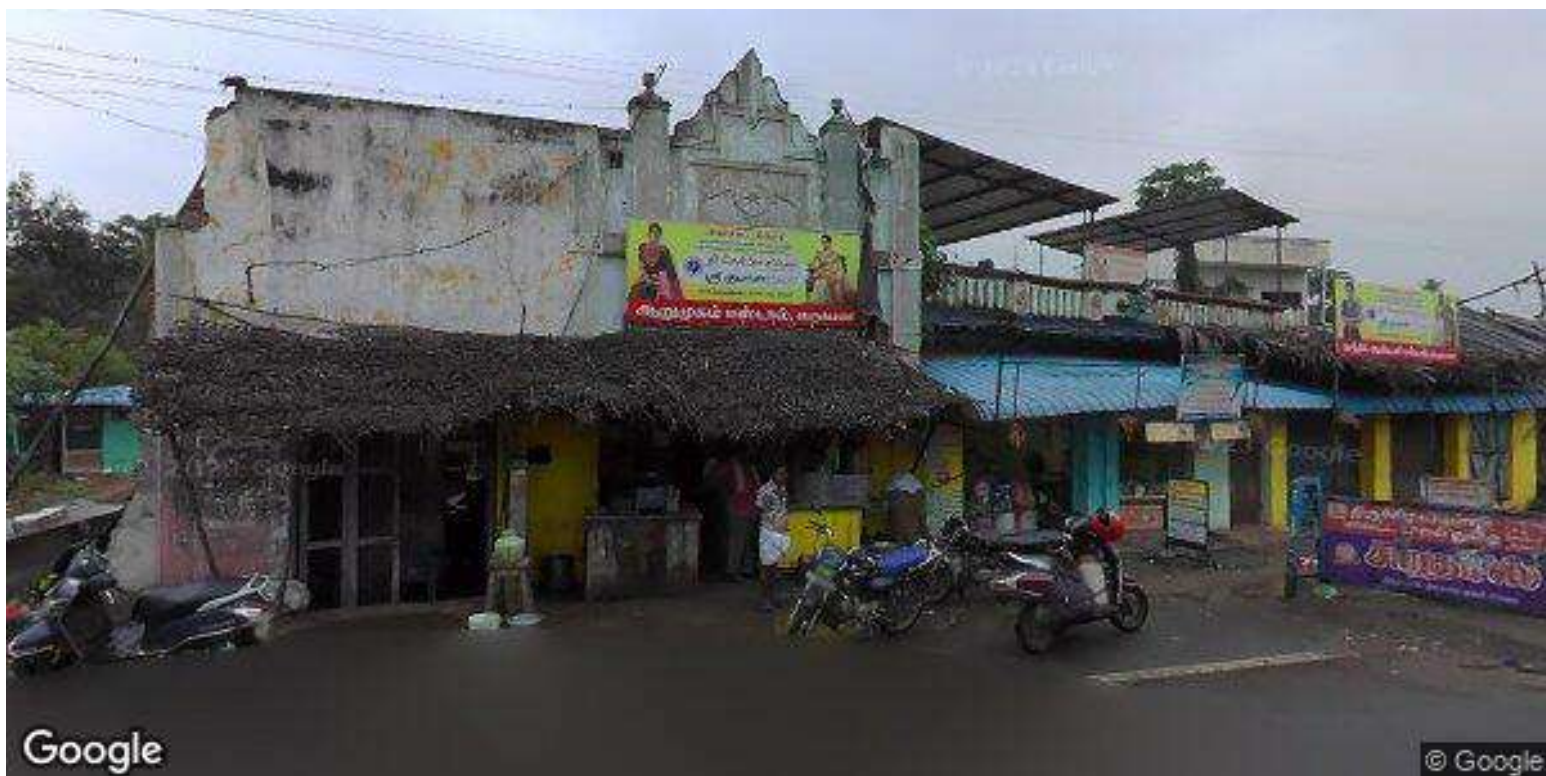
**Risk Type:** Blind Spot  
**Risk Level:** Blind Spot  
**Speed Limit:** 10 KM/Hr  
**Coordinates:** 10.88965, 78.54586

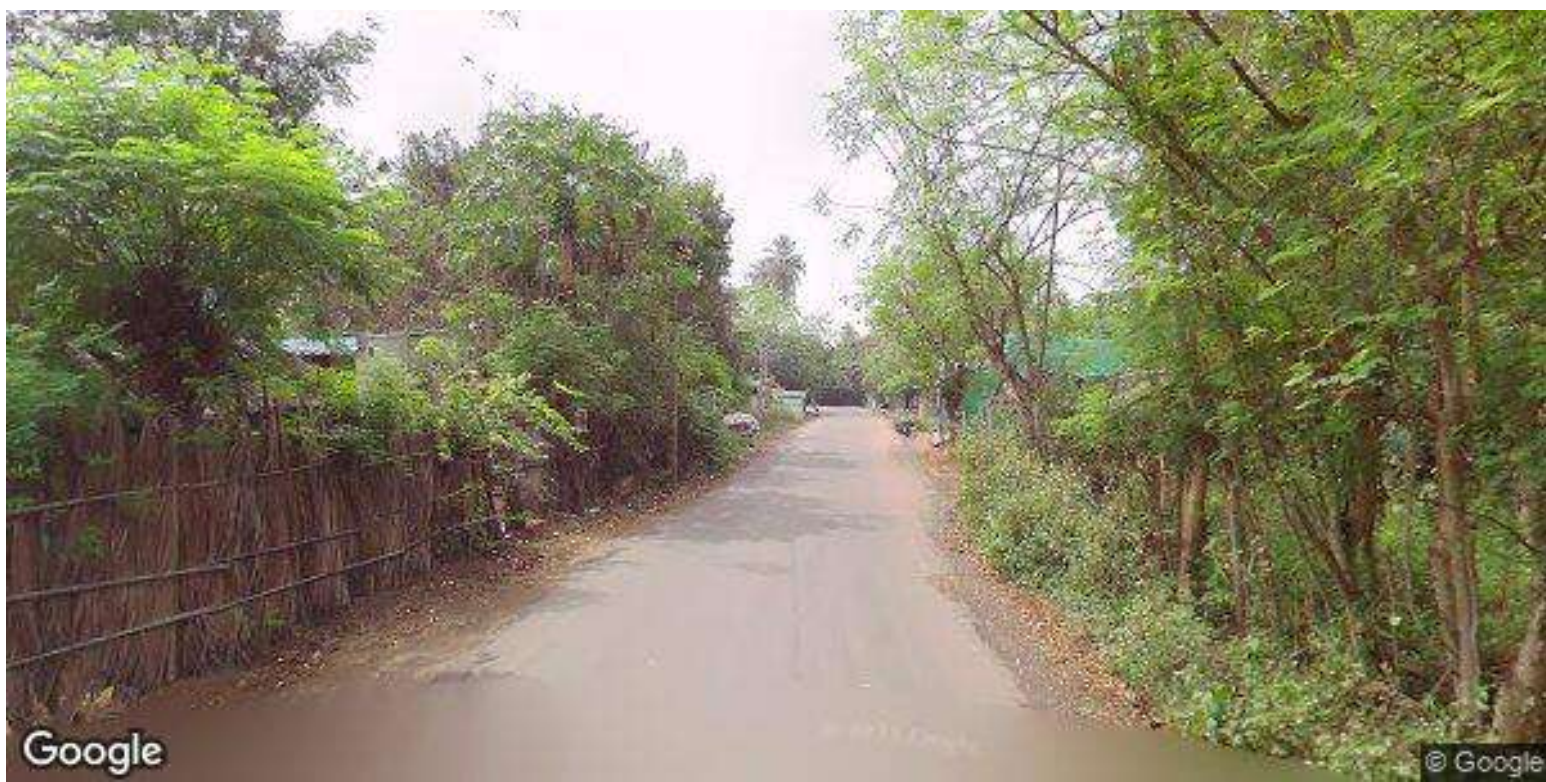
**Risk Type:** Turn

**Risk Level:** High

**Speed Limit:** 15 KM/Hr

**Coordinates:** 10.88043, 78.54458

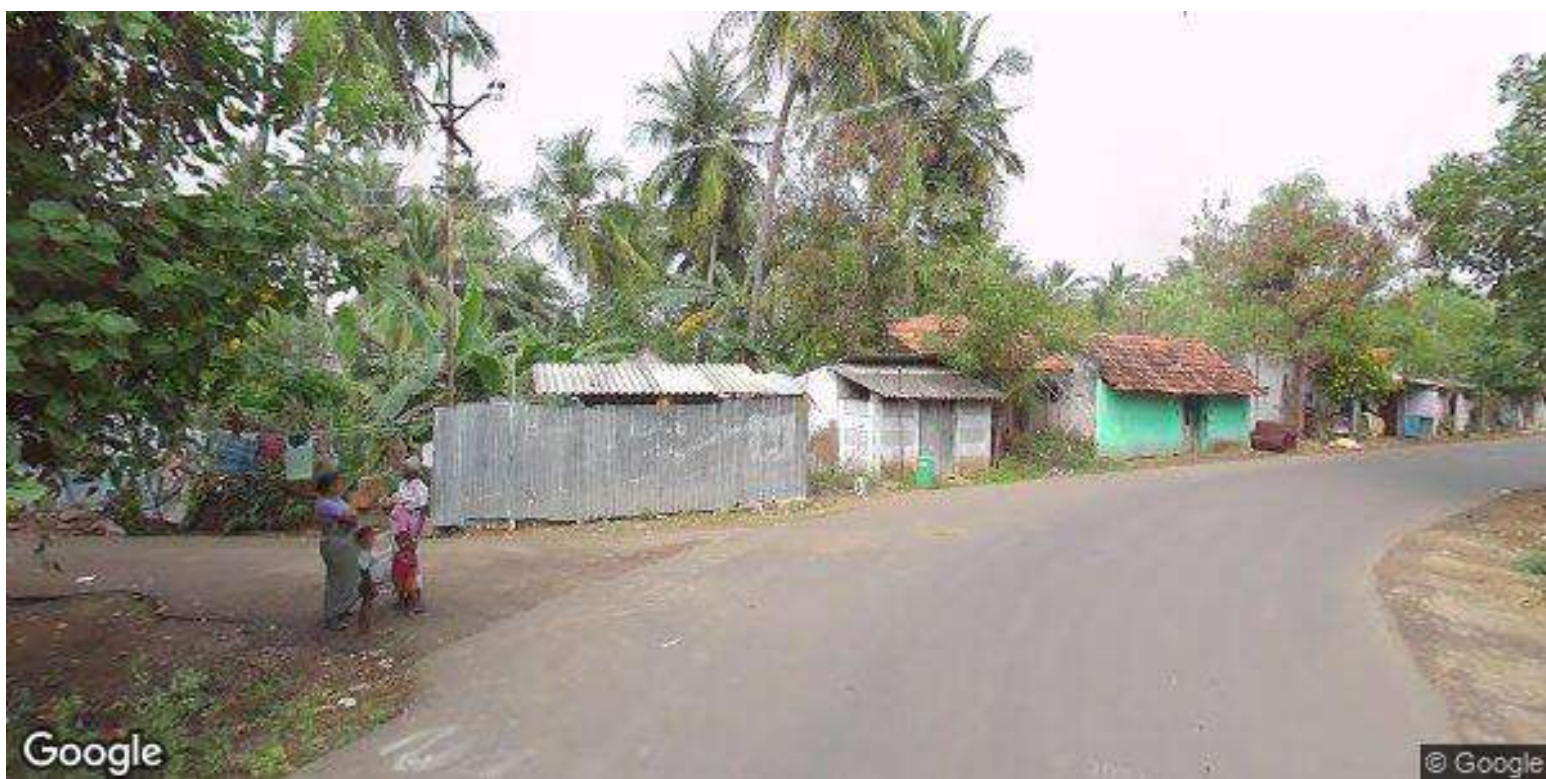
**Risk Type:** Turn

**Risk Level:** High

**Speed Limit:** 15 KM/Hr

**Coordinates:** 10.88035, 78.54354

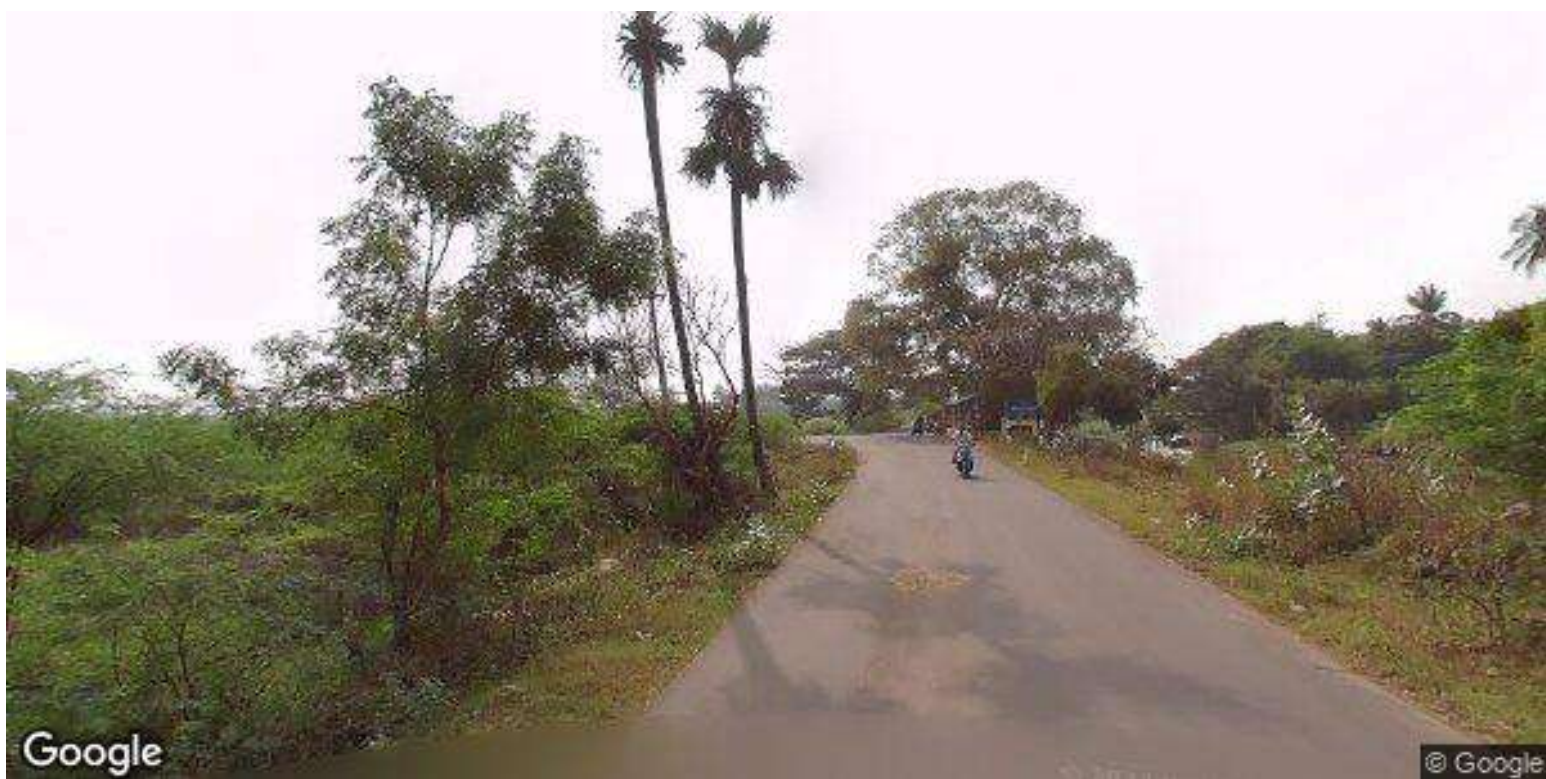
**Risk Type:** Turn  
**Risk Level:** High  
**Speed Limit:** 15 KM/Hr  
**Coordinates:** 10.87949, 78.54326

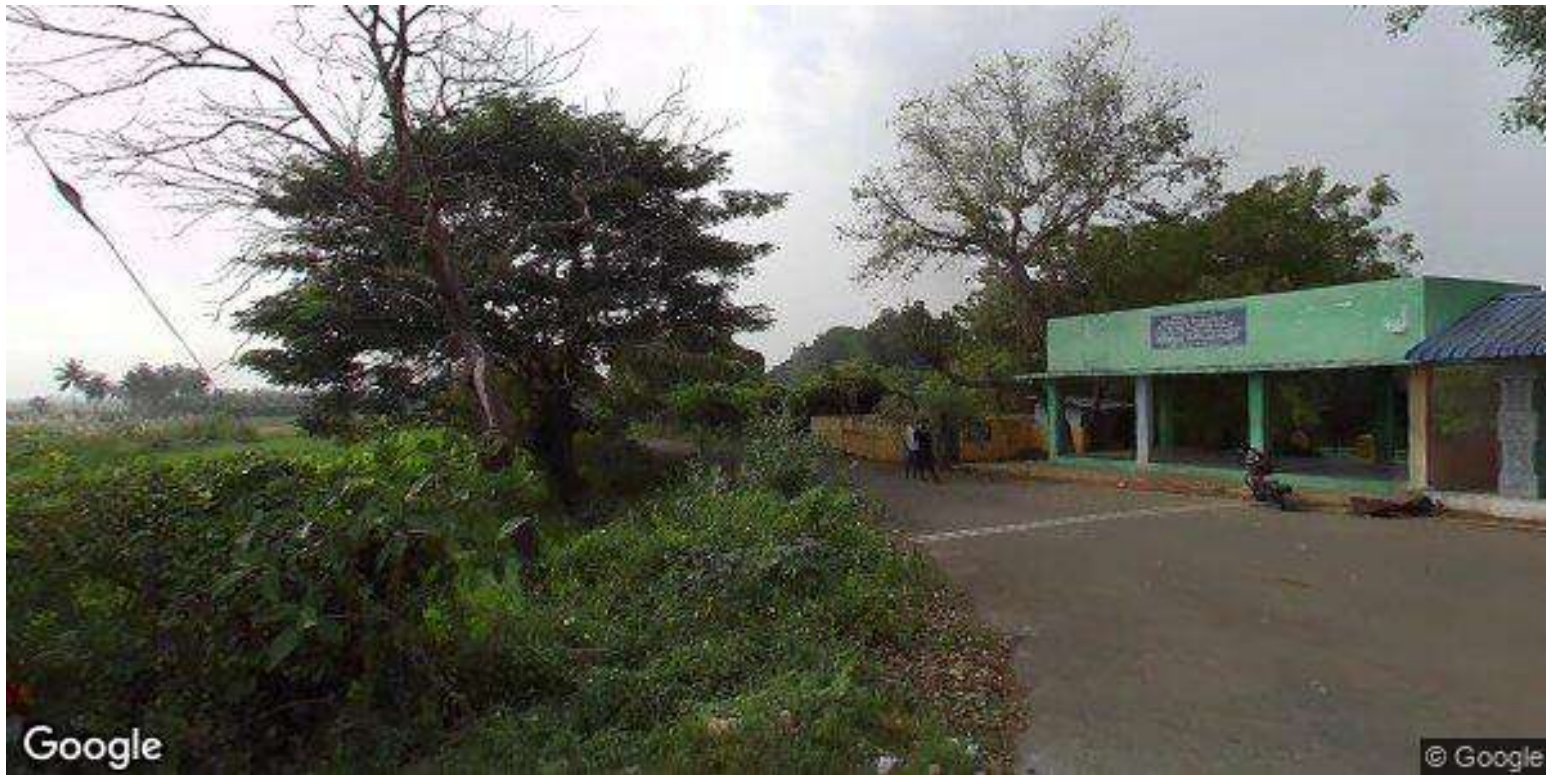
**Risk Type:** Turn  
**Risk Level:** High  
**Speed Limit:** 15 KM/Hr  
**Coordinates:** 10.87931, 78.54275

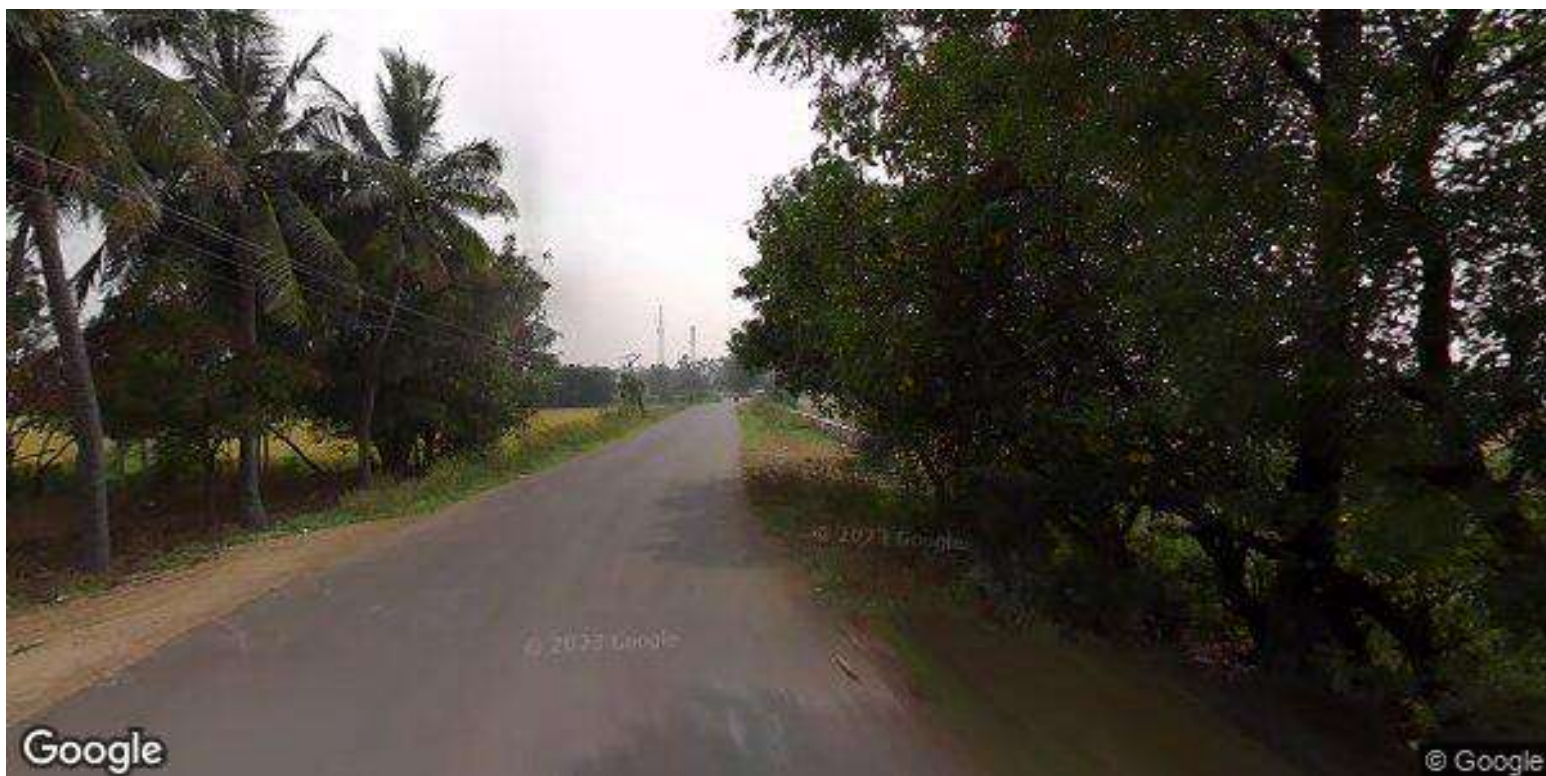
**Risk Type:** Turn  
**Risk Level:** Medium  
**Speed Limit:** 30 KM/Hr  
**Coordinates:** 10.87339, 78.54096

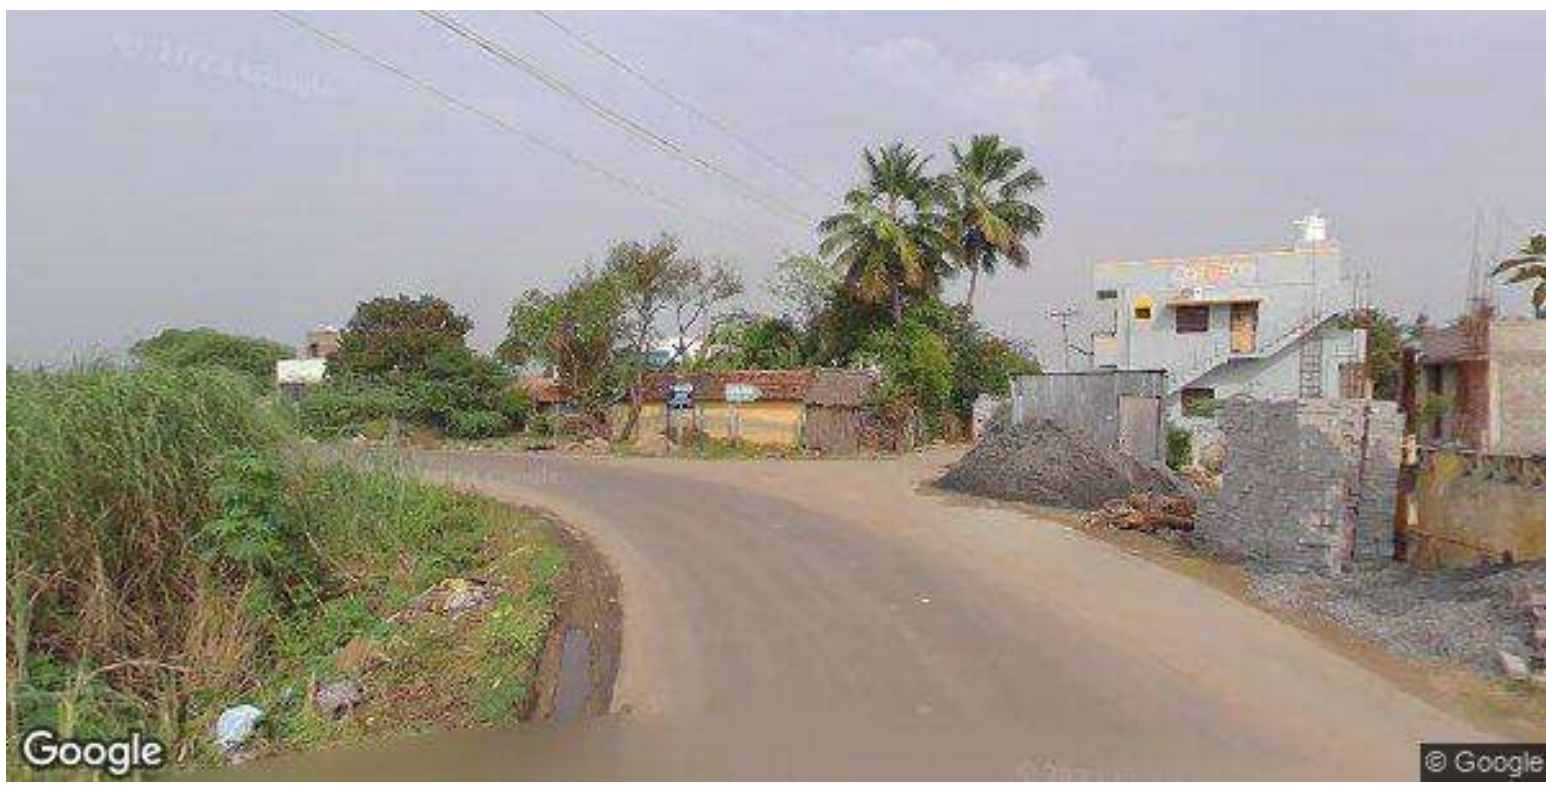
**Risk Type:** Turn

**Risk Level:** Medium

**Speed Limit:** 30 KM/Hr

**Coordinates:** 10.87090, 78.53973

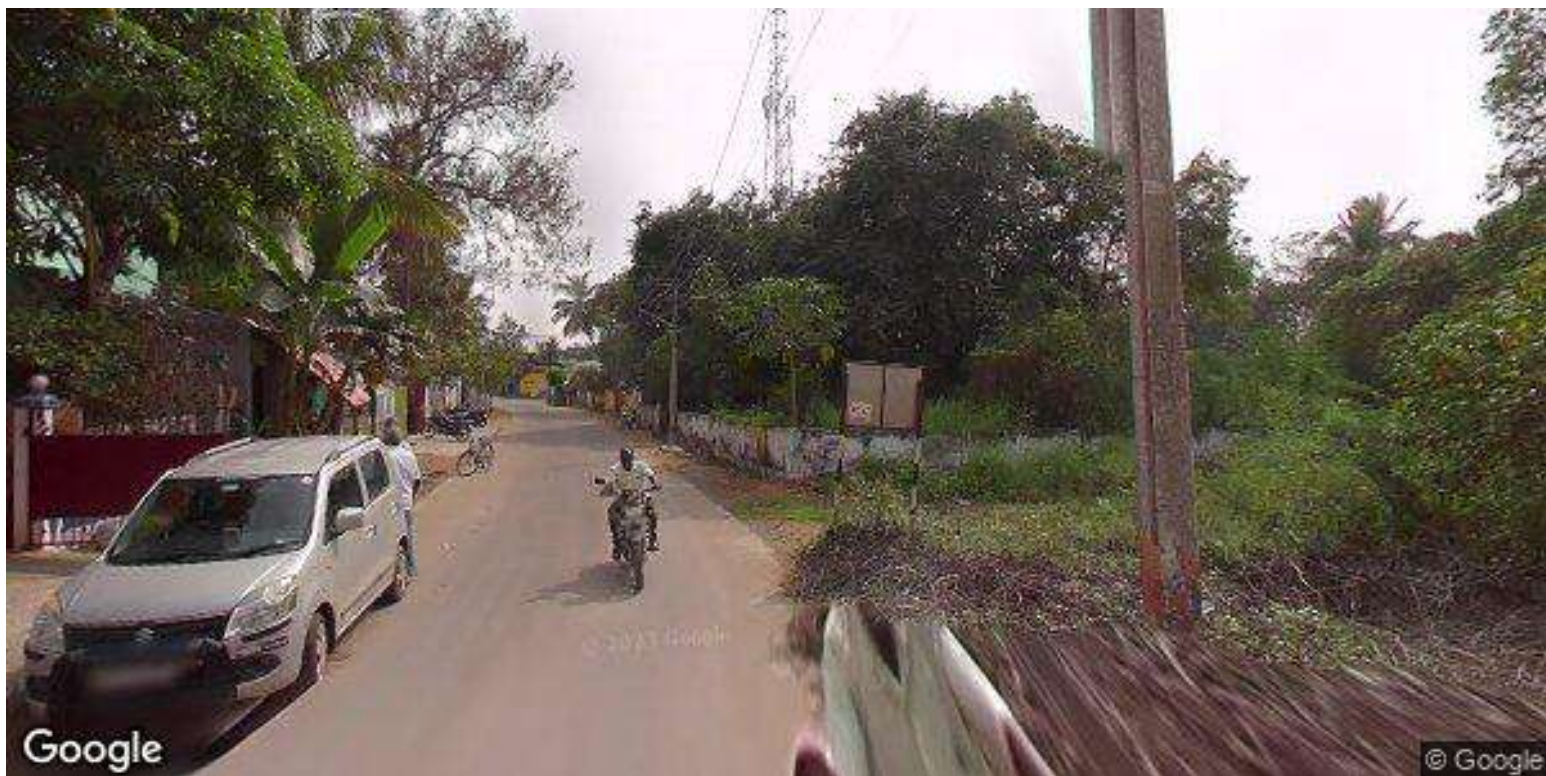
**Risk Type:** Turn

**Risk Level:** High

**Speed Limit:** 15 KM/Hr

**Coordinates:** 10.87065, 78.53930

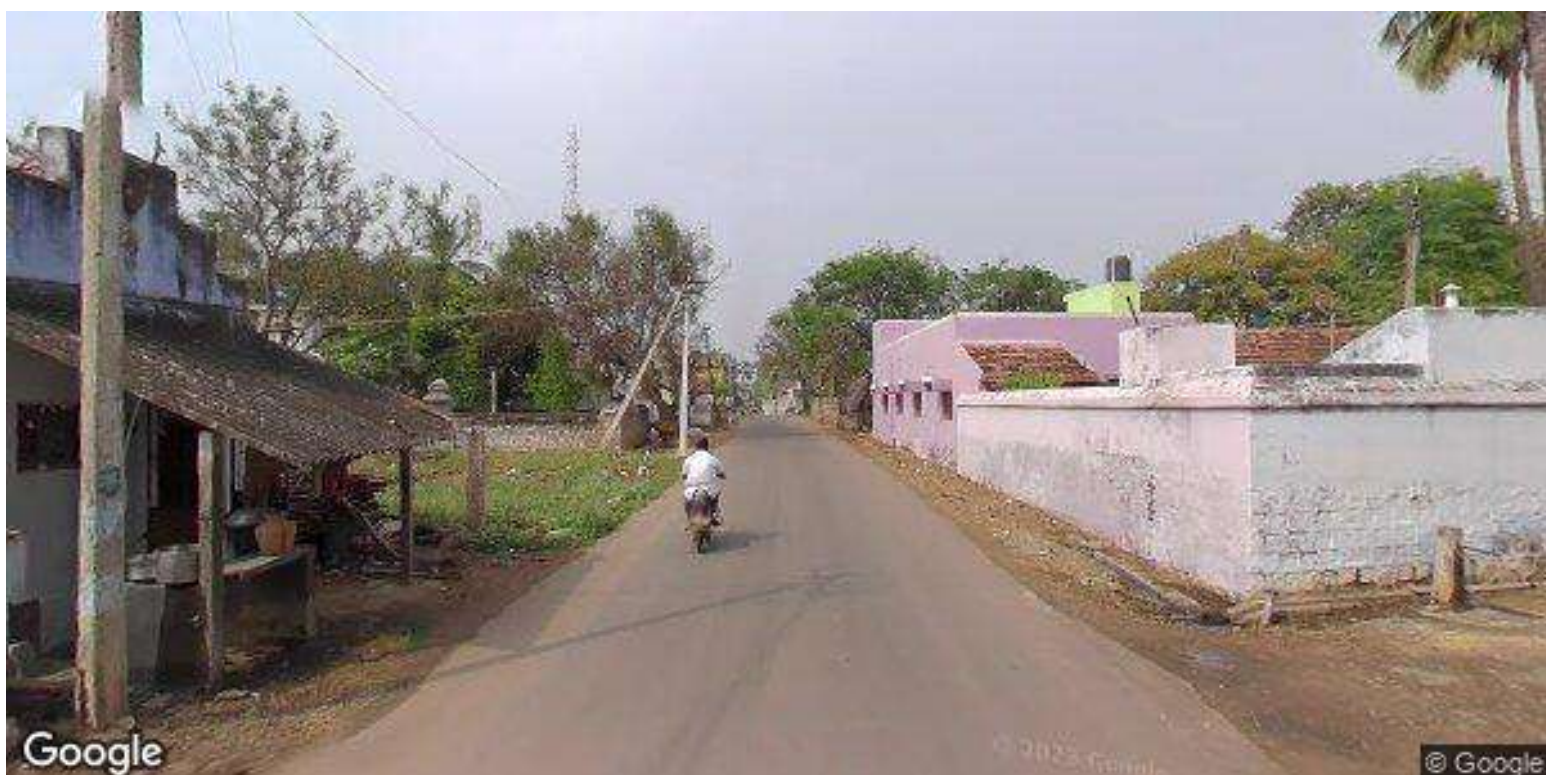
**Risk Type:** Turn

**Risk Level:** Medium

**Speed Limit:** 30 KM/Hr

**Coordinates:** 10.86866, 78.53904

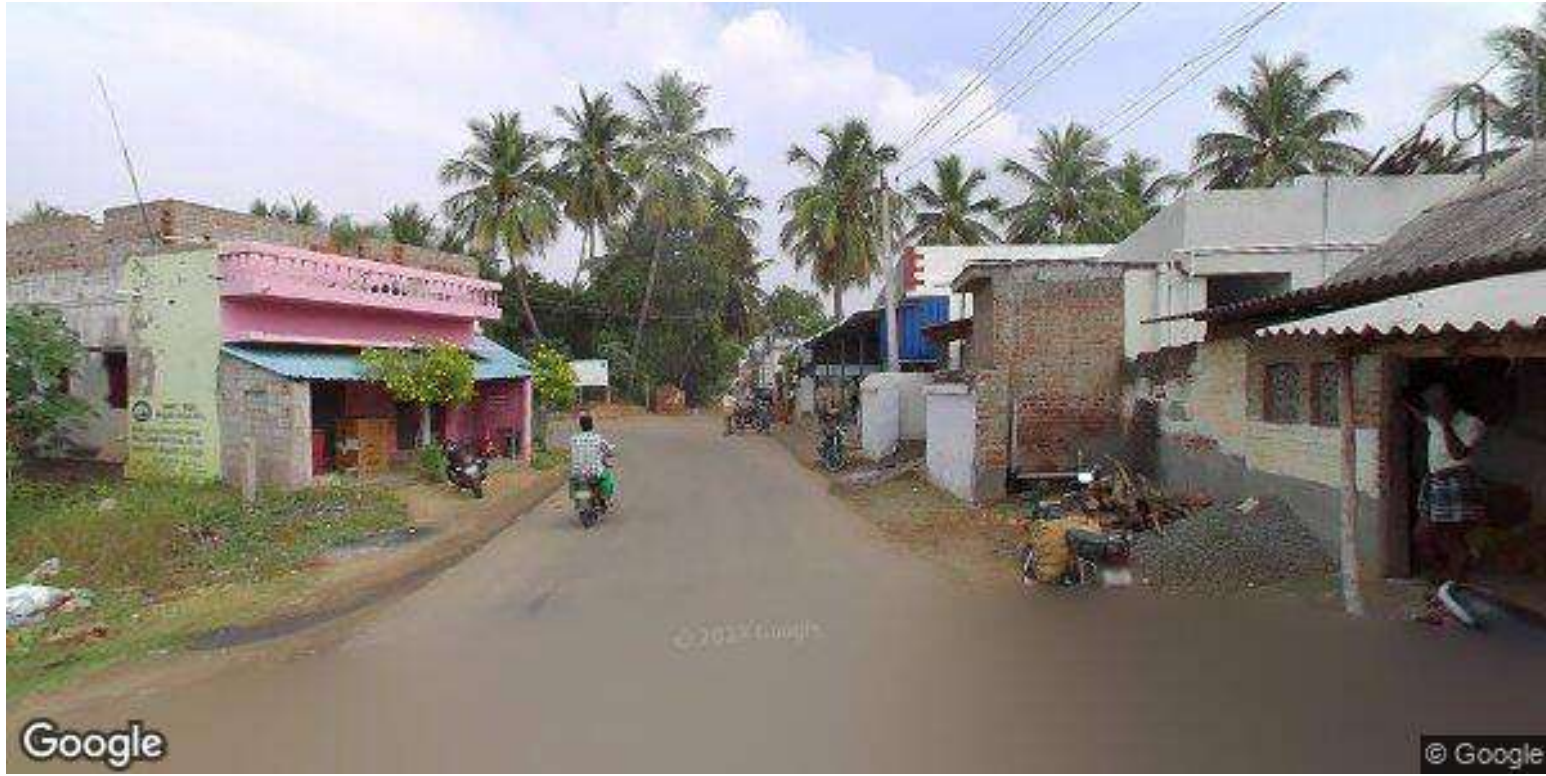
**Risk Type:** Turn

**Risk Level:** High

**Speed Limit:** 15 KM/Hr

**Coordinates:** 10.86817, 78.53870

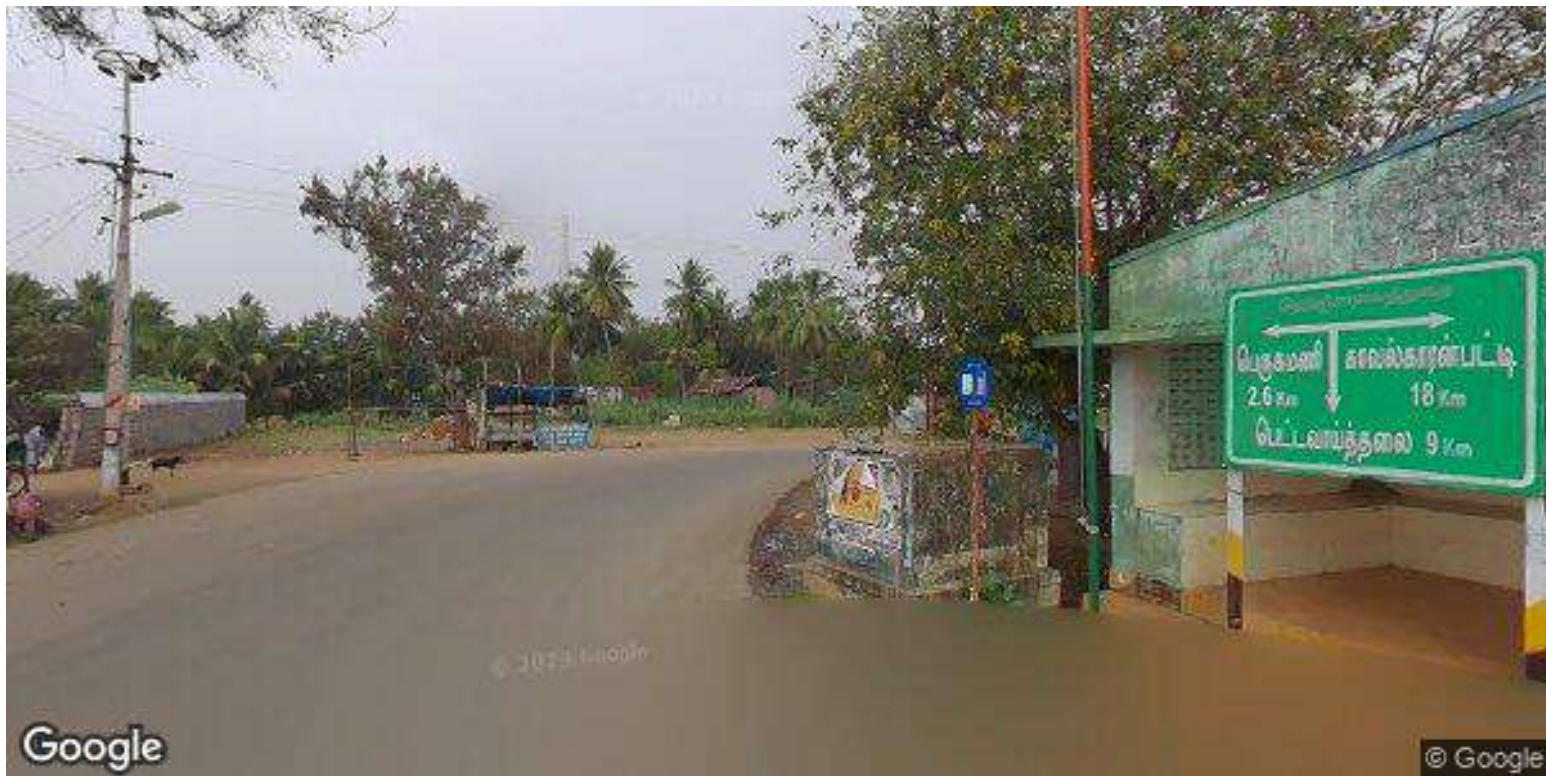
**Risk Type:** Turn

**Risk Level:** High

**Speed Limit:** 15 KM/Hr

**Coordinates:** 10.86814, 78.53816

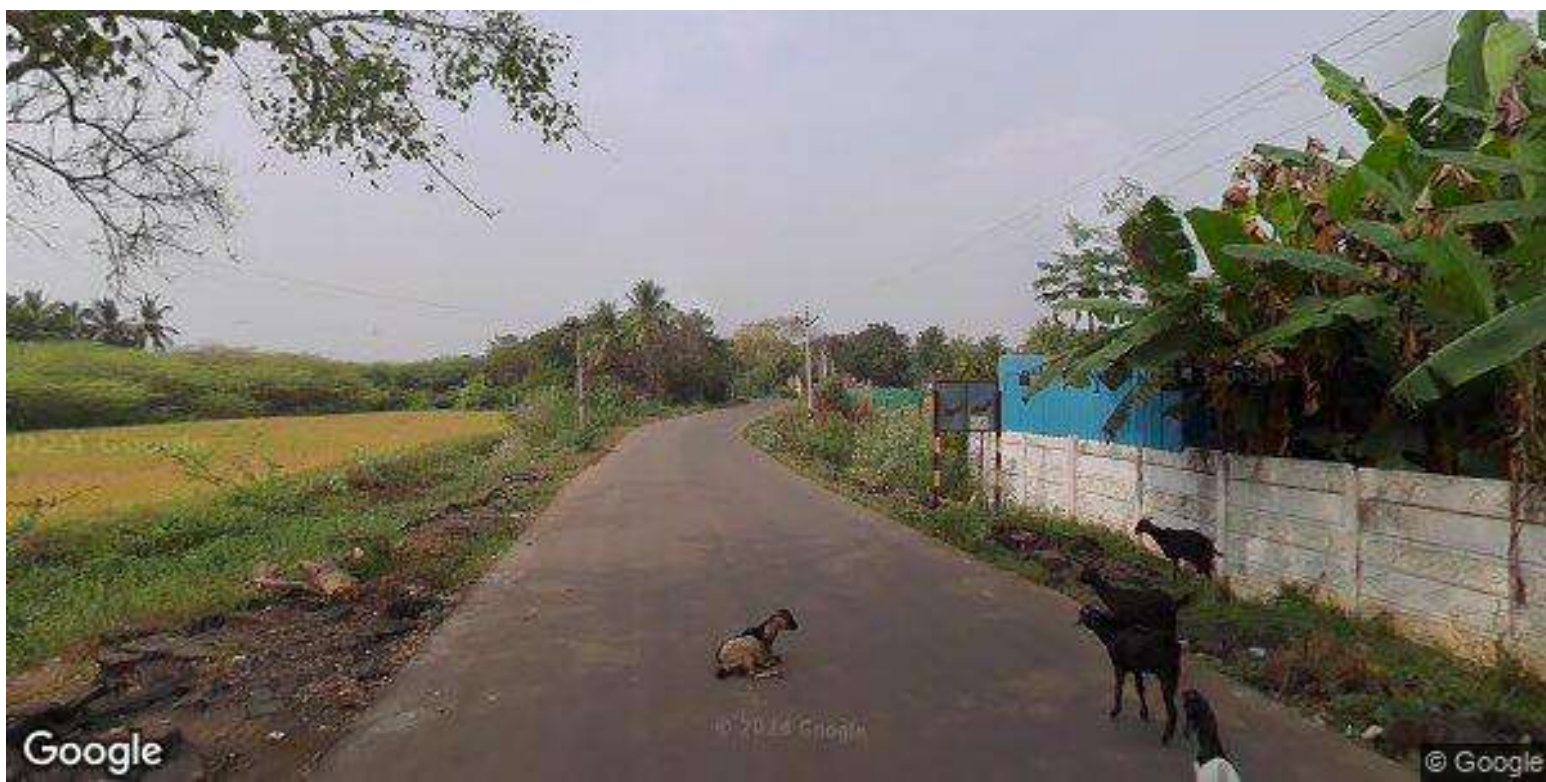
**Risk Type:** Turn

**Risk Level:** High

**Speed Limit:** 15 KM/Hr

**Coordinates:** 10.86518, 78.53852

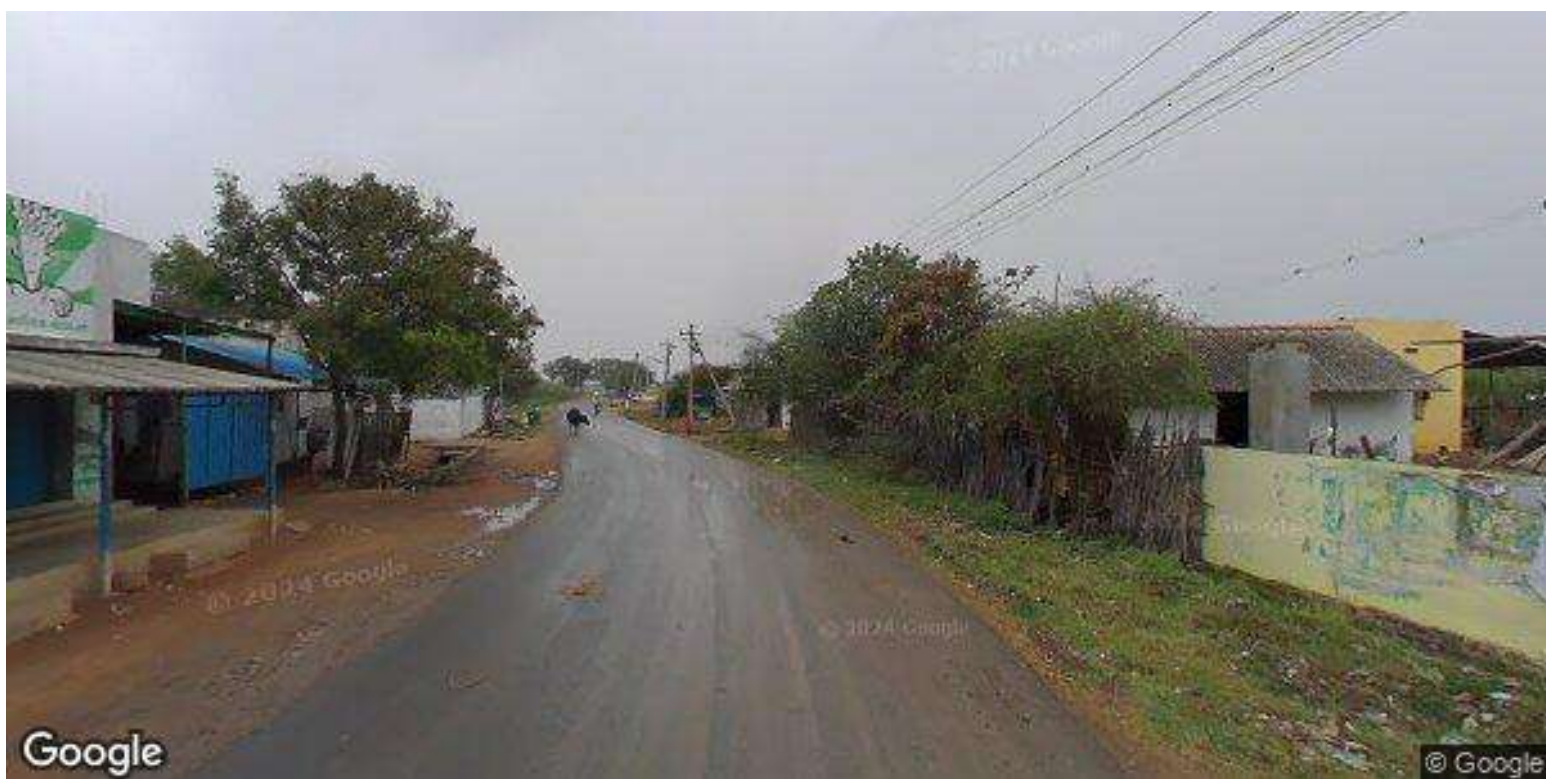
**Risk Type:** Turn

**Risk Level:** Medium

**Speed Limit:** 30 KM/Hr

**Coordinates:** 10.86079, 78.53641

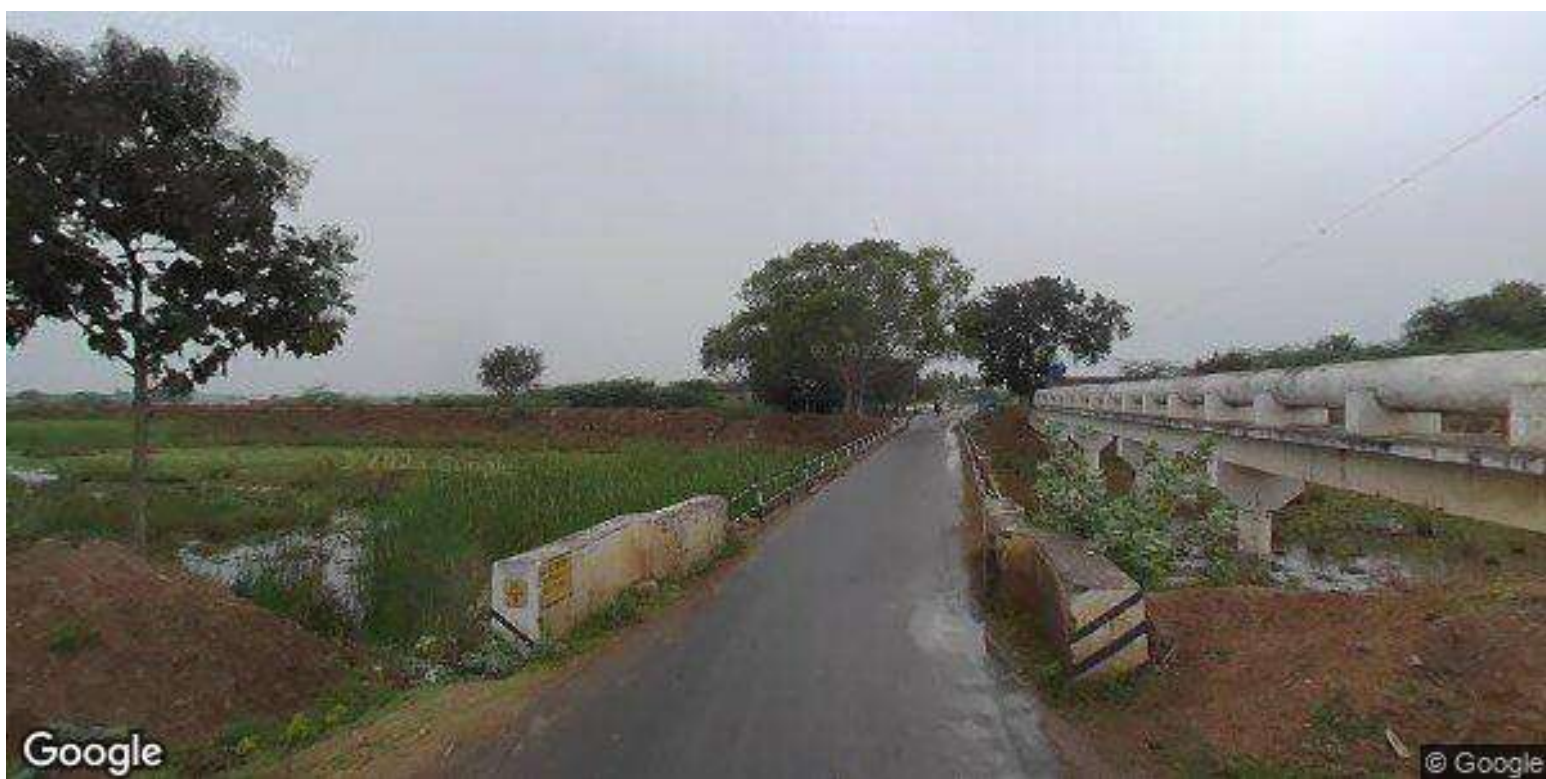
**Risk Type:** Turn  
**Risk Level:** Medium  
**Speed Limit:** 30 KM/Hr  
**Coordinates:** 10.85759, 78.53682

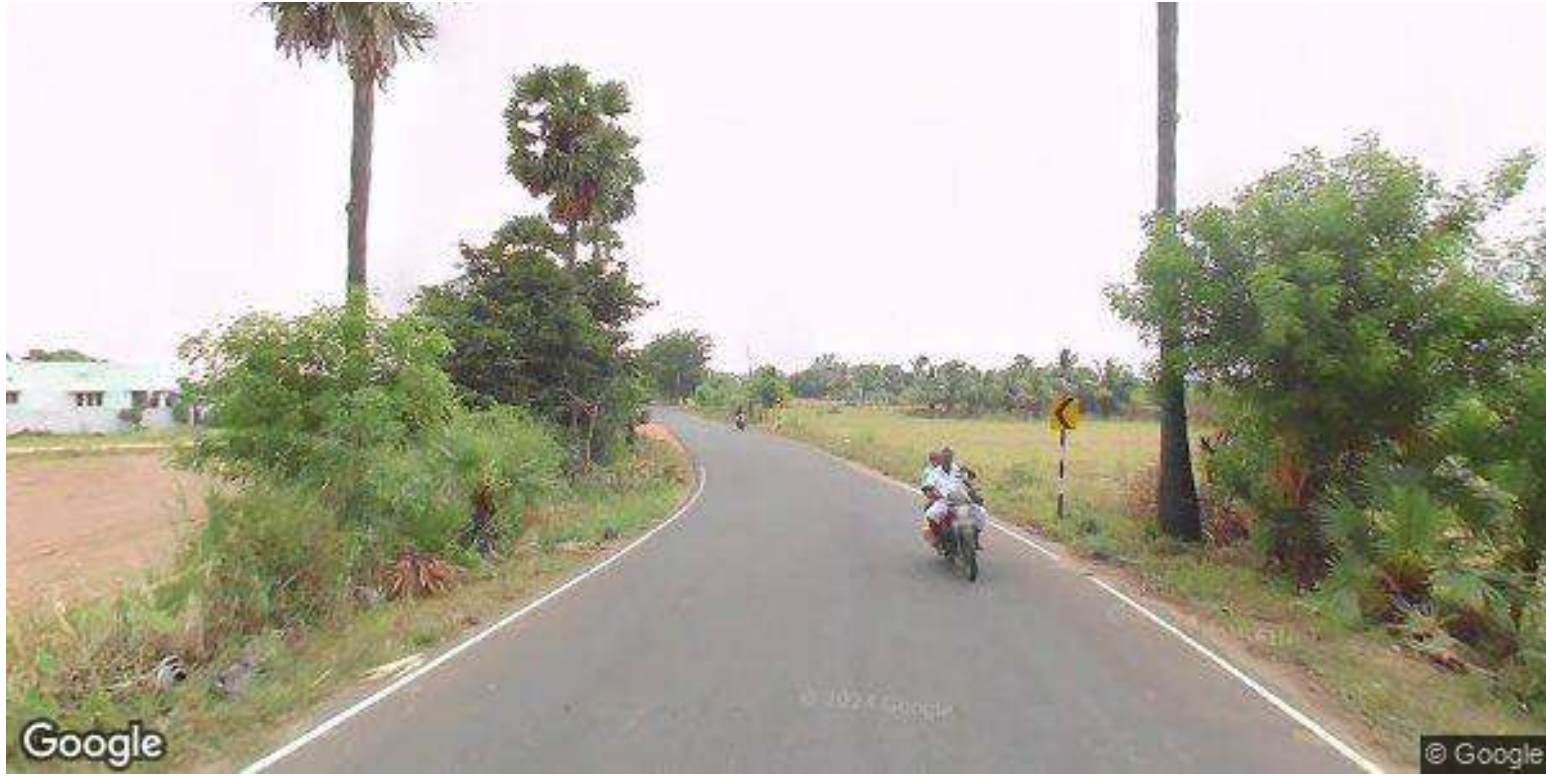
**Risk Type:** Turn  
**Risk Level:** Medium  
**Speed Limit:** 30 KM/Hr  
**Coordinates:** 10.85289, 78.54270

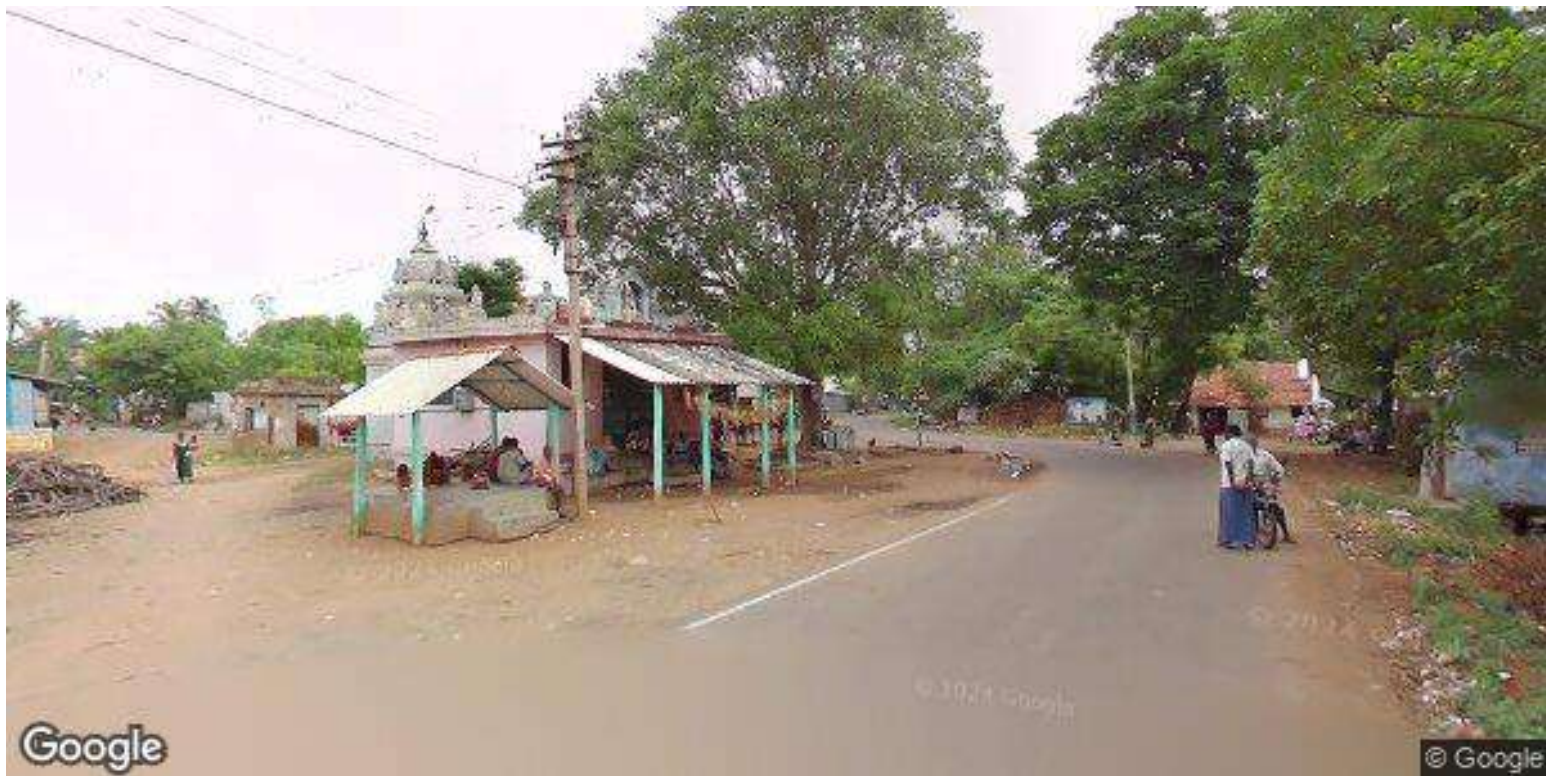
**Risk Type:** Turn  
**Risk Level:** Medium  
**Speed Limit:** 30 KM/Hr  
**Coordinates:** 10.83579, 78.54689

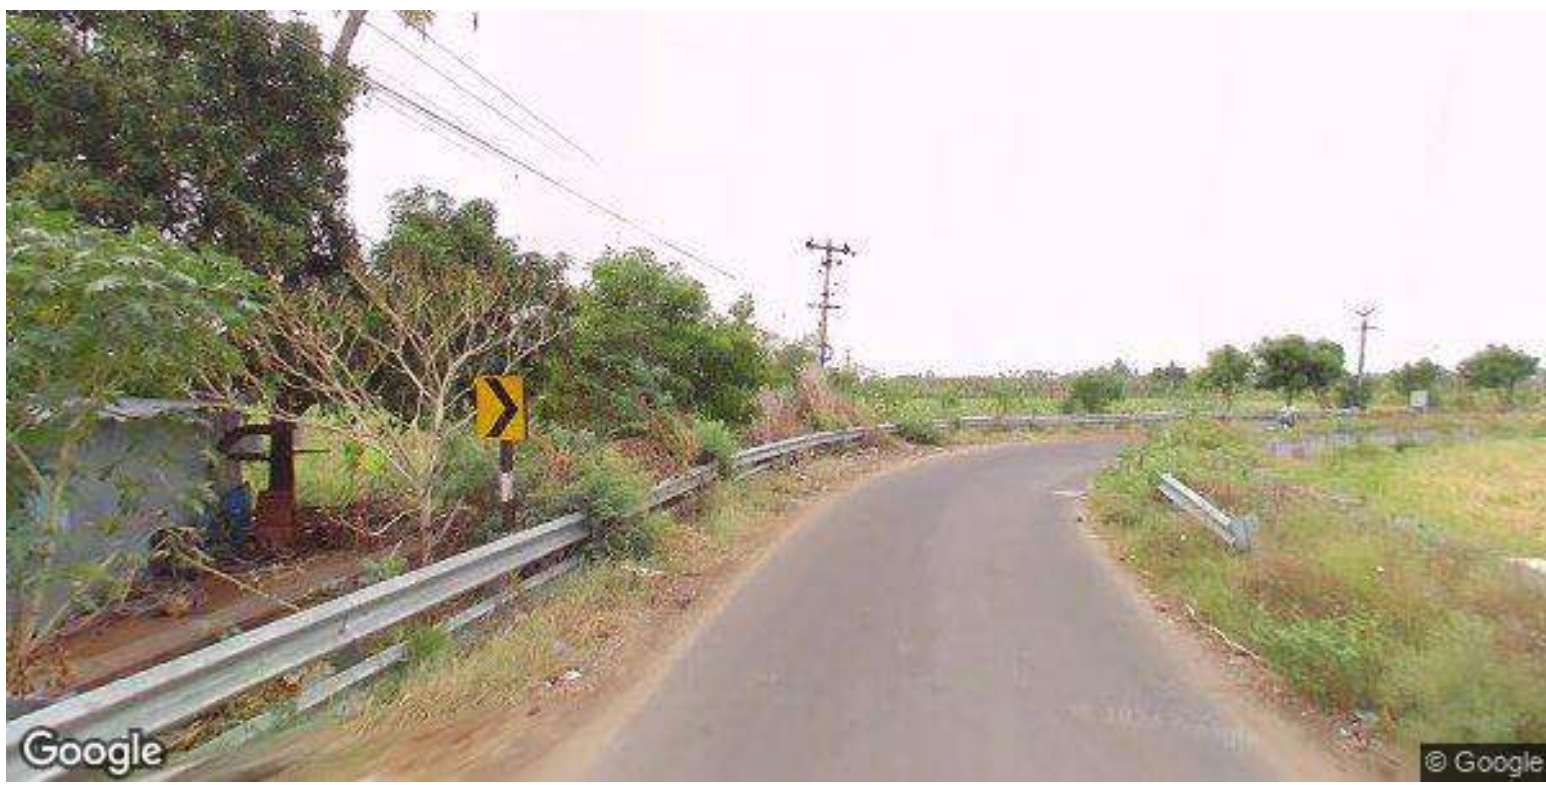
**Risk Type:** Turn

**Risk Level:** High
