# IndianOil

## JOURNEY RISK MANAGEMENT (JRM) STUDY

### Salem Terminal TO MANITHAM PETROLEUM

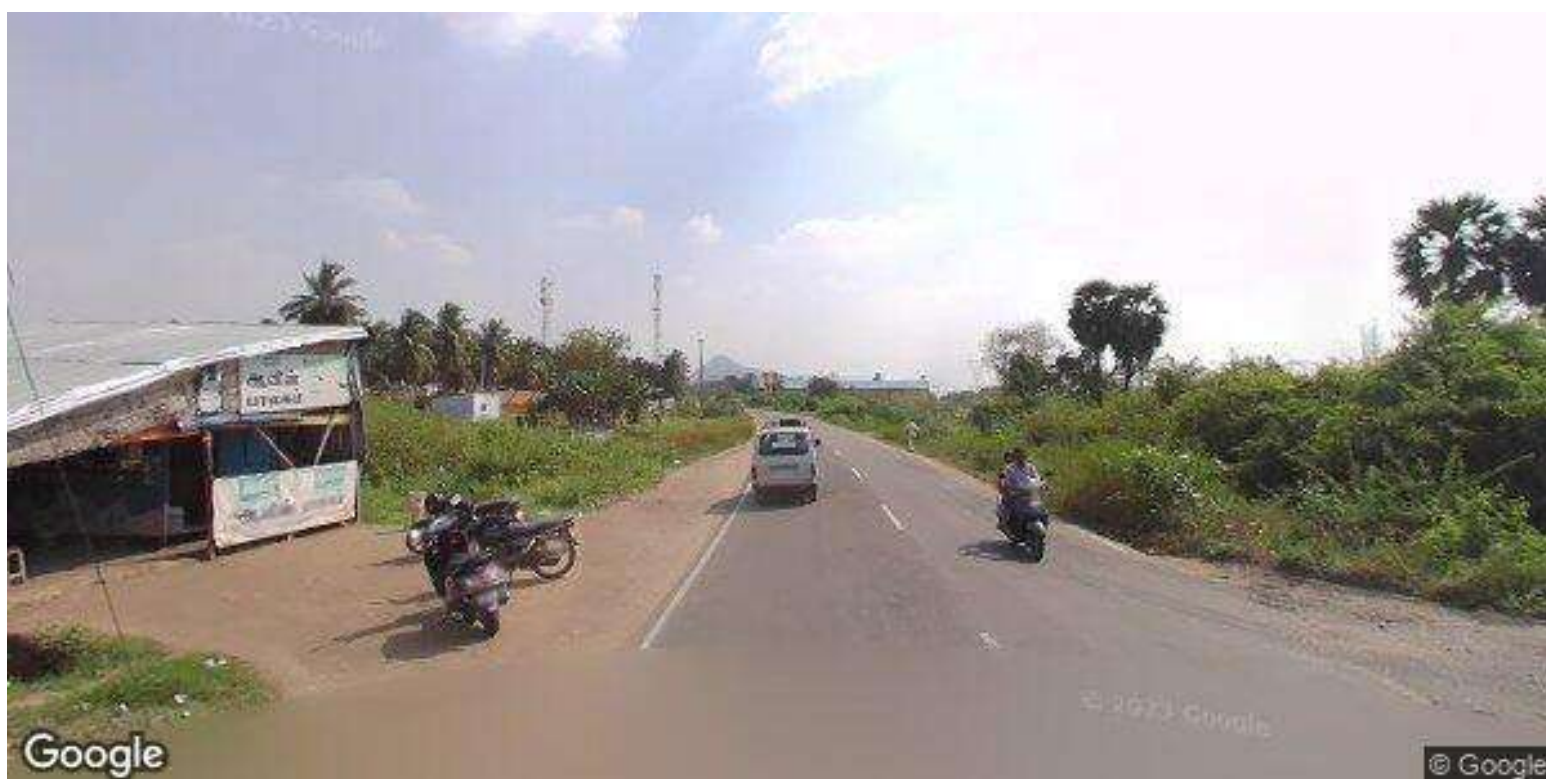
**Coordinates: 11.44022, 77.87546**

**Risk Type: Turn**

**Risk Level: High**

**Speed Limit: 15 KM/Hr**

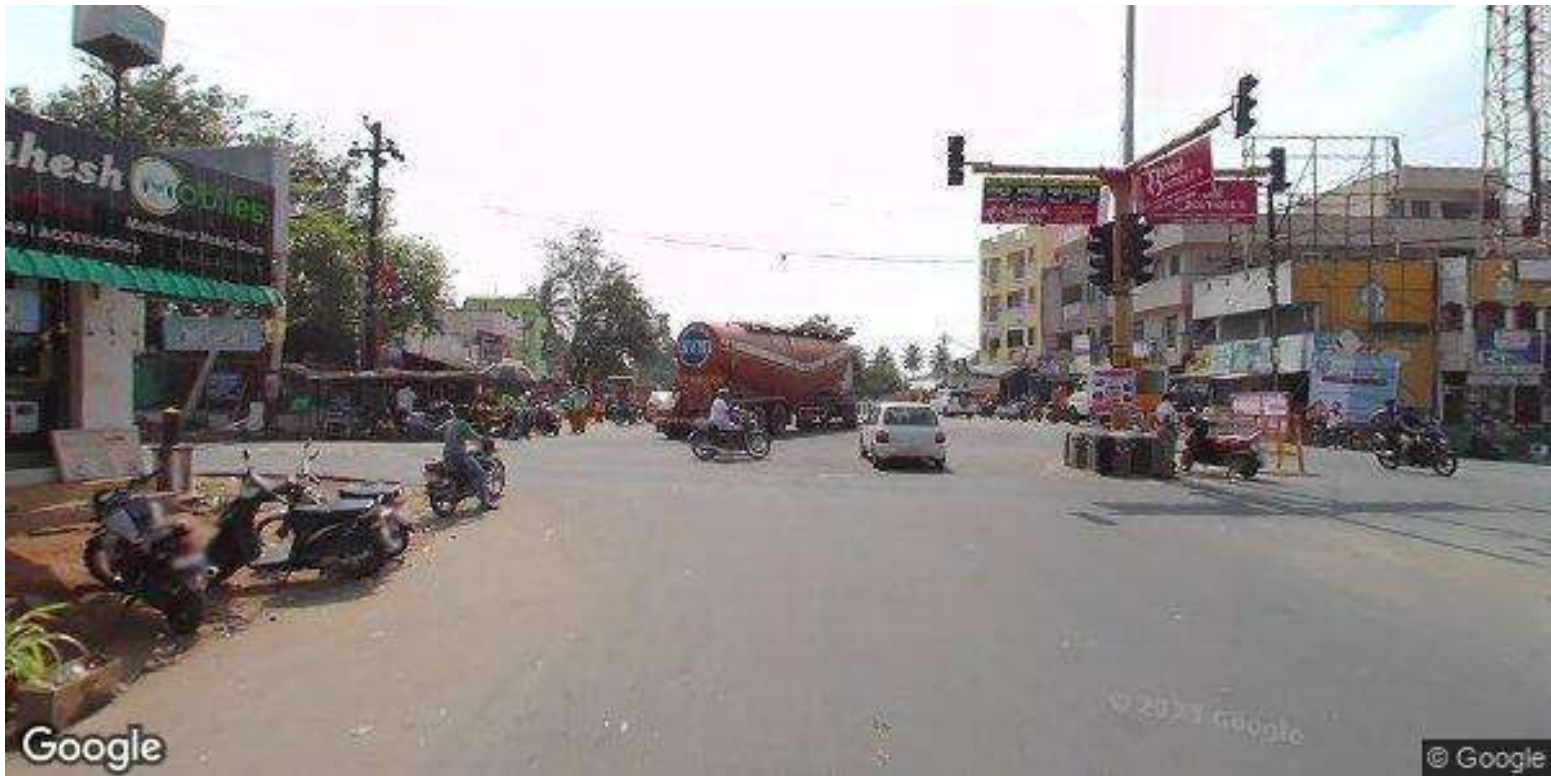
**Risk Type:** Turn  
**Risk Level:** High  
**Speed Limit:** 15 KM/Hr  
**Coordinates:** 11.36616, 77.88885

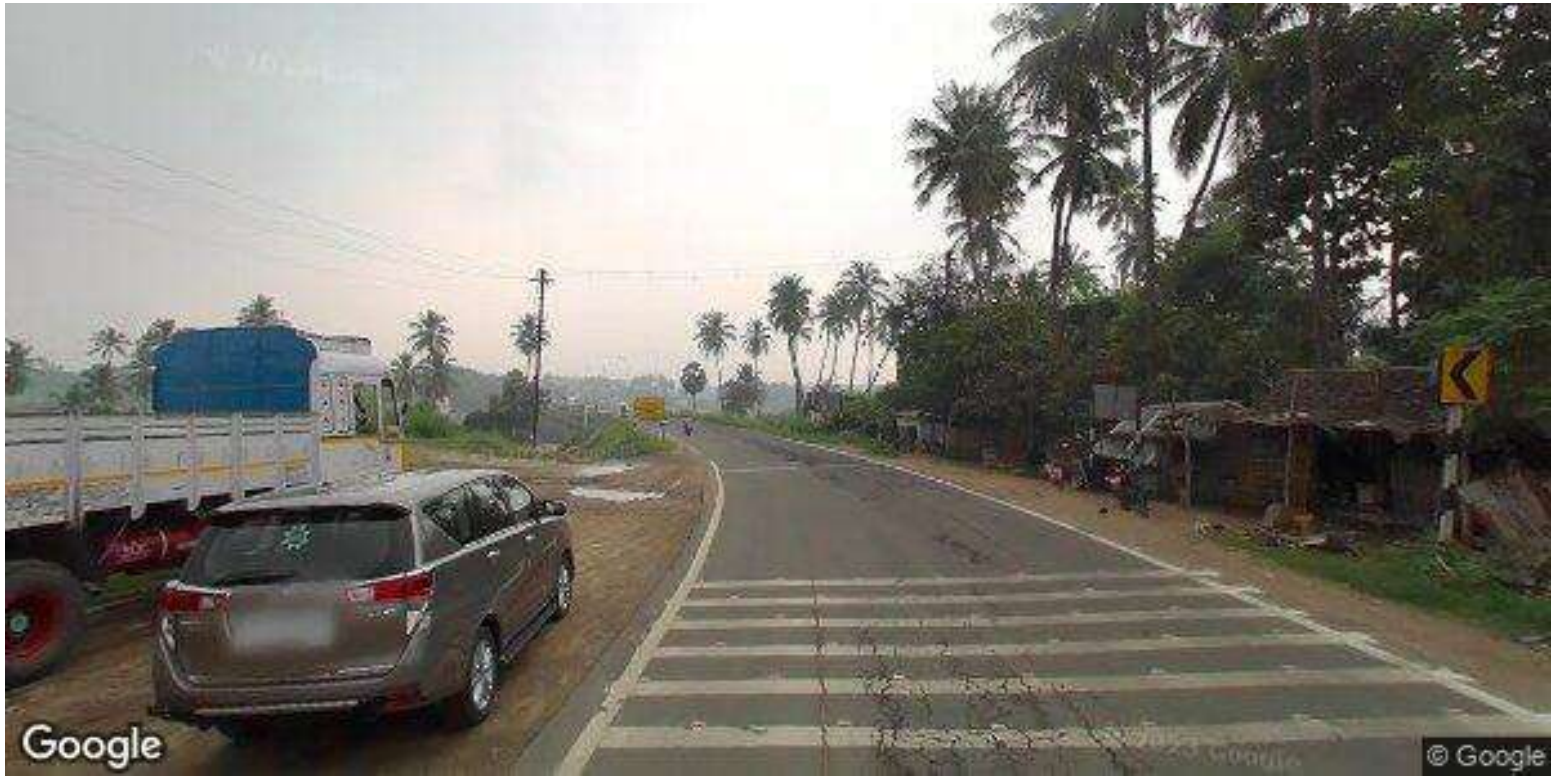
**Risk Type:** Turn  
**Risk Level:** Medium  
**Speed Limit:** 30 KM/Hr  
**Coordinates:** 11.30952, 77.77587

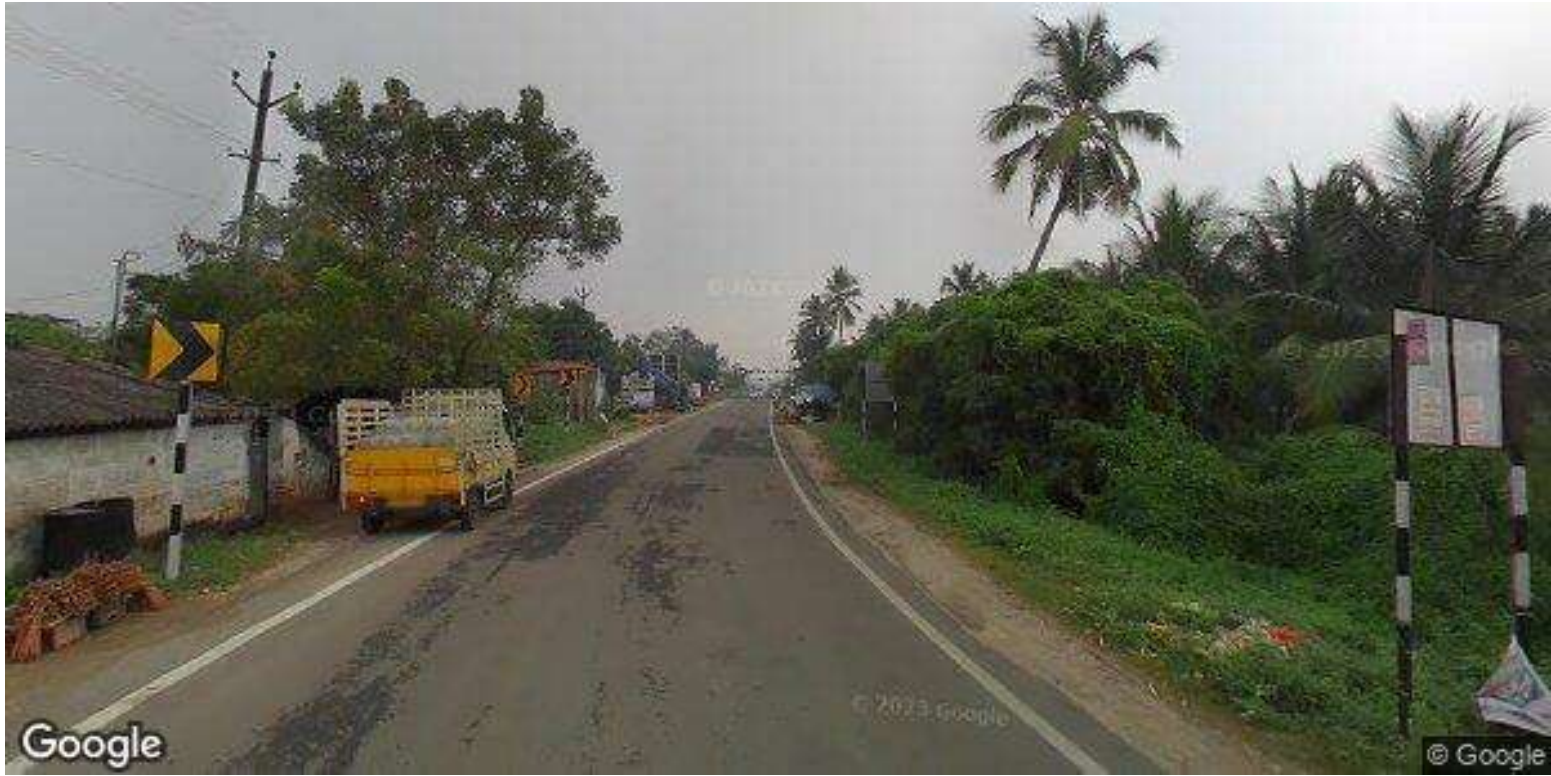
**Risk Type:** Turn  
**Risk Level:** Medium  
**Speed Limit:** 30 KM/Hr  
**Coordinates:** 11.30973, 77.76712

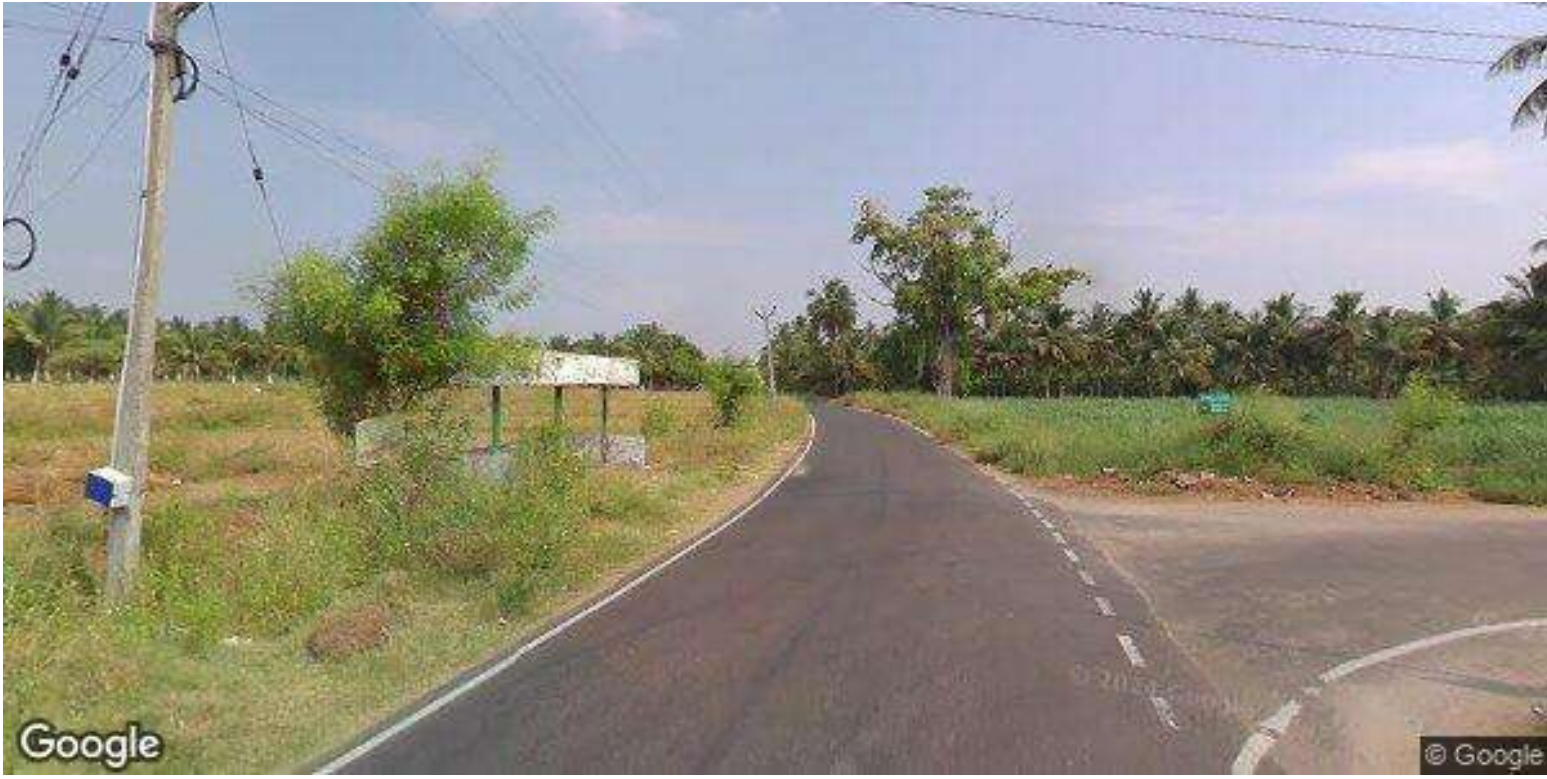
**Risk Type:** Turn  
**Risk Level:** High  
**Speed Limit:** 15 KM/Hr  
**Coordinates:** 11.29141, 77.74662

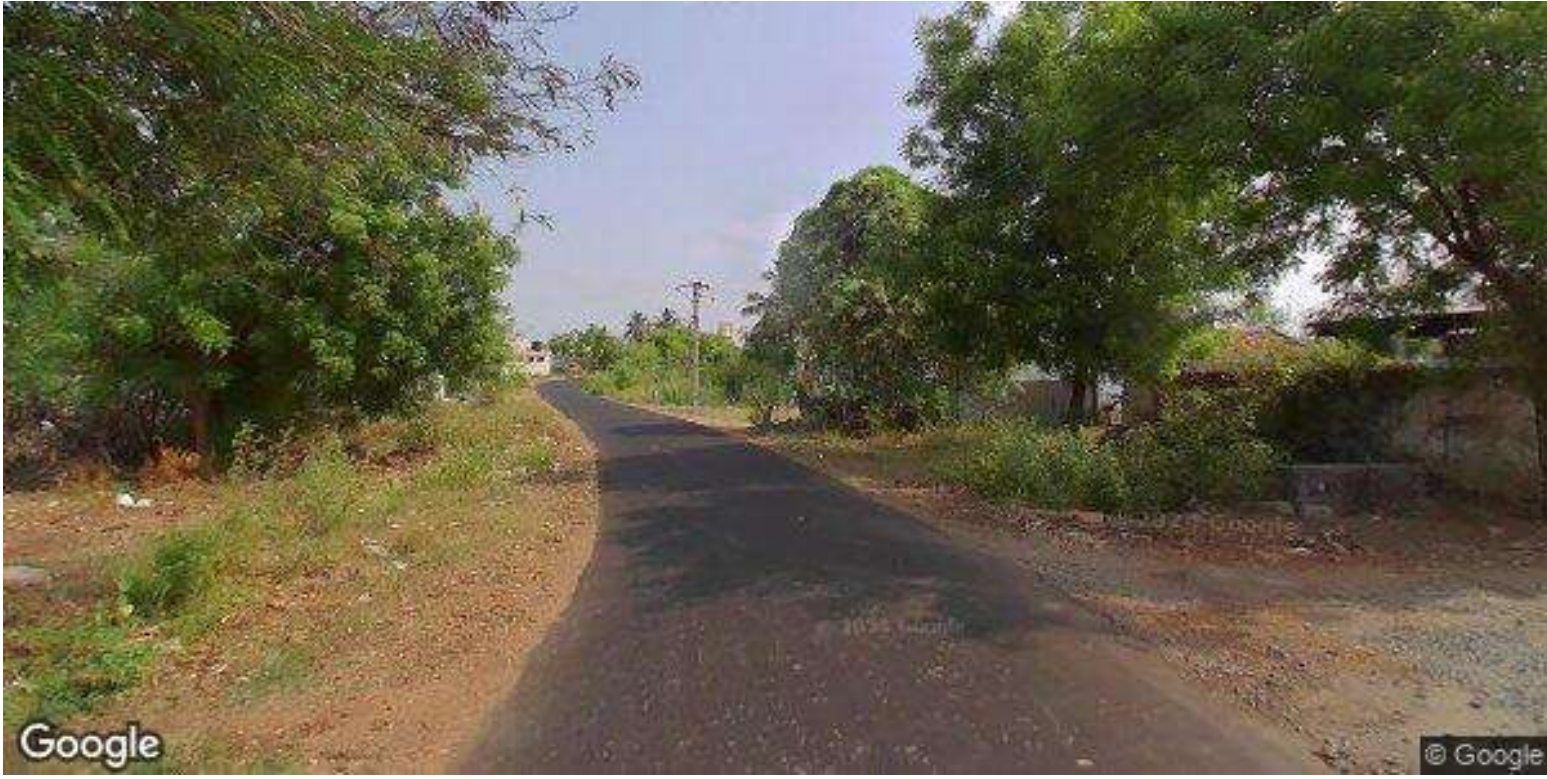
**Coordinates: 11.28844, 77.74319**

**Risk Type: Turn**

**Risk Level: Medium**

**Speed Limit: 30 KM/Hr**

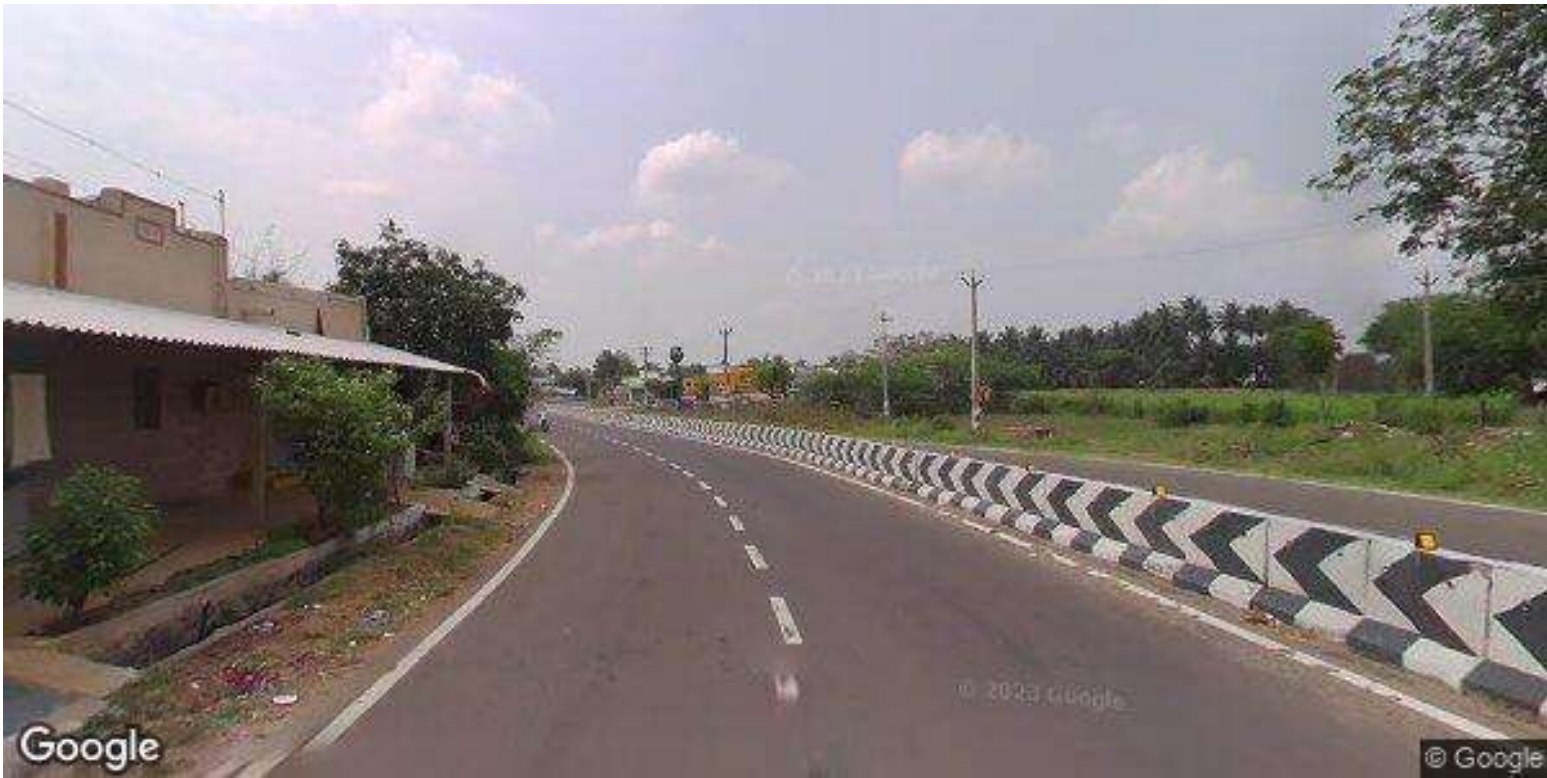
**Risk Type:** Turn  
**Risk Level:** Medium  
**Speed Limit:** 30 KM/Hr  
**Coordinates:** 11.22387, 77.71385

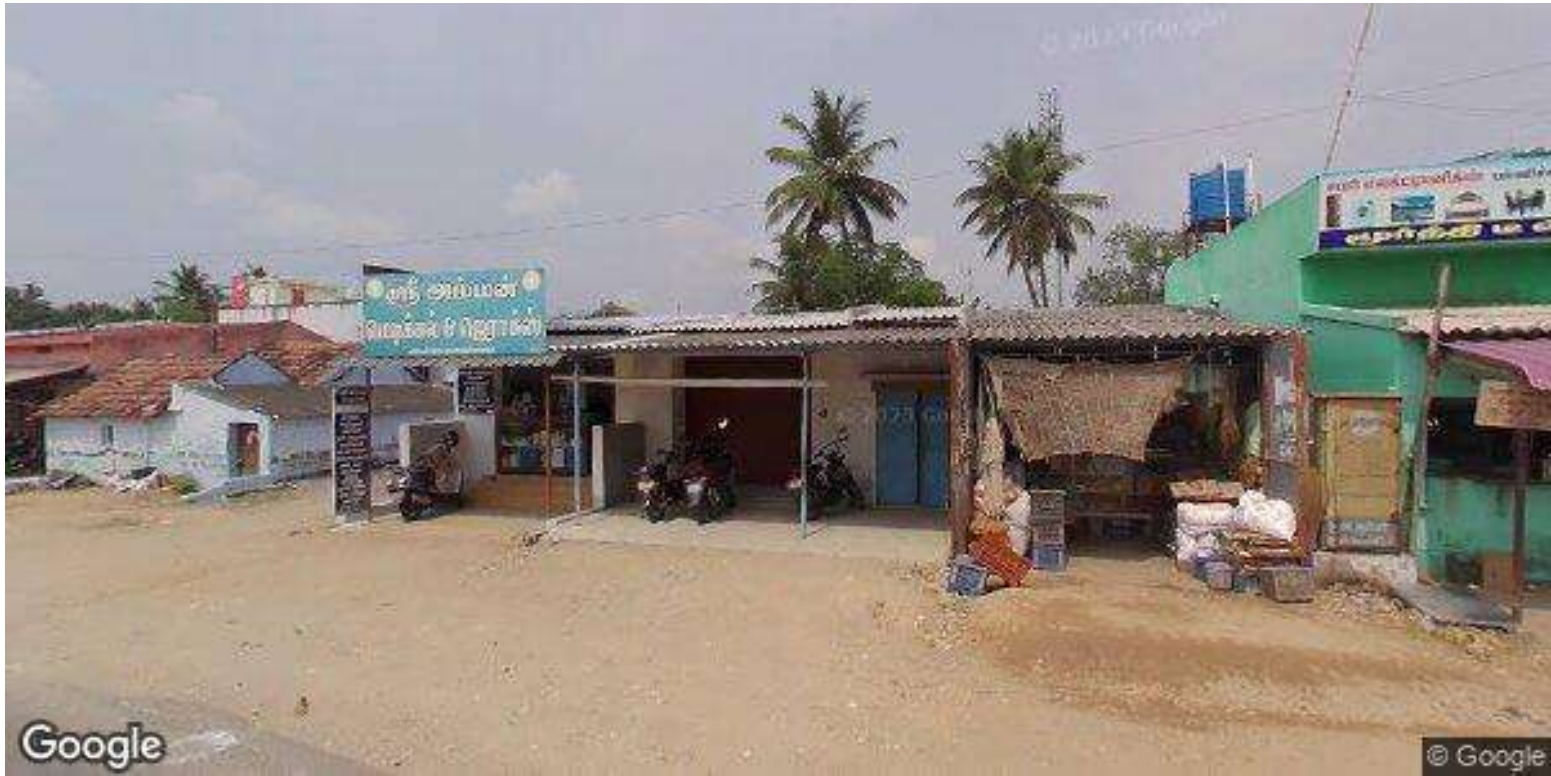
**Risk Type:** Turn  
**Risk Level:** Medium  
**Speed Limit:** 30 KM/Hr  
**Coordinates:** 11.20776, 77.70916

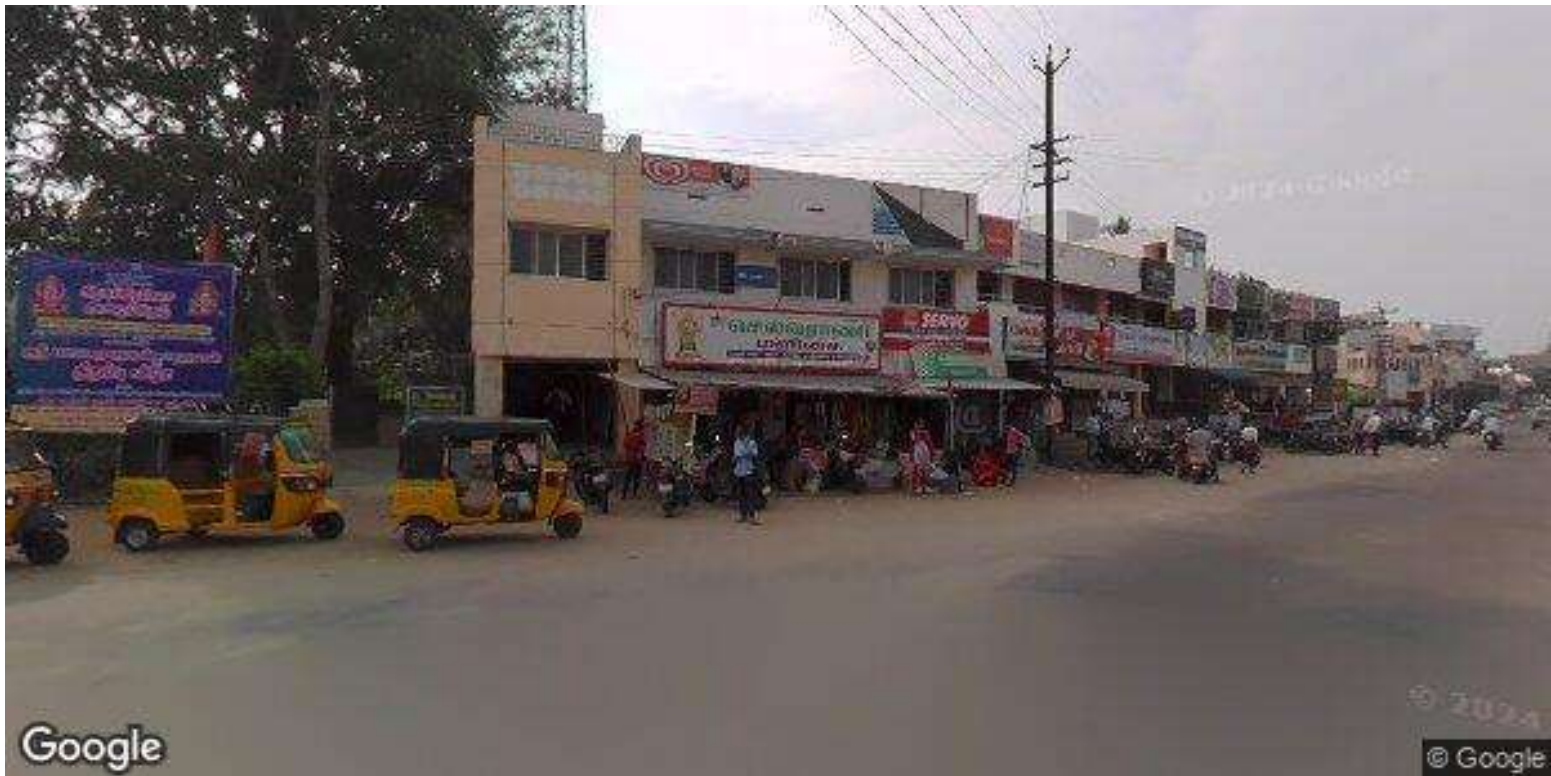
**Risk Type:** Turn  
**Risk Level:** High  
**Speed Limit:** 15 KM/Hr  
**Coordinates:** 11.15942, 77.70068

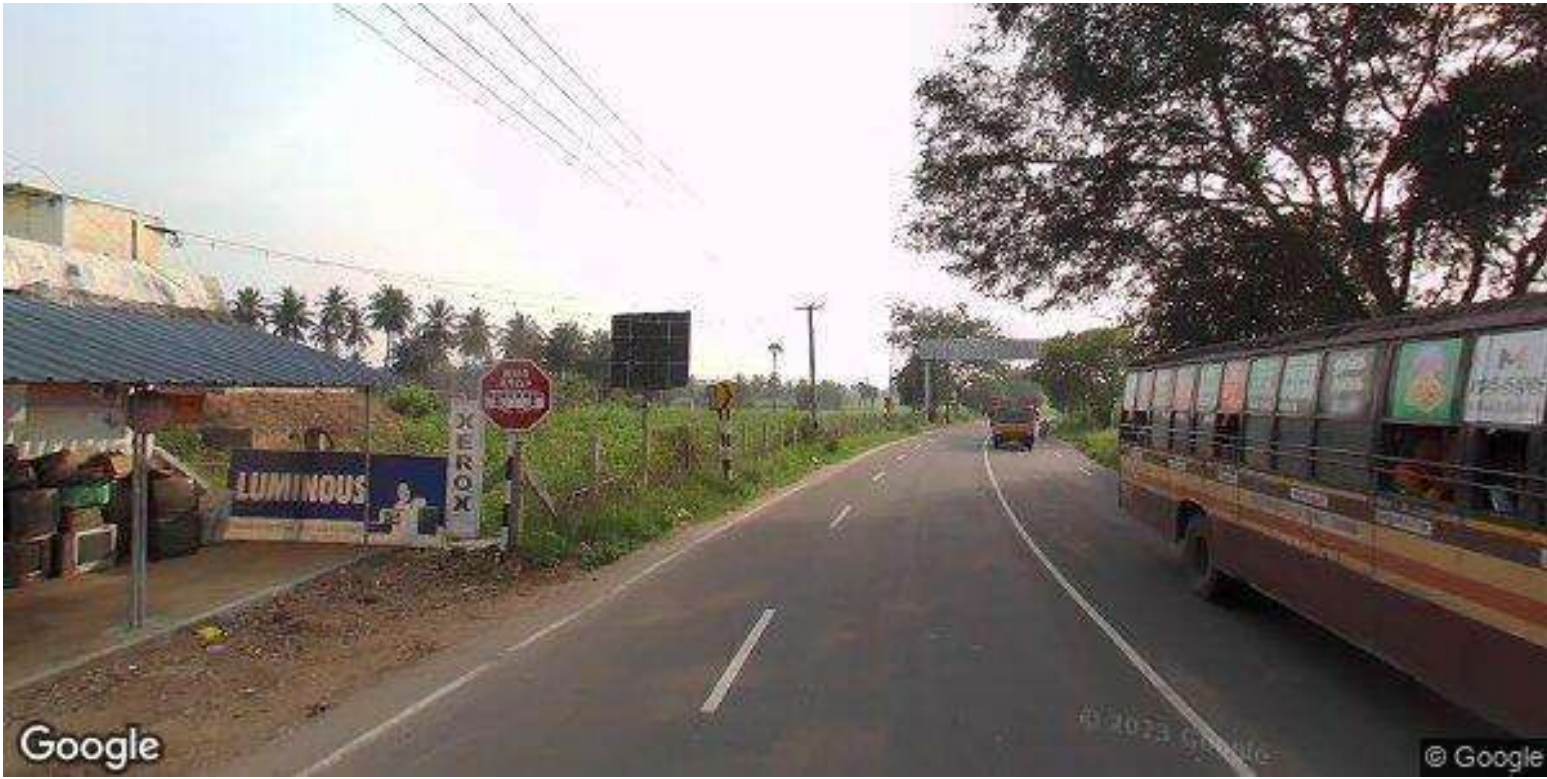
**Risk Type:** Turn  
**Risk Level:** Medium  
**Speed Limit:** 30 KM/Hr  
**Coordinates:** 11.12102, 77.67919

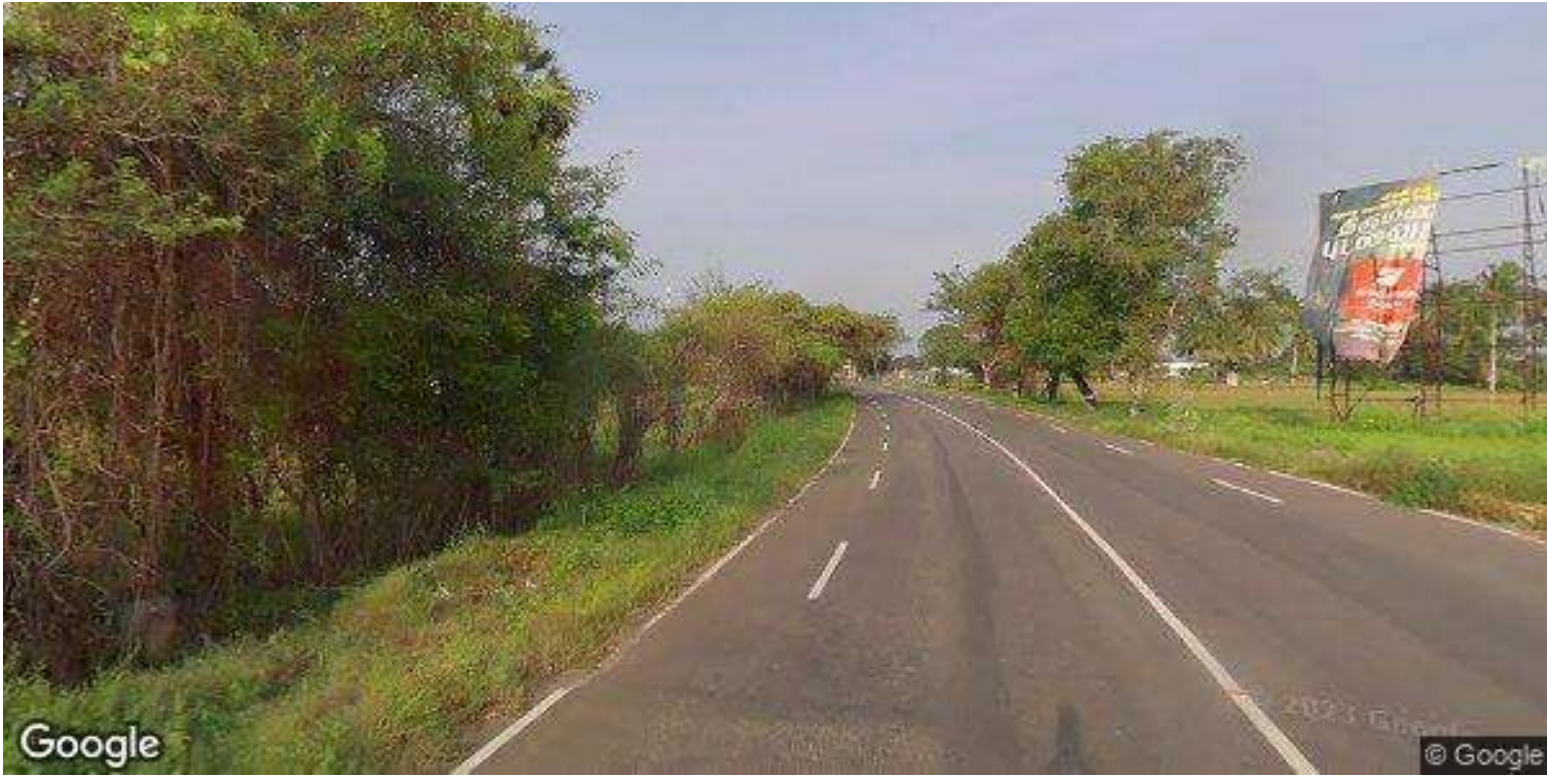
**Risk Type:** Turn  
**Risk Level:** Medium  
**Speed Limit:** 30 KM/Hr  
**Coordinates:** 11.11932, 77.67786

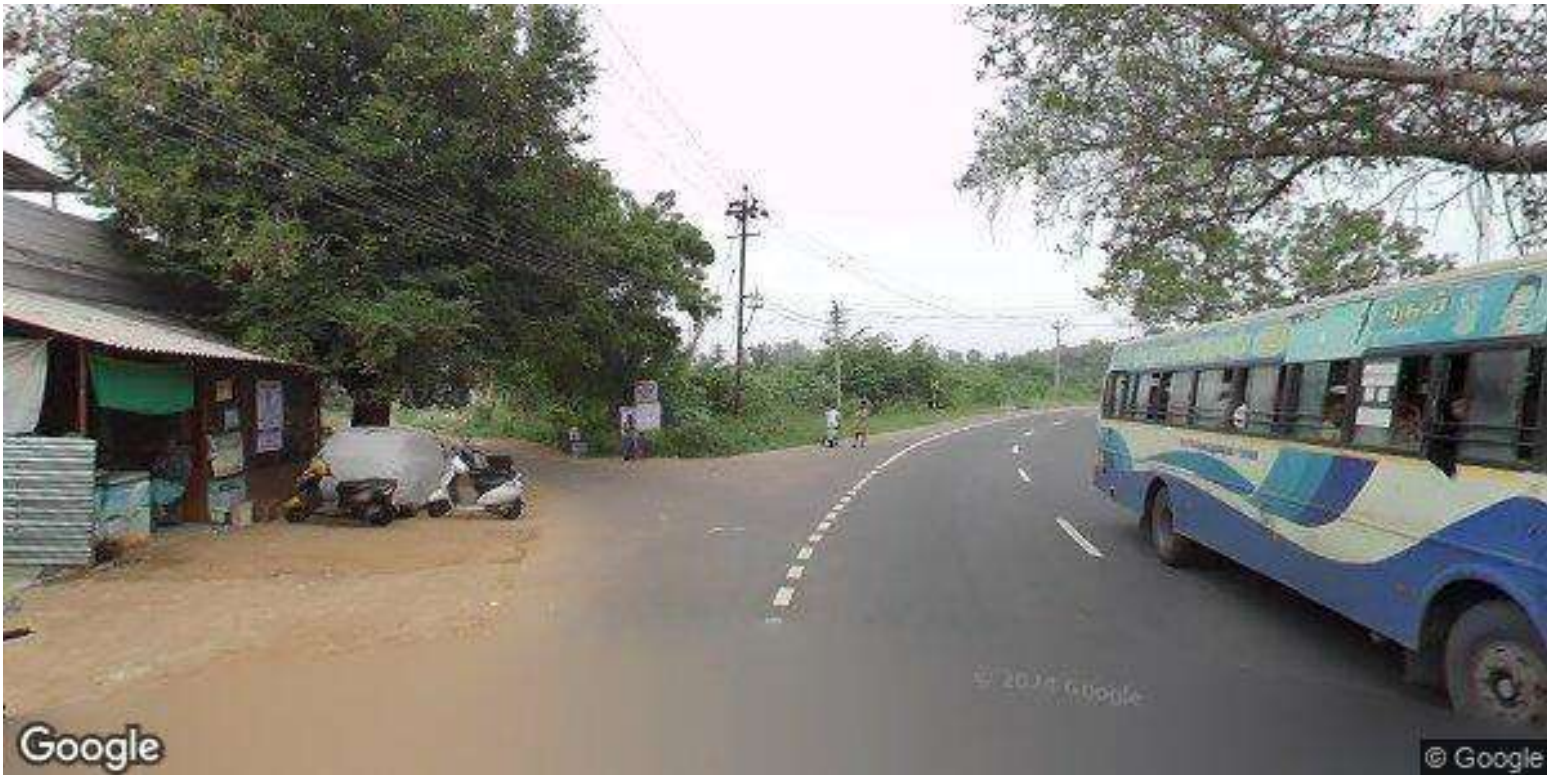
**Risk Type:** Turn  
**Risk Level:** Medium  
**Speed Limit:** 30 KM/Hr  
**Coordinates:** 11.11710, 77.67175

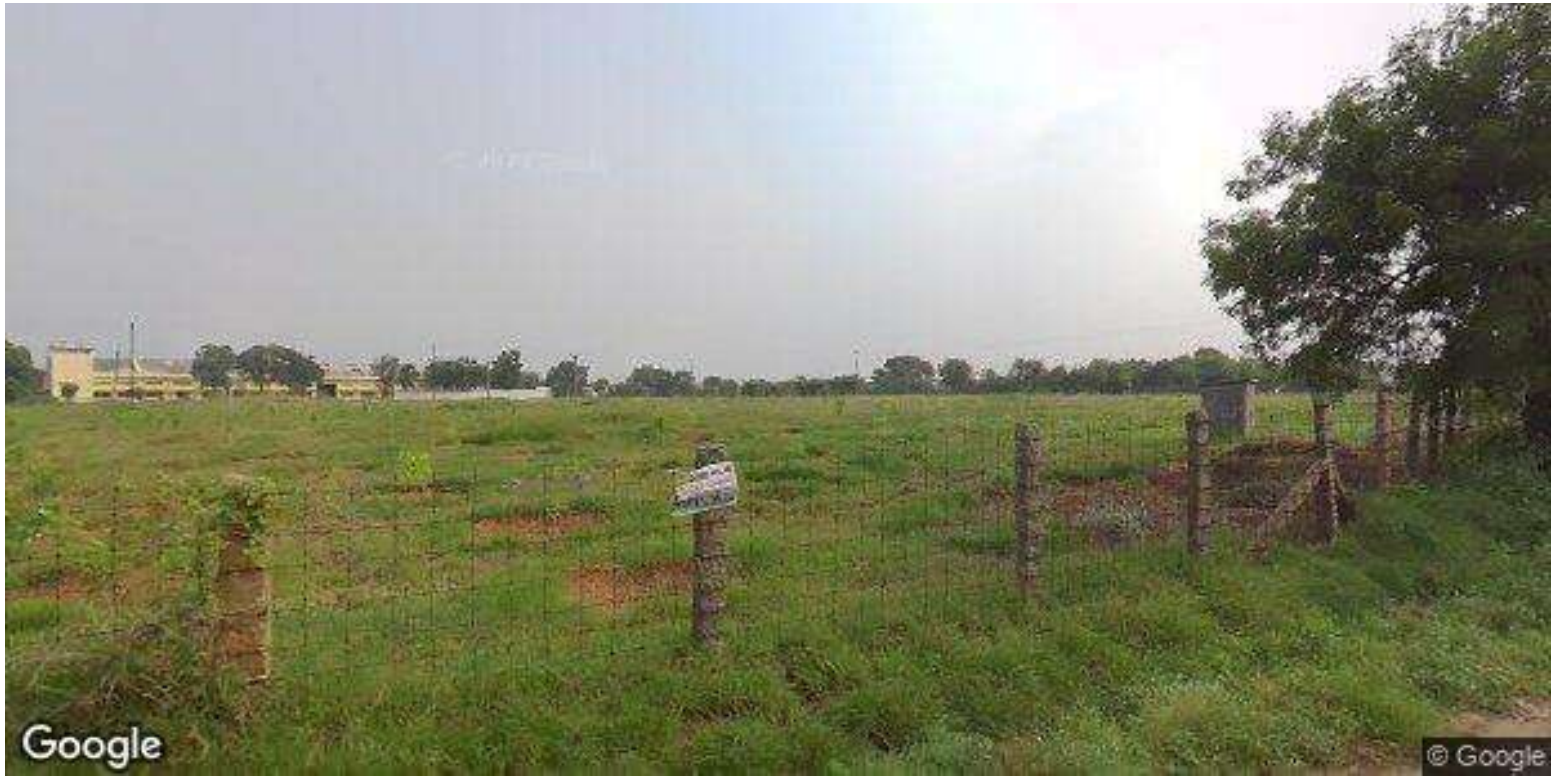
**Risk Type:** Turn  
**Risk Level:** Medium  
**Speed Limit:** 30 KM/Hr  
**Coordinates:** 11.09491, 77.66603

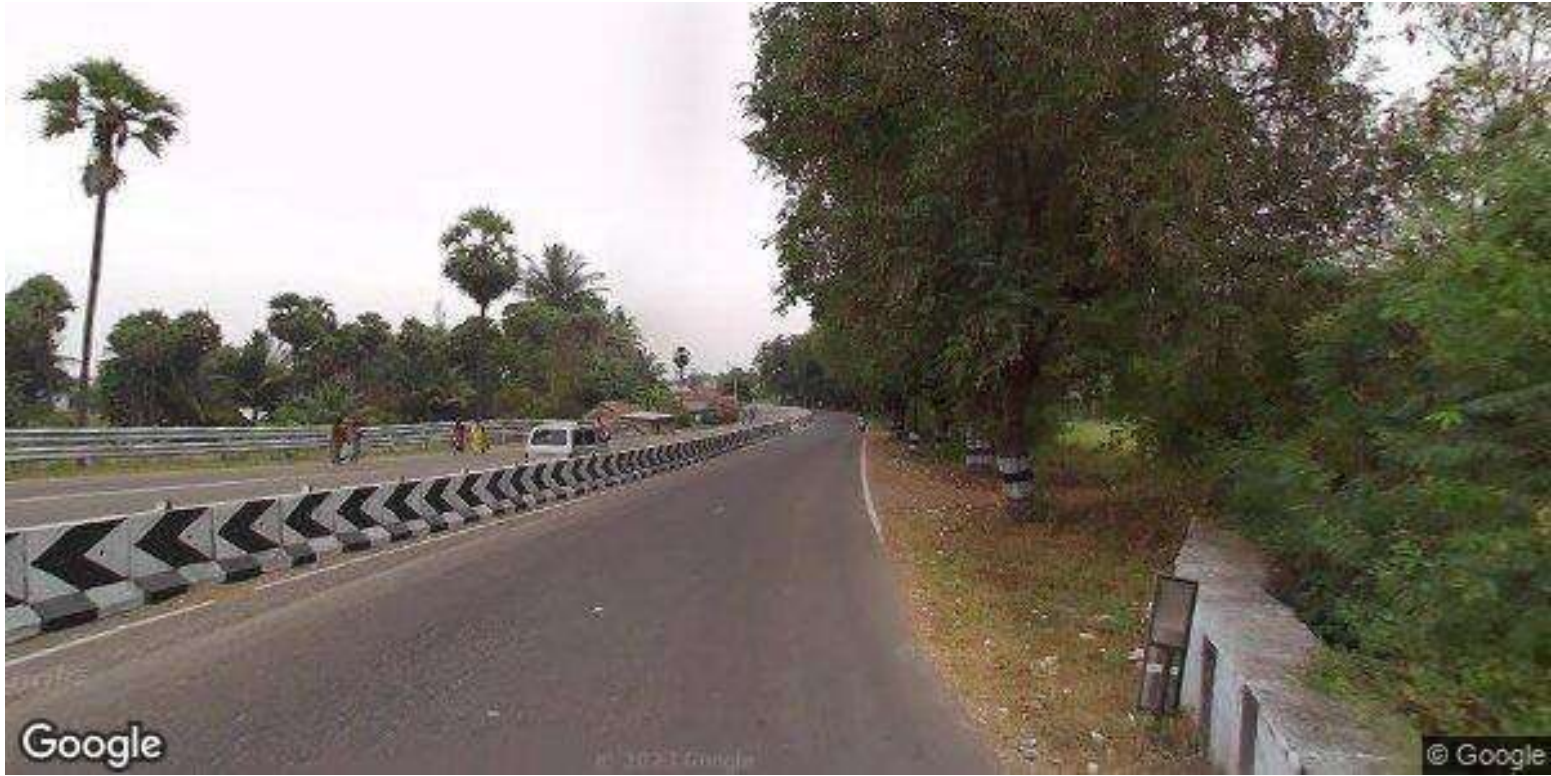
**Risk Type:** Turn  
**Risk Level:** Medium  
**Speed Limit:** 30 KM/Hr  
**Coordinates:** 11.08296, 77.65857

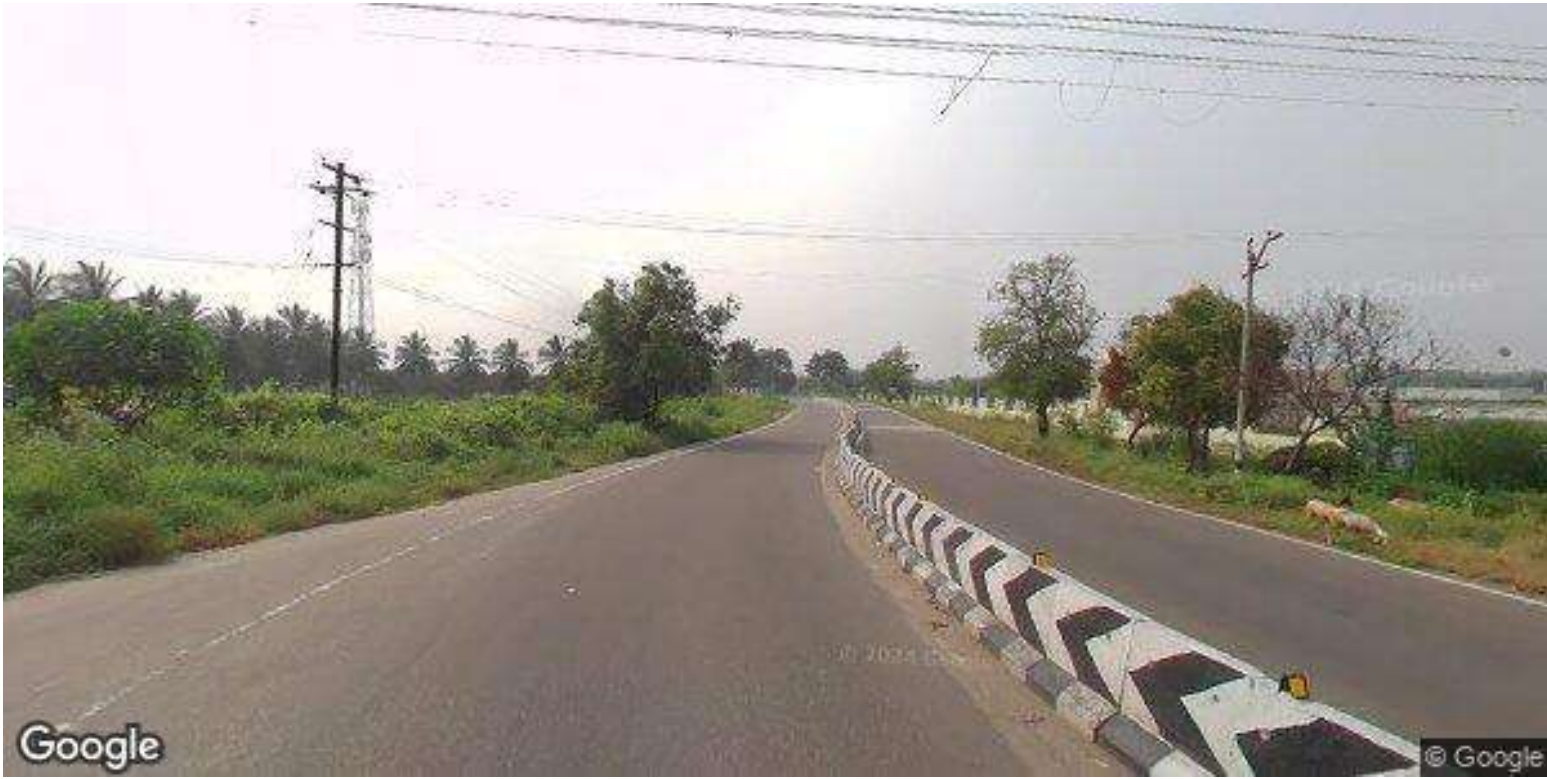
**Risk Type:** Turn  
**Risk Level:** Medium  
**Speed Limit:** 30 KM/Hr  
**Coordinates:** 11.06183, 77.63924

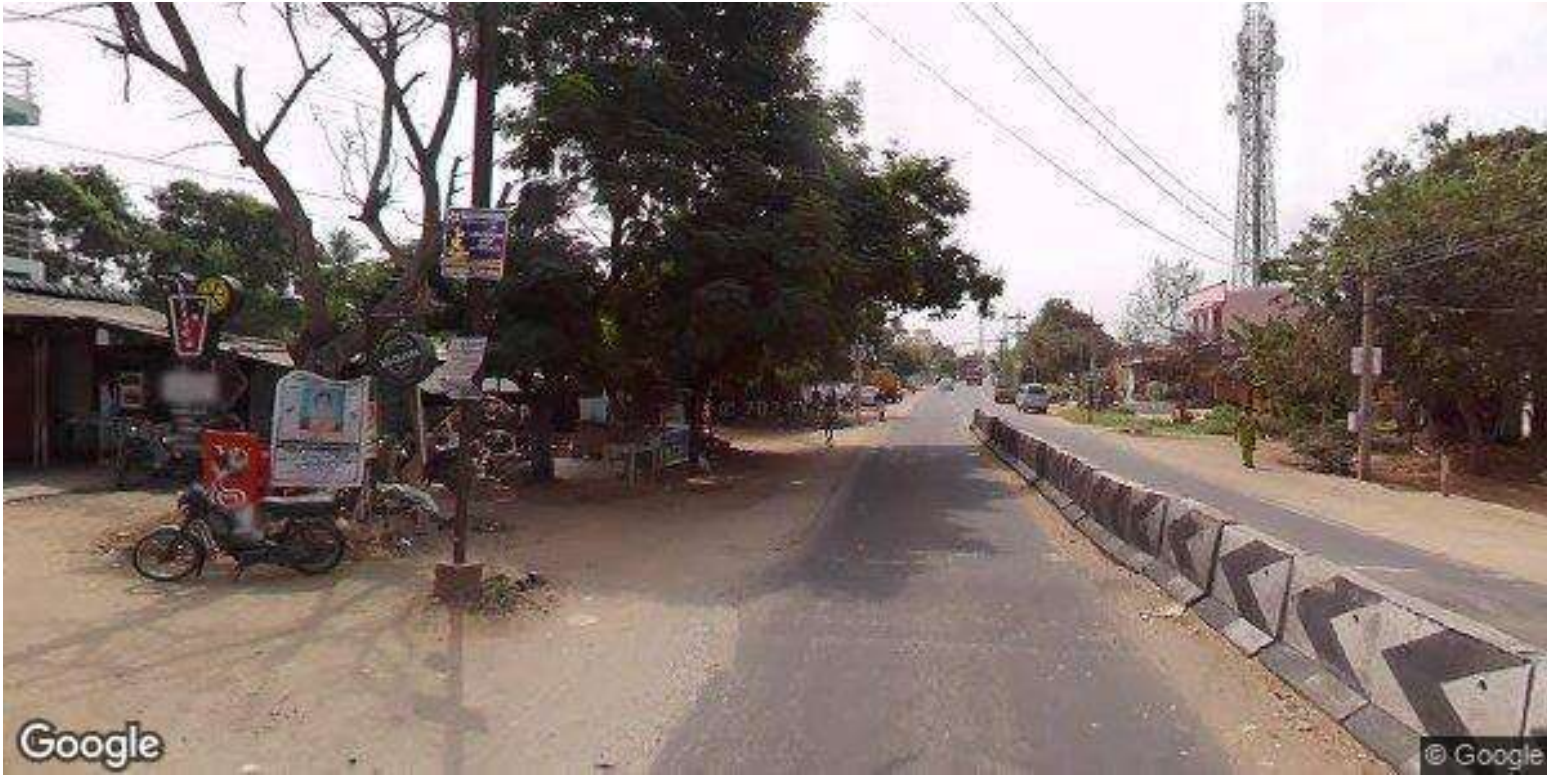
**Risk Type:** Turn  
**Risk Level:** High  
**Speed Limit:** 15 KM/Hr  
**Coordinates:** 11.00826, 77.56962

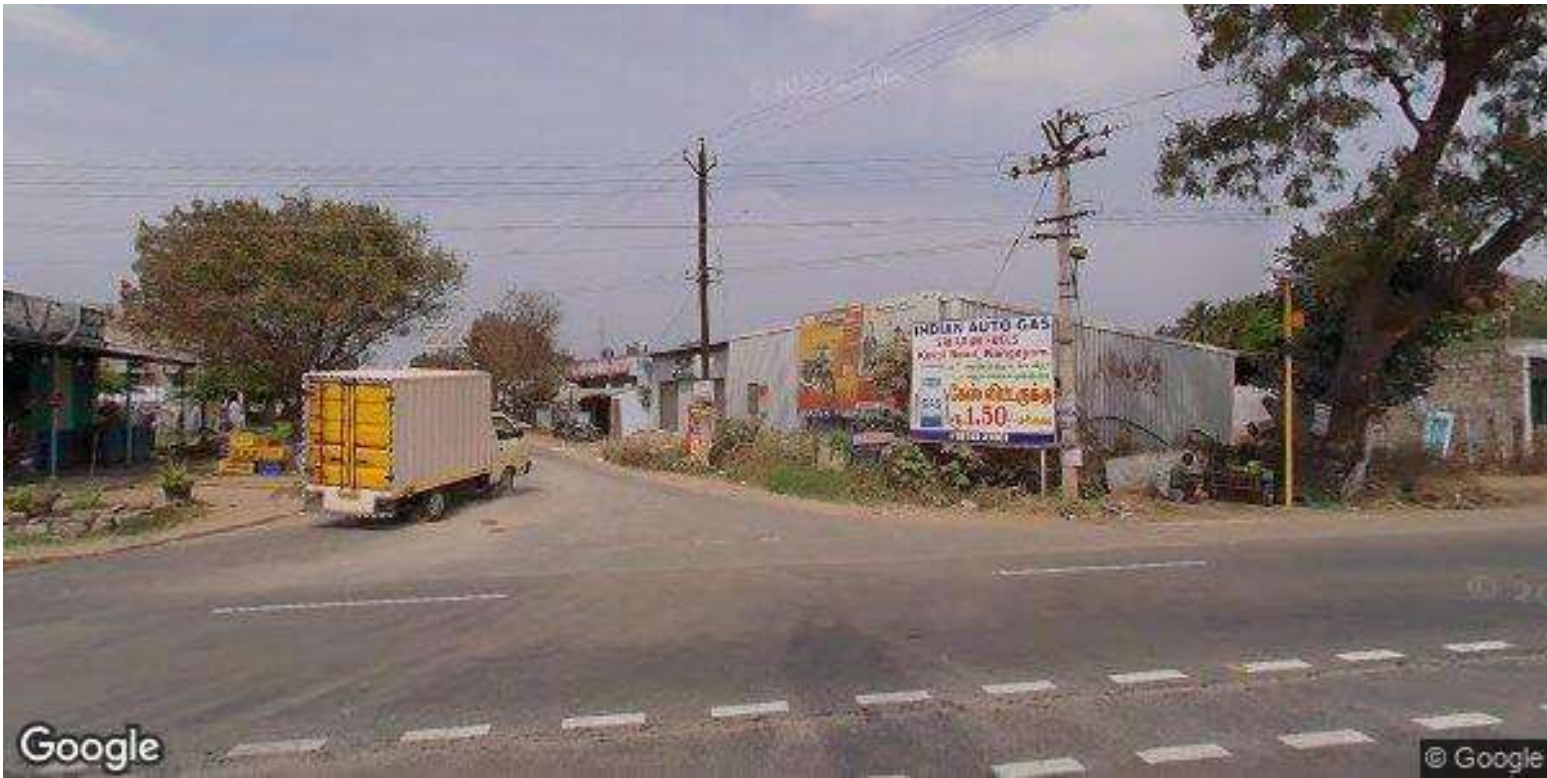
**Risk Type:** Blind Spot  
**Risk Level:** Blind Spot  
**Speed Limit:** 10 KM/Hr  
**Coordinates:** 11.00058, 77.56882

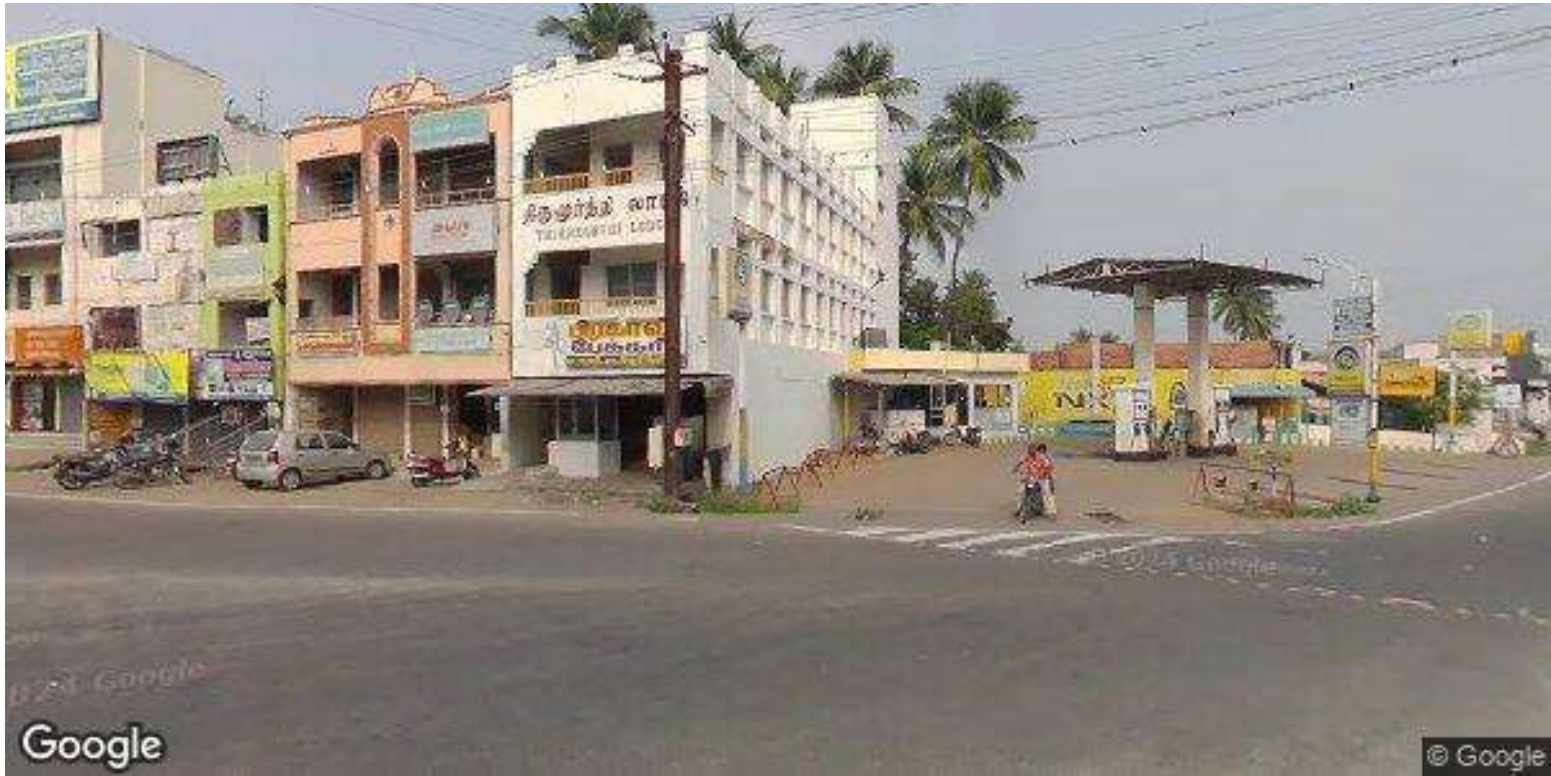
**Risk Type:** Turn  
**Risk Level:** High  
**Speed Limit:** 15 KM/Hr  
**Coordinates:** 11.00172, 77.56268
