# IndianOil

## JOURNEY RISK MANAGEMENT (JRM) STUDY

### Salem Terminal TO MANITHAM PETROLEUM

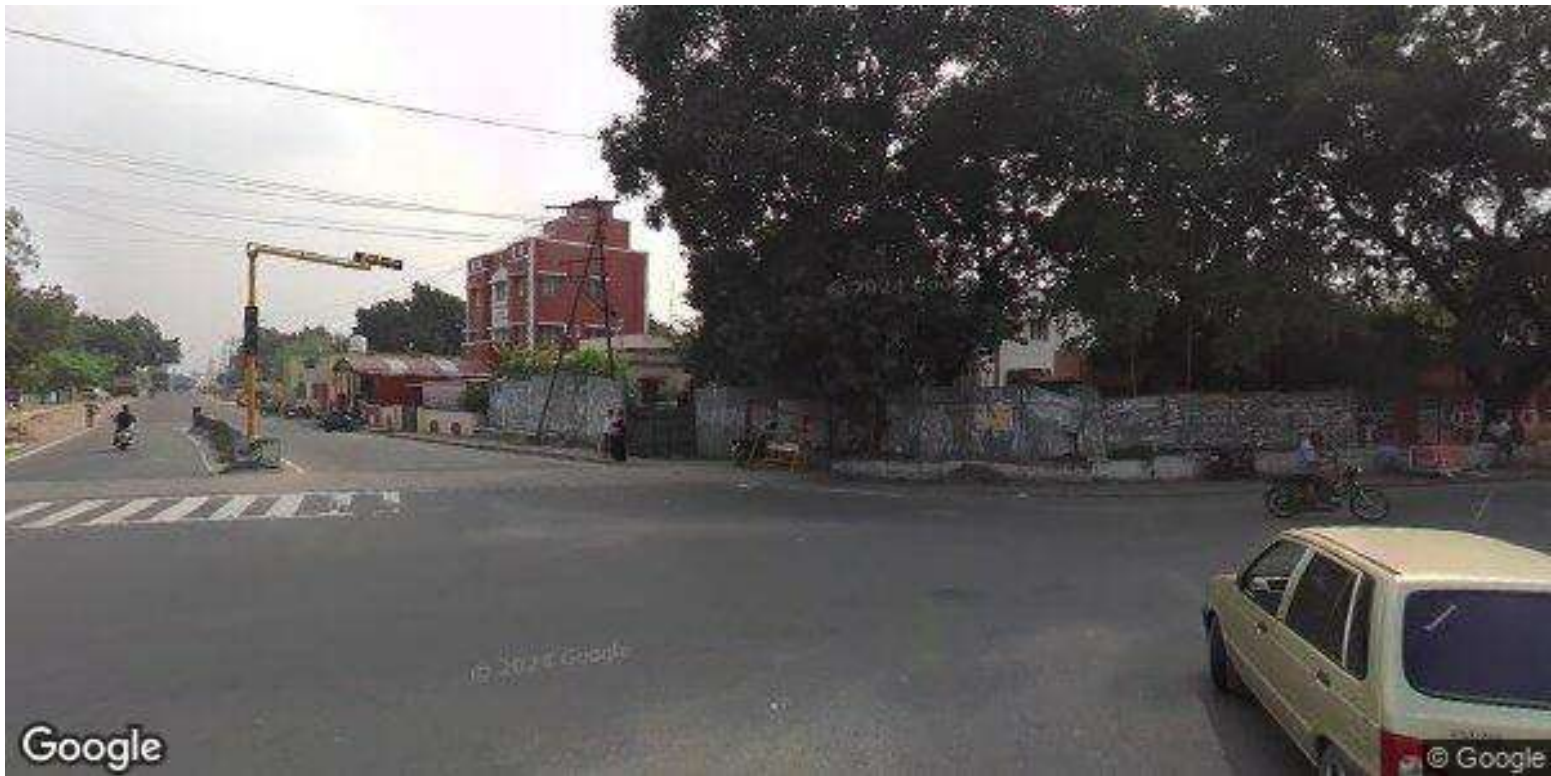
**Risk Type:** Turn  
**Risk Level:** Medium  
**Speed Limit:** 30 KM/Hr  
**Coordinates:** 11.00170, 77.56267

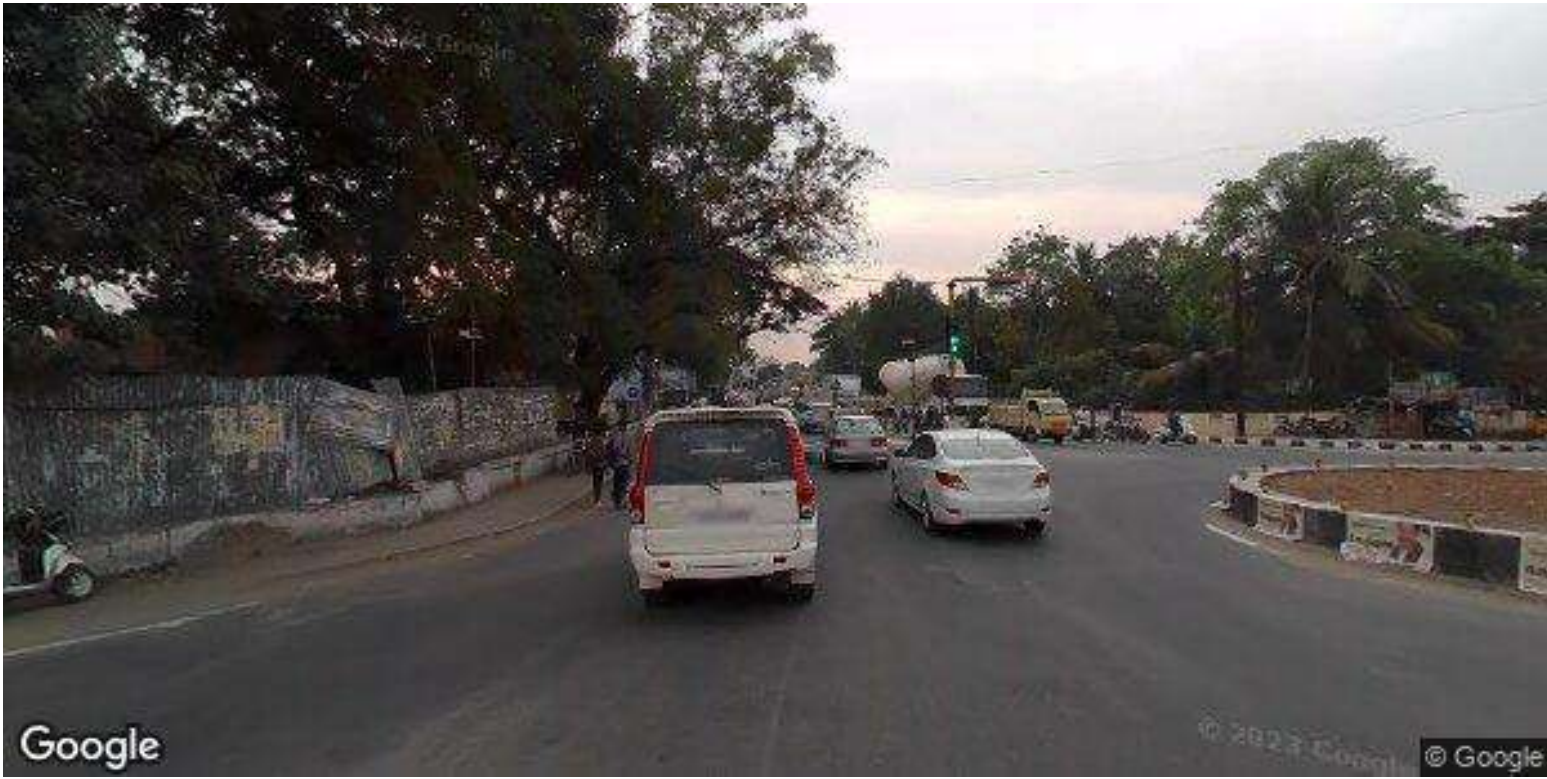
**Risk Type:** Turn  
**Risk Level:** Medium  
**Speed Limit:** 30 KM/Hr  
**Coordinates:** 11.00168, 77.56264

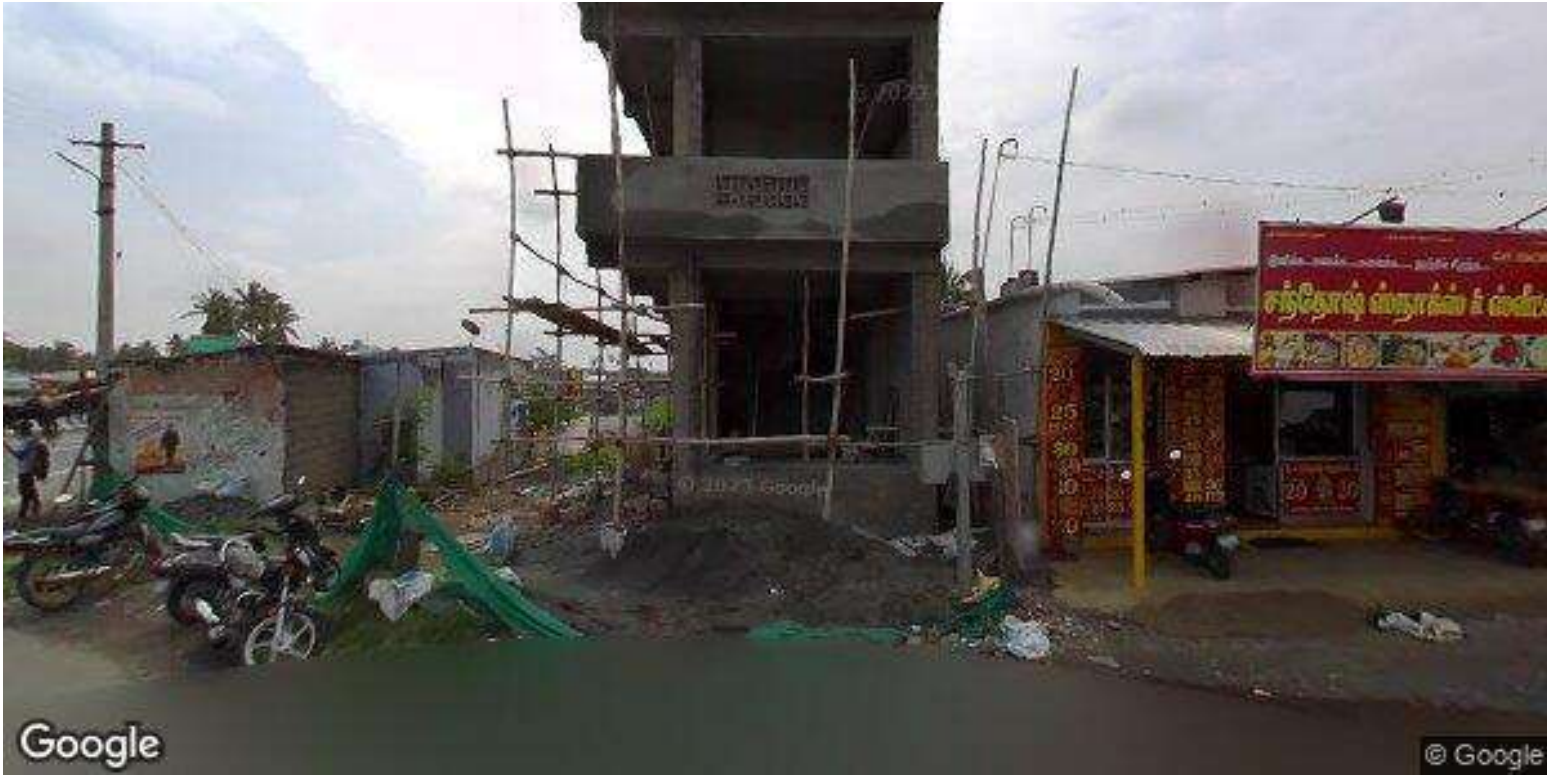
**Risk Type:** Turn  
**Risk Level:** High  
**Speed Limit:** 15 KM/Hr  
**Coordinates:** 10.97018, 77.42713

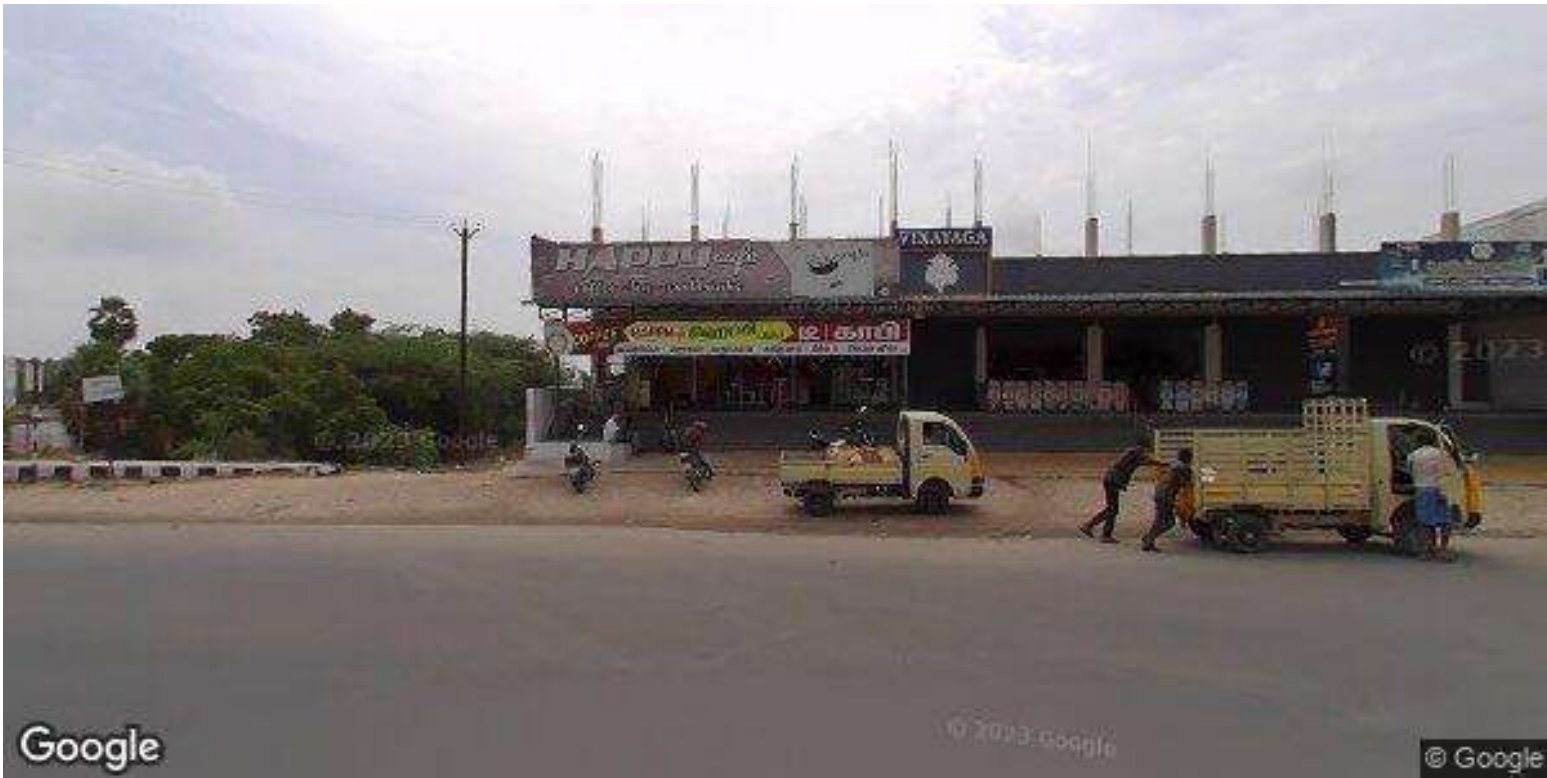
**Coordinates:** 10.96805, 77.42718

**Risk Type:** Turn

**Risk Level:** High

**Speed Limit:** 15 KM/Hr
