# IndianOil

## JOURNEY RISK MANAGEMENT (JRM) STUDY

### Salem Terminal TO PONNI SERVICE STATION UNIT II

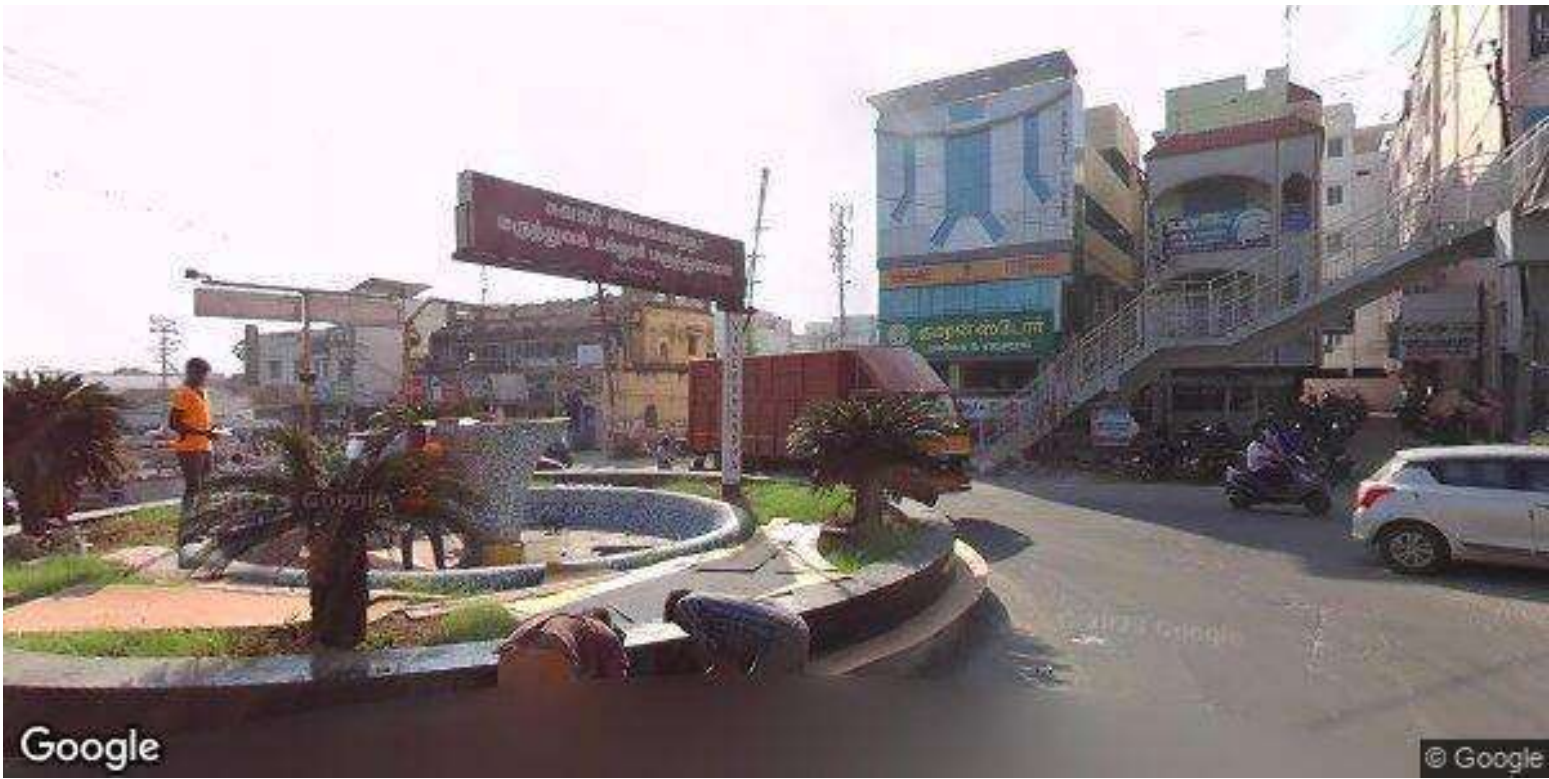
Coordinates: 11.38395, 77.89480

Risk Type: Roundabout

Risk Level: High

Speed Limit: 15 KM/Hr

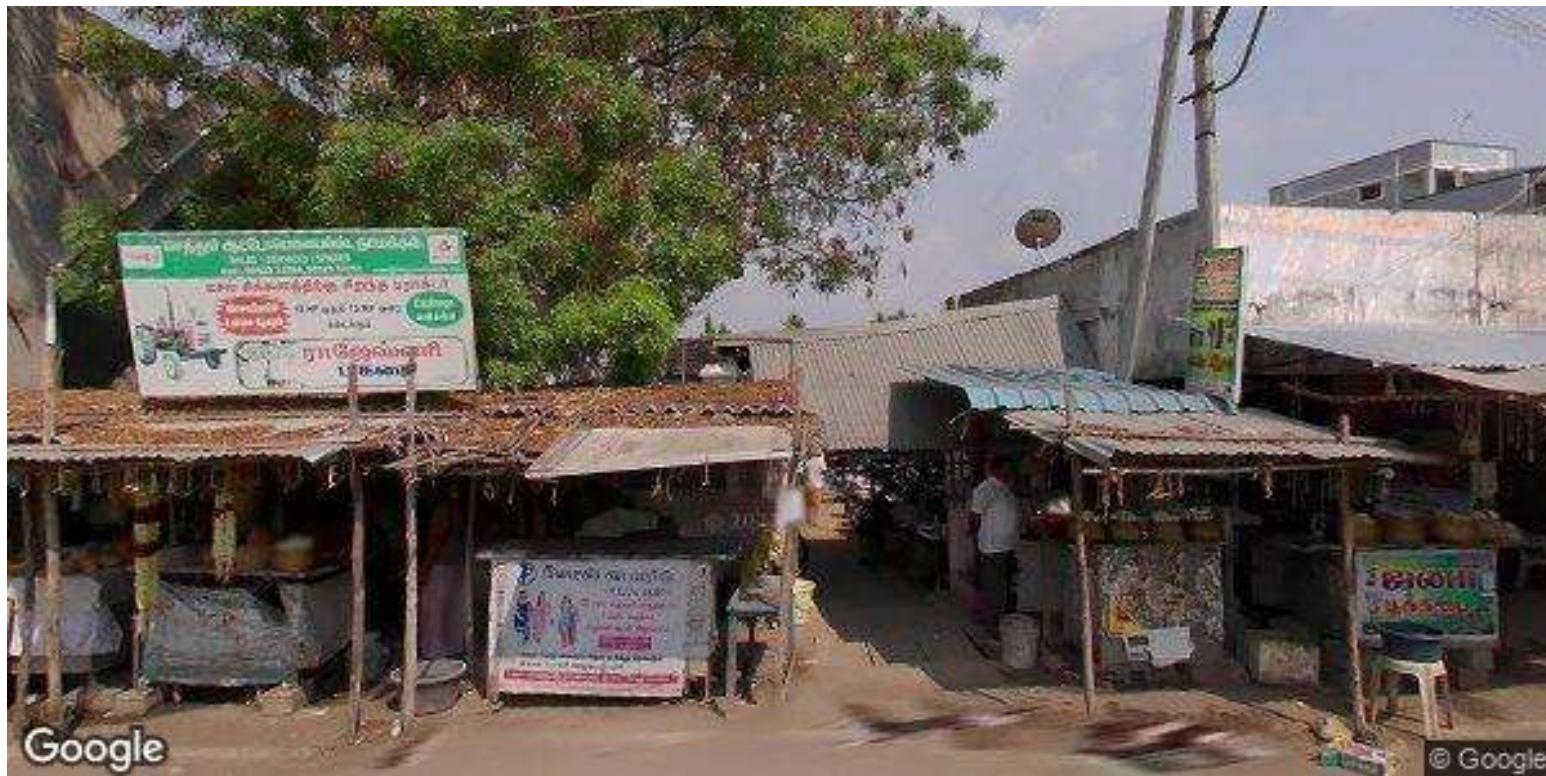
Coordinates: 11.15573, 78.02176

| | Risk Type | Risk Level | Coordinates | Speed Limit |
|---|---|---|---|---|
| 7 | Blind Spot | Blind Spot | 11.15573, 78.02176 | 10 KM/Hr |

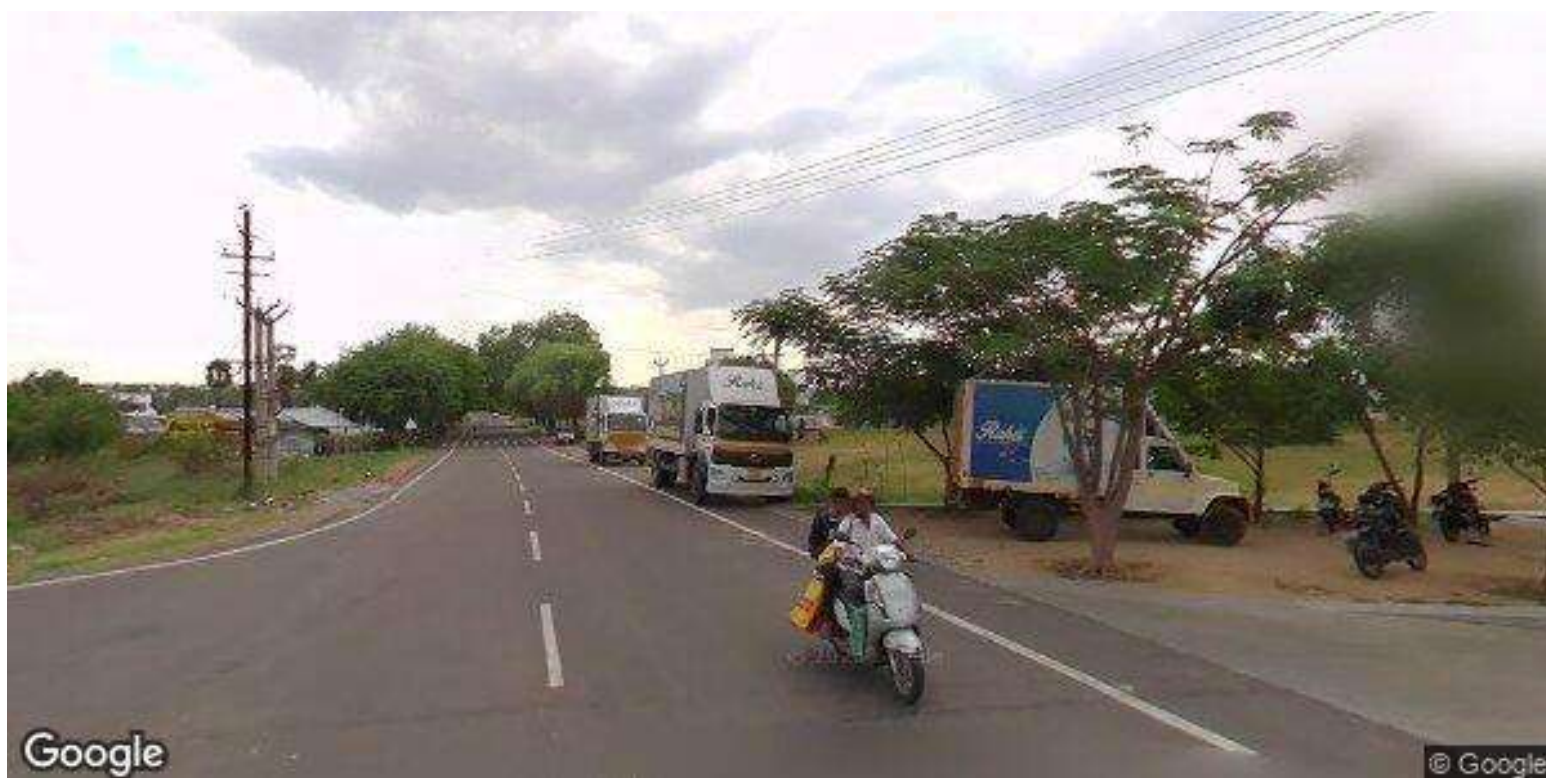
Coordinates: 11.16243, 78.02715

| | Risk Type | Risk Level | Coordinates | Speed Limit |
|---|---|---|---|---|
| 8 | Turn | Medium | 11.16243, 78.02715 | 30 KM/Hr |

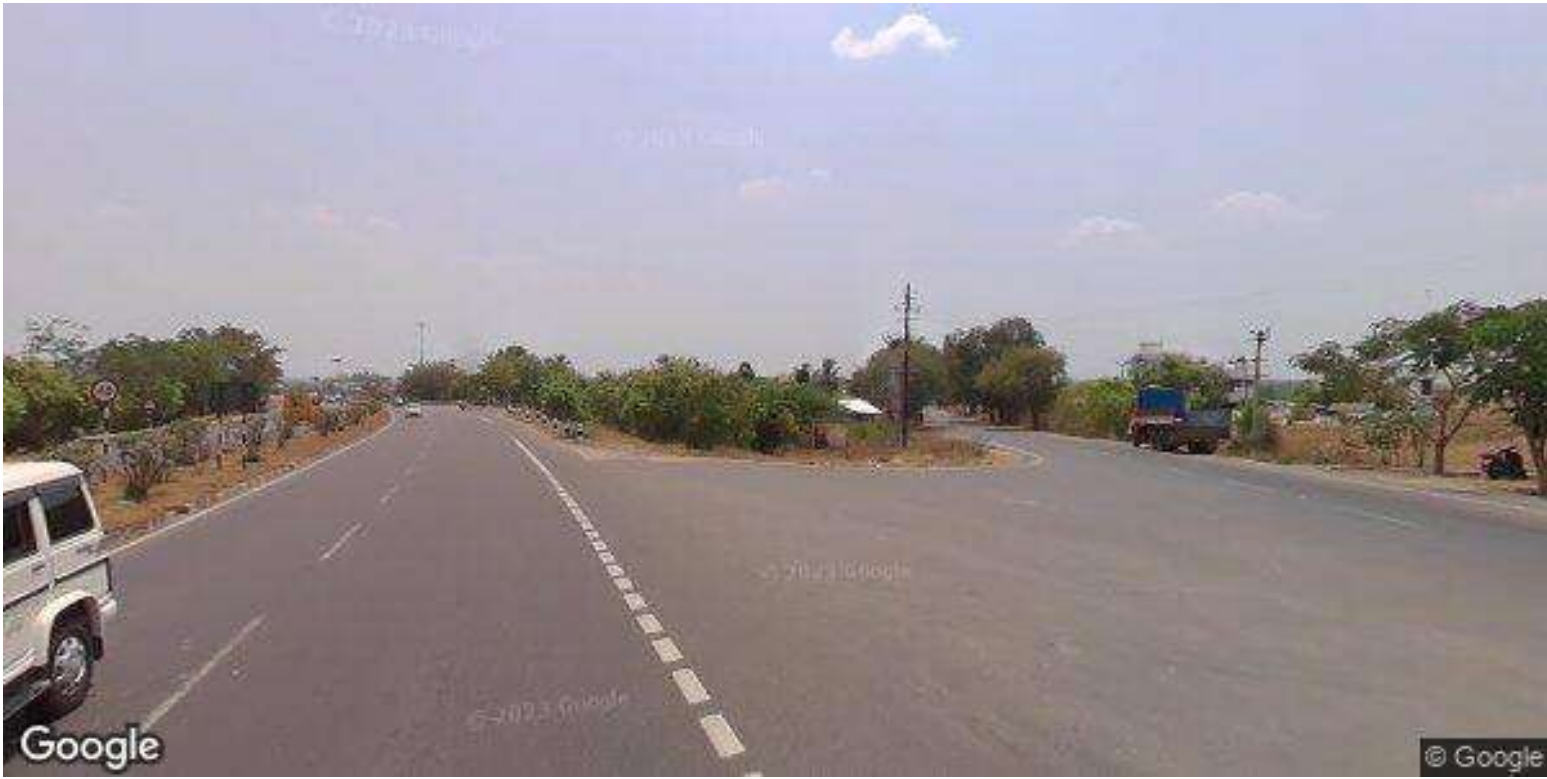
**Coordinates:** 11.16241, 78.02729

**Risk Type:** Turn

**Risk Level:** High

**Speed Limit:** 15 KM/Hr
