# IndianOil

## JOURNEY RISK MANAGEMENT (JRM) STUDY

### Salem Terminal to ADVG AGENCIES

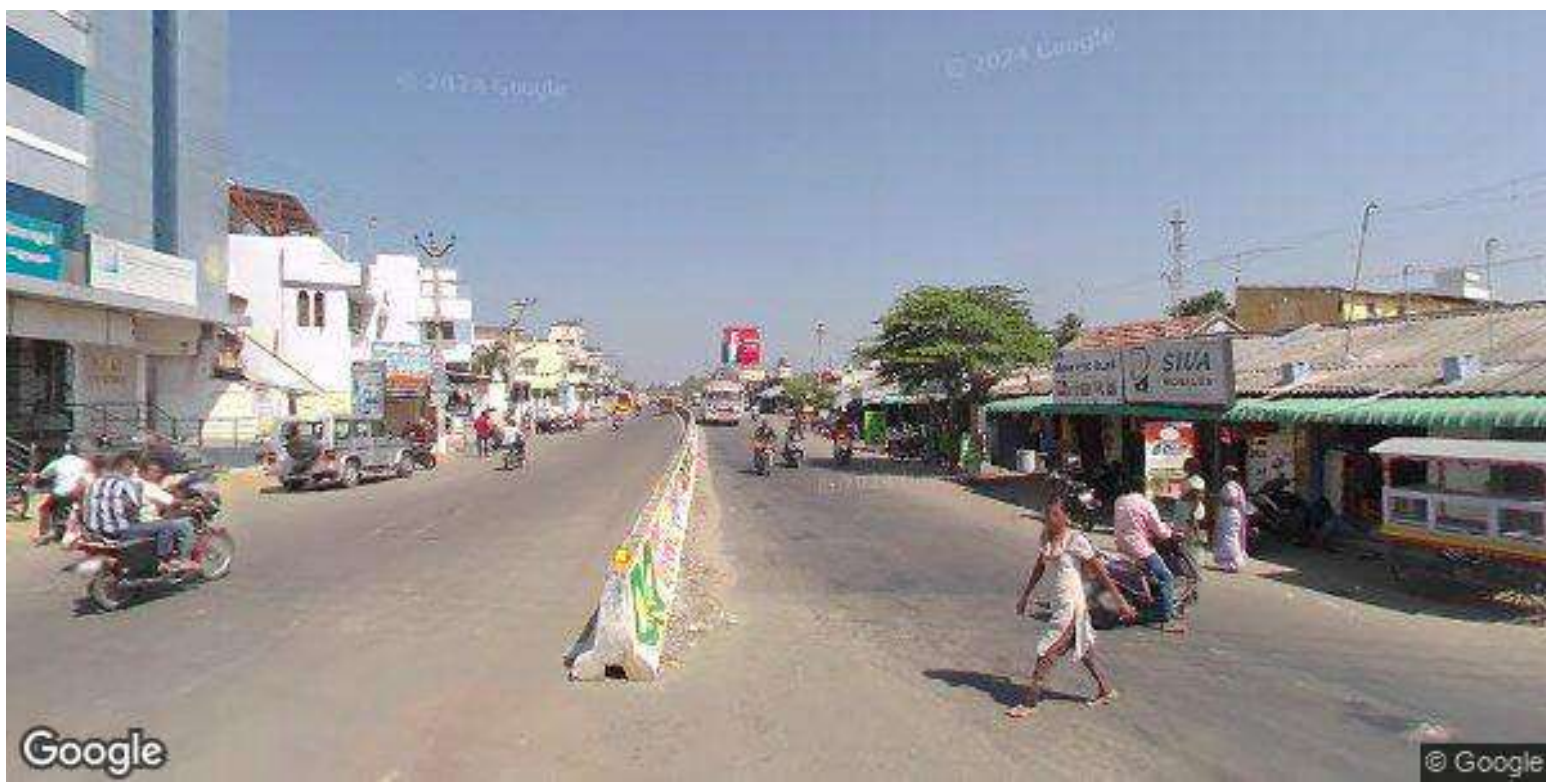
**Coordinates:** 11.37086, 77.74828

**Risk Type:** Roundabout

**Risk Level:** High

**Speed Limit:** 15 KM/Hr

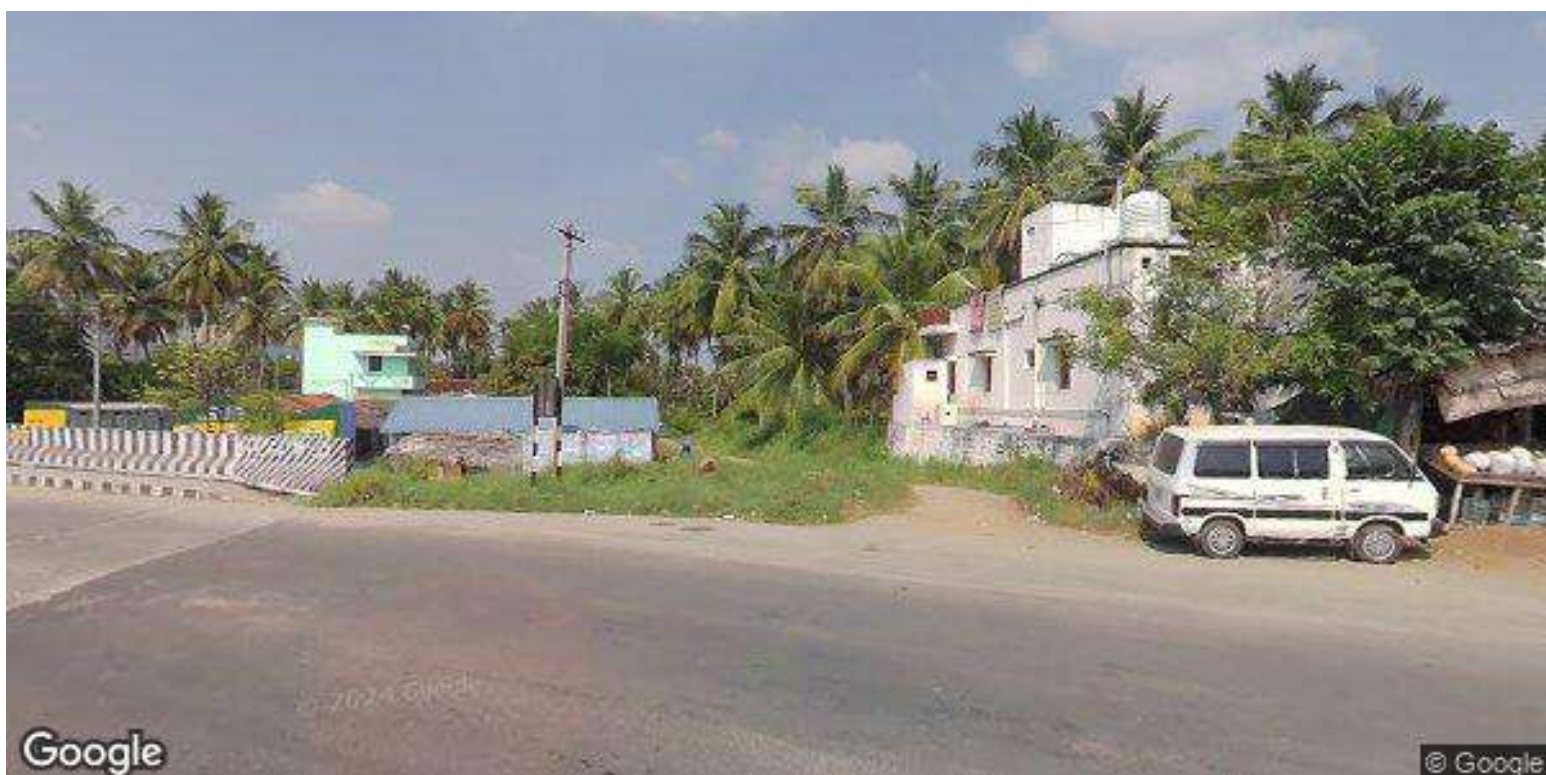
**Risk Type:** Turn  
**Risk Level:** Medium  
**Speed Limit:** 30 KM/Hr  
**Coordinates:** 11.44898, 77.87410

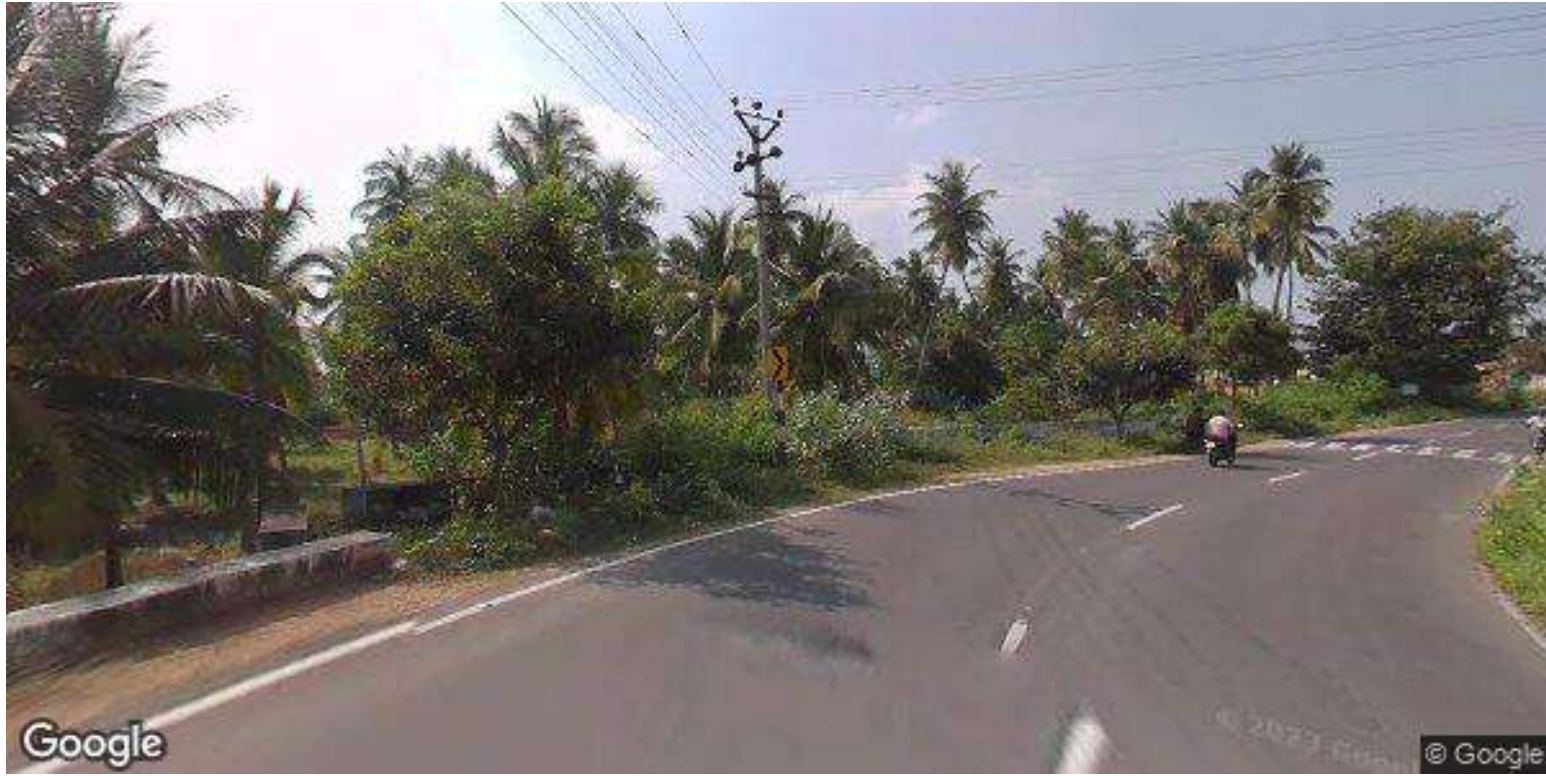
**Risk Type:** Turn  
**Risk Level:** Medium  
**Speed Limit:** 30 KM/Hr  
**Coordinates:** 11.45348, 77.85706

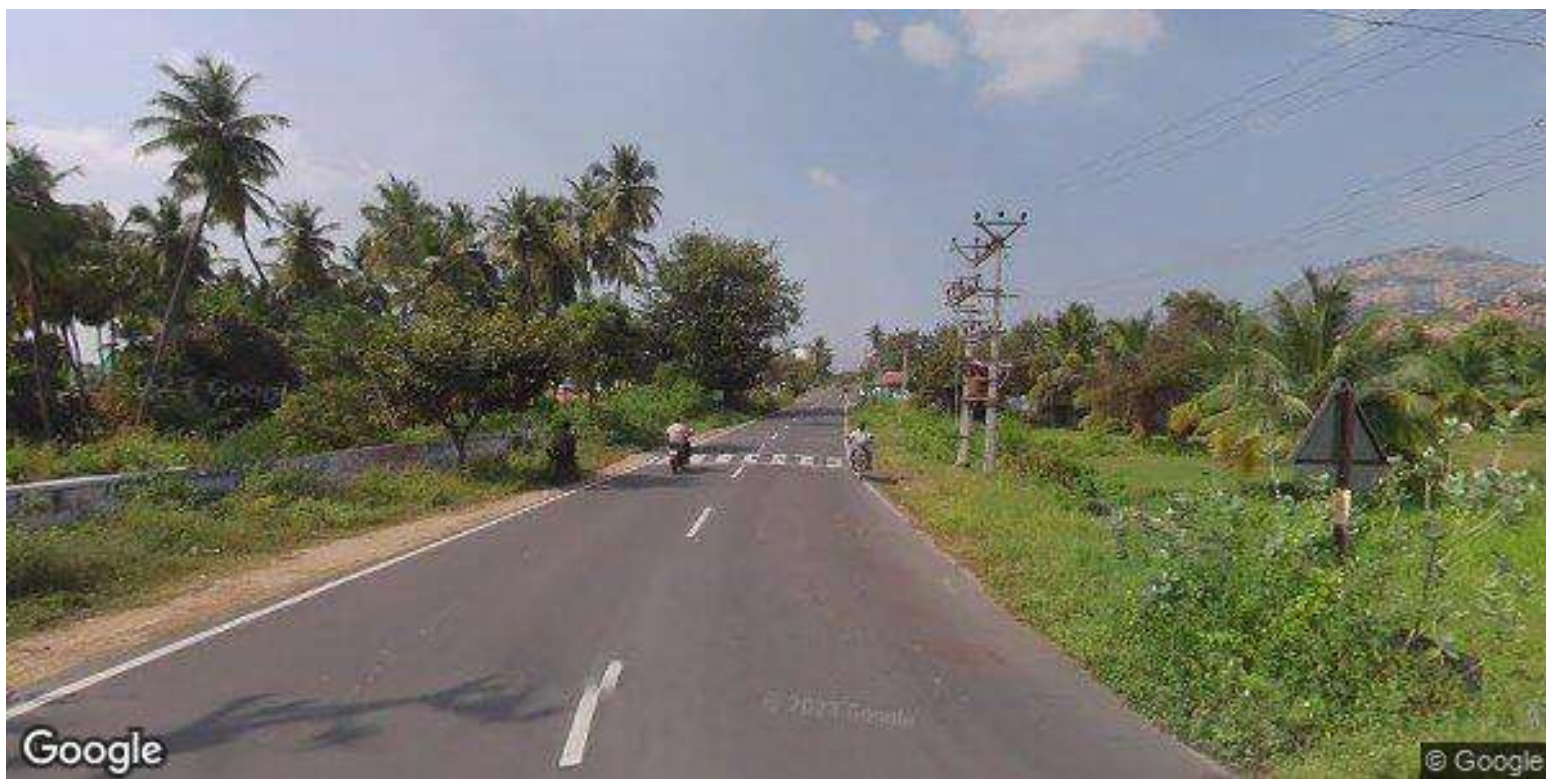
**Risk Type:** Turn  
**Risk Level:** Medium  
**Speed Limit:** 30 KM/Hr  
**Coordinates:** 11.45352, 77.85698

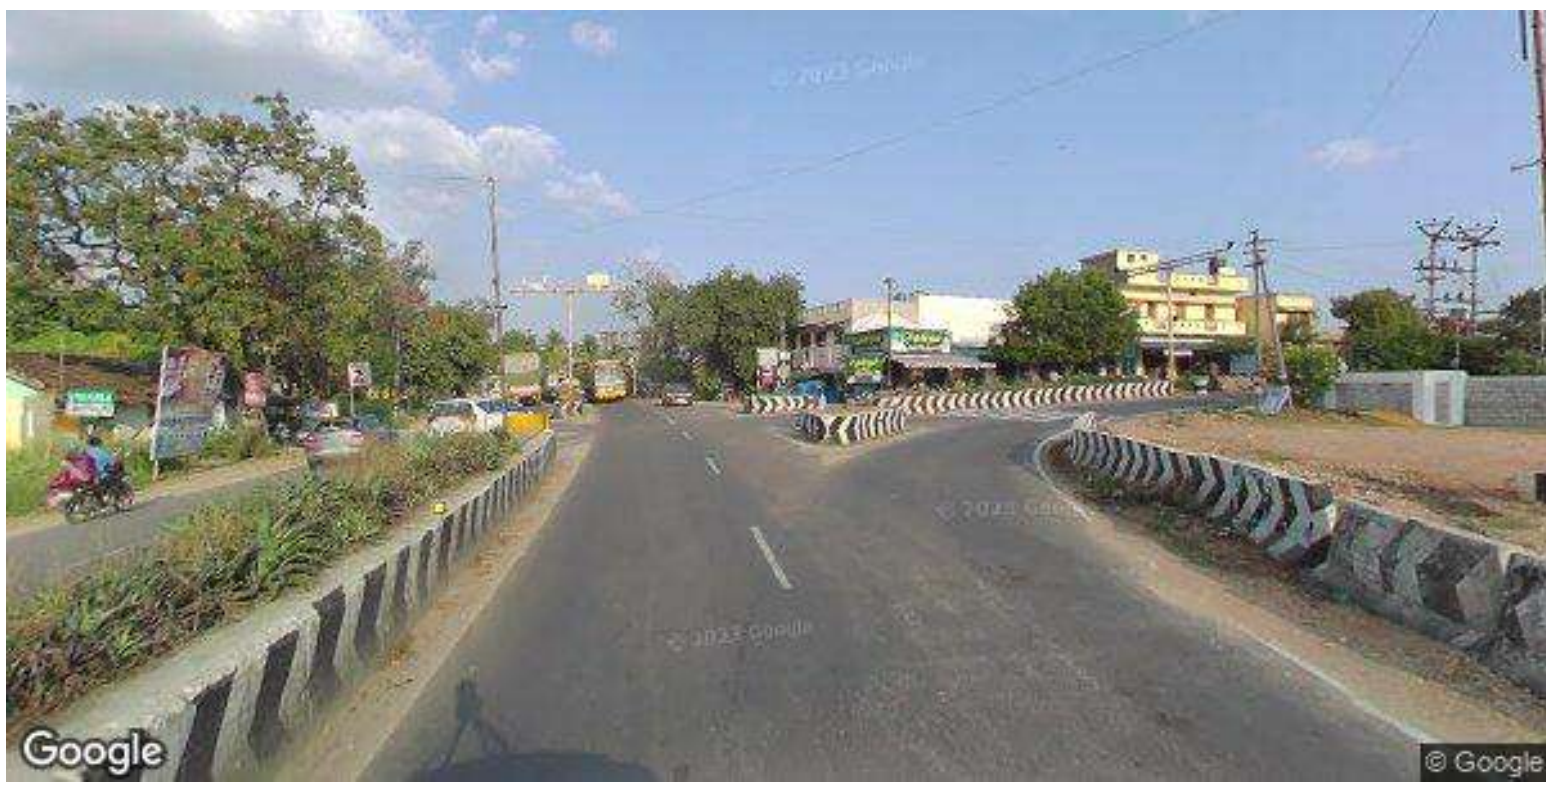
**Coordinates:** 11.46318, 77.84913

**Risk Type:** Turn

**Risk Level:** Medium

**Speed Limit:** 30 KM/Hr

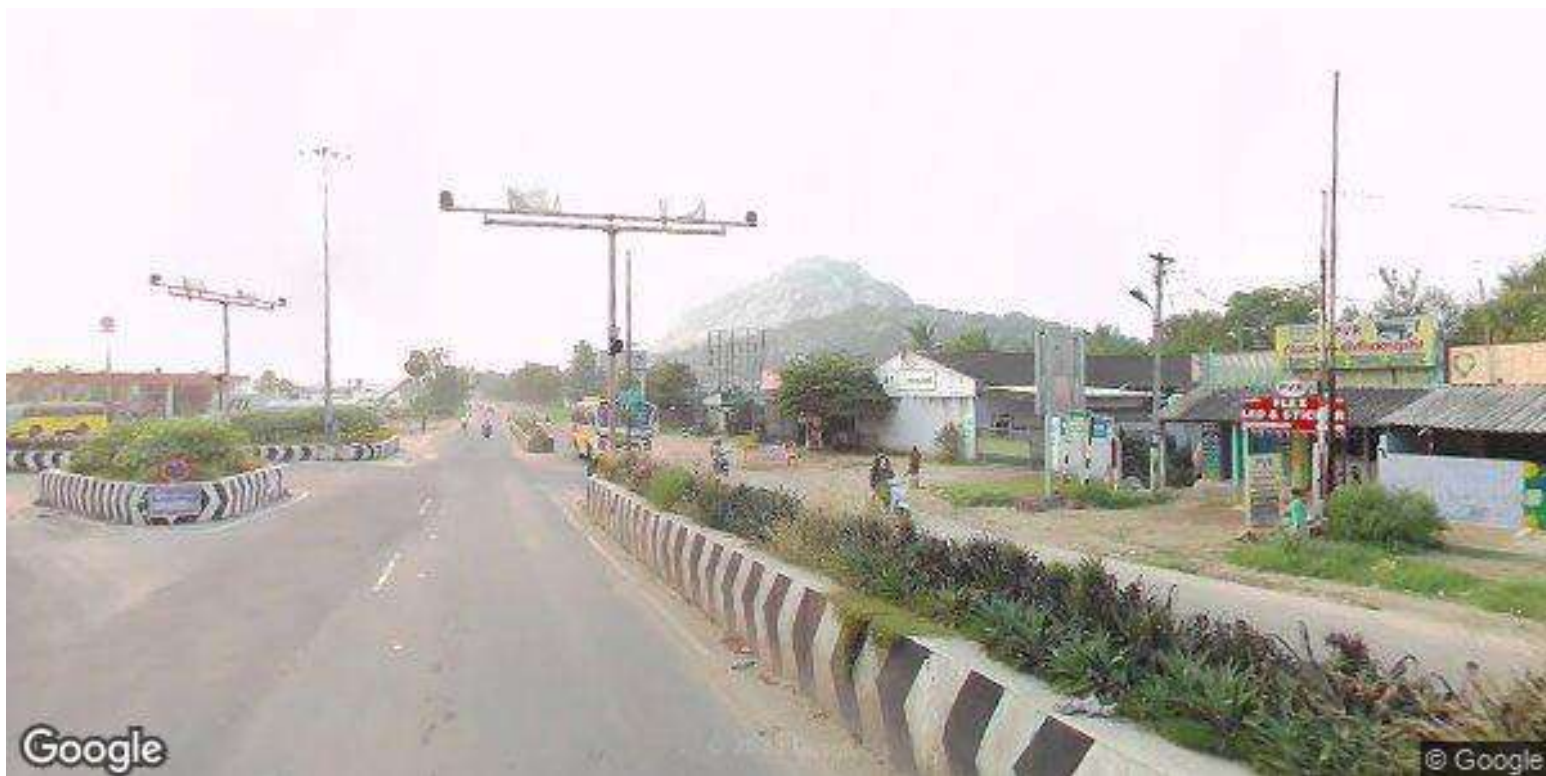
**Coordinates:** 11.46312, 77.84886

**Risk Type:** Turn

**Risk Level:** Medium

**Speed Limit:** 30 KM/Hr

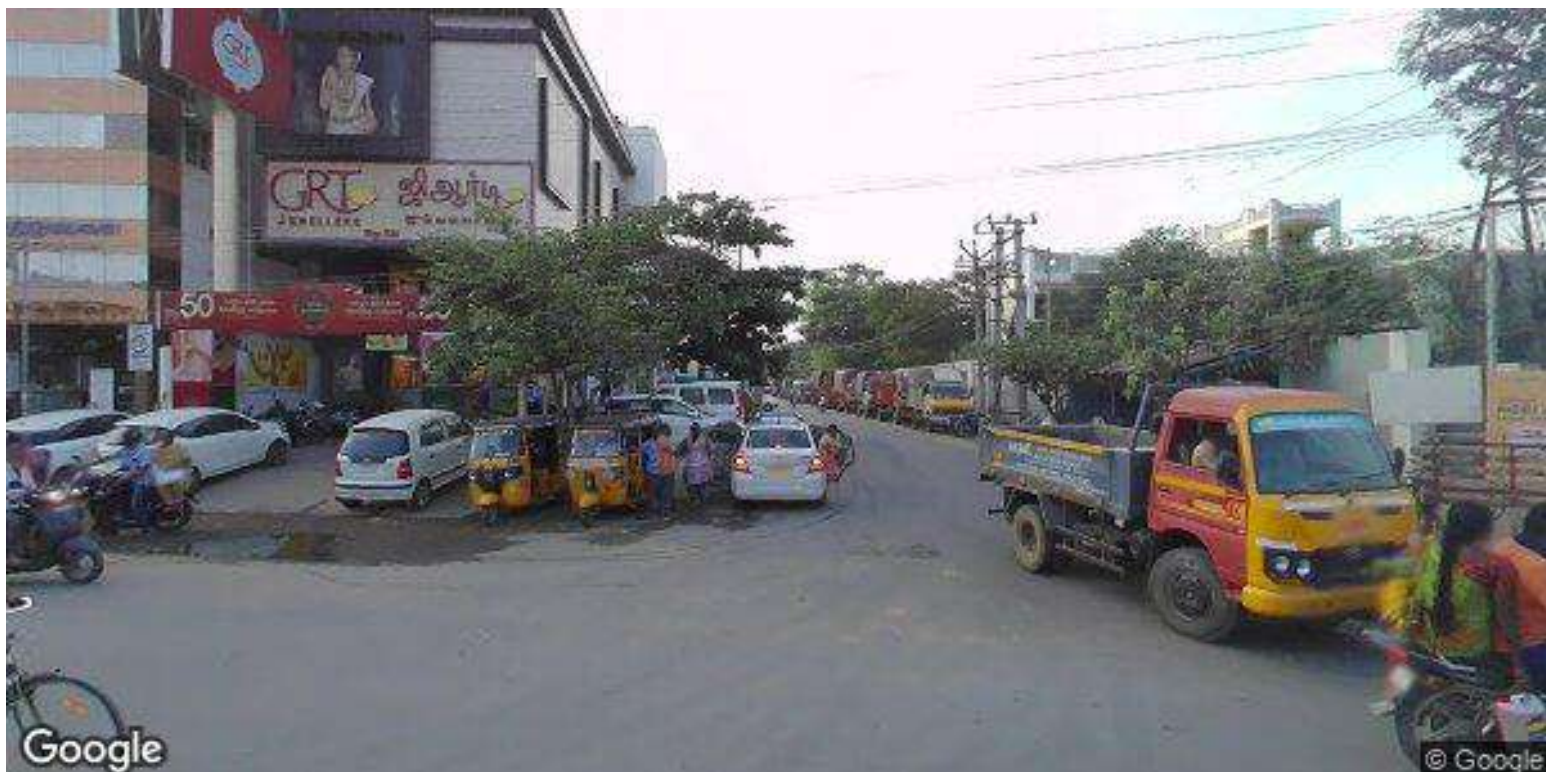
**Coordinates:** 11.34678, 77.73104

**Risk Type:** Turn

**Risk Level:** High

**Speed Limit:** 15 KM/Hr

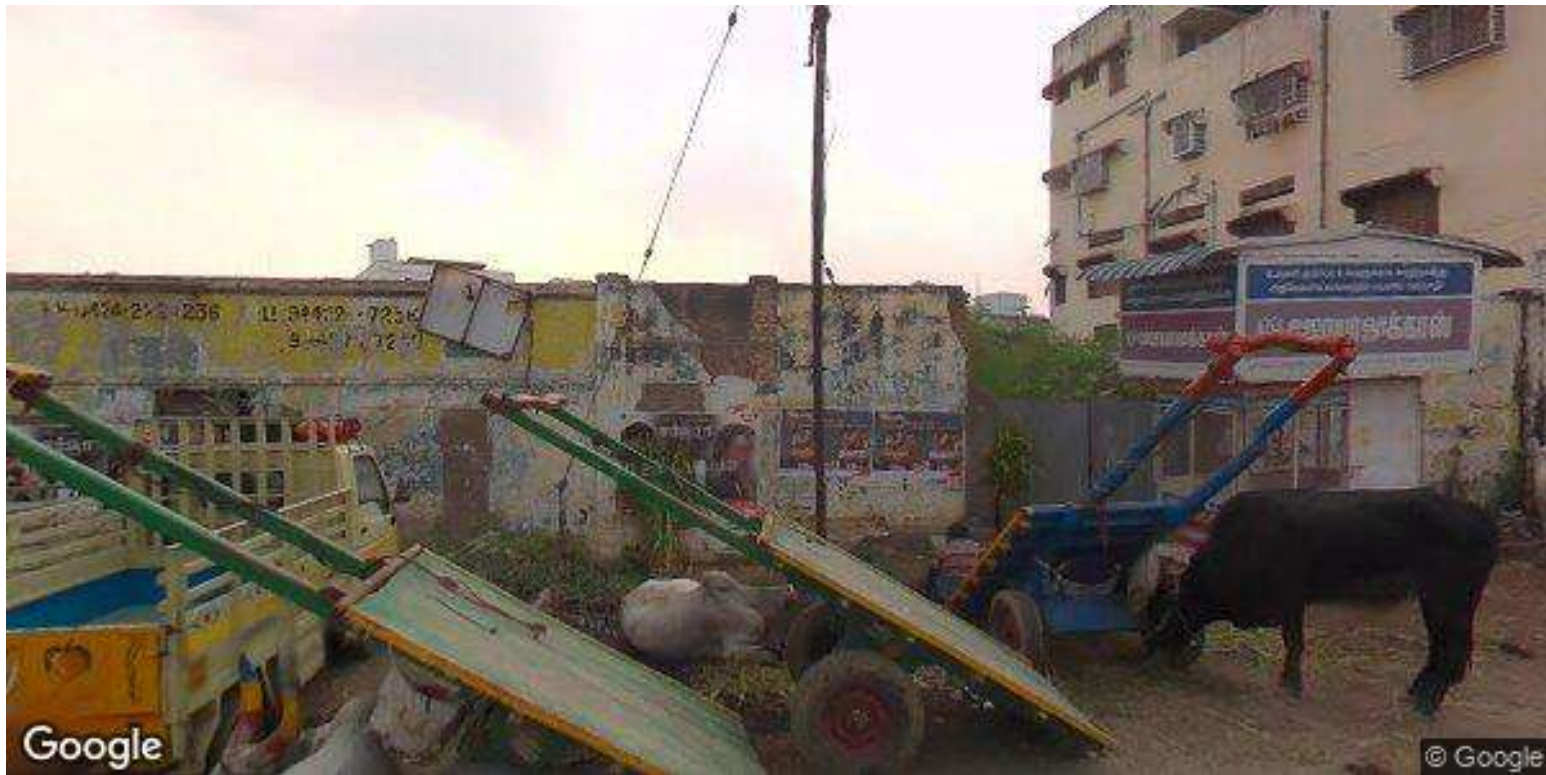
**Coordinates:** 11.34678, 77.72581

**Risk Type:** Turn

**Risk Level:** High

**Speed Limit:** 15 KM/Hr

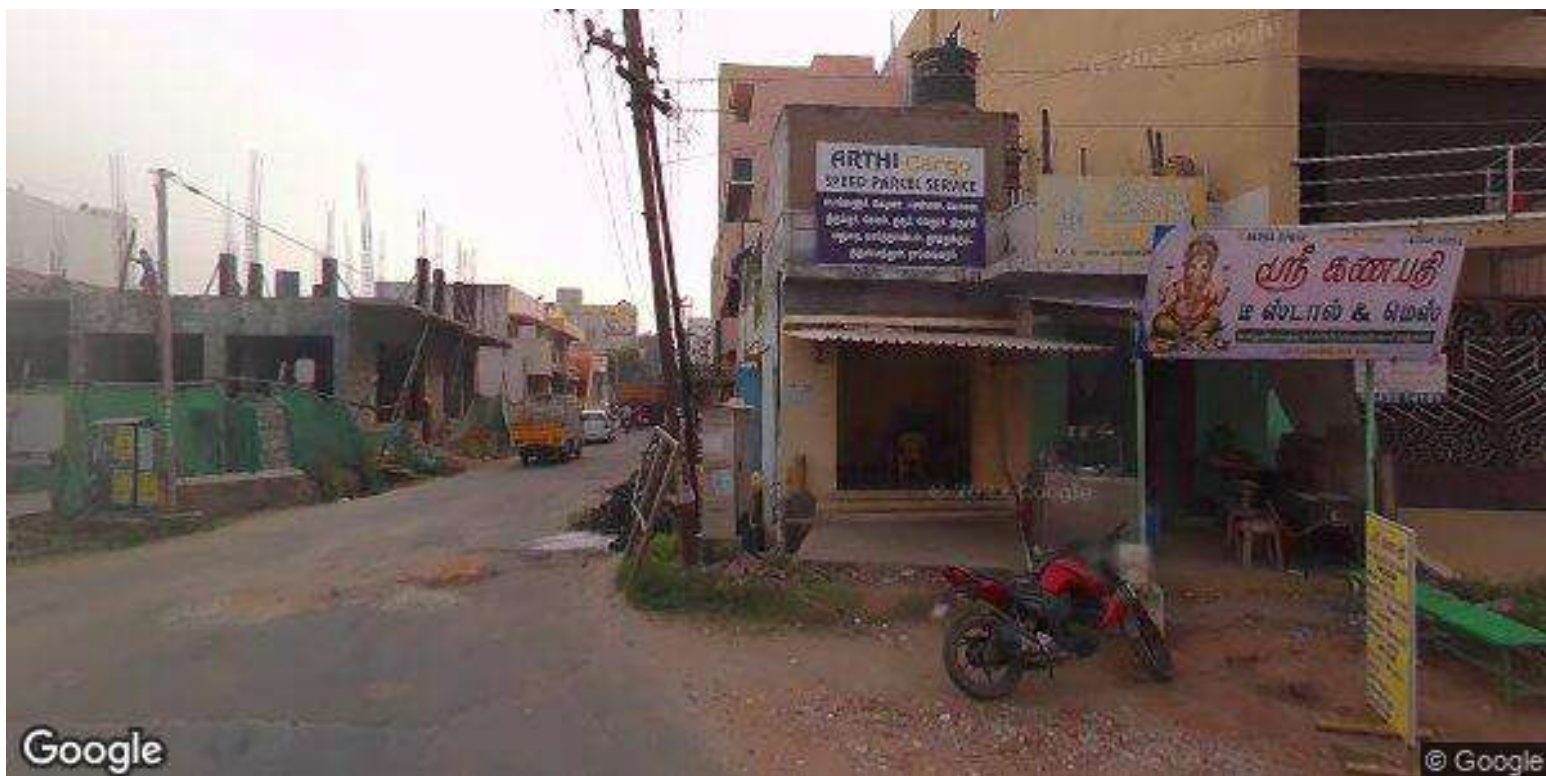
**Coordinates:** 11.34803, 77.72478

**Risk Type:** Blind Spot

**Risk Level:** Blind Spot

**Speed Limit:** 10 KM/Hr

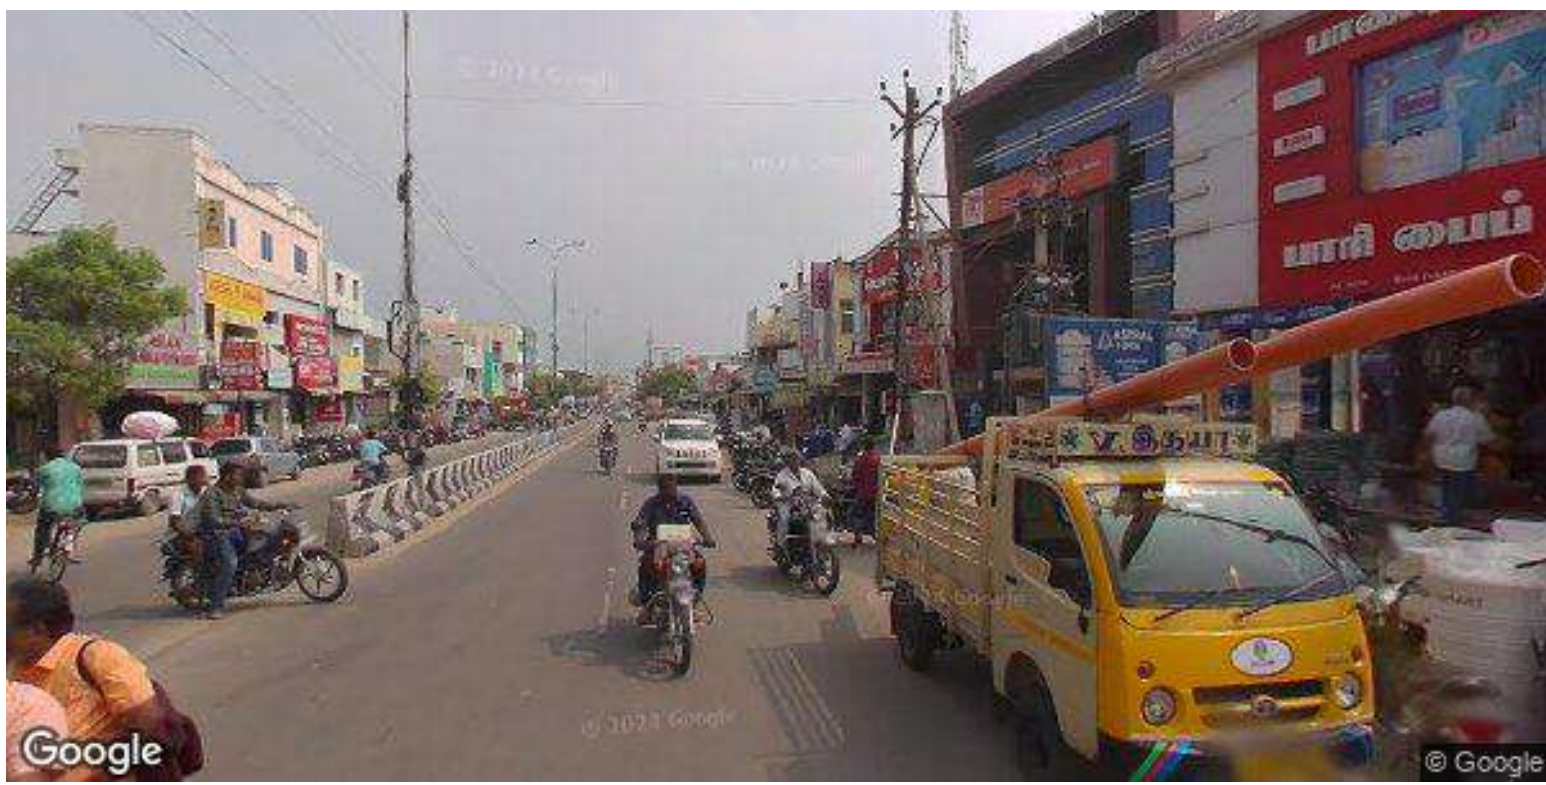
**Coordinates:** 11.34625, 77.72392

**Risk Type:** Blind Spot

**Risk Level:** Blind Spot

**Speed Limit:** 10 KM/Hr

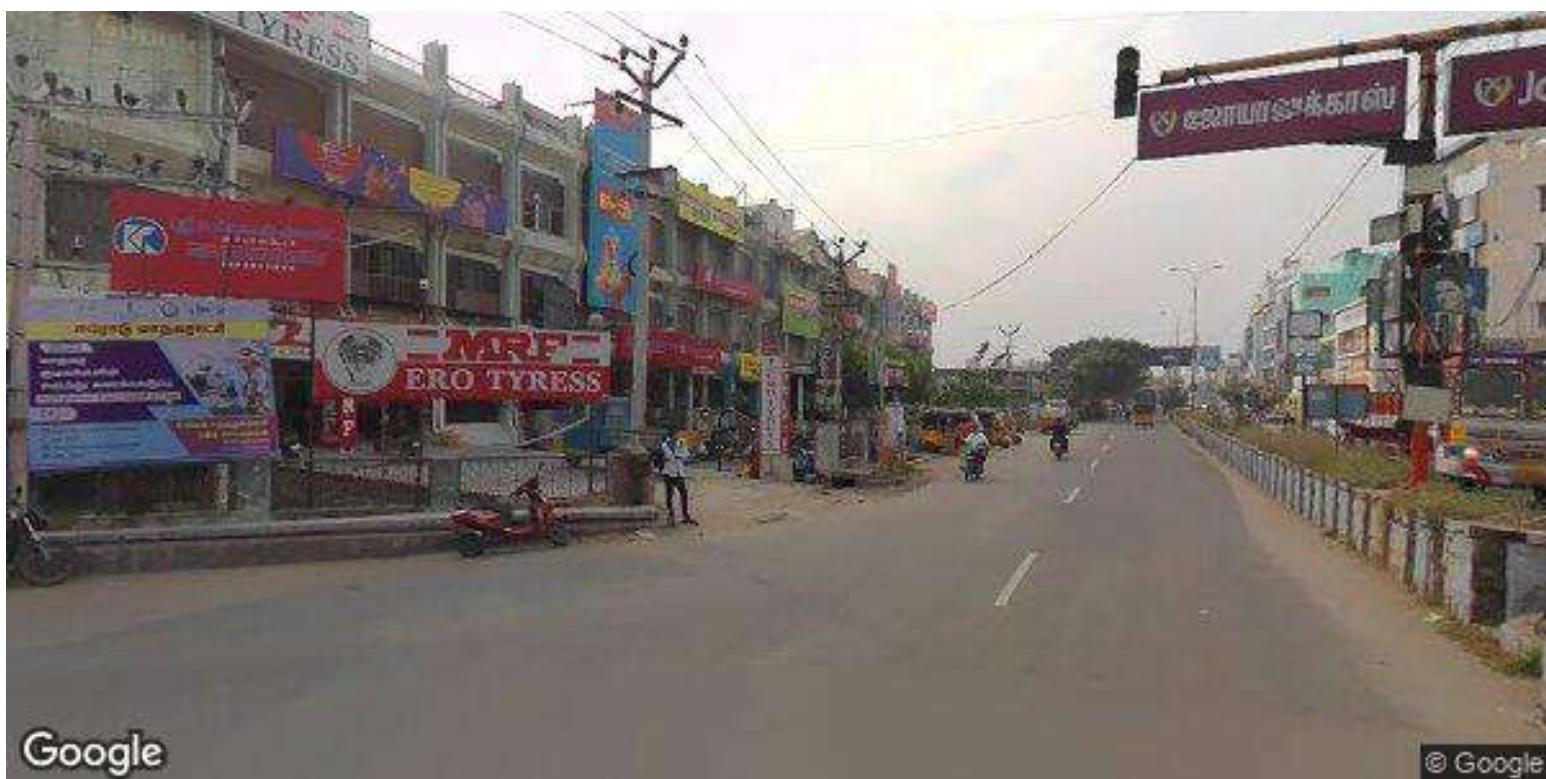
**Coordinates:** 11.34727, 77.72138

**Risk Type:** Turn

**Risk Level:** High

**Speed Limit:** 15 KM/Hr
