# IndianOil

## JOURNEY RISK MANAGEMENT (JRM) STUDY

### Salem Terminal to KAVIRAJ AGENCY

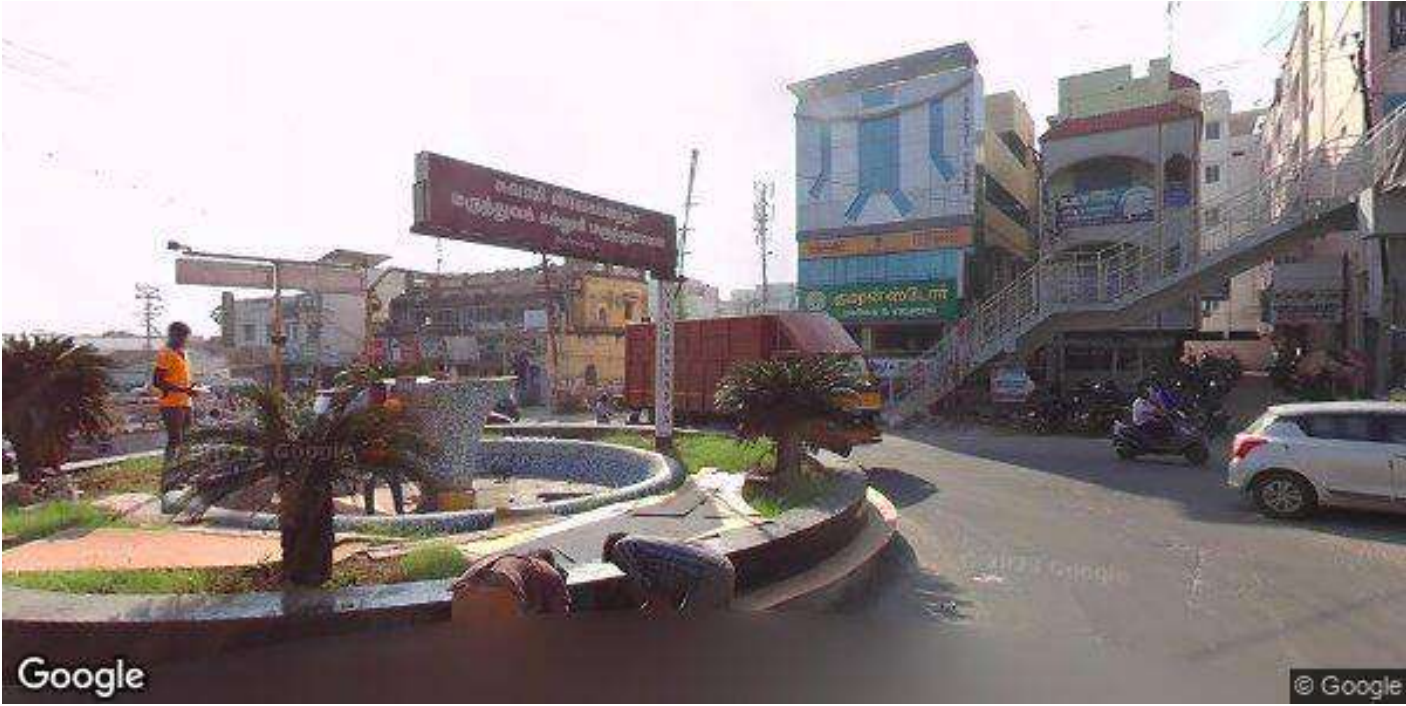
Risk Type: Roundabout

Risk Level: High

Speed Limit: 15 KM/Hr

Coordinates: 11.38395, 77.89480

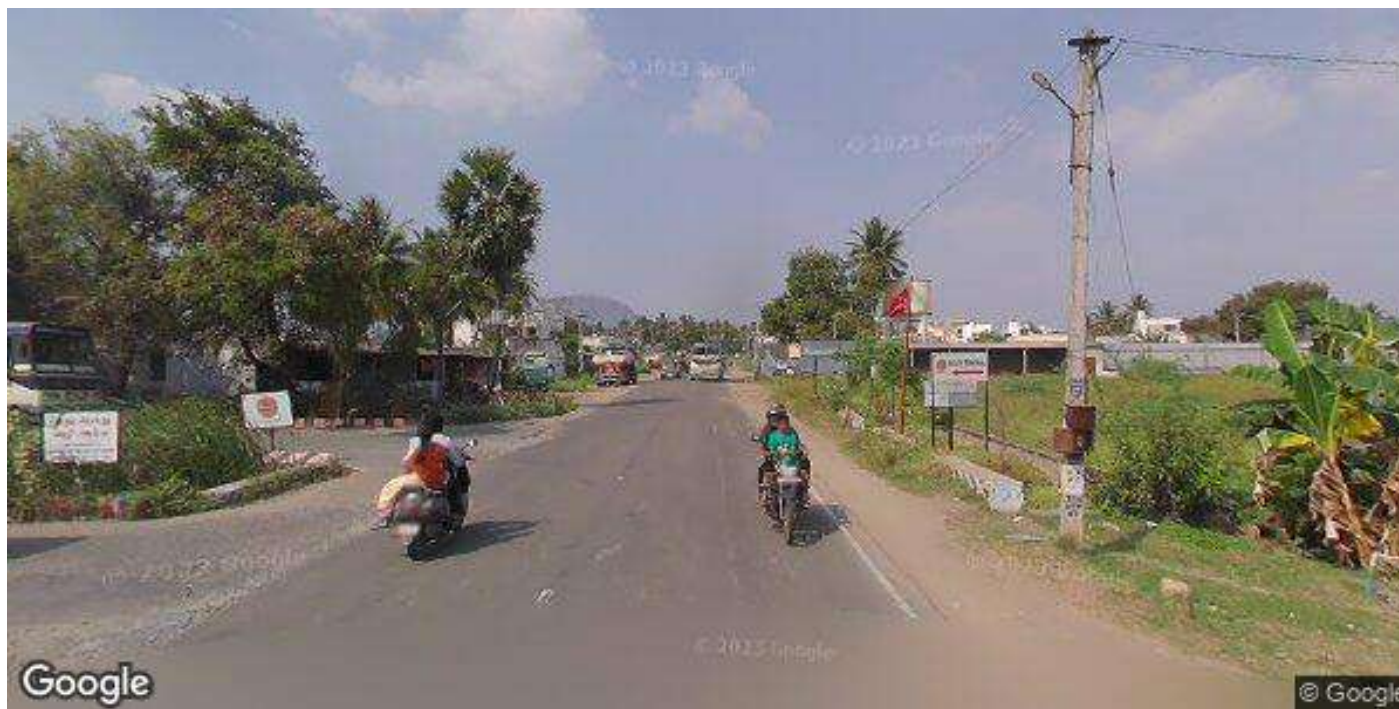
**Risk Type:** Turn  
**Risk Level:** High  
**Speed Limit:** 15 KM/Hr  
**Coordinates:** 11.44019, 77.87547

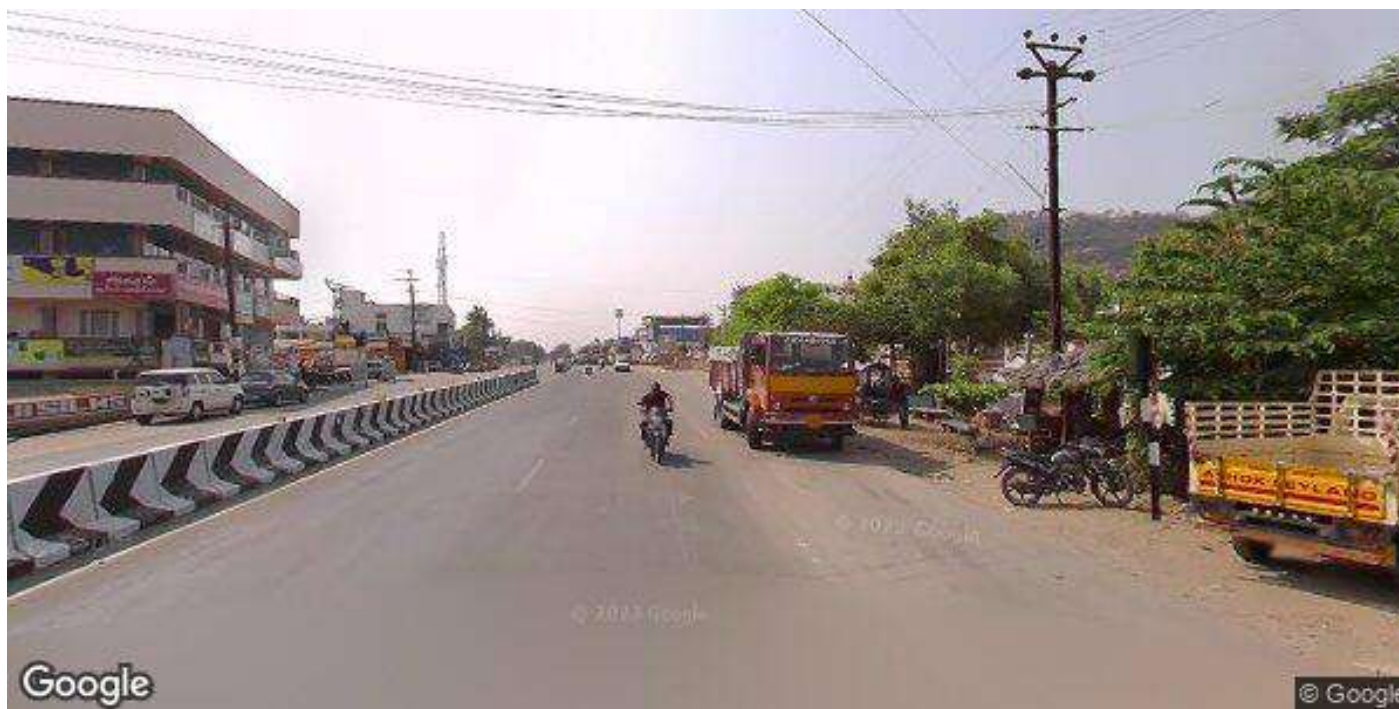
**Risk Type:** Turn  
**Risk Level:** Medium  
**Speed Limit:** 30 KM/Hr  
**Coordinates:** 11.39685, 77.88861

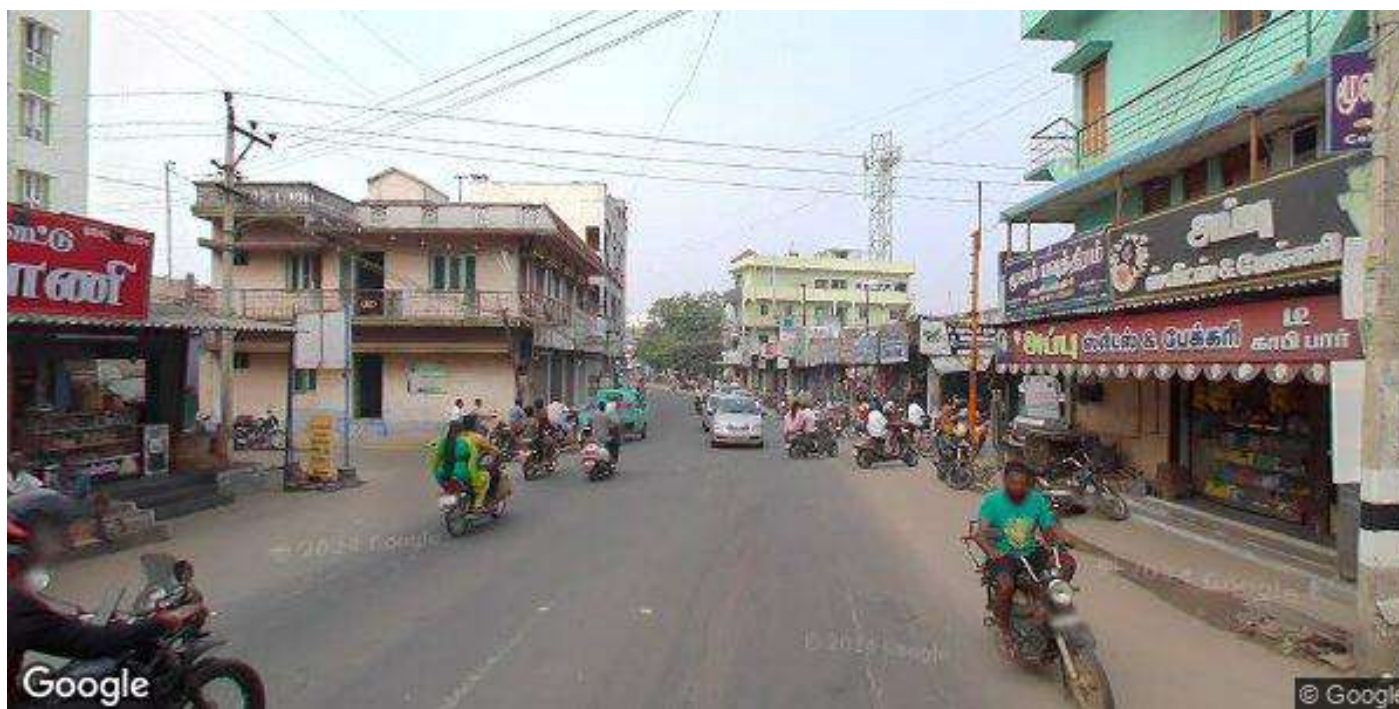
**Risk Type:** Turn  
**Risk Level:** Medium  
**Speed Limit:** 30 KM/Hr  
**Coordinates:** 11.38376, 77.89914

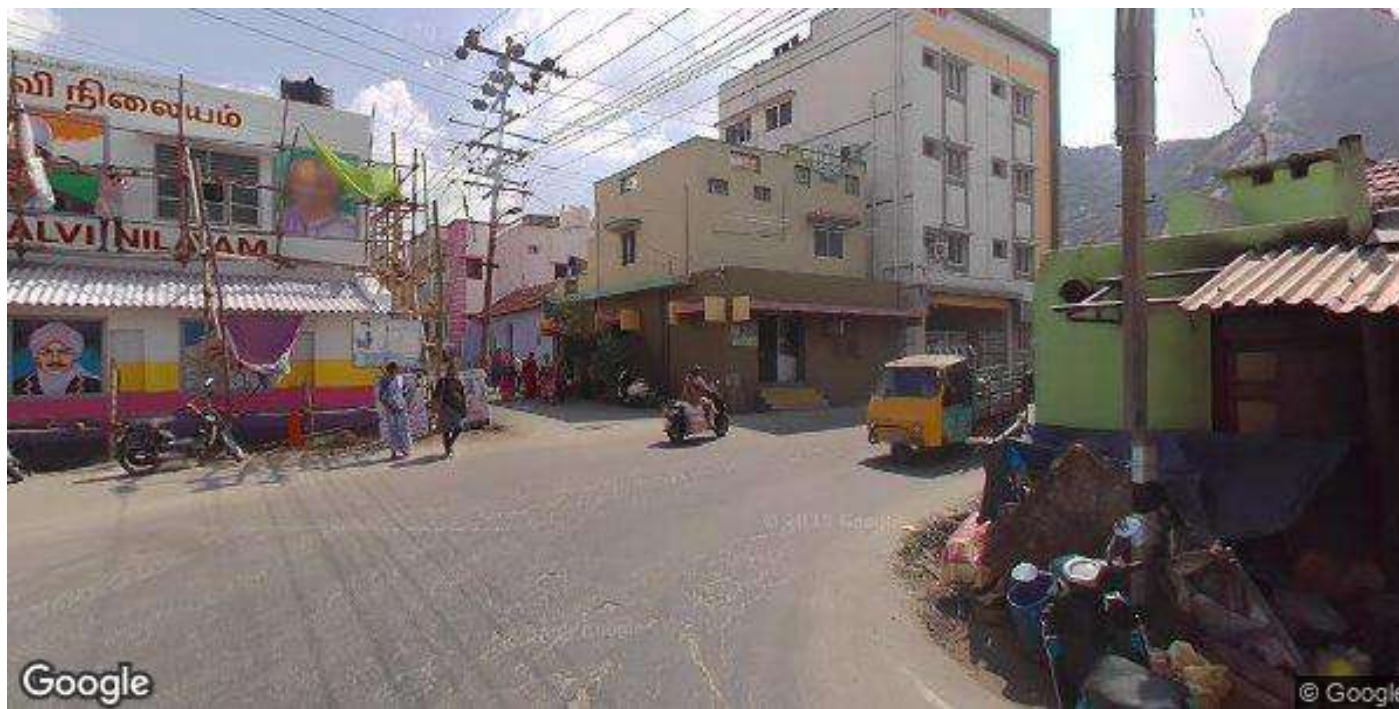
**Risk Type:** Turn  
**Risk Level:** High  
**Speed Limit:** 15 KM/Hr  
**Coordinates:** 11.38186, 77.90258

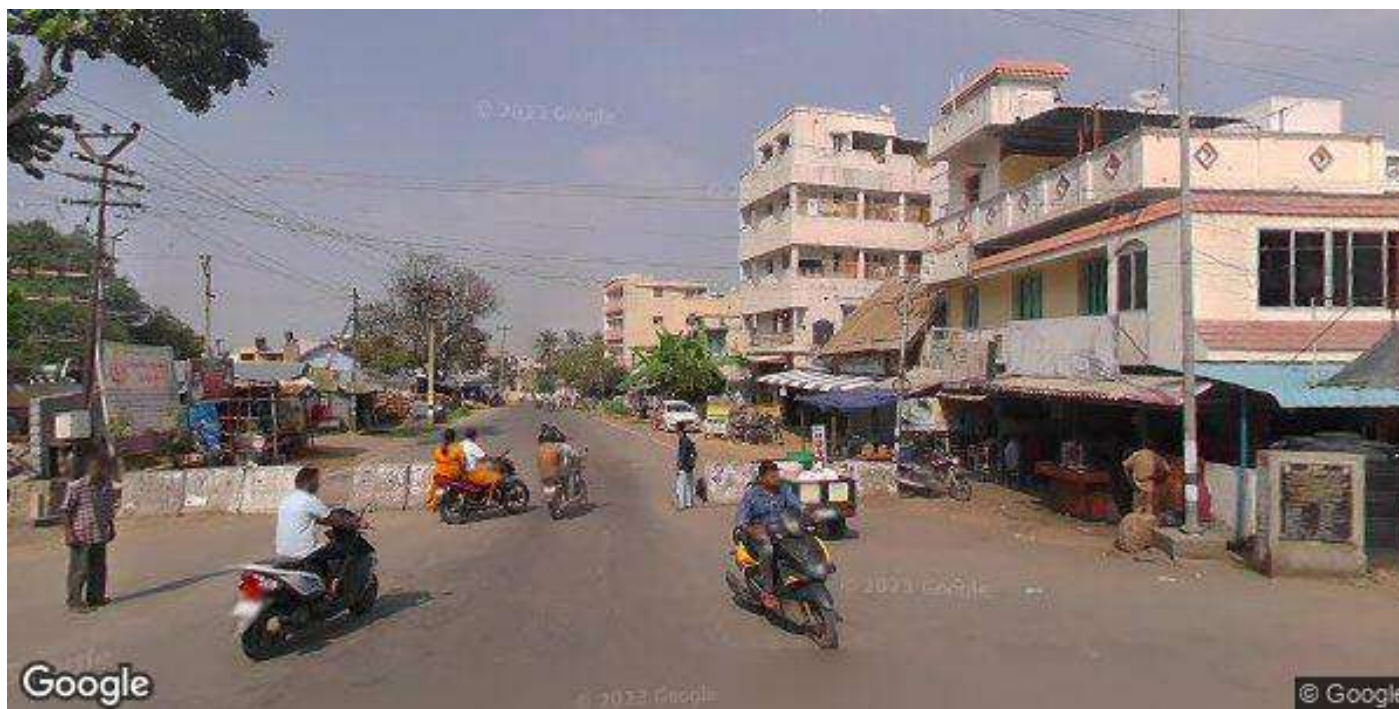
**Risk Type:** Blind Spot  
**Risk Level:** Blind Spot  
**Speed Limit:** 10 KM/Hr  
**Coordinates:** 11.37841, 77.90140

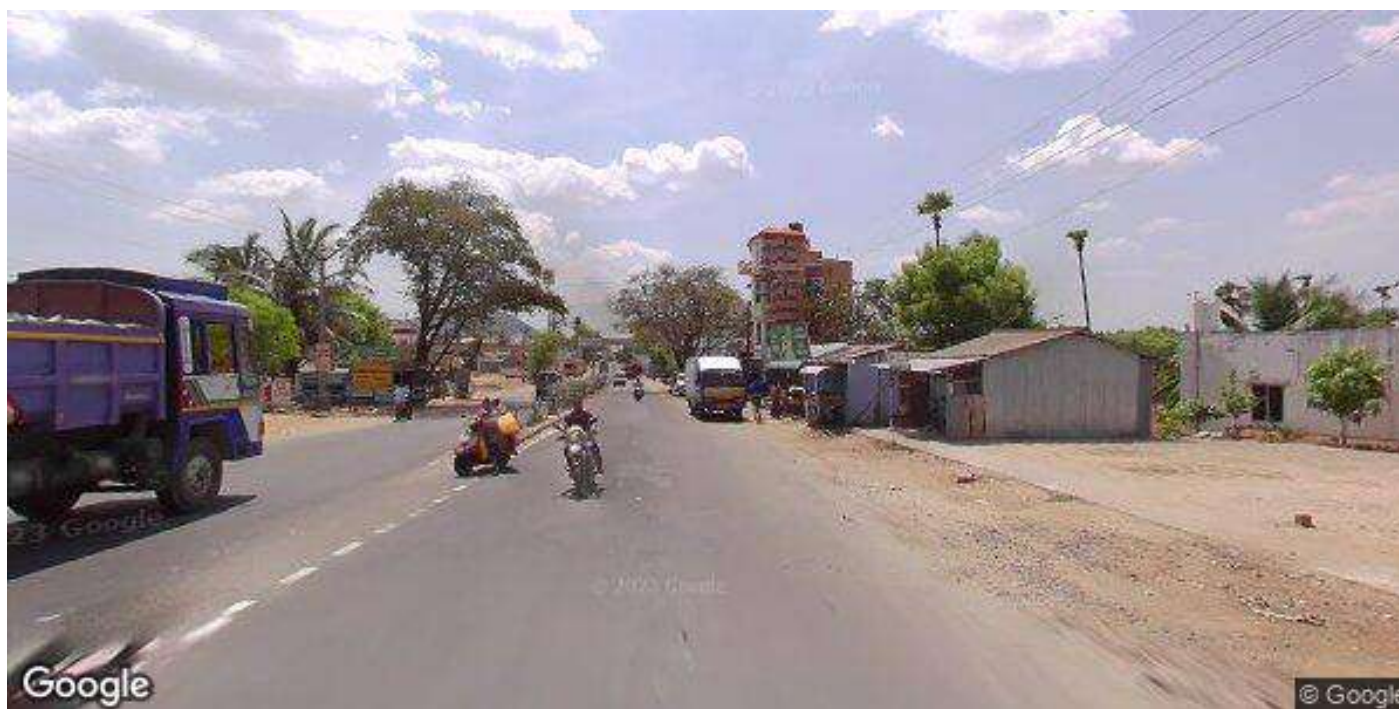
**Risk Type:** Turn  
**Risk Level:** Medium  
**Speed Limit:** 30 KM/Hr  
**Coordinates:** 11.36754, 77.93919

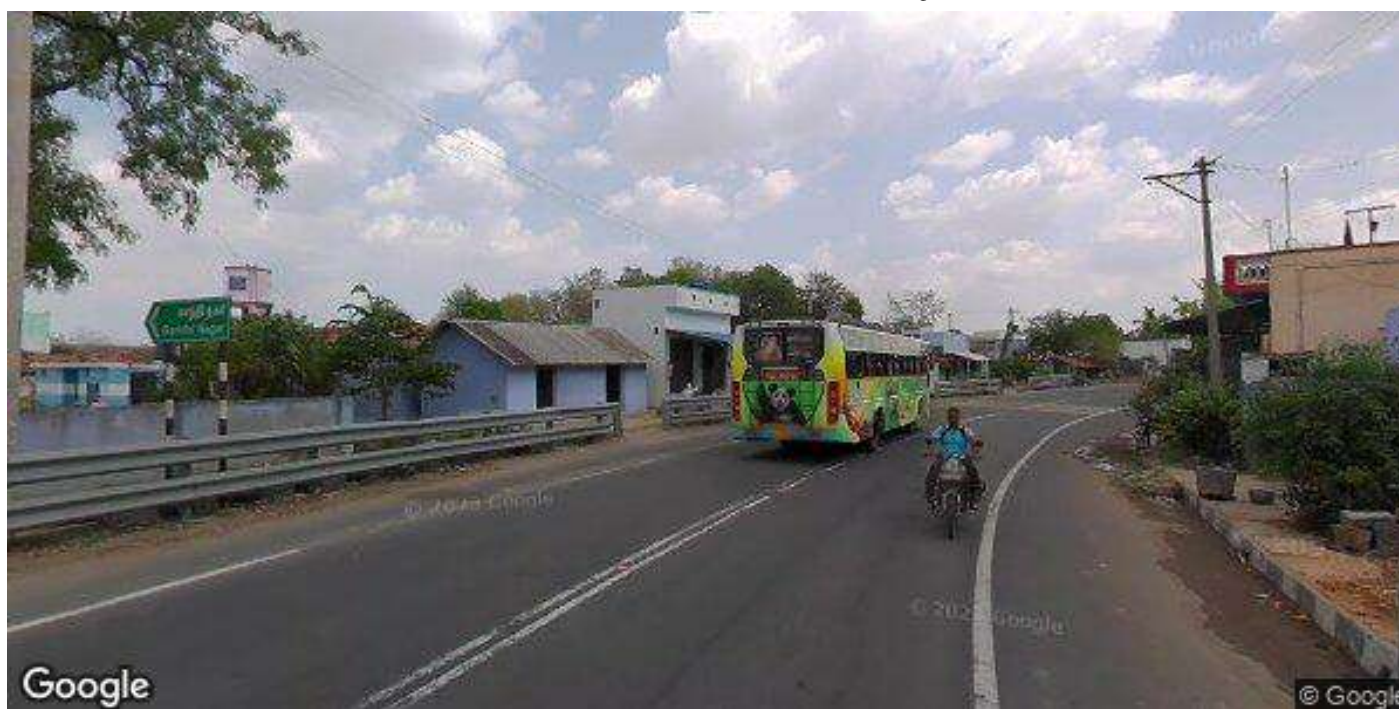
**Risk Type:** Turn  
**Risk Level:** Medium  
**Speed Limit:** 30 KM/Hr  
**Coordinates:** 11.41354, 78.08075

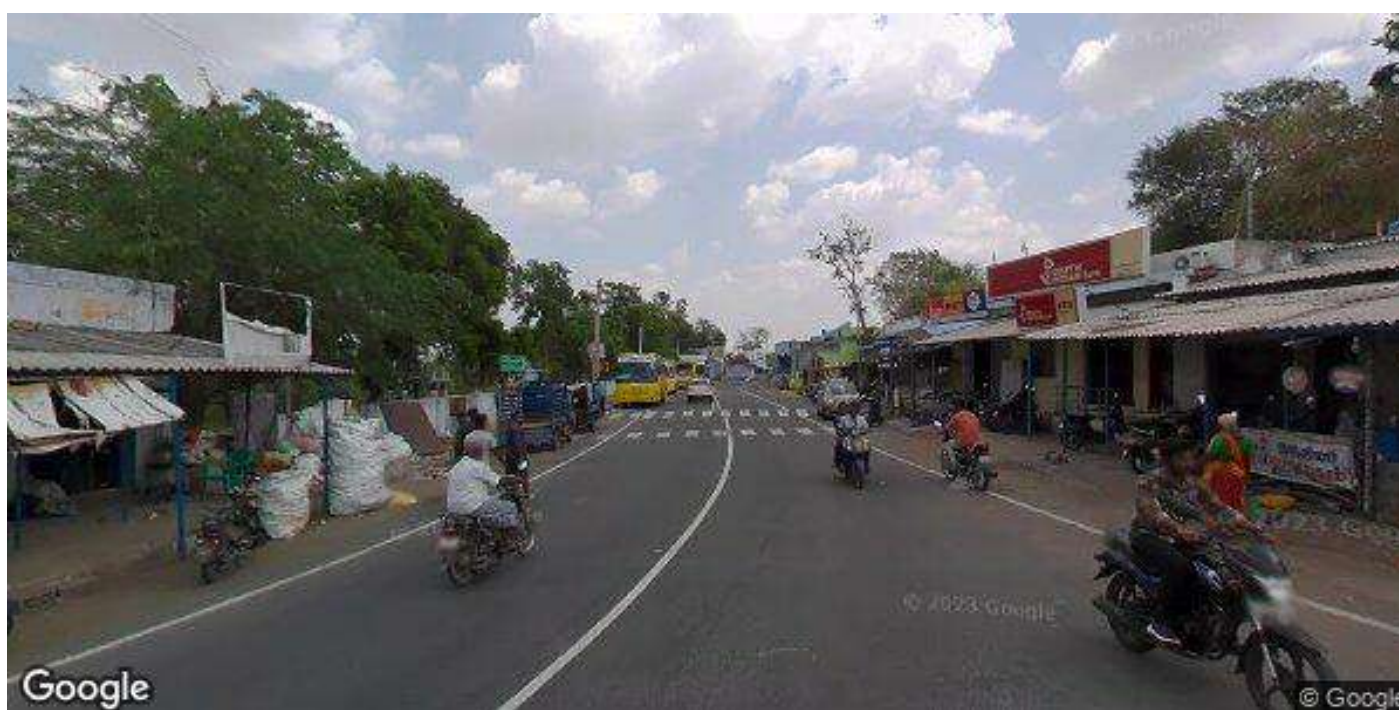
**Risk Type:** Turn  
**Risk Level:** High  
**Speed Limit:** 15 KM/Hr  
**Coordinates:** 11.41447, 78.08063

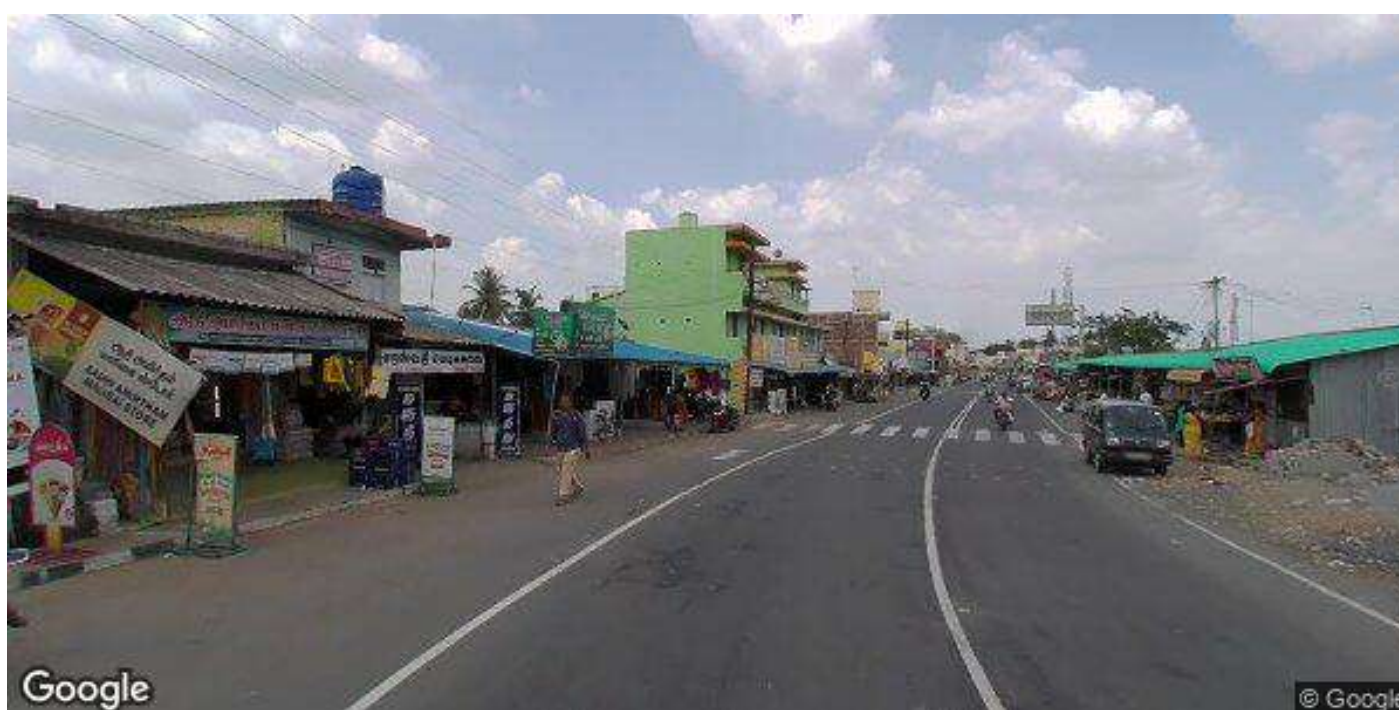
**Risk Type:** Turn  
**Risk Level:** High  
**Speed Limit:** 15 KM/Hr  
**Coordinates:** 11.41475, 78.08087

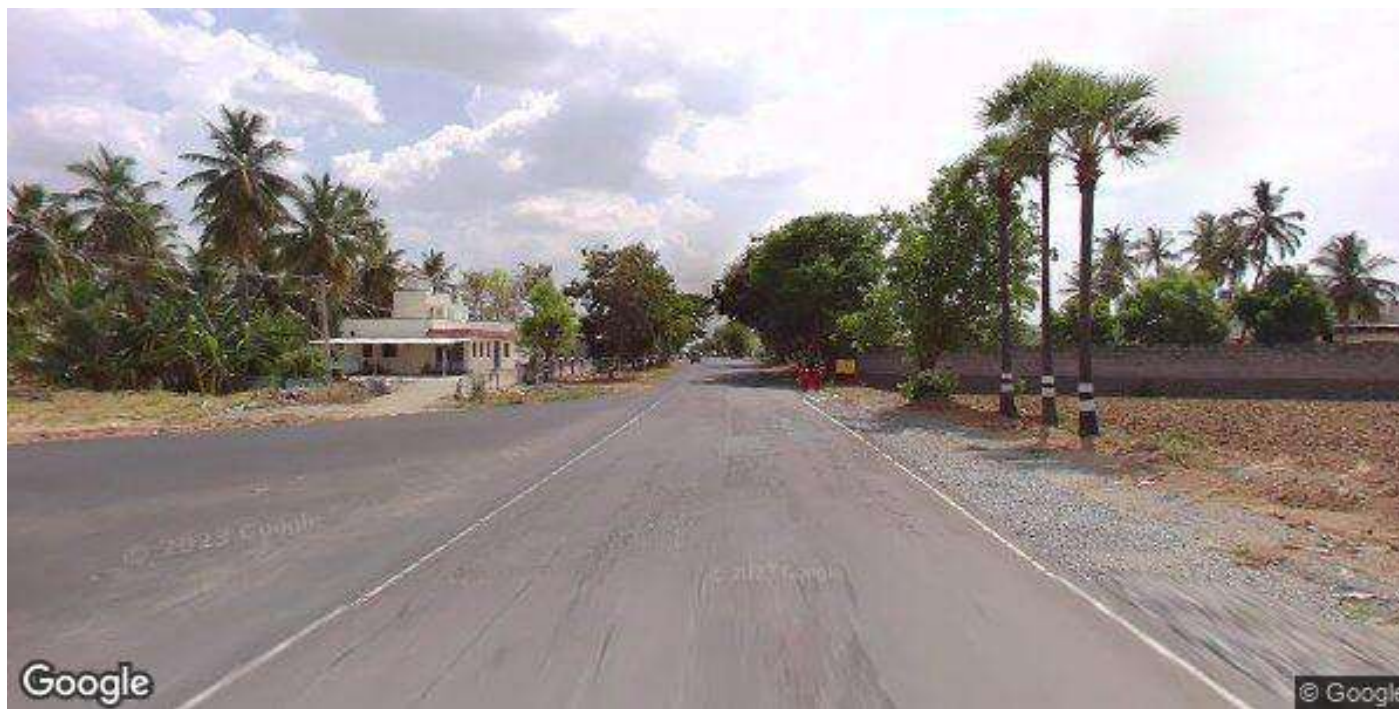
**Risk Type:** Turn  
**Risk Level:** High  
**Speed Limit:** 15 KM/Hr  
**Coordinates:** 11.42964, 78.11587

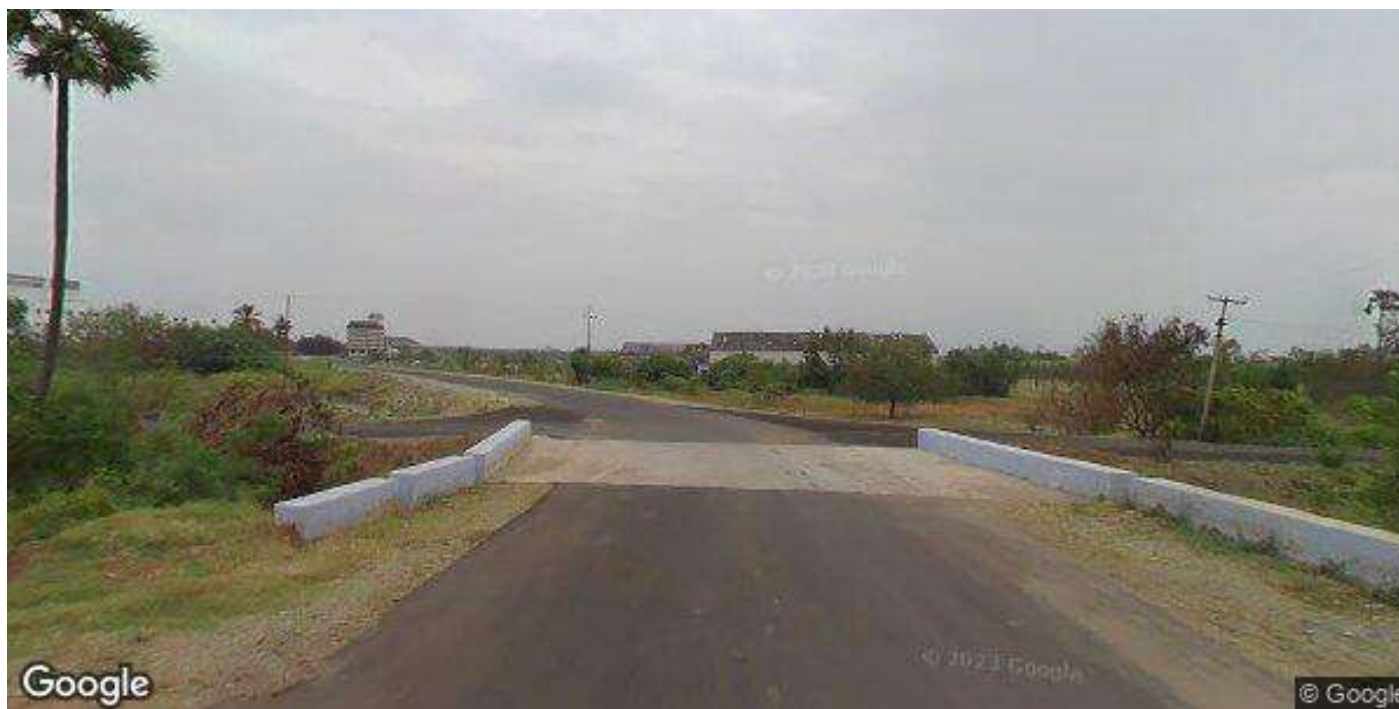
**Risk Type:** Turn  
**Risk Level:** Medium  
**Speed Limit:** 30 KM/Hr  
**Coordinates:** 11.42447, 78.15264

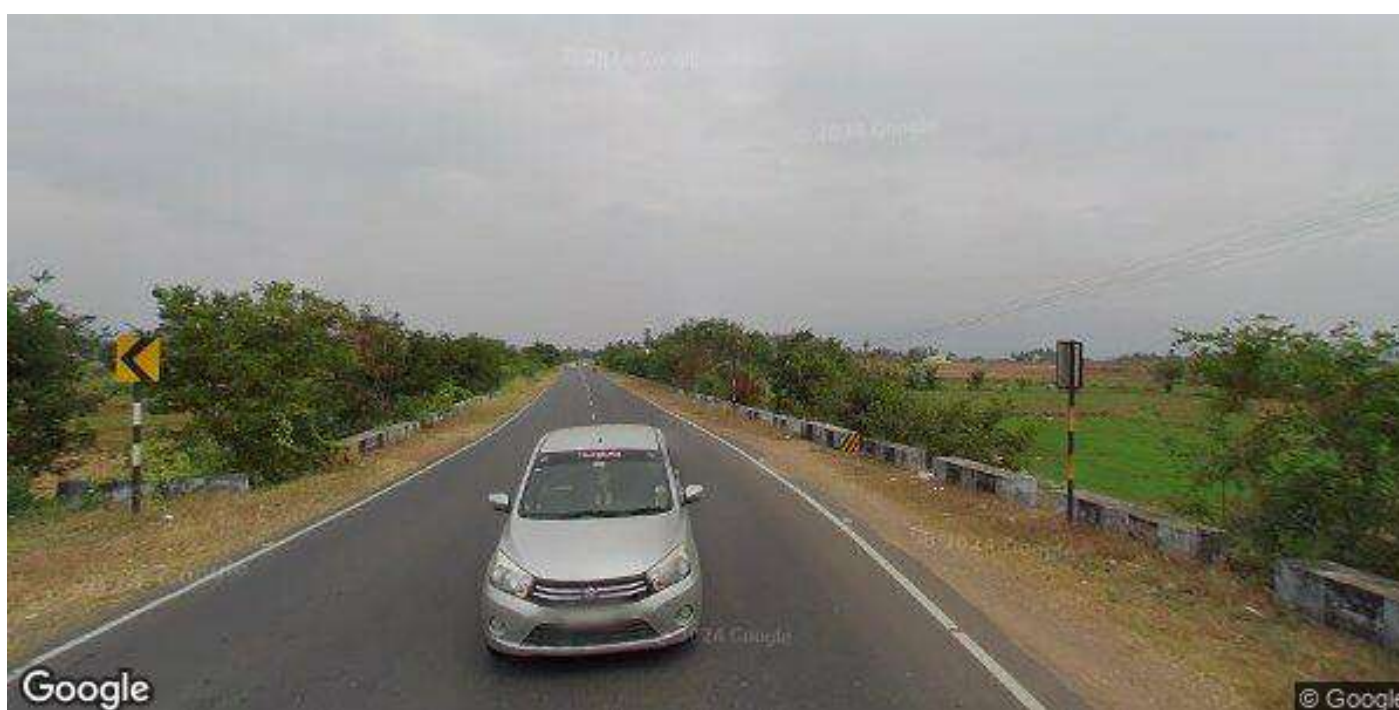
**Risk Type:** Turn  
**Risk Level:** Medium  
**Speed Limit:** 30 KM/Hr  
**Coordinates:** 11.43142, 78.18808

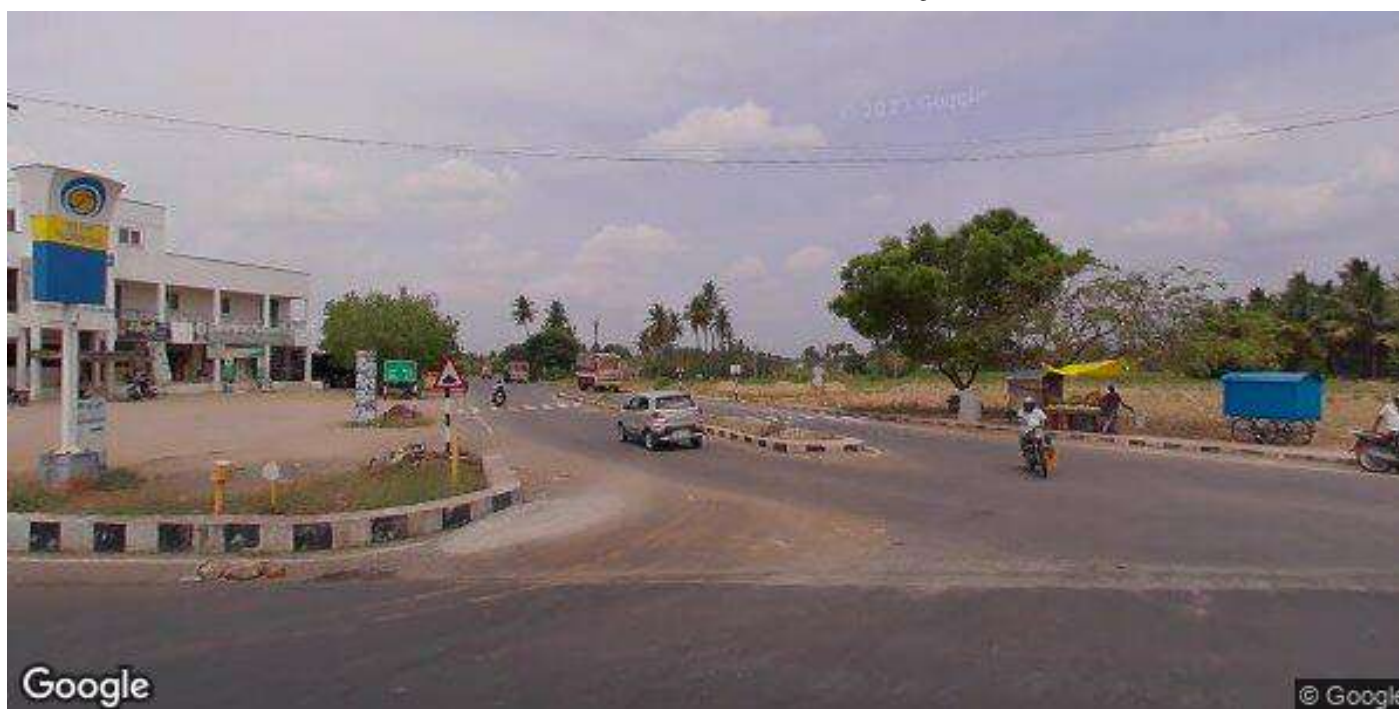
**Risk Type:** Turn  
**Risk Level:** Medium  
**Speed Limit:** 30 KM/Hr  
**Coordinates:** 11.43521, 78.20729

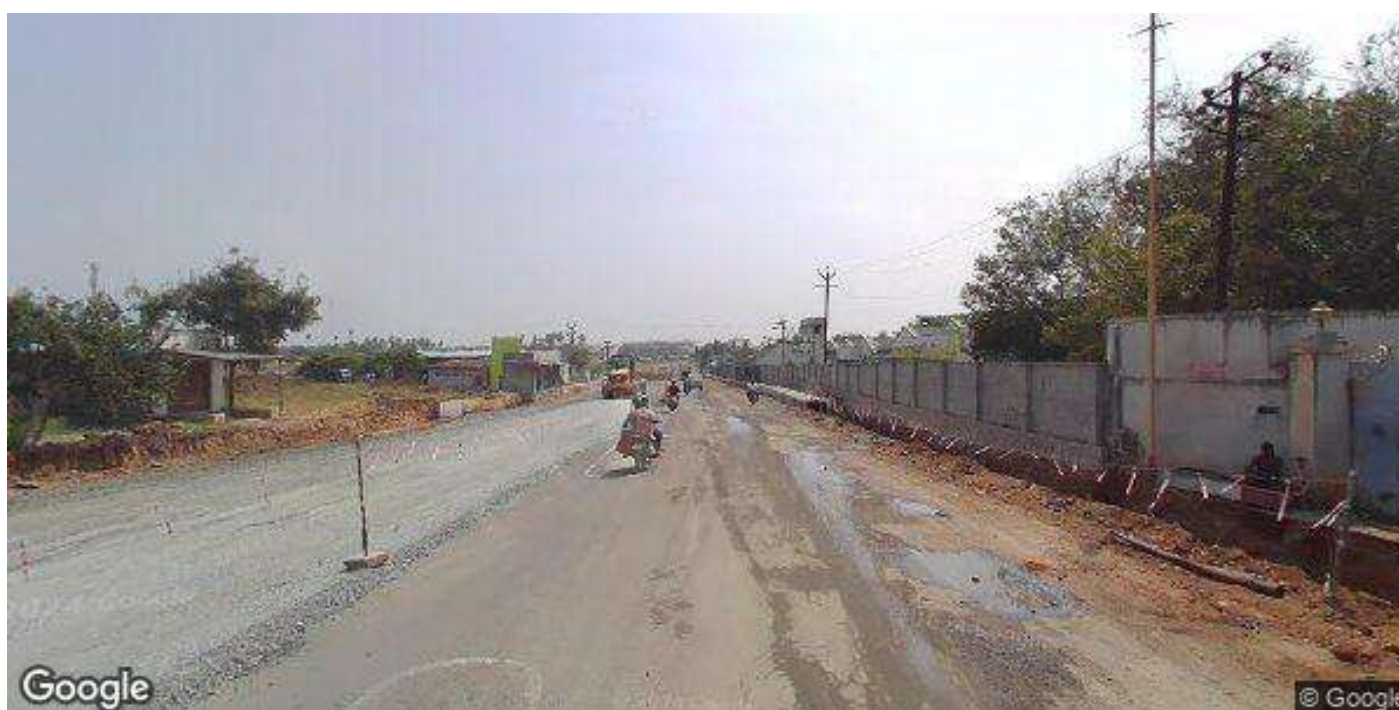
**Risk Type:** Turn  
**Risk Level:** High  
**Speed Limit:** 15 KM/Hr  
**Coordinates:** 11.45070, 78.20393

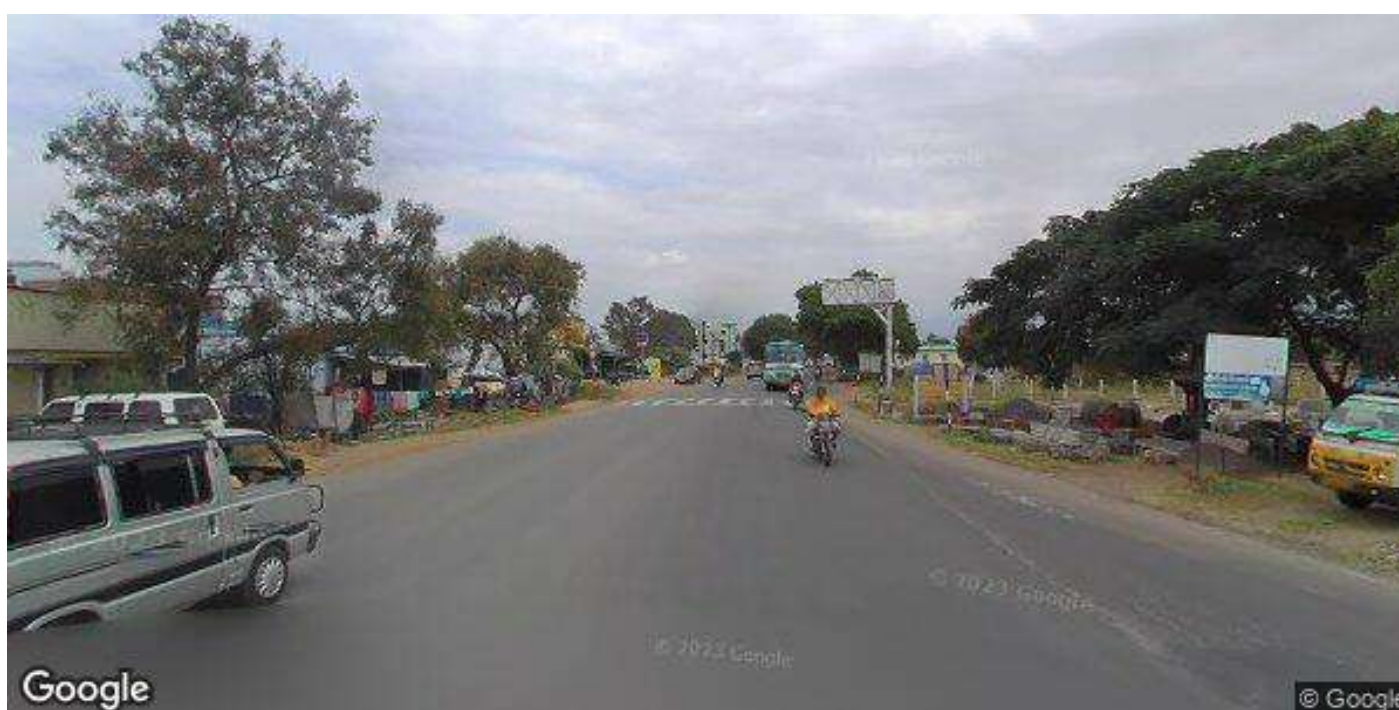
**Risk Type:** Turn  
**Risk Level:** High  
**Speed Limit:** 15 KM/Hr  
**Coordinates:** 11.45098, 78.20412

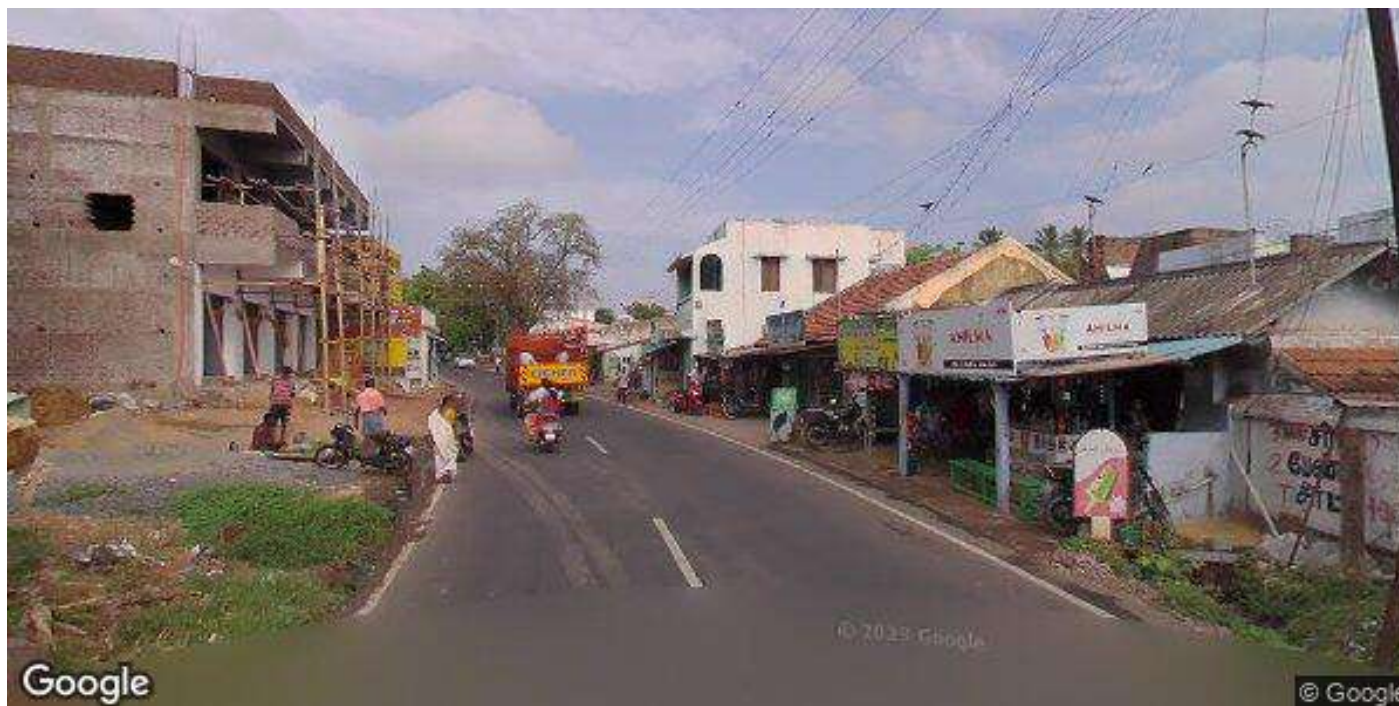
**Risk Type:** Turn  
**Risk Level:** Medium  
**Speed Limit:** 30 KM/Hr  
**Coordinates:** 11.44993, 78.22152

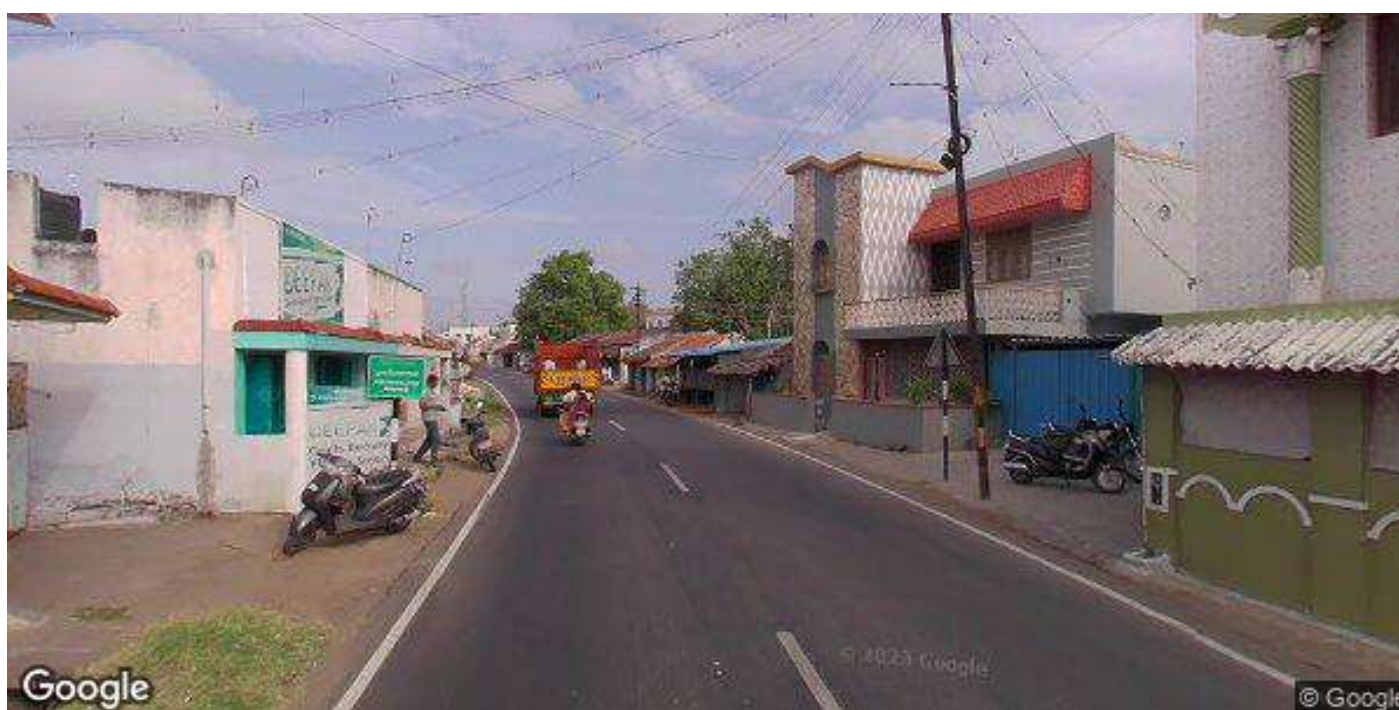
**Risk Type:** Turn  
**Risk Level:** High  
**Speed Limit:** 15 KM/Hr  
**Coordinates:** 11.44951, 78.22263

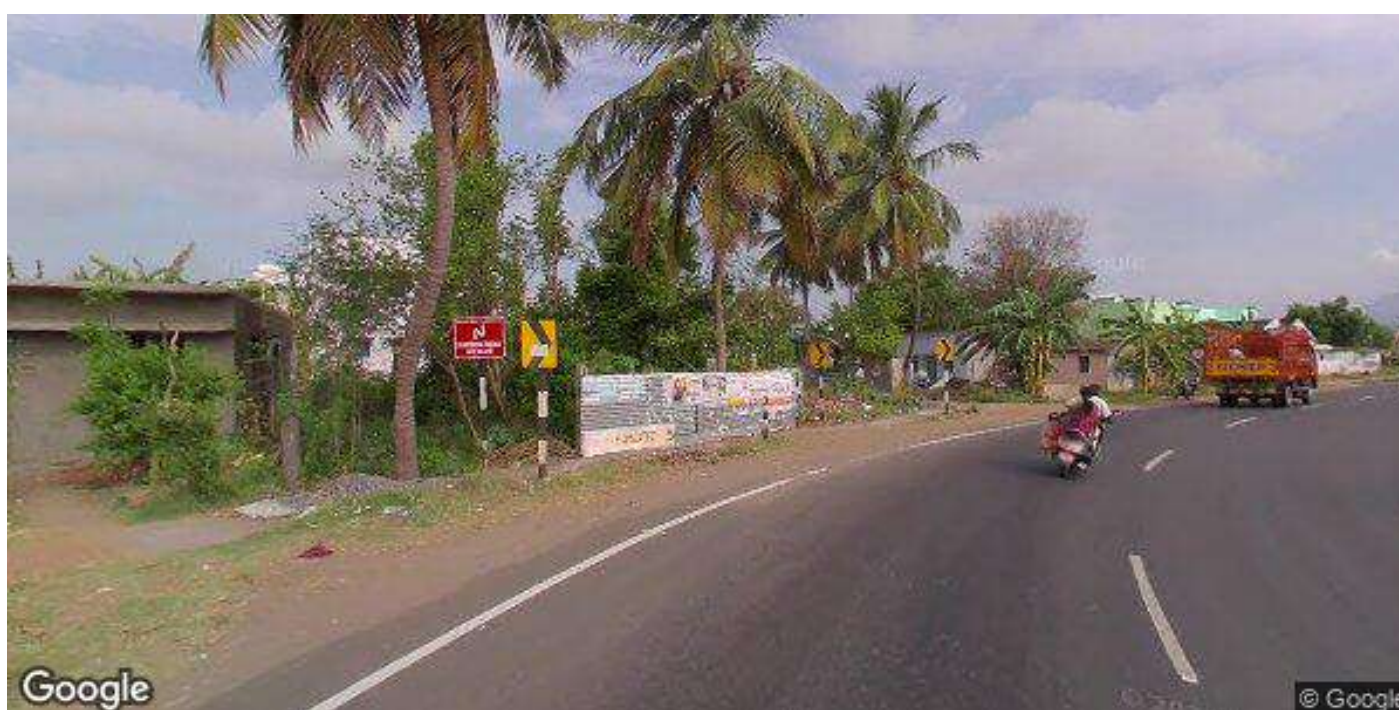
**Risk Type:** Turn  
**Risk Level:** High  
**Speed Limit:** 15 KM/Hr  
**Coordinates:** 11.44797, 78.22314

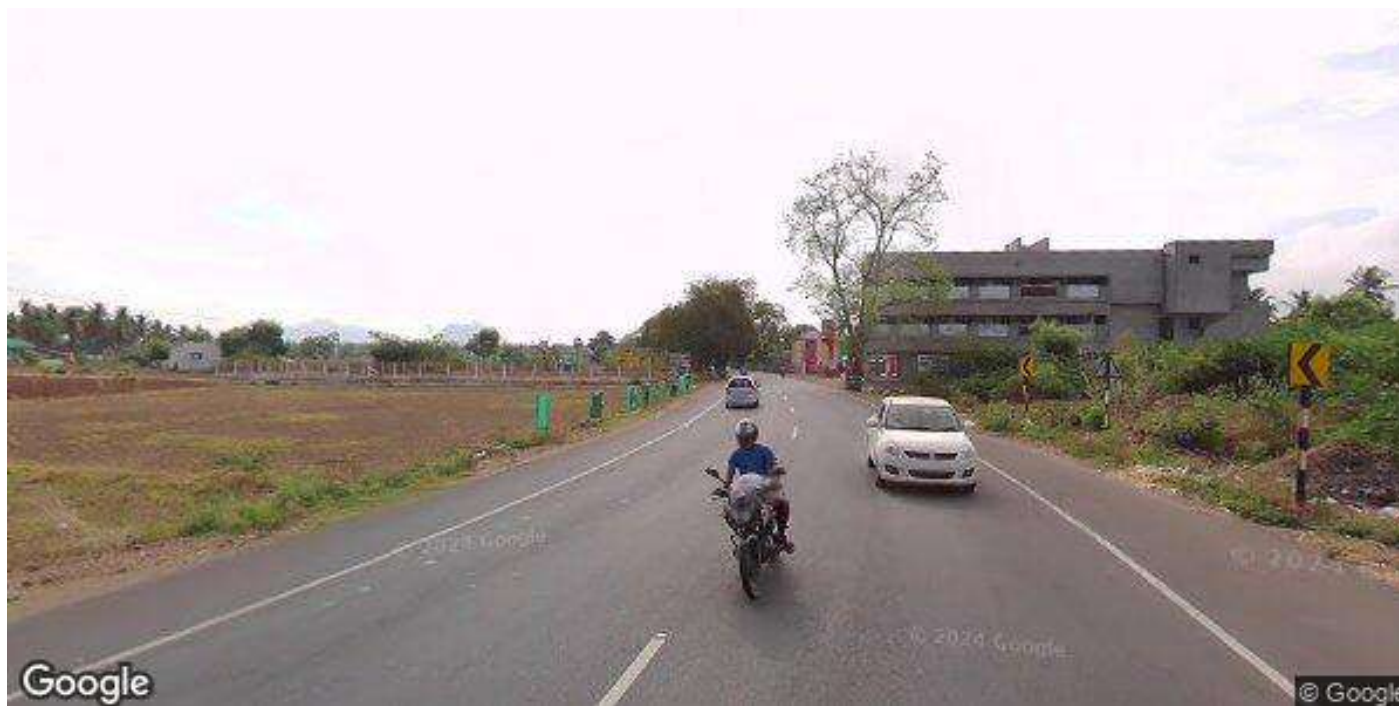
**Risk Type:** Turn  
**Risk Level:** Medium  
**Speed Limit:** 30 KM/Hr  
**Coordinates:** 11.44756, 78.22414

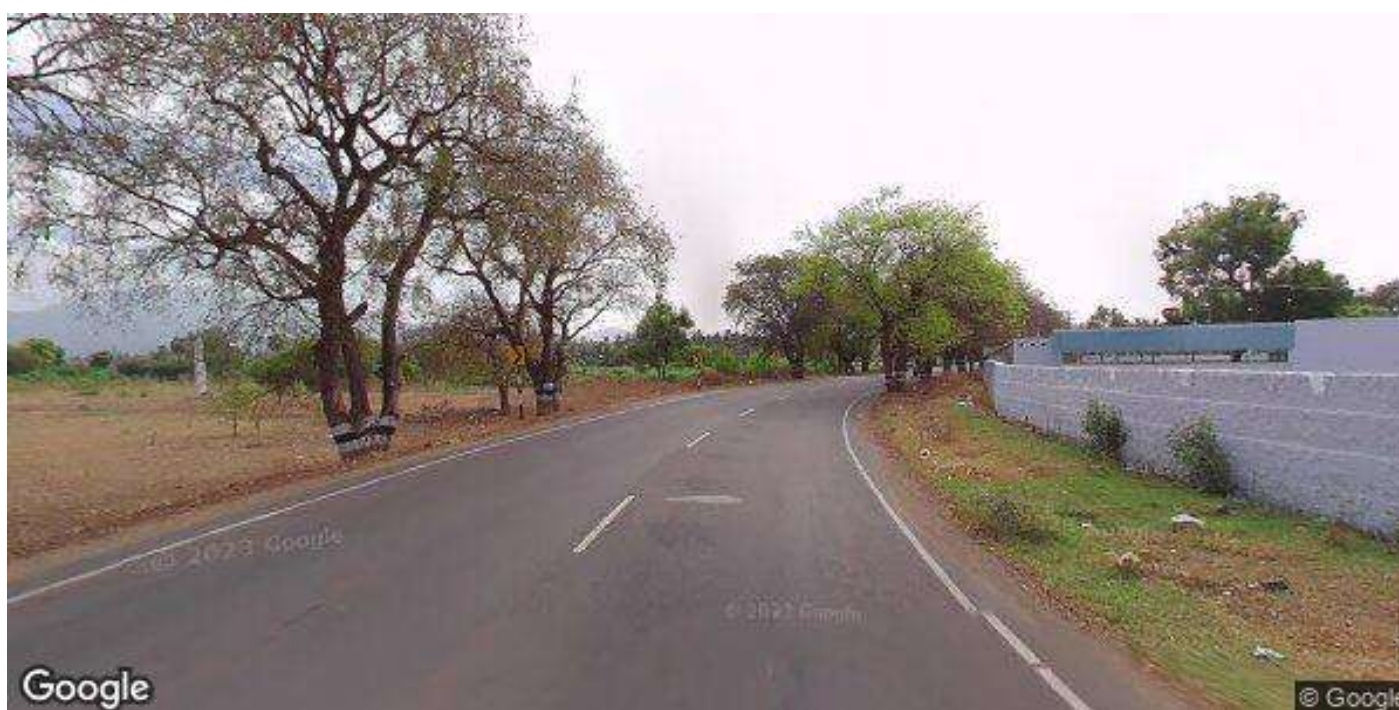
**Risk Type:** Turn  
**Risk Level:** Medium  
**Speed Limit:** 30 KM/Hr  
**Coordinates:** 11.45353, 78.23584

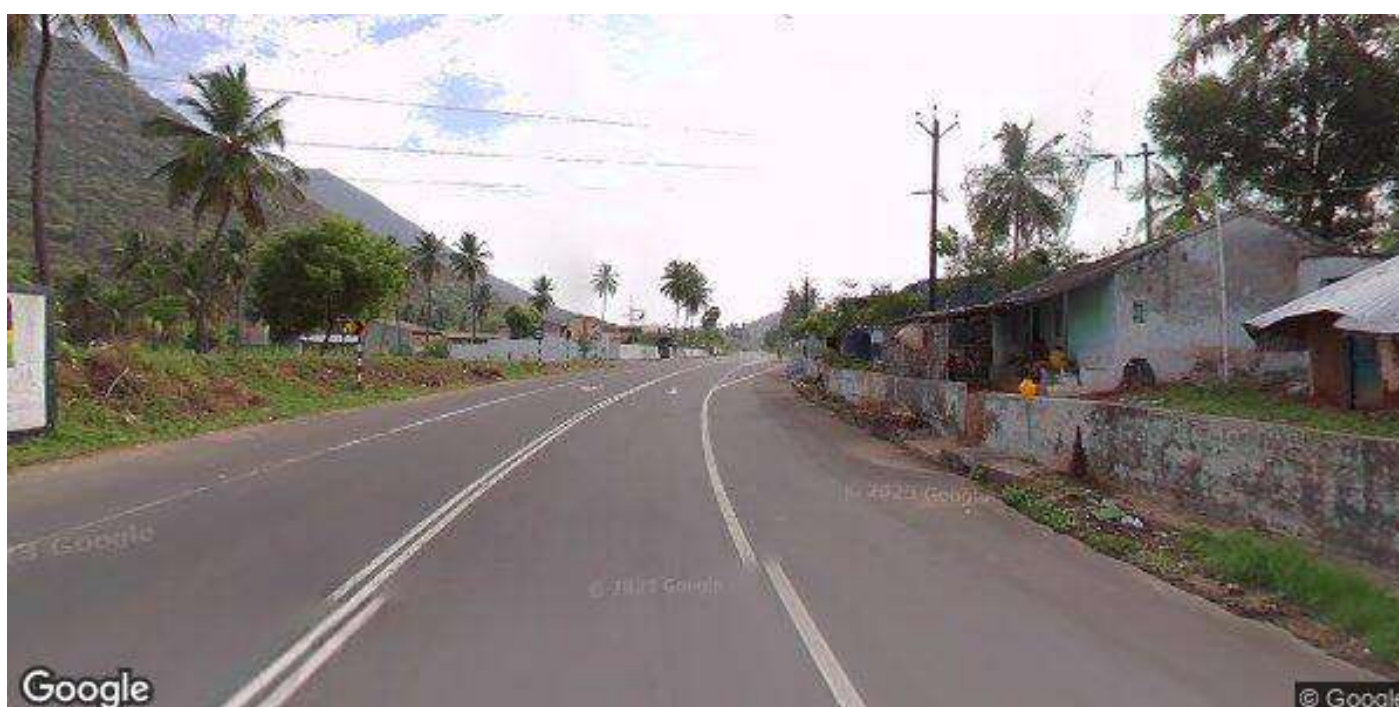
**Risk Type:** Turn  
**Risk Level:** Medium  
**Speed Limit:** 30 KM/Hr  
**Coordinates:** 11.49835, 78.32417
