# IndianOil

## JOURNEY RISK MANAGEMENT (JRM) STUDY

### Salem Terminal to KAVIRAJ AGENCY

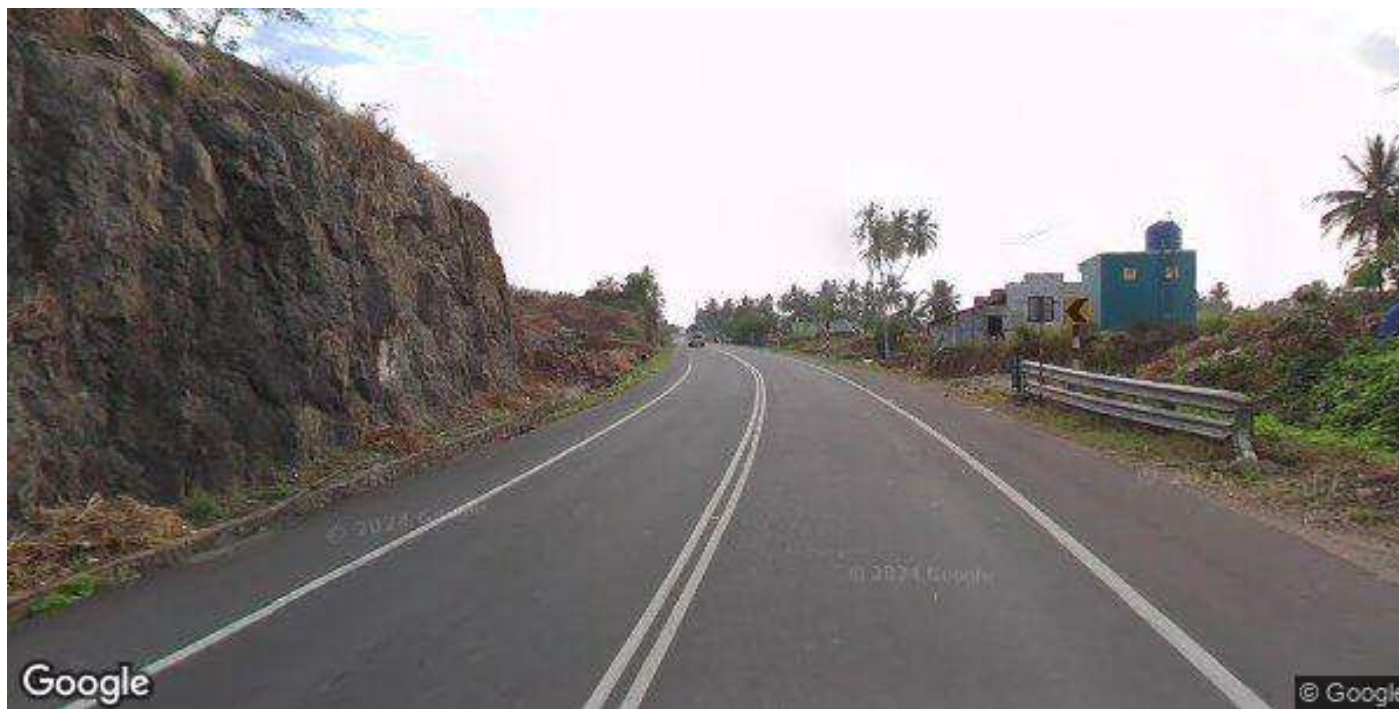
**Risk Type:** Turn  
**Risk Level:** Medium  
**Speed Limit:** 30 KM/Hr  
**Coordinates:** 11.50865, 78.33966

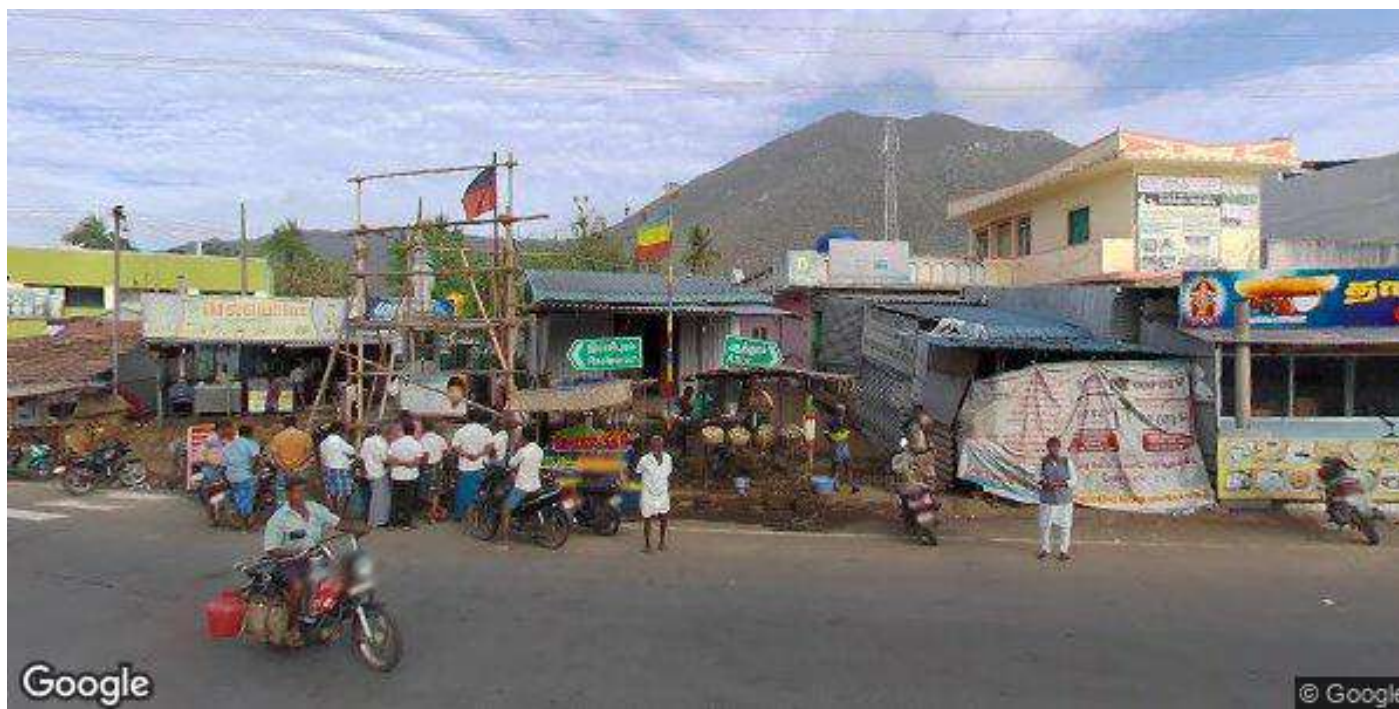
**Risk Type:** Turn  
**Risk Level:** High  
**Speed Limit:** 15 KM/Hr  
**Coordinates:** 11.51183, 78.34416

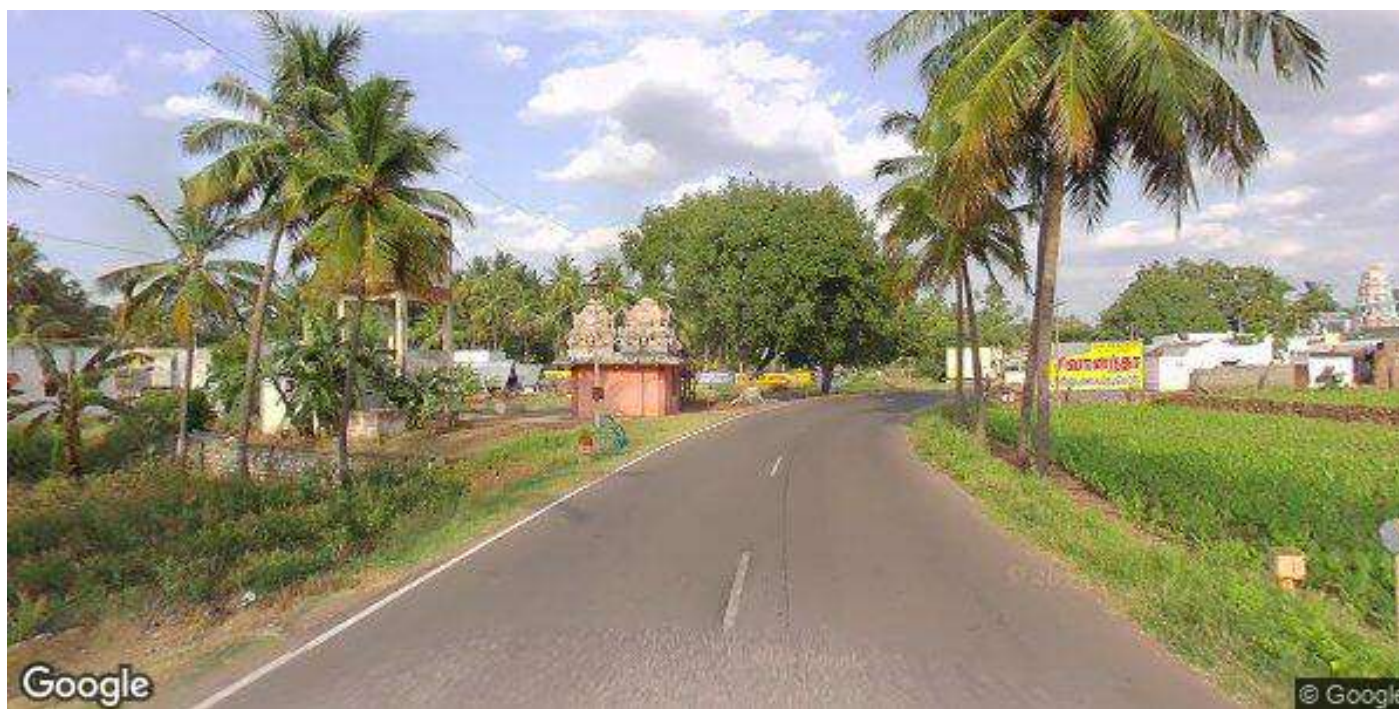
**Risk Type:** Turn  
**Risk Level:** Medium  
**Speed Limit:** 30 KM/Hr  
**Coordinates:** 11.51042, 78.34865

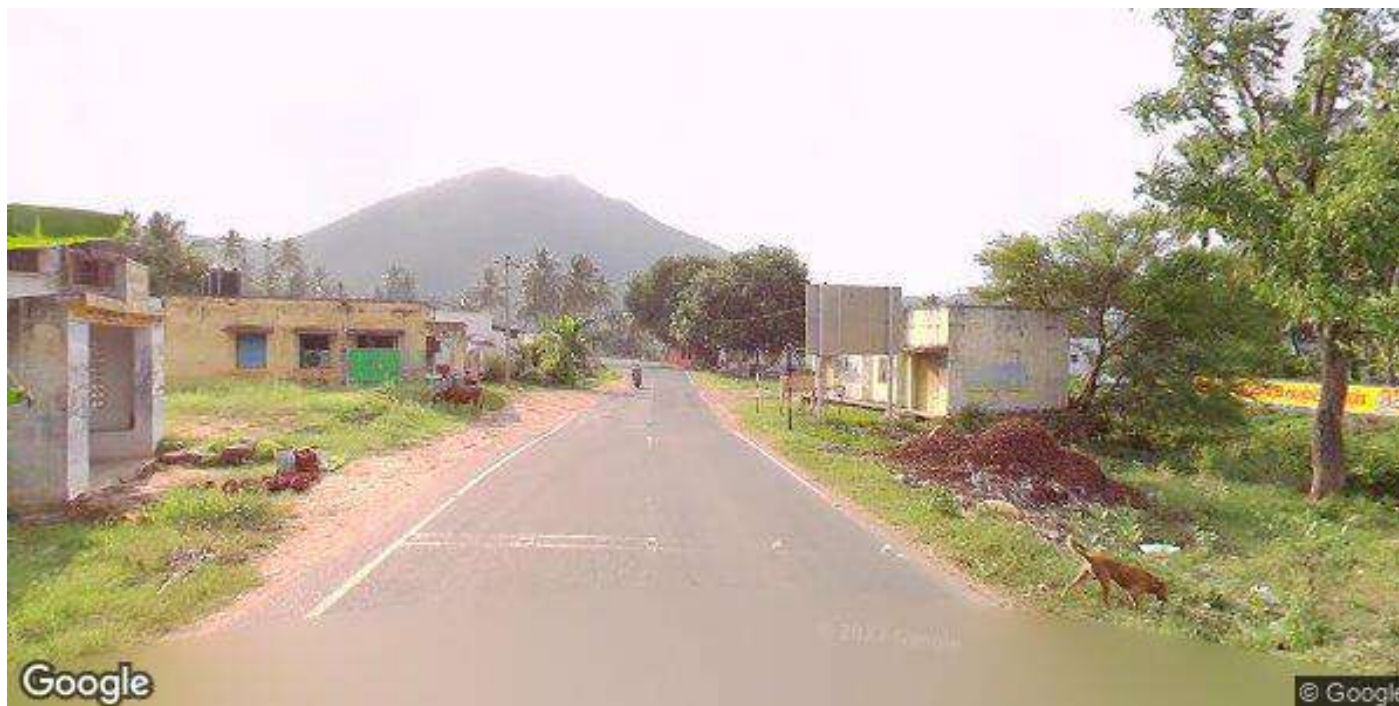
**Risk Type:** Turn  
**Risk Level:** Medium  
**Speed Limit:** 30 KM/Hr  
**Coordinates:** 11.50973, 78.34962

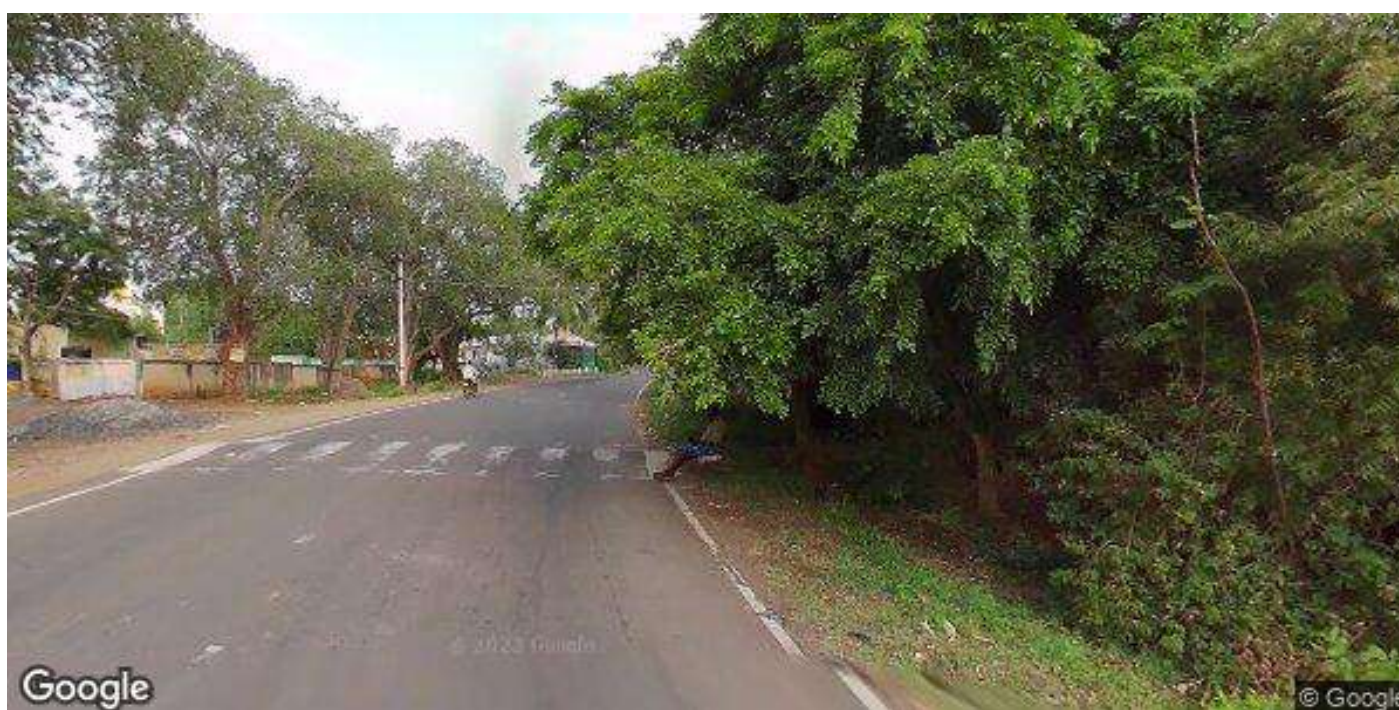
**Risk Type:** Turn  
**Risk Level:** Medium  
**Speed Limit:** 30 KM/Hr  
**Coordinates:** 11.50909, 78.35278

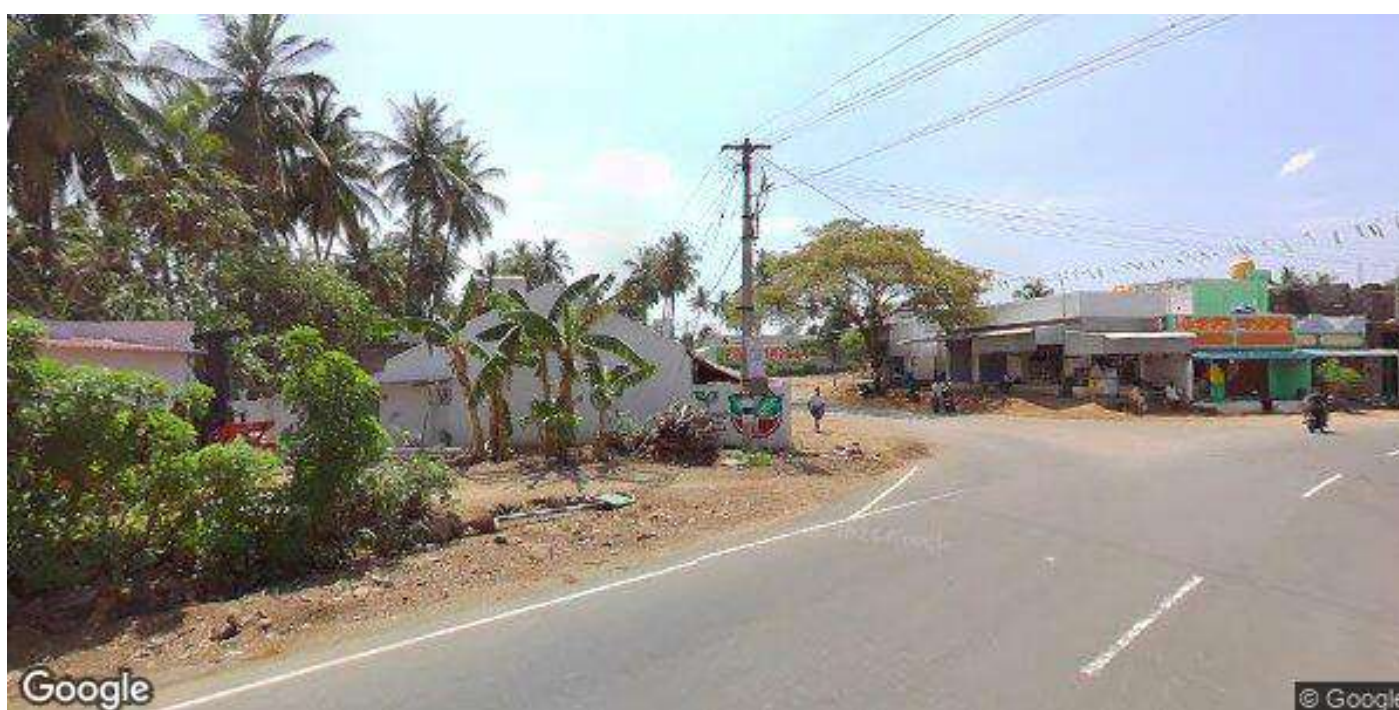
**Risk Type:** Turn  
**Risk Level:** Medium  
**Speed Limit:** 30 KM/Hr  
**Coordinates:** 11.47991, 78.38028

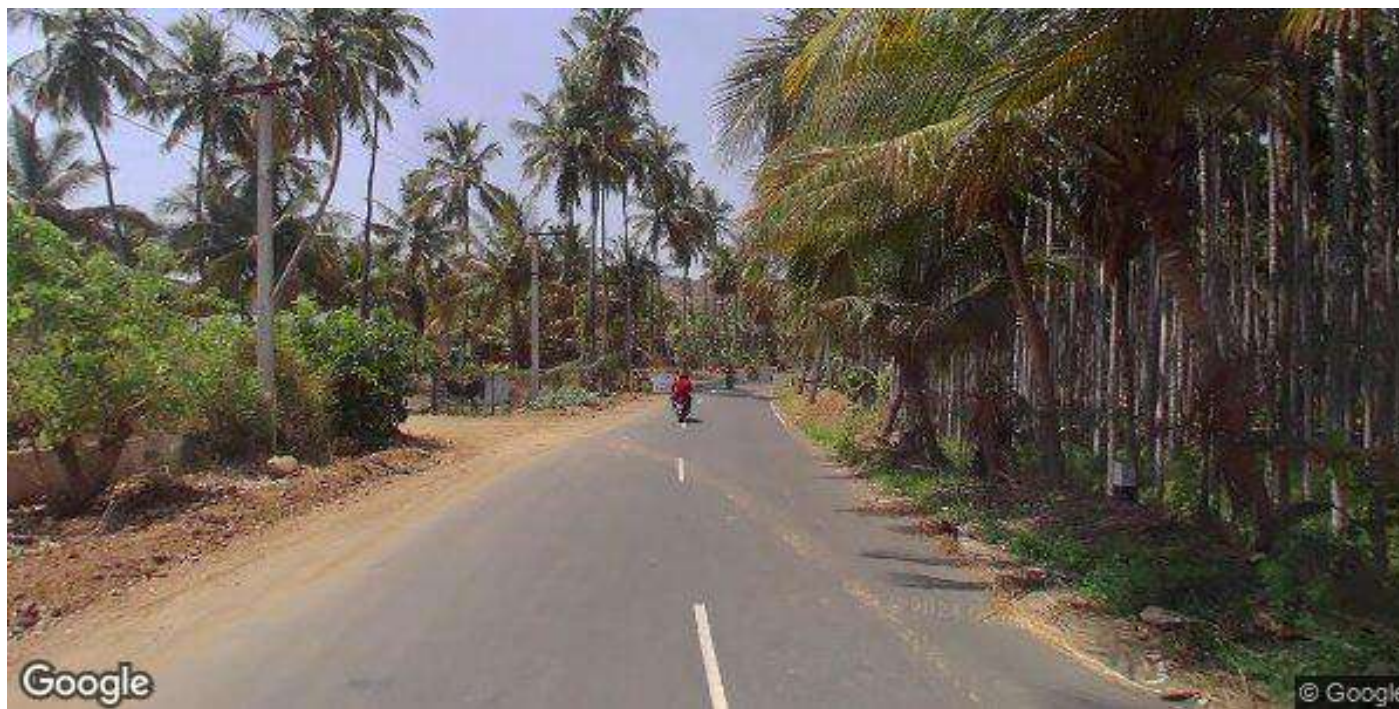
**Risk Type:** Turn  
**Risk Level:** Medium  
**Speed Limit:** 30 KM/Hr  
**Coordinates:** 11.46964, 78.39358

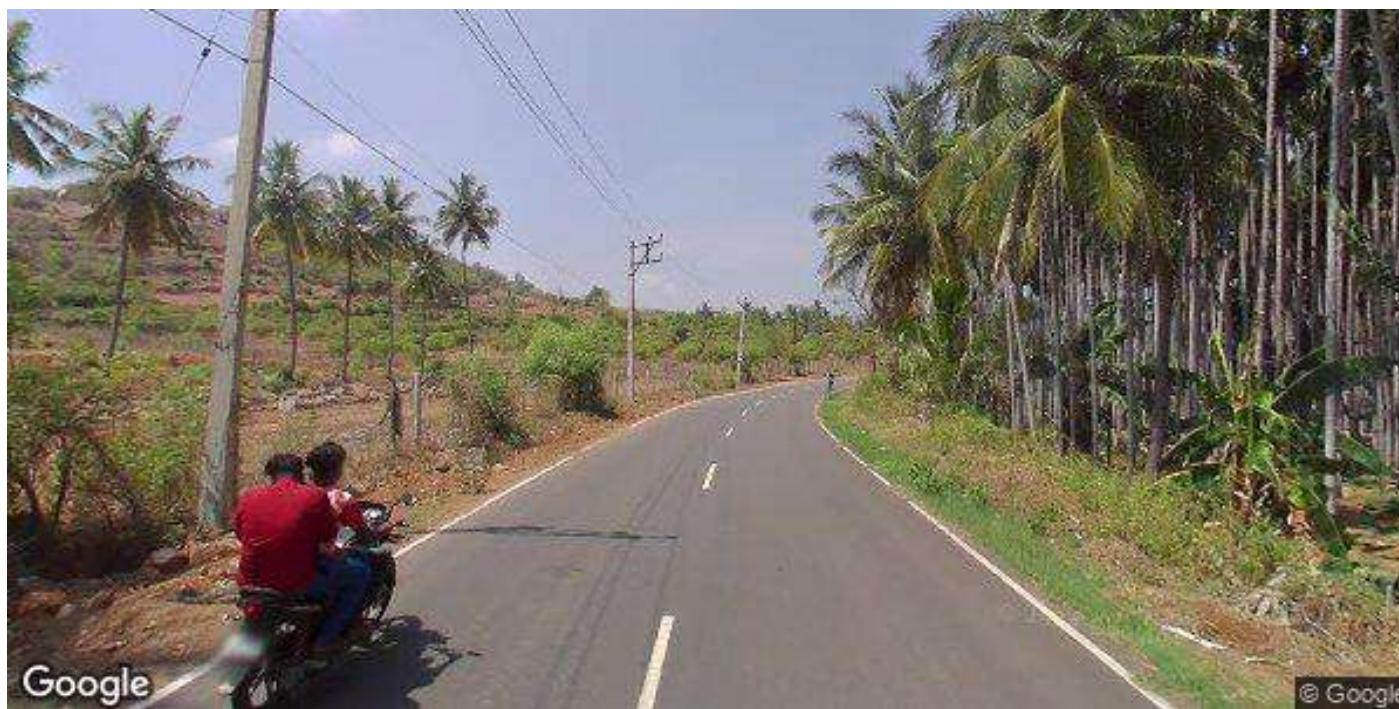
**Risk Type:** Turn  
**Risk Level:** Medium  
**Speed Limit:** 30 KM/Hr  
**Coordinates:** 11.46790, 78.39420

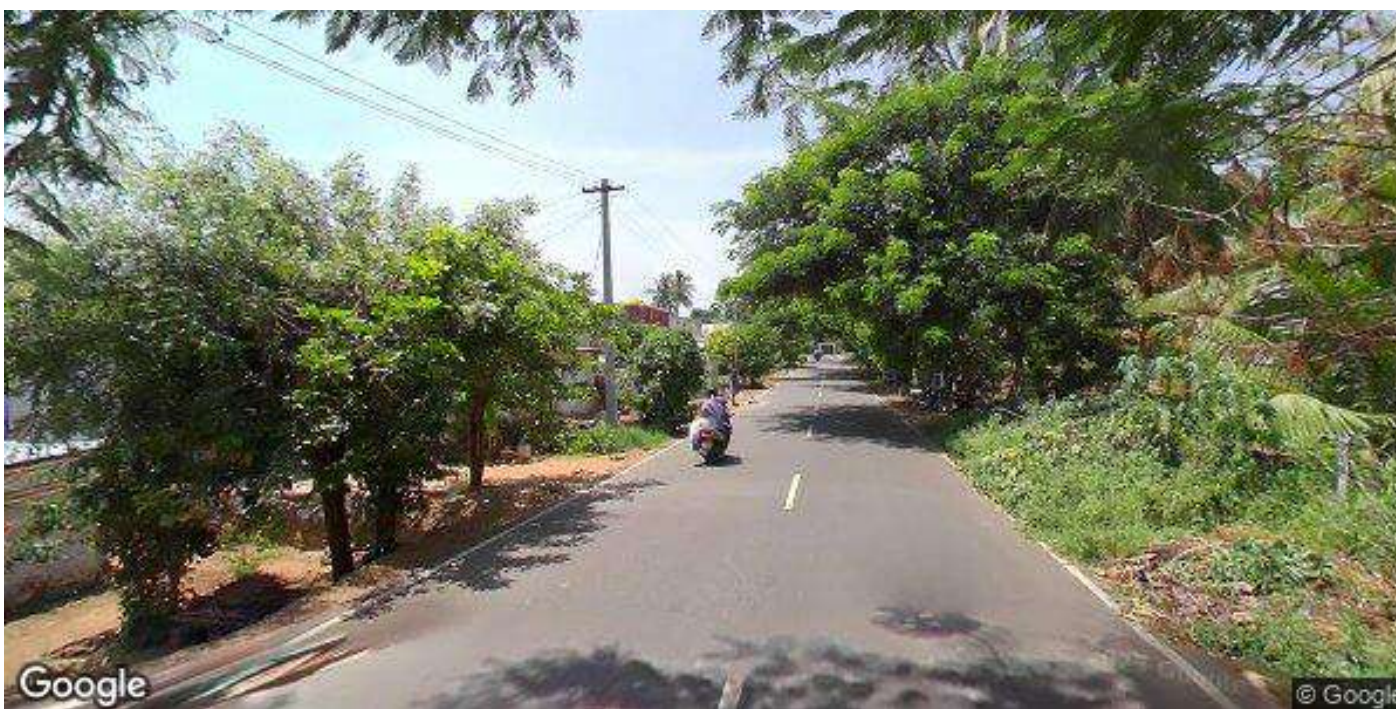
**Risk Type:** Turn  
**Risk Level:** Medium  
**Speed Limit:** 30 KM/Hr  
**Coordinates:** 11.45563, 78.40251

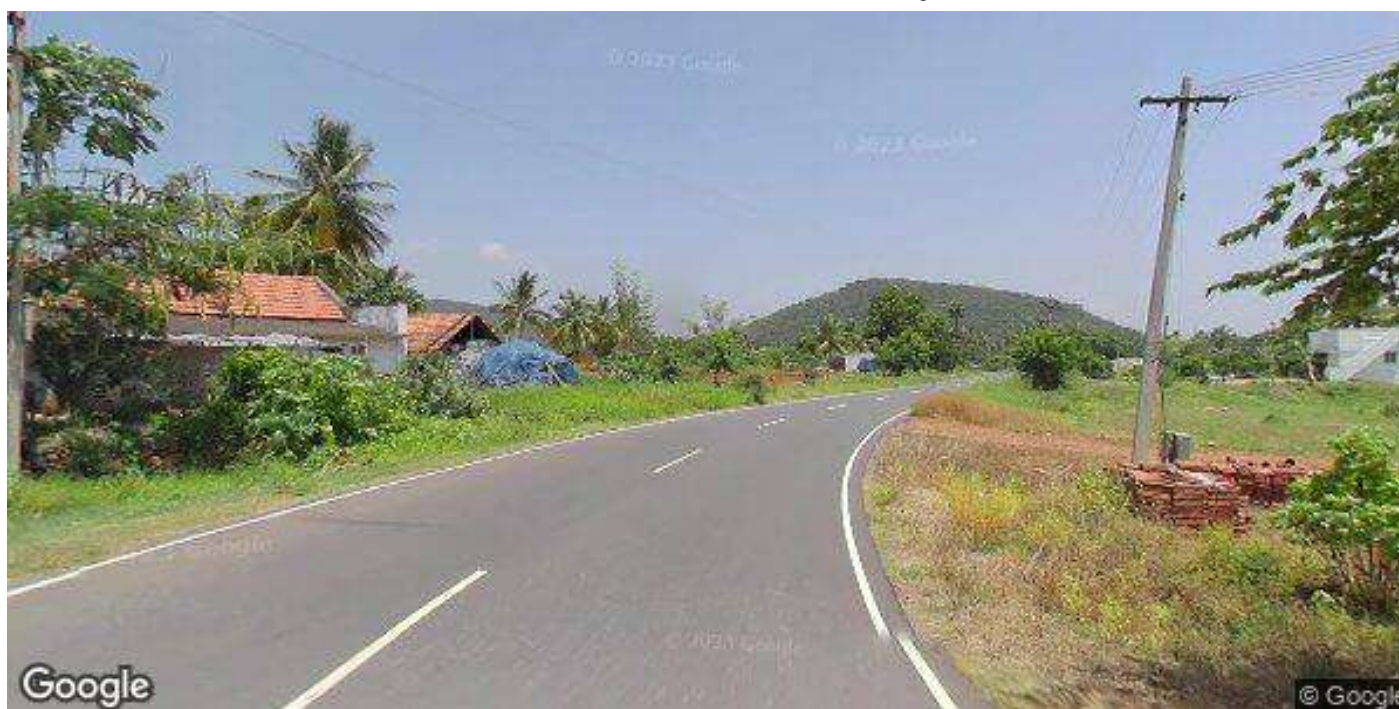
**Risk Type:** Turn  
**Risk Level:** Medium  
**Speed Limit:** 30 KM/Hr  
**Coordinates:** 11.45658, 78.40441

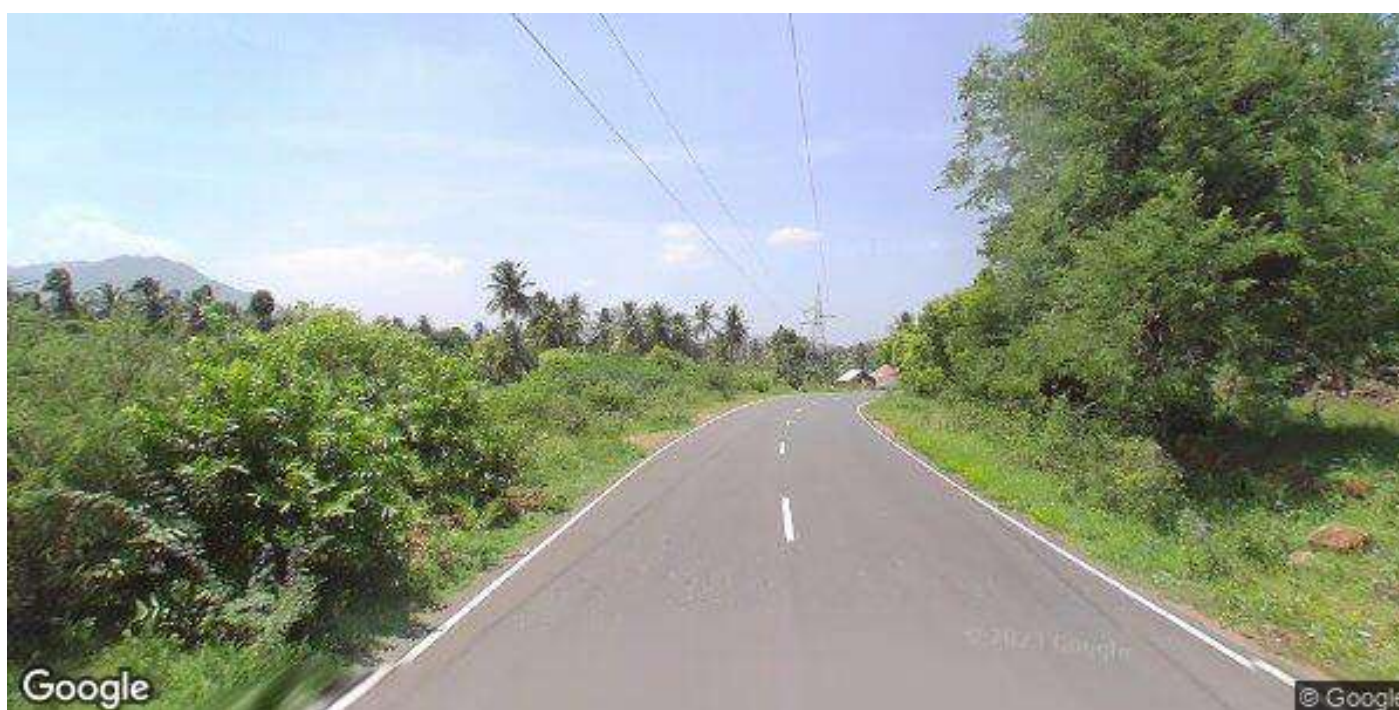
**Risk Type:** Turn  
**Risk Level:** Medium  
**Speed Limit:** 30 KM/Hr  
**Coordinates:** 11.45458, 78.40886

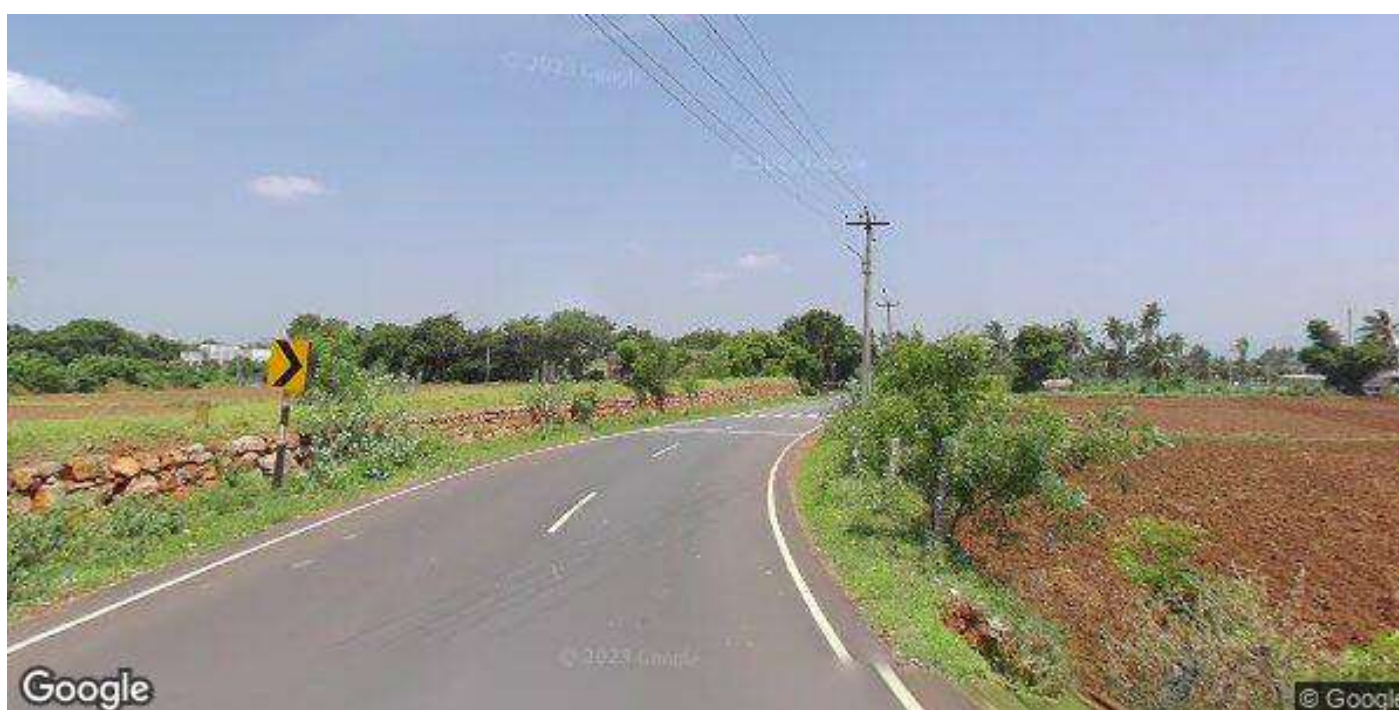
**Risk Type:** Turn  
**Risk Level:** Medium  
**Speed Limit:** 30 KM/Hr  
**Coordinates:** 11.46740, 78.45082

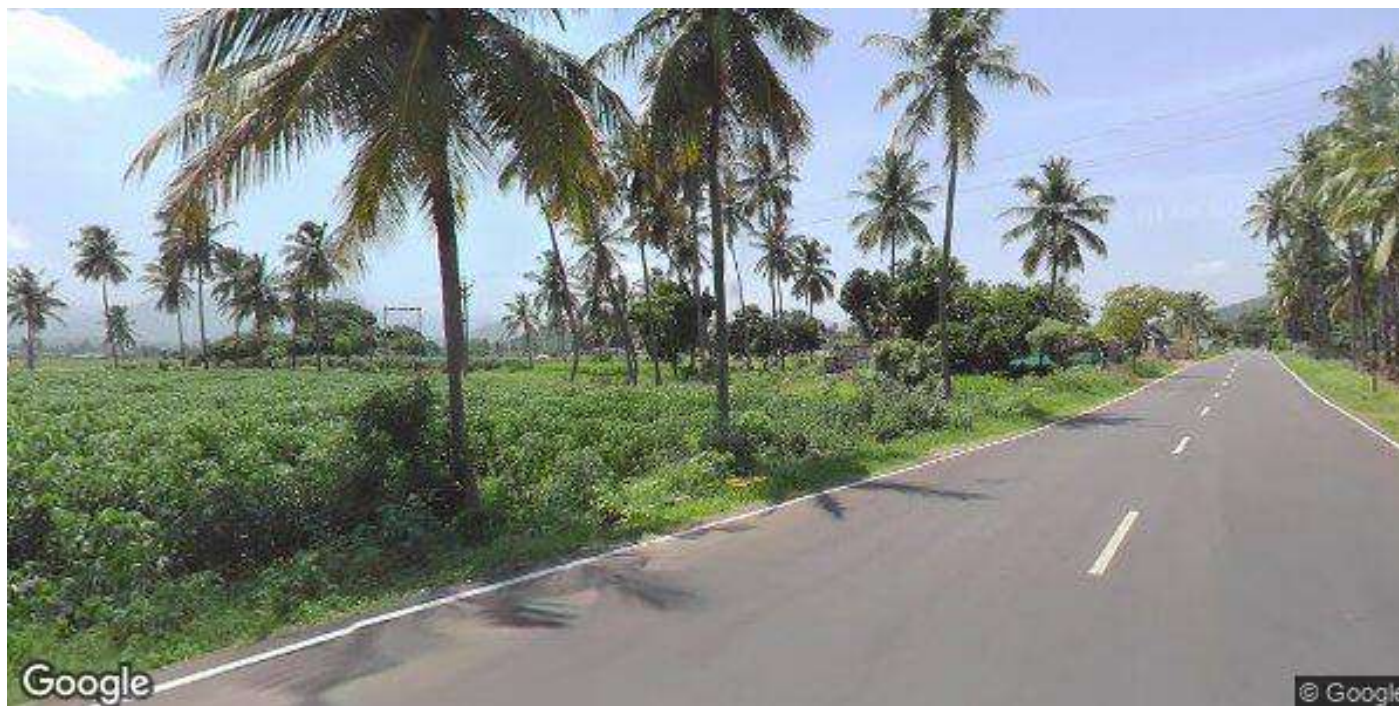
**Risk Type:** Turn  
**Risk Level:** Medium  
**Speed Limit:** 30 KM/Hr  
**Coordinates:** 11.46728, 78.45442

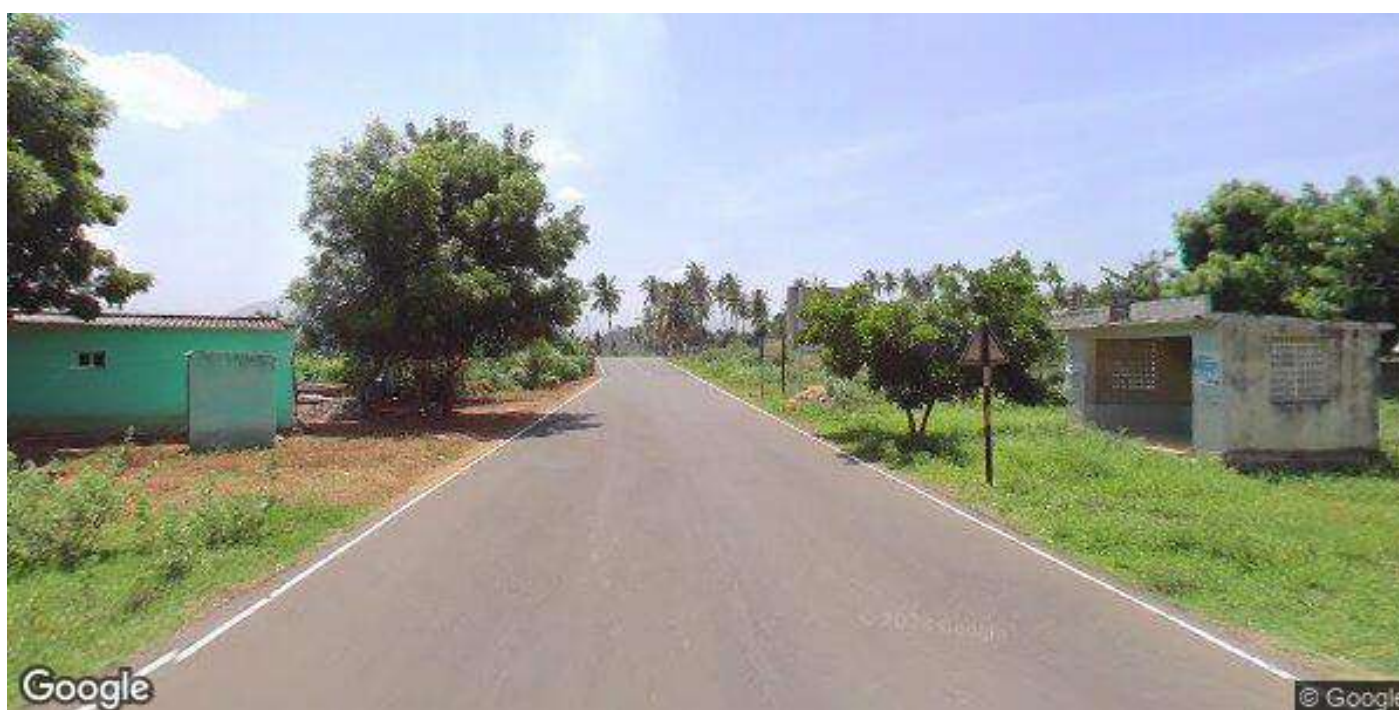
**Risk Type:** Turn  
**Risk Level:** Medium  
**Speed Limit:** 30 KM/Hr  
**Coordinates:** 11.46798, 78.45523

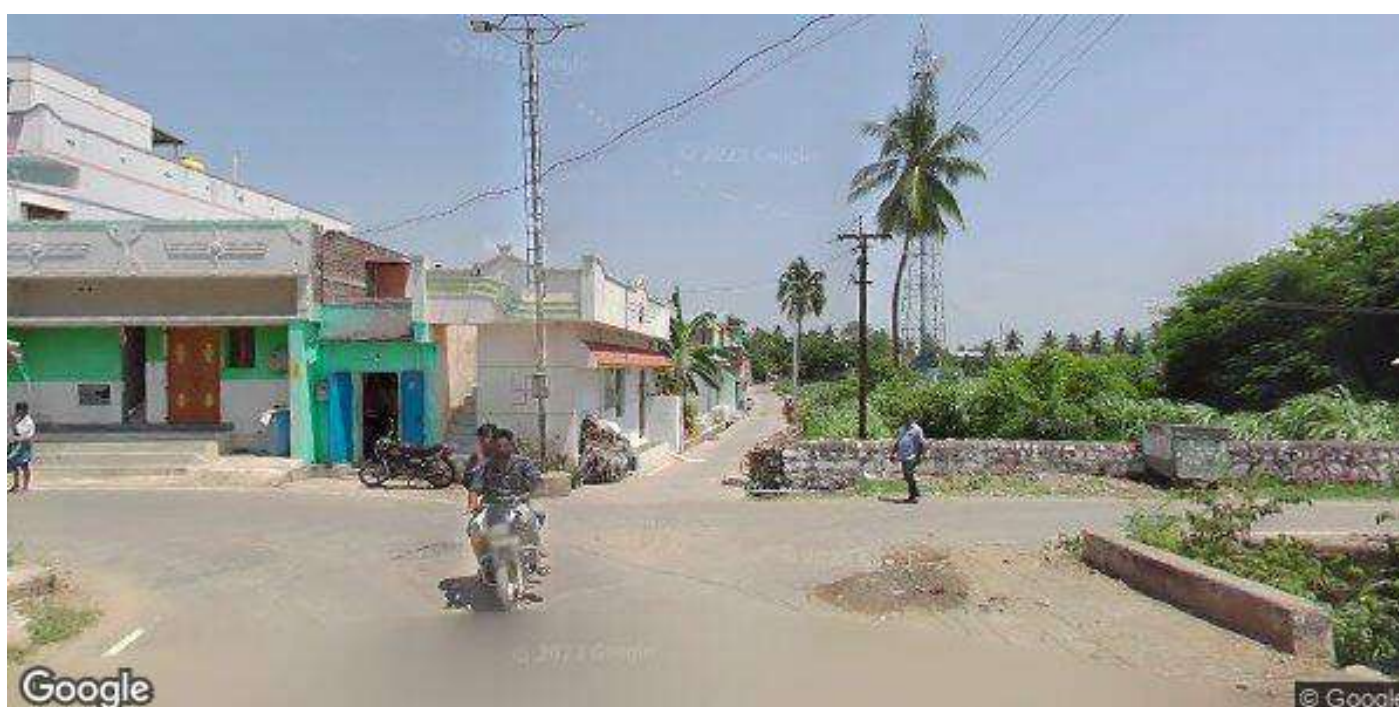
**Risk Type:** Turn  
**Risk Level:** High  
**Speed Limit:** 15 KM/Hr  
**Coordinates:** 11.46798, 78.45844

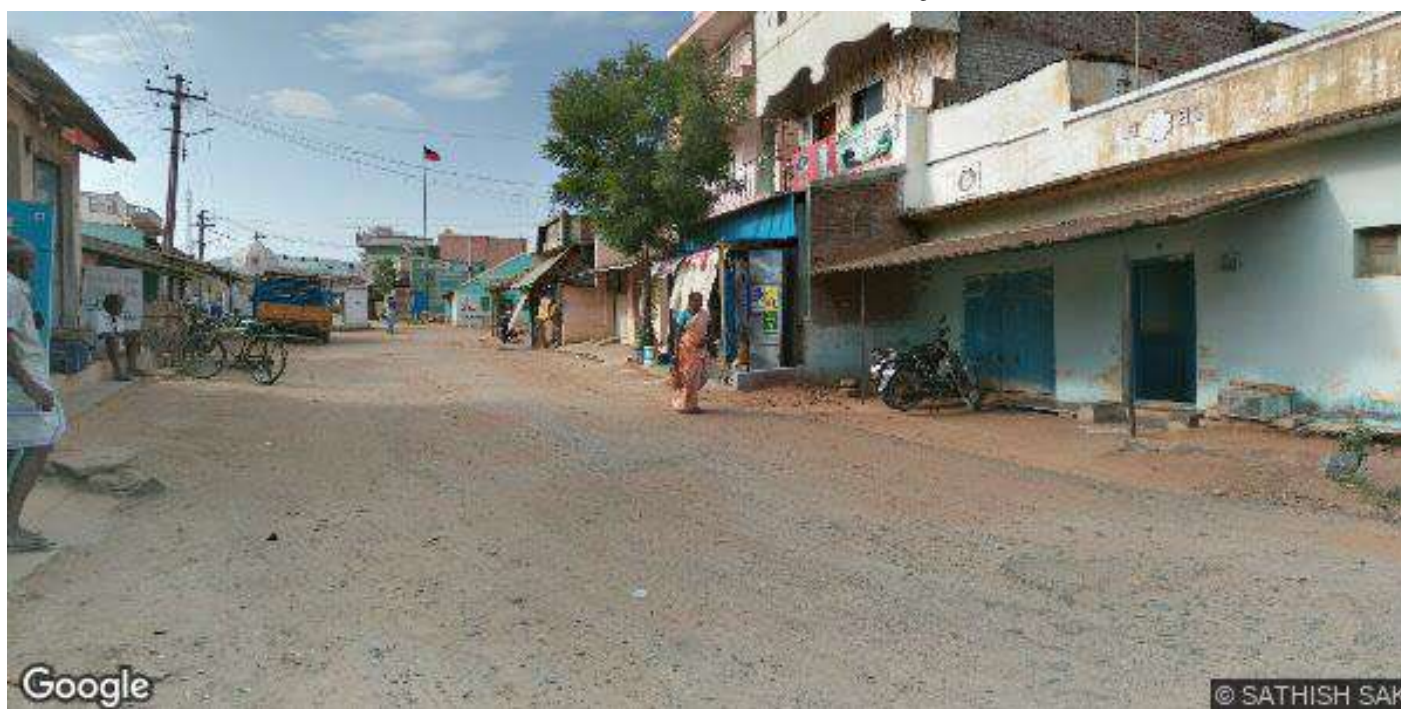
**Risk Type:** Blind Spot  
**Risk Level:** Blind Spot  
**Speed Limit:** 10 KM/Hr  
**Coordinates:** 11.46857, 78.45844

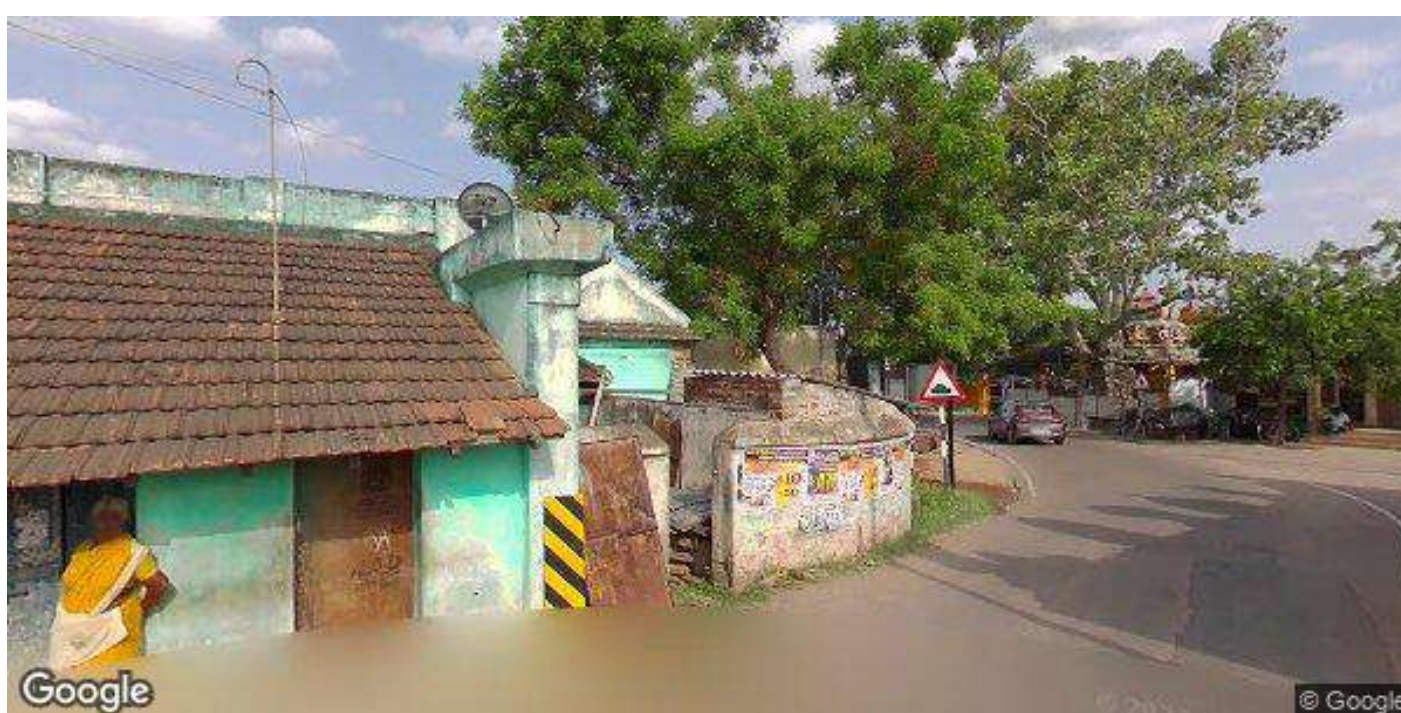
**Risk Type:** Turn  
**Risk Level:** Medium  
**Speed Limit:** 30 KM/Hr  
**Coordinates:** 11.46835, 78.45959

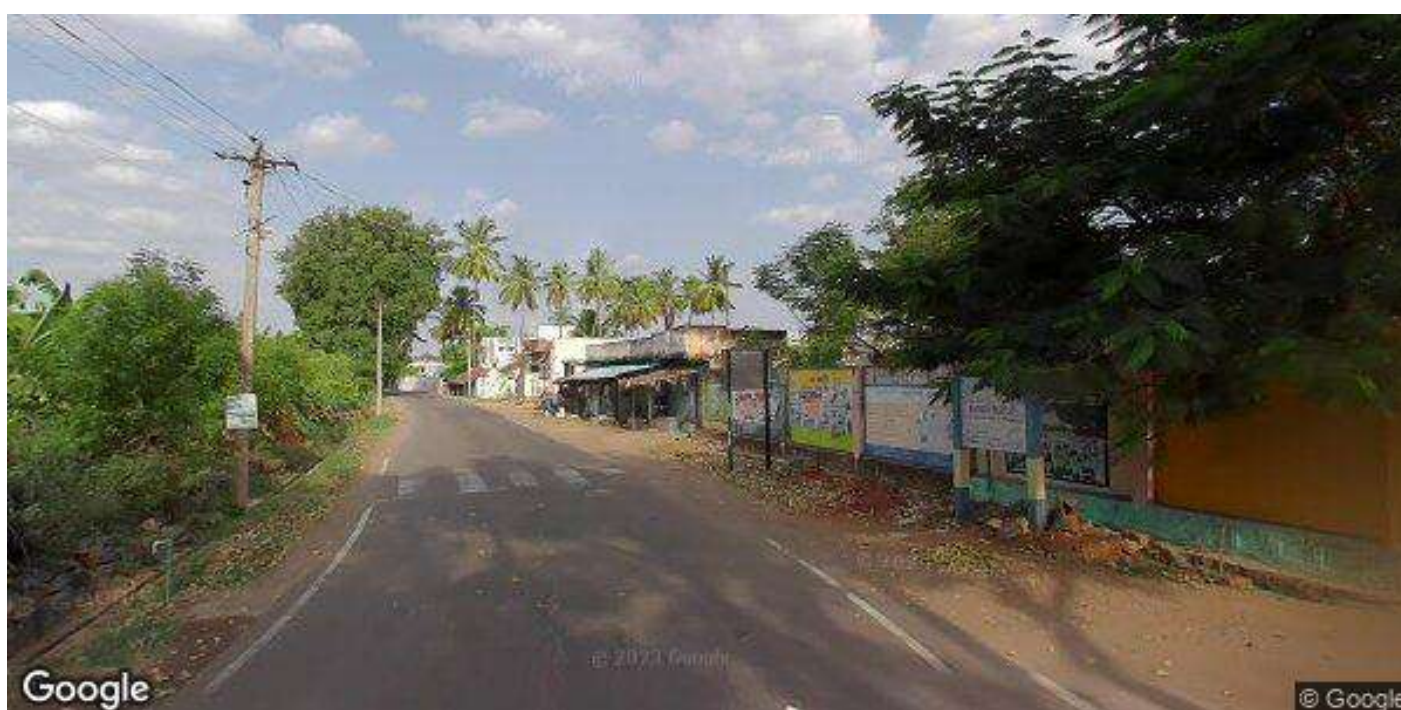
**Risk Type:** Turn  
**Risk Level:** High  
**Speed Limit:** 15 KM/Hr  
**Coordinates:** 11.46800, 78.45987

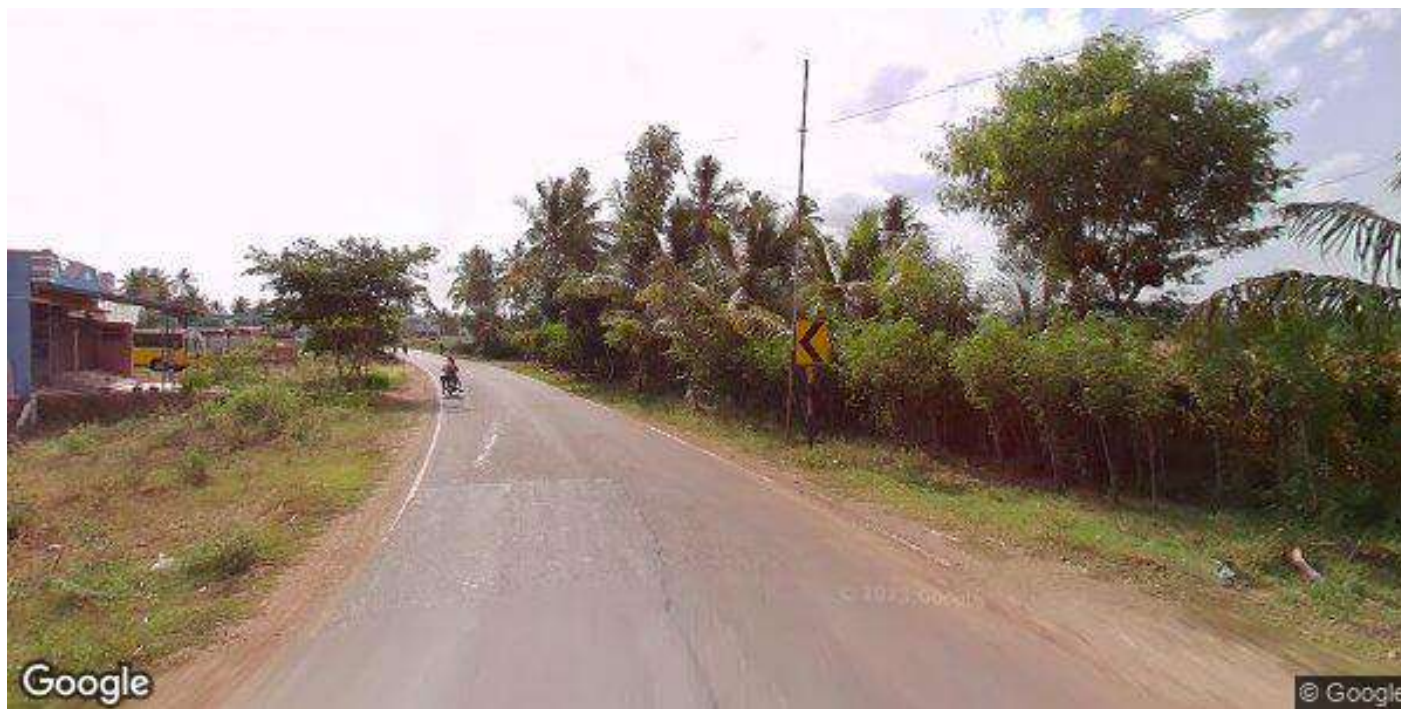
**Risk Type:** Turn  
**Risk Level:** Medium  
**Speed Limit:** 30 KM/Hr  
**Coordinates:** 11.46461, 78.47397

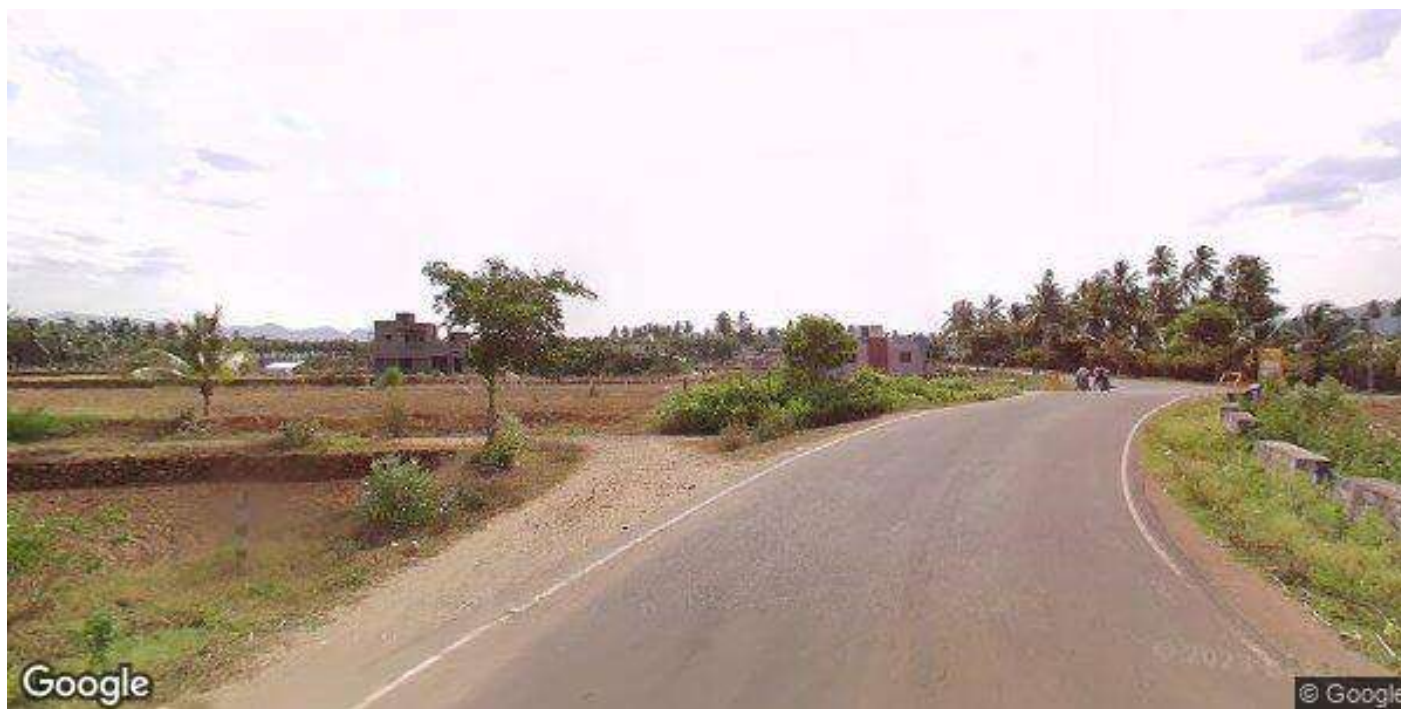
**Risk Type:** Turn  
**Risk Level:** Medium  
**Speed Limit:** 30 KM/Hr  
**Coordinates:** 11.46419, 78.47445

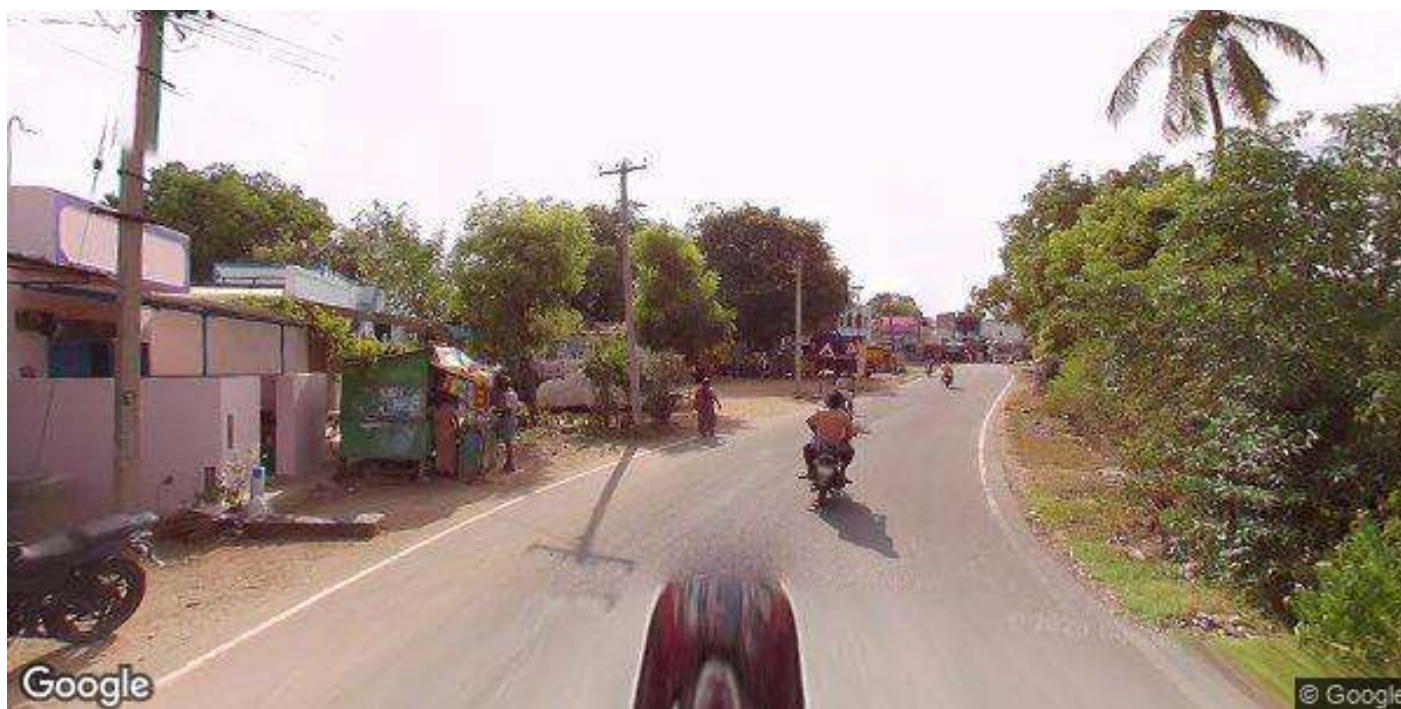
**Risk Type:** Turn  
**Risk Level:** Medium  
**Speed Limit:** 30 KM/Hr  
**Coordinates:** 11.46211, 78.48159

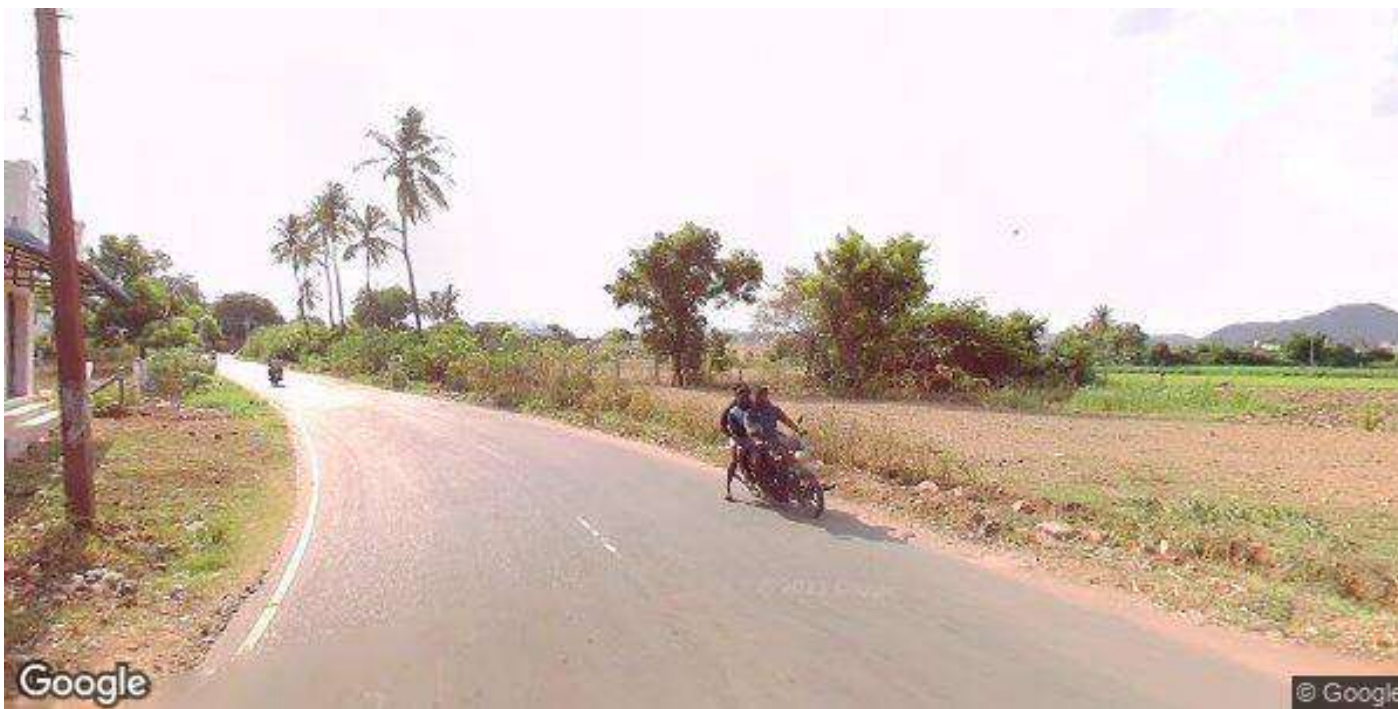
**Risk Type:** Turn  
**Risk Level:** Medium  
**Speed Limit:** 30 KM/Hr  
**Coordinates:** 11.46184, 78.48270
