# IndianOil

## JOURNEY RISK MANAGEMENT (JRM) STUDY

### Salem Terminal to KAVIRAJ AGENCY

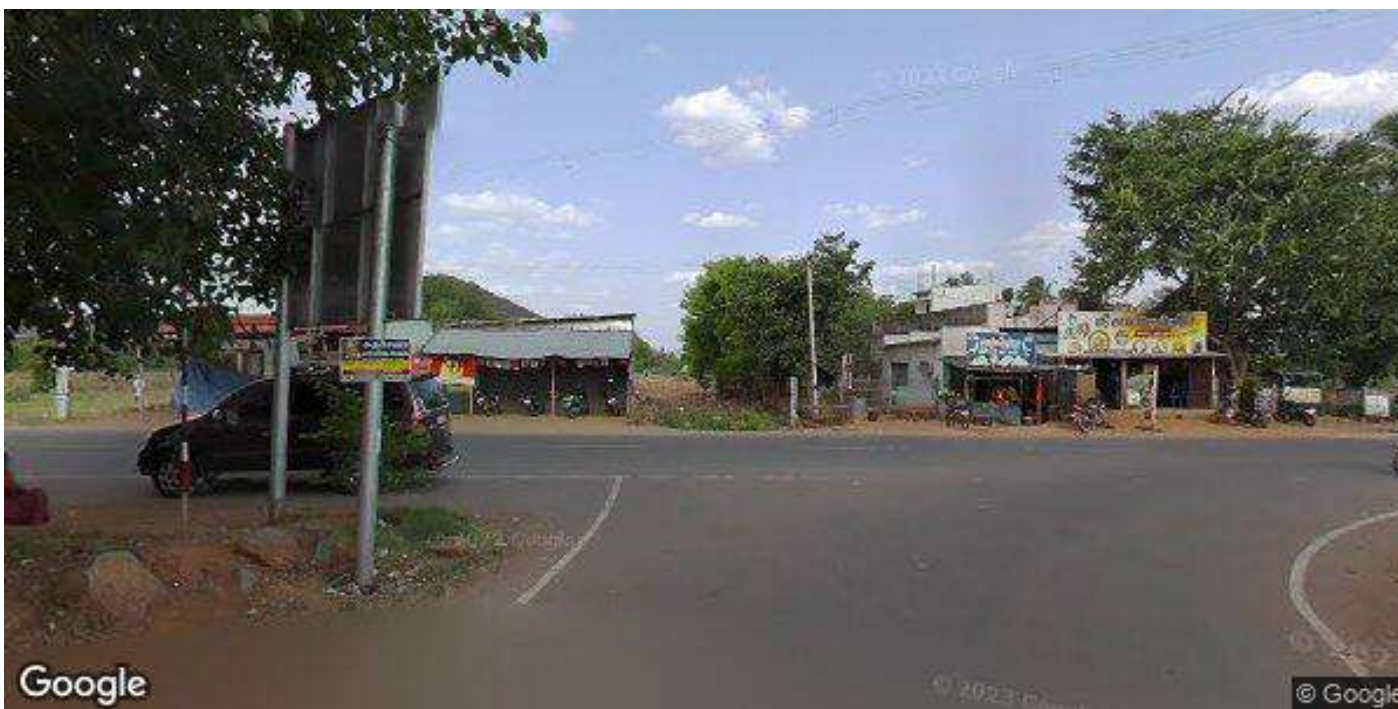
**Risk Type:** Turn  
**Risk Level:** Medium  
**Speed Limit:** 30 KM/Hr  
**Coordinates:** 11.46106, 78.48357

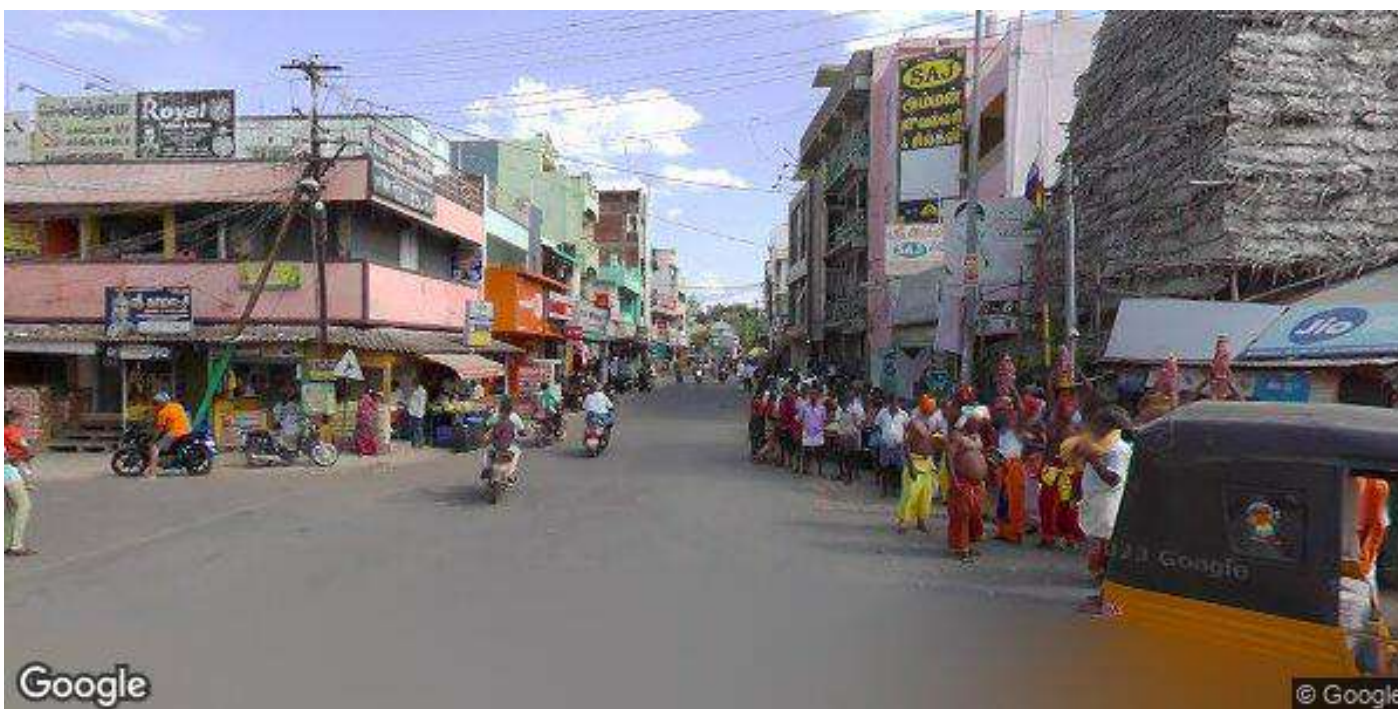
**Risk Type:** Blind Spot  
**Risk Level:** Blind Spot  
**Speed Limit:** 10 KM/Hr  
**Coordinates:** 11.44233, 78.48592

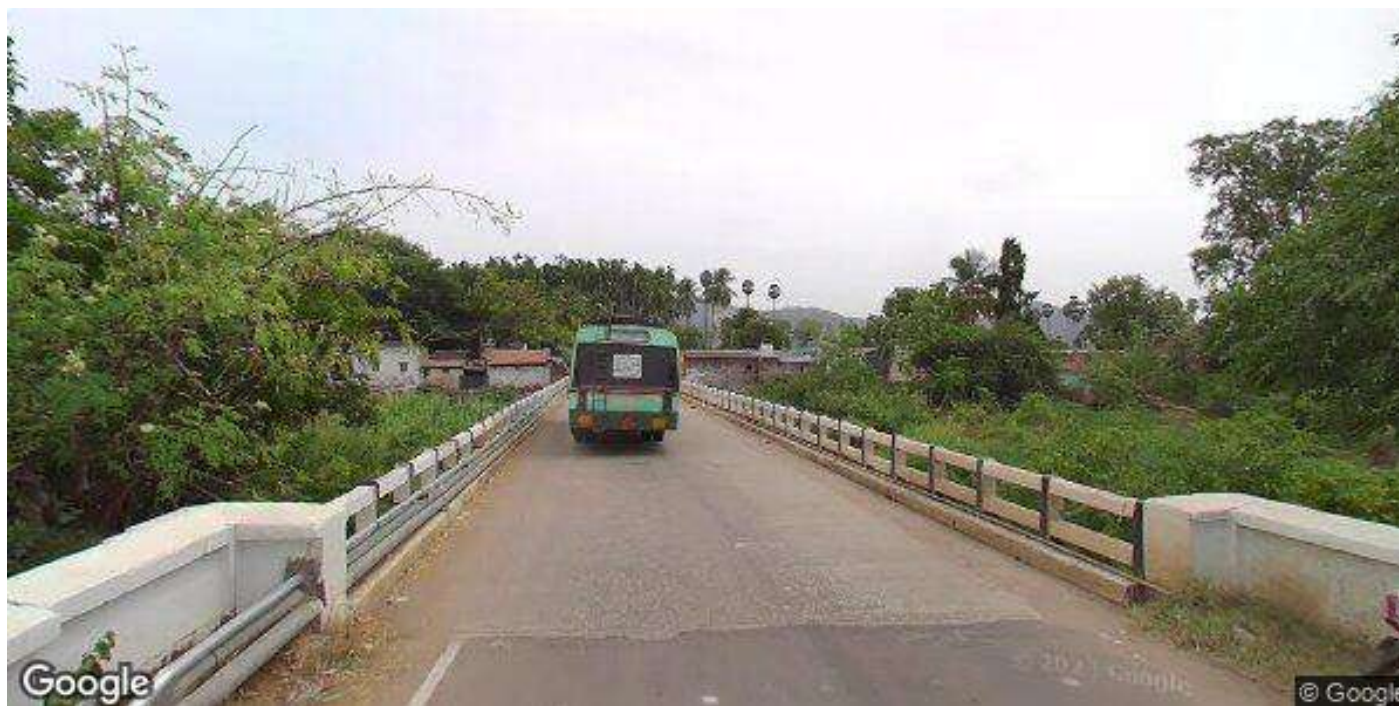
**Risk Type:** Turn  
**Risk Level:** High  
**Speed Limit:** 15 KM/Hr  
**Coordinates:** 11.45641, 78.52757

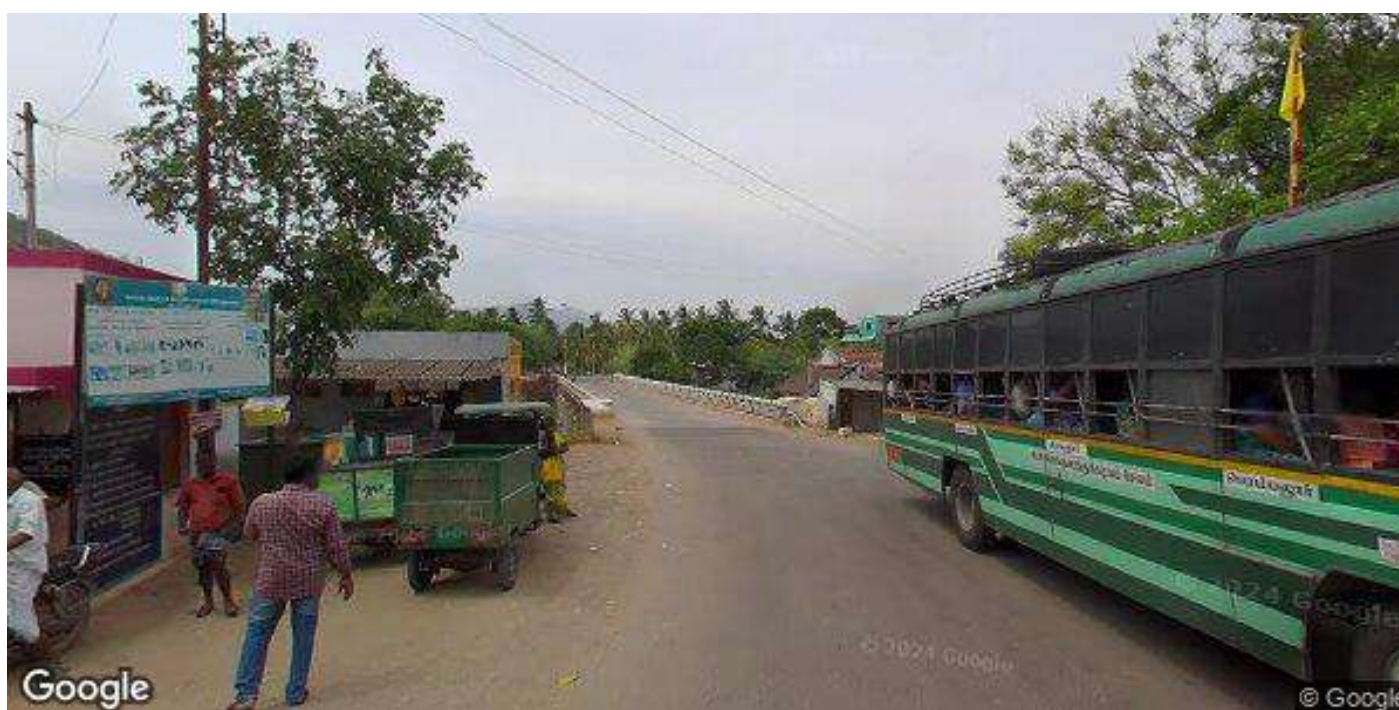
**Risk Type:** Turn  
**Risk Level:** High  
**Speed Limit:** 15 KM/Hr  
**Coordinates:** 11.45723, 78.52761

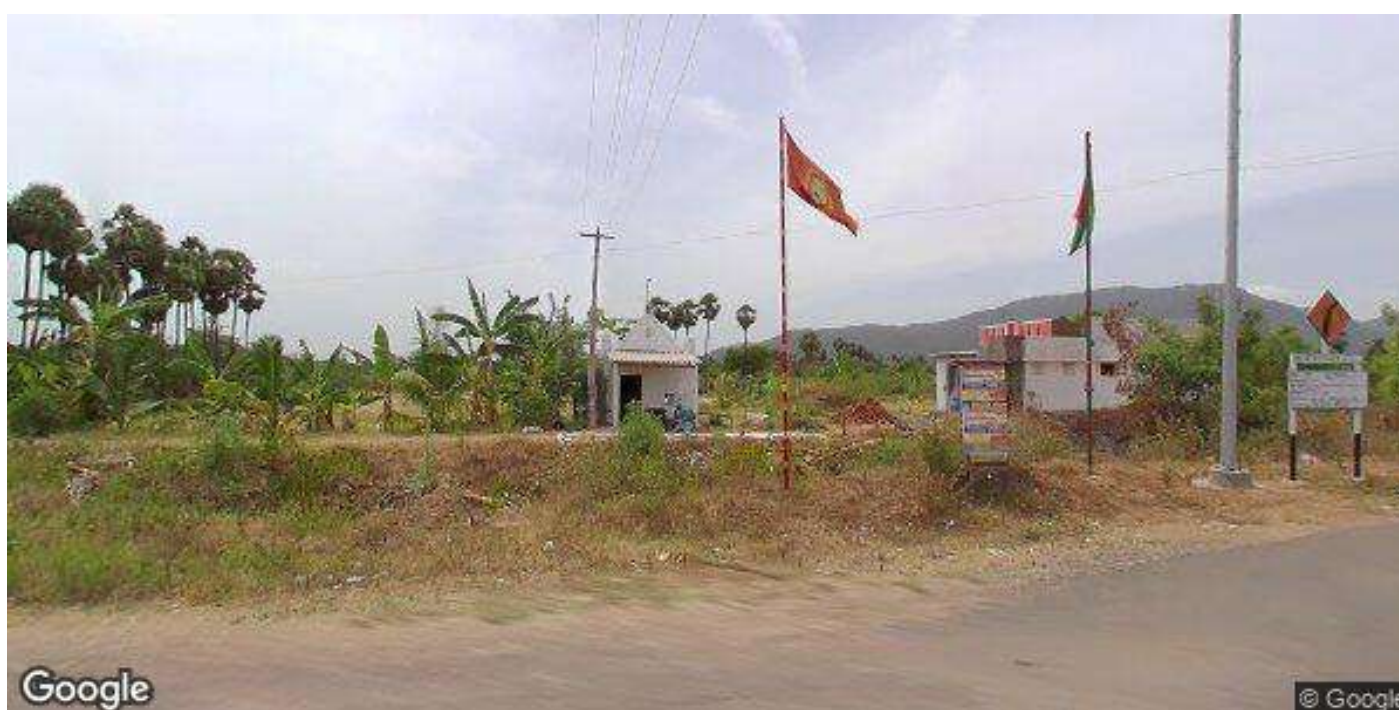
**Risk Type:** Turn  
**Risk Level:** Medium  
**Speed Limit:** 30 KM/Hr  
**Coordinates:** 11.48770, 78.63405

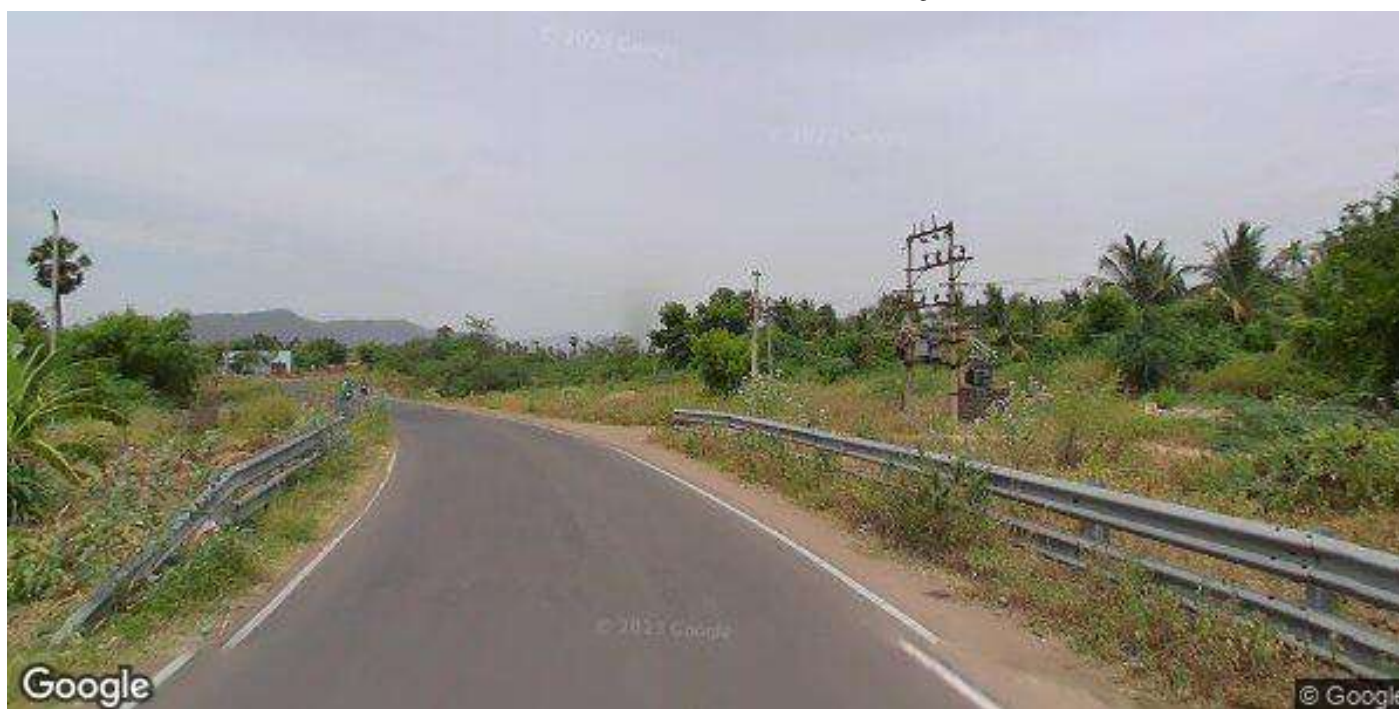
**Risk Type:** Turn  
**Risk Level:** High  
**Speed Limit:** 15 KM/Hr  
**Coordinates:** 11.48870, 78.63452

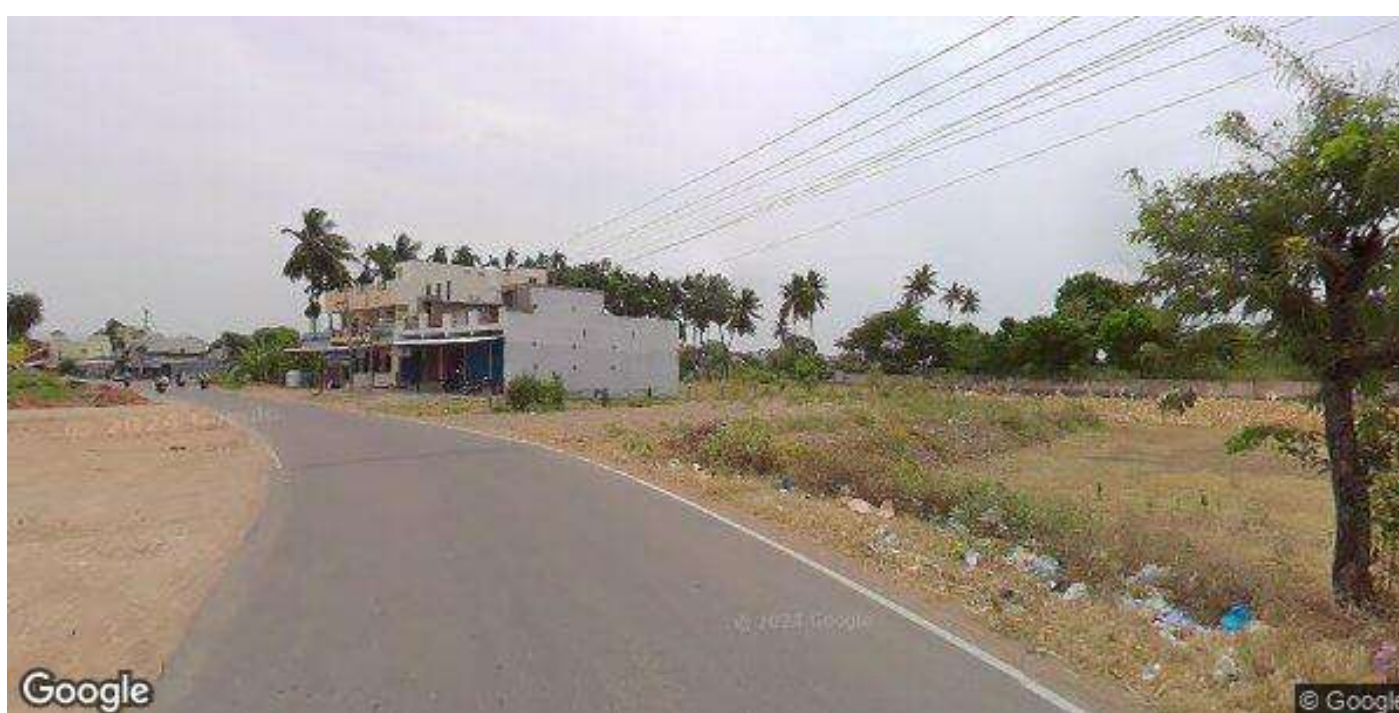
**Risk Type:** Turn  
**Risk Level:** Medium  
**Speed Limit:** 30 KM/Hr  
**Coordinates:** 11.49431, 78.64705

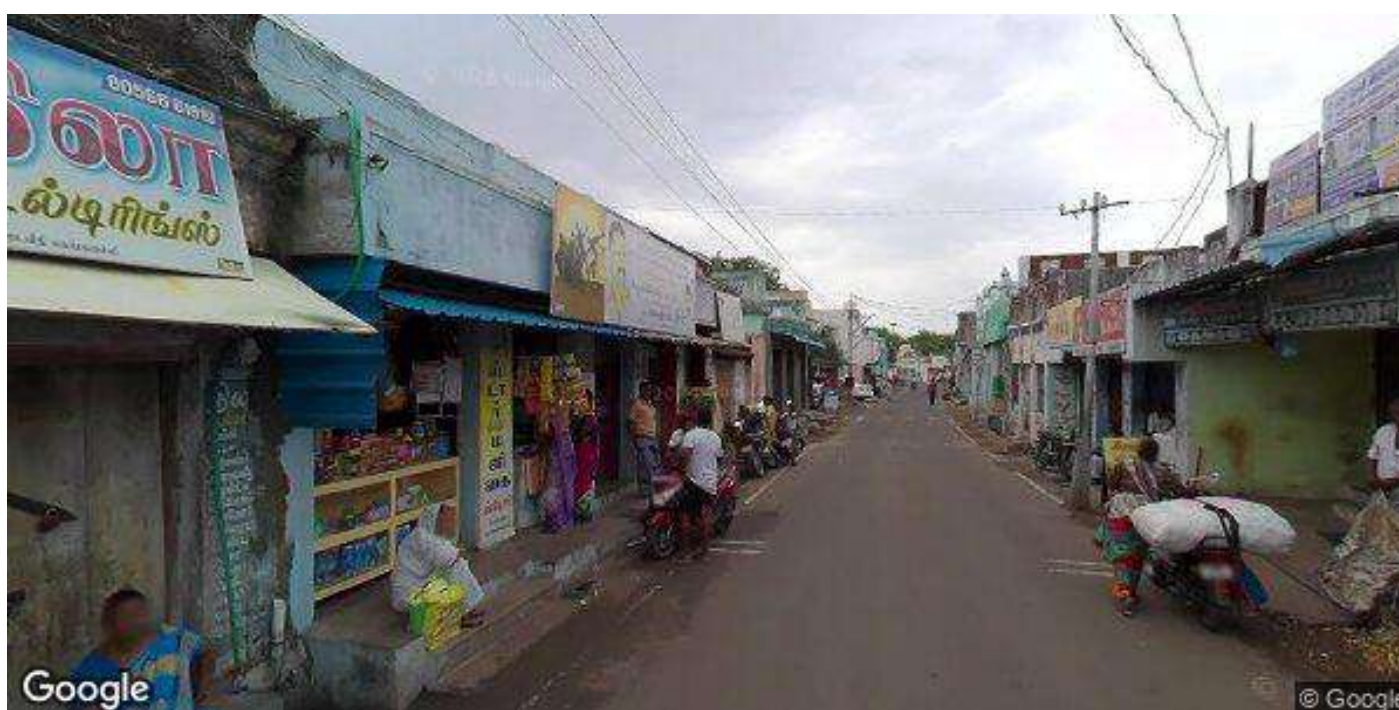
**Risk Type:** Turn  
**Risk Level:** High  
**Speed Limit:** 15 KM/Hr  
**Coordinates:** 11.49697, 78.64738
