# IndianOil

## JOURNEY RISK MANAGEMENT (JRM) STUDY

**Salem Terminal to CHAKRAVARTHY & CO**

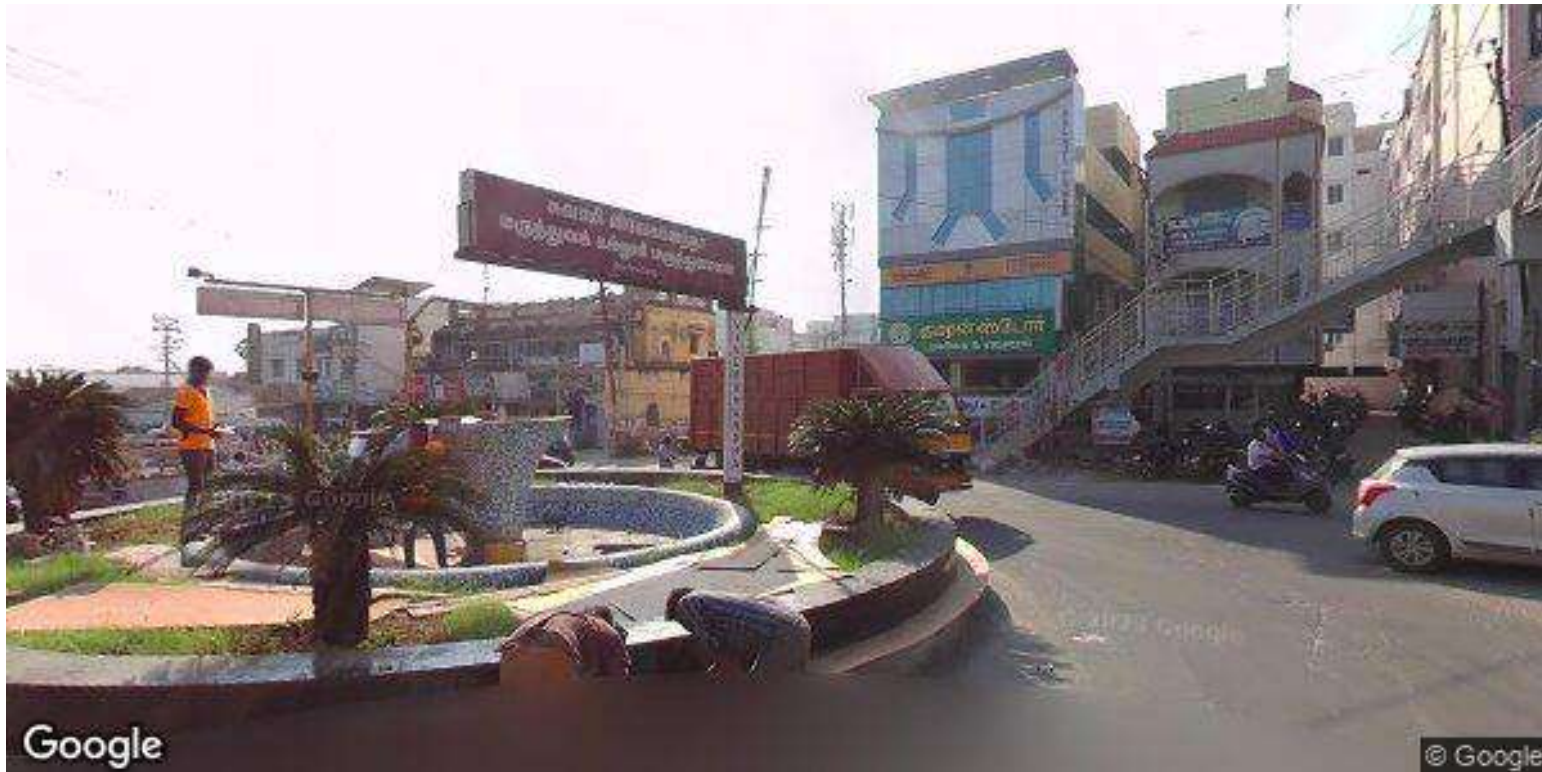
**Coordinates:** 11.38395, 77.89480

**Risk Type:** Roundabout

**Risk Level:** High

**Speed Limit:** 15 KM/Hr

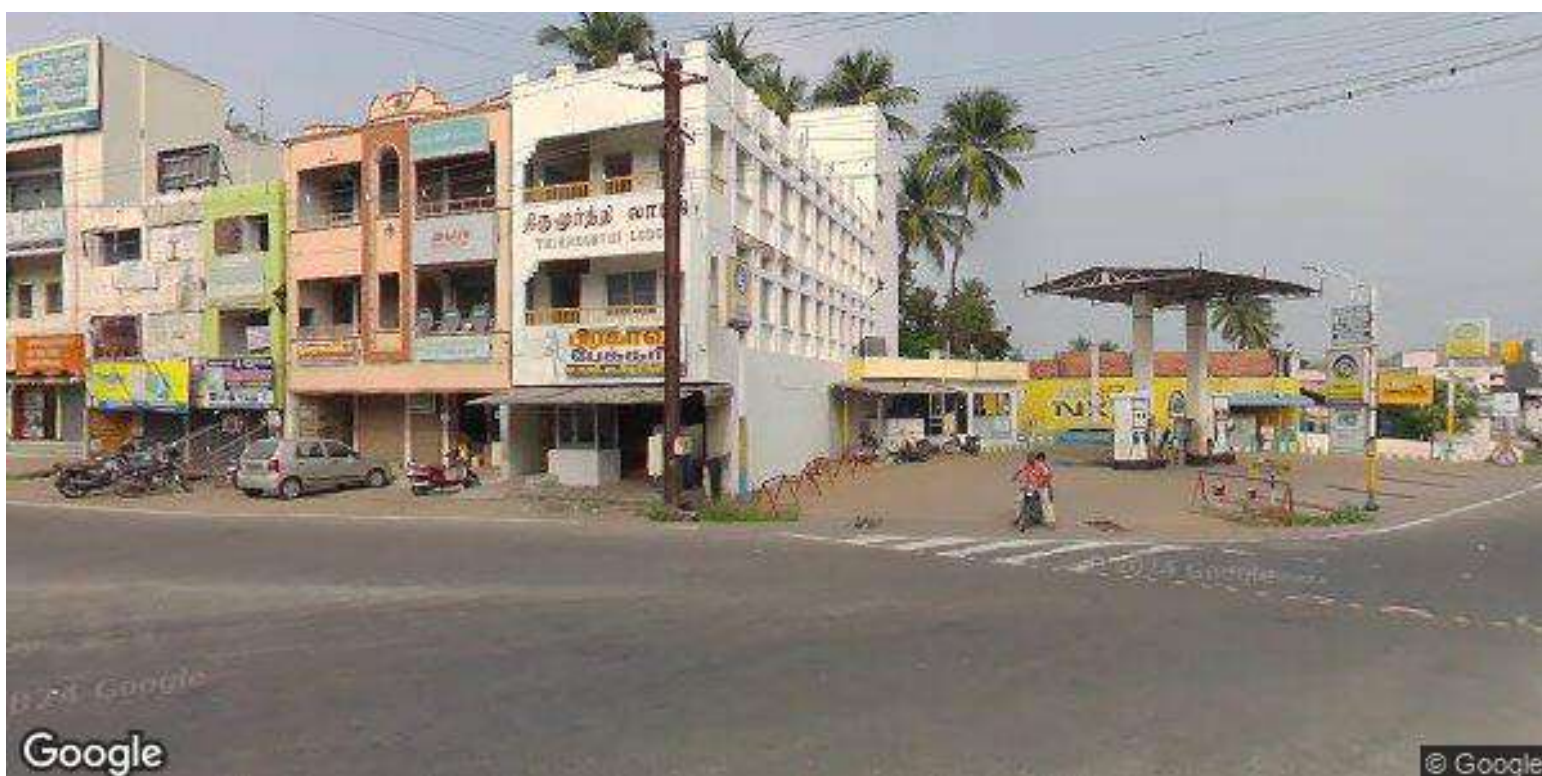
**Coordinates:** 11.00172, 77.56268

**Risk Type:** Roundabout

**Risk Level:** High

**Speed Limit:** 15 KM/Hr

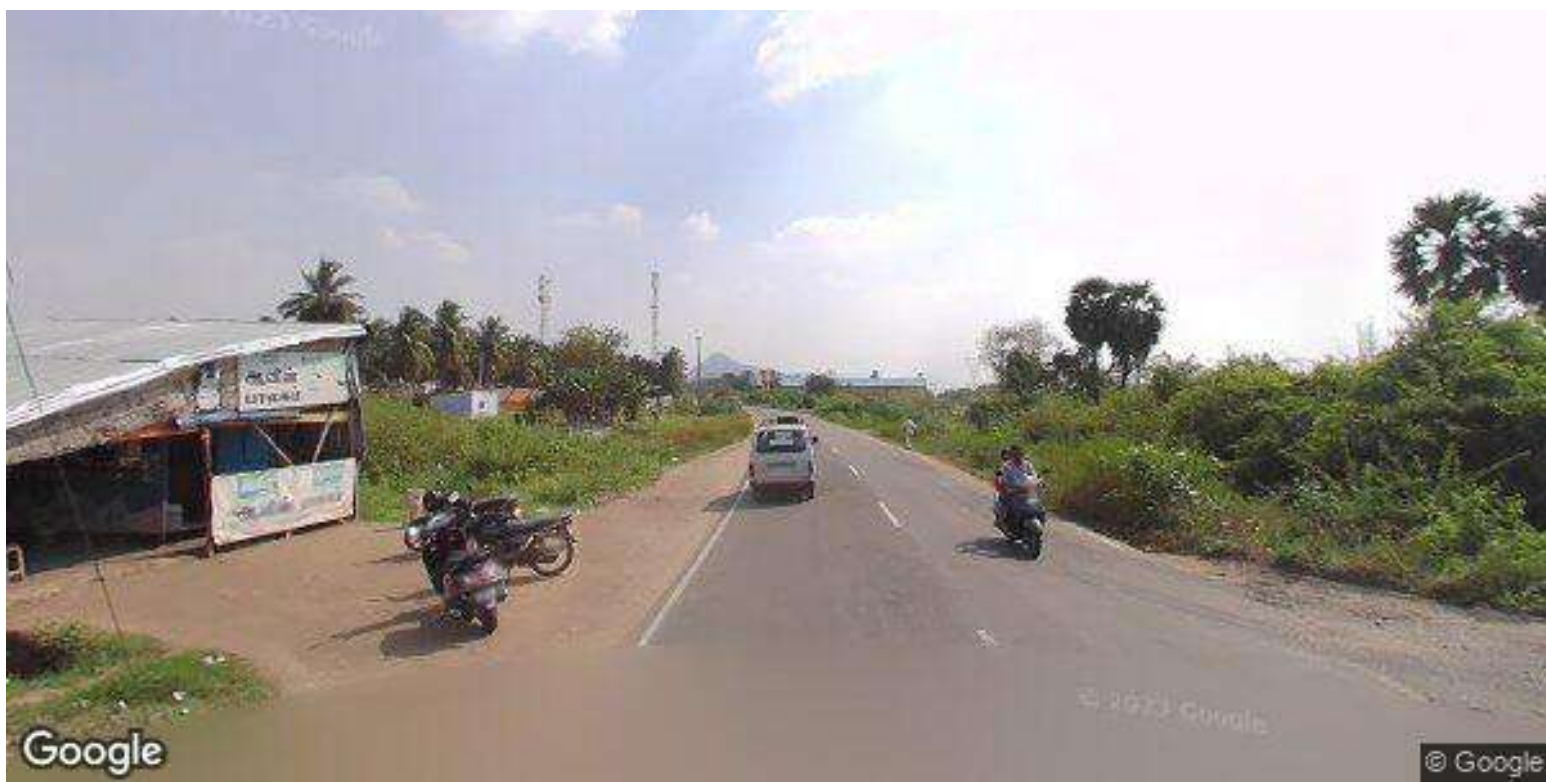
**Coordinates:** 11.44022, 77.87546

**Risk Type:** Turn

**Risk Level:** High

**Speed Limit:** 15 KM/Hr

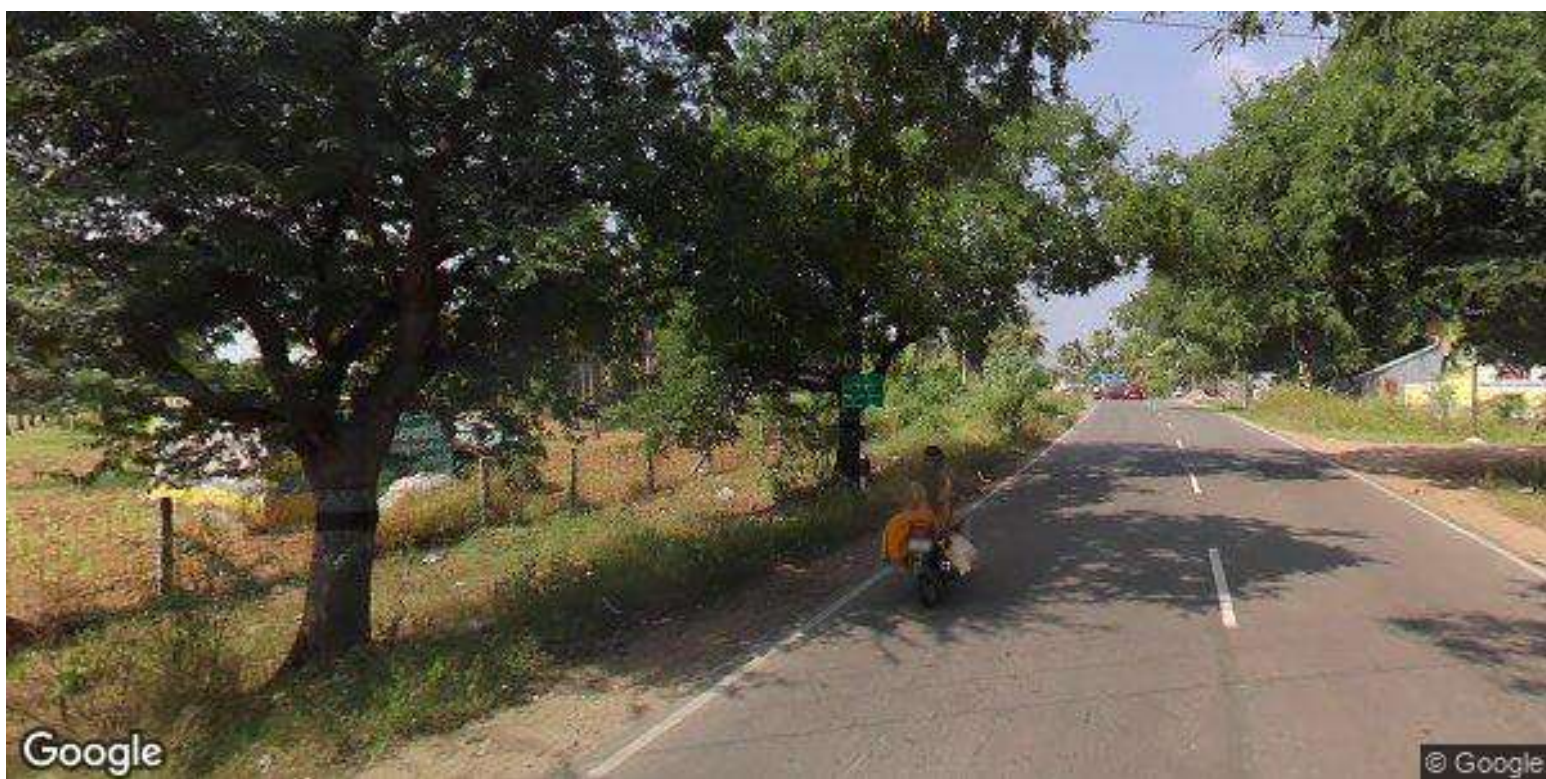
**Coordinates:** 11.43107, 77.88171

**Risk Type:** Turn

**Risk Level:** Medium

**Speed Limit:** 30 KM/Hr

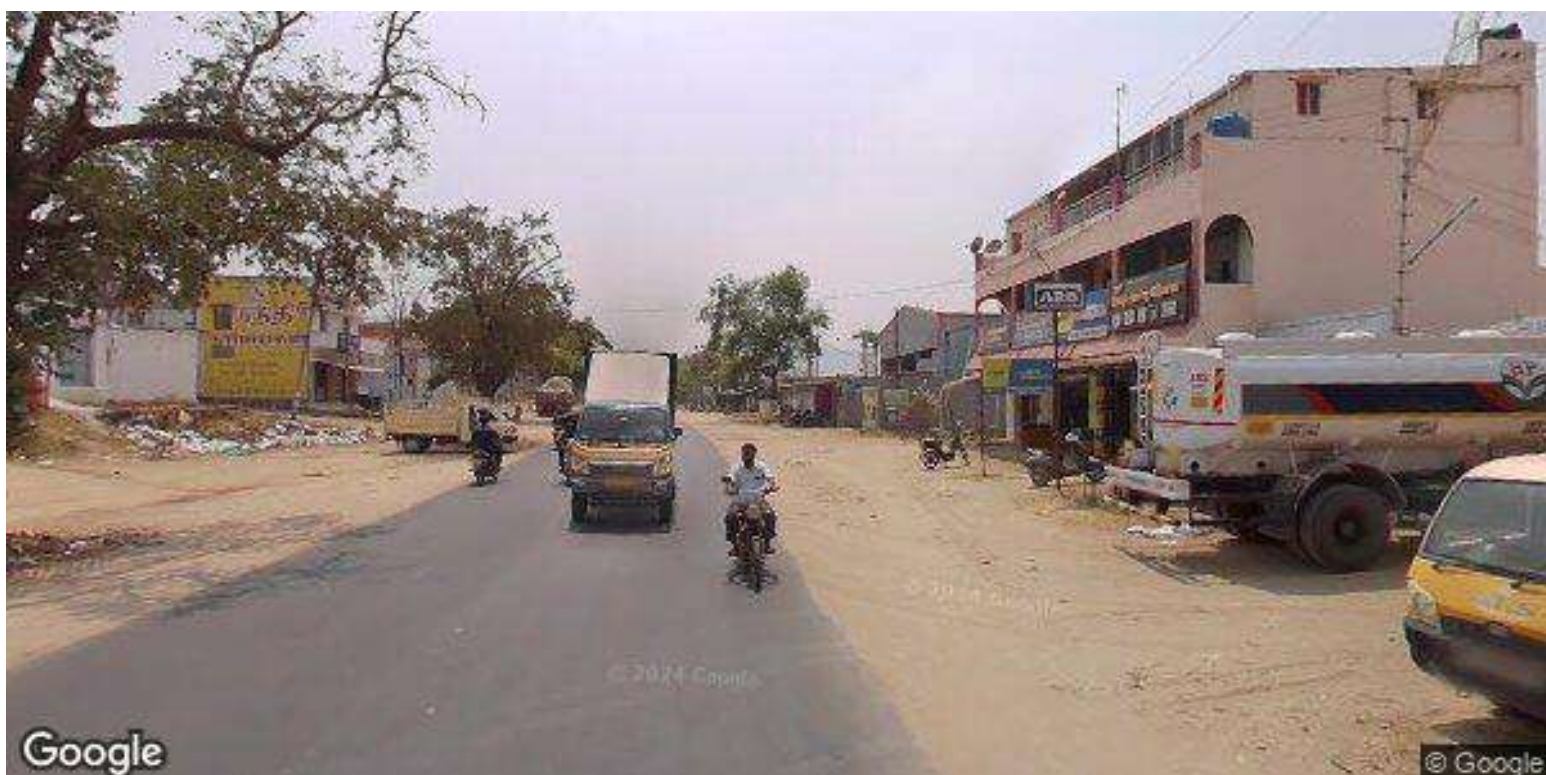
**Coordinates: 11.39976, 77.88382**

**Risk Type: Turn**

**Risk Level: Medium**

**Speed Limit: 30 KM/Hr**

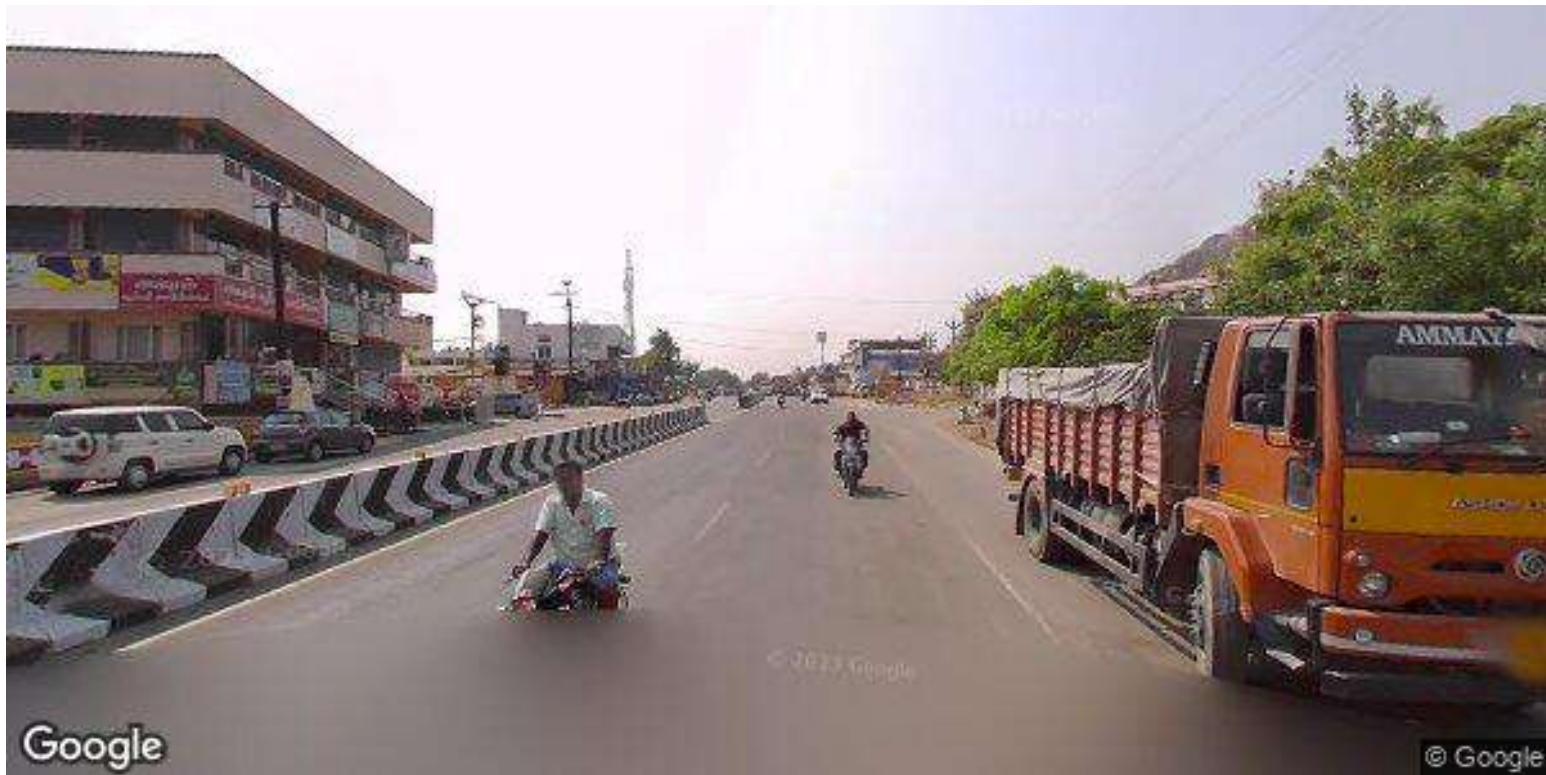
**Coordinates: 11.39690, 77.88852**

**Risk Type: Turn**

**Risk Level: Medium**

**Speed Limit: 30 KM/Hr**

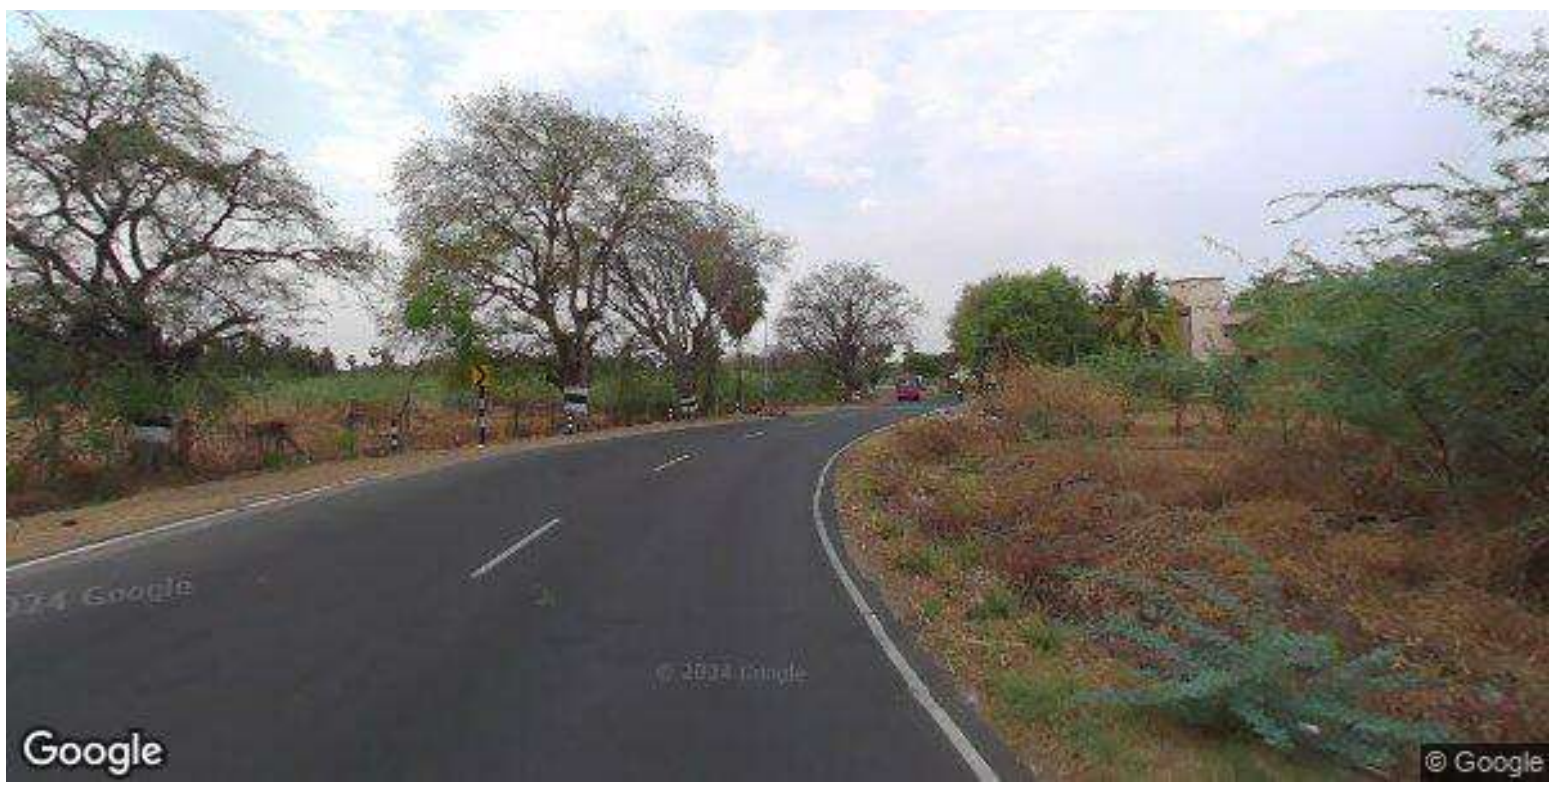
**Coordinates:** 11.34067, 77.86347

**Risk Type:** Turn

**Risk Level:** Medium

**Speed Limit:** 30 KM/Hr

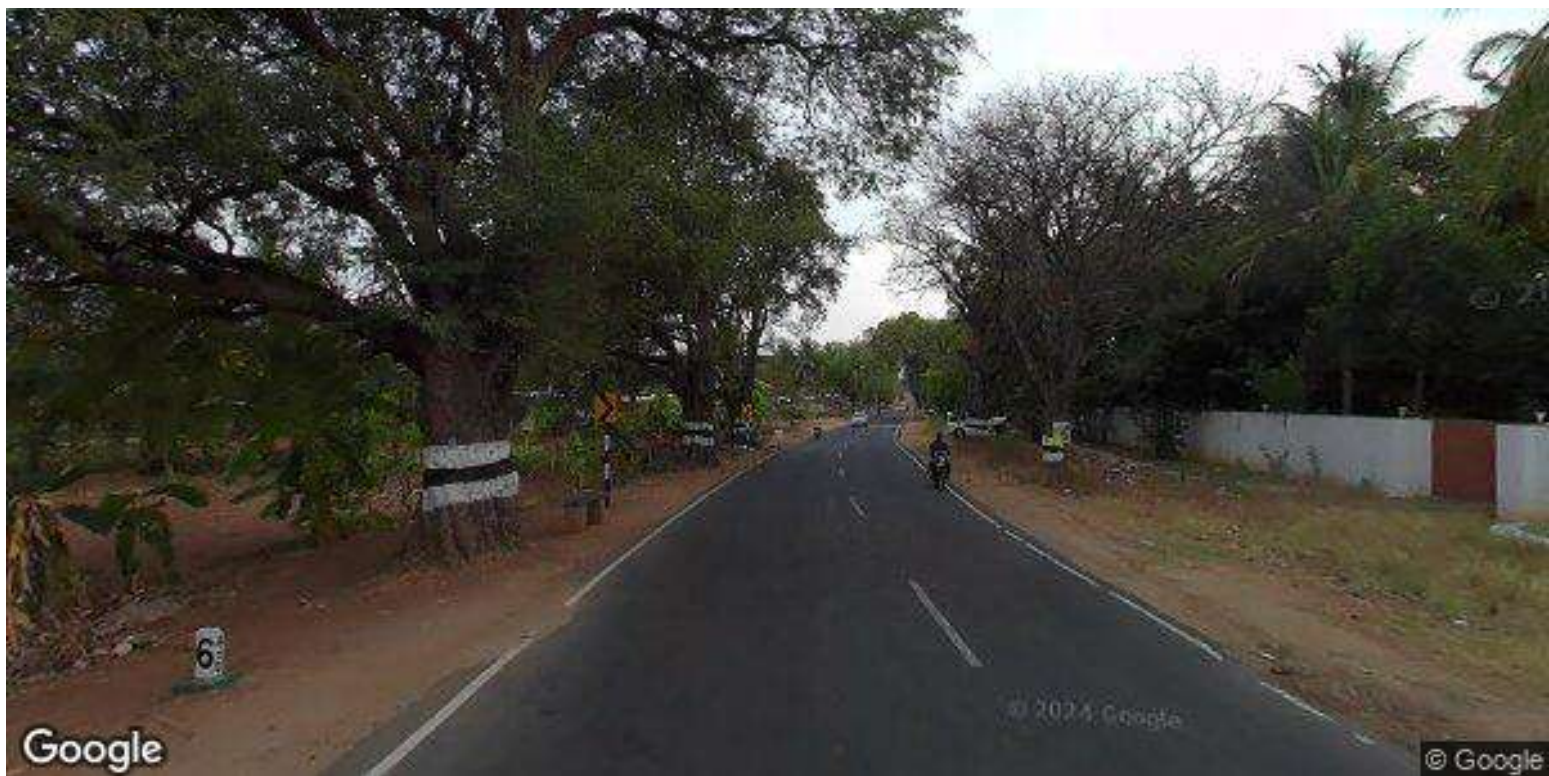
**Coordinates:** 11.33561, 77.86176

**Risk Type:** Turn

**Risk Level:** Medium

**Speed Limit:** 30 KM/Hr

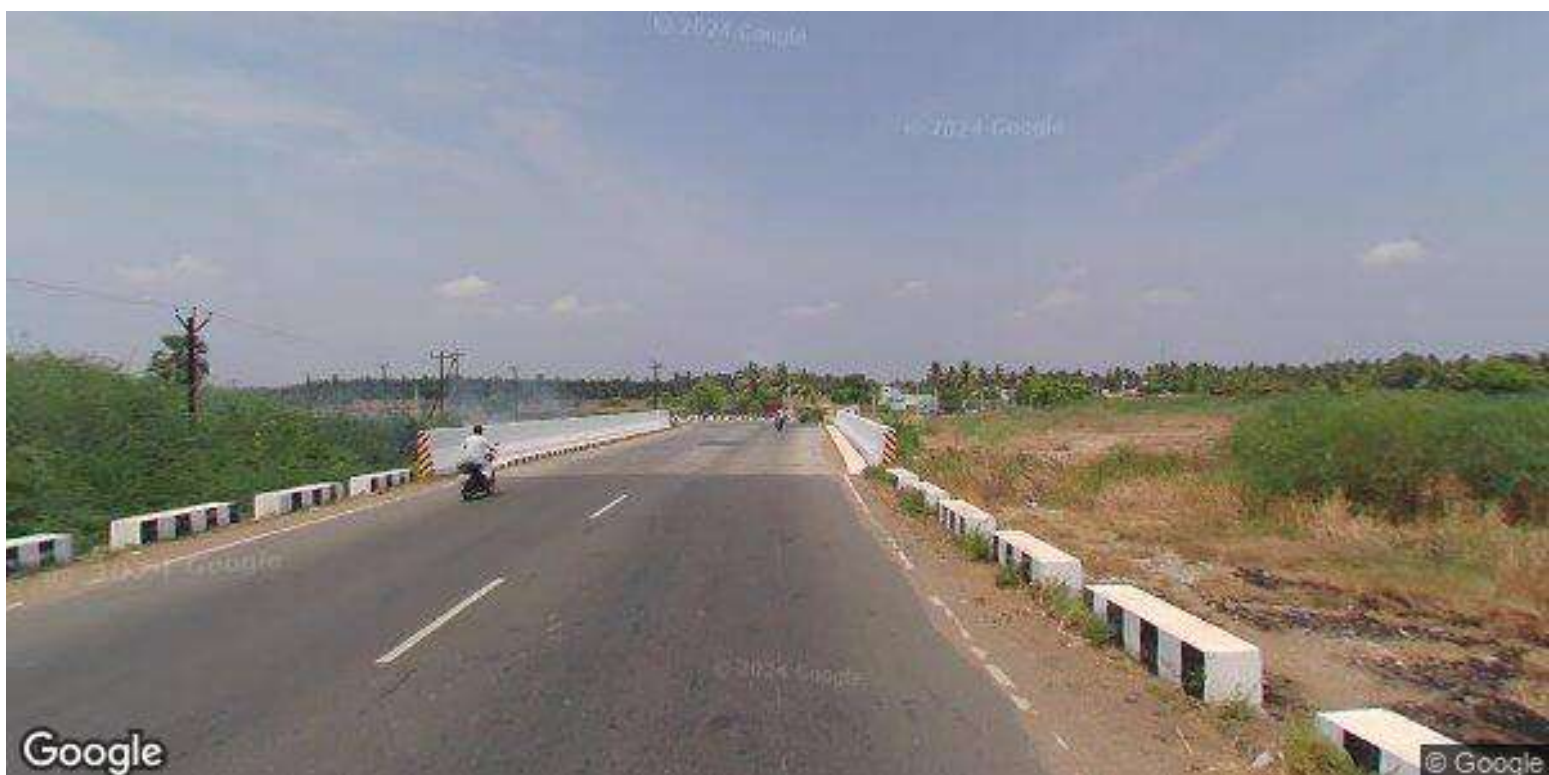
**Risk Type:** Turn  
**Risk Level:** Medium  
**Speed Limit:** 30 KM/Hr  
**Coordinates:** 11.31777, 77.84310

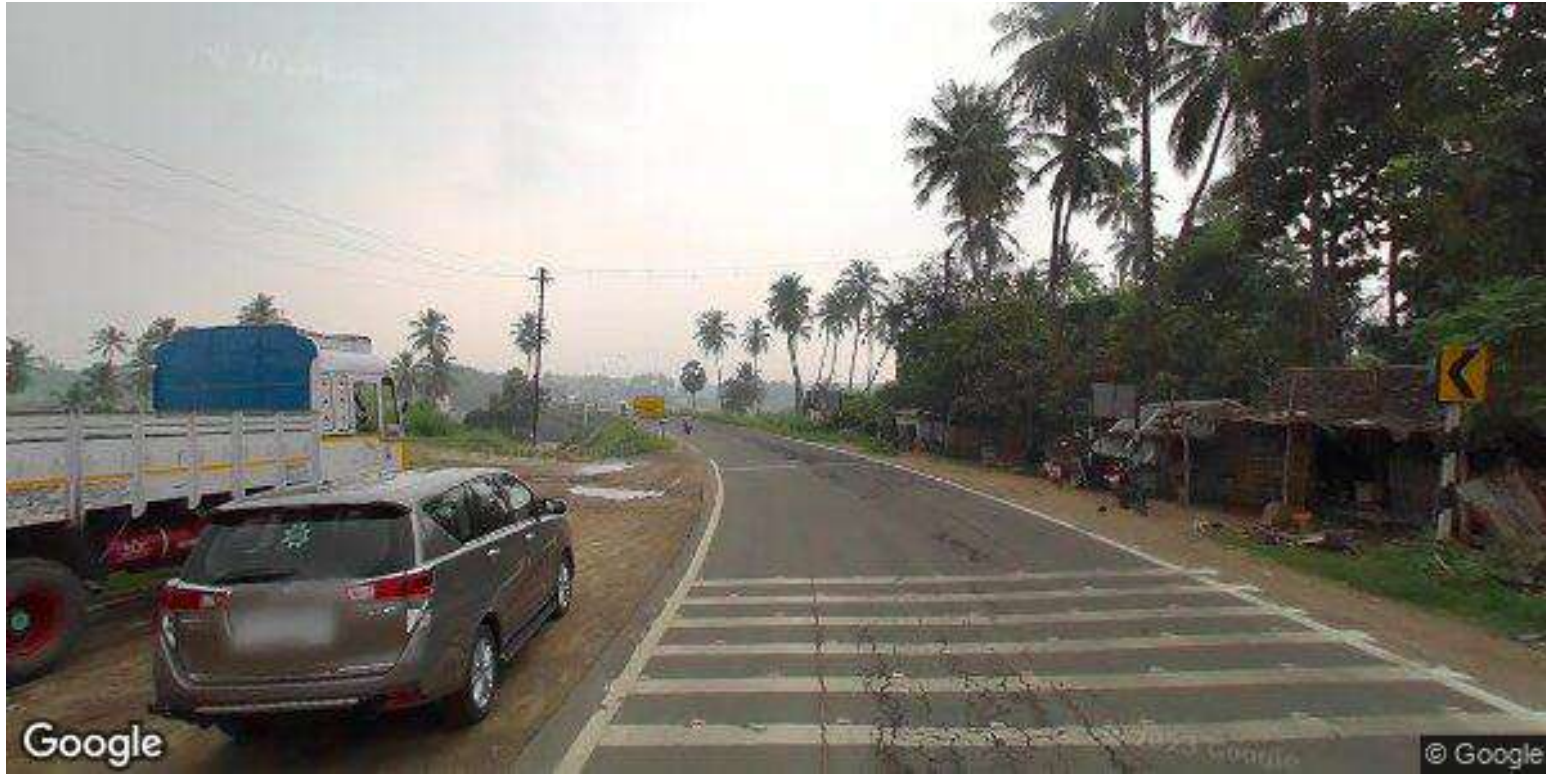
**Risk Type:** Turn  
**Risk Level:** Medium  
**Speed Limit:** 30 KM/Hr  
**Coordinates:** 11.30952, 77.77587

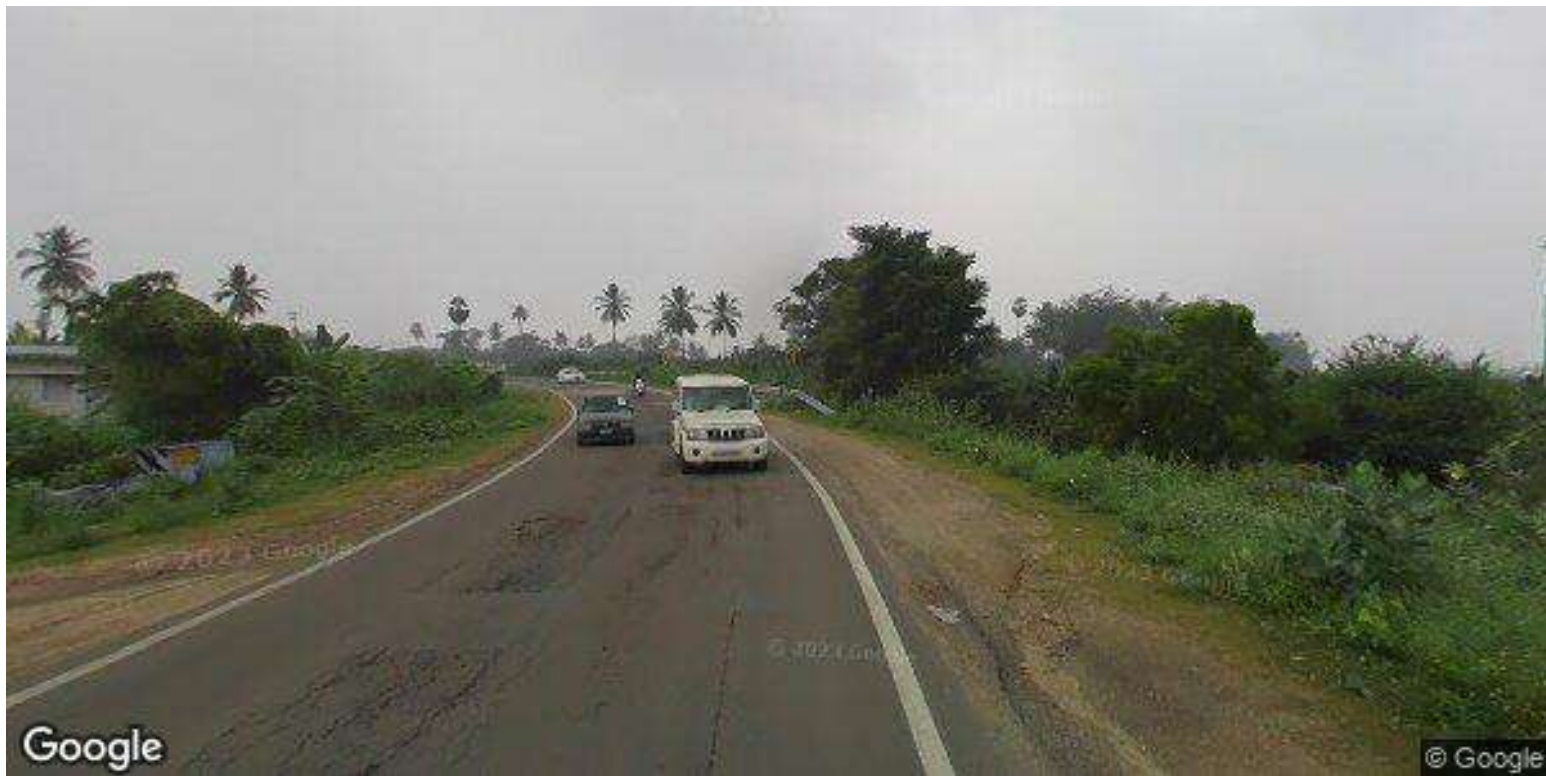
**Risk Type:** Turn  
**Risk Level:** Medium  
**Speed Limit:** 30 KM/Hr  
**Coordinates:** 11.31111, 77.77178

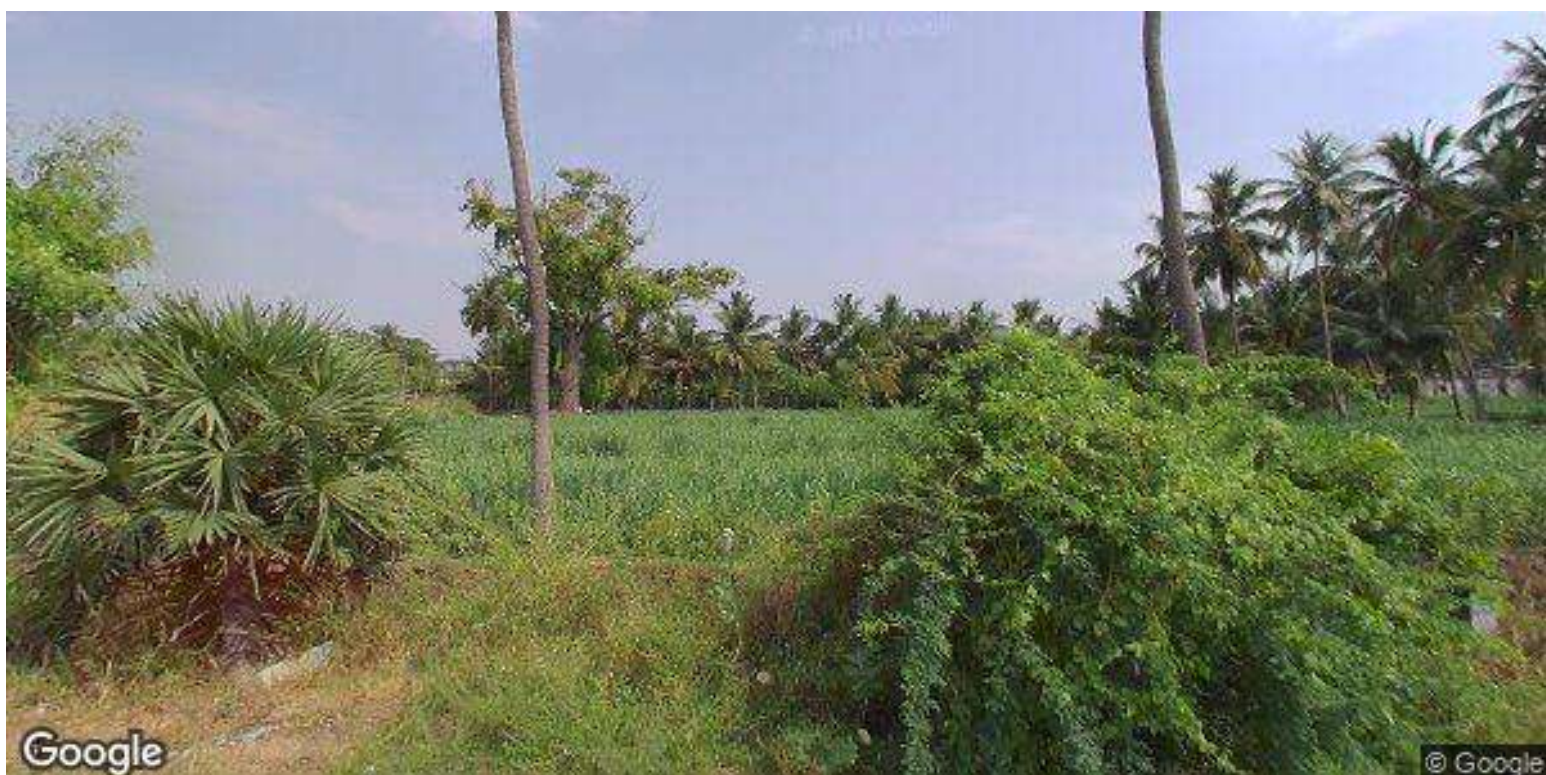
**Risk Type:** Turn  
**Risk Level:** High  
**Speed Limit:** 15 KM/Hr  
**Coordinates:** 11.29125, 77.74646

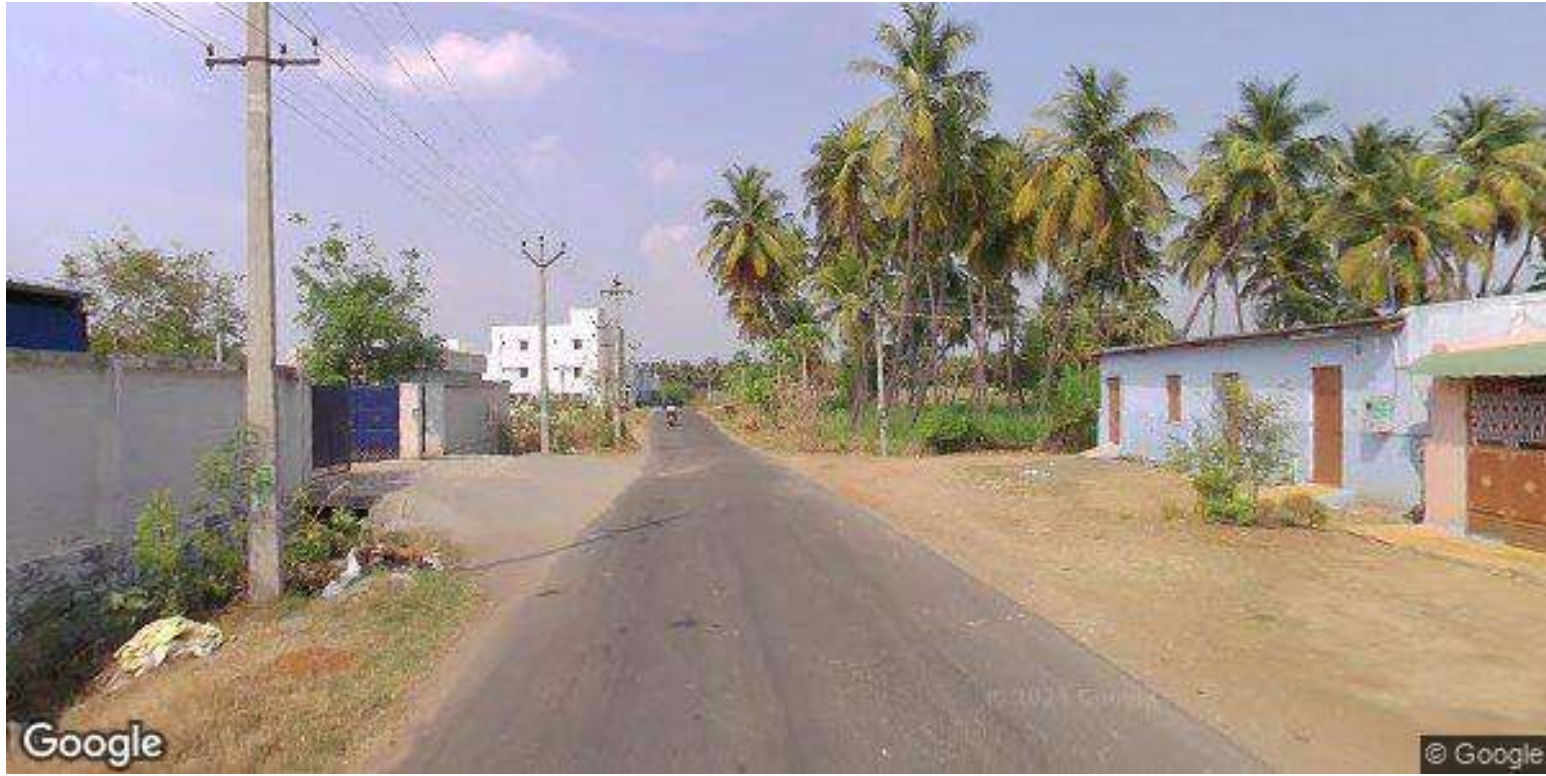
**Risk Type:** Turn  
**Risk Level:** Medium  
**Speed Limit:** 30 KM/Hr  
**Coordinates:** 11.29076, 77.74528

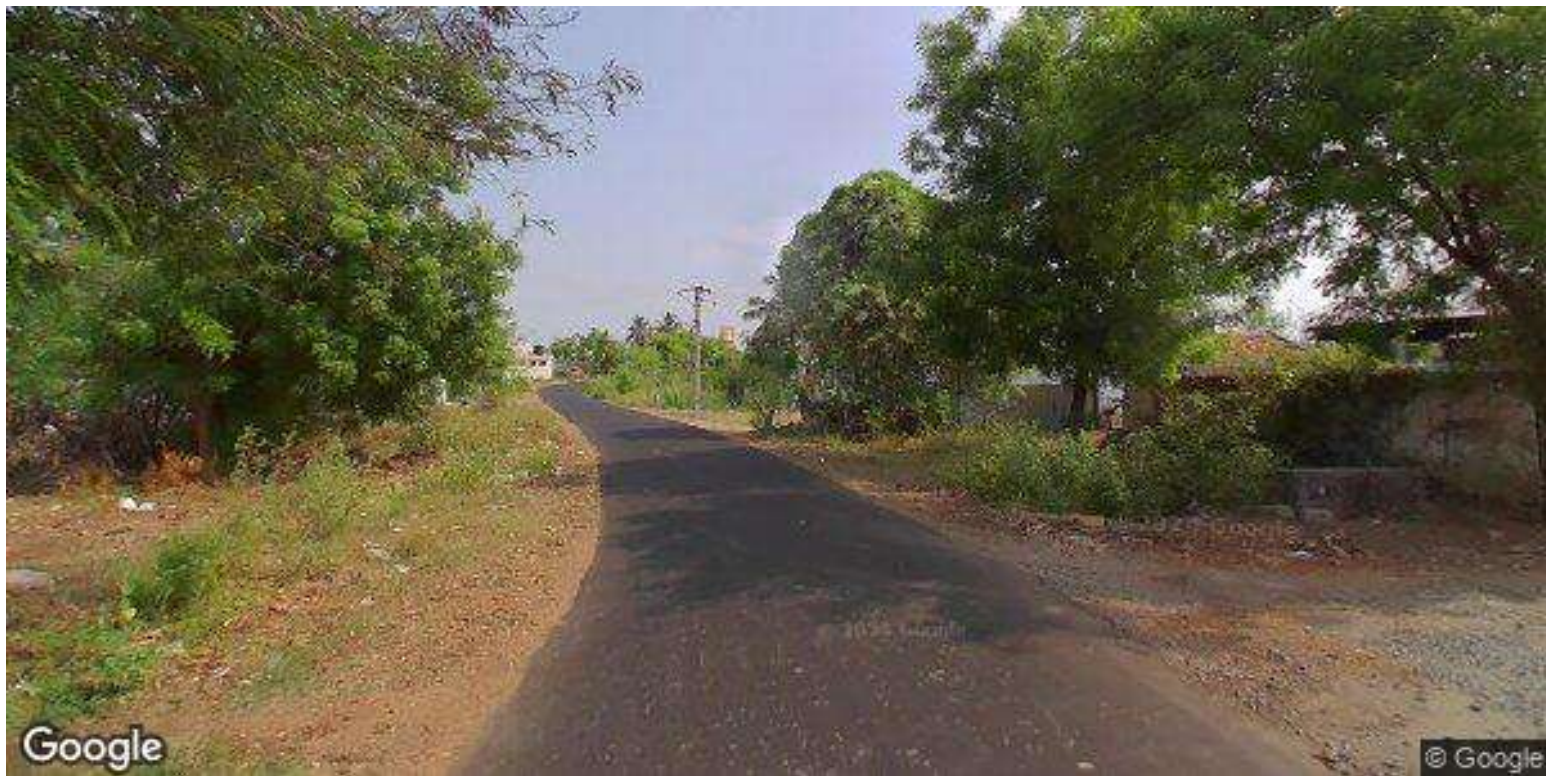
**Risk Type:** Turn  
**Risk Level:** Medium  
**Speed Limit:** 30 KM/Hr  
**Coordinates:** 11.28844, 77.74319

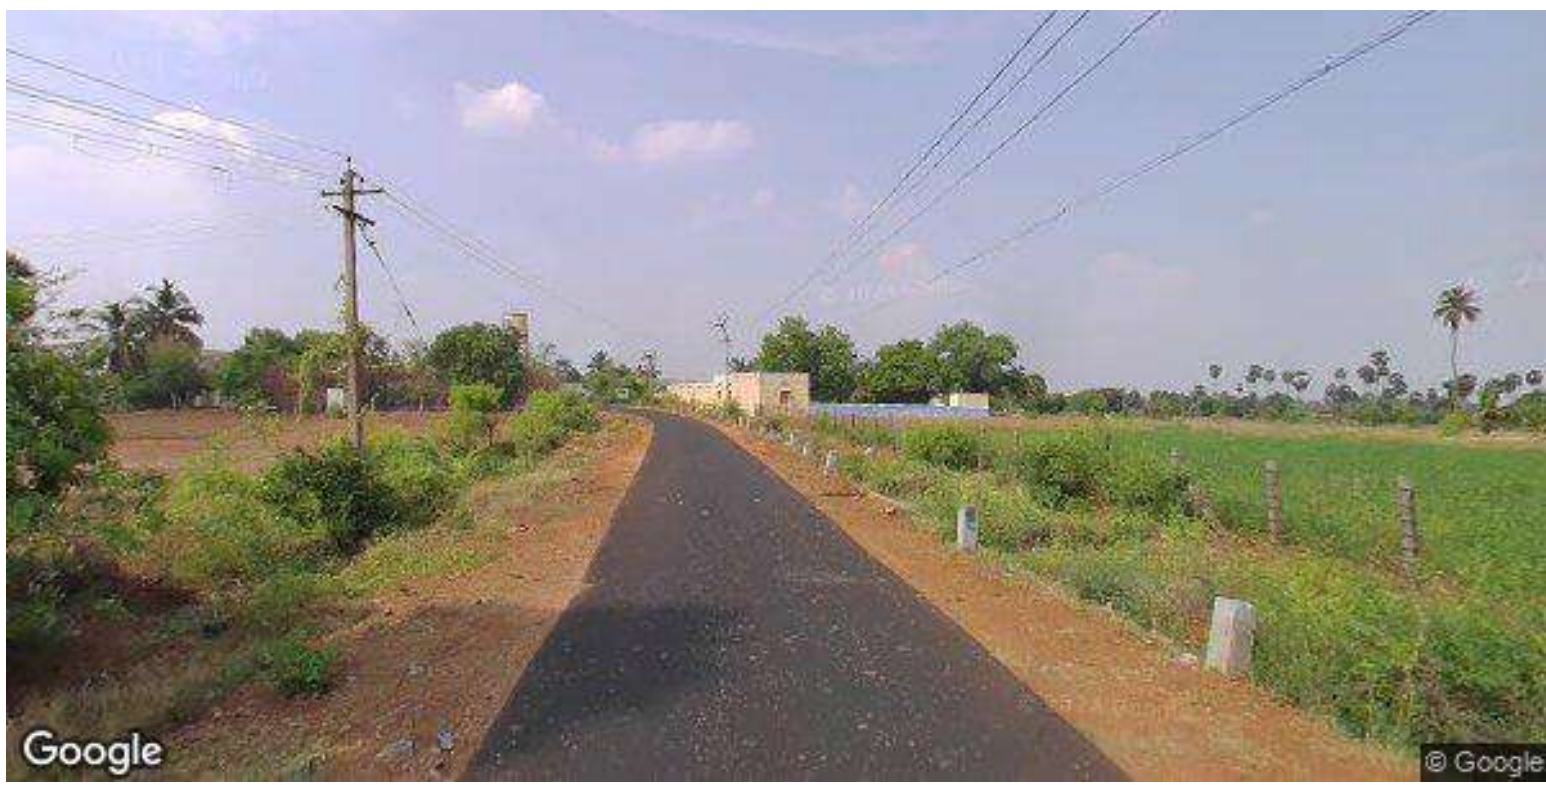
**Coordinates:** 11.28518, 77.74231

**Risk Type:** Turn

**Risk Level:** Medium

**Speed Limit:** 30 KM/Hr

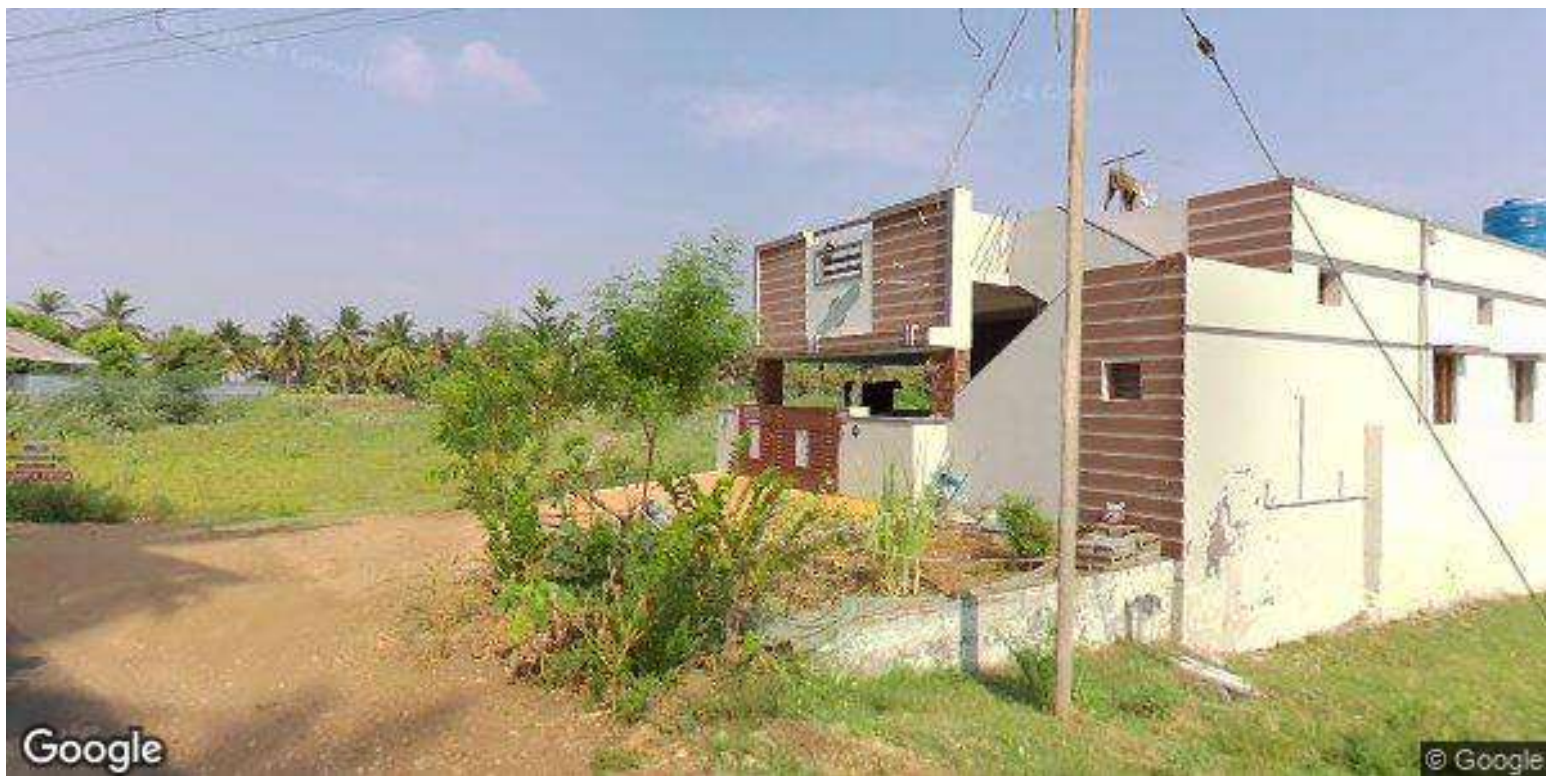
**Coordinates:** 11.27319, 77.72981

**Risk Type:** Turn

**Risk Level:** High

**Speed Limit:** 15 KM/Hr

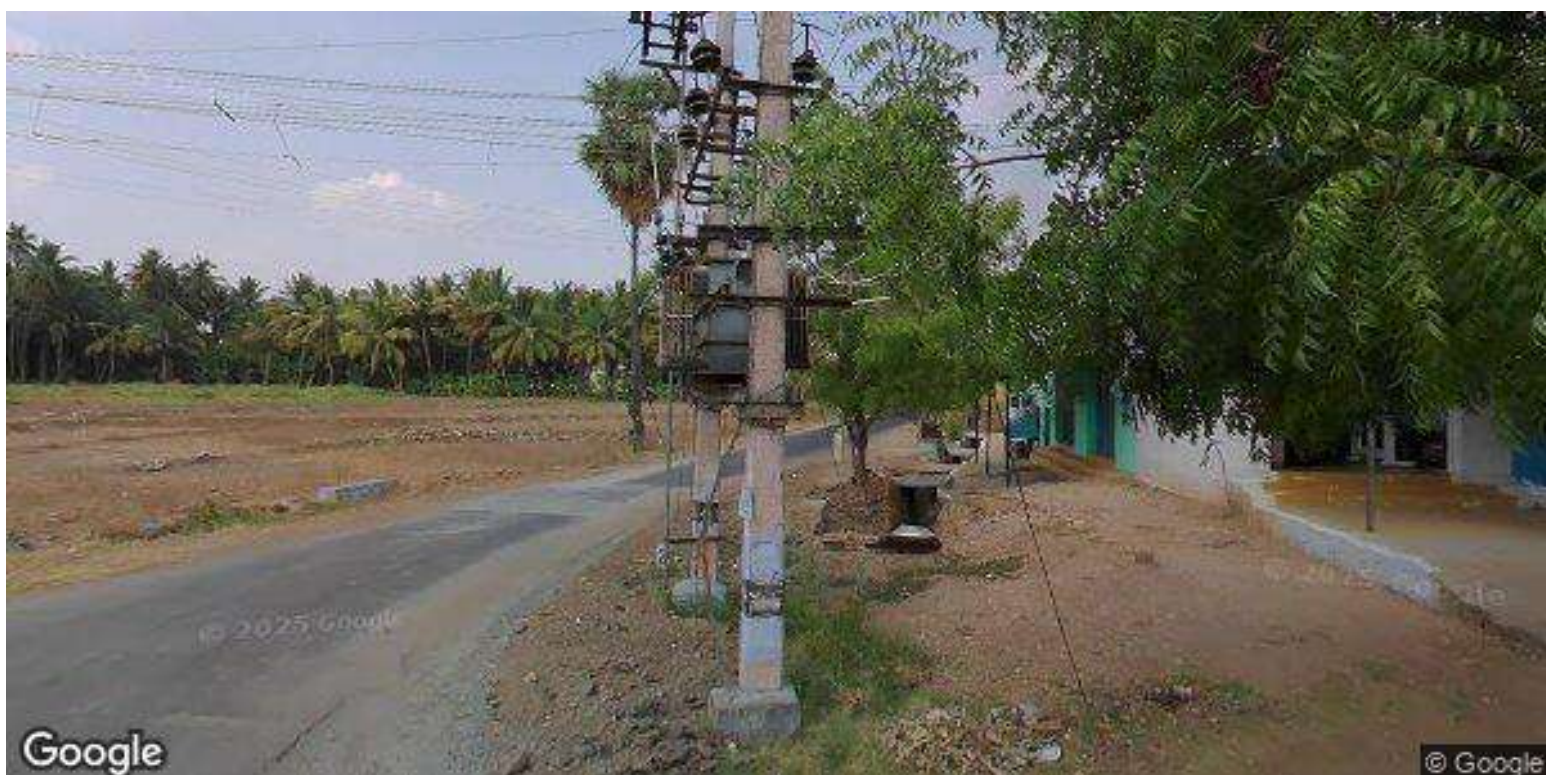
**Risk Type:** Blind Spot  
**Risk Level:** Blind Spot  
**Speed Limit:** 10 KM/Hr  
**Coordinates:** 11.27330, 77.72715

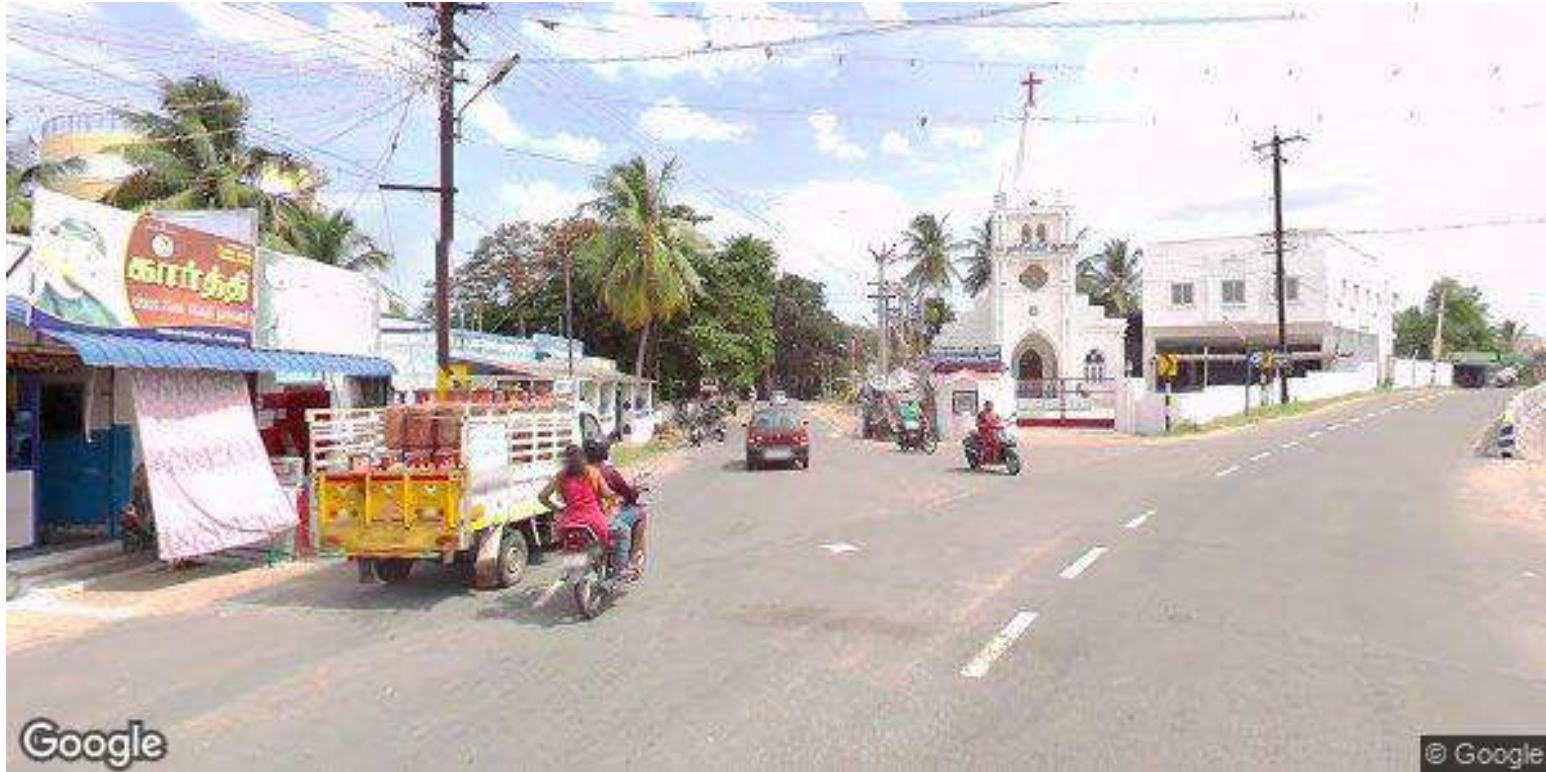
**Risk Type:** Turn  
**Risk Level:** Medium  
**Speed Limit:** 30 KM/Hr  
**Coordinates:** 11.23054, 77.71796

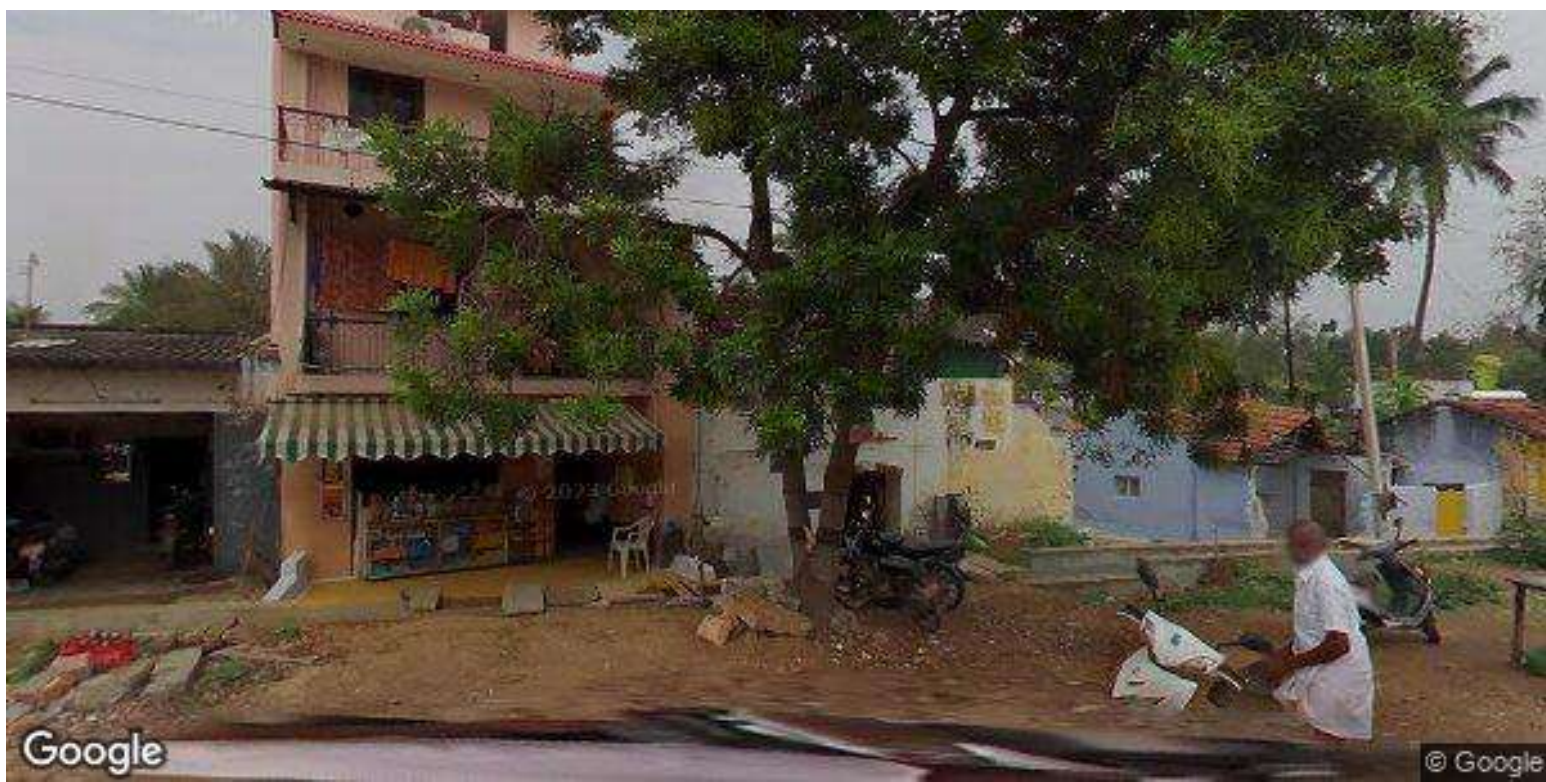
**Coordinates:** 11.08696, 77.66407

**Risk Type:** Turn

**Risk Level:** Medium

**Speed Limit:** 30 KM/Hr
