# IndianOil

## JOURNEY RISK MANAGEMENT (JRM) STUDY

**Salem Terminal to CHAKRAVARTHY & CO**

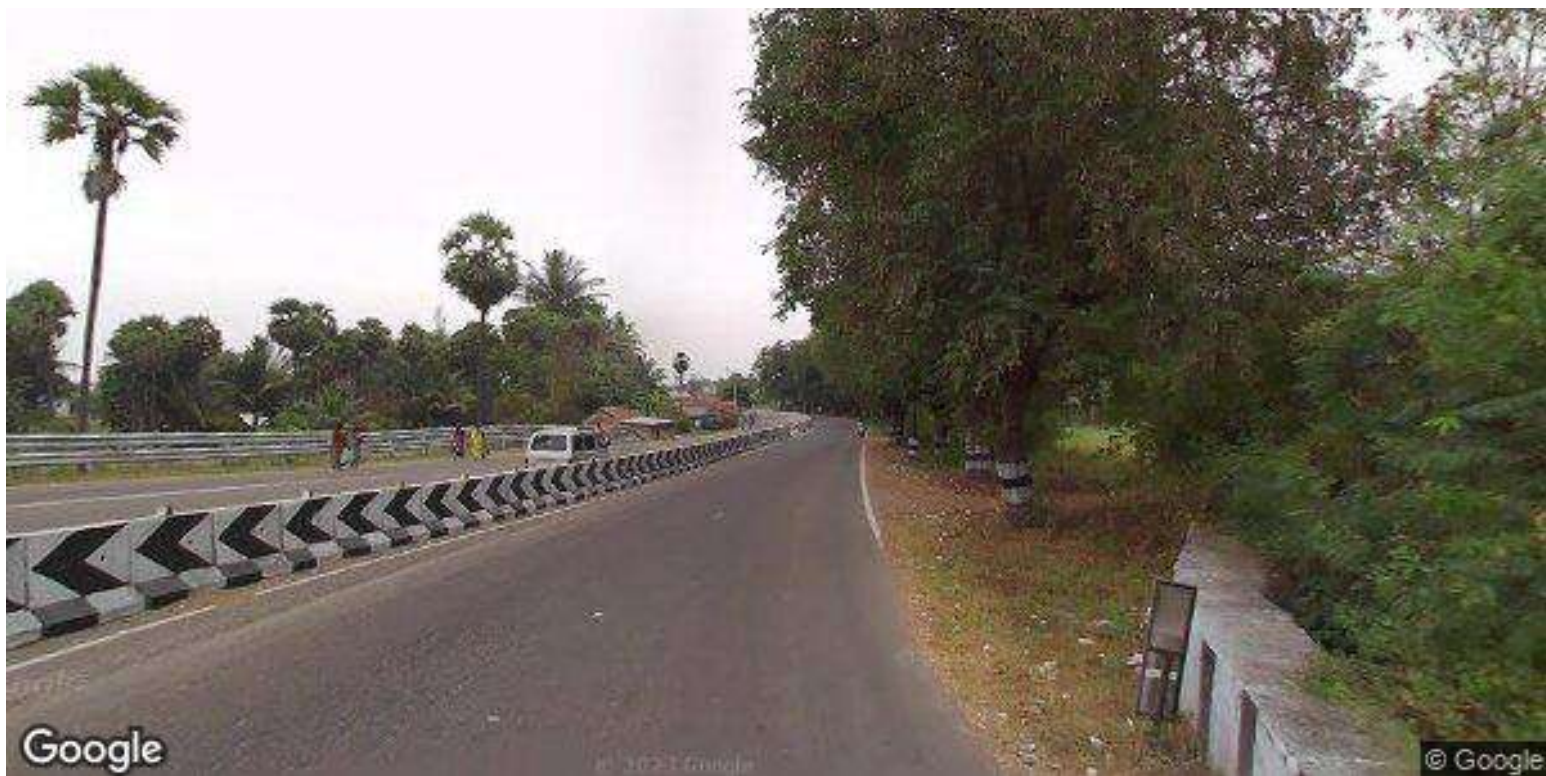
**Coordinates:** 11.08296, 77.65857

**Risk Type:** Turn

**Risk Level:** Medium

**Speed Limit:** 30 KM/Hr

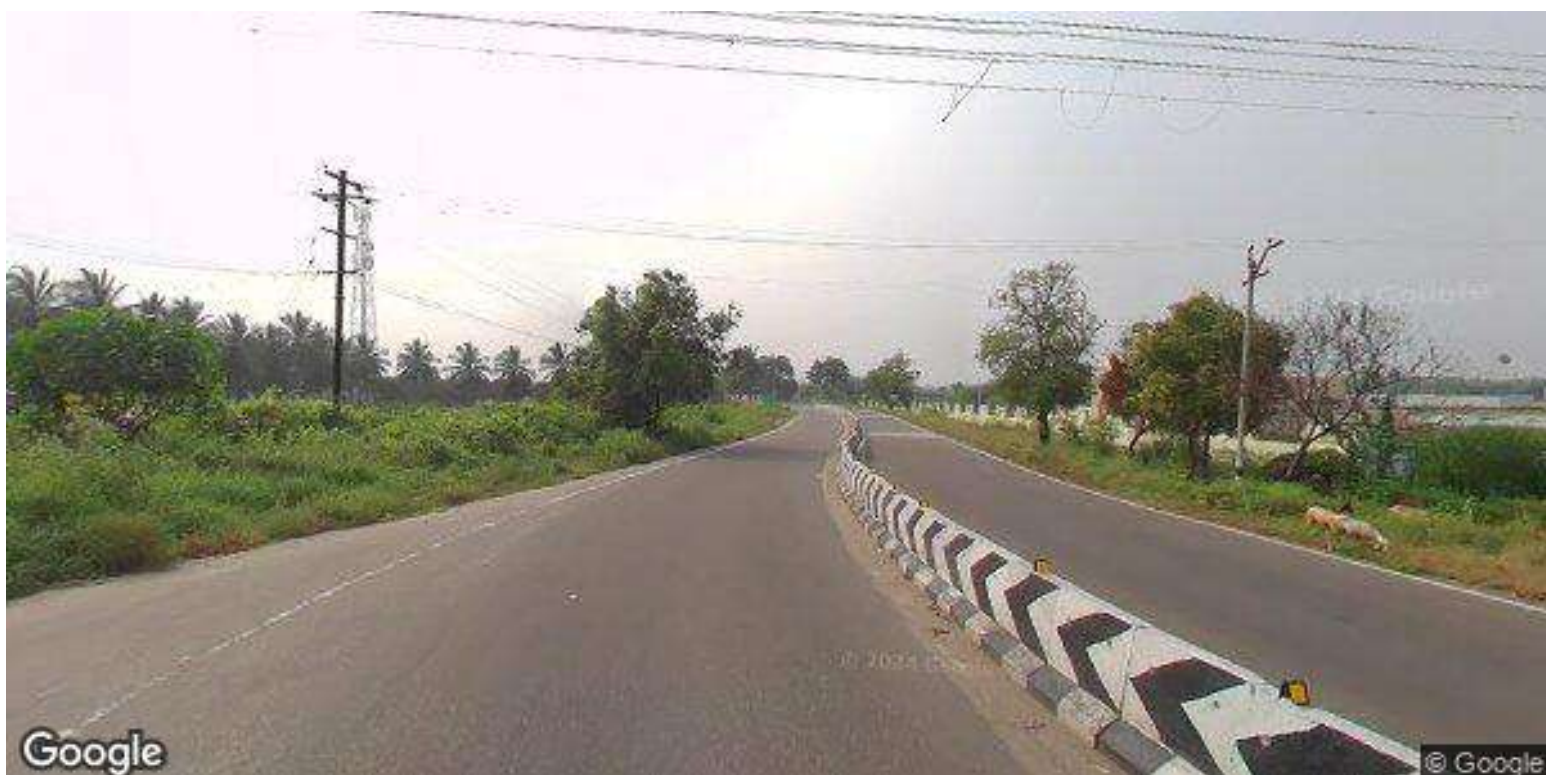
**Coordinates:** 11.06183, 77.63924

**Risk Type:** Turn

**Risk Level:** Medium

**Speed Limit:** 30 KM/Hr

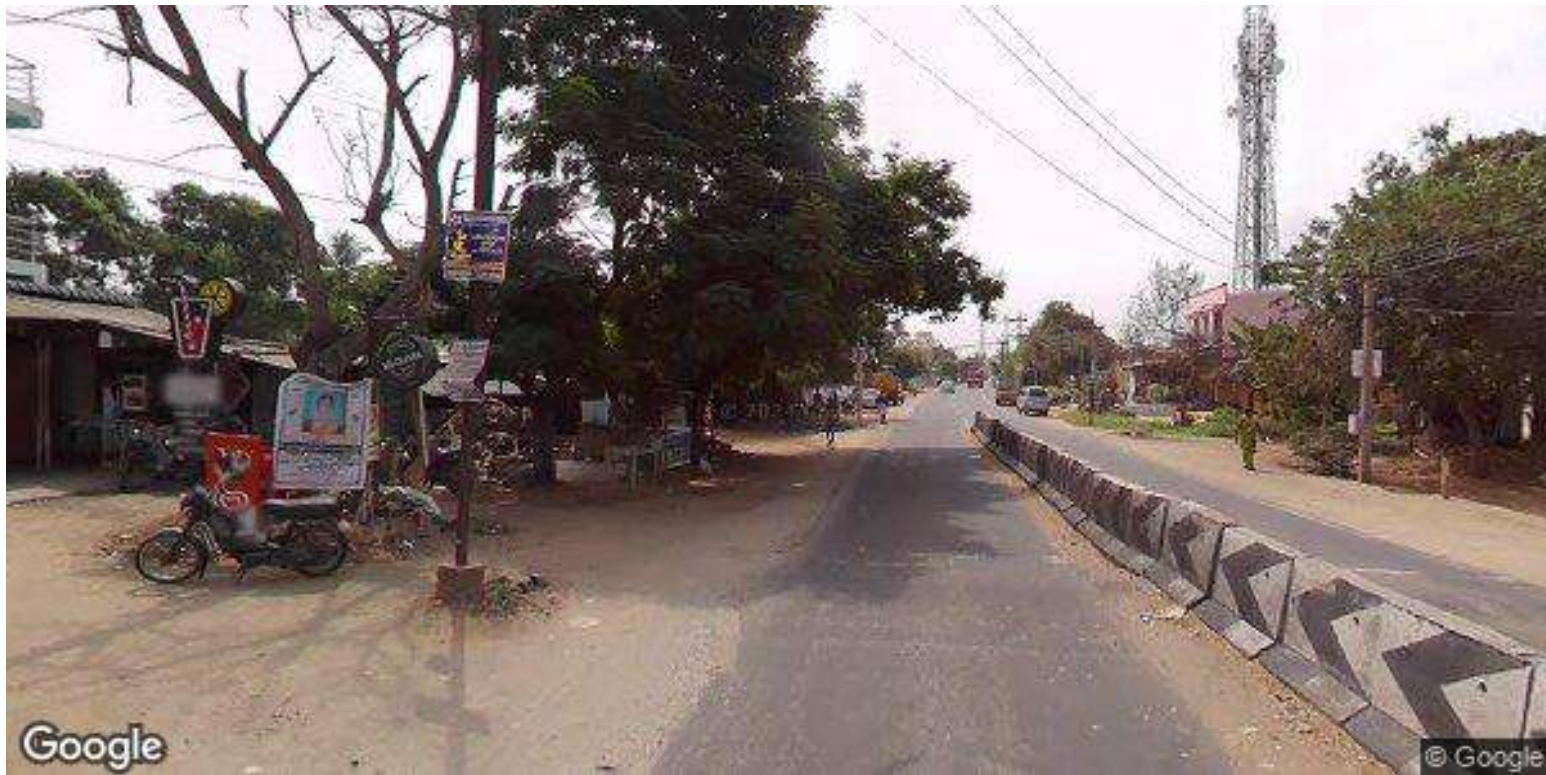
**Coordinates:** 11.00826, 77.56962

**Risk Type:** Turn

**Risk Level:** High

**Speed Limit:** 15 KM/Hr

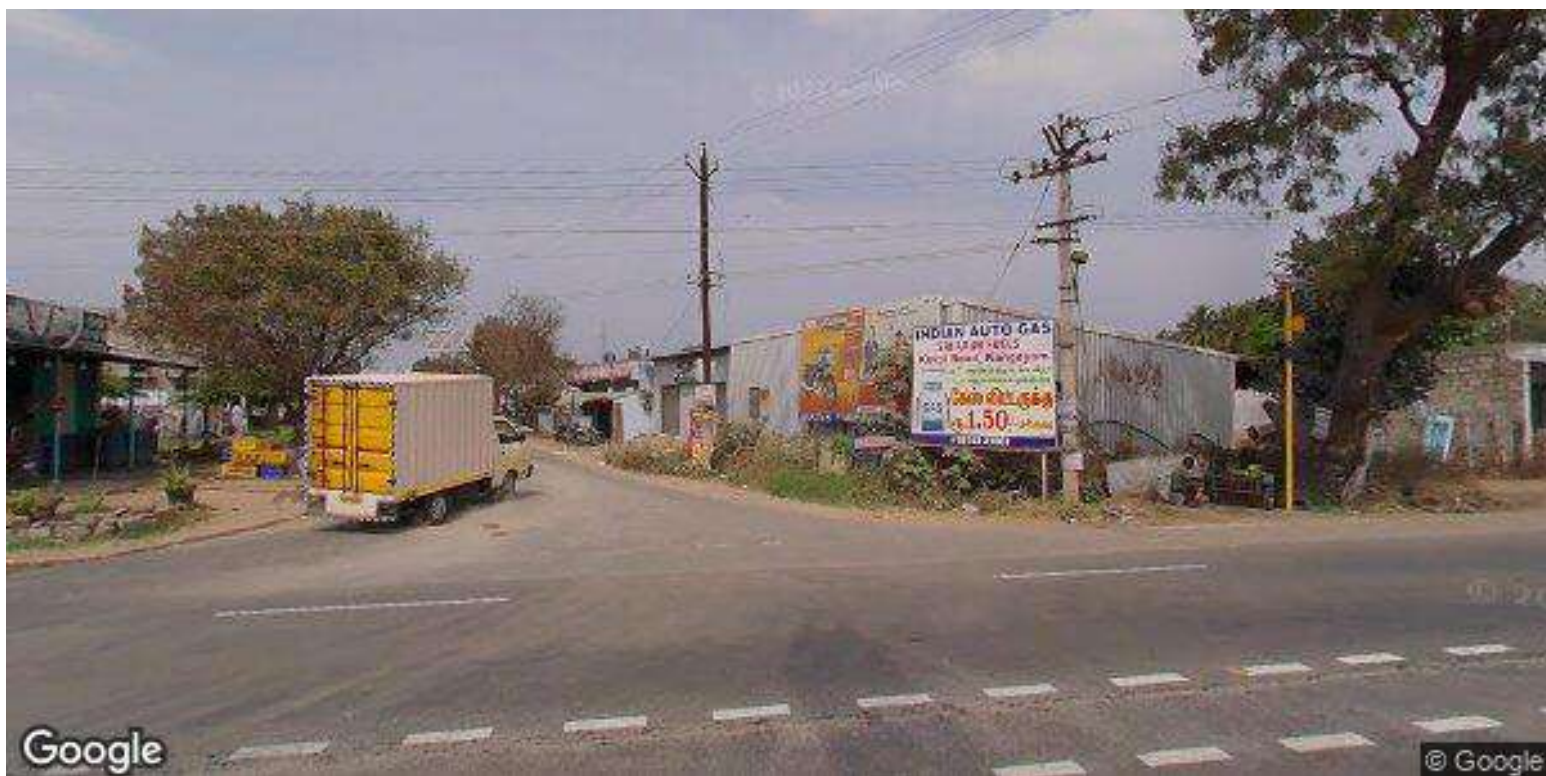
**Coordinates:** 11.00058, 77.56882

**Risk Type:** Blind Spot

**Risk Level:** Blind Spot

**Speed Limit:** 10 KM/Hr

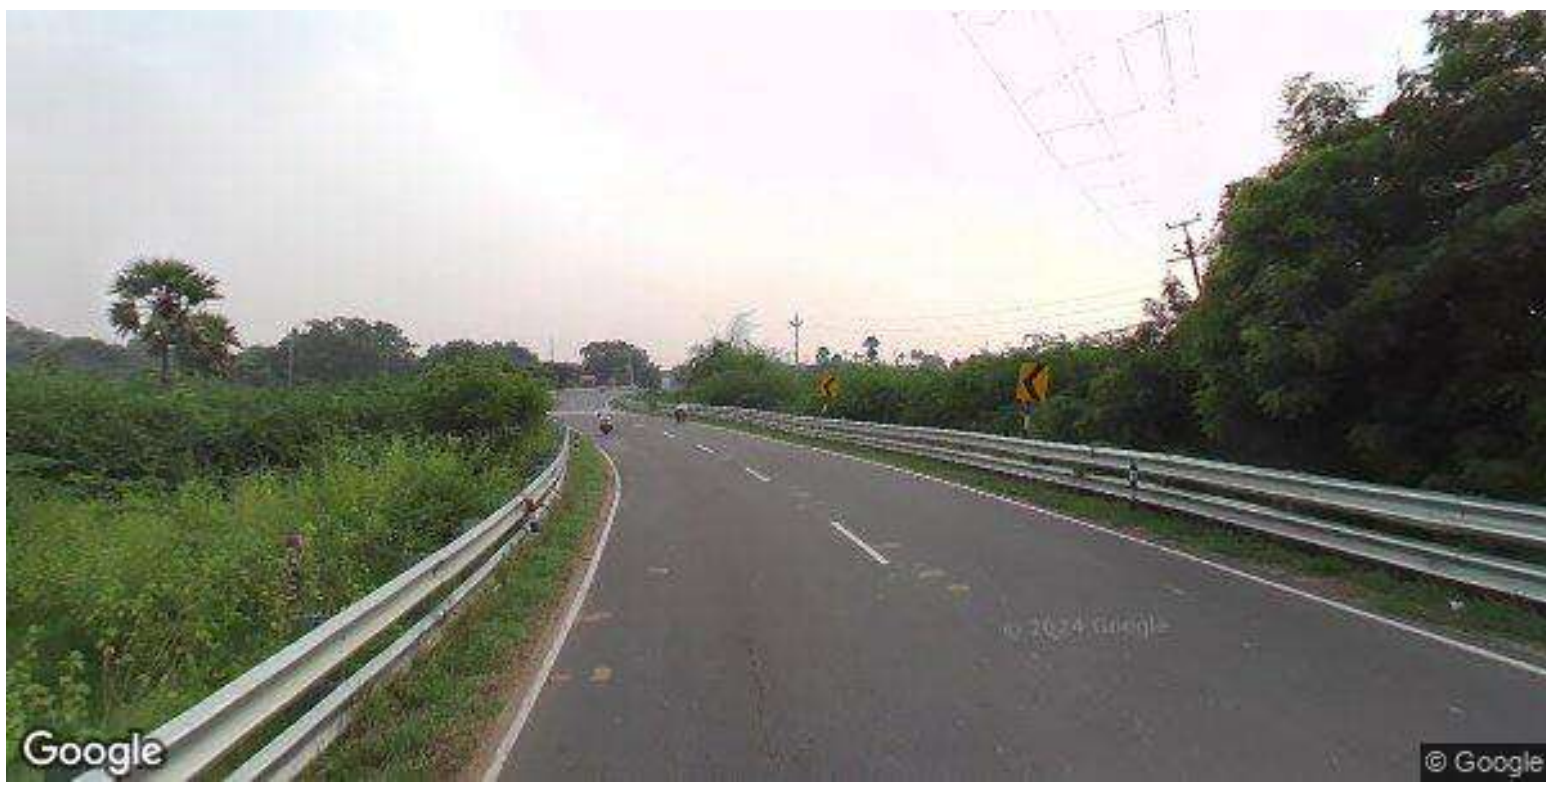
**Coordinates:** 10.94862, 77.54680

**Risk Type:** Turn

**Risk Level:** Medium

**Speed Limit:** 30 KM/Hr

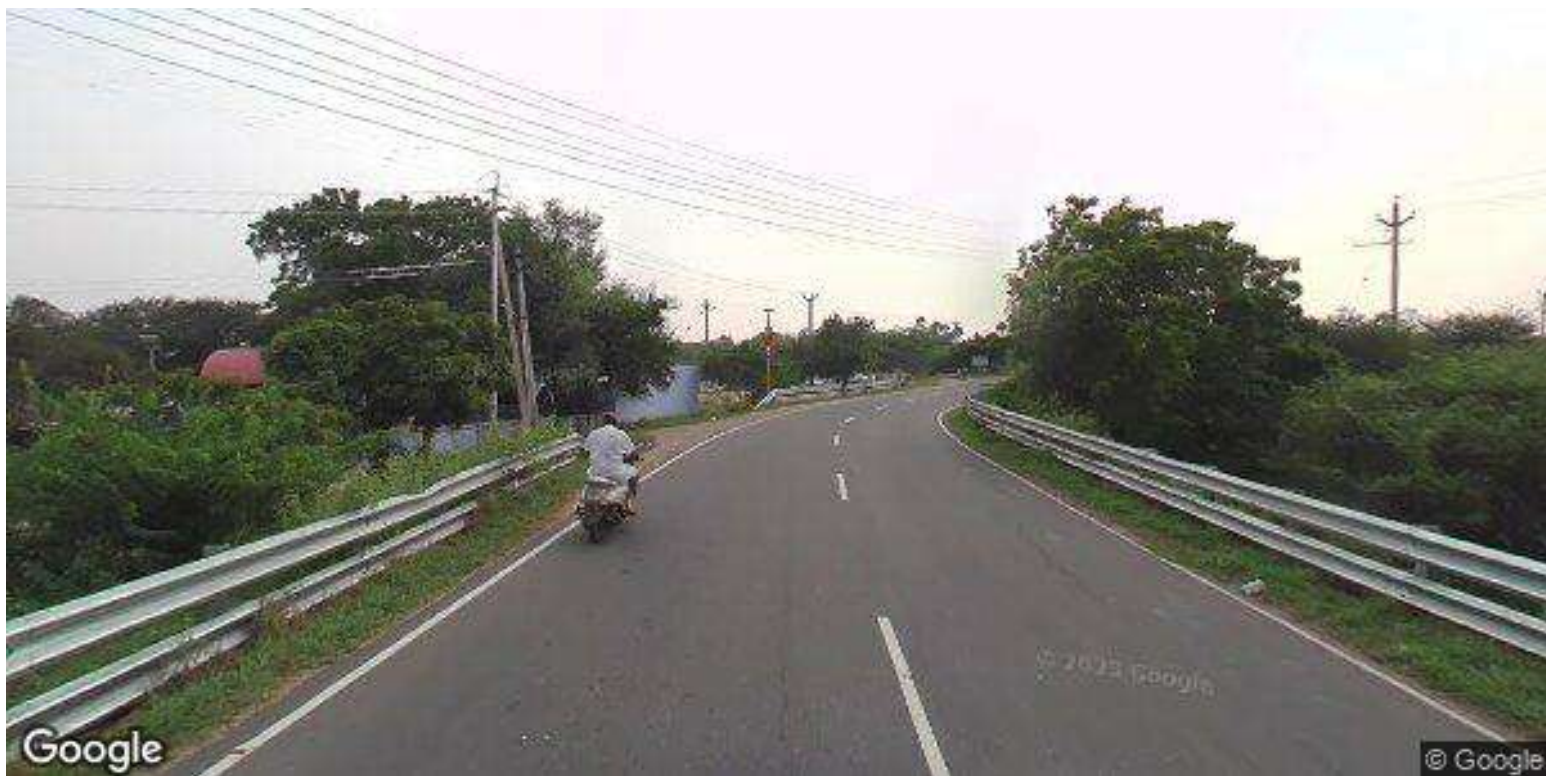
**Coordinates:** 10.94722, 77.54709

**Risk Type:** Turn

**Risk Level:** High

**Speed Limit:** 15 KM/Hr

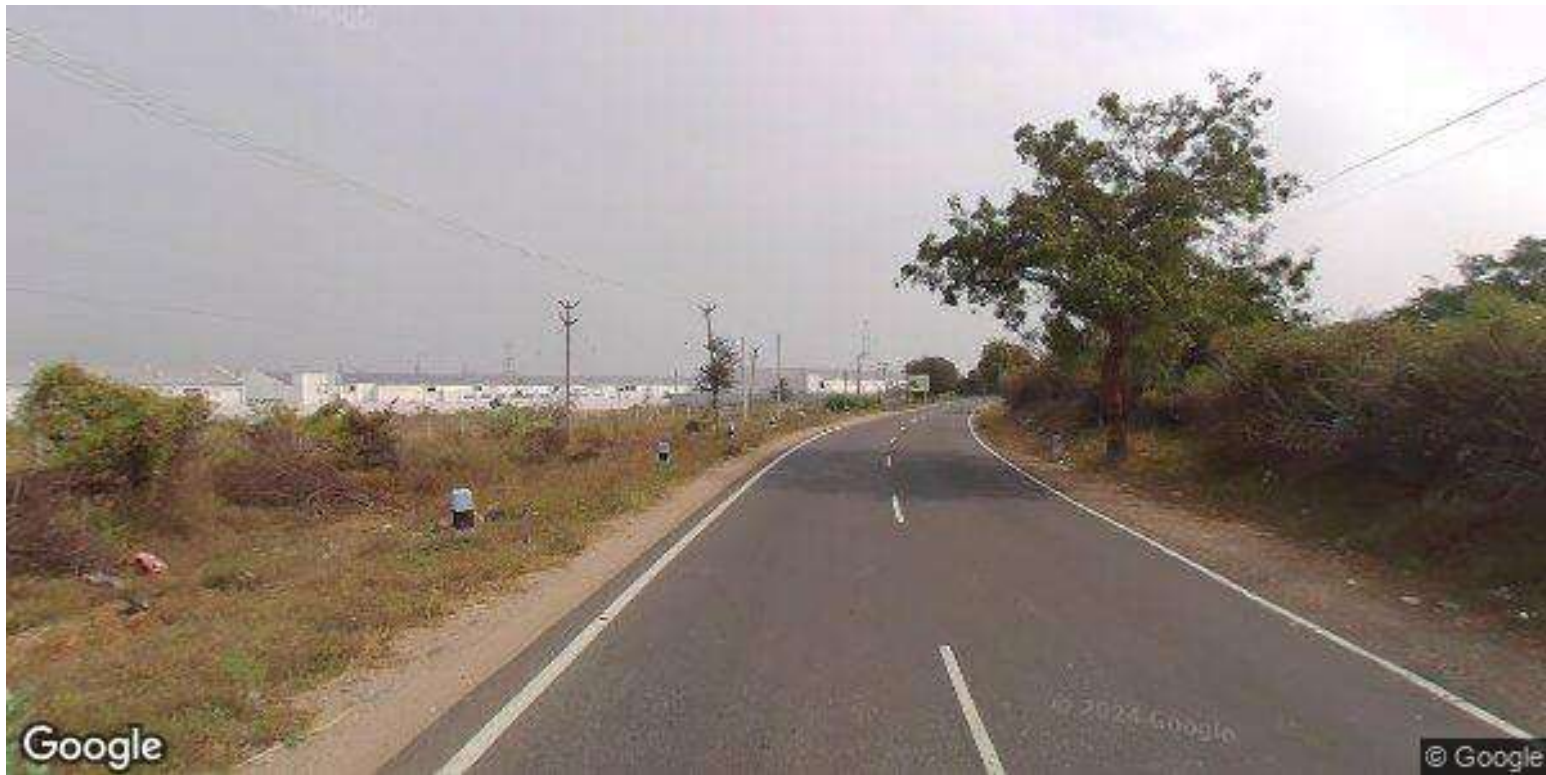
**Coordinates:** 10.93765, 77.53710

**Risk Type:** Turn

**Risk Level:** Medium

**Speed Limit:** 30 KM/Hr

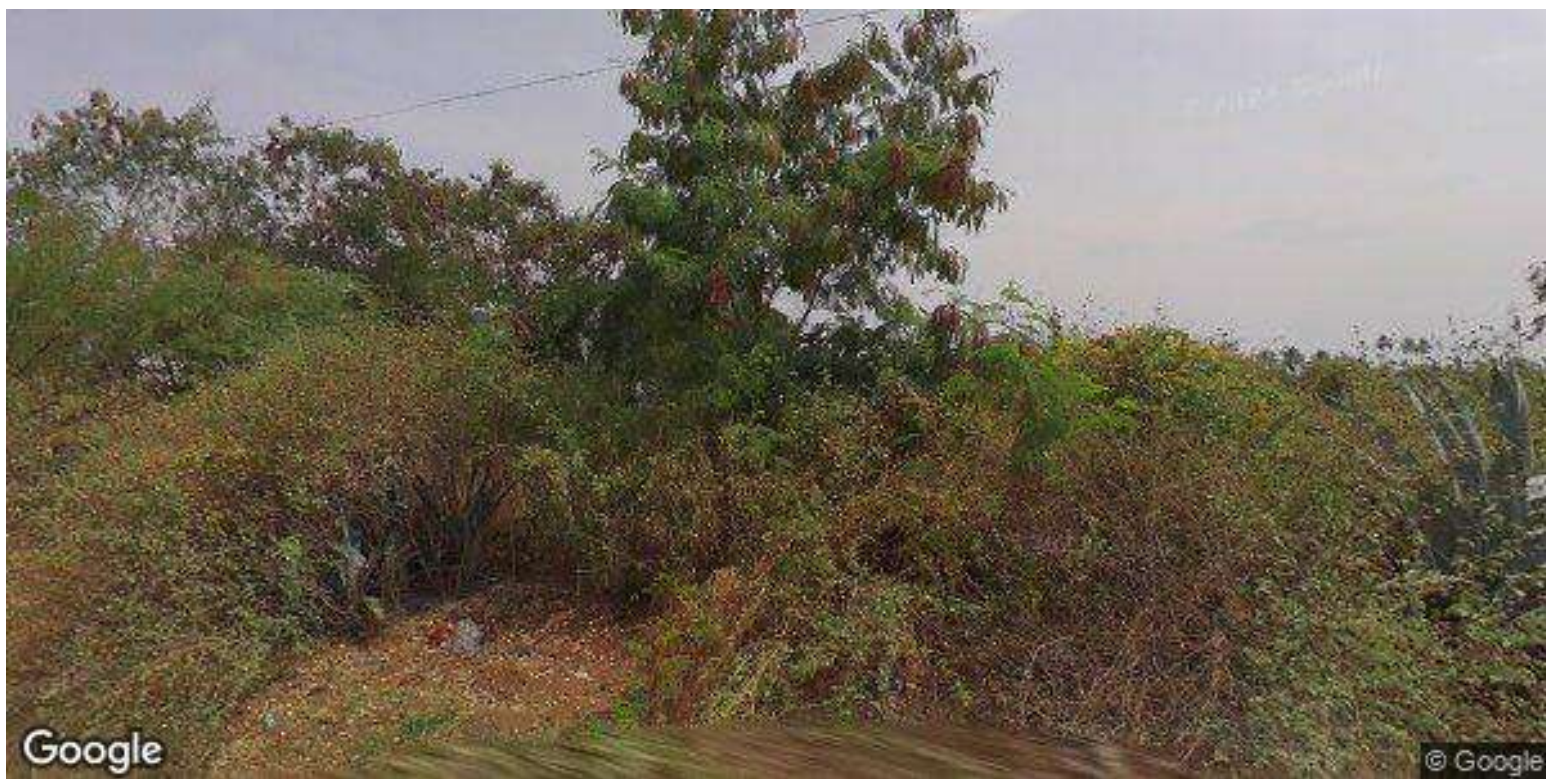
**Coordinates:** 10.93054, 77.53265

**Risk Type:** Turn

**Risk Level:** Medium

**Speed Limit:** 30 KM/Hr

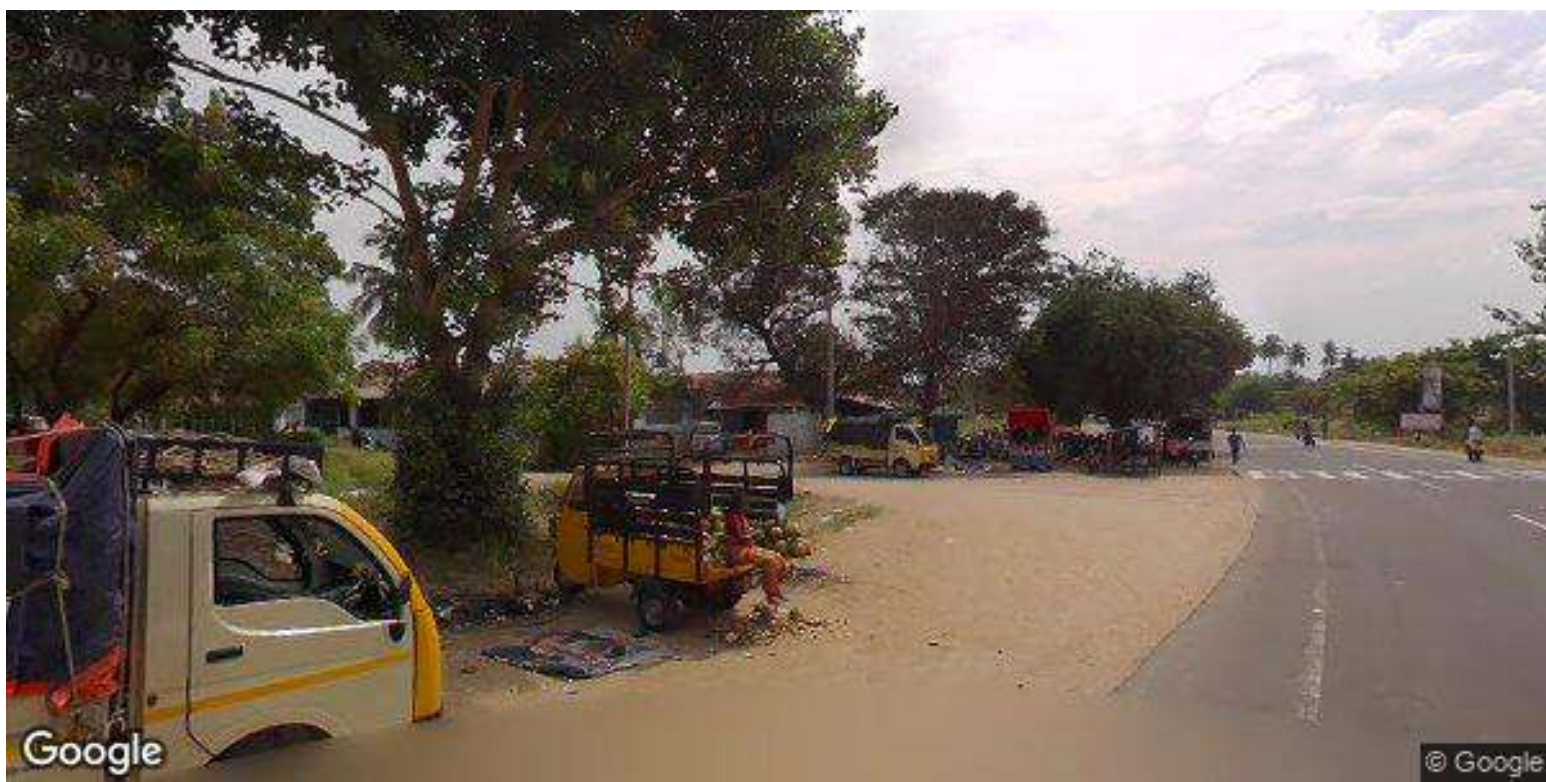
**Coordinates:** 10.89213, 77.52646

**Risk Type:** Turn

**Risk Level:** Medium

**Speed Limit:** 30 KM/Hr

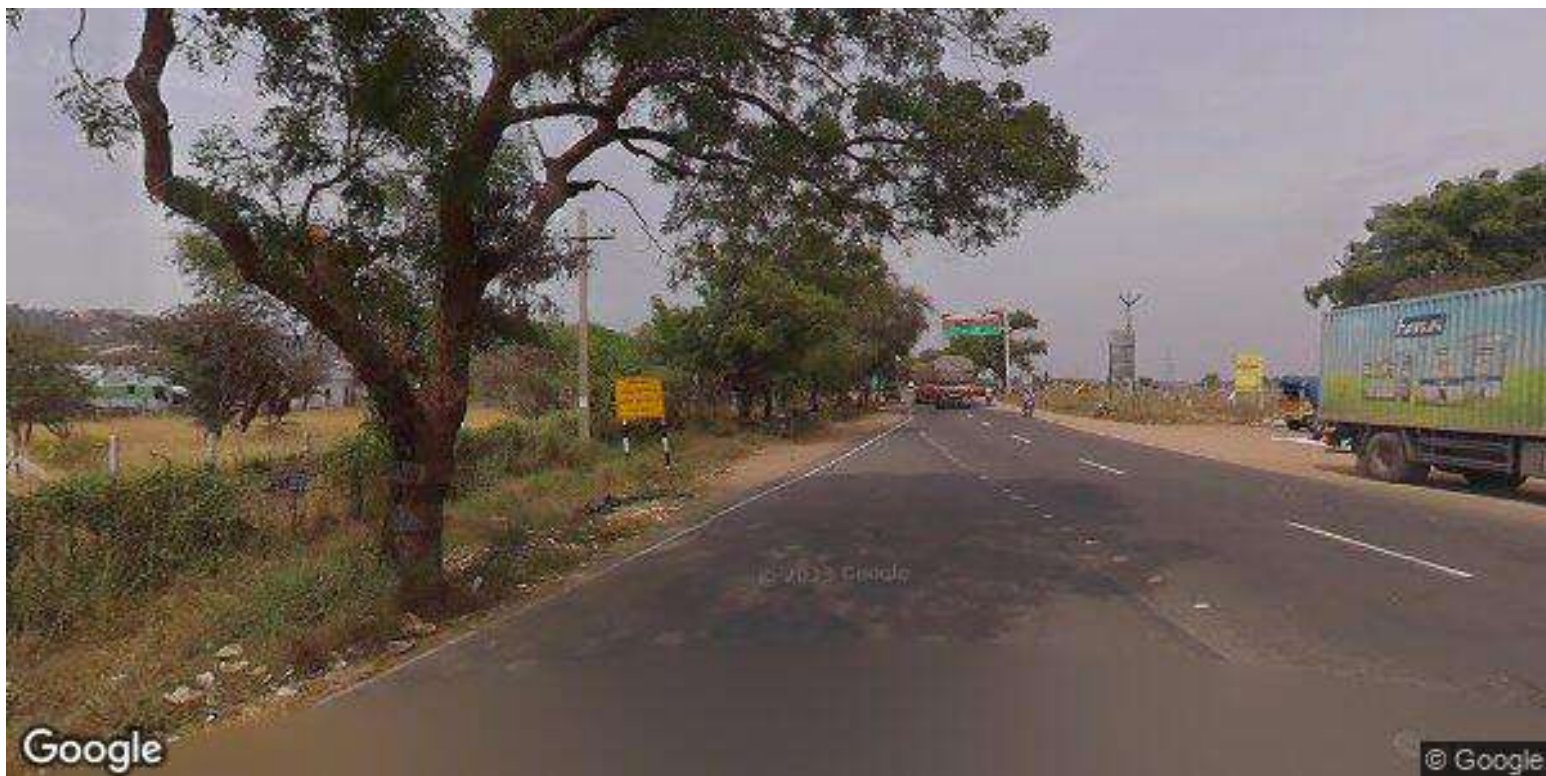
**Coordinates:** 10.87916, 77.52773

**Risk Type:** Turn

**Risk Level:** High

**Speed Limit:** 15 KM/Hr

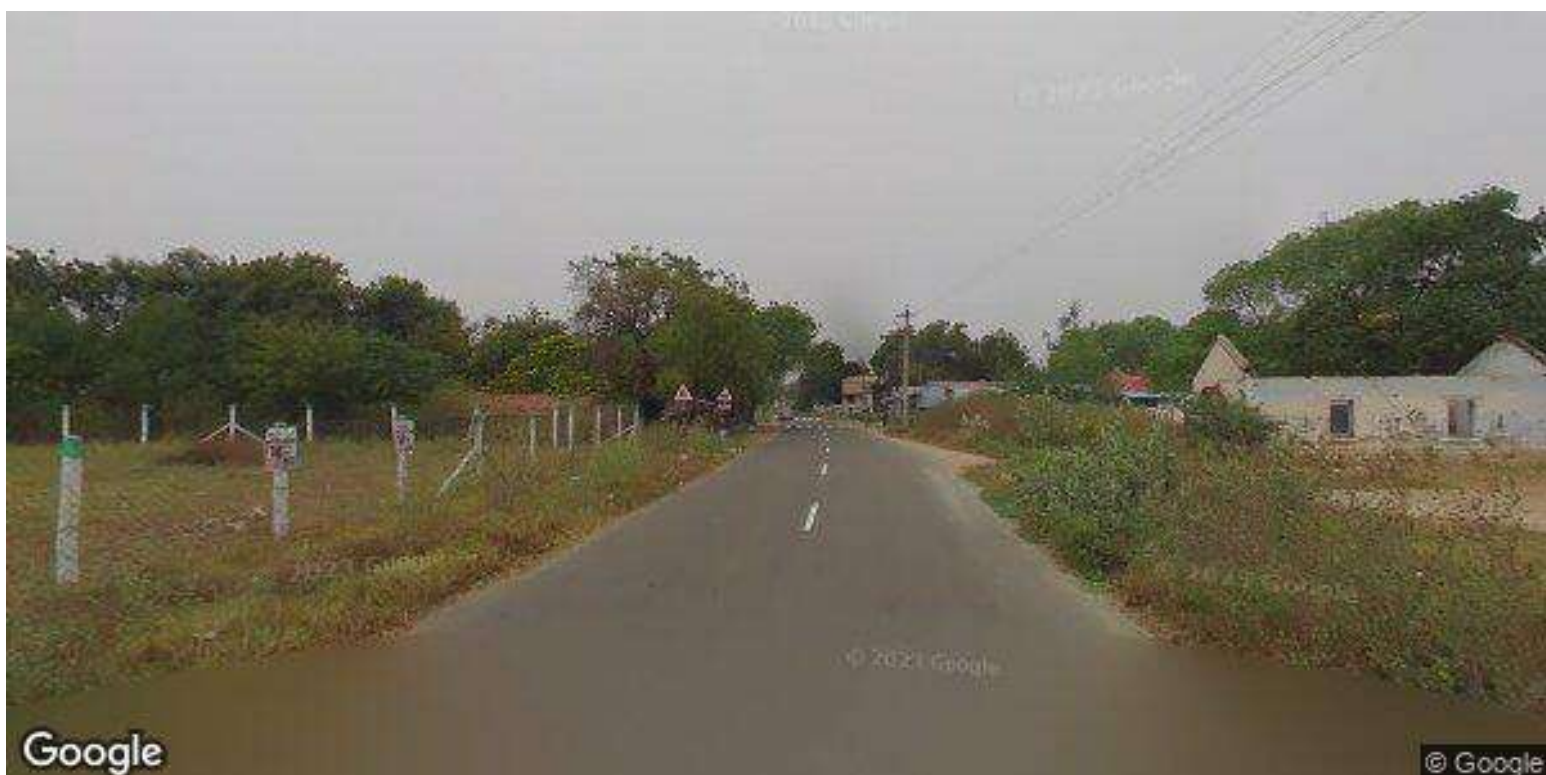
**Risk Type:** Turn  
**Risk Level:** Medium  
**Speed Limit:** 30 KM/Hr  
**Coordinates:** 10.88265, 77.48996

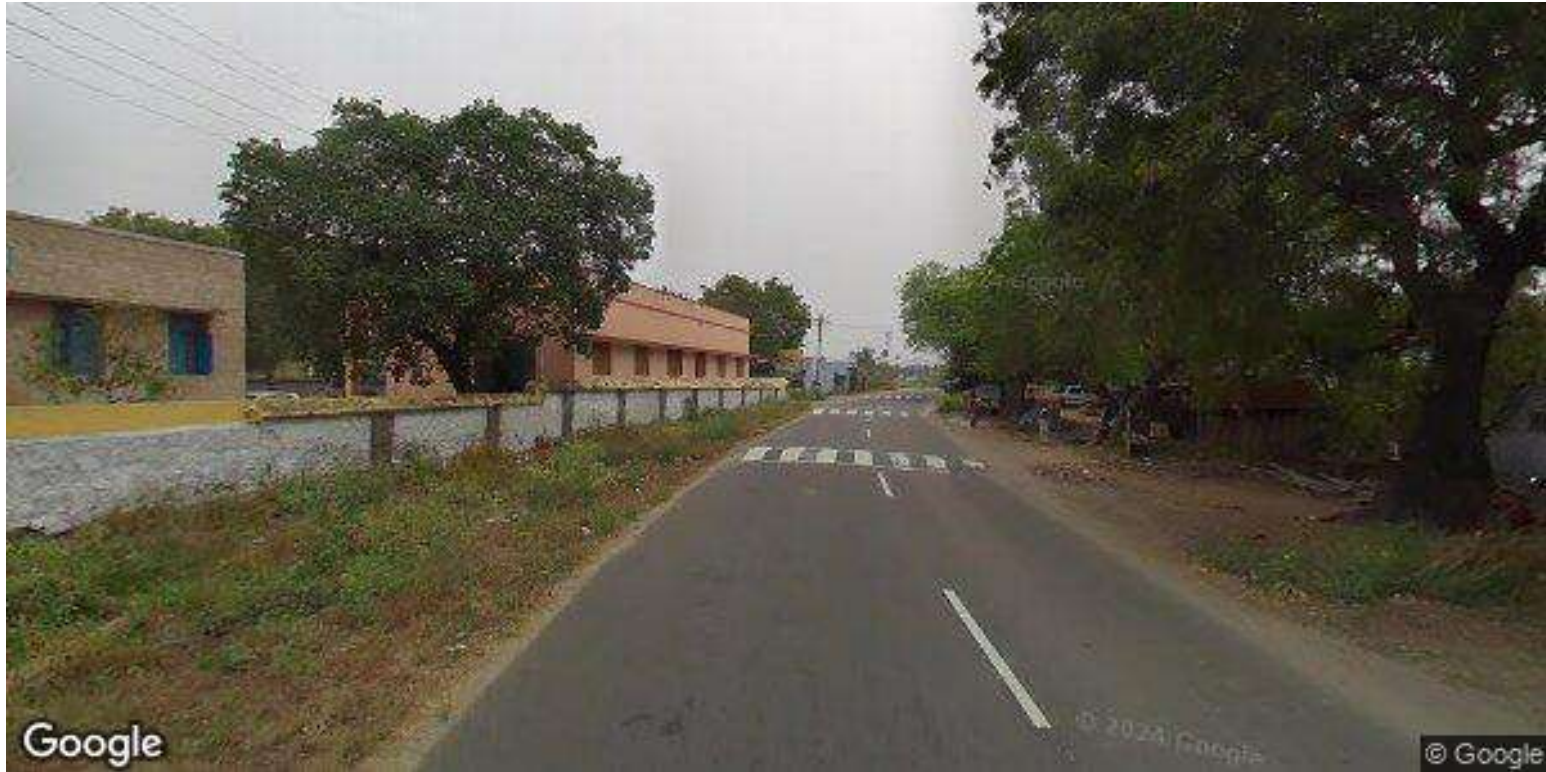
**Risk Type:** Turn  
**Risk Level:** Medium  
**Speed Limit:** 30 KM/Hr  
**Coordinates:** 10.88260, 77.48881

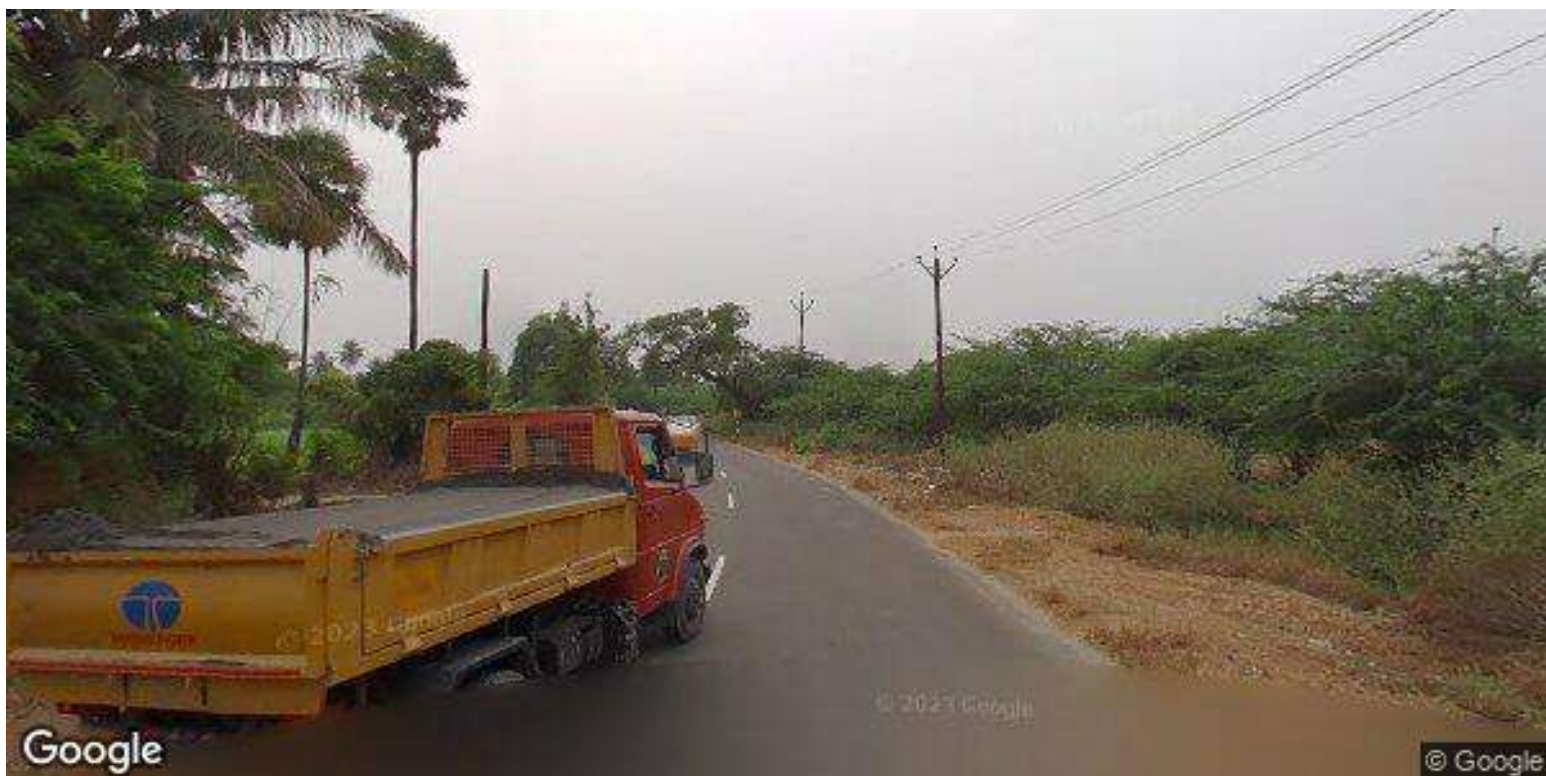
**Risk Type:** Turn  
**Risk Level:** High  
**Speed Limit:** 15 KM/Hr  
**Coordinates:** 10.88221, 77.48831

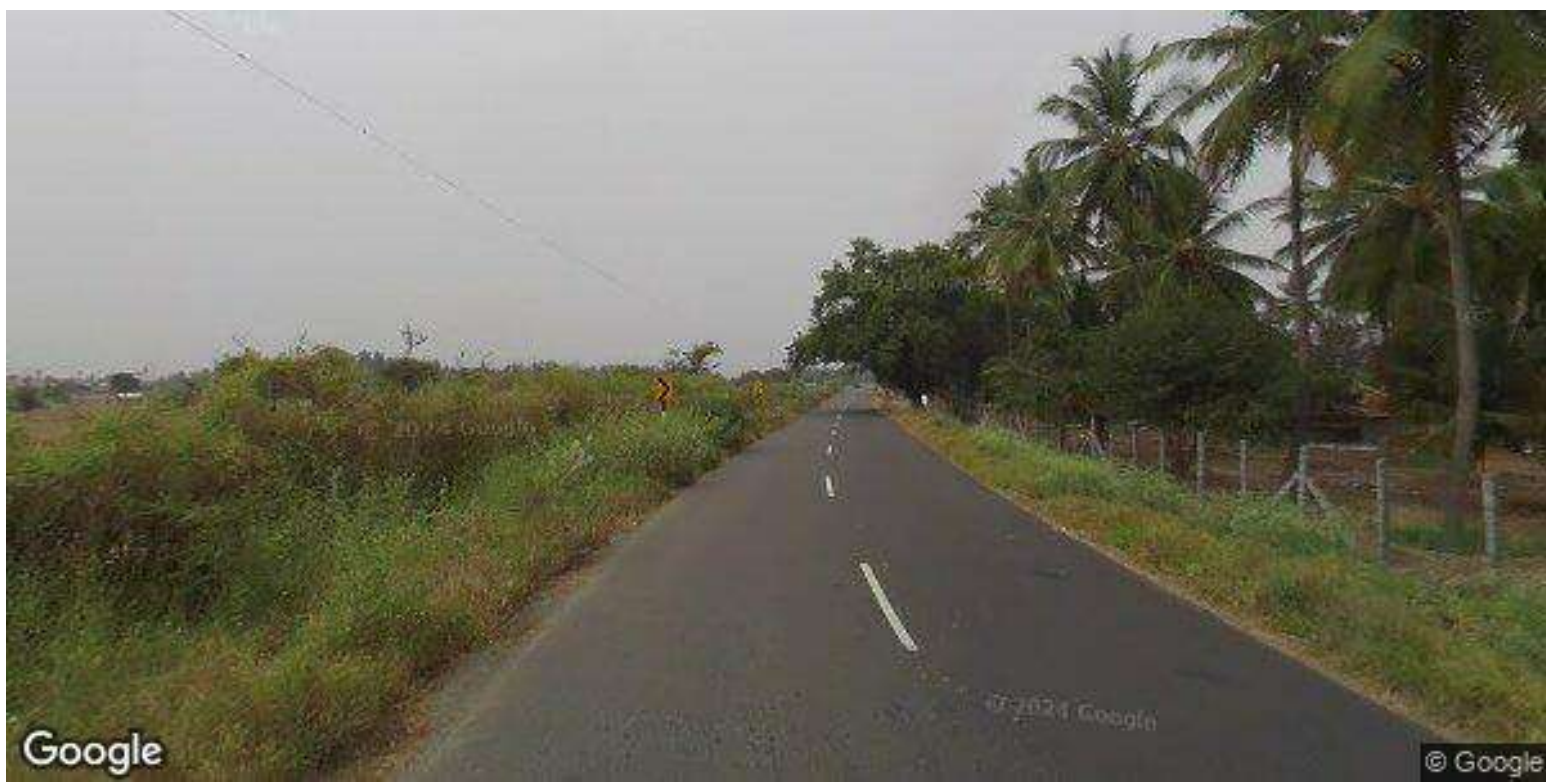
**Coordinates:** 10.87783, 77.48740

**Risk Type:** Turn

**Risk Level:** High

**Speed Limit:** 15 KM/Hr

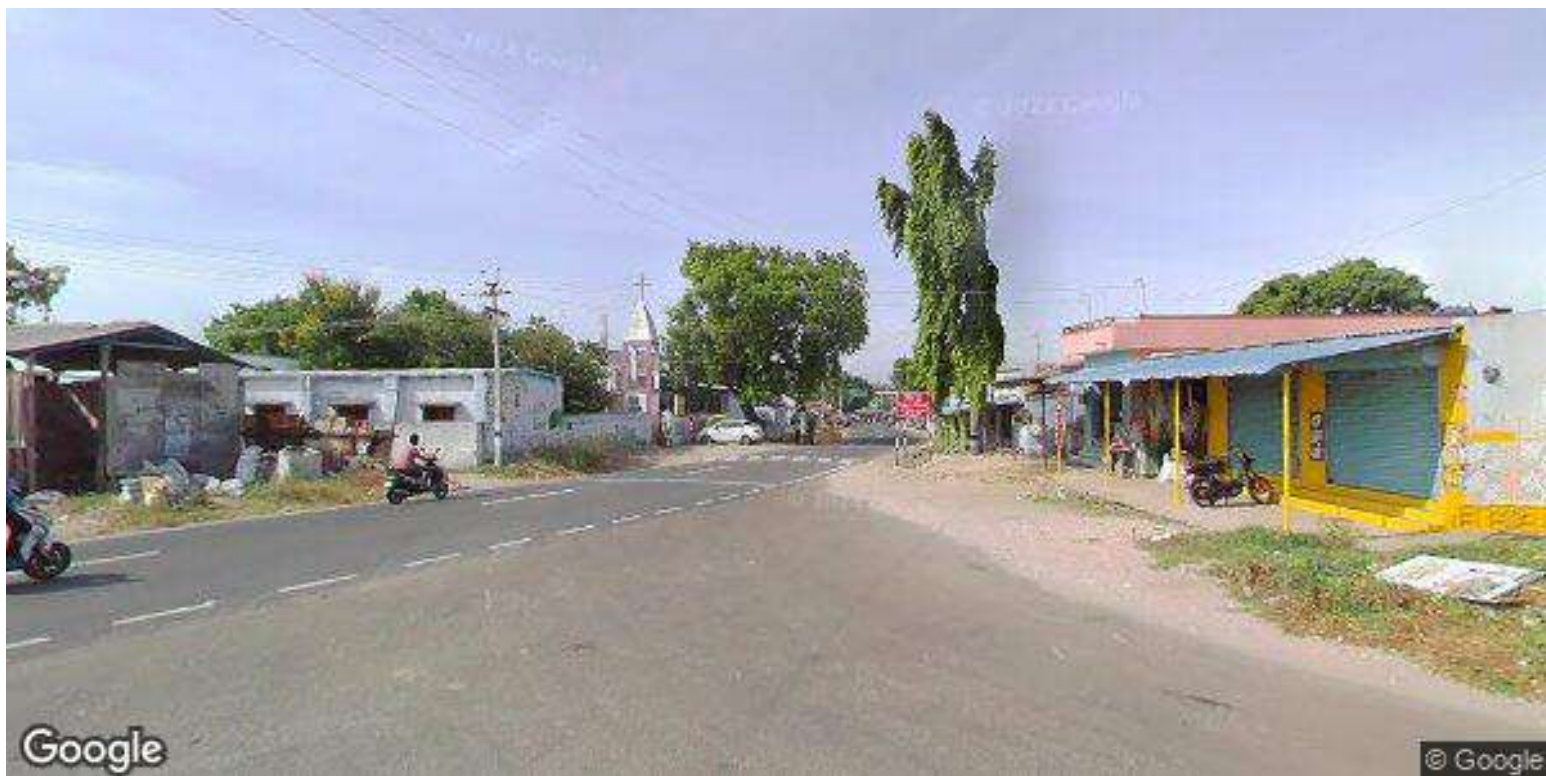
**Coordinates:** 10.85164, 77.44708

**Risk Type:** Turn

**Risk Level:** High

**Speed Limit:** 15 KM/Hr

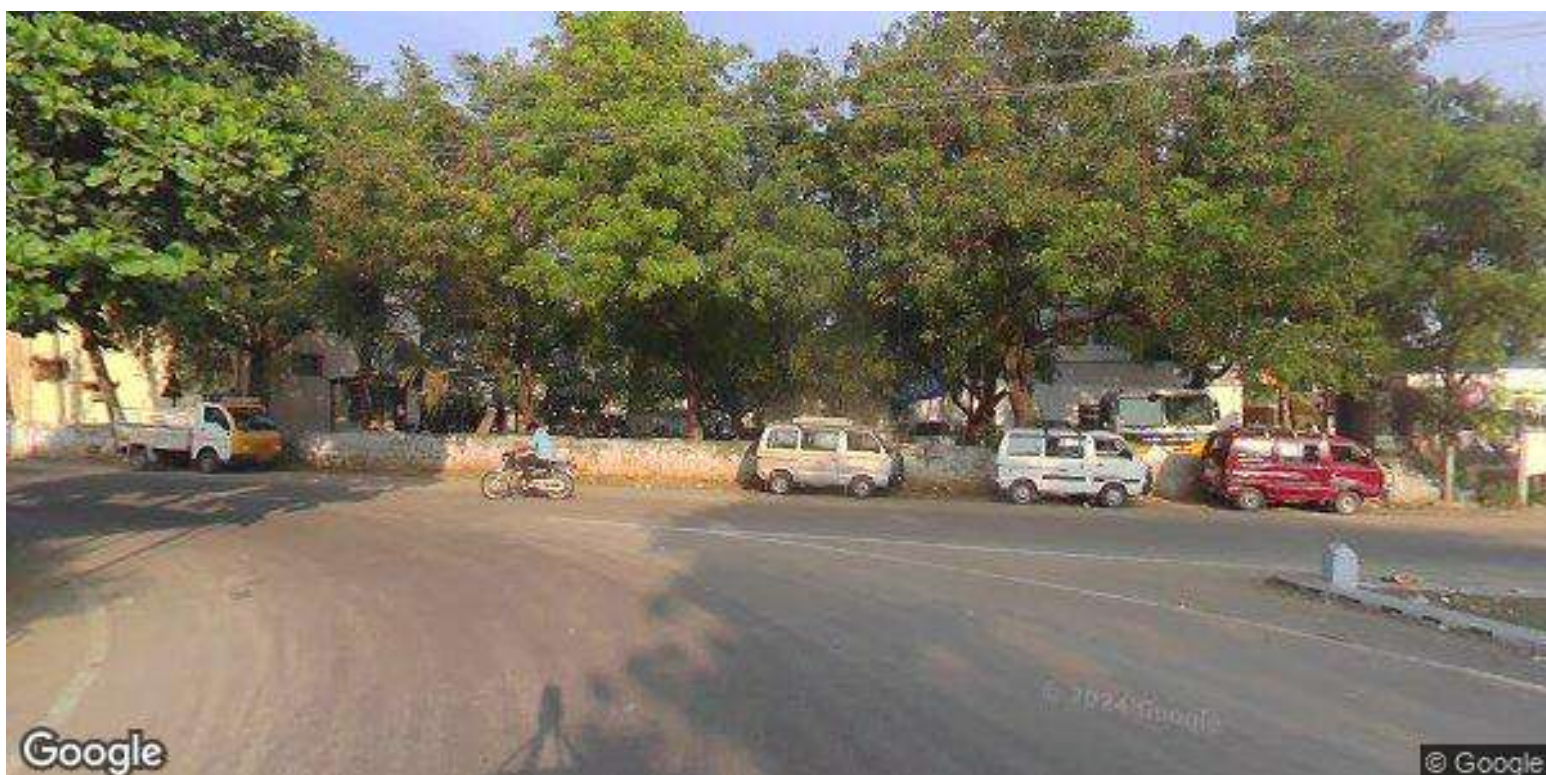
**Risk Type:** Blind Spot  
**Risk Level:** Blind Spot  
**Speed Limit:** 10 KM/Hr  
**Coordinates:** 10.84969, 77.44694

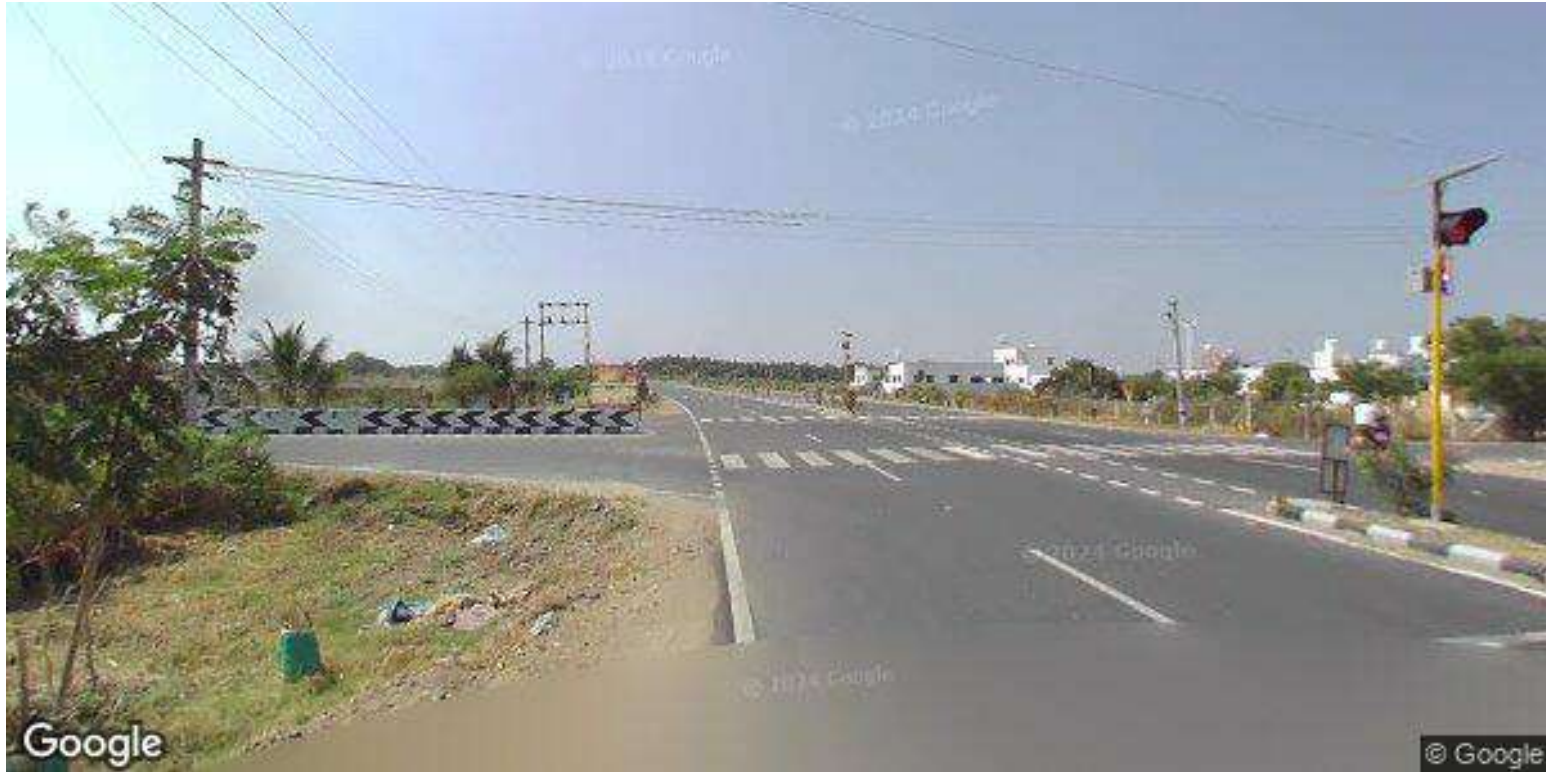
**Risk Type:** Turn  
**Risk Level:** High  
**Speed Limit:** 15 KM/Hr  
**Coordinates:** 10.85361, 77.43716

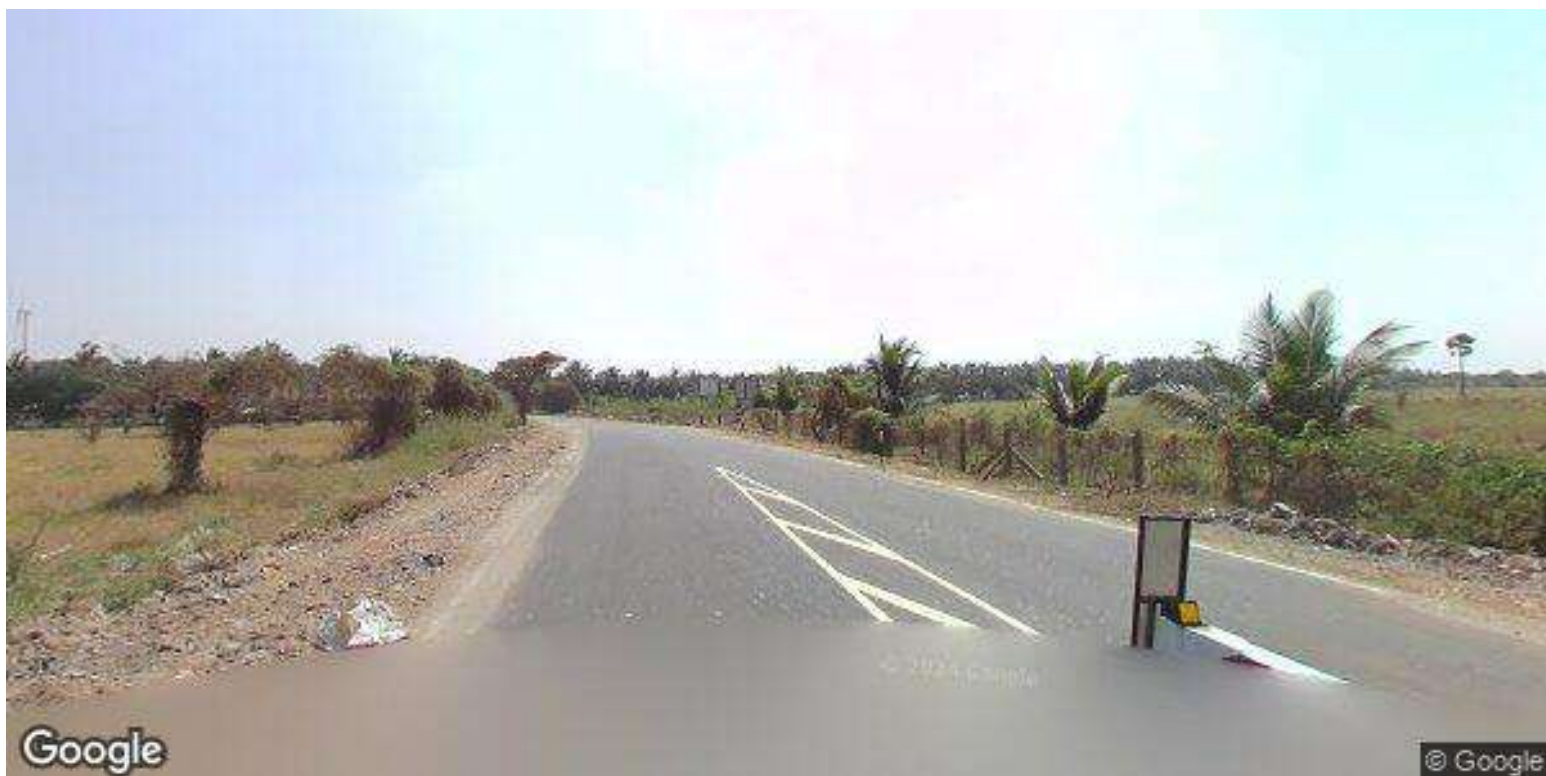
**Risk Type:** Turn  
**Risk Level:** Medium  
**Speed Limit:** 30 KM/Hr  
**Coordinates:** 10.85334, 77.43681

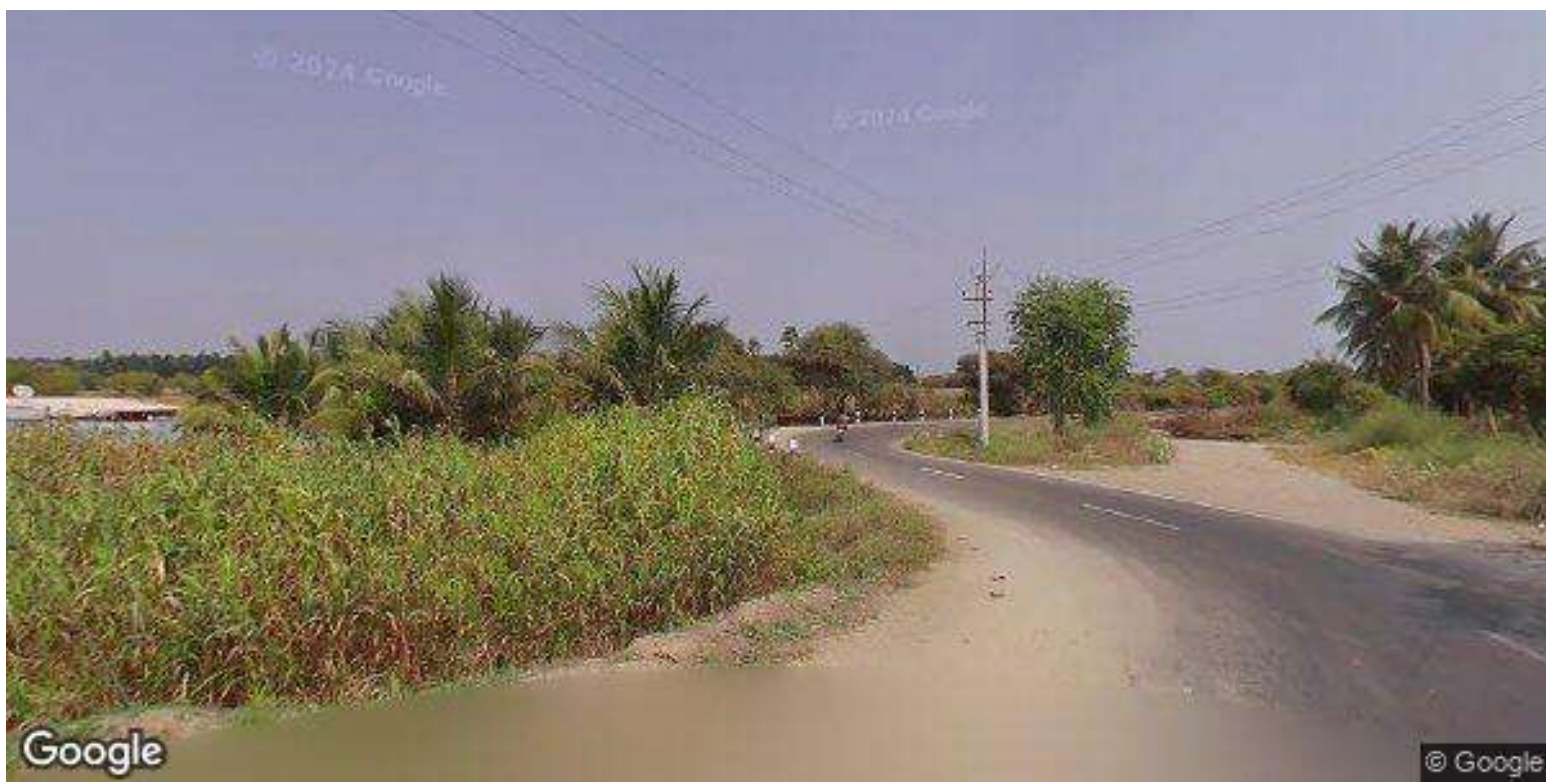
**Coordinates:** 10.84267, 77.43414

**Risk Type:** Turn

**Risk Level:** Medium

**Speed Limit:** 30 KM/Hr
