# IndianOil

## JOURNEY RISK MANAGEMENT (JRM) STUDY

**Salem Terminal to CHAKRAVARTHY & CO**

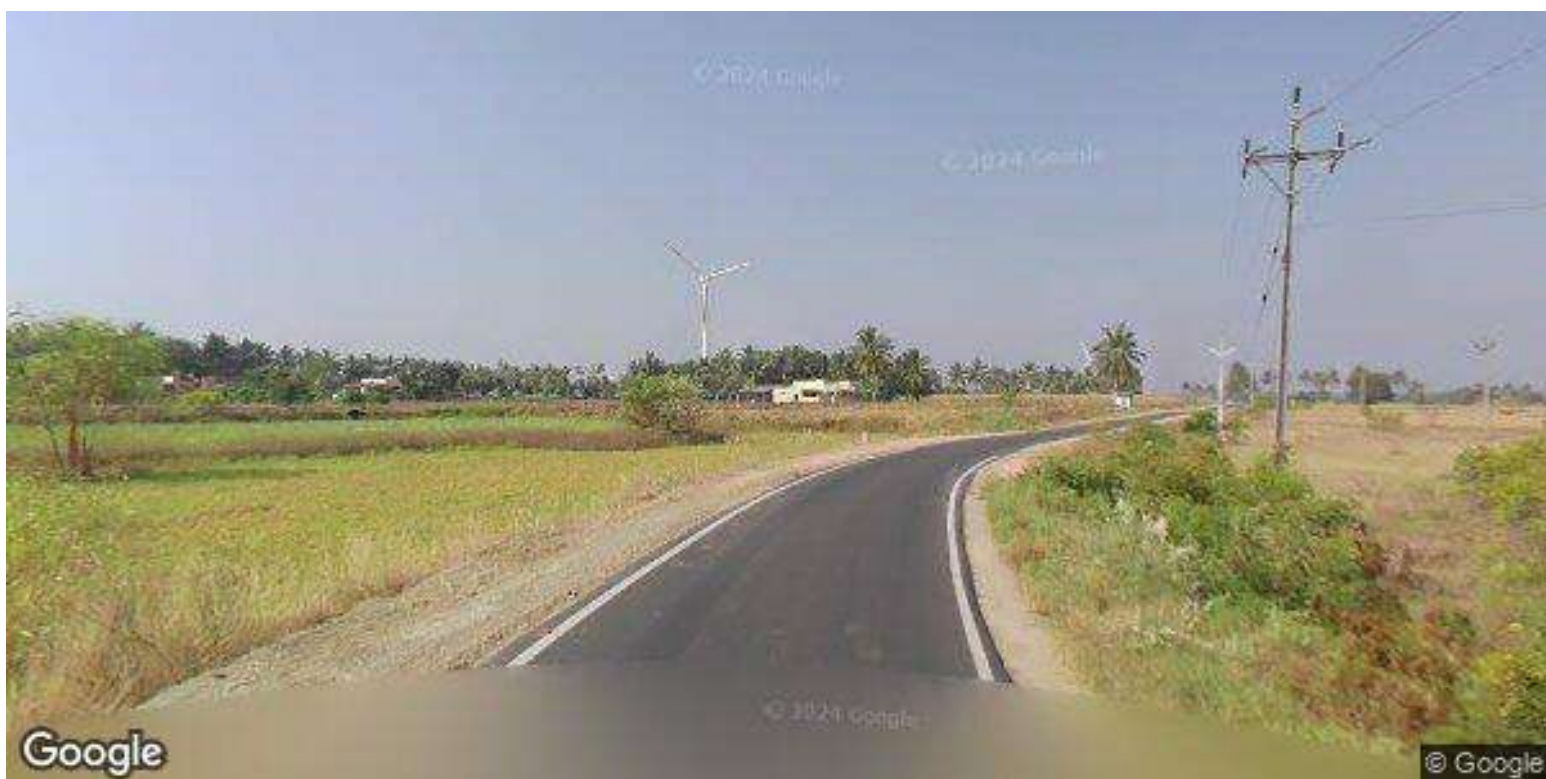
**Coordinates:** 10.83777, 77.40922

**Risk Type:** Turn

**Risk Level:** High

**Speed Limit:** 15 KM/Hr

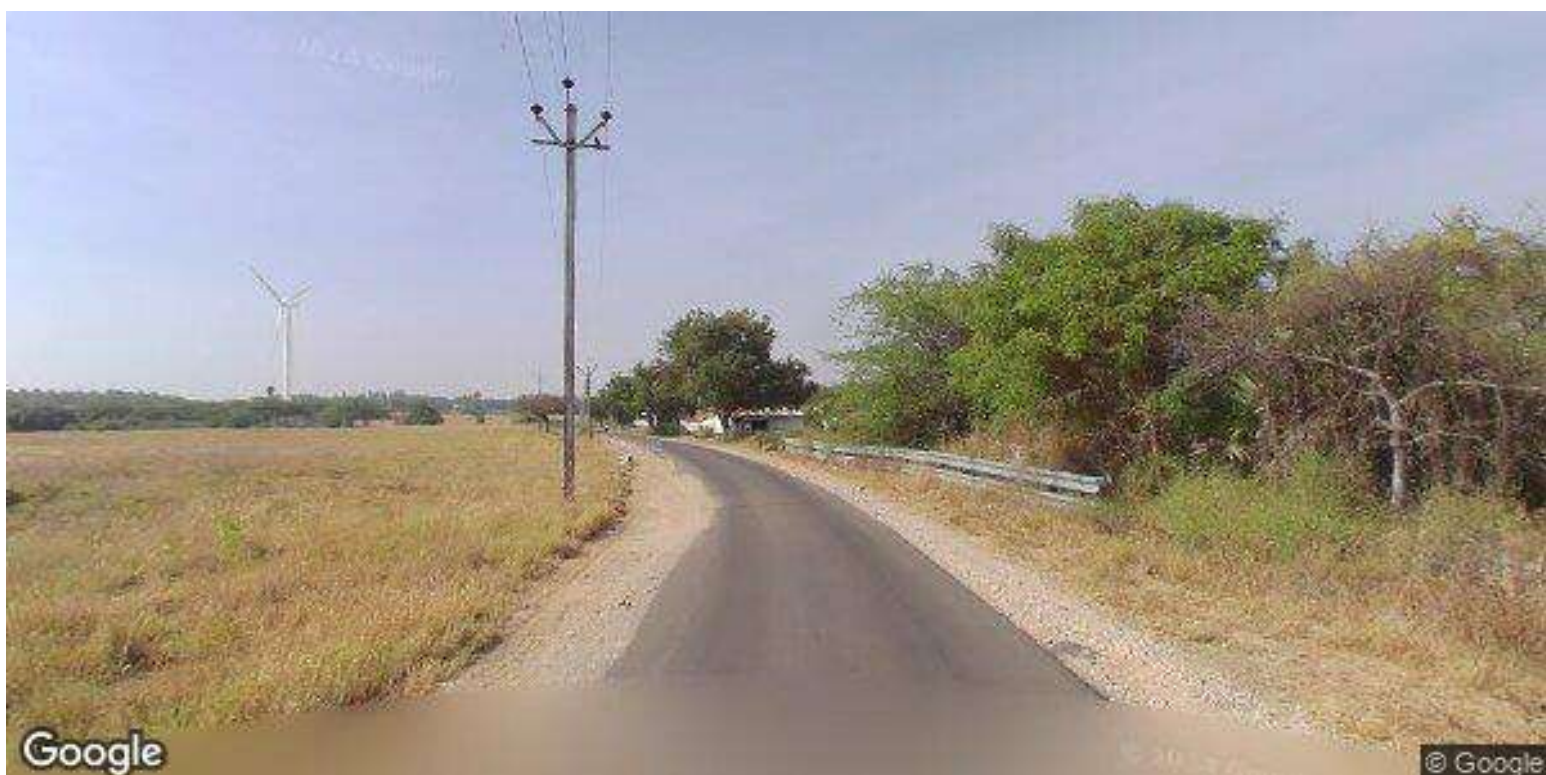
**Risk Type:** Turn  
**Risk Level:** Medium  
**Speed Limit:** 30 KM/Hr  
**Coordinates:** 10.83495, 77.39394

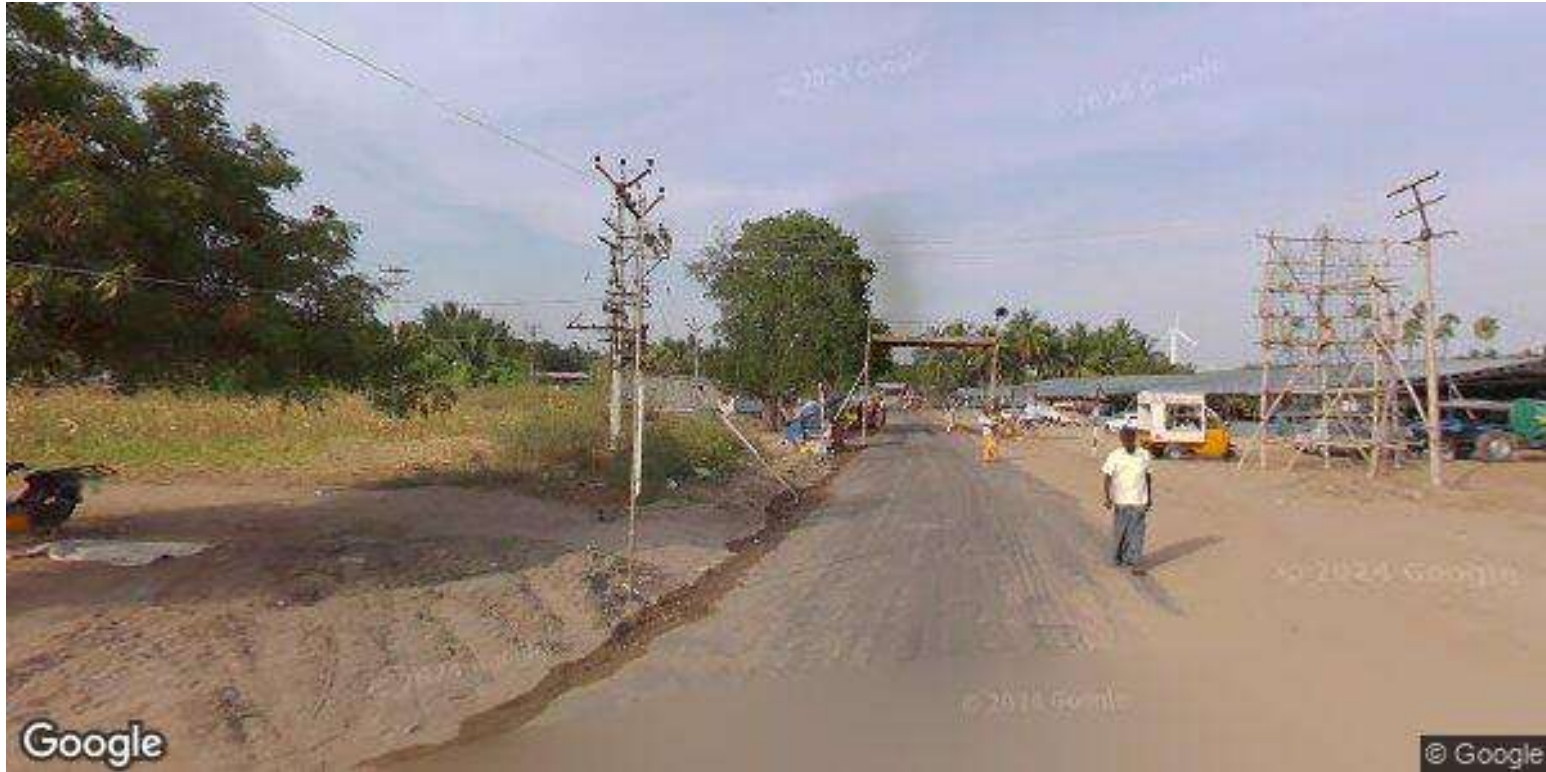
**Risk Type:** Turn  
**Risk Level:** Medium  
**Speed Limit:** 30 KM/Hr  
**Coordinates:** 10.82716, 77.38831

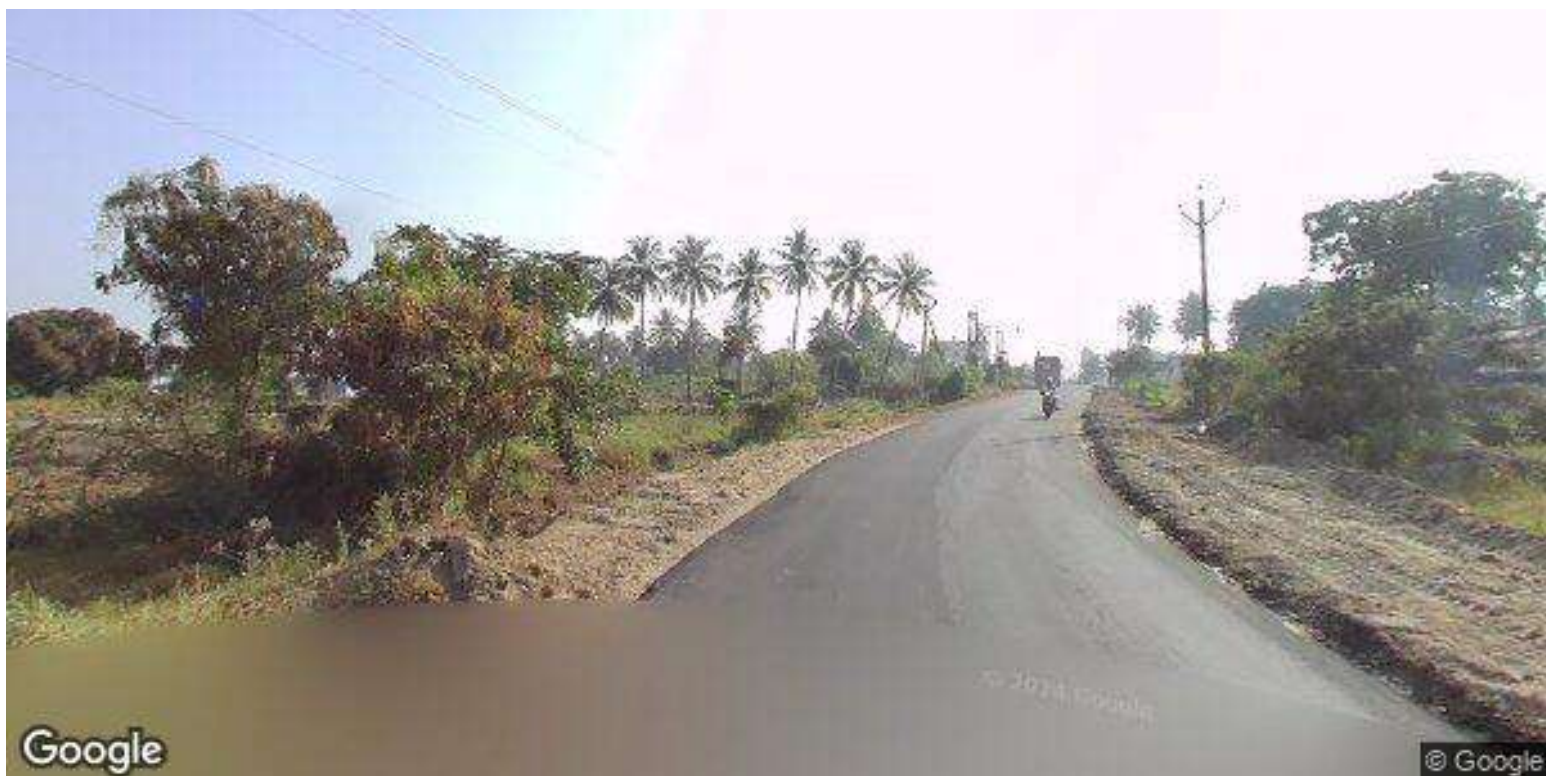
**Risk Type:** Turn  
**Risk Level:** Medium  
**Speed Limit:** 30 KM/Hr  
**Coordinates:** 10.82438, 77.37275

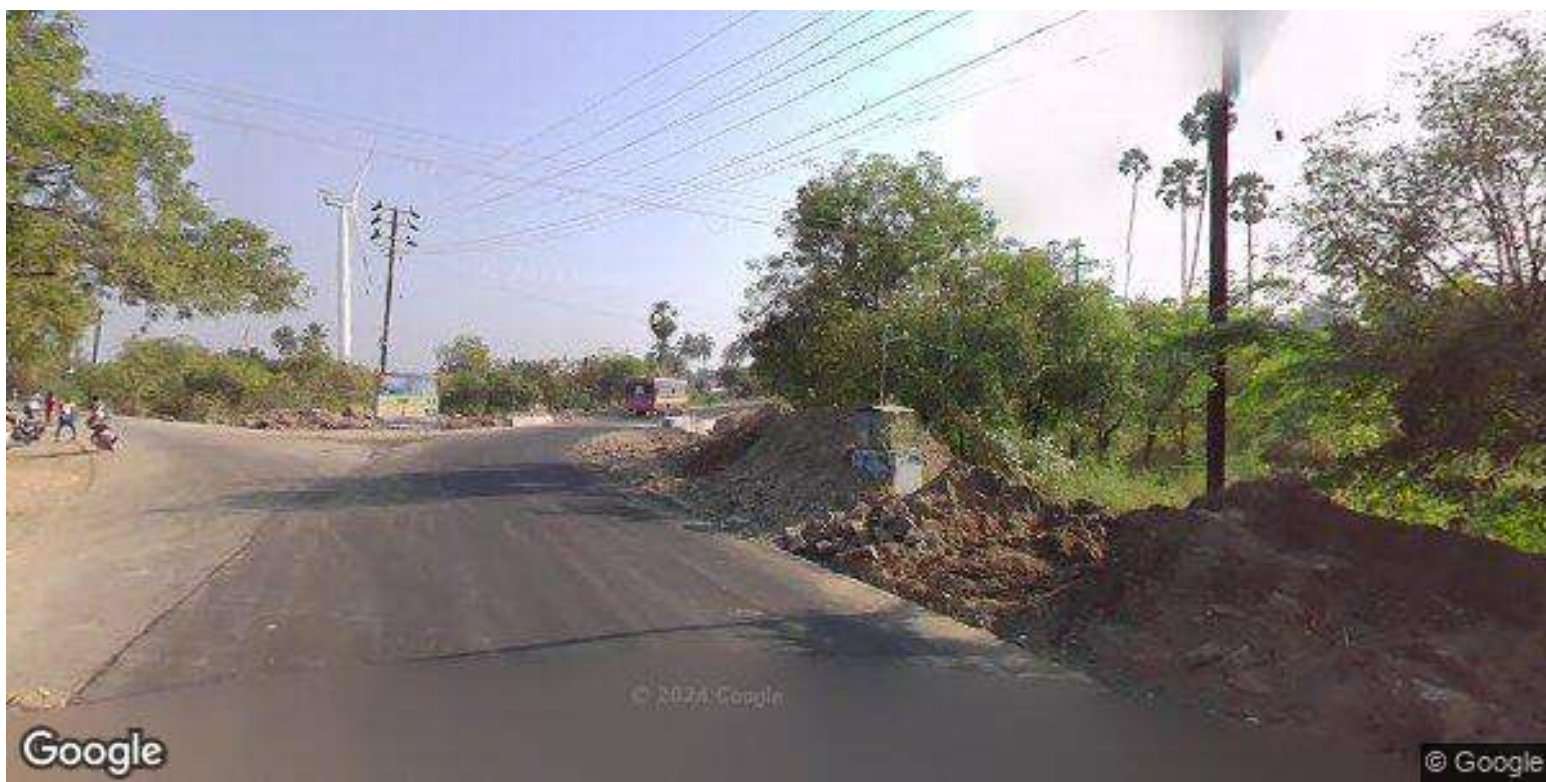
**Coordinates:** 10.82376, 77.37202

**Risk Type:** Turn

**Risk Level:** Medium

**Speed Limit:** 30 KM/Hr

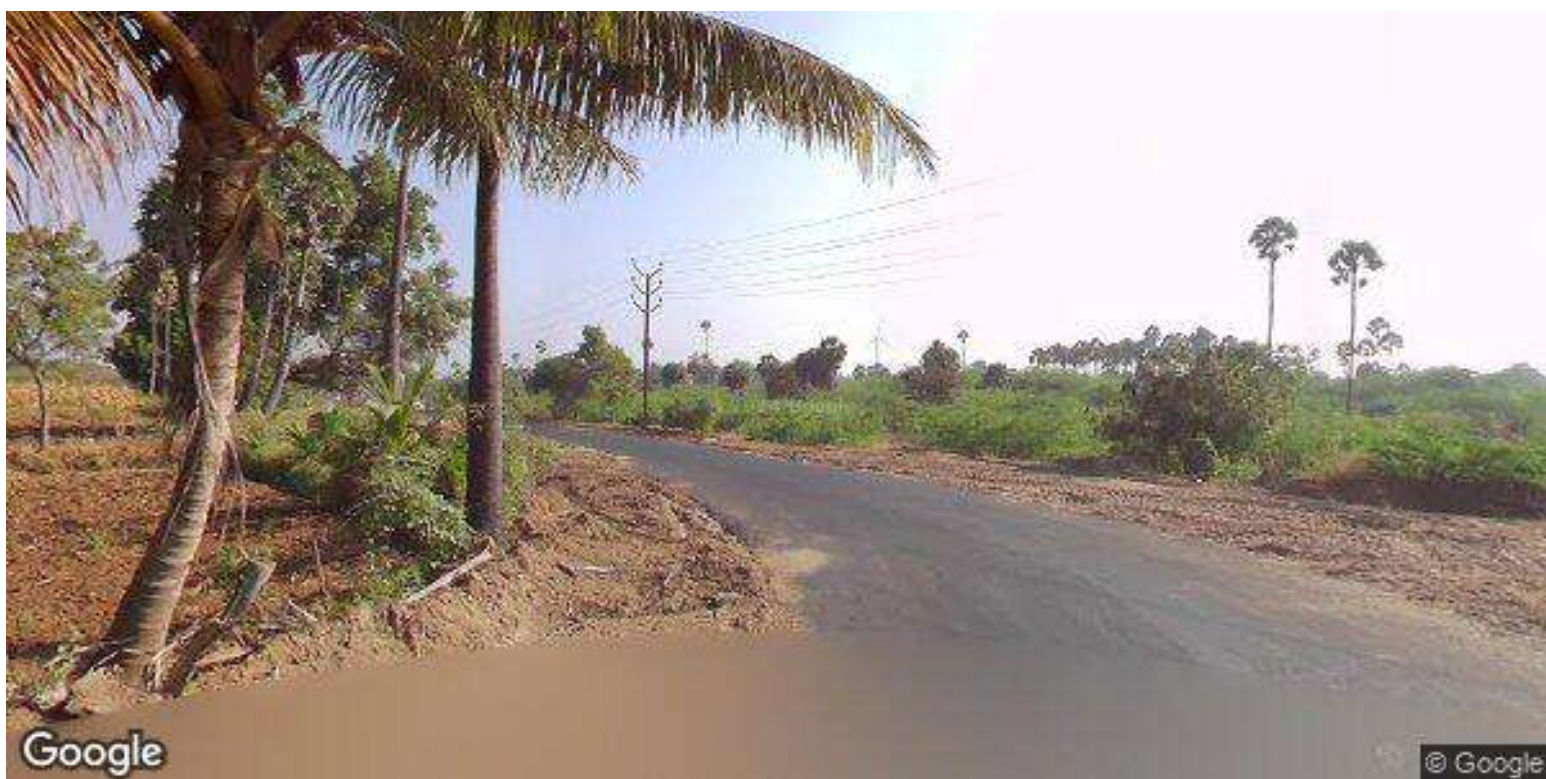
**Coordinates:** 10.82150, 77.37132

**Risk Type:** Turn

**Risk Level:** High

**Speed Limit:** 15 KM/Hr

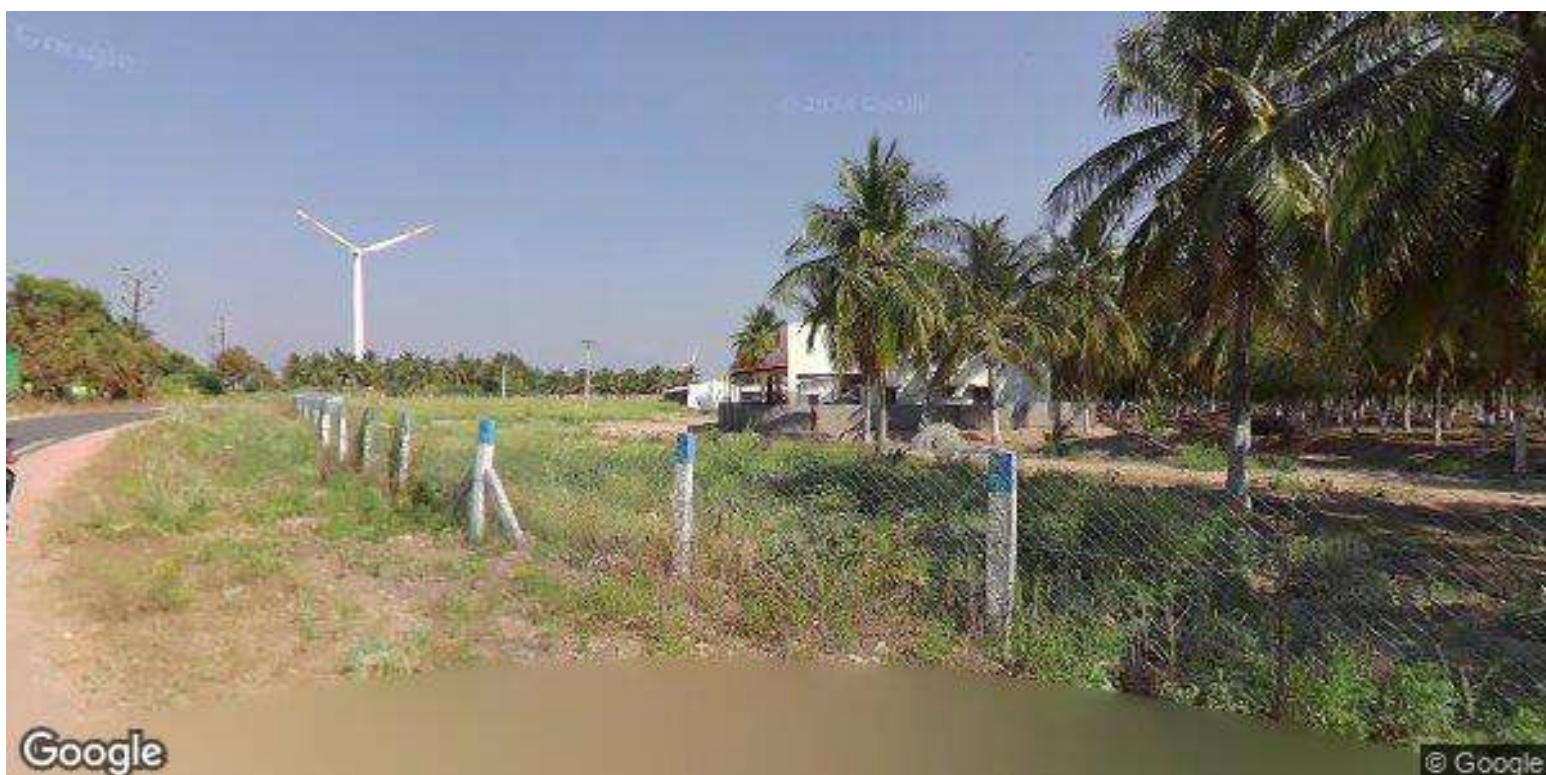
**Coordinates:** 10.81588, 77.34834

**Risk Type:** Turn

**Risk Level:** Medium

**Speed Limit:** 30 KM/Hr
