## JOURNEY RISK MANAGEMENT (JRM) STUDY

### Salem Terminal TO SWAGAT COCO NAMAKKAL

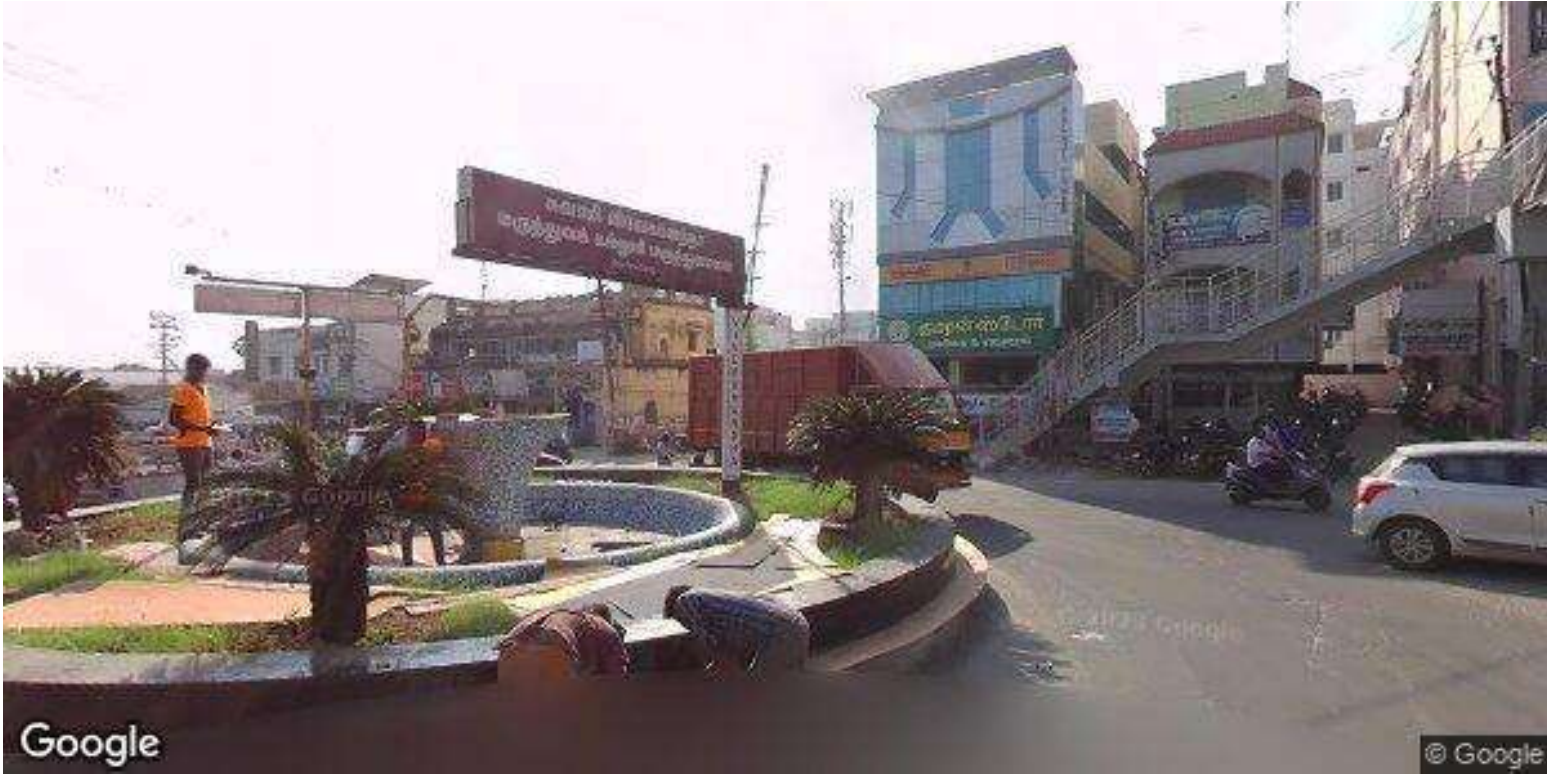
| | Risk Type | Risk Level | Coordinates | Speed Limit |
|---|---|---|---|---|
| 0 | Roundabout | High | 11.38395, 77.89480 | 15 KM/Hr |

Risk Type: Roundabout  
Risk Level: High  
Speed Limit: 15 KM/Hr  
Coordinates: 11.38395, 77.89480

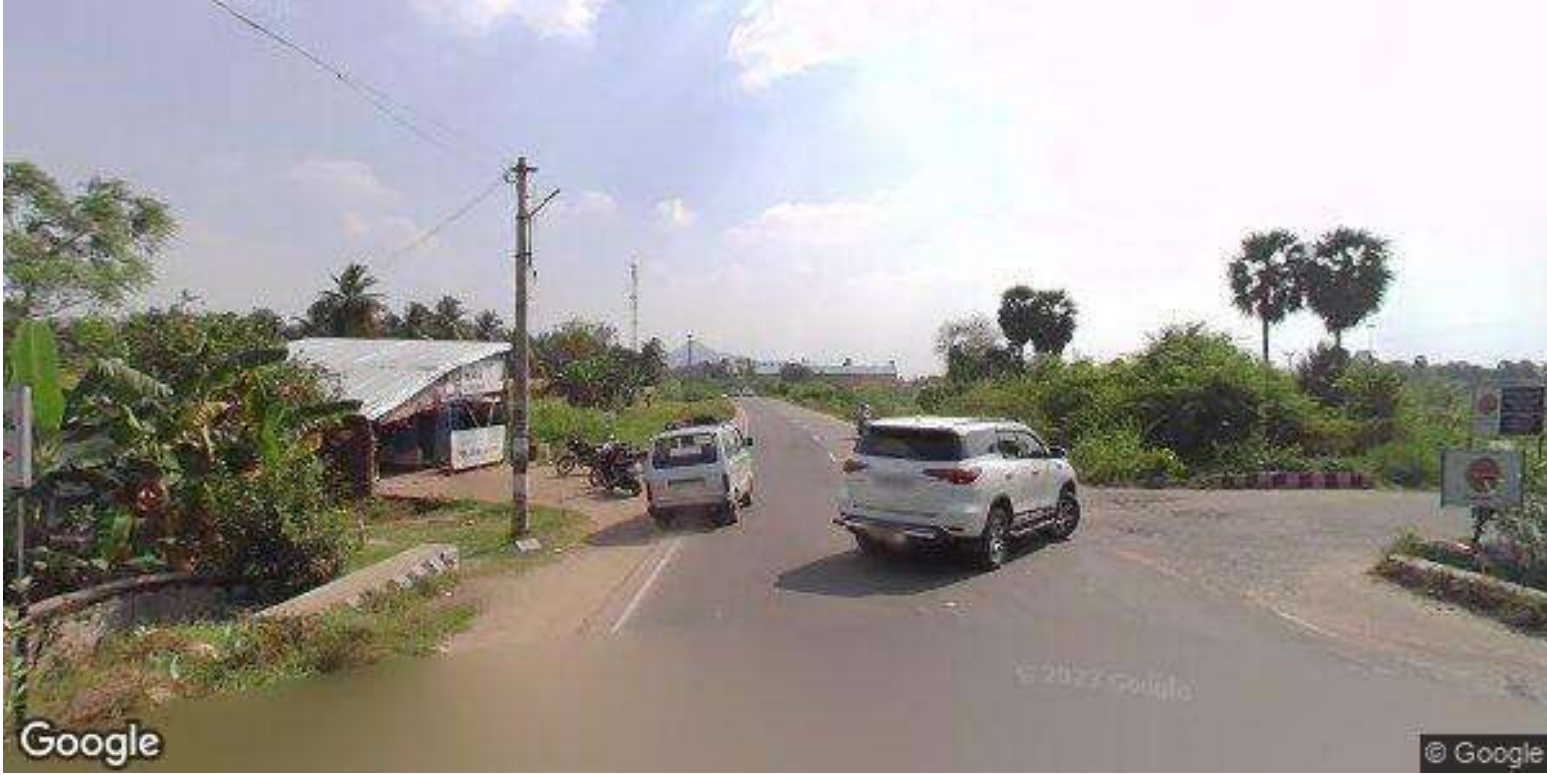
| | Risk Type | Risk Level | Coordinates | Speed Limit |
|---|---|---|---|---|
| 4 | Blind Spot | Blind Spot | 11.44029, 77.87544 | 10 KM/Hr |

Risk Type: Blind Spot  
Risk Level: Blind Spot  
Speed Limit: 10 KM/Hr  
Coordinates: 11.44029, 77.87544

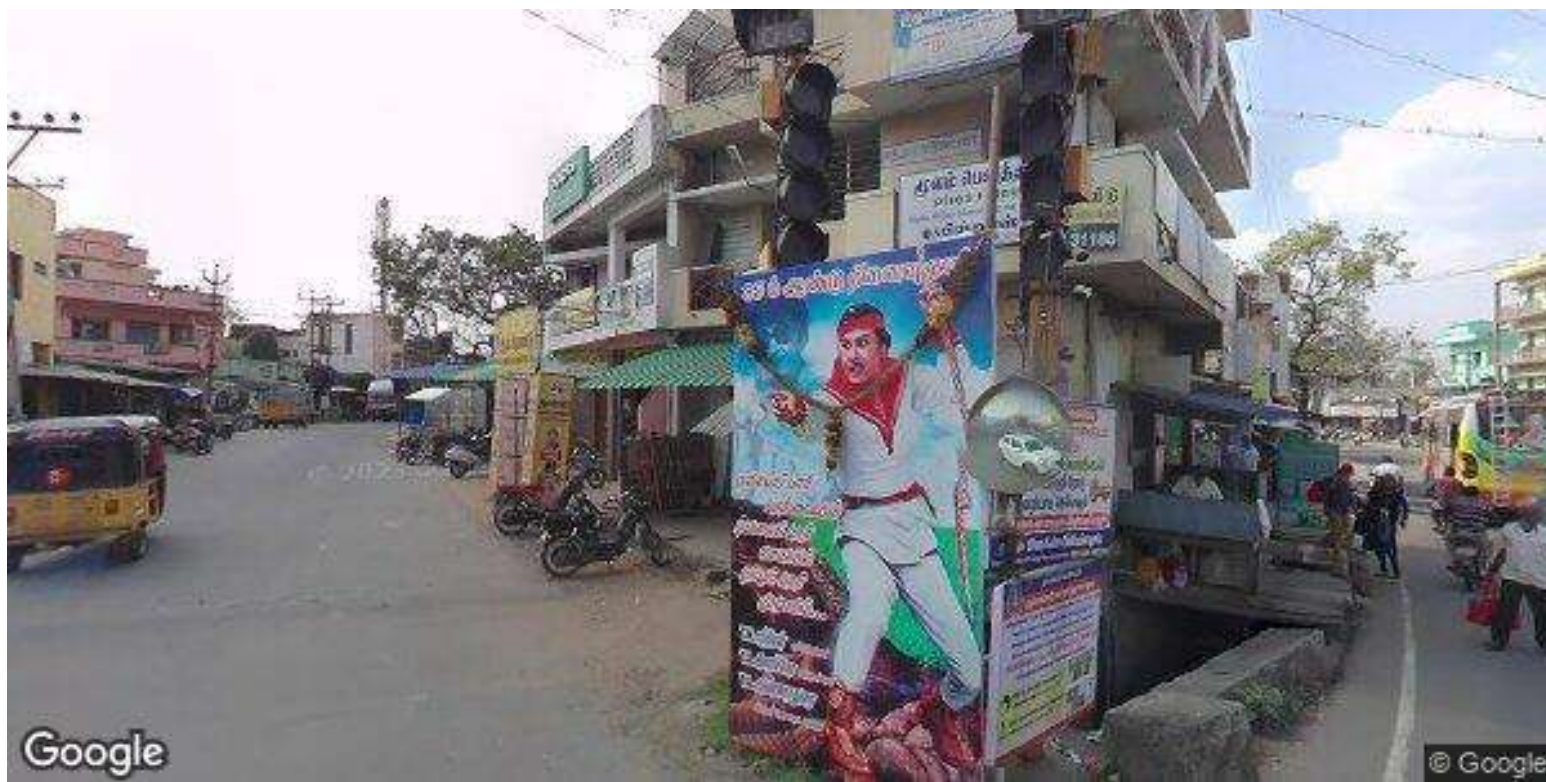
**Coordinates:** 11.38342, 77.89975

| | Risk Type | Risk Level | Coordinates | Speed Limit |
|---|---|---|---|---|
| 5 | Turn | Medium | 11.38342, 77.89975 | 30 KM/Hr |

**Risk Type:** Turn

**Risk Level:** Medium

**Speed Limit:** 30 KM/Hr

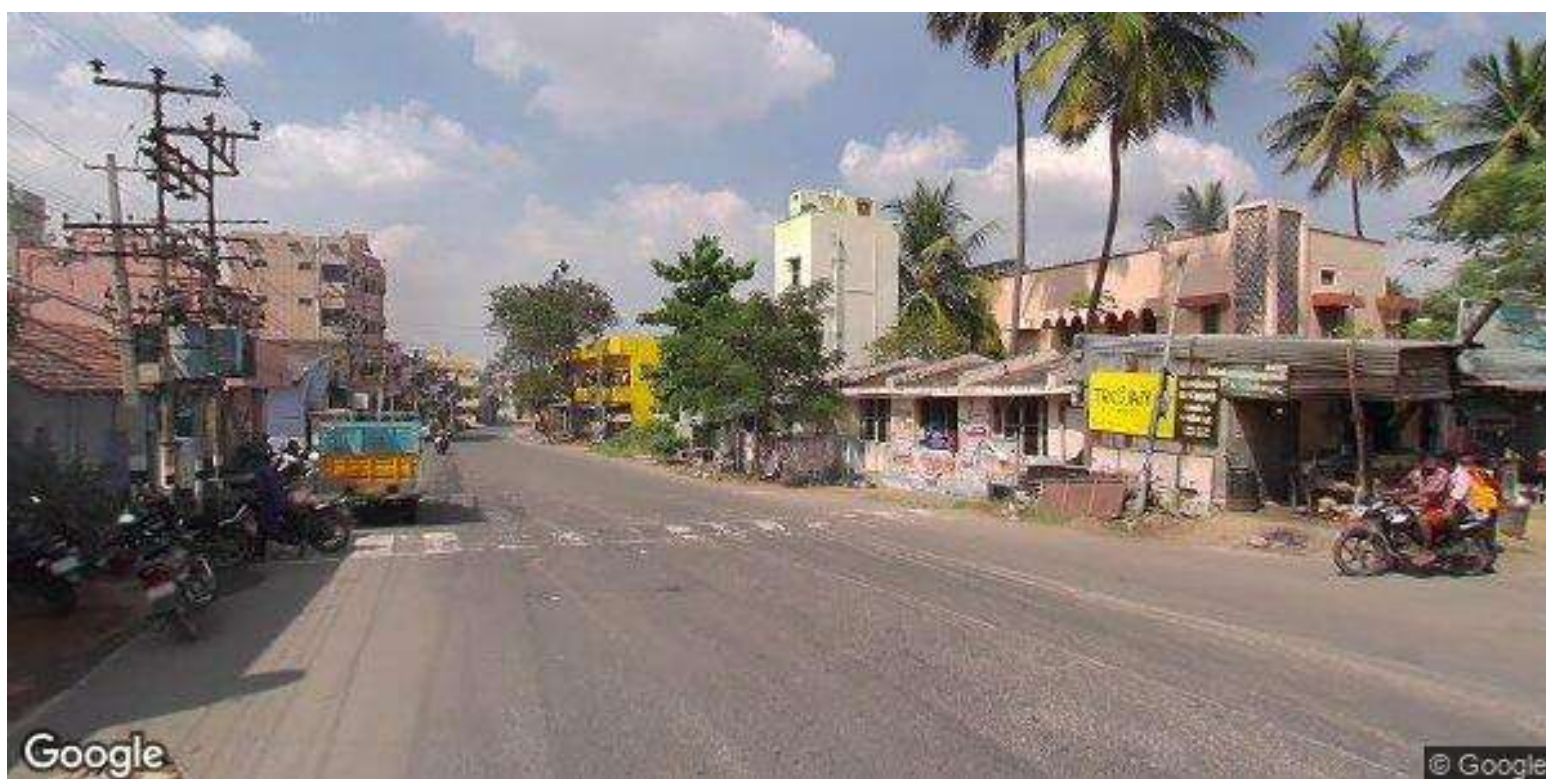
**Coordinates:** 11.38190, 77.90254

| | Risk Type | Risk Level | Coordinates | Speed Limit |
|---|---|---|---|---|
| 6 | Turn | Medium | 11.38190, 77.90254 | 30 KM/Hr |

**Risk Type:** Turn

**Risk Level:** Medium

**Speed Limit:** 30 KM/Hr

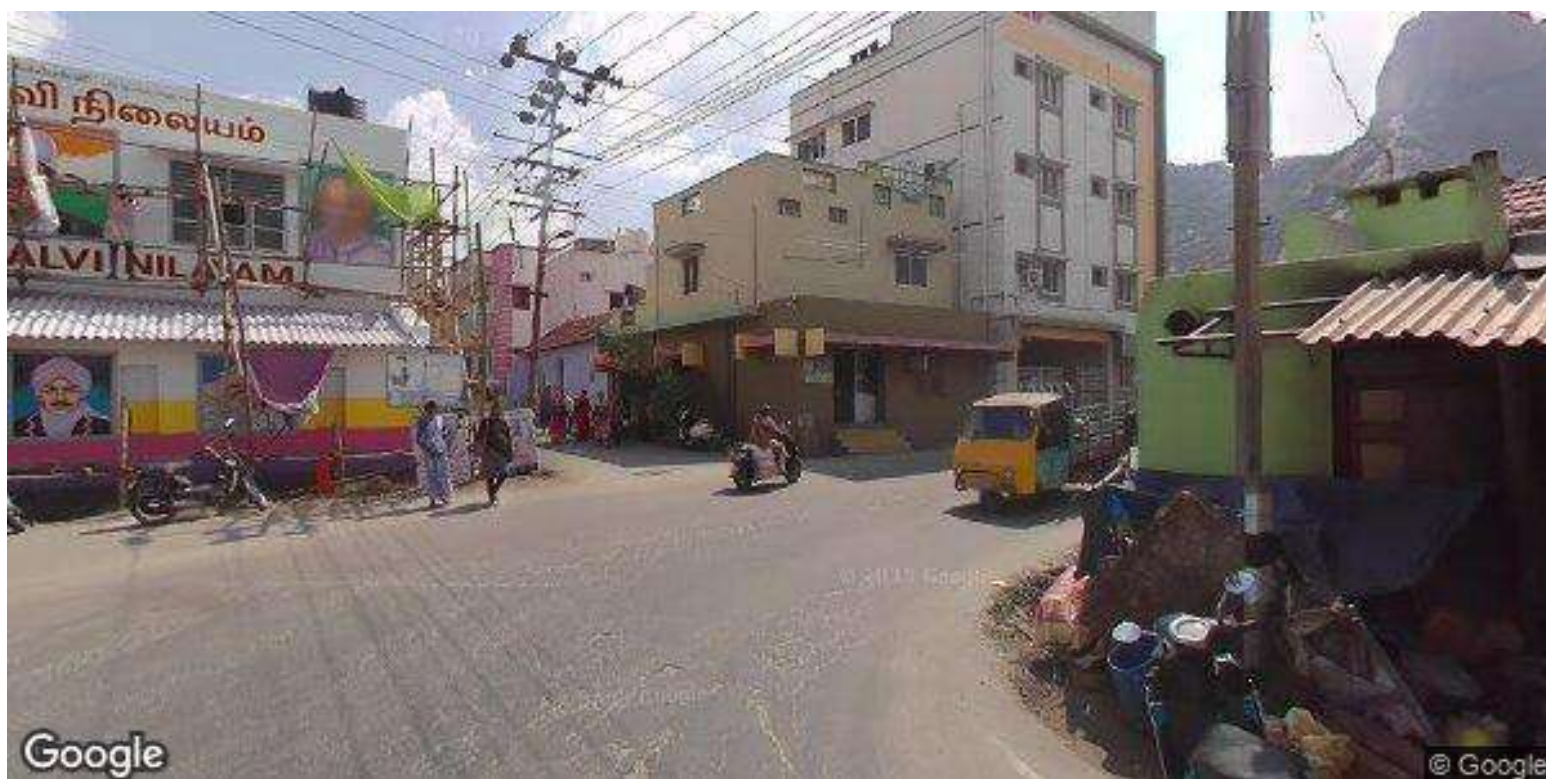
**Coordinates: 11.38186, 77.90258**

| | Risk Type | Risk Level | Coordinates | Speed Limit |
|---|---|---|---|---|
| 7 | Turn | High | 11.38186, 77.90258 | 15 KM/Hr |

**Risk Type: Turn**

**Risk Level: High**

**Speed Limit: 15 KM/Hr**

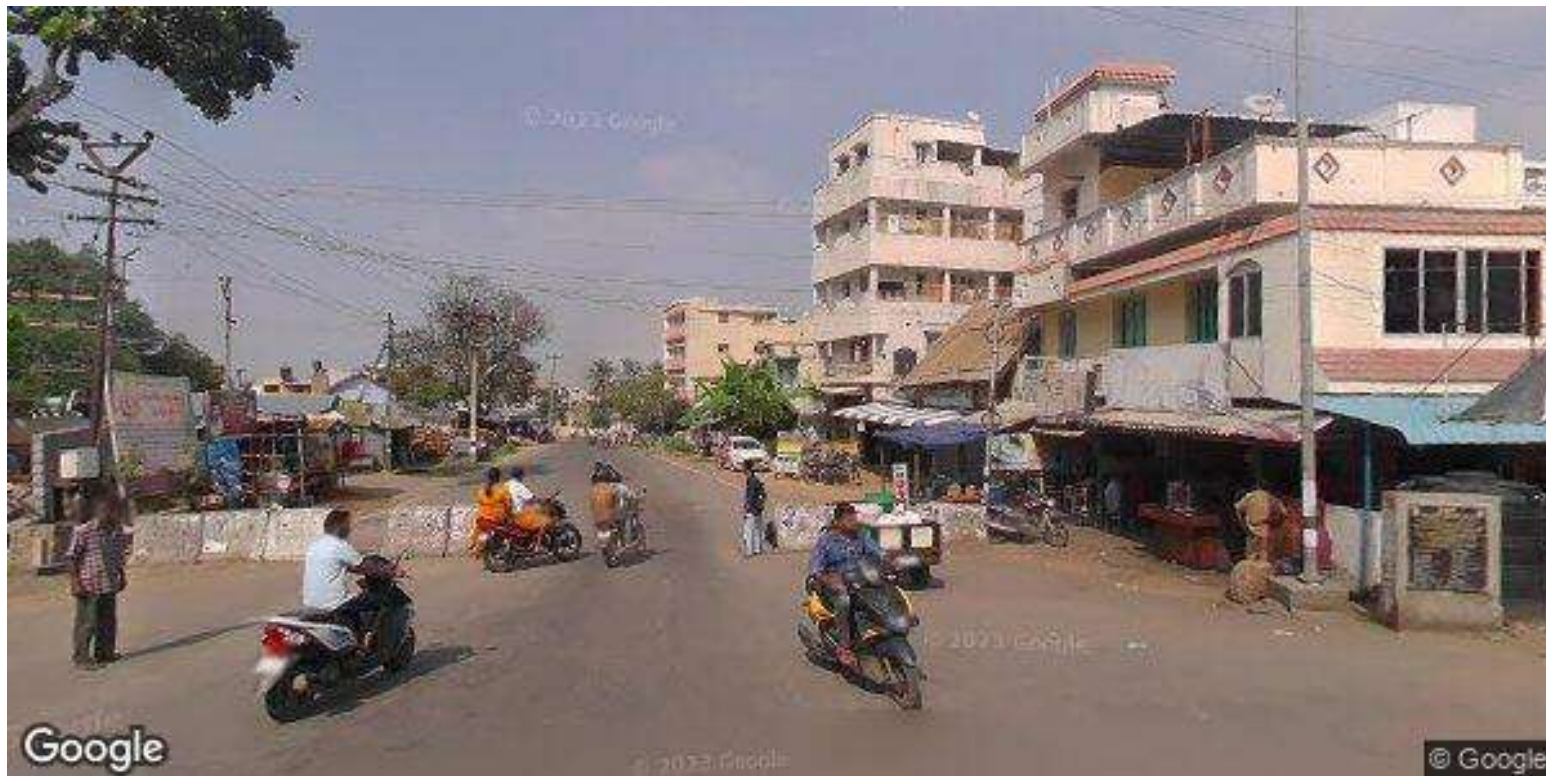
**Coordinates: 11.37841, 77.90140**

| | Risk Type | Risk Level | Coordinates | Speed Limit |
|---|---|---|---|---|
| 8 | Blind Spot | Blind Spot | 11.37841, 77.90140 | 10 KM/Hr |

**Risk Type: Blind Spot**

**Risk Level: Blind Spot**

**Speed Limit: 10 KM/Hr**

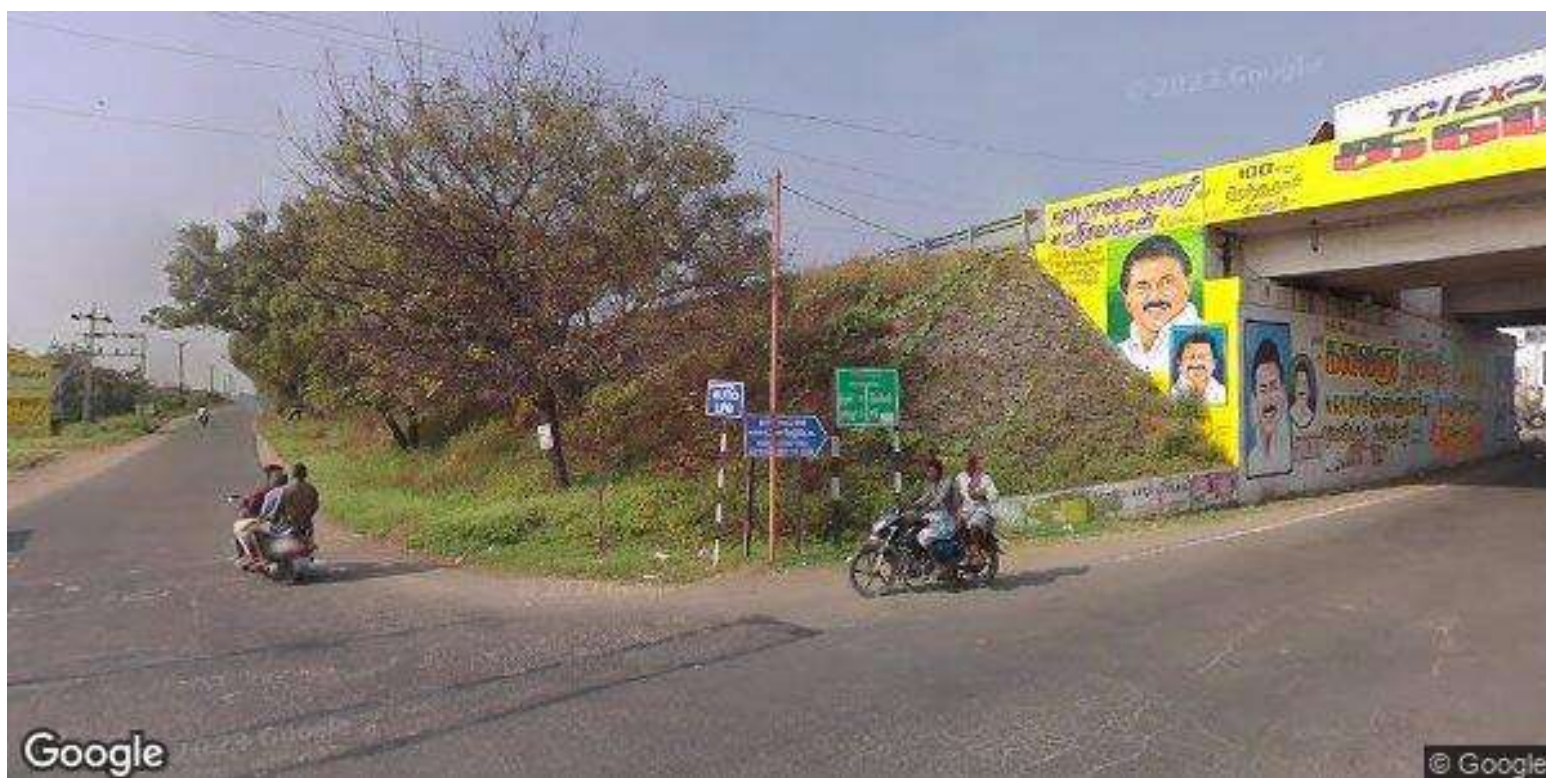
**Coordinates: 11.23936, 78.14267**

| | Risk Type | Risk Level | Coordinates | Speed Limit |
|---|---|---|---|---|
| 9 | Blind Spot | Blind Spot | 11.23936, 78.14267 | 10 KM/Hr |

**Risk Type: Blind Spot**

**Risk Level: Blind Spot**

**Speed Limit: 10 KM/Hr**

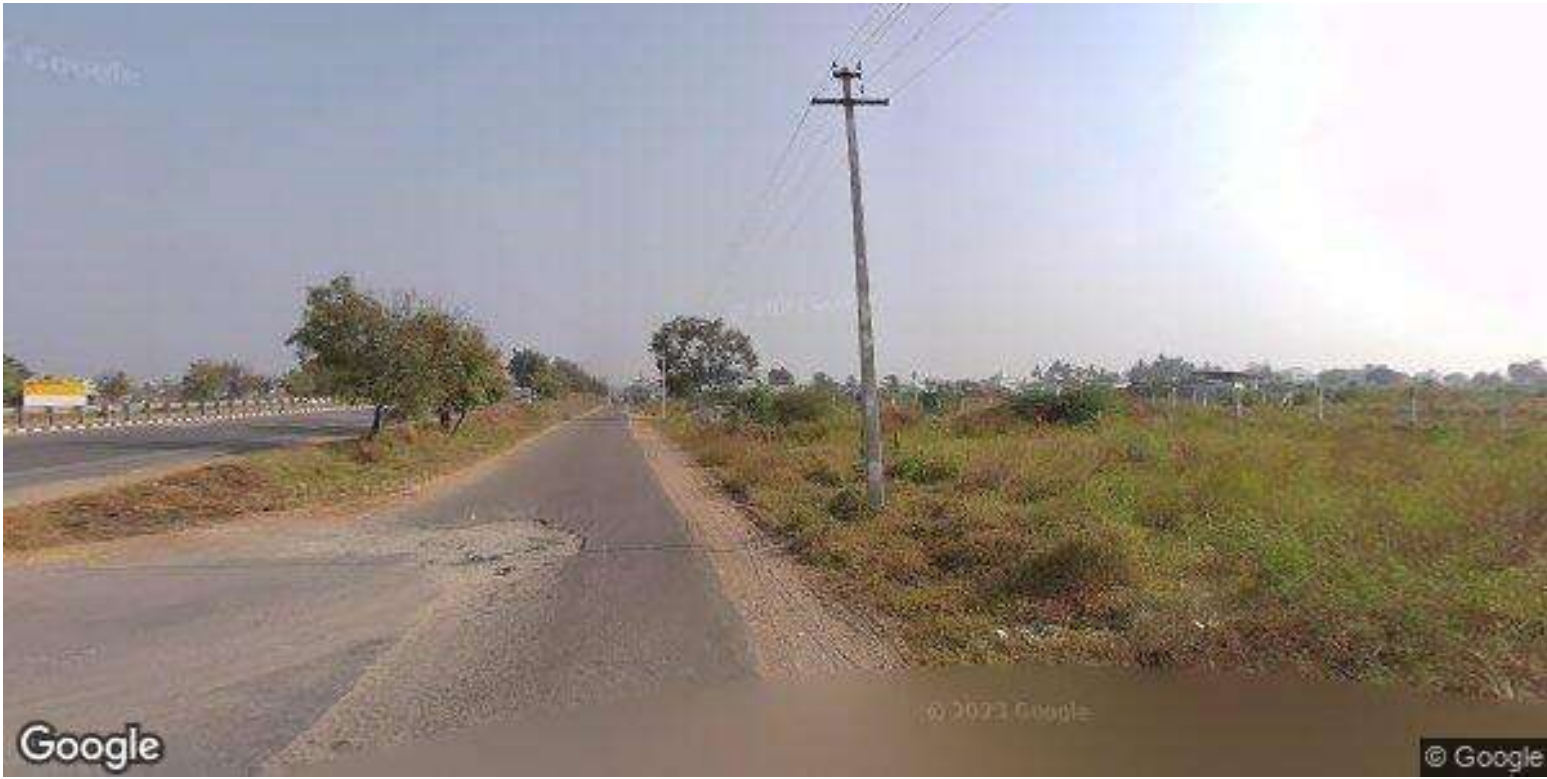
| | Risk Type | Risk Level | Coordinates | Speed Limit |
|---|---|---|---|---|
| 10 | Turn | High | 11.22817, 78.13576 | 15 KM/Hr |

**Risk Type:** Turn  
**Risk Level:** High  
**Speed Limit:** 15 KM/Hr  
**Coordinates:** 11.22817, 78.13576

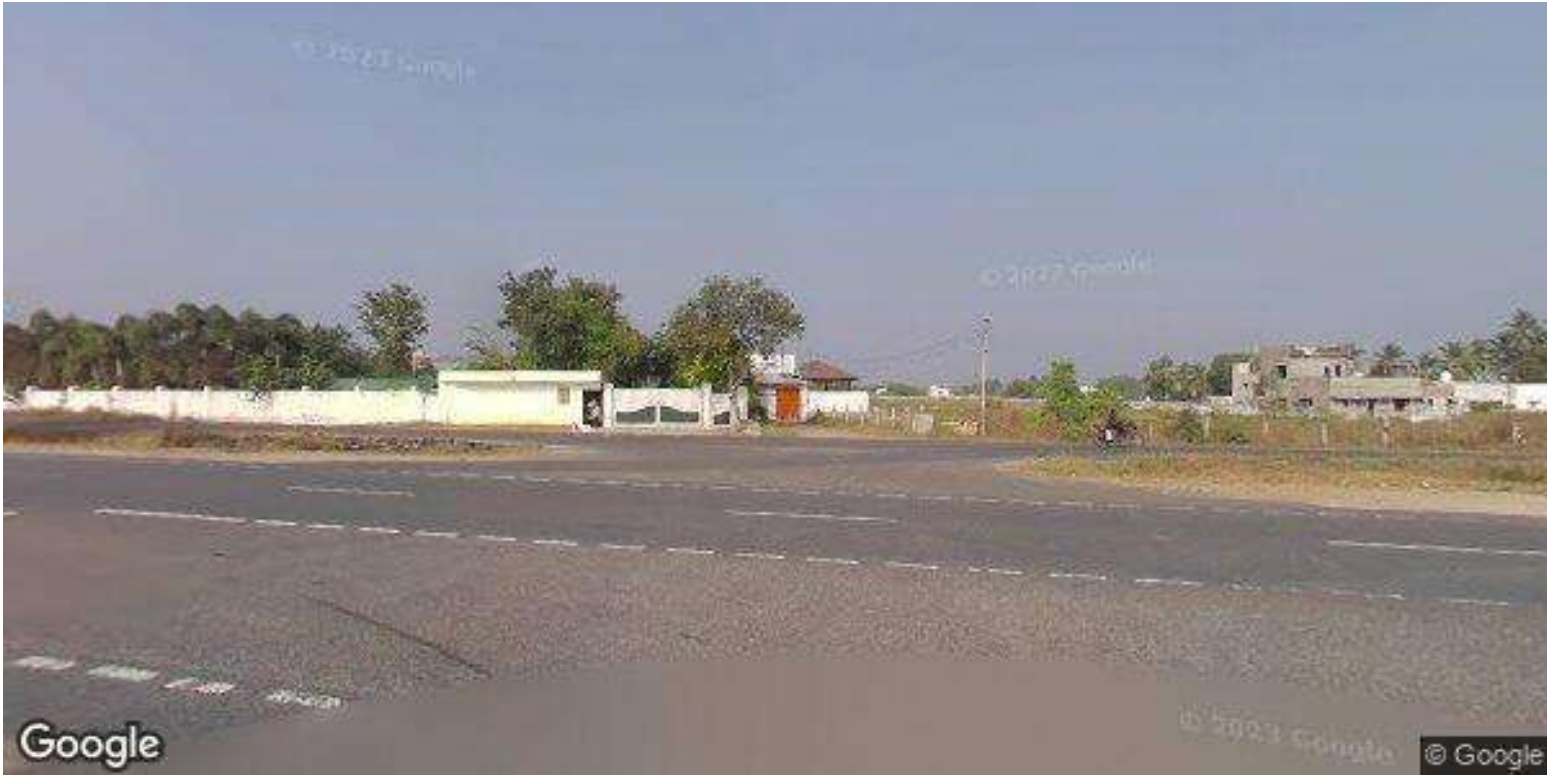
| | Risk Type | Risk Level | Coordinates | Speed Limit |
|---|---|---|---|---|
| 11 | Turn | High | 11.22822, 78.13561 | 15 KM/Hr |

**Risk Type:** Turn  
**Risk Level:** High  
**Speed Limit:** 15 KM/Hr  
**Coordinates:** 11.22822, 78.13561
