# IndianOil

## JOURNEY RISK MANAGEMENT (JRM) STUDY

### Salem Terminal TO SAI FUEL AGENCY

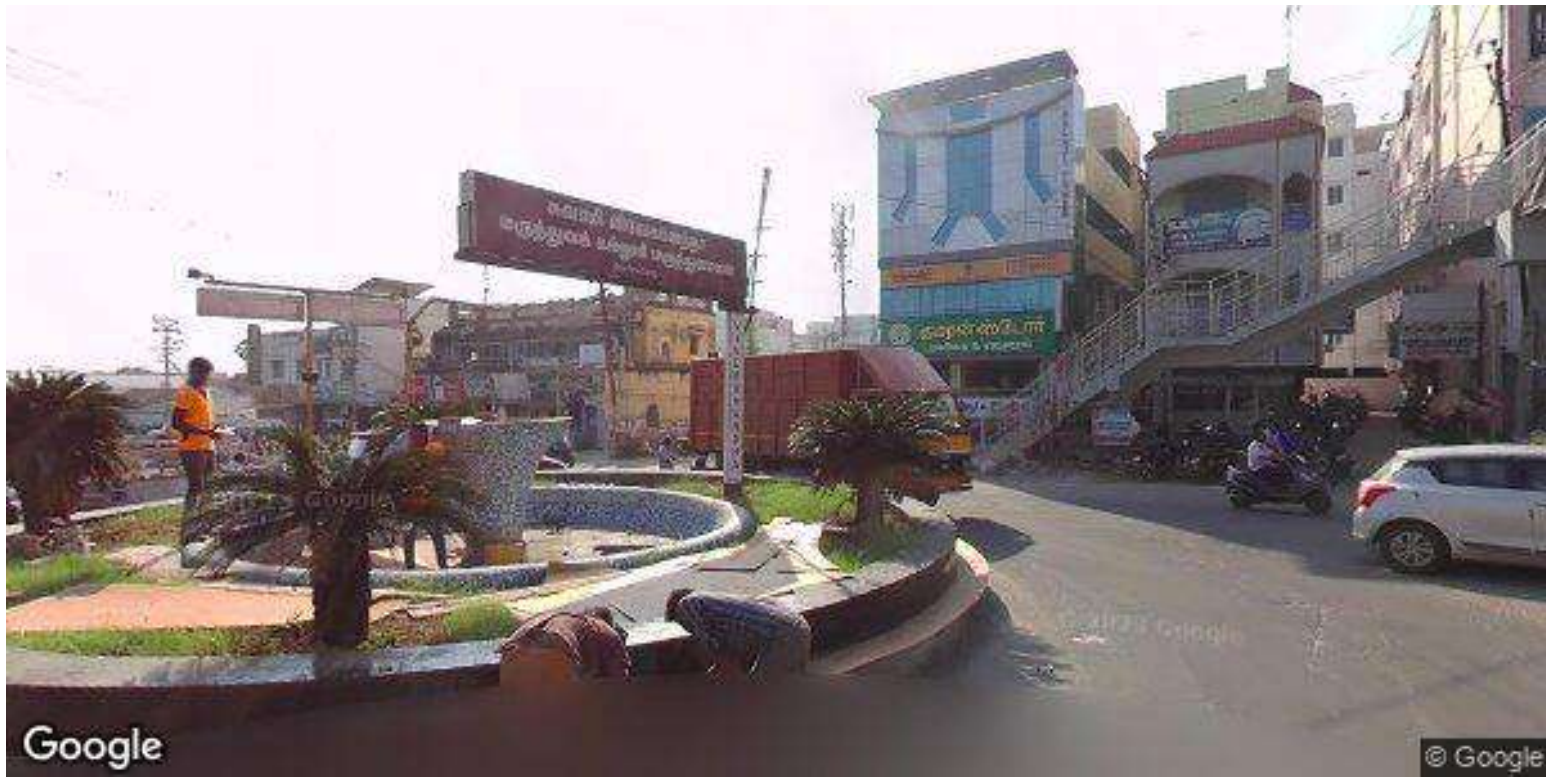
**Coordinates:** 11.38395, 77.89480

**Risk Type:** Roundabout

**Risk Level:** High

**Speed Limit:** 15 KM/Hr

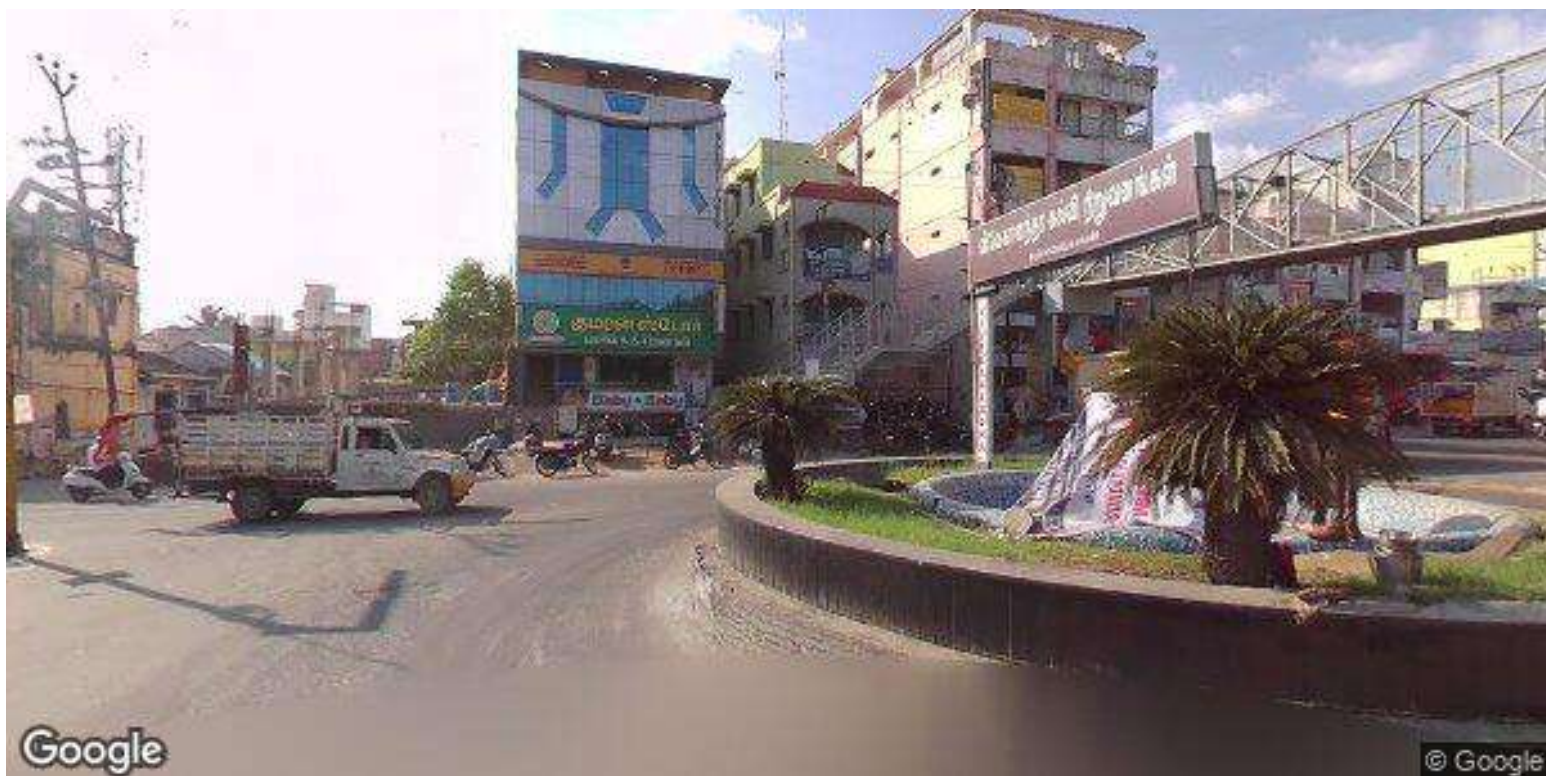
**Risk Type:** Roundabout

**Risk Level:** High

**Speed Limit: 15 KM/Hr**  
**Coordinates: 11.38386, 77.89482**

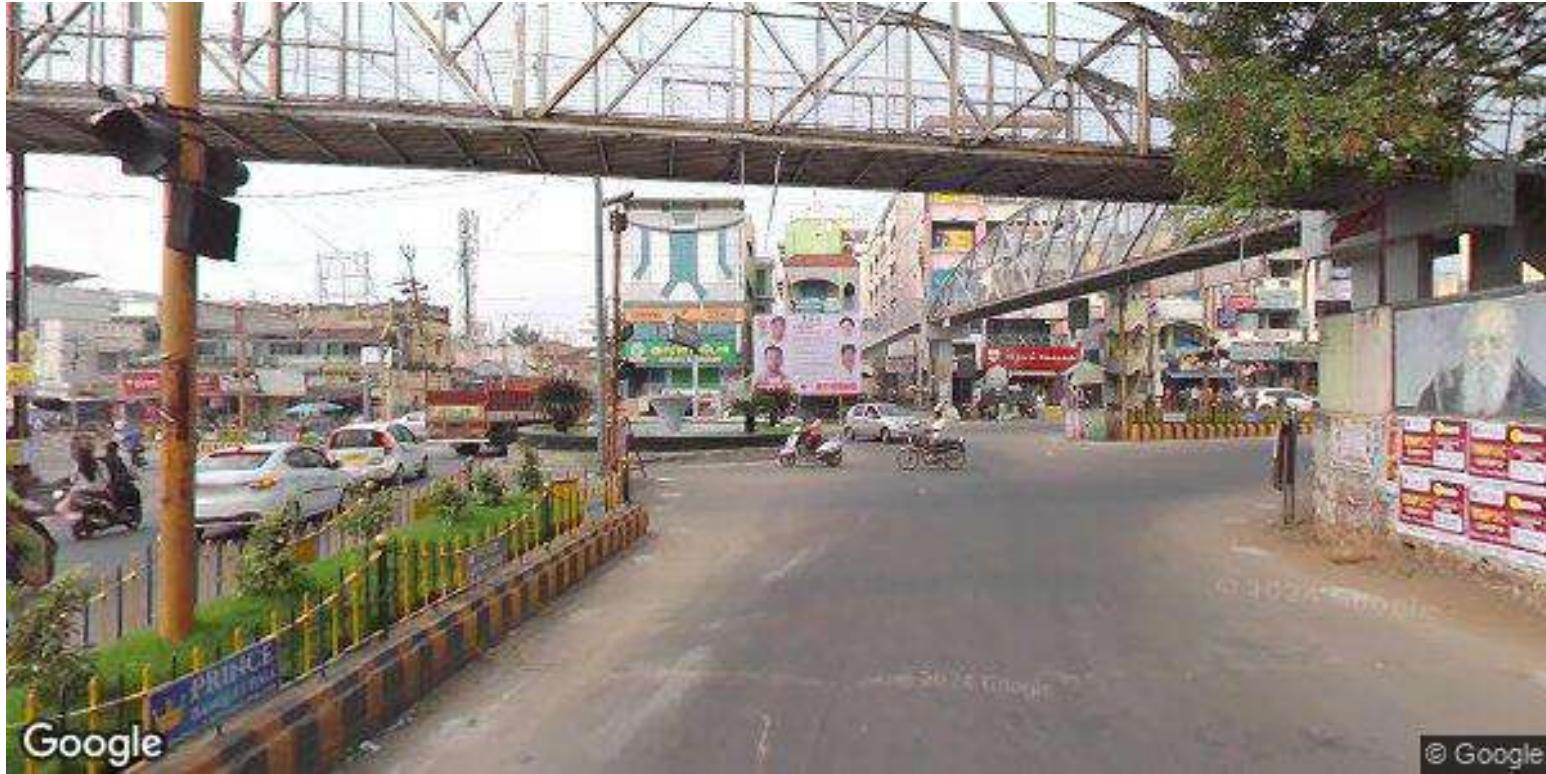
**Risk Type: U-Turn**  
**Risk Level: High**  
**Speed Limit: 10 KM/Hr**  
**Coordinates: 11.3839218, 77.8950042**

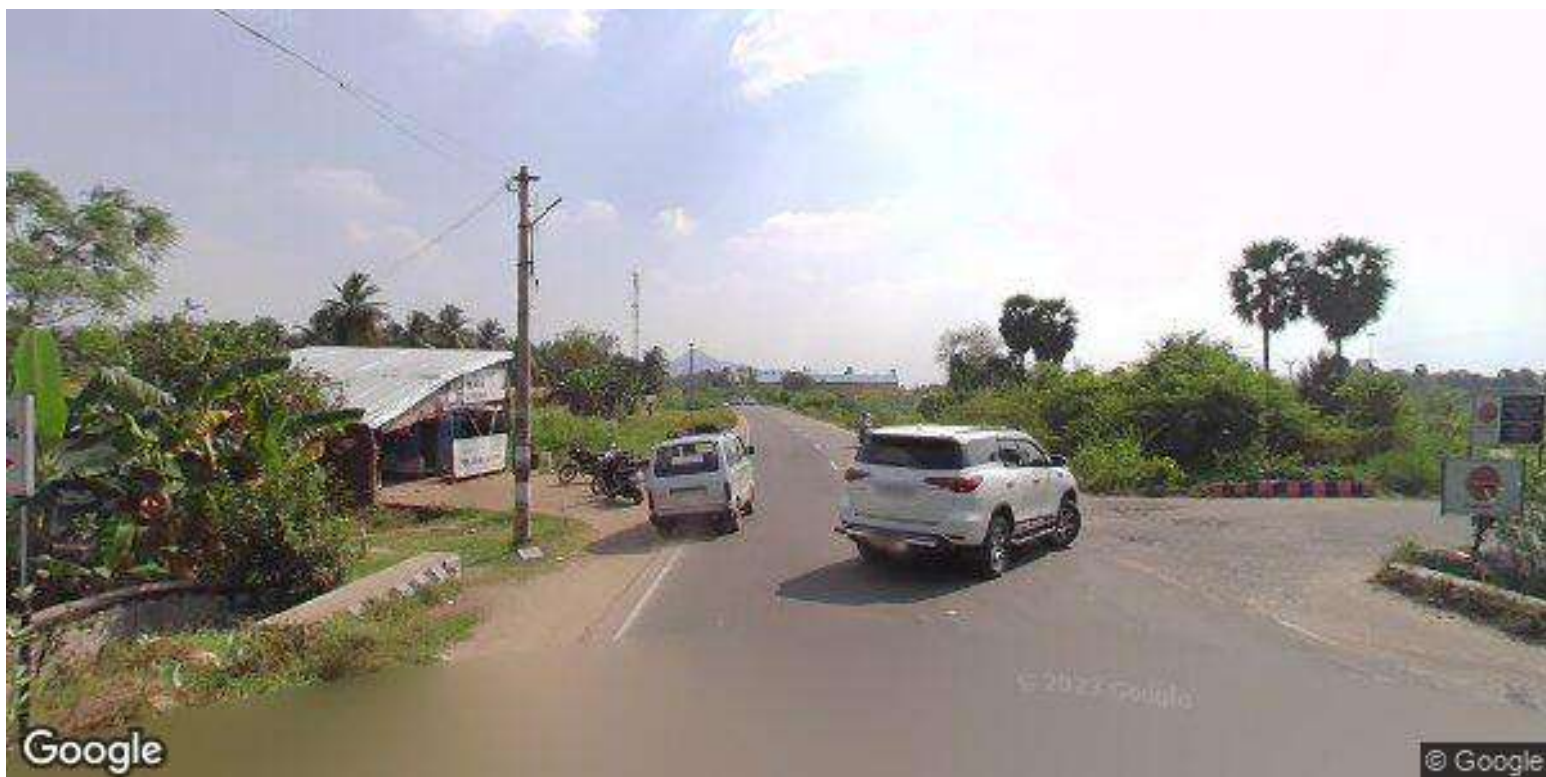
**Risk Type: Blind Spot**  
**Risk Level: Blind Spot**  
**Speed Limit: 10 KM/Hr**  
**Coordinates: 11.44029, 77.87544**

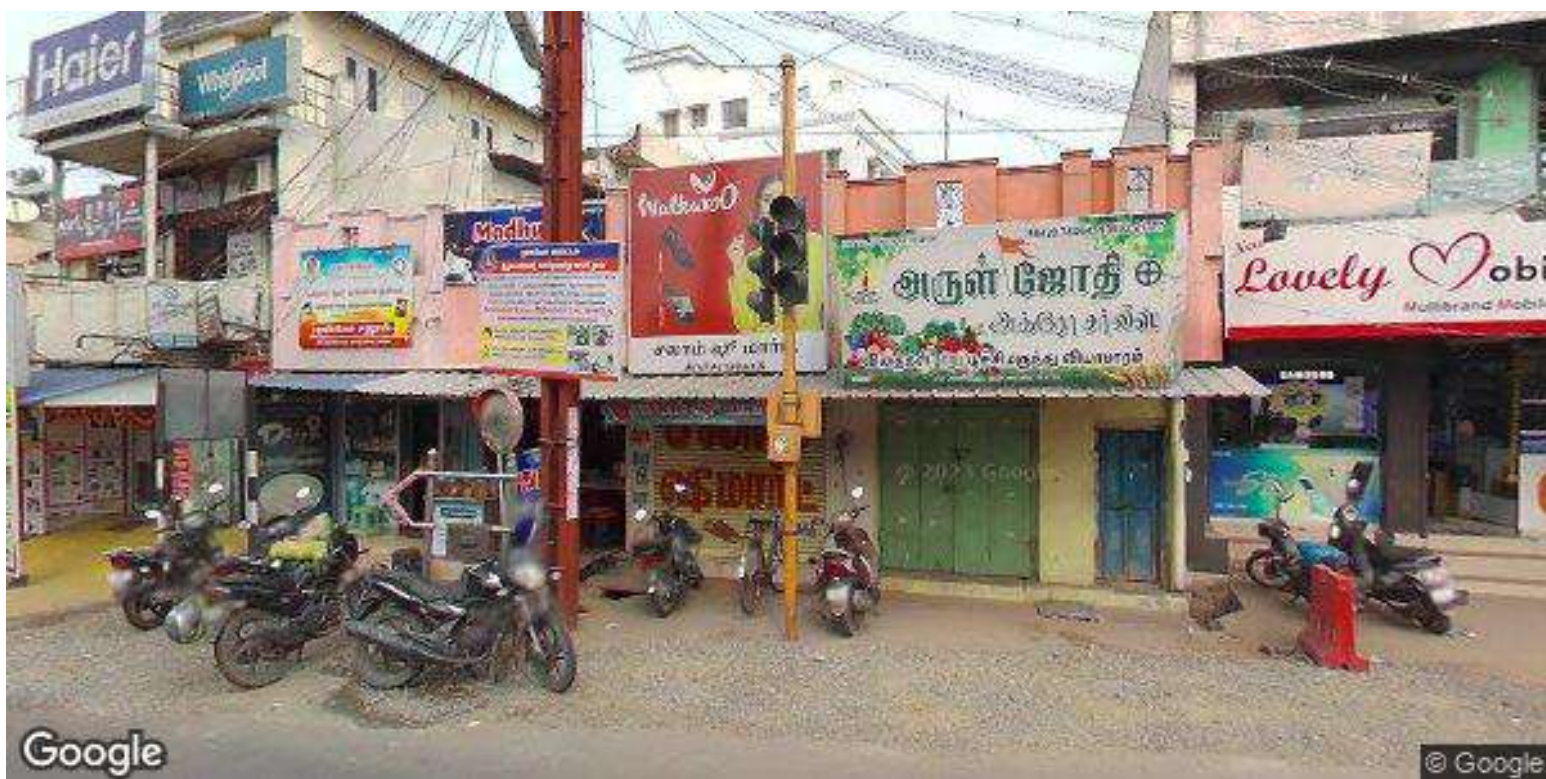
**Coordinates:** 11.37850, 77.89453

**Risk Type:** Turn

**Risk Level:** High

**Speed Limit:** 15 KM/Hr

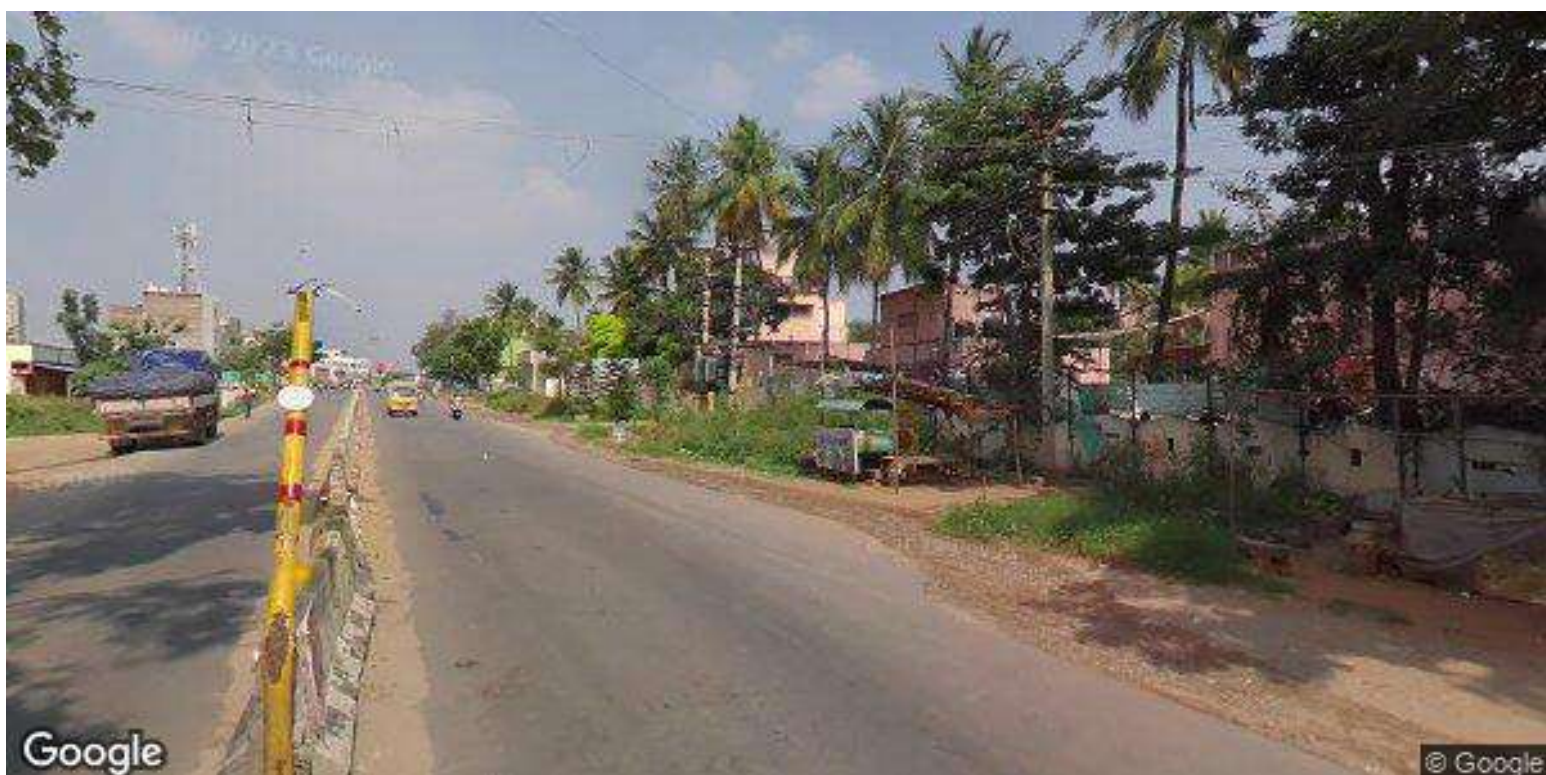
**Risk Type:** Turn  
**Risk Level:** Medium  
**Speed Limit:** 30 KM/Hr  
**Coordinates:** 11.36439, 77.88943

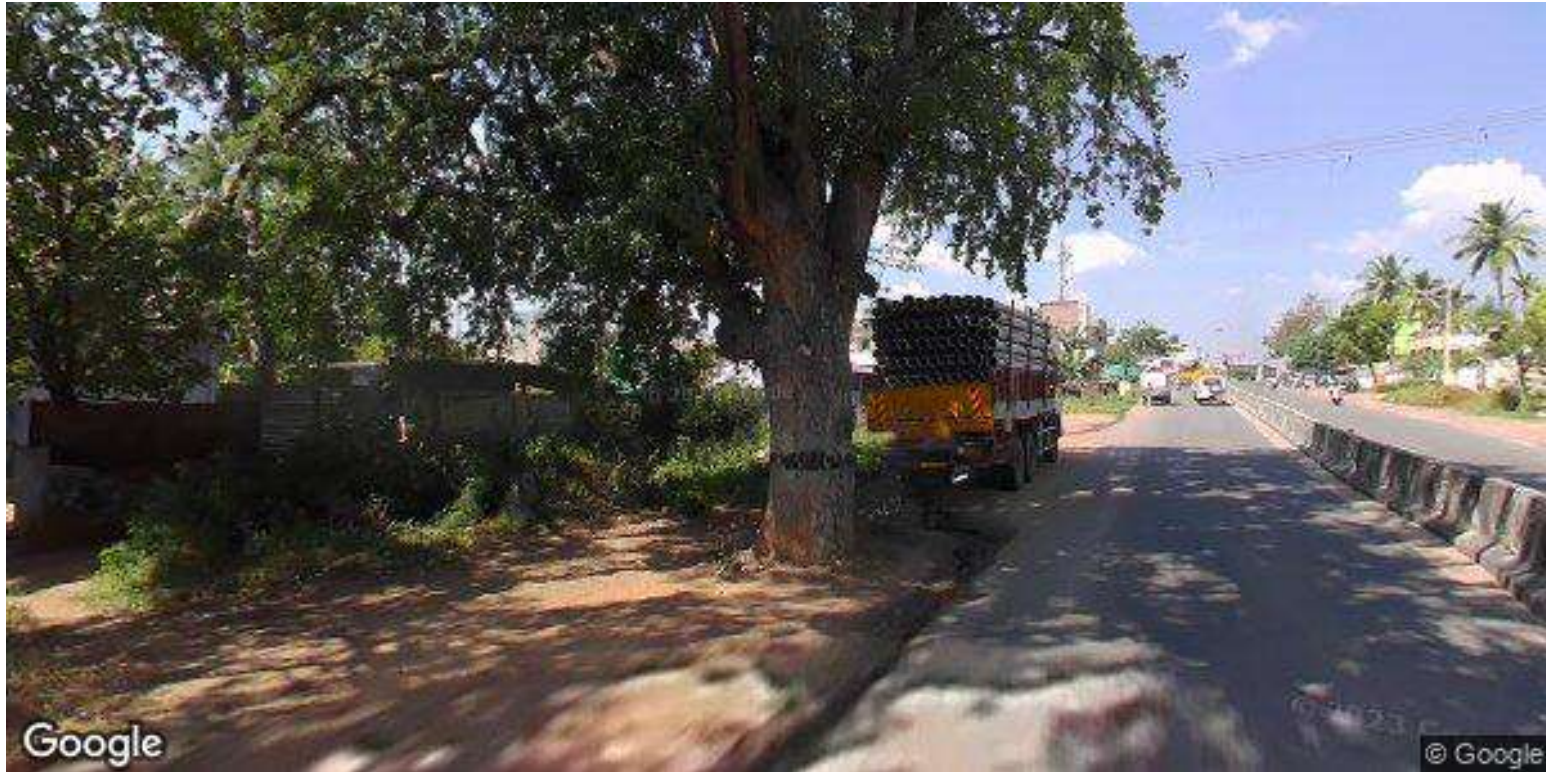
**Risk Type:** Turn  
**Risk Level:** Medium  
**Speed Limit:** 30 KM/Hr  
**Coordinates:** 11.36434, 77.88942

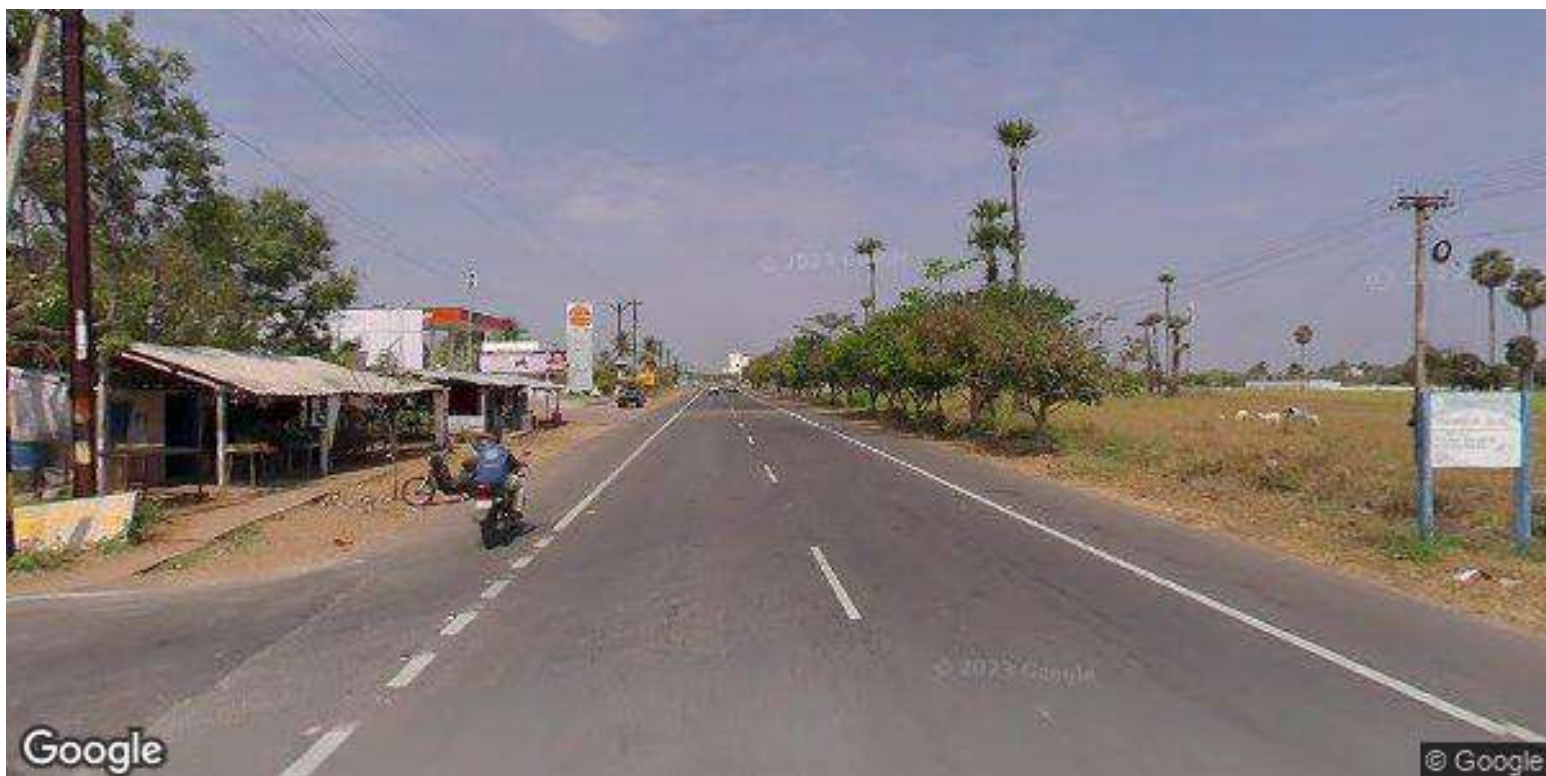
**Risk Type:** Blind Spot  
**Risk Level:** Blind Spot  
**Speed Limit:** 10 KM/Hr  
**Coordinates:** 11.28479, 77.94438

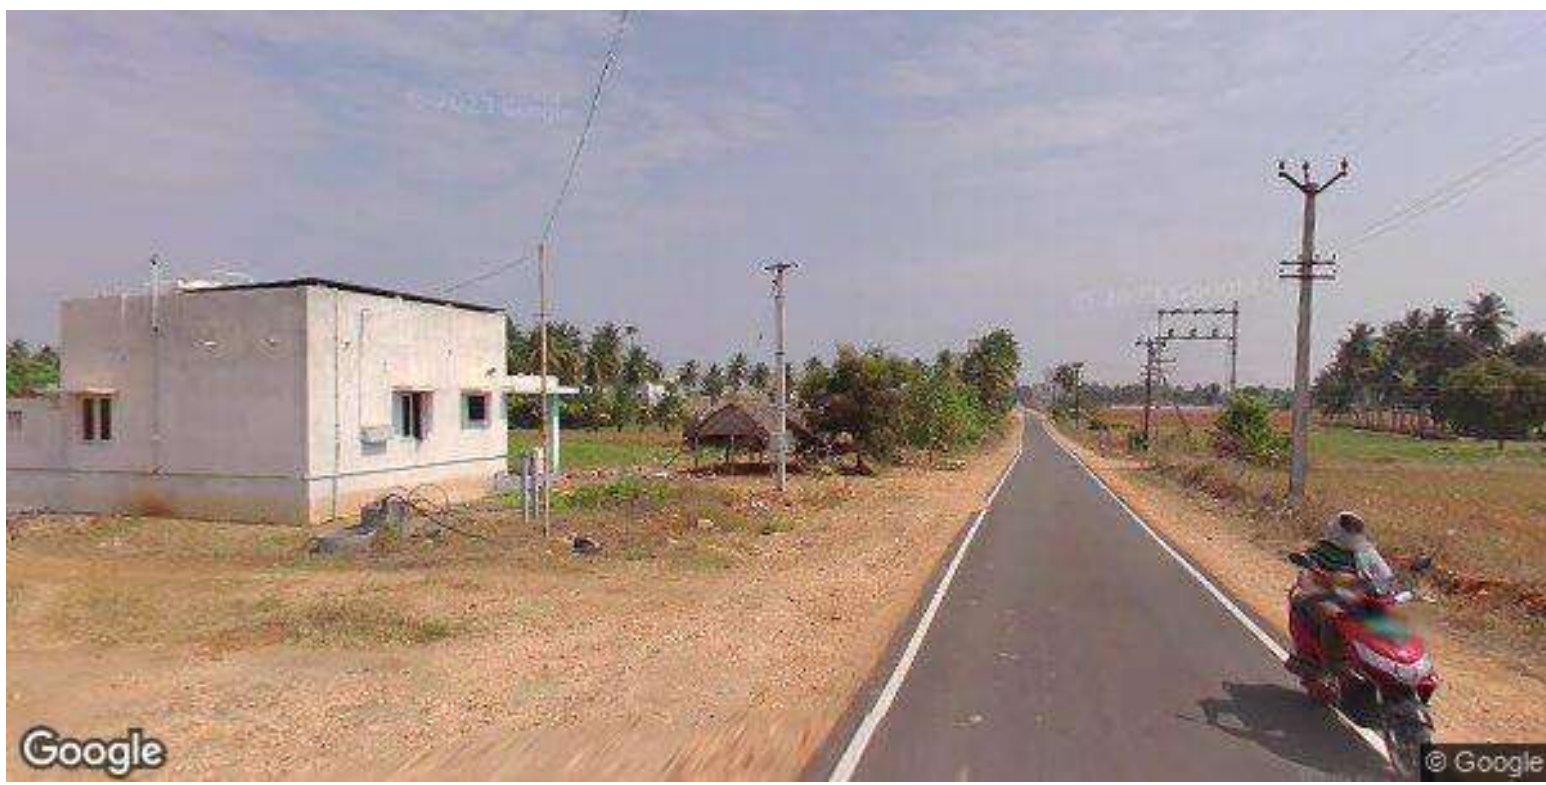
**Coordinates:** 11.28476, 77.94029

**Risk Type:** Turn

**Risk Level:** High

**Speed Limit:** 15 KM/Hr
