## JOURNEY RISK MANAGEMENT (JRM) STUDY

### Salem Terminal to SRI RAM AGENCIES

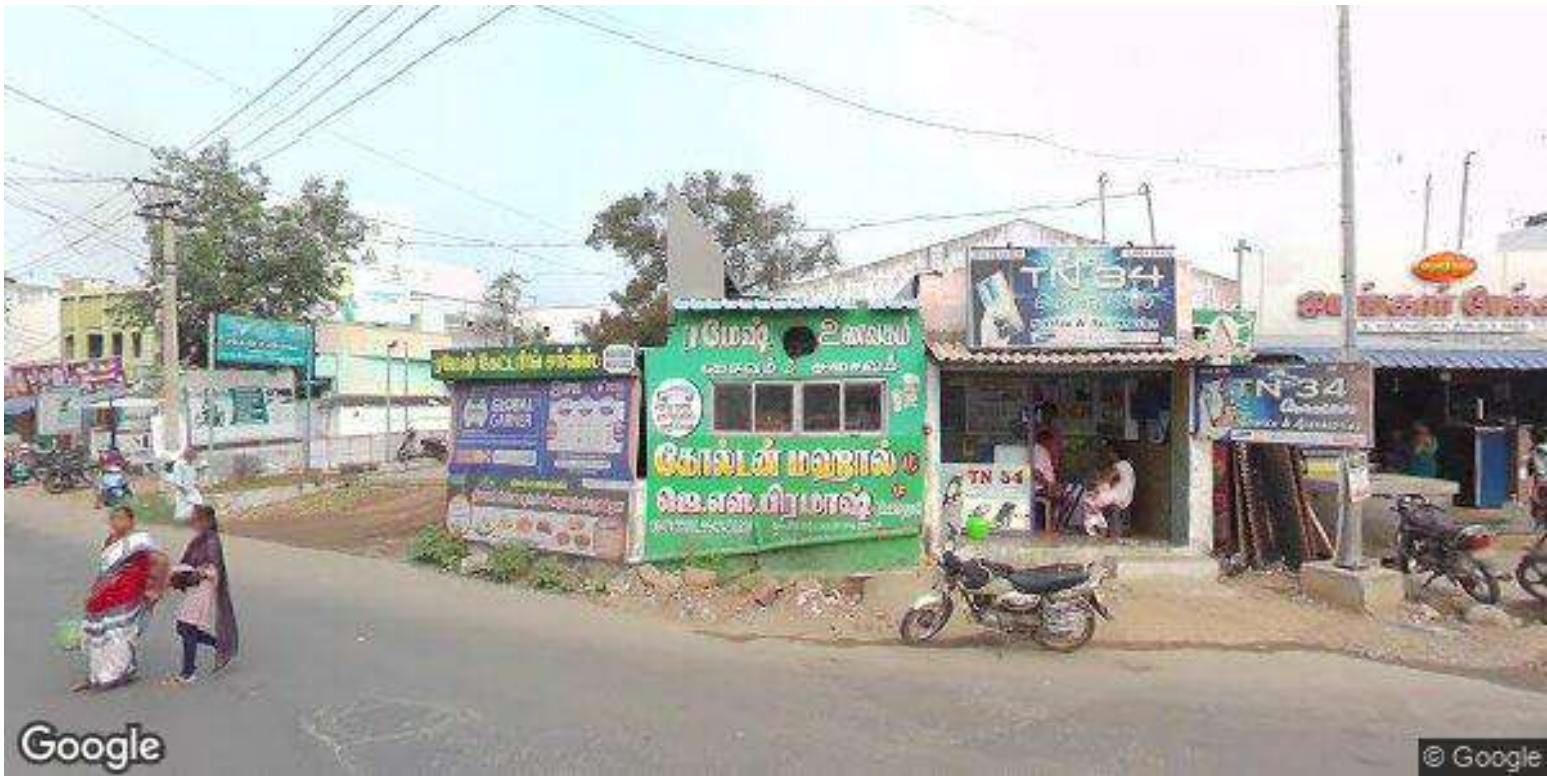
**Risk Type: Turn**

**Risk Level: Medium**

**Speed Limit: 30 KM/Hr**

**Coordinates: 11.38346, 77.89975**

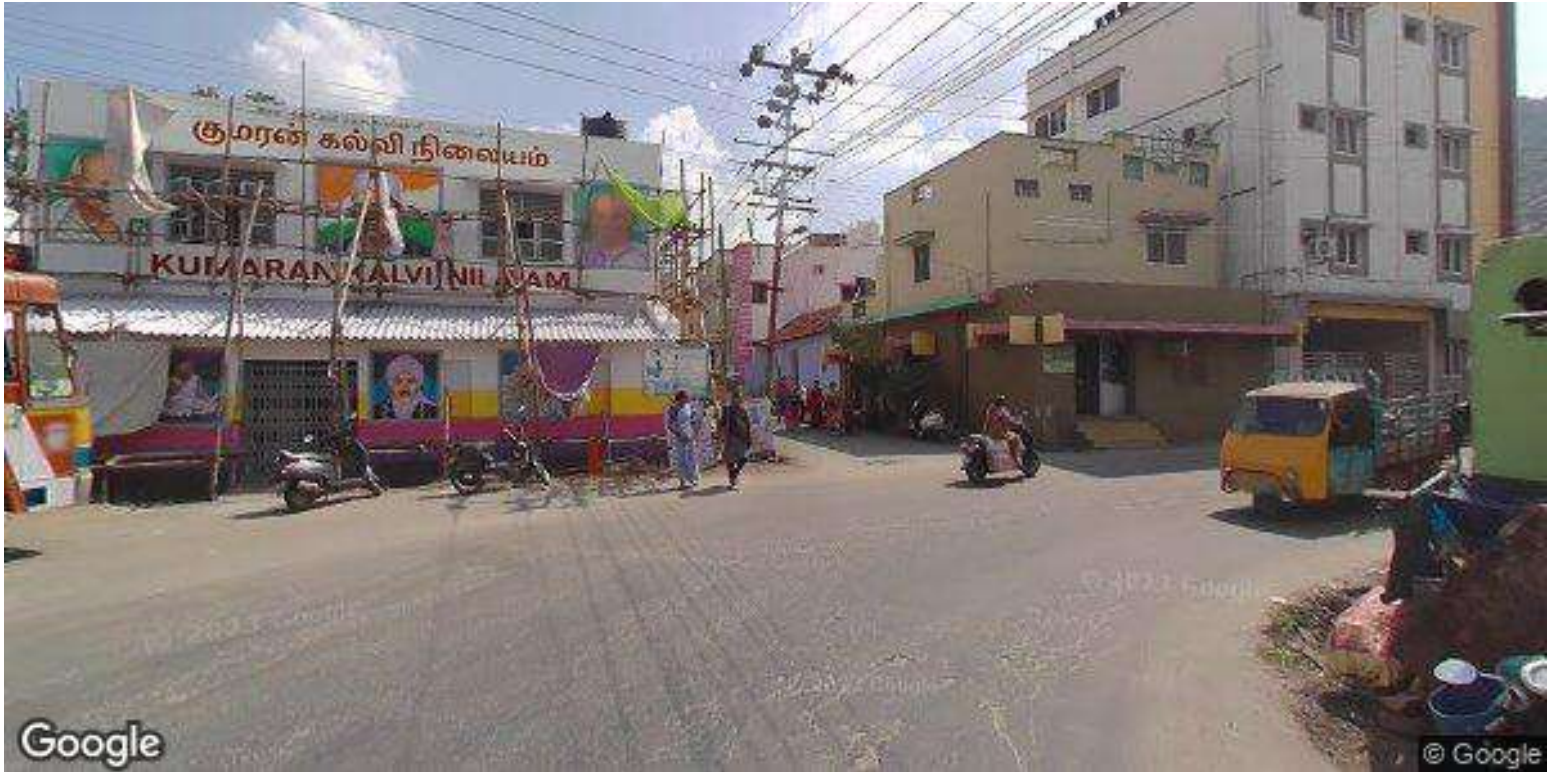
**Risk Type: Blind Spot**

**Risk Level: Blind Spot**

**Speed Limit: 10 KM/Hr**

**Coordinates: 11.38188, 77.90257**

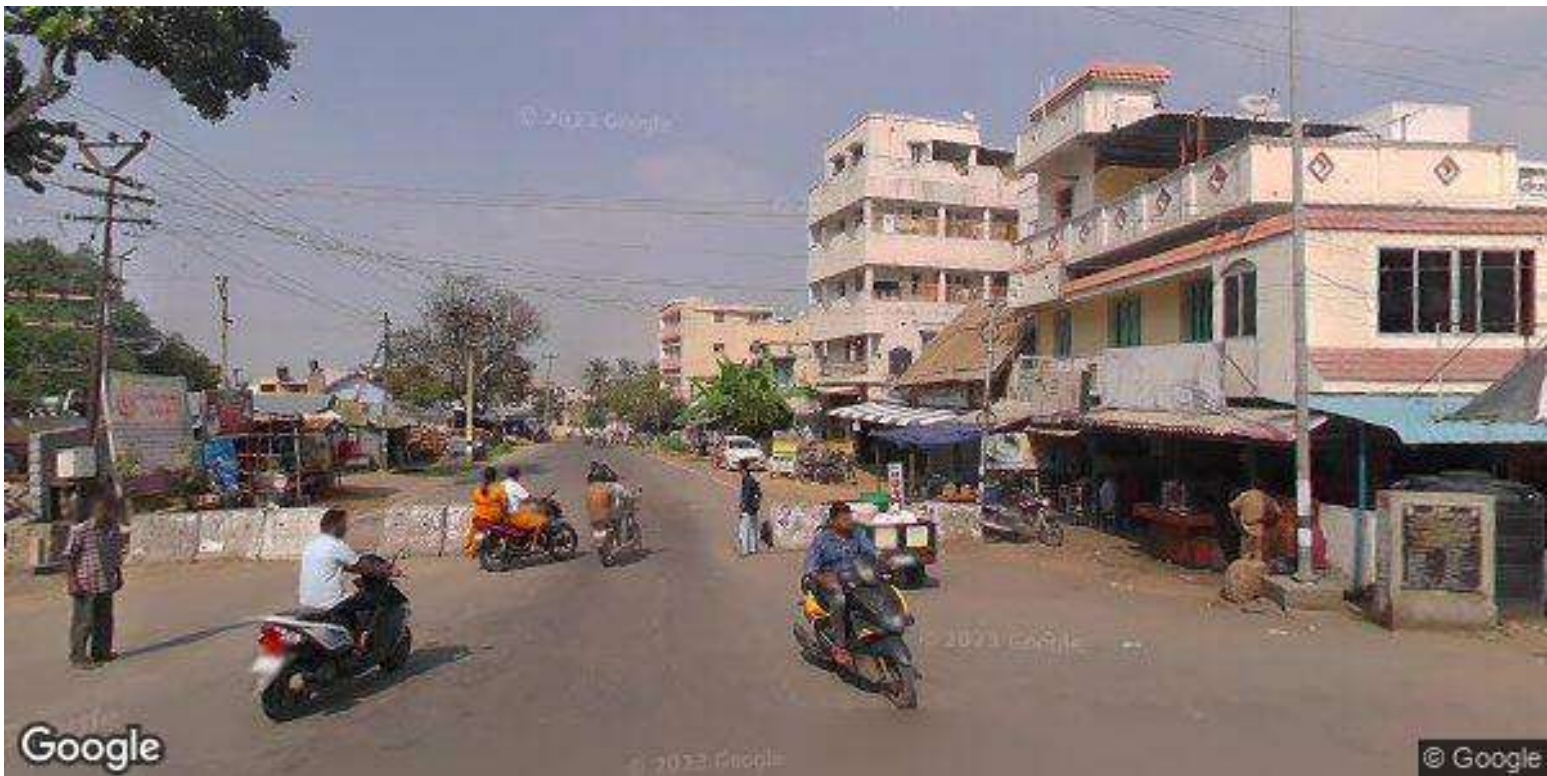
**Risk Type: Blind Spot**

**Risk Level: Blind Spot**

**Speed Limit: 10 KM/Hr**

**Coordinates: 11.37841, 77.90140**

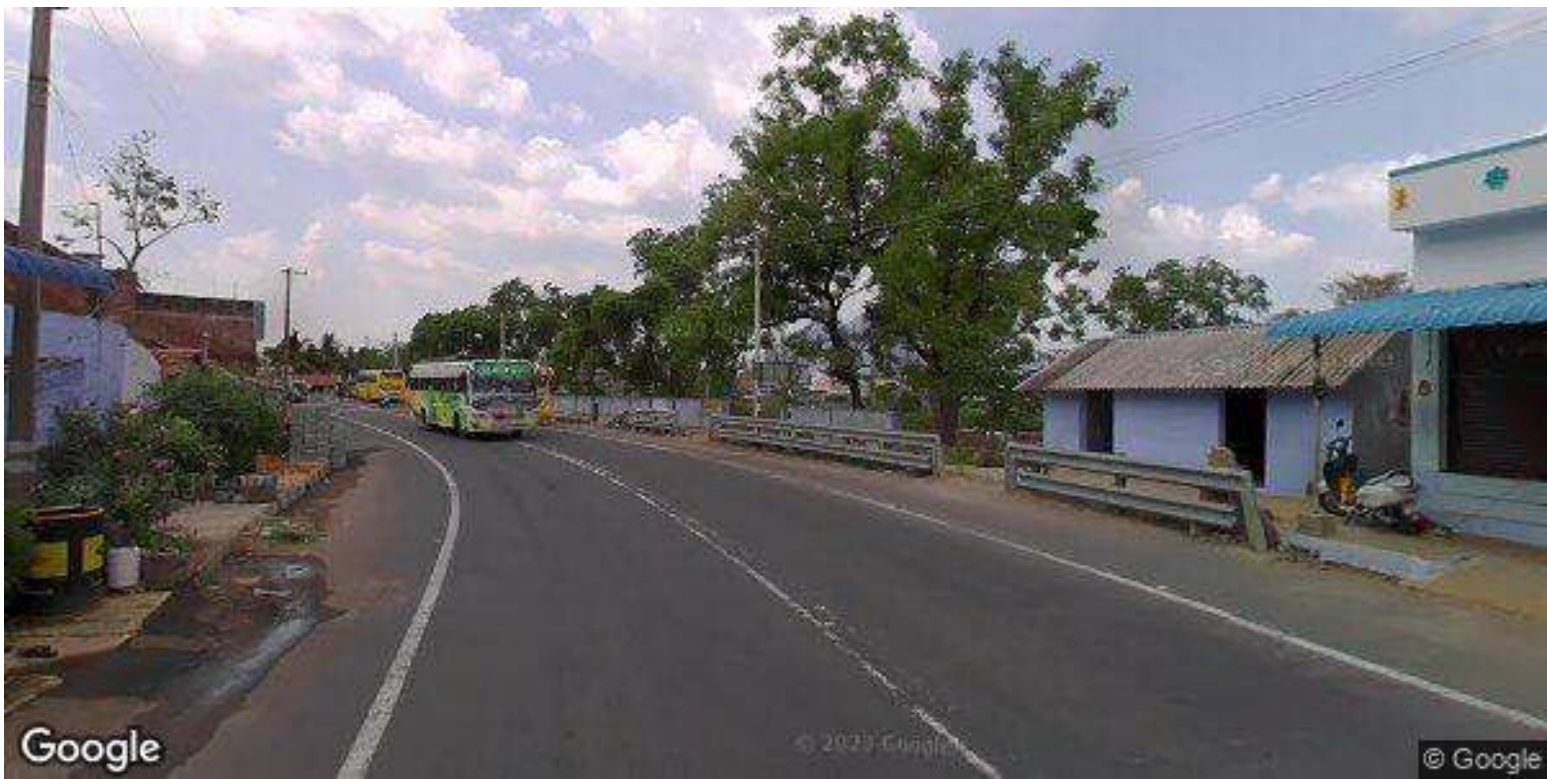
**Risk Type:** Turn

**Risk Level:** Medium

**Speed Limit:** 30 KM/Hr

**Coordinates:** 11.41332, 78.08072

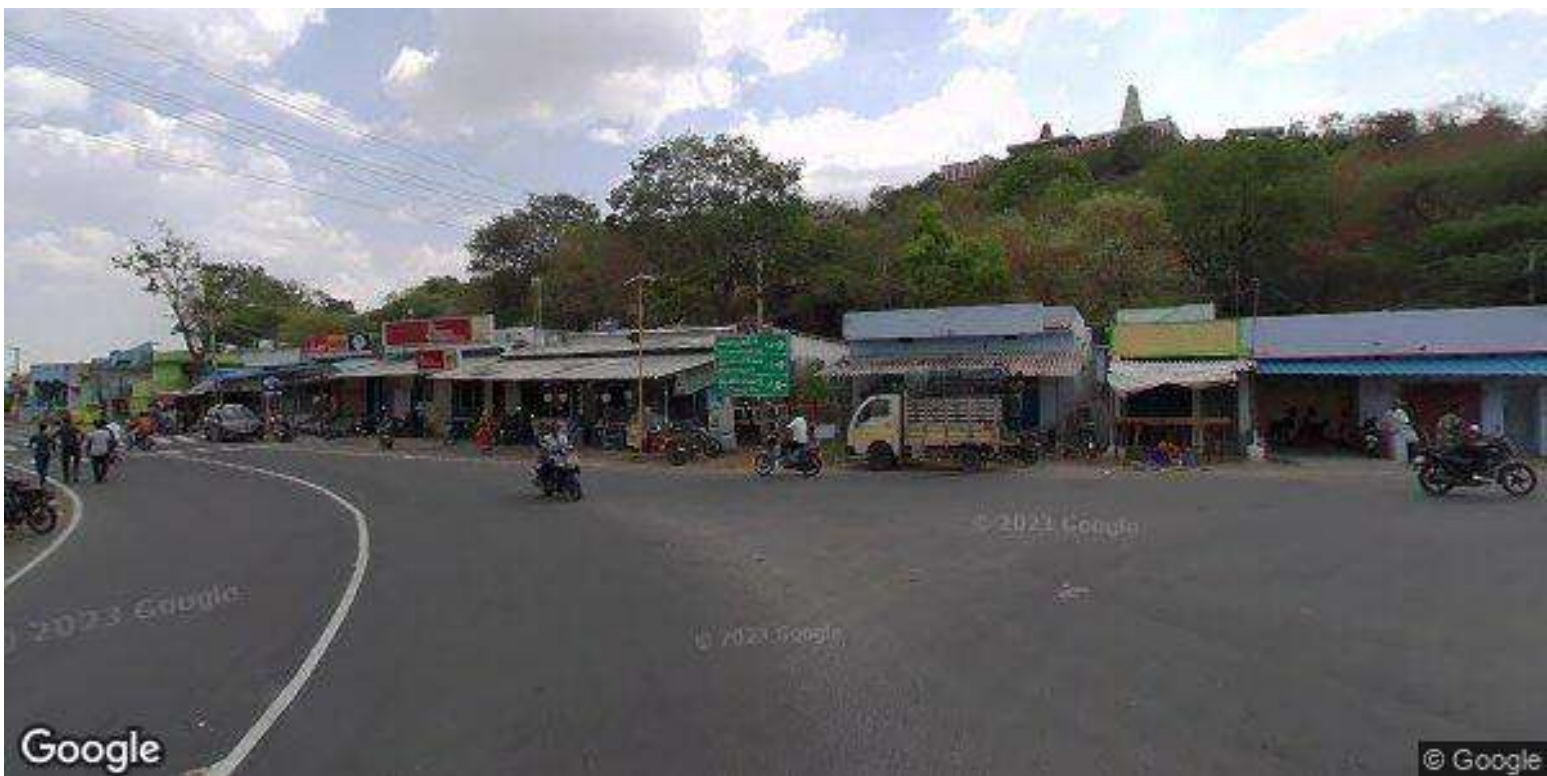
**Risk Type:** Turn

**Risk Level:** Medium

**Speed Limit:** 30 KM/Hr

**Coordinates:** 11.41463, 78.08067

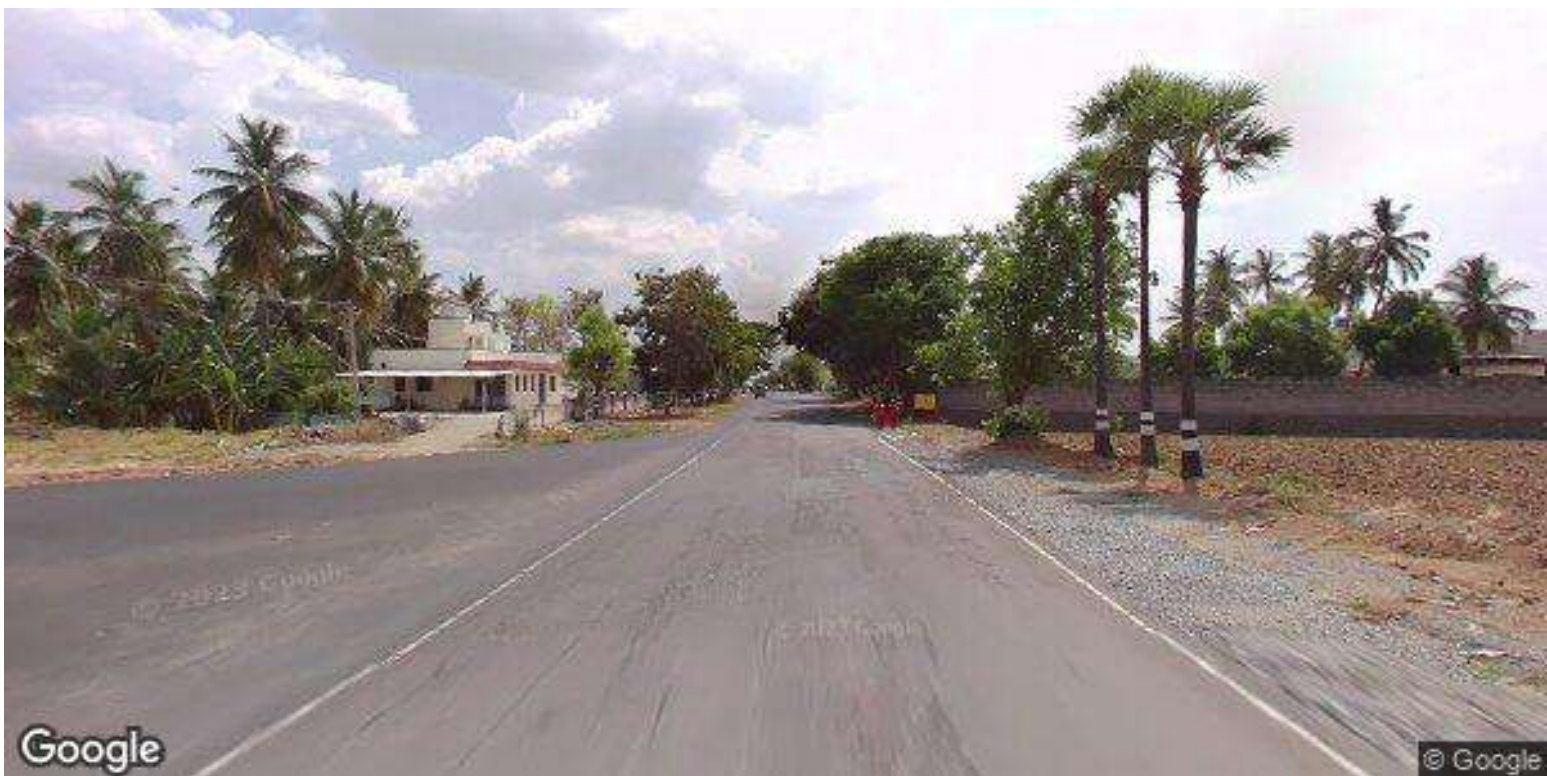
**Risk Type:** Turn  
**Risk Level:** High  
**Speed Limit:** 15 KM/Hr  
**Coordinates:** 11.42964, 78.11587

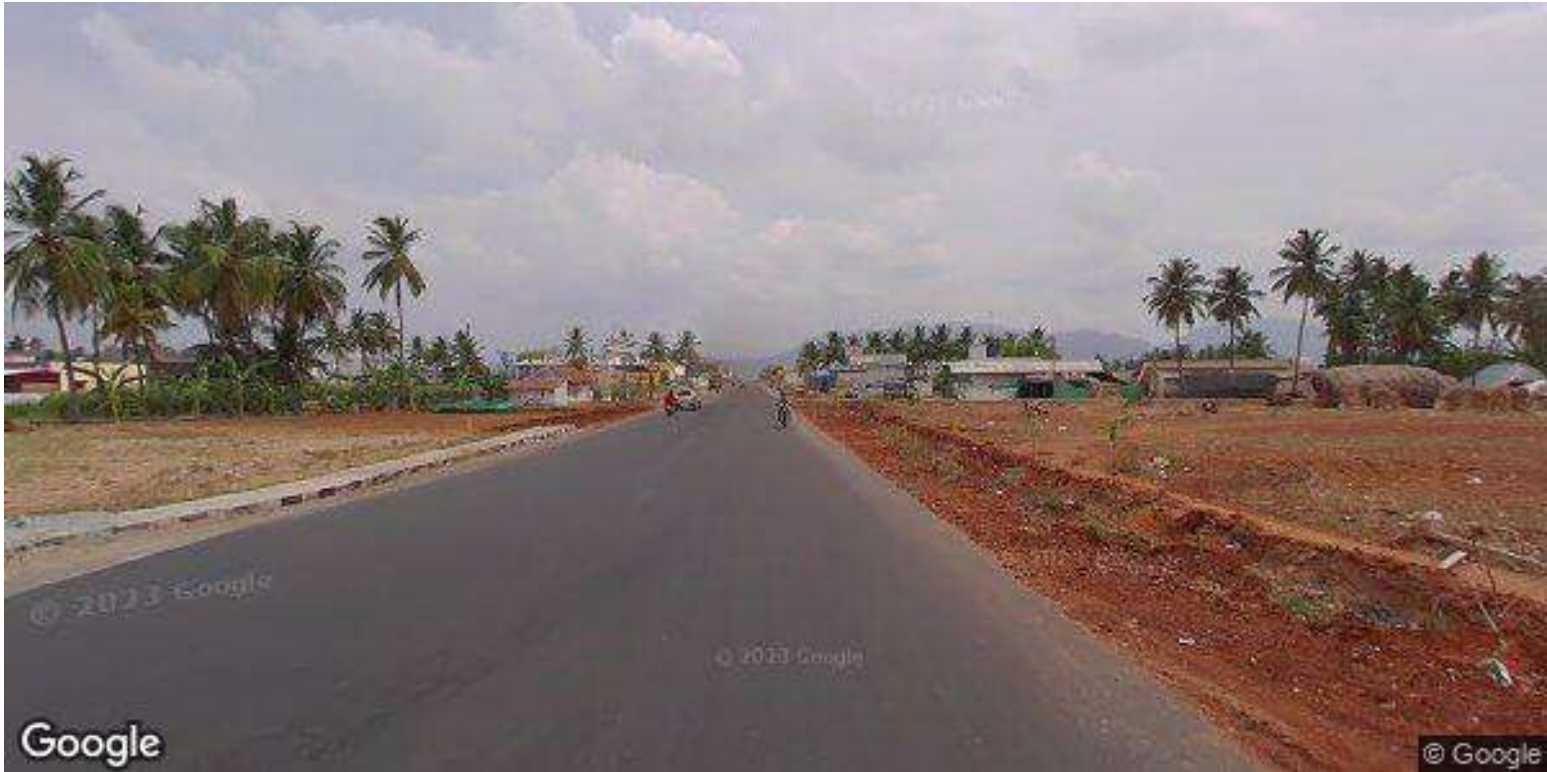
**Risk Type:** Turn  
**Risk Level:** High  
**Speed Limit:** 15 KM/Hr  
**Coordinates:** 11.43542, 78.20754

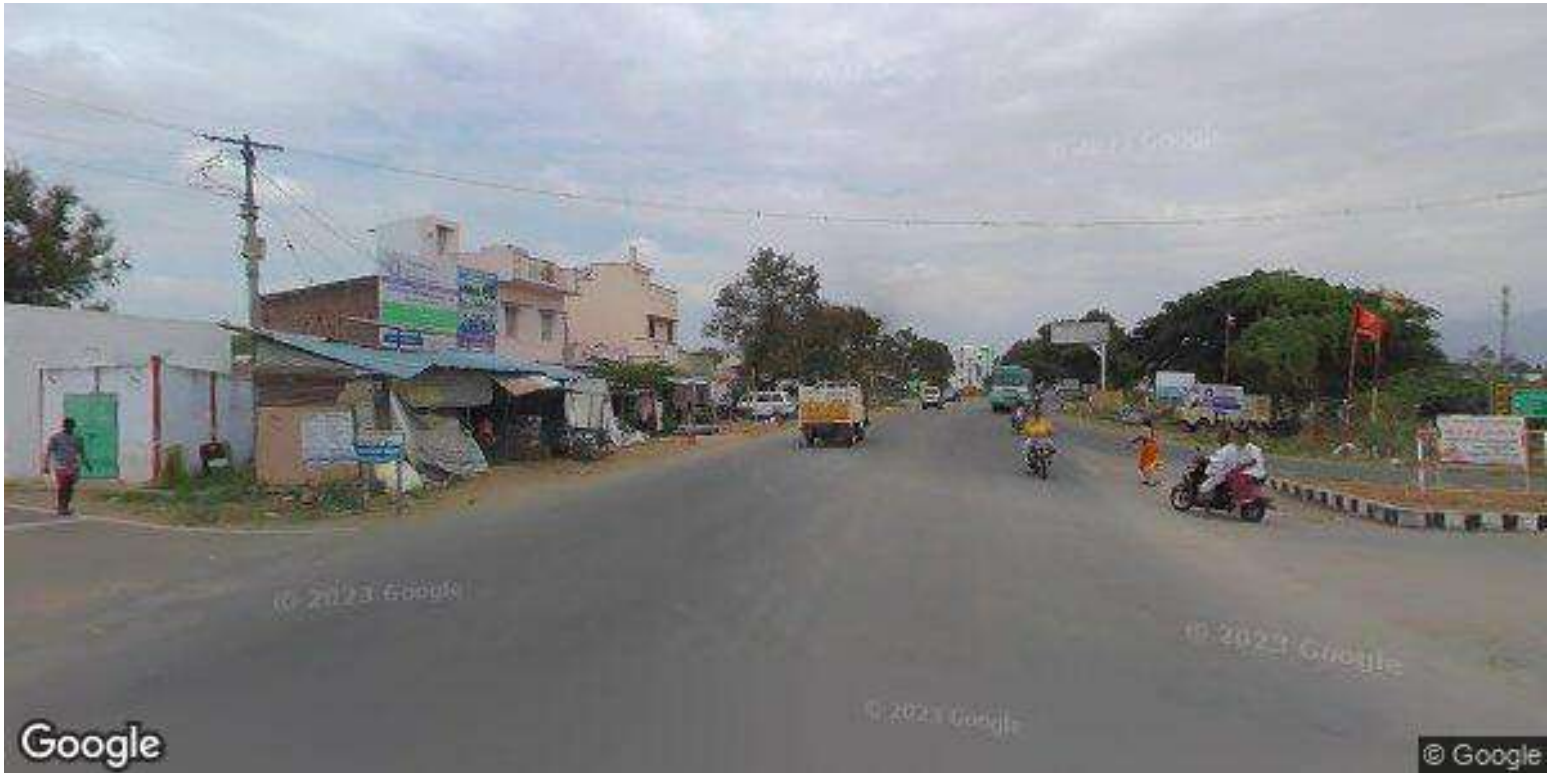
**Risk Type:** Blind Spot  
**Risk Level:** Blind Spot  
**Speed Limit:** 10 KM/Hr  
**Coordinates:** 11.45100, 78.20385

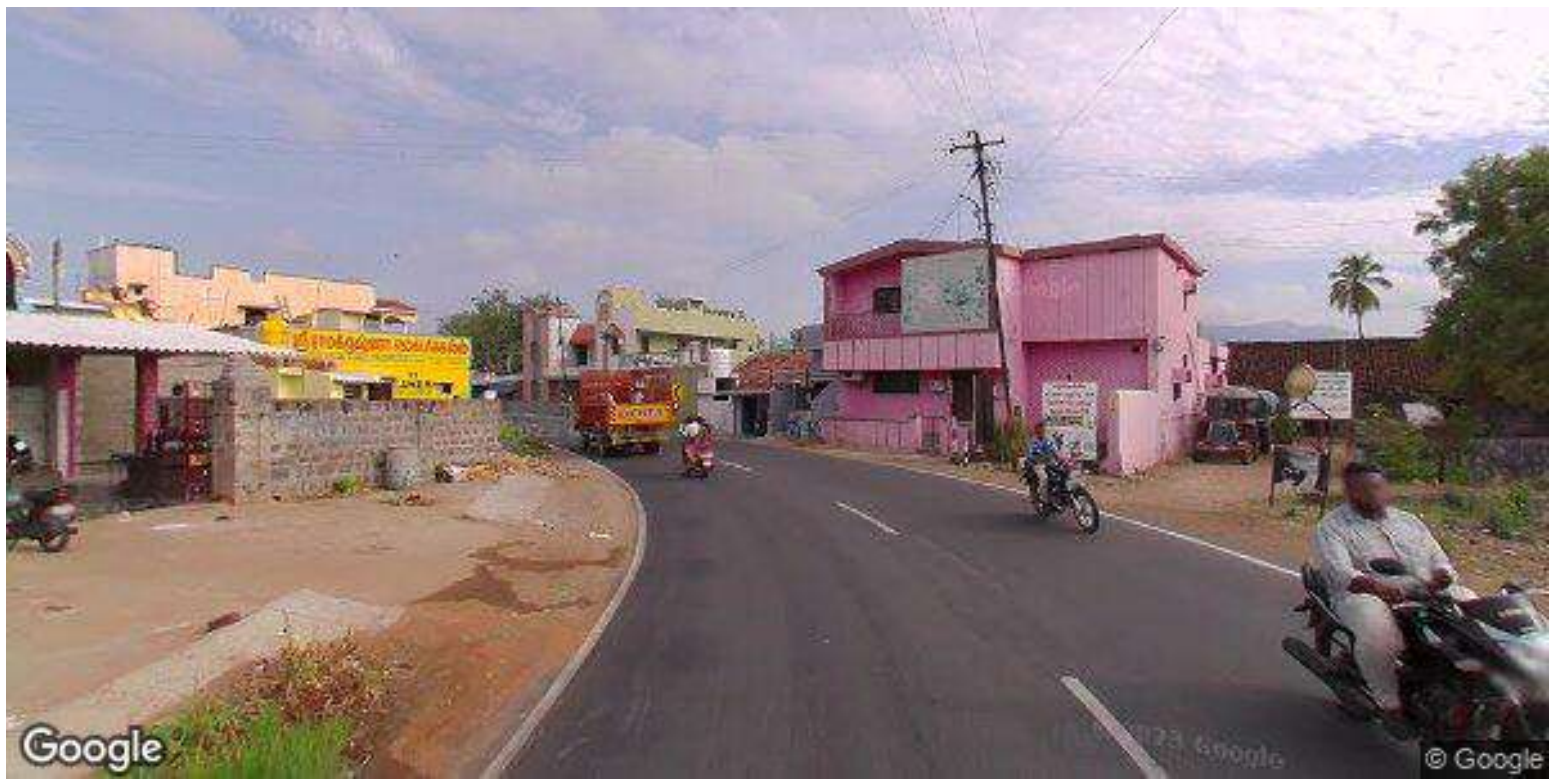
**Risk Type:** Turn

**Risk Level:** Medium

**Speed Limit:** 30 KM/Hr

**Coordinates:** 11.44925, 78.22288

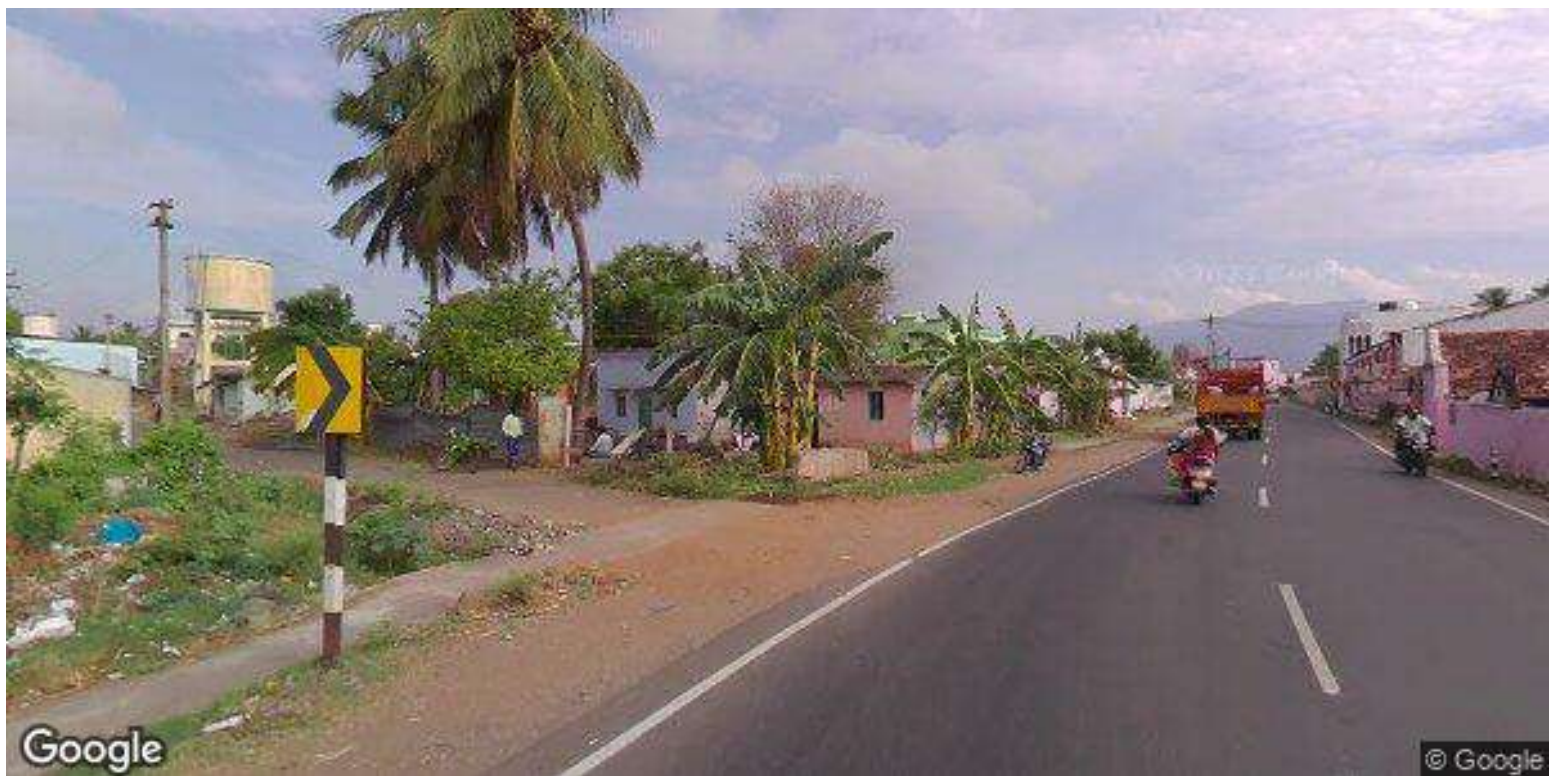
**Risk Type:** Turn

**Risk Level:** Medium

**Speed Limit:** 30 KM/Hr

**Coordinates:** 11.44813, 78.22305

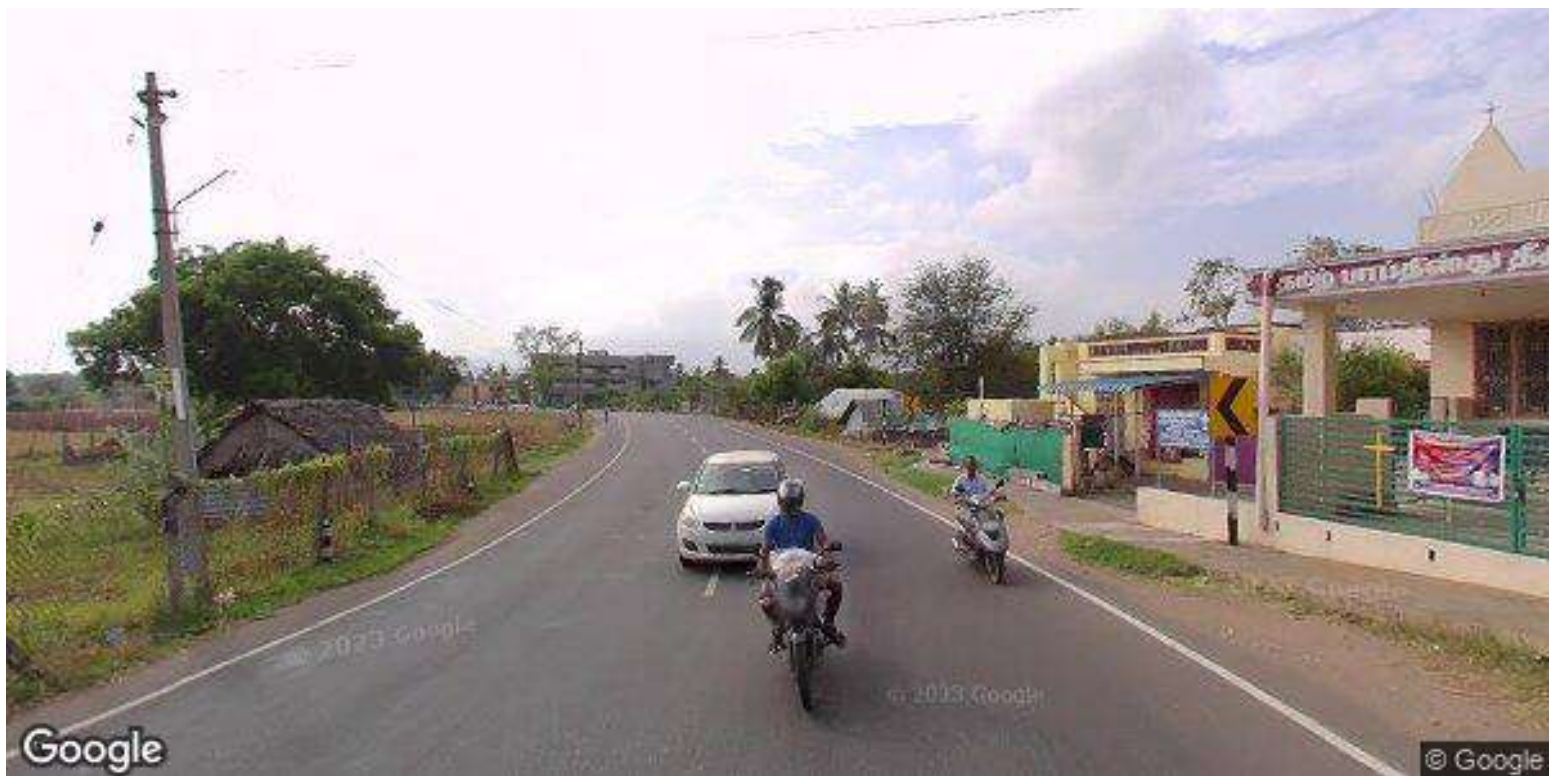
**Risk Type:** Turn

**Risk Level:** Medium

**Speed Limit:** 30 KM/Hr

**Coordinates:** 11.44793, 78.22320
