# IndianOil

## JOURNEY RISK MANAGEMENT (JRM) STUDY

### Salem Terminal to GK FUELS

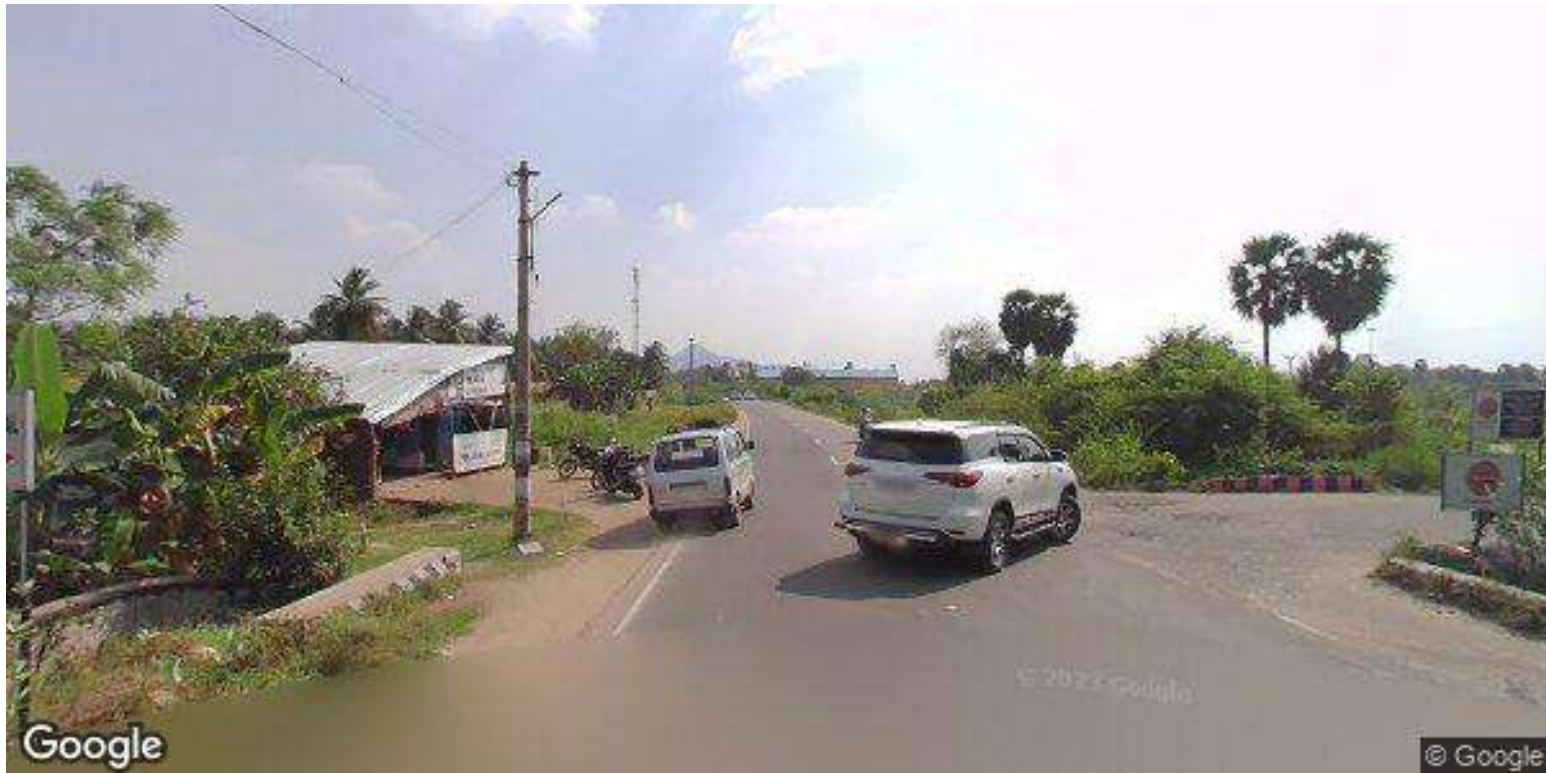
**Coordinates:** 11.44029, 77.87544

**Risk Type:** Turn

**Risk Level:** High

**Speed Limit:** 15 KM/Hr

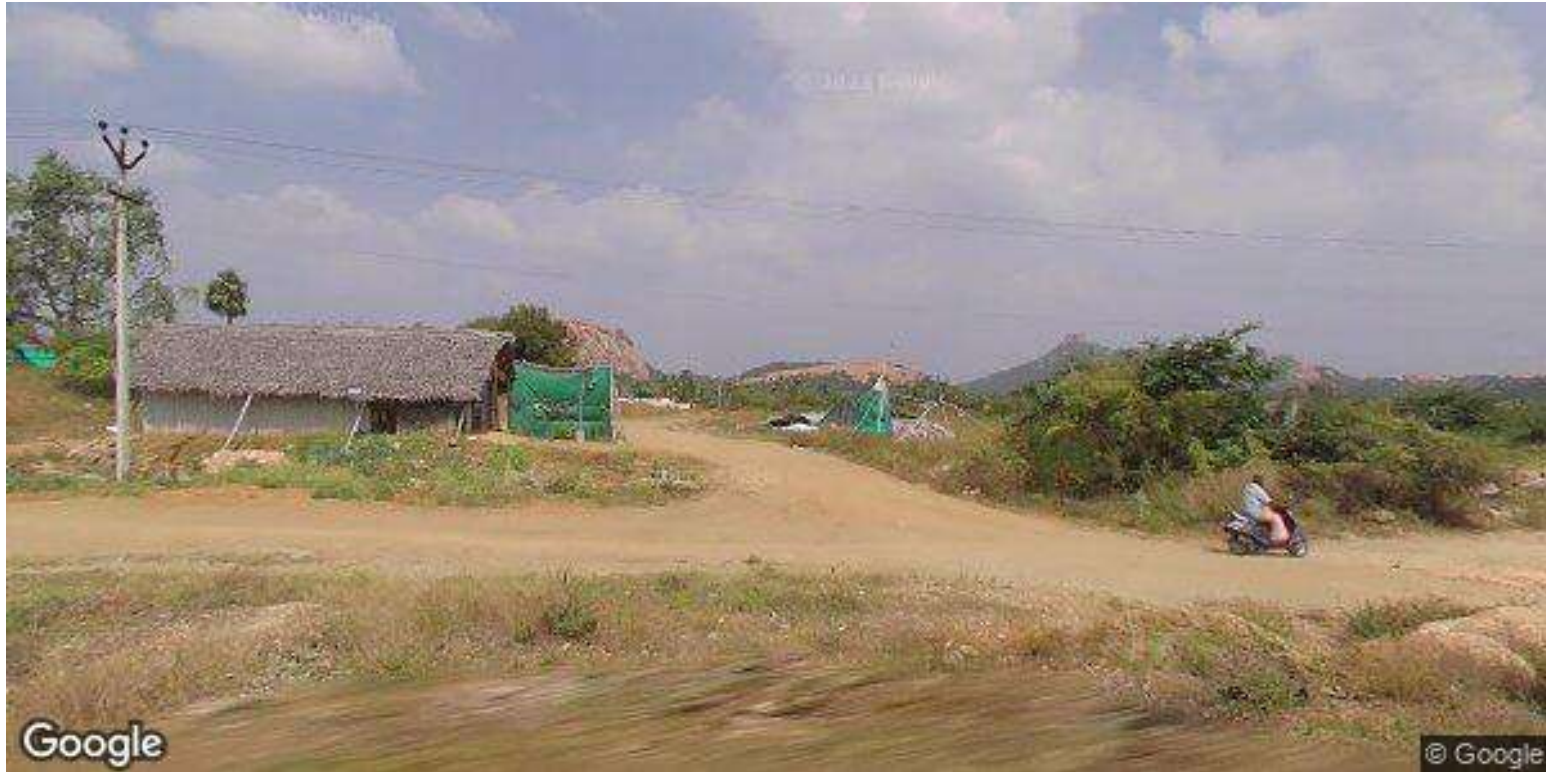
**Risk Type:** Turn  
**Risk Level:** Medium  
**Speed Limit:** 30 KM/Hr  
**Coordinates:** 11.49416, 77.88011

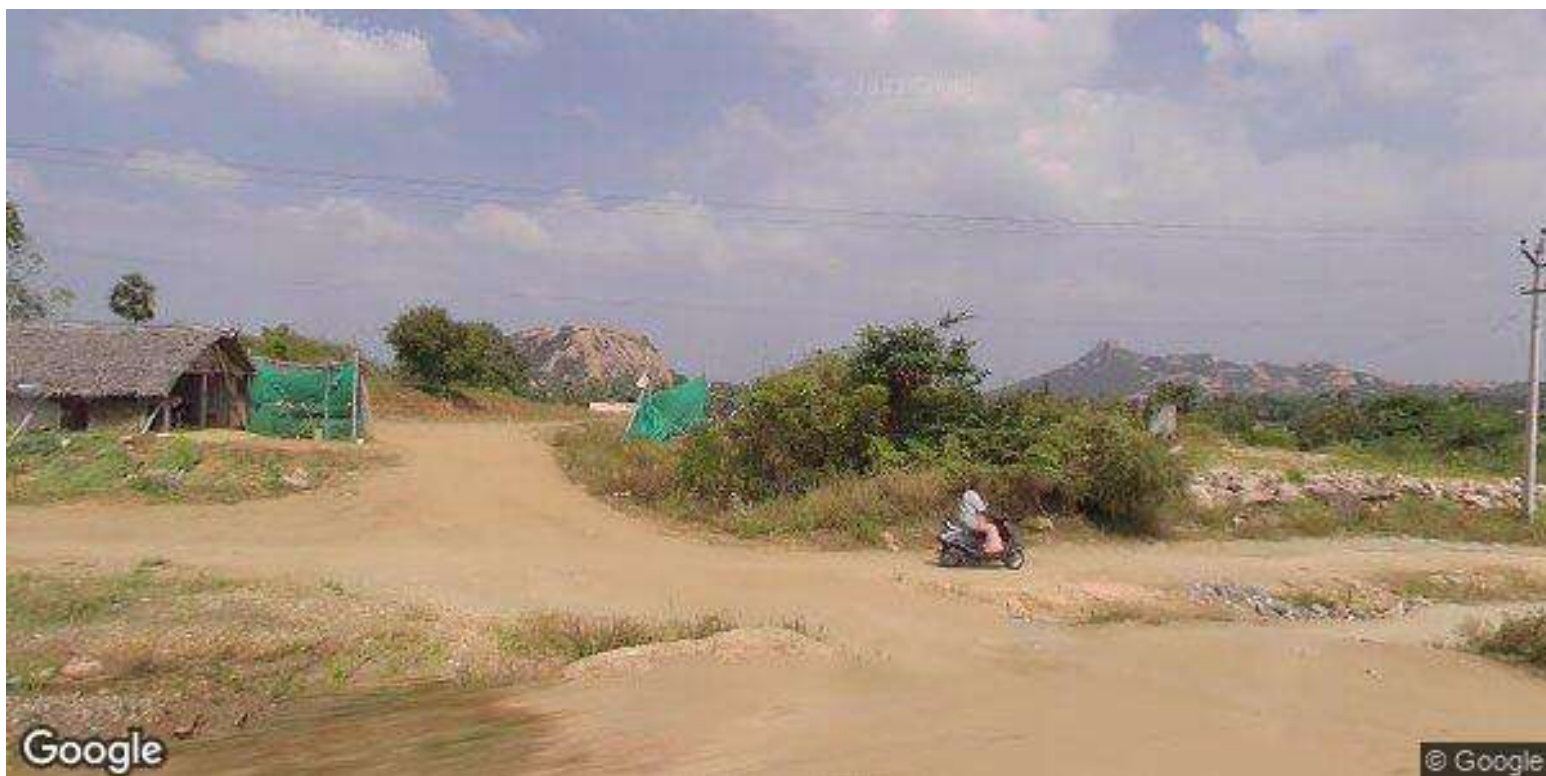
**Risk Type:** Turn  
**Risk Level:** Medium  
**Speed Limit:** 30 KM/Hr  
**Coordinates:** 11.49421, 77.88021

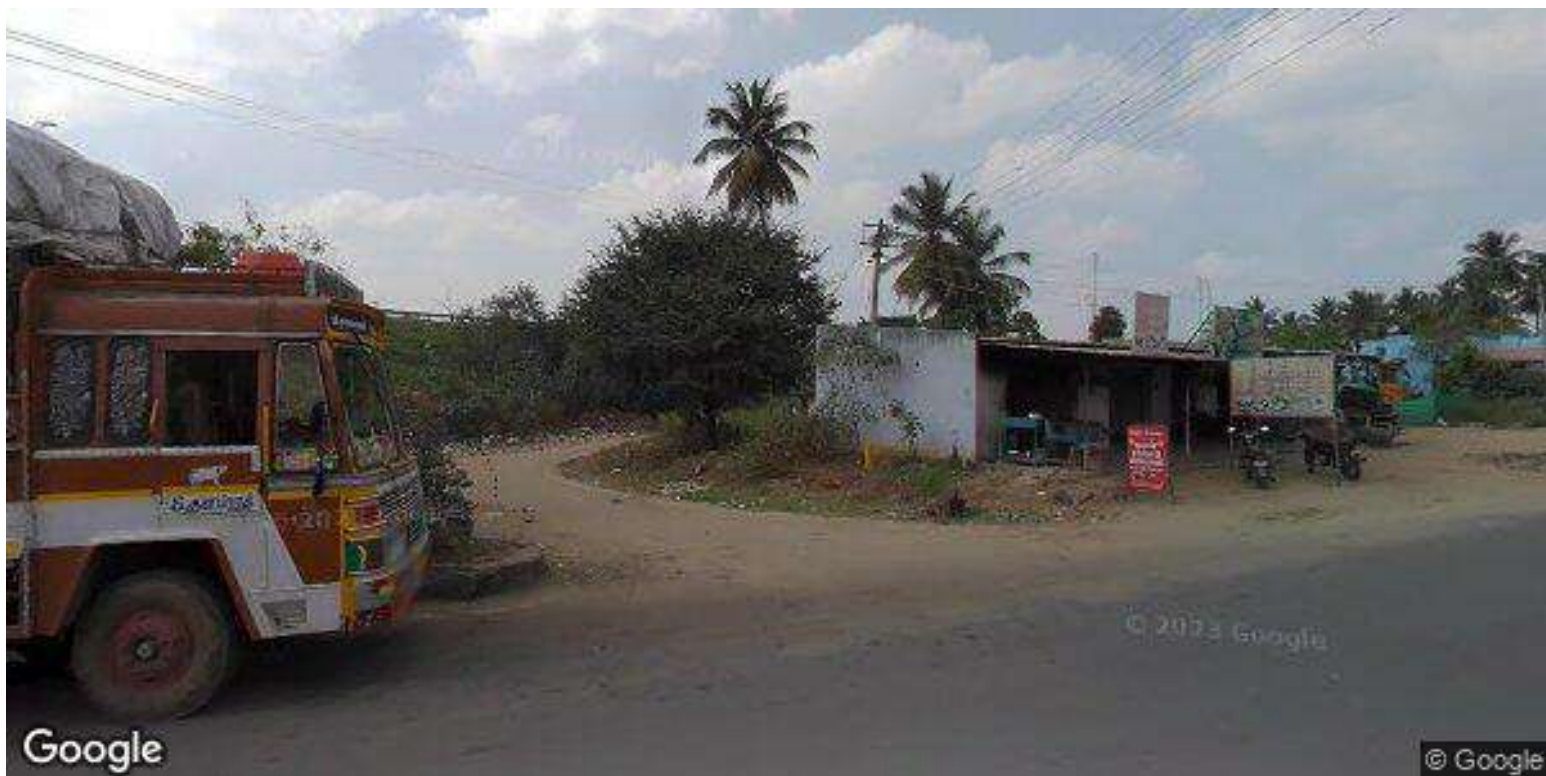
**Coordinates:** 11.49395, 77.88537

**Risk Type:** Turn

**Risk Level:** High

**Speed Limit:** 15 KM/Hr

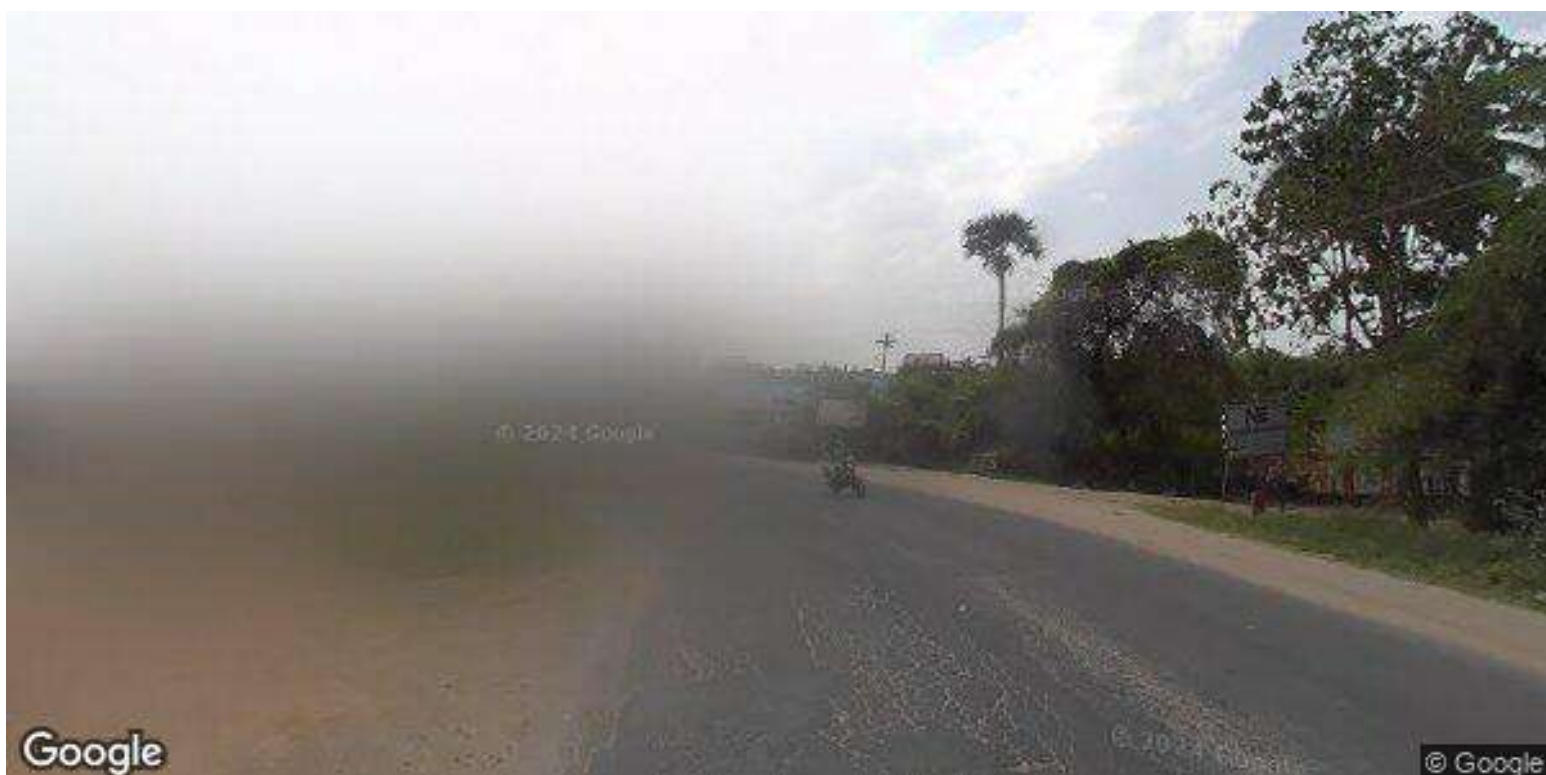
**Coordinates:** 11.49465, 77.88488

**Risk Type:** Turn

**Risk Level:** Medium

**Speed Limit:** 30 KM/Hr

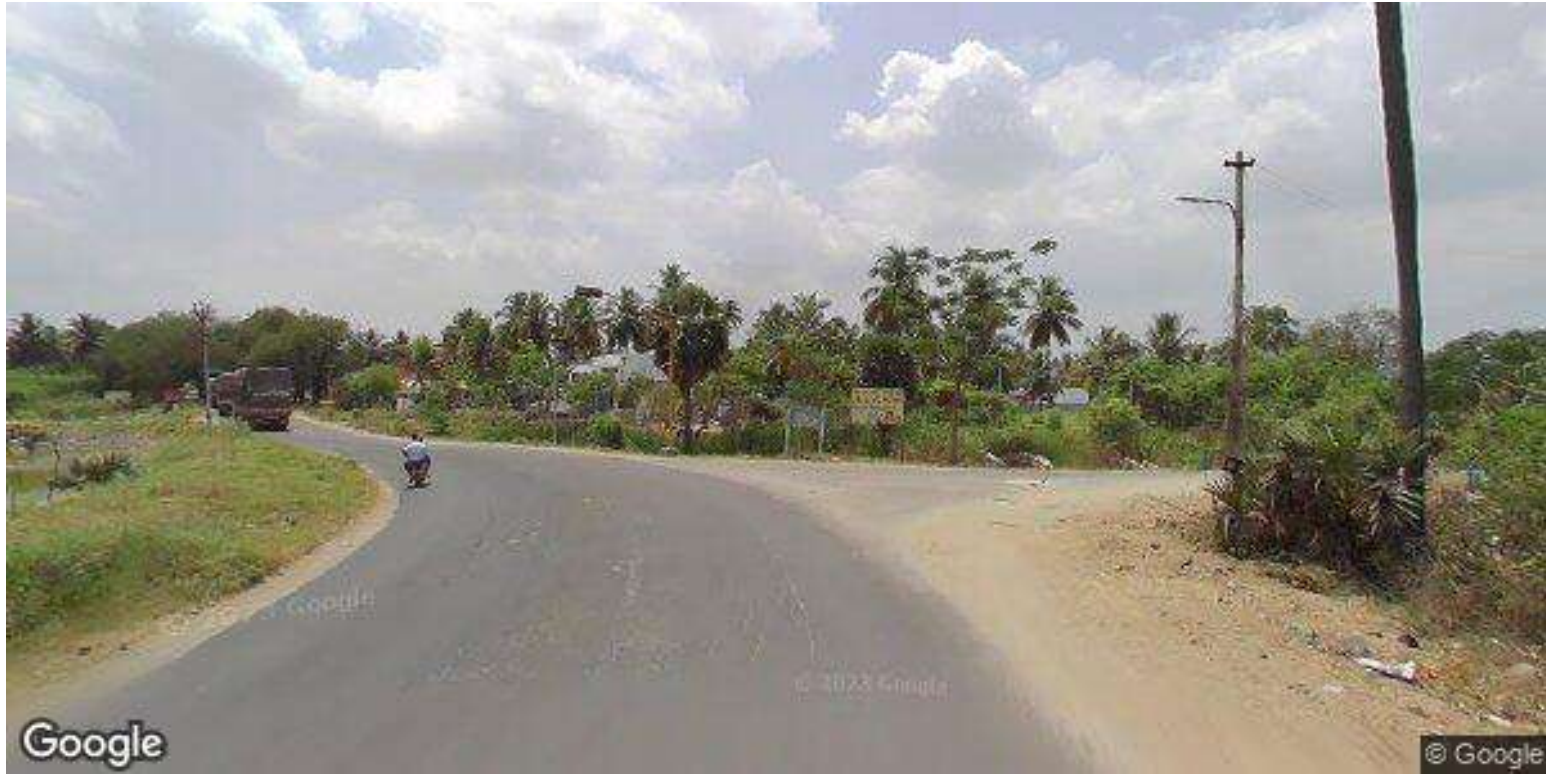
**Coordinates:** 11.56096, 77.89931

**Risk Type:** Turn

**Risk Level:** Medium

**Speed Limit:** 30 KM/Hr

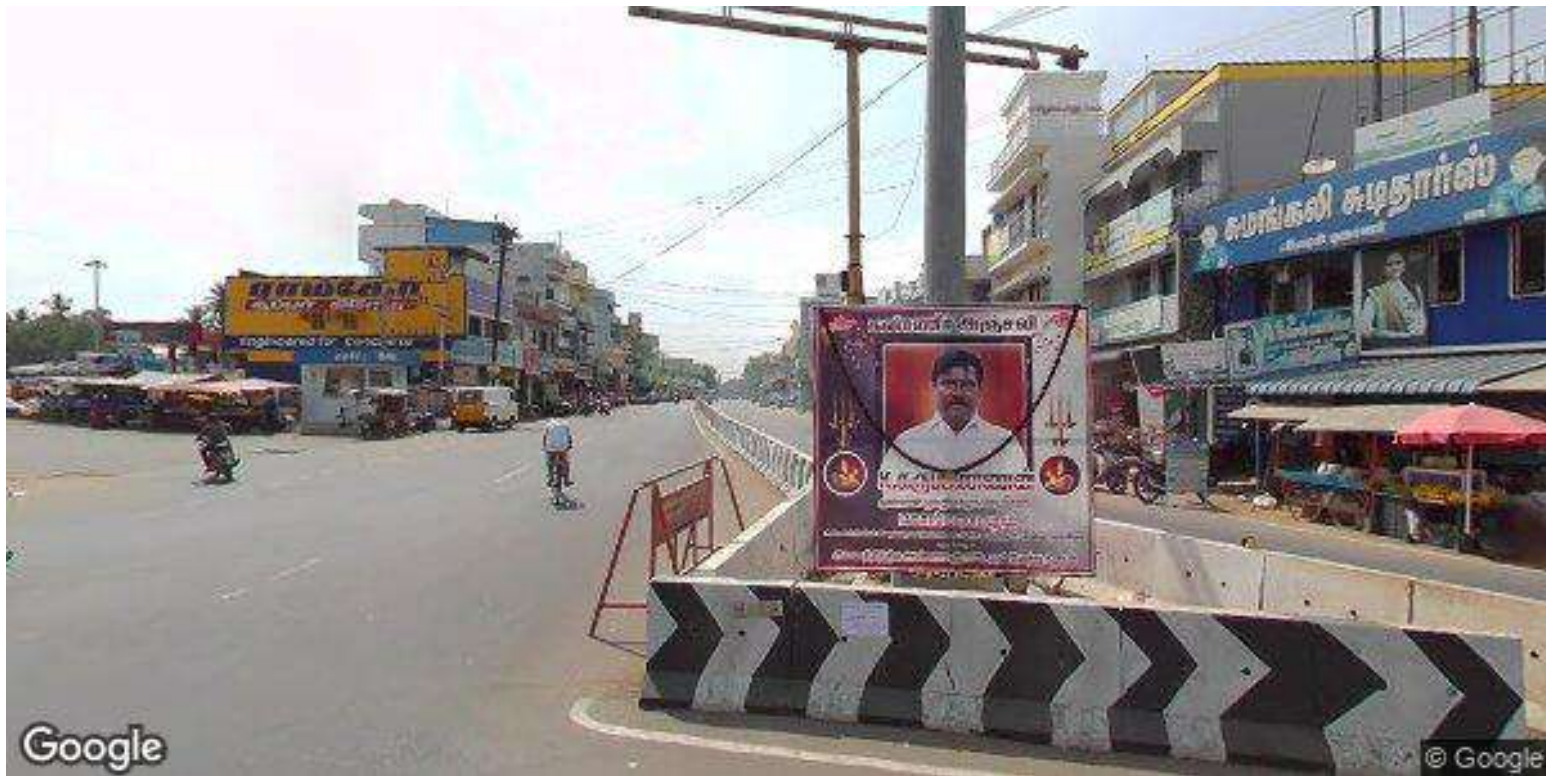
**Coordinates:** 11.57035, 77.90223

**Risk Type:** Turn

**Risk Level:** High

**Speed Limit:** 15 KM/Hr

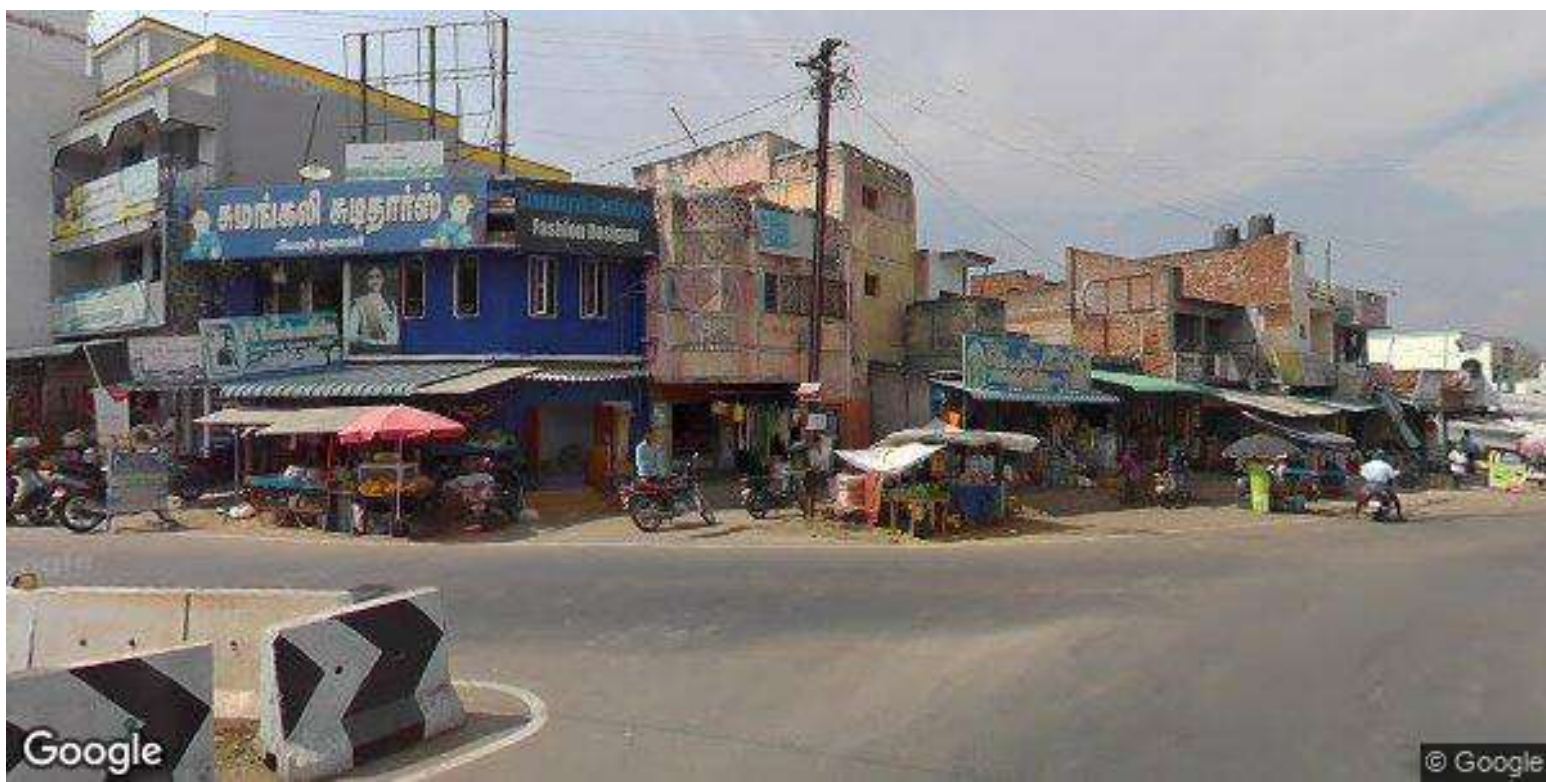
**Coordinates:** 11.57041, 77.90221

**Risk Type:** Turn

**Risk Level:** High

**Speed Limit:** 15 KM/Hr

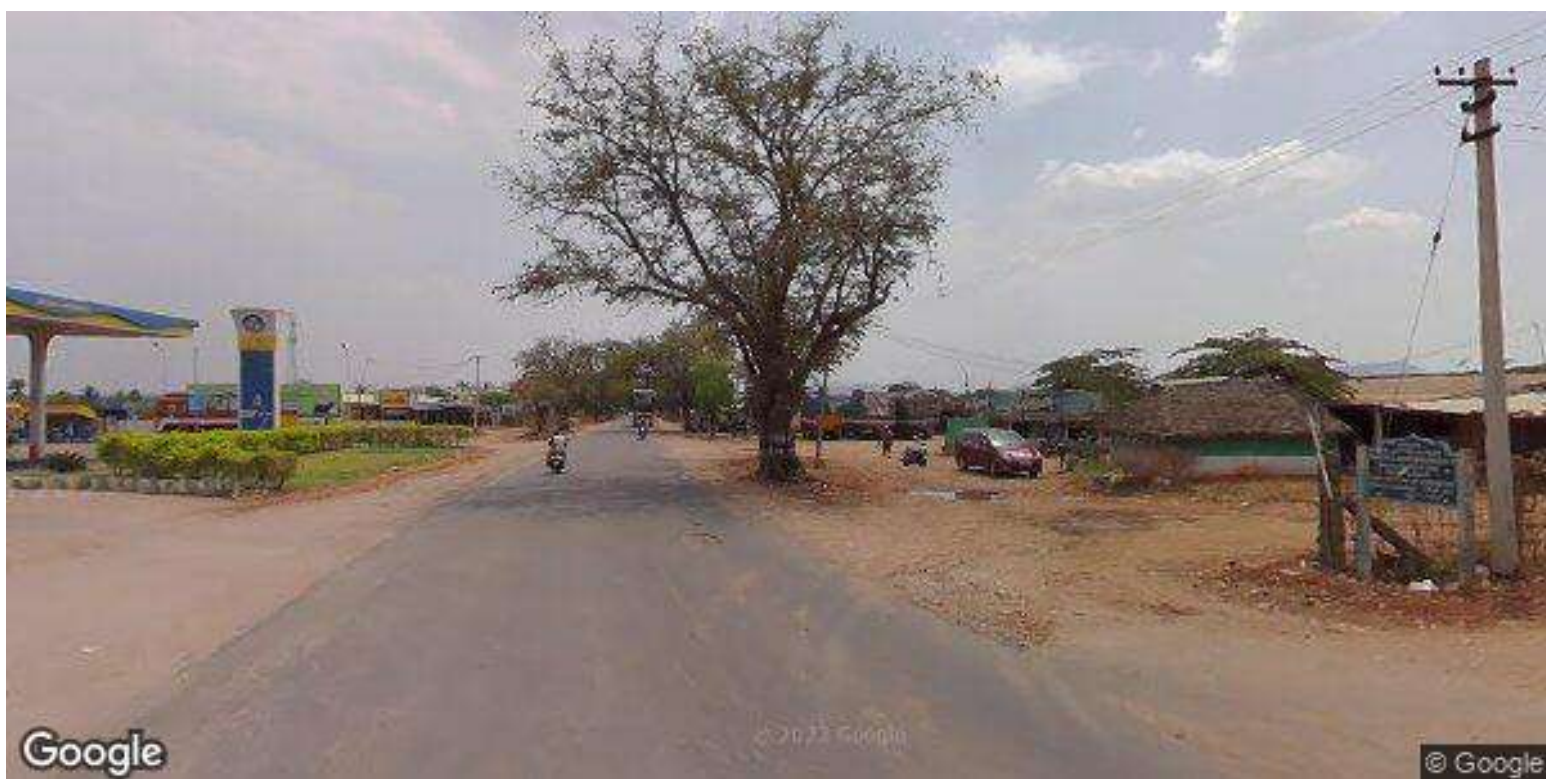
**Coordinates:** 11.58279, 77.90658

**Risk Type:** Turn

**Risk Level:** Medium

**Speed Limit:** 30 KM/Hr

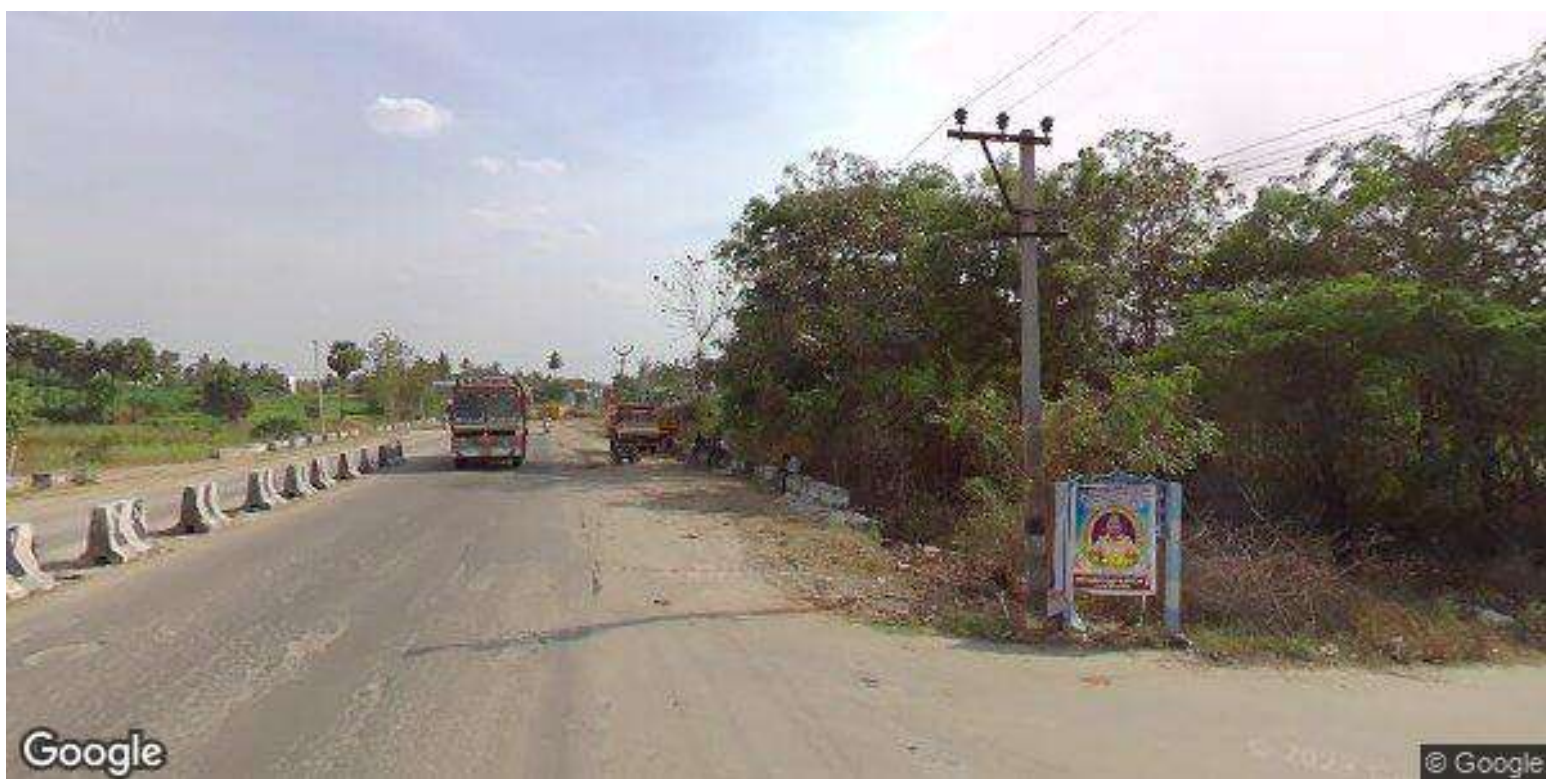
**Risk Type:** Turn  
**Risk Level:** Medium  
**Speed Limit:** 30 KM/Hr  
**Coordinates:** 11.63833, 77.94818

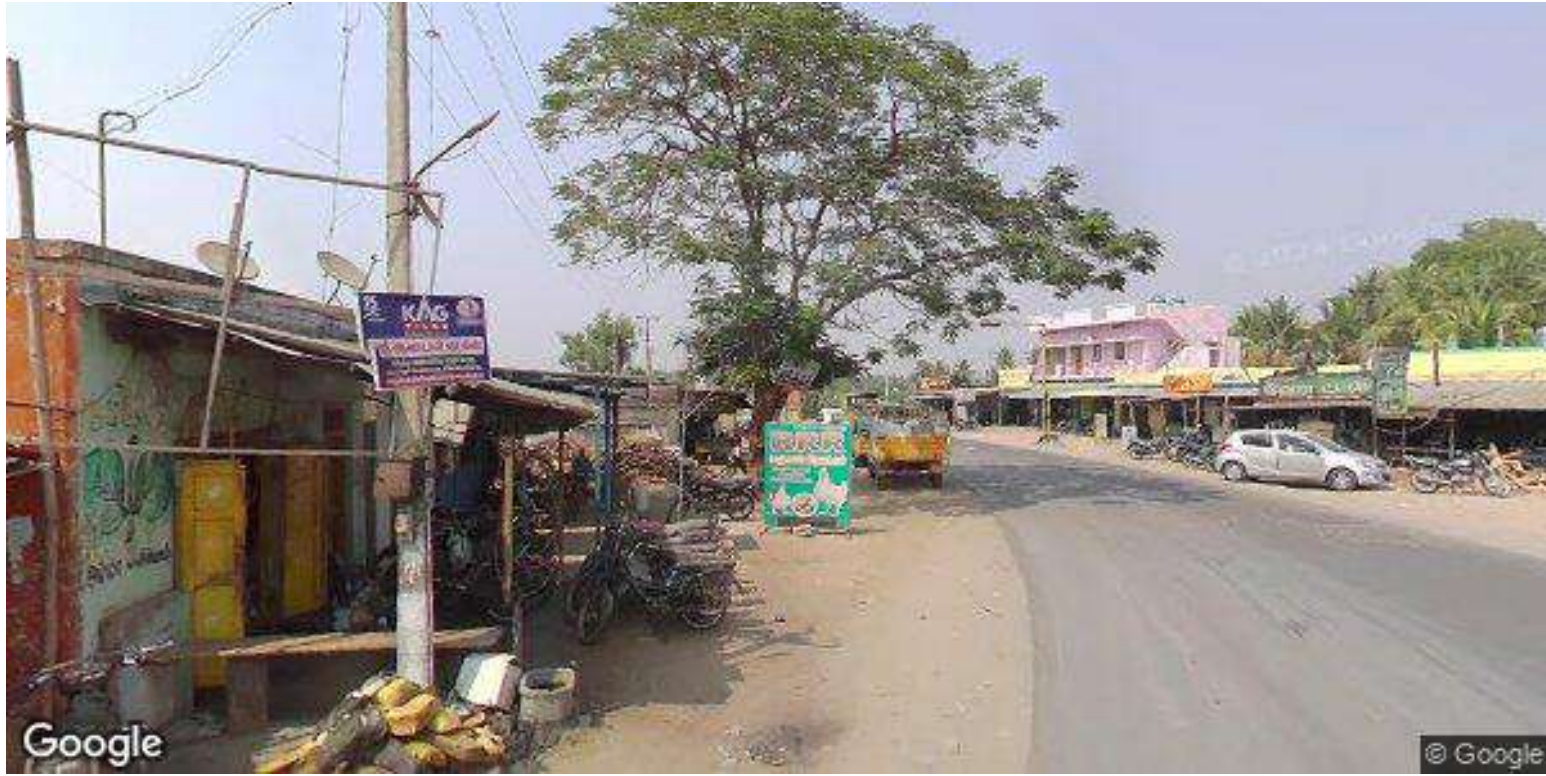
**Risk Type:** Turn  
**Risk Level:** Medium  
**Speed Limit:** 30 KM/Hr  
**Coordinates:** 11.64171, 77.95184

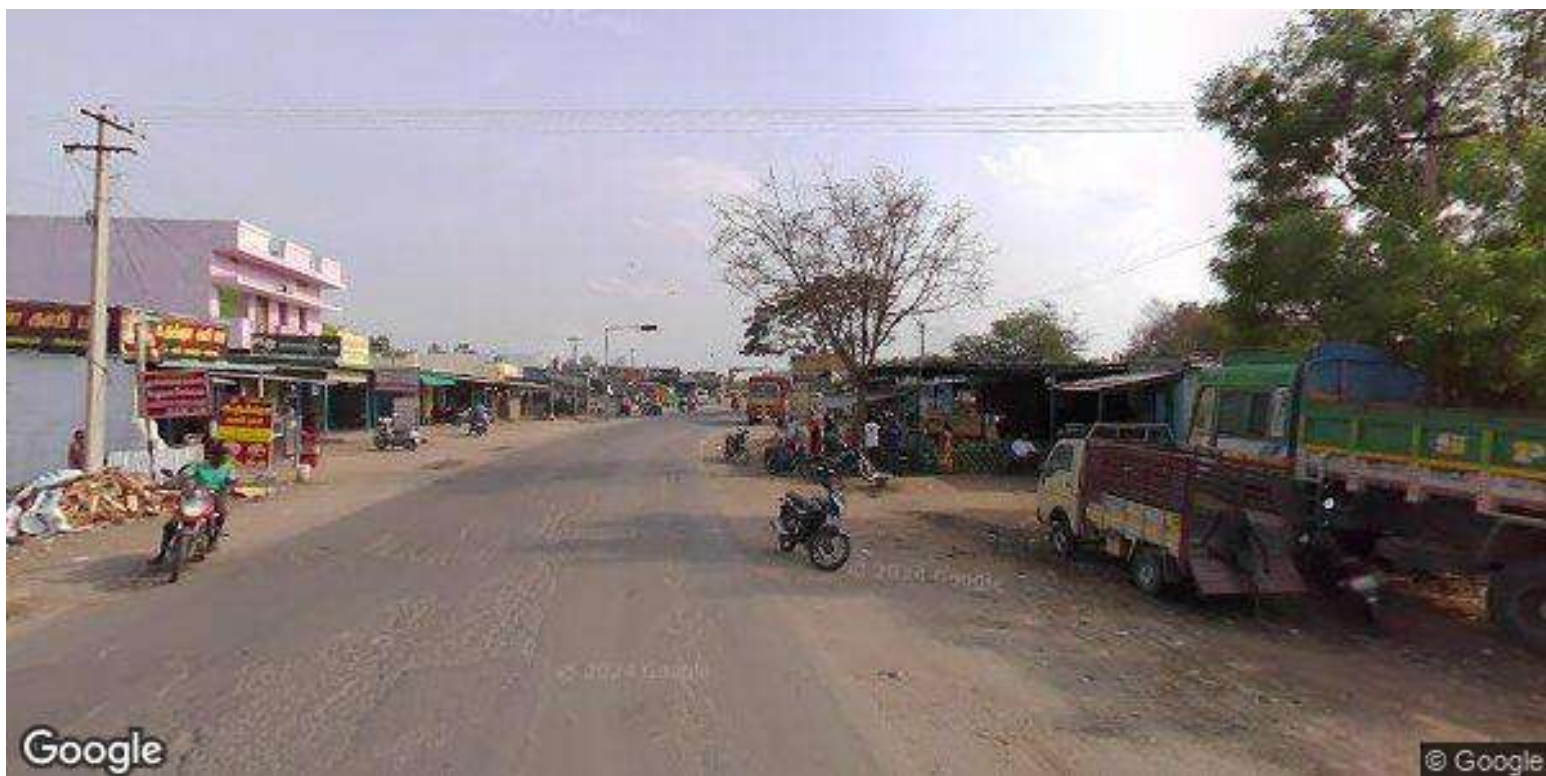
**Risk Type:** Turn  
**Risk Level:** Medium  
**Speed Limit:** 30 KM/Hr  
**Coordinates:** 11.64243, 77.95198

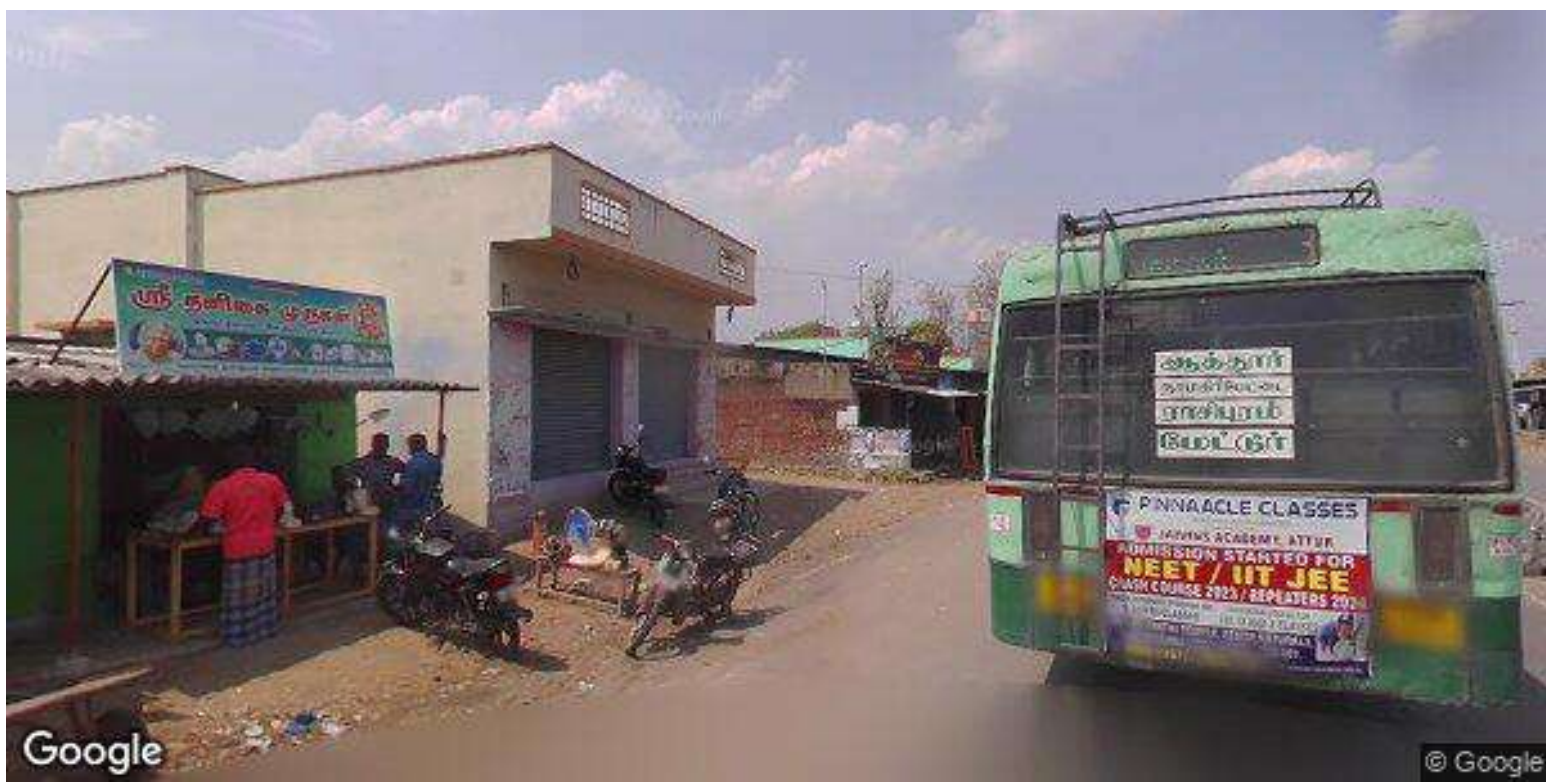
**Coordinates:** 11.64721, 77.95118

**Risk Type:** Turn

**Risk Level:** Medium

**Speed Limit:** 30 KM/Hr

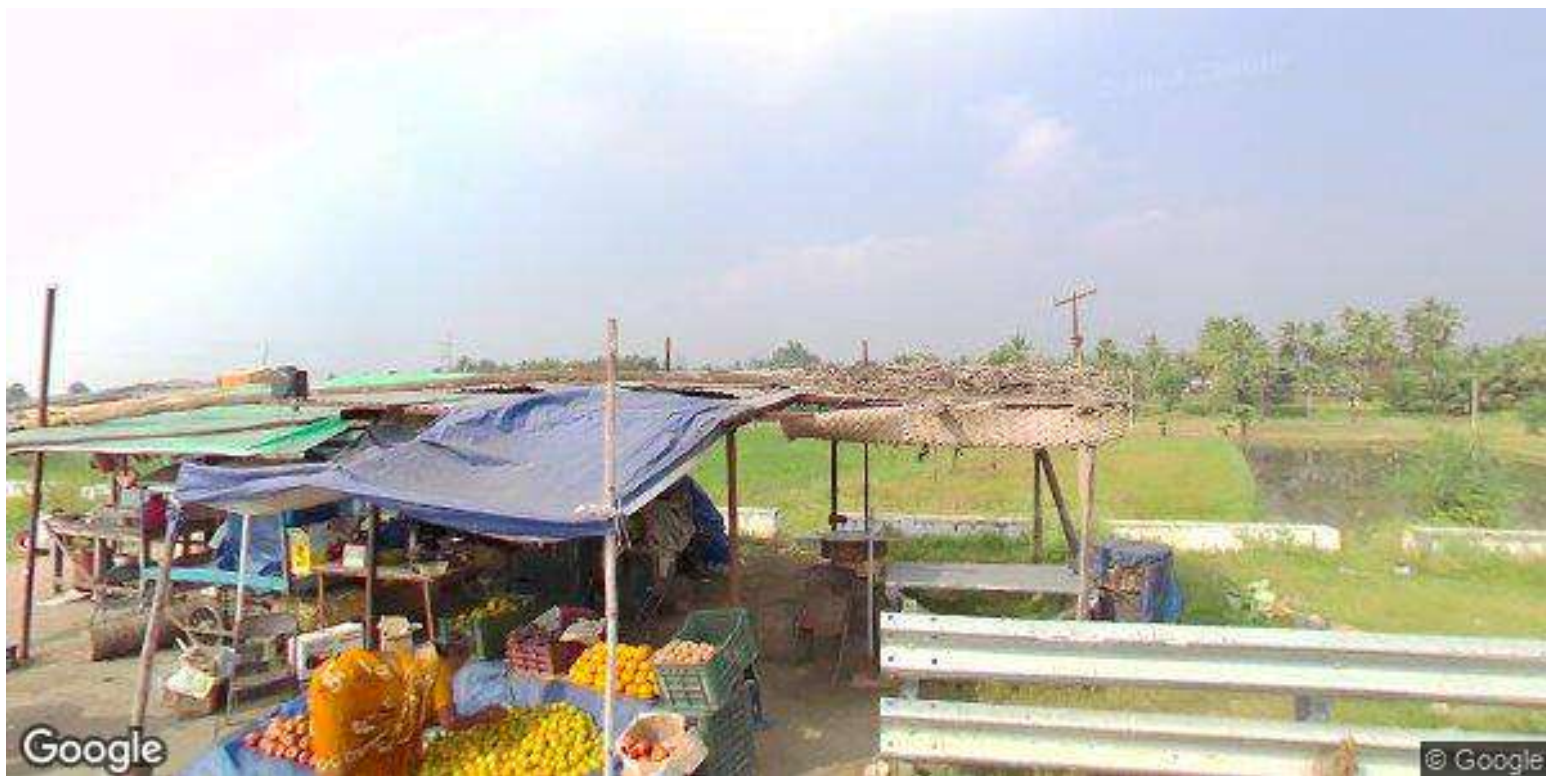
**Coordinates:** 11.67858, 77.96834

**Risk Type:** Turn

**Risk Level:** Medium

**Speed Limit:** 30 KM/Hr

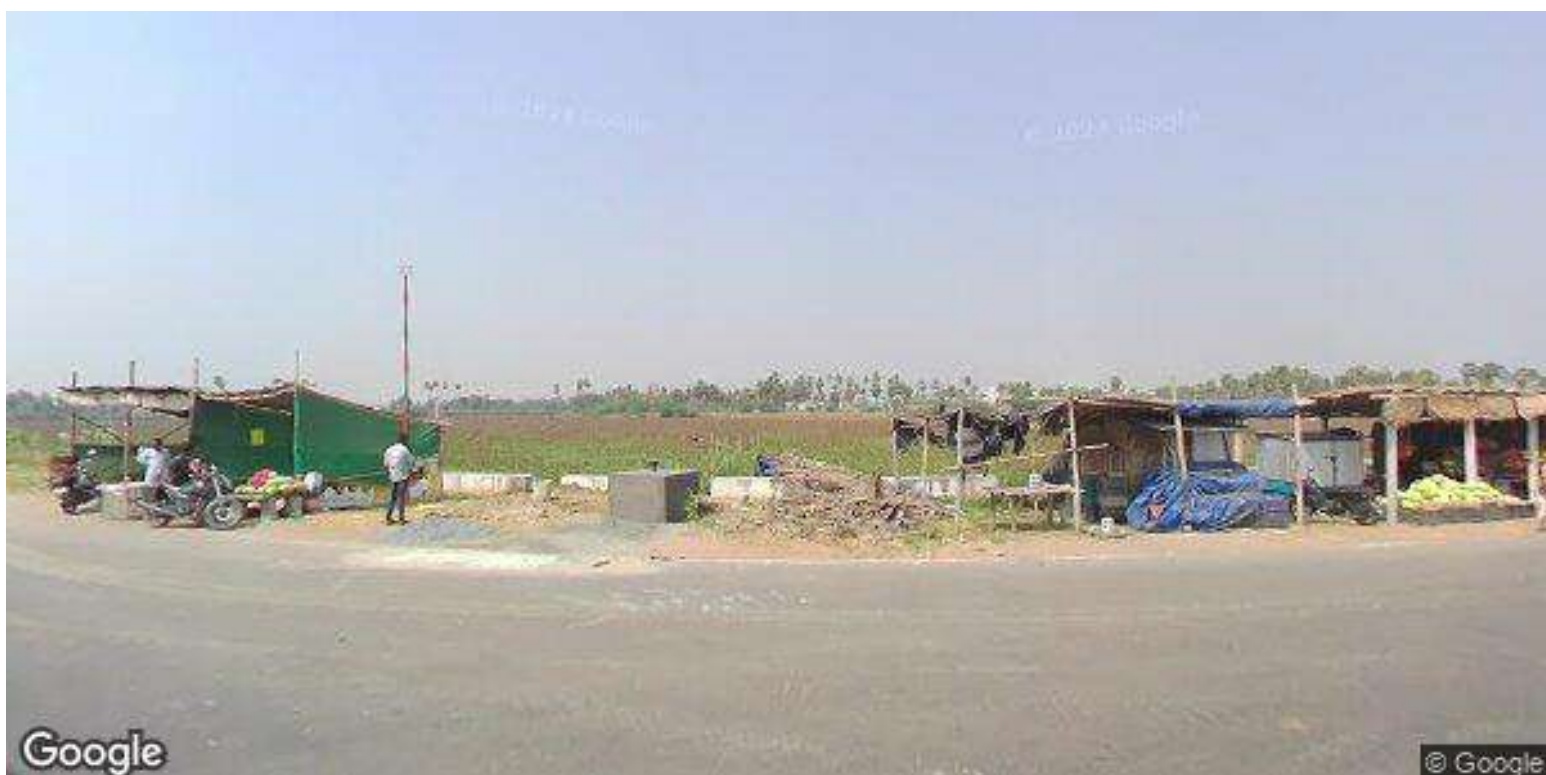
**Risk Type:** Turn  
**Risk Level:** Medium  
**Speed Limit:** 30 KM/Hr  
**Coordinates:** 11.68915, 77.97734

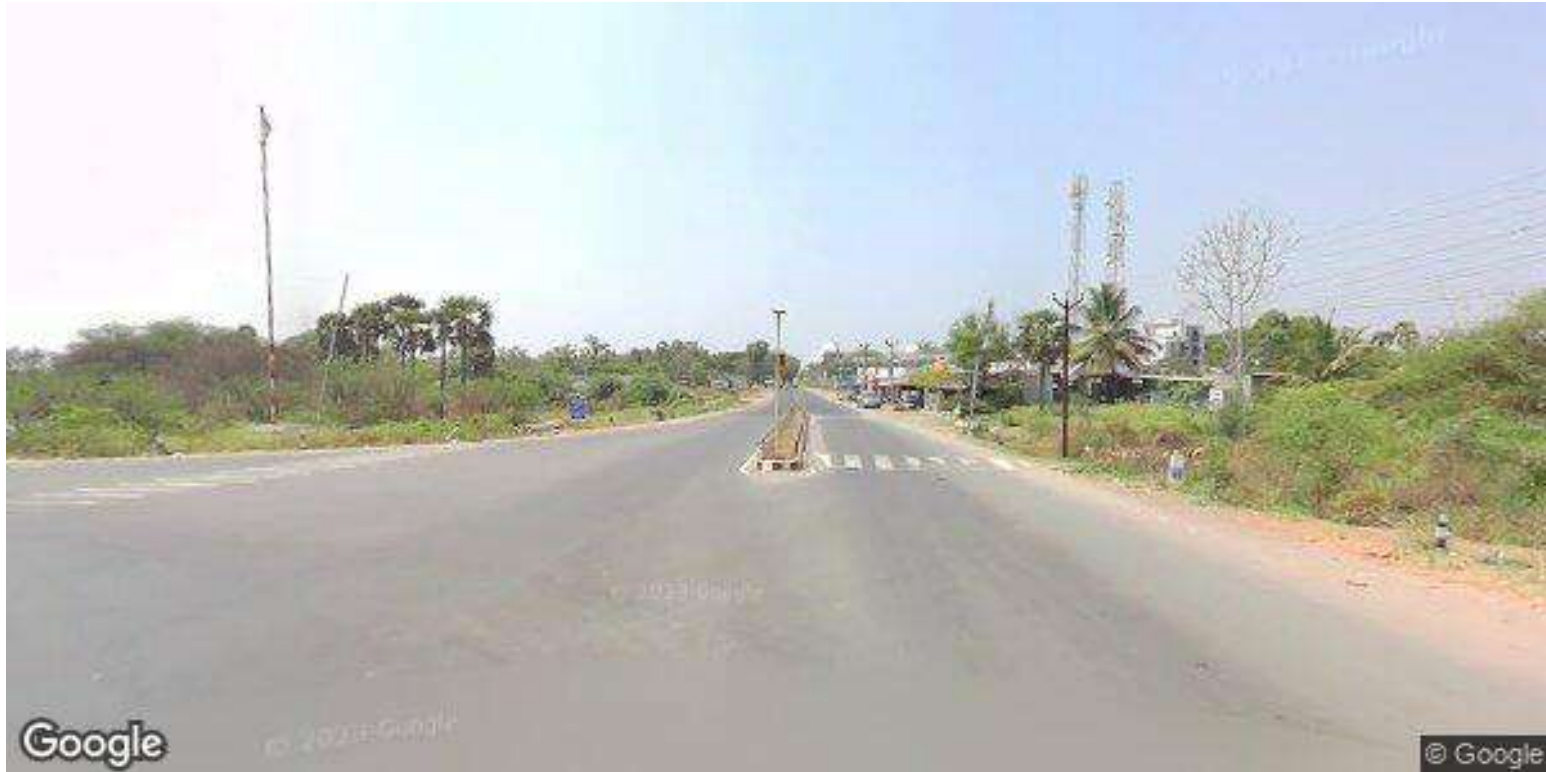
**Risk Type:** Turn  
**Risk Level:** High  
**Speed Limit:** 15 KM/Hr  
**Coordinates:** 11.70227, 77.97864

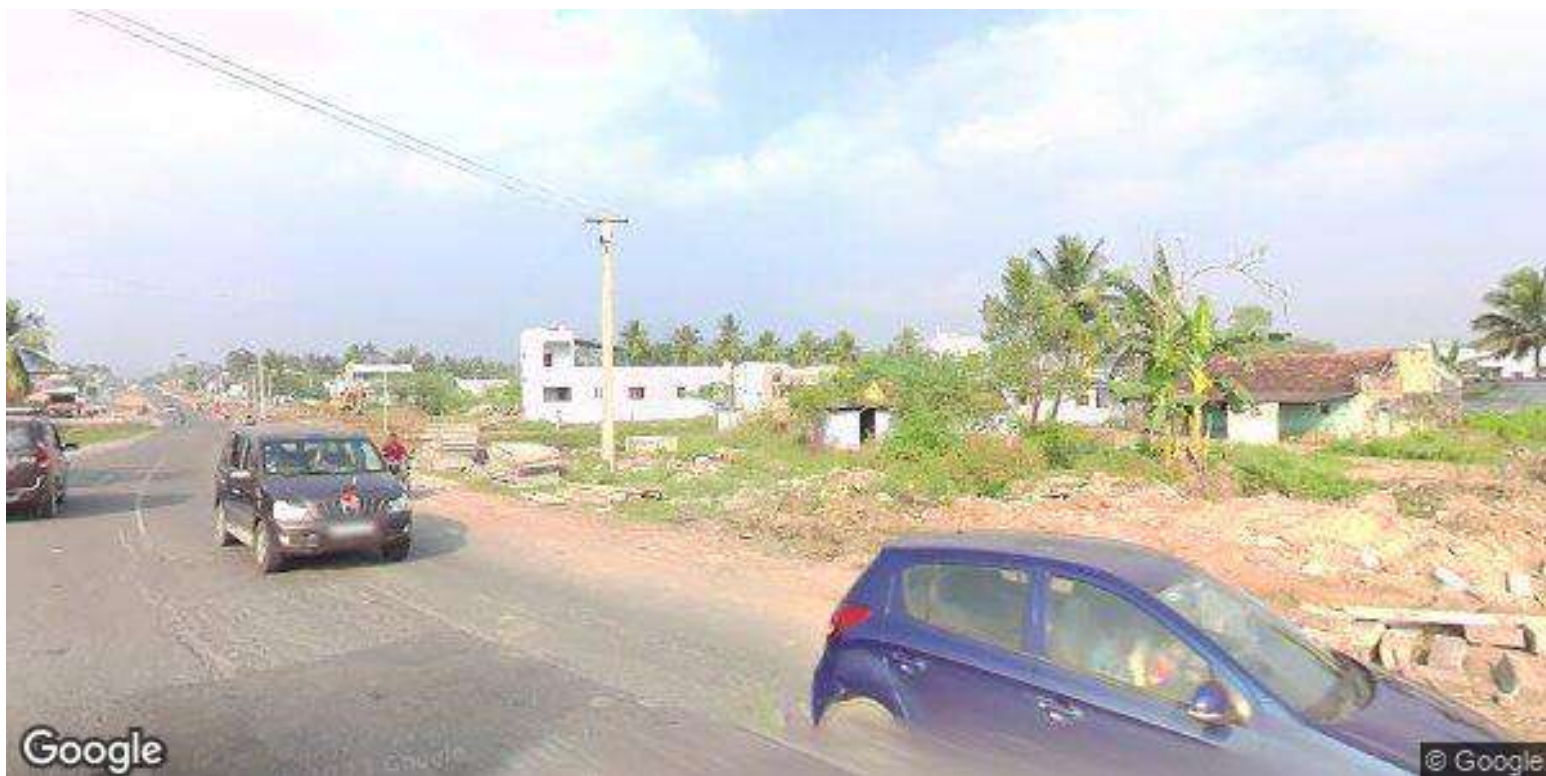
**Risk Type:** Turn  
**Risk Level:** Medium  
**Speed Limit:** 30 KM/Hr  
**Coordinates:** 11.71921, 78.01133

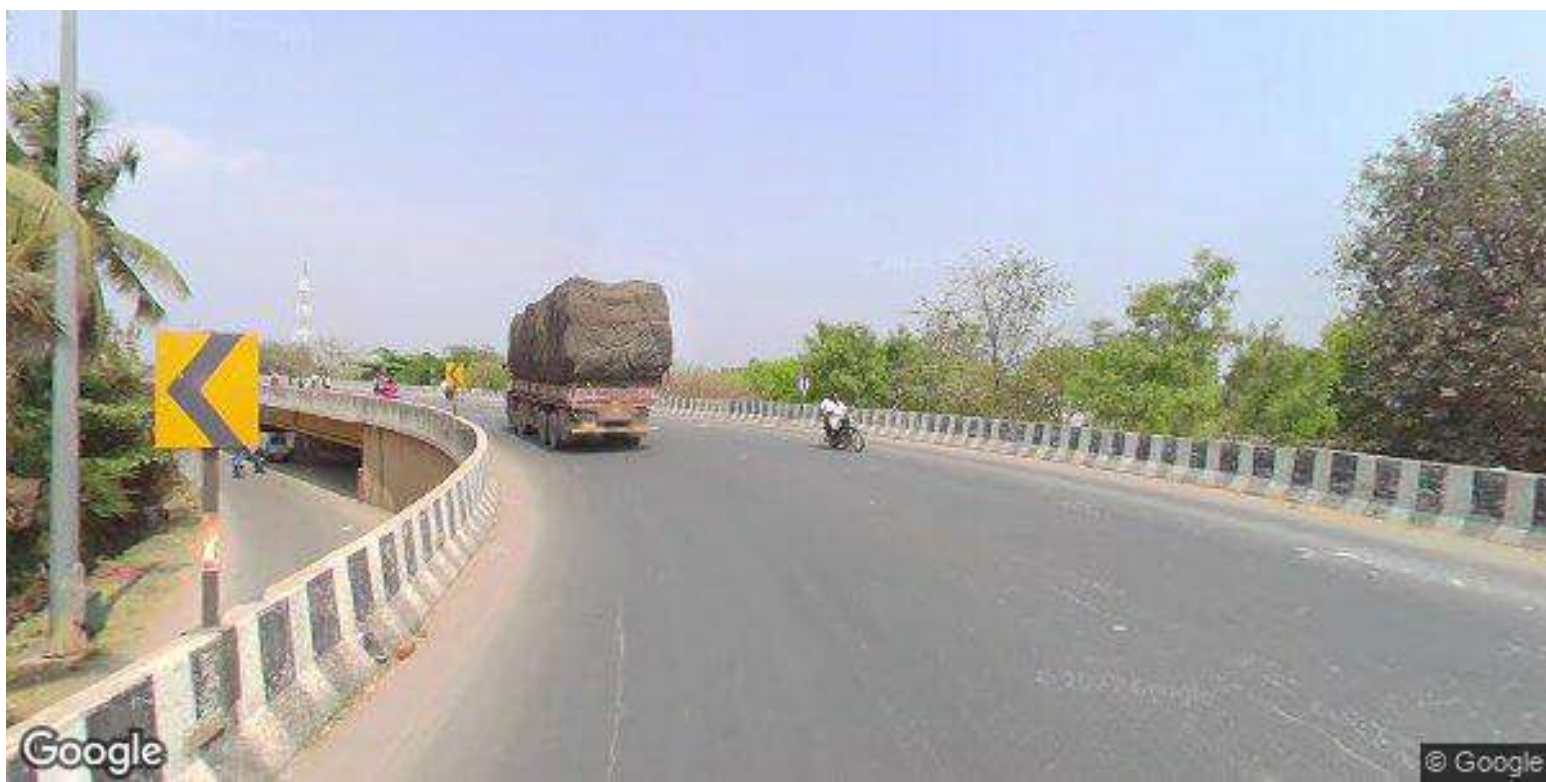
**Coordinates:** 11.73651, 78.03878

**Risk Type:** Turn

**Risk Level:** High

**Speed Limit:** 15 KM/Hr

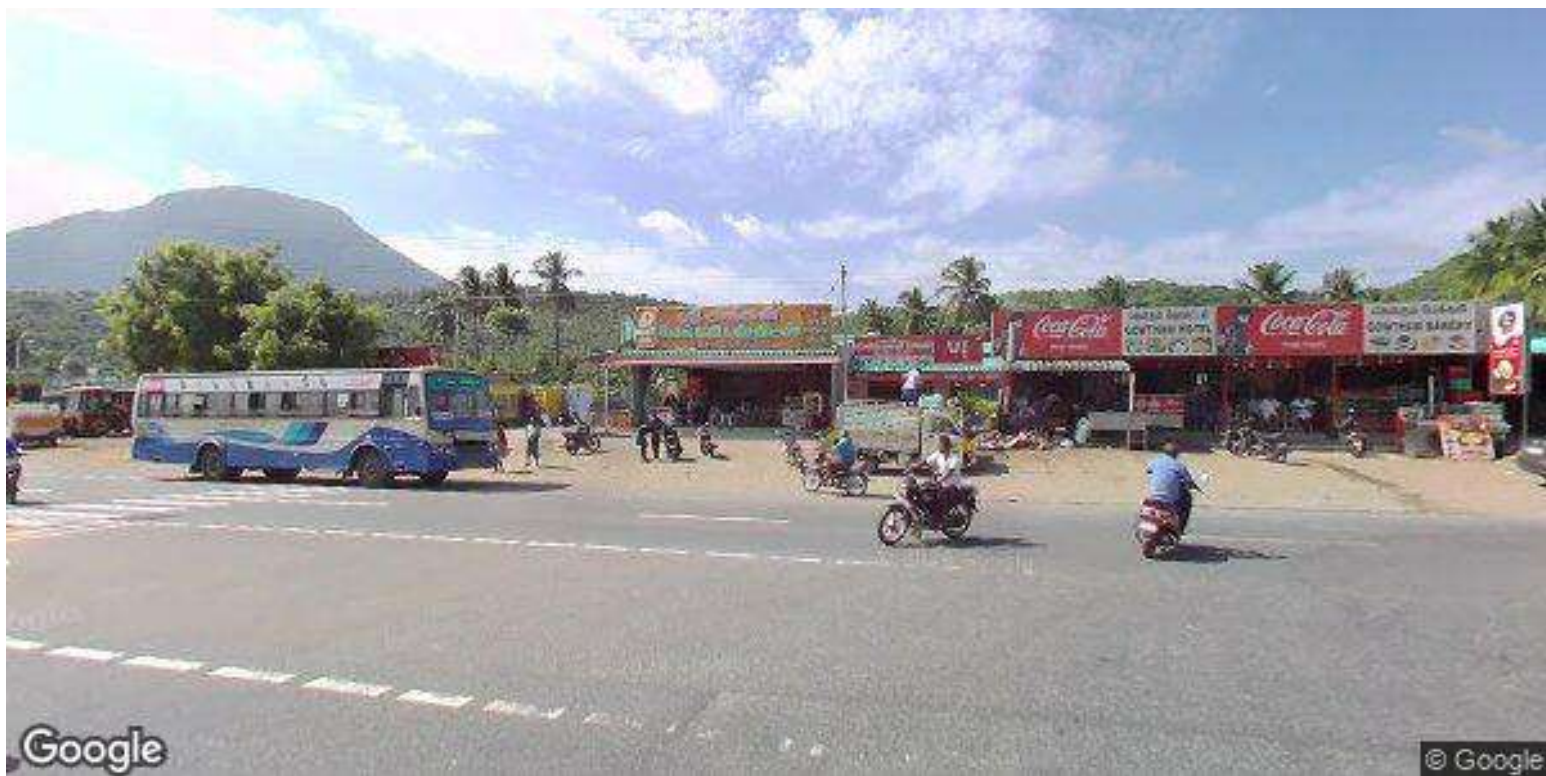
**Coordinates:** 11.93670, 78.05606

**Risk Type:** Turn

**Risk Level:** High

**Speed Limit:** 15 KM/Hr
