# IndianOil

## JOURNEY RISK MANAGEMENT (JRM) STUDY

### Salem Terminal to GK FUELS

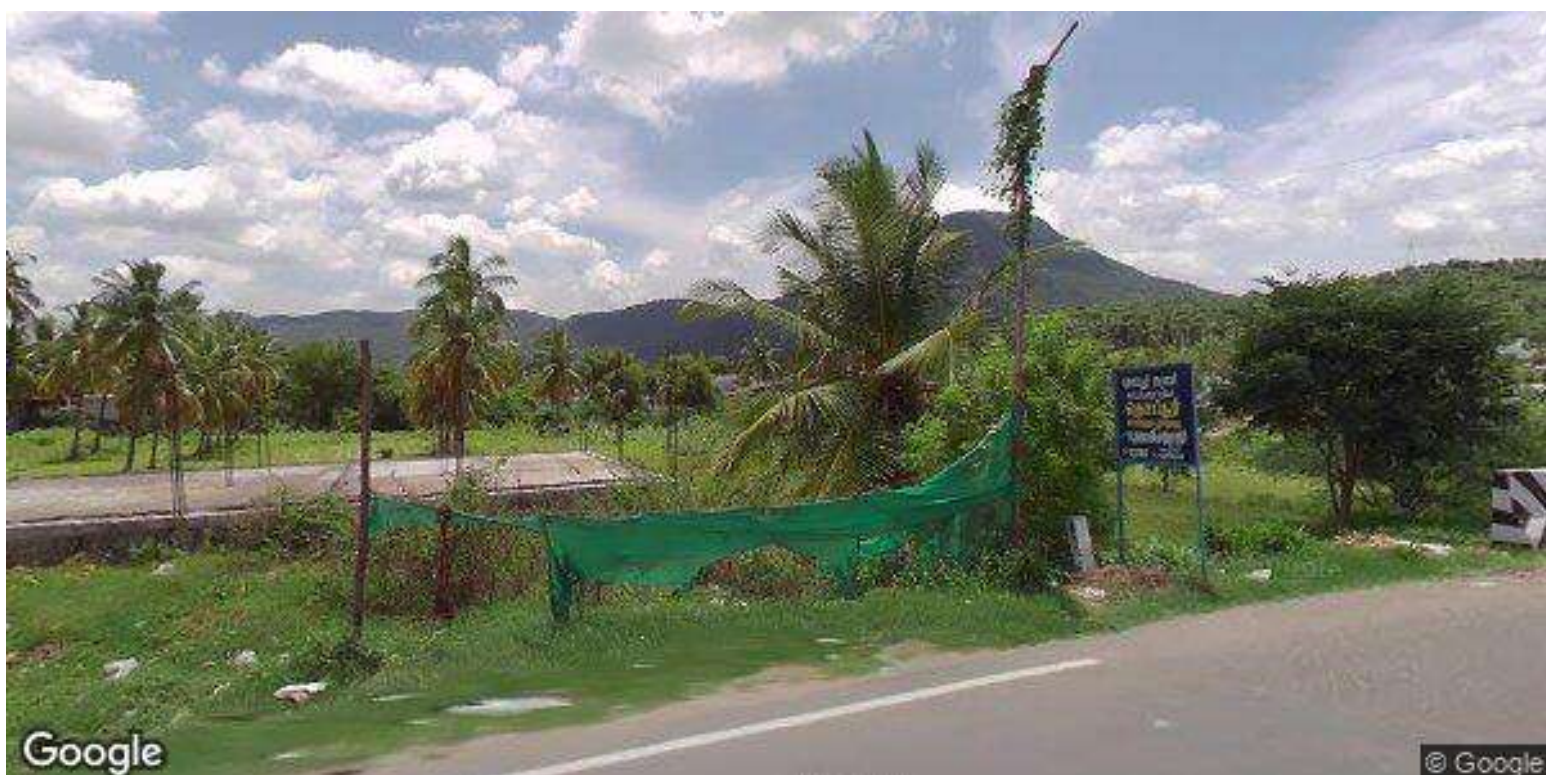
**Coordinates:** 11.93877, 78.05736

**Risk Type:** Turn

**Risk Level:** Medium

**Speed Limit:** 30 KM/Hr

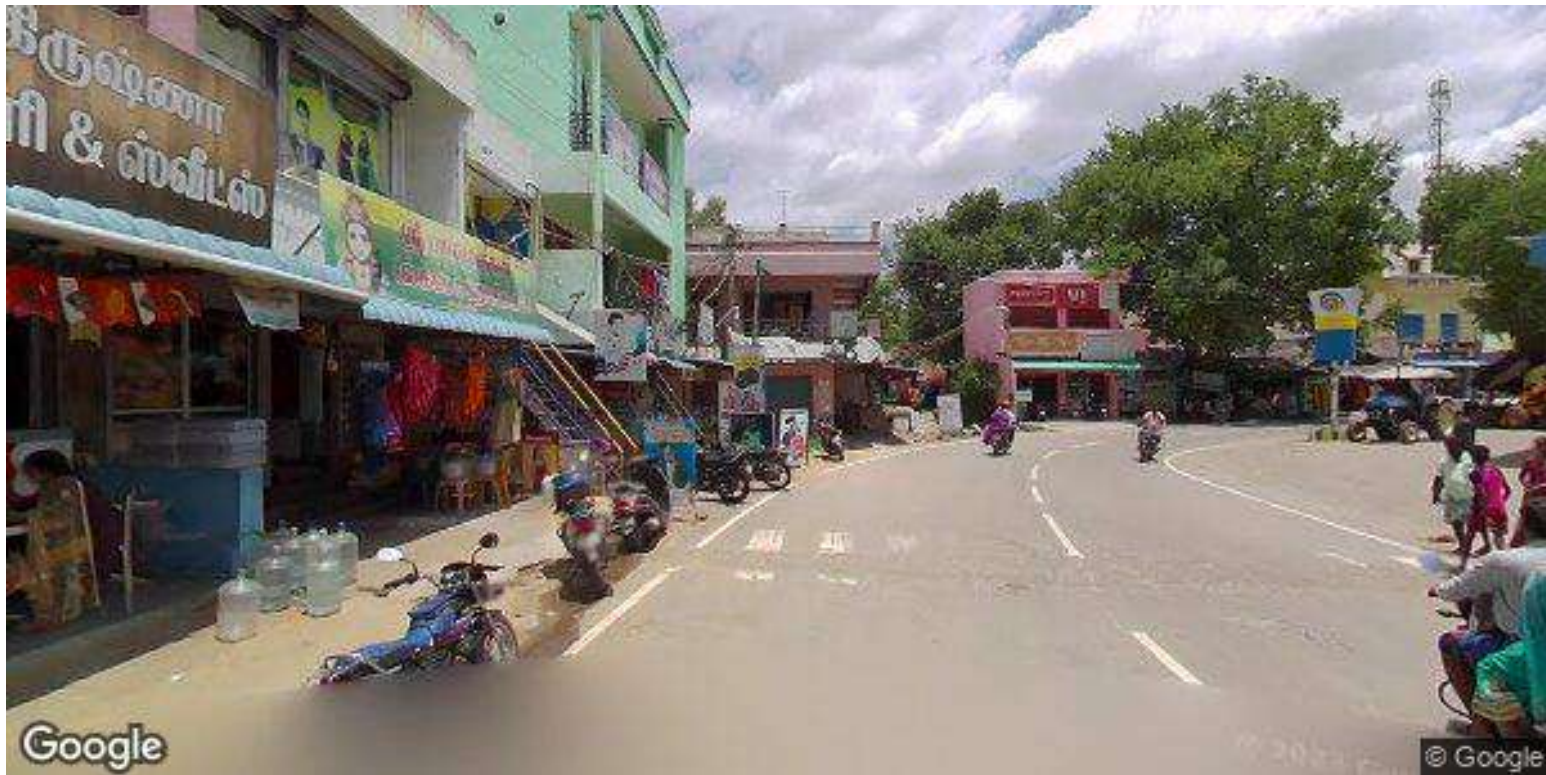
**Coordinates:** 11.93965, 78.05742

**Risk Type:** Turn

**Risk Level:** Medium

**Speed Limit:** 30 KM/Hr

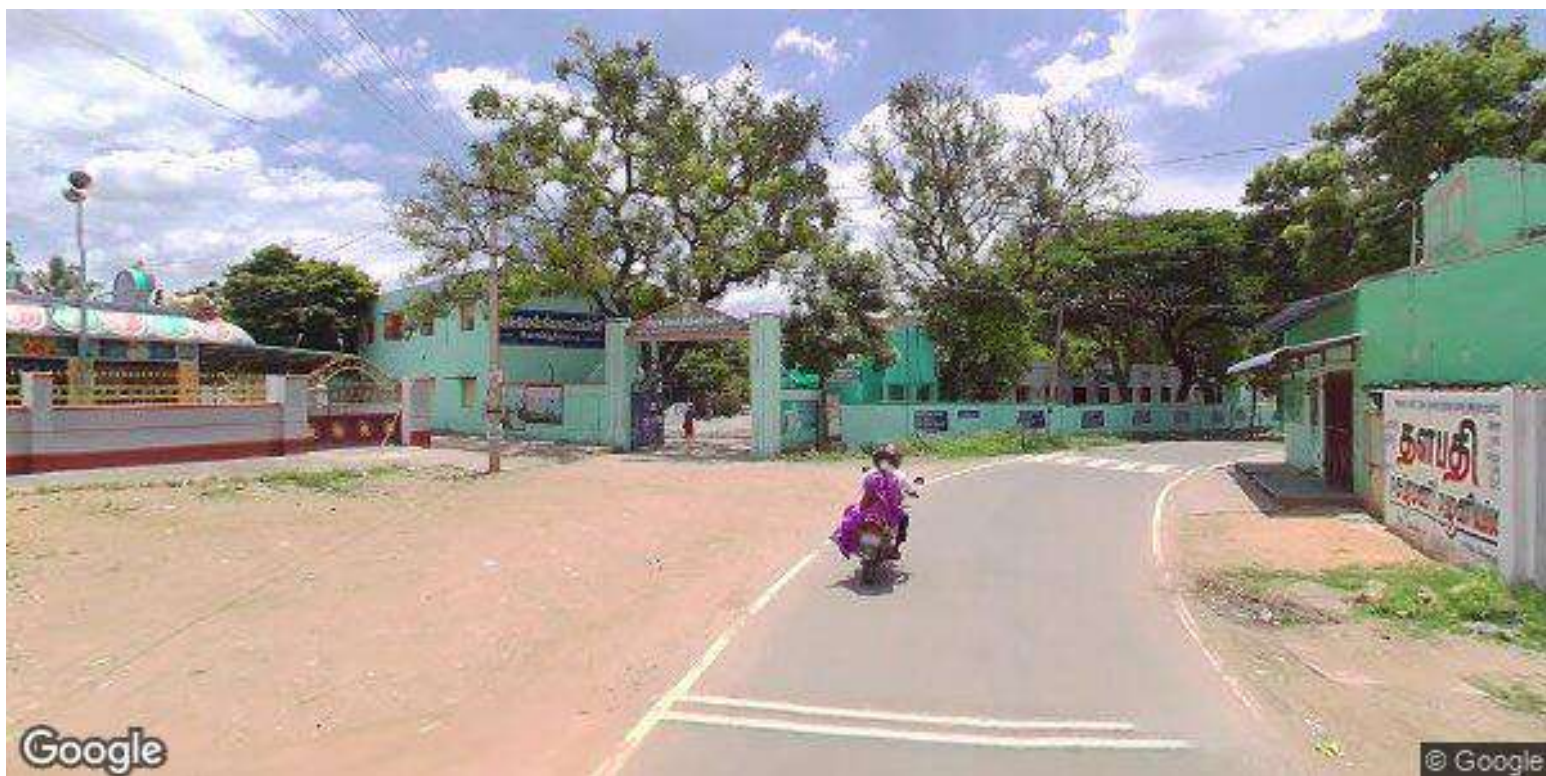
**Coordinates:** 11.94007, 78.05886

**Risk Type:** Turn

**Risk Level:** Medium

**Speed Limit:** 30 KM/Hr

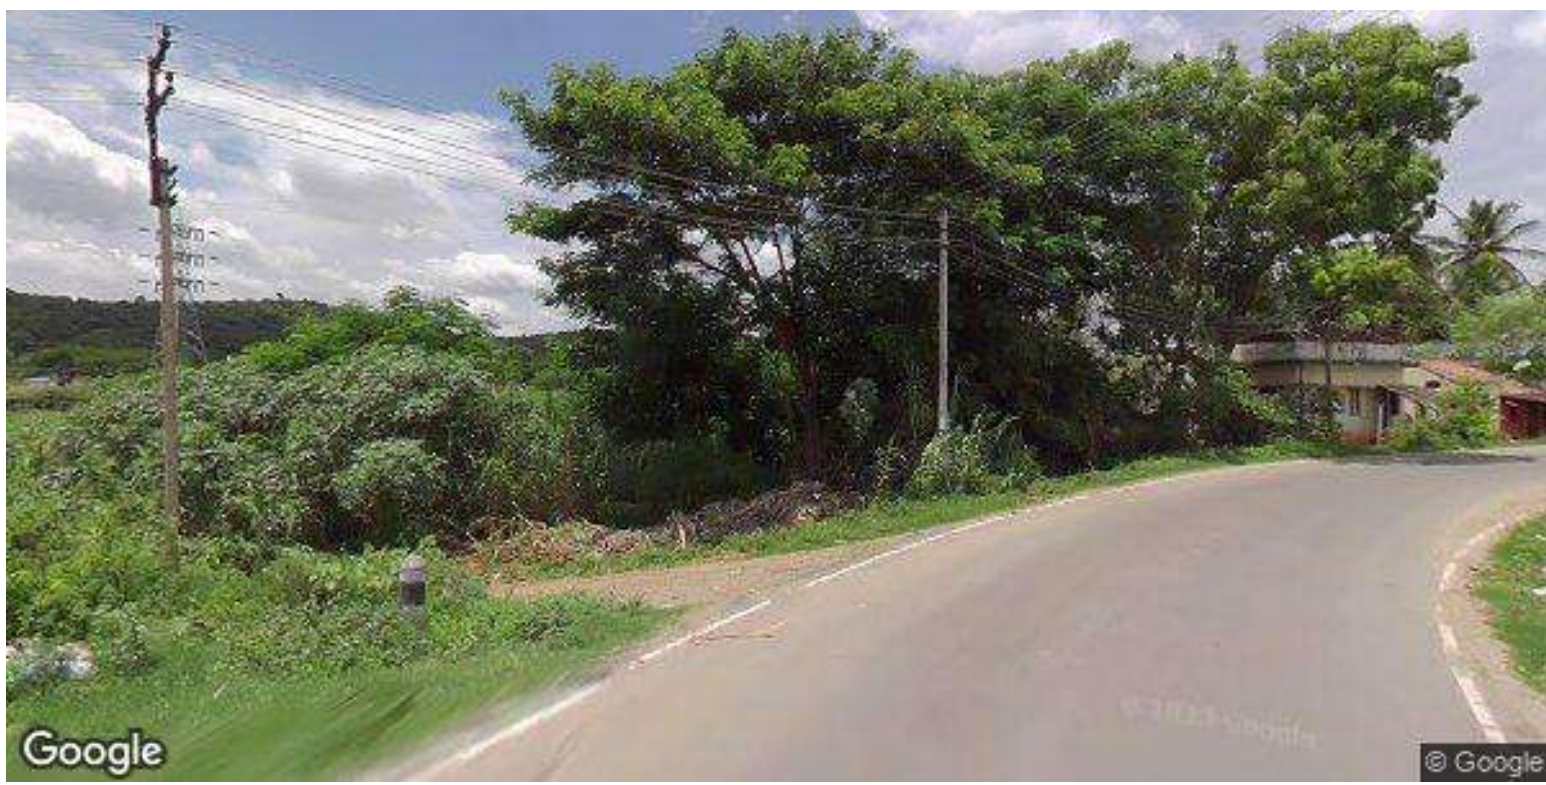
**Coordinates:** 11.93896, 78.06064

**Risk Type:** Turn

**Risk Level:** High

**Speed Limit:** 15 KM/Hr
