# IndianOil

## **JOURNEY RISK MANAGEMENT (JRM) STUDY**

### **Salem Terminal TO SARASWATHI FUELS**

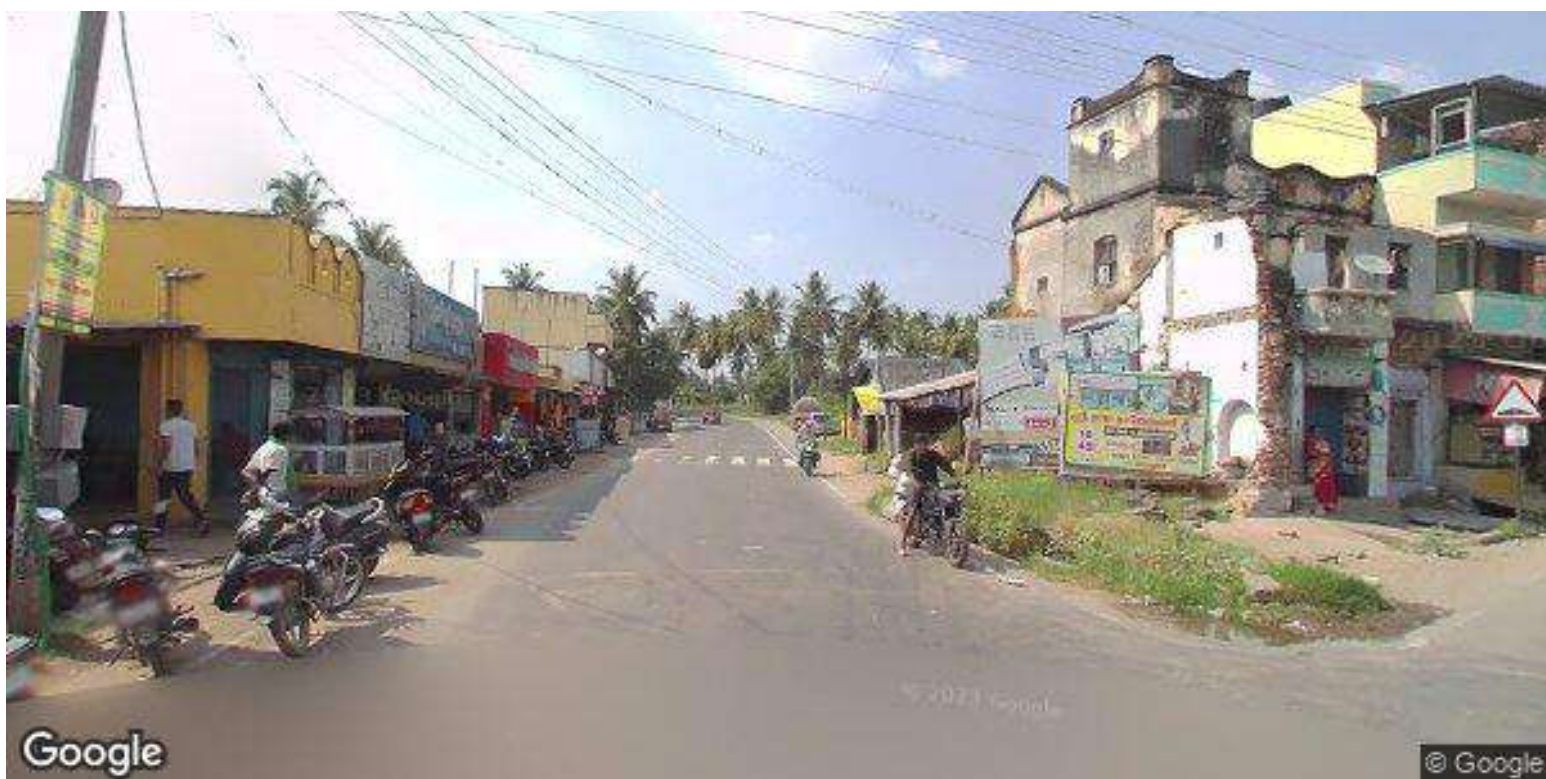
**Coordinates:** 11.45007, 77.87201

**Risk Type:** Turn

**Risk Level:** High

**Speed Limit:** 15 KM/Hr

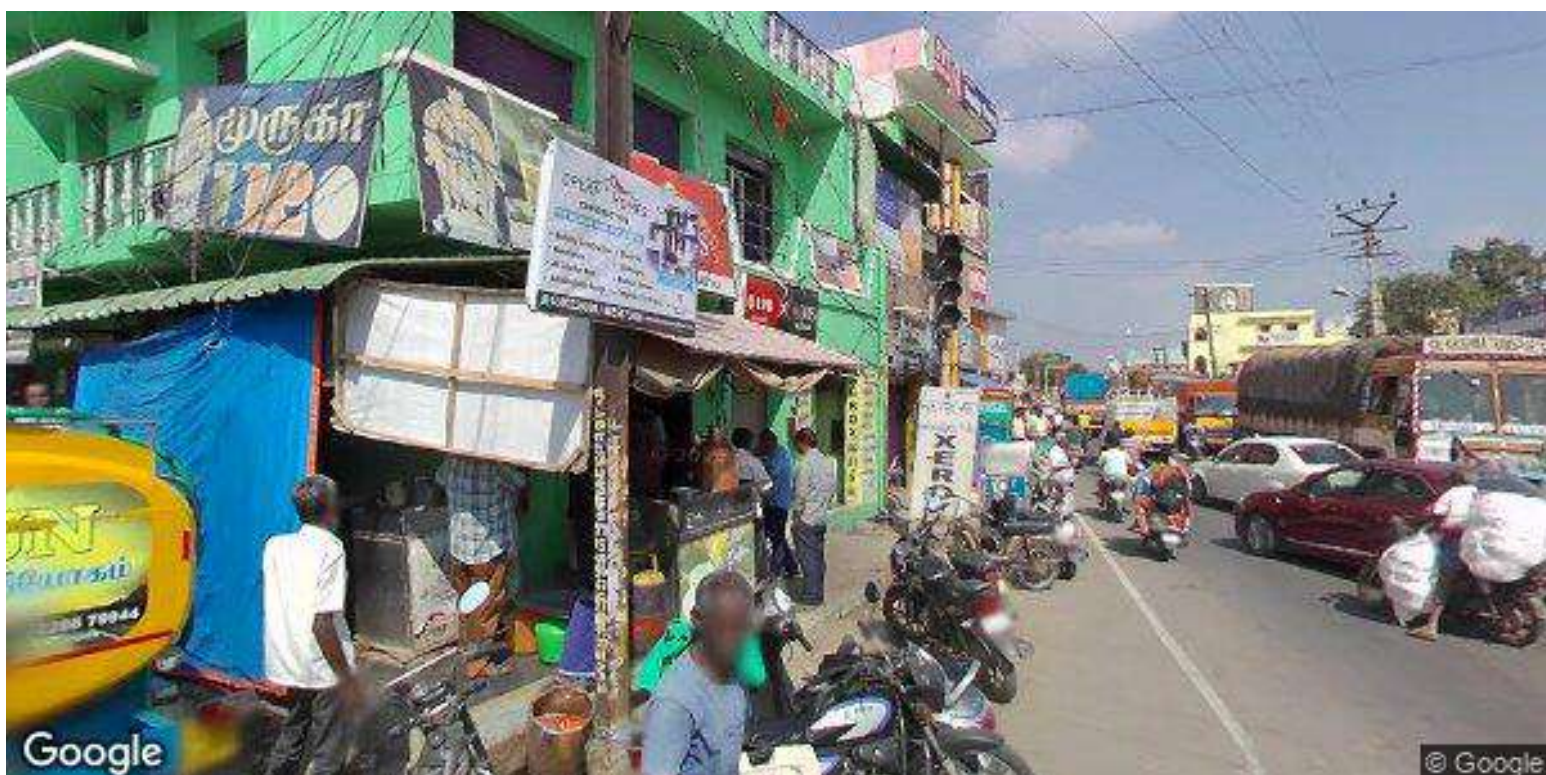
**Coordinates:** 11.47407, 77.86839

**Risk Type:** Turn

**Risk Level:** High

**Speed Limit:** 15 KM/Hr

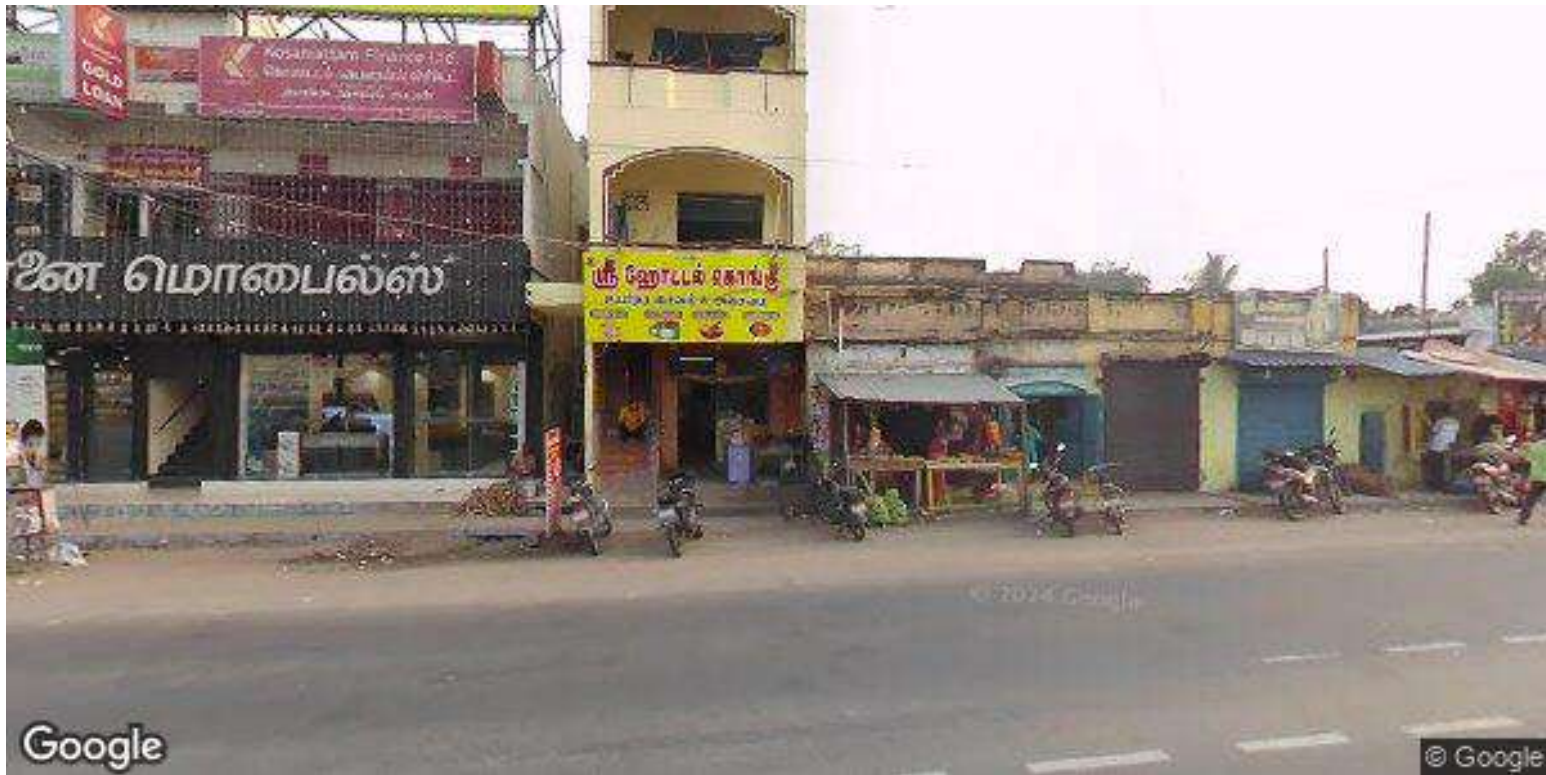
**Coordinates:** 11.47451, 77.86914

**Risk Type:** Turn

**Risk Level:** High

**Speed Limit:** 15 KM/Hr

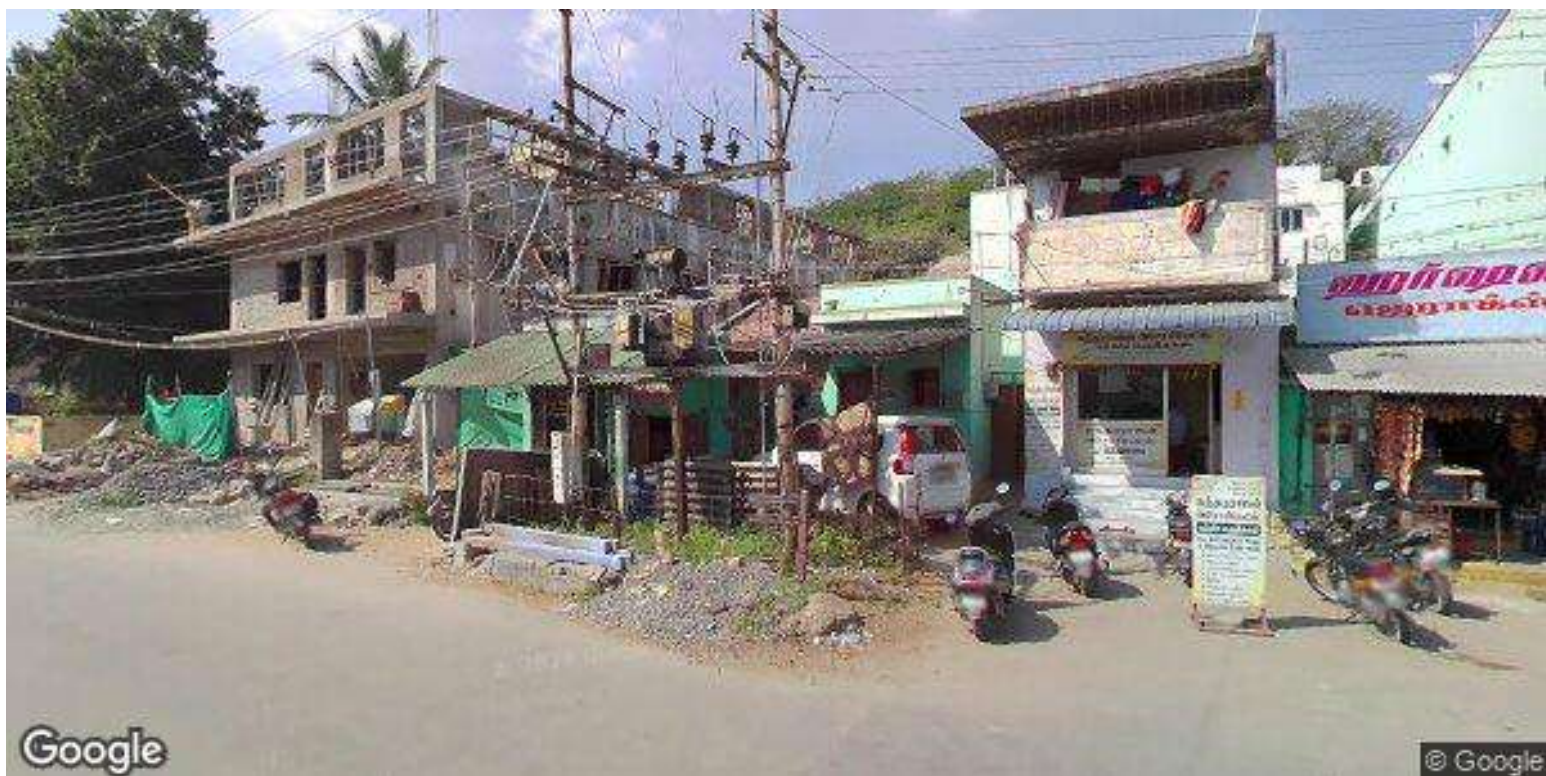
**Coordinates:** 11.47920, 77.86989

**Risk Type:** Turn

**Risk Level:** Medium

**Speed Limit:** 30 KM/Hr

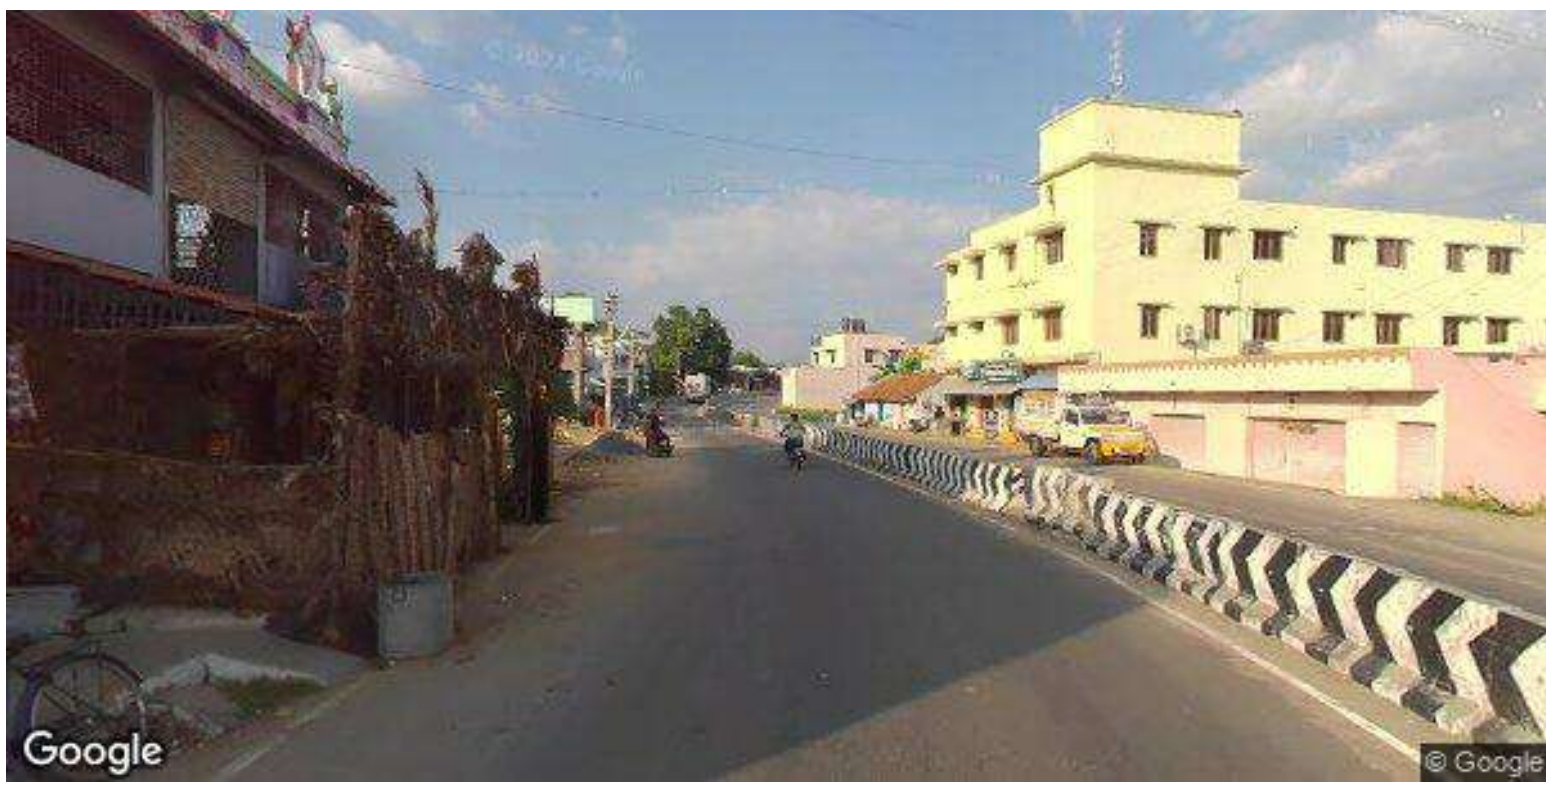
**Coordinates:** 11.48063, 77.87165

**Risk Type:** Turn

**Risk Level:** Medium

**Speed Limit:** 30 KM/Hr

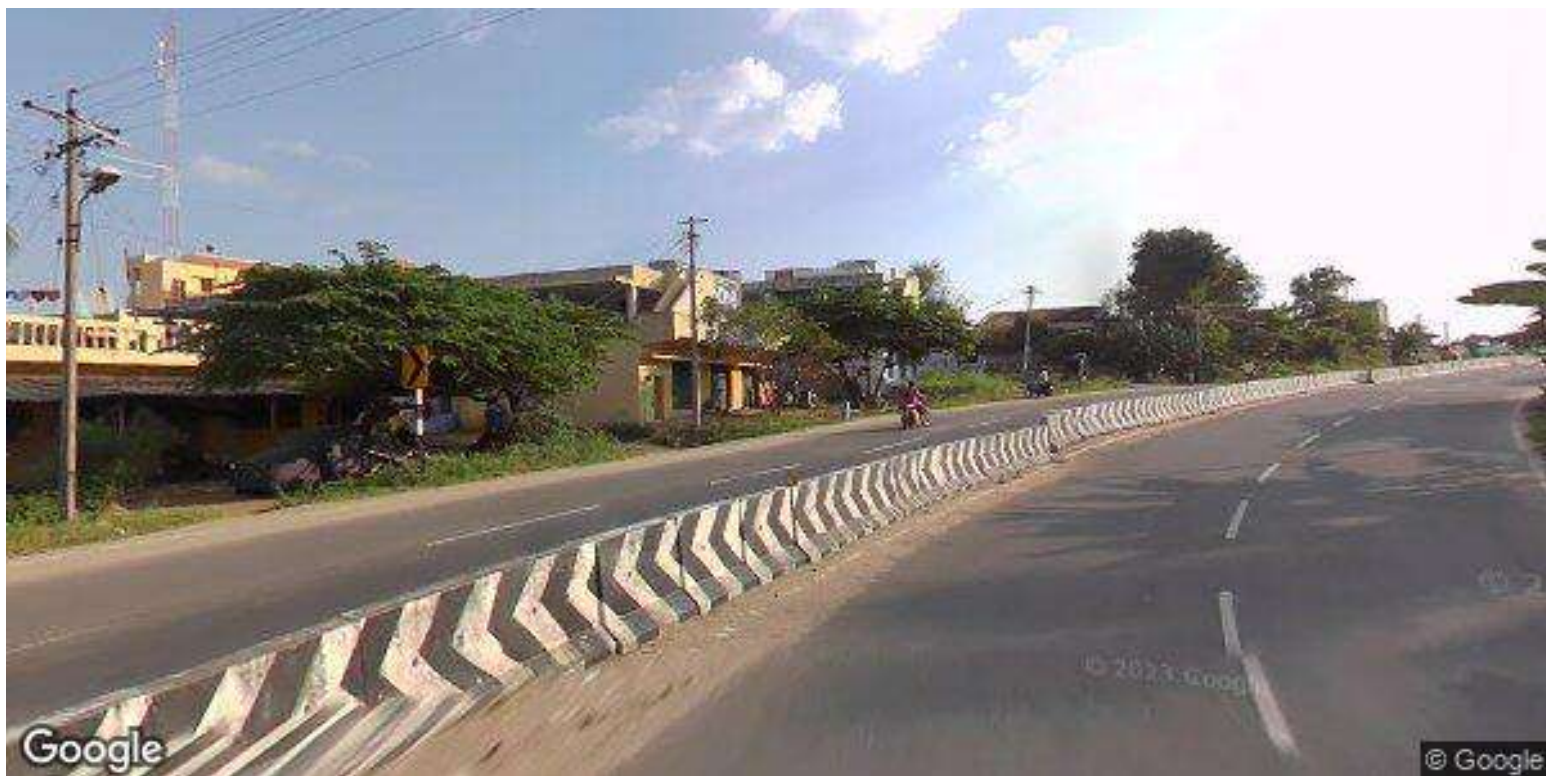
**Coordinates:** 11.48258, 77.87250

**Risk Type:** Turn

**Risk Level:** Medium

**Speed Limit:** 30 KM/Hr

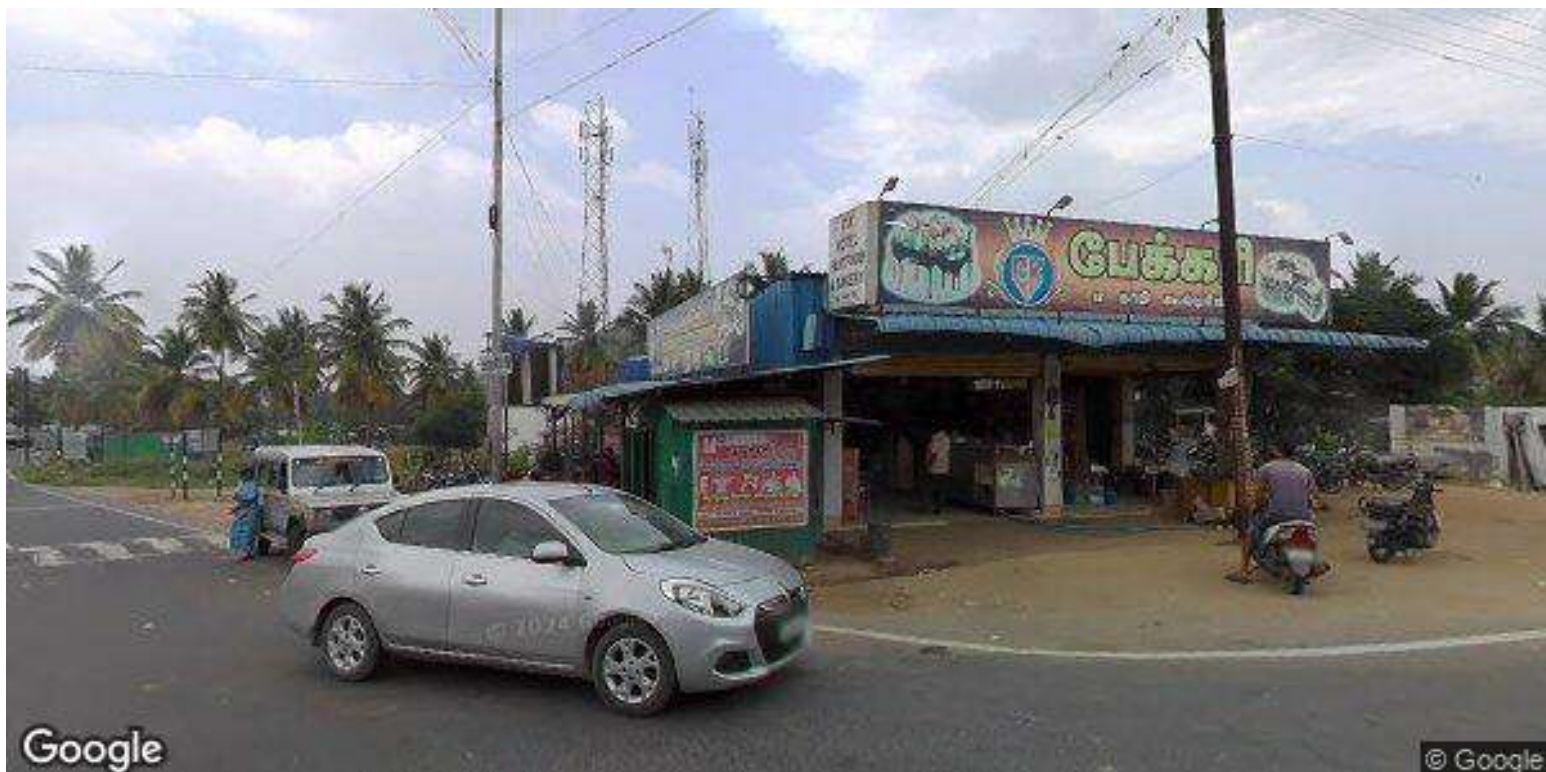
**Risk Type:** Blind Spot  
**Risk Level:** Blind Spot  
**Speed Limit:** 10 KM/Hr  
**Coordinates:** 11.49390, 77.86748

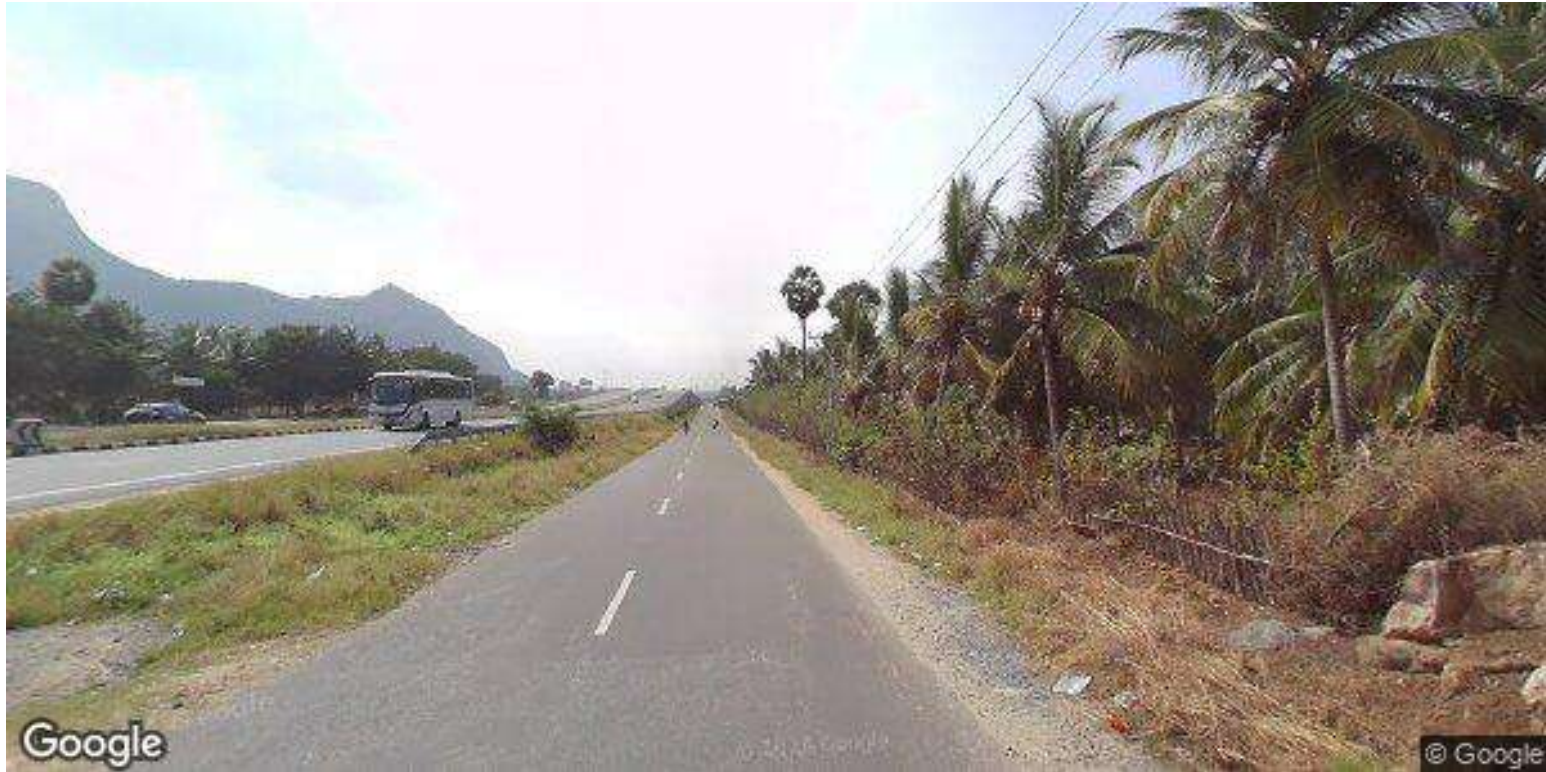
**Risk Type:** Turn  
**Risk Level:** Medium  
**Speed Limit:** 30 KM/Hr  
**Coordinates:** 11.49431, 77.87032

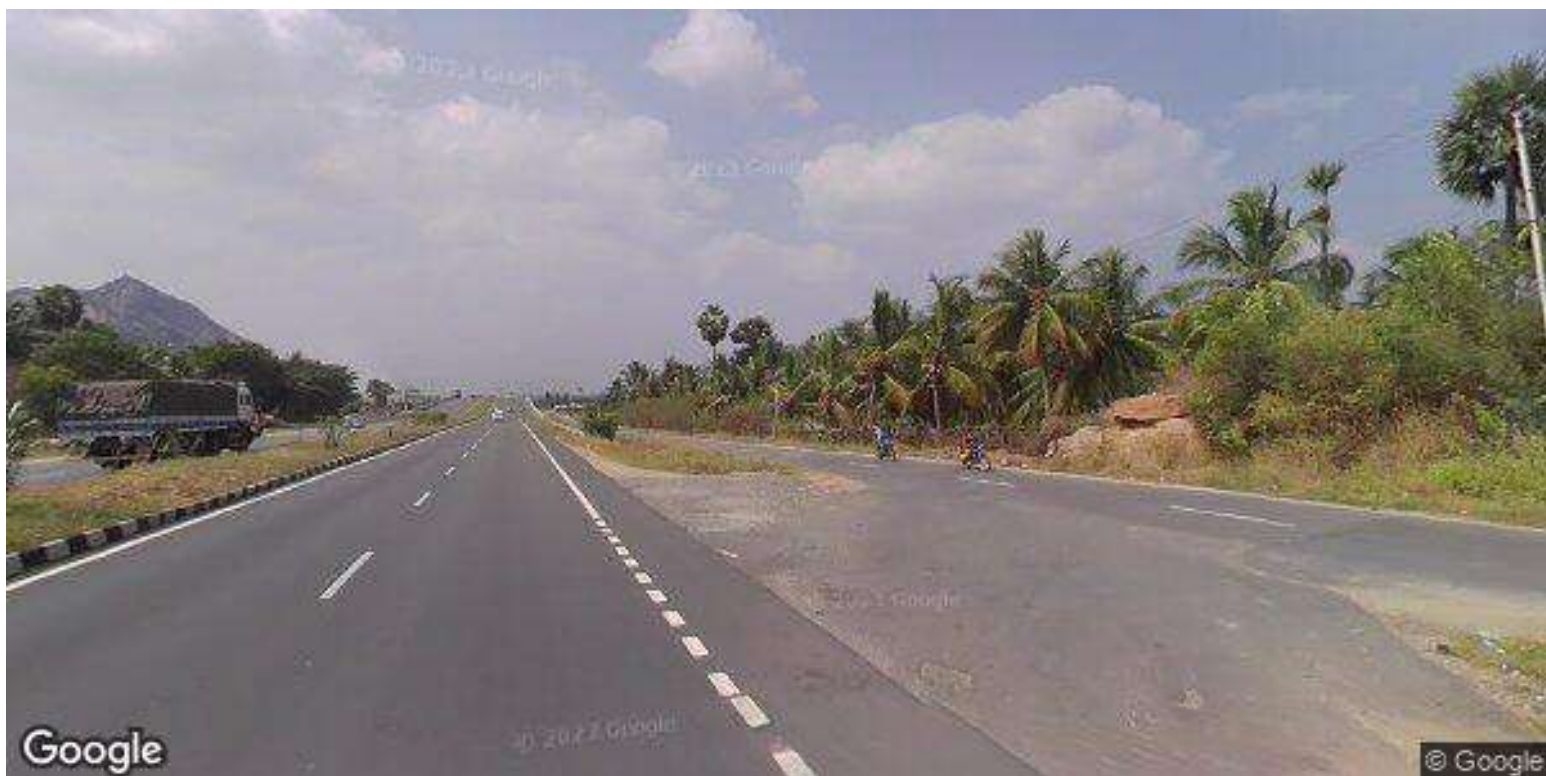
**Risk Type:** Turn  
**Risk Level:** Medium  
**Speed Limit:** 30 KM/Hr  
**Coordinates:** 11.49420, 77.87051

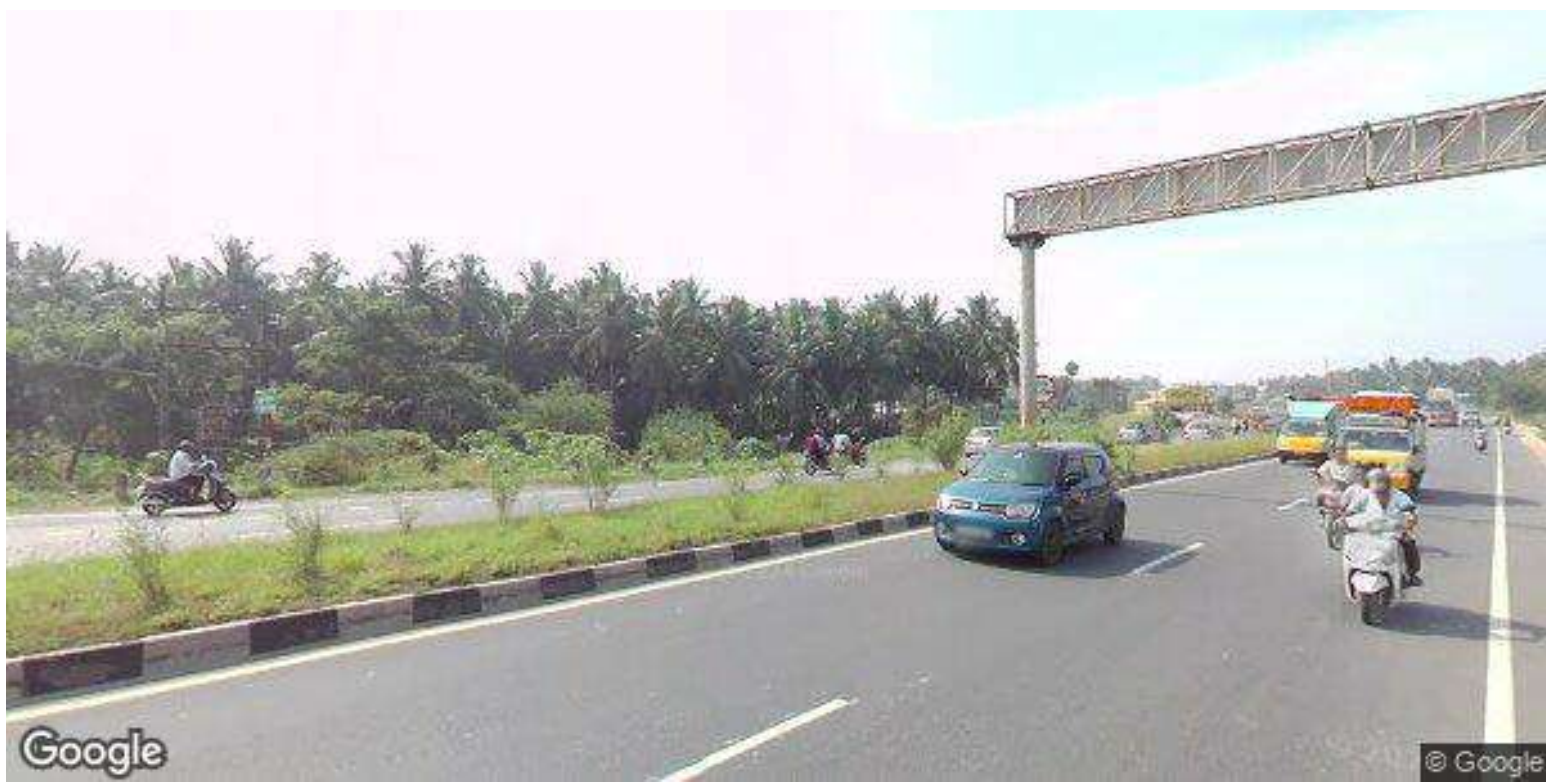
**Coordinates:** 11.60942, 78.10056

**Risk Type:** Turn

**Risk Level:** Medium

**Speed Limit:** 30 KM/Hr

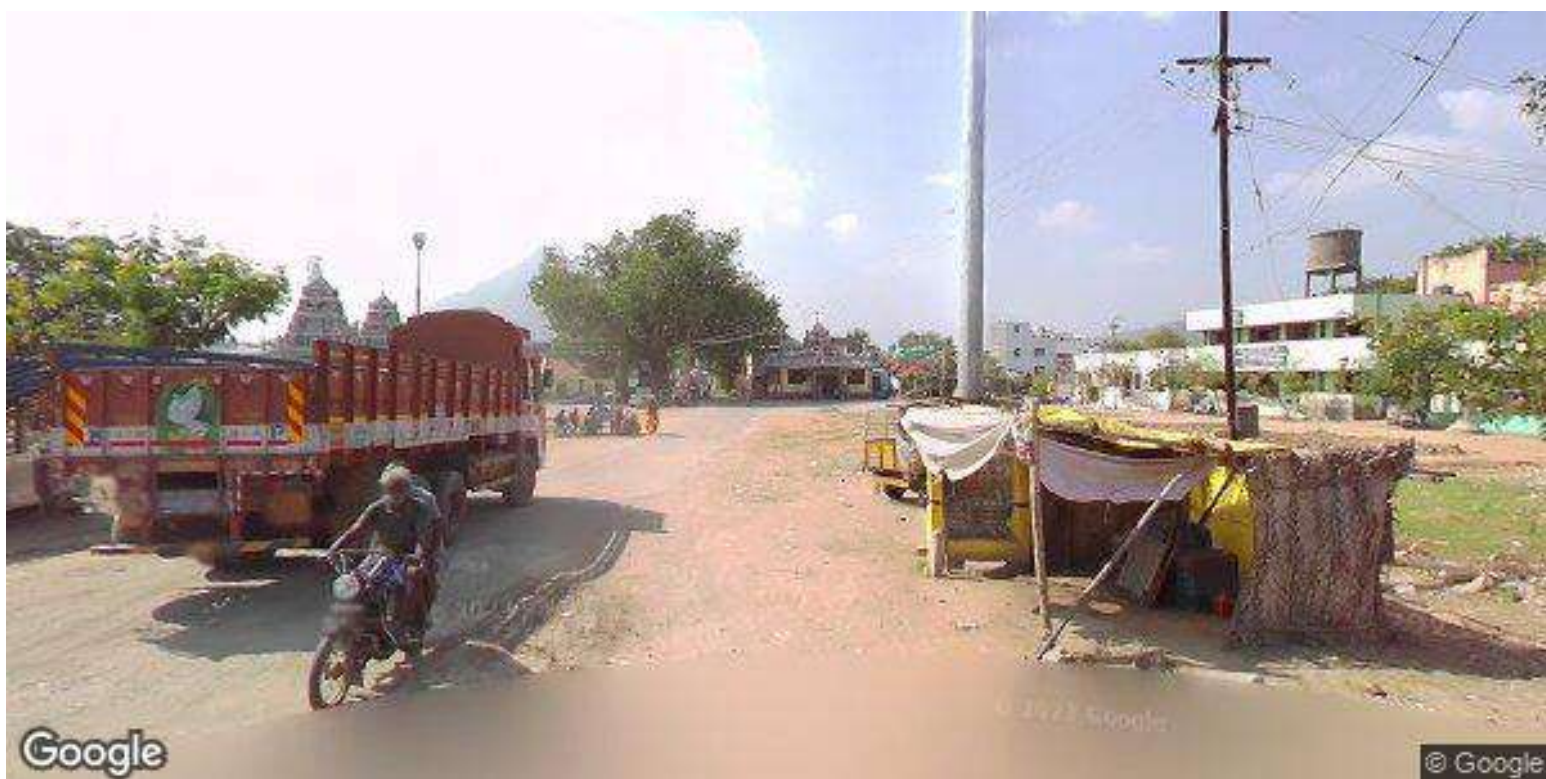
**Coordinates:** 11.62145, 78.10740

**Risk Type:** Blind Spot

**Risk Level:** Blind Spot

**Speed Limit:** 10 KM/Hr

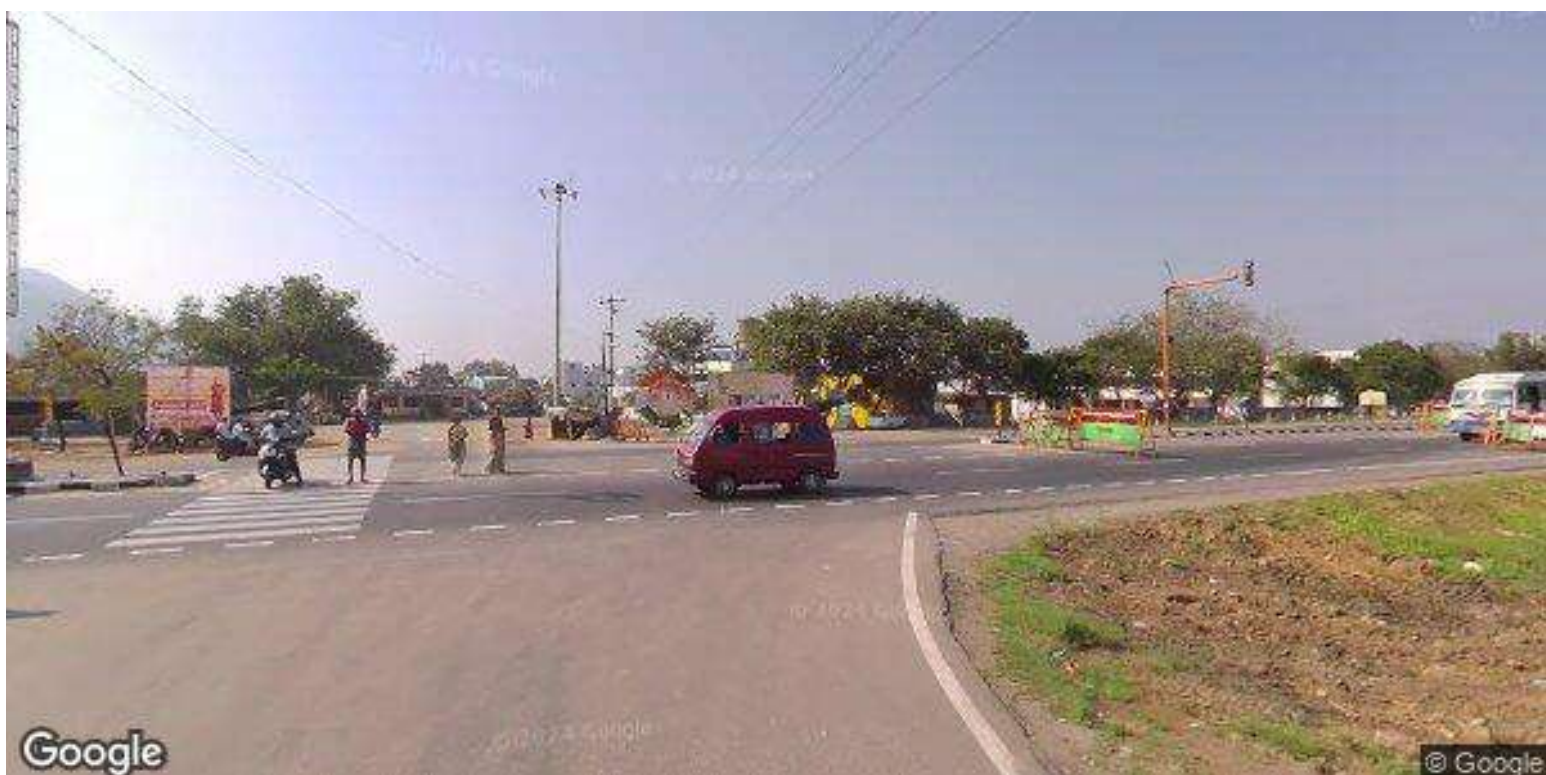
**Risk Type:** Turn  
**Risk Level:** High  
**Speed Limit:** 15 KM/Hr  
**Coordinates:** 11.62130, 78.10776

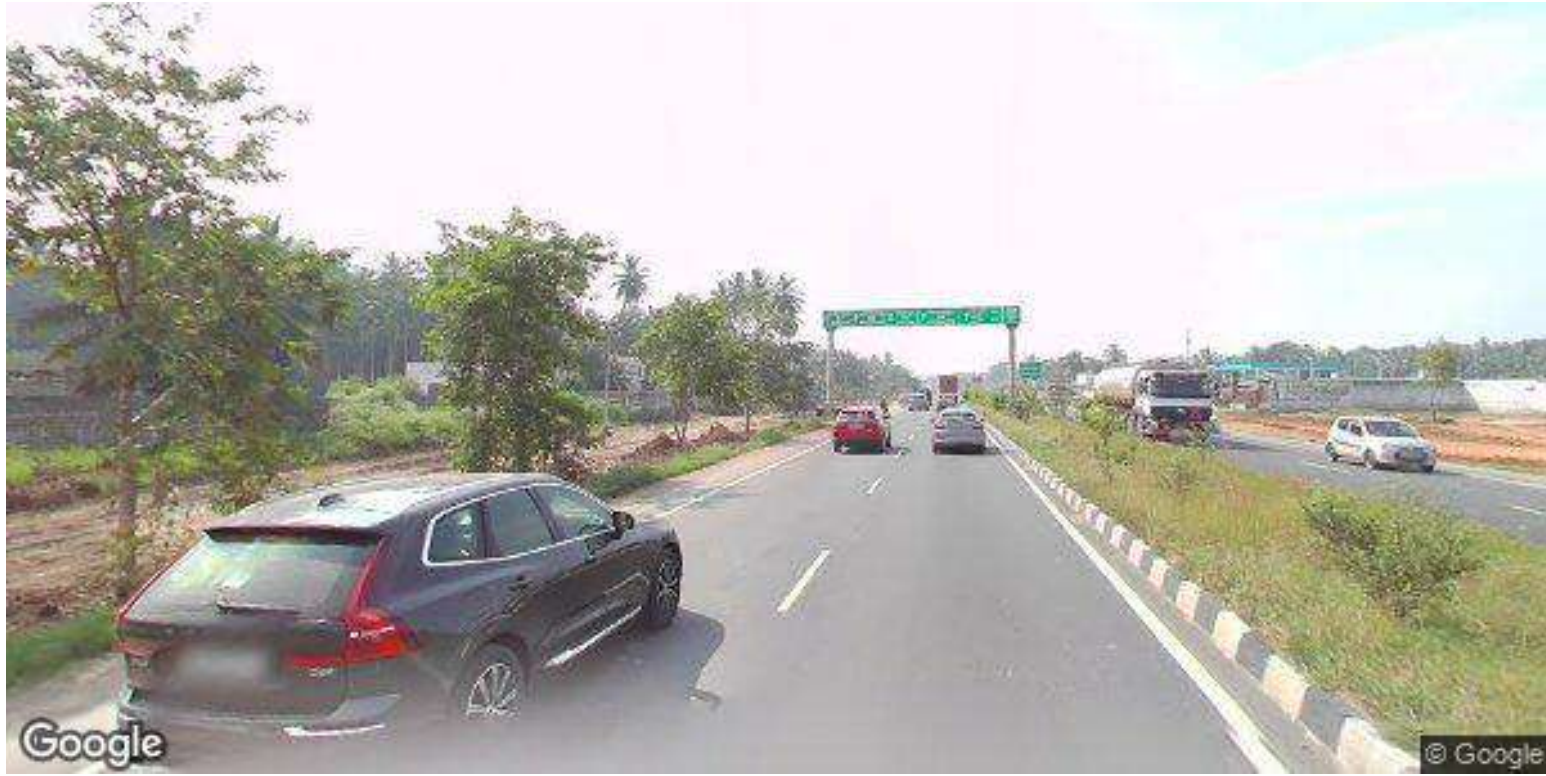
**Risk Type:** Turn  
**Risk Level:** Medium  
**Speed Limit:** 30 KM/Hr  
**Coordinates:** 11.61801, 78.10639
