## JOURNEY RISK MANAGEMENT (JRM) STUDY

### Salem Terminal TO HALLMARK AGENCY

#### Objective of the JRM Report

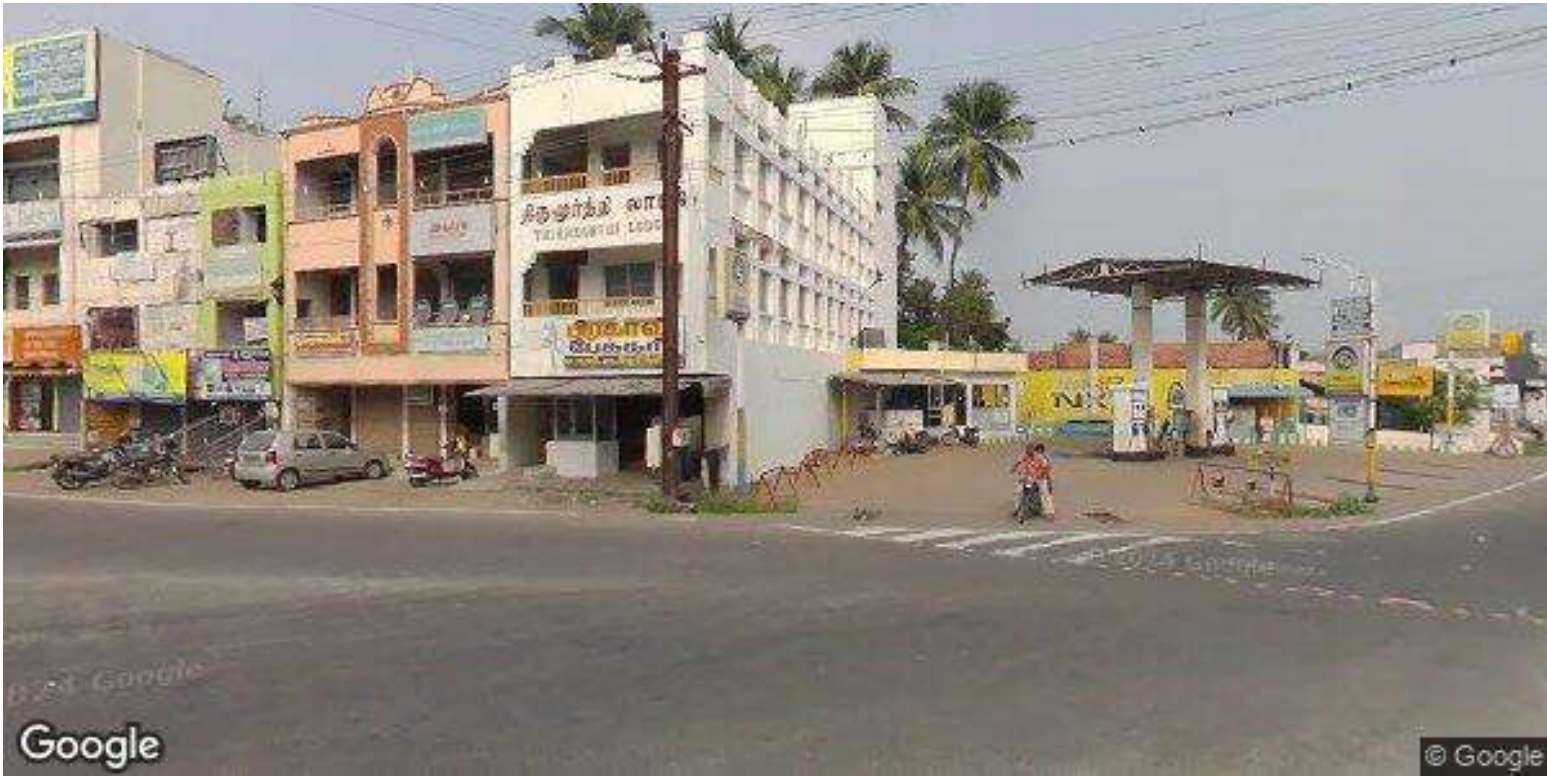
Coordinates: 11.00172, 77.56268

Risk Type: Roundabout

Risk Level: High

Speed Limit: 15 KM/Hr

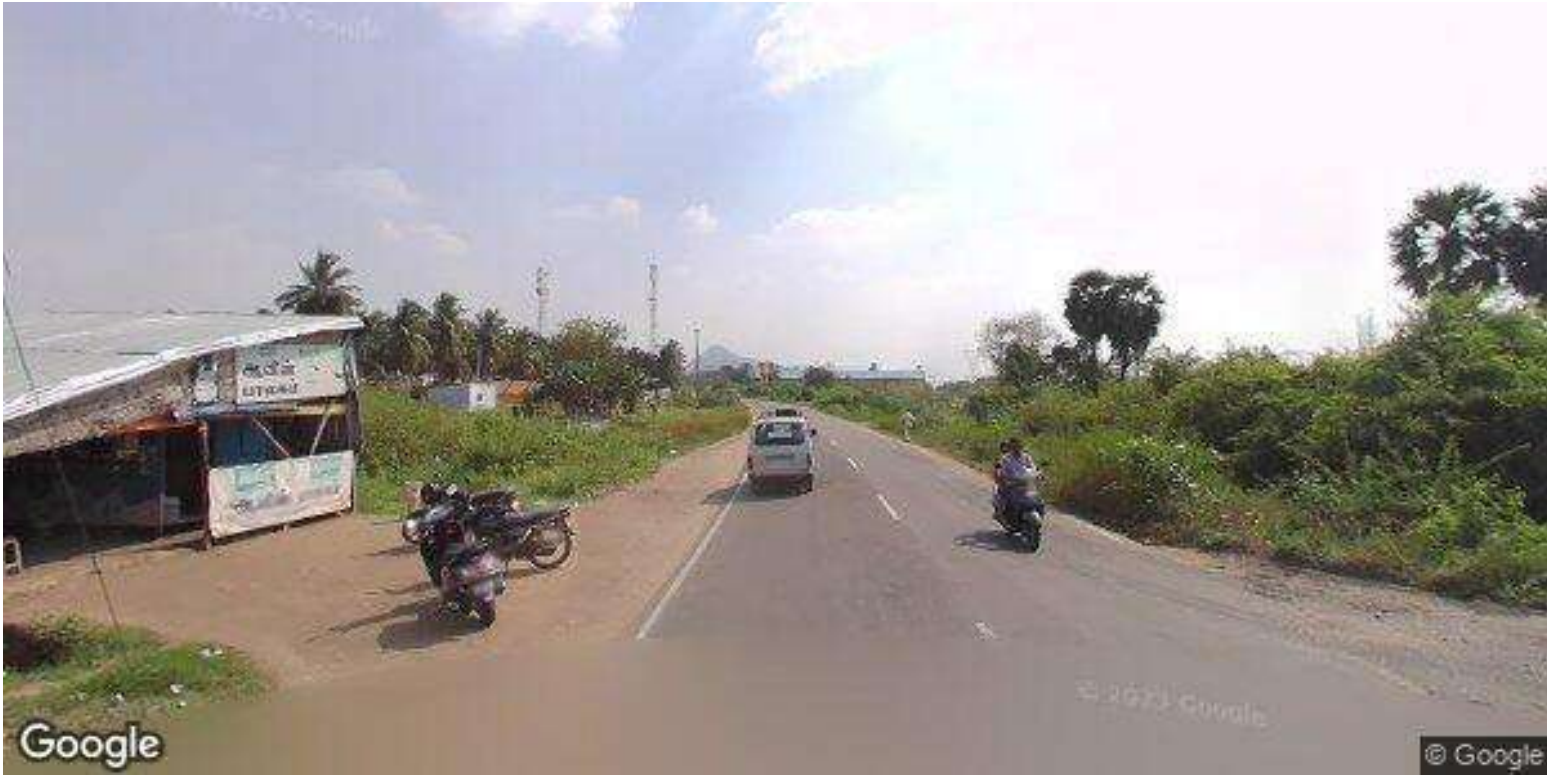
Coordinates: 11.44022, 77.87546

Risk Type: Turn

Risk Level: High

Speed Limit: 15 KM/Hr

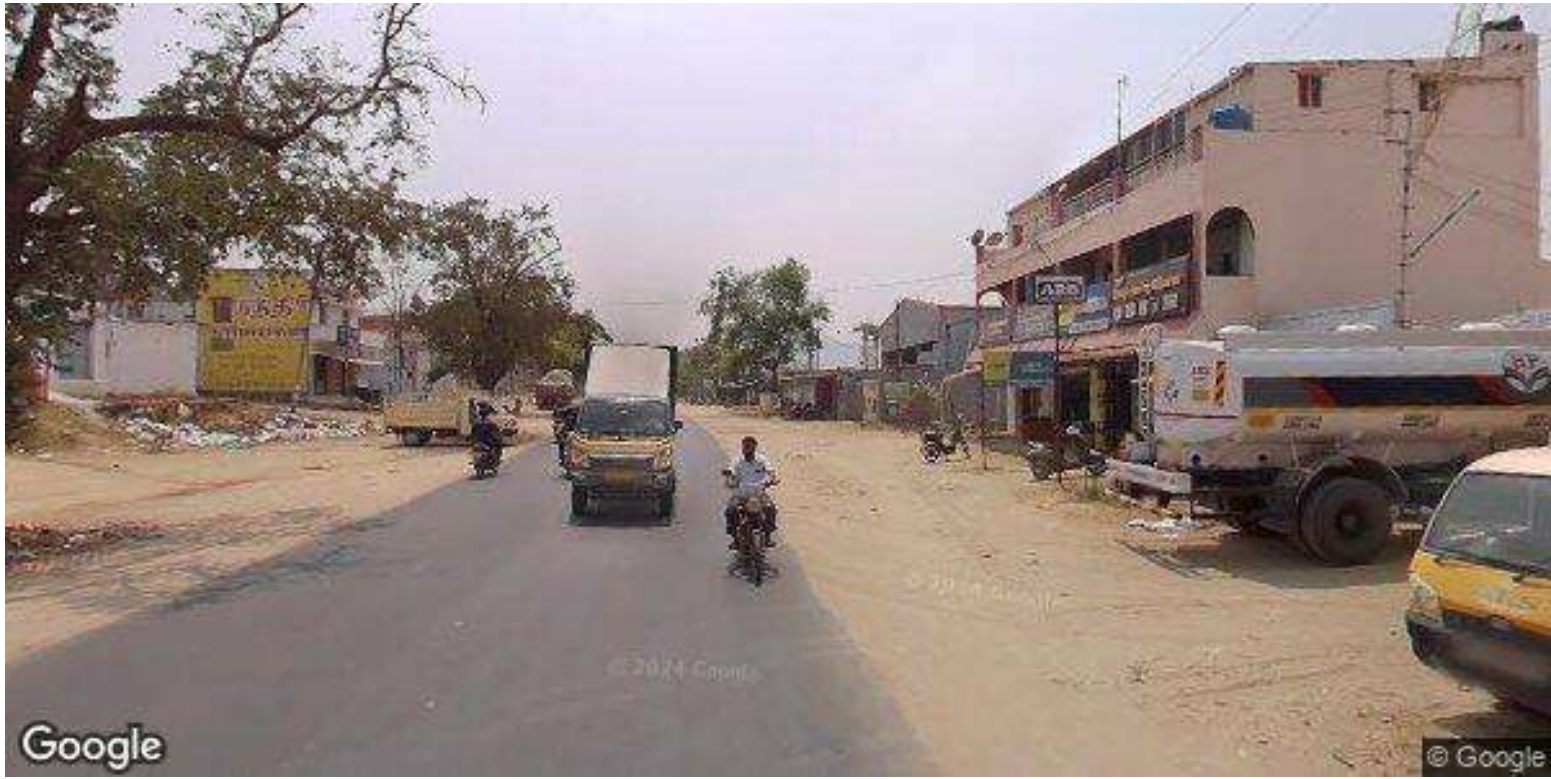
**Risk Type:** Turn  
**Risk Level:** Medium  
**Speed Limit:** 30 KM/Hr  
**Coordinates:** 11.39976, 77.88382

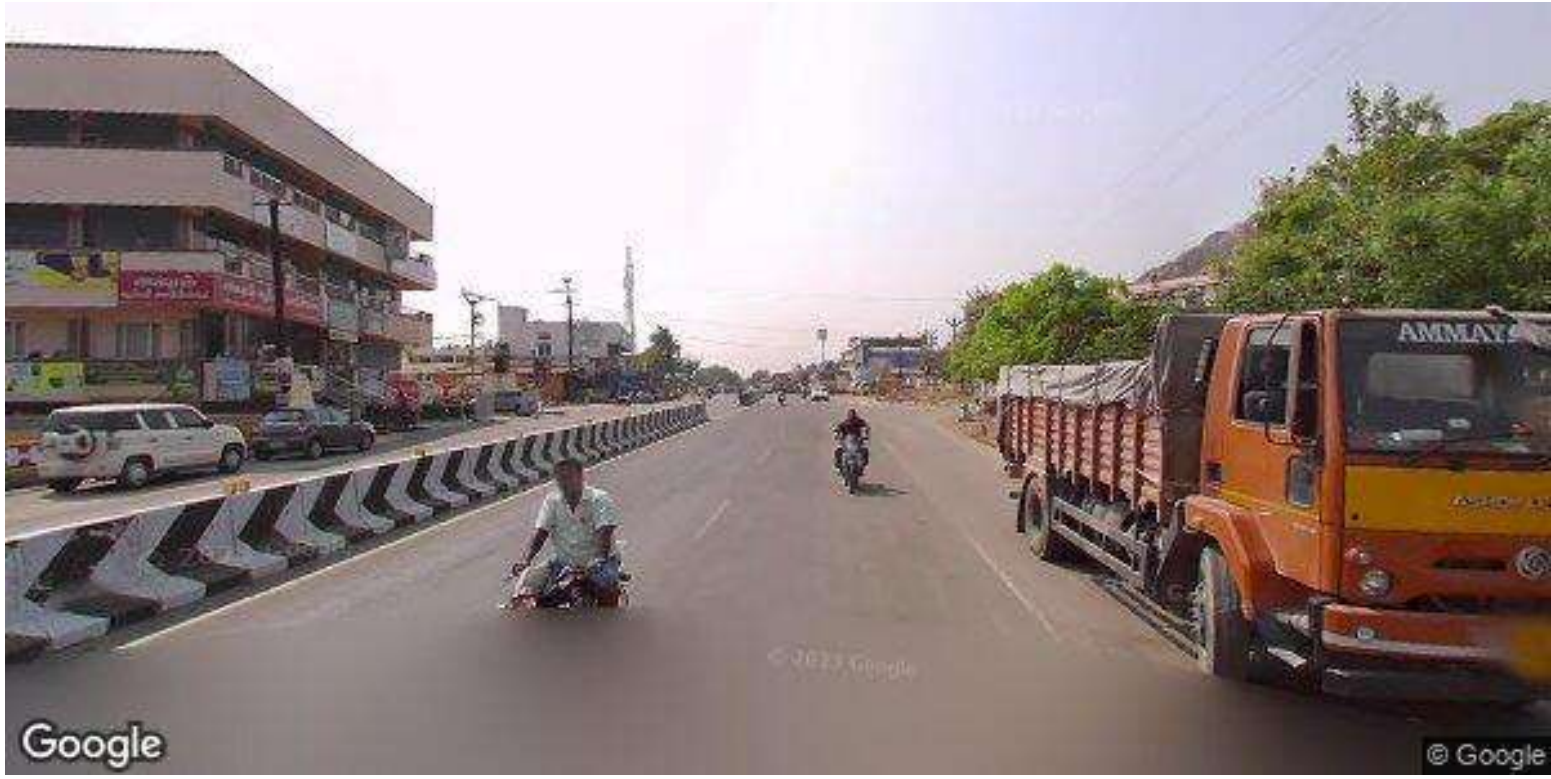
**Risk Type:** Turn  
**Risk Level:** Medium  
**Speed Limit:** 30 KM/Hr  
**Coordinates:** 11.39690, 77.88852

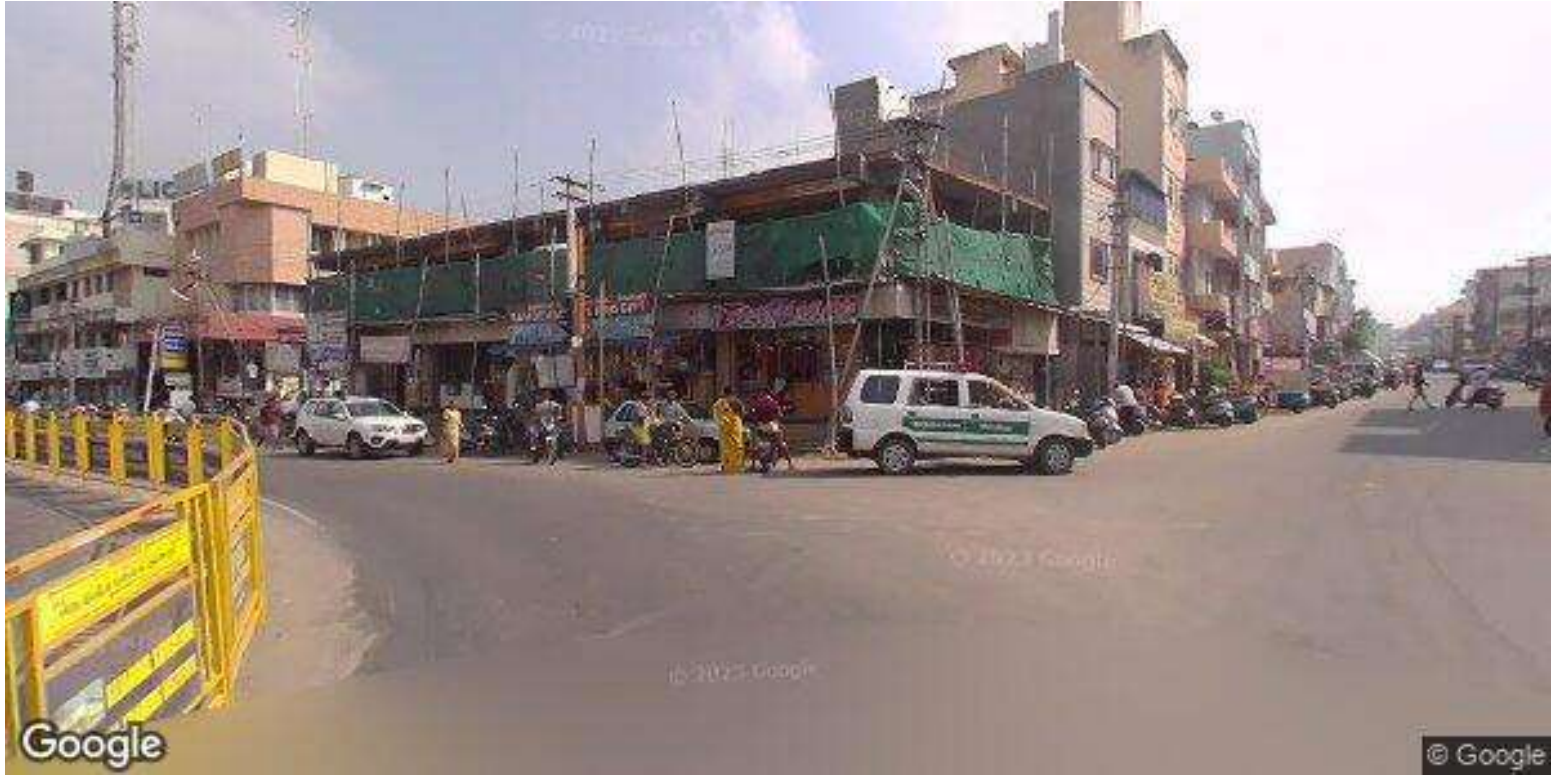
**Risk Type:** Turn  
**Risk Level:** High  
**Speed Limit:** 15 KM/Hr  
**Coordinates:** 11.37868, 77.89498

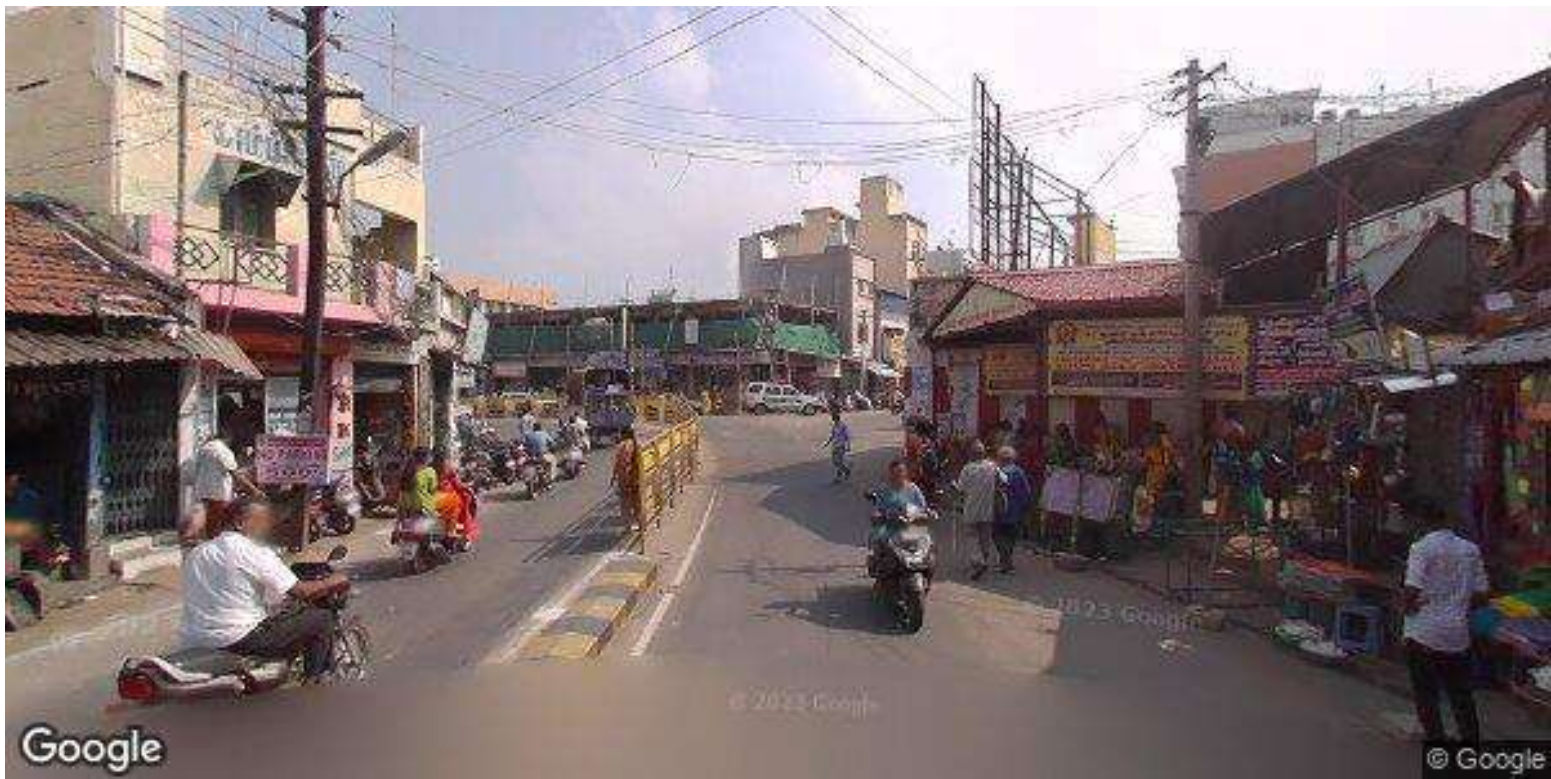
**Risk Type:** Turn  
**Risk Level:** Medium  
**Speed Limit:** 30 KM/Hr  
**Coordinates:** 11.37857, 77.89473

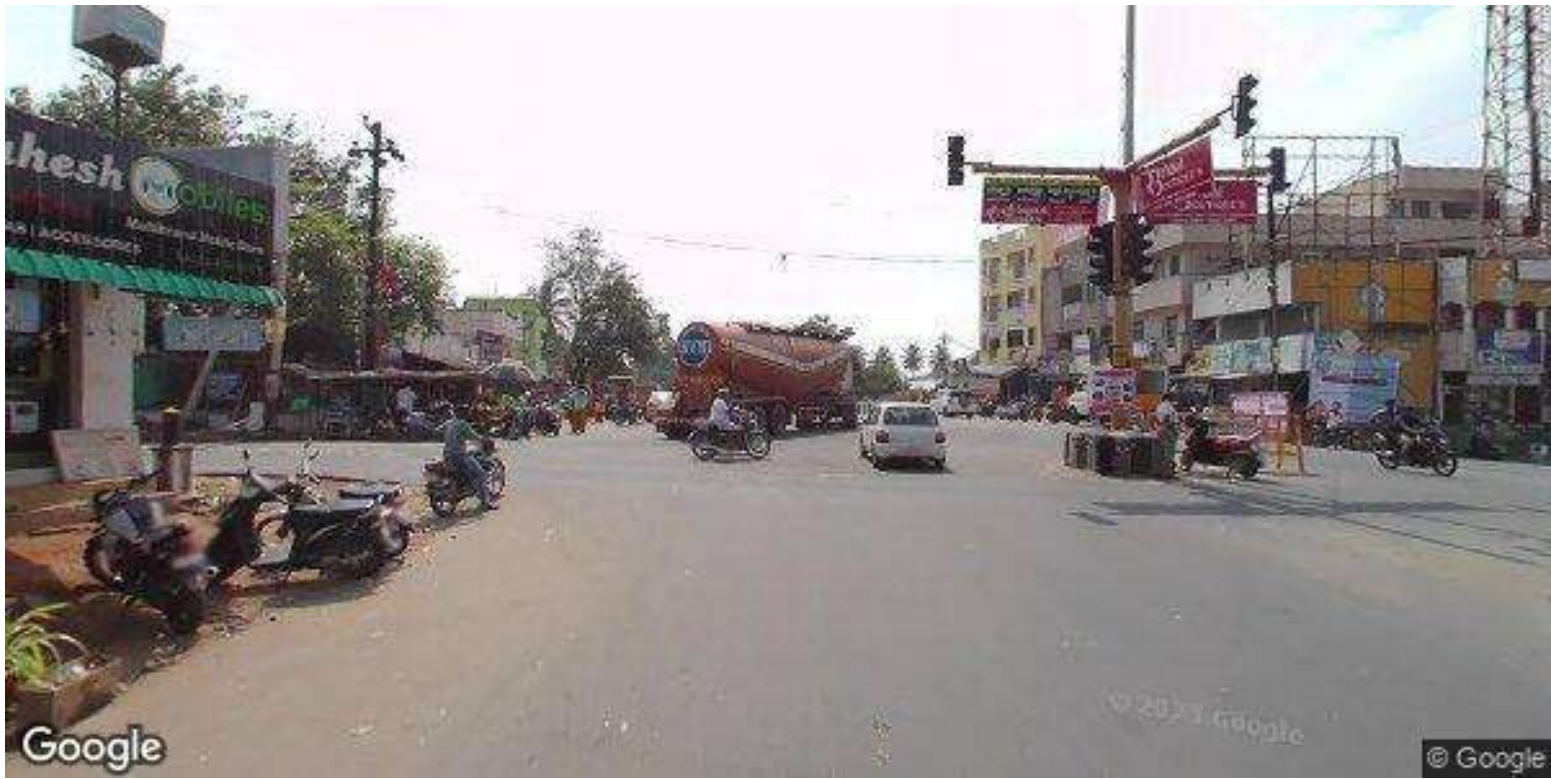
**Risk Type:** Turn  
**Risk Level:** High  
**Speed Limit:** 15 KM/Hr  
**Coordinates:** 11.36616, 77.88885

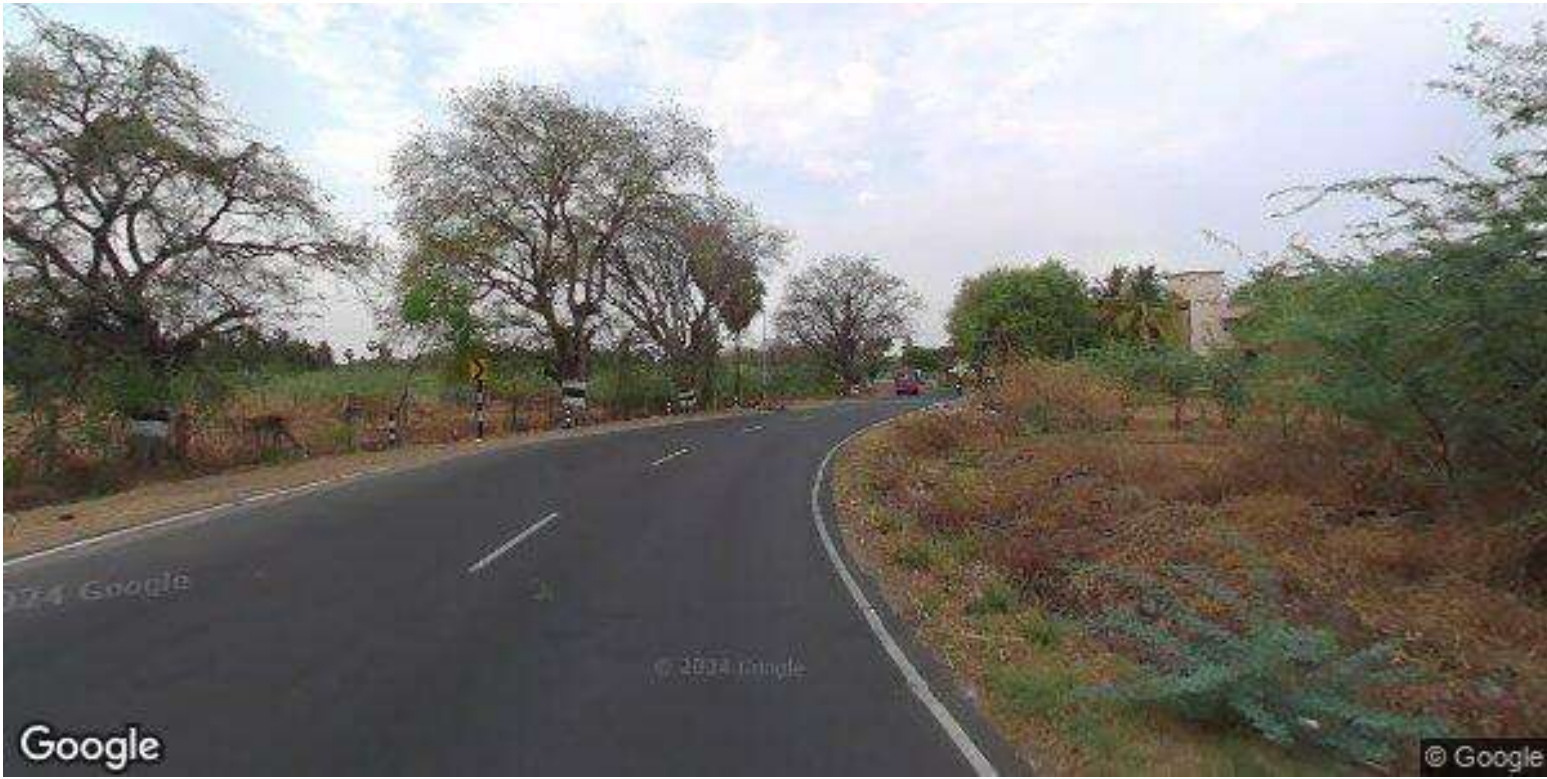
**Risk Type:** Turn  
**Risk Level:** Medium  
**Speed Limit:** 30 KM/Hr  
**Coordinates:** 11.34067, 77.86347

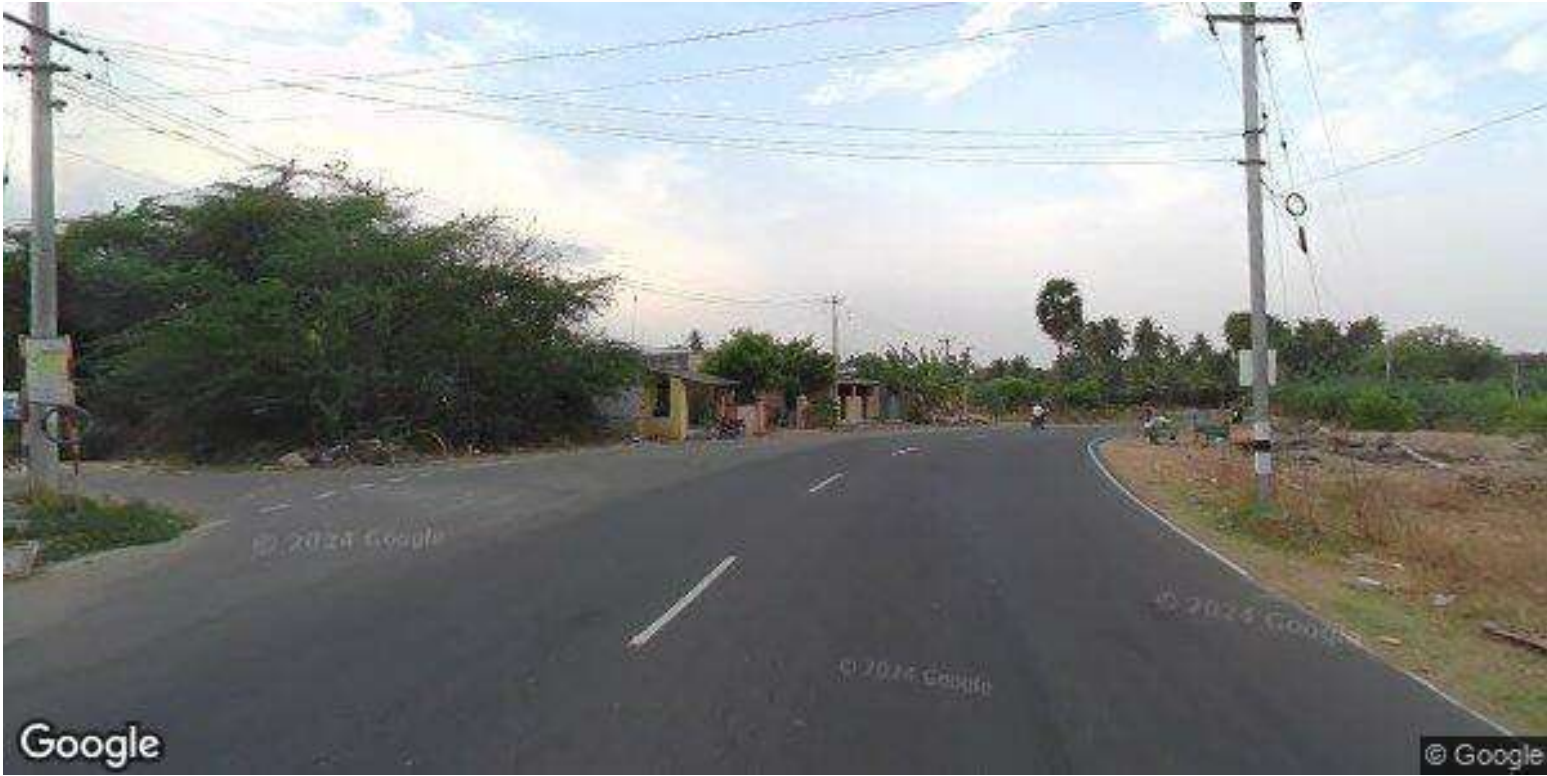
**Risk Type:** Turn  
**Risk Level:** Medium  
**Speed Limit:** 30 KM/Hr  
**Coordinates:** 11.33854, 77.86216

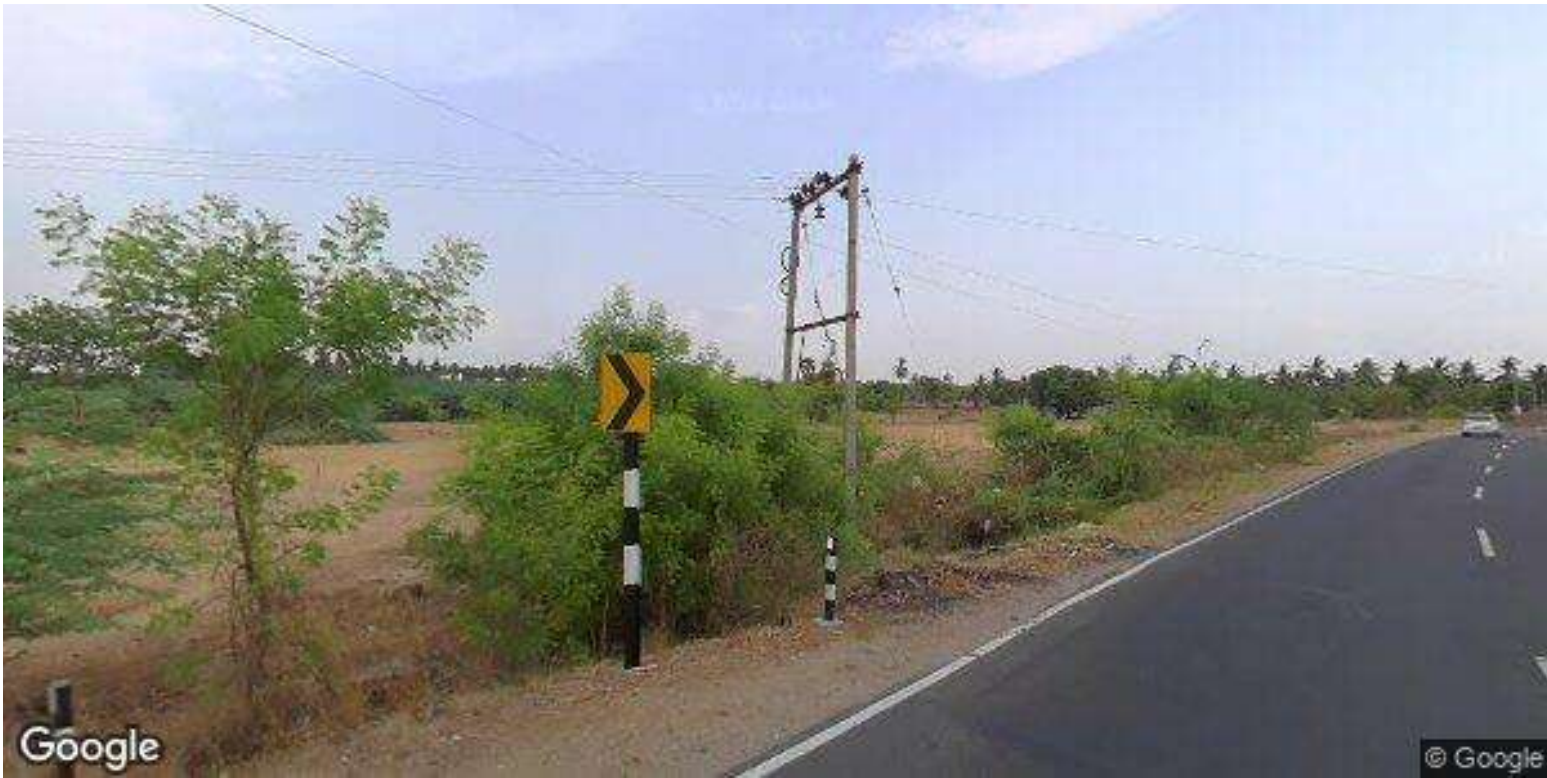
**Risk Type:** Turn  
**Risk Level:** Medium  
**Speed Limit:** 30 KM/Hr  
**Coordinates:** 11.33778, 77.86236

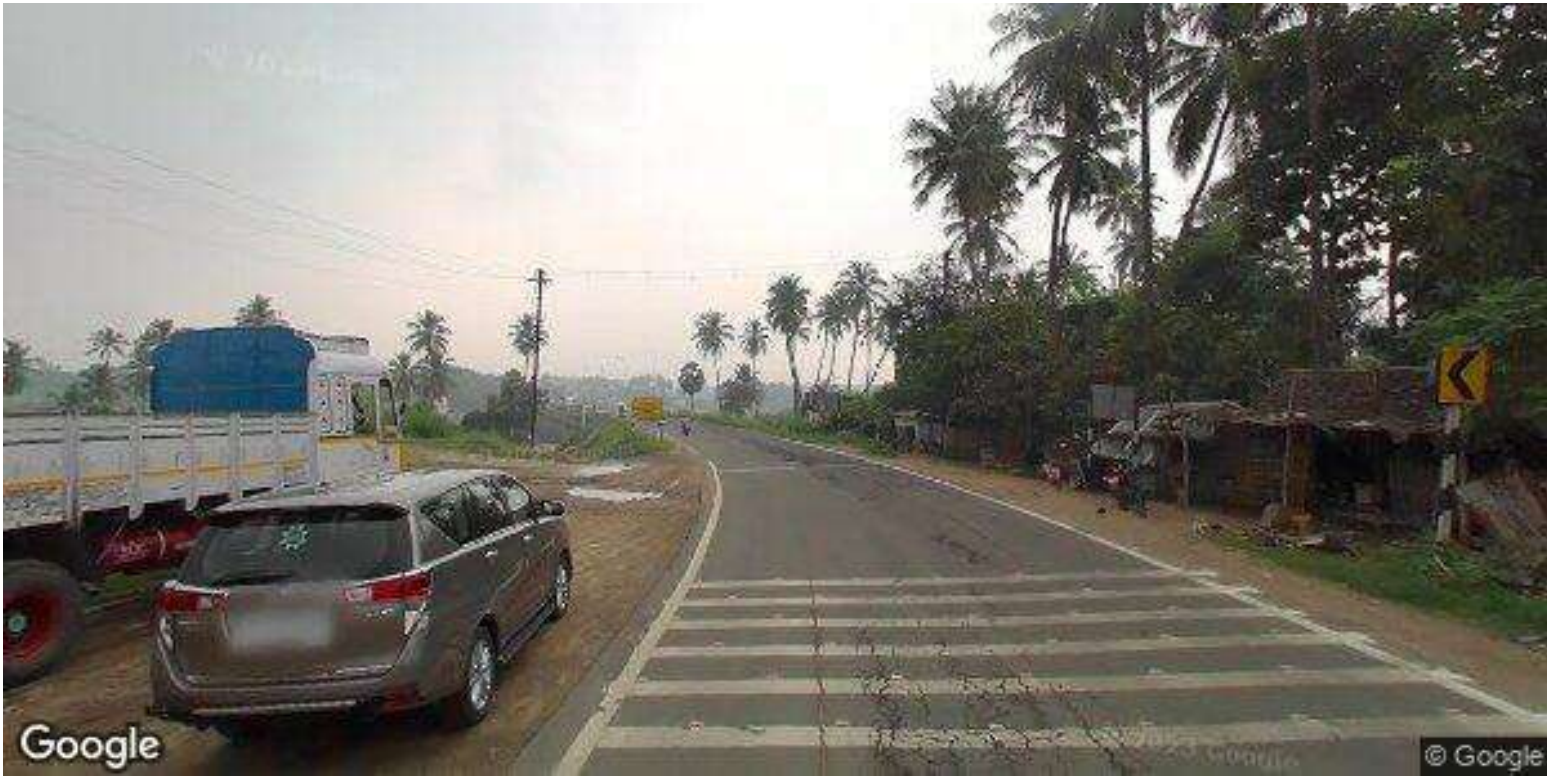
**Risk Type:** Turn  
**Risk Level:** Medium  
**Speed Limit:** 30 KM/Hr  
**Coordinates:** 11.30952, 77.77587

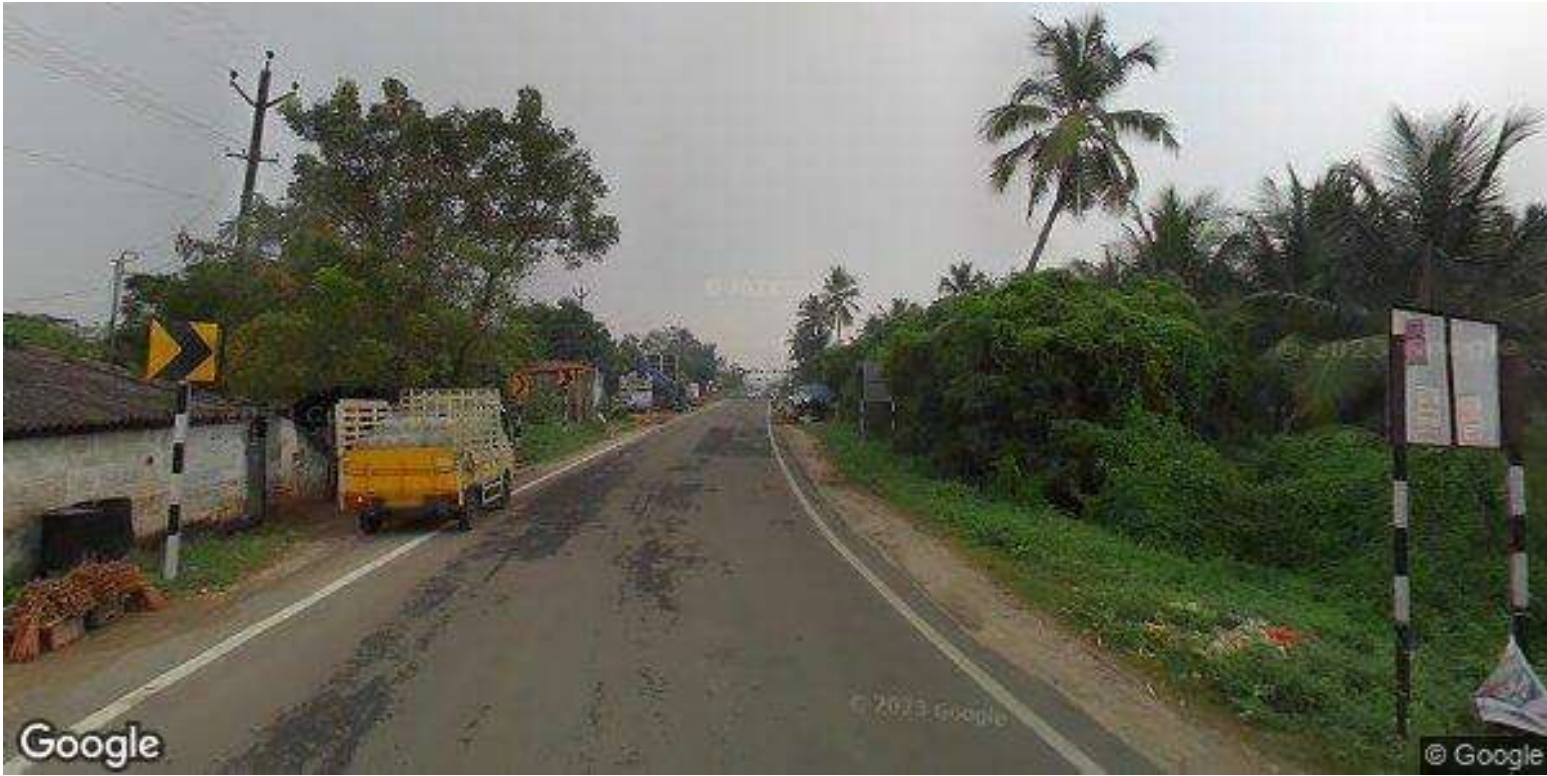
**Risk Type:** Turn  
**Risk Level:** Medium  
**Speed Limit:** 30 KM/Hr  
**Coordinates:** 11.30973, 77.76712

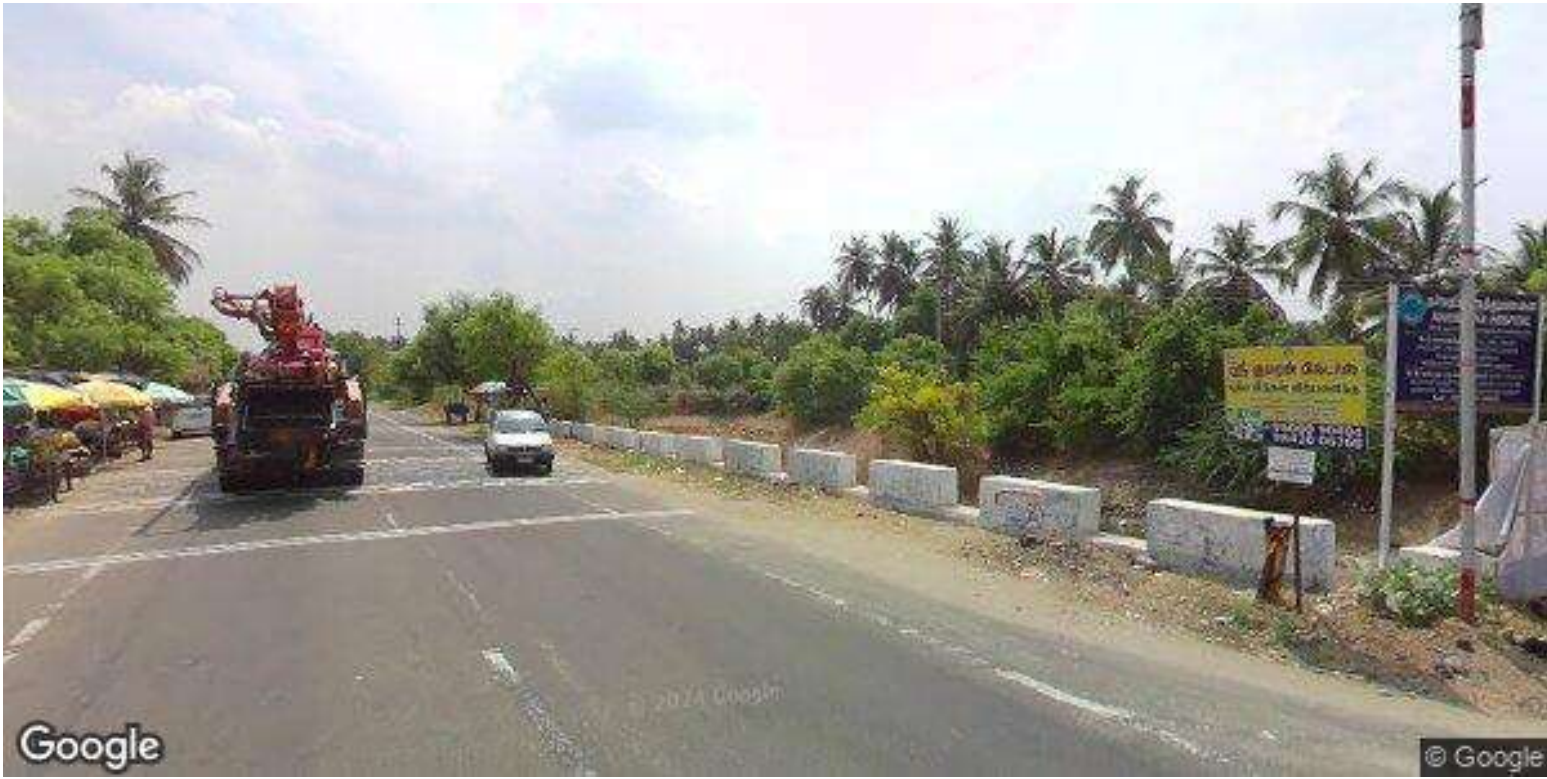
**Risk Type:** Turn  
**Risk Level:** High  
**Speed Limit:** 15 KM/Hr  
**Coordinates:** 11.29490, 77.74685

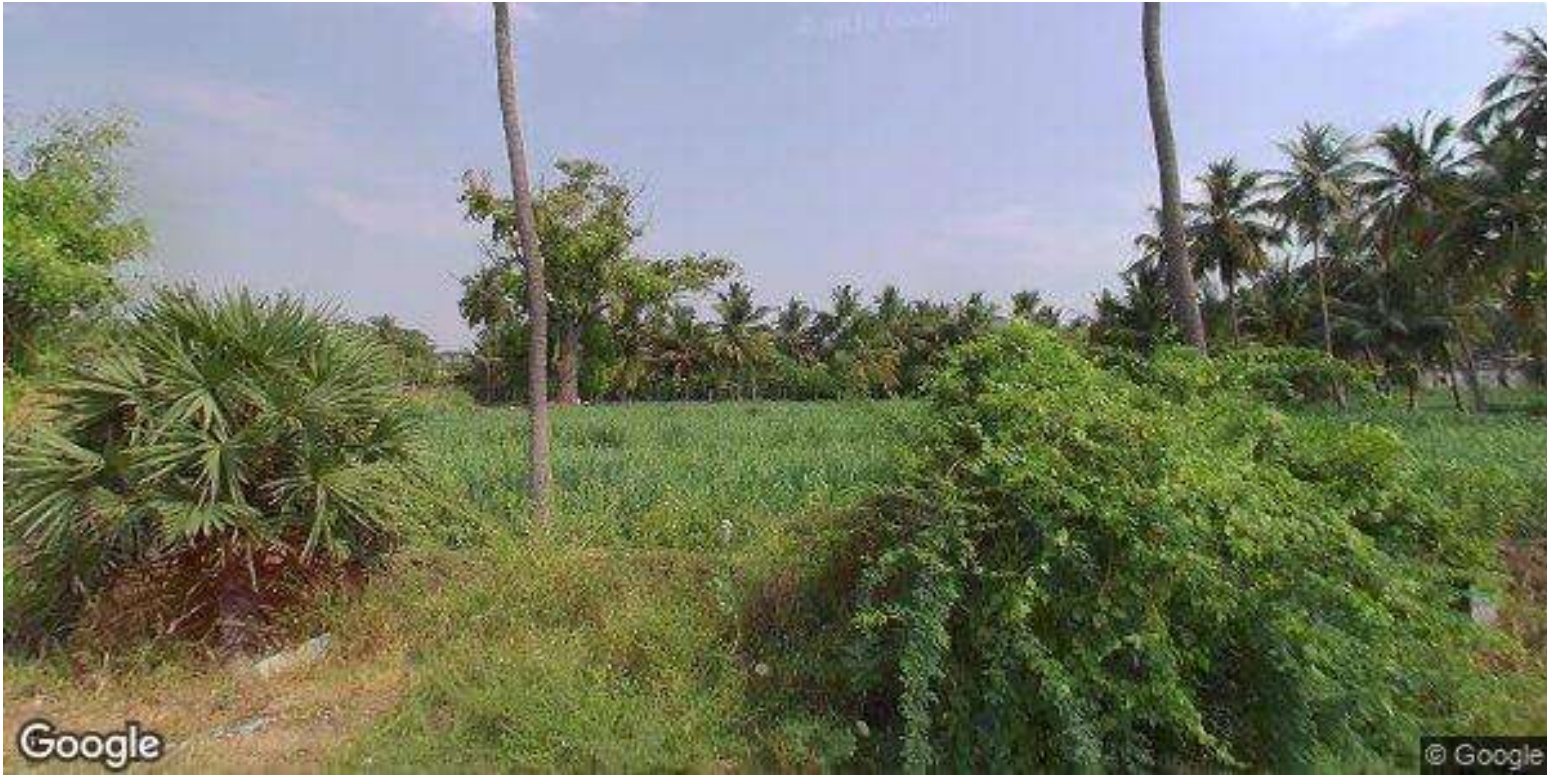
**Risk Type:** Turn  
**Risk Level:** High  
**Speed Limit:** 15 KM/Hr  
**Coordinates:** 11.29125, 77.74646

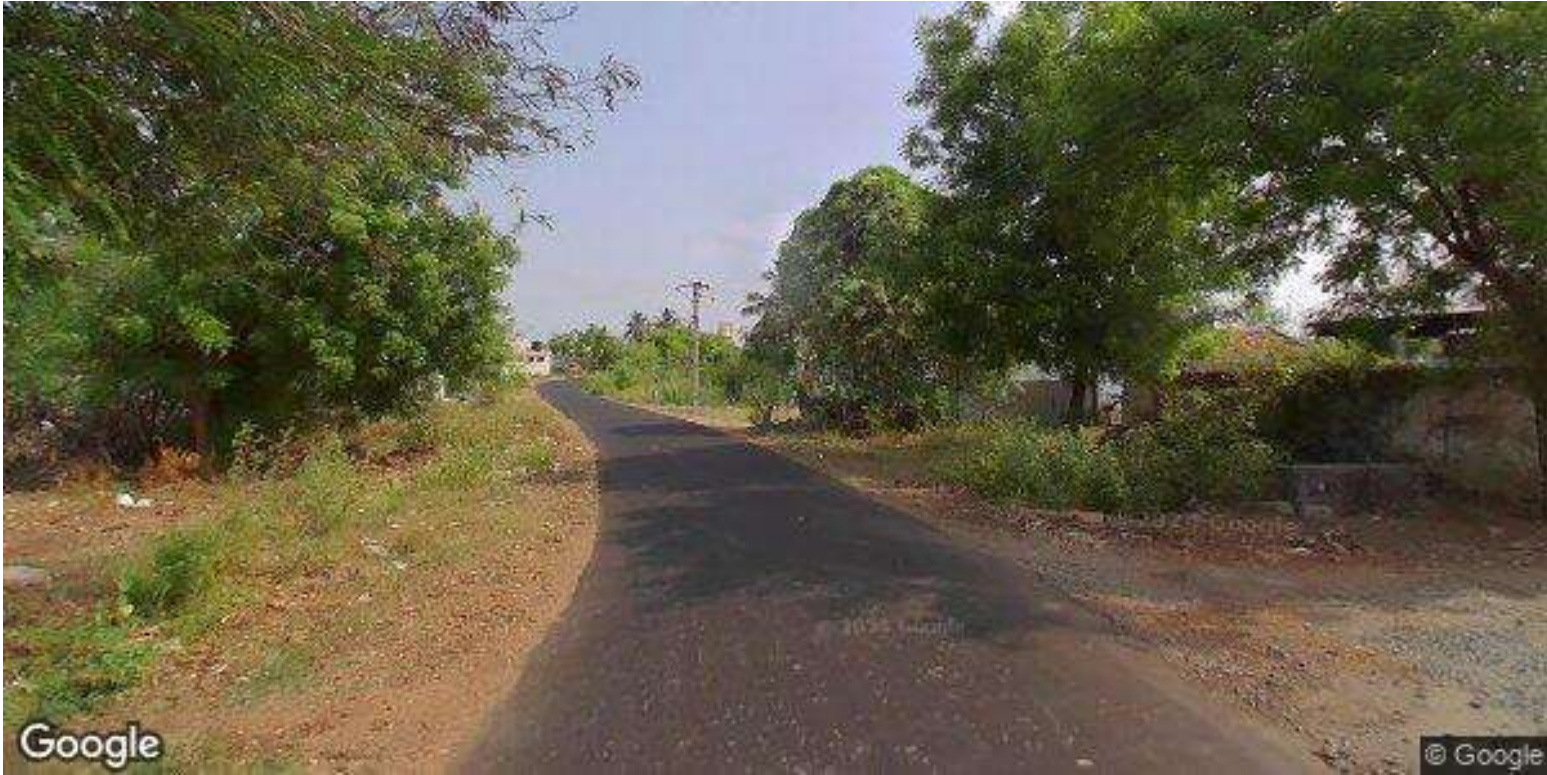
**Coordinates: 11.28844, 77.74319**

**Risk Type: Turn**

**Risk Level: Medium**

**Speed Limit: 30 KM/Hr**

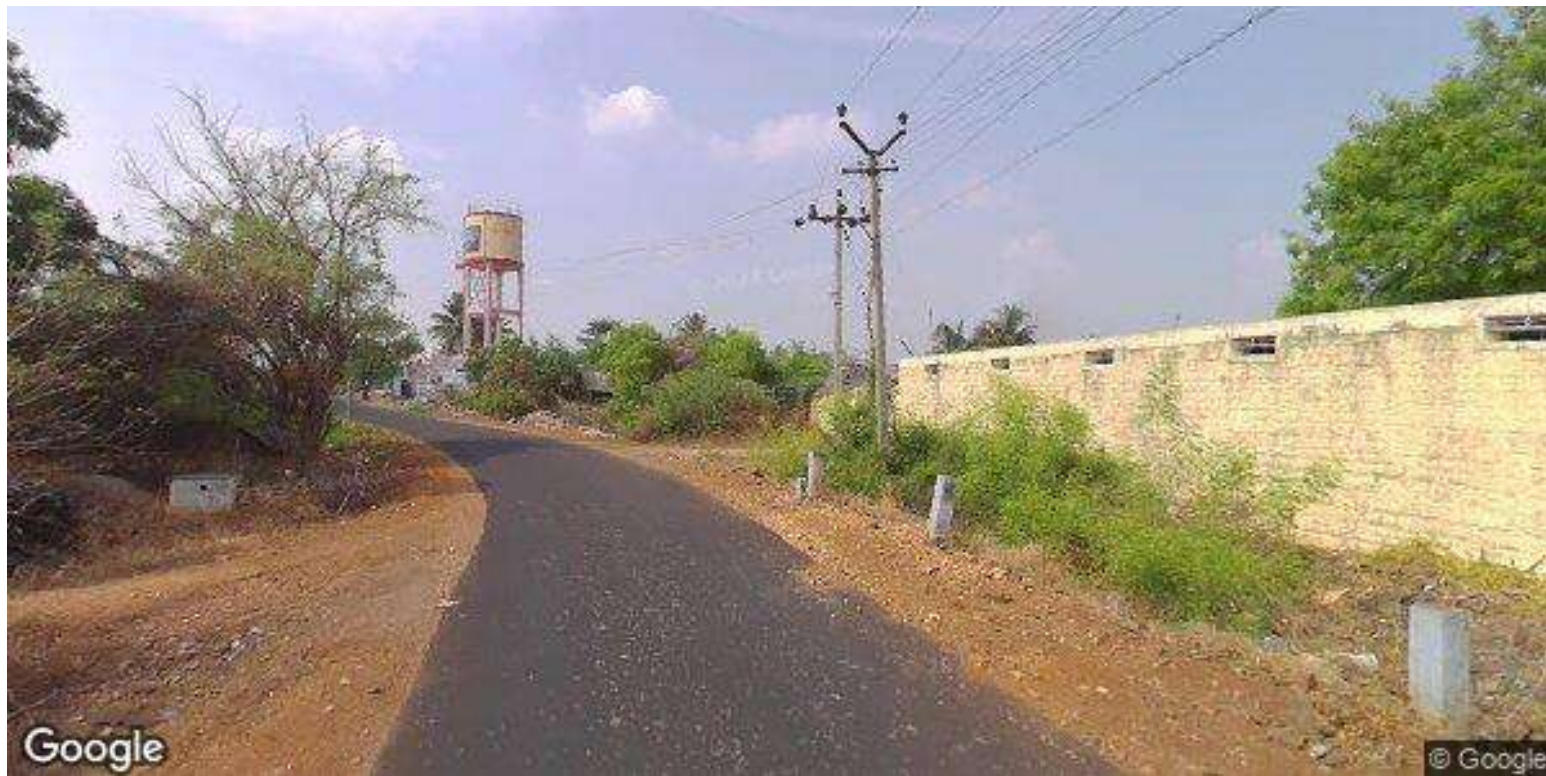
**Coordinates: 11.28573, 77.74281**

**Risk Type: Turn**

**Risk Level: Medium**

**Speed Limit: 30 KM/Hr**

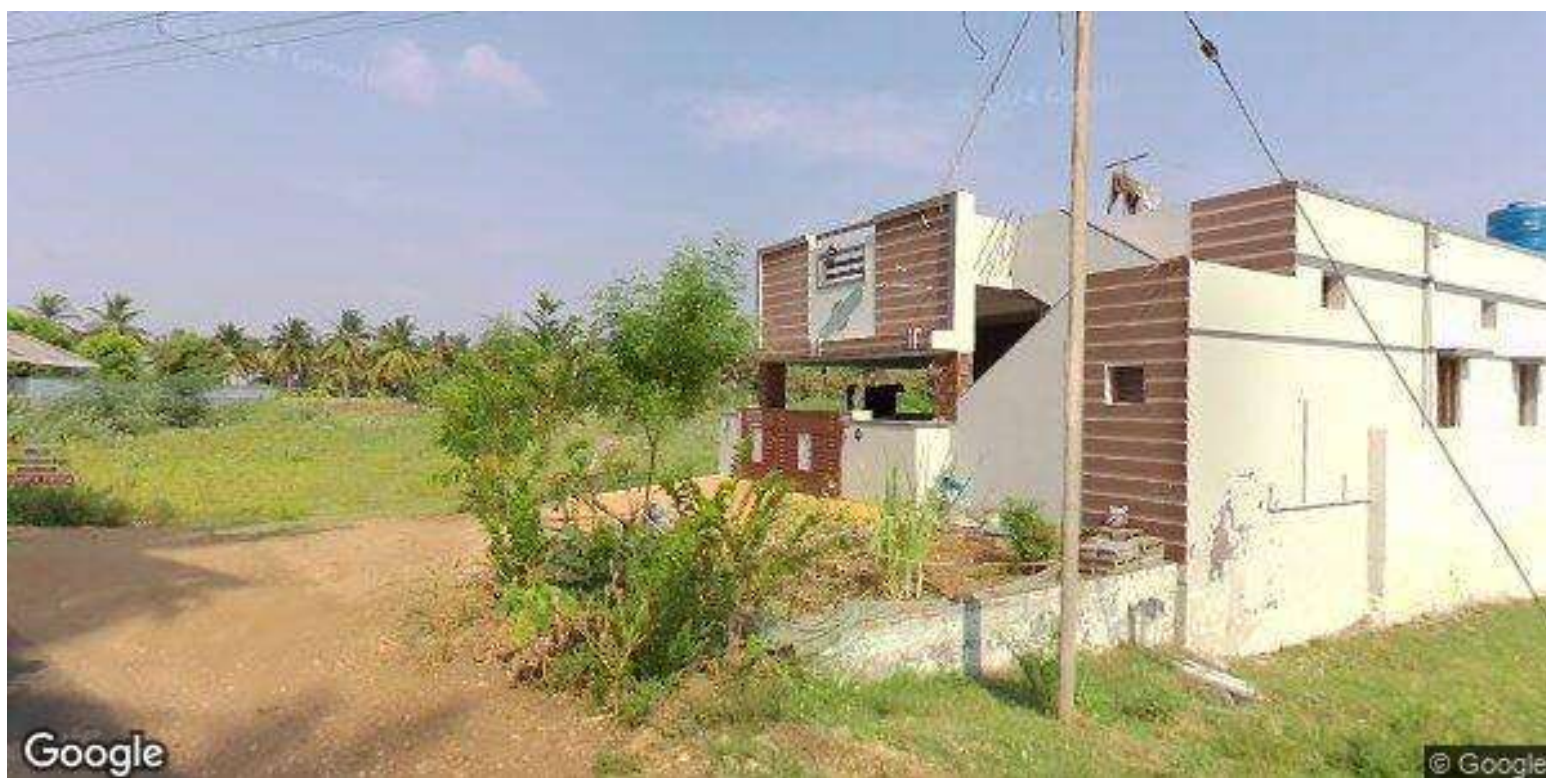
**Coordinates: 11.27319, 77.72981**

**Risk Type: Turn**

**Risk Level: High**

**Speed Limit: 15 KM/Hr**

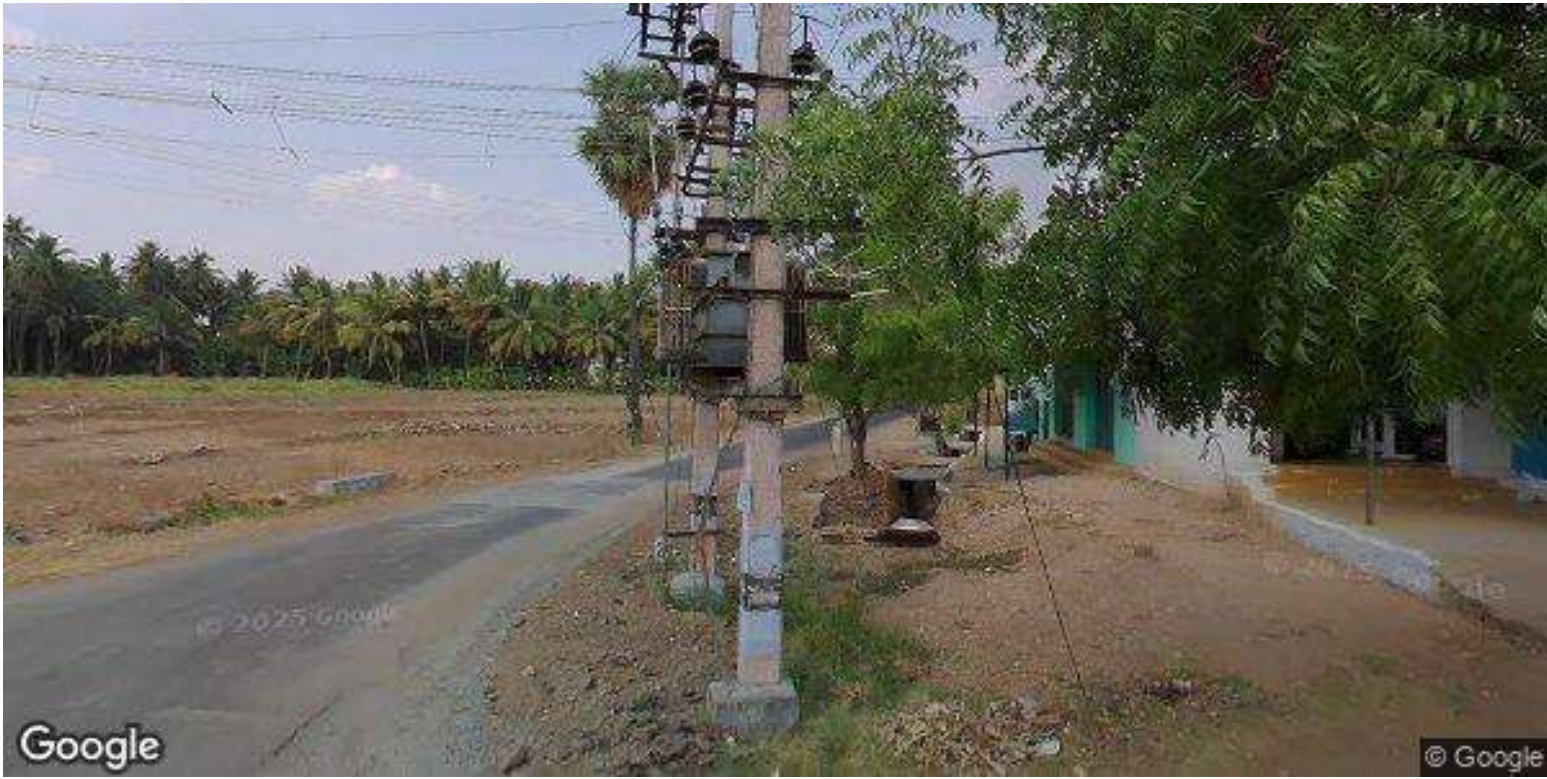
**Risk Type:** Blind Spot  
**Risk Level:** Blind Spot  
**Speed Limit:** 10 KM/Hr  
**Coordinates:** 11.27330, 77.72715
