## JOURNEY RISK MANAGEMENT (JRM) STUDY

### Salem Terminal TO HALLMARK AGENCY

#### Objective of the JRM Report

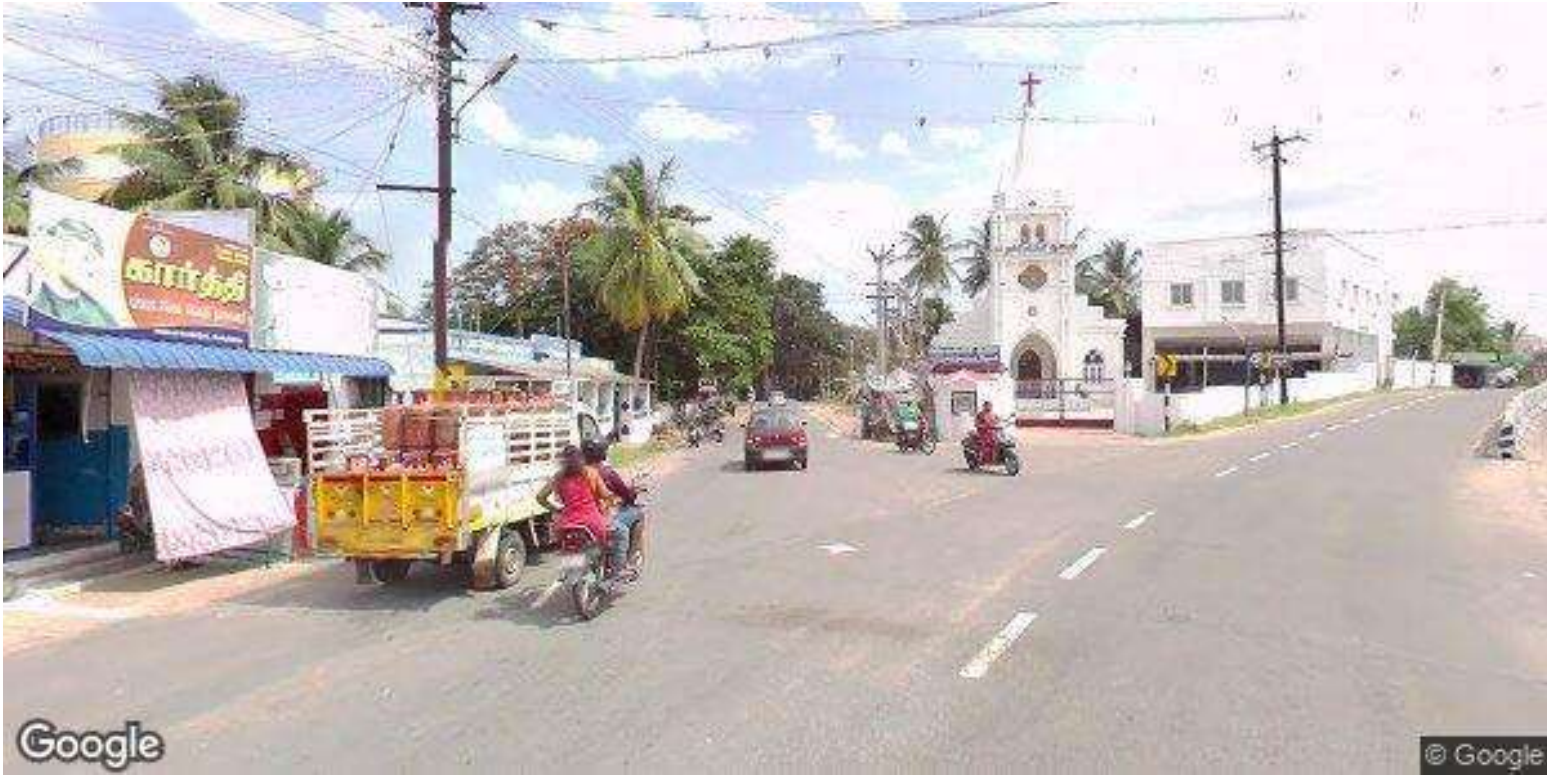
**Risk Type:** Turn  
**Risk Level:** Medium  
**Speed Limit:** 30 KM/Hr  
**Coordinates:** 11.23054, 77.71796

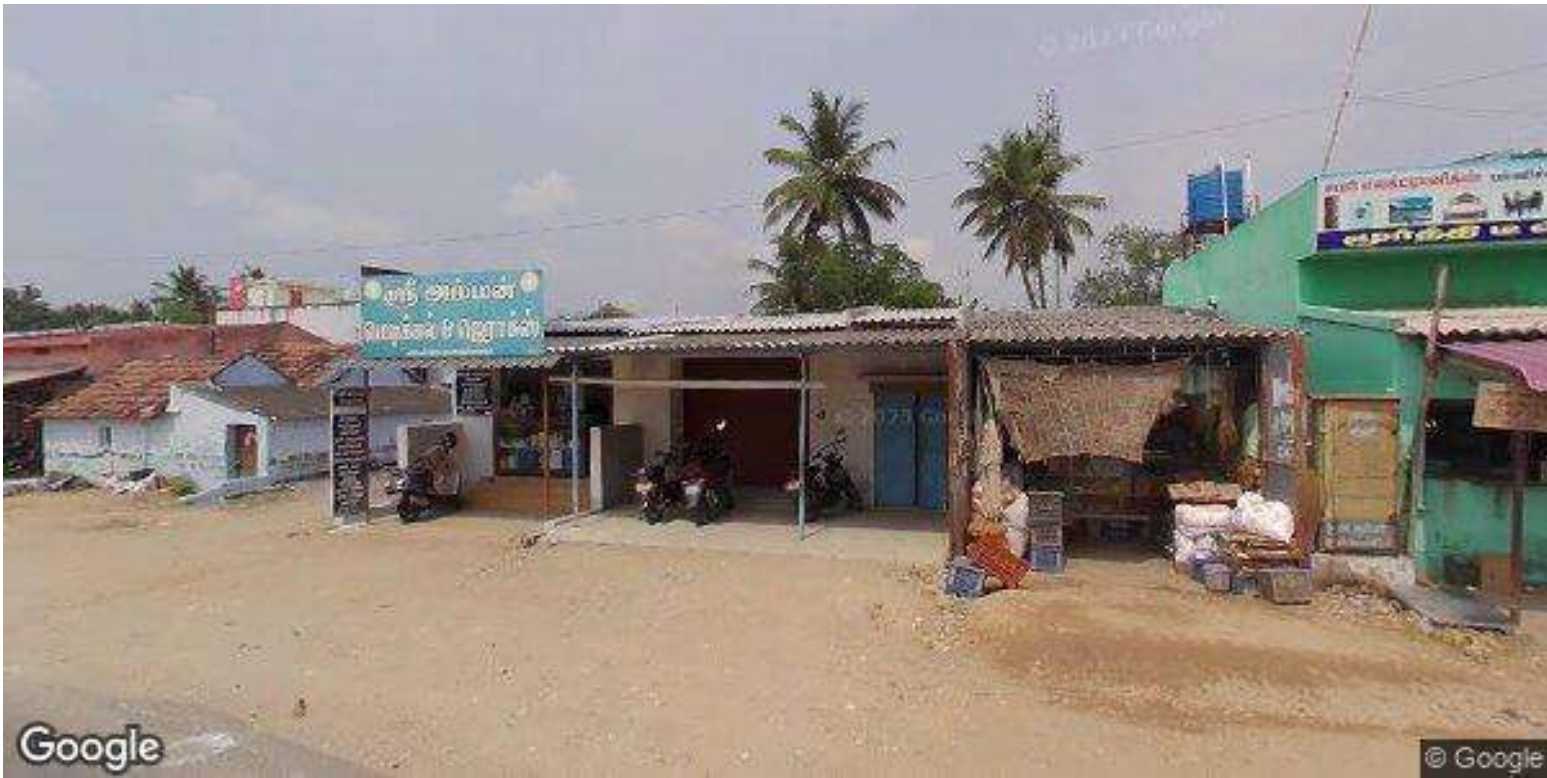
**Risk Type:** Turn  
**Risk Level:** Medium  
**Speed Limit:** 30 KM/Hr  
**Coordinates:** 11.20776, 77.70916

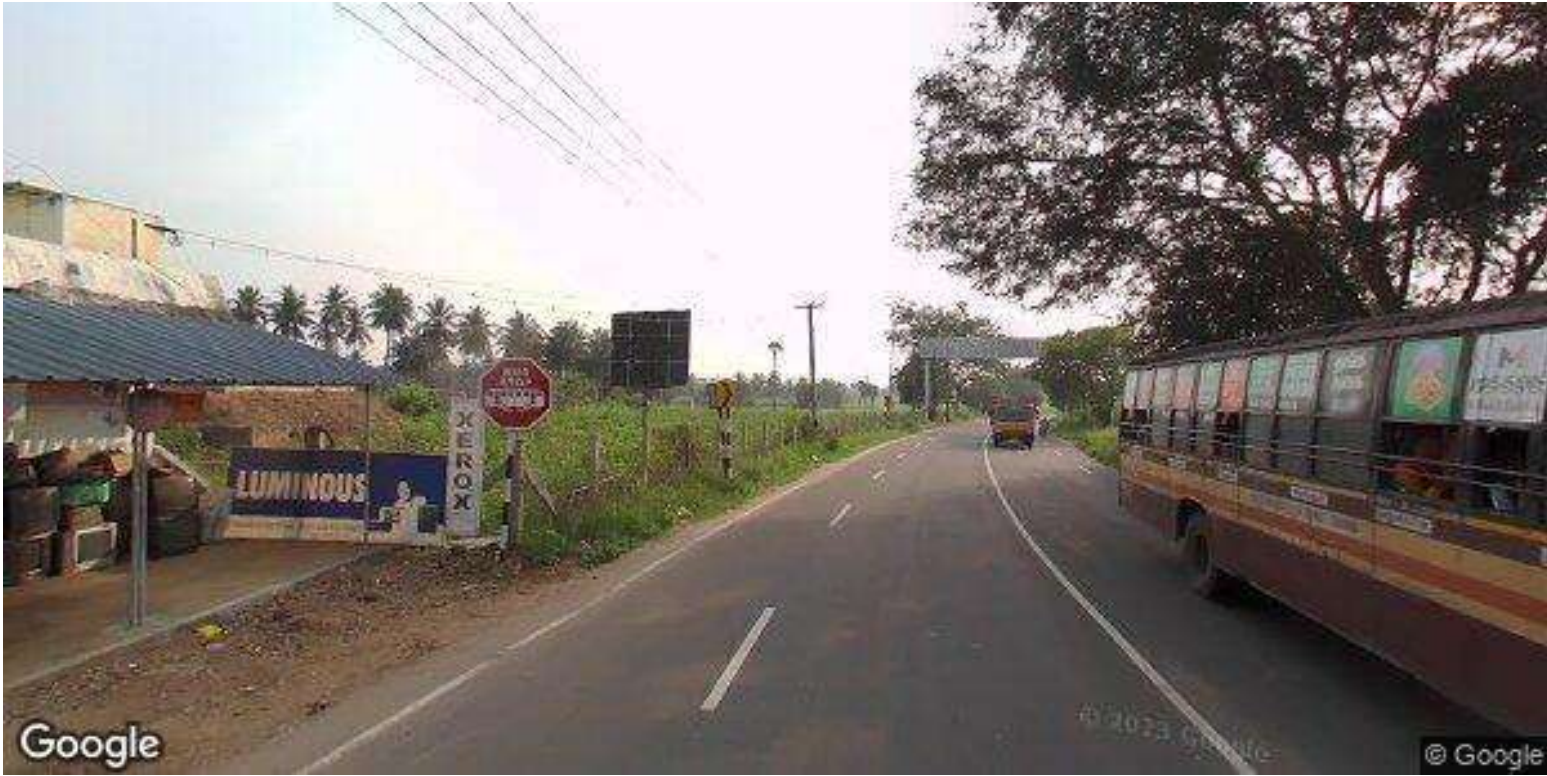
**Risk Type:** Turn  
**Risk Level:** Medium  
**Speed Limit:** 30 KM/Hr  
**Coordinates:** 11.12102, 77.67919

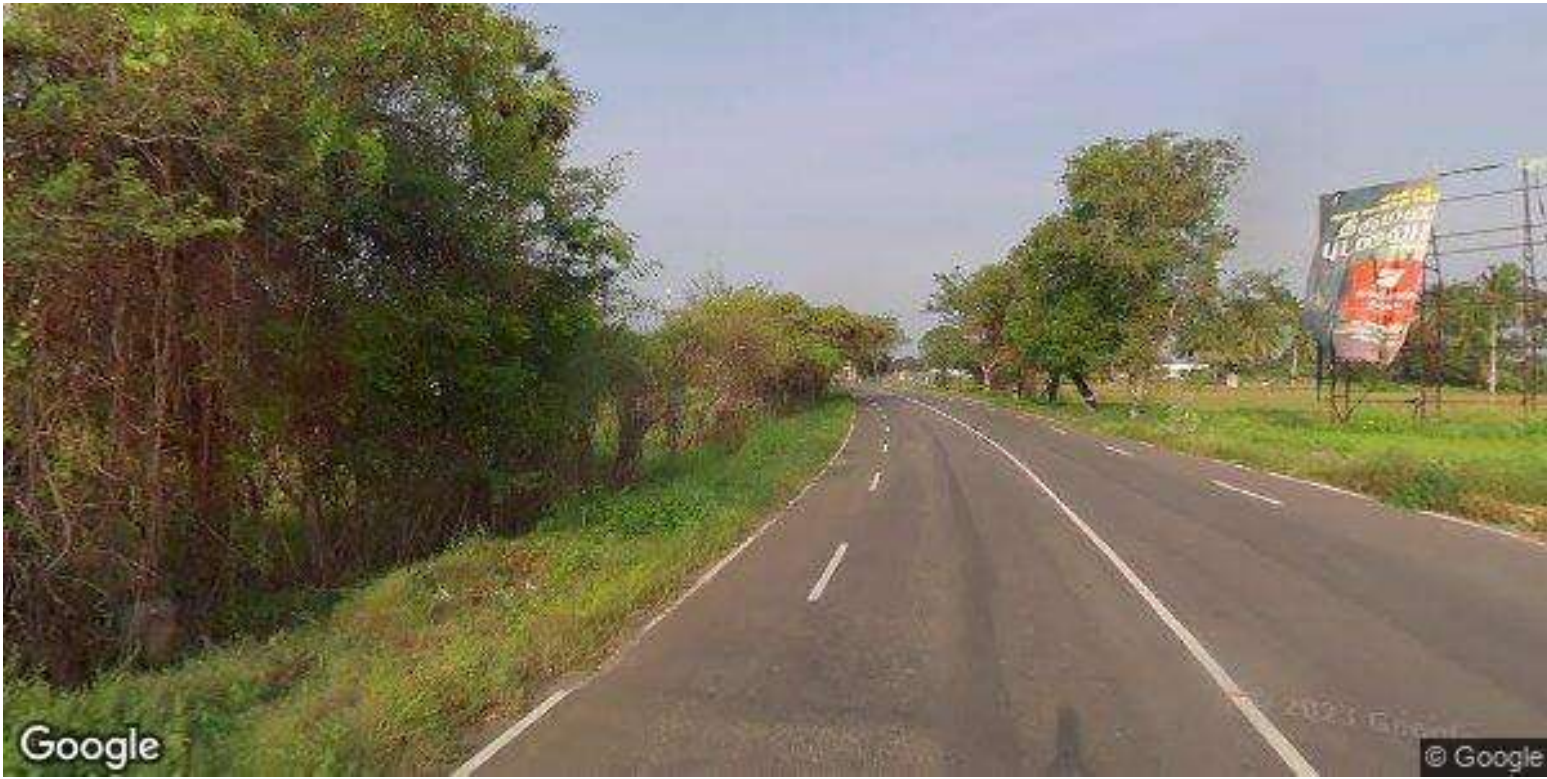
**Risk Type:** Turn  
**Risk Level:** Medium  
**Speed Limit:** 30 KM/Hr  
**Coordinates:** 11.11932, 77.67786

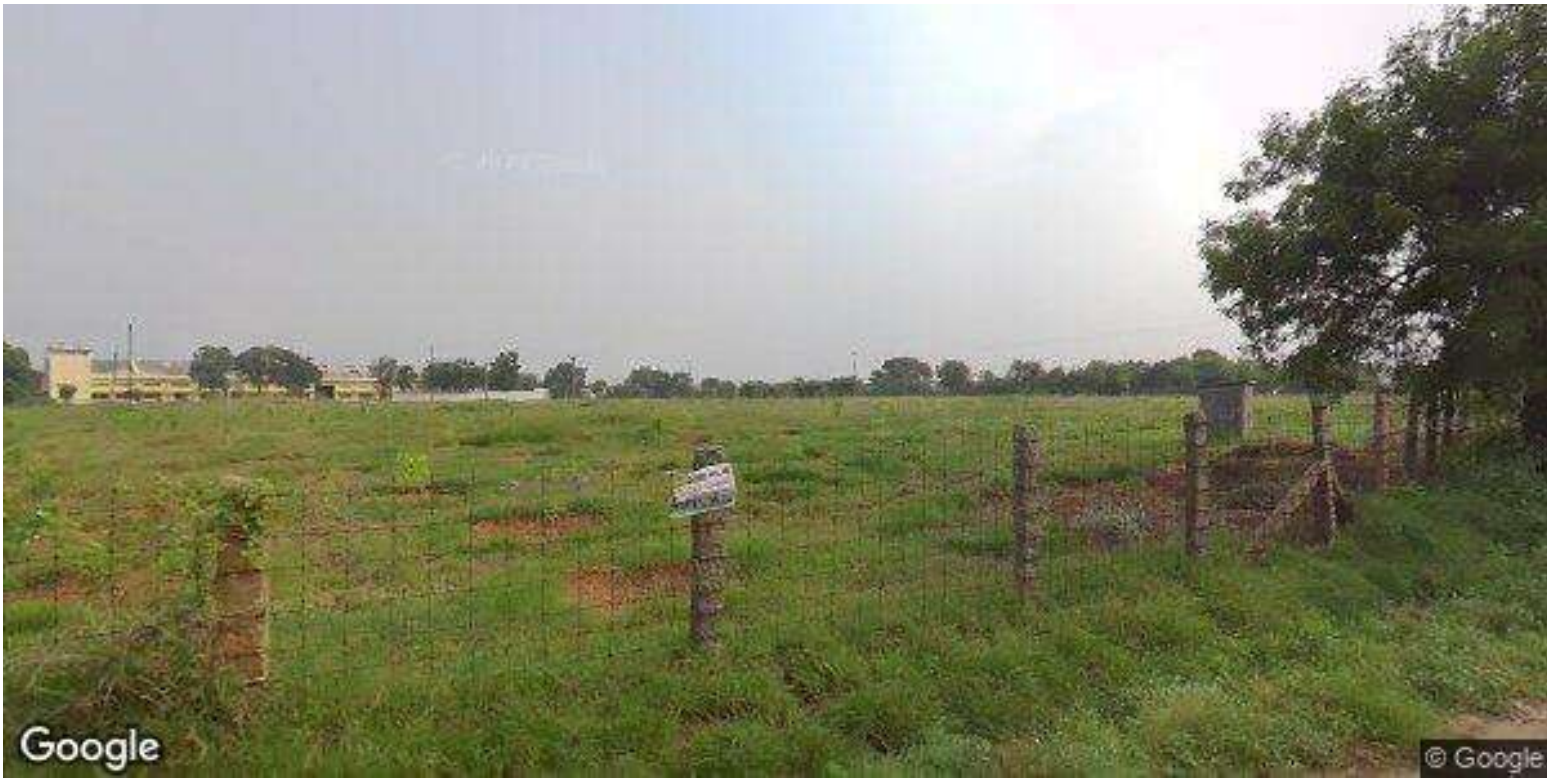
**Risk Type:** Turn  
**Risk Level:** Medium  
**Speed Limit:** 30 KM/Hr  
**Coordinates:** 11.09491, 77.66603

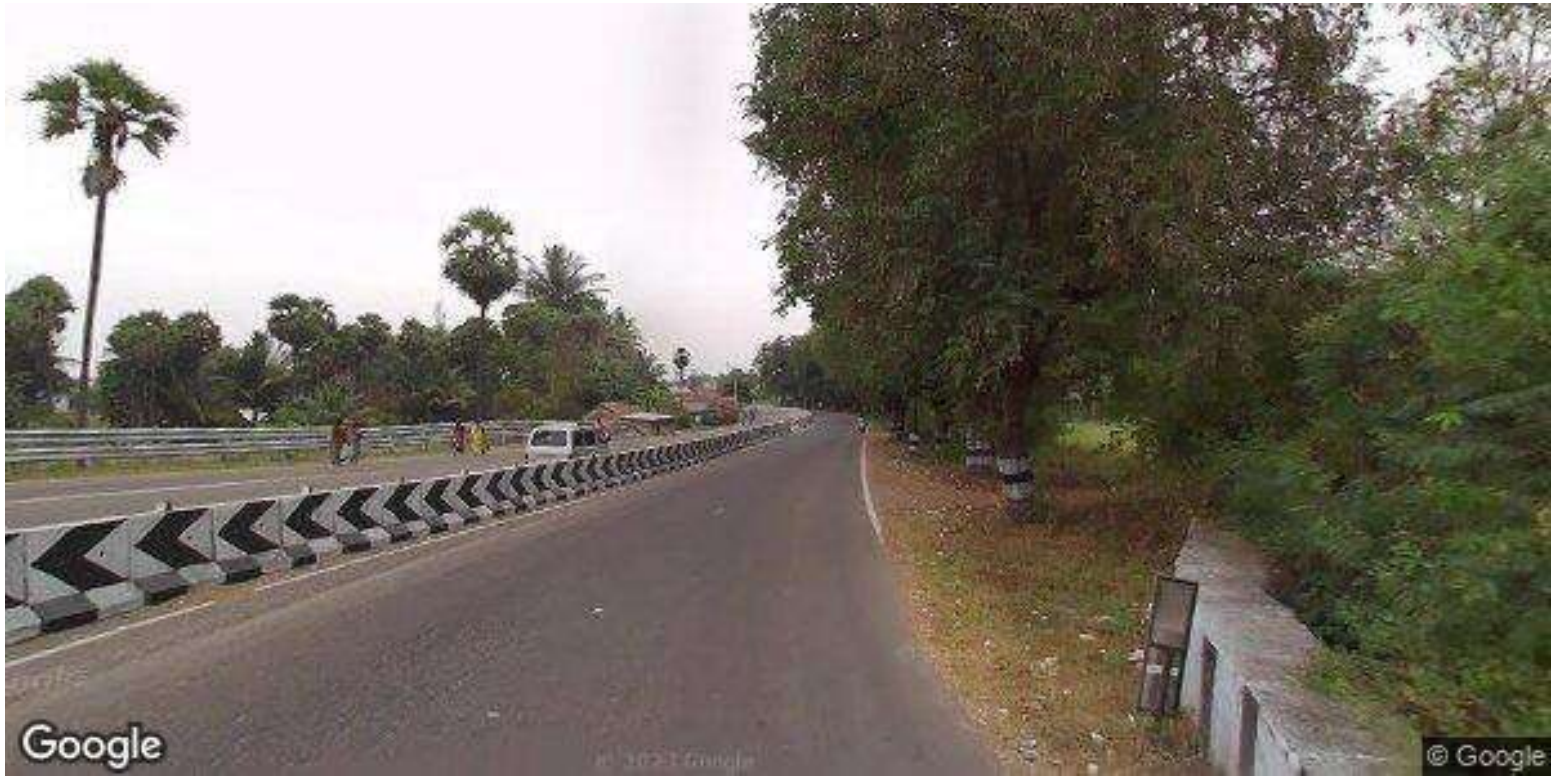
**Risk Type:** Turn  
**Risk Level:** Medium  
**Speed Limit:** 30 KM/Hr  
**Coordinates:** 11.08296, 77.65857

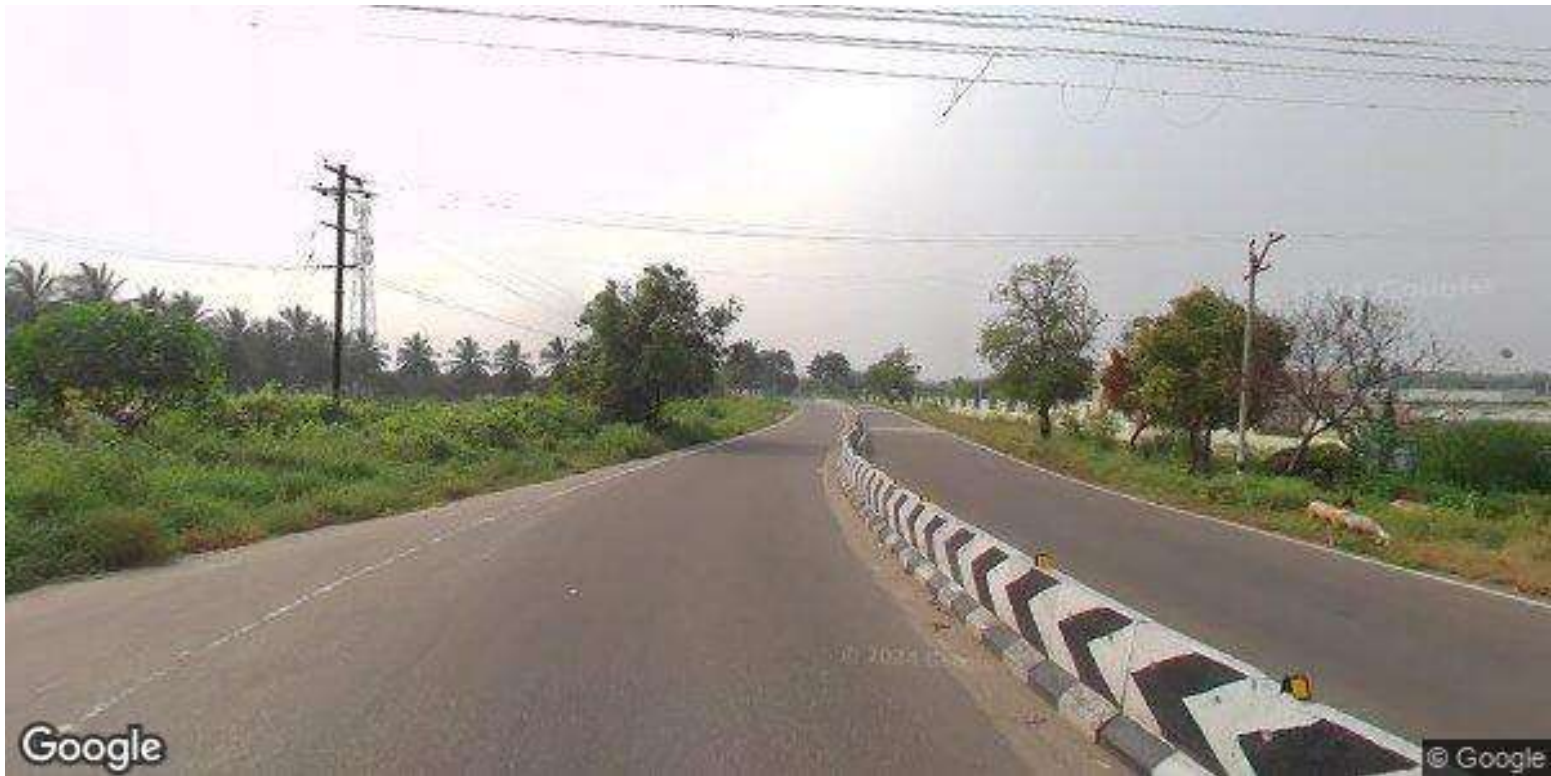
**Risk Type:** Turn  
**Risk Level:** Medium  
**Speed Limit:** 30 KM/Hr  
**Coordinates:** 11.06183, 77.63924

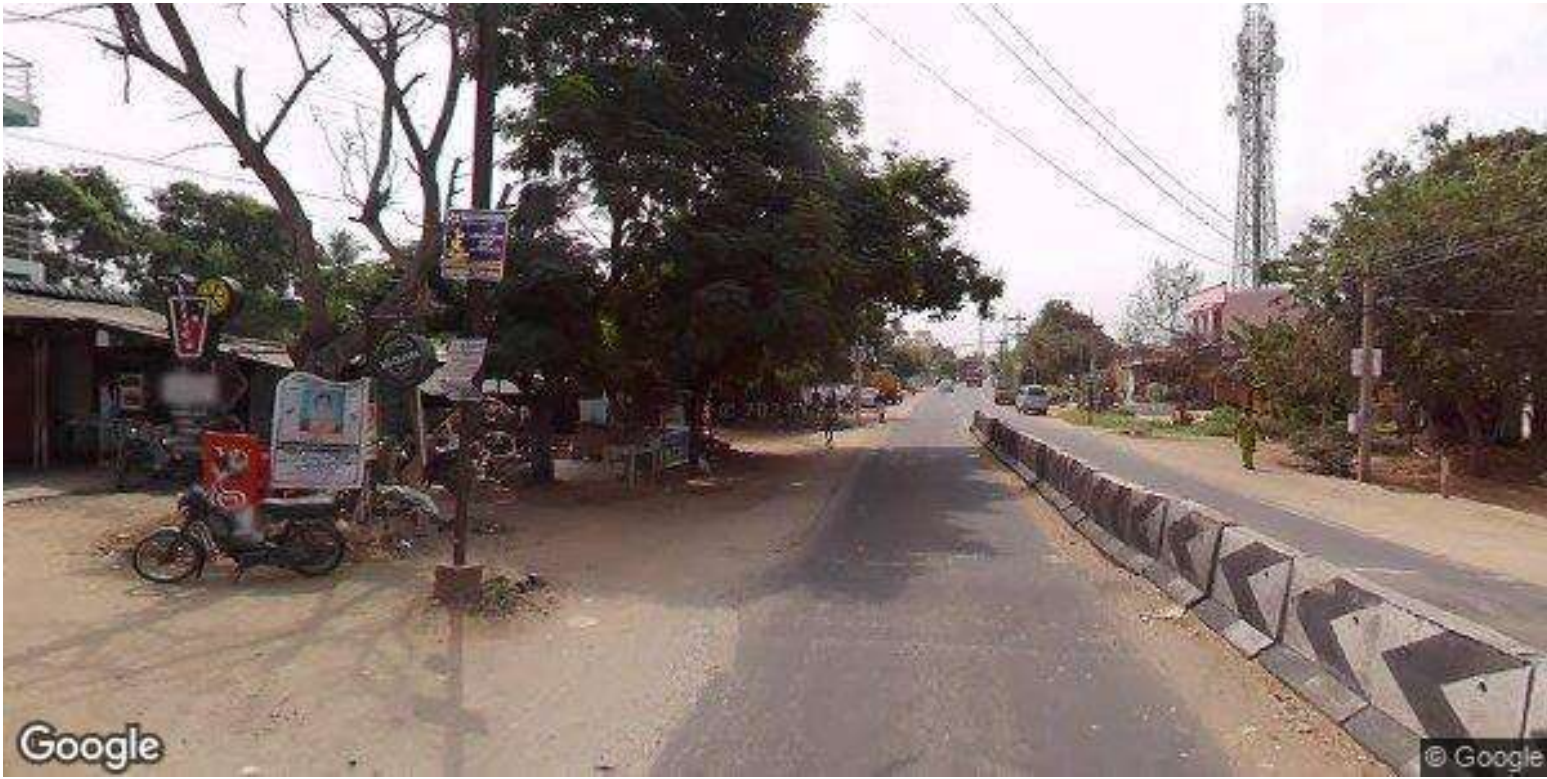
**Risk Type:** Turn  
**Risk Level:** High  
**Speed Limit:** 15 KM/Hr  
**Coordinates:** 11.00826, 77.56962

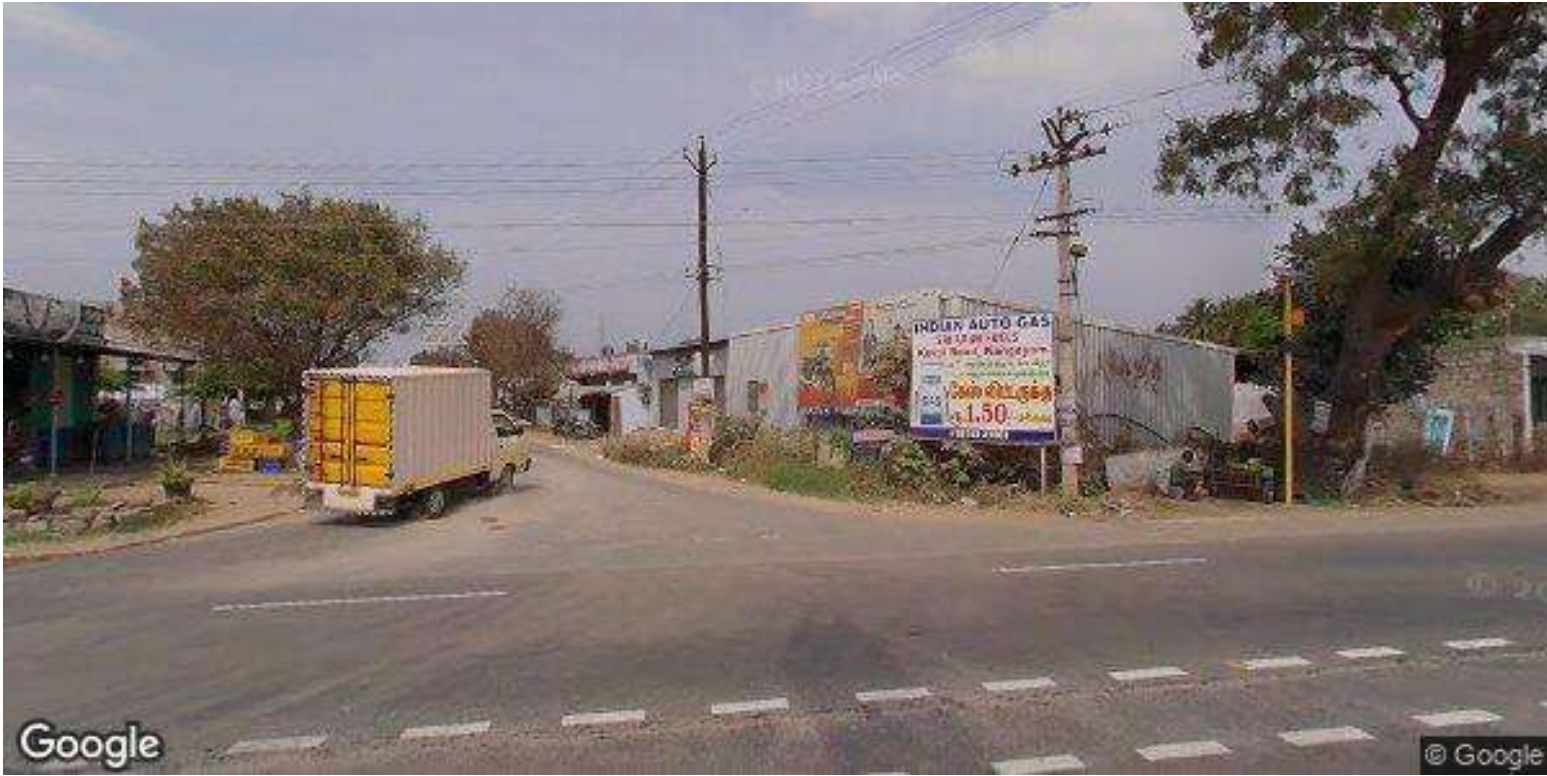
**Risk Type:** Blind Spot  
**Risk Level:** Blind Spot  
**Speed Limit:** 10 KM/Hr  
**Coordinates:** 11.00058, 77.56882

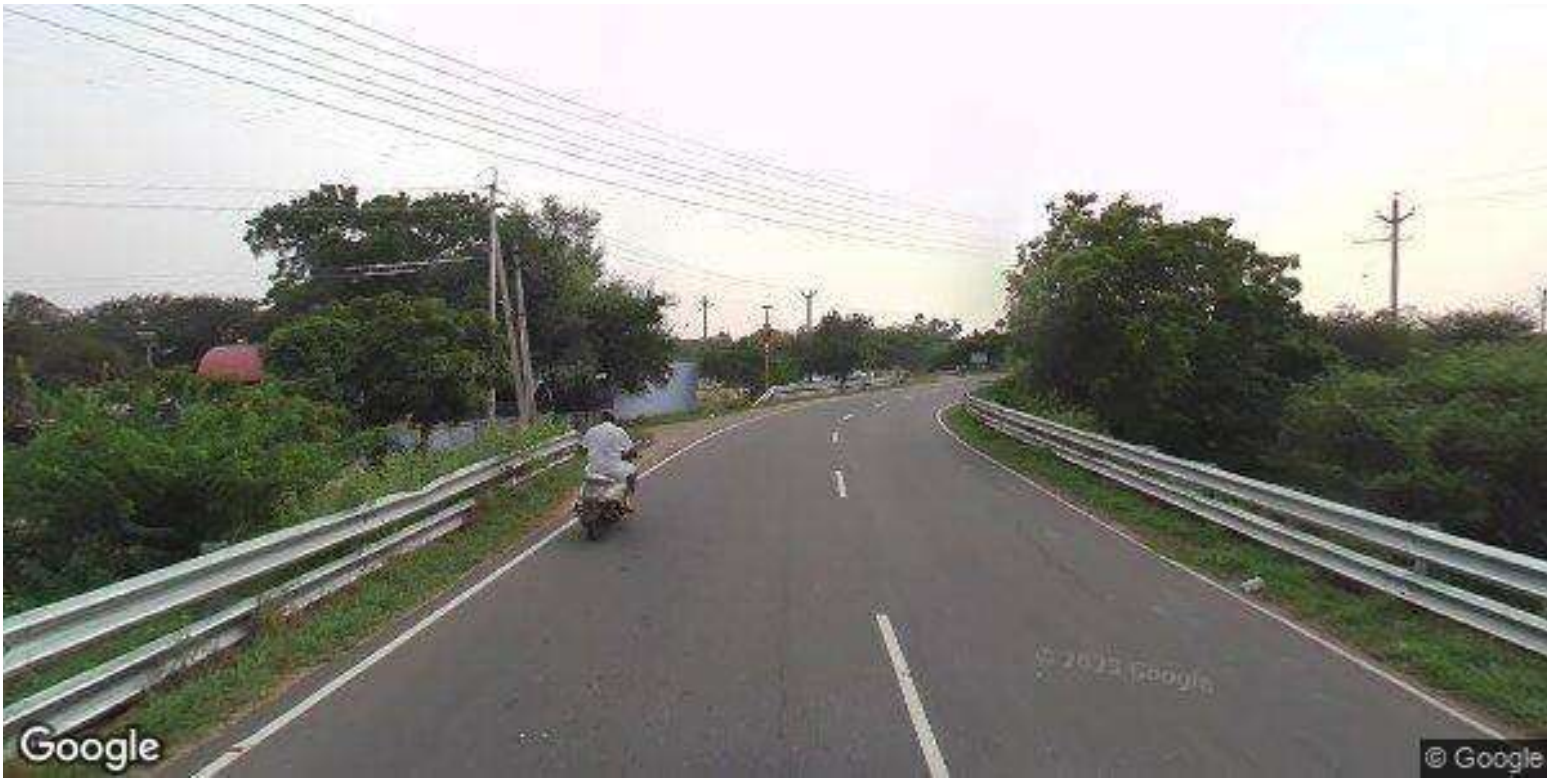
**Risk Type:** Turn  
**Risk Level:** Medium  
**Speed Limit:** 30 KM/Hr  
**Coordinates:** 10.94722, 77.54709

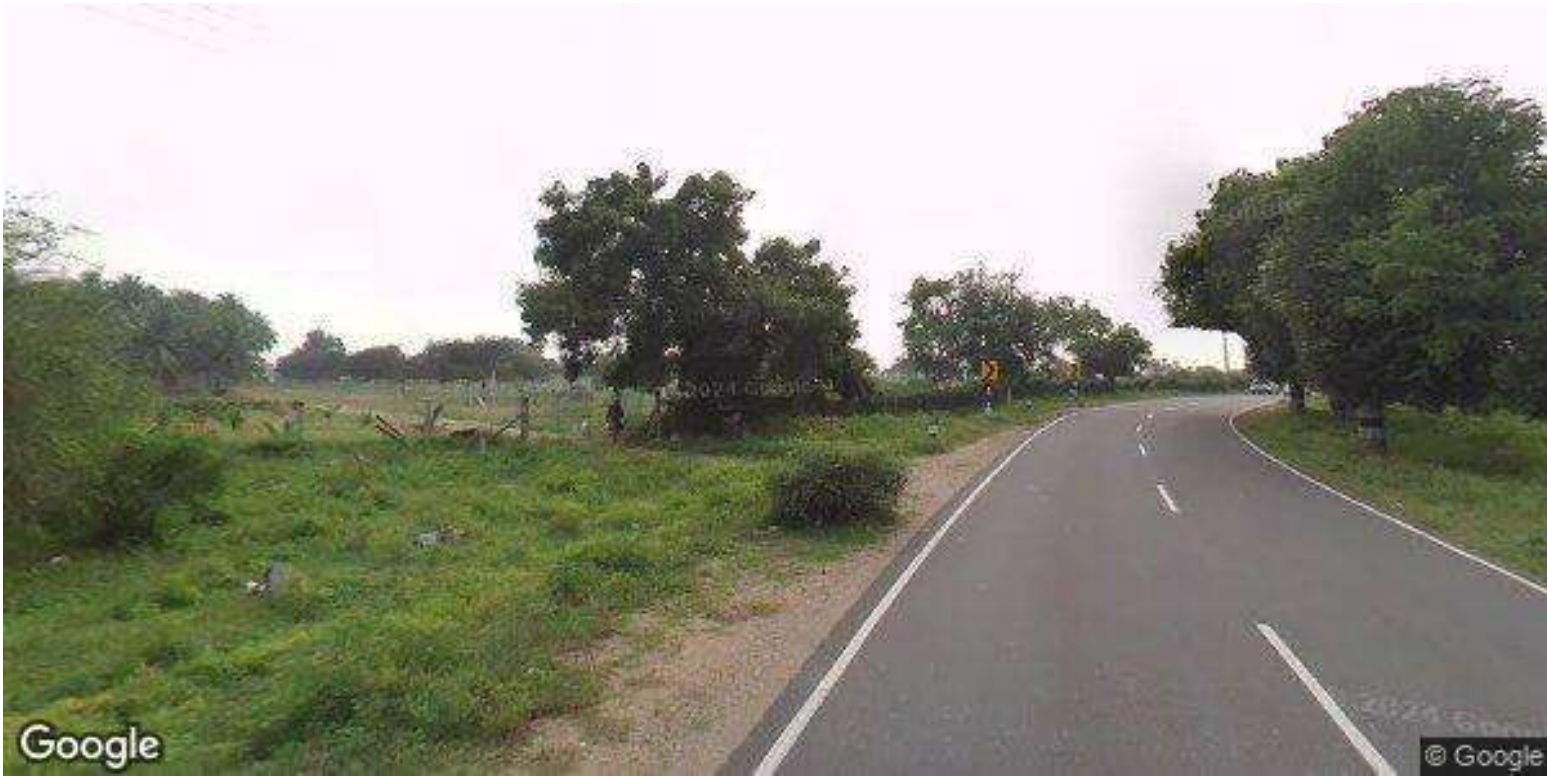
**Risk Type:** Turn  
**Risk Level:** Medium  
**Speed Limit:** 30 KM/Hr  
**Coordinates:** 10.93895, 77.53976

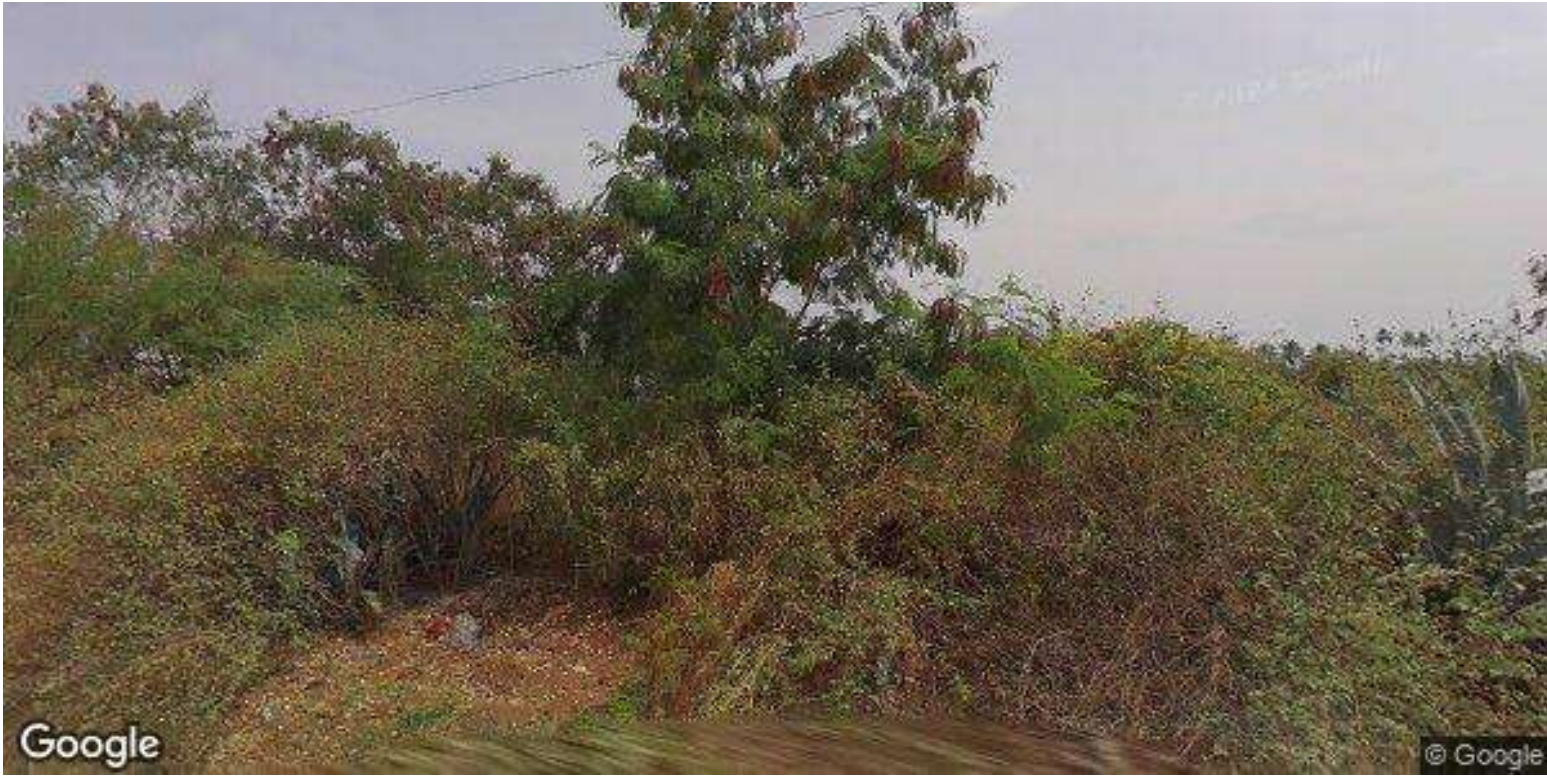
**Risk Type:** Turn  
**Risk Level:** Medium  
**Speed Limit:** 30 KM/Hr  
**Coordinates:** 10.93054, 77.53265

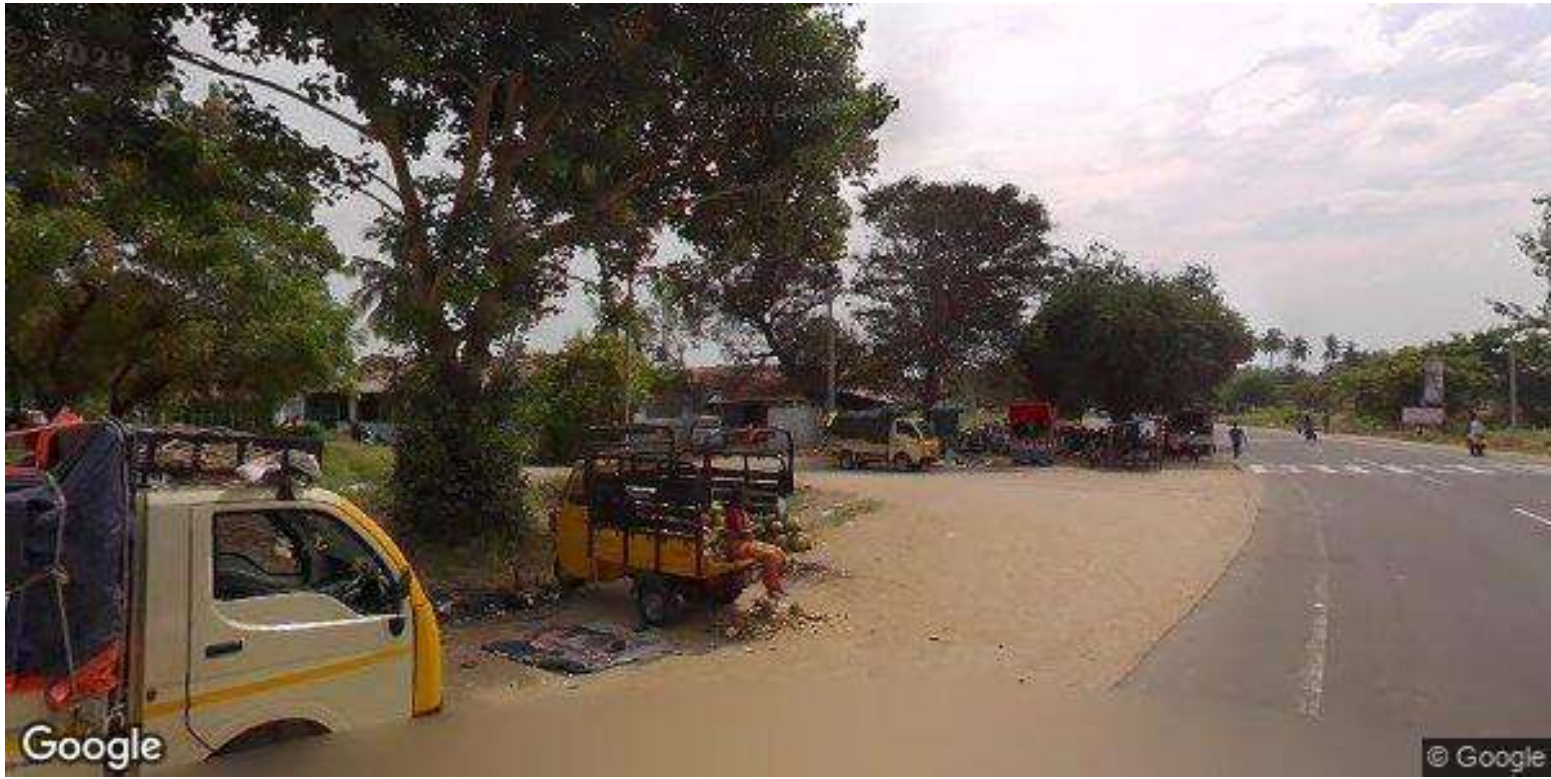
**Risk Type:** Turn  
**Risk Level:** Medium  
**Speed Limit:** 30 KM/Hr  
**Coordinates:** 10.89213, 77.52646

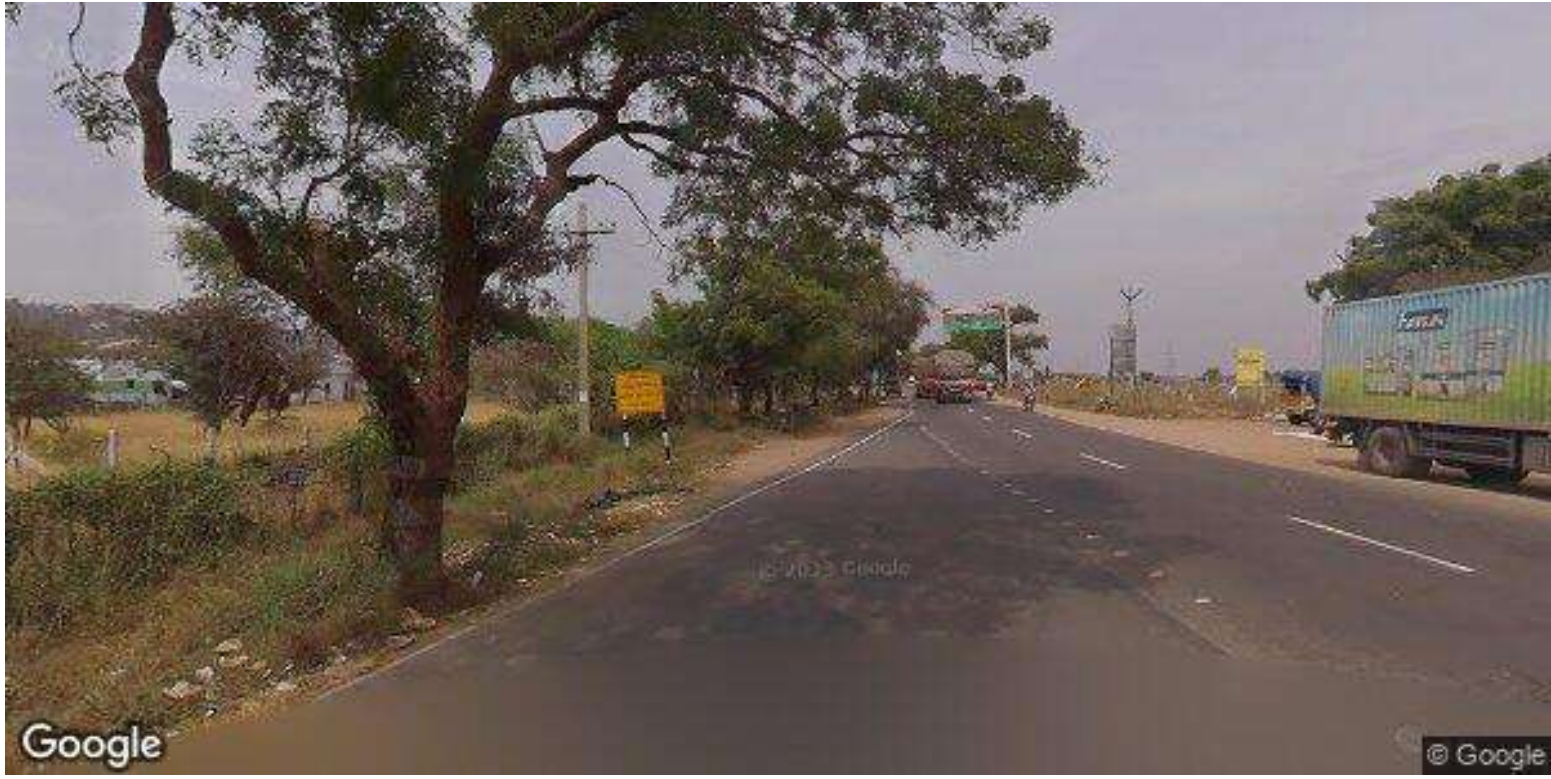
**Risk Type:** Turn  
**Risk Level:** High  
**Speed Limit:** 15 KM/Hr  
**Coordinates:** 10.87916, 77.52773

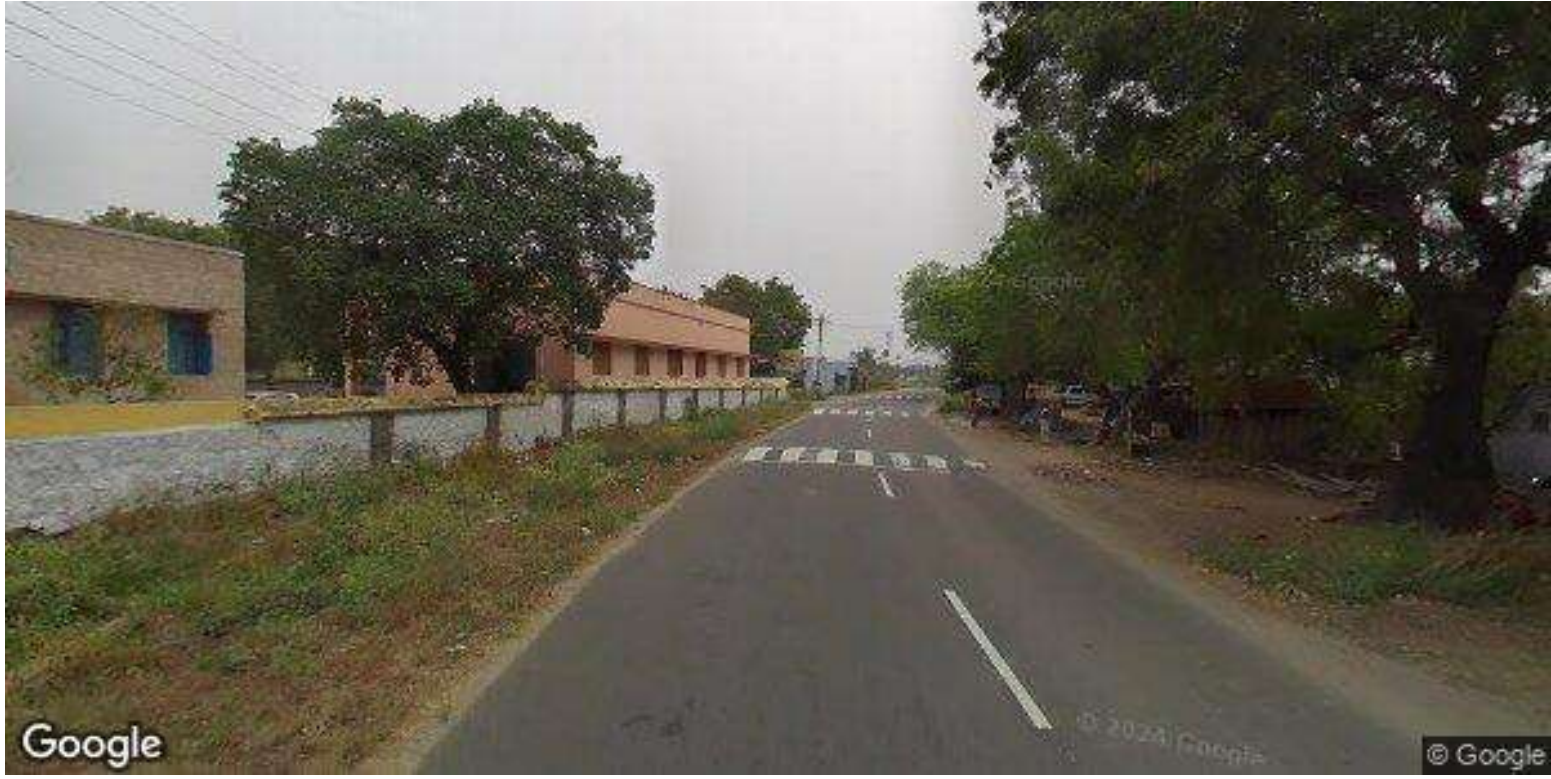
**Risk Type:** Turn  
**Risk Level:** Medium  
**Speed Limit:** 30 KM/Hr  
**Coordinates:** 10.88260, 77.48881

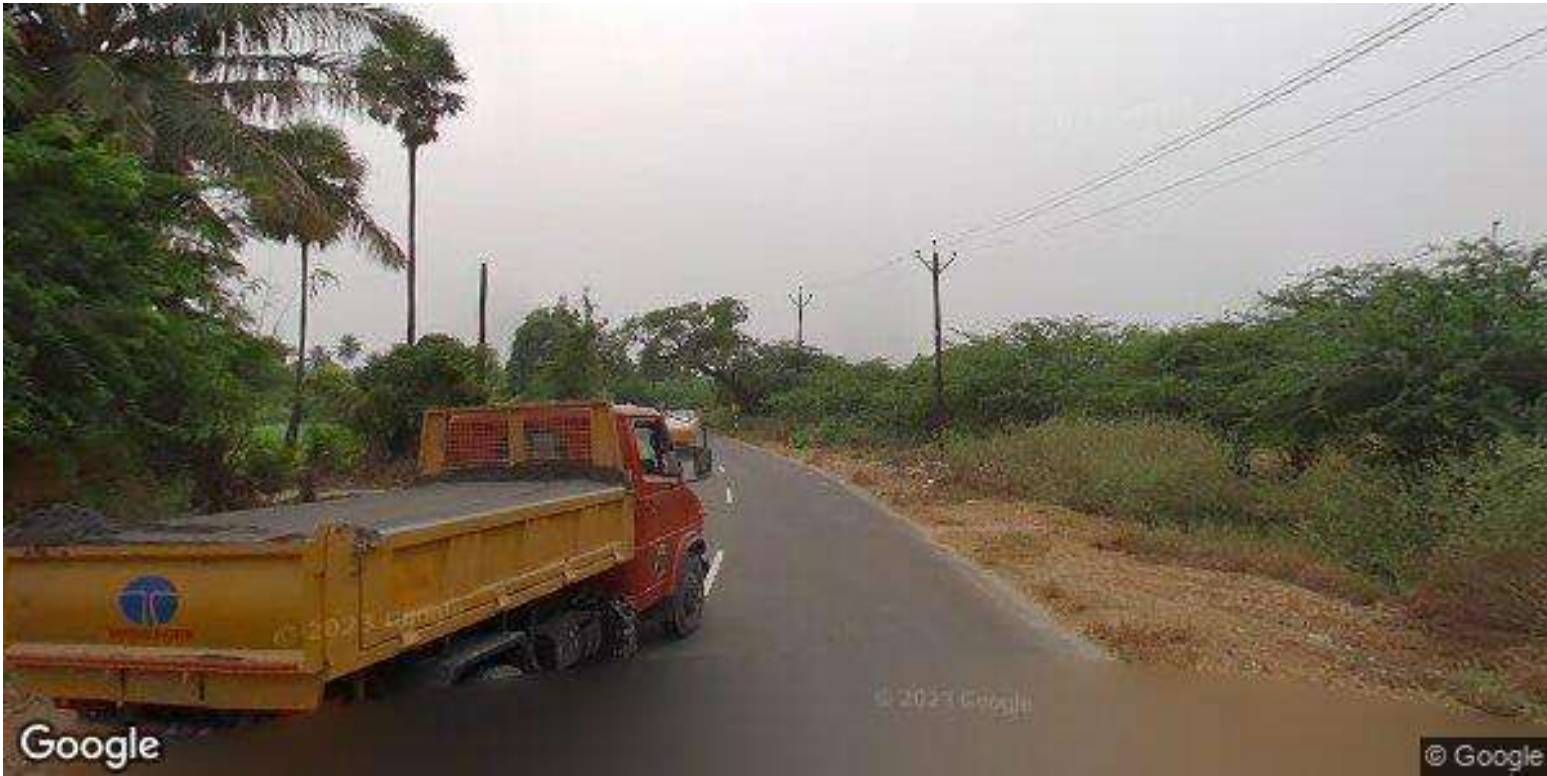
**Risk Type:** Turn  
**Risk Level:** High  
**Speed Limit:** 15 KM/Hr  
**Coordinates:** 10.88221, 77.48831

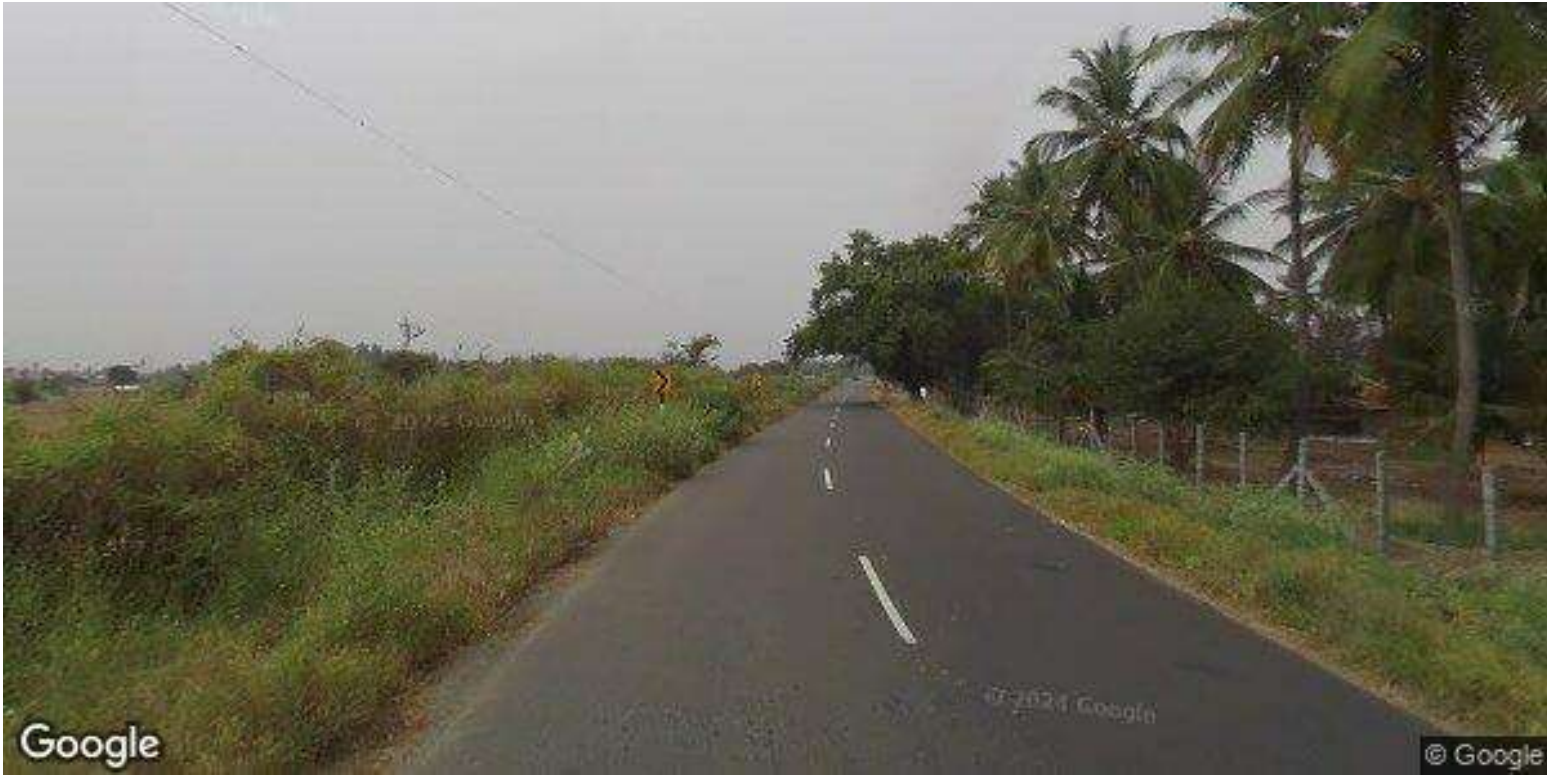
**Risk Type:** Turn  
**Risk Level:** High  
**Speed Limit:** 15 KM/Hr  
**Coordinates:** 10.87783, 77.48740

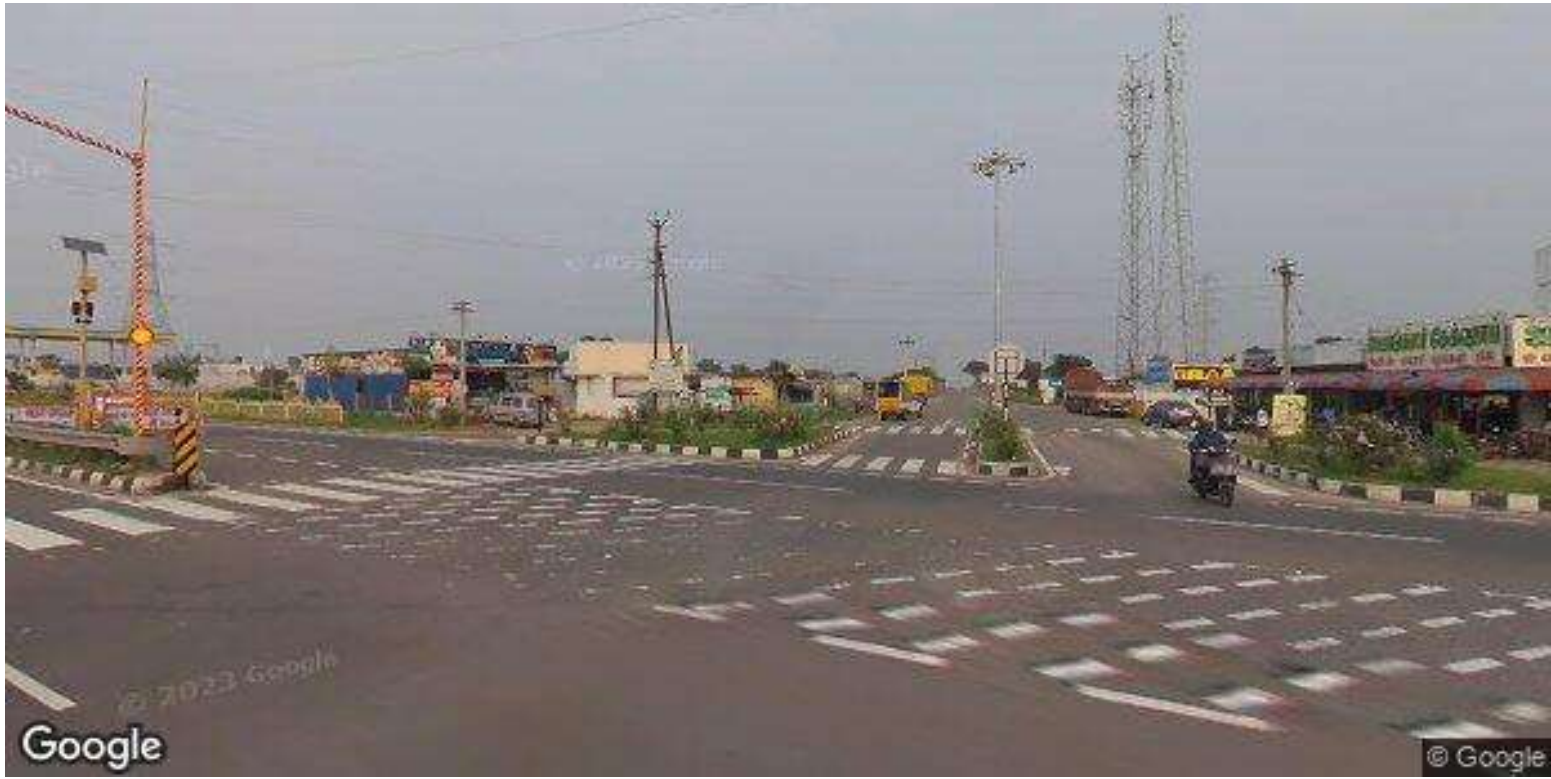
**Risk Type:** Blind Spot  
**Risk Level:** Blind Spot  
**Speed Limit:** 10 KM/Hr  
**Coordinates:** 10.86065, 77.46480
