## **JOURNEY RISK MANAGEMENT (JRM) STUDY**

### **Salem Terminal To SK FUELS**

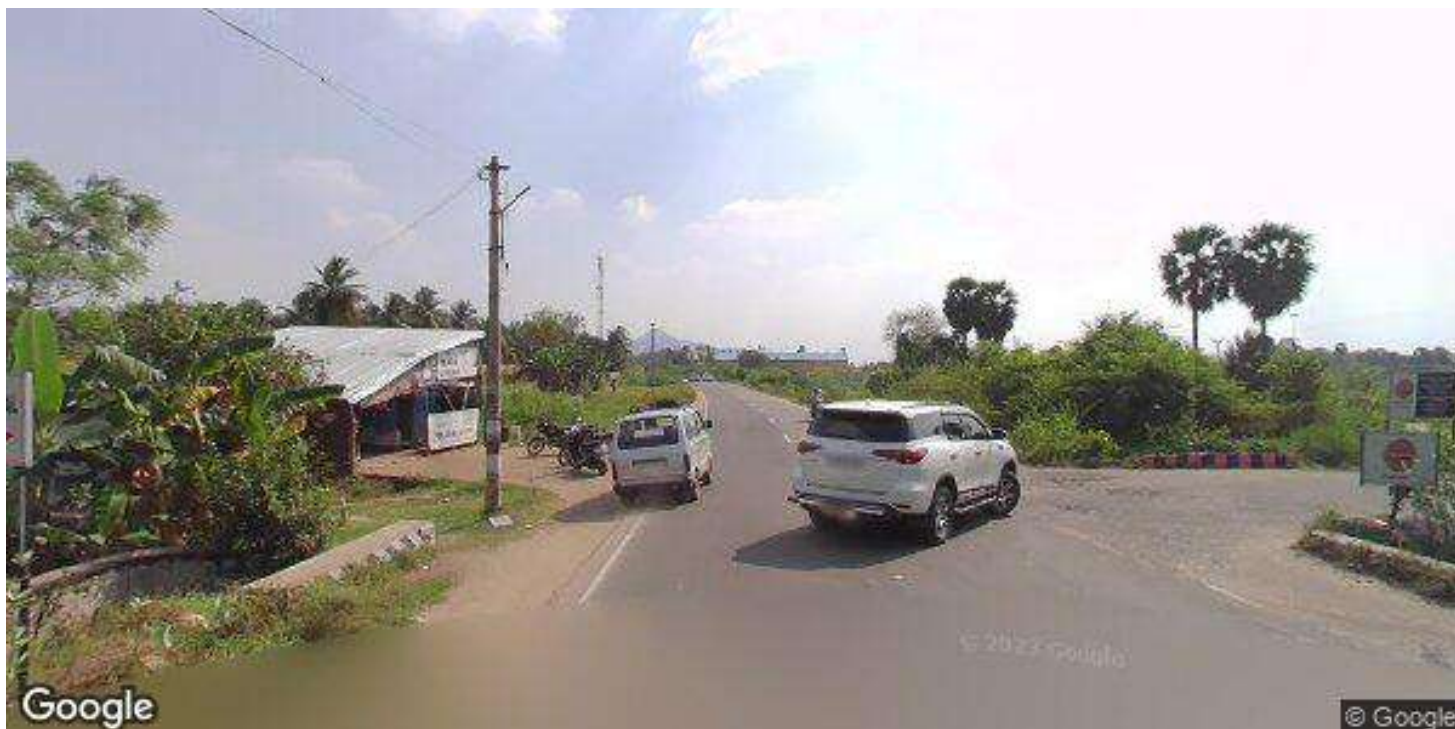
**Coordinates:** 11.44029, 77.87544

| | Risk Type | Risk Level | Coordinates | Speed Limit |
|---|---|---|---|---|
| 3 | Turn | High | 11.44029, 77.87544 | 15 KM/Hr |

**Risk Type:** Turn

**Risk Level:** High

**Speed Limit:** 15 KM/Hr

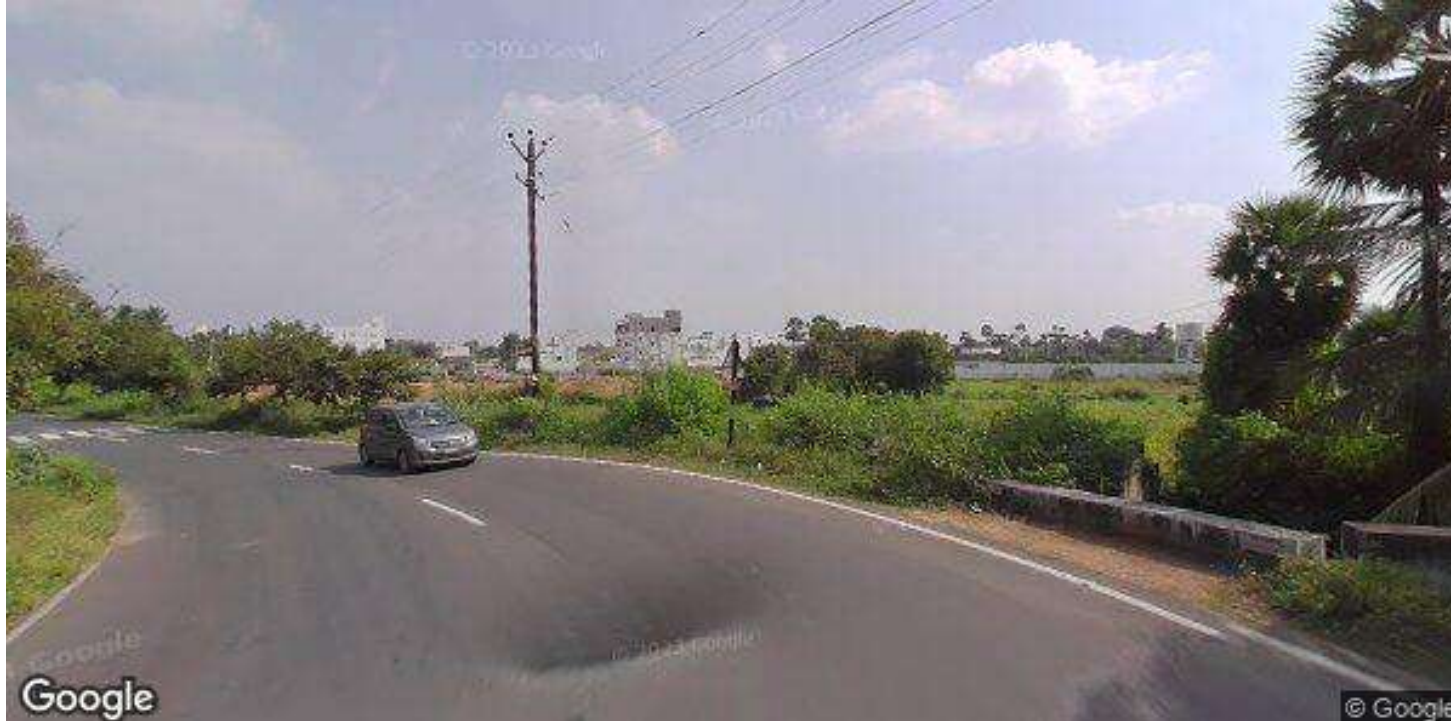
| | Risk Type | Risk Level | Coordinates | Speed Limit |
|---|---|---|---|---|
| 4 | Turn | Medium | 11.45350, 77.85700 | 30 KM/Hr |

**Risk Type:** Turn  
**Risk Level:** Medium  
**Speed Limit:** 30 KM/Hr  
**Coordinates:** 11.45350, 77.85700

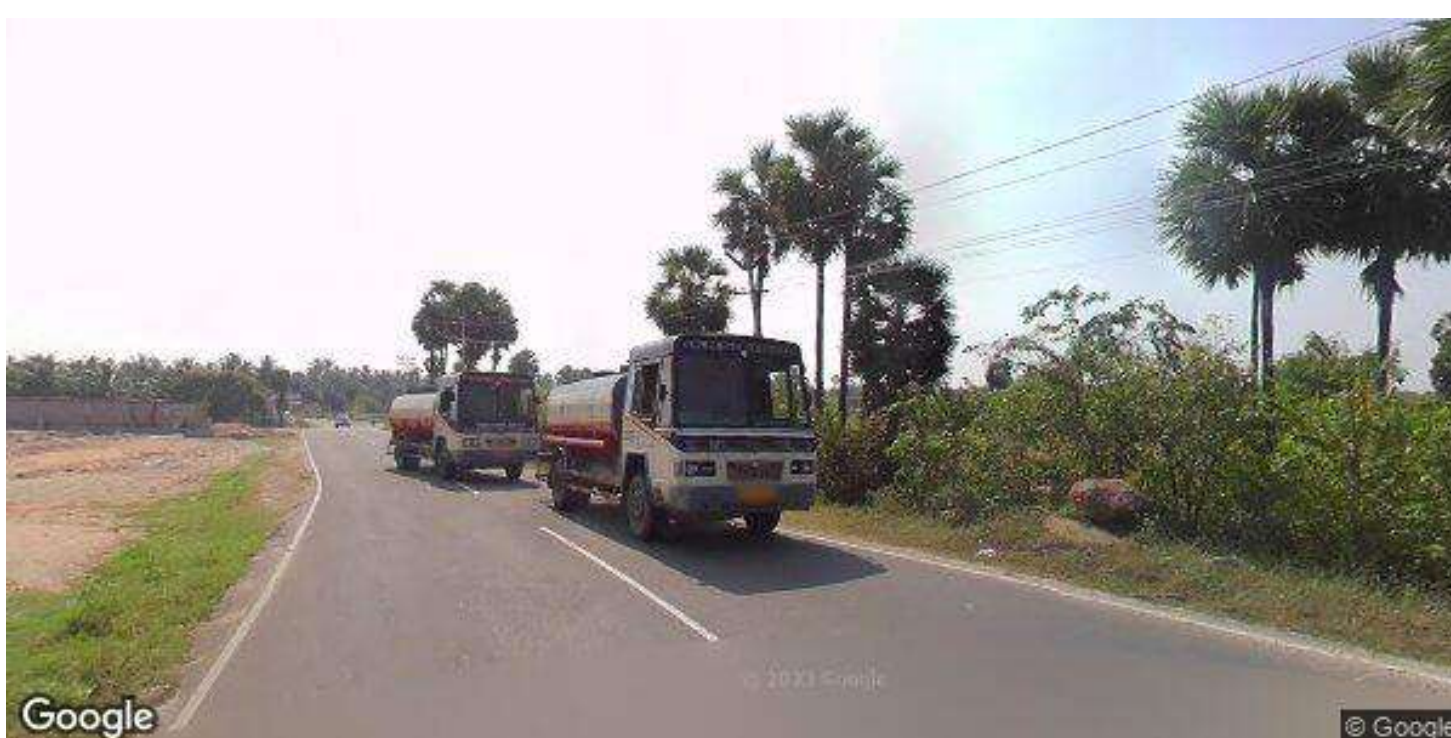
| | Risk Type | Risk Level | Coordinates | Speed Limit |
|---|---|---|---|---|
| 5 | Turn | Medium | 11.45833, 77.85146 | 30 KM/Hr |

**Risk Type:** Turn  
**Risk Level:** Medium  
**Speed Limit:** 30 KM/Hr  
**Coordinates:** 11.45833, 77.85146

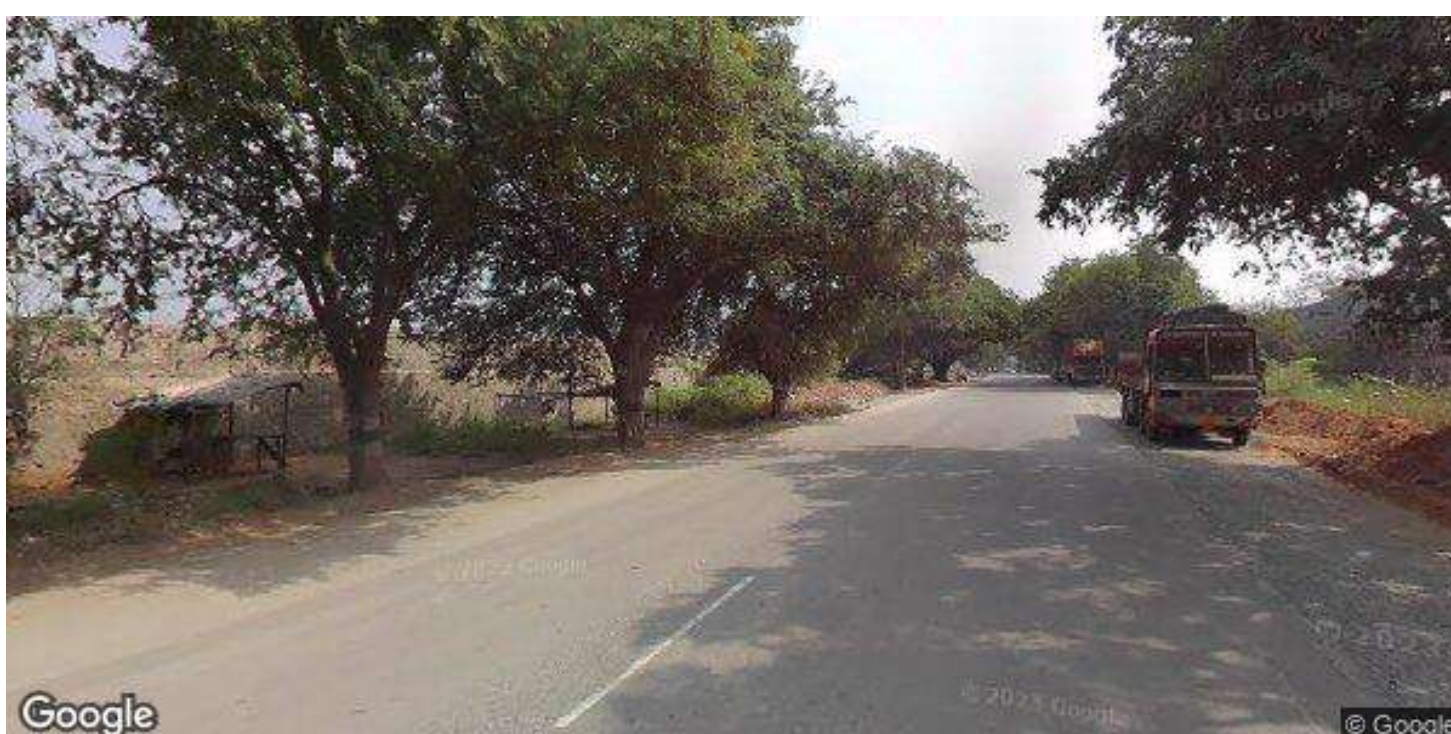
Coordinates: 11.45697, 77.82719

| | Risk Type | Risk Level | Coordinates | Speed Limit |
|---|---|---|---|---|
| 6 | Turn | Medium | 11.45697, 77.82719 | 30 KM/Hr |

**Risk Type:** Turn  
**Risk Level:** Medium

Speed Limit: 30 KM/Hr

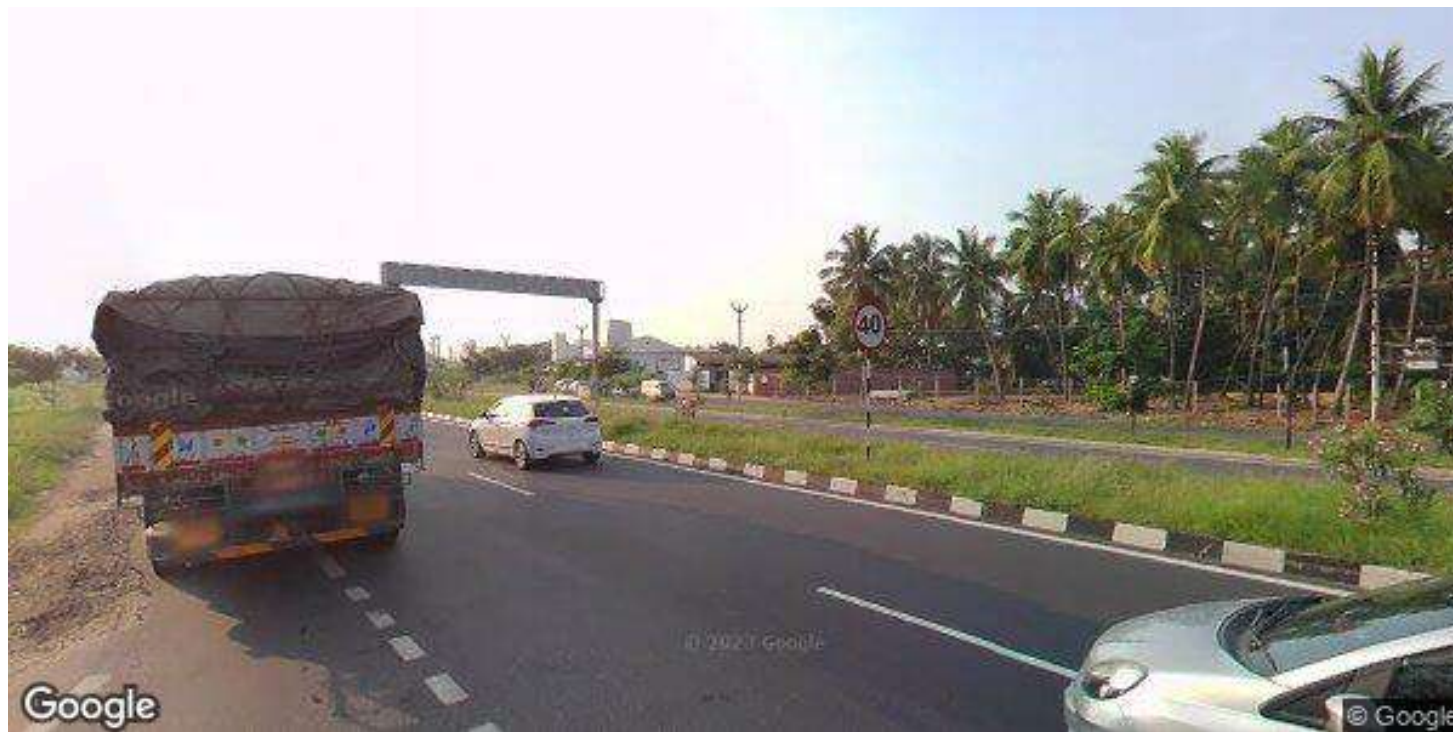
Coordinates: 11.45518, 77.81344

| | Risk Type | Risk Level | Coordinates | Speed Limit |
|---|---|---|---|---|
| 7 | Turn | High | 11.45518, 77.81344 | 15 KM/Hr |

Risk Type: Turn

Risk Level: High

Speed Limit: 15 KM/Hr

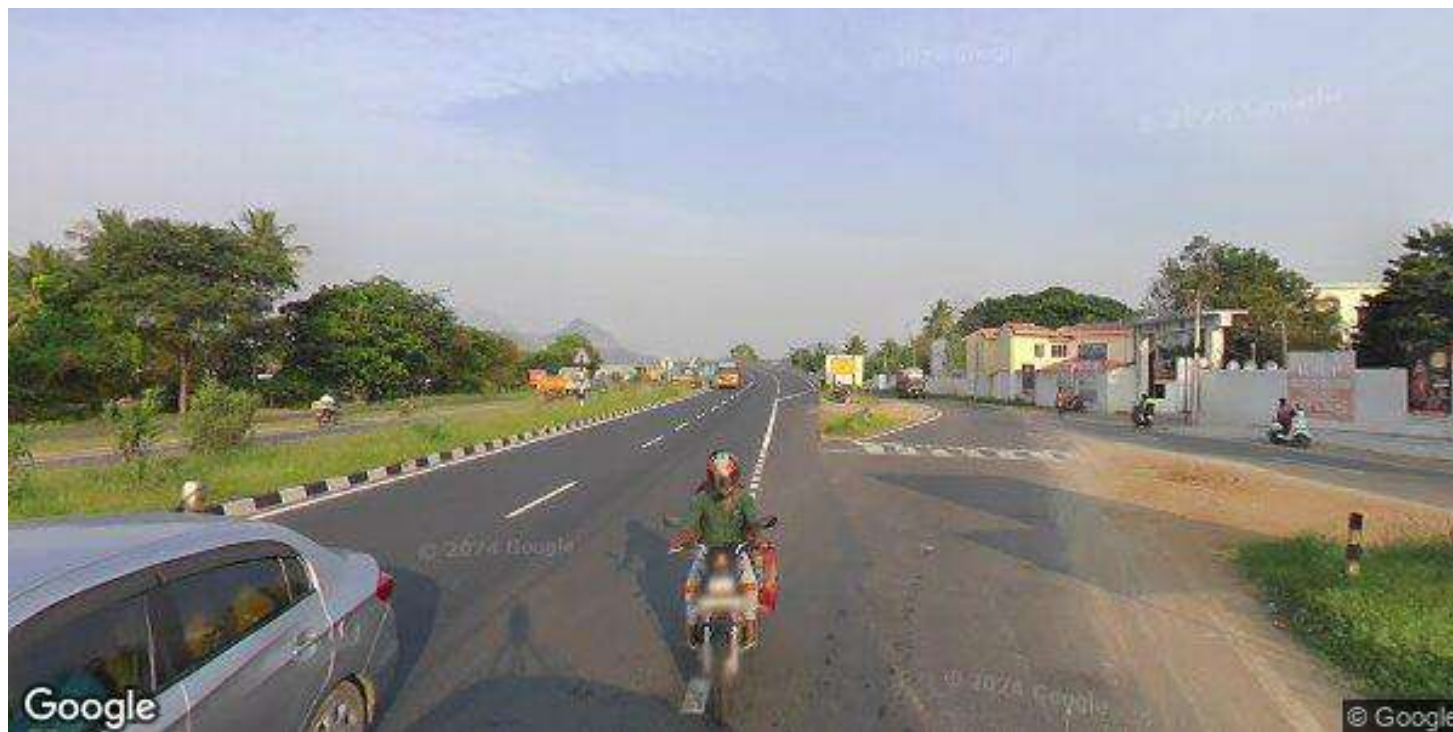
Coordinates: 11.45521, 77.81343

| | Risk Type | Risk Level | Coordinates | Speed Limit |
|---|---|---|---|---|
| 8 | Turn | High | 11.45521, 77.81343 | 15 KM/Hr |

Risk Type: Turn

Risk Level: High

Speed Limit: 15 KM/Hr

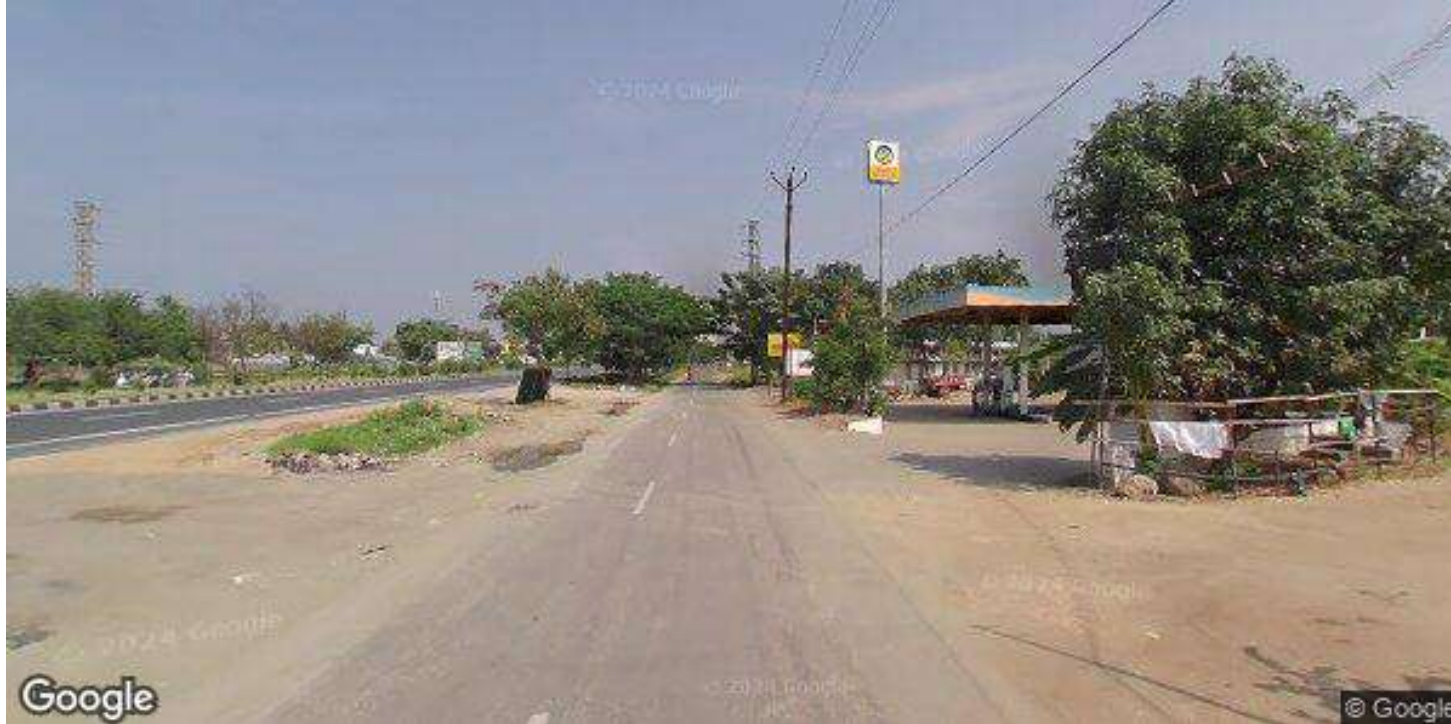
**Coordinates:** 11.43994, 77.71111

| | Risk Type | Risk Level | Coordinates | Speed Limit |
|---|---|---|---|---|
| 9 | Turn | Medium | 11.43994, 77.71111 | 30 KM/Hr |

**Risk Type:** Turn

**Risk Level:** Medium

**Speed Limit:** 30 KM/Hr

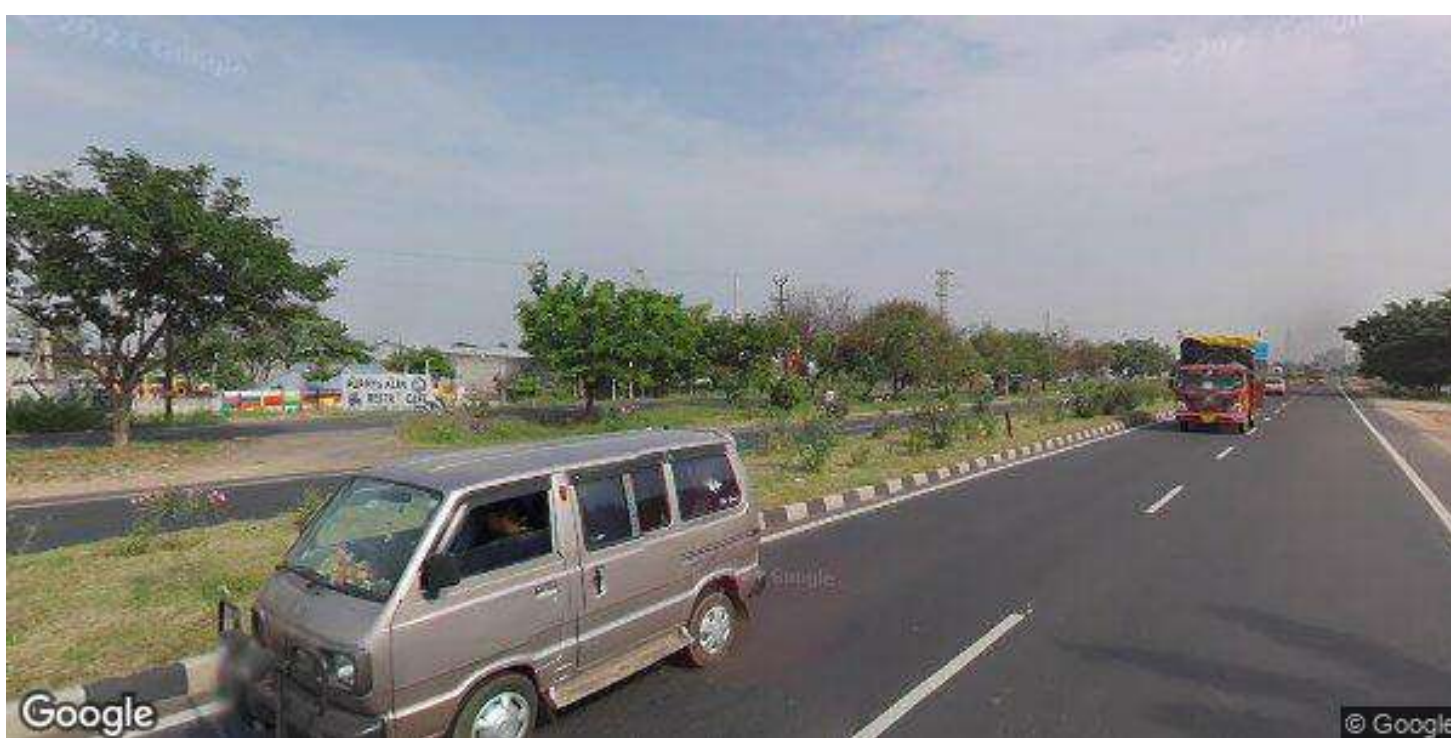
**Coordinates:** 11.43982, 77.71084

| | Risk Type | Risk Level | Coordinates | Speed Limit |
|---|---|---|---|---|
| 10 | Turn | Medium | 11.43982, 77.71084 | 30 KM/Hr |

**Risk Type:** Turn

**Risk Level:** Medium

**Speed Limit:** 30 KM/Hr

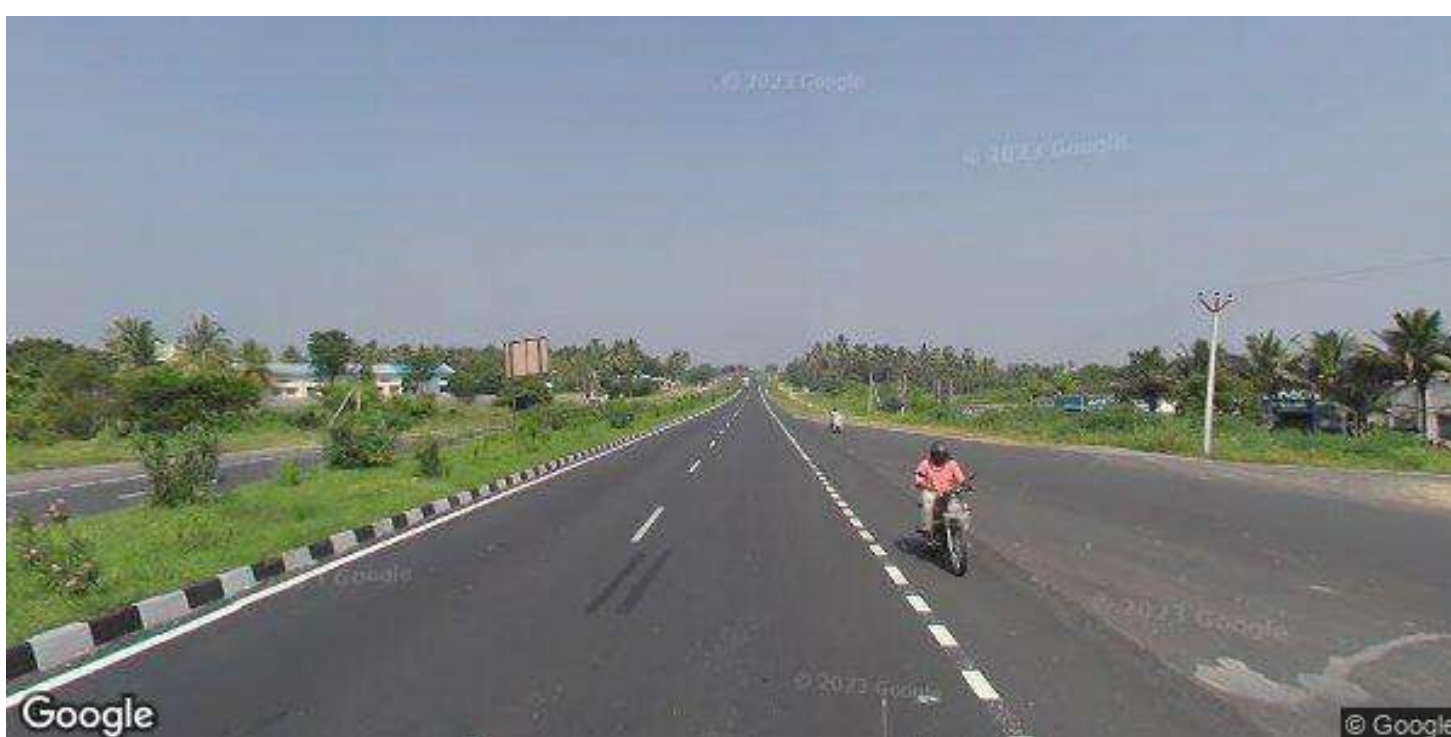
**Coordinates: 11.40046, 77.65371**

| | Risk Type | Risk Level | Coordinates | Speed Limit |
|---|---|---|---|---|
| 11 | Turn | High | 11.40046, 77.65371 | 15 KM/Hr |

**Risk Type:** Turn

**Risk Level:** High

**Speed Limit: 15 KM/Hr**

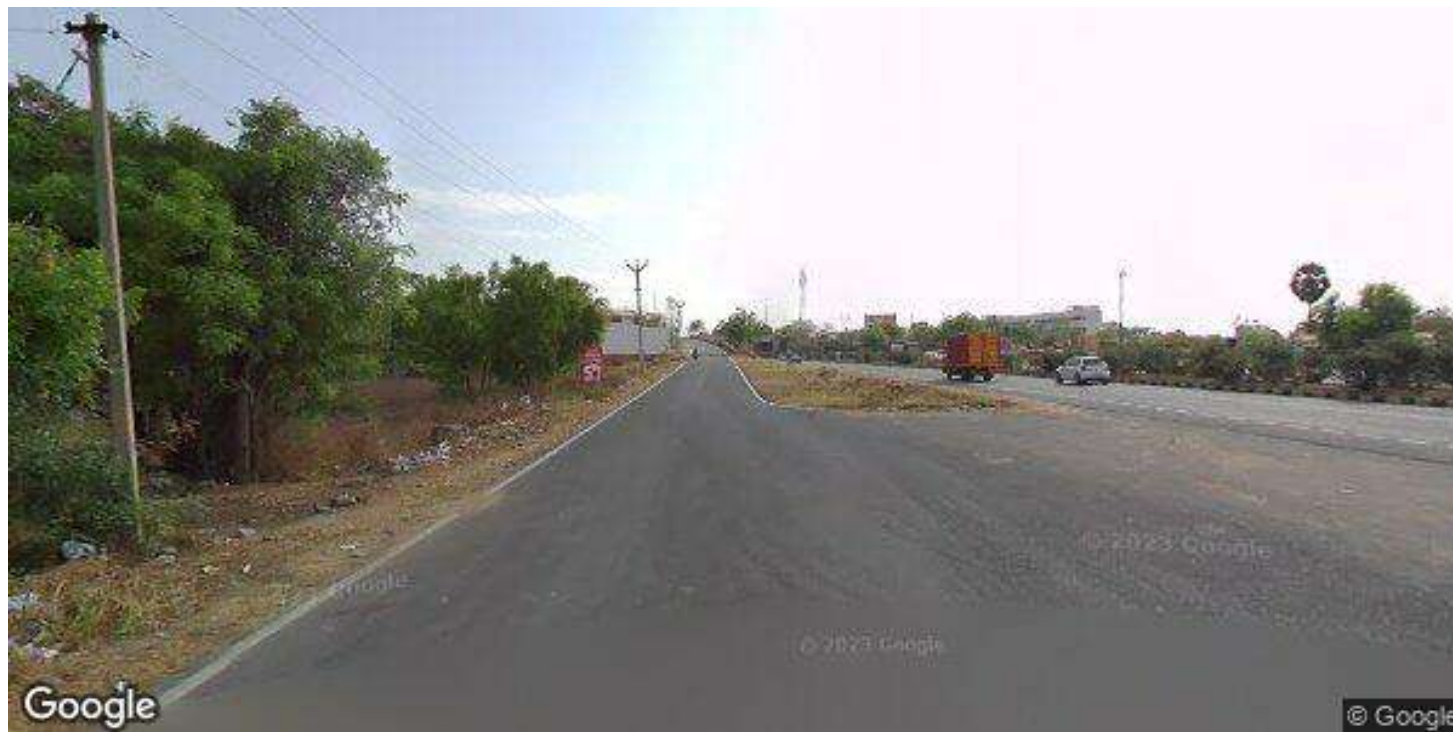
**Coordinates: 11.40035, 77.65383**

| | Risk Type | Risk Level | Coordinates | Speed Limit |
|---|---|---|---|---|
| 12 | Turn | High | 11.40035, 77.65383 | 15 KM/Hr |

**Risk Type: Turn**

**Risk Level: High**

**Speed Limit: 15 KM/Hr**

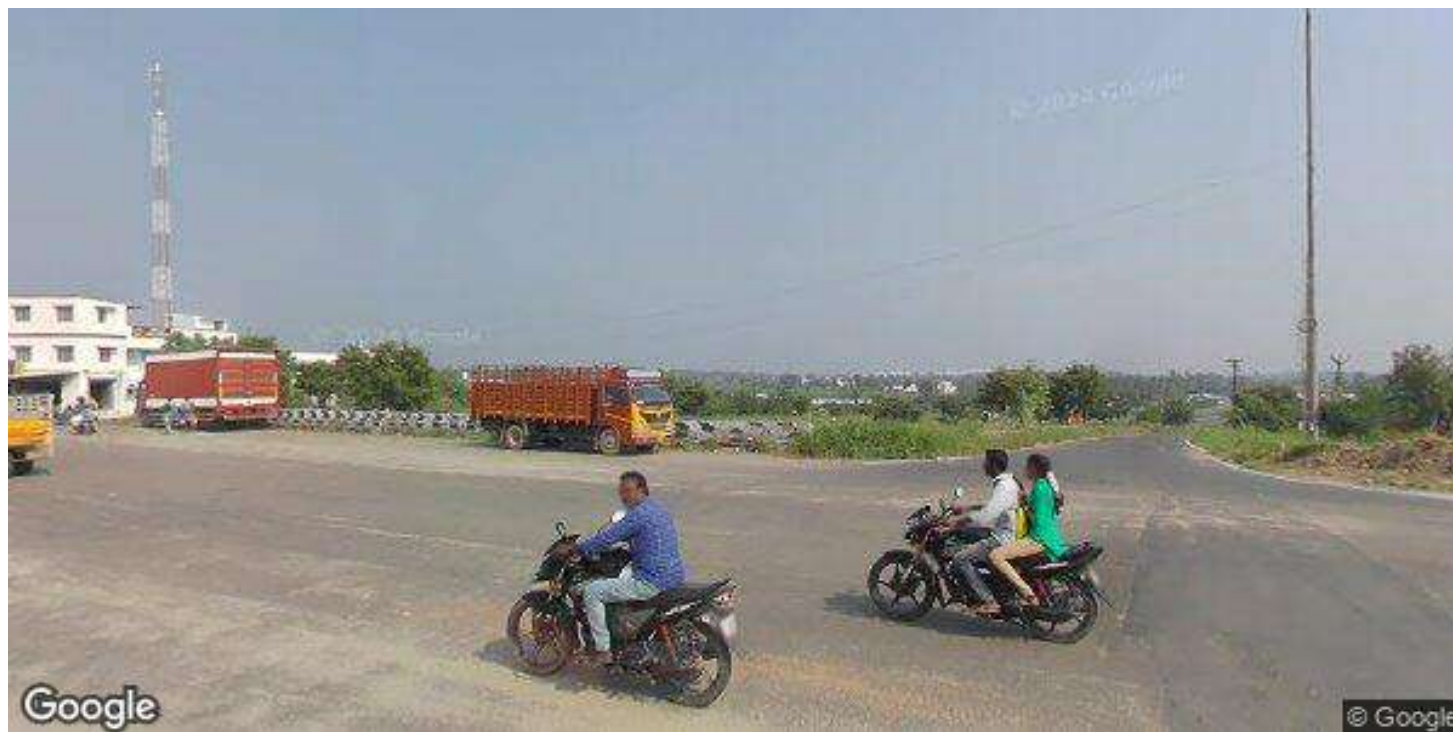
**Coordinates: 11.39827, 77.65237**

| | Risk Type | Risk Level | Coordinates | Speed Limit |
|---|---|---|---|---|
| 13 | Turn | High | 11.39827, 77.65237 | 15 KM/Hr |

**Risk Type: Turn**

**Risk Level: High**

**Speed Limit: 15 KM/Hr**

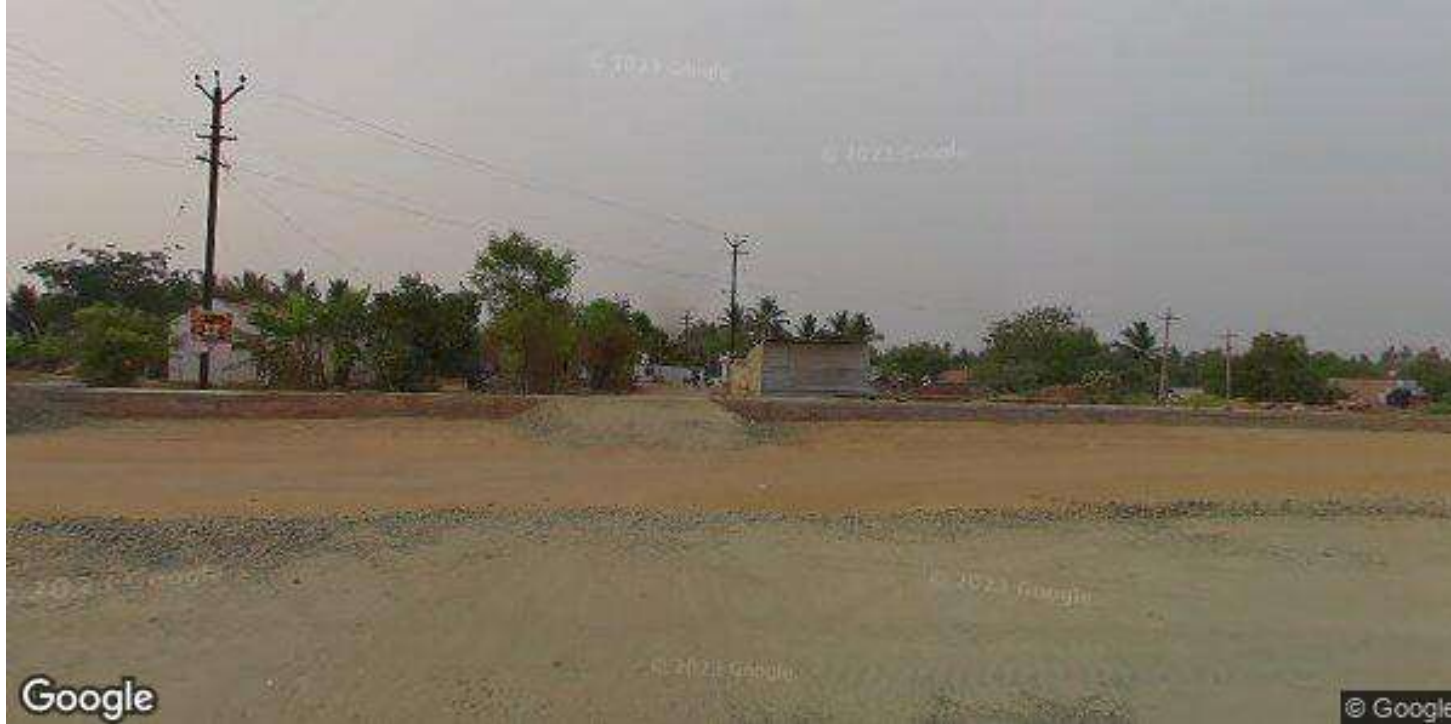
| | Risk Type | Risk Level | Coordinates | Speed Limit |
|---|---|---|---|---|
| 14 | Turn | High | 11.39972, 77.64797 | 15 KM/Hr |

**Risk Type:** Turn  
**Risk Level:** High  
**Speed Limit:** 15 KM/Hr  
**Coordinates:** 11.39972, 77.64797

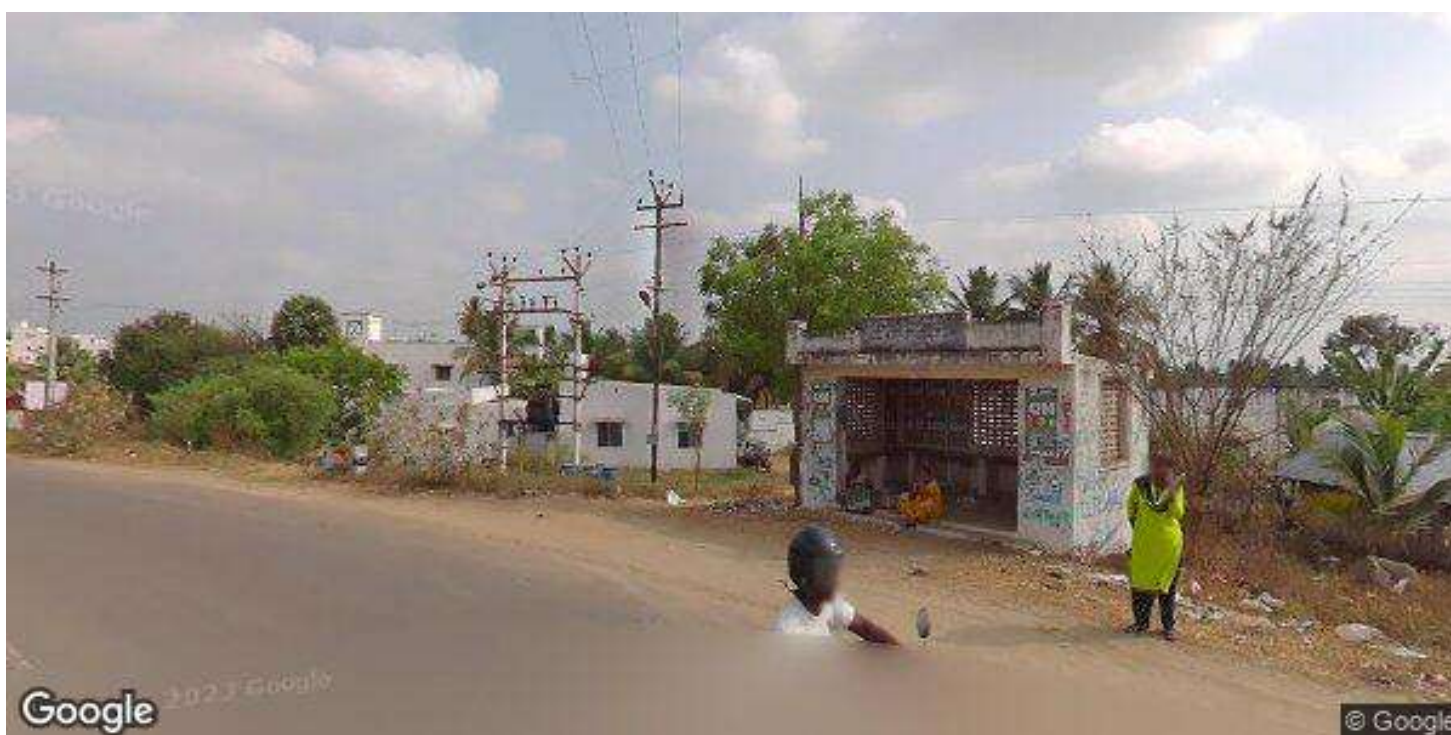
| | Risk Type | Risk Level | Coordinates | Speed Limit |
|---|---|---|---|---|
| 15 | Turn | High | 11.40025, 77.64811 | 15 KM/Hr |

**Risk Type:** Turn  
**Risk Level:** High  
**Speed Limit:** 15 KM/Hr  
**Coordinates:** 11.40025, 77.64811

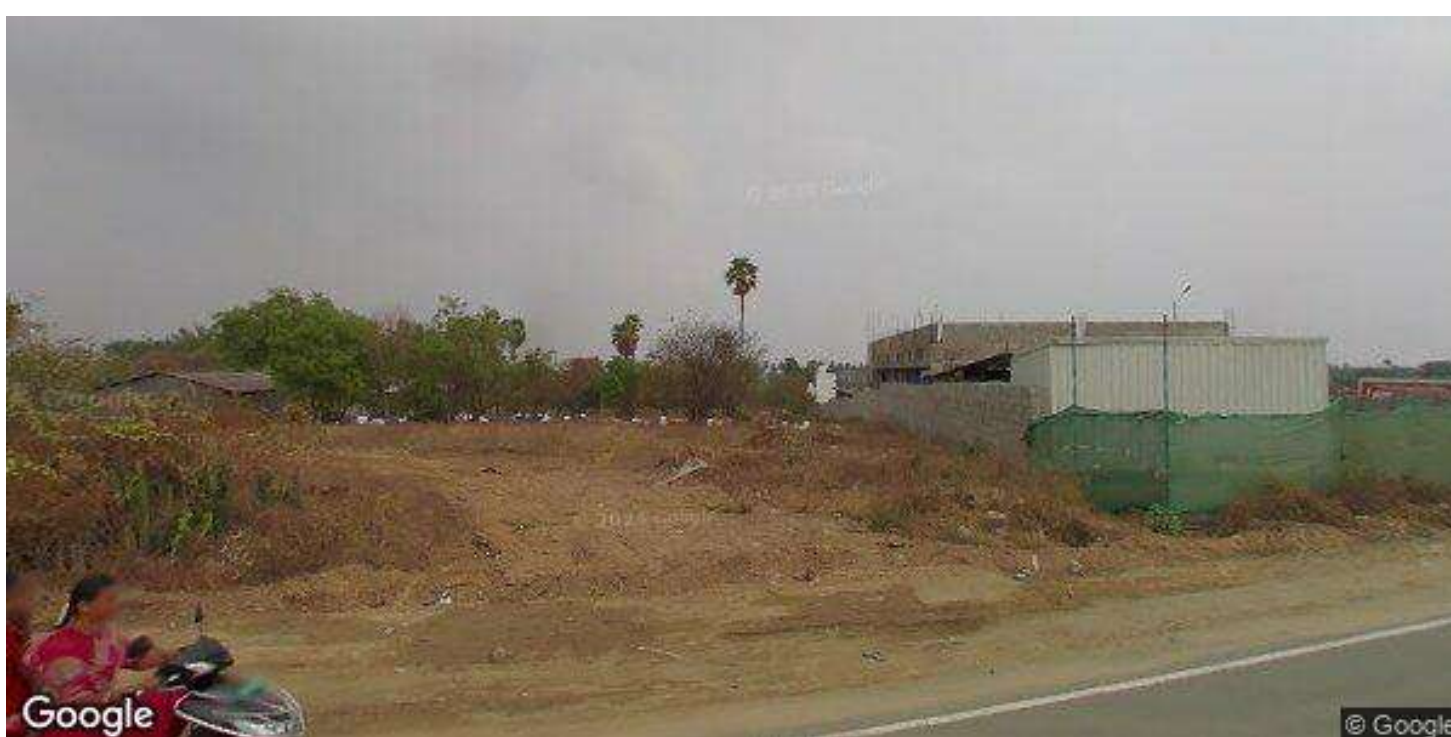
| | Risk Type | Risk Level | Coordinates | Speed Limit |
|---|---|---|---|---|
| 16 | Blind Spot | Blind Spot | 11.39995, 77.64214 | 10 KM/Hr |

**Risk Type:** Blind Spot  
**Risk Level:** Blind Spot

**Speed Limit: 10 KM/Hr**  
**Coordinates: 11.39995, 77.64214**
