## **JOURNEY RISK MANAGEMENT (JRM) STUDY**

**Salem Terminal to ADHOC SRI GARUDA AGENCY UNIT  
II, 330720 JANANEYSHRI FUELS**

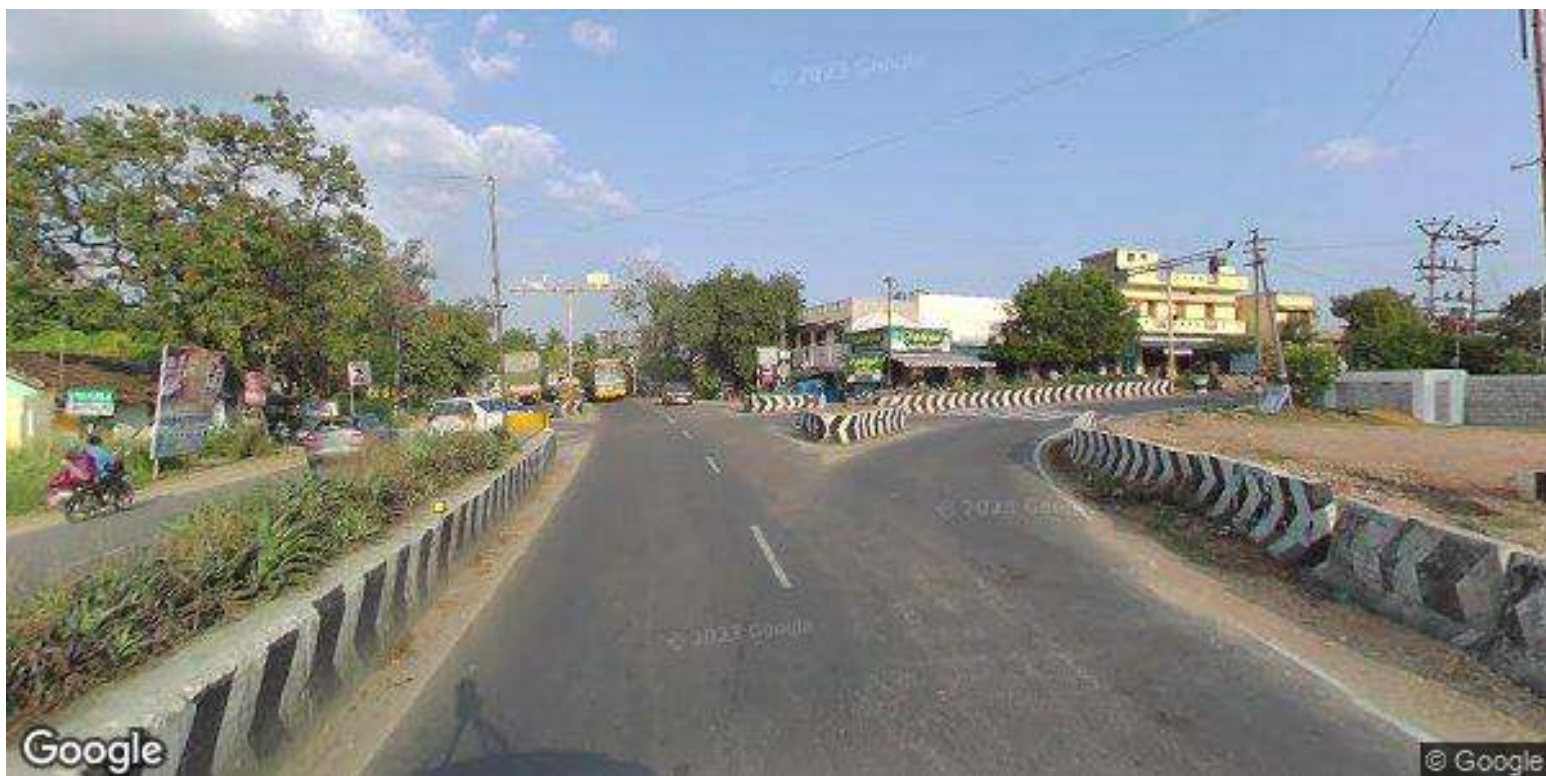
**Coordinates: 11.46318, 77.84913**

**Risk Type: Turn**

**Risk Level: Medium**

**Speed Limit: 30 KM/Hr**

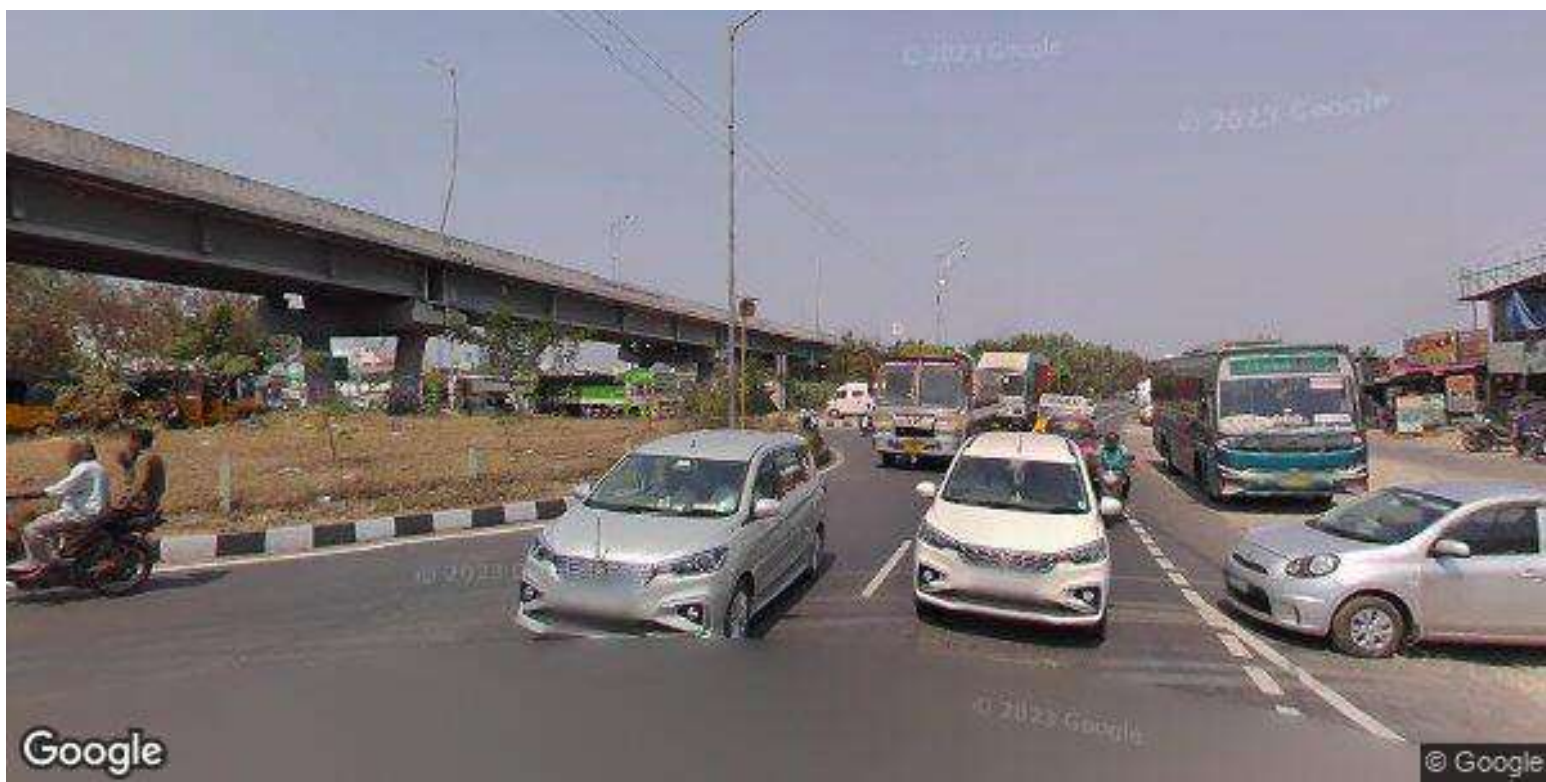
**Coordinates:** 11.43001, 77.67575

**Risk Type:** Turn

**Risk Level:** High

**Speed Limit:** 15 KM/Hr

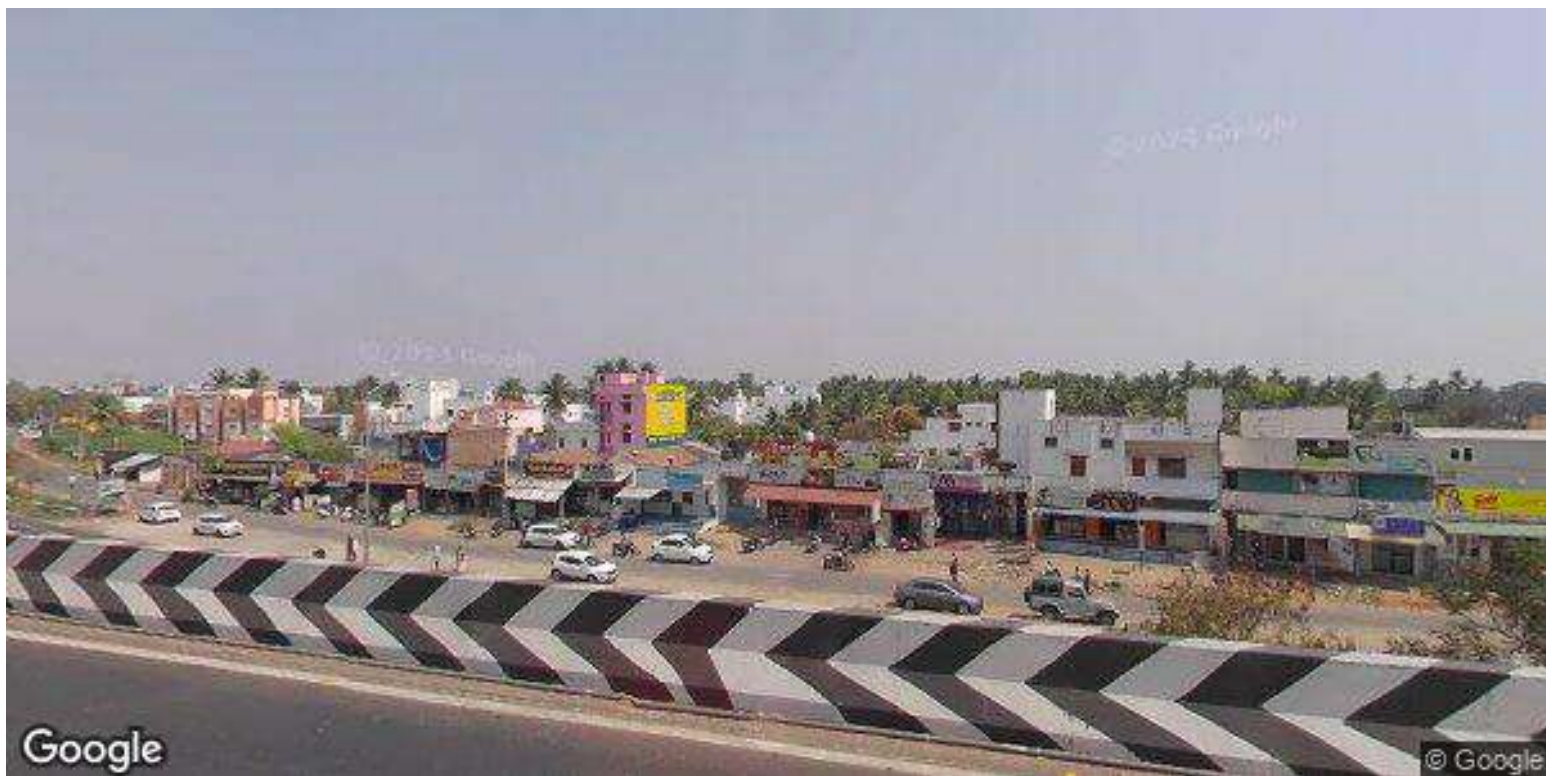
**Coordinates:** 11.43003, 77.67551

**Risk Type:** Turn

**Risk Level:** Medium

**Speed Limit:** 30 KM/Hr

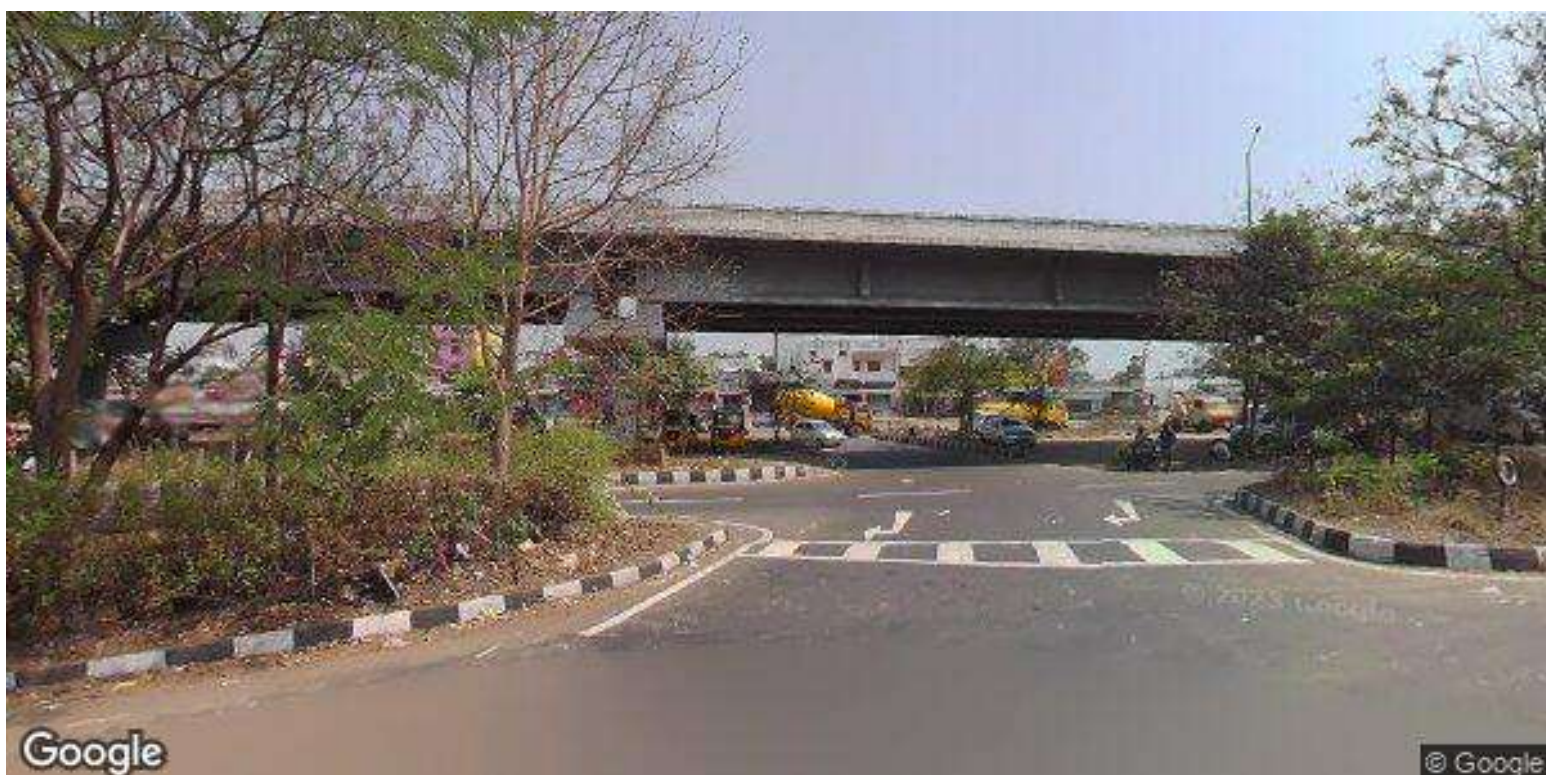
**Risk Type:** Turn  
**Risk Level:** High  
**Speed Limit:** 15 KM/Hr  
**Coordinates:** 11.43026, 77.67525

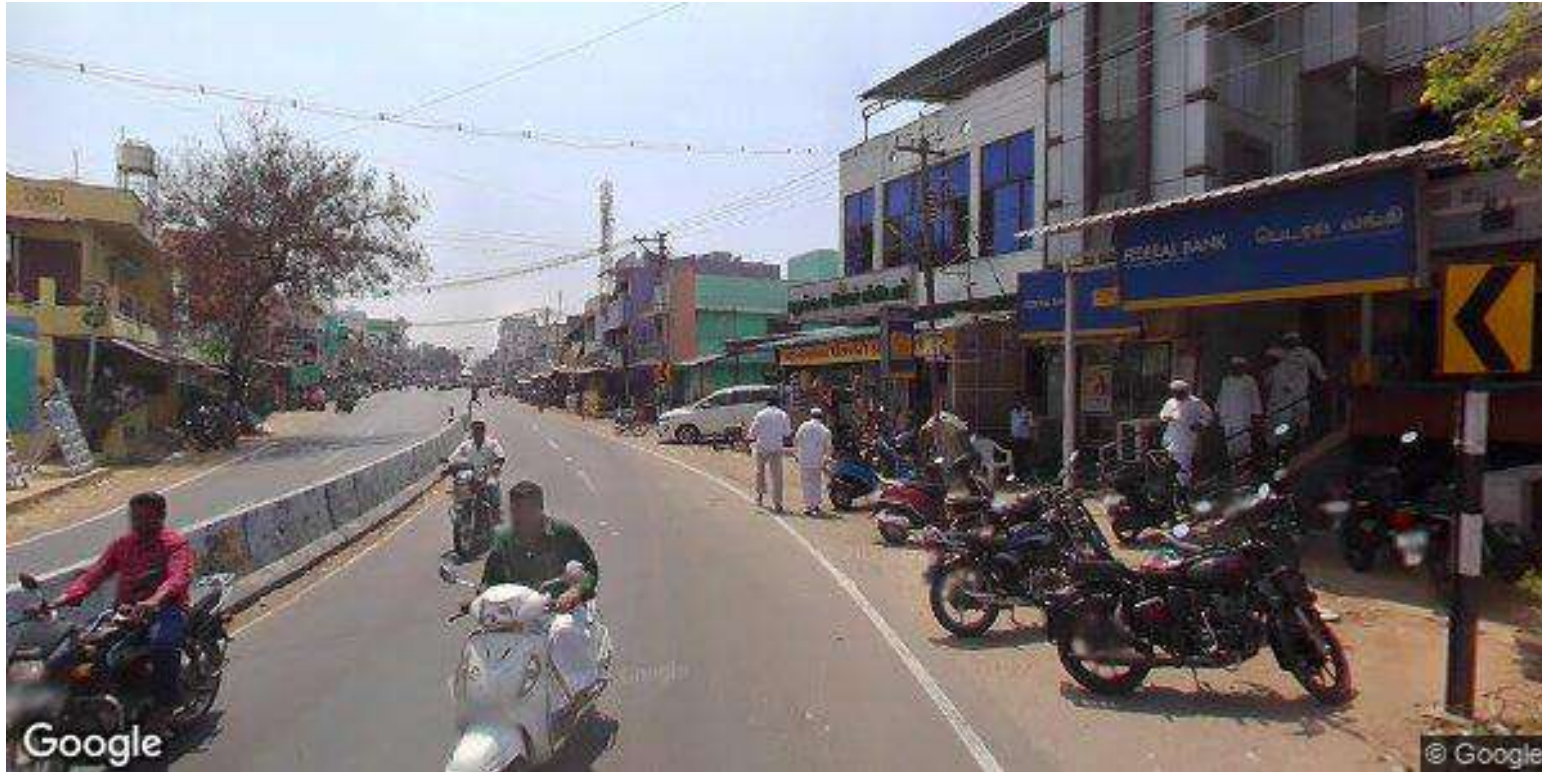
**Risk Type:** Turn  
**Risk Level:** Medium  
**Speed Limit:** 30 KM/Hr  
**Coordinates:** 11.43769, 77.67810

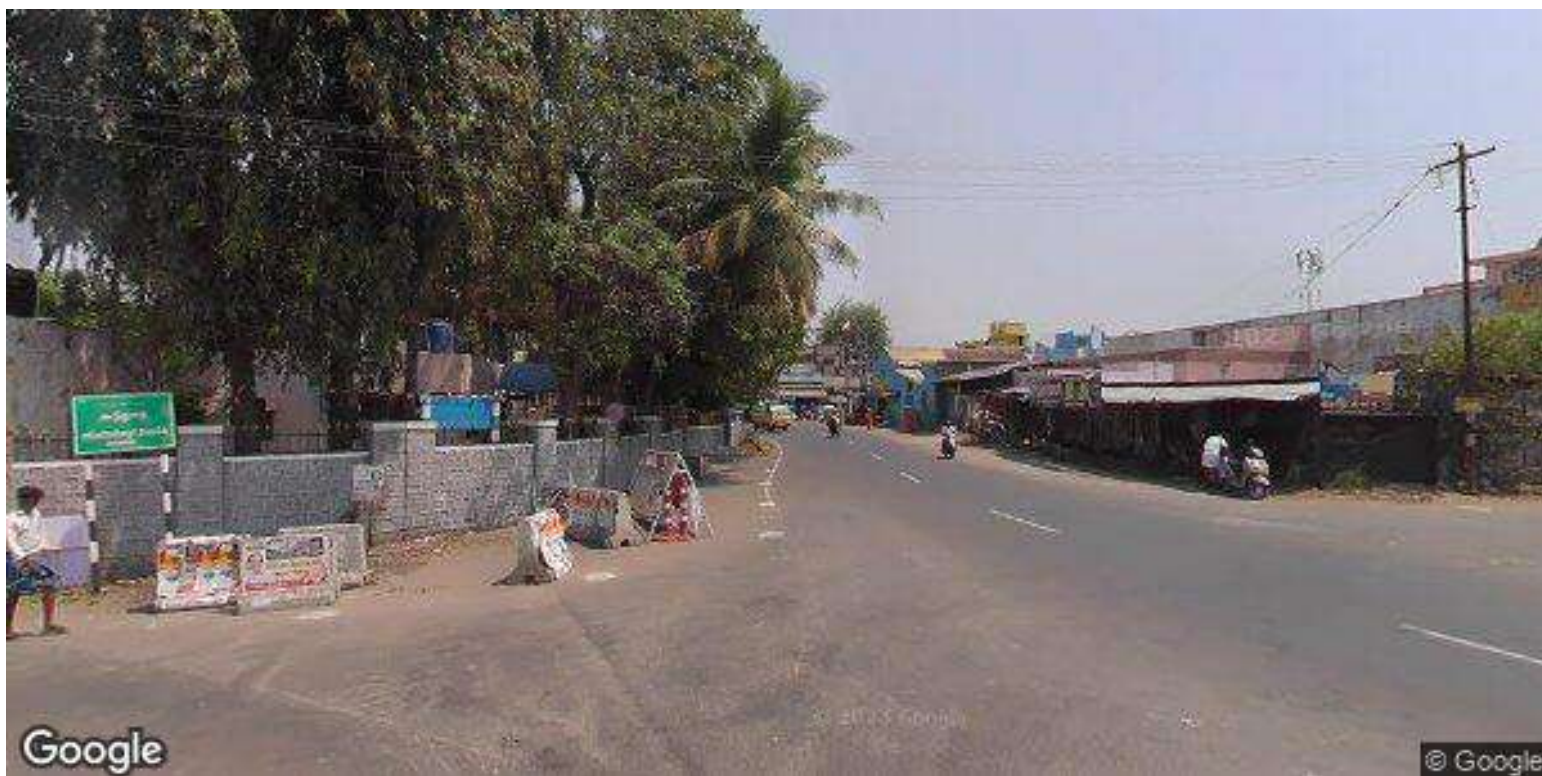
**Risk Type:** Turn  
**Risk Level:** High  
**Speed Limit:** 15 KM/Hr  
**Coordinates:** 11.43863, 77.68223

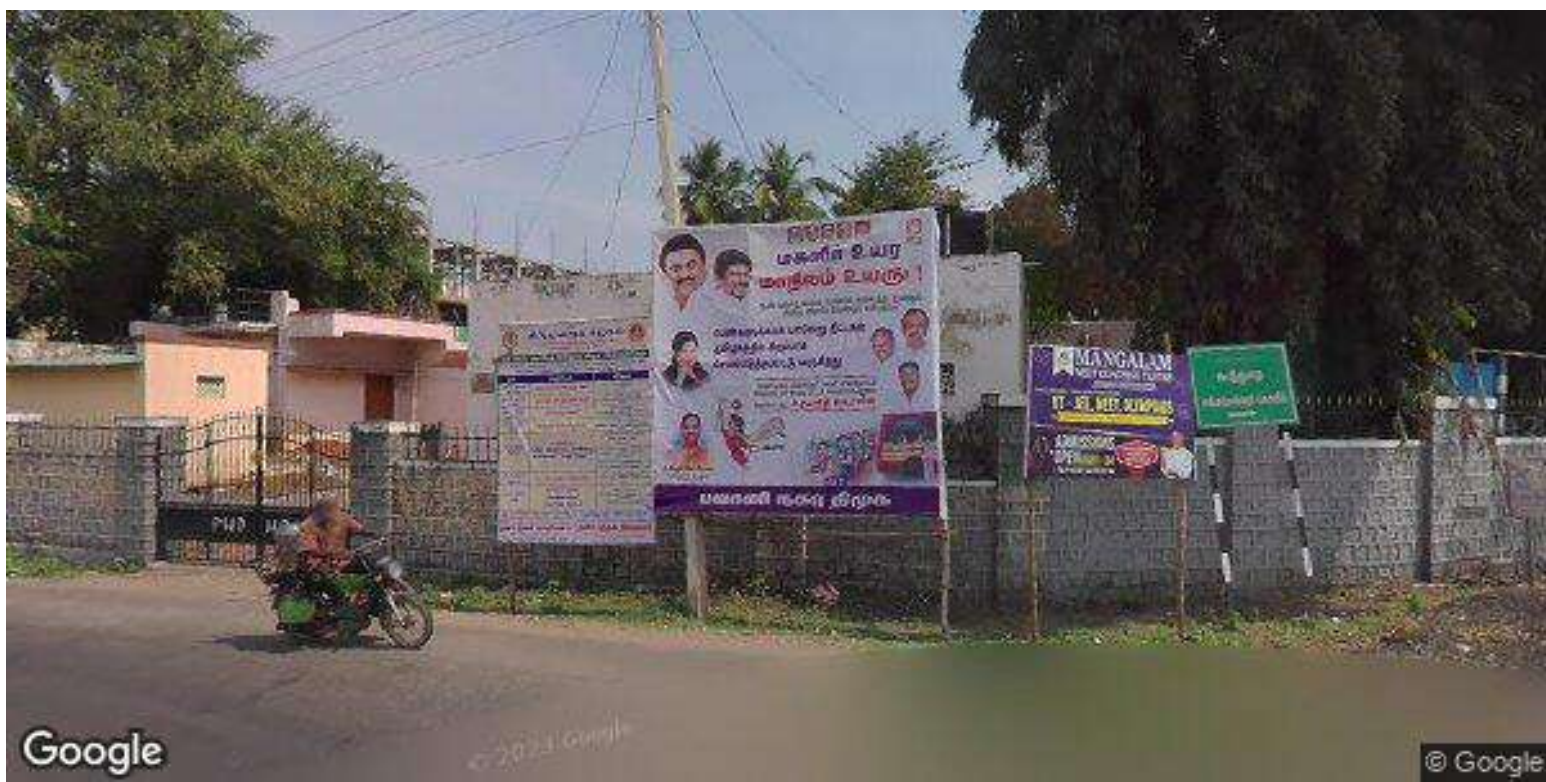
**Coordinates:** 11.43871, 77.68228

**Risk Type:** Turn

**Risk Level:** Medium

**Speed Limit:** 30 KM/Hr

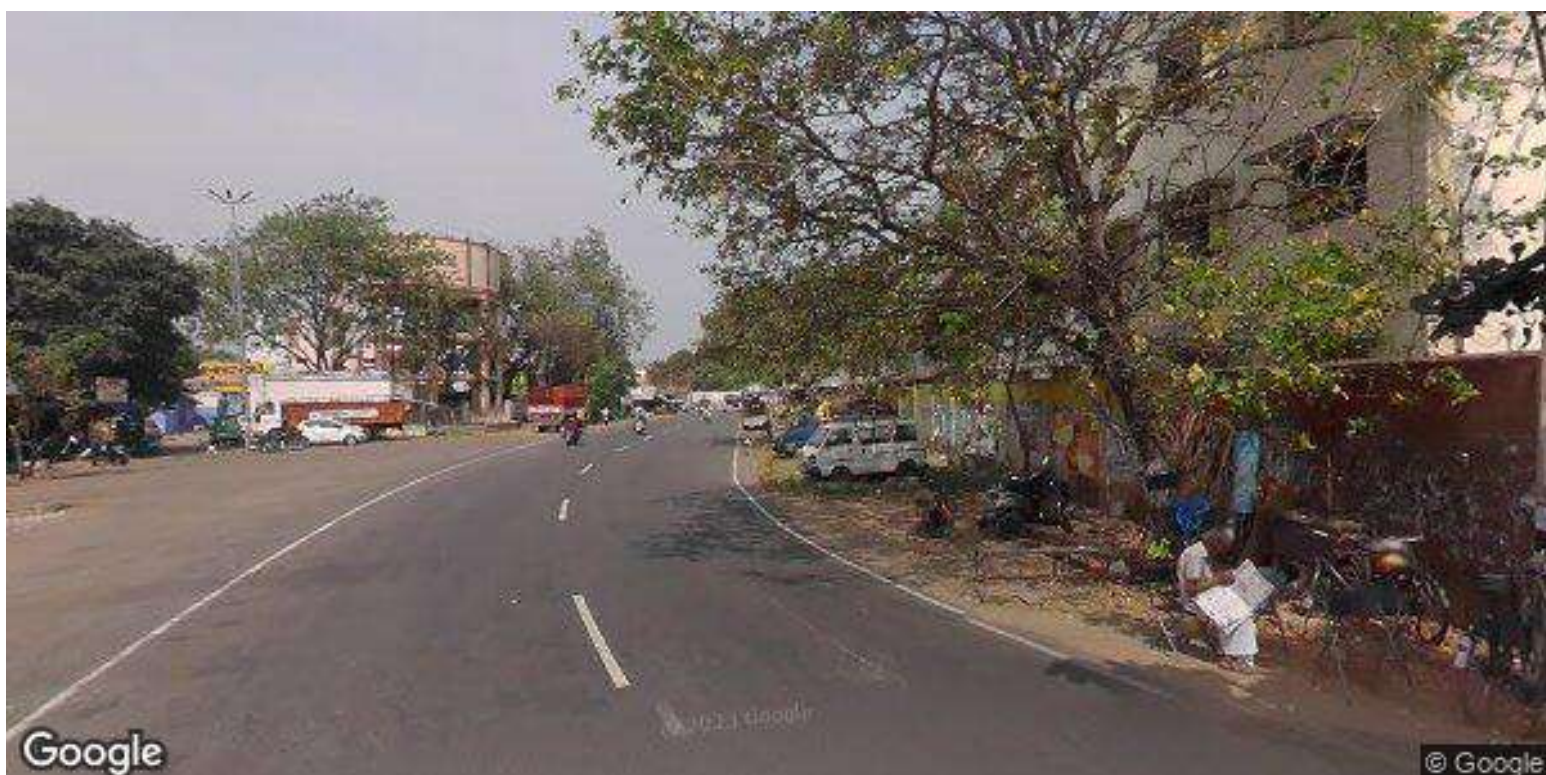
**Coordinates:** 11.43997, 77.68198

**Risk Type:** Turn

**Risk Level:** Medium

**Speed Limit:** 30 KM/Hr

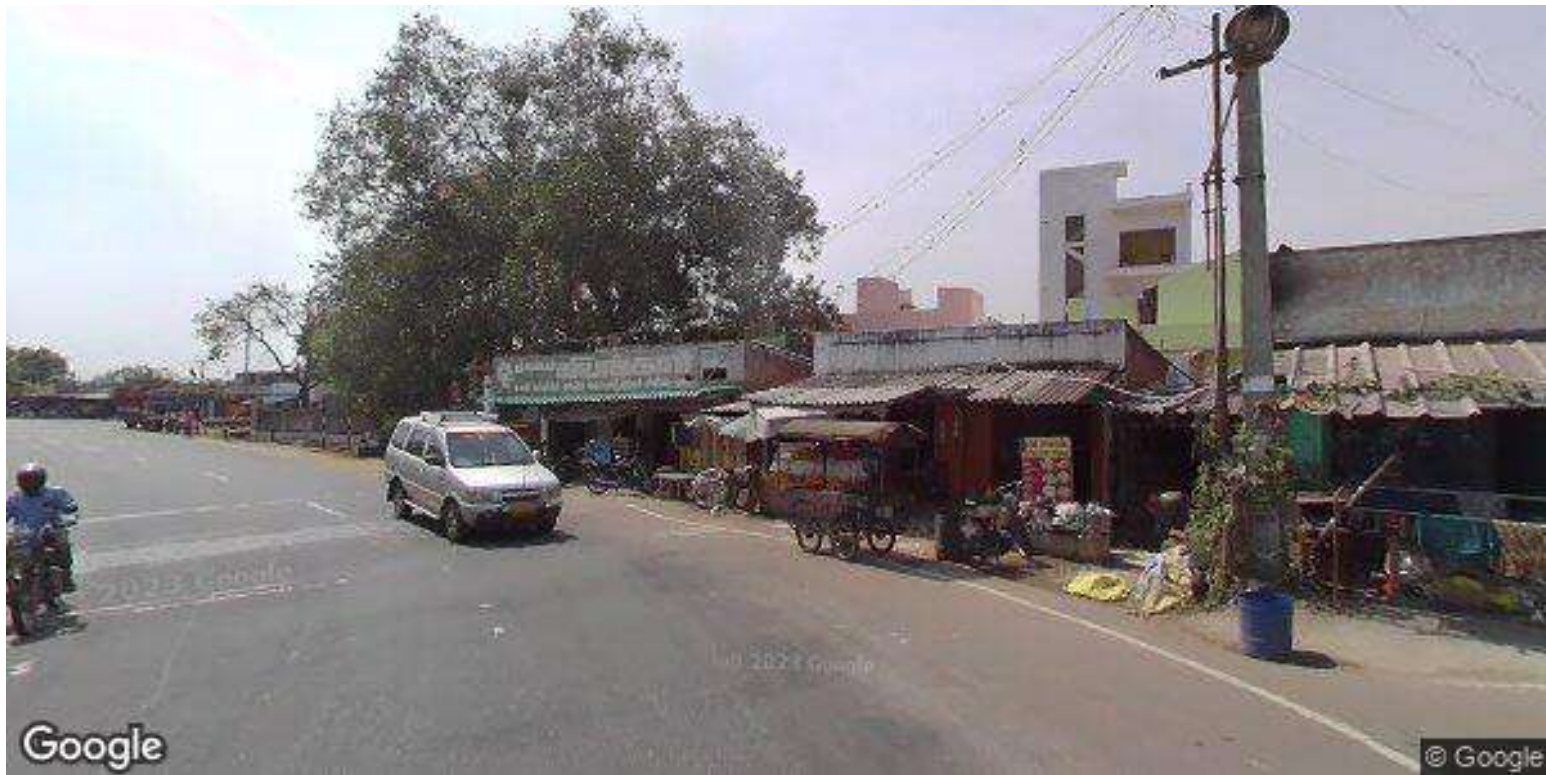
**Coordinates:** 11.44105, 77.68187

**Risk Type:** Turn

**Risk Level:** High

**Speed Limit:** 15 KM/Hr

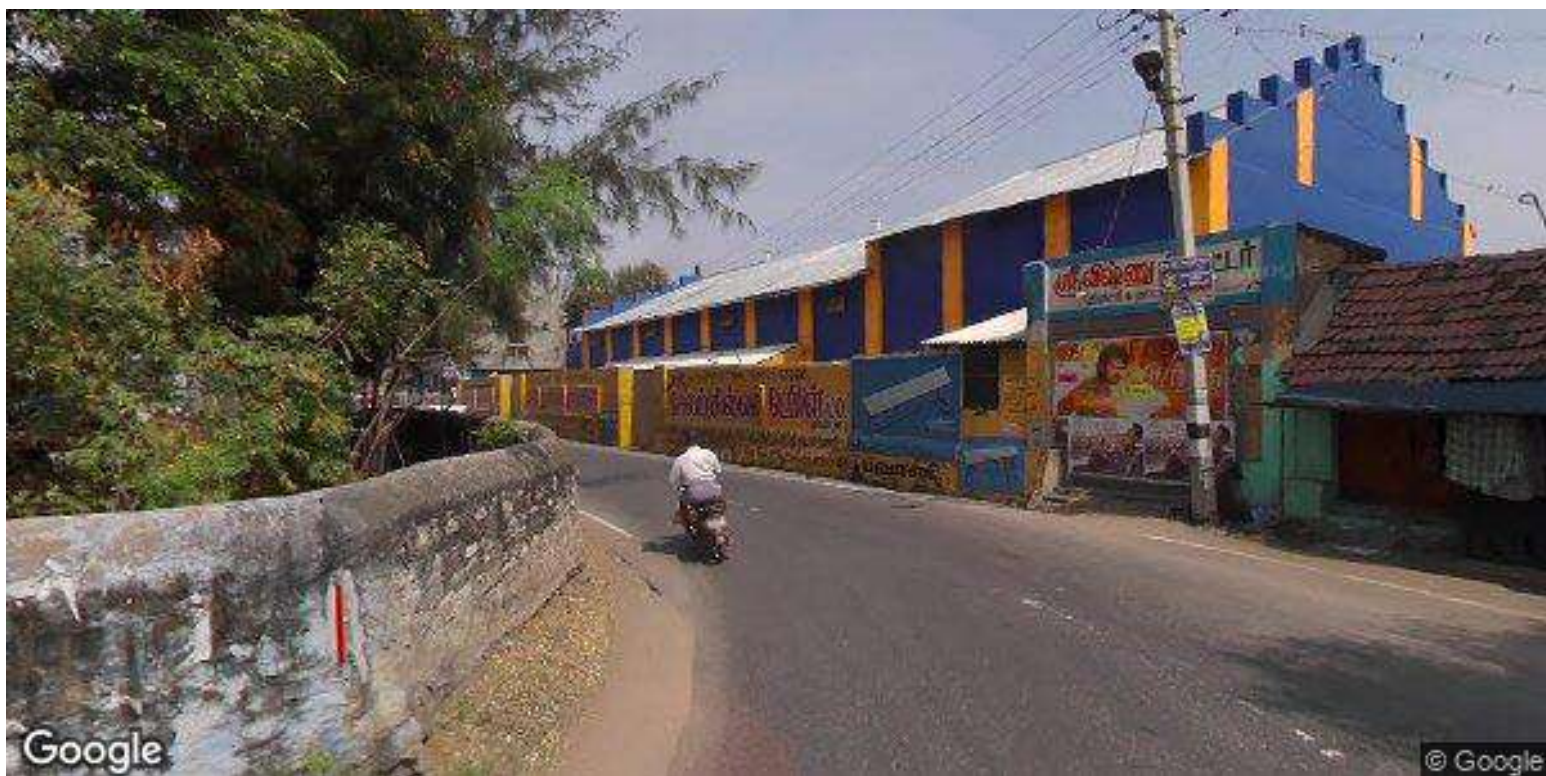
**Coordinates:** 11.44119, 77.68217

**Risk Type:** Turn

**Risk Level:** High

**Speed Limit:** 15 KM/Hr

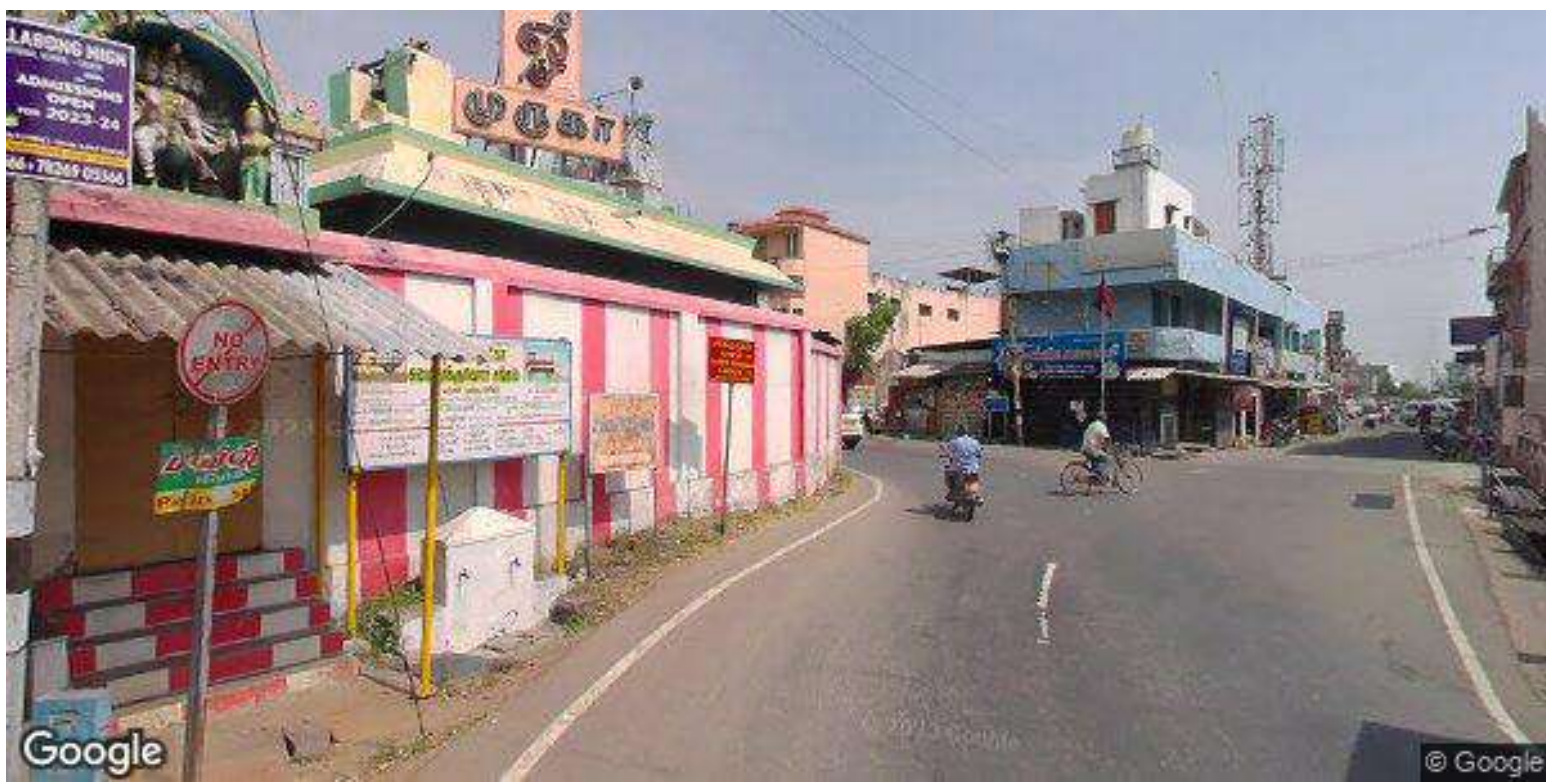
**Coordinates:** 11.44295, 77.68261

**Risk Type:** Turn

**Risk Level:** Medium

**Speed Limit:** 30 KM/Hr

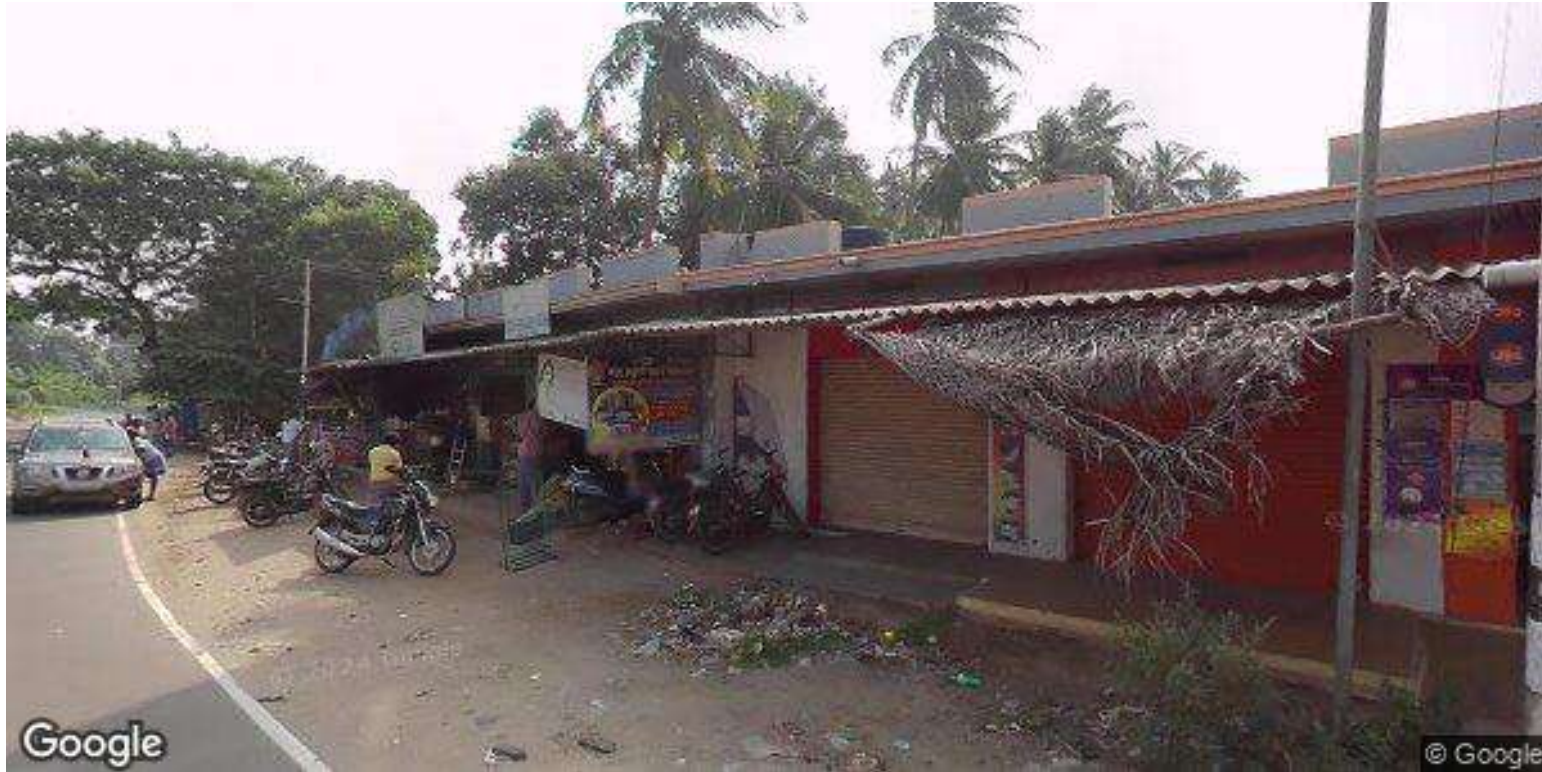
**Coordinates:** 11.52420, 77.52412

**Risk Type:** Blind Spot

**Risk Level:** Blind Spot

**Speed Limit:** 10 KM/Hr
