# IndianOil

## JOURNEY RISK MANAGEMENT (JRM) STUDY

**Salem Terminal to ADHOC SRI RAGAVENDRA FUELS  
UNIT II 325143 SRM SANJAY PETROLEUM**

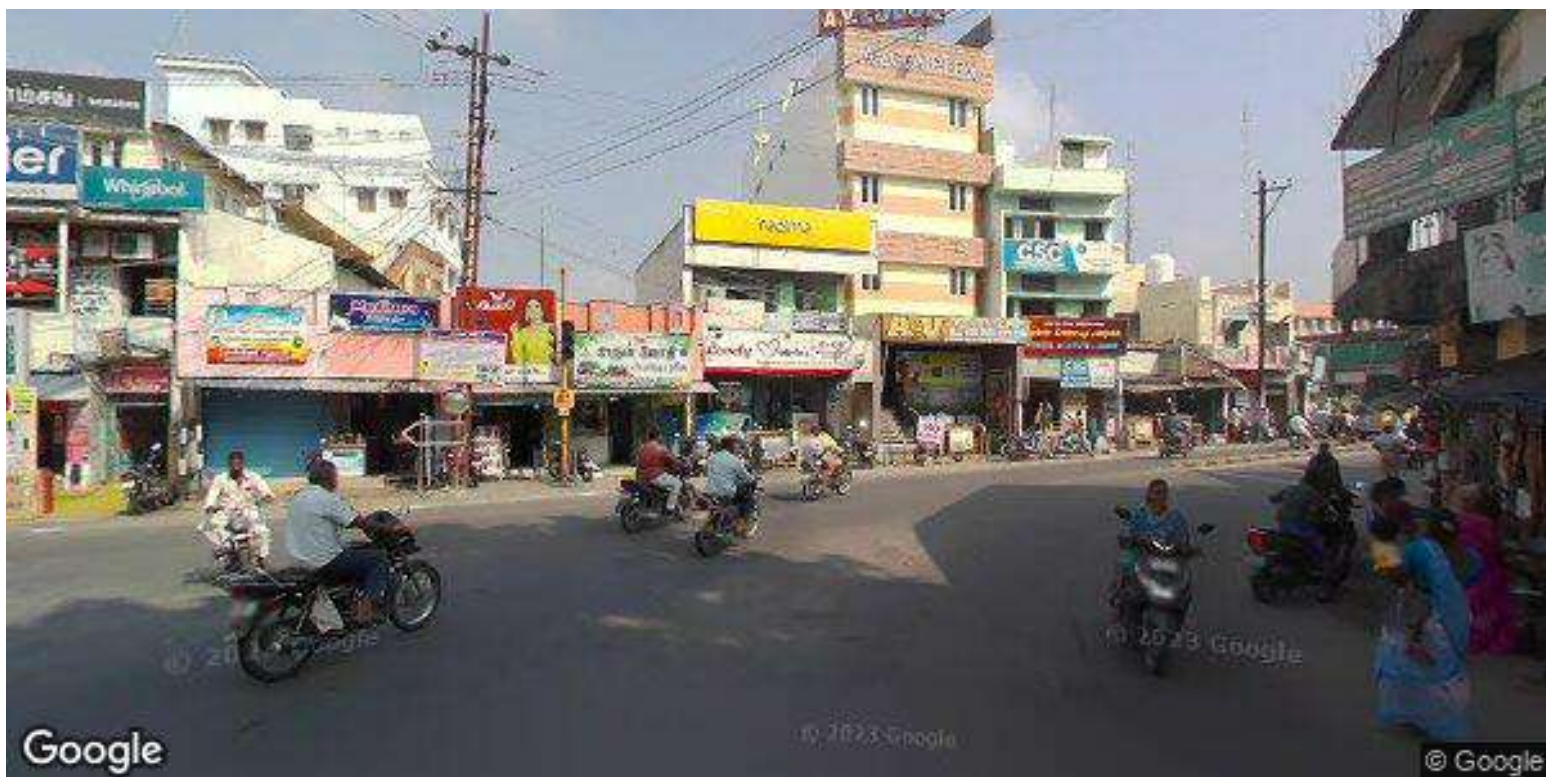
**Risk Type: Turn**  
**Risk Level: Medium**  
**Speed Limit: 30 KM/Hr**  
**Coordinates: 11.37842, 77.89452**

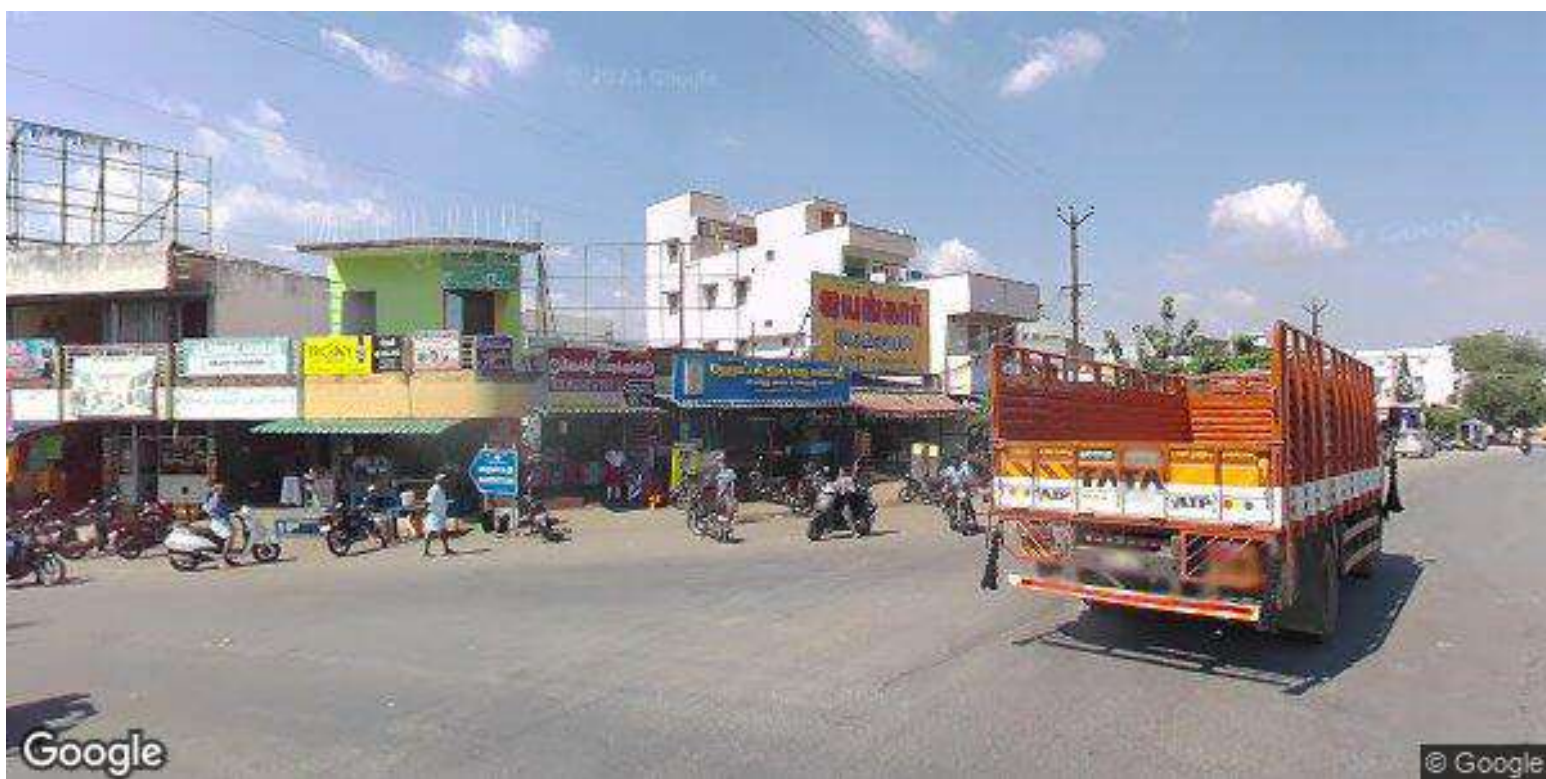
**Coordinates:** 11.36602, 77.88875

**Risk Type:** Turn

**Risk Level:** Medium

**Speed Limit:** 30 KM/Hr

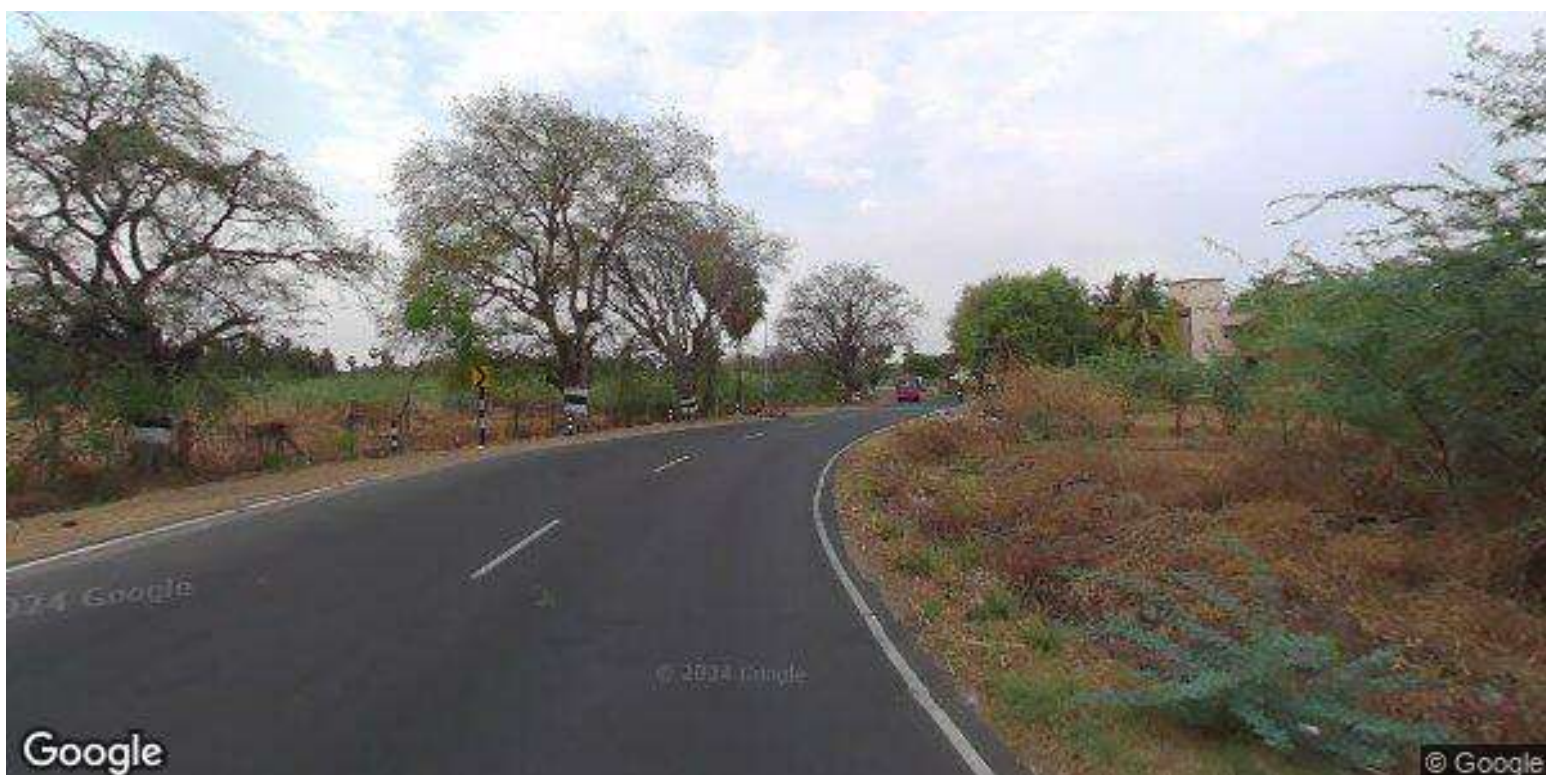
**Risk Type:** Turn  
**Risk Level:** Medium  
**Speed Limit:** 30 KM/Hr  
**Coordinates:** 11.34067, 77.86347

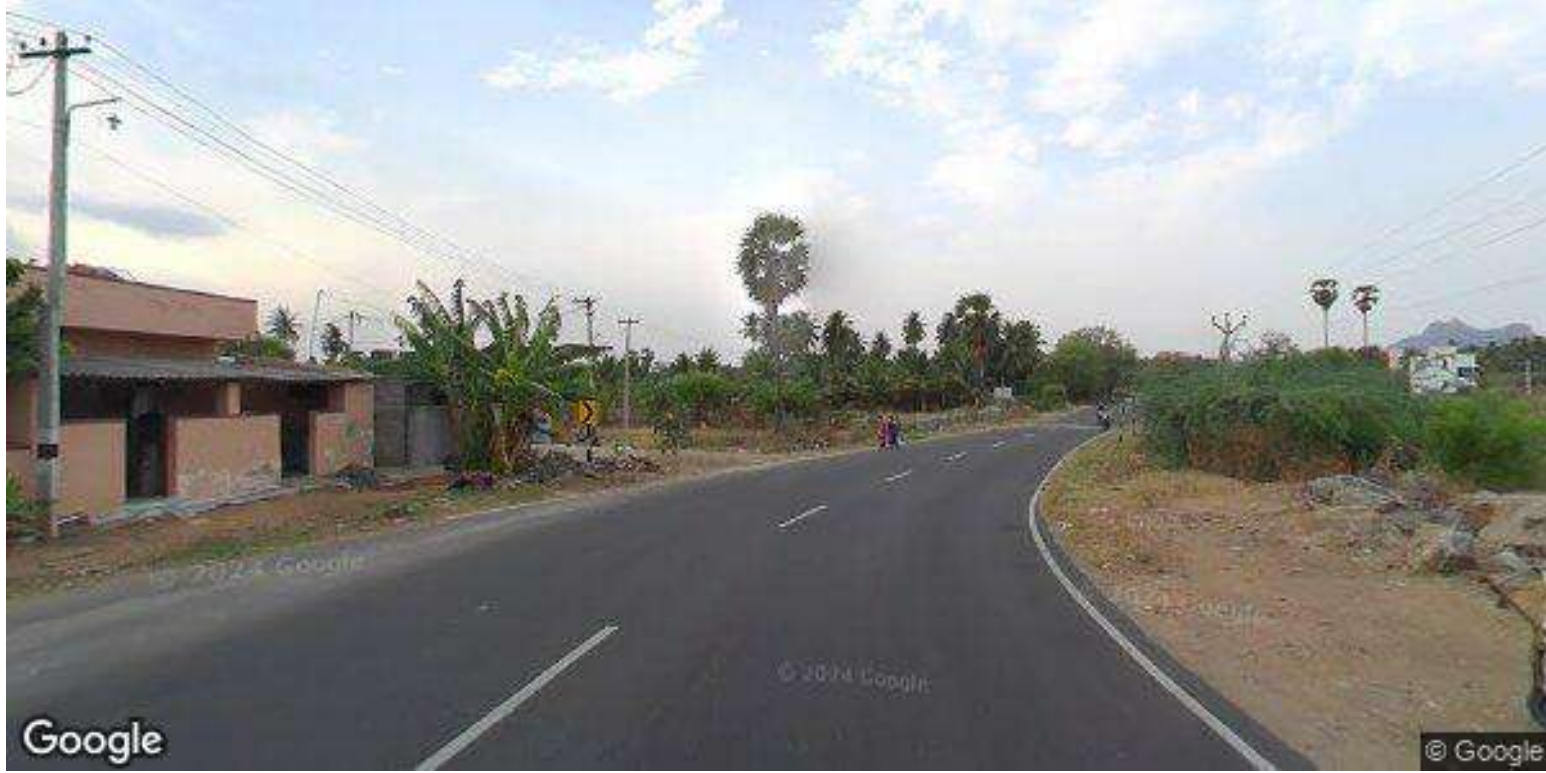
**Risk Type:** Turn  
**Risk Level:** Medium  
**Speed Limit:** 30 KM/Hr  
**Coordinates:** 11.33882, 77.86218

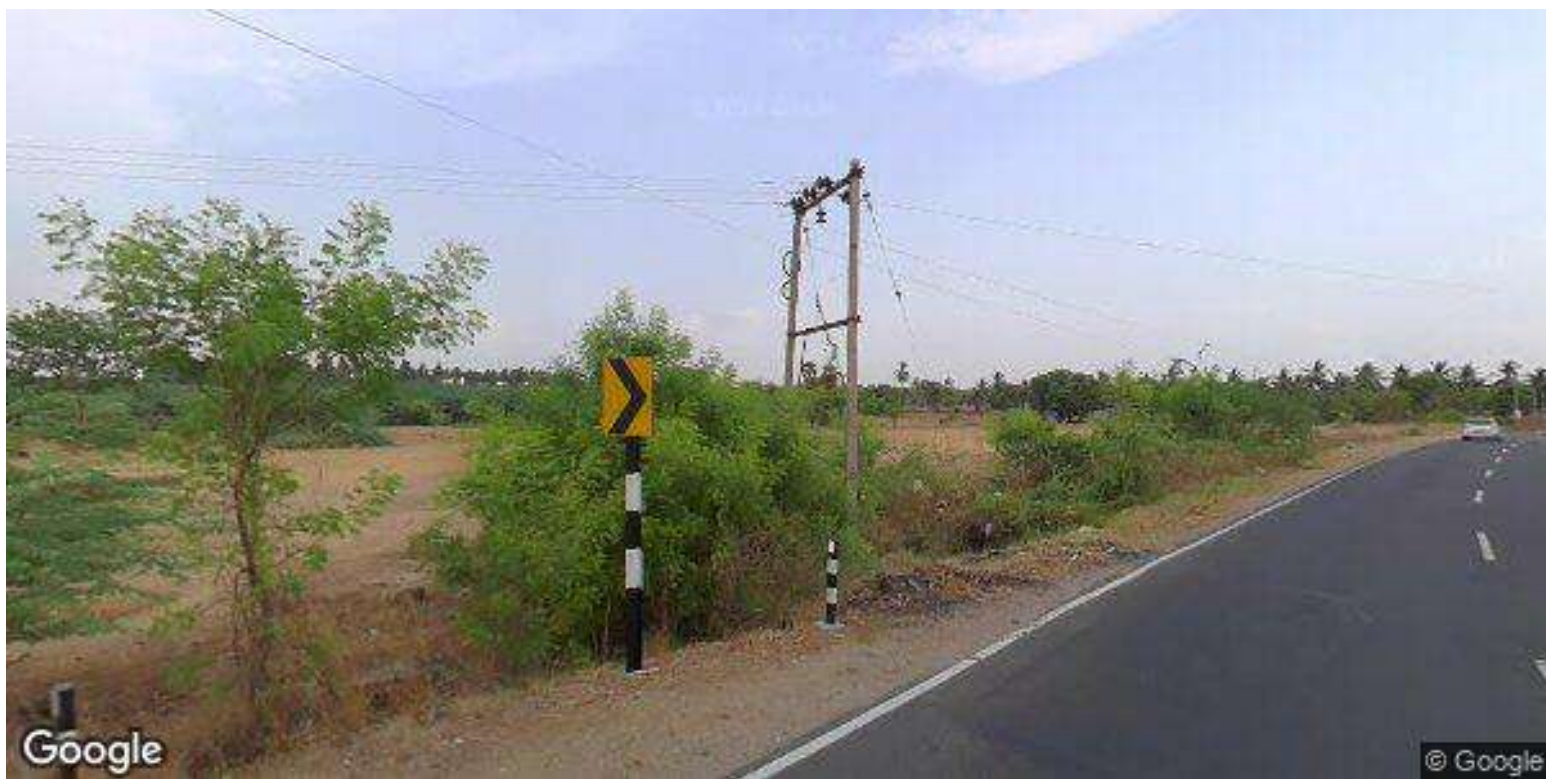
**Risk Type:** Turn  
**Risk Level:** Medium  
**Speed Limit:** 30 KM/Hr  
**Coordinates:** 11.33778, 77.86236

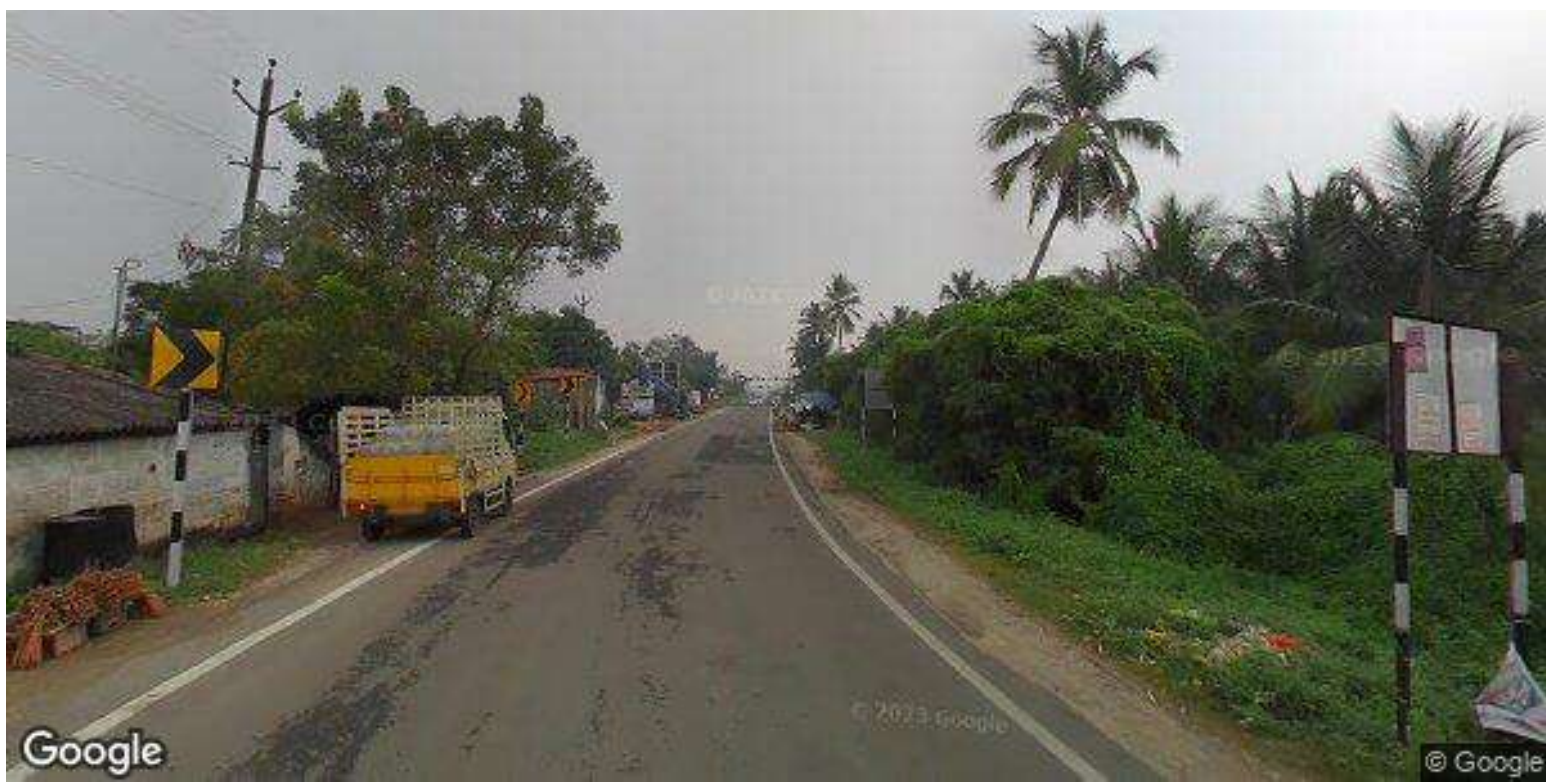
**Coordinates:** 11.30973, 77.76712

**Risk Type:** Turn

**Risk Level:** Medium

**Speed Limit:** 30 KM/Hr

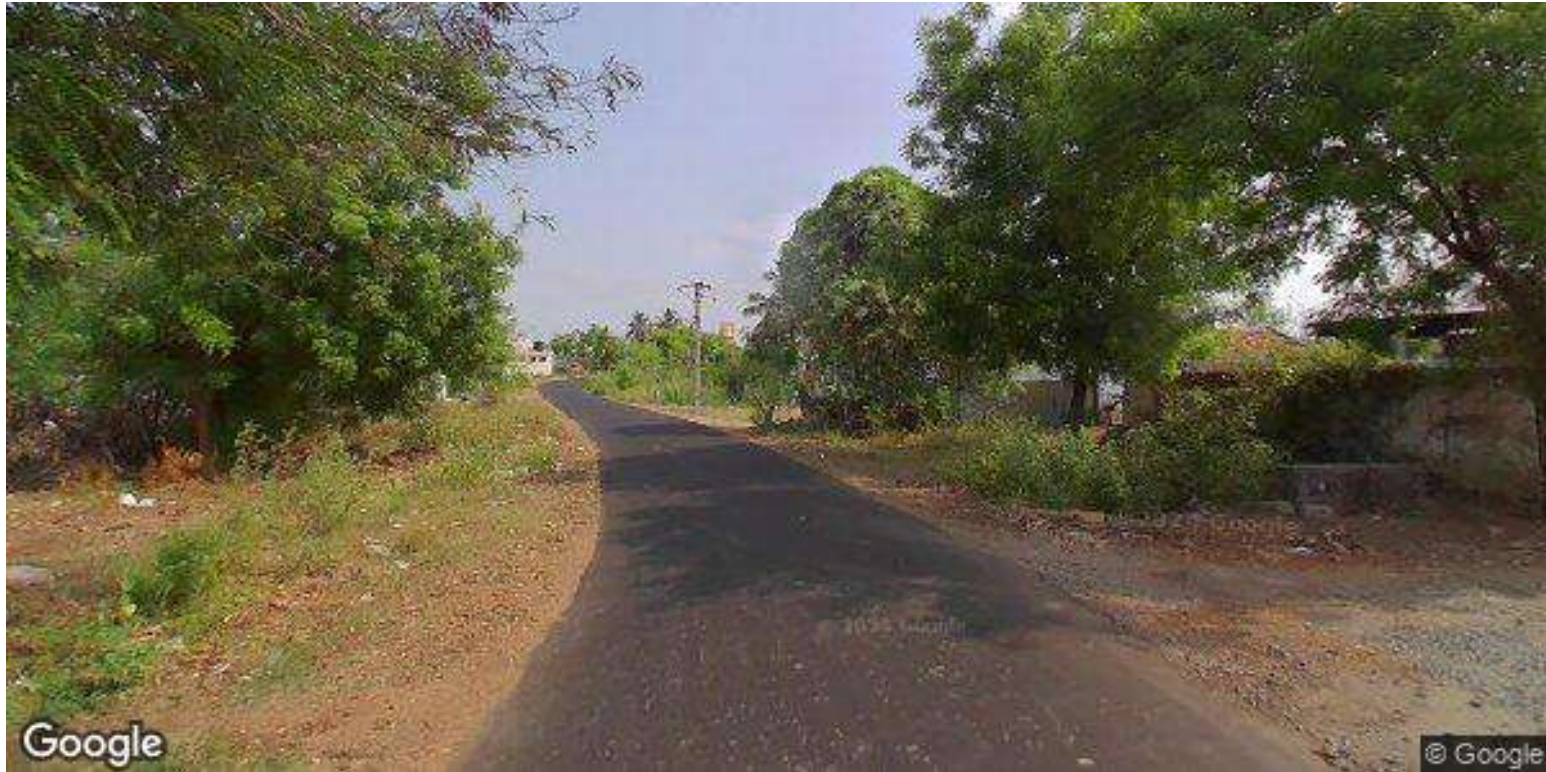
**Risk Type:** Turn  
**Risk Level:** Medium  
**Speed Limit:** 30 KM/Hr  
**Coordinates:** 11.28844, 77.74319

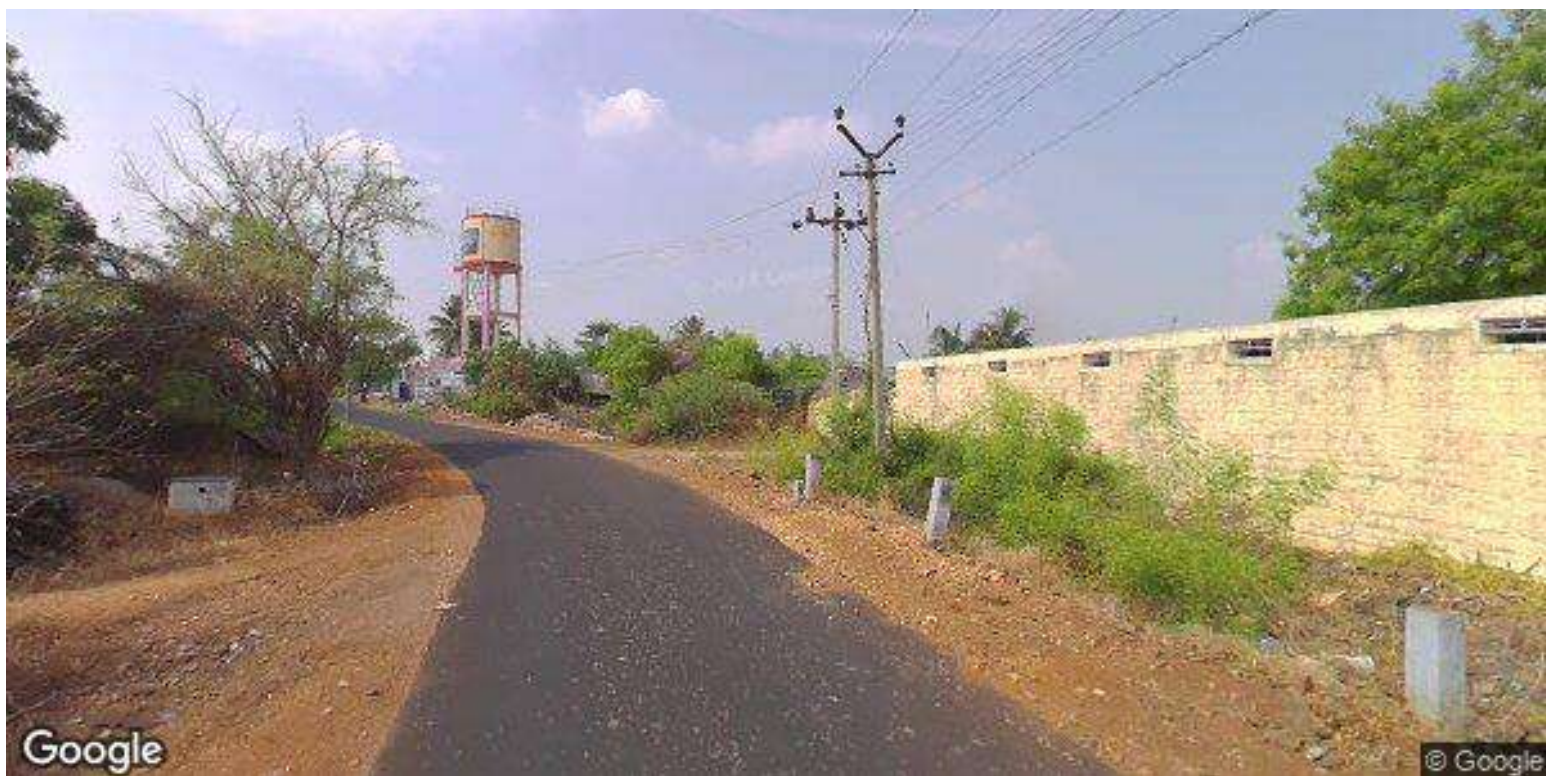
**Risk Type:** Turn  
**Risk Level:** Medium  
**Speed Limit:** 30 KM/Hr  
**Coordinates:** 11.28573, 77.74281

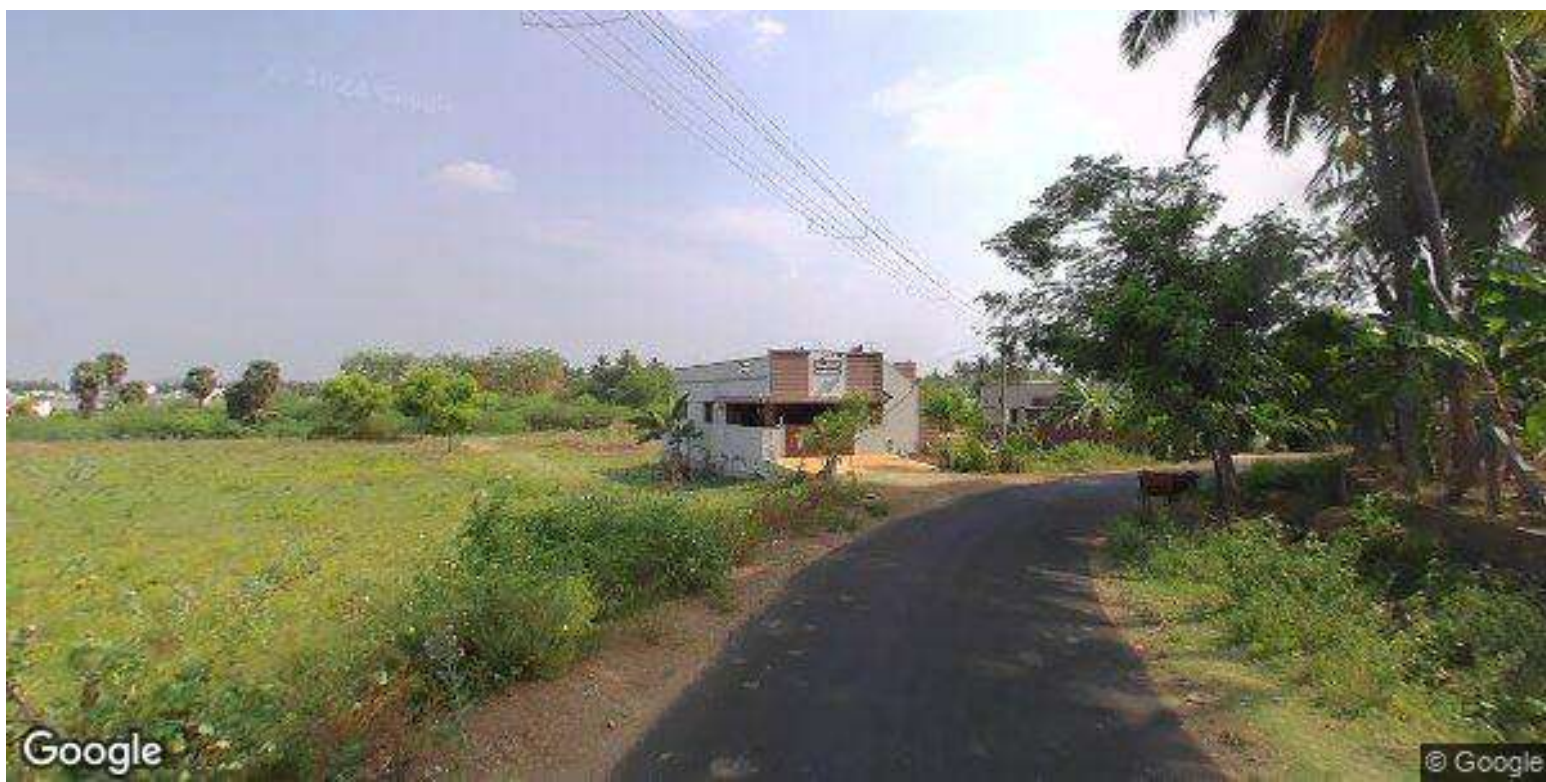
**Coordinates:** 11.27336, 77.72999

**Risk Type:** Turn

**Risk Level:** Medium

**Speed Limit:** 30 KM/Hr

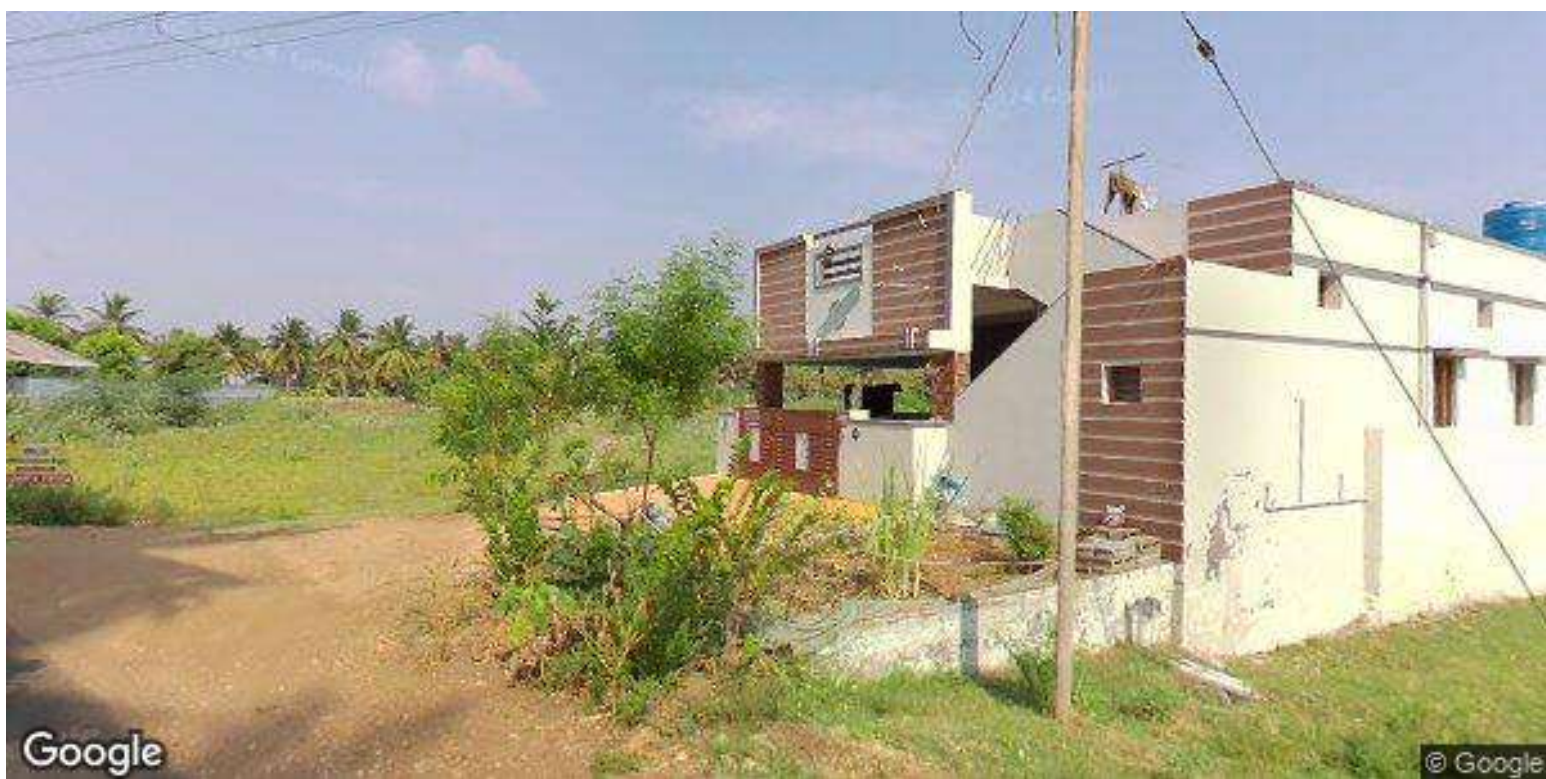
**Coordinates:** 11.27319, 77.72981

**Risk Type:** Turn

**Risk Level:** Medium

**Speed Limit:** 30 KM/Hr

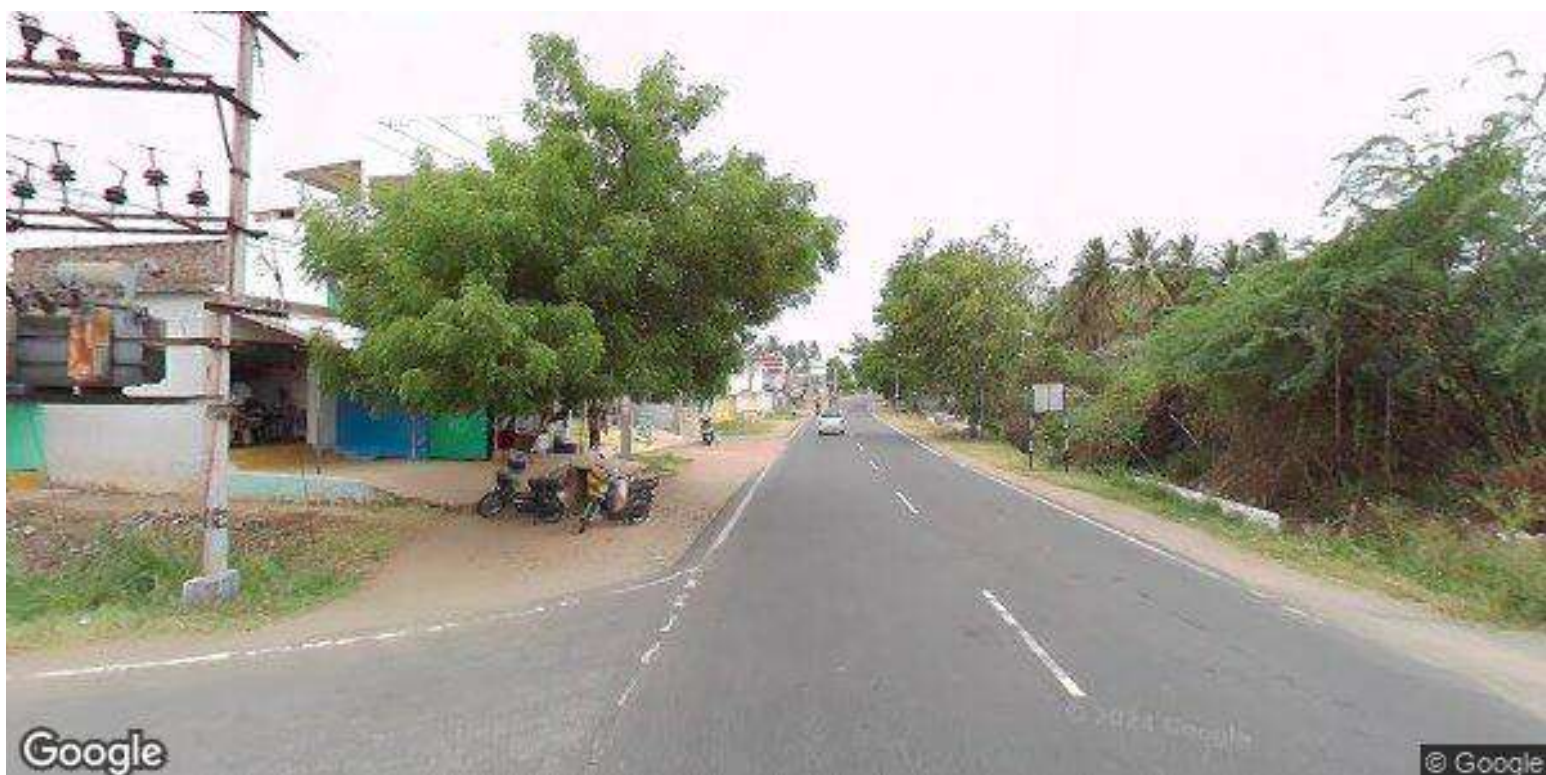
**Risk Type:** Turn  
**Risk Level:** High  
**Speed Limit:** 15 KM/Hr  
**Coordinates:** 11.27328, 77.72705

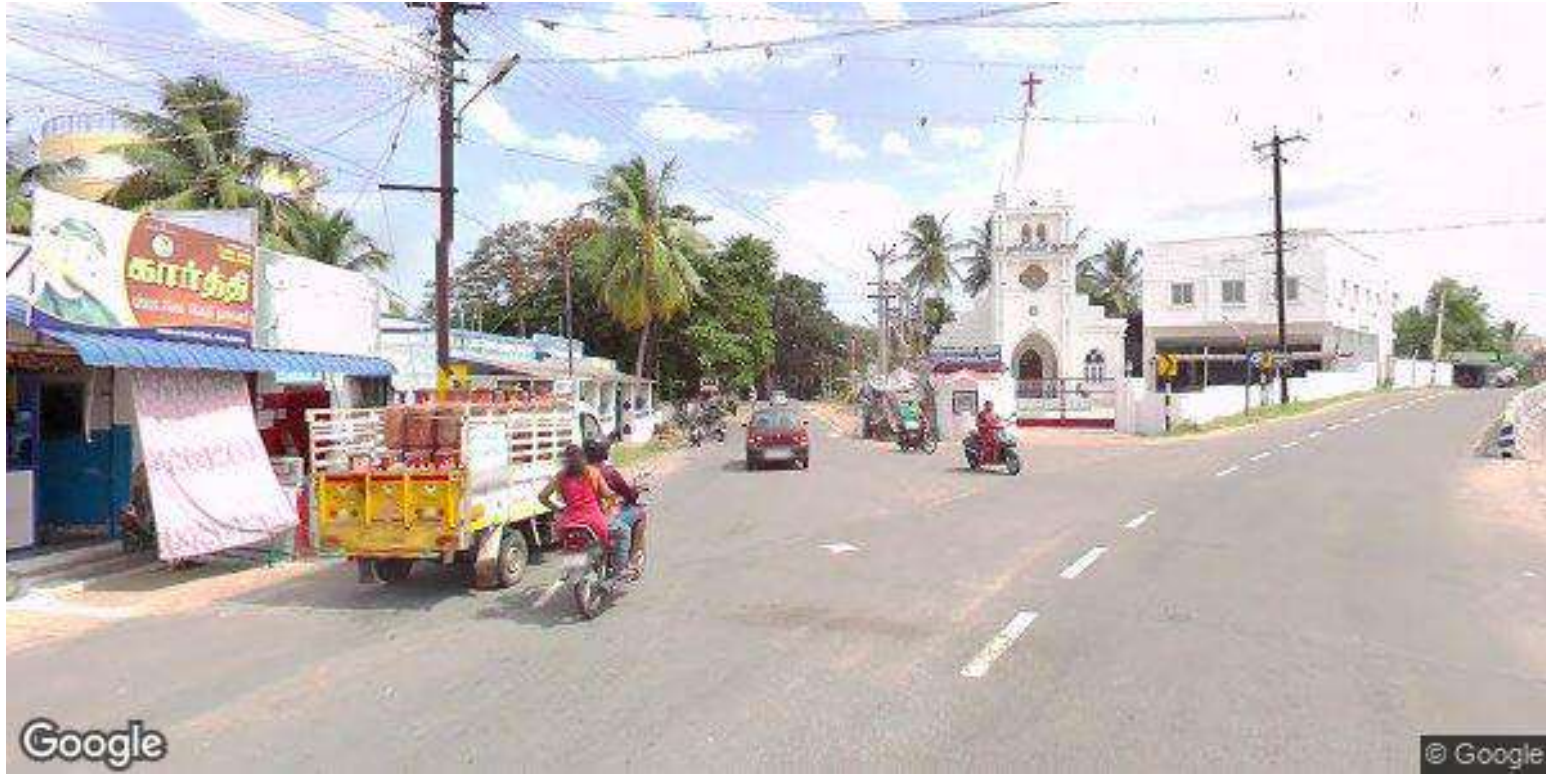
**Risk Type:** Turn  
**Risk Level:** Medium  
**Speed Limit:** 30 KM/Hr  
**Coordinates:** 11.23054, 77.71796

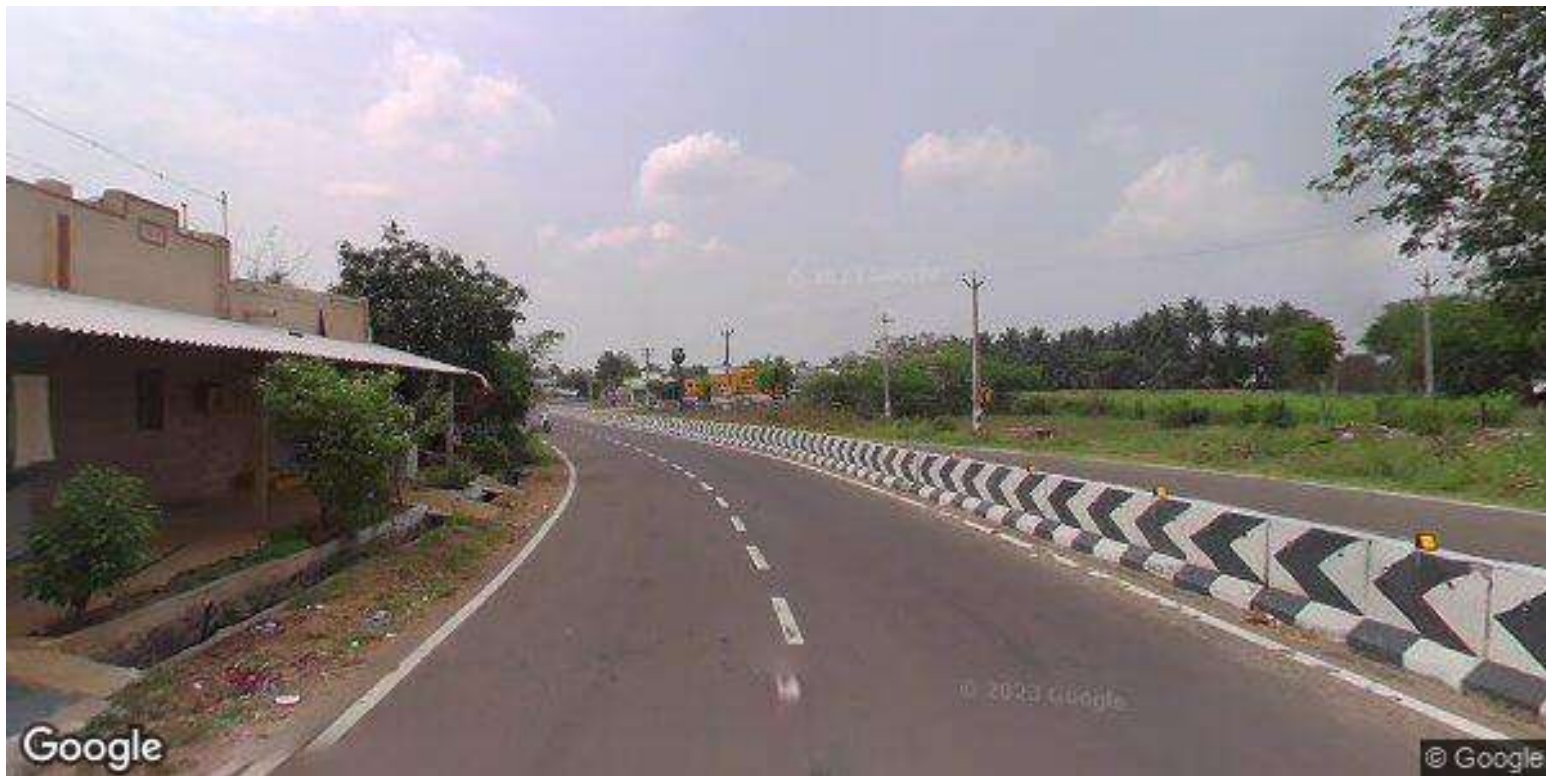
**Risk Type:** Turn  
**Risk Level:** Medium  
**Speed Limit:** 30 KM/Hr  
**Coordinates:** 11.22387, 77.71385

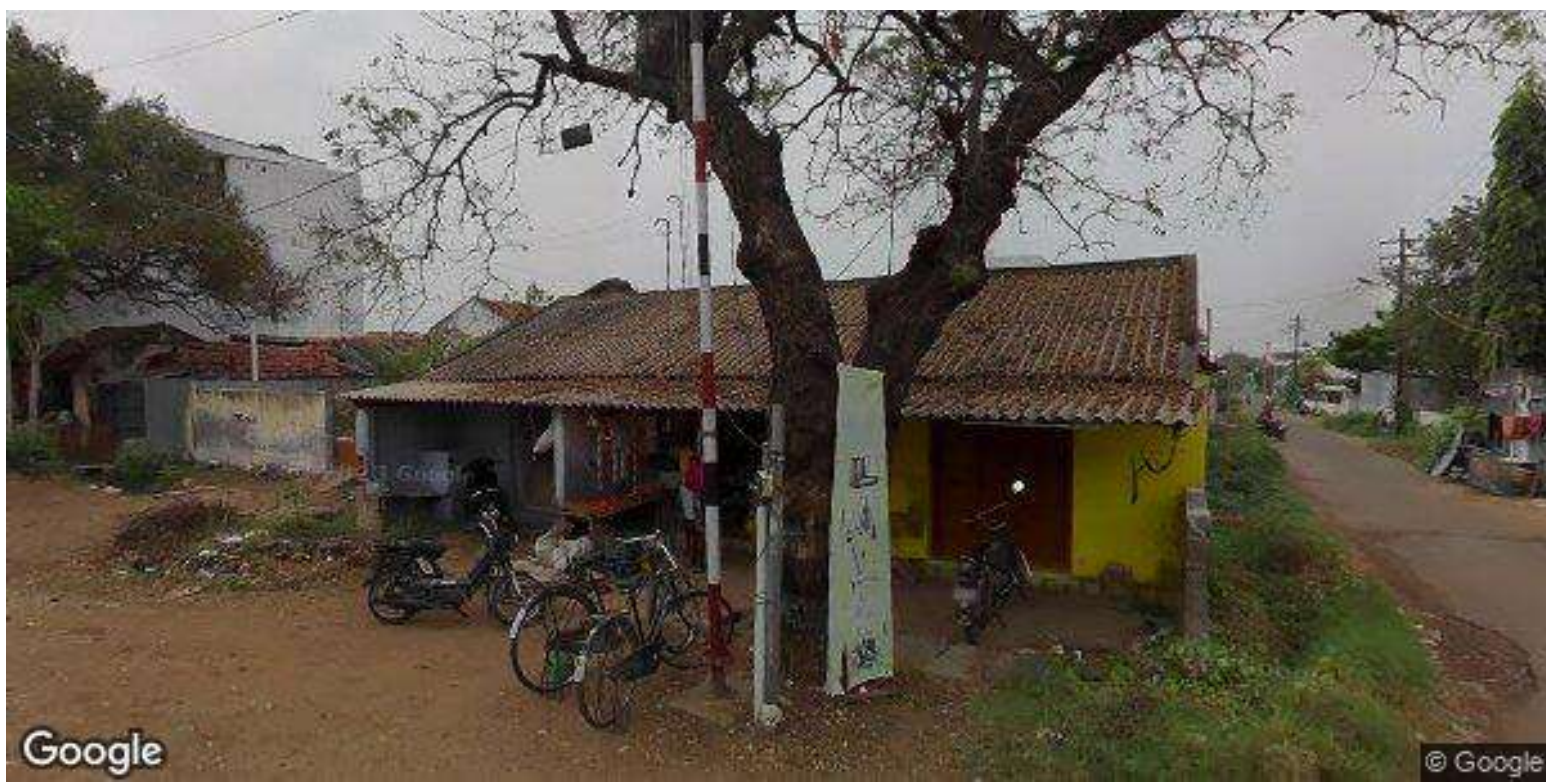
**Coordinates:** 11.09884, 77.66786

**Risk Type:** Turn

**Risk Level:** High

**Speed Limit:** 15 KM/Hr

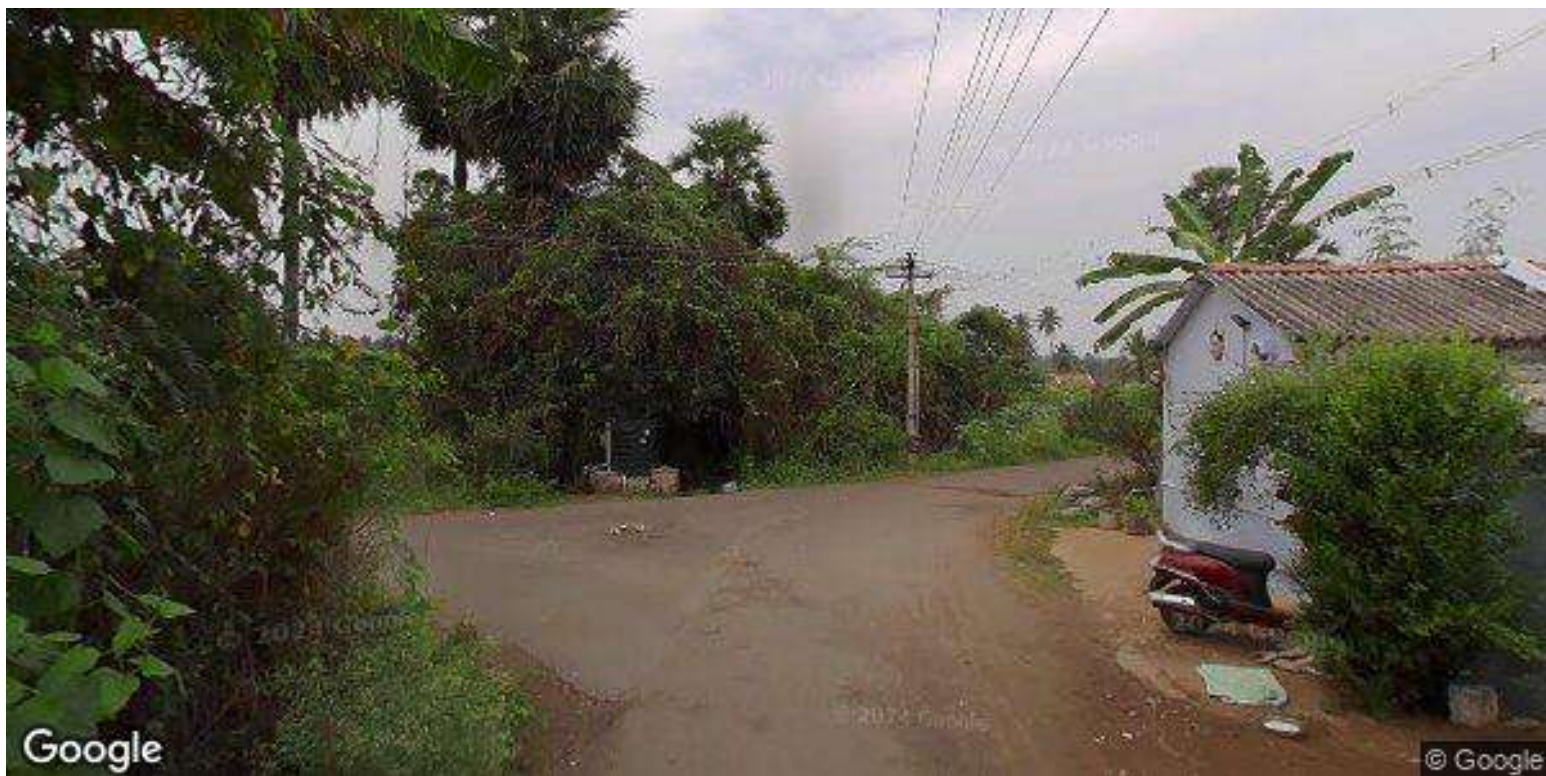
**Coordinates:** 11.09931, 77.66252

**Risk Type:** Turn

**Risk Level:** Medium

**Speed Limit:** 30 KM/Hr

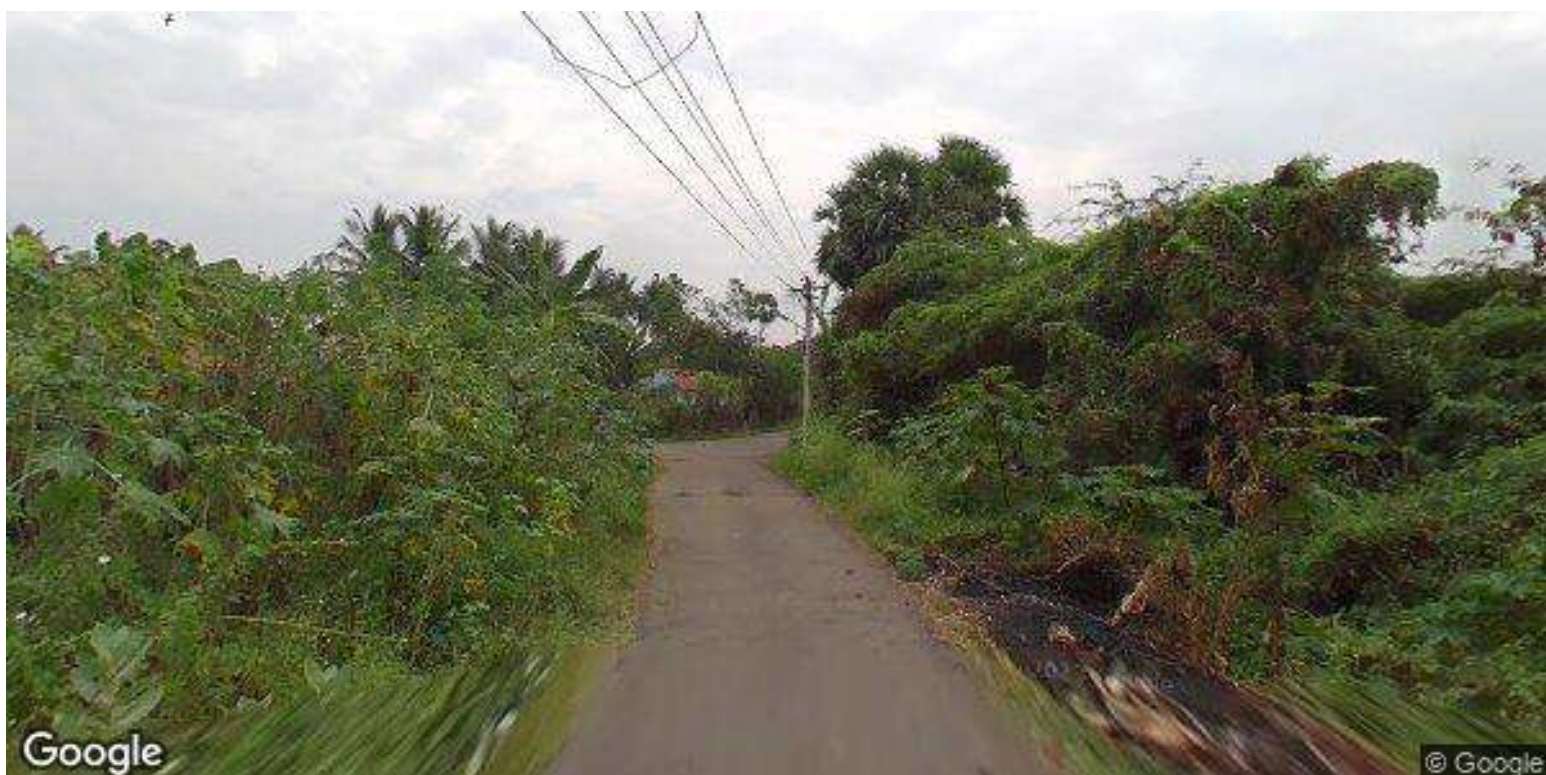
**Risk Type:** Turn  
**Risk Level:** Medium  
**Speed Limit:** 30 KM/Hr  
**Coordinates:** 11.09945, 77.66218

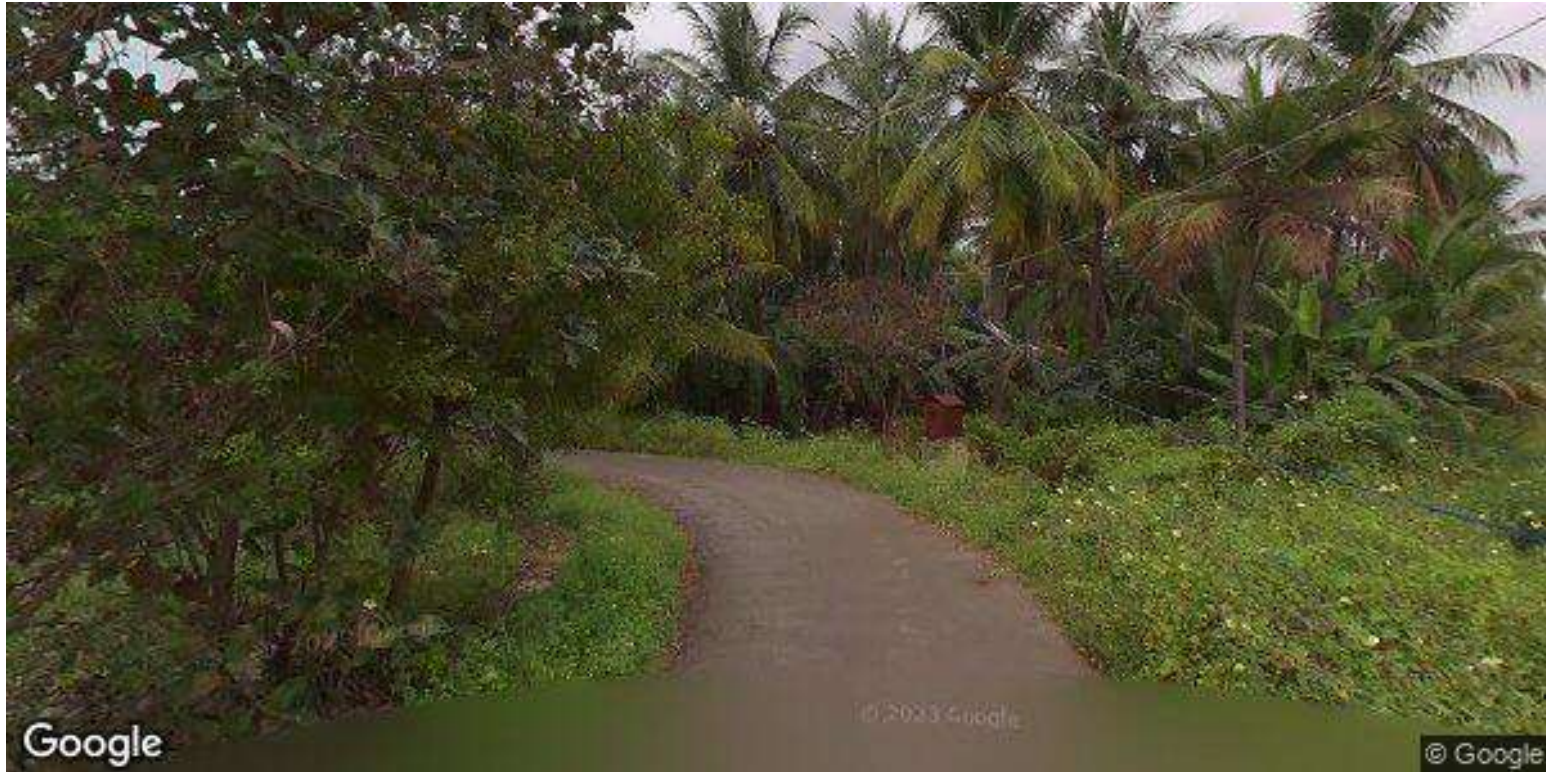
**Risk Type:** Turn  
**Risk Level:** High  
**Speed Limit:** 15 KM/Hr  
**Coordinates:** 11.09991, 77.66186

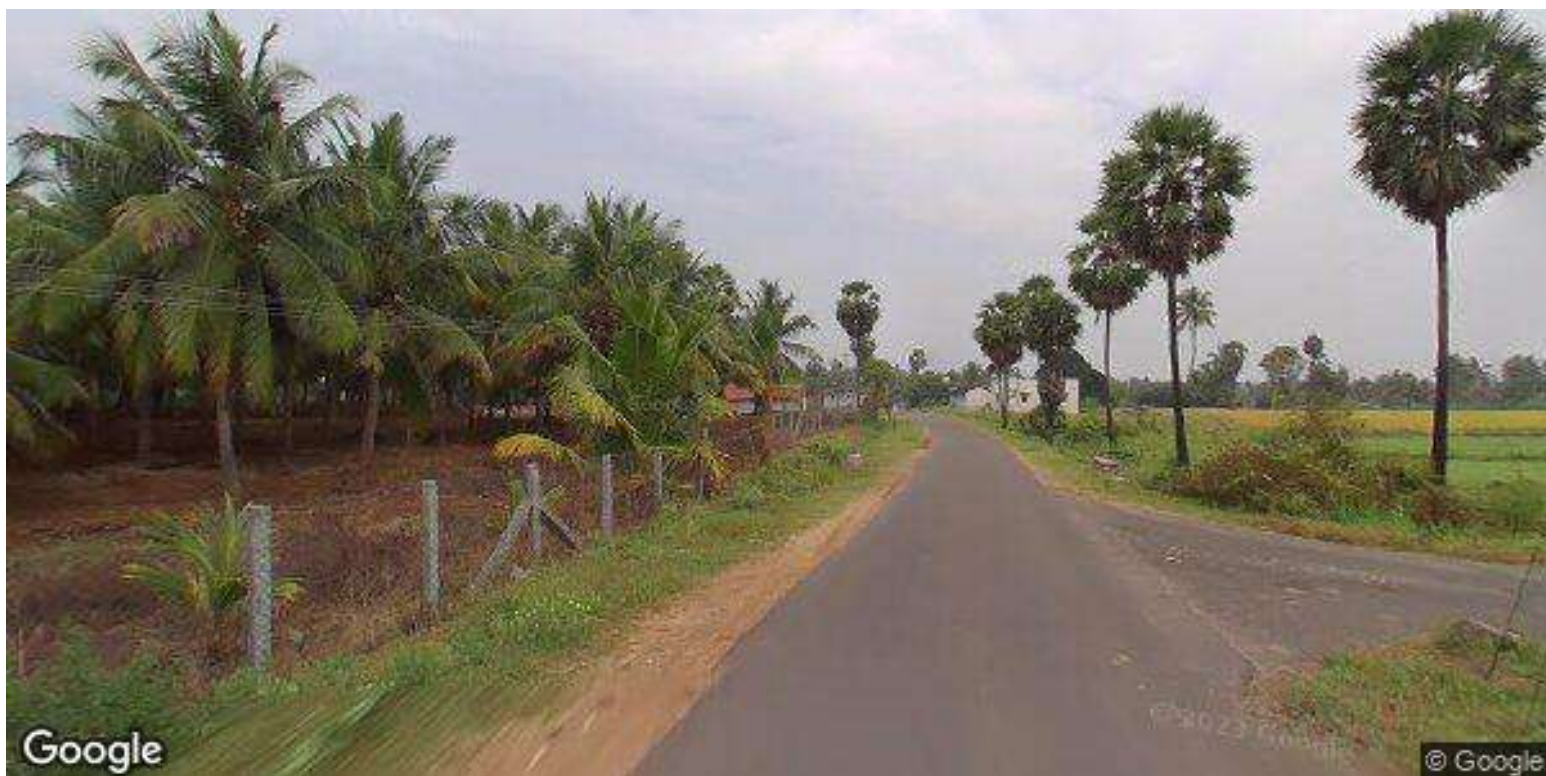
**Risk Type:** Blind Spot  
**Risk Level:** Blind Spot  
**Speed Limit:** 10 KM/Hr  
**Coordinates:** 11.09944, 77.65833
