# IndianOil

## JOURNEY RISK MANAGEMENT (JRM) STUDY

**Salem Terminal to ADHOC SRI RAGAVENDRA FUELS  
UNIT II 325143 SRM SANJAY PETROLEUM**

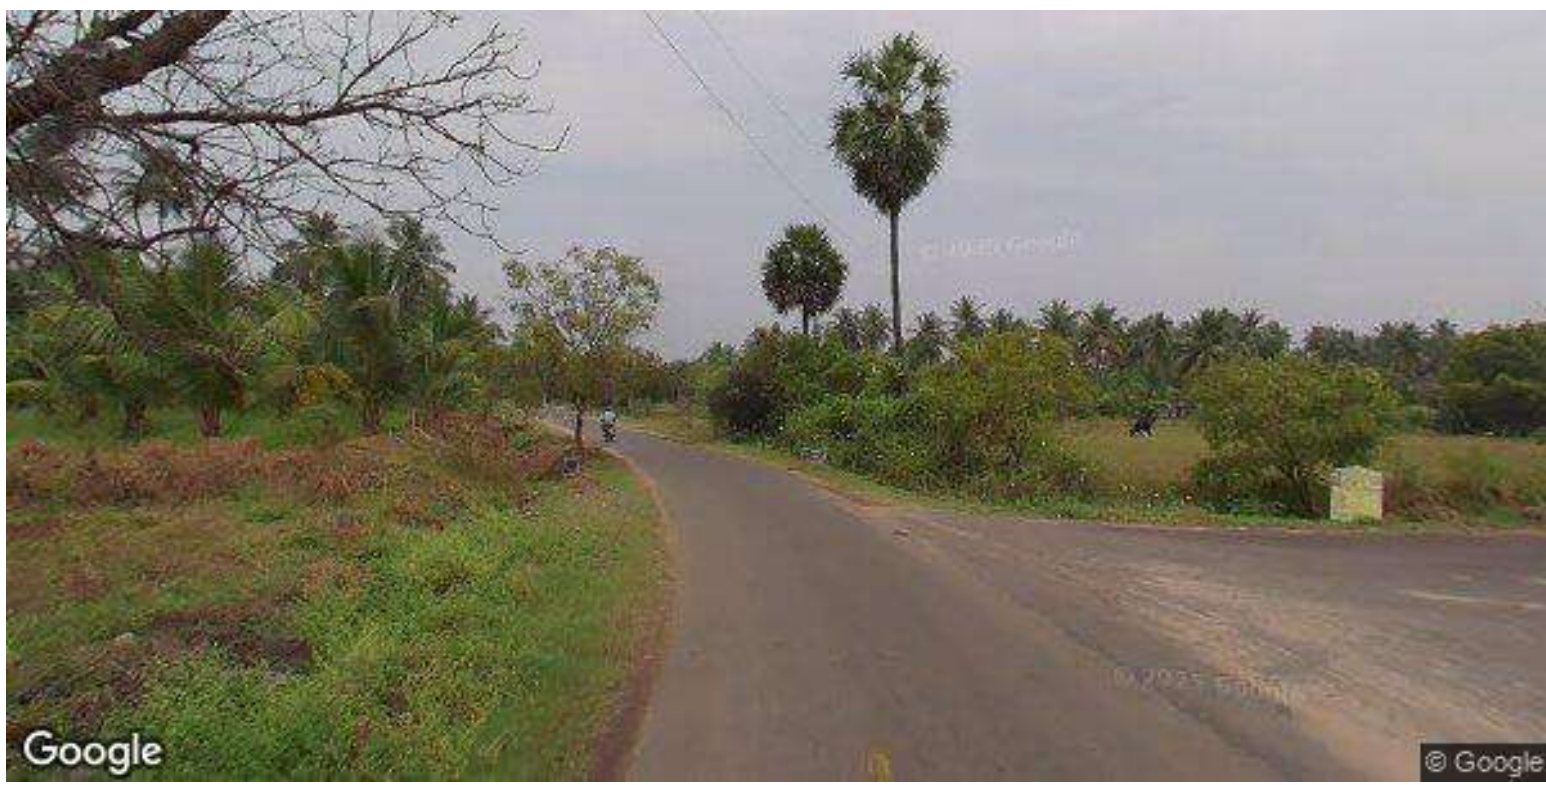
**Coordinates:** 11.10092, 77.65837

**Risk Type:** Turn

**Risk Level:** Medium

**Speed Limit:** 30 KM/Hr

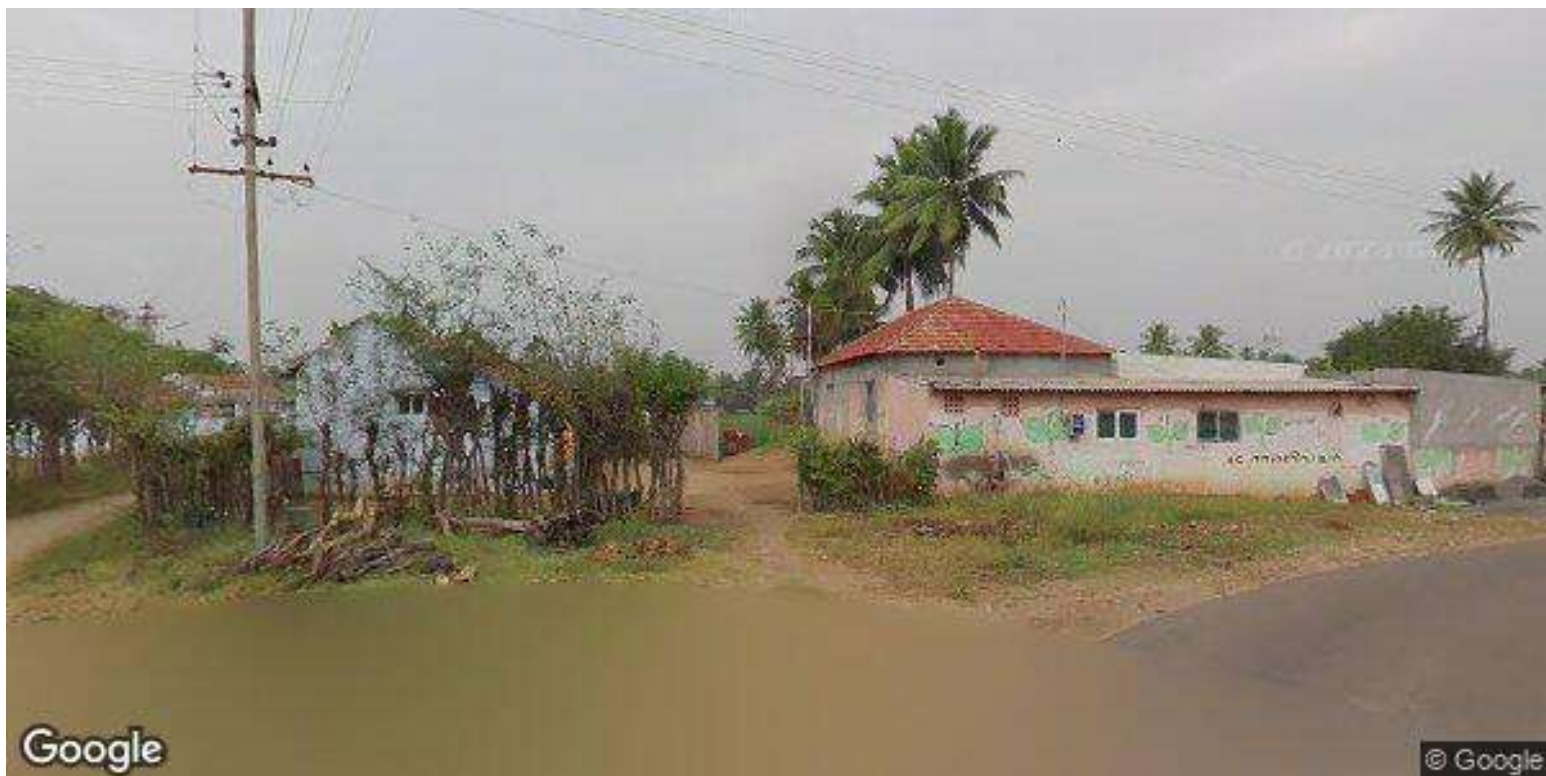
**Coordinates:** 11.10200, 77.65646

**Risk Type:** Turn

**Risk Level:** High

**Speed Limit:** 15 KM/Hr
