# IndianOil

## JOURNEY RISK MANAGEMENT (JRM) STUDY

### Salem Terminal TO NKK FUELS ADHOC

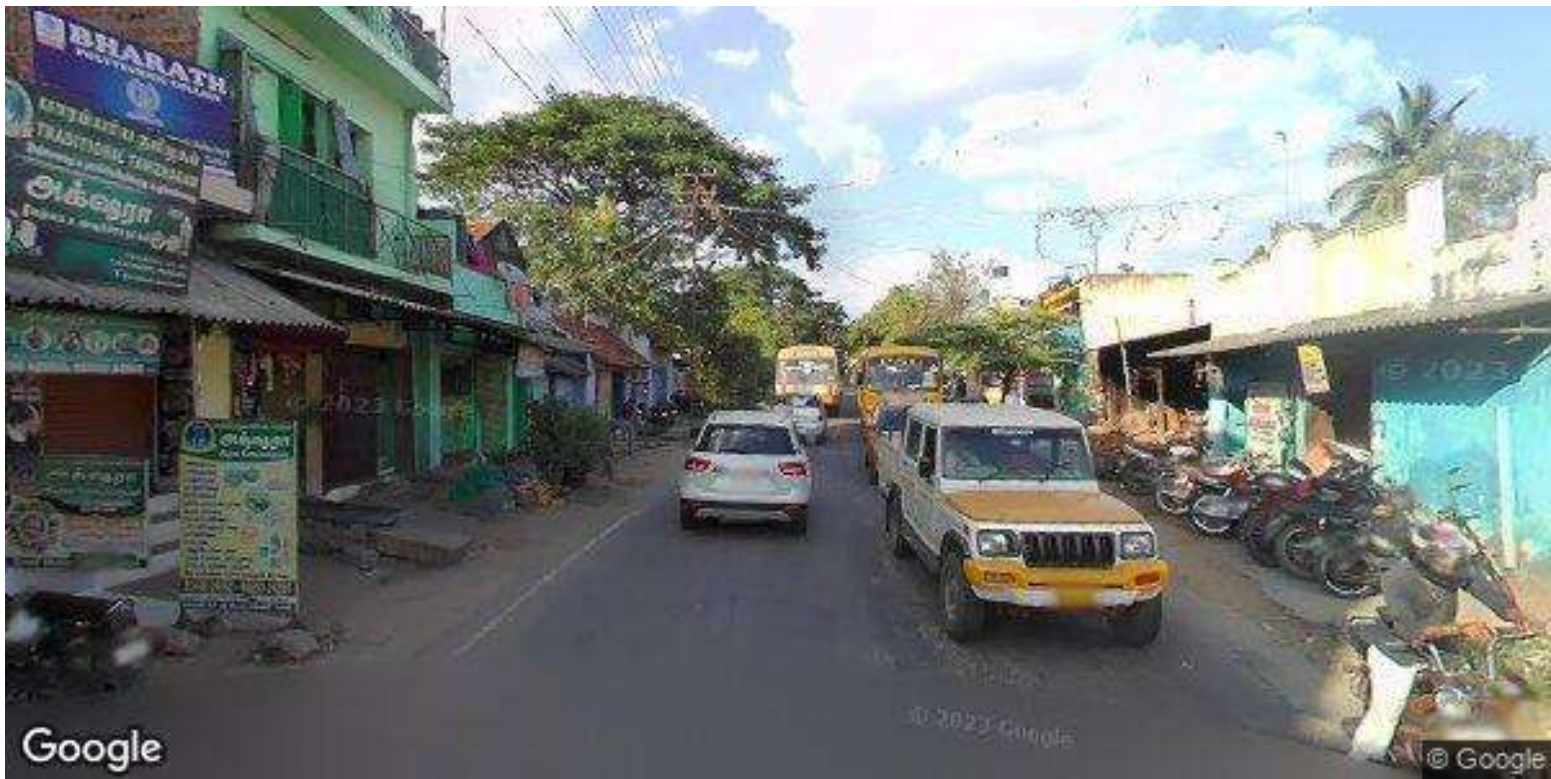
**Risk Type:** Turn  
**Risk Level:** High  
**Speed Limit:** 15 KM/Hr  
**Coordinates:** 11.45028, 77.87202

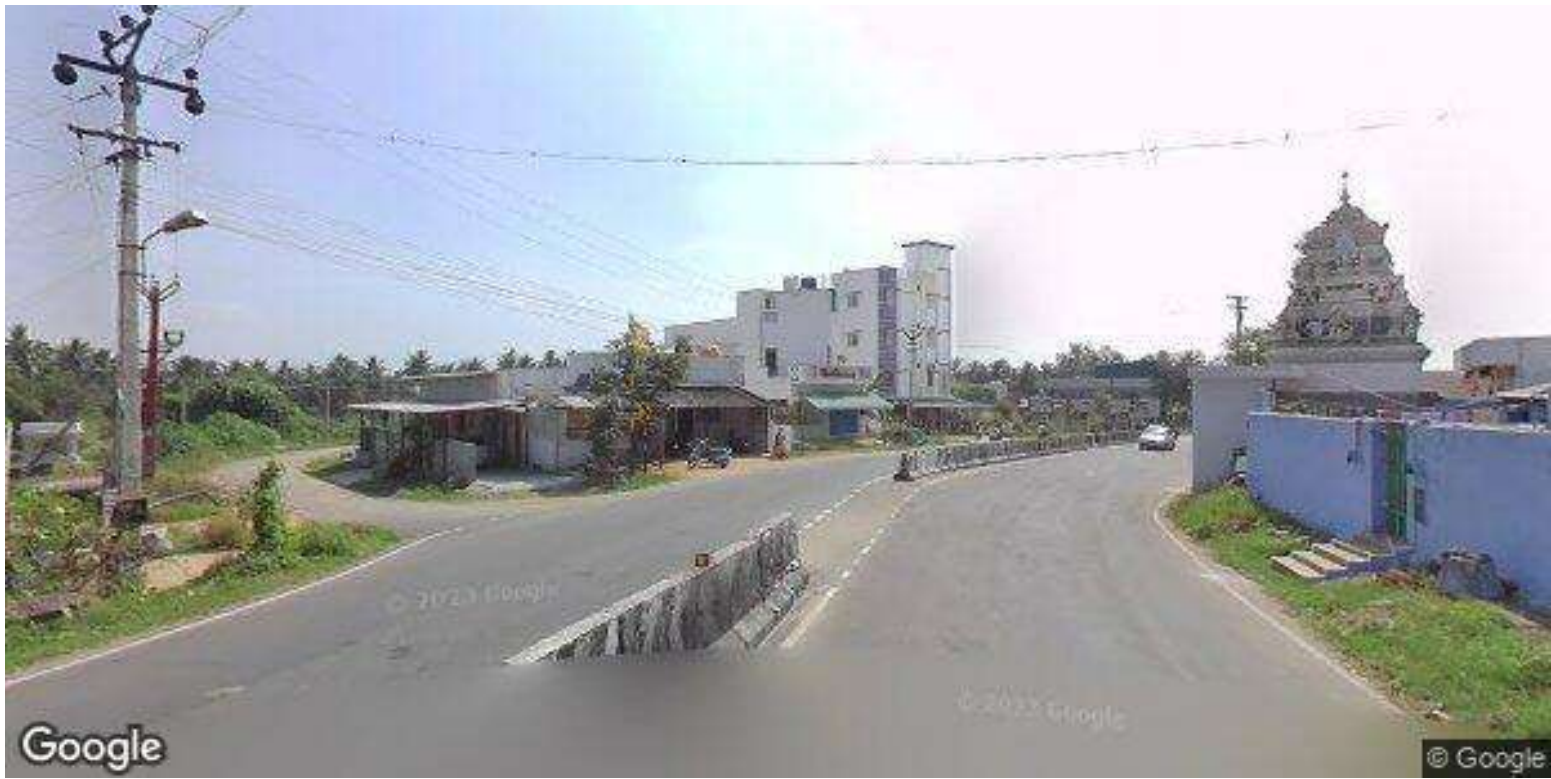
**Risk Type:** Turn  
**Risk Level:** Medium  
**Speed Limit:** 30 KM/Hr  
**Coordinates:** 11.46400, 77.87323

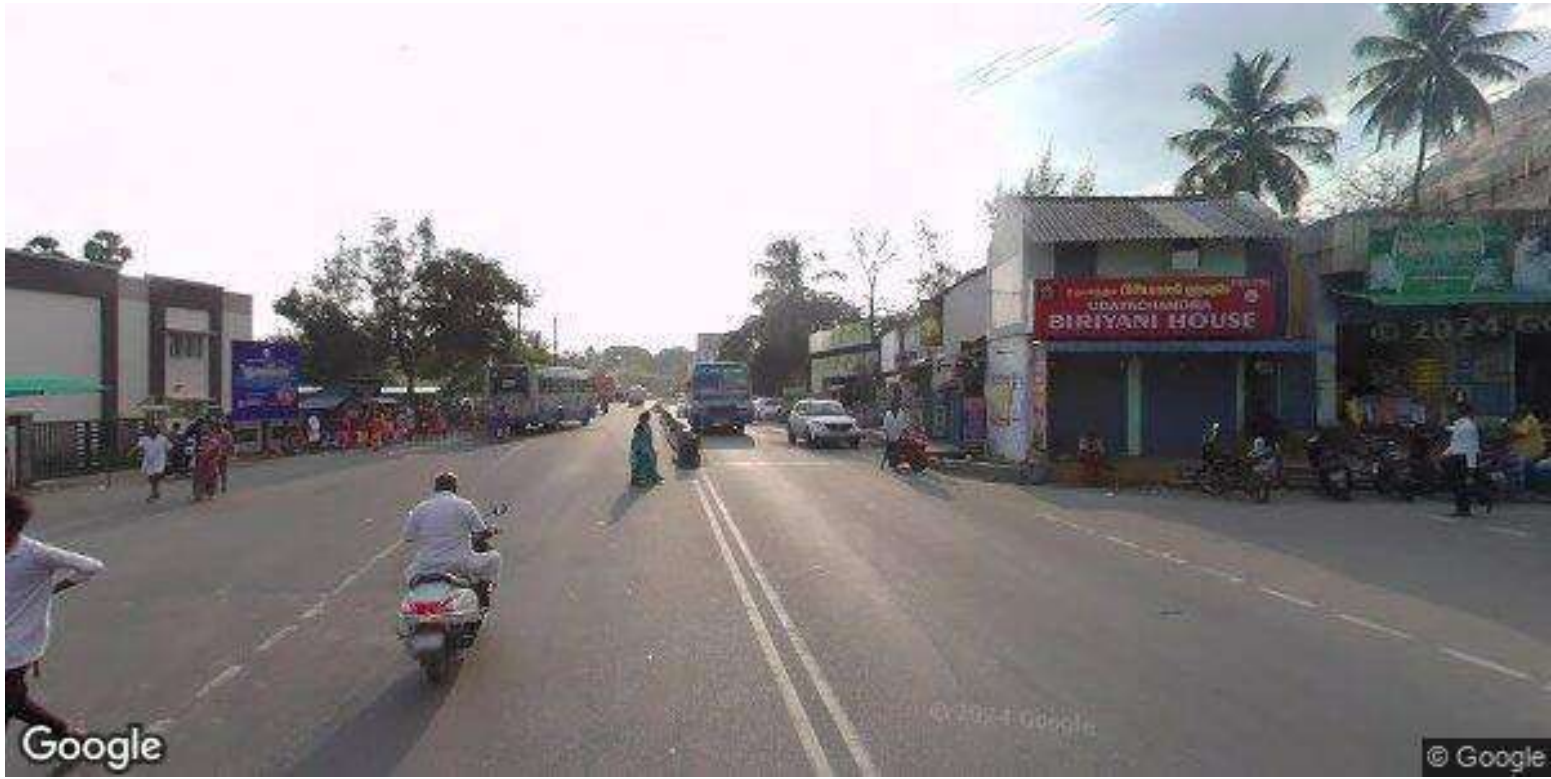
Risk Type: Turn  
Risk Level: High  
Speed Limit: 15 KM/Hr  
Coordinates: 11.47403, 77.86841

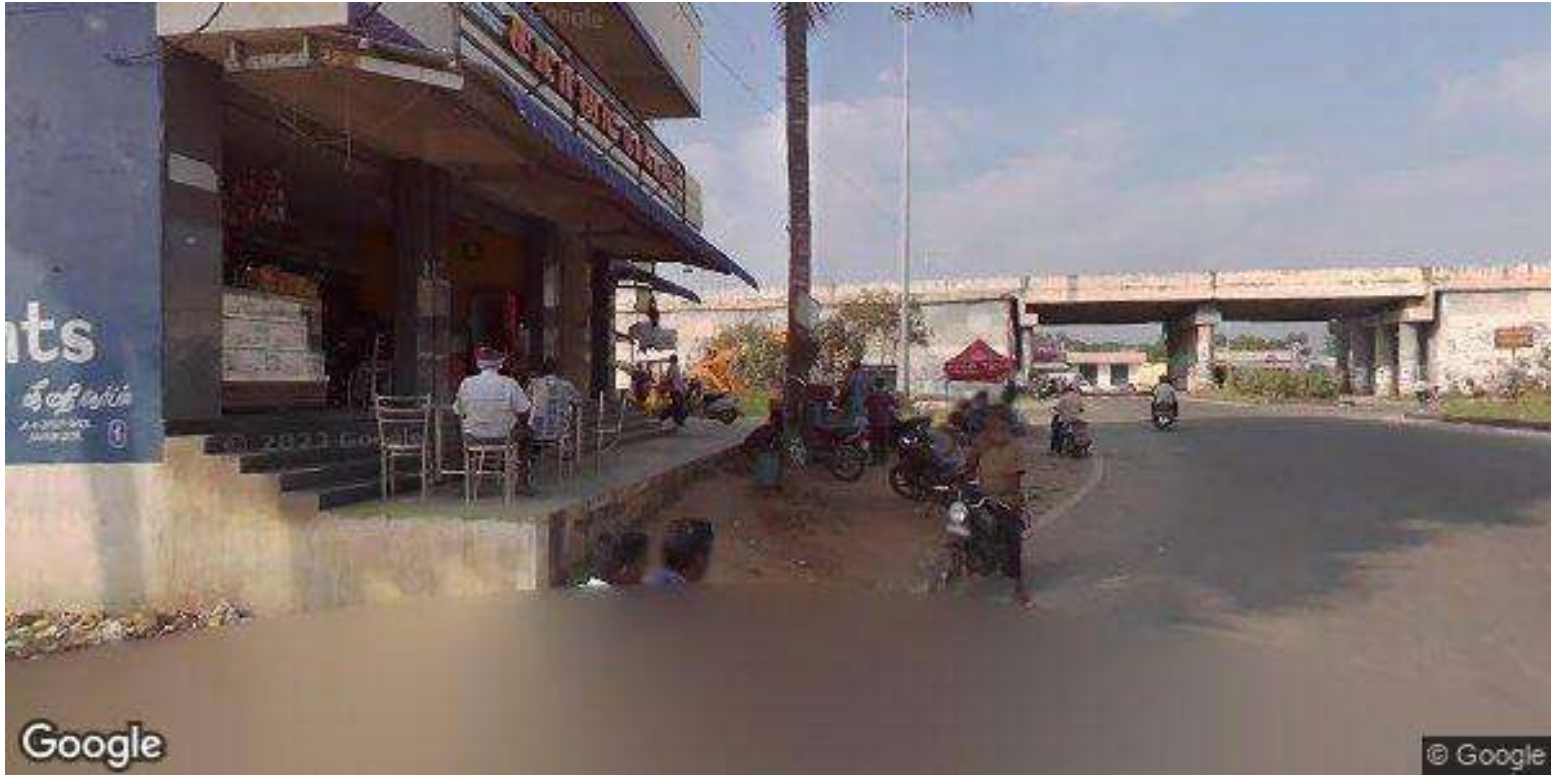
Risk Type: Turn  
Risk Level: High  
Speed Limit: 15 KM/Hr  
Coordinates: 11.49149, 77.89601

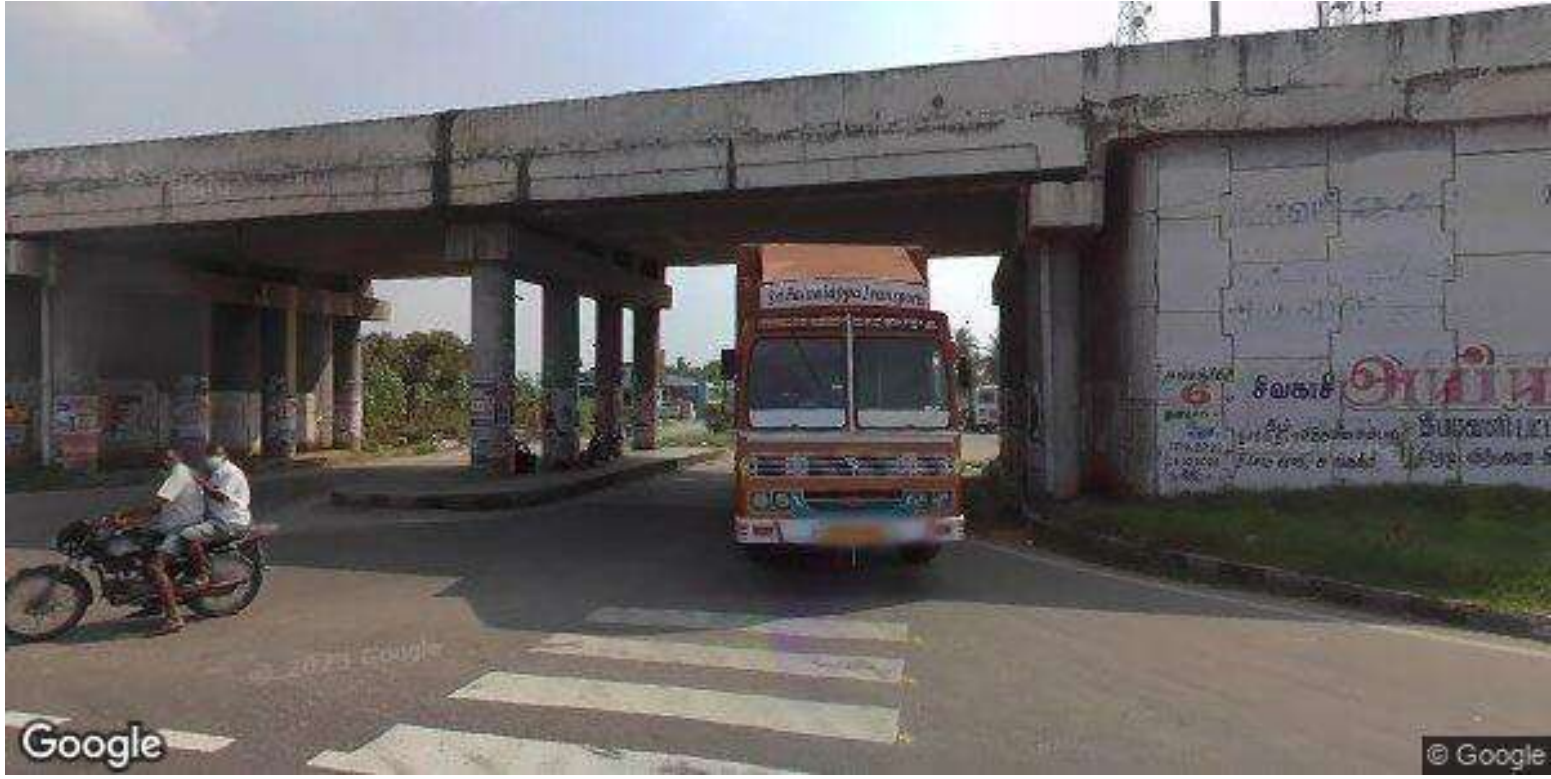
**Risk Type:** Turn  
**Risk Level:** High  
**Speed Limit:** 15 KM/Hr  
**Coordinates:** 11.49224, 77.89601

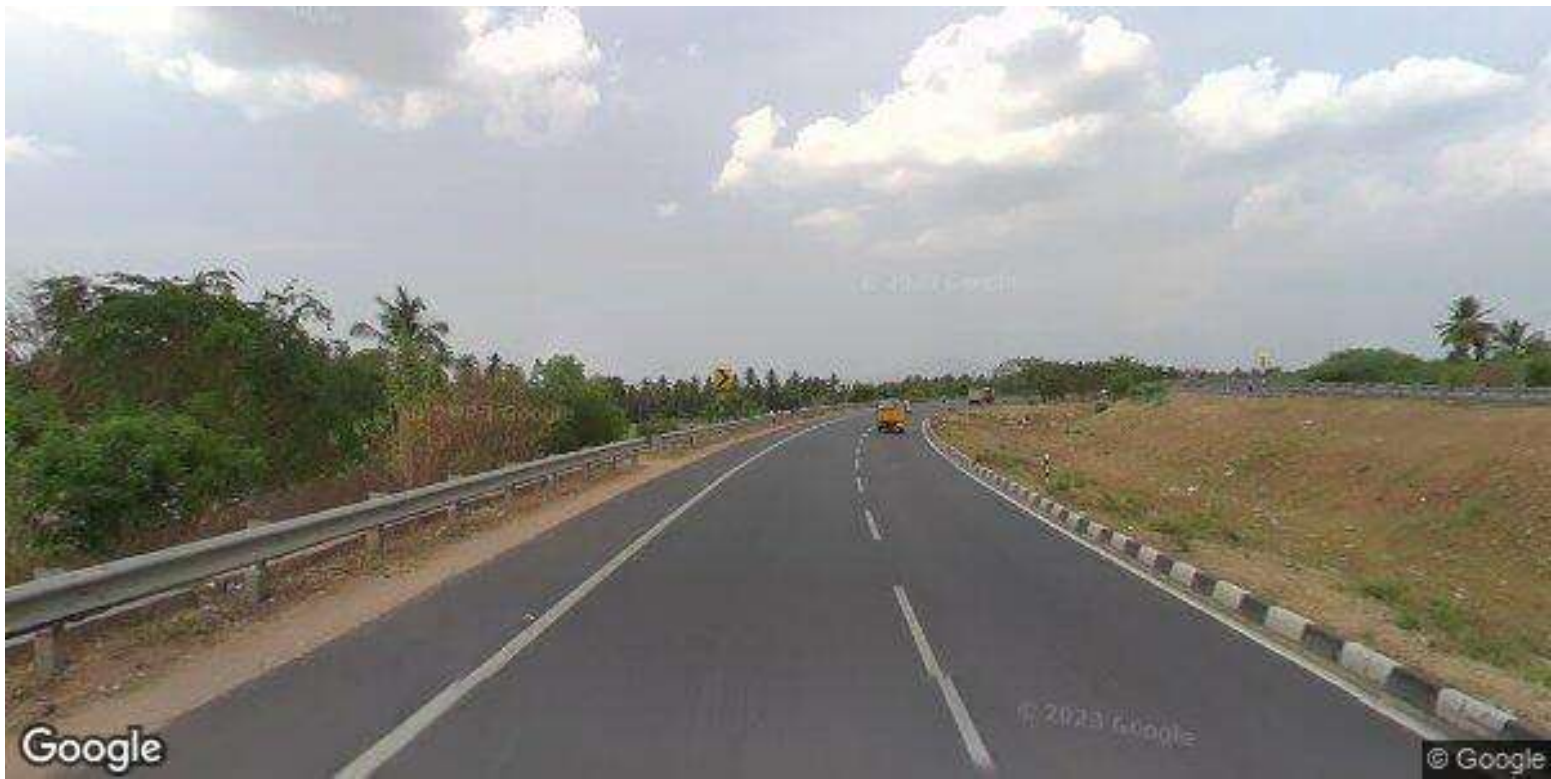
**Risk Type:** Turn  
**Risk Level:** Medium  
**Speed Limit:** 30 KM/Hr  
**Coordinates:** 11.53501, 77.95707

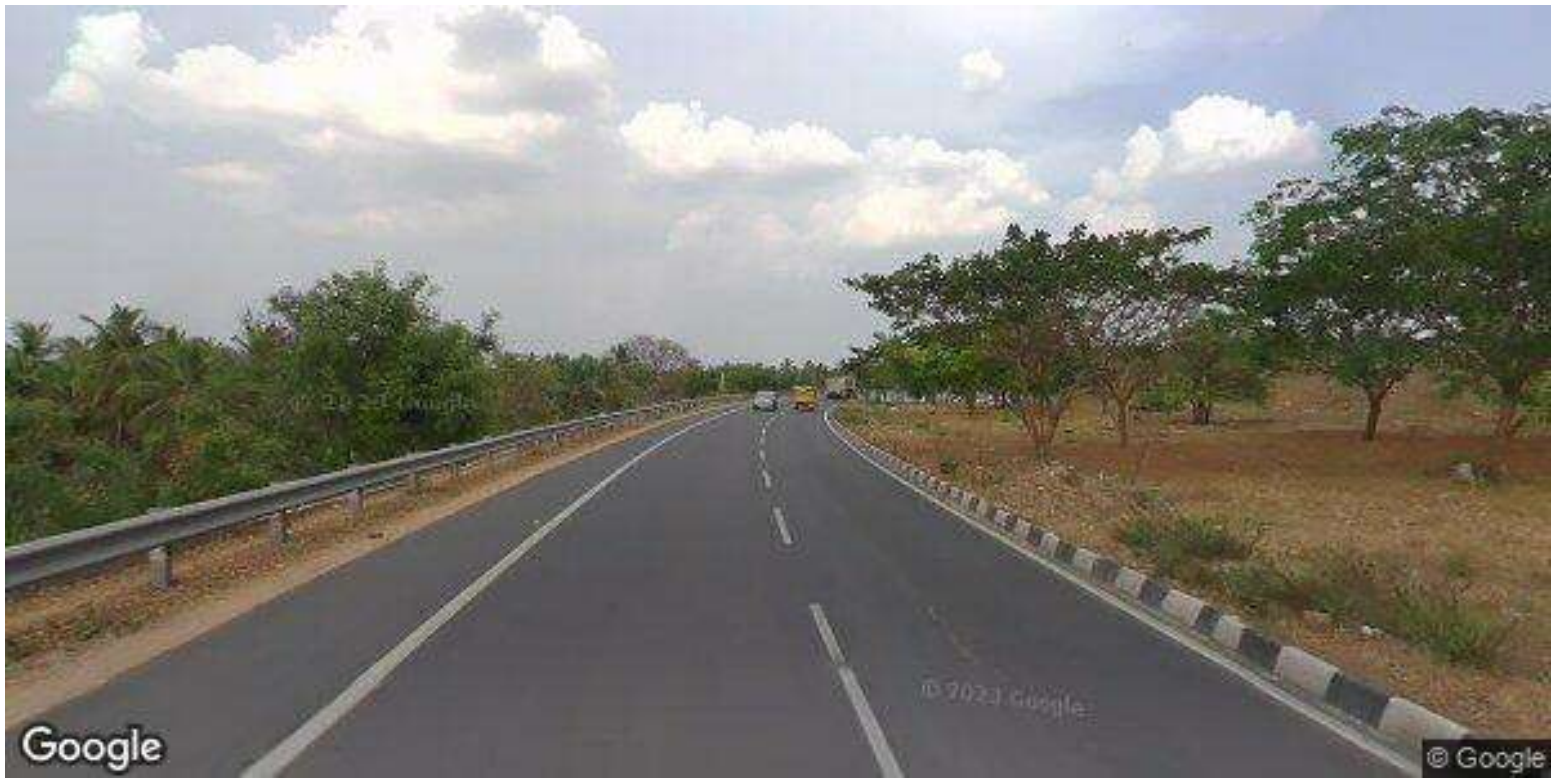
**Risk Type:** Turn  
**Risk Level:** Medium  
**Speed Limit:** 30 KM/Hr  
**Coordinates:** 11.53601, 77.95856

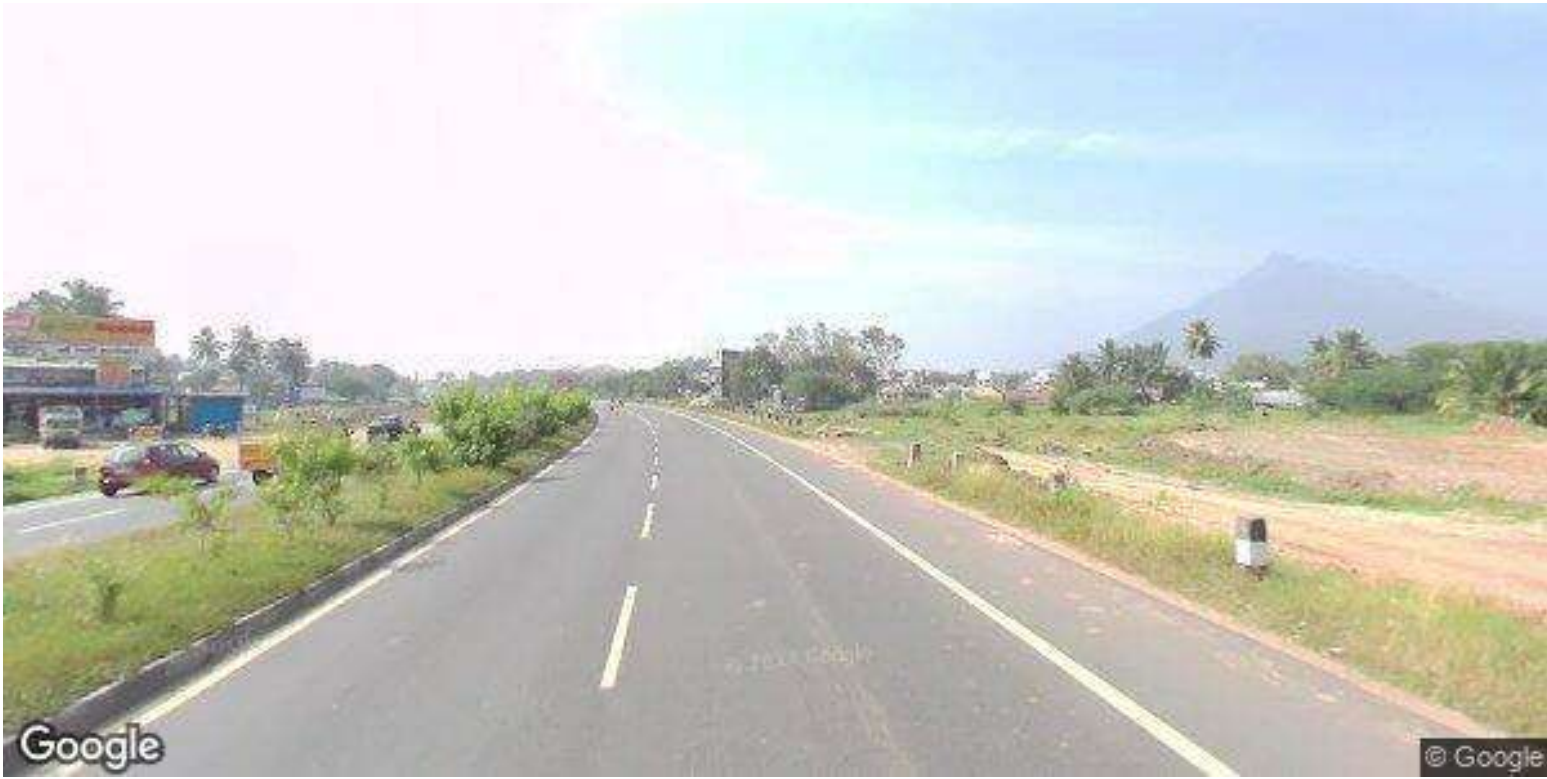
**Risk Type:** Turn  
**Risk Level:** Medium  
**Speed Limit:** 30 KM/Hr  
**Coordinates:** 11.62403, 78.10893

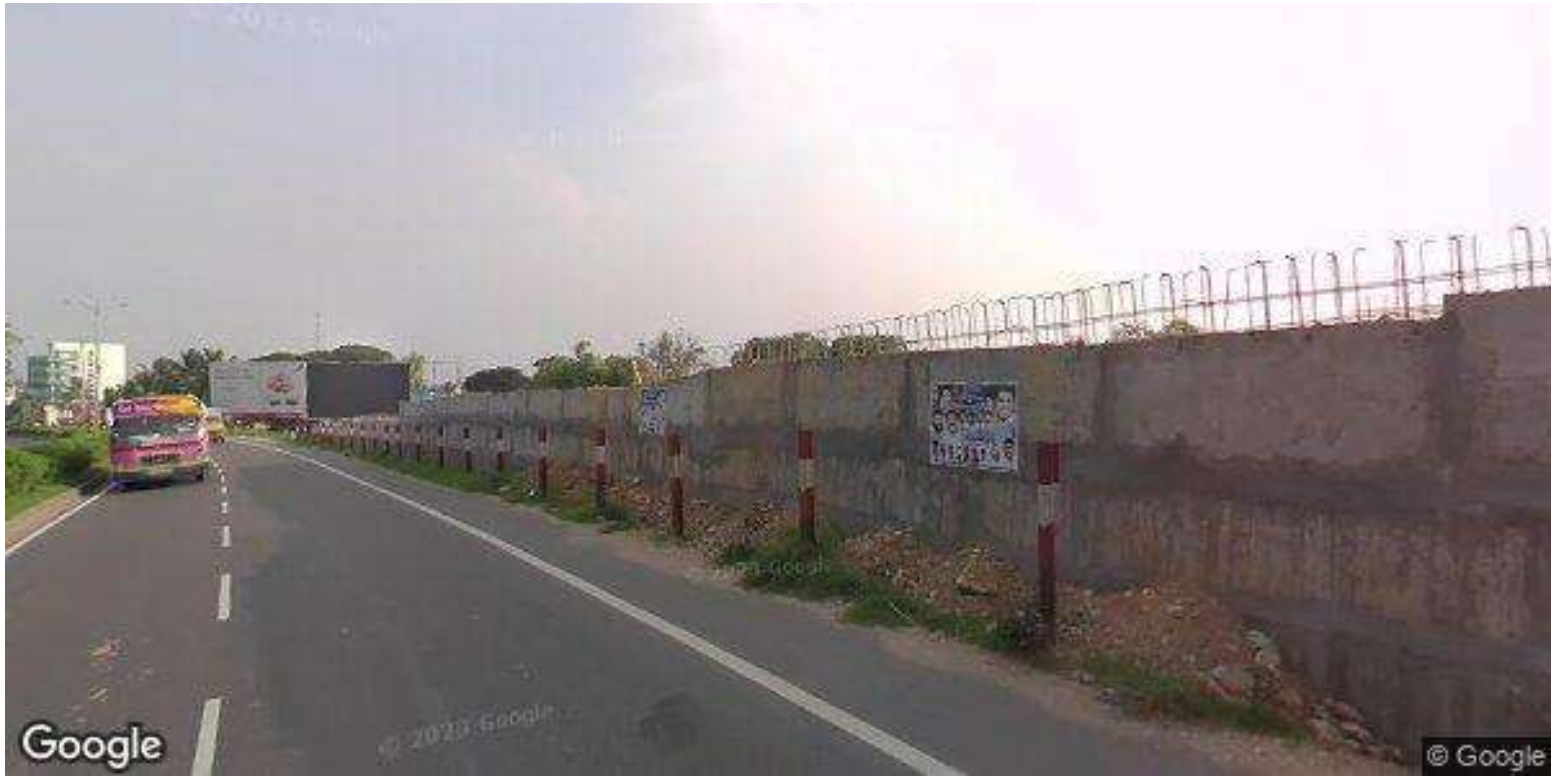
**Risk Type:** Turn  
**Risk Level:** Medium  
**Speed Limit:** 30 KM/Hr  
**Coordinates:** 11.69519, 78.10775

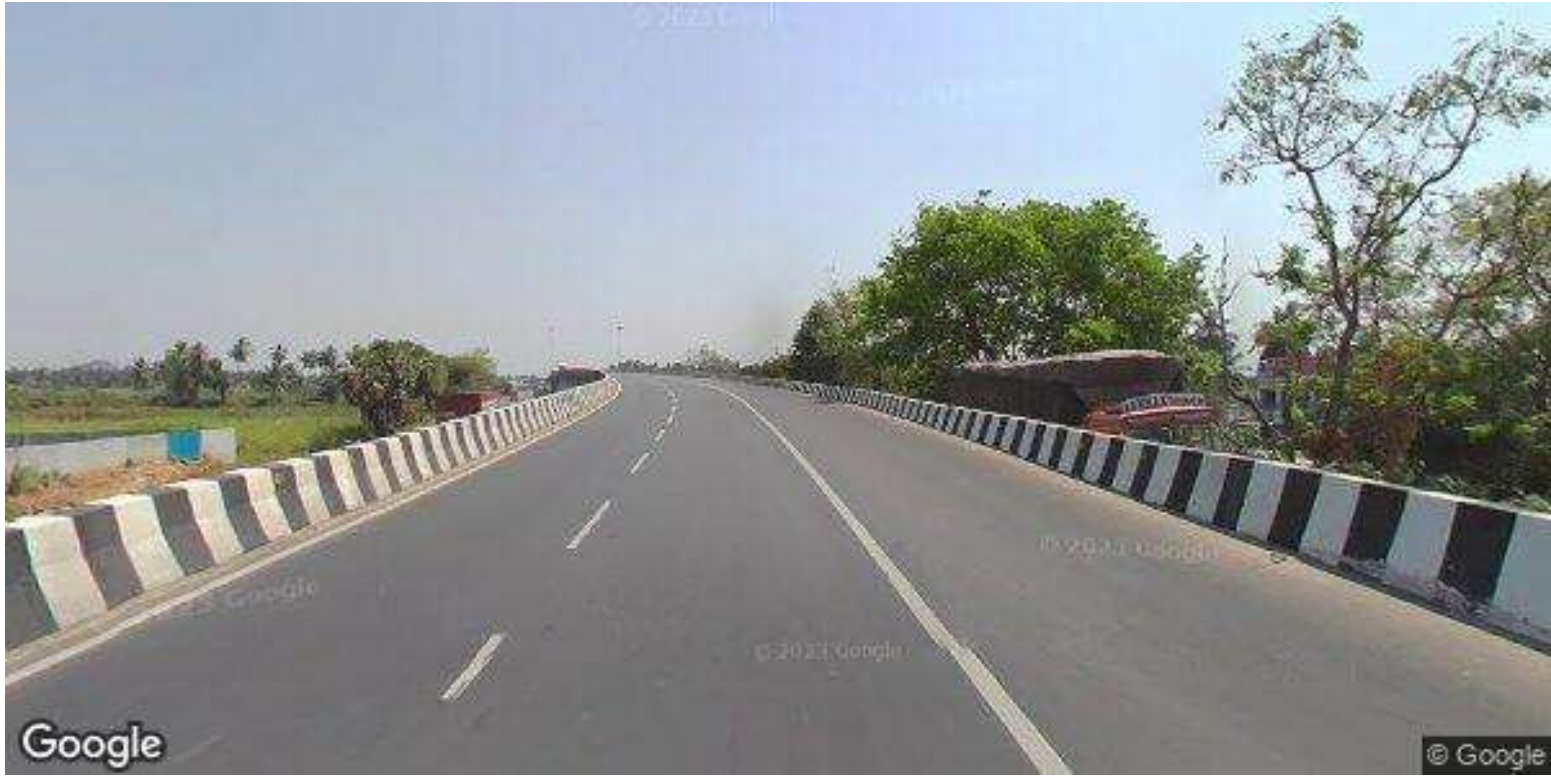
**Risk Type:** Turn  
**Risk Level:** Medium  
**Speed Limit:** 30 KM/Hr  
**Coordinates:** 11.73958, 78.05105

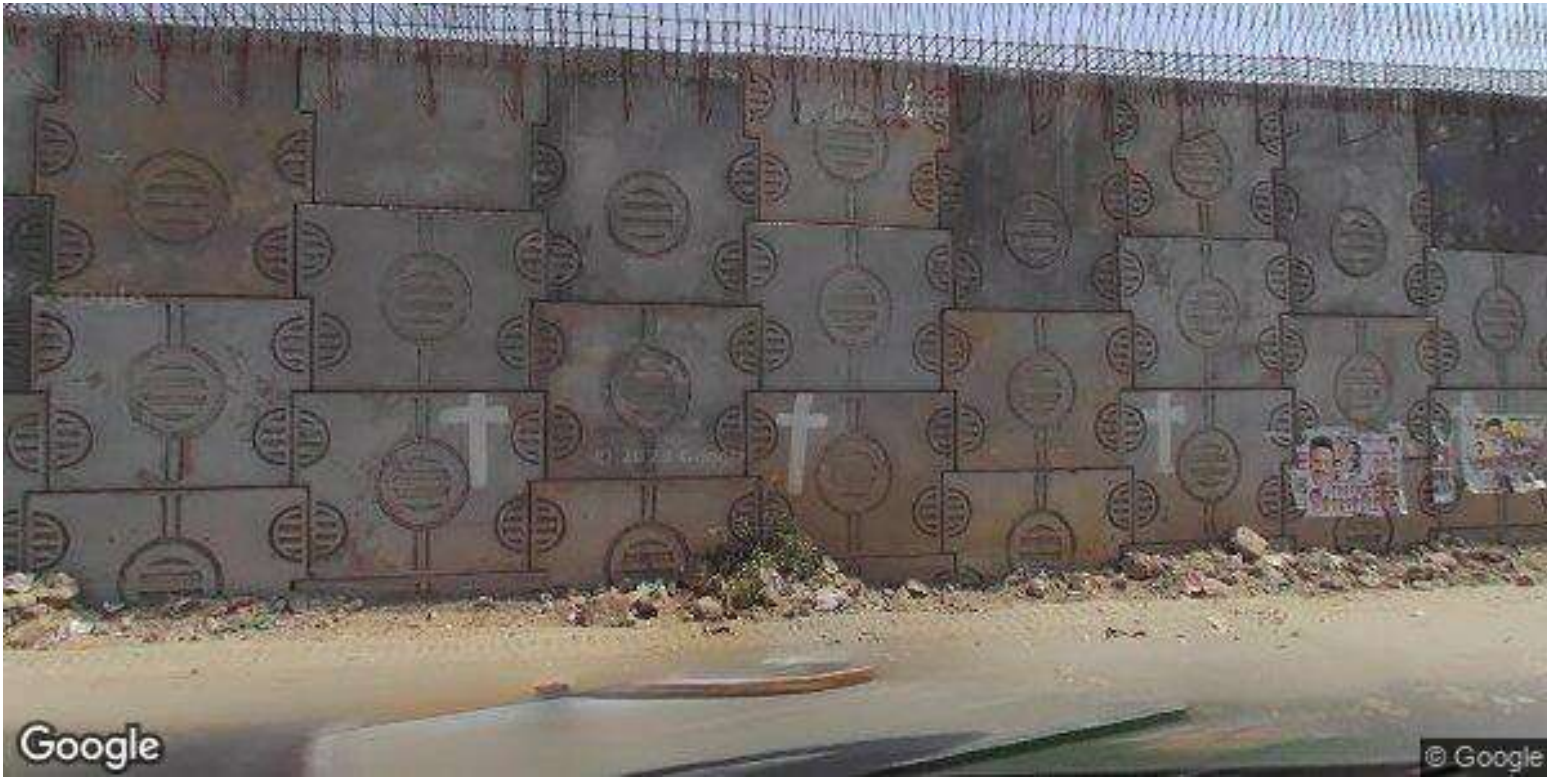
**Risk Type:** Turn  
**Risk Level:** Medium  
**Speed Limit:** 30 KM/Hr  
**Coordinates:** 11.75835, 78.05016

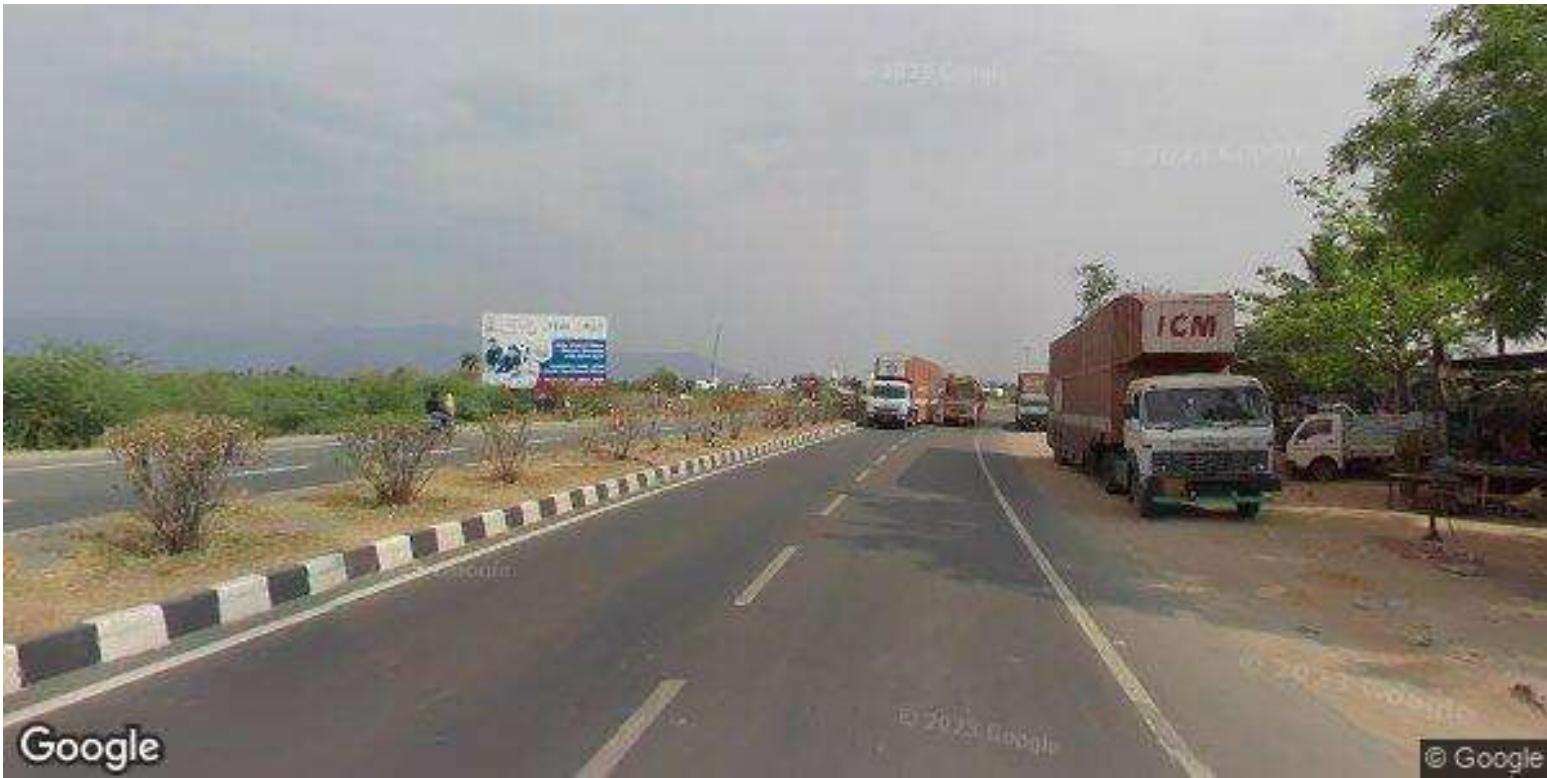
**Risk Type:** Turn  
**Risk Level:** Medium  
**Speed Limit:** 30 KM/Hr  
**Coordinates:** 11.87942, 78.08197

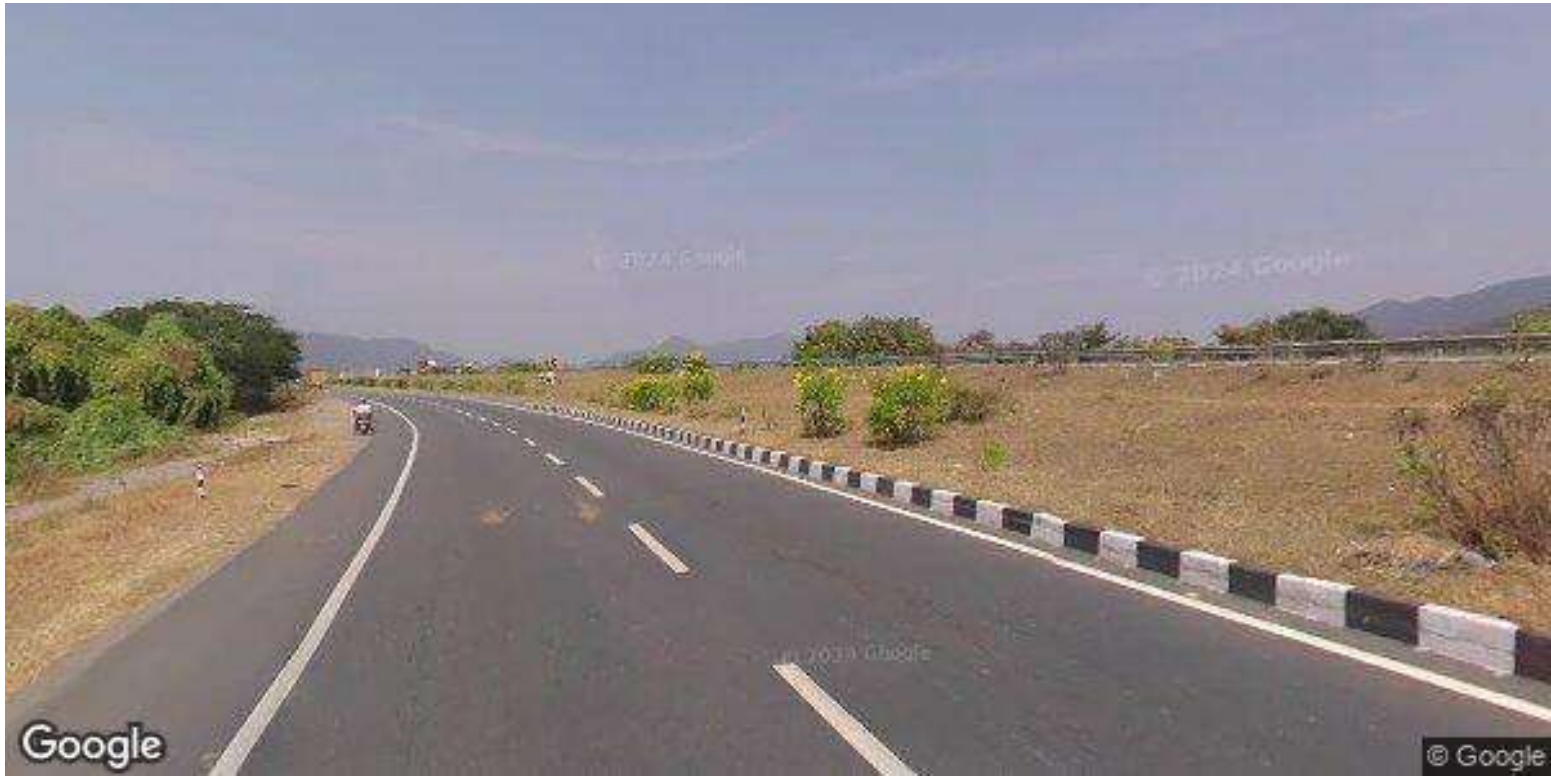
**Risk Type:** Turn  
**Risk Level:** Medium  
**Speed Limit:** 30 KM/Hr  
**Coordinates:** 11.92585, 78.06507

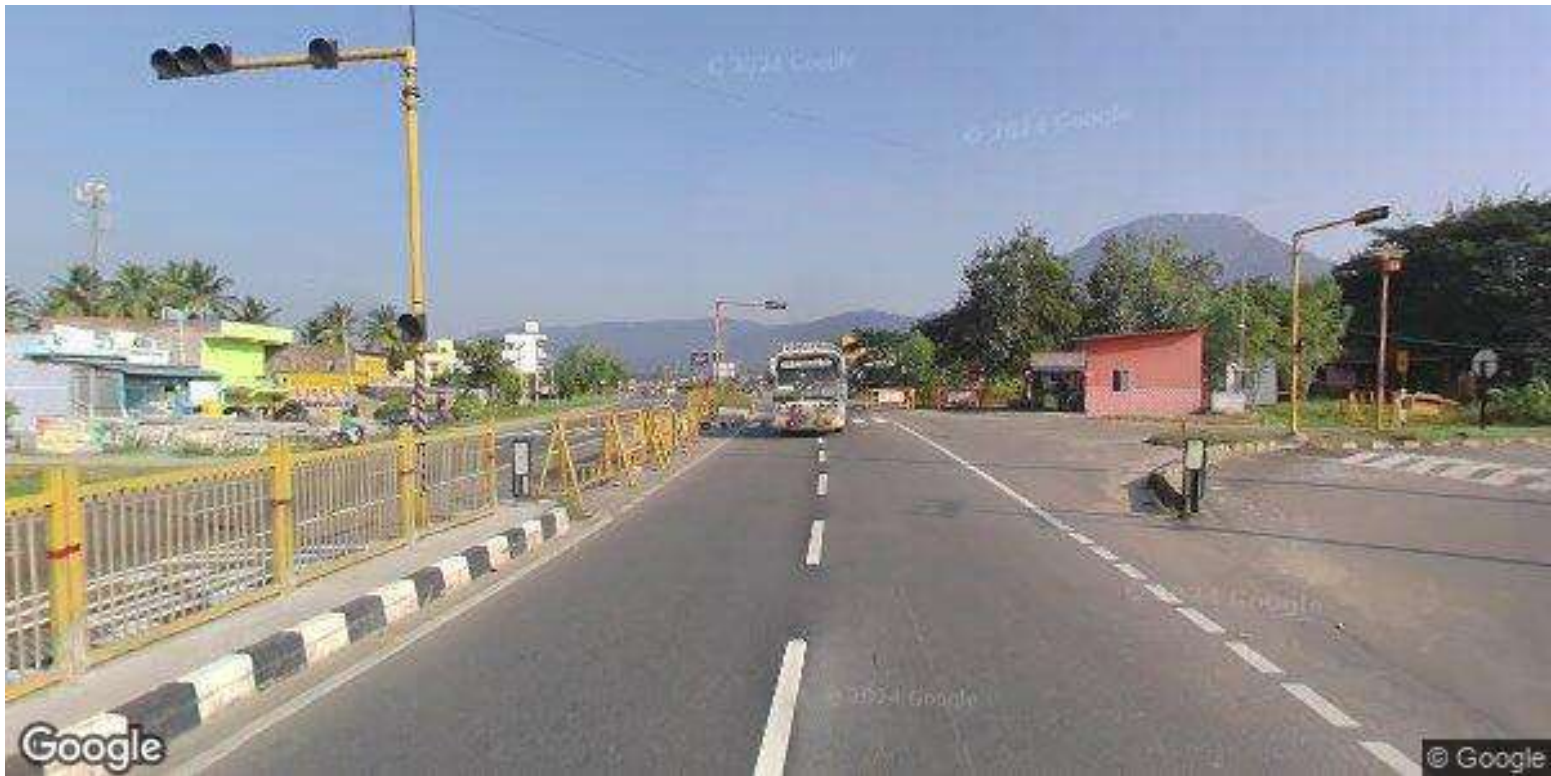
**Risk Type:** Turn  
**Risk Level:** Medium  
**Speed Limit:** 30 KM/Hr  
**Coordinates:** 11.93704, 78.05402

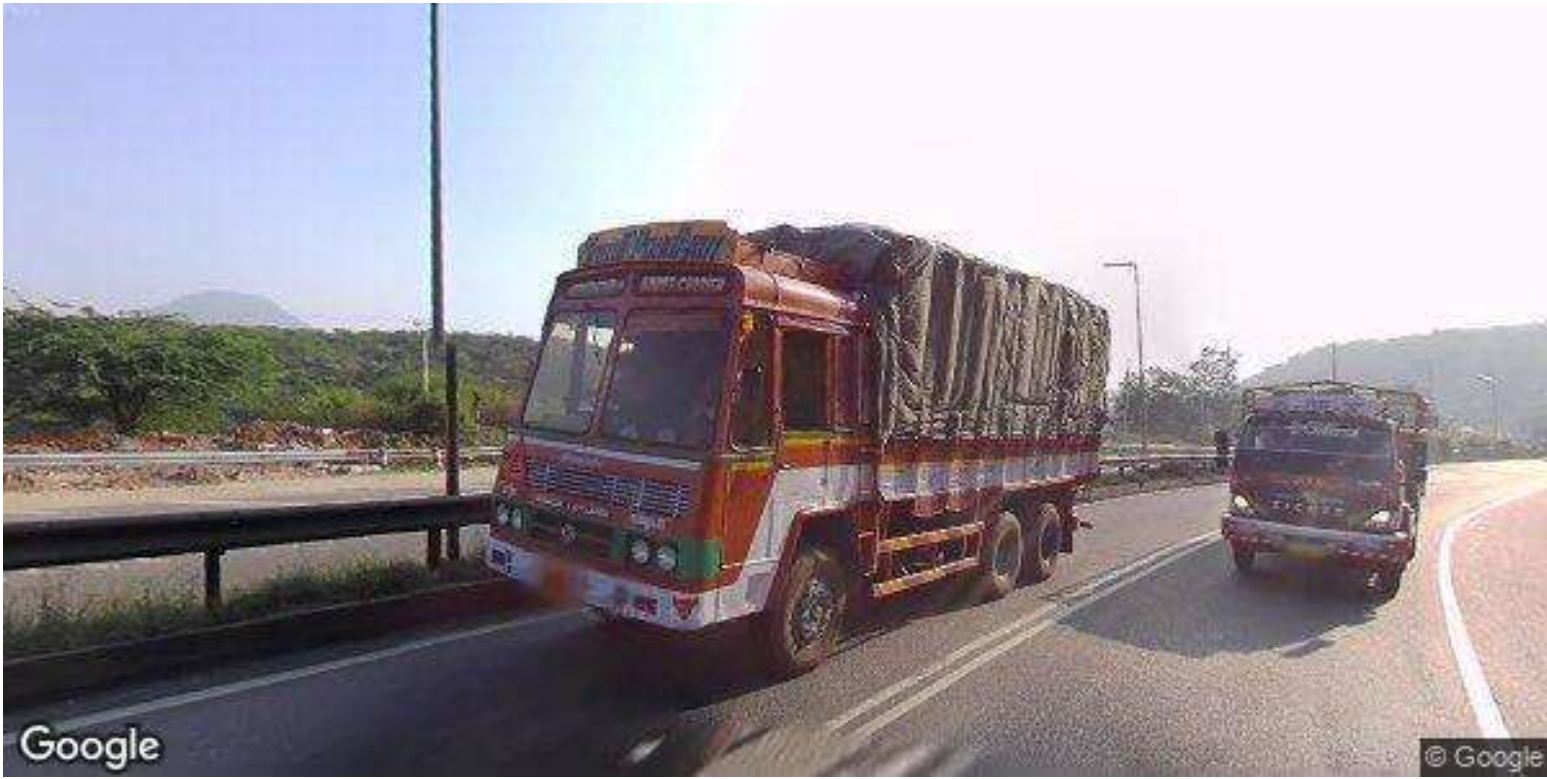
**Risk Type:** Turn  
**Risk Level:** High  
**Speed Limit:** 15 KM/Hr  
**Coordinates:** 11.95818, 78.04978

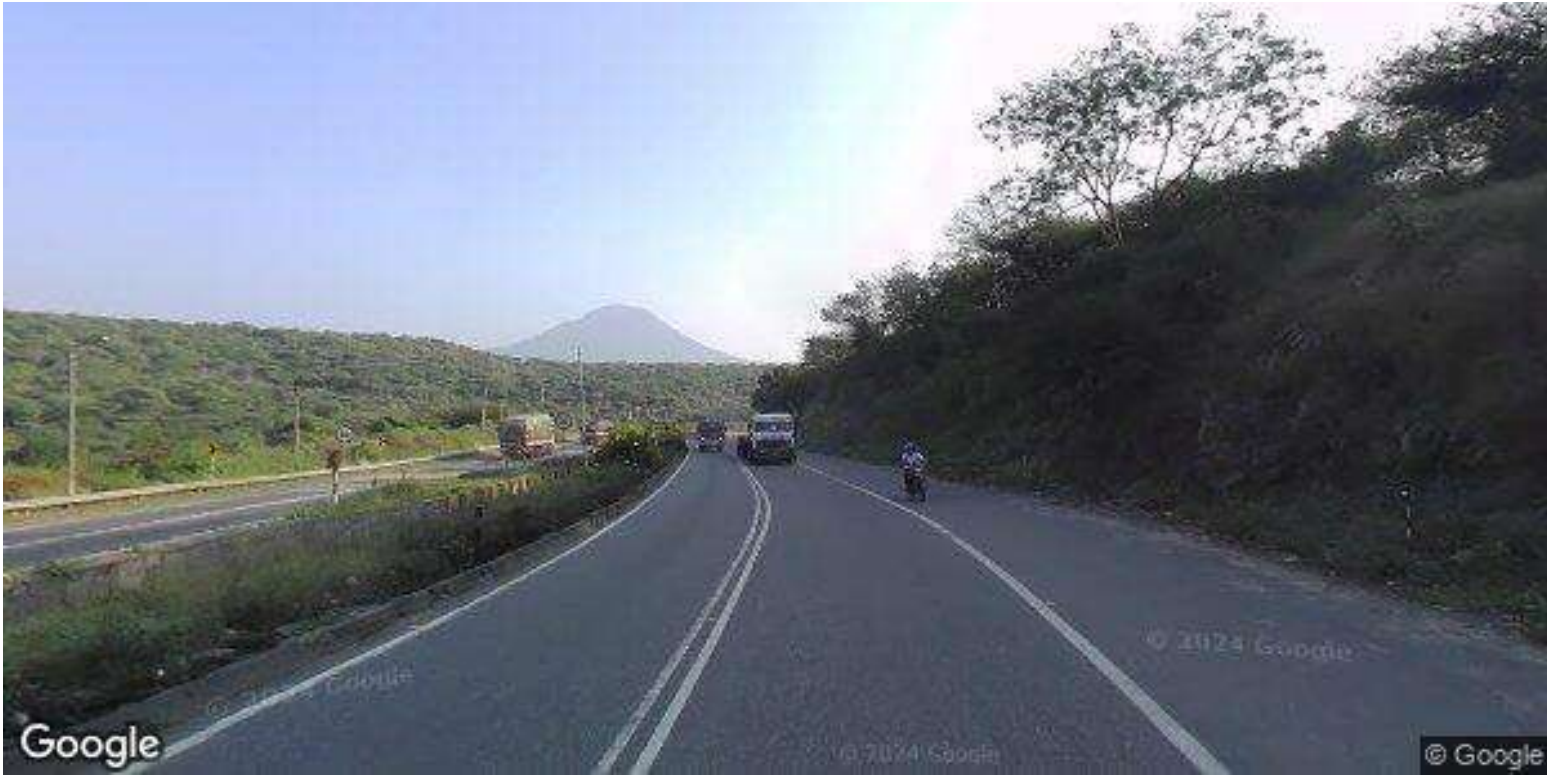
**Risk Type:** Turn  
**Risk Level:** Medium  
**Speed Limit:** 30 KM/Hr  
**Coordinates:** 11.95988, 78.04948

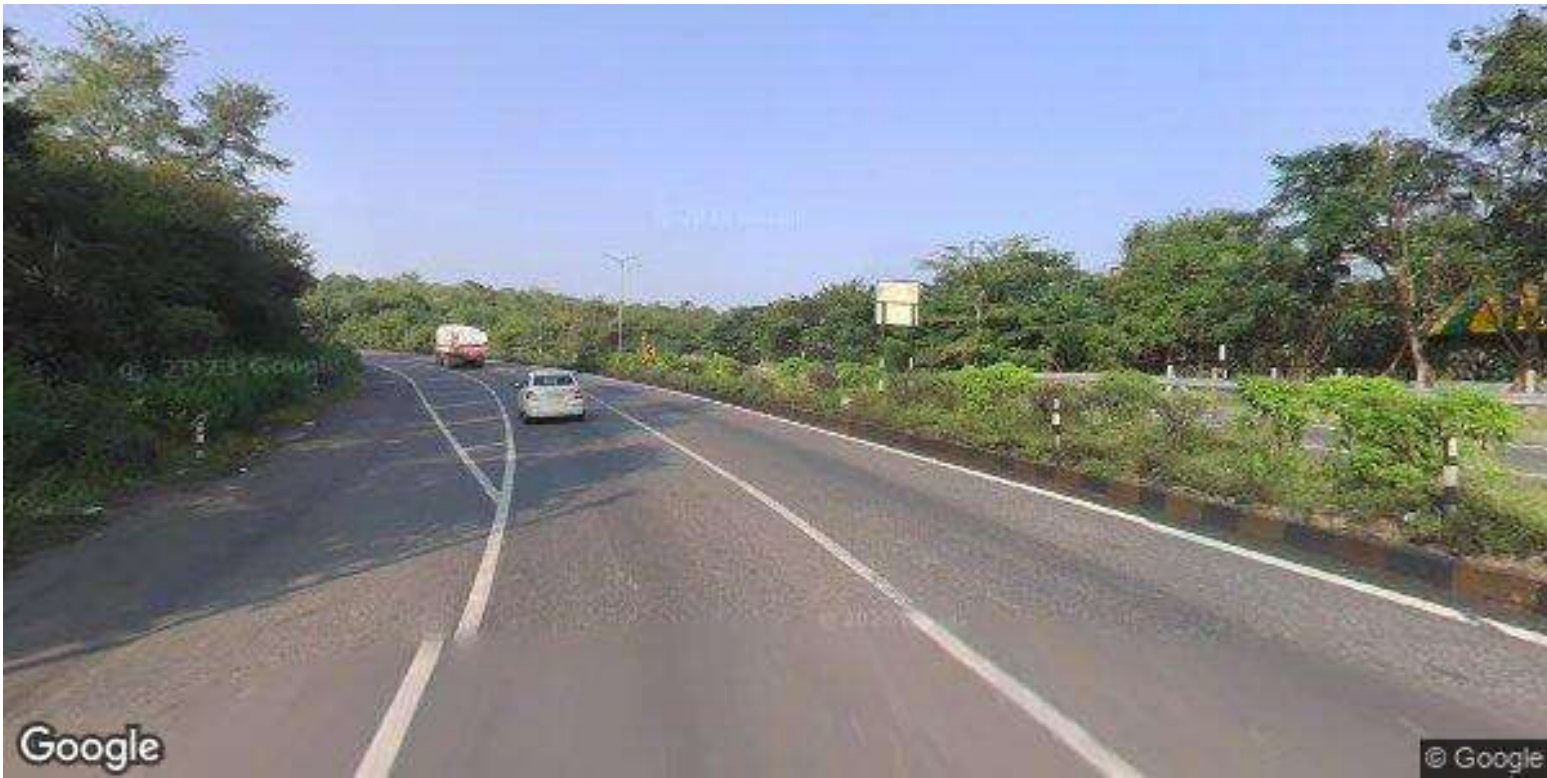
**Risk Type:** Turn  
**Risk Level:** Medium  
**Speed Limit:** 30 KM/Hr  
**Coordinates:** 11.96304, 78.05136

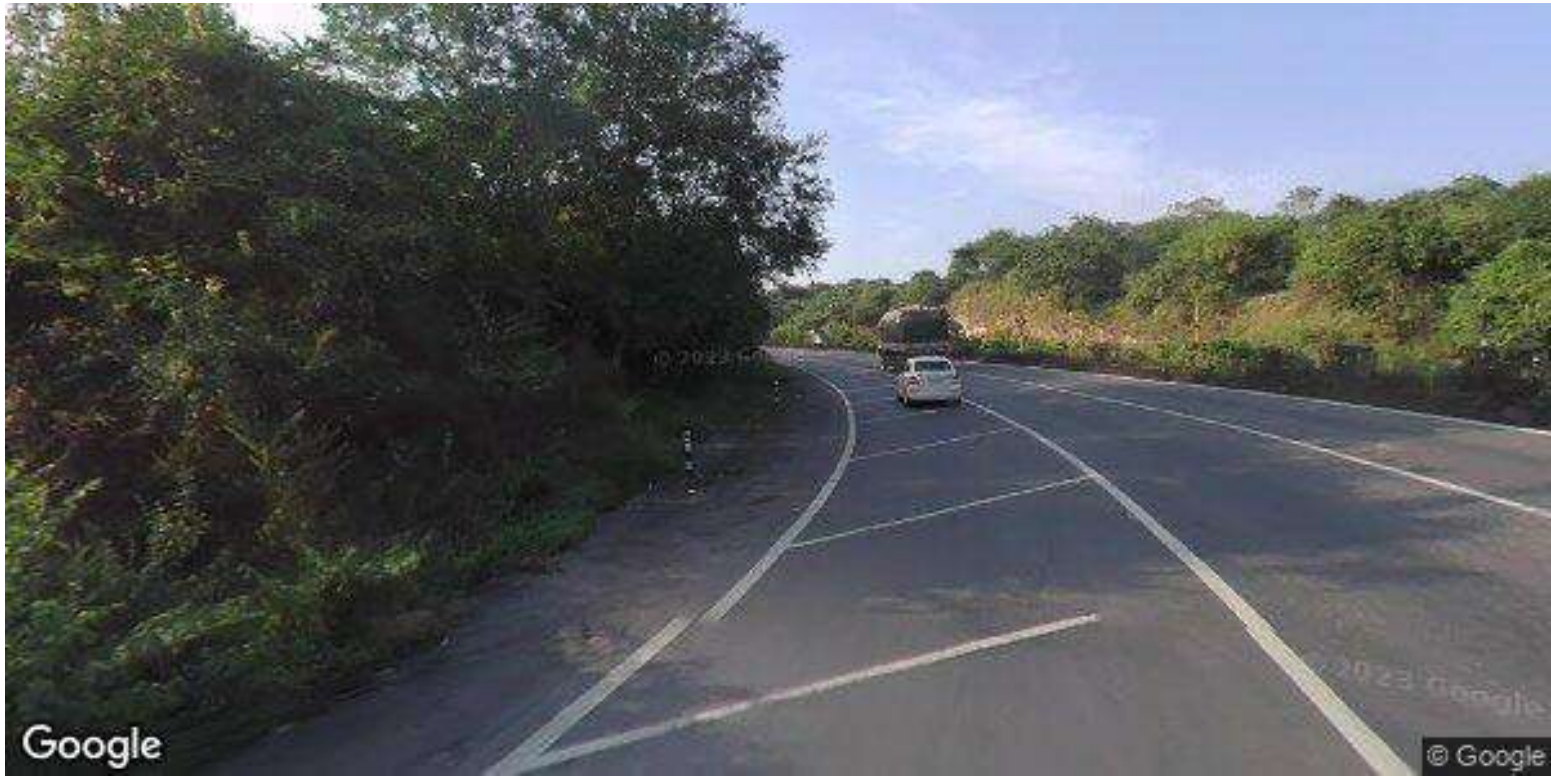
**Risk Type:** Turn  
**Risk Level:** High  
**Speed Limit:** 15 KM/Hr  
**Coordinates:** 11.96399, 78.05135
