# IndianOil

## JOURNEY RISK MANAGEMENT (JRM) STUDY

### Salem Terminal TO NKK FUELS ADHOC

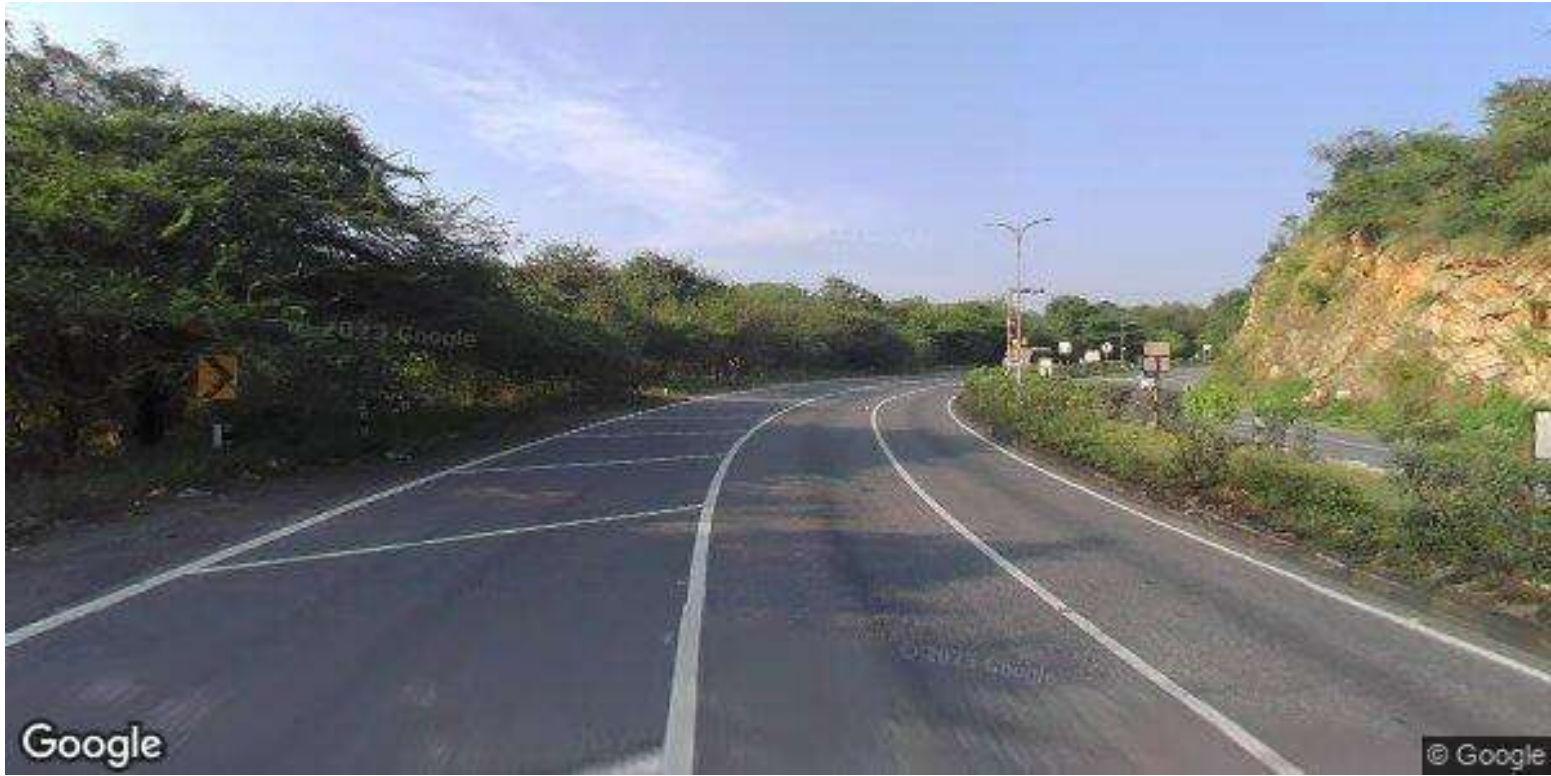
**Risk Type:** Turn  
**Risk Level:** High  
**Speed Limit:** 15 KM/Hr  
**Coordinates:** 11.96580, 78.04923

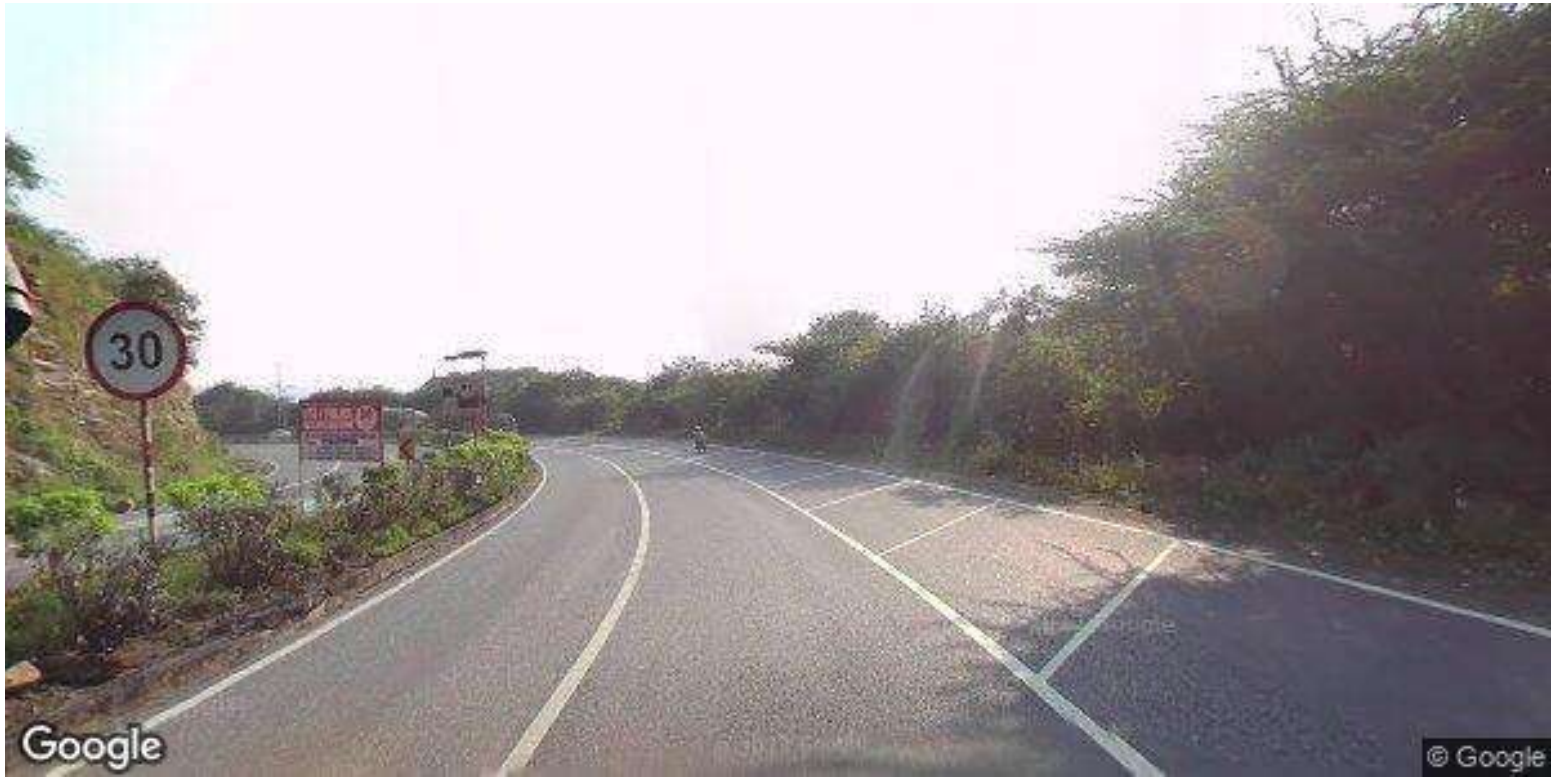
**Risk Type:** Turn  
**Risk Level:** Medium  
**Speed Limit:** 30 KM/Hr  
**Coordinates:** 11.96675, 78.04939

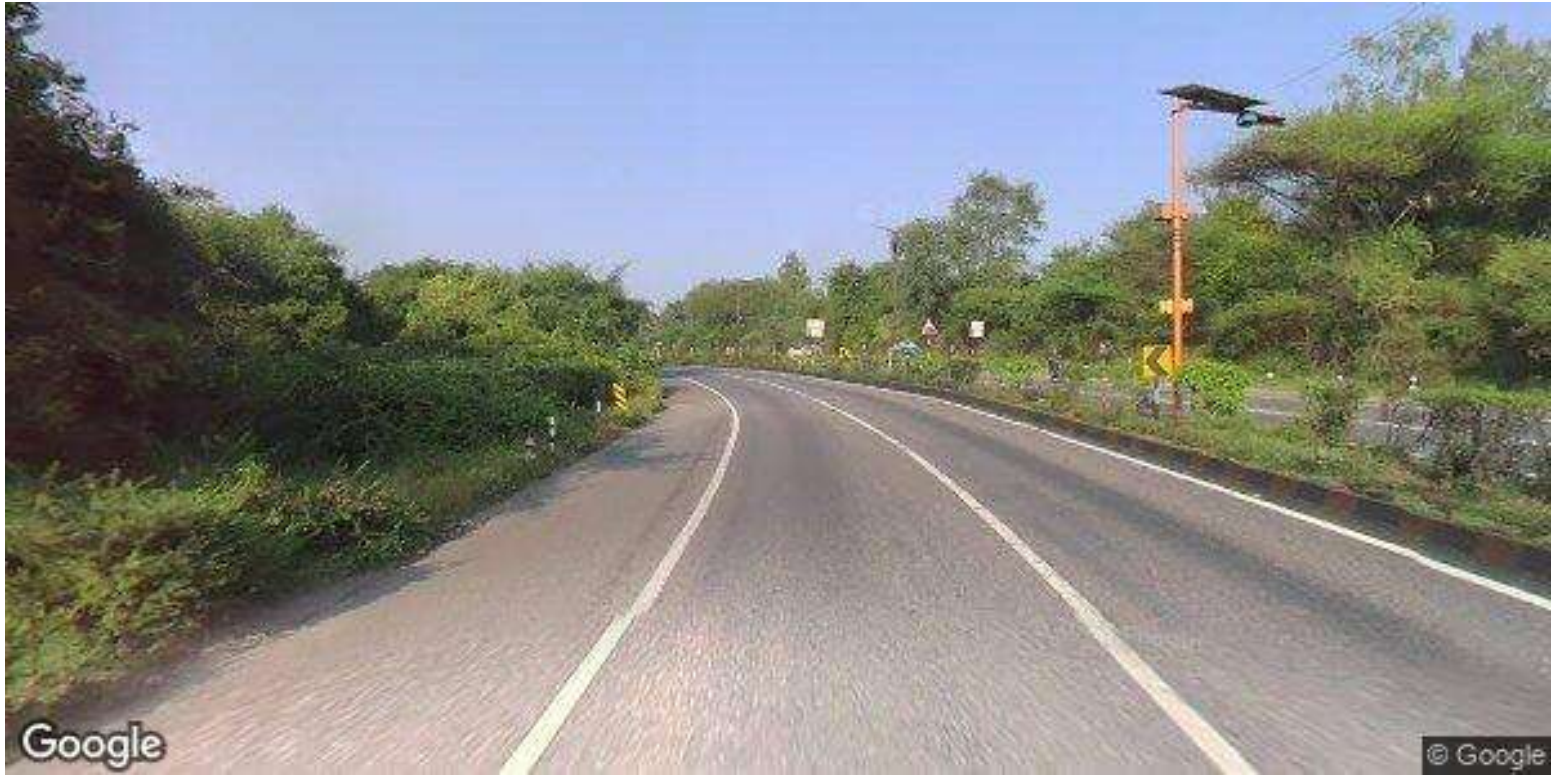
**Risk Type:** Turn  
**Risk Level:** Medium  
**Speed Limit:** 30 KM/Hr  
**Coordinates:** 11.96791, 78.05070

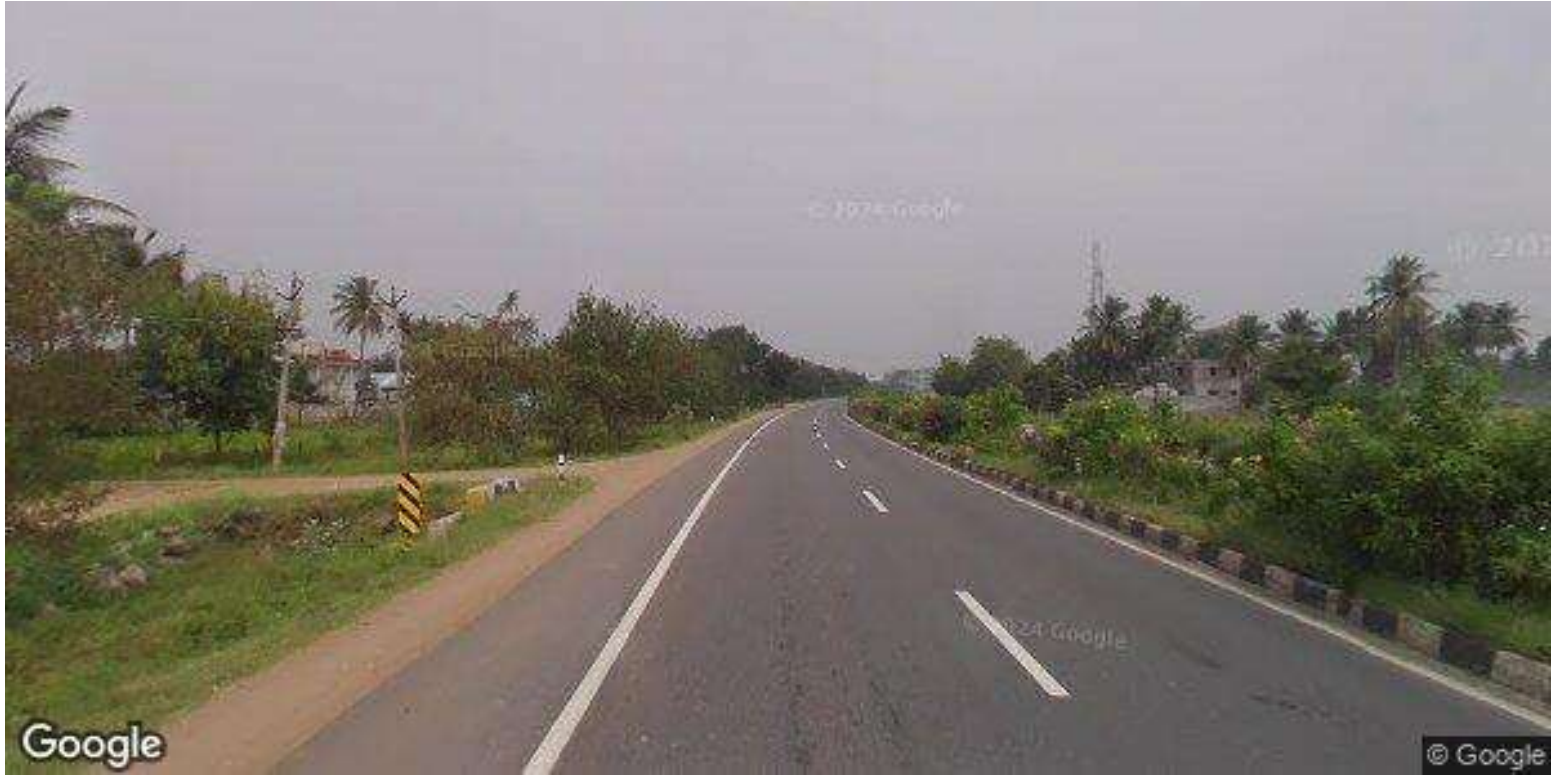
**Risk Type:** Turn  
**Risk Level:** Medium  
**Speed Limit:** 30 KM/Hr  
**Coordinates:** 12.19881, 78.18157

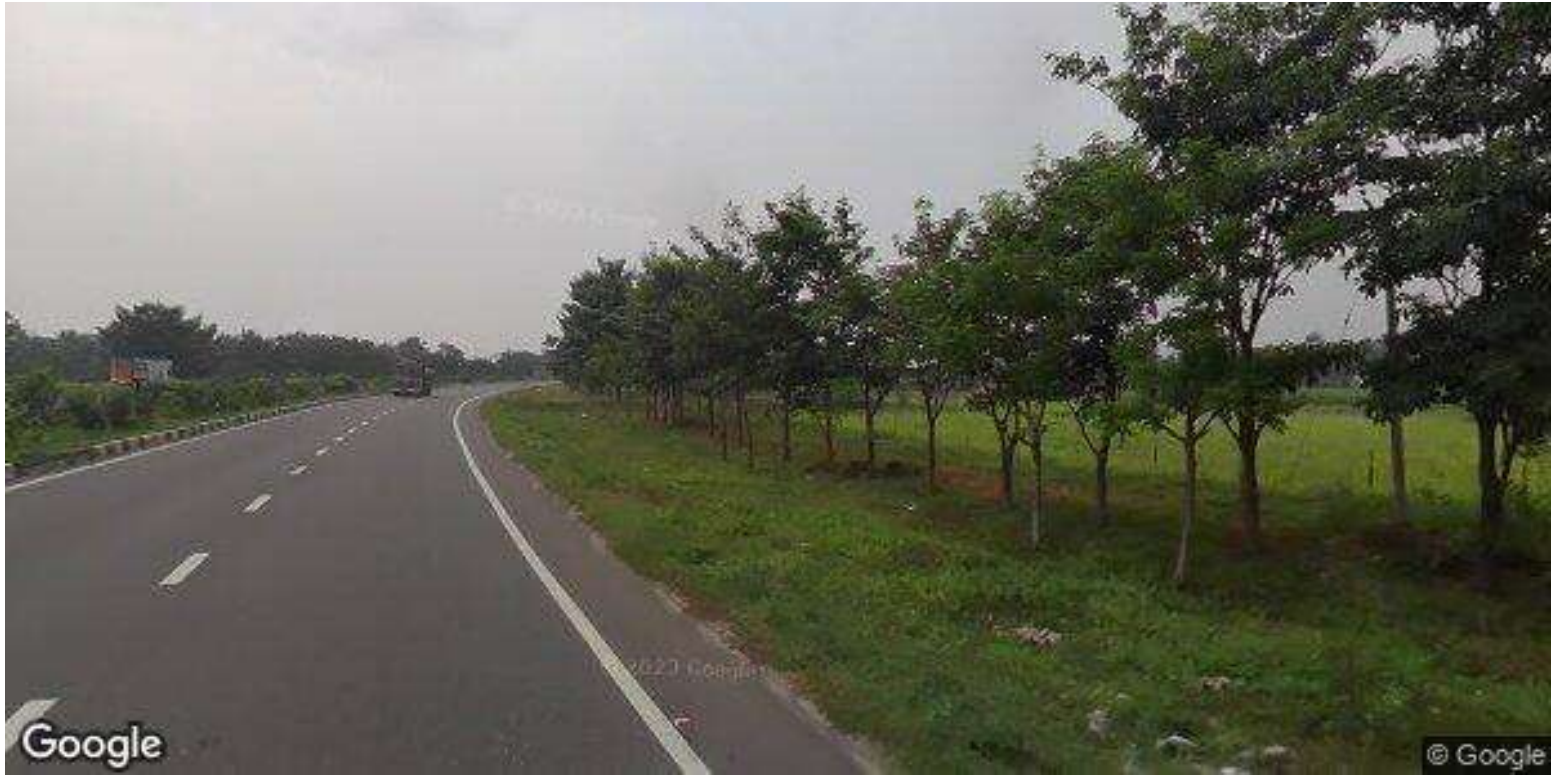
**Risk Type:** Turn  
**Risk Level:** Medium  
**Speed Limit:** 30 KM/Hr  
**Coordinates:** 12.25060, 78.19977

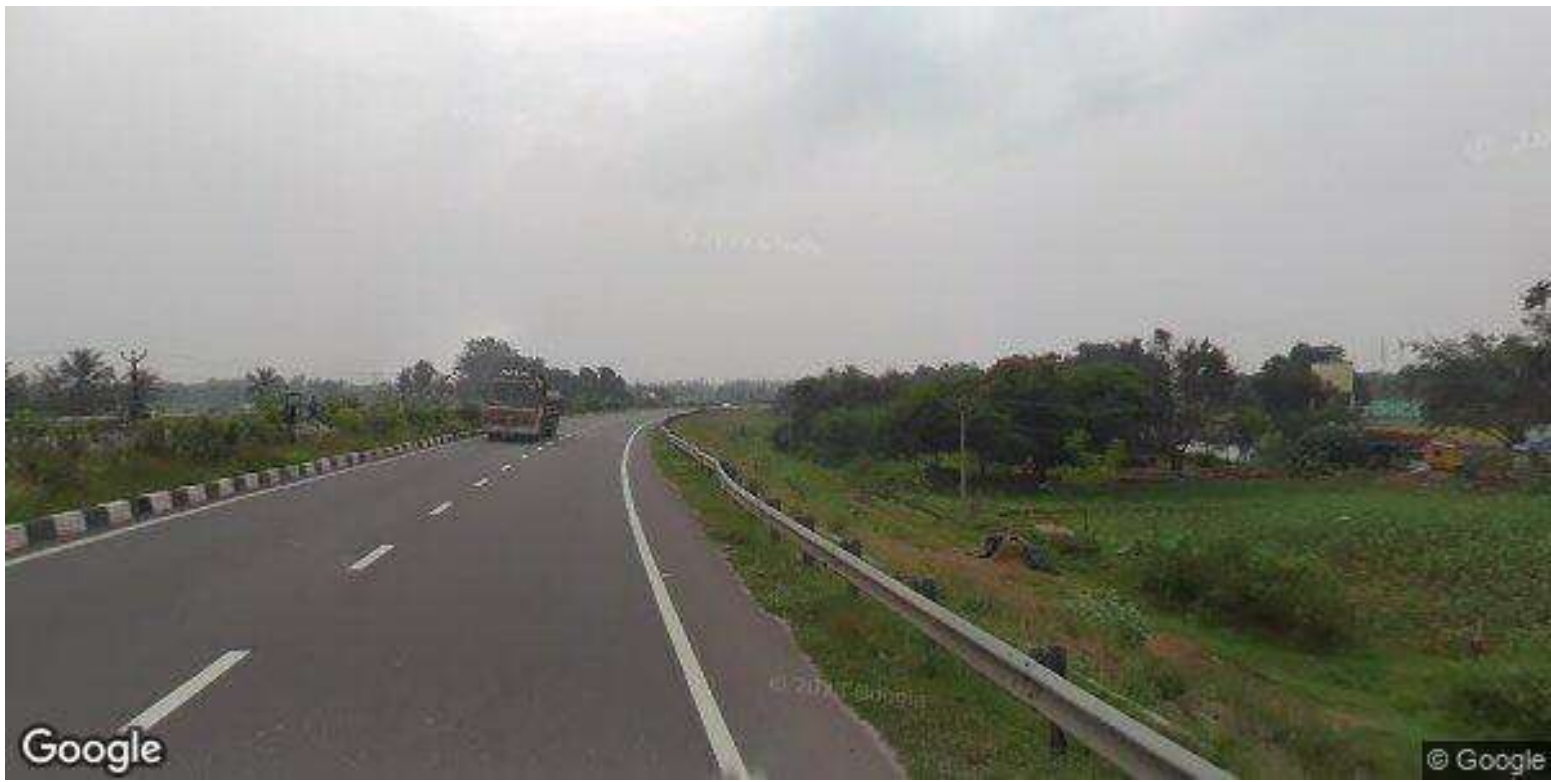
**Coordinates:** 12.25329, 78.20039

**Risk Type:** Turn

**Risk Level:** Medium

**Speed Limit:** 30 KM/Hr

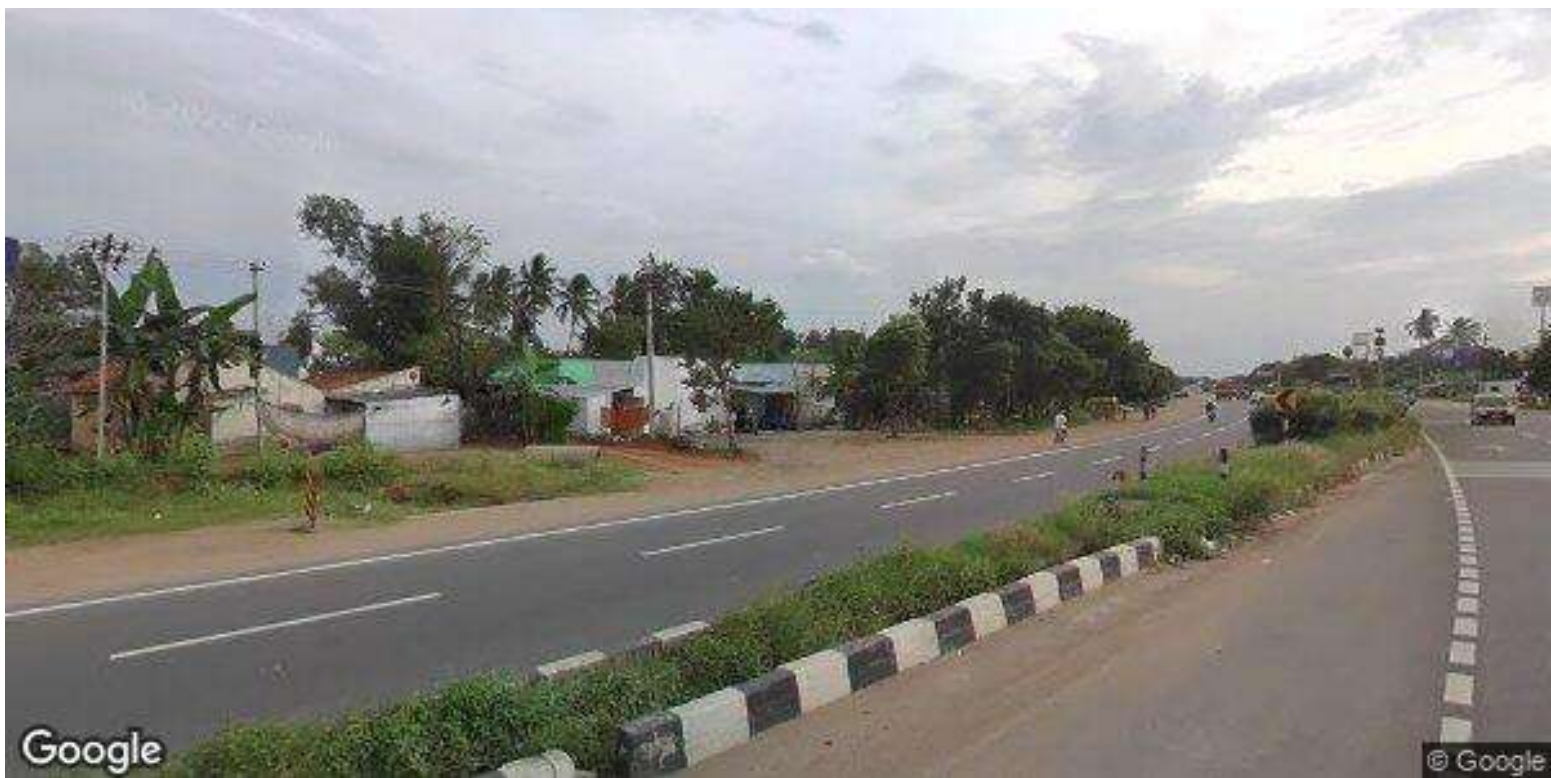
**Coordinates:** 12.29110, 78.19909

**Risk Type:** Turn

**Risk Level:** Medium

**Speed Limit:** 30 KM/Hr

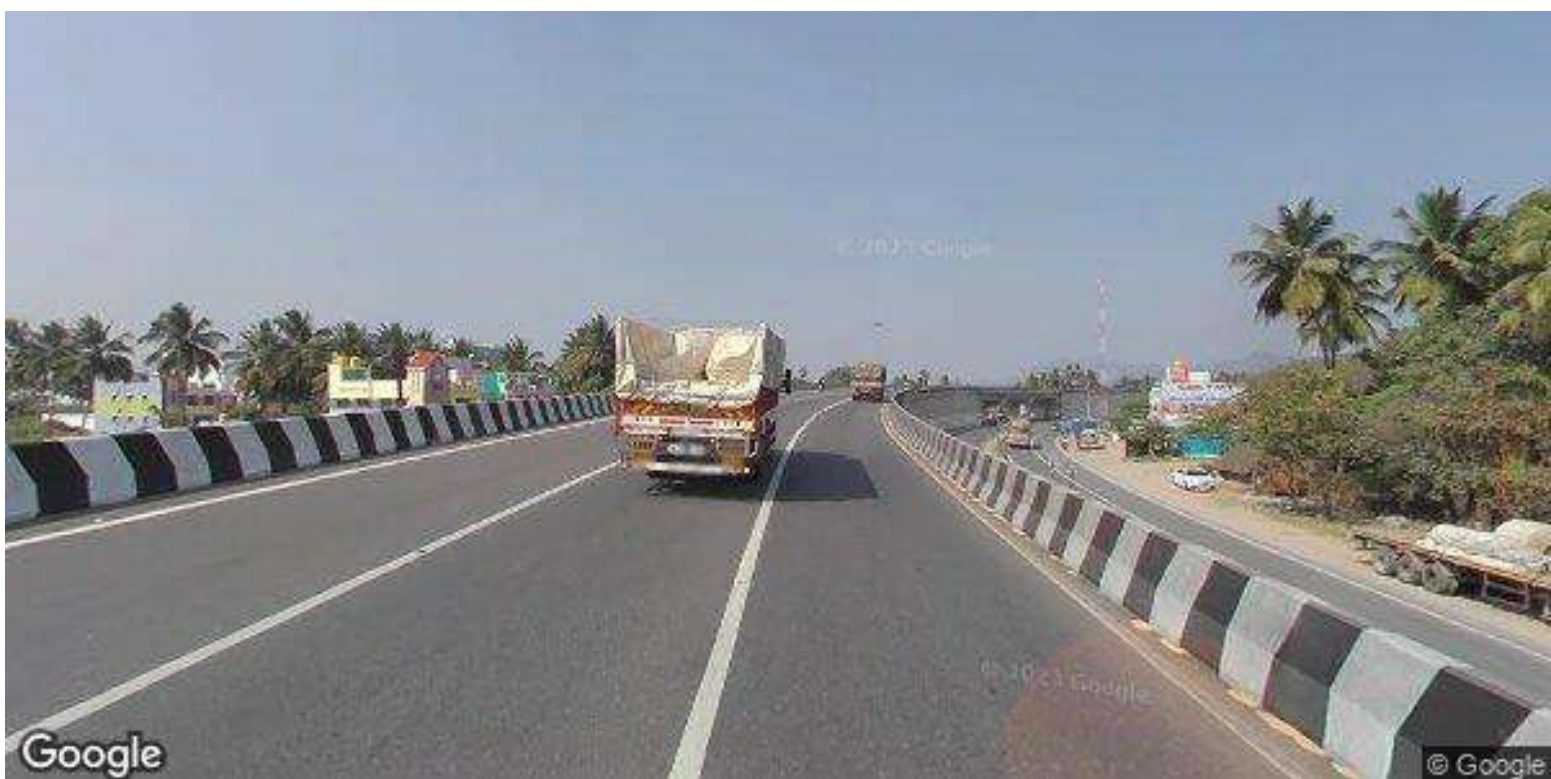
**Risk Type:** Turn  
**Risk Level:** Medium  
**Speed Limit:** 30 KM/Hr  
**Coordinates:** 12.39904, 78.21764

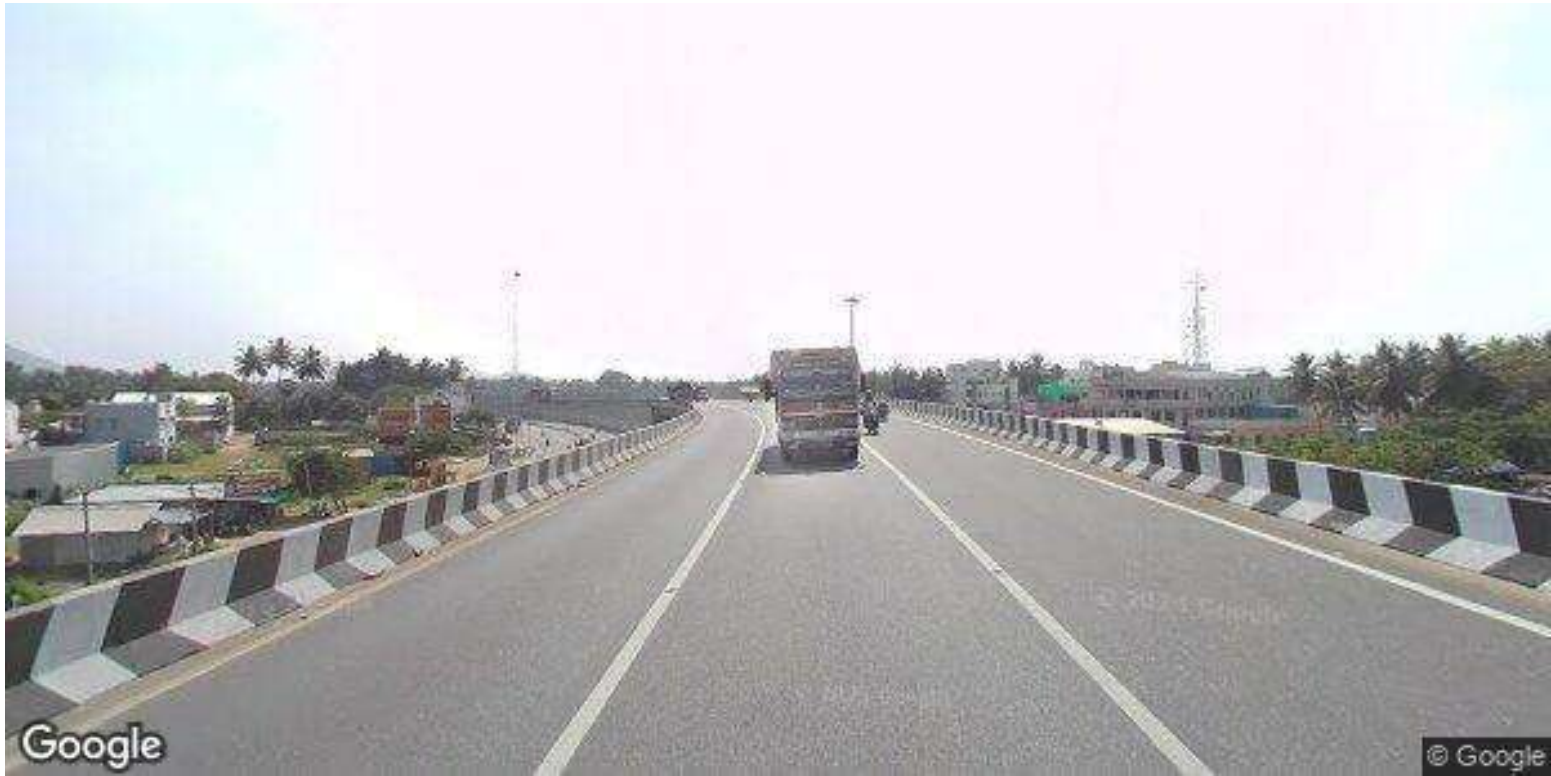
**Risk Type:** Turn  
**Risk Level:** Medium  
**Speed Limit:** 30 KM/Hr  
**Coordinates:** 12.40156, 78.21845

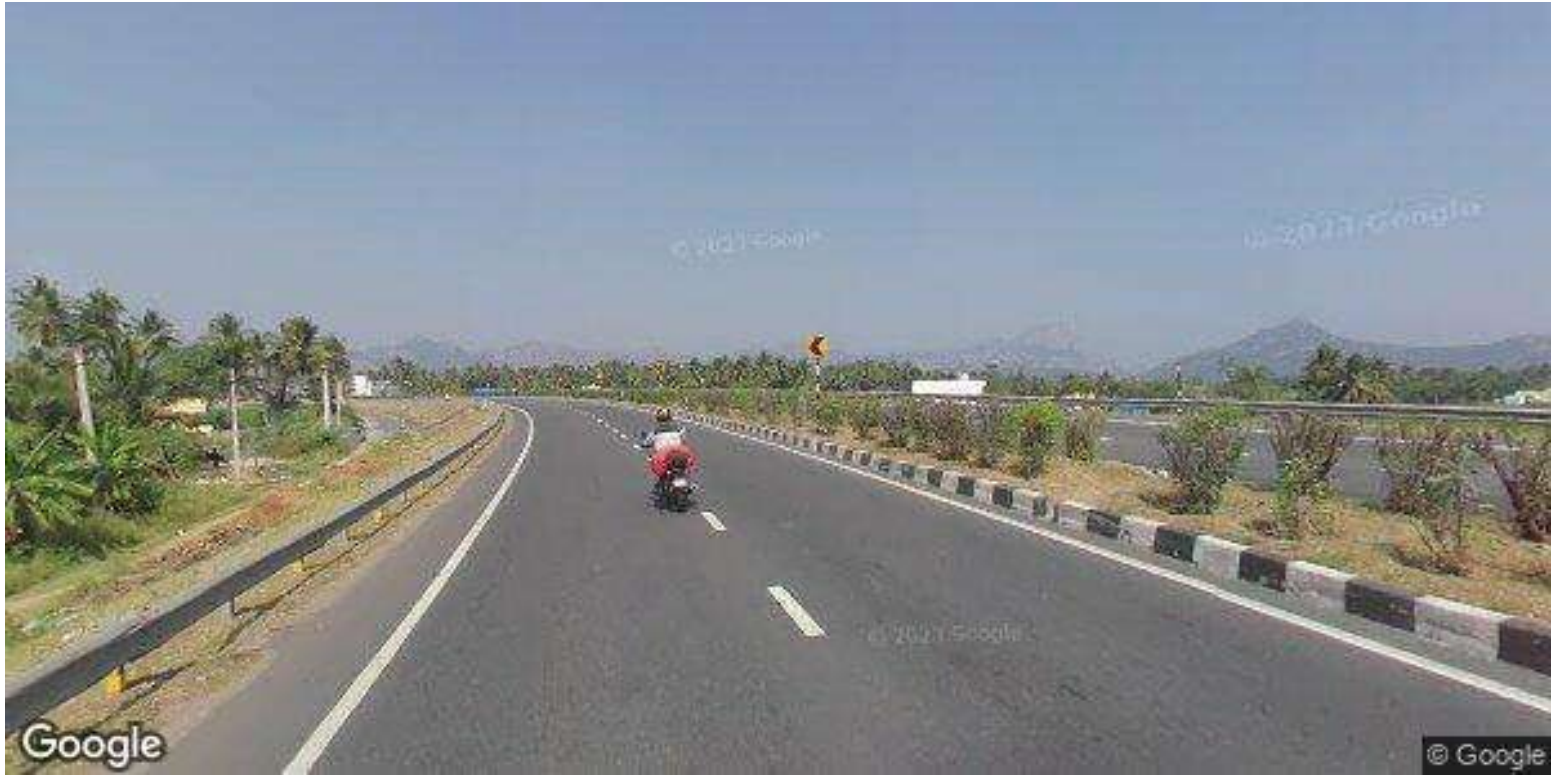
**Risk Type:** Turn  
**Risk Level:** Medium  
**Speed Limit:** 30 KM/Hr  
**Coordinates:** 12.40589, 78.22275
