# IndianOil

## JOURNEY RISK MANAGEMENT (JRM) STUDY

### Salem Terminal TO SHRI RAMESH BABU AGENCY UNIT II

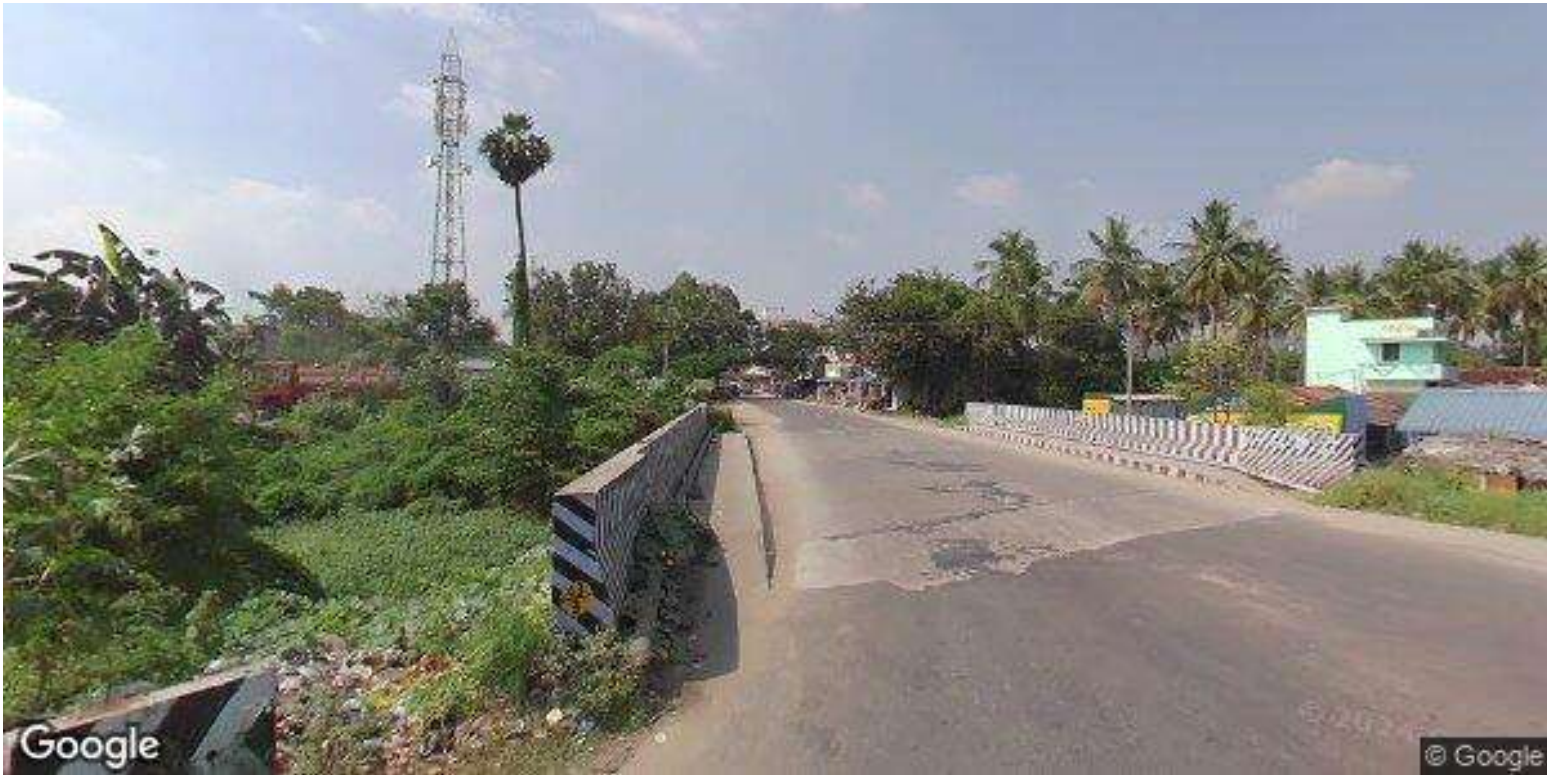
Coordinates: 11.44900, 77.87406

Risk Type: Turn

Risk Level: High

Speed Limit: 15 KM/Hr

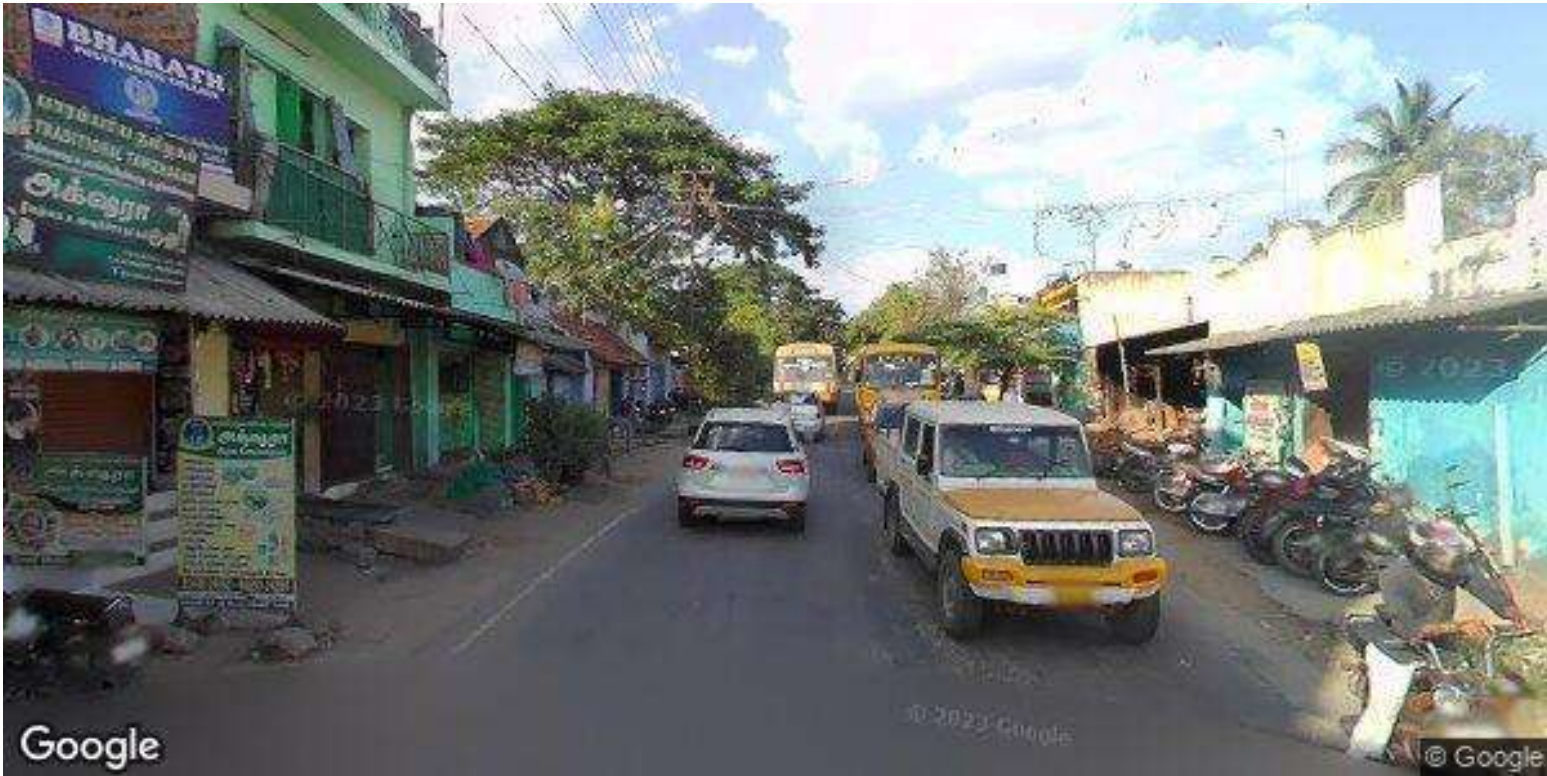
**Risk Type:** Turn  
**Risk Level:** High  
**Speed Limit:** 15 KM/Hr  
**Coordinates:** 11.45028, 77.87202

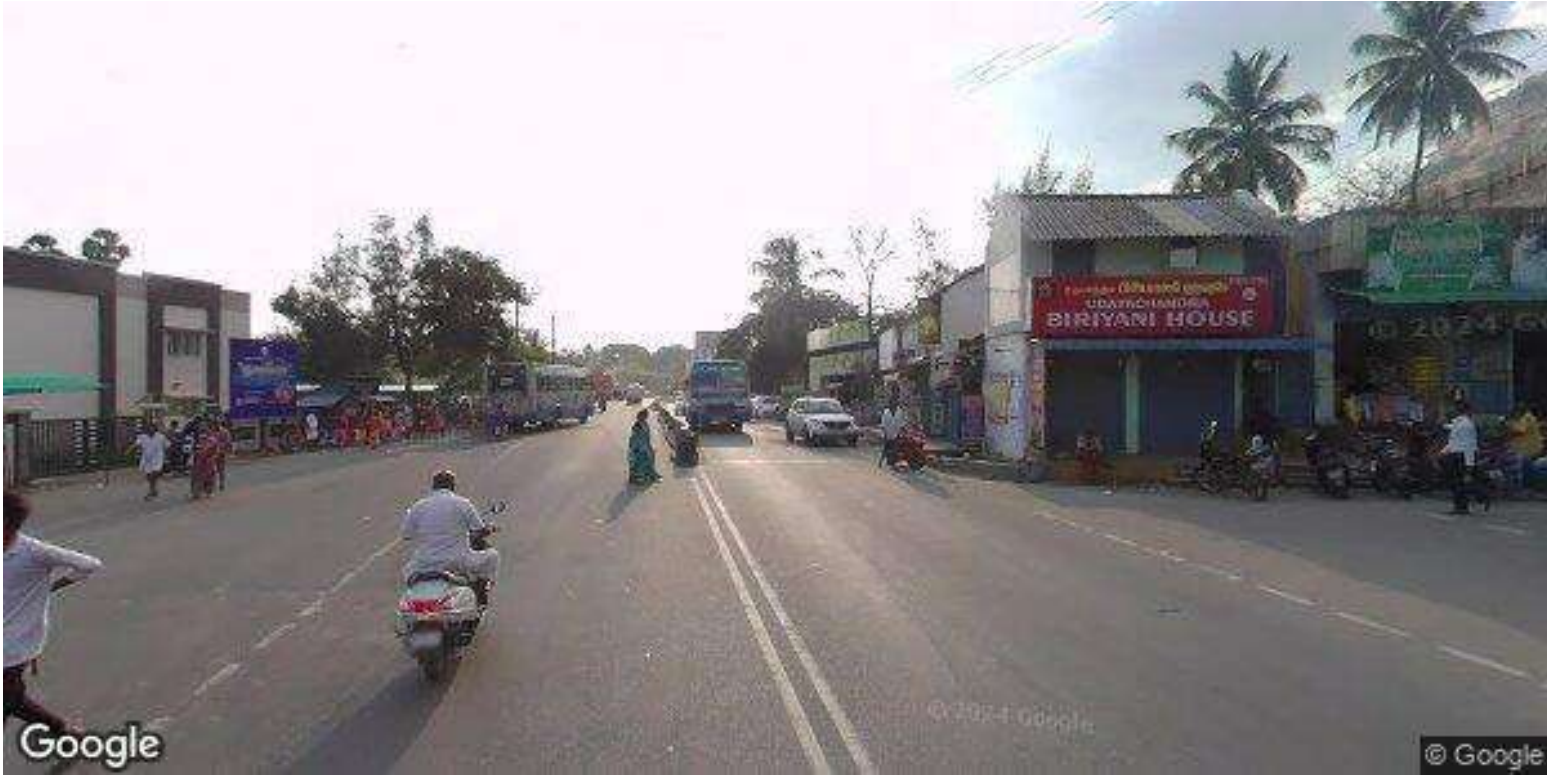
**Risk Type:** Turn  
**Risk Level:** High  
**Speed Limit:** 15 KM/Hr  
**Coordinates:** 11.47403, 77.86841

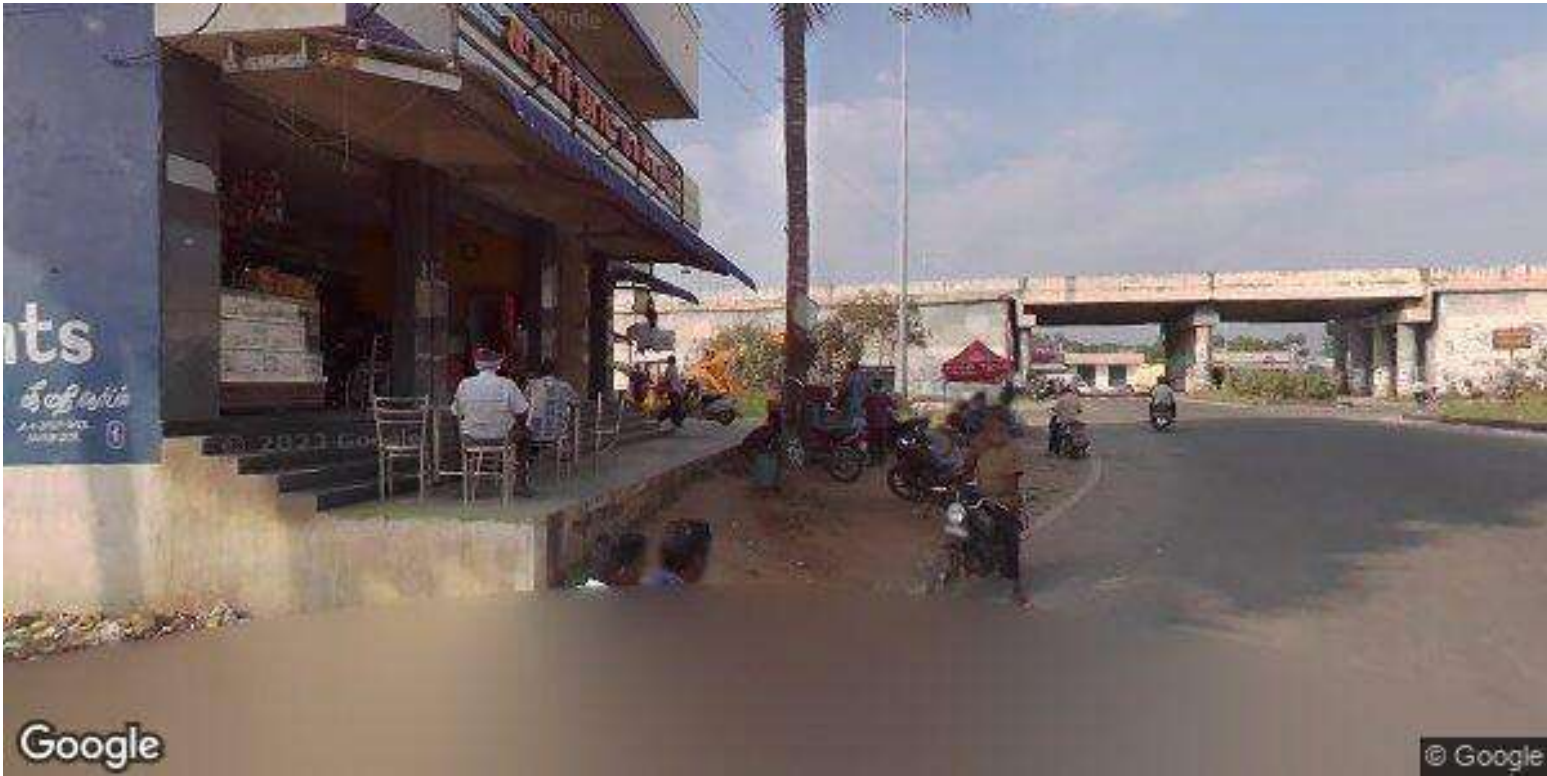
**Risk Type:** Turn  
**Risk Level:** High  
**Speed Limit:** 15 KM/Hr  
**Coordinates:** 11.49149, 77.89601

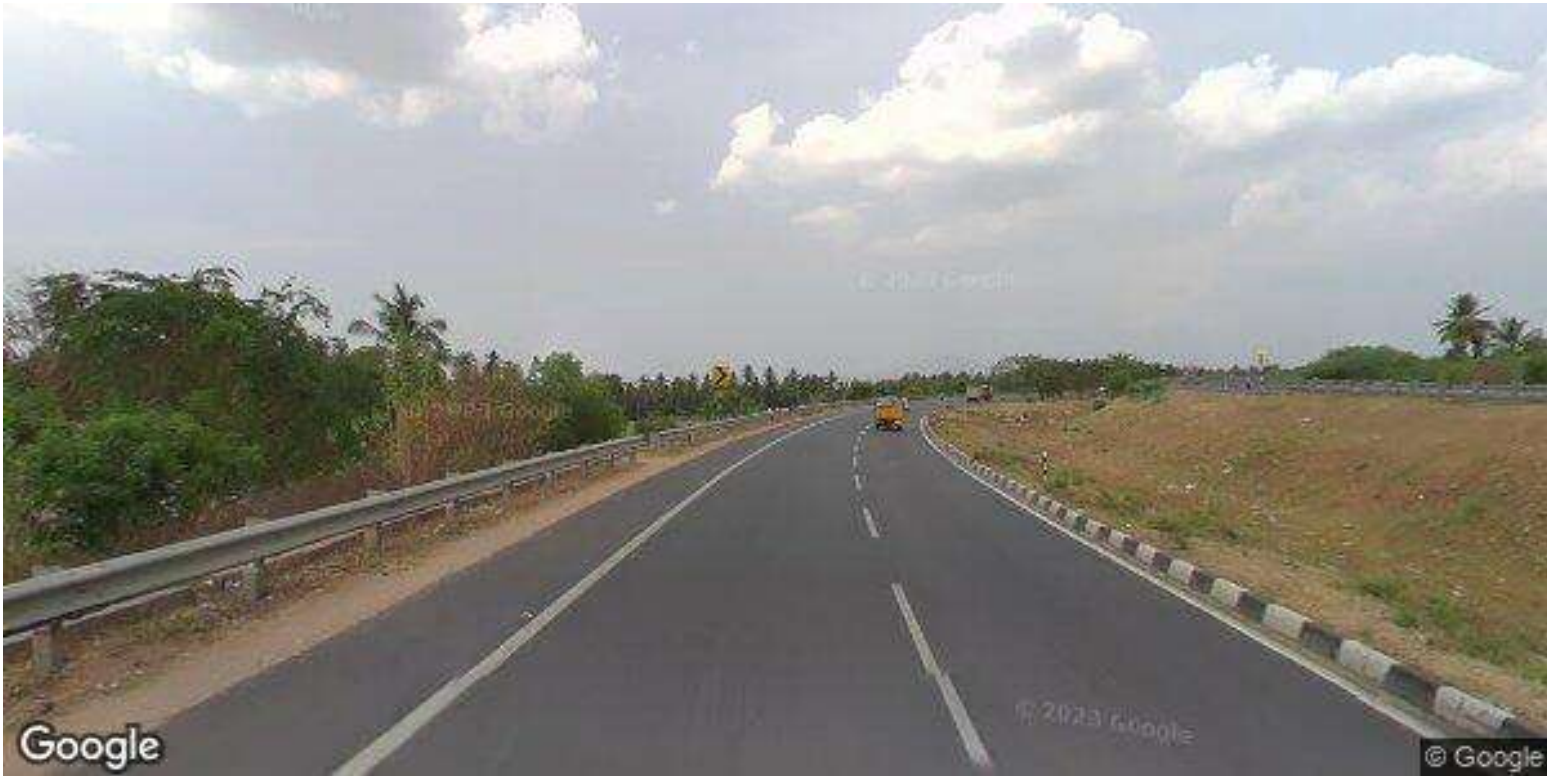
**Risk Type:** Turn  
**Risk Level:** Medium  
**Speed Limit:** 30 KM/Hr  
**Coordinates:** 11.53501, 77.95707

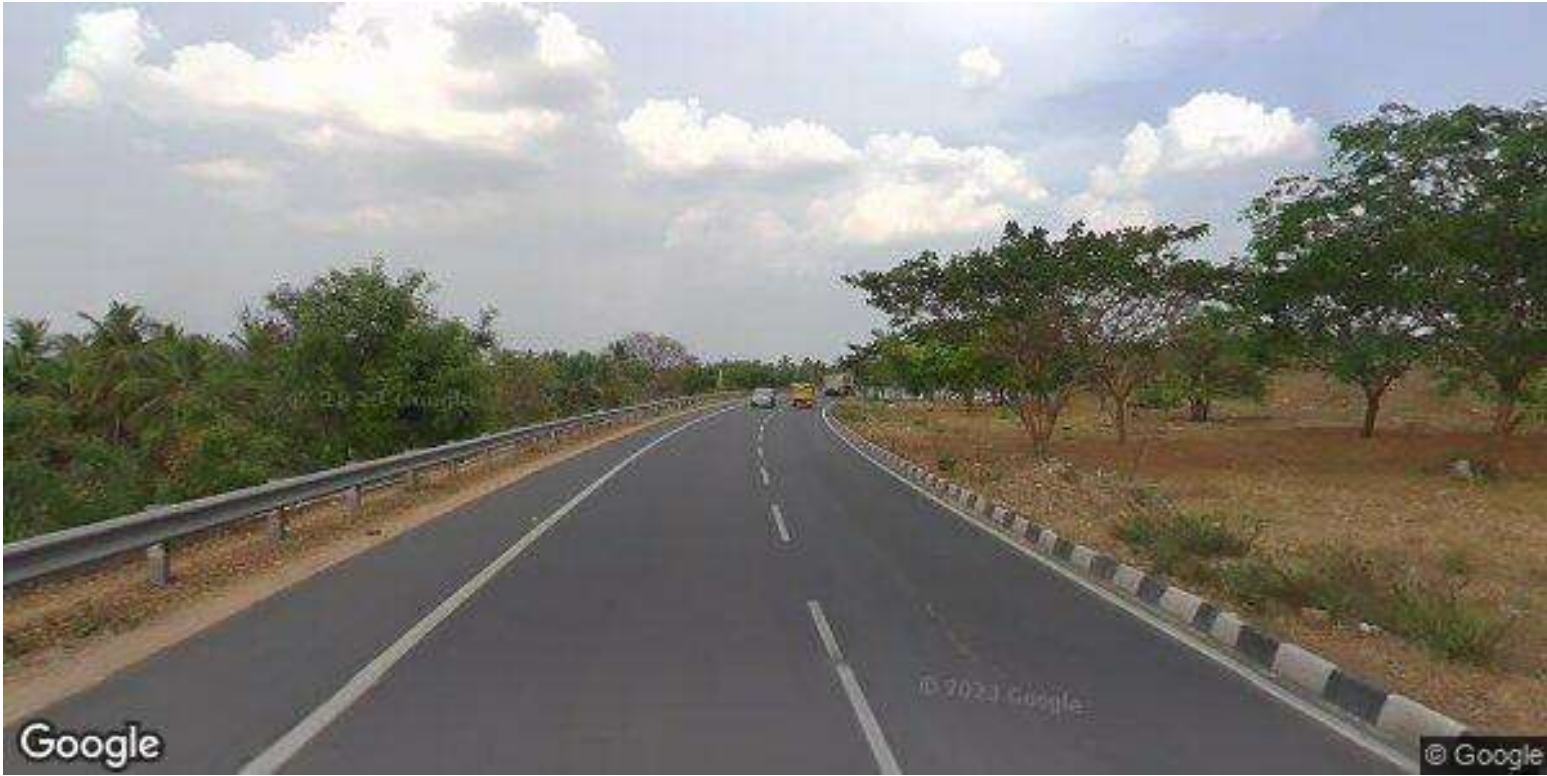
**Risk Type:** Turn  
**Risk Level:** Medium  
**Speed Limit:** 30 KM/Hr  
**Coordinates:** 11.53601, 77.95856

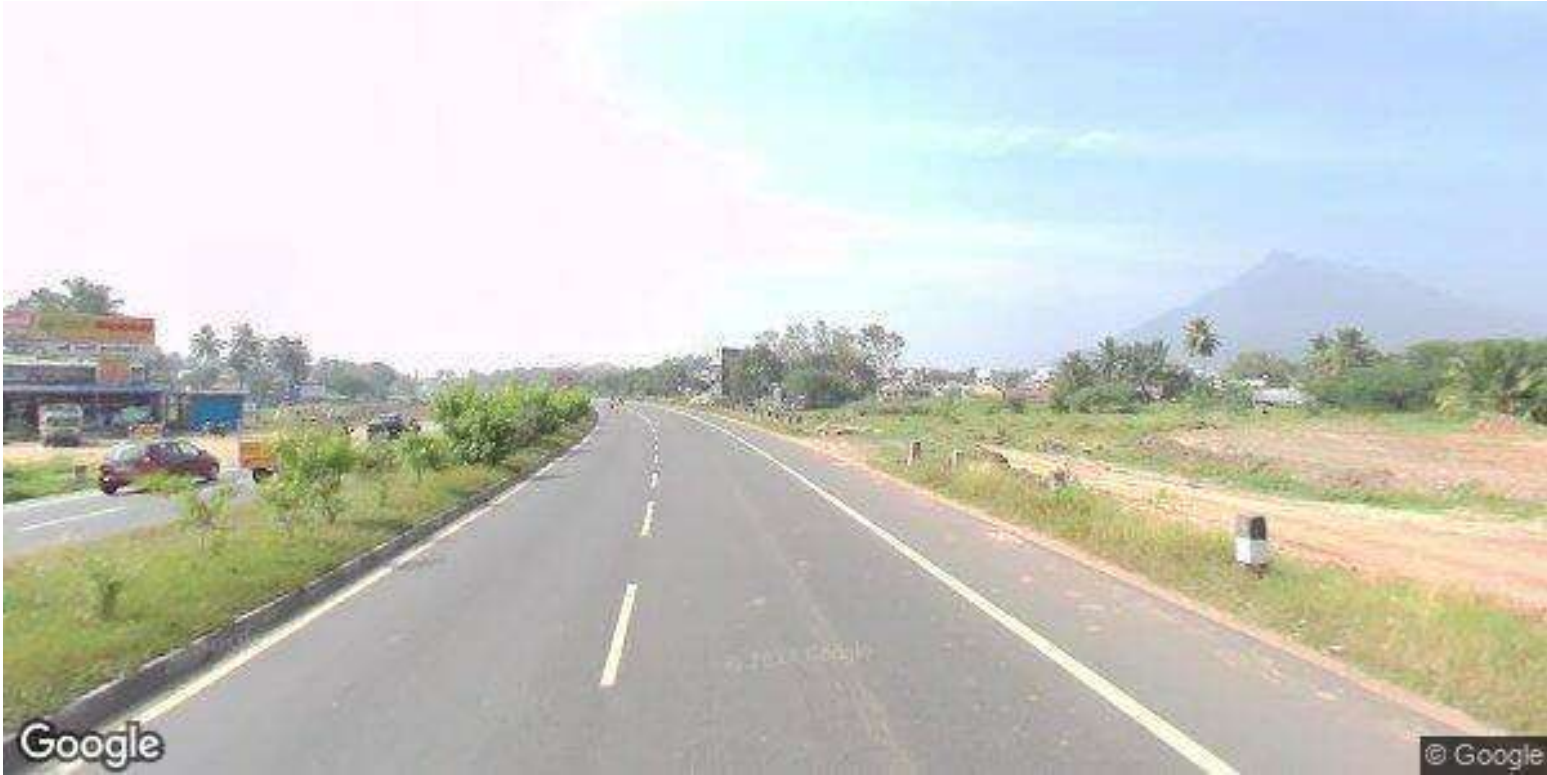
**Risk Type:** Turn  
**Risk Level:** Medium  
**Speed Limit:** 30 KM/Hr  
**Coordinates:** 11.62403, 78.10893

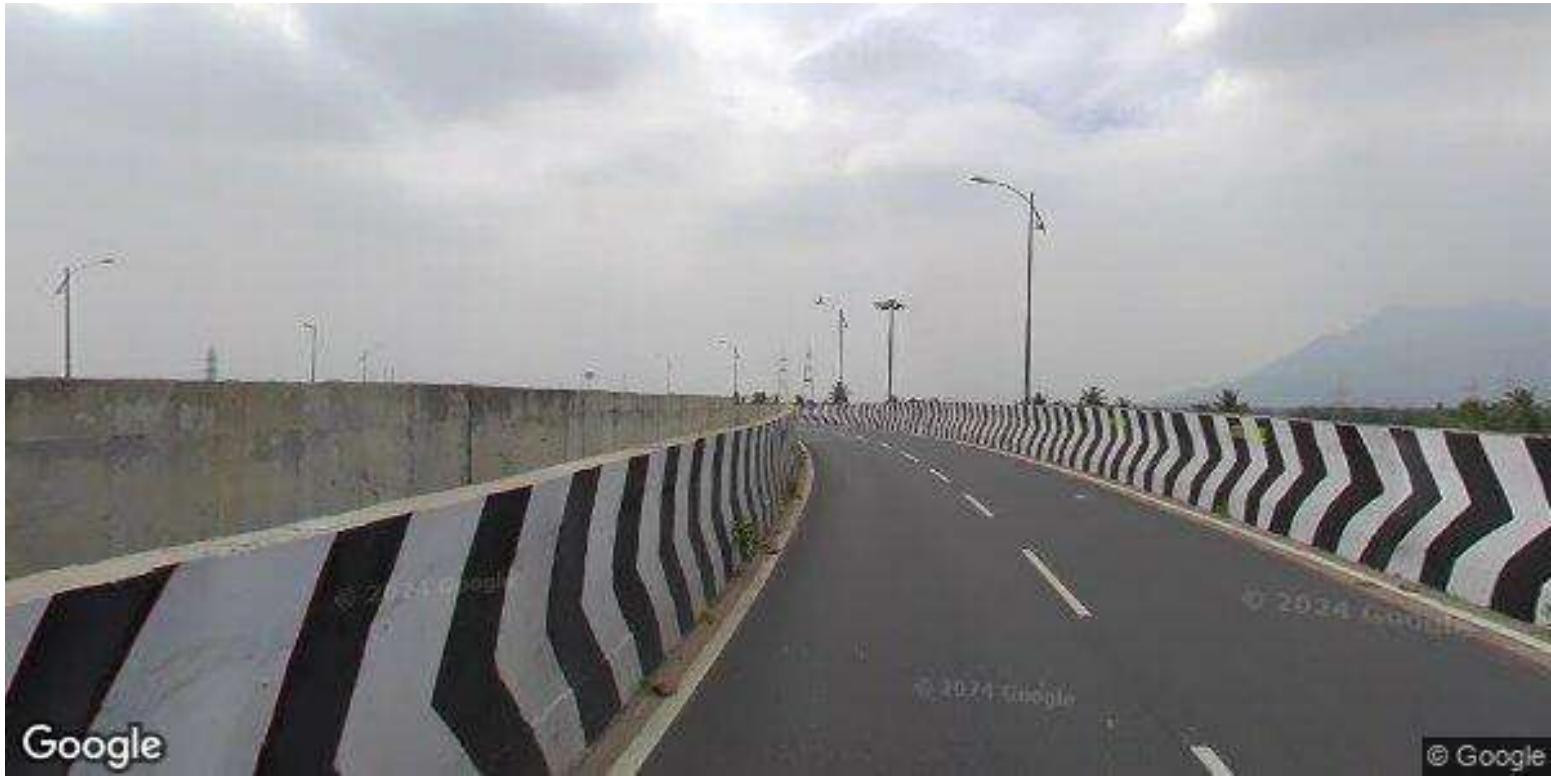
**Risk Type:** Turn  
**Risk Level:** High  
**Speed Limit:** 15 KM/Hr  
**Coordinates:** 11.64180, 78.11808

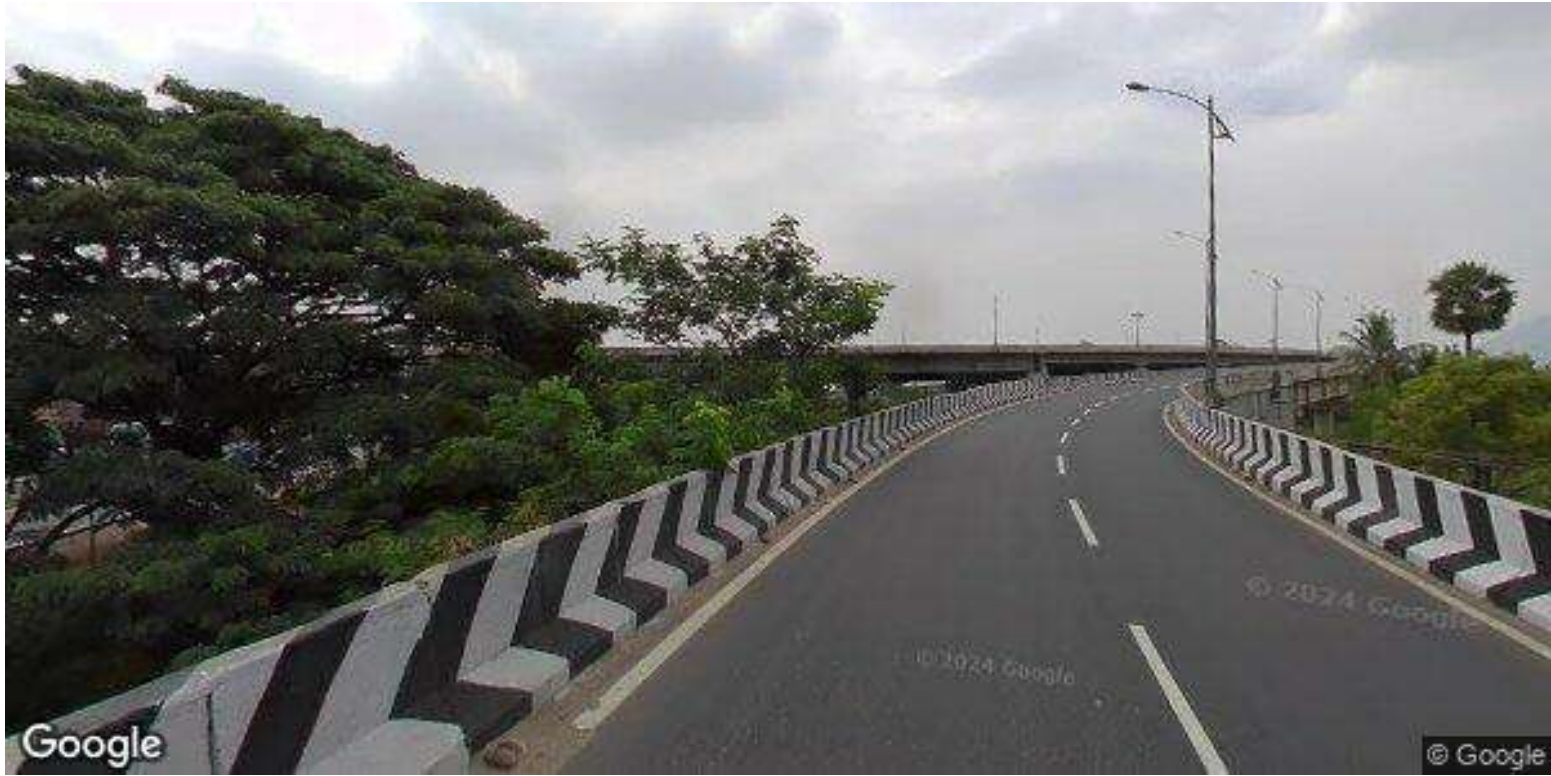
**Risk Type:** Turn  
**Risk Level:** High  
**Speed Limit:** 15 KM/Hr  
**Coordinates:** 11.64325, 78.11993

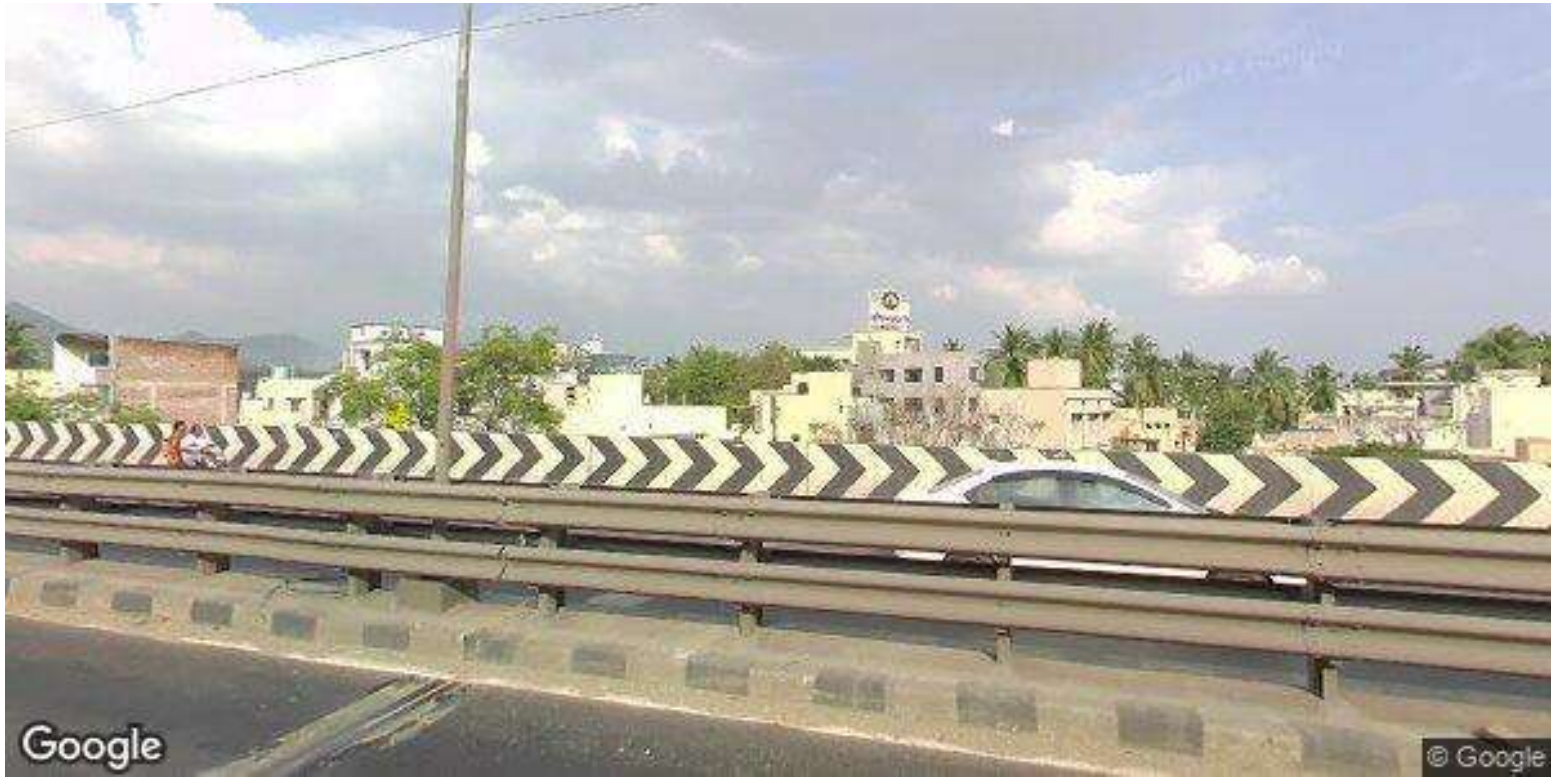
**Risk Type:** Turn  
**Risk Level:** Medium  
**Speed Limit:** 30 KM/Hr  
**Coordinates:** 11.67865, 78.12803

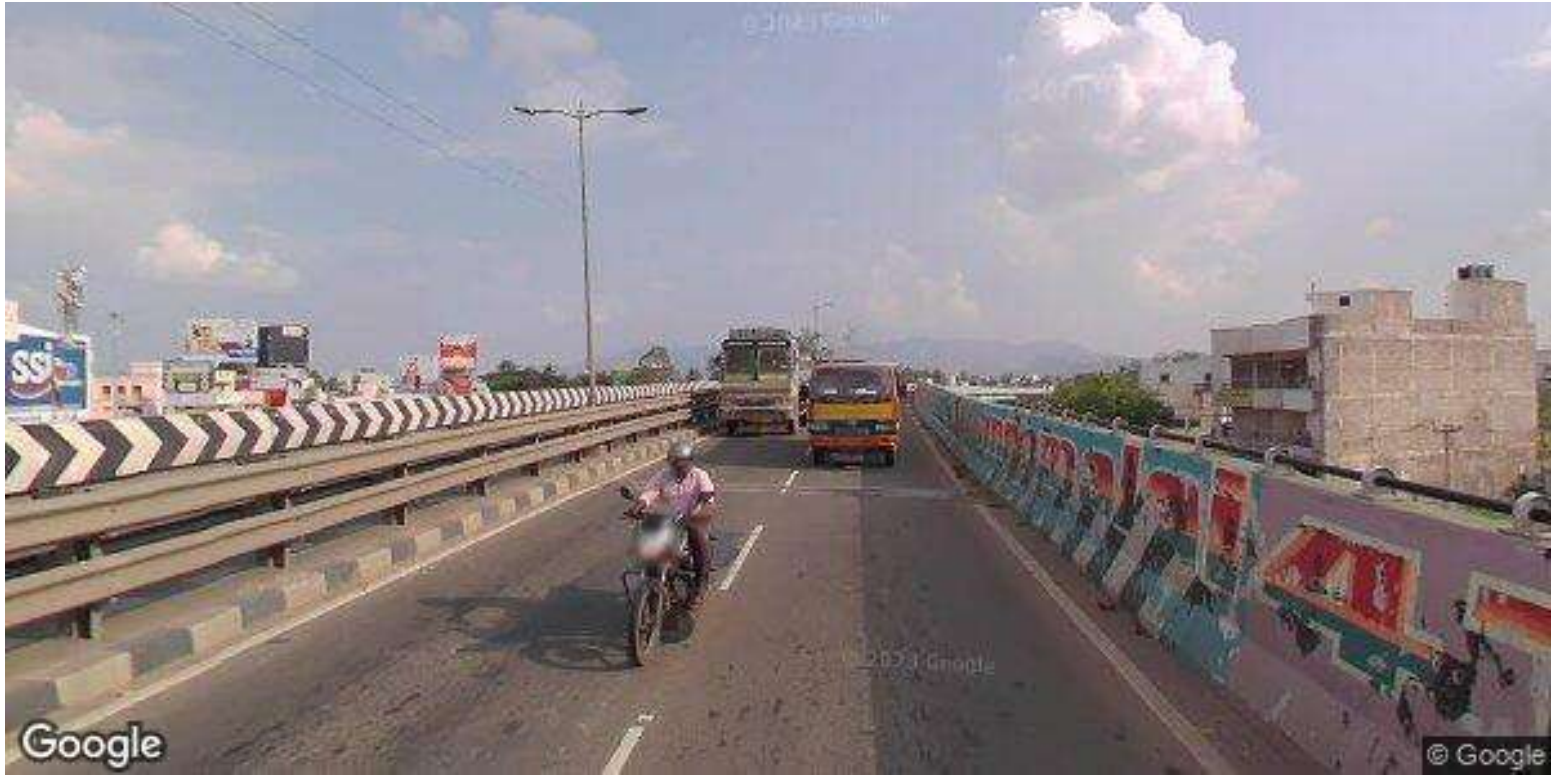
**Risk Type:** Turn  
**Risk Level:** Medium  
**Speed Limit:** 30 KM/Hr  
**Coordinates:** 11.68201, 78.12639

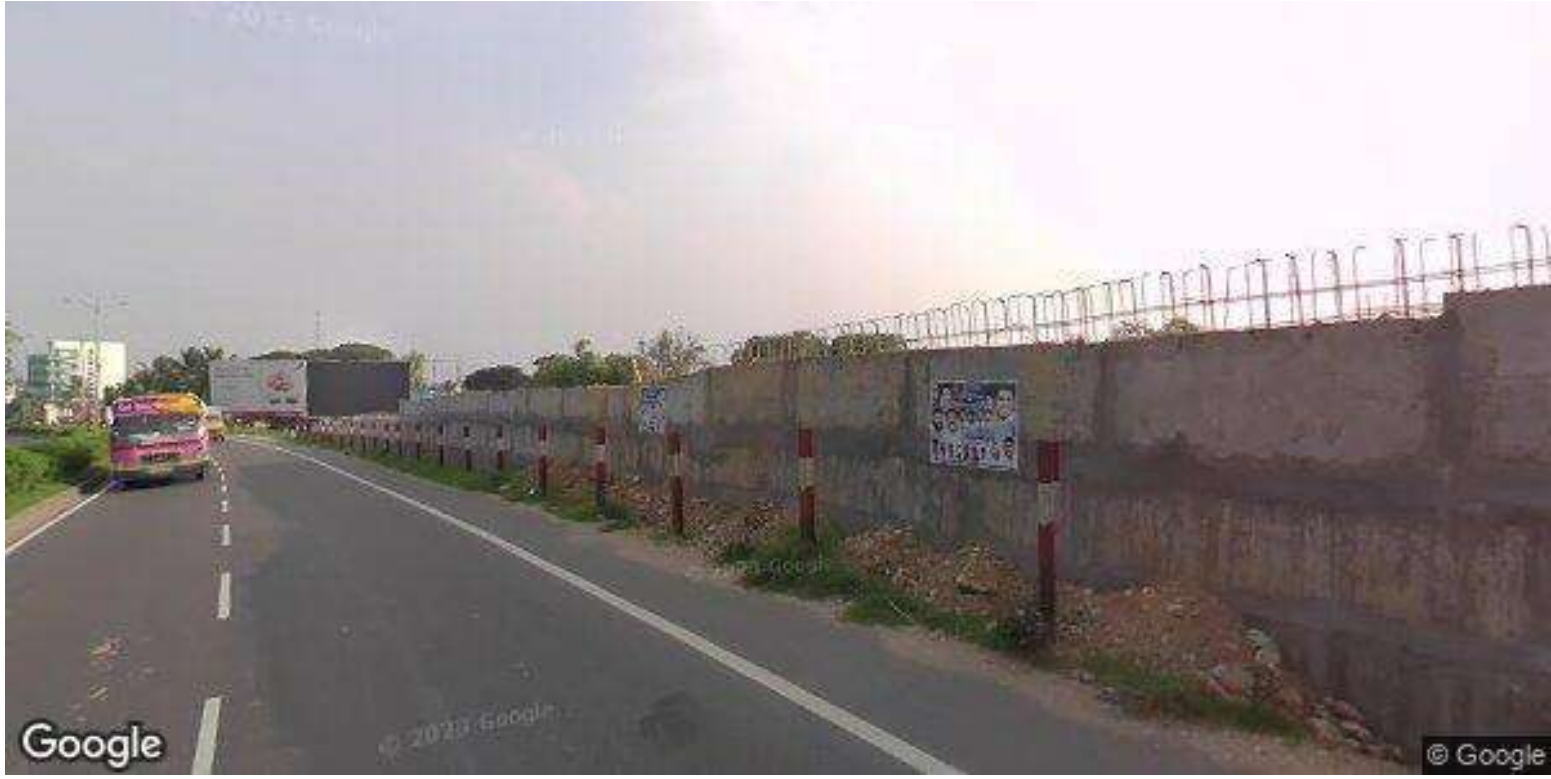
**Risk Type:** Turn  
**Risk Level:** Medium  
**Speed Limit:** 30 KM/Hr  
**Coordinates:** 11.69519, 78.10775

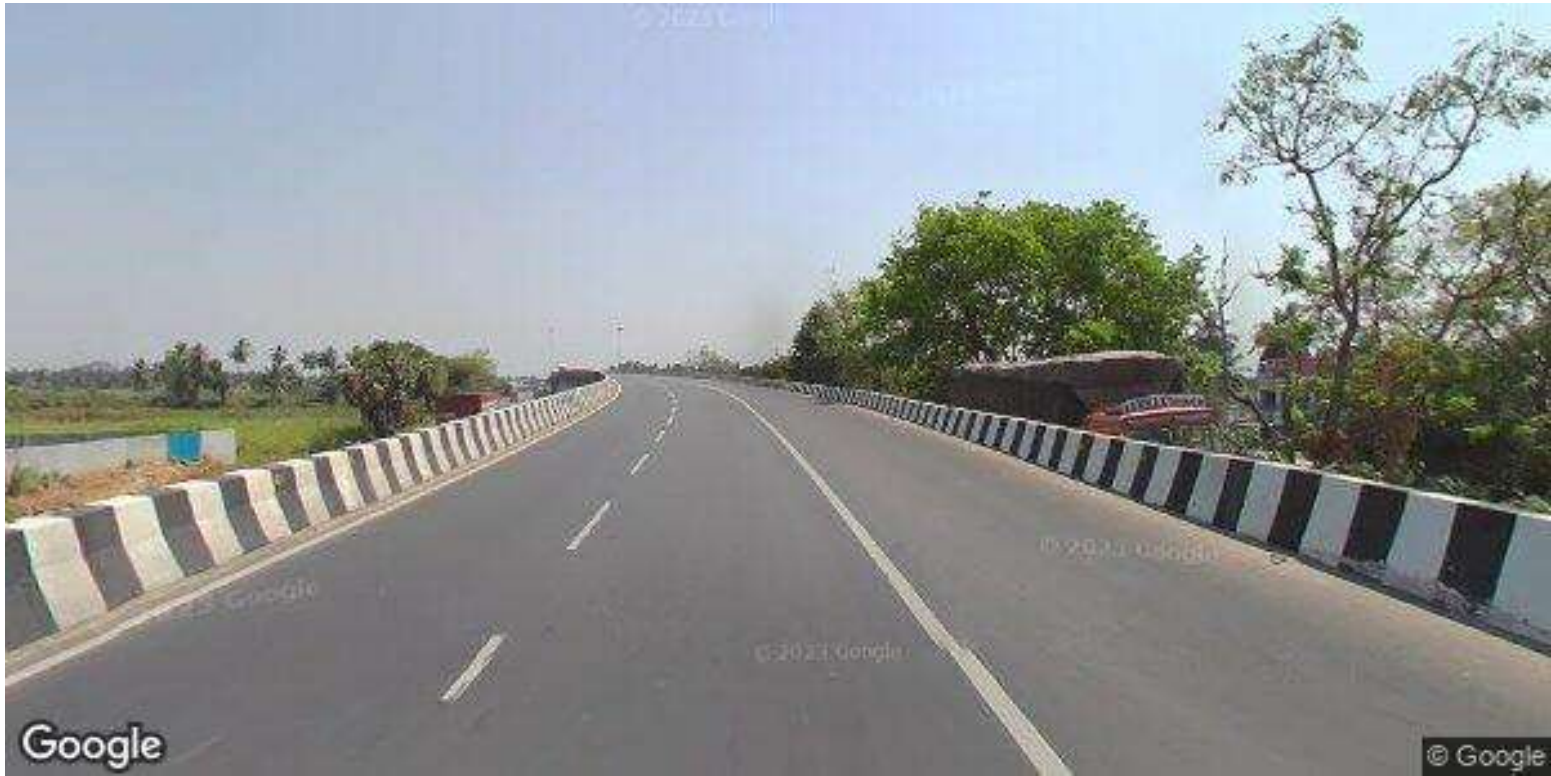
**Risk Type:** Turn  
**Risk Level:** Medium  
**Speed Limit:** 30 KM/Hr  
**Coordinates:** 11.73958, 78.05105

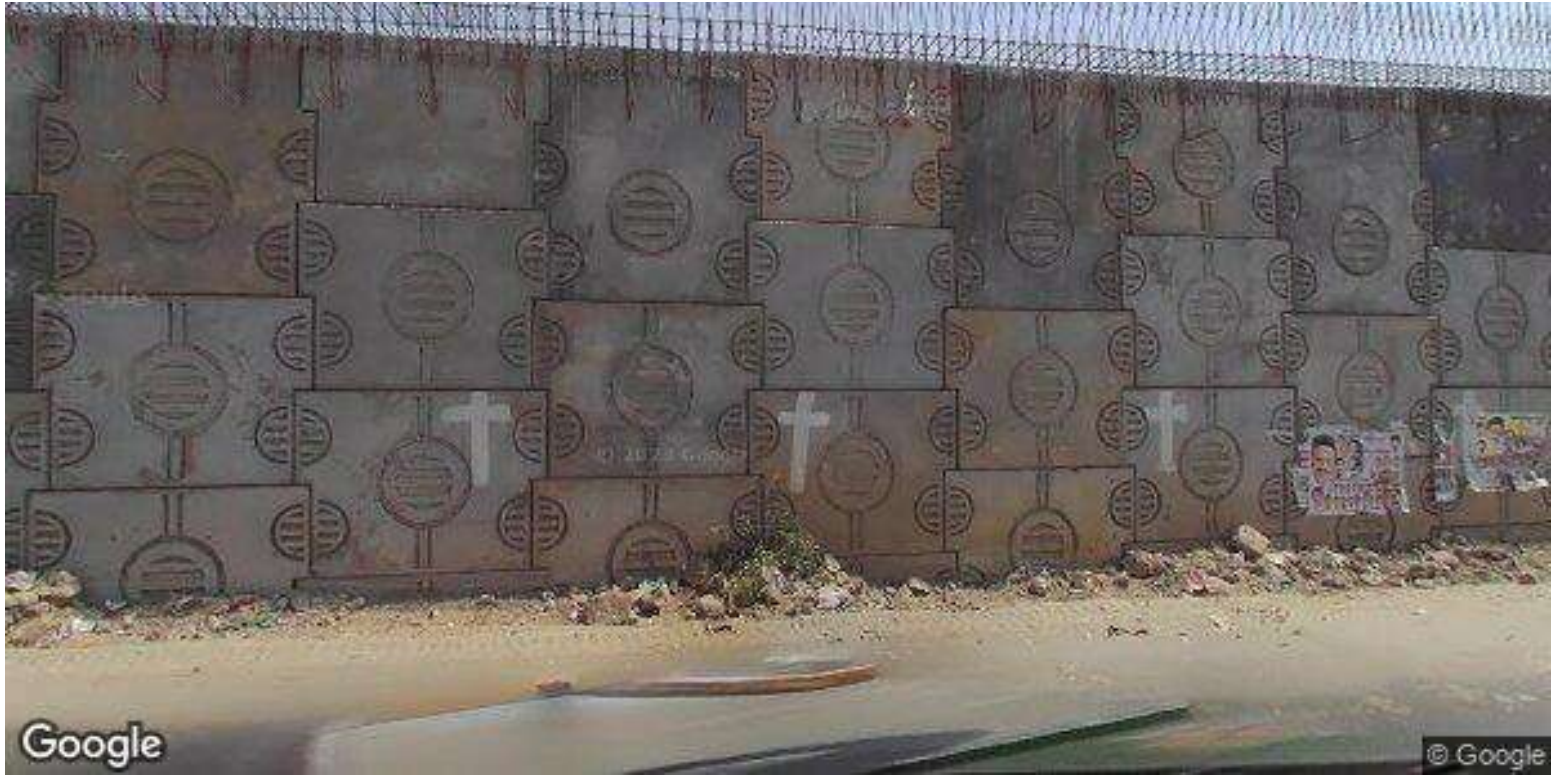
**Risk Type:** Turn  
**Risk Level:** Medium  
**Speed Limit:** 30 KM/Hr  
**Coordinates:** 11.75835, 78.05016

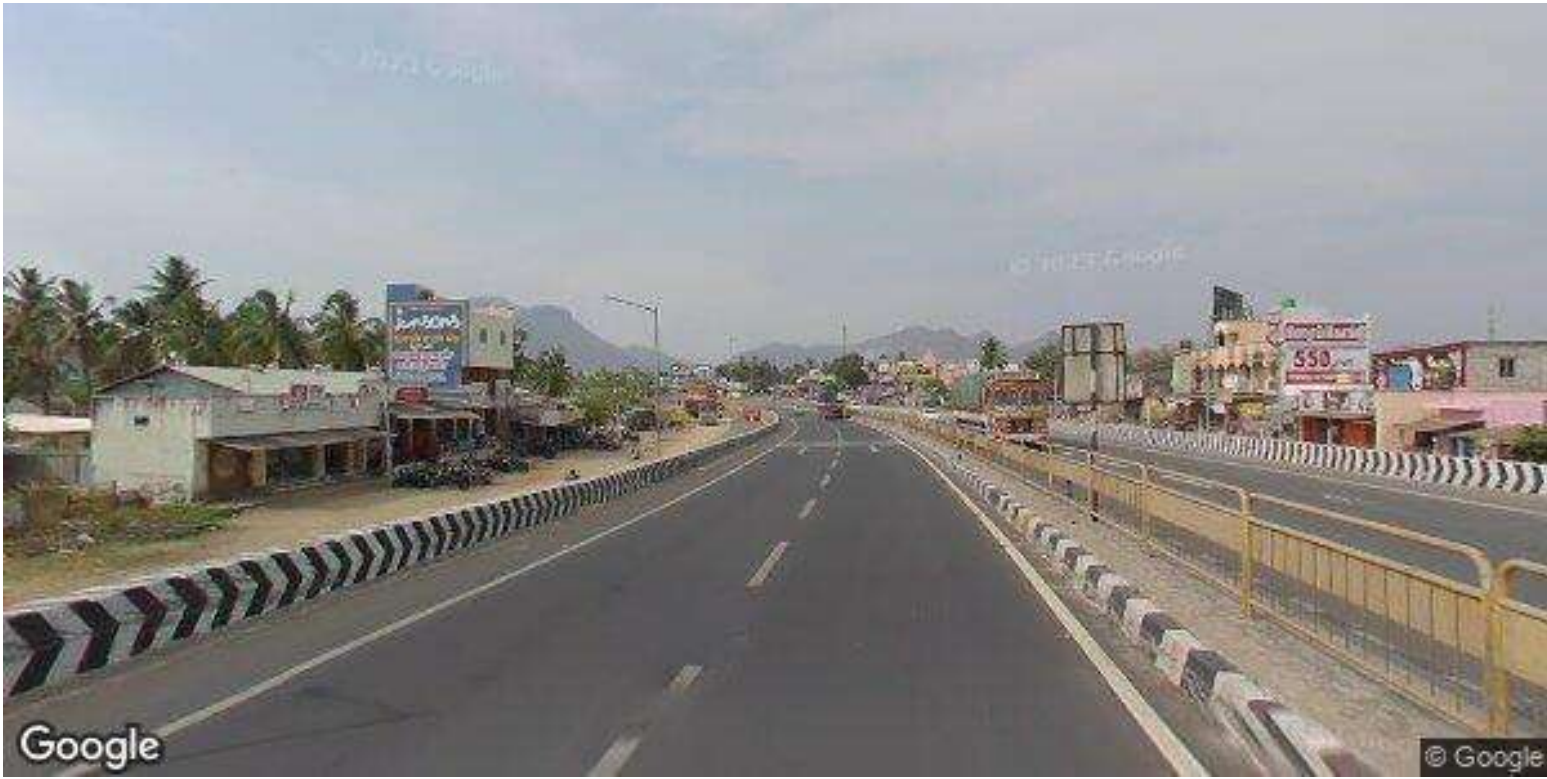
**Risk Type:** Turn  
**Risk Level:** Medium  
**Speed Limit:** 30 KM/Hr  
**Coordinates:** 11.86847, 78.08367

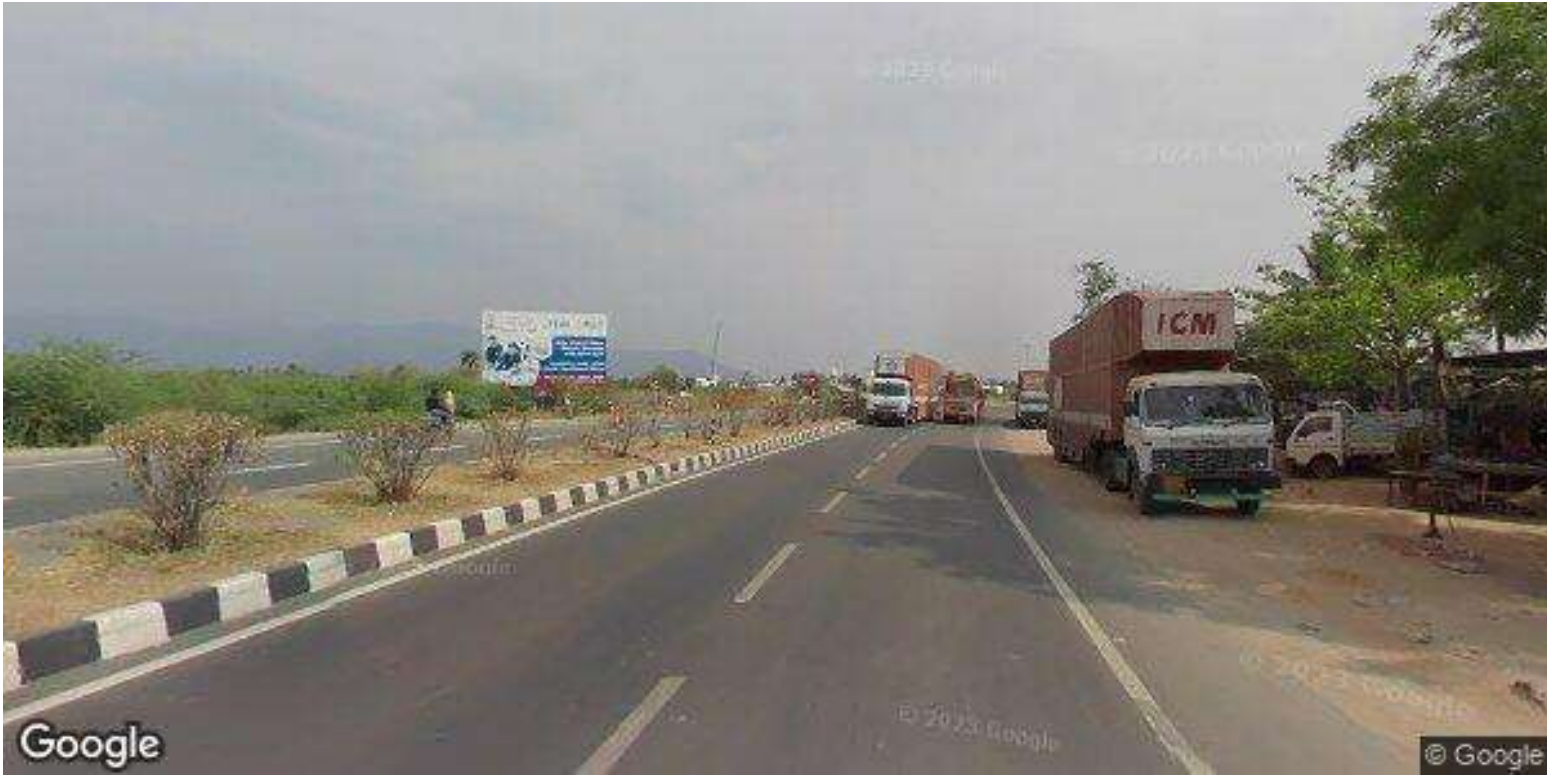
**Risk Type:** Turn  
**Risk Level:** Medium  
**Speed Limit:** 30 KM/Hr  
**Coordinates:** 11.87942, 78.08197

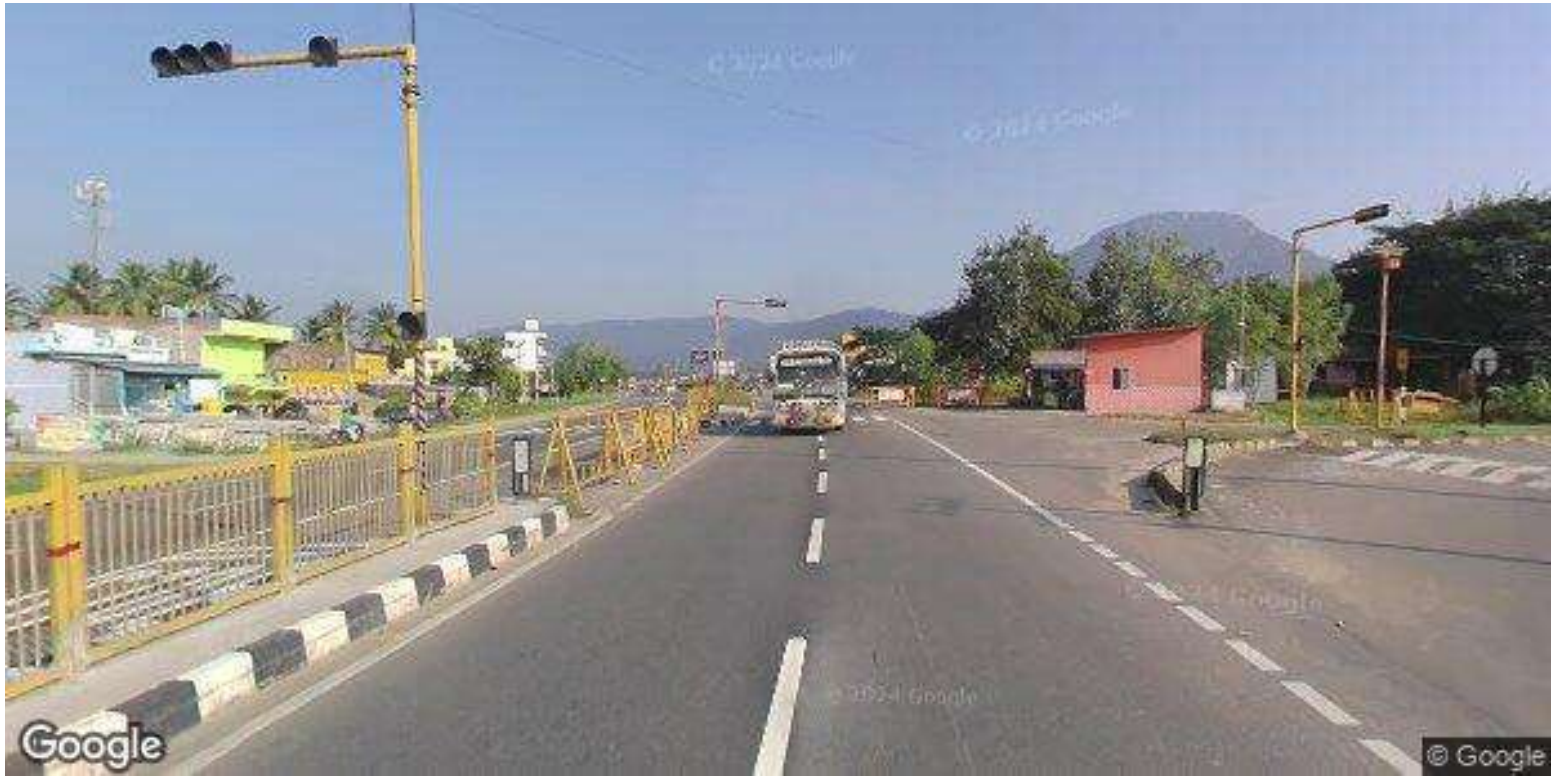
**Risk Type:** Turn  
**Risk Level:** Medium  
**Speed Limit:** 30 KM/Hr  
**Coordinates:** 11.93704, 78.05402

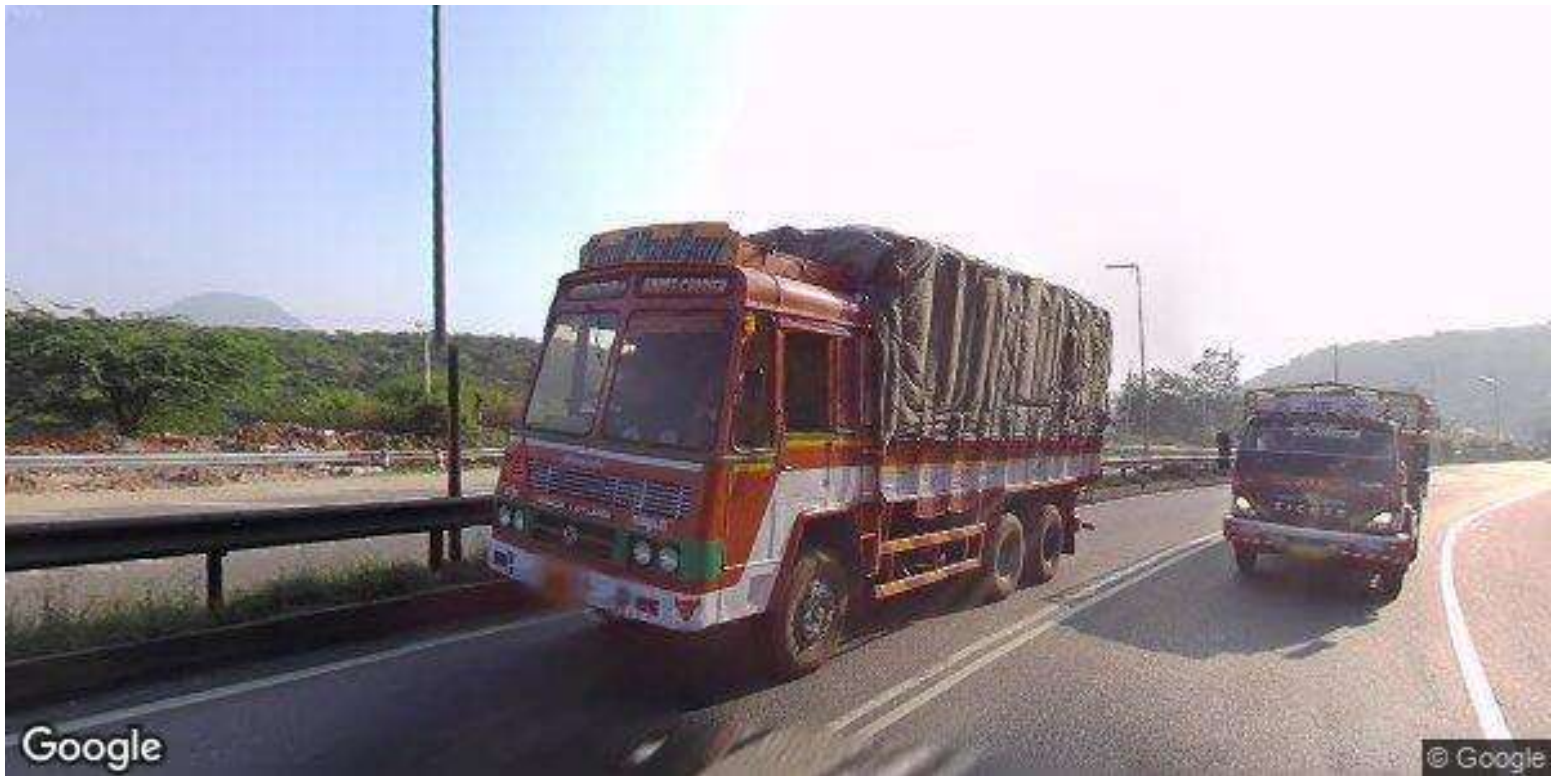
**Risk Type:** Turn  
**Risk Level:** High  
**Speed Limit:** 15 KM/Hr  
**Coordinates:** 11.95818, 78.04978
