# IndianOil

## JOURNEY RISK MANAGEMENT (JRM) STUDY

### Salem Terminal TO SHRI RAMESH BABU AGENCY UNIT II

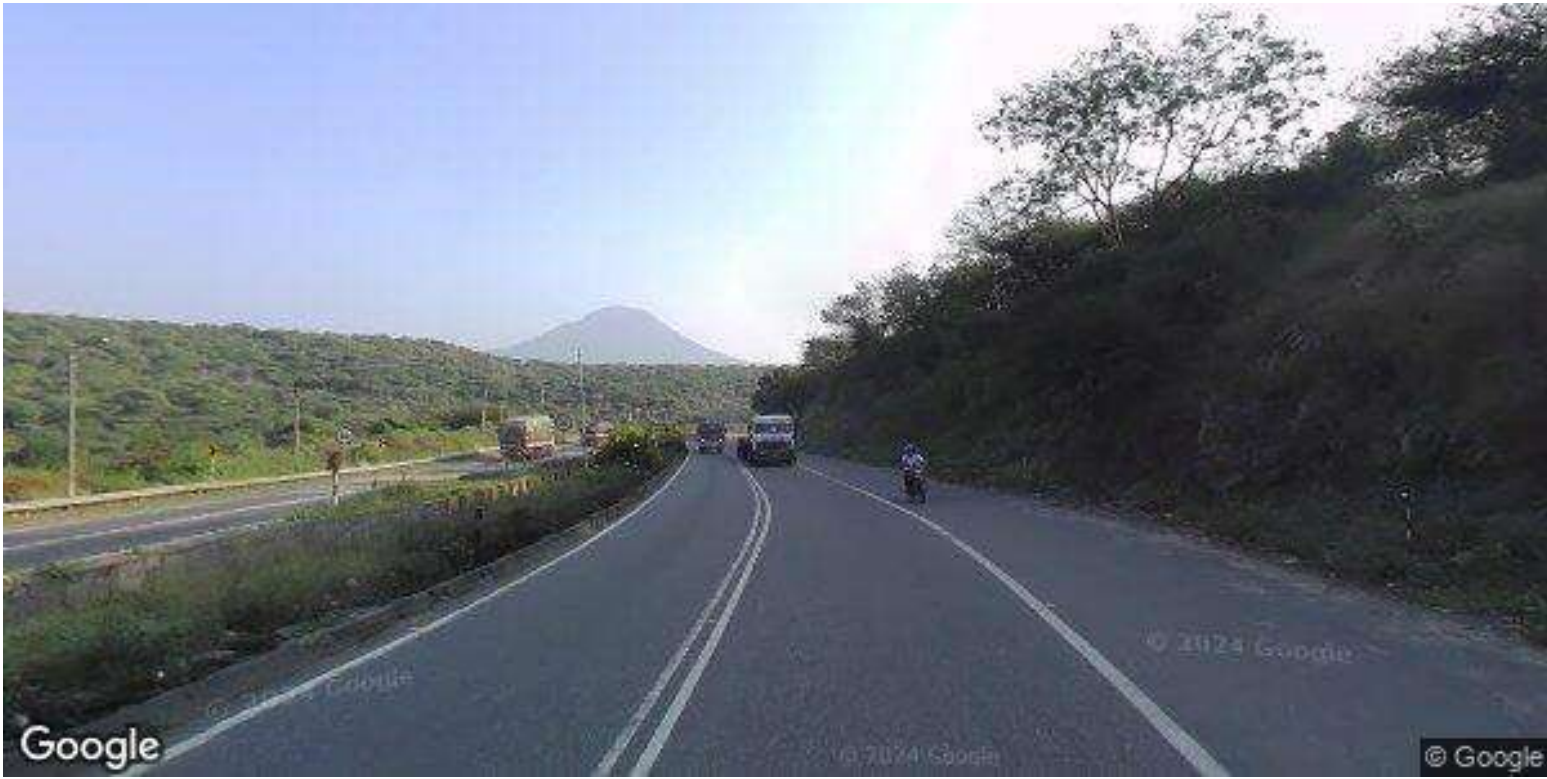
**Risk Type:** Turn  
**Risk Level:** Medium  
**Speed Limit:** 30 KM/Hr  
**Coordinates:** 11.95988, 78.04948

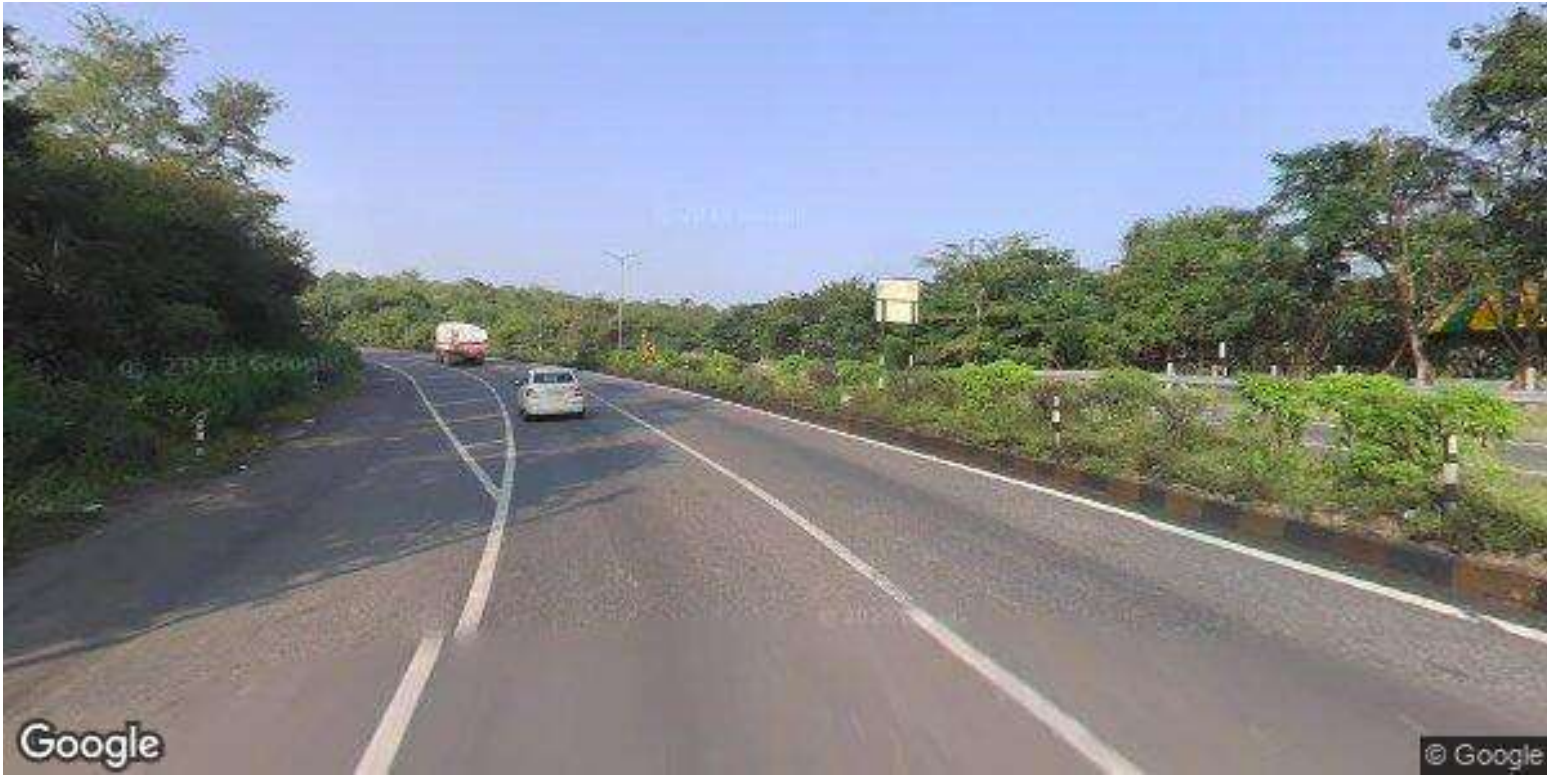
**Risk Type:** Turn  
**Risk Level:** Medium  
**Speed Limit:** 30 KM/Hr  
**Coordinates:** 11.96304, 78.05136

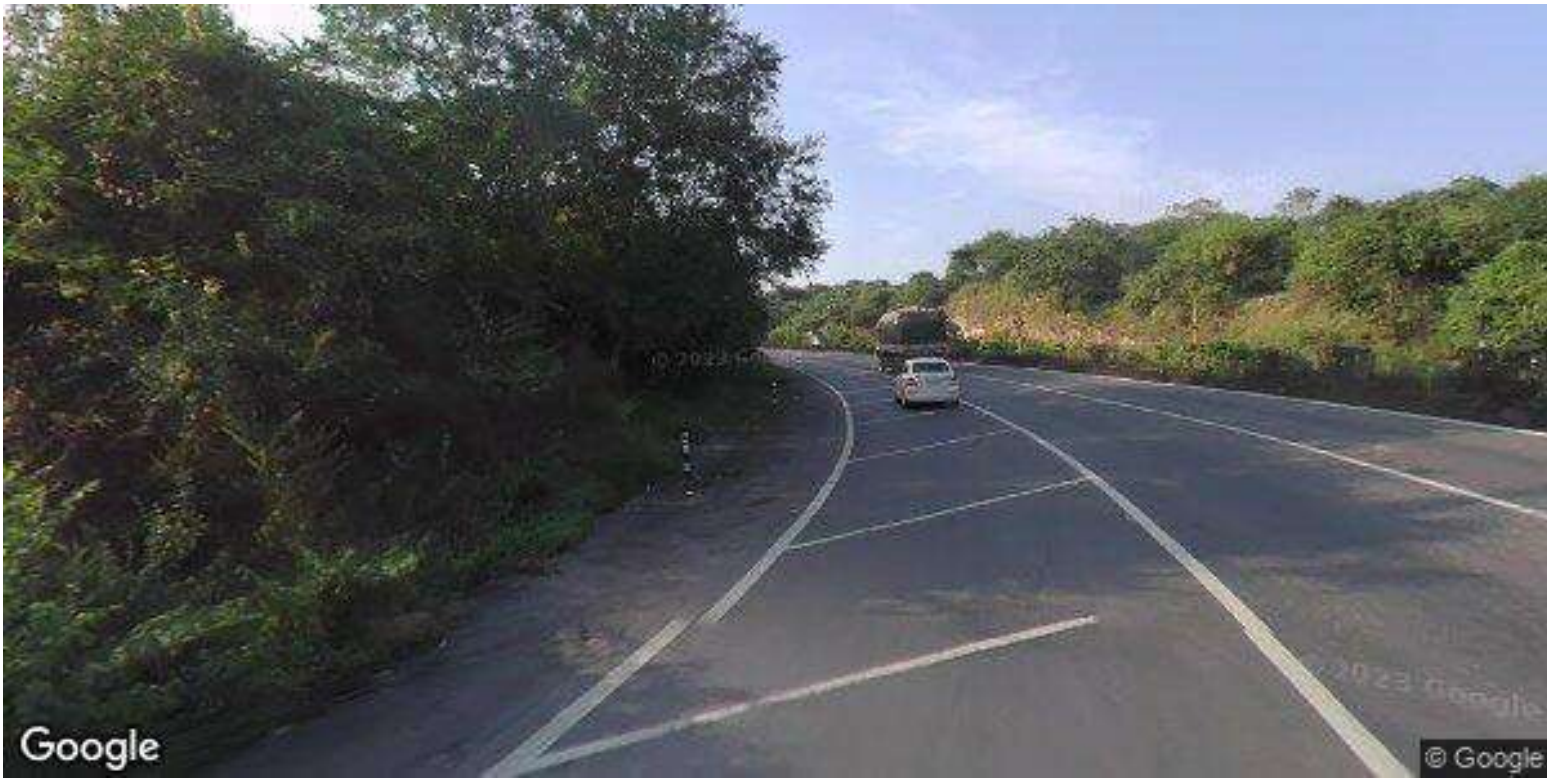
**Risk Type:** Turn  
**Risk Level:** High  
**Speed Limit:** 15 KM/Hr  
**Coordinates:** 11.96399, 78.05135

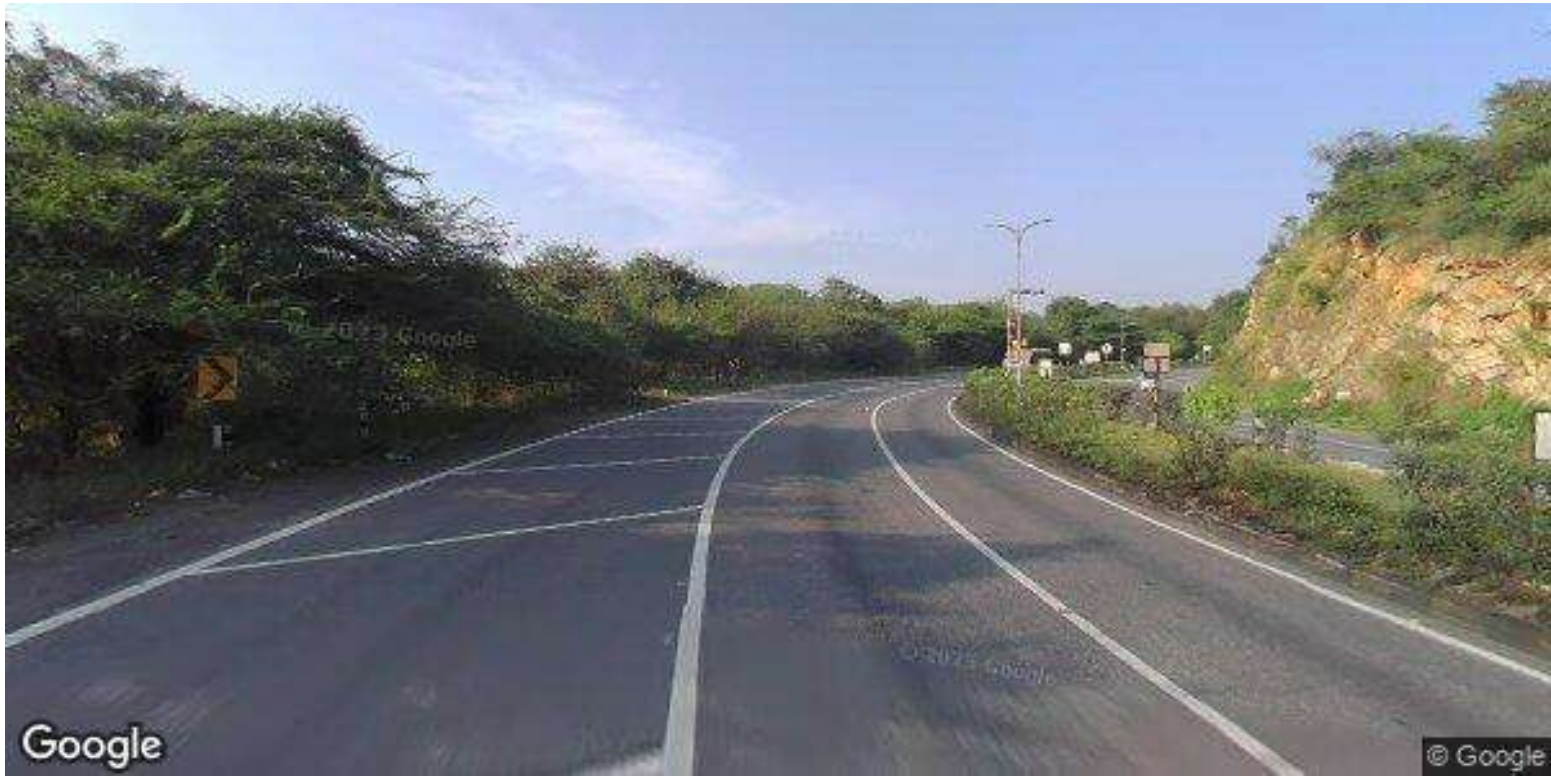
**Risk Type:** Turn  
**Risk Level:** High  
**Speed Limit:** 15 KM/Hr  
**Coordinates:** 11.96580, 78.04923

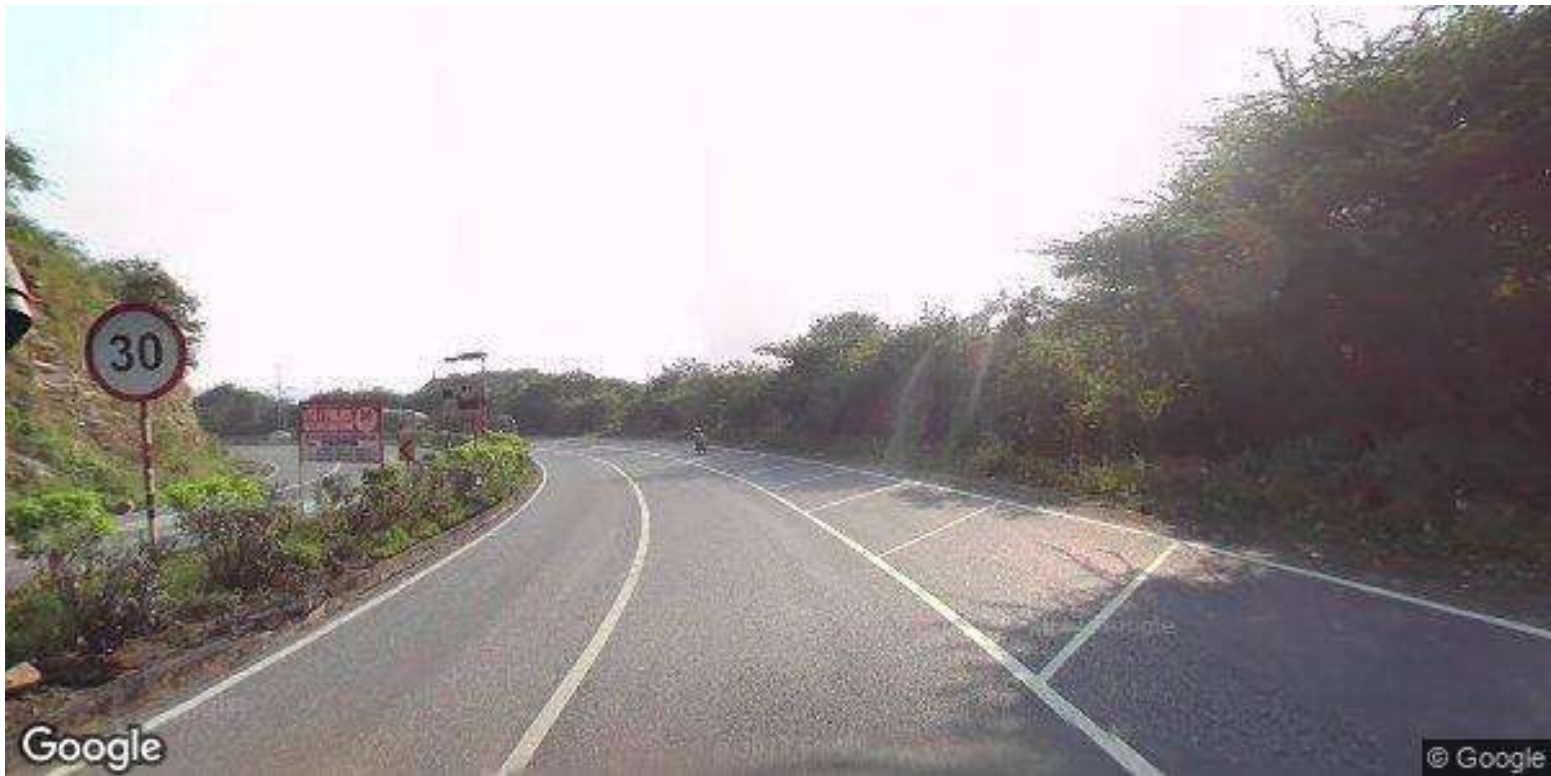
**Risk Type:** Turn  
**Risk Level:** Medium  
**Speed Limit:** 30 KM/Hr  
**Coordinates:** 11.96675, 78.04939

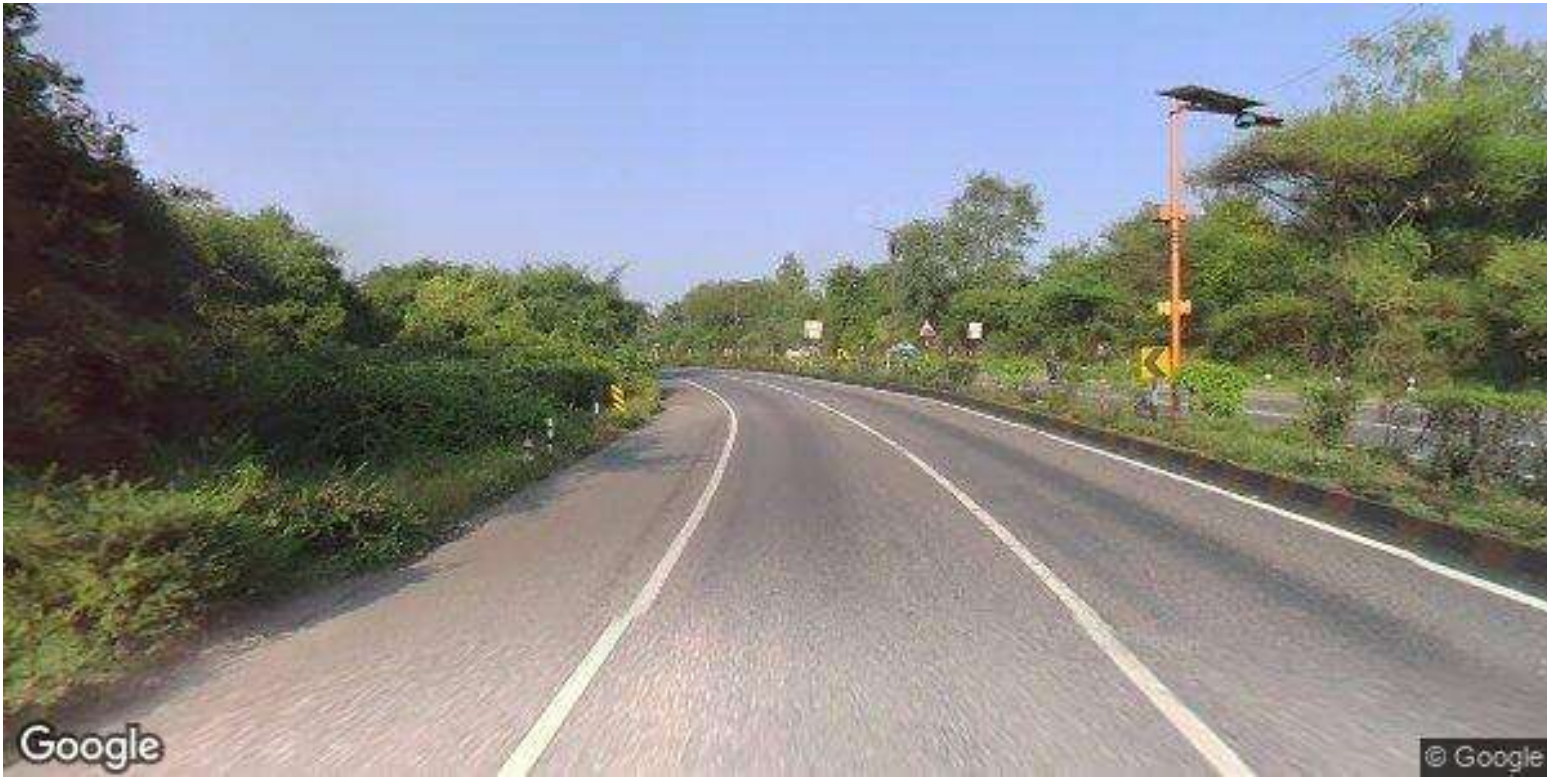
**Risk Type:** Turn  
**Risk Level:** Medium  
**Speed Limit:** 30 KM/Hr  
**Coordinates:** 11.96791, 78.05070

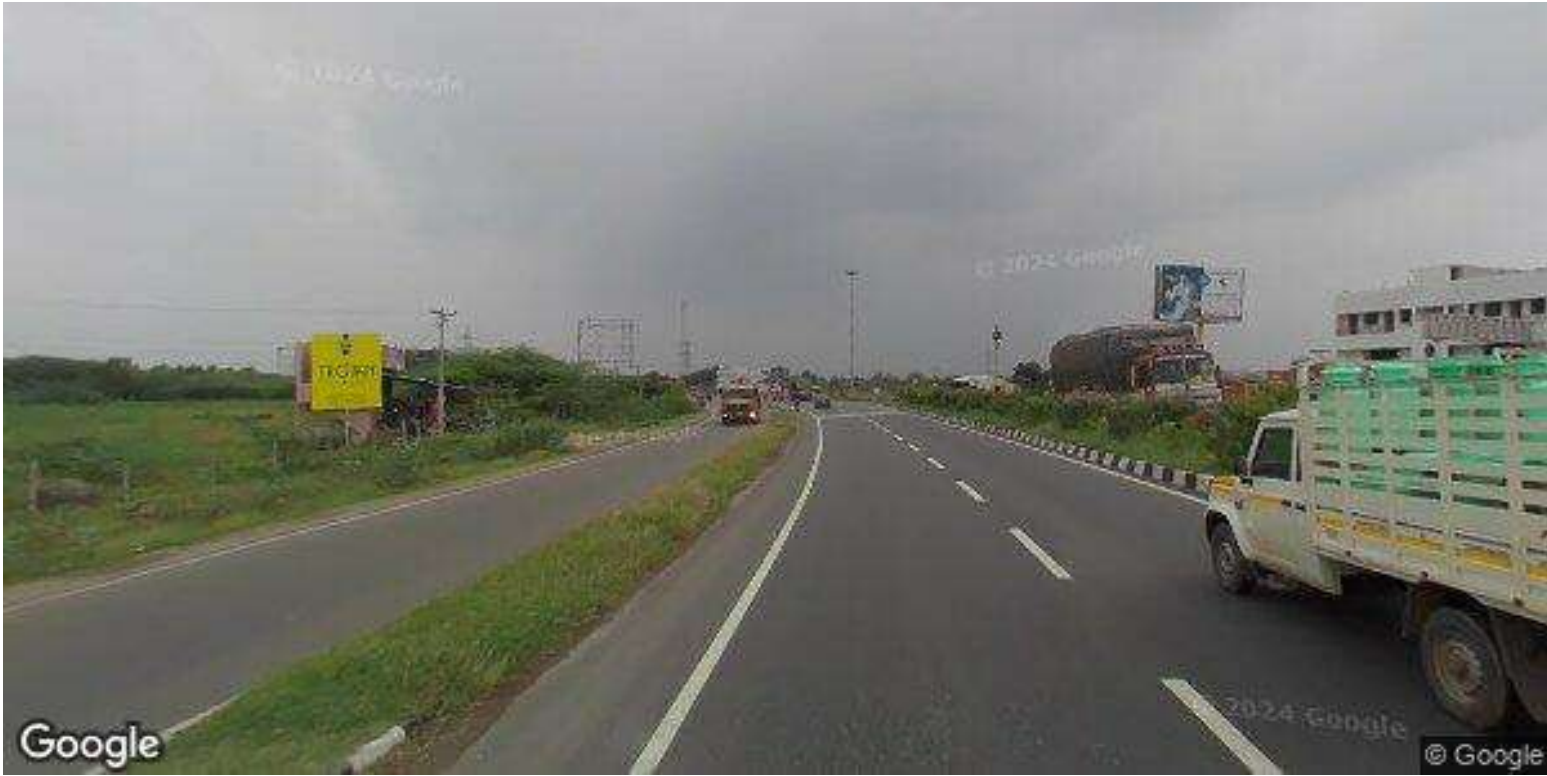
**Risk Type:** Turn  
**Risk Level:** Medium  
**Speed Limit:** 30 KM/Hr  
**Coordinates:** 12.16983, 78.16769

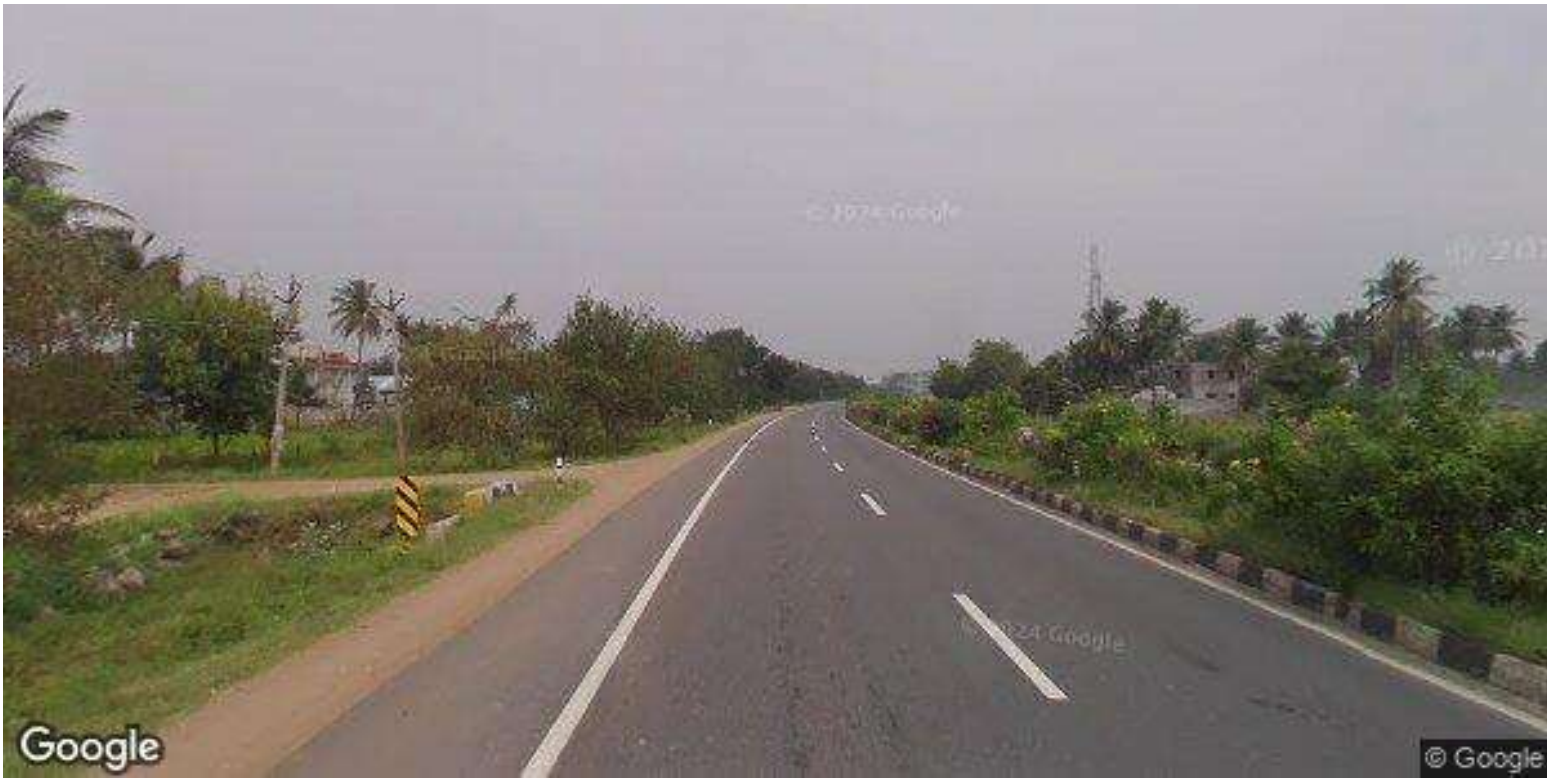
**Risk Type:** Turn  
**Risk Level:** Medium  
**Speed Limit:** 30 KM/Hr  
**Coordinates:** 12.19881, 78.18157

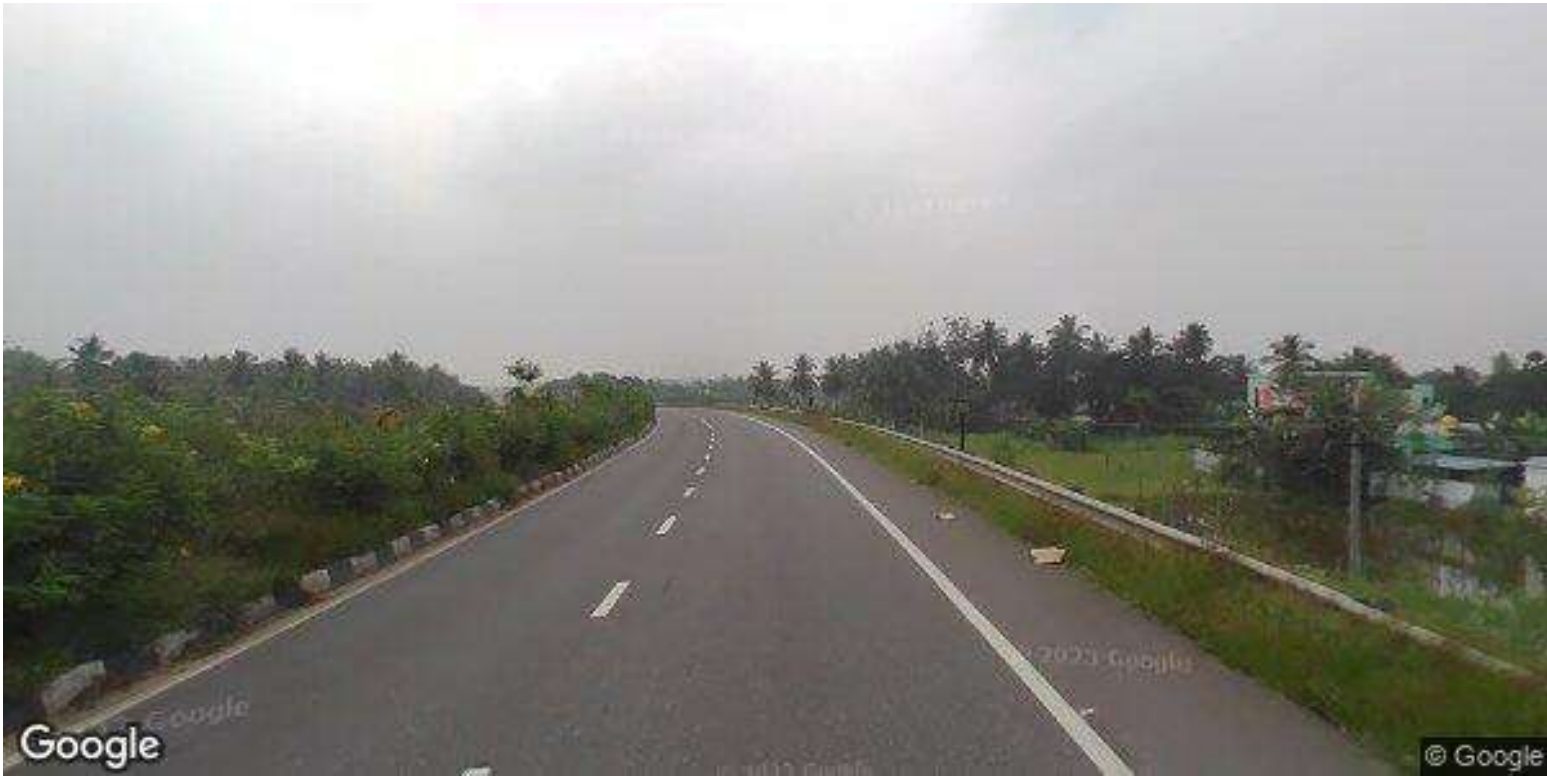
**Risk Type:** Turn  
**Risk Level:** Medium  
**Speed Limit:** 30 KM/Hr  
**Coordinates:** 12.22459, 78.19136

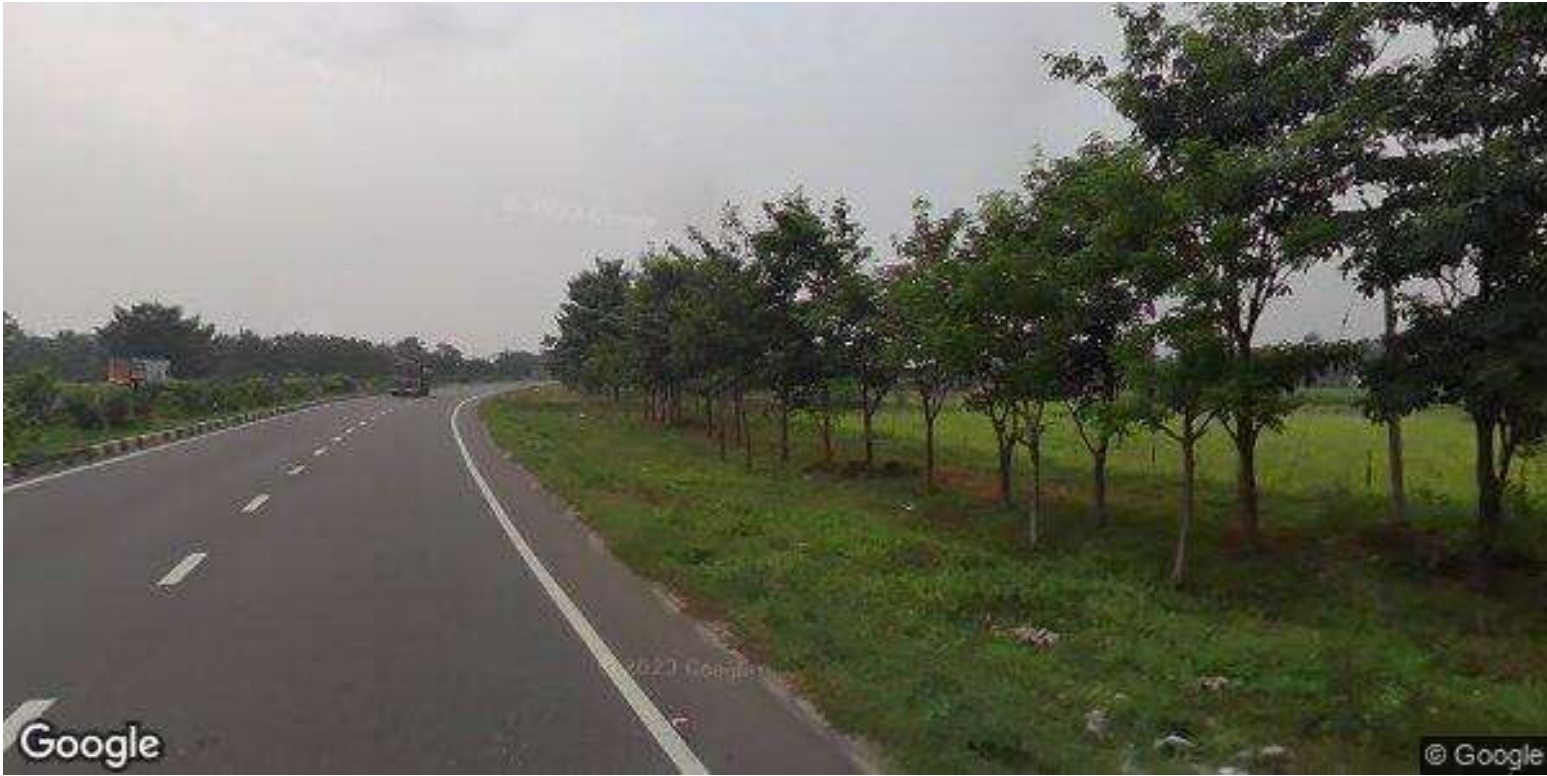
**Risk Type:** Turn  
**Risk Level:** Medium  
**Speed Limit:** 30 KM/Hr  
**Coordinates:** 12.25060, 78.19977

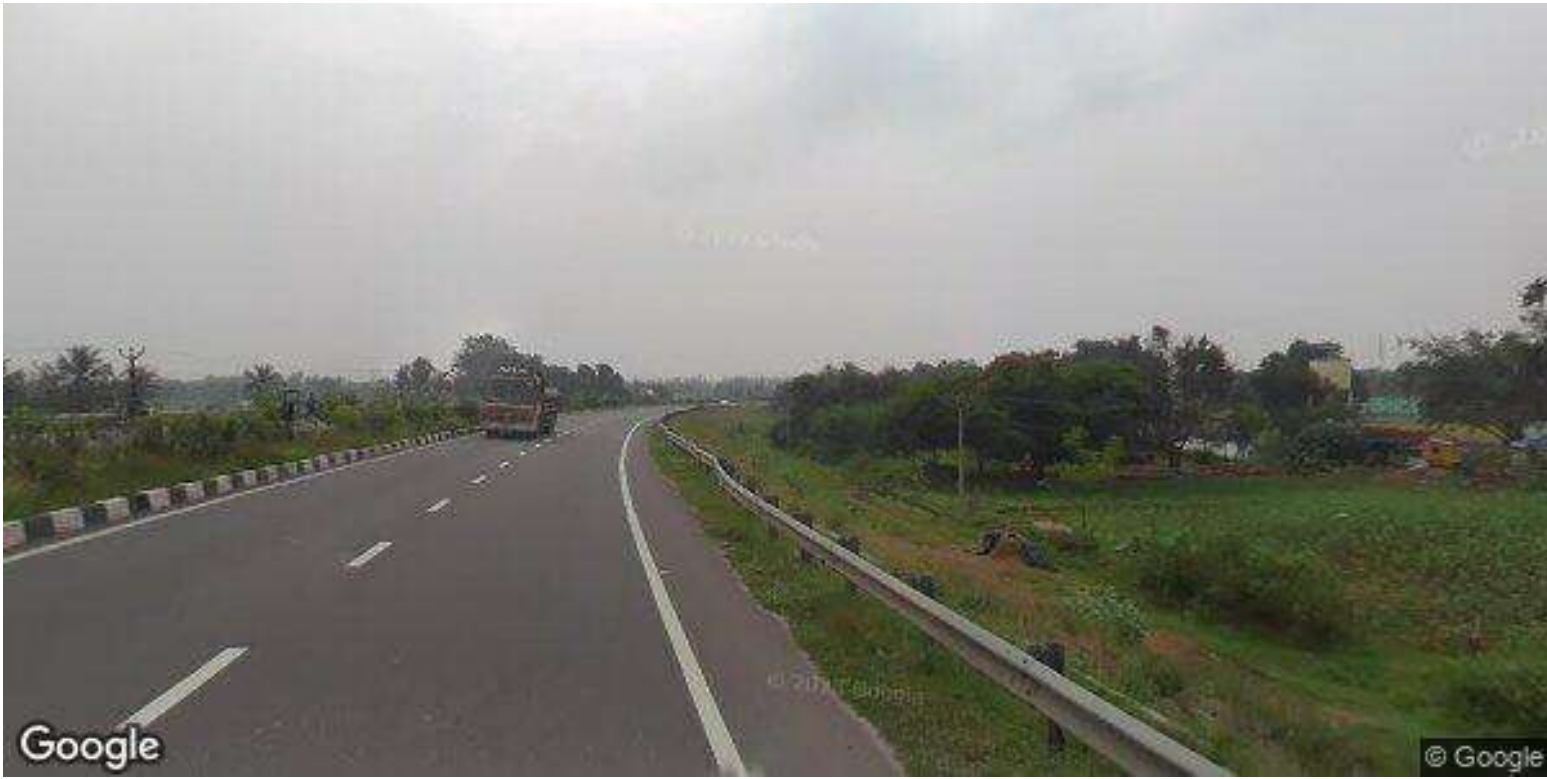
**Risk Type:** Turn  
**Risk Level:** Medium  
**Speed Limit:** 30 KM/Hr  
**Coordinates:** 12.25329, 78.20039

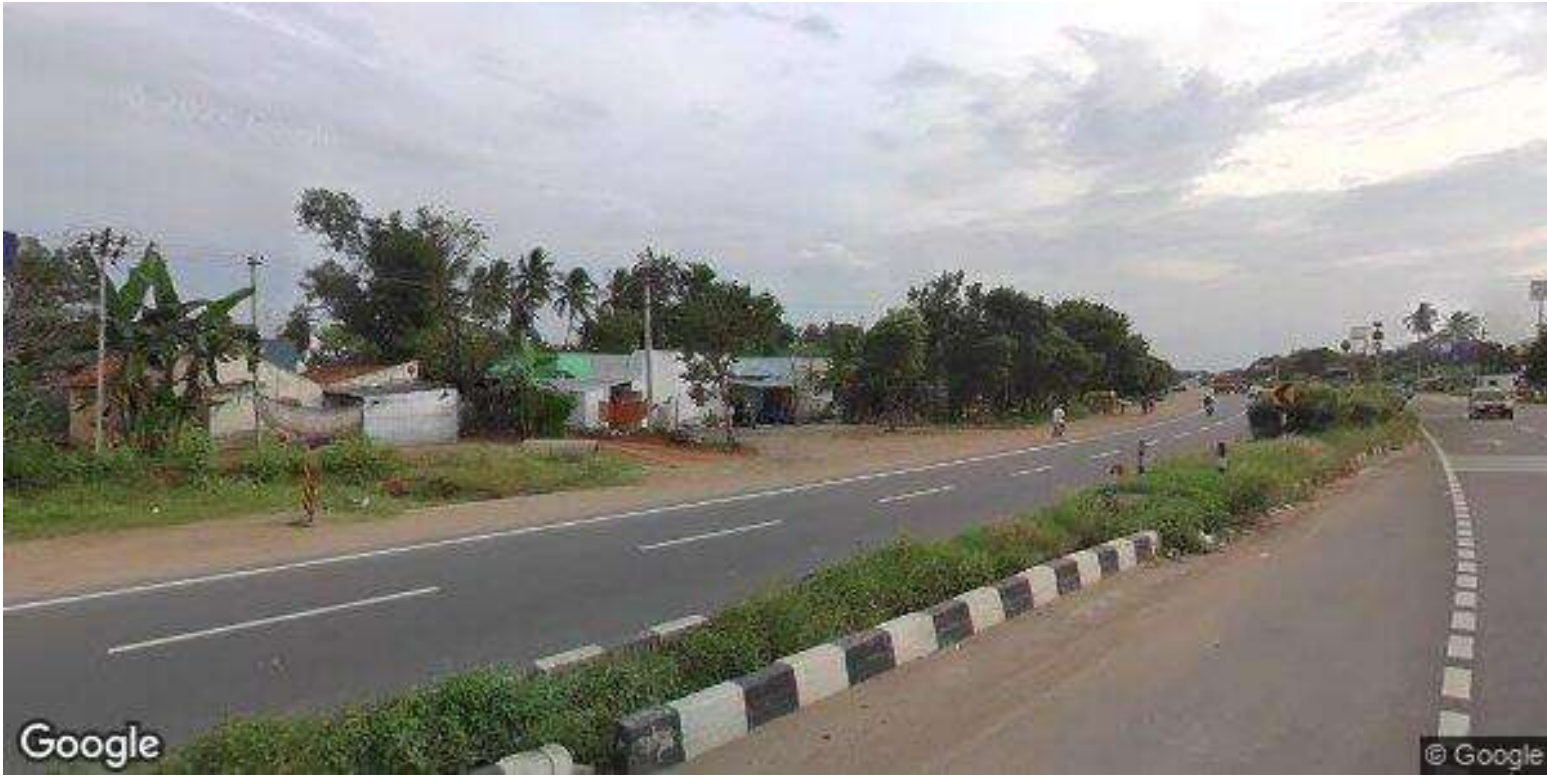
**Risk Type:** Turn  
**Risk Level:** Medium  
**Speed Limit:** 30 KM/Hr  
**Coordinates:** 12.29110, 78.19909

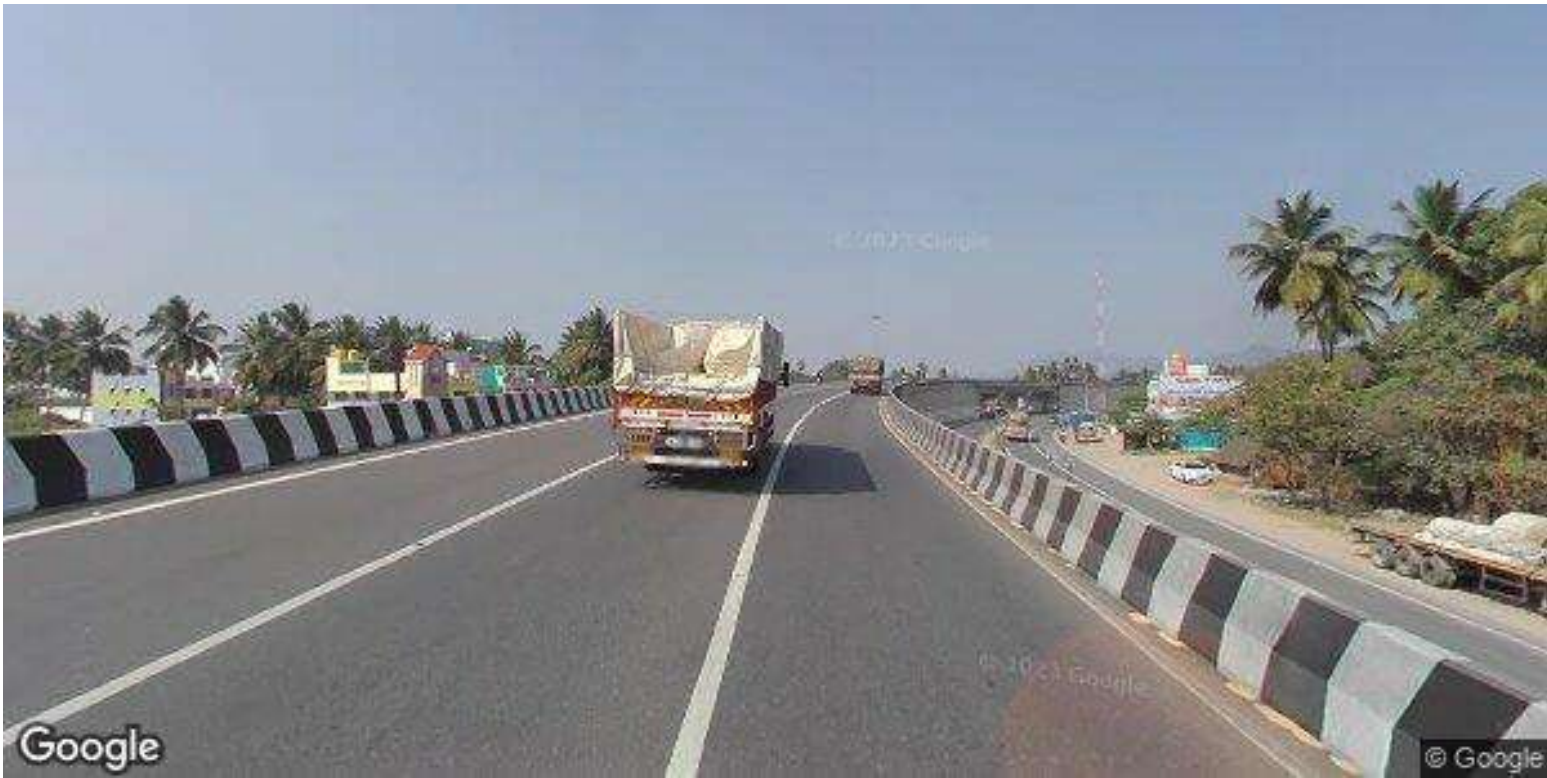
**Risk Type:** Turn  
**Risk Level:** Medium  
**Speed Limit:** 30 KM/Hr  
**Coordinates:** 12.39904, 78.21764

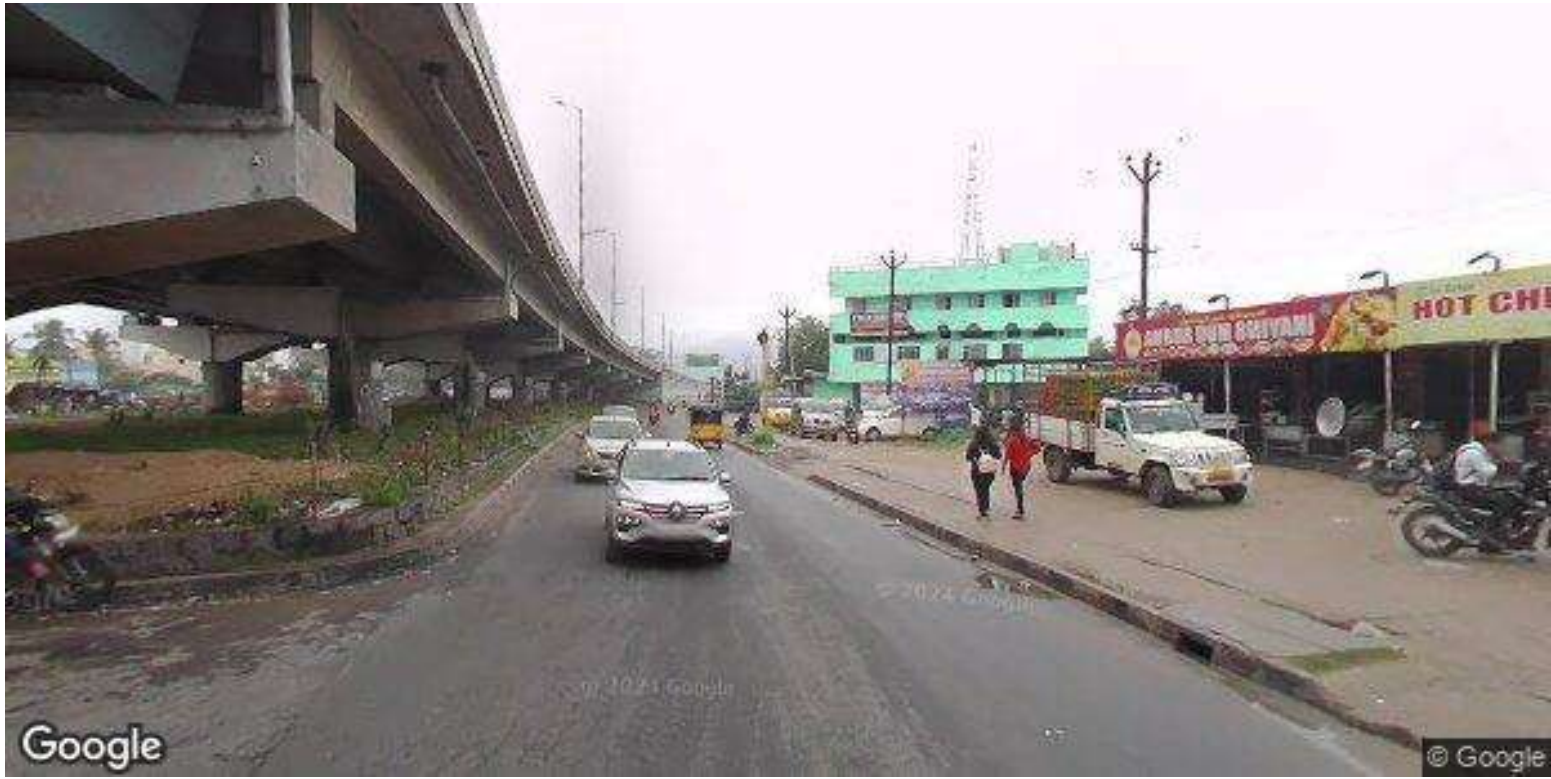
**Coordinates:** 12.50709, 78.22230

**Risk Type:** Turn

**Risk Level:** High

**Speed Limit:** 15 KM/Hr
